SUMMARY

1234 Main St. Lenoir City Tennessee
37771

Michael Vance
Certified Professional Inspector /
Certified Indoor Air Consultant # IAC2-
06-8842 / TN. License # 1736
Home Sentry LLC
(865) 816-3765
info@homesentryllc.com

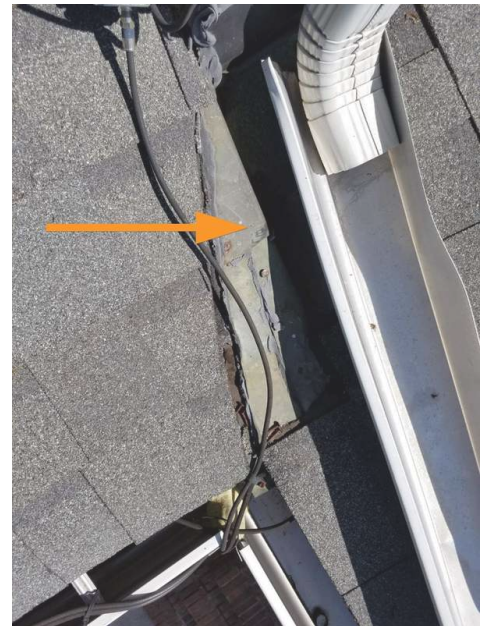
BACK OF HOUSE

SHINGLES MISSING

Observed an area that appeared to be missing sufficient coverings. Recommend qualified roofing contractor evaluate and/or repair.

Contact a qualified roofing professional.

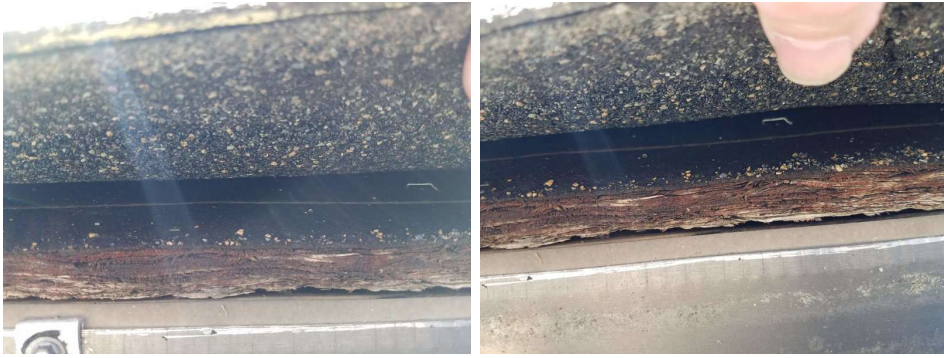
MISSING ROOF EDGE FLASHING

The roof was missing roof edge flashing. Lack of roof edge flashing leaves the edges of roof sheathing and underlayment exposed to potential moisture damage from wood decay and/or delamination. Recommend evaluation and/or placement of roof edge flashing by a licensed roofing professional.

Contact a qualified roofing professional.

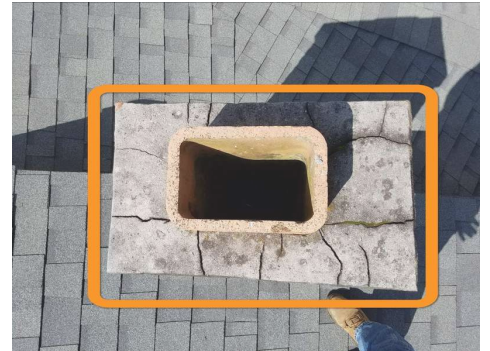
CHIMNEY CAP- MODERATE CRACKING

Moderate cracking visible in the chimney cap should be filled with an appropriate sealant to prevent worsening damage caused by moisture in the cracks expanding as it freezes. All work should be performed by a qualified professional.

Recommendation
Contact a qualified chimney contractor.

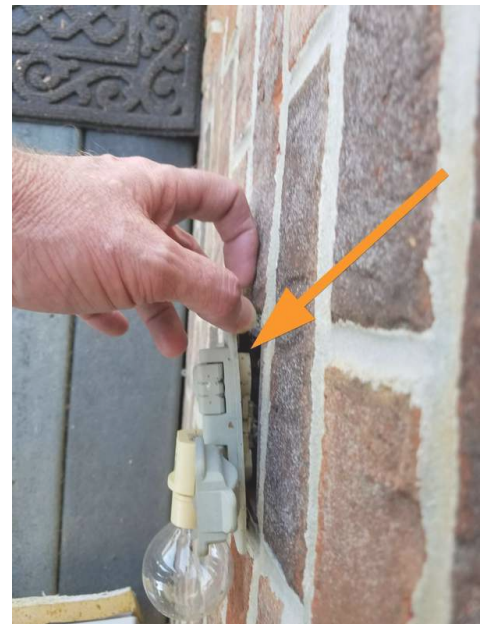
BACK OF HOUSE

DAMAGED COVER

An exterior outlet had a damaged weatherproof cover on the Back of the home. This is safety hazard should be corrected by a qualified electrical contractor.

Recommendation
Contact a qualified electrical contractor.

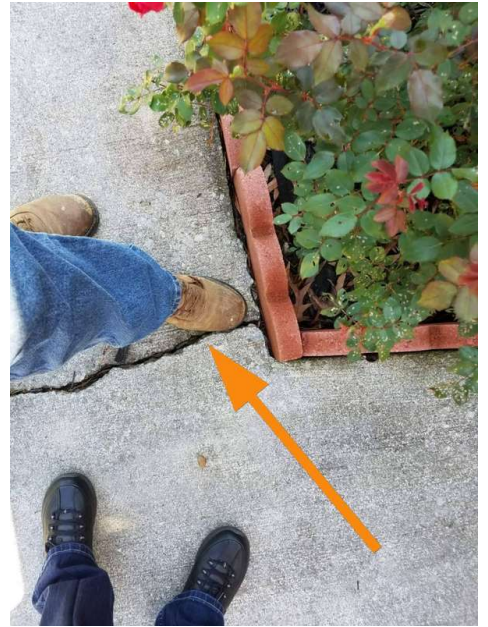
MODERATE HEAVING

Moderate heaving of soil beneath the walkways had created trip hazards that should be corrected by a qualified contractor.

Recommendation
Contact a qualified concrete contractor.

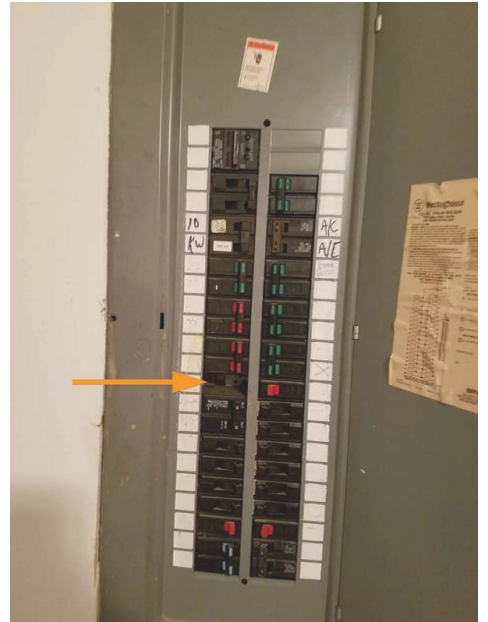
UTILITY ROOM

OPEN SLOTS, BREAKERS

One or more slots where circuit breakers are normally installed were open in panel. Energized equipment was exposed and is a shock hazard. Recommend that a qualified person install closure covers where missing.

Recommendation
Contact a qualified professional.

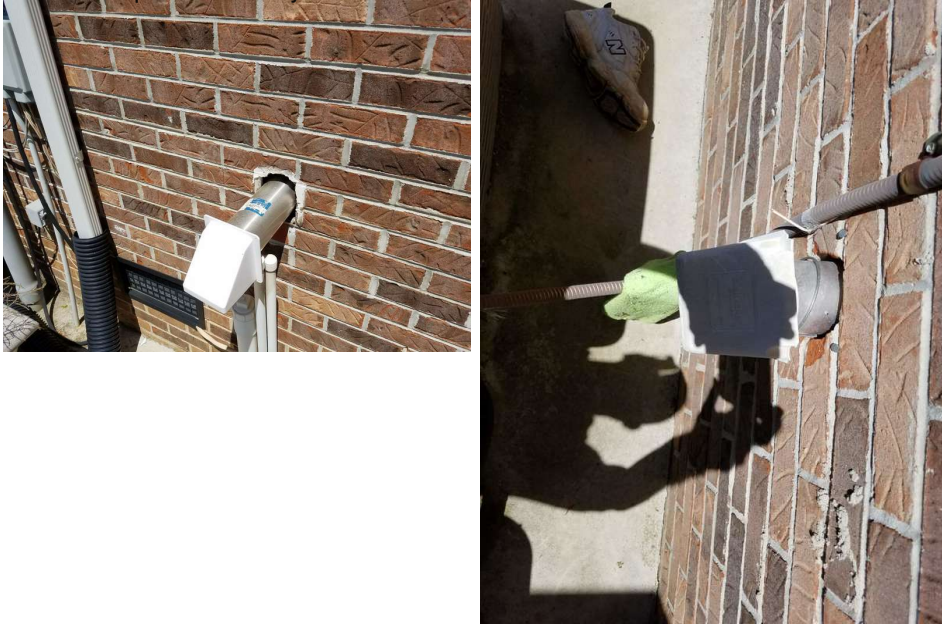
BACK OF HOUSE

GAP AT DRYER VENT

Vent pipes are too long. Pipes should be trimmed to allow the vent caps to sit flush with the exterior wall. Gaps around the dryer vent where it penetrated the exterior wall should then be filled with an appropriate sealant to prevent insect entry. All work should be performed by a qualified contractor.

Recommendation
Contact a qualified handyman.

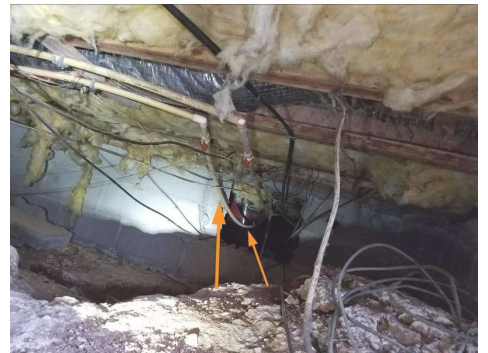
CRAWLSPACE

IMPROPER SUPPORTS OR LACK OF SUPPORTS

A small section of distribution pipes were installed in a sub-standard way. Recommend a qualified plumber evaluate and properly fit and install new pipe section and/or proper support hangers.

Recommendation
Contact a qualified plumbing contractor.

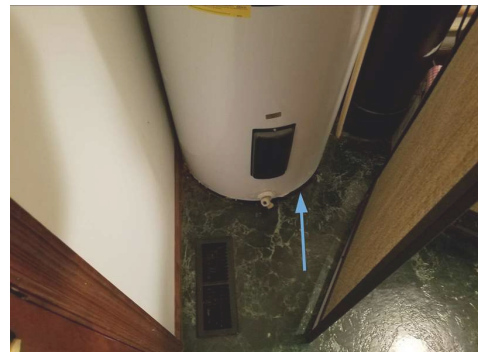
UTILITY ROOM

NO DRIP PAN

Although this water heater was installed in a location in which leakage of the tank or plumbing connections would cause damage, no drip pan was installed. A proper drip pan should be installed to prevent possible water damage.

Recommendation
Contact a qualified professional.

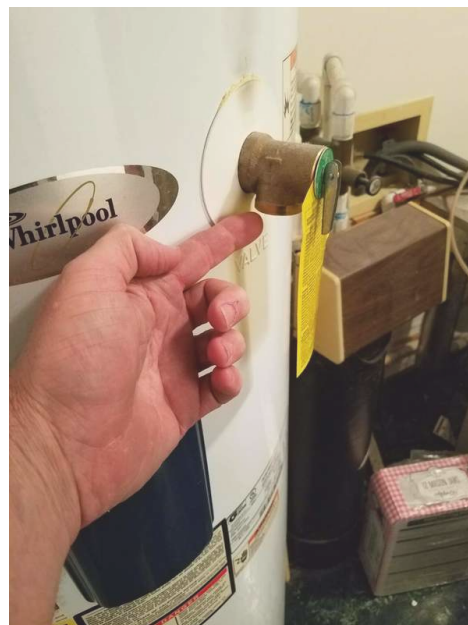
UTILITY ROOM

NO DISCHARGE PIPE

The temperature/pressure relief (TPR) valve had no discharge pipe installed. If the valve were to activate while a person was nearby, that person could be badly burned. The Inspector recommends that a properly-configured TPR discharge pipe be installed by a qualified plumbing contractor. The TPR VALVE SHOULD NOT BE TESTED UNTIL A PROPER DISCHARGE PIPE HAS BEEN INSTALLED

Recommendation
Contact a qualified professional.

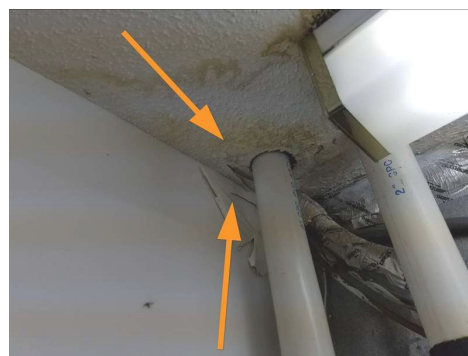
BEDROOM 4 COAT CLOSET, 2ND FLOOR

MOISTURE DAMAGE

Stains on the walls visible at the time of the inspection appeared to be the result of moisture intrusion. The source of moisture may have been corrected. Recommend further examination by a qualified contractor to provide confirmation.

Recommendation
Contact a qualified professional.

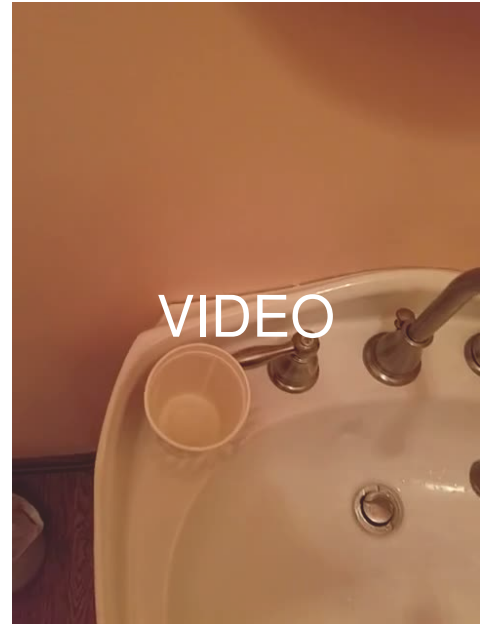
HALF BATHROOM, FIRST FLOOR

WALL-MOUNTED LAVATORY LOOSE

The wall-mounted lavatory was insecurely fastened to the wall. I recommend that steps be taken to properly secure the sink to the wall.

Recommendation
Contact a qualified professional.

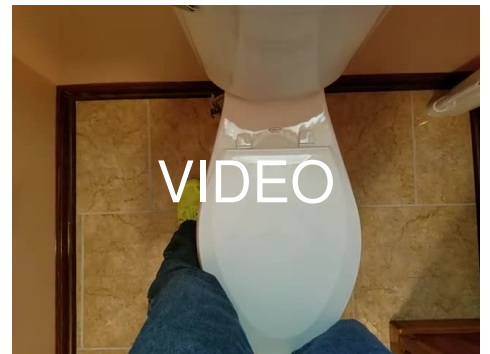
GUEST HOUSE BATHROOM

12.12.1 Toilet Observations
LOOSE AT FLOOR

The toilet was loose at the floor. Recommend it to be re-attached by a qualified plumbing contractor.

Recommendation
Contact a qualified plumbing contractor.

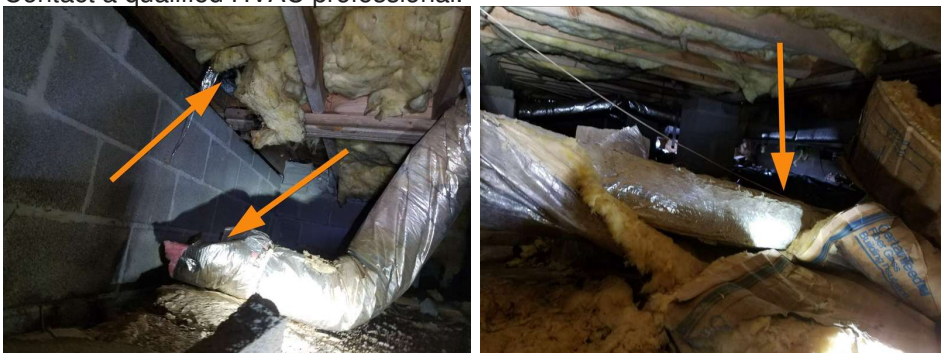
CRAWLSPACE

16.1.1 Heating & Cooling Distribution
JOINT DISCONNECTED

There are disconnected joints in the ductwork, resulting in significant energy loss. Recommend repair or replace.

Recommendation
Contact a qualified HVAC professional.
