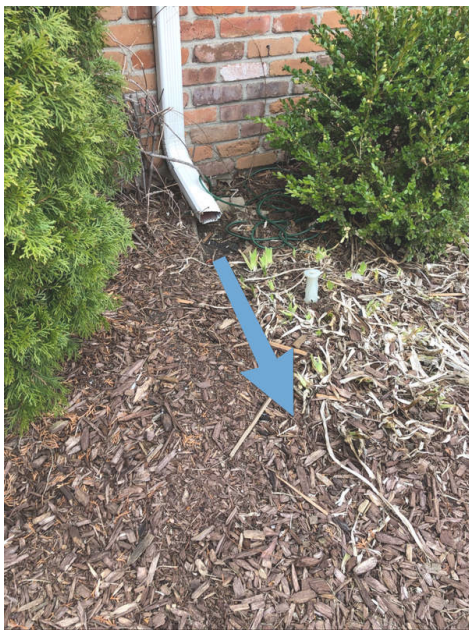
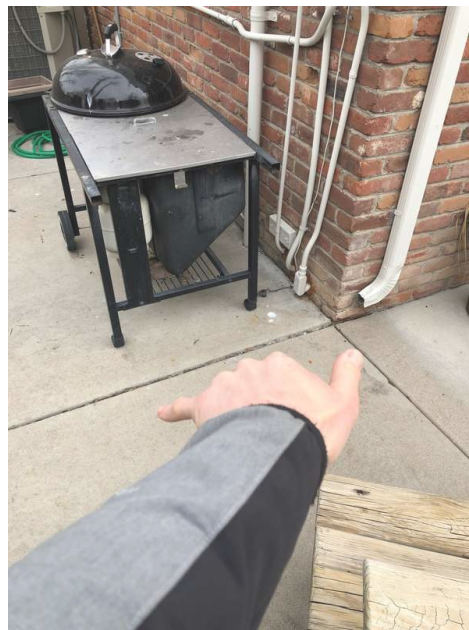
2.5.1 Roof Drainage Systems

DOWNSPOUT RUNOUT NEEDS EXTENSION

Downspout extensions are recommended to discharge roof drainage a minimum of 6 feet from the foundation. Downspout extensions are a simple improvement that have a great impact on preventing water accumulation and intrusion around the foundation.

Recommendation
Contact a qualified handyman.

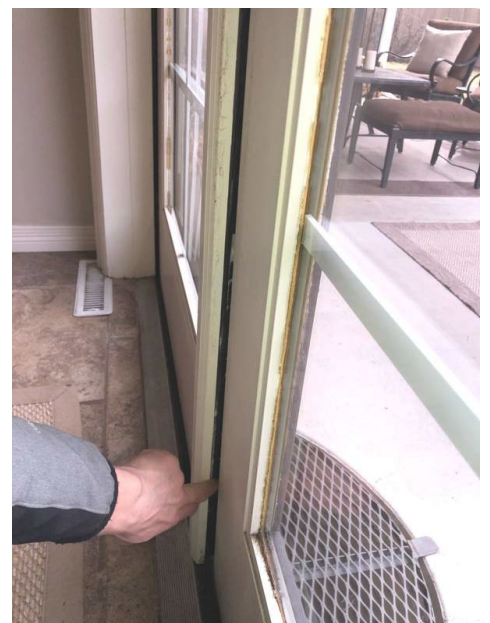
3.4.1 Exterior Doors

DOOR IS MISALIGNED AND HAS DAMAGED STRIKER PLATE

Door does not close or latch properly. Recommend qualified handyman adjust strike plate and/or lock.

Recommendation
Contact a qualified door repair/installation contractor.

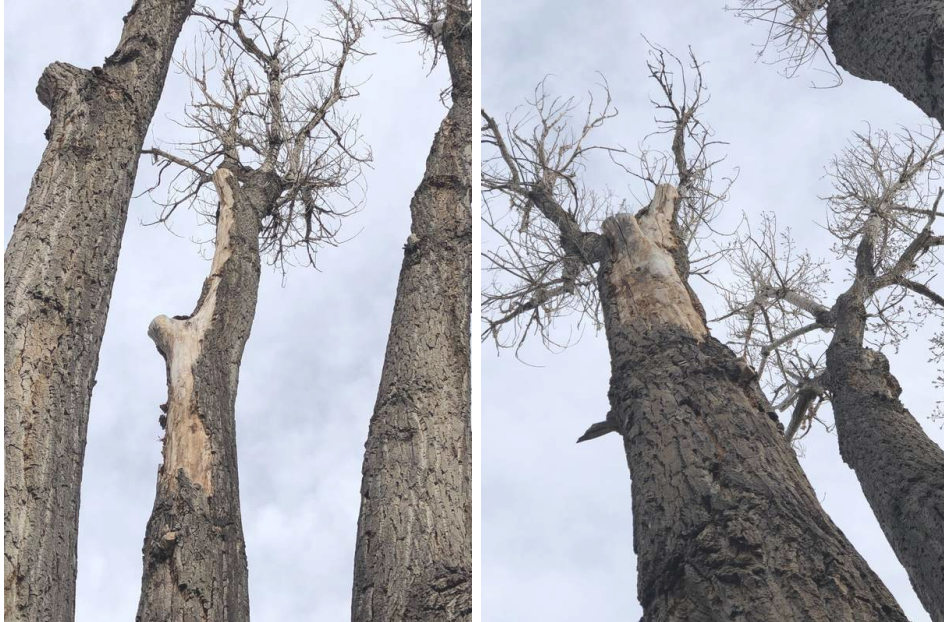
3.7.1 Vegetation, Grading, Drainage & Retaining Walls

DYING TREE

A dying tree on the property will eventually fall or be blown over by wind and may cause injury or damage. The Inspector recommends removal of the tree for safety reasons.

Contact a qualified tree service company.

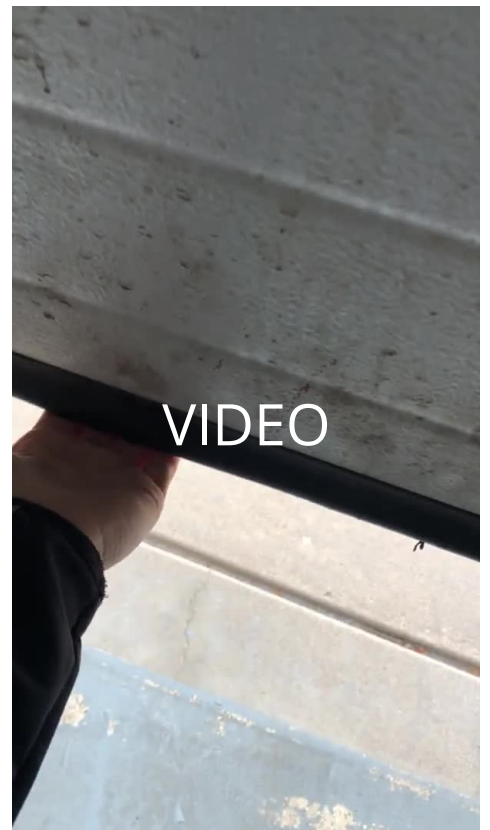
4.4.1 Garage Door

AUTO REVERSE CONTACT SENSOR NOT WORKING PROPERLY

The auto reverse pressure sensor was not responding at time of inspection. This is a safety hazard to children and pets. Recommend a qualified garage door contractor evaluate and repair/replace.

Contact a qualified garage door contractor.

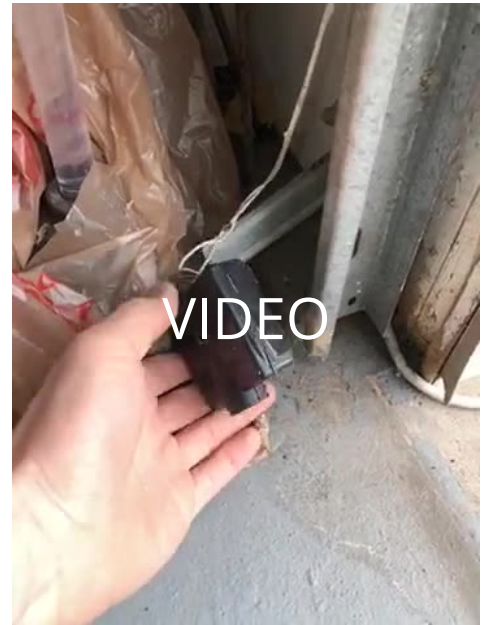
4.4.2 Garage Door

OPTICAL SAFETY SENSOR LOOSE

One of the optical safety sensors was loose, and may lead to improper function. This will present a safety danger if the sensor does not properly function. Recommend that a qualified professional repair safety devices.

Contact a qualified garage door contractor.

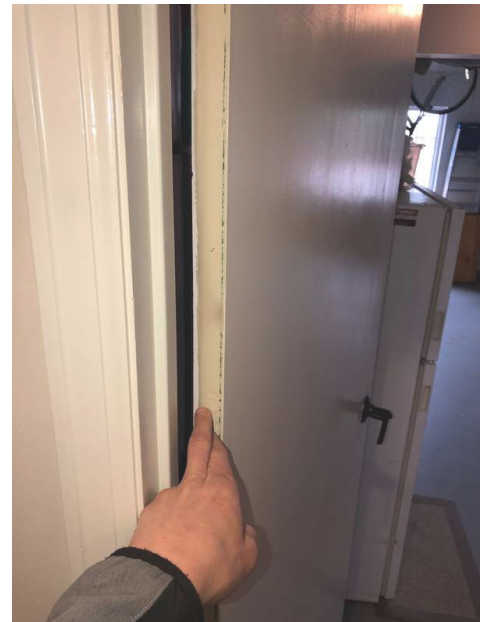
4.6.1 Occupant Door

DOOR DOES NOT MEET SEPARATION REQUIREMENTS

Door separating garage and home does not meet safety standards. Doors in firewalls must be at least 1 3/8-inch thick, metal/steel, or a 20-minute fire-rated door.

Contact a qualified door repair/installation contractor.

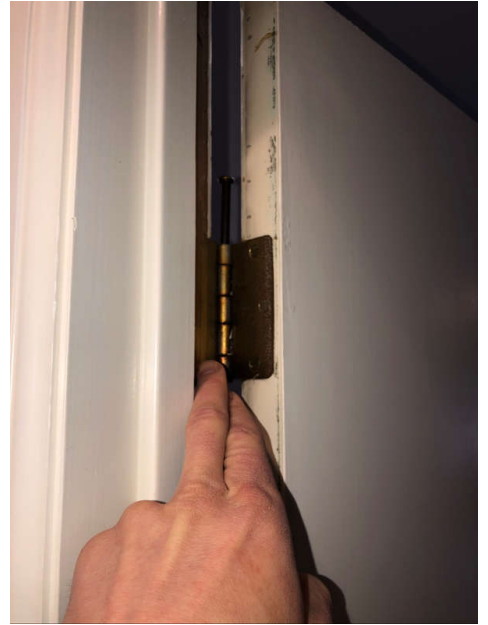
4.6.2 Occupant Door

NOT SELF-CLOSING

Door from garage to home should have self-closing hinges to help prevent spread of a fire to living space. Recommend a qualified contractor install self-closing hinges, or adjust self closing hinges if they are present but not functioning properly.

Contact a qualified door repair/installation contractor.

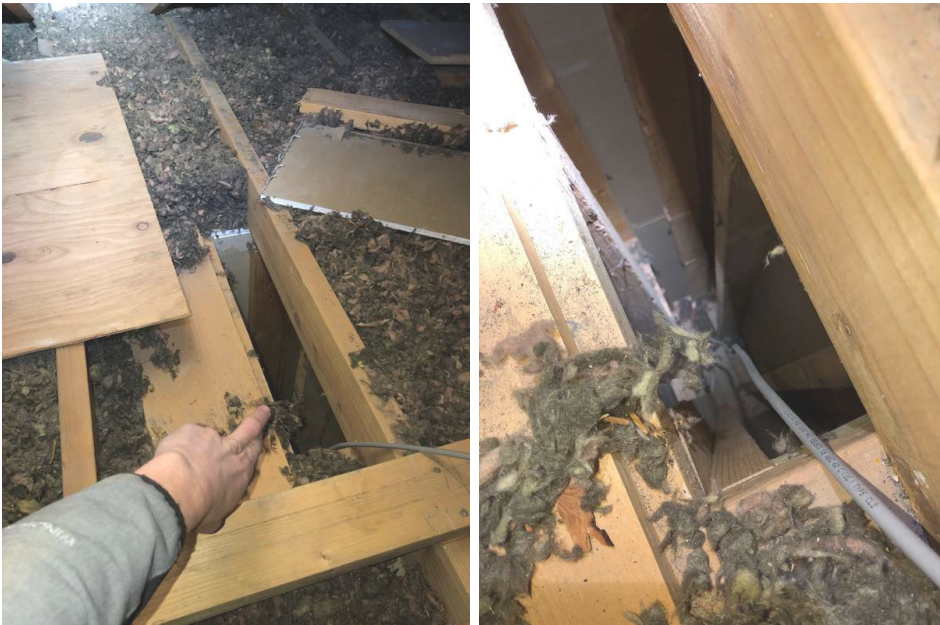
5.2.1 Attic Insulation

COMFORT AND EFFICIENCY RECOMMENDATION - THERMAL BYPASS

A thermal bypass was observed. A thermal bypass allows for unconditioned air to move into an area of conditioned space, or a space that should be sealed off from unconditioned areas. Recommend having this bypass sealed and insulated by a qualified home performance contractor.

Contact a qualified insulation contractor.

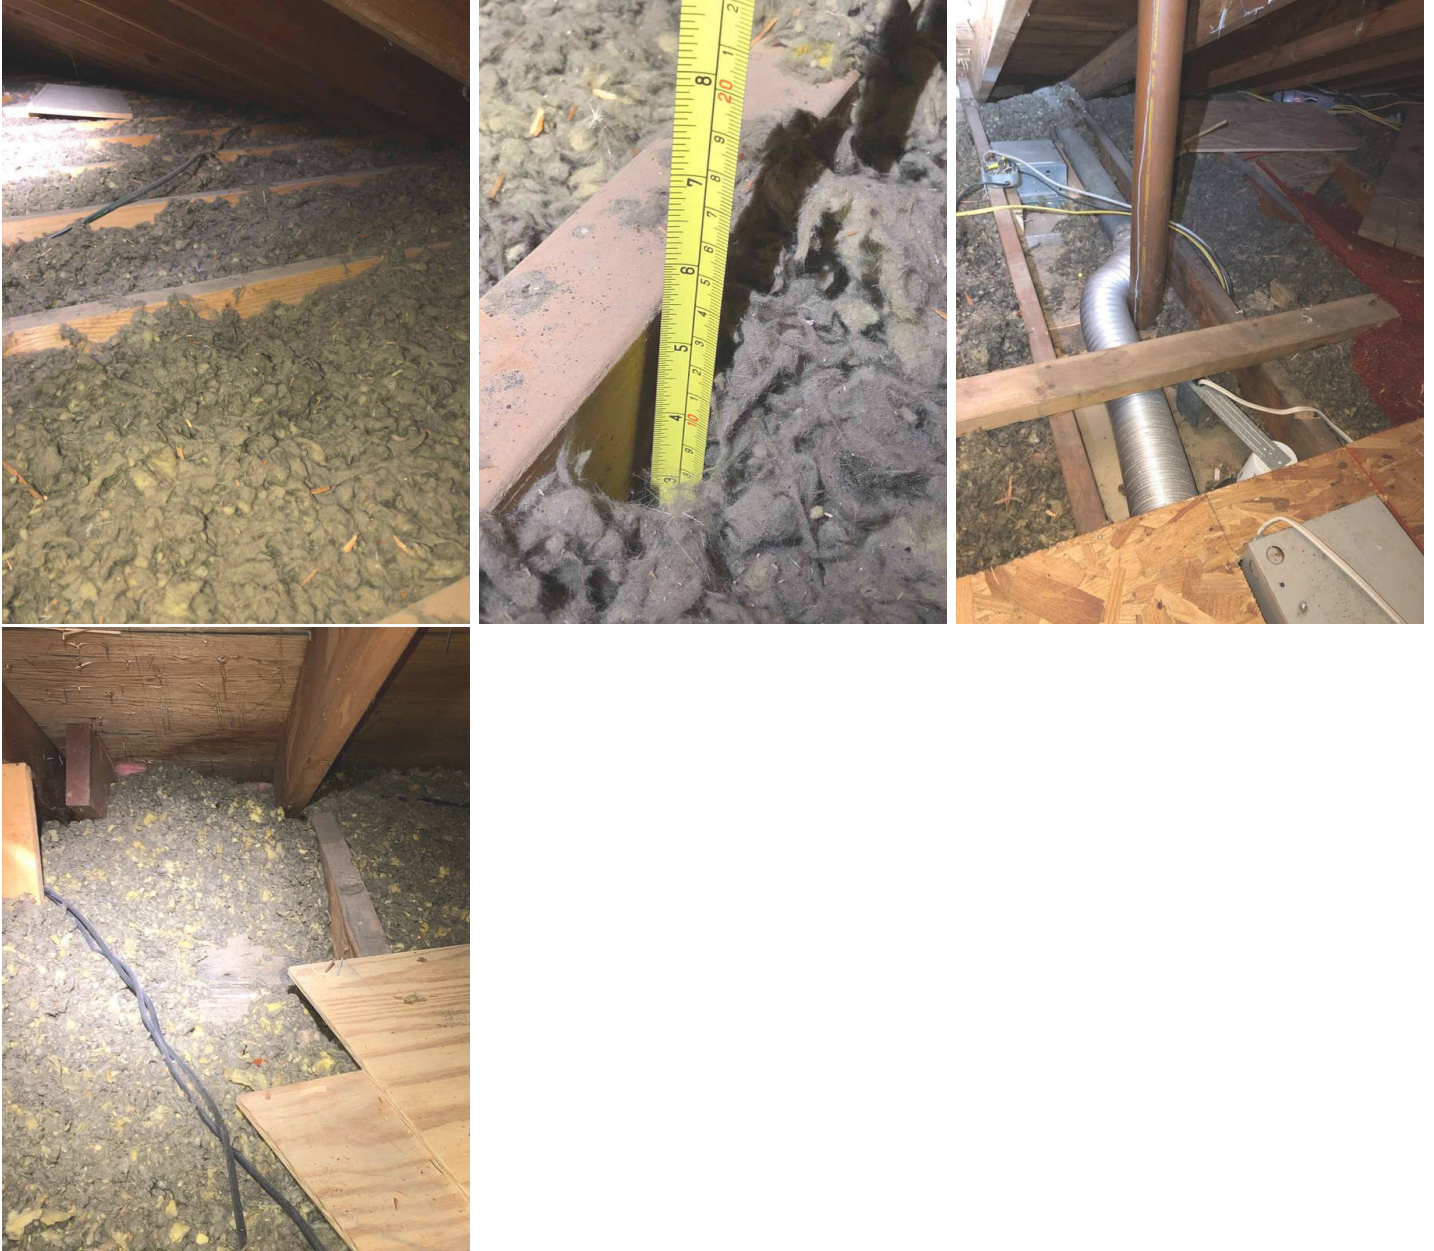
5.2.2 Attic Insulation

COMFORT AND EFFICIENCY RECOMMENDATION-INSUFFICIENT INSULATION

Insulation depth was inadequate. Modern energy efficiency standards suggest a minimum of R-38 insulation (around 12" of blown insulation) up to R-60 (about 18" of blown insulation). Sufficient attic insulation is one of the most impactful measures that can be taken to improve occupant comfort and reduce energy demands. Insulation is relatively inexpensive and can qualify for rebates from local utilities if eligibility is met. Recommend a qualified attic insulation contractor install additional insulation.

Contact a qualified insulation contractor.

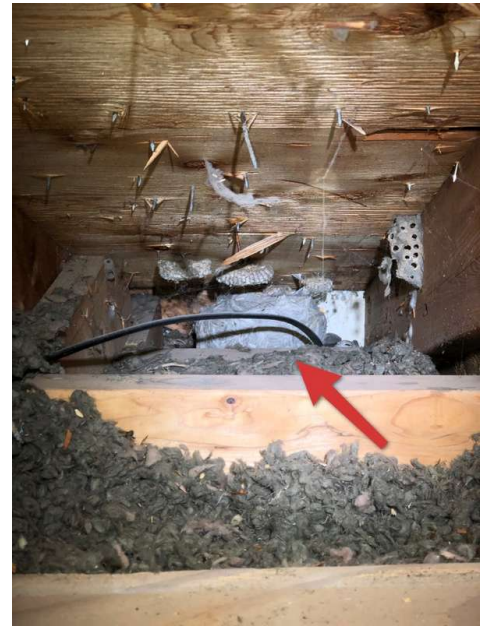
5.2.3 Attic Insulation

WASPS NEST

A wasps nest was visible in the attic at the time of inspection. The nest was not active at the time of inspection, but may be due to the season. The Inspector recommends nest removal by a qualified contractor.

Contact a qualified pest control specialist.

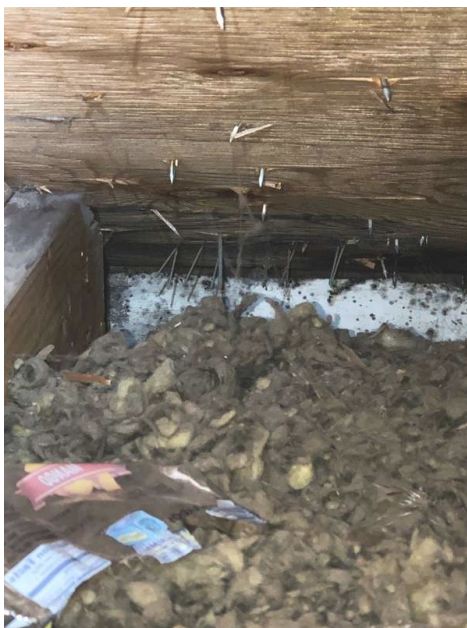
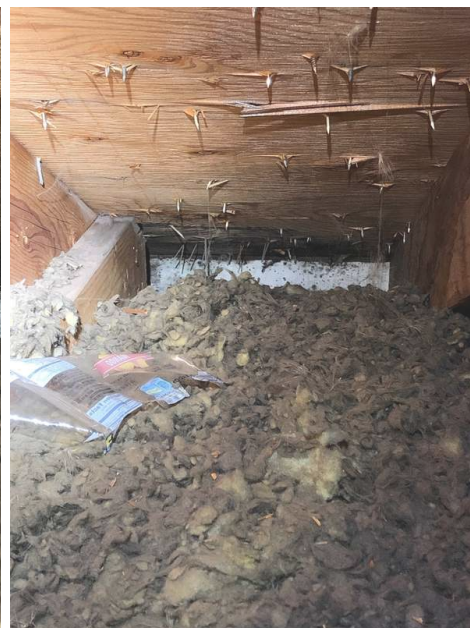
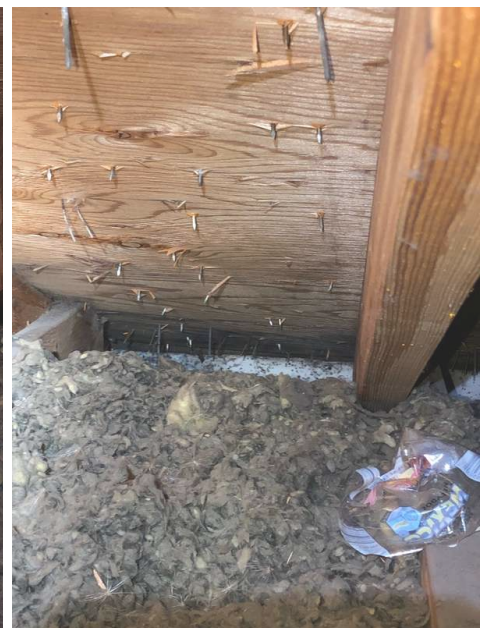
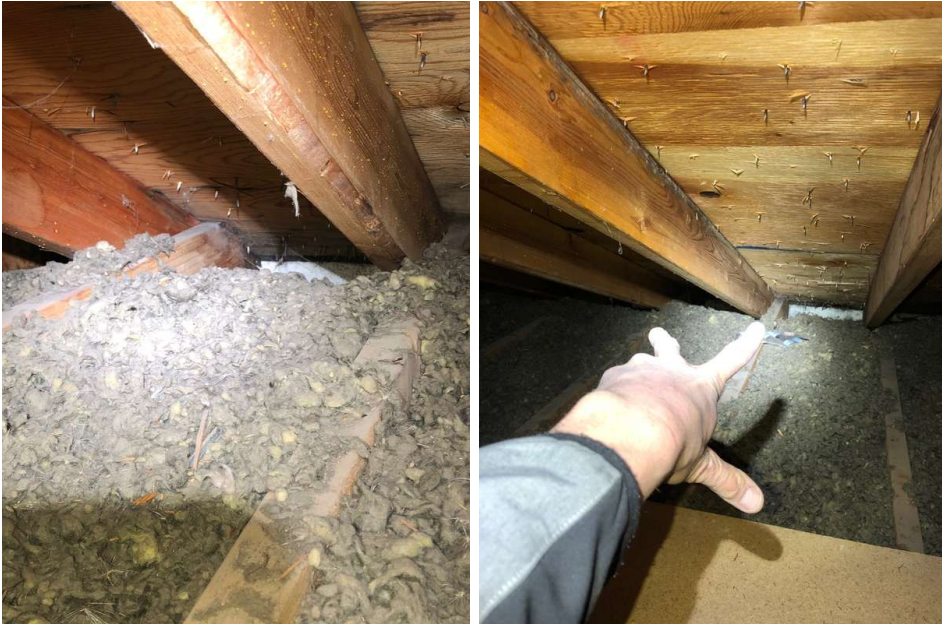
6.7.1 Roof Structure

MOISTURE DAMAGE AND POSSIBLE MICROBIAL GROWTH

Evidence of past water intrusion, associated moisture, and visible apparent microbial growth was noted in one localized area of the underside of the roof deck surface at the NE eve.. The moisture damage and staining appeared to be caused by roof leakage, potentially from ice damming, or the possibility of ventilation issues. It's most likely that the microbial growth is not currently active, and although present, dead. Recommend further evaluation of the area to determine the exact cause a need for remediation. Recommend mold testing of the affected areas to determine the status of the apparent microbial growth

Contact a qualified environmental contractor

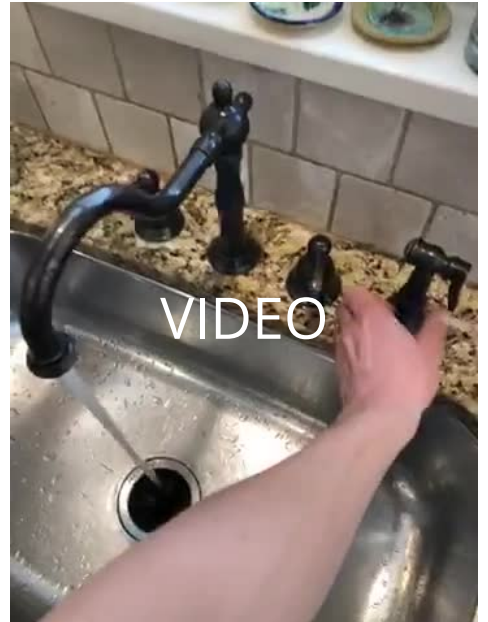
7.3.1 Plumbing Fixtures

**KITCHEN SINK SPRAYER -
IMPROPER FUNCTION**

The kitchen sprayer, when engaged, turns the water flow off. It's speculated that this is due to an odd functional byproduct of higher water pressure, but further recommendation by a plumber would be recommended for accurate analysis.

Contact a qualified plumbing contractor.

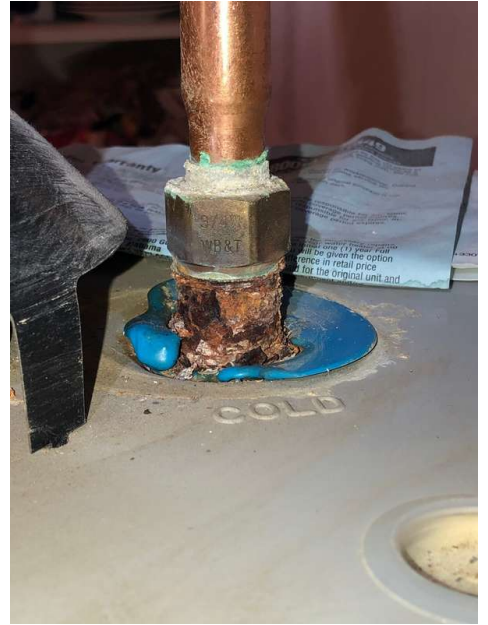
7.5.1 Hot Water Systems, Controls, Flues & Vents

**PIPE CORROSION - DISSIMILAR
METALS**

Corrosion visible on water pipes connected to this water heater appeared to be the result of dissimilar metals in contact with each other. This condition can cause galvanic corrosion. The Inspector recommends installation of a dielectric union by a qualified plumbing contractor to help prevent further corrosion, deterioration and/or leakage made possible by this condition.

Contact a qualified plumbing contractor.

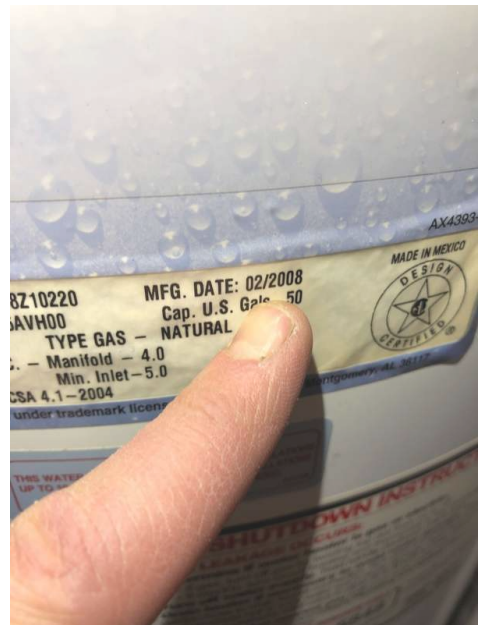
7.5.2 Hot Water Systems, Controls, Flues & Vents

NEAR END OF SERVICE LIFE

The water heater showed normal signs of wear and tear, and is nearing the end of its expected 6-12 year service life. Recommend monitoring it's effectiveness and replacing in the near future.

Contact a qualified plumbing contractor.

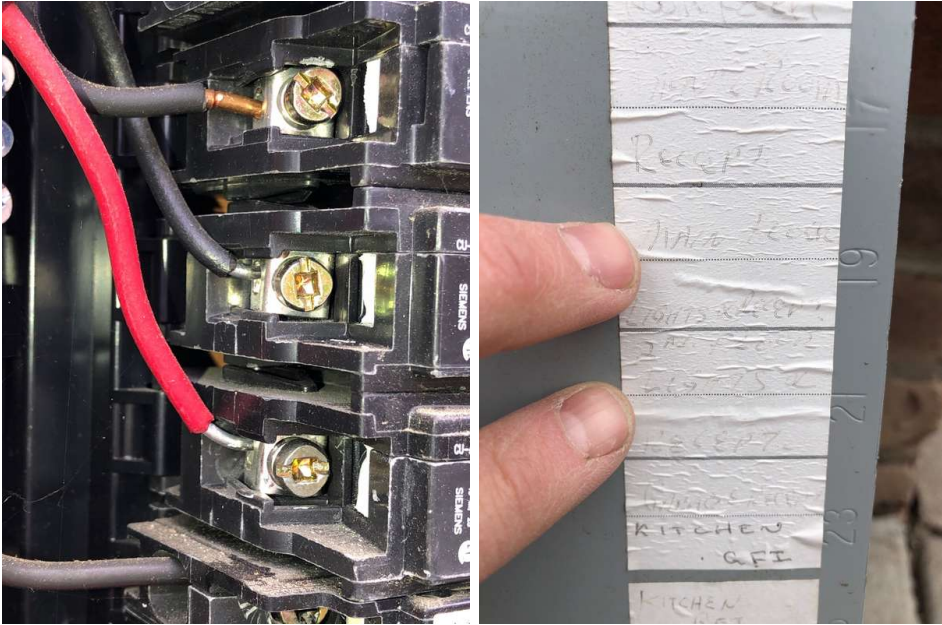
8.3.1 Branch Wiring Circuits, Breakers & Fuses

2 ALUMINUM BRANCH CIRCUITS

Aluminum wire appears to be installed on 2 branch electrical circuits in the subject premises. These single strand, branch circuit aluminum wires were used widely in houses during the mid 1960s and 1970s. According to the U.S. Consumer Product Safety Commission, problems due to expansion can cause overheating at connections between the wire and devices (switches and outlets) or at splices, which has resulted in fires. For further information on aluminum wiring contact the U.S. Consumer Product Safety Commission via the Internet at <http://www.cpsc.gov/> . It is recommended that the electrical system be evaluated by a licensed electrician.

Contact a qualified electrical contractor.

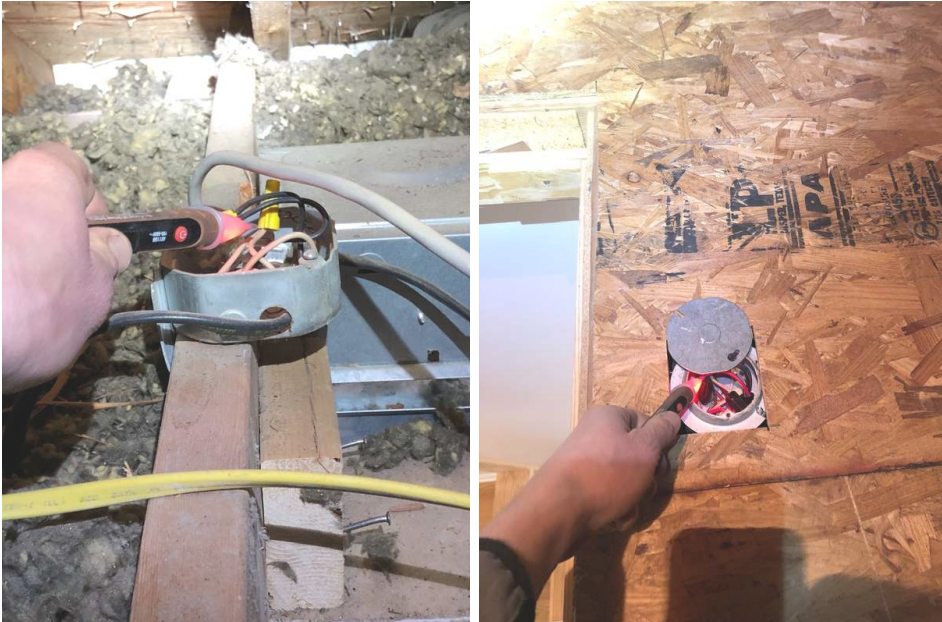
8.3.2 Branch Wiring Circuits, Breakers & Fuses

OPEN ELECTRIC JUNCTION BOX

An electrical junction box was not properly enclosed and had exposed wiring. This is a safety/shock hazard and needs to be remedied by a licensed electrician.

Contact a qualified electrical contractor.

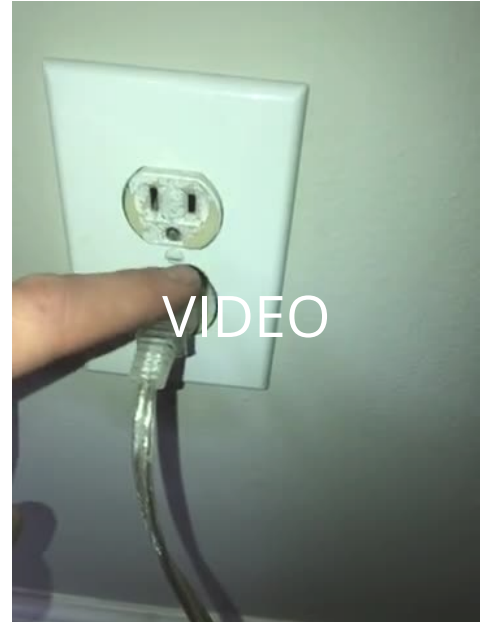
8.4.1 Lighting Fixtures, Switches & Receptacles

DAMAGED RECEPTACLE

A receptacle was physically damaged. The receptacle poses a potential shock hazard and should be replaced even if currently functional.

Recommendation
Contact a qualified electrical contractor.

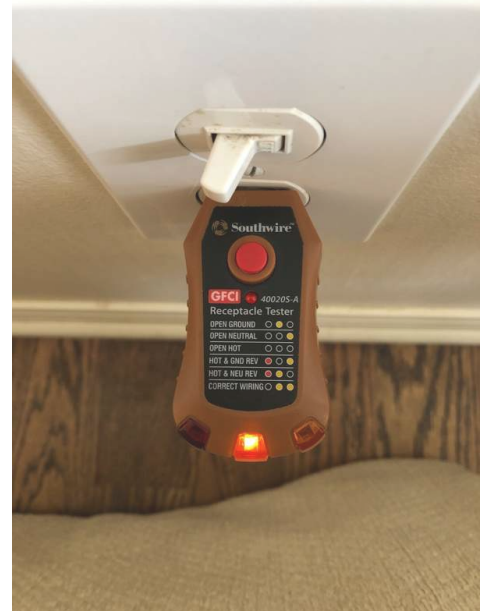
8.4.2 Lighting Fixtures, Switches & Receptacles

OPEN GROUND

An electrical receptacle had an open ground. Other receptacles in the home were grounded. This receptacle should have a functional equipment grounding conductor installed by qualified electrical contractor.

Recommendation
Contact a qualified electrical contractor.

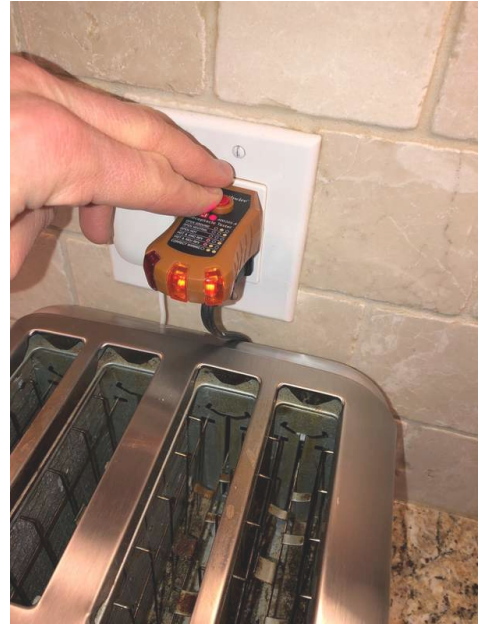
8.5.1 GFCI & AFCI

**NO GFCI PROTECTION INSTALLED -
SPECIFIC LOCATION**

No ground fault circuit interrupter (GFCI) protection was provided at this location at the time of inspection. Although GFCI protection may not have been required in this location at the time the home was built, for safety reasons, the Inspector recommends that electrical receptacles located in basements, crawlspaces, garages, the home exterior, and interior receptacles located within 6 feet of a plumbing fixture be provided with ground fault circuit interrupter (GFCI) protection in good working order to avoid potential electric shock or electrocution hazards. This can be achieved relatively inexpensively by:

1. Replacing an individual standard receptacle with a GFCI receptacle.
2. Replacing the electrical circuit receptacle located closest to the overcurrent protection device (usually a breaker) with a GFCI receptacle.
3. Replacing the breaker currently protecting the electrical circuit that contains the receptacles of concern with a GFCI breaker.

Contact a qualified electrical contractor.

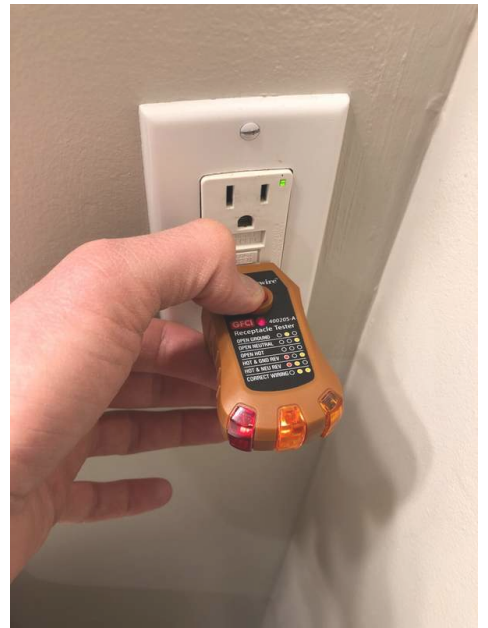
8.5.2 GFCI & AFCI

NON FUNCTIONING GFCI

A ground fault circuit interrupter (GFCI) electrical receptacle did not respond to testing, did not re-set, was slow to re-set or made a buzzing sound when re-set. The Inspector recommends replacement of the receptacle to ensure that it works correctly when required. All work should be performed by a qualified contractor.

Contact a qualified electrical contractor.

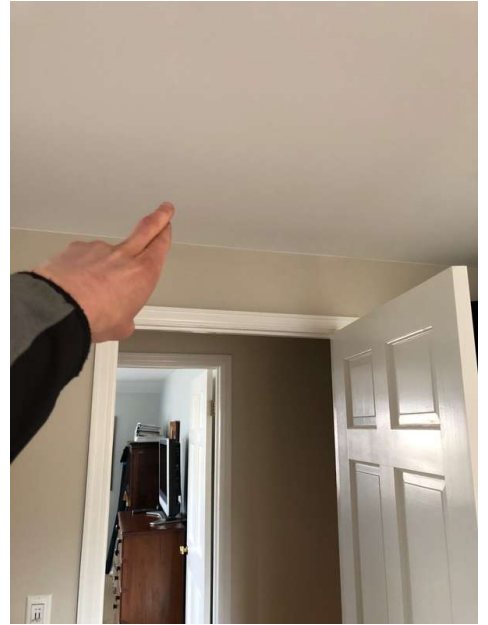
8.6.1 Smoke Alarms

SAFETY RECOMMENDATION - INSTALL ADDITIONAL SMOKE ALARMS

The amount of smoke alarms observed in the home at the time of inspection is inadequate by accepted safety standards. The National Fire Alarm and Signaling Code requires as a minimum that smoke alarms be installed inside every sleep room (even for existing homes) in addition to requiring them outside each sleeping area and on every level of the home.

Contact a handyman or DIY project

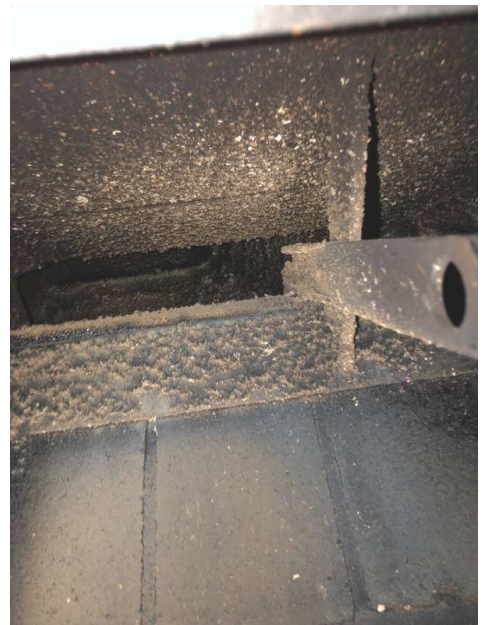
9.9.1 Solid Fuel Heating Device (Fireplace, Woodstove)

BUILDUP - FLUE NEEDS CLEANING

the flue for the wood-burning fireplace appeared to need cleaning. Dirty fireplaces are potential fire hazards. The flue should be cleaned by a qualified contractor.

Contact a qualified fireplace contractor.

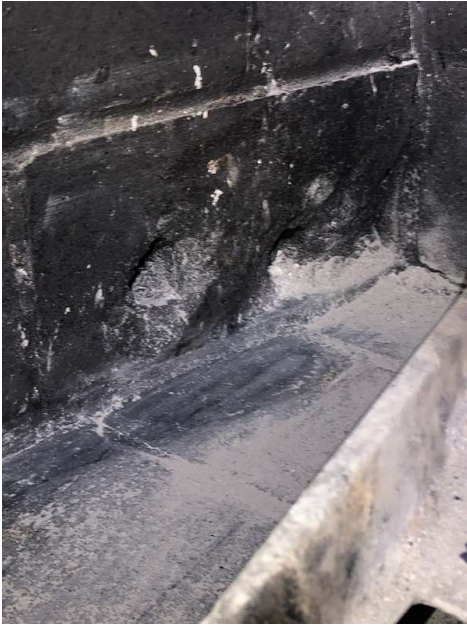
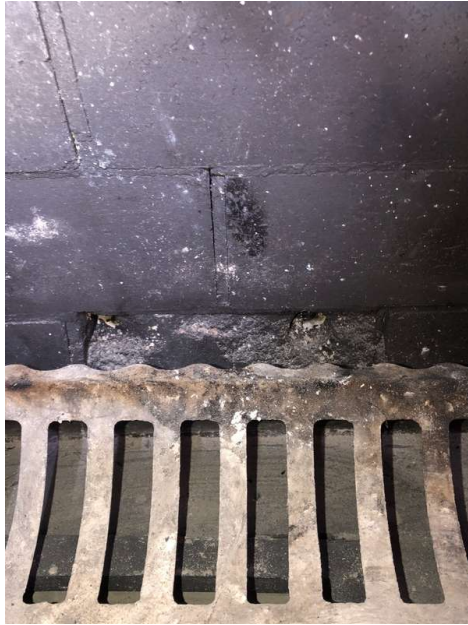
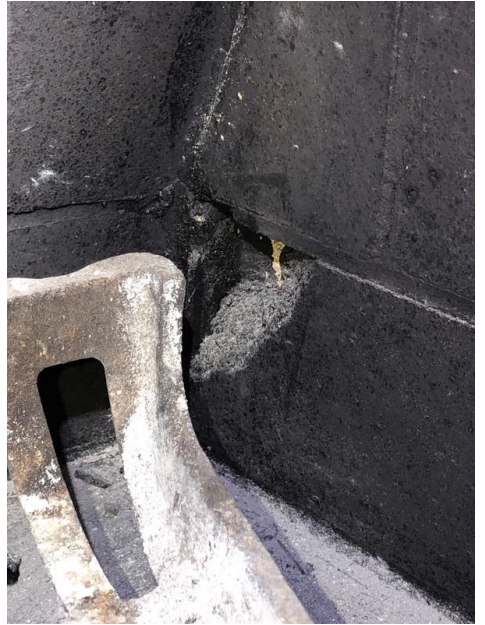
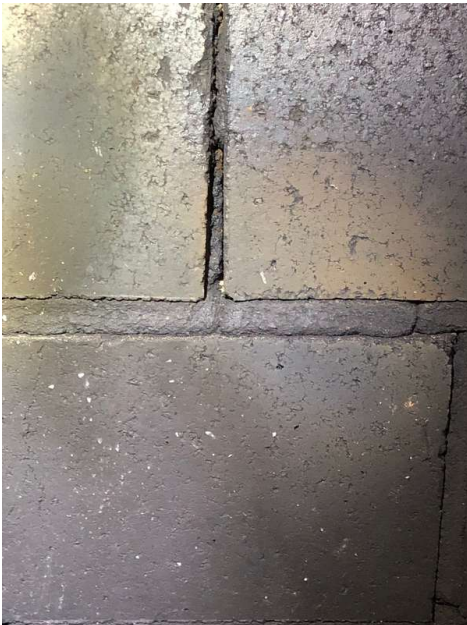
9.9.2 Solid Fuel Heating Device (Fireplace, Woodstove)

CRACKED FIREWALL

The fireplace firewall was cracked in one area, and a gap in mortar on the sides was noted. This could lead to further chimney damage or toxic fumes entering the home upon operation of the fireplace. Recommend a qualified fireplace contractor evaluate and repair.

Contact a qualified chimney contractor.

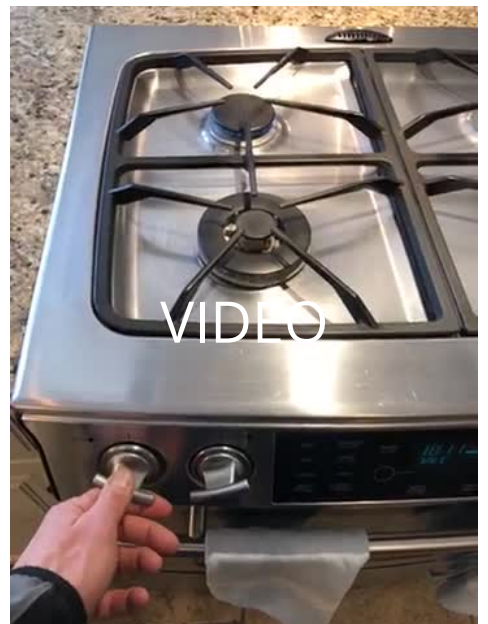
12.4.1 Range/Oven/Cooktop

BURNER NOT FUNCTIONING

One or more heating elements did not heat up/ignite when turned on. Recommend qualified professional evaluate & repair.

Contact a qualified appliance repair professional.

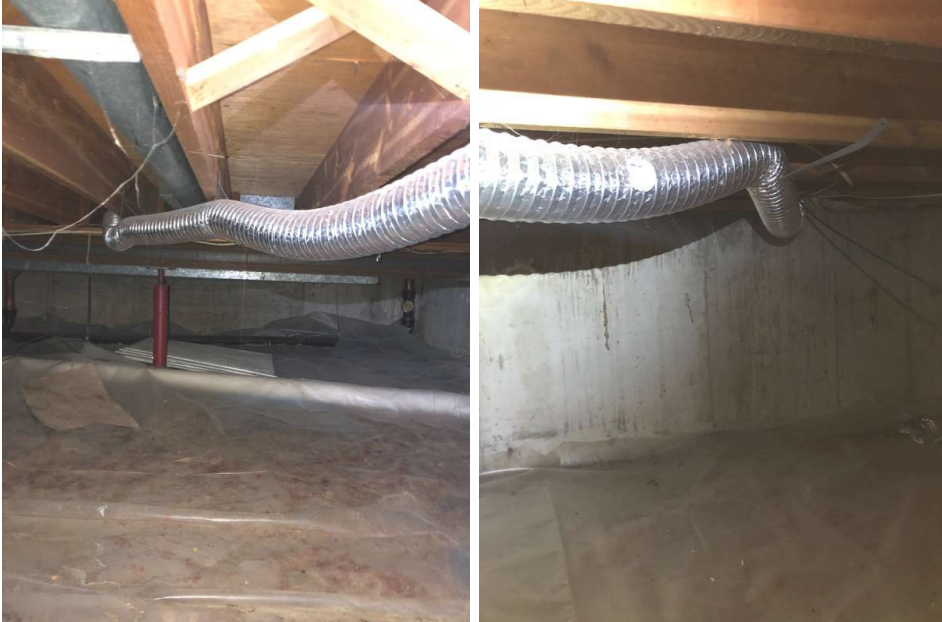
12.5.2 Washer/Dryer

EXCESSIVE VENT LENGTH

The dryer vent was observed to be too long. Dryer vents that are too long will not vent properly and are subject to faster clogging with lint. Recommend shortening or moving vent for proper air flow. A flex dryer vent should be no longer than 25' total run. Each 90 degree turn derates the total length by 5' and each 45 degree bend derates the total length by 2.5'.

Contact a qualified appliance repair professional.

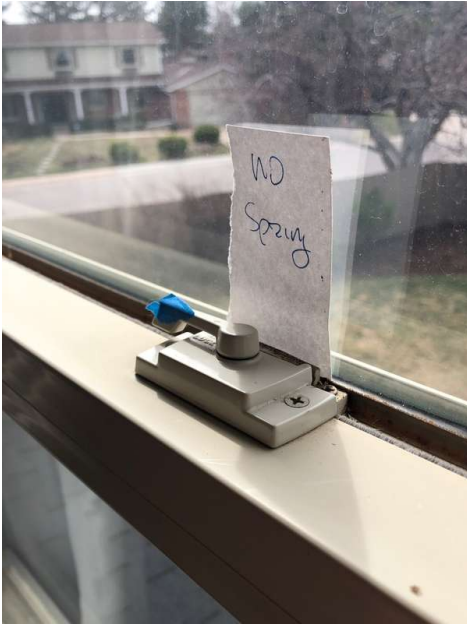
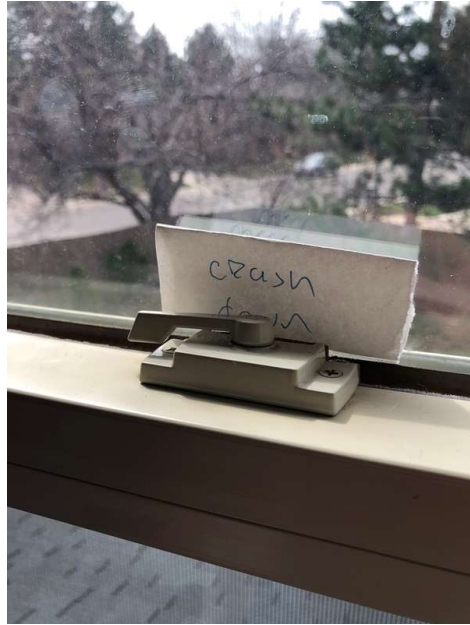
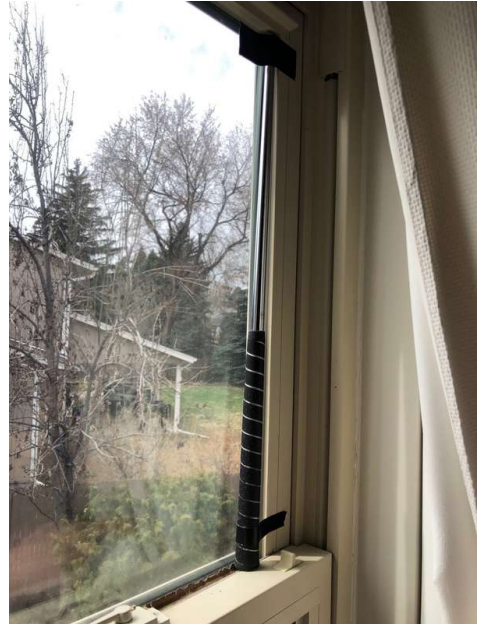
13.2.3 Windows

WINDOW DOES NOT STAY OPEN

Multiple windows would not stay open on their own at the time of inspection, and would slam when unlatched. The inspector can speak to this after having an upper window sash close quickly on a fingernail while unlatching the window. Recommend repair or replacement by a qualified window specialist.

Contact a qualified window repair/installation contractor.

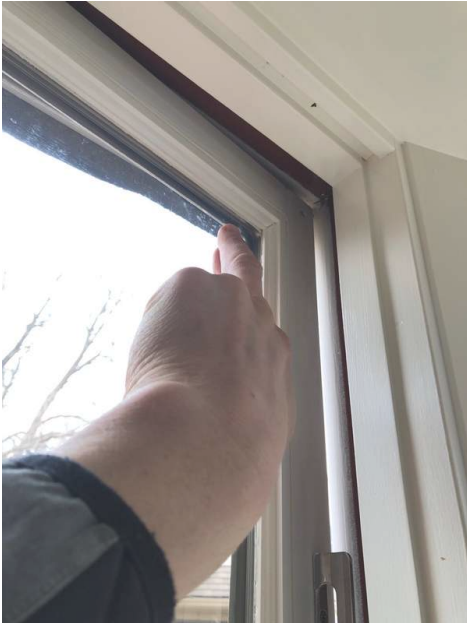
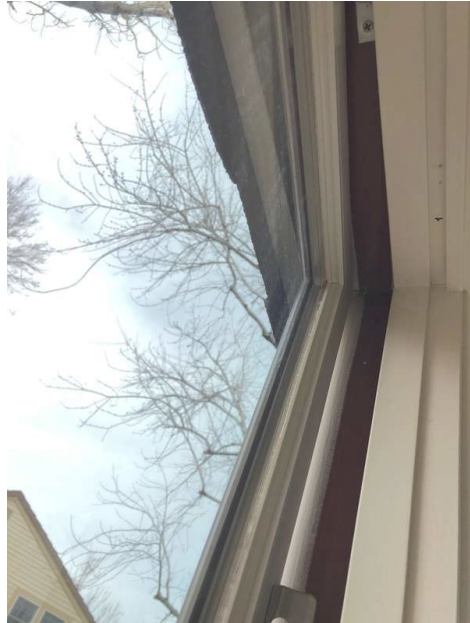
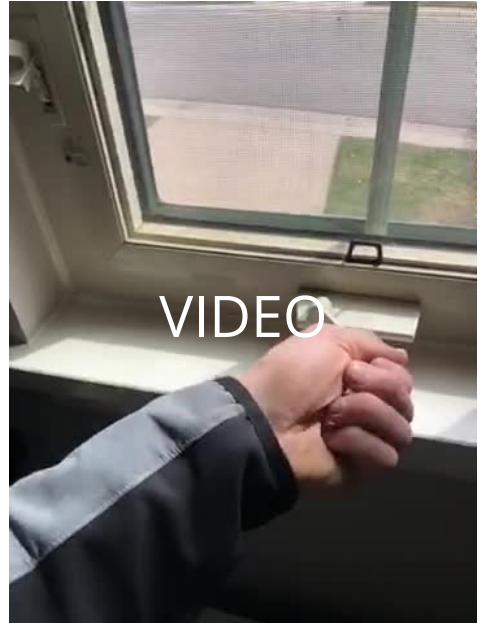
13.2.4 Windows

WINDOW JAMMED/STUCK

Four windows were not fully inoperable at time of inspection. The 2 bay windows in the dining room were caught on the drip flashing above, and the upstairs bathroom crank windows would not open. Recommend repair by a qualified professional.

Contact a qualified window repair/installation contractor.

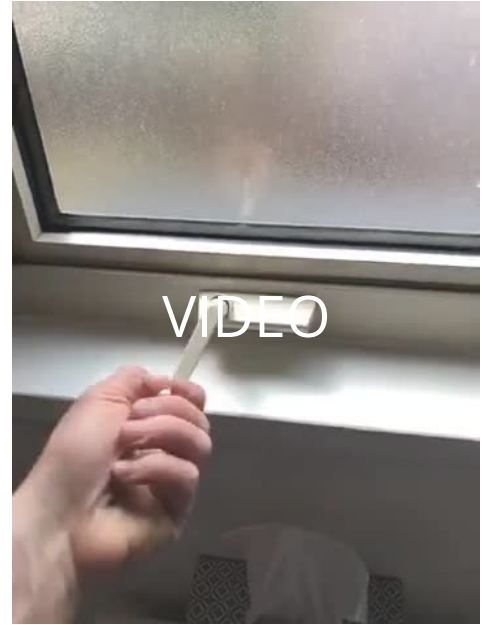
13.2.5 Windows

CRANK INOPERABLE

A window crank was inoperable at the time of inspection. Recommend repair in order to restore full functionality of the window.

Recommendation
Contact a qualified window repair/installation contractor.

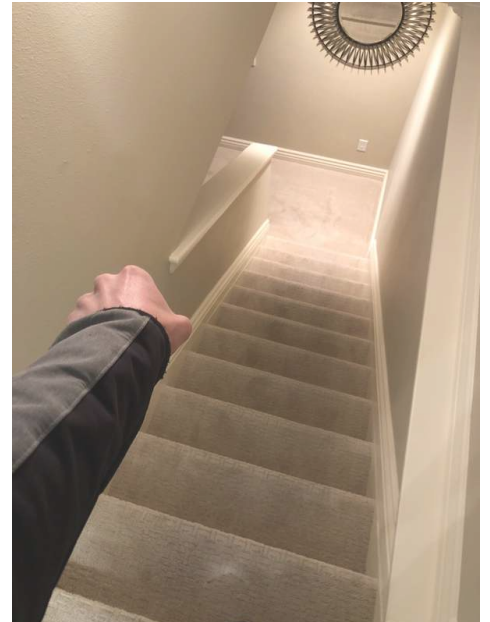
13.6.1 Steps, Stairways & Railings
NO HANDRAIL

Although it had 4 or more risers, this staircase had no handrail installed. This condition is a potential fall hazard. In order to comply with generally-accepted current standards which require a handrail at staircases with 4 or more risers, this staircase would need a handrail installed. The Inspector recommends that a handrail be installed that complies with modern safety standards. All work should be performed by a qualified contractor.

Recommendation
Contact a qualified carpenter.
