**SUMMARY**  
1234 Main St. Merrimack NH 03054  
Buyer Name  
01/21/2019 9:00AM

Chris Caisse  
InterNACHI Certified...  
Platinum Home Inspections  
603.897.5495

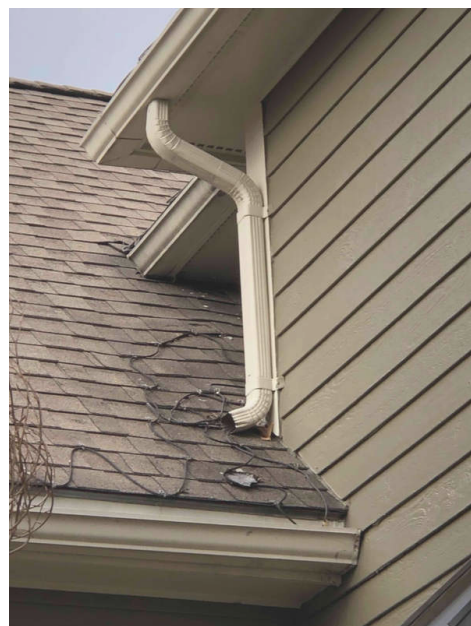
#### HEATING CABLE

Roof de-icing / heat cable was observed at the home. These heat cables were not inspected or tested for operation. It is unknown if these cables are operable, powered by a switch or are wired properly. Recommend to inspect these cables to understand how they operate and to ensure they are in proper working condition prior to first snowfall. Monitor as part of preventative maintenance to ensure satisfactory operation. De-icing / heat cables may have been installed as a result of a known ice-dam issue. For more information regarding ice-dams, read here.

Contact a qualified professional.

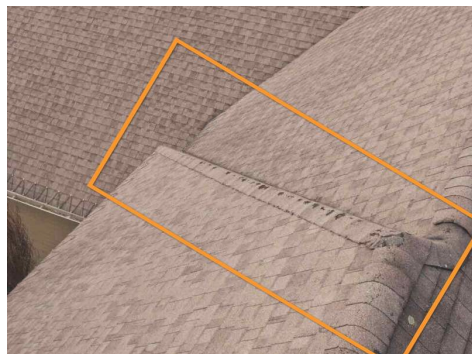
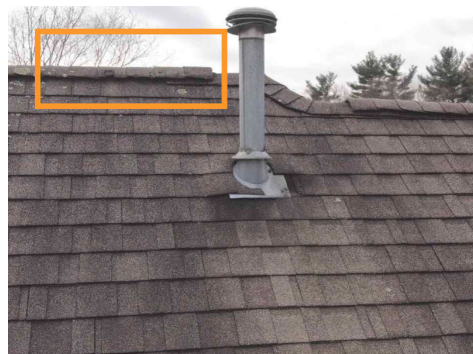
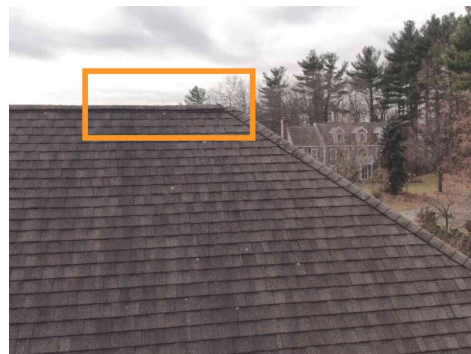
#### DAMAGED RIDGE CAP SHINGLES

Cap shingles/ridge vent shingles are damaged/aging. Cap shingles are shingles that cover areas where the roof changes direction, like at roof peaks and hips. Recommend roofing professional evaluate and repair as needed.

Contact a qualified roofing professional.

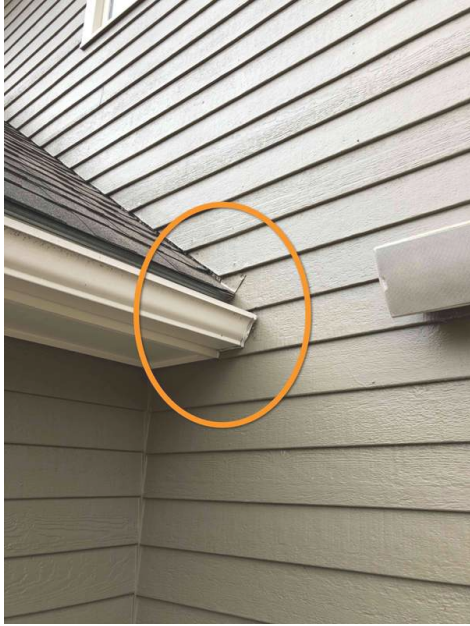
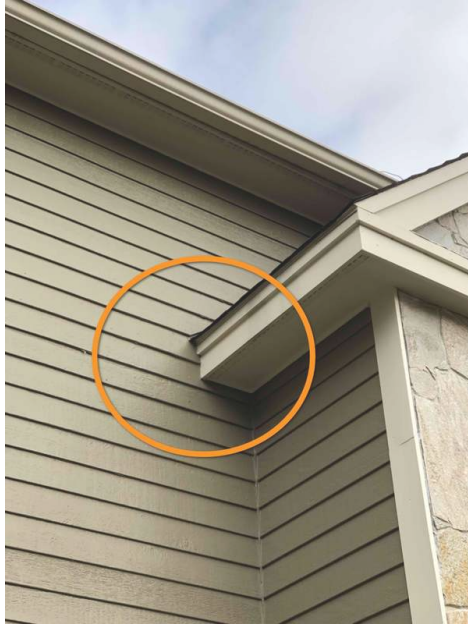
**MISSING KICK-OUT FLASHING**

Kick-out flashing was missing where walls extended past roof edges.

Contact a qualified roofing professional.

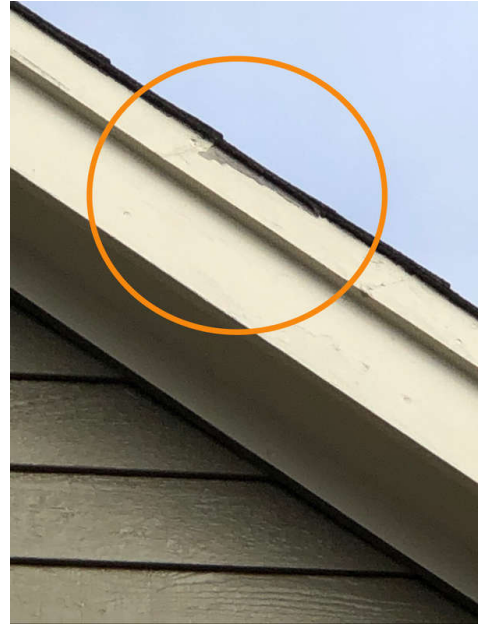
Front

**PEELING PAINT**

Minor areas of peeling paint was observed on exterior surfaces, such as Siding, Trim, Fascia, Soffits, and Eve edges. Recommend qualified contractor to perform normal paint maintenance to prevent moisture damage to these areas.

Contact a qualified painter.

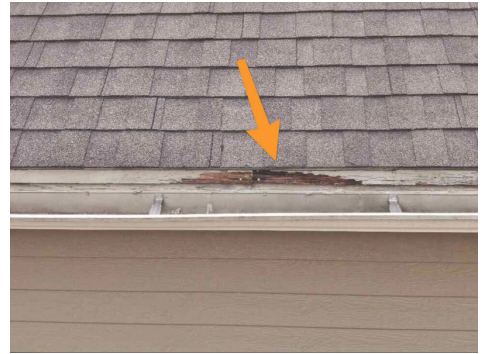
### FASCIA - ROTTED

One or more sections of the fascia appear to be rotted. Listing agent explained that this damage is not rot, but caused by woodpeckers. Recommend qualified roofer evaluate & repair as needed.

Contact a qualified roofing professional.

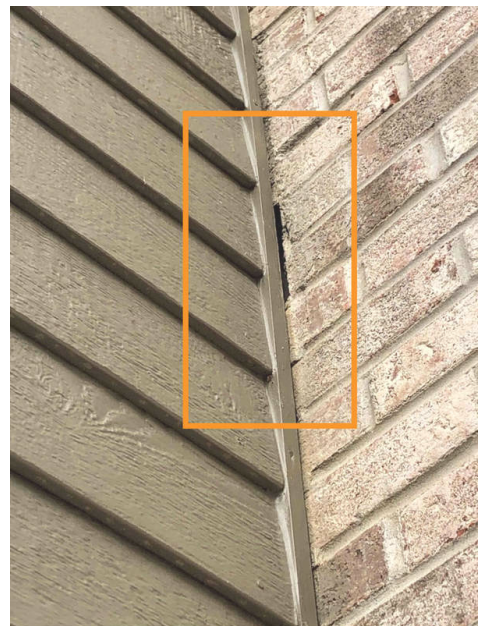
### GAP WHERE CHIMNEY MEETS SIDING

Observed a gap where the house siding meets the brick chimney. Recommend repointing/caulking to prevent moisture/insect intrusion.

Contact a qualified professional.

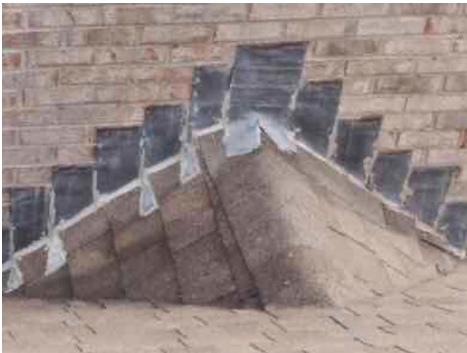
### CRICKET - MOSTLY OK

A cricket was installed to protect roofing near the chimney. A cricket is a small roof built on the uphill side of and abutting the chimney. Its purpose is to keep roof drainage from pooling on the uphill side of the chimney and eventually causing leakage. The Inspector observed few deficiencies in the condition of the cricket such as excessive caulking around the flashing as well as aging flashing. Recommend monitoring and have professional roofer repair as needed.

Contact a qualified roofing professional.

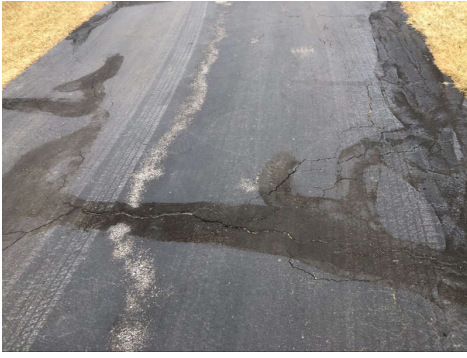
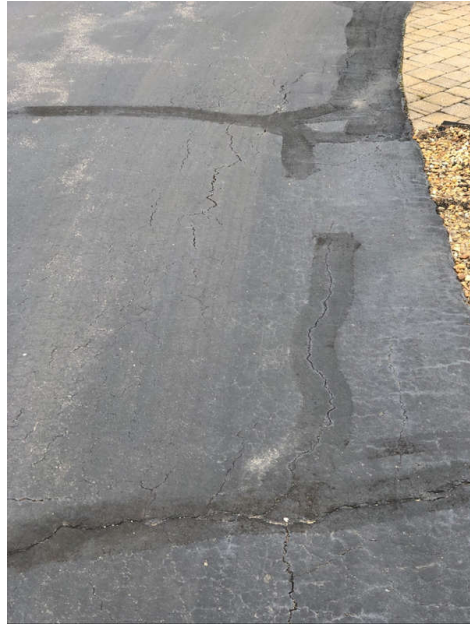
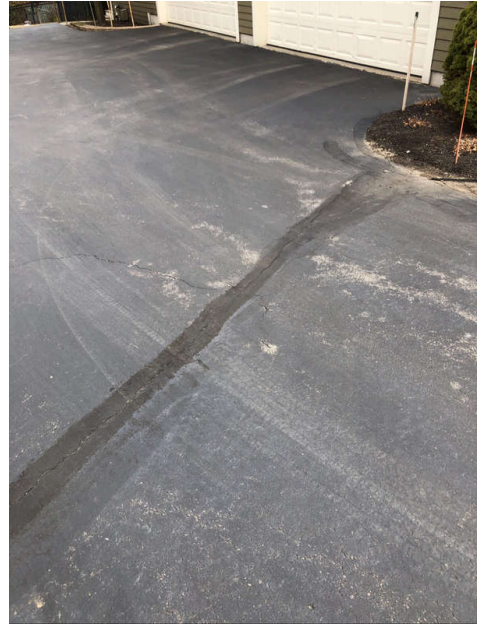
### ASPHALT DRIVEWAY - TYPICAL CRACKING

Asphalt driveway... this material has typical cracking which is normal for its age recommend seal coating as needed to prolong life expectancy.

Contact a qualified professional.

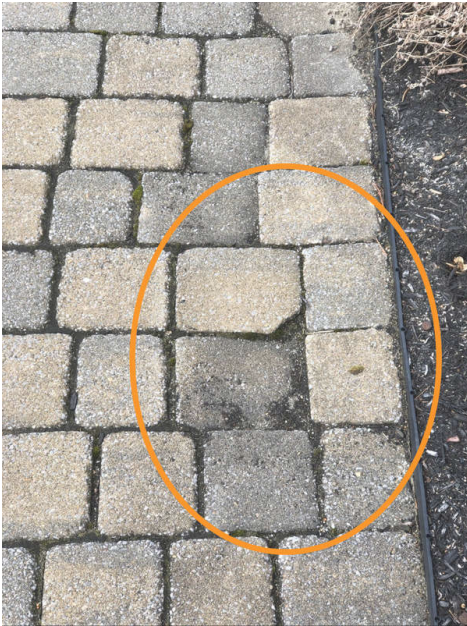
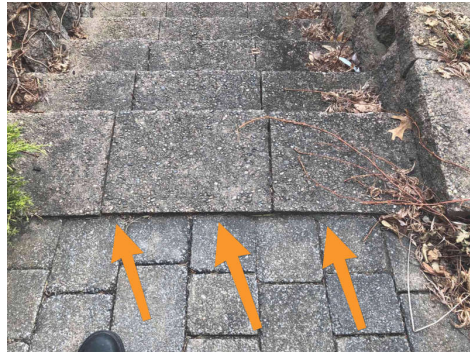
**WALKWAY TRIP HAZARD**

Trip hazards observed. Patch or repair recommended.

Pavers have sunk along stair tread

Recommendation  
Contact a qualified concrete contractor.

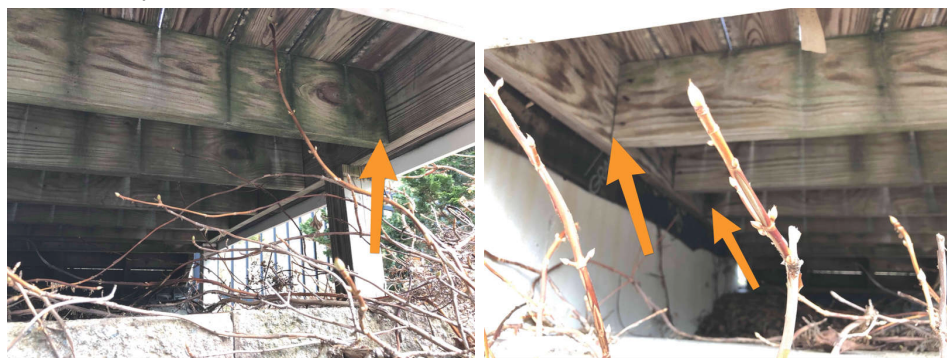
#### **JOIST HANGERS - MISSING**

Joist hanger(s) are missing or improperly installed. This could cause the deck structure to fail. Recommend that joist hangers be properly installed by qualified contractor.

Contact a qualified deck contractor.

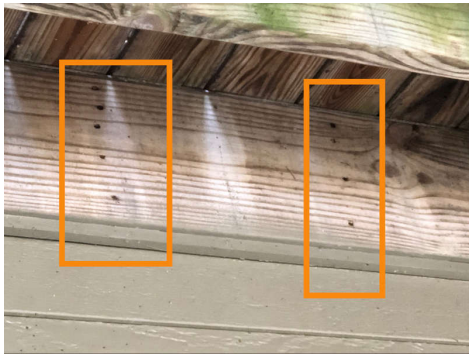
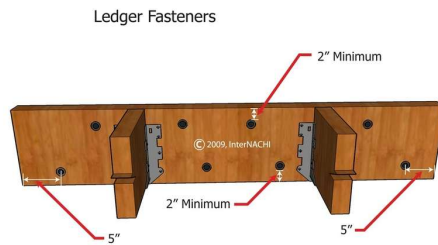
#### **LEDGER BOARD - NAILED ON, NO SCREWS OR BOLTS**

Ledger boards for one or more decks, balconies or porches appeared to be attached with nails only. This method of attachment is substandard and may result in such structures separating from the main building. This is a potential safety hazard. Modern standards call for ledger boards to be installed with 1/2 inch lag screws or bolts into solid backing, and brackets such as [Simpson Strong Tie DTT2 brackets and threaded rod](#), connecting interior and exterior joists. Recommend that a qualified contractor repair per standard building practices. For more information, visit:

Contact a qualified deck contractor.

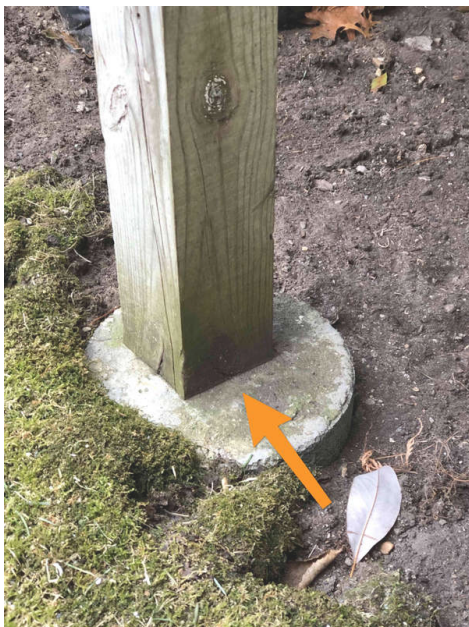
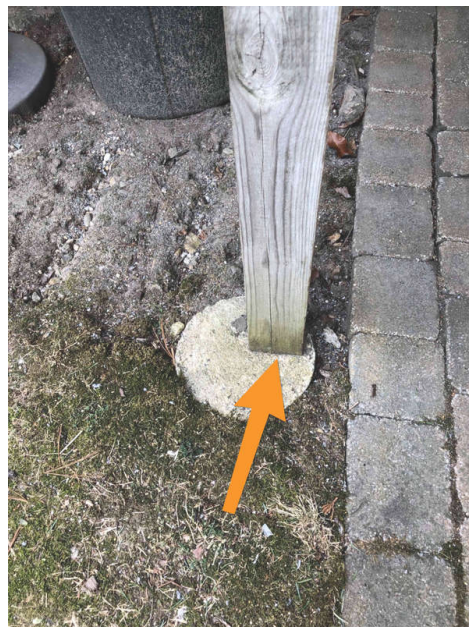
#### **SUPPORT POSTS - MISSING ANCHORS**

While the deck structure seems solid at the time of inspection the support posts are missing anchors. Recommended installing metal base anchors with 1/2" through bolts for added stability.

Contact a qualified deck contractor.

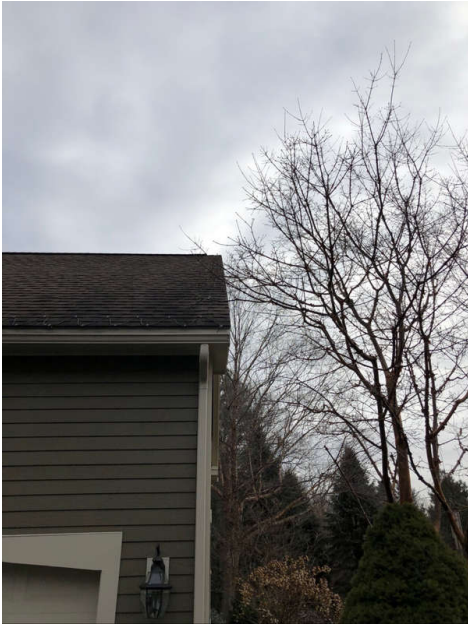
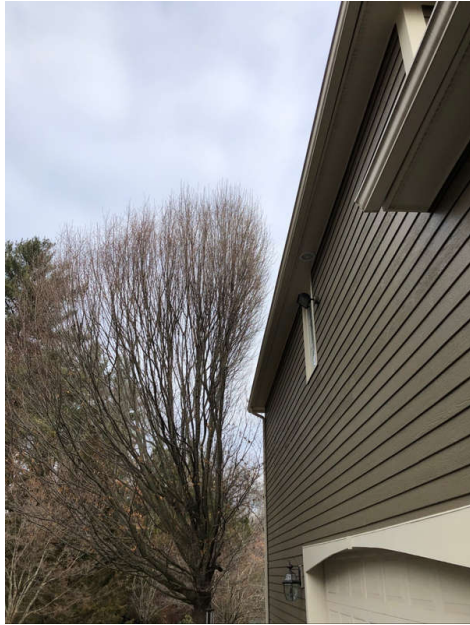
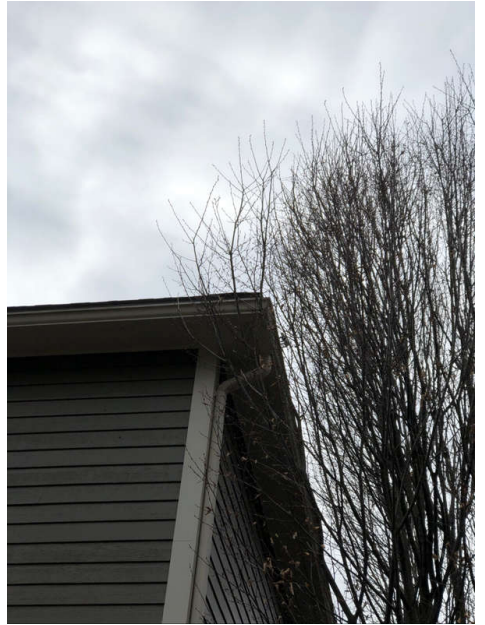
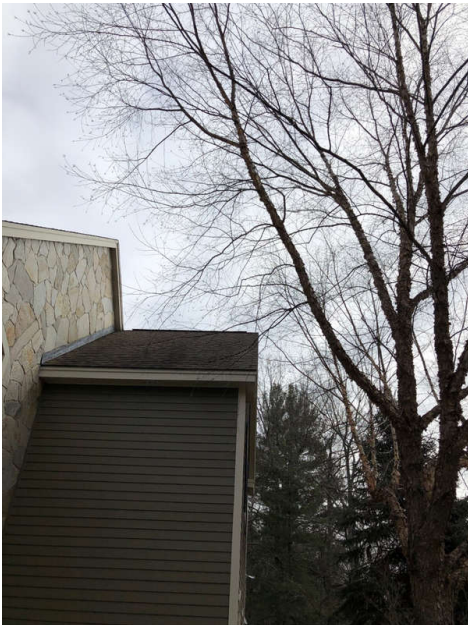
#### **TREE OVERHANG**

Trees observed overhanging the roof. This can cause damage to the roof and prevent proper drainage. Recommend a qualified tree service trim to allow for proper drainage.

Contact a qualified tree service company.

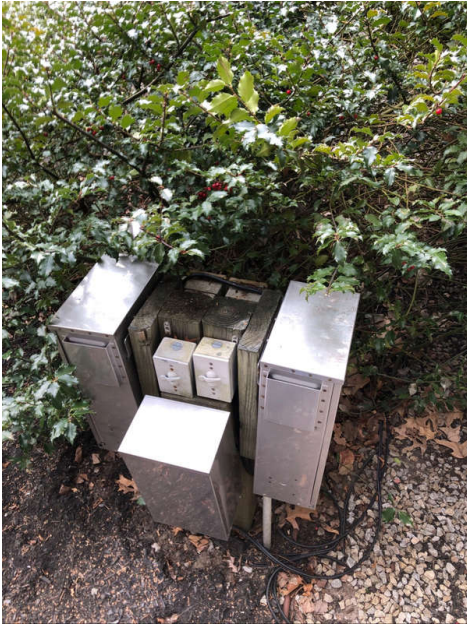
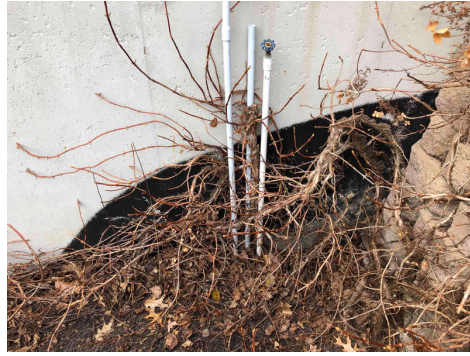
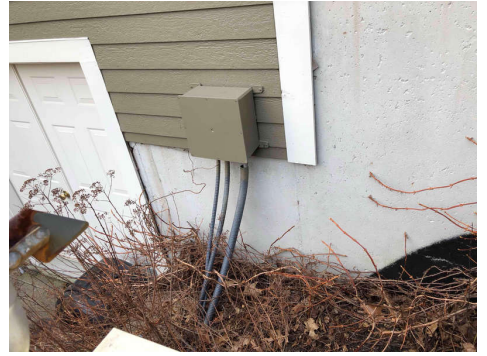
#### **VEGETATION ON HOME**

Vegetation growing on home, recommend removal to prevent possible moisture damage.

Contact a qualified landscaping contractor

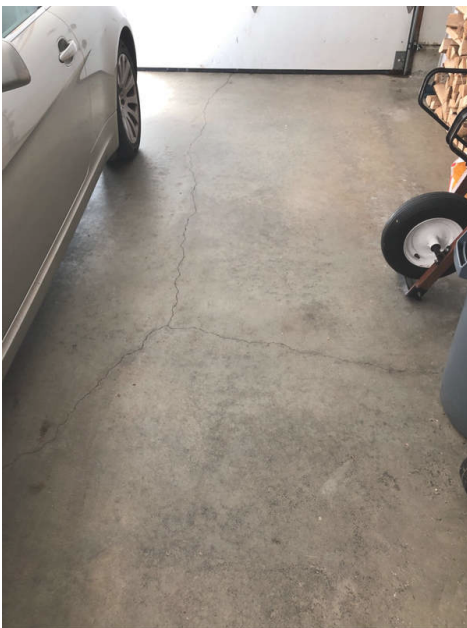
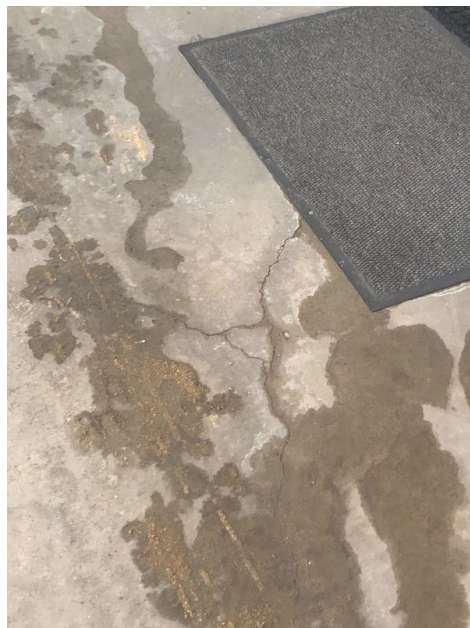
#### 4.2.1 Floor **CRACKING**

Typical cracking/settlement observed in concrete. If trip hazards become present, recommend licensed contractor to repair to prevent injuries.

Recommendation  
Contact a qualified concrete contractor.

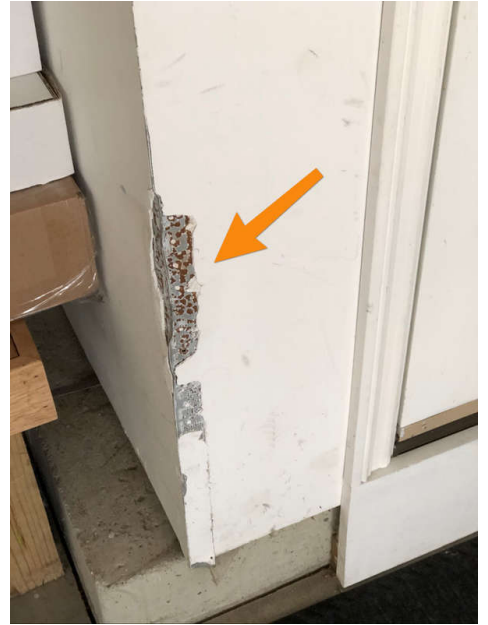
#### 4.3.1 Walls & Firewalls **DAMAGED DRYWALL**

Garage wall had damaged drywall. Recommend drywall contractor repair.

Recommendation  
Contact a qualified drywall contractor.

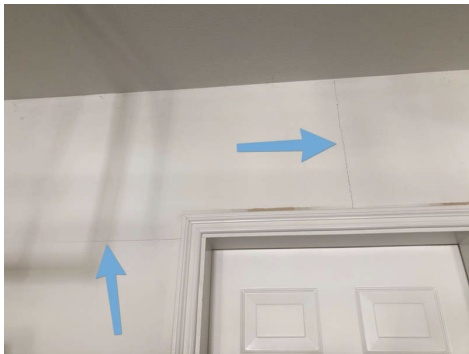
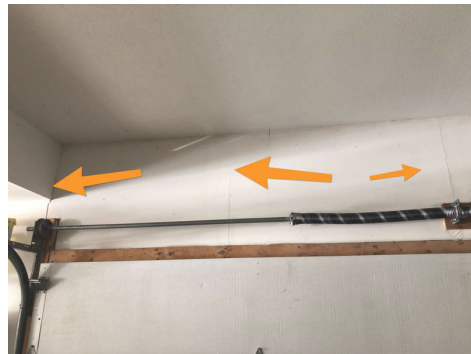
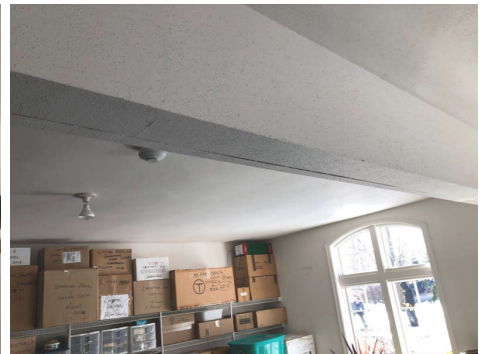
#### 4.3.2 Walls & Firewalls **CRACKING-MINOR**

Observed typical cracking in the drywall of the garage.

Corner bead pulling away

Recommendation  
Contact a qualified professional.

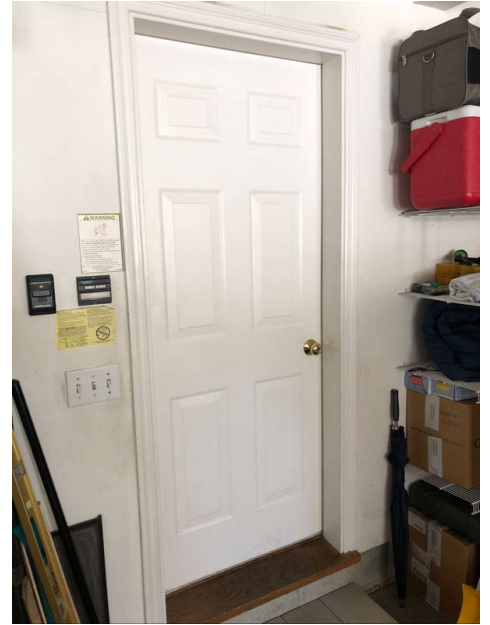
#### **NOT SELF-CLOSING**

Door from garage to home should have self-closing hinges to help prevent spread of a fire to living space. Recommend a qualified contractor install self-closing hinges.

Recommendation  
Contact a qualified door repair/installation contractor.

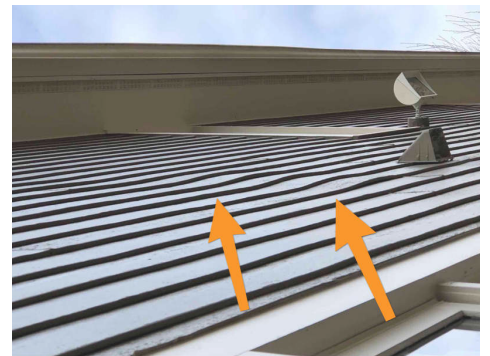
#### **WARPING/BUCKLING**

Clapboard siding had one area that is warping or buckling. As there is a vent directly to the right of the subject area this is most likely caused by excessive moisture venting to this area. There were no other signs of warping anywhere else on the exterior. Recommend a qualified siding contractor evaluate and repair.

Recommendation  
Contact a qualified siding specialist.

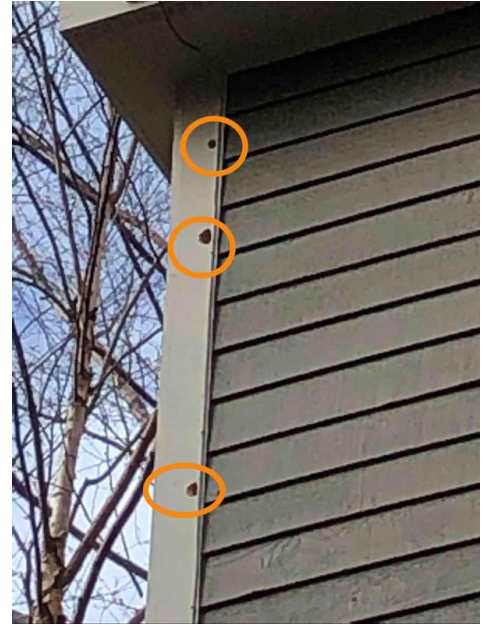
#### **DAMAGE TRIM BOARD**

Observed a few holes in the right side trim. Recommend repairing to prevent moisture intrusion.

Recommendation  
Contact a qualified professional.

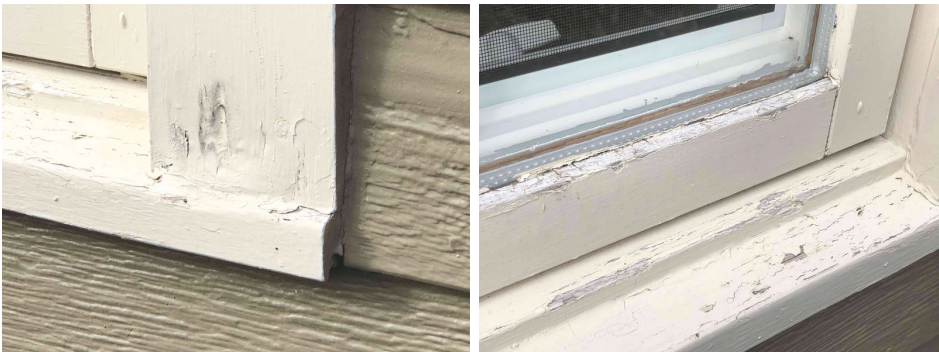
#### **PEELING PAINT**

Exterior windows have painted components that are peeling, recommend qualified contractor to perform normal paint maintenance as needed to prevent potential damage.

Recommendation  
Contact a qualified painter.

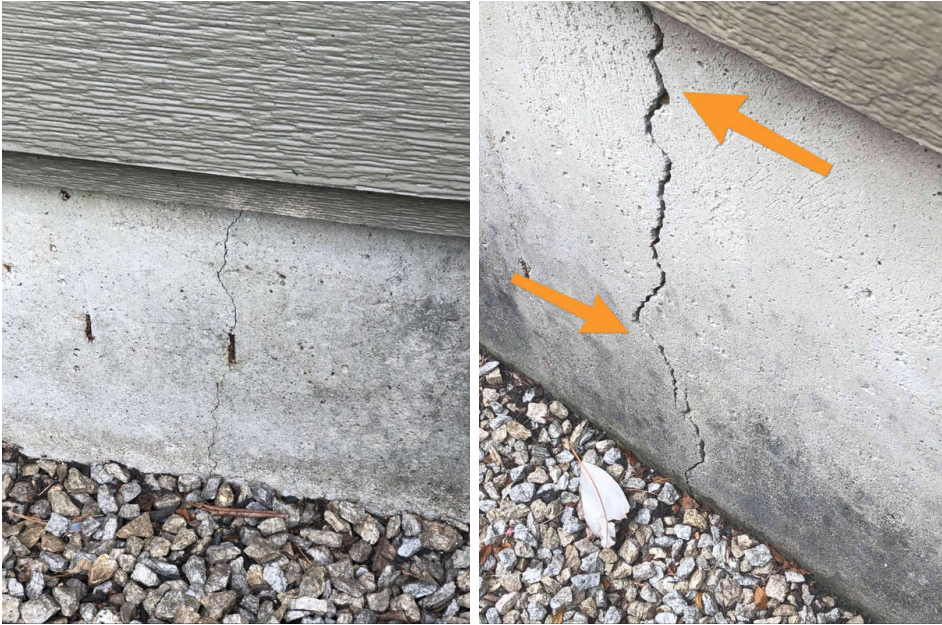
Left front, near elec meter

#### **TYPICAL CRACKING**

Exterior foundation contains typical cracks due to shrinkage and normal freeze thaw cycle. Recommend patching as needed to prevent moisture intrusion.

Recommendation  
Contact a foundation contractor.

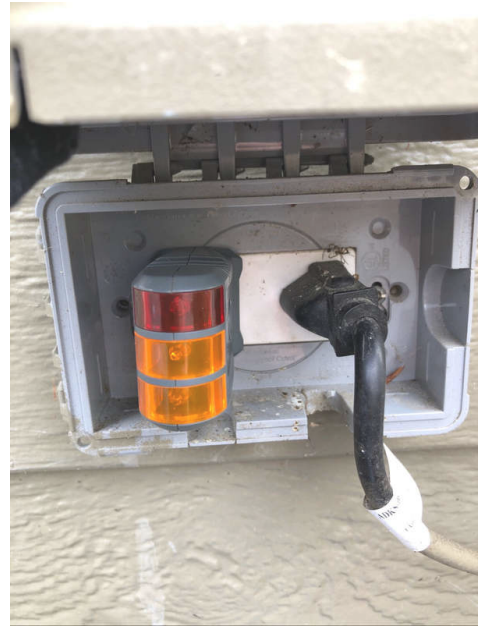
Garage

#### **NO GFCI PROTECTION INSTALLED**

No GFCI protection present in all locations. Recommend licensed electrician upgrade by installing ground fault receptacles in all locations.

Contact a qualified electrical contractor.

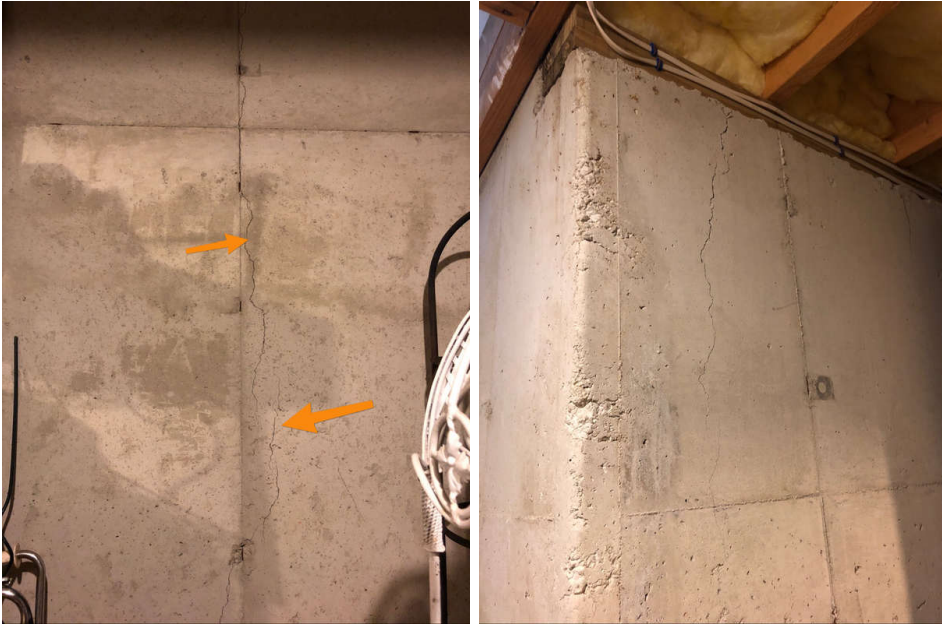
#### **FOUNDATION CRACKS - MINOR**

Minor cracking was noted at the foundation. This is common as concrete ages and shrinkage surface cracks are normal. Recommend monitoring for more serious shifting/displacement.

Contact a foundation contractor.

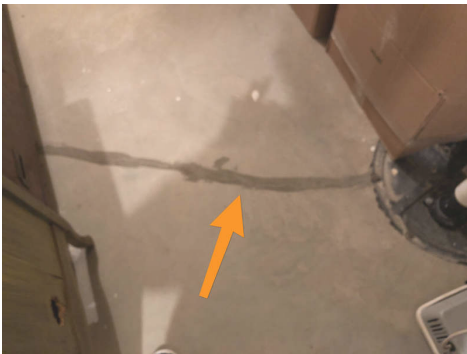
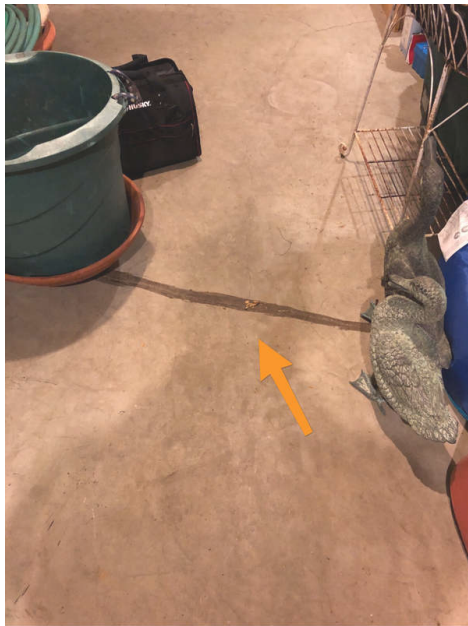
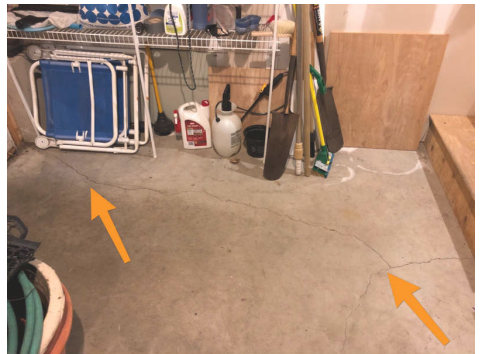
#### **TYPICAL CRACKING**

Contact a qualified professional.

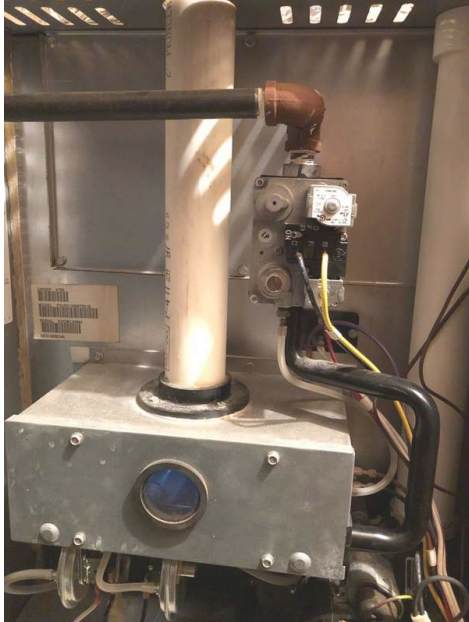
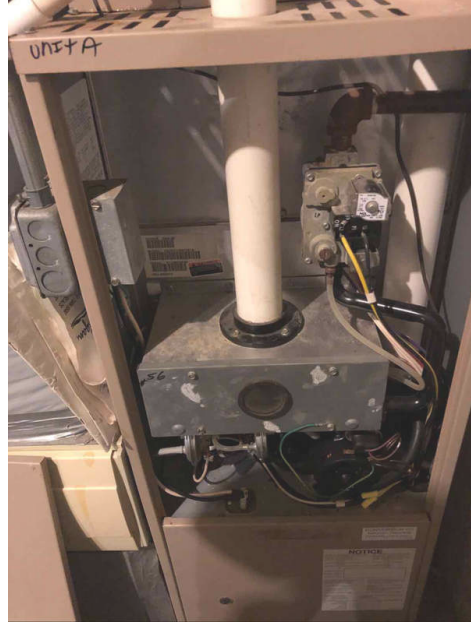
#### SEALED CHAMBER

The furnace was a high-efficiency system and had a sealed combustion chamber which would require invasive measures which lie beyond the scope of the General Home Inspection to inspect. The Inspector recommends that an evaluation be performed by a qualified heating, ventilation and air-conditioning (HVAC) contractor.

Contact a qualified HVAC professional.

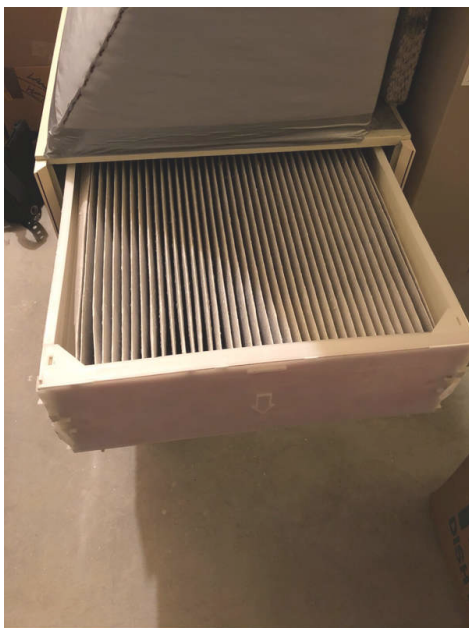
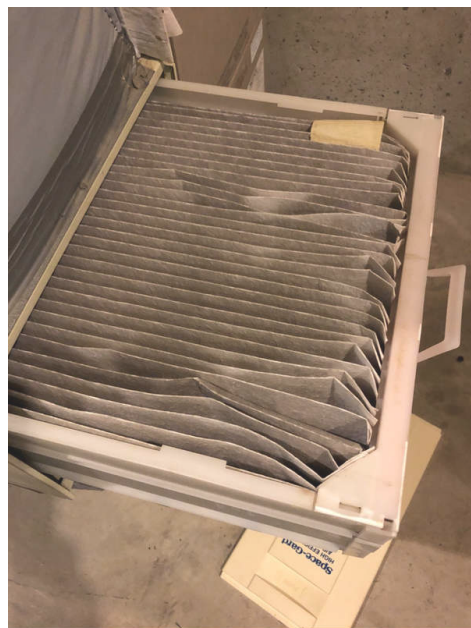
#### FILTER DIRTY

The furnace filter is dirty and should to be replaced every 6 months.

Contact a qualified HVAC professional.

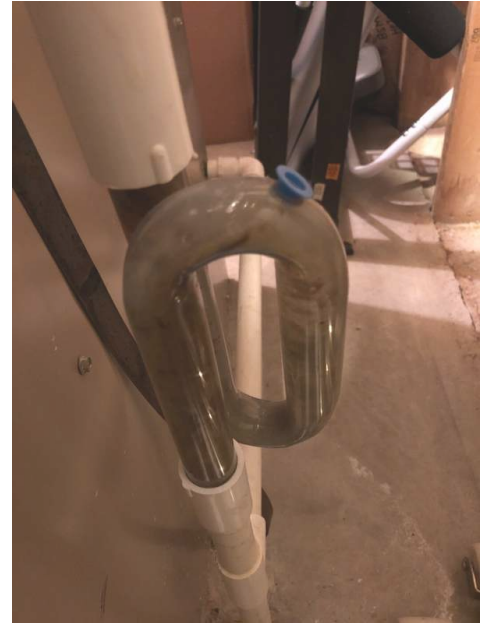
Unit B

**MICROBIAL GROWTH IN CONDENSATE TUBE**

The condensation tube from the appeared to contain microbial growth. Some types of microbes can cause health problems in sensitive people. The Inspector recommends tube replacement by a qualified heating, ventilation and air-conditioning (HVAC) contractor.

Contact a qualified HVAC professional.

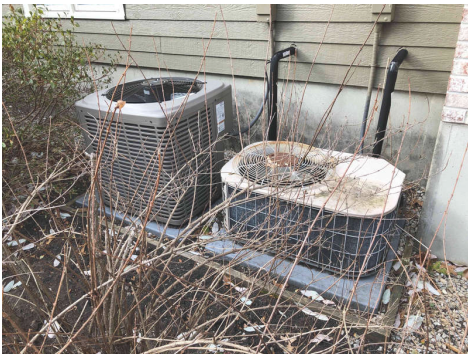
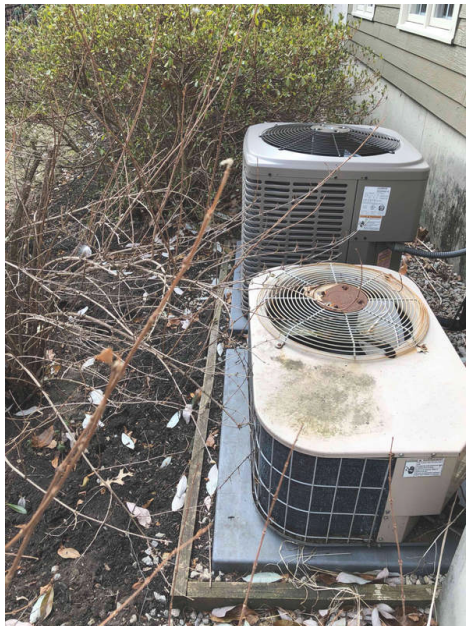
**VEGETATION TOO CLOSE**

Vegetation was too close to the compressor, which can limit heat dissipation and limit effectiveness. Recommend cutting back vegetation to avoid overheating compressor.

Contact a qualified landscaping contractor

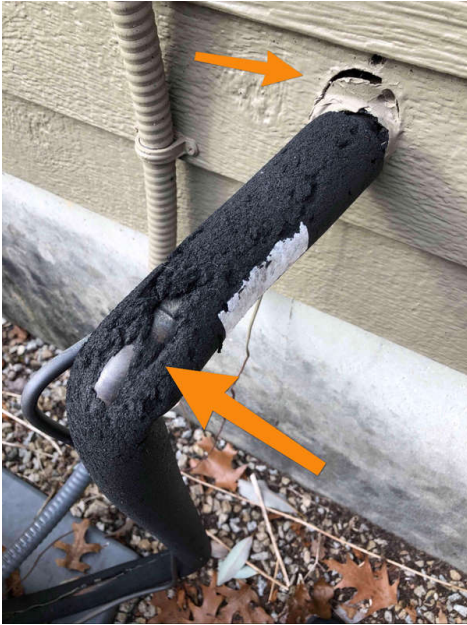
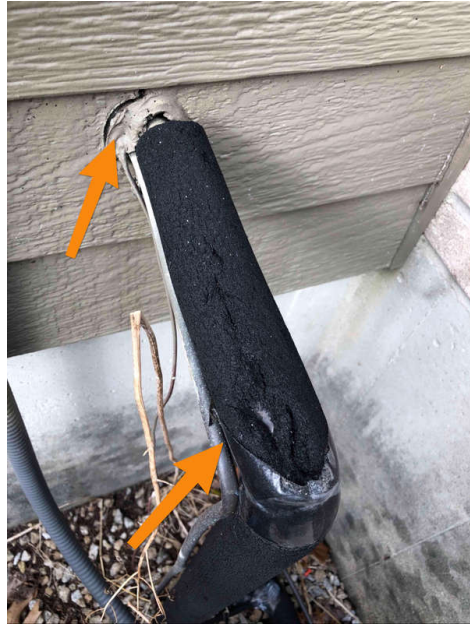
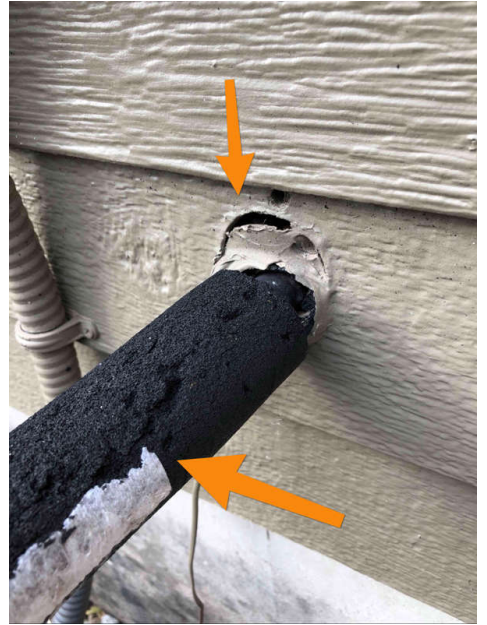
**DAMAGED / MISSING INSULATION**

Insulation on the A/C suction (large, insulated) line was damaged or missing at areas and should be replaced by a qualified HVAC contractor. Deteriorated penetrations should also be resealed.

Contact a qualified HVAC professional.

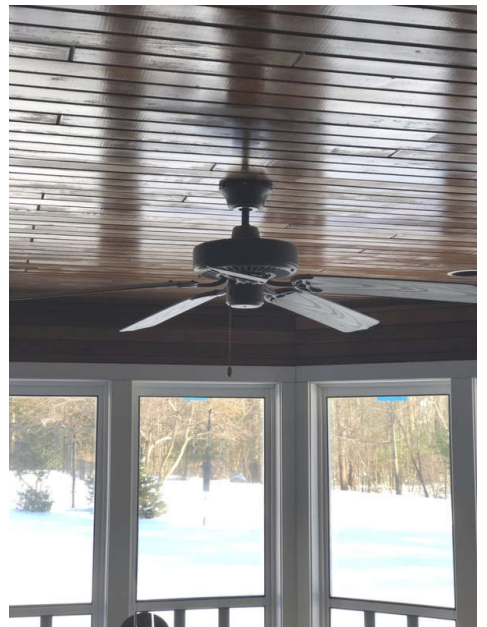
**CEILING FAN NOT  
OPERATIONAL**

Sunroom ceiling fan not operational recommend licensed contractor to further evaluate and repair as needed

Recommendation  
Contact a qualified professional.

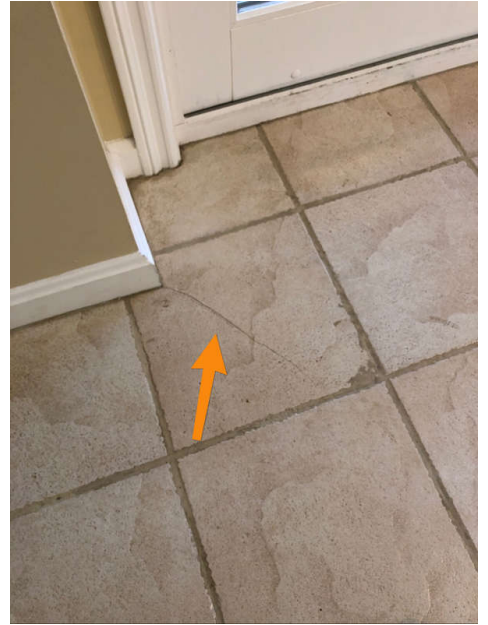
Basement

**CRACKED TILE**

Recommendation  
Contact a qualified professional.

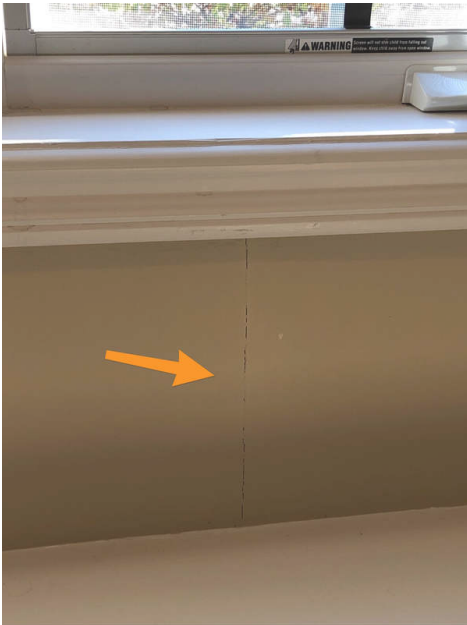
Basement

#### TYPICAL CRACKS OBSERVED

Typical cracks in drywall/plaster were observed. These cracks may develop due to normal aging of a home, minor settling, as well as moisture/temperature changes. Recommend repair as needed. No evidence of structural defect observed at time of inspection.

Contact a qualified drywall contractor.

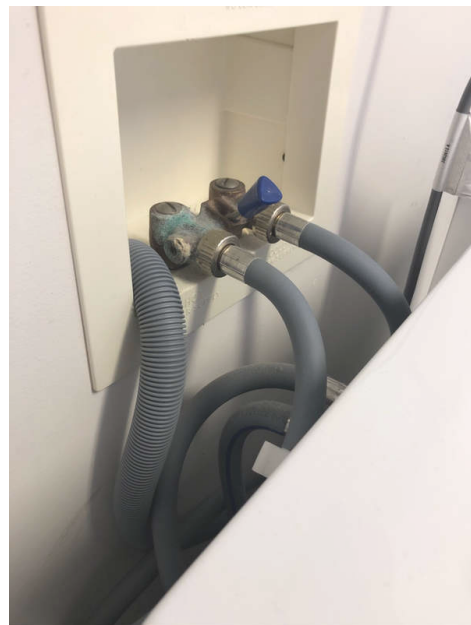
#### WASHER HOSES IMPROPER

Current hoses are rubber. Recommend replacing with Stainless Steel Braided hoses as rubber can crack and burst.

Recommendation  
Contact a qualified professional.

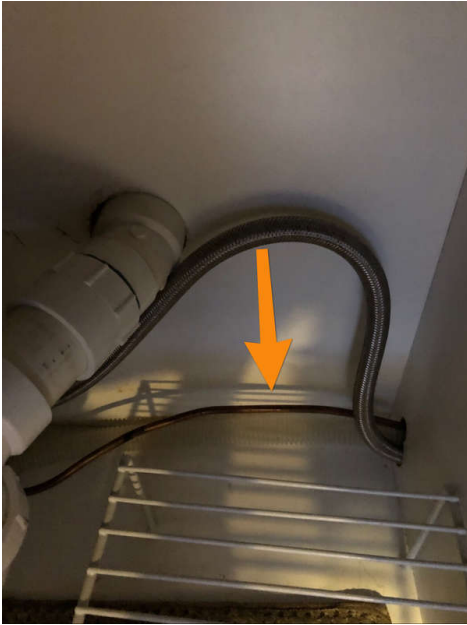
15.3.2 Dishwasher  
**HIGH LOOP NOT PRESENT**

The high loop is designed to prevent wastewater from contaminating the dishwasher. The drain for this DW runs straight along the bottom of the base cabinet then up into drain.

Recommendation  
Contact a qualified professional.

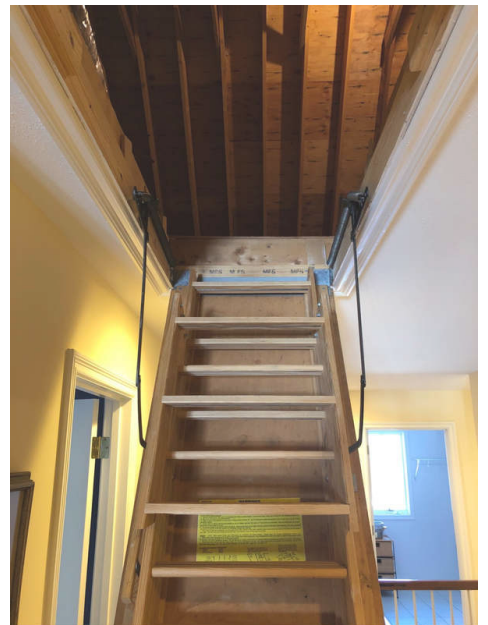
## INSULATE PULL DOWN ACCESS

Recommend insulating above the pull down attic access to prevent unwanted heat loss into the attic.

Contact a qualified professional.

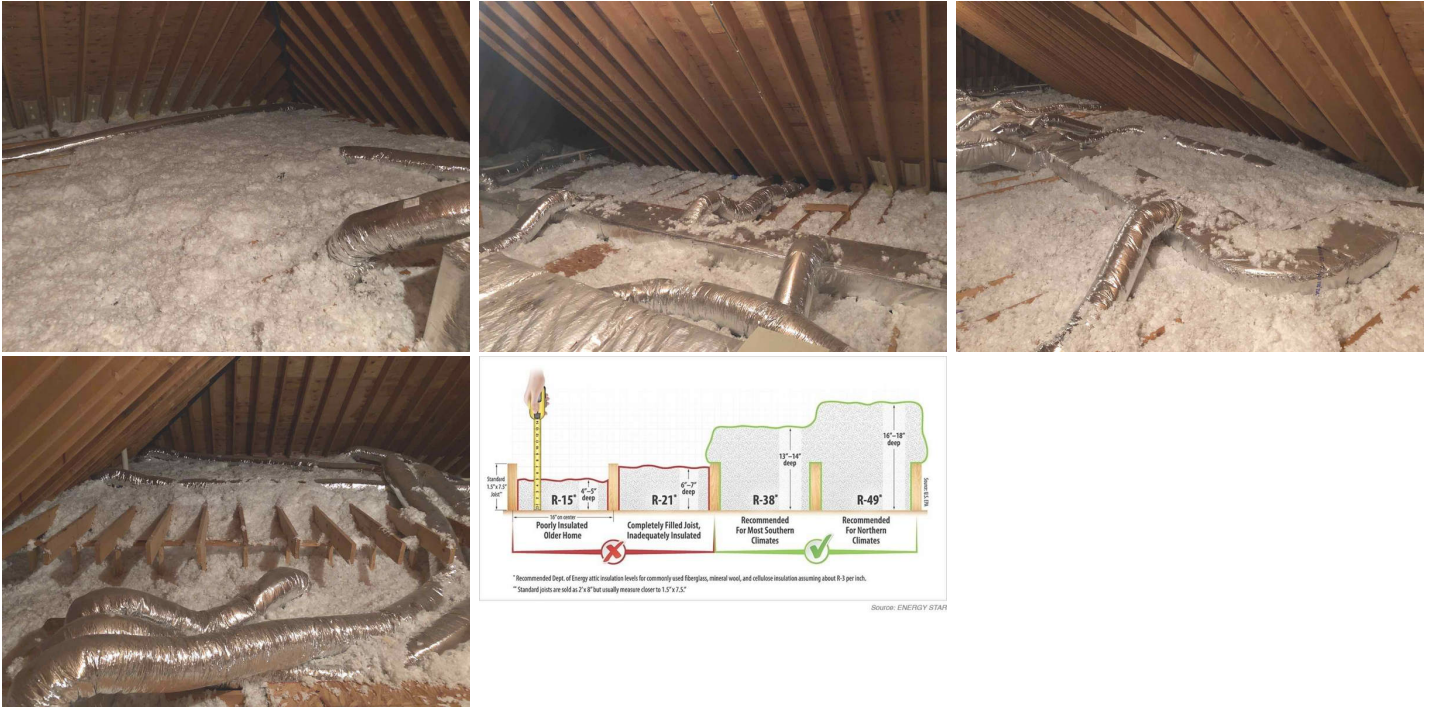
## INSUFFICIENT INSULATION

Insulation depth was inadequate. Recommend a qualified attic insulation contractor install additional insulation. An R rating of R-49 is the recommended insulation value for this climate region.

Recommendation  
Contact a qualified insulation contractor.

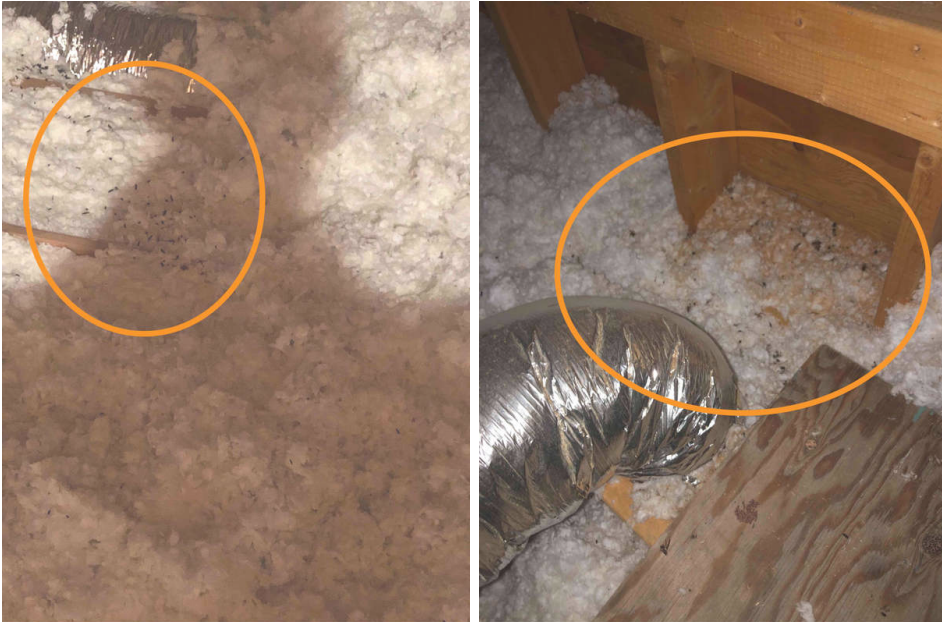
#### PEST

Evidence of pest and / or rodent feces was observed in attic area, recommend licensed pest control contractor to evaluate and repair as needed.

Recommendation  
Contact a qualified pest control specialist.

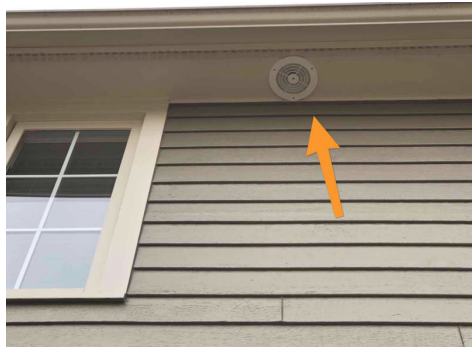
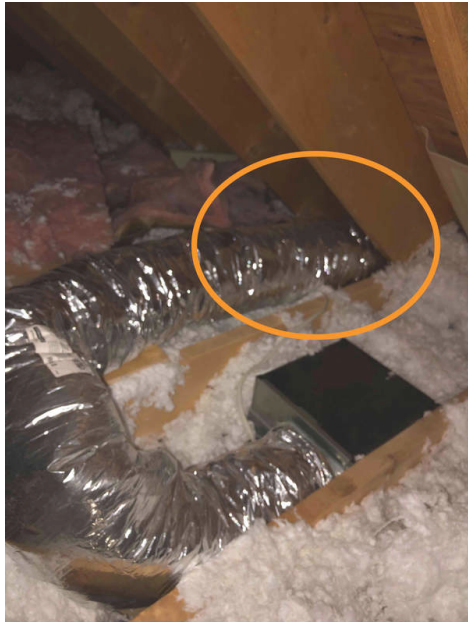
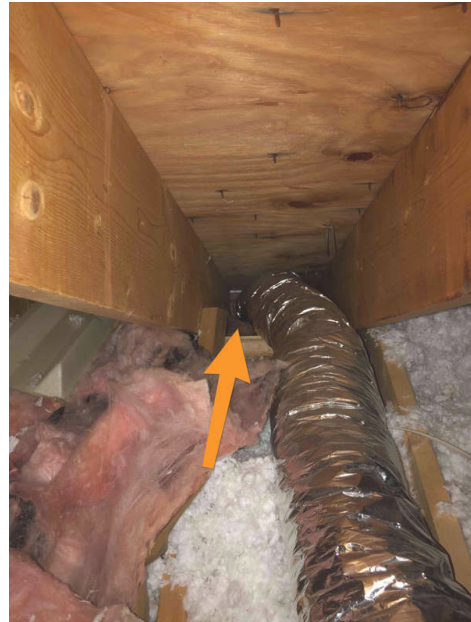
#### EXHAUST DUCTS TO SOFFIT

One or more exhaust fan ducts terminated at a soffit vent rather than at a dedicated hood or cap. Soffit vents are designed to allow cool air to be drawn into the attic, and to prevent excess moisture from accumulating in the attic. When such ducts are routed to terminate at soffit vents, the moist exhaust air may flow back into the attic and the soffit venting will be reduced. There were no signs of moisture in the attic at the time of inspection. Recommend that a qualified contractor repair per standard building practices. For example, by installing approved hoods or caps at the roof surface or exterior wall(s), and permanently securing exhaust ducts to them.

Contact a qualified professional.
