SUMMARY

1234 Main St. Turlock California 95380

Buyer Name
09/06/2018 9:00AM

Scott Fitzgerald
InterNACHI Certified Professional
Inspector
Pinnacle Home Inspection
209-426-0100
scott@pinnaclehomeinspect.com

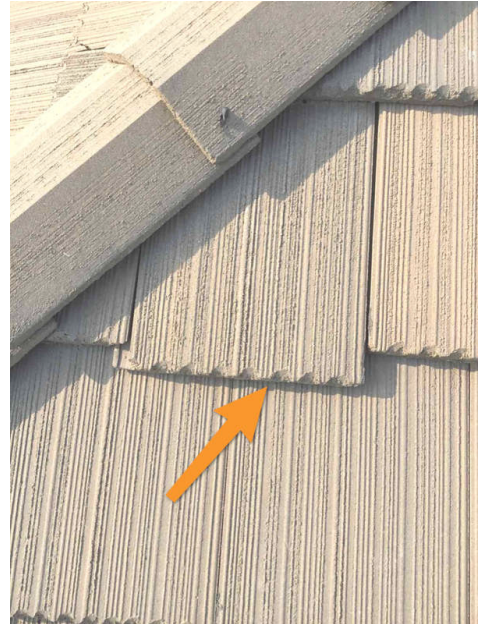
North side of garage roof.

IMPROPER/INCOMPLETE NAILING

Roof coverings showed signs of improper fastening. Tile has slipped out of position. Recommend a qualified roofing contractor evaluate and repair.

Contact a qualified roofing professional.

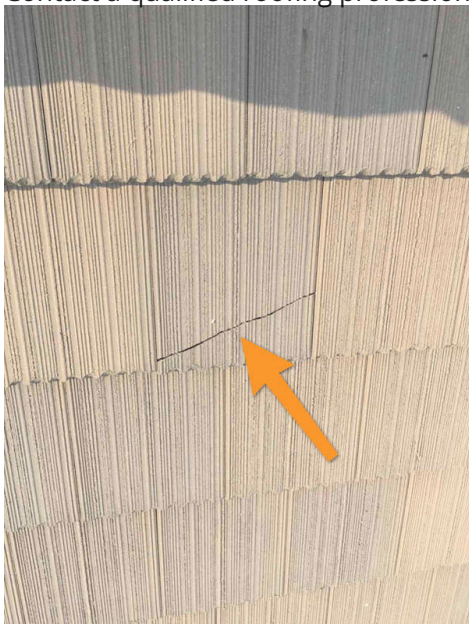
North side of garage roof.

TILES CRACKED/BROKEN

Roof had cracked/broken tiles. This can cause potential water intrusion and lead to further damage. Recommend a qualified roof contractor repair or replace broken tiles.

Contact a qualified roofing professional.

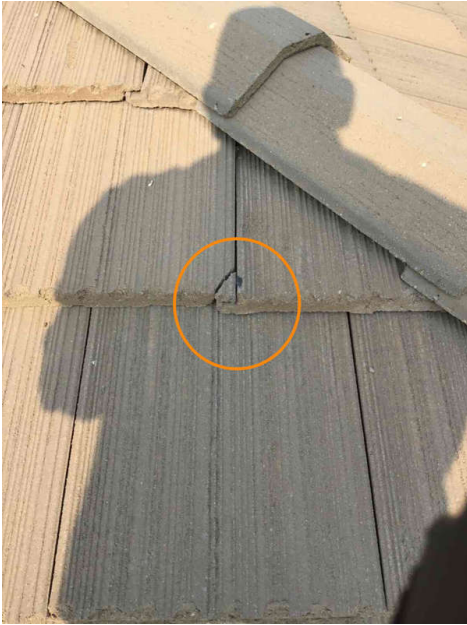
Condition observed at multiple locations.

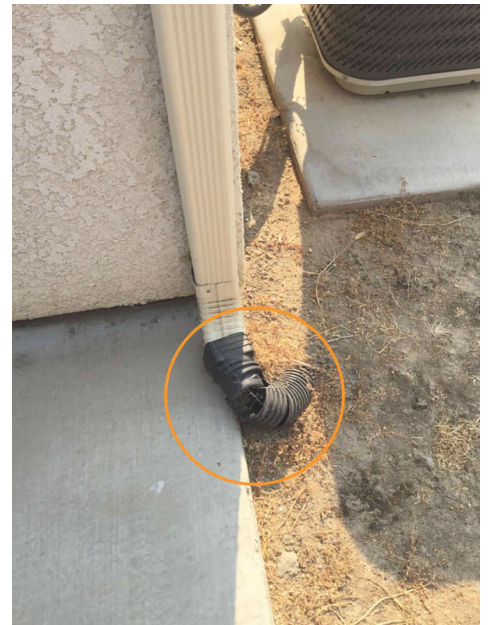
Southwest corner of building.

DOWNSPOUT DAMAGED

Downspout extension is damaged. This can lead to water in the soil at the foundation causing movement or damage. Recommend replacing downspout extension.

Contact a handyman or DIY project

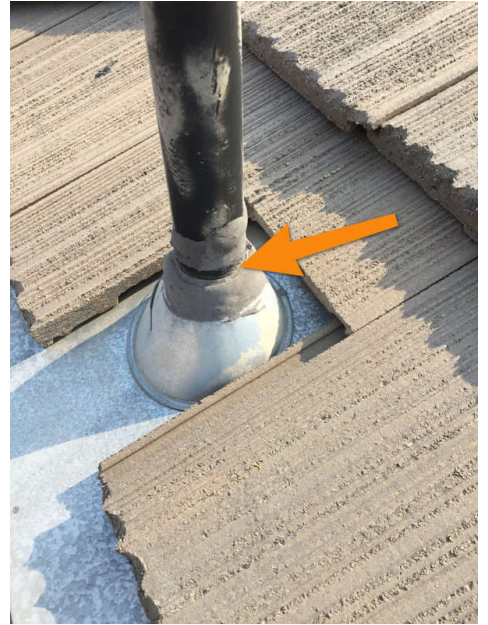
PLUMBING JACK

Mastic sealant at plumbing jack is worn away. This occurs as the mastic hardens and the plastic plumbing vent pipe expands and contracts with the changing weather. This can lead to potential water intrusion and further damage. Recommend resealing and maintaining these annually.

Condition observed at multiple locations.

Contact a handyman or DIY project

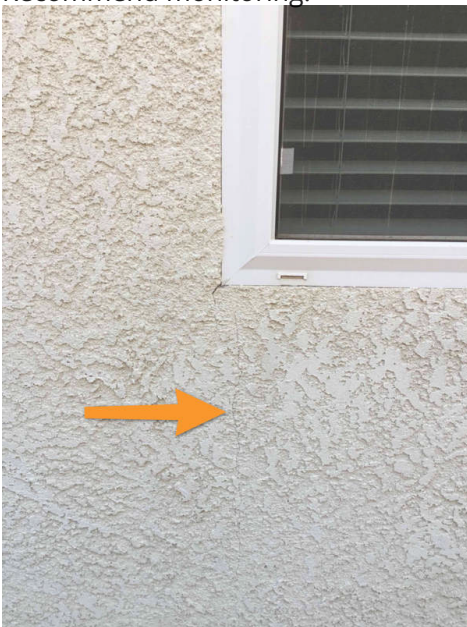
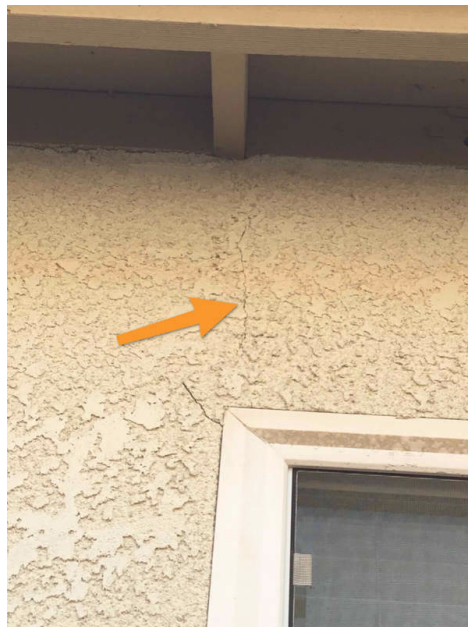
West side of building below window. West side of building above window.

CRACKING - MINOR

Stucco showed cracking in one or more places. This is a result of temperature changes and settling, and typical as homes with stucco age. Recommend monitoring.

Recommendation
Recommend monitoring.

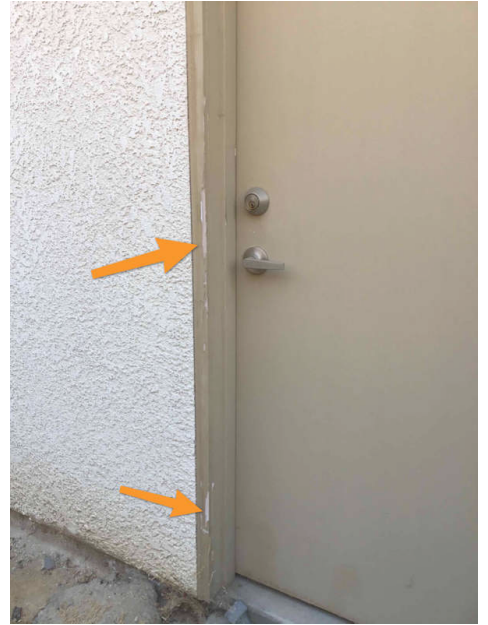
West side garage door trim.

PAINT/FINISH FAILING

Paint on wood trim is cracked and peeling. This can lead to deterioration of the underlying surface. Recommend repainting.

Recommendation
Contact a handyman or DIY project

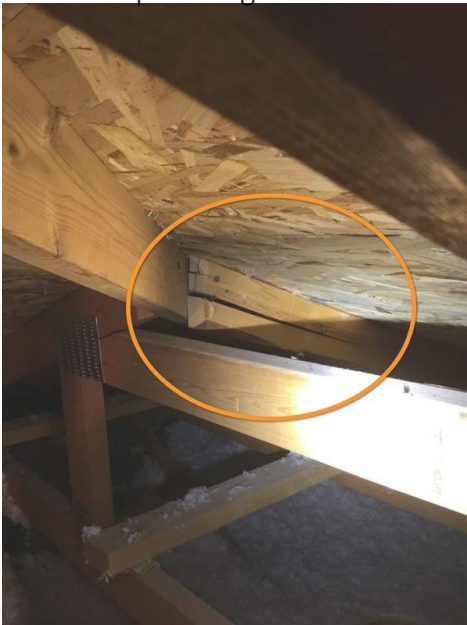
Near end of equipment platform looking Southwest.

TRUSS DAMAGE

A crack was observed at the end of a jack rafter and another jack rafter appeared to be cut short. This could potentially cause additional damage. Recommend further evaluation and repair by a qualified professional.

Recommendation
Contact a qualified general contractor.

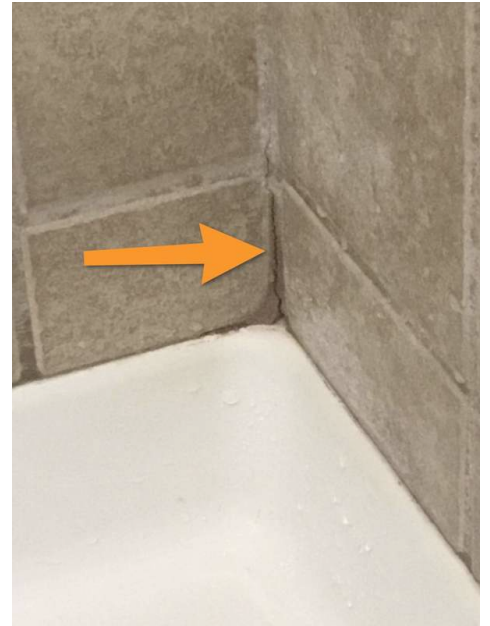
SHOWER WALL TILE

Cracked grout at bottom corner of tile shower wall in Master Bathroom. This can cause potential water leaks and damage. Recommend repairing the damaged grout.

Recommendation
Contact a handyman or DIY project

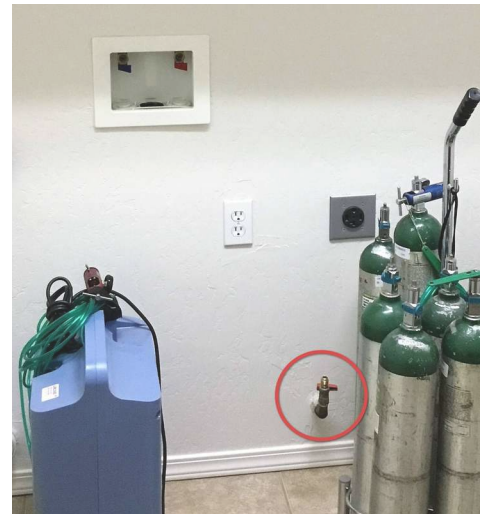
LAUNDRY ROOM, WEST WALL

GAS SHUT-OFF

The shut-off valve is not connected to an appliance. It could be opened, causing a gas leak and explosion hazard. Gas outlets that do not connect to appliances should be capped gas-tight.

Gas shut-off valve for dryer.

Recommendation
Contact a qualified plumbing contractor.

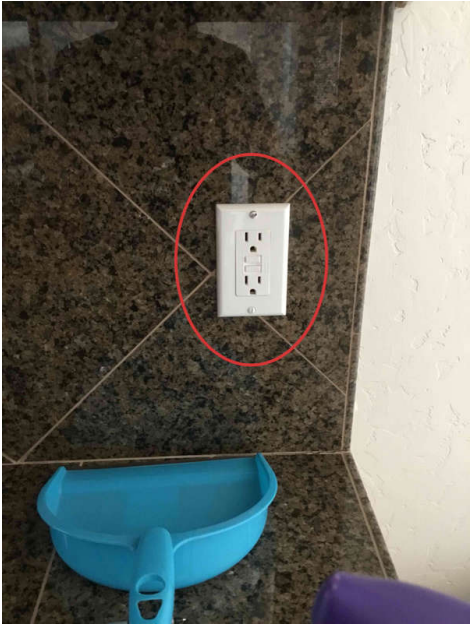
IN THE KITCHEN ON THE RIGHT SIDE OF THE SINK.

INOPERATIVE GFCI

GFCI outlet did not trip when tested. This is a potential shock hazard. Recommend repair or replacement by a qualified electrician.

Recommendation
Contact a qualified electrical contractor.
