SUMMARY
1234 Main St. Merrimack NH 03054
Buyer Name
07/12/2019 9:00AM

Chris Caisse
InterNACHI Certified Professional
Inspector
Platinum Home Inspections
603-897-5495

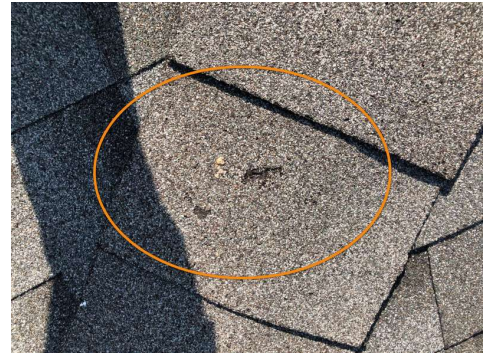
2.1.1 Coverings

DAMAGED RIDGE CAP SHINGLES

ABOVE PORCH

Cap shingles/ridge vent shingles are damaged/aging. Cap shingles are shingles that cover areas where the roof changes direction, like at roof peaks and hips. Recommend roofing professional evaluate and repair as needed.

Contact a qualified roofing professional.

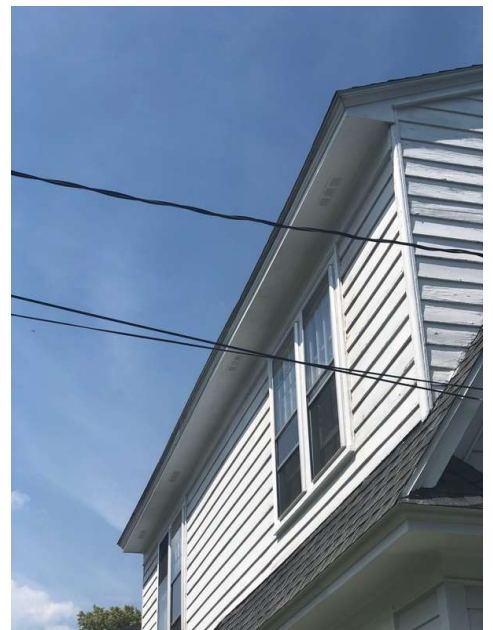
2.2.1 Roof Drainage Systems

GUTTERS MISSING

There are no gutters present on the structure. Gutters are recommended because they collect rain water from the roof and direct it away from the building.

Contact a qualified gutter contractor

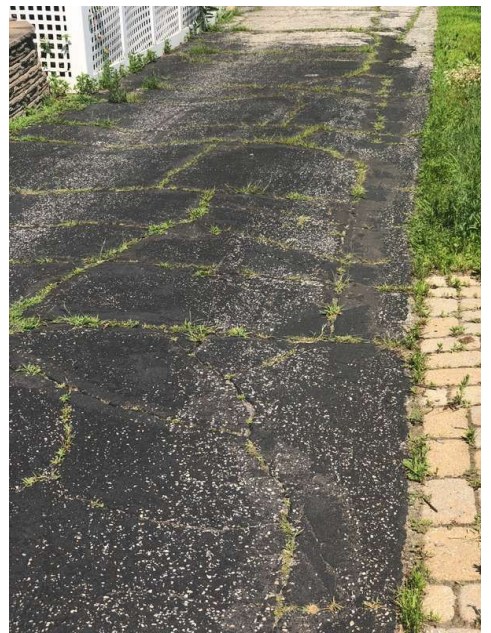
3.1.1 Walkways, Patios & Driveways

ASPHALT DRIVEWAY - TYPICAL CRACKING

Asphalt driveway... this material has typical cracking which is normal for its age recommend seal coating as needed to prolong life expectancy.

Recommend monitoring.

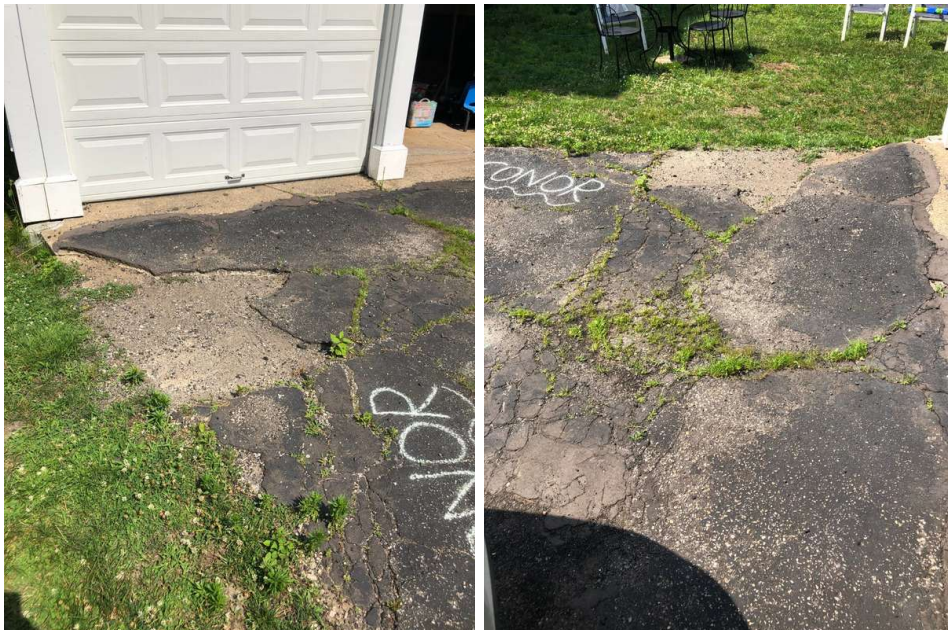
3.1.2 Walkways, Patios & Driveways

DRIVEWAY CRACKING/SETTLEMENT - MAJOR

Major cracks and settling observed. Recommend qualified professional evaluate and repair as needed to prolong the life of the driveway.

Contact a qualified professional.

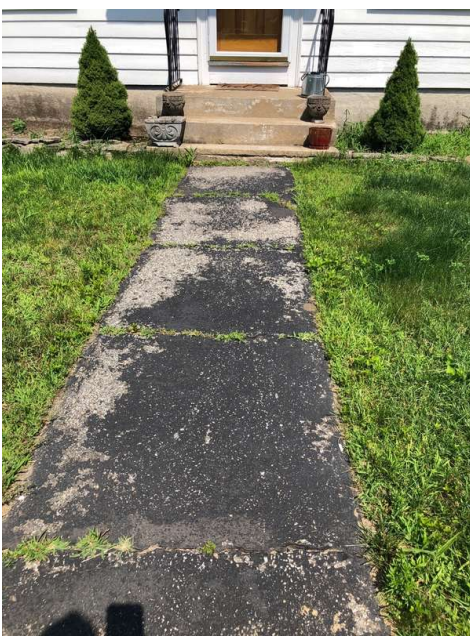
3.1.3 Walkways, Patios & Driveways

WALKWAY CRACKING - MINOR

Minor cosmetic cracks observed. Recommend monitor and/or patch/seal.

Recommend monitoring.

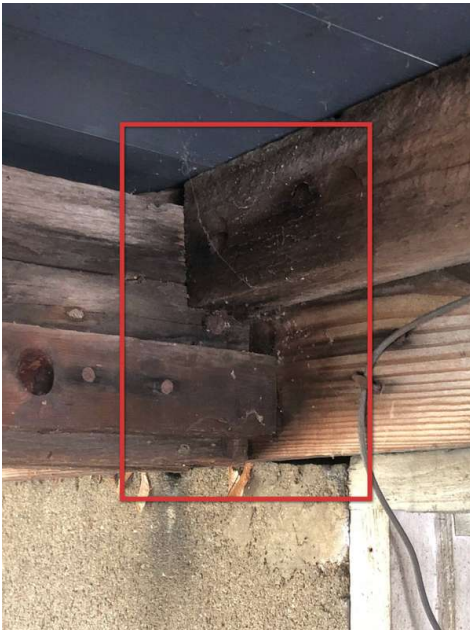
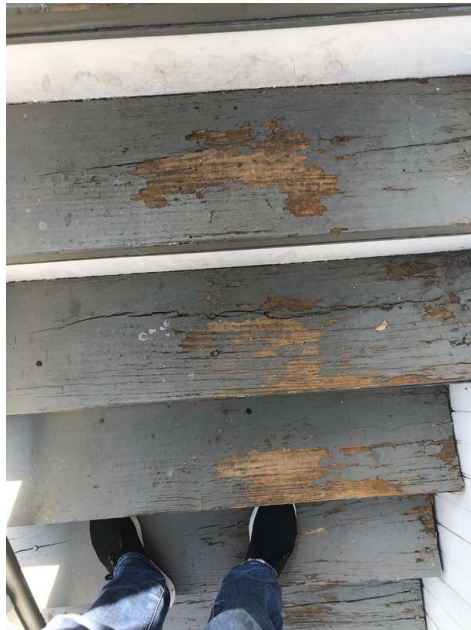
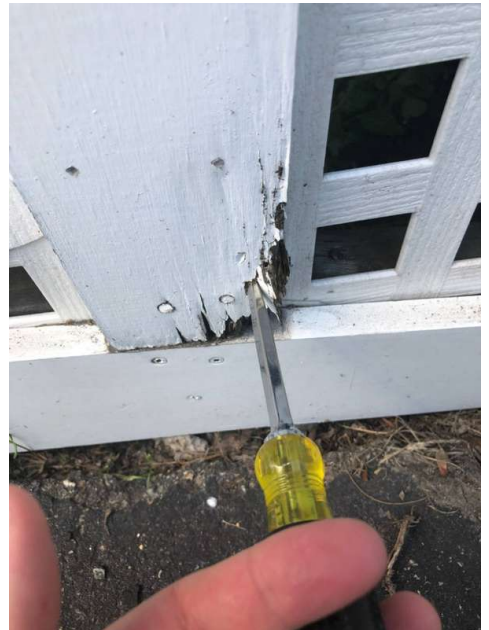
3.2.1 Decks, Balconies, Porches & Steps

IMPROPER DECK CONSTRUCTION PRACTICES

Recommend qualified deck contractor evaluate. These construction practices may have been normal at time of original construction, but do not meet current safety standards. Issues of note are not joist or stair stringer hangers present, loosely nailed stairs, stair supports move freely, peeling paint, cracked/weathered boards that need replacing, loose guardrails, improper supports and more.

Contact a qualified deck contractor.

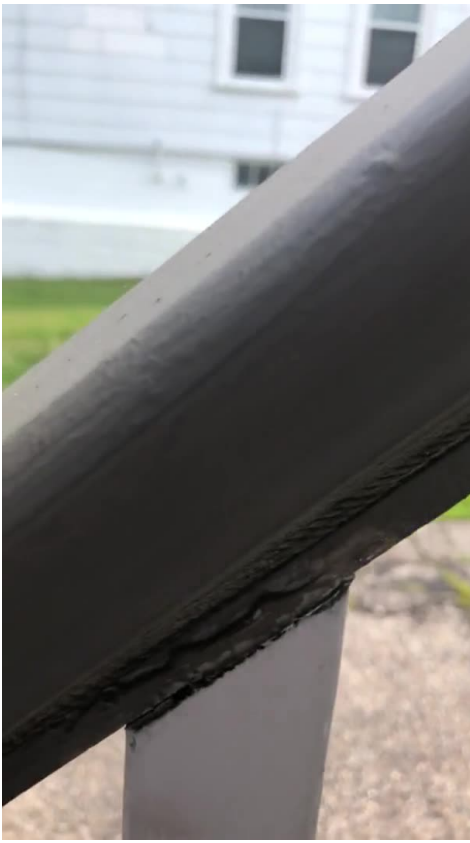
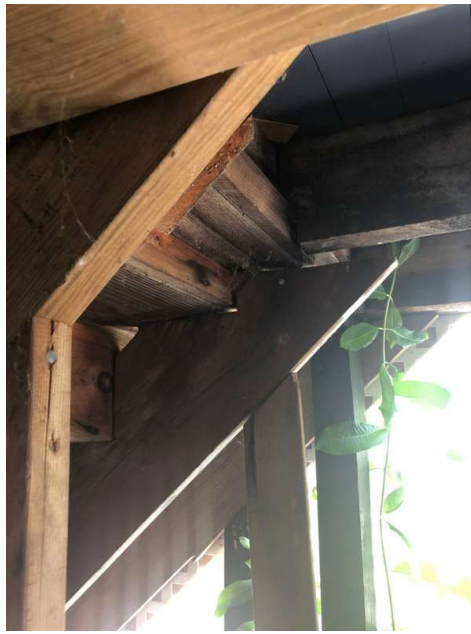
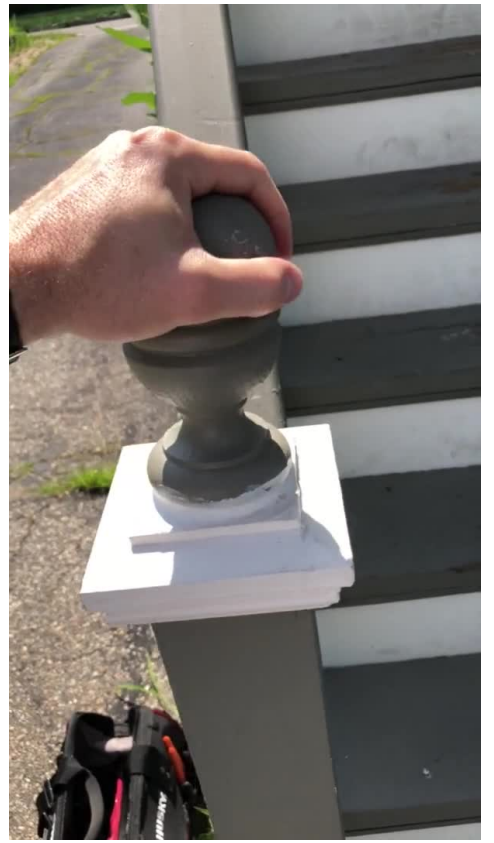
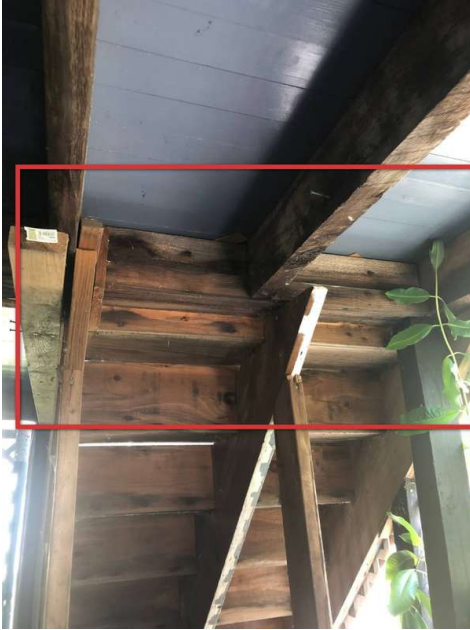
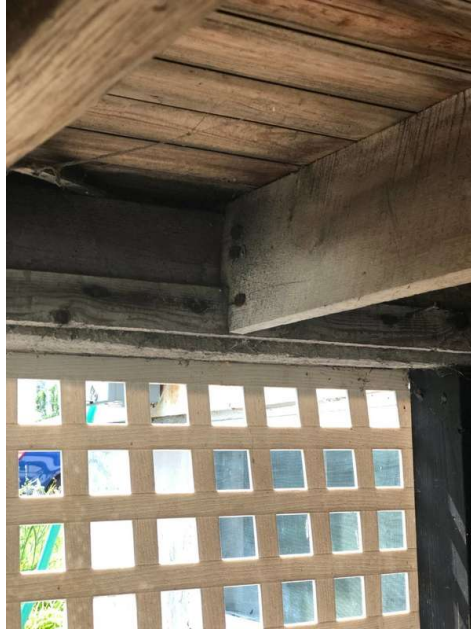
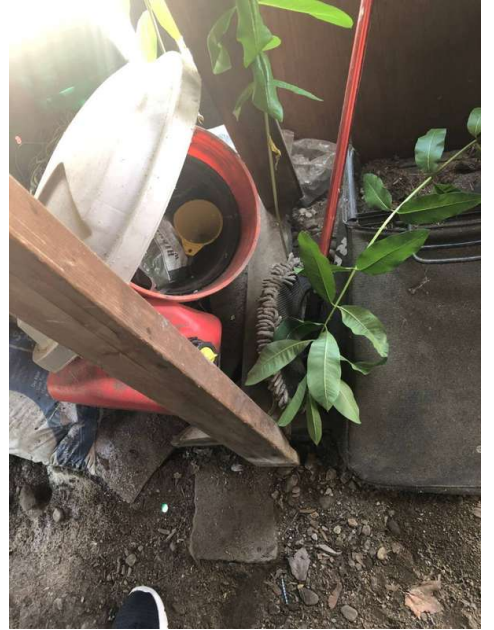
Rot

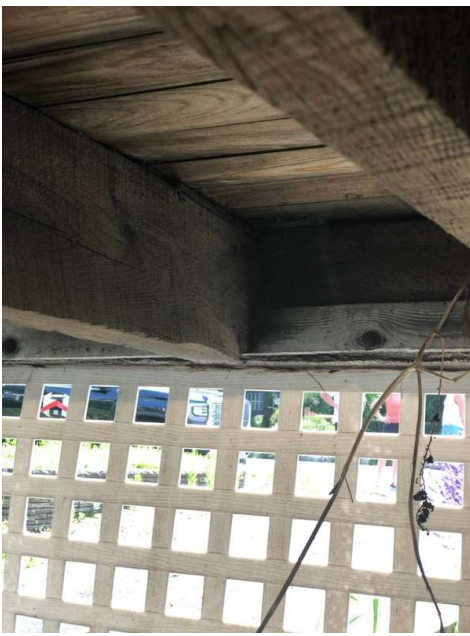
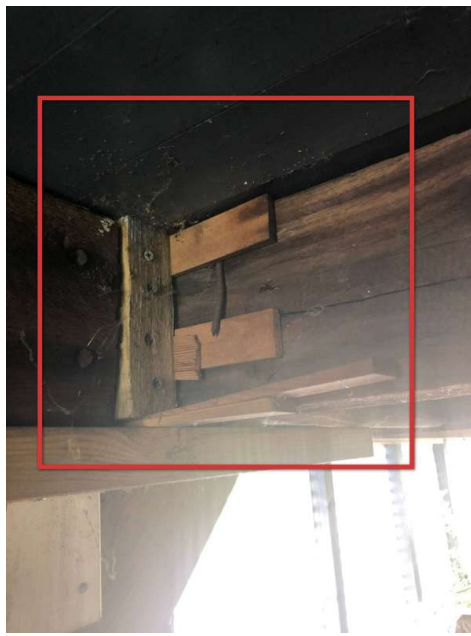
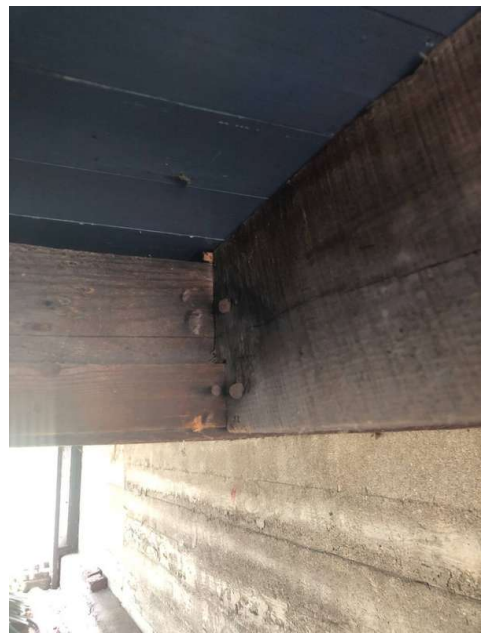
Improper Supports

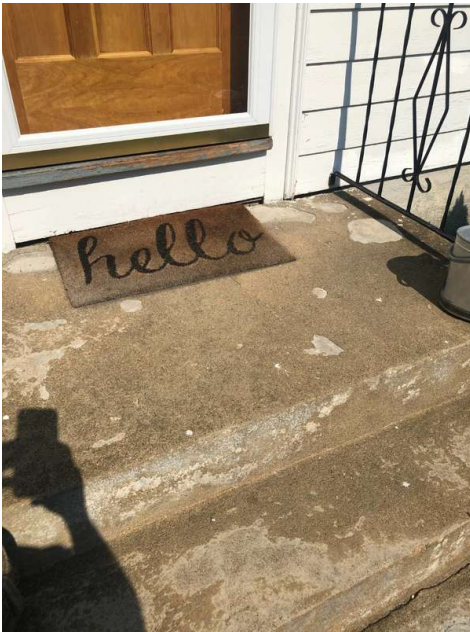
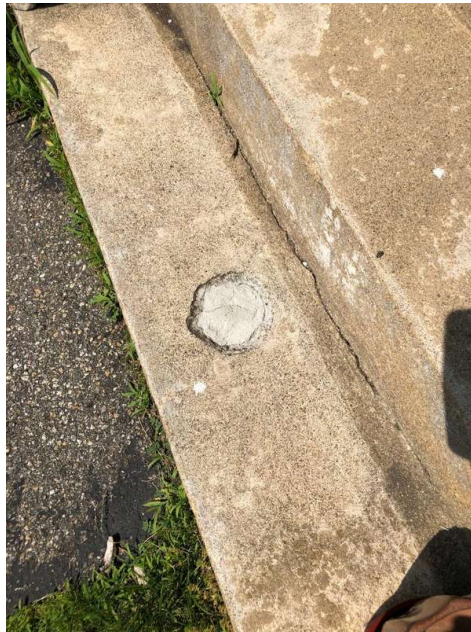
3.2.2 Decks, Balconies, Porches & Steps

FRONT STOOP DAMAGE

Entryway stoop concrete is damaged recommend licensed contractor to repair/replace

Contact a qualified concrete contractor.

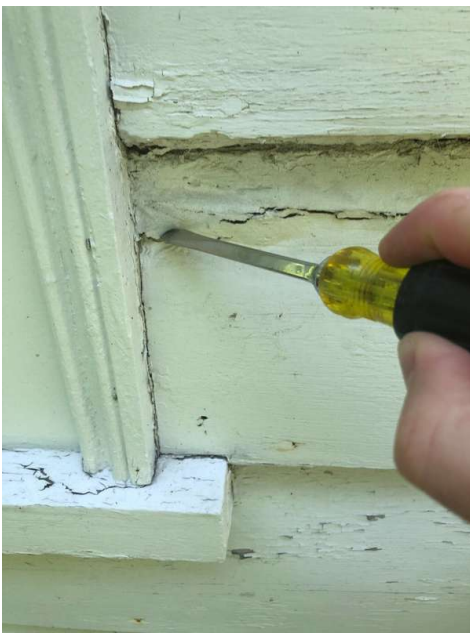
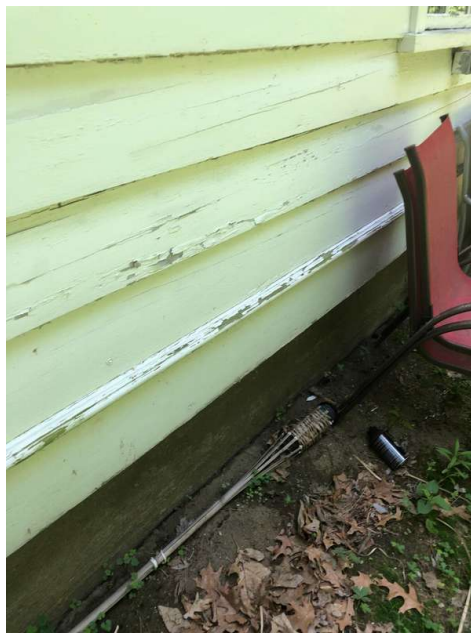
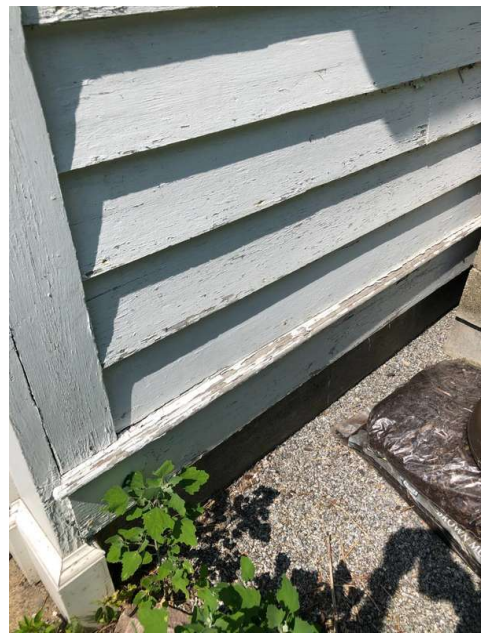
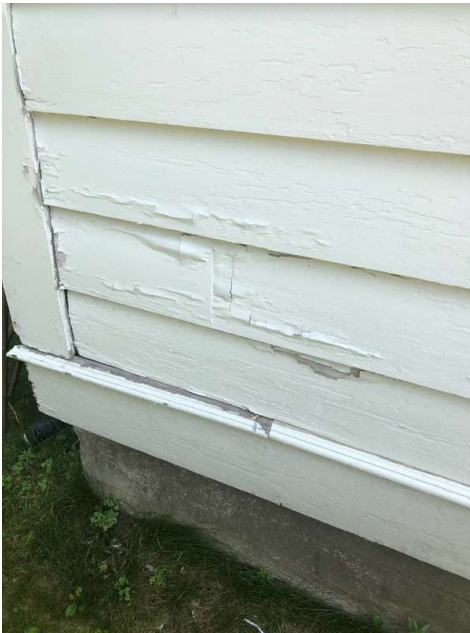
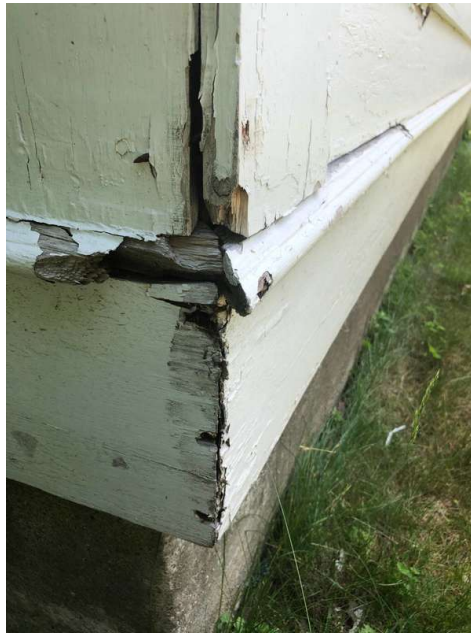
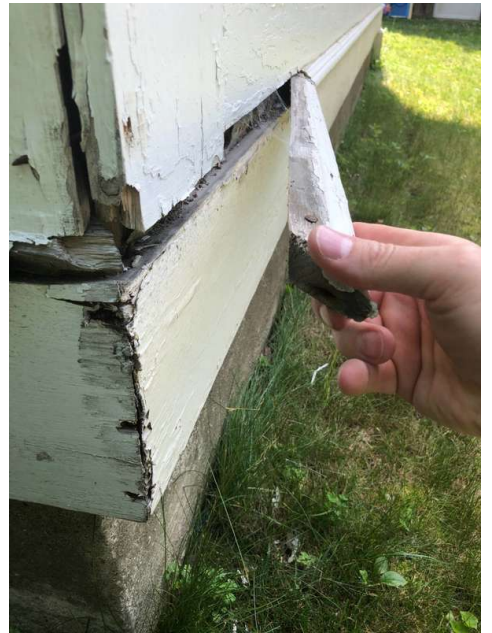
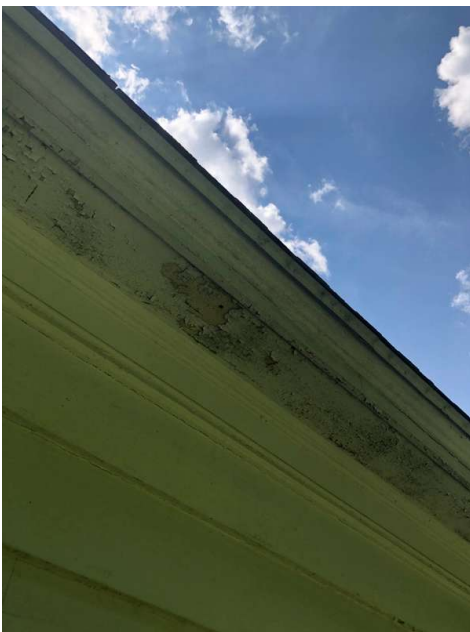
4.2.1 Siding, Trim, Fascia, Soffit, Eaves

PEELING PAINT / DAMAGED SIDING

Peeling paint along with damaged areas was observed on exterior surfaces, such as Siding, Trim, Fascia, Soffits, and Eave edges. Recommend qualified contractor to perform normal paint maintenance to prevent moisture damage to these areas.

Contact a qualified painting contractor.

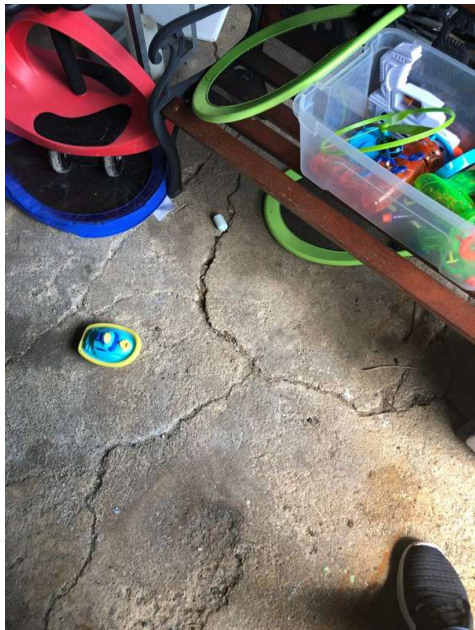
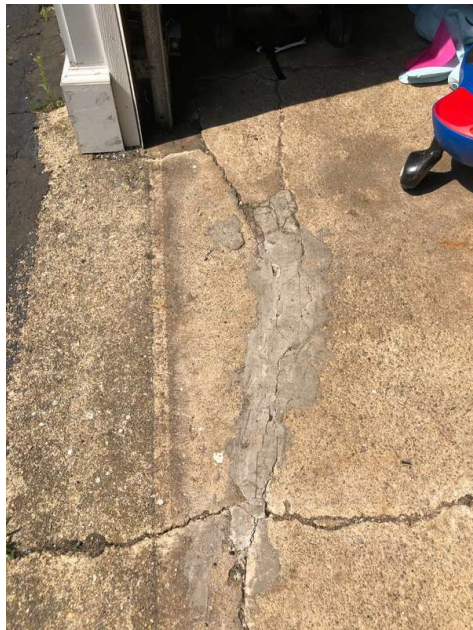
4.4.1 Floor
SETTLING/CRACKING

Garage floor shows signs of settling in the soil beneath the slab.

Contact a qualified concrete contractor.

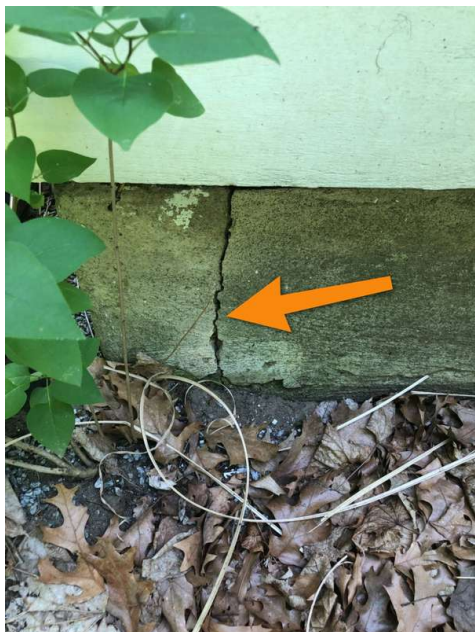
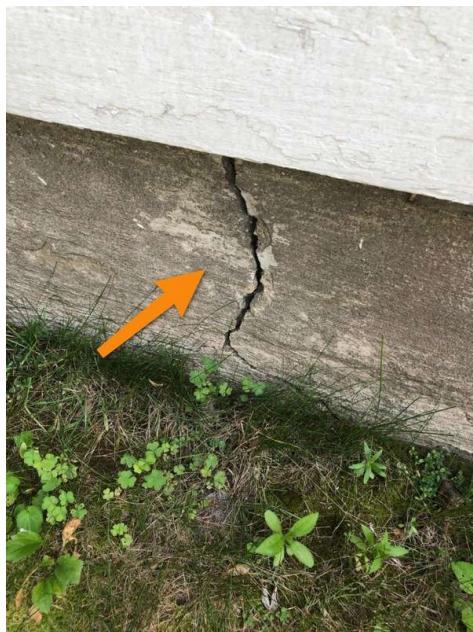
4.5.1 Walls, Ceiling & Firewalls

FOUNDATION CRACKING-MINOR

Observed a crack(s) in the foundation wall of the garage. There were no signs of moisture intrusion at the time of inspection.

Recommend monitoring.

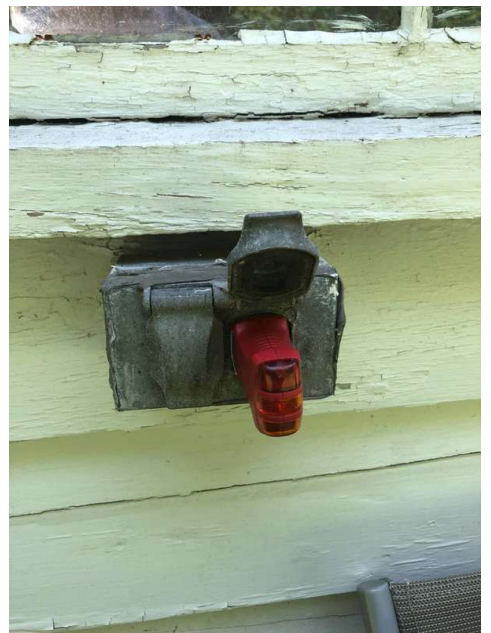
4.6.1 Garage Electrical

OUTLETS OKAY, NO GFCI PROTECTION

At the time of the inspection, the Inspector observed no deficiencies in the condition of electrical receptacles in the garage, but receptacles in the garage had no ground fault circuit interrupter (GFCI) protection. Although this condition may have been commonly considered safe or acceptable at the time the home was originally constructed, as general knowledge of safe building practices has improved with the passage of time, building standards have changed to reflect current understanding. Consider having GFCI protection installed as a safety precaution. This can be achieved by: 1. Replacing the current standard receptacles with GFCI outlets 2. In the garage circuit, replacing the receptacle nearest the main electrical service panel with a GFCI outlet. 3. Replacing the breakers currently protecting garage electrical circuits with GFCI breakers.

Contact a qualified professional.

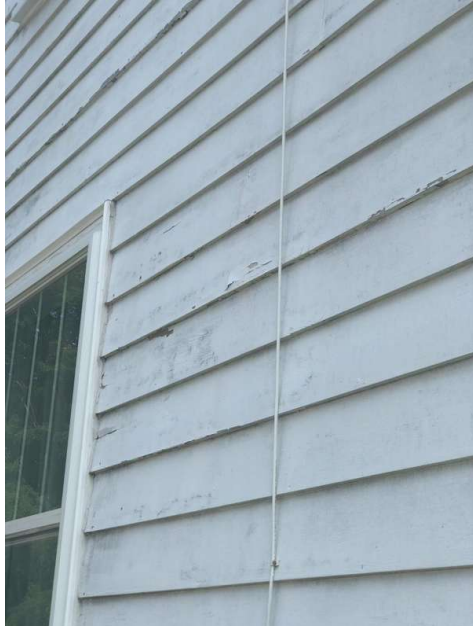
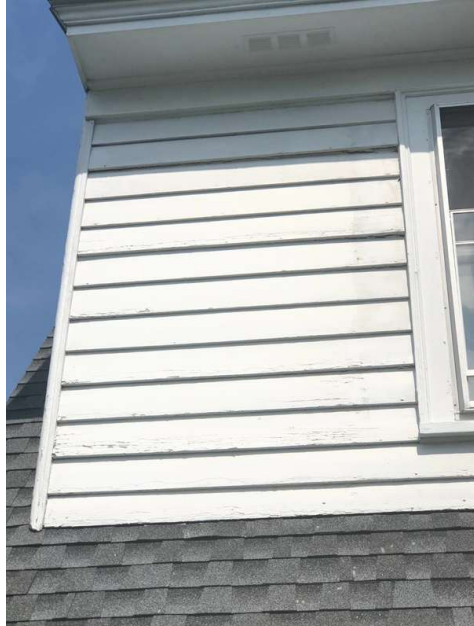
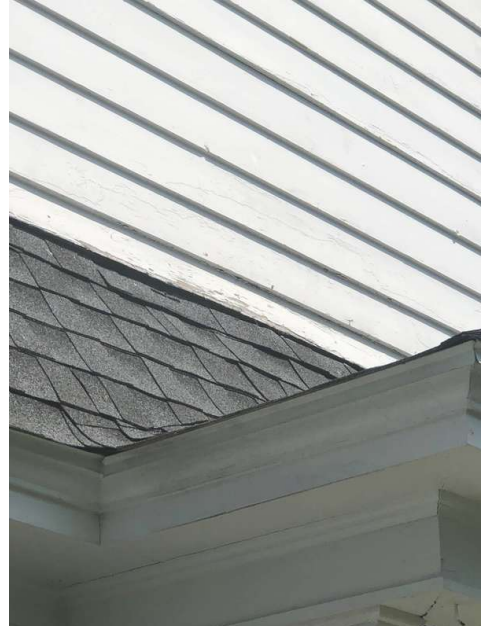
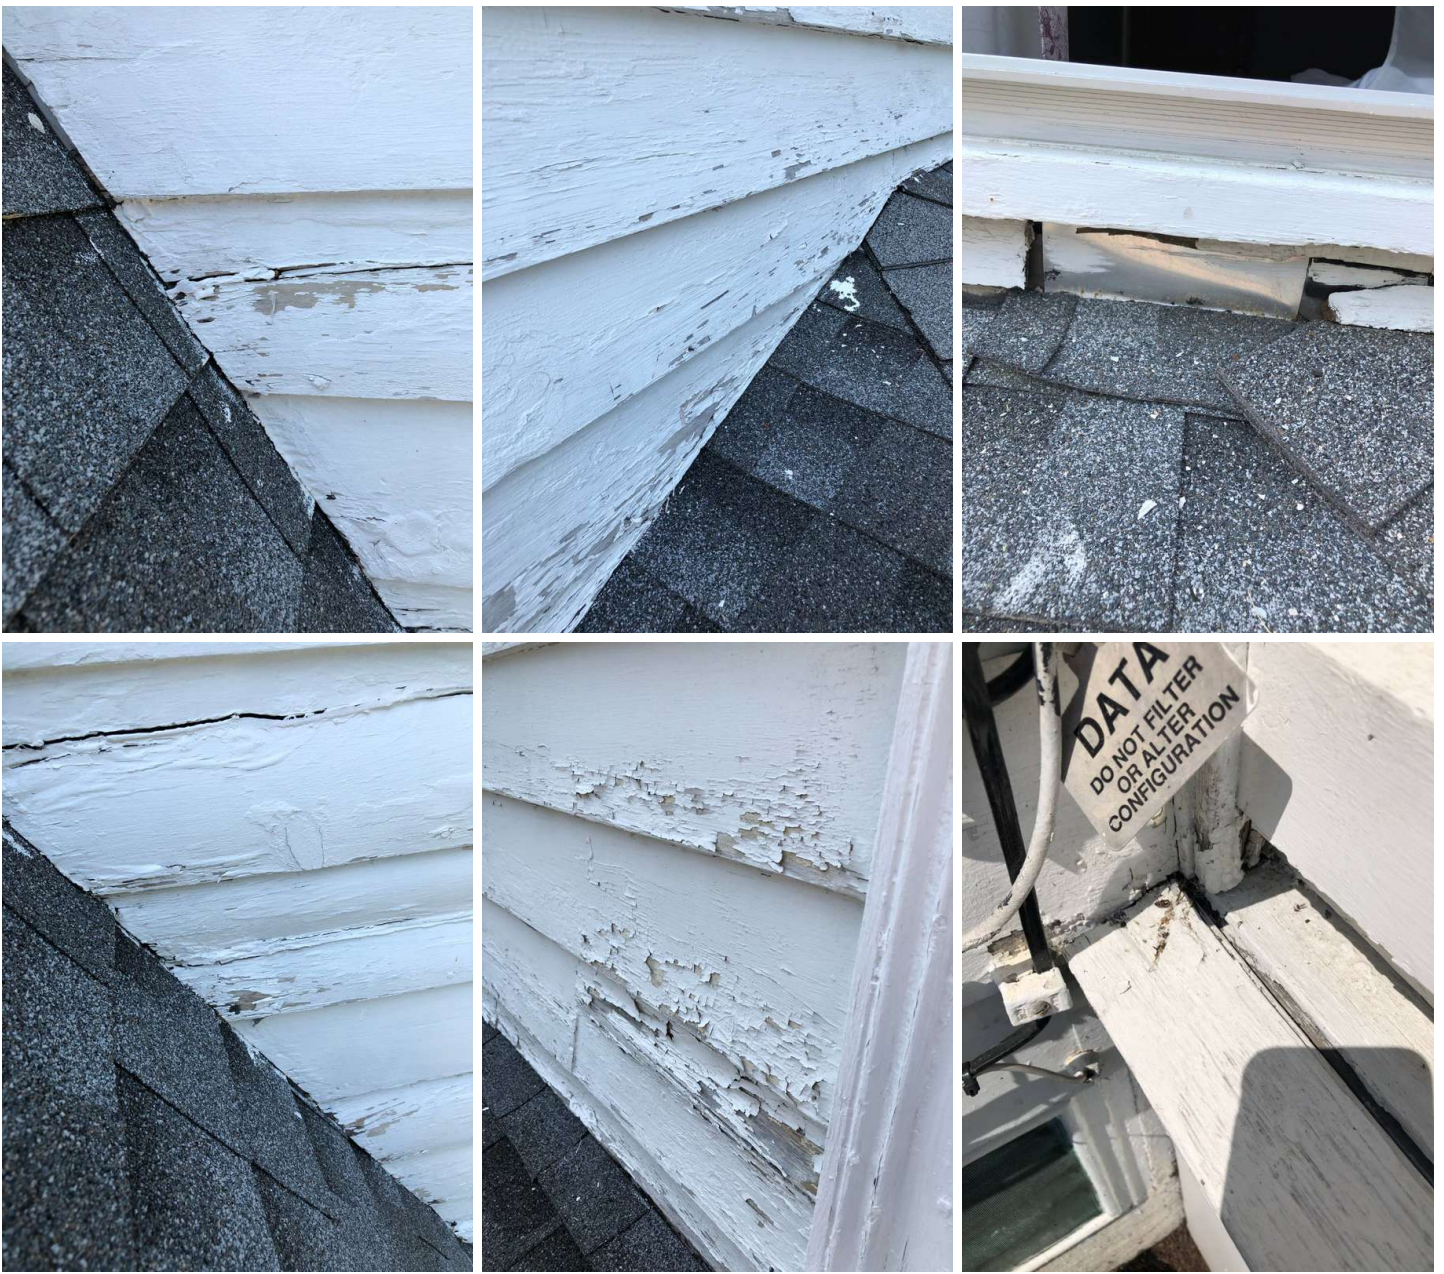
5.1.1 Siding, Flashing & Trim

PEELING/WEATHERED PAINT & ROTTING/DAMAGE

Peeling paint along with areas of minor rotting and damage was observed on exterior surfaces, such as Siding, Trim, Fascia, Soffits, and Eave edges. Recommend qualified contractor to perform normal paint maintenance to prevent moisture damage to these areas.

Contact a qualified painting contractor.

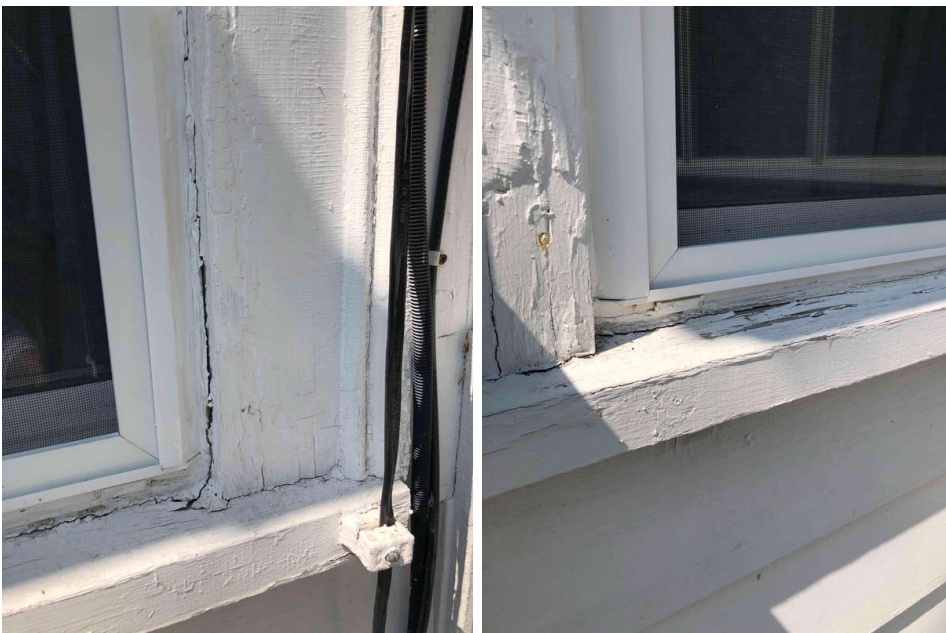
5.2.1 Exterior Windows

PEELING PAINT

Exterior windows have painted components that are peeling, recommend qualified contractor to perform normal paint maintenance as needed to prevent potential damage.

Contact a qualified painting contractor.

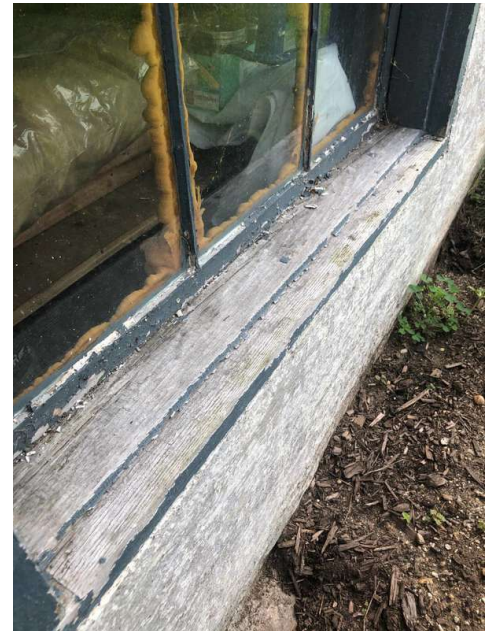
5.4.1 Basement windows

PEELING PAINT

Exterior windows have painted components that are peeling, recommend qualified contractor to perform normal paint maintenance as needed to prevent potential damage.

Contact a qualified painting contractor.

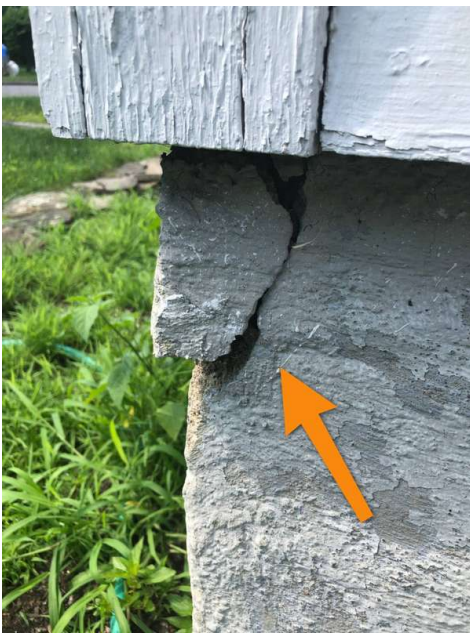
5.5.1 Exterior foundation

MINOR DAMAGE

FRONT RIGHT SIDE

Concrete foundation block has minor damage recommend licensed foundation contractor to repair

Contact a foundation contractor.

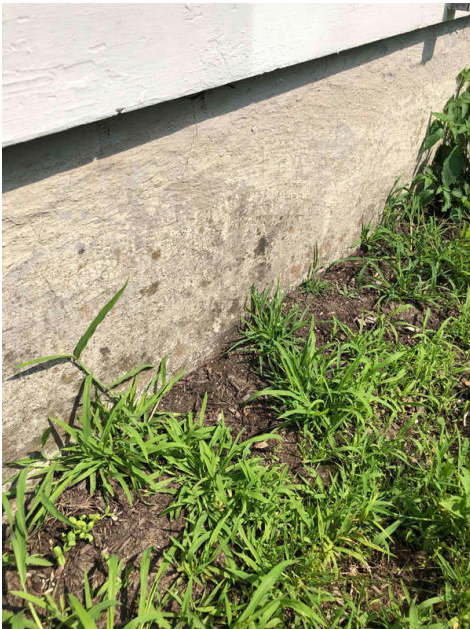
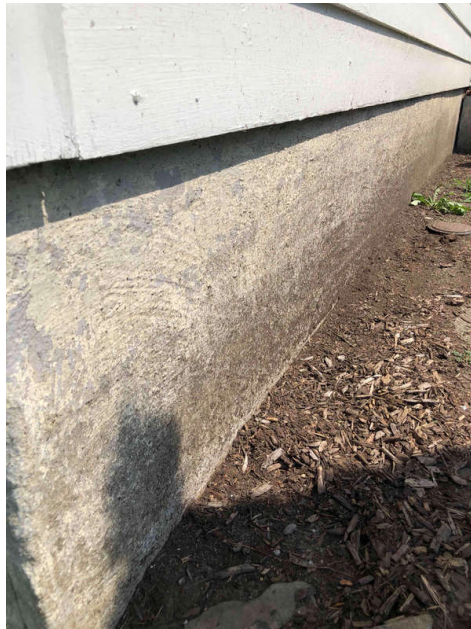
5.5.2 Exterior foundation

PARGING

Evidence of Parging was observed. Recommend monitoring for changes in condition.

Recommendation
Recommend monitoring.

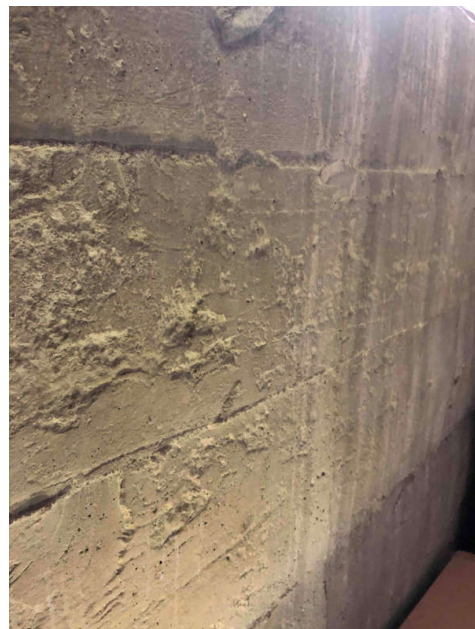
6.2.1 Foundation

PARGING APPLIED

Parging has been applied to interior foundation surface. This is a common repair that shows evidence of moisture intrusion. Recommend licensed foundation contractor to further evaluate and repair as needed to prevent moisture damage.

Recommendation
Recommend monitoring.

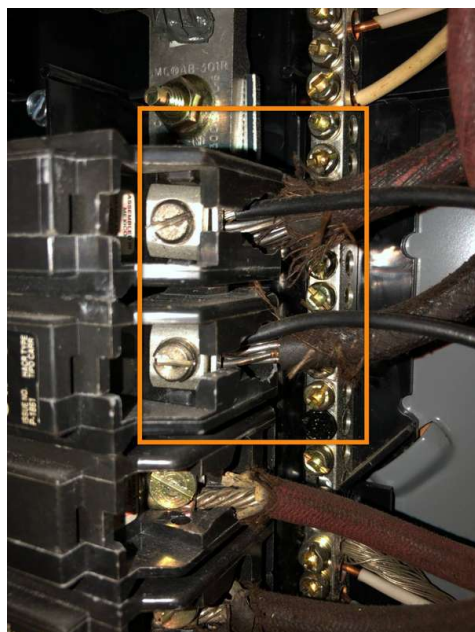
7.1.1 Main & Subpanels, Service & Grounding, Main Overcurrent Device

DOUBLE TAPS

In the service panel, two wires were connected to a circuit breaker designed for only one wire. This is known as a "double-tap" and is a defective condition that should be corrected by a qualified electrical contractor.

Recommendation
Contact a qualified electrical contractor.

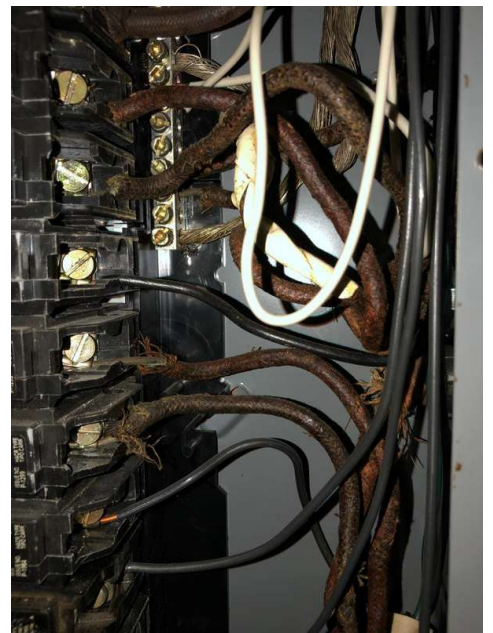
7.2.1 Branch Wiring Circuits, Breakers & Fuses

CLOTH COVERED WIRING

There is visible cloth wiring in the main panel being used as branch wiring. There is a rubber coating below the cloth on the wiring, the rubber coating deteriorates and cracks as the wires age. This can lead to electrical shorts. Recommend to have any cloth wiring replaced with modern wires.

Recommendation
Contact a qualified electrical contractor.

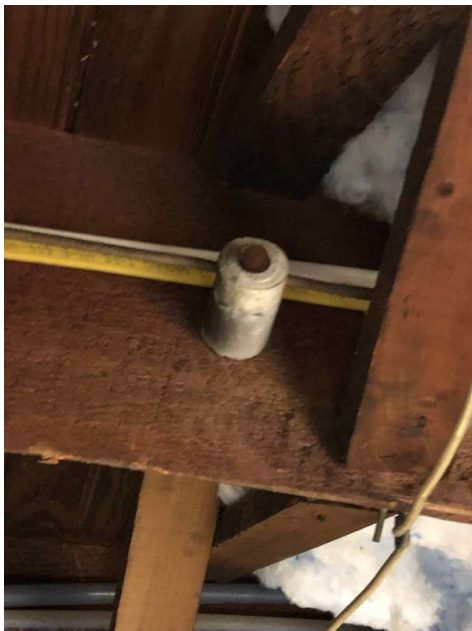
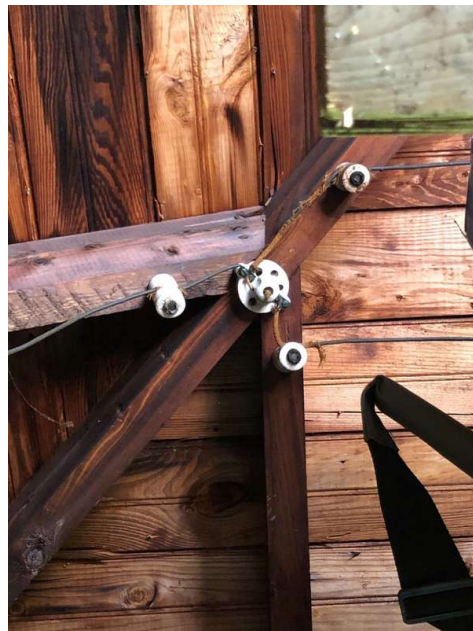
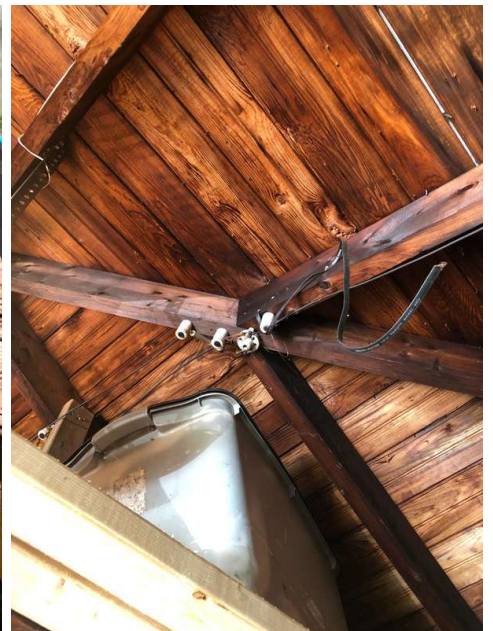
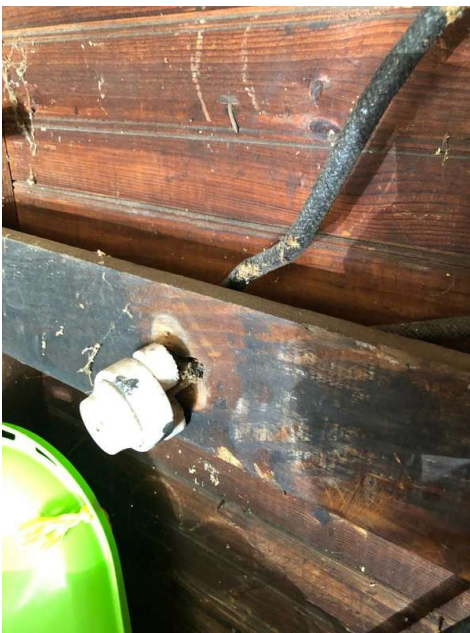
7.2.2 Branch Wiring Circuits, Breakers & Fuses

KNOB AND TUBE WIRING

This home and garage was originally wired using Knob and Tube wiring. This older wiring can become a safety hazard and is recommended to be replaced or repaired to prevent possible injury. Recommend licensed electrician evaluate further and removed as needed.

Recommendation
Contact a qualified electrical contractor.

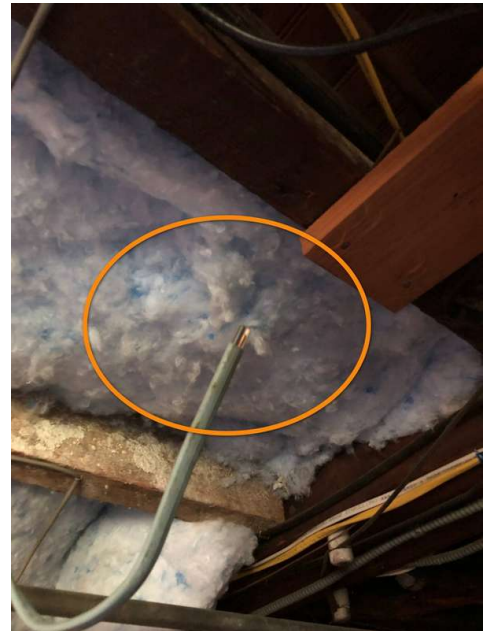
7.2.3 Branch Wiring
Circuits, Breakers &
Fuses

ABANDONED WIRING - EVALUATE

BASEMENT

Miscellaneous abandoned wiring visible in the basement should be evaluated by a qualified electrical contractor to determine whether any wiring is still energized. Improperly terminated, energized wiring is a shock/electrocution hazard.

Near panel

Contact a qualified electrical contractor.

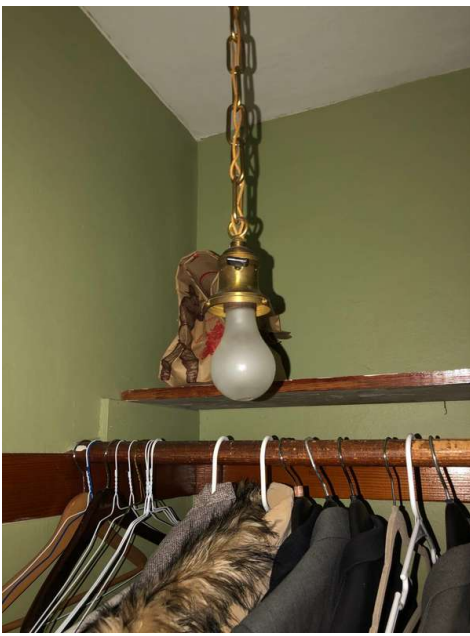
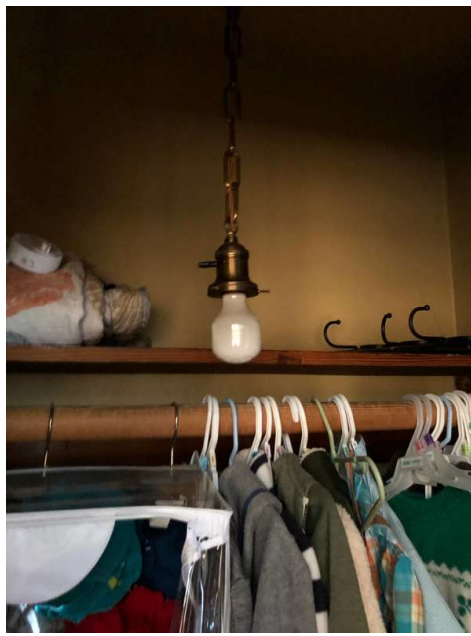
7.3.1 Electrical Fixtures, Switches and Receptacles

INCANDESCENT LIGHT IN CLOSET

BEDROOM CLOSETS

Exposed incandescent light bulbs are no longer permitted inside a closet space. Closet light should only be recessed light or surface mount fixture. Recommend licensed electrician evaluate and repair as needed. Not all closets are photographed.

Contact a qualified electrical contractor.

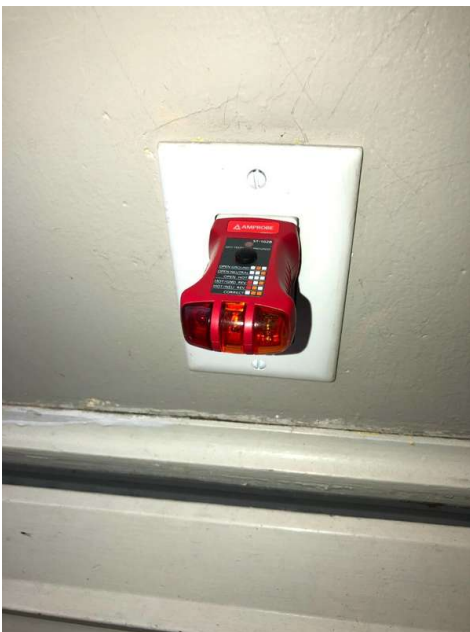
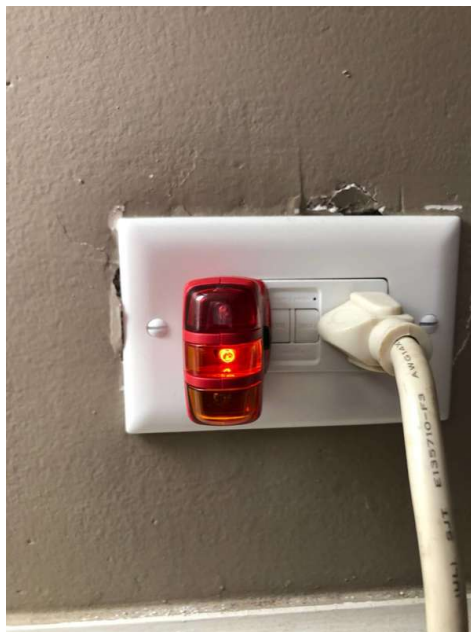
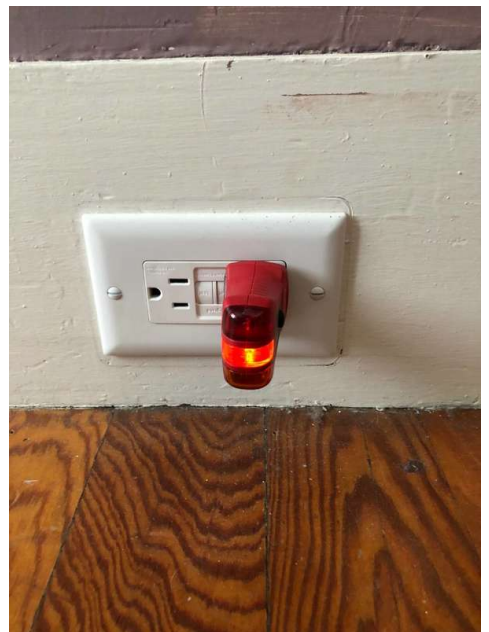
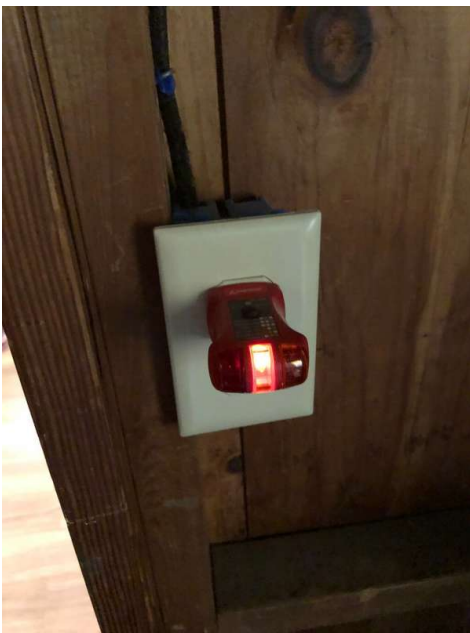
7.3.2 Electrical Fixtures, Switches and Receptacles

OPEN GROUND

2ND FLOOR & BASEMENT

One or more receptacles are ungrounded. An open ground means that a missing grounding conductor or unconnected grounding conductor at the receptacle, or one is missing at an upstream receptacle. To eliminate safety hazards, all 3 prong outlets should be grounded. Where grounding is not possible (no ground wire present), a 2 prong receptacle or GFCI protected receptacle can be installed. Many of the receptacles in these areas have GFCI receptacles in place.

Note: GFCI protection of an ungrounded 3 prong outlet will not protect electronics. A physical ground system is required to protect electronics or allow surge protectors to function properly. Have a licensed electrician evaluate further and repair as necessary for safest operation.

Contact a qualified electrical contractor.

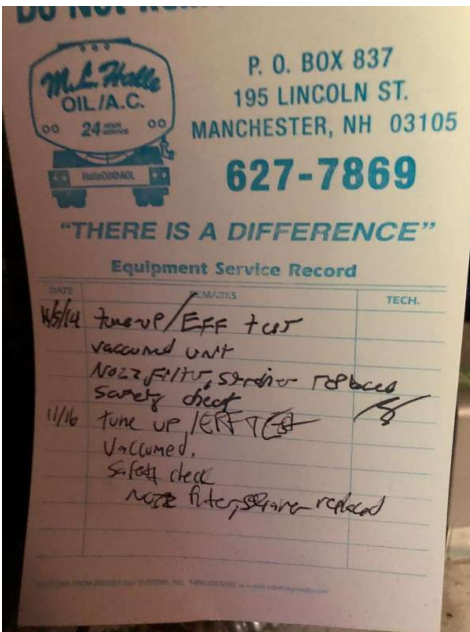
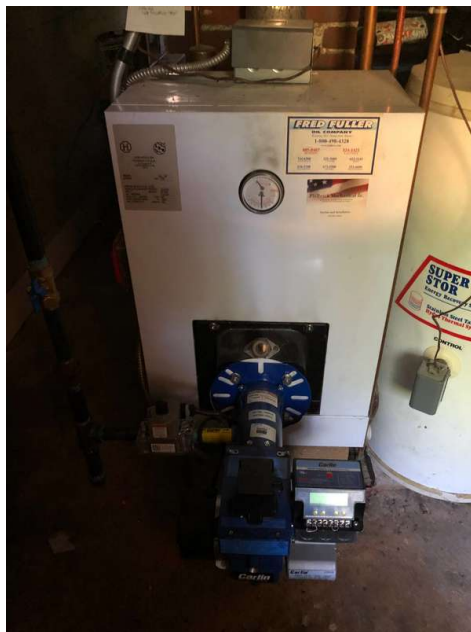
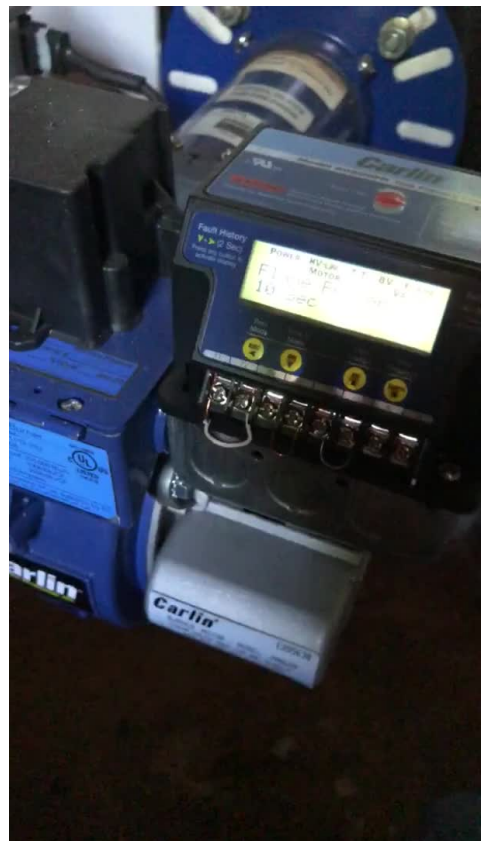
8.1.1 Heating Equipment

NEEDS SERVICING/CLEANING (BOILER)

Boiler should be cleaned and serviced annually. There was no current service tag visible during the time of inspection. Recommend asking the seller about verification/proof of a recent cleaning/servicing otherwise have a qualified HVAC contractor clean, service and certify boiler. Last service tag onsite is from 2016.

Contact a qualified HVAC professional.

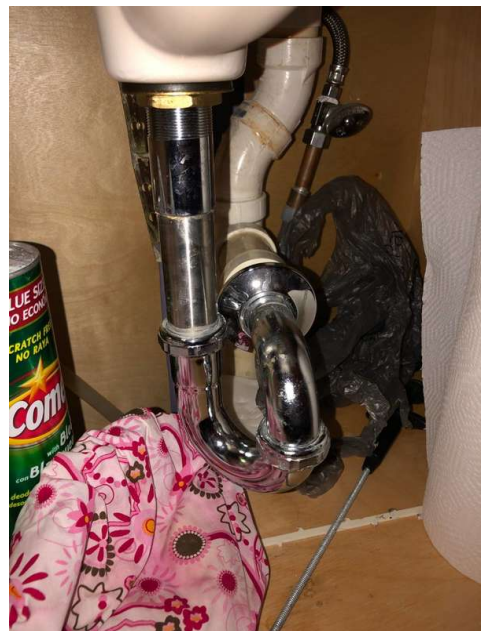
CHROME PLATED BRASS DRAIN PIPE-CORROSION

The bathroom drain pipe is made of chrome plated brass. These pipes are prone to corrosion and leaking. Minor signs of corrosion is present and recommend be replaced by a licensed plumber.

Contact a qualified plumbing contractor.

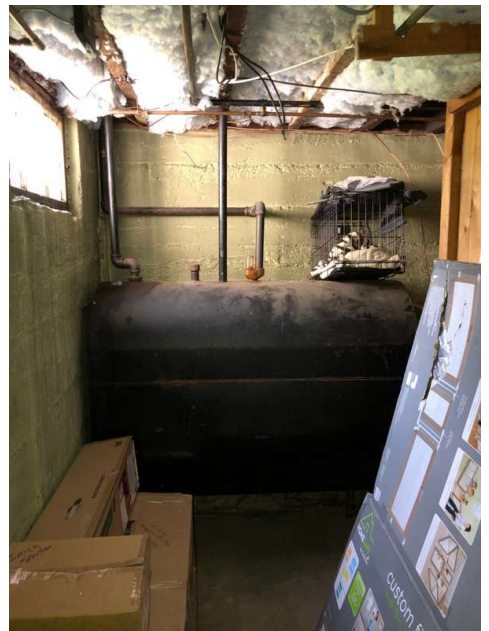
ABANDONED FUEL OIL TANK PRESENT

A fuel oil tank is presently installed. Tank does not appear to be in active use, as another fuel source is providing fuel to home. Recommend qualified contractor to remove fuel tank, as fuel oil vapors may be a "Safety Hazard"

Contact a qualified professional.

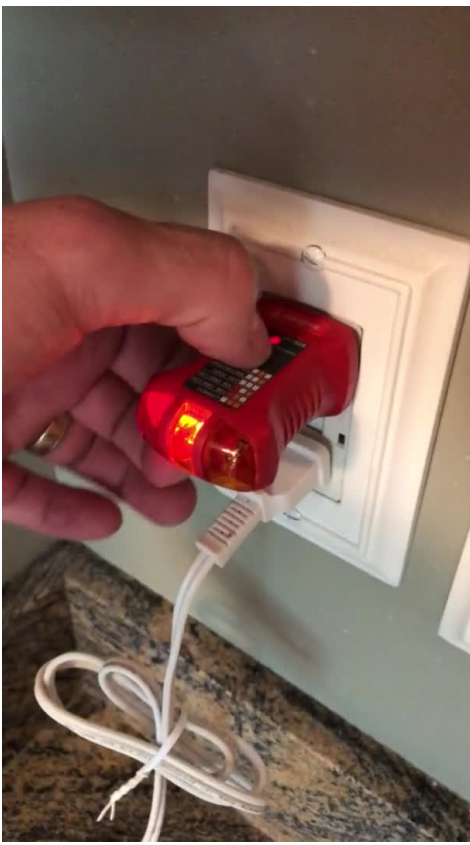
BATHROOM ELECTRICAL RECEPTACLES NOT TO CURRENT STANDARDS

2ND FLOOR BATHROOM

Bathroom electrical receptacles do not meet current safety standards. Recommend licensed electrician to repair to current standards to prevent possible injury.

Contact a qualified electrical contractor.
