SUMMARY
1234 Main St. Merrimack NH 03054
Buyer Name
07/12/2019 9:00AM

Chris Caisse
InterNACHI Certified Professional
Inspector
Platinum Home Inspections
603-897-5495

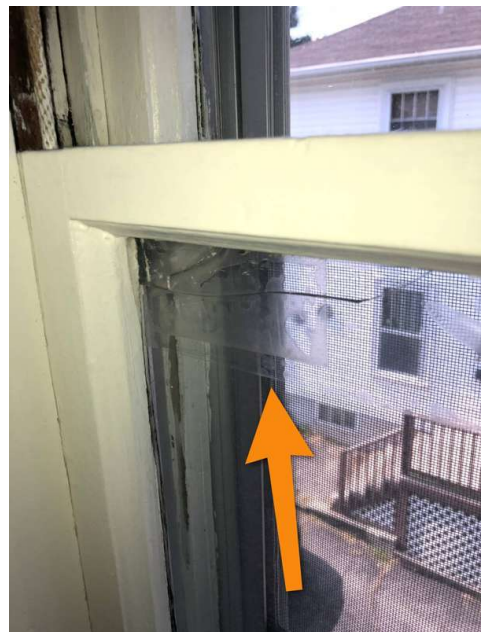
11.2.1 Interior Windows

CRACKED GLASS

BEDROOM

Window has cracked/broken glass, recommend replacement.

Contact a qualified window repair/installation contractor.

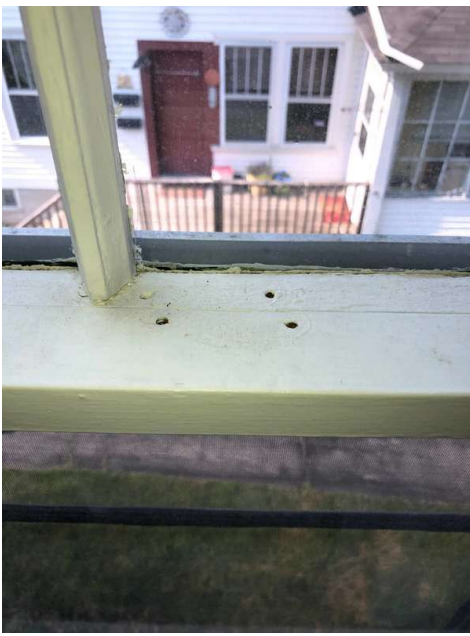
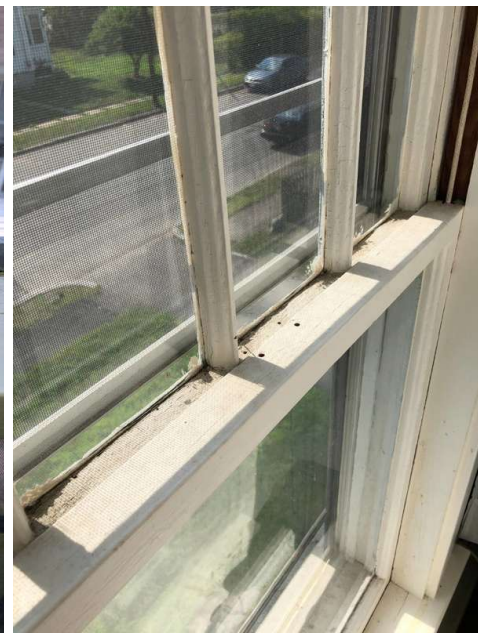
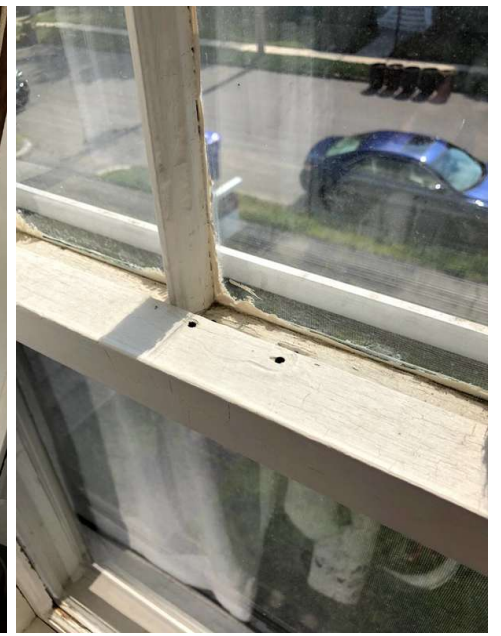
11.2.2 Interior Windows

MISSING HARDWARE

Missing window hardware on bedroom wood windows.

Contact a qualified professional.

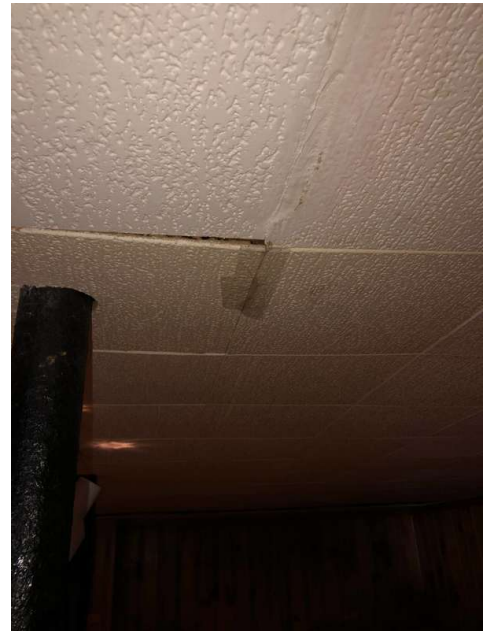
11.5.1 Walls and Ceilings

MINOR DAMAGE

BASEMENT

Minor damage or deterioration to ceiling in basement was visible at the time of the inspection.

Recommendation
Contact a qualified professional.

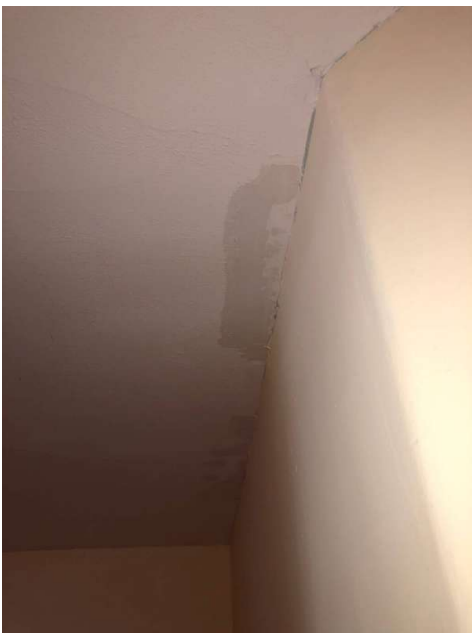
2nd Floor

POOR PATCHING

Sub-standard drywall / plaster patching observed at time of inspection. Recommend re-patching.

Recommendation
Contact a qualified drywall contractor.

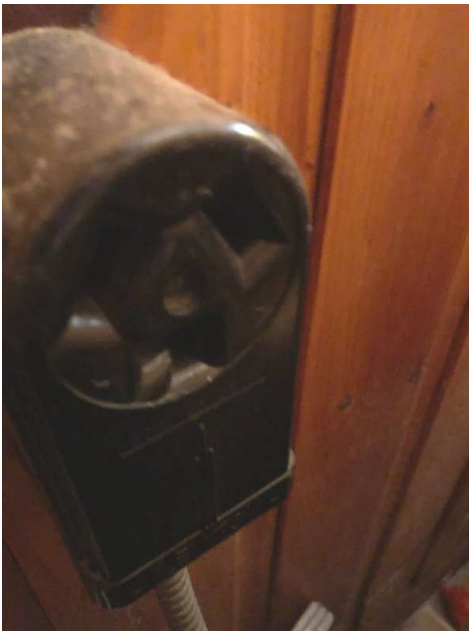
12.2.1 Electrical Components

OLDER 3-PRONG OUTLET

The laundry area had an older-style 3-prong 240 volt dryer receptacle. Newer dryers come equipped with 4-prong plugs. To accommodate a newer dryer, either the electrical receptacle or dryer cord will need to be replaced.

Contact a qualified professional.

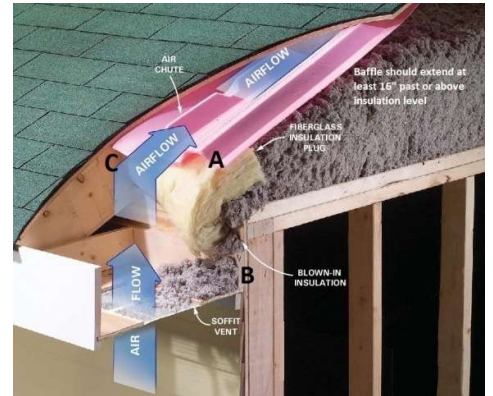
15.2.1 Ventilation

SOFFIT VENTS BLOCKED

One or more soffit vents were blocked by insulation. This can reduce air flow through the roof structure or attic and result in reduced service life for the roof surface materials because of high temperatures. Moisture from condensation is also likely to accumulate in the roof structure and/or attic and can be a conducive condition for wood-destroying organisms. Recommend that a qualified person repair as necessary so air flows freely through all vents. For example, by moving or removing insulation and installing attic baffles.

Contact a qualified insulation contractor.

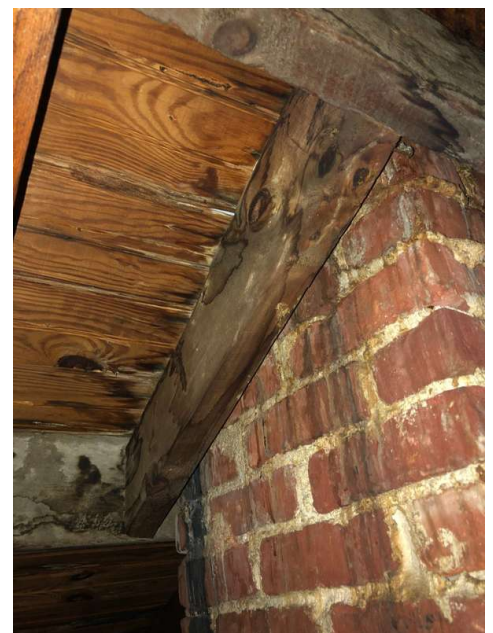
15.5.1 Chimney in Attic

PRIOR MOISTURE STAINS

Observed moisture stains on the roof structure surrounding the chimney chase. The areas were dry with no active moisture at the time of inspection. These may have been caused from prior moisture intrusion before the current roof and chimney flashing that are in place where installed. Recommend monitoring for any future issues and repair as needed.

Recommend monitoring.
