SUMMARY
1234 Main St. Merrimack NH 03054
Buyer Name
05/15/2019 9:00AM

Chris Caisse
InterNACHI Certified...
Platinum Home Inspections
603-897-5495

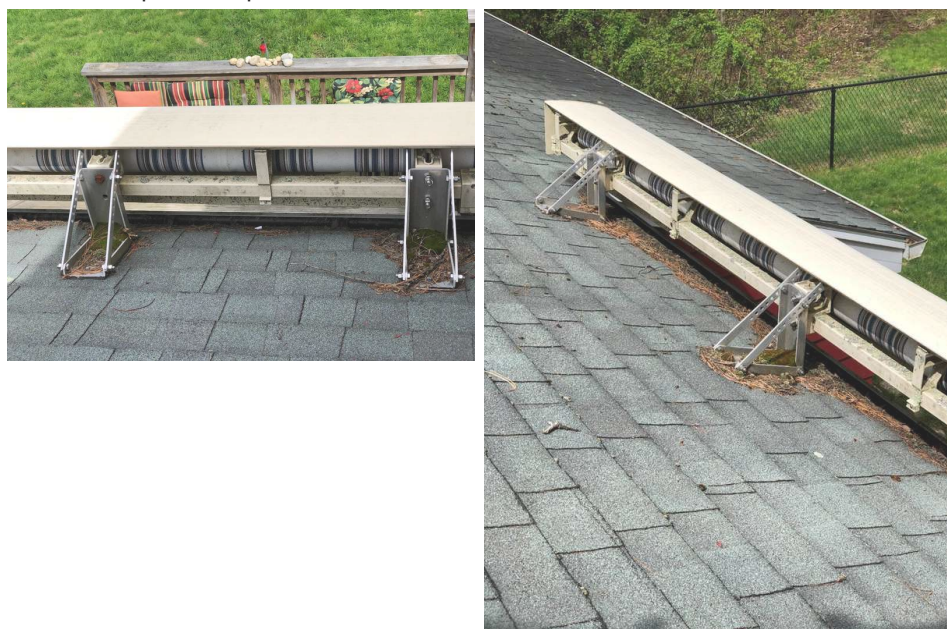
2.1.1 Coverings

TREE DEBRIS

Roof coverings at the area where the awning is present have debris from the above trees. Recommend cleaning periodically to extend the life of the roof covering.

Recommendation
Contact a qualified professional.

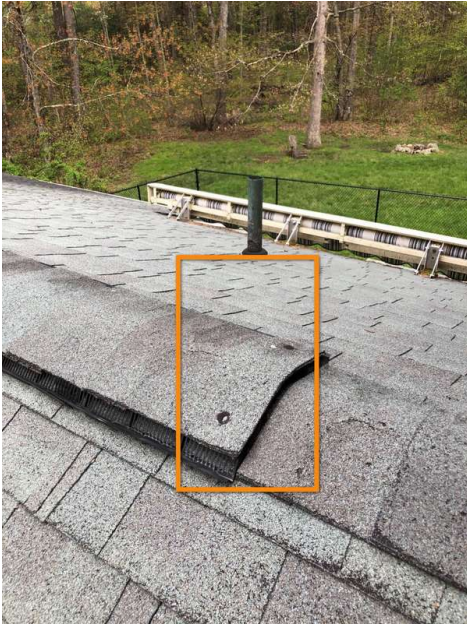
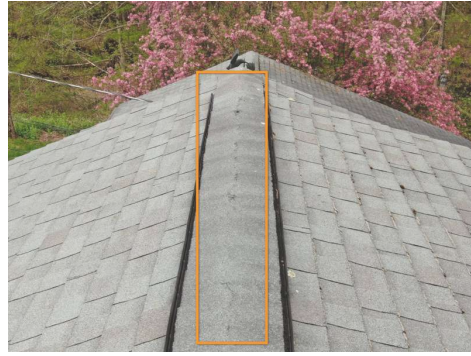
2.1.2 Coverings

DAMAGED RIDGE CAP SHINGLES

Cap shingles/ridge vent shingles are damaged/aging. Cap shingles are shingles that cover areas where the roof changes direction, like at roof peaks and hips. Recommend roofing professional evaluate and repair as needed.

Cracking at ridge vent

Recommendation
Contact a qualified roofing professional.

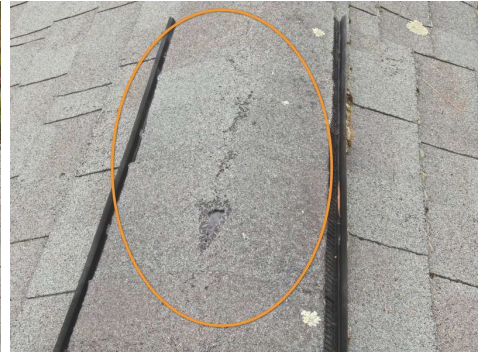
Shingle worn through

Need sealant over roof penetrations.

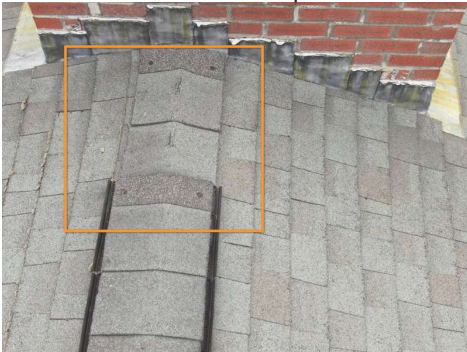
Cracking present and sealant is needed over penetrations.

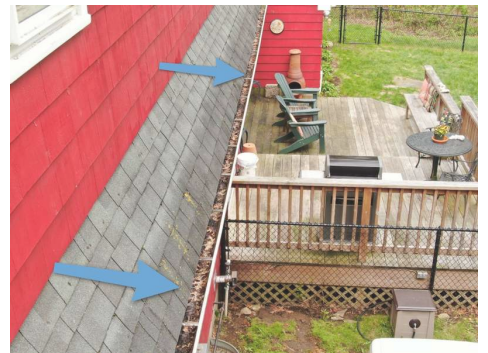
2.2.1 Roof Drainage Systems

DEBRIS

Debris has accumulated in the gutters. Recommend cleaning to facilitate water flow.

Contact a qualified handyman.

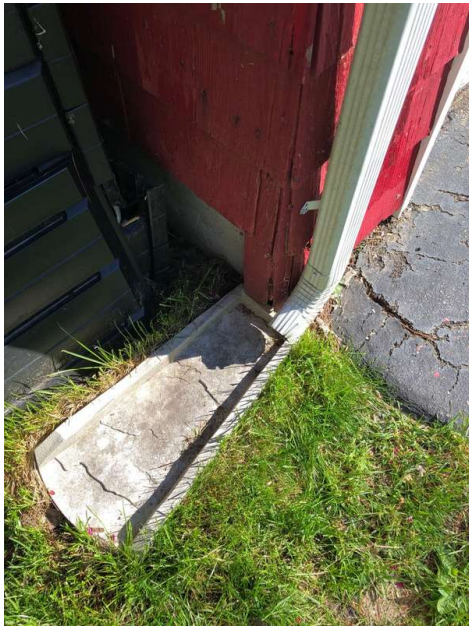
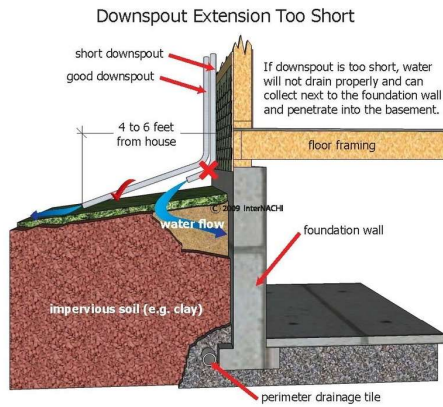
2.2.2 Roof Drainage Systems

DOWNSPOUTS DRAIN NEAR HOUSE

One or more downspouts drain too close to the home's foundation. This can result in excessive moisture in the soil at the foundation, which can lead to foundation/structural movement. Recommend a qualified contractor adjust downspout extensions to drain at least 6 feet from the foundation.

Contact a handyman or DIY project

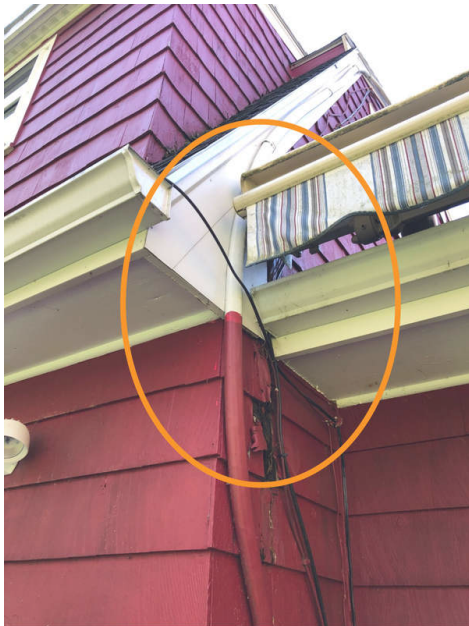
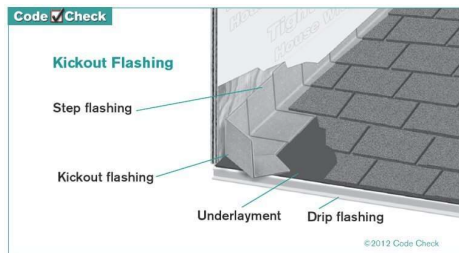
2.3.1 Flashings

MISSING KICK-OUT FLASHING

Kick-out flashing was missing where walls extended past roof edges.

Contact a qualified roofing professional.

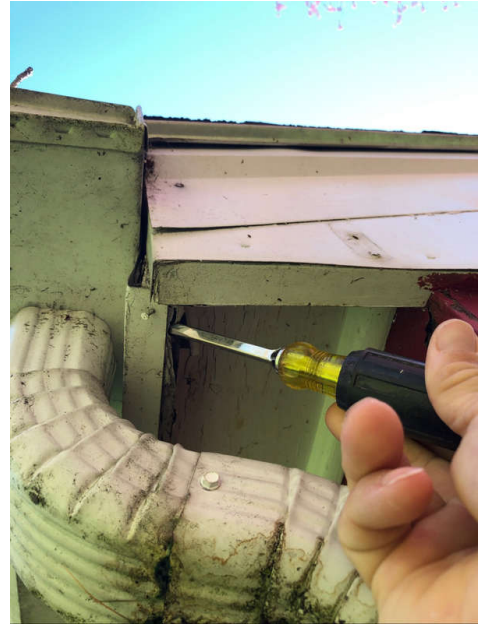
2.4.1 Eaves, Soffits & Fascia

SOFFIT - ROTTED

One or more sections of the fascia are rotted. Recommend qualified roofer evaluate & repair.

Contact a qualified roofing professional.

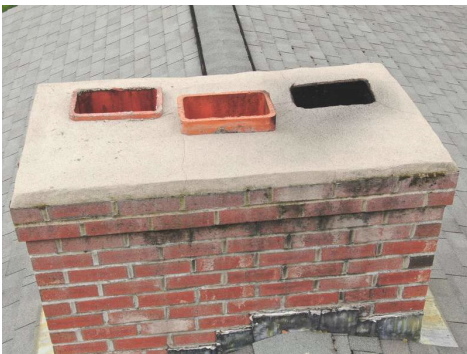
2.5.1 Skylights, Chimneys & Other Roof Penetrations

CHIMNEY CAP MISSING

Chimney cap was not observed or improper. This is important to protect from moisture intrusion and protect the chimney. Recommend a qualified roofer or chimney expert install.

Contact a qualified chimney contractor.

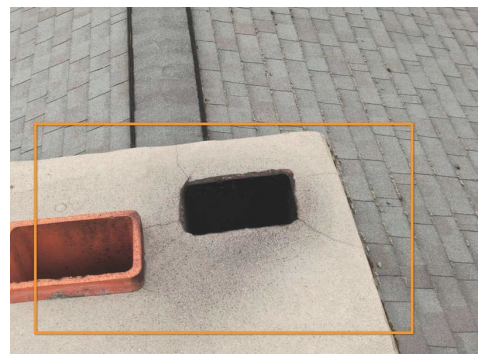
2.5.2 Skylights, Chimneys & Other Roof Penetrations

CRACKED/DAMAGED CHIMNEY CROWN

Observed the crown of the chimney to have cracks and should be repaired by a qualified contractor to prevent moisture instruction into the chimney liner and chase.

Contact a qualified chimney contractor.

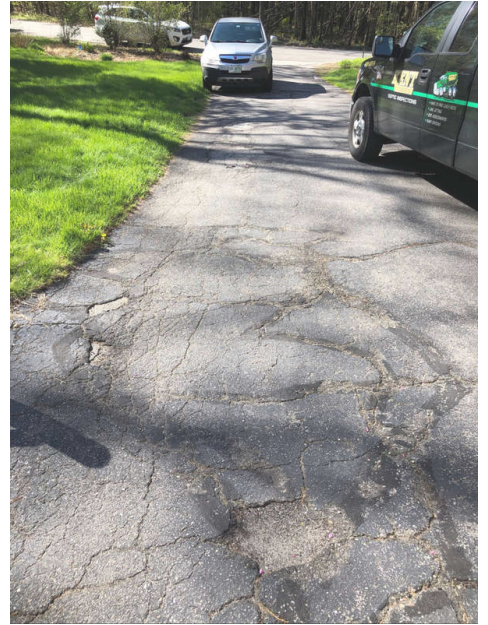
3.2.1 Walkways, Patios & Driveways

ASPHALT DRIVEWAY - TYPICAL CRACKING

Asphalt driveway... this material has typical cracking which is normal for its age recommend seal coating as needed to prolong life expectancy.

Contact a qualified professional.

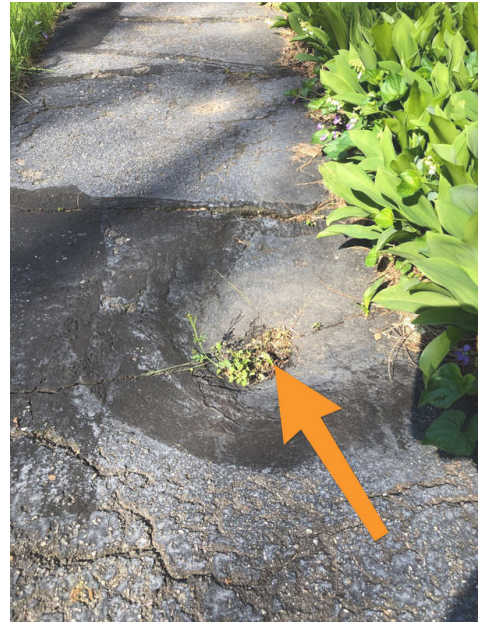
3.2.2 Walkways, Patios & Driveways

WALKWAY TRIP HAZARD

Trip hazards observed. Patch or repair recommended.

Contact a qualified concrete contractor.

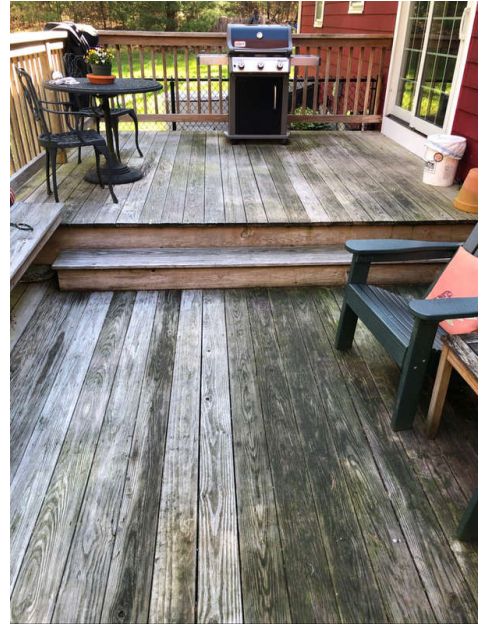
3.3.1 Decks, Balconies, Porches & Steps

DECK - WATER SEALANT REQUIRED

Deck is showing signs of weathering and/or water damage. Recommend water sealant/weatherproofing be applied.

Recommended DIY Project

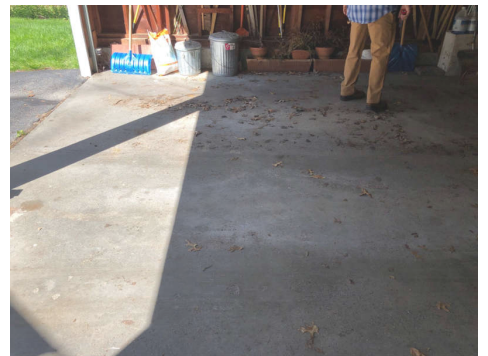
4.2.1 Floor **CRACKING**

Typical cracking/settlement observed in concrete. If trip hazards become present, recommend licensed contractor to repair to prevent injuries.

Recommendation
Recommend monitoring.

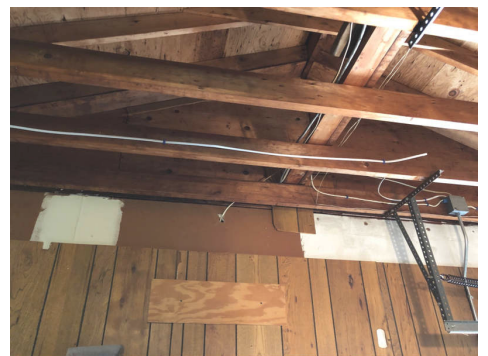
4.3.1 Walls, Ceiling & Firewalls **FIREWALL NOT TO STANDARDS (OLDER HOME)**

Garage wall/ceilings adjoining living space were not drywalled with type X fire-rated drywall as is required by generally-accepted current standards. The home was older and type X fire-rated drywall may not have been required when the home was originally built. Homes are not required to be upgraded to meet newly-enacted standards.

Recommendation
Contact a qualified drywall contractor.

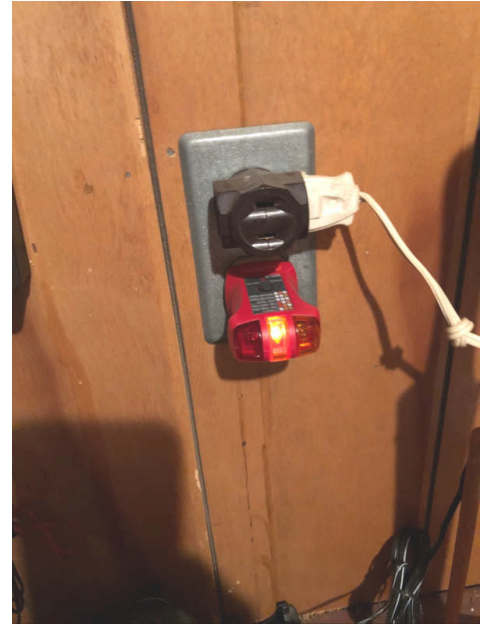
4.4.1 Garage Electrical **OPEN GROUND**

One or more receptacles are ungrounded. To eliminate safety hazards. All 3 prong outlets should be grounded. Where grounding is not possible (no ground wire present), a 2 prong receptacle or GFCI protected receptacle can be installed.

Note: GFCI protection of an ungrounded 3 prong outlet will not protect electronics. A physical ground system is required to protect electronics or allow surge protectors to function properly. Have a licensed electrician evaluate further and repair as necessary for safest operation.

Contact a qualified electrical contractor.

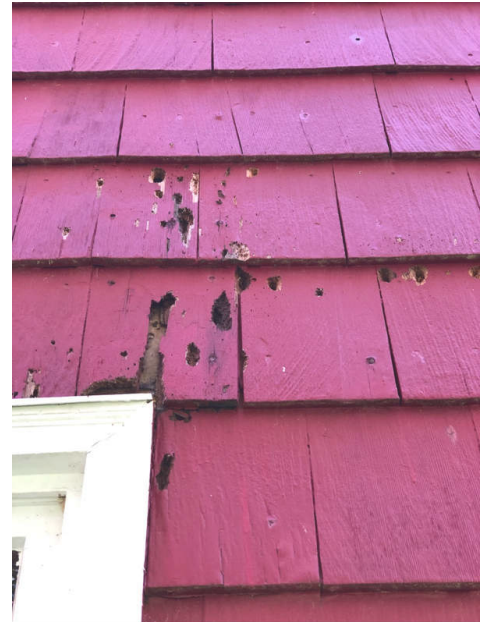
5.1.1 Siding, Flashing & Trim

MINOR DAMAGE

Siding has some typical minor damage. Recommend repair/replace as needed.

Carpenter Bees

Contact a qualified siding specialist.

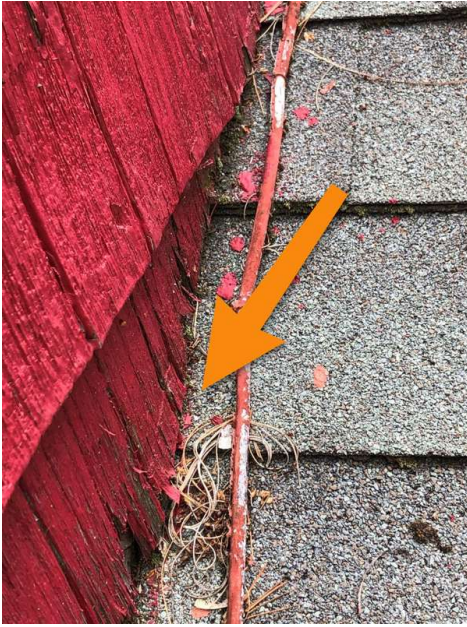
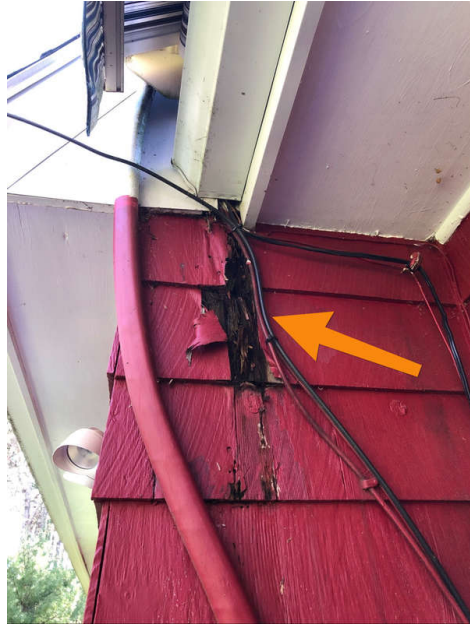
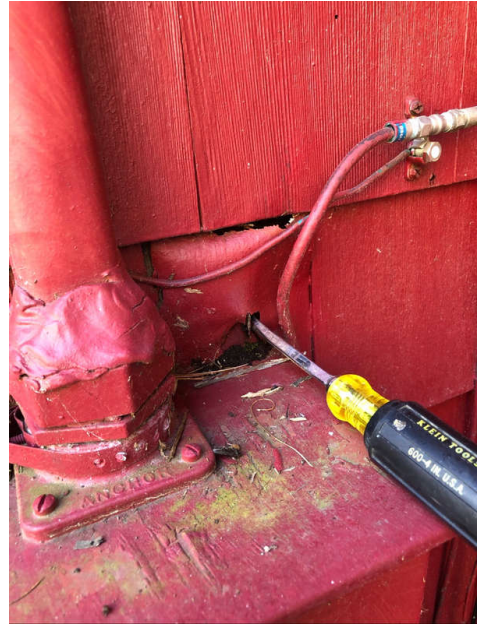
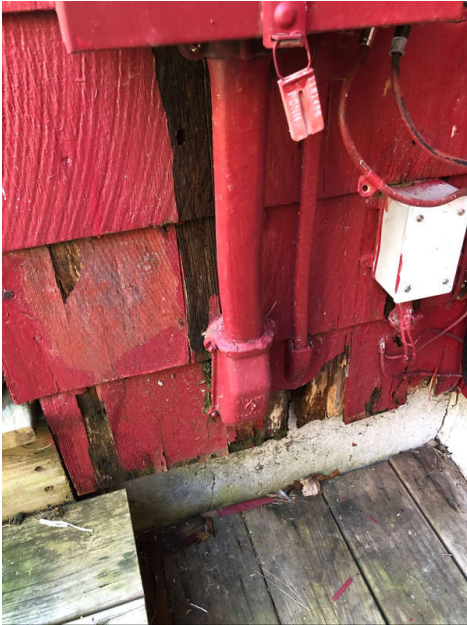
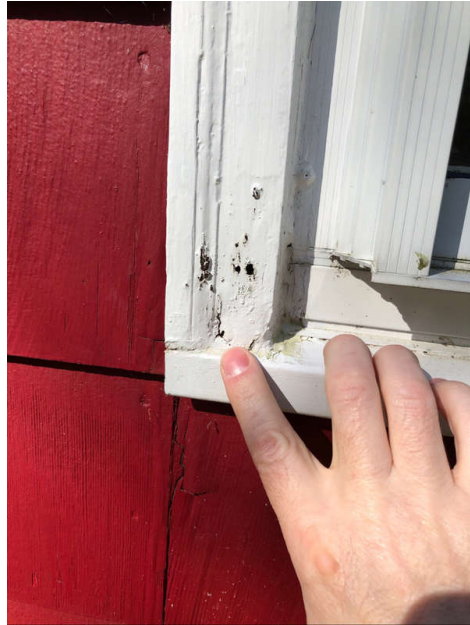
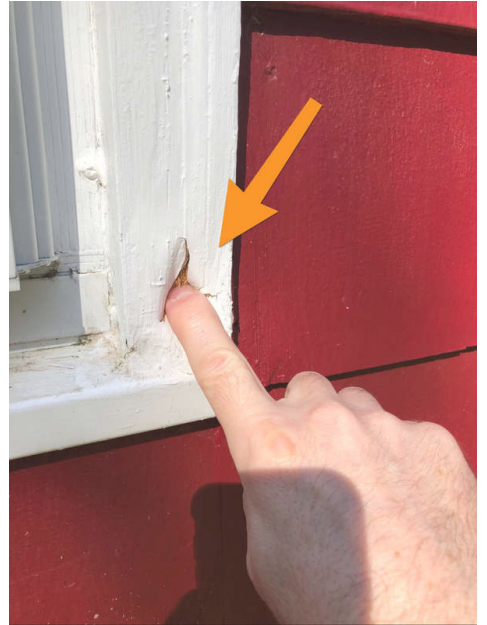
5.1.2 Siding, Flashing & Trim

ROTTED SIDING & TRIM BOARDS

Evidence of wood rot/damage on siding and trim boards throughout various areas of the structure such as but not limited too; all window trim on the right side, above and below the electrical meter as well as along areas where the roof covering meet the siding. Recommend licensed contractor to repair/replace as needed.

Contact a qualified carpenter.

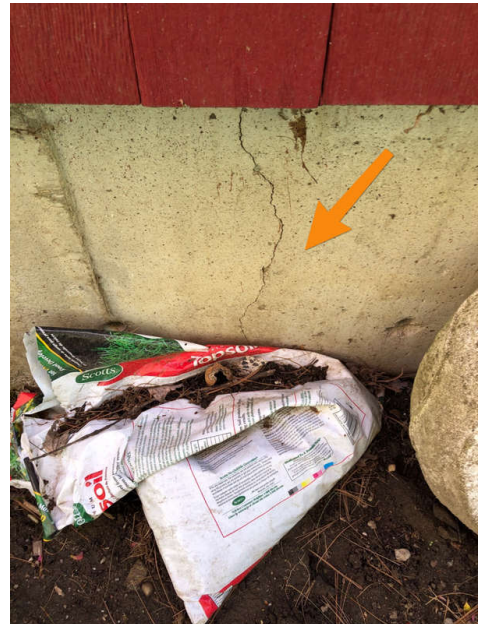
5.5.1 Exterior foundation **TYPICAL CRACKING**

Exterior foundation contains typical cracks due to shrinkage and normal freeze thaw cycle. Recommend patching as needed to prevent moisture intrusion.

Recommendation
Recommend monitoring.

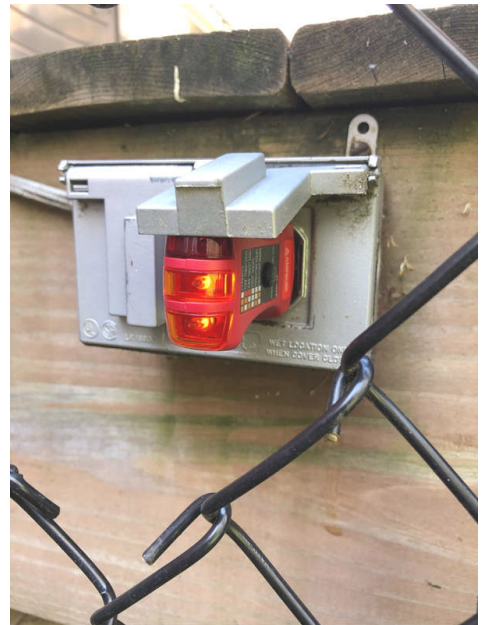
5.6.1 Exterior lighting and receptacles

NO GFCI PROTECTION INSTALLED

No GFCI protection present in all locations. Recommend licensed electrician upgrade by installing ground fault receptacles in all locations.

Contact a qualified electrical contractor.

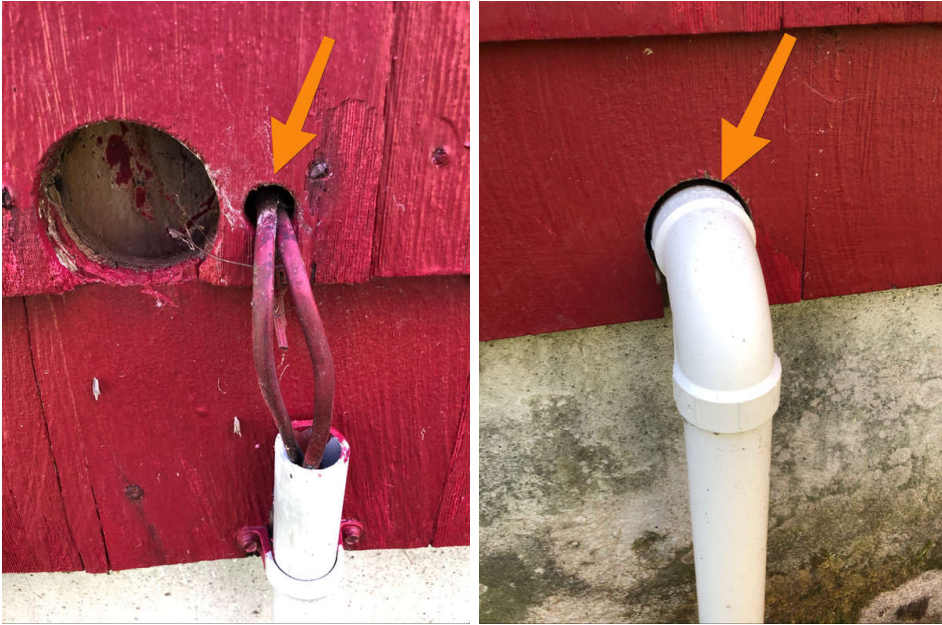
5.9.1 Exterior Wall Penetrations

SEAL PENETRATIONS

Exterior wall penetrations left gaps that needed to be sealed with an appropriate sealant to prevent moisture and insect entry. All work should be performed by a qualified contractor.

Contact a qualified professional.

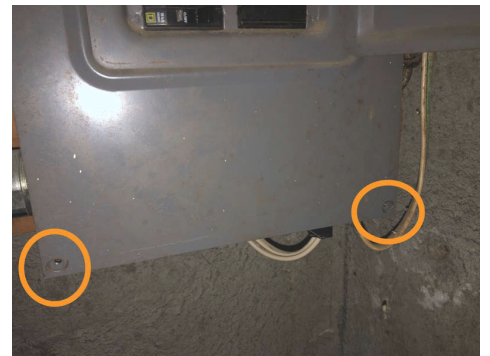
7.1.1 Main & Subpanels, Service & Grounding, Main Overcurrent Device

MISSING SCREWS

One or more screws that attach the cover or dead front to panel(s) were missing or not installed. Recommend installing screws where missing so the cover or dead front is secure. Only screws with blunt tips approved for this purpose should be installed, so wiring inside the panel is not damaged. Because energized wires may be located directly behind screw holes, the client should consider replacing missing screws.

Recommendation
Recommended DIY Project

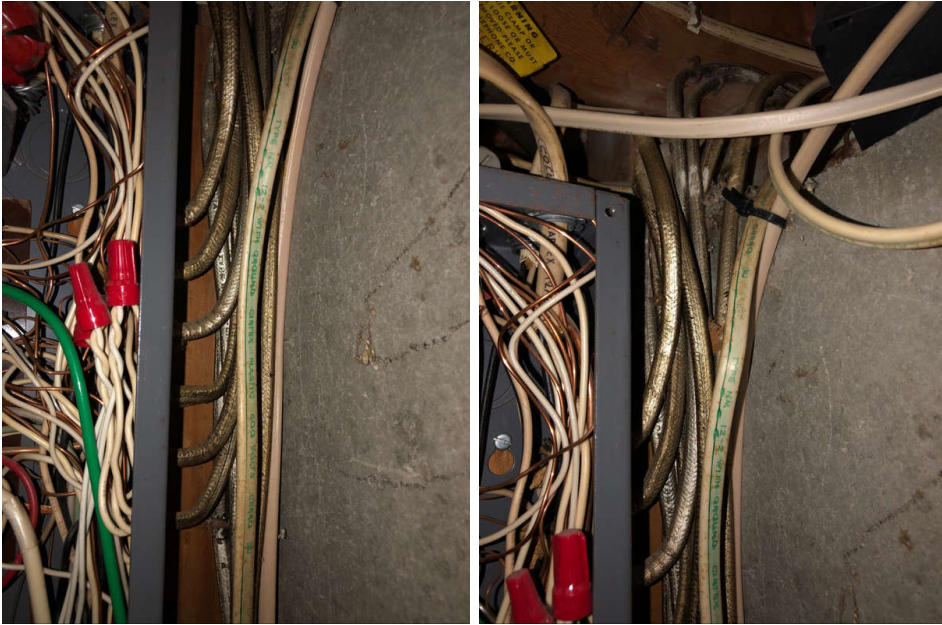
7.2.1 Branch Wiring Circuits, Breakers & Fuses

CLOTH COVERED WIRING

There is visible cloth wiring in the main panel being used as branch wiring. There is a rubber coating below the cloth on the wiring, the rubber coating deteriorates and cracks as the wires age. This can lead to electrical shorts. Recommend to have any cloth wiring replaced with modern wires.

Recommendation
Contact a qualified electrical contractor.

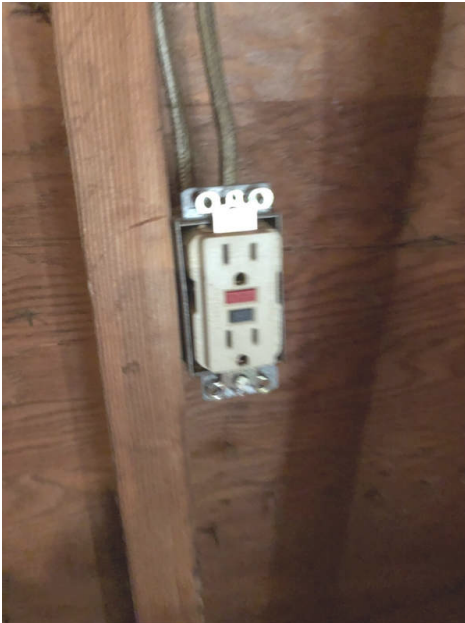
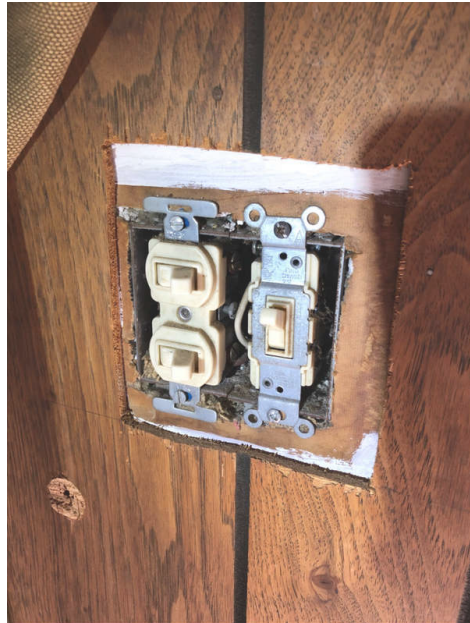
7.3.1 Electrical Fixtures, Switches and Receptacles

COVER PLATES MISSING

One or more receptacles are missing a cover plate. This causes short and shock risk. Recommend installation of plates.

Contact a qualified electrical contractor.

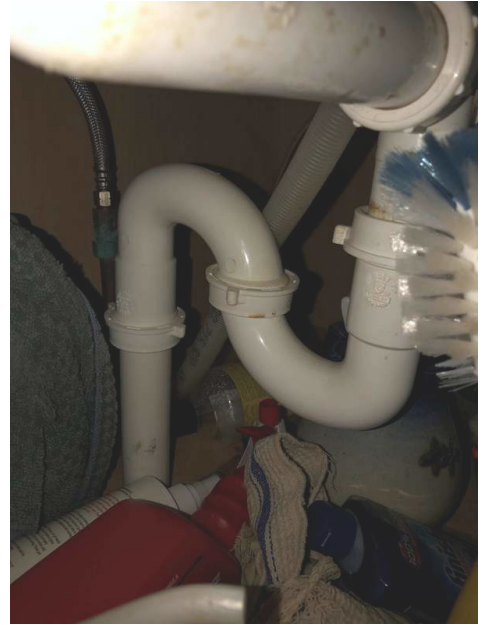
9.4.1 Drain, Waste, & Vent Systems (DWV)

S TRAP PRESENT

There is an S Trap present at the bathroom sink drain. S traps will cause siphoning and loss of trap seals. Trap seals must be maintained to prevent sewer gases from entering the dwelling. Recommend licensed plumber install a P-trap with air admittance valve

Recommendation
Contact a qualified plumbing contractor.

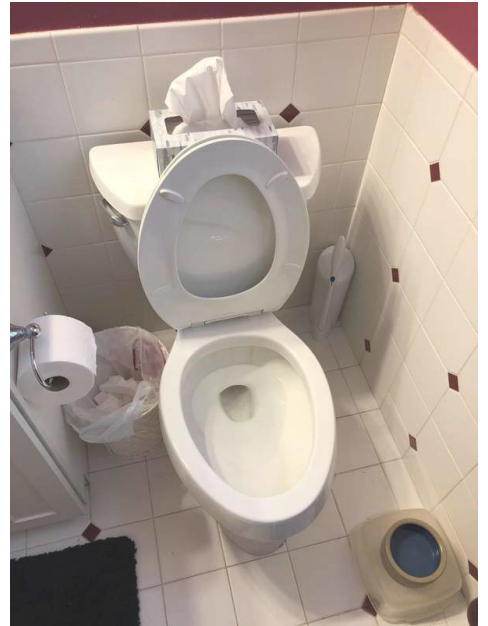
10.4.1 Fixtures, Toilets, Tubs & Showers

TOILET LOOSE

Toilet bowl connection is loose. Recommend licensed plumber to properly secure to prevent possible moisture damage.

Recommendation
Contact a qualified plumbing contractor.

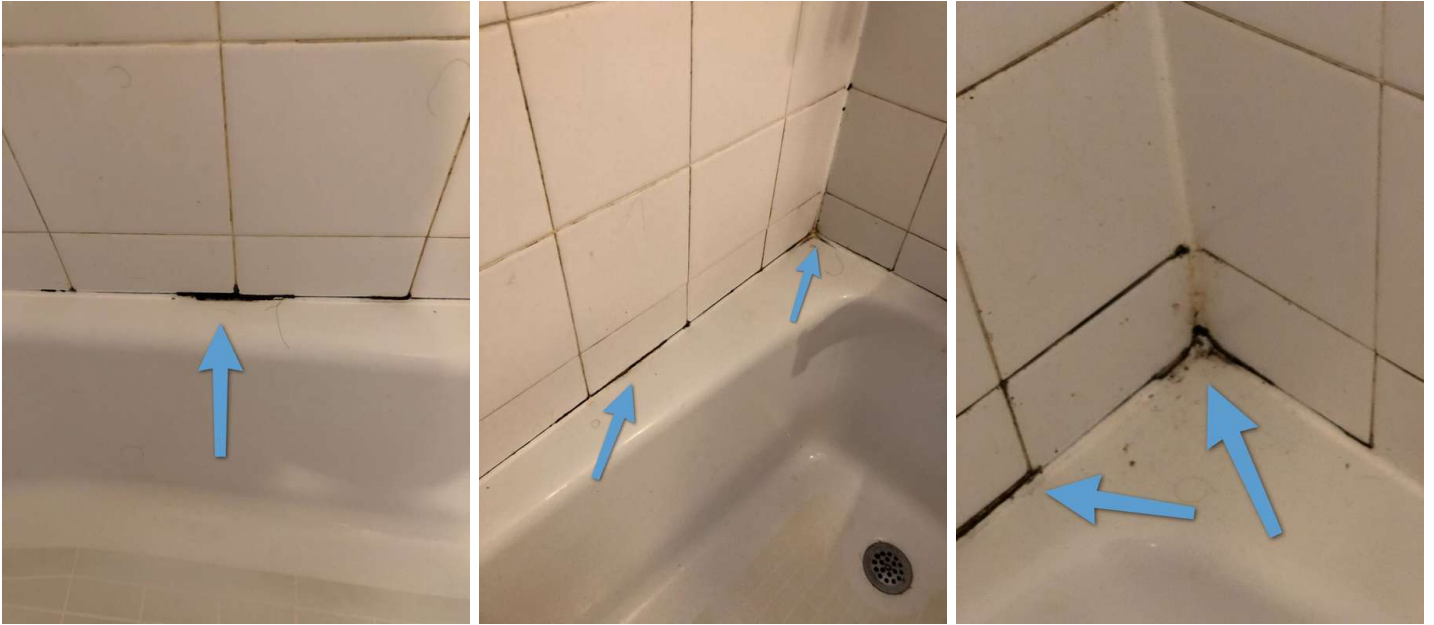
10.4.2 Fixtures, Toilets, Tubs & Showers

IMPROPER CAULKING

Shower/Tub surround is improperly caulked, moisture stains were evident. Recommend contractor to repair to prevent moisture damage.

Recommendation
Contact a qualified professional.

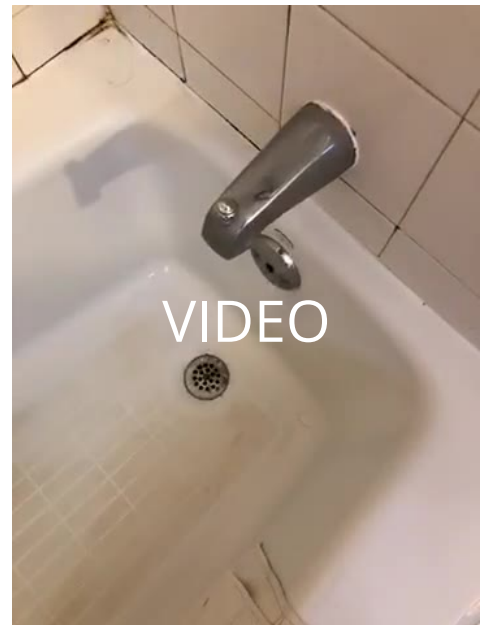
10.4.3 Fixtures, Toilets, Tubs & Showers

LOOSE TUB SPOUT

2nd floor tub spout is loose and moves freely which can allow water intrusion. Recommend filling behind spout with expanding spray foam which will secure the spout in place.

Contact a qualified professional.

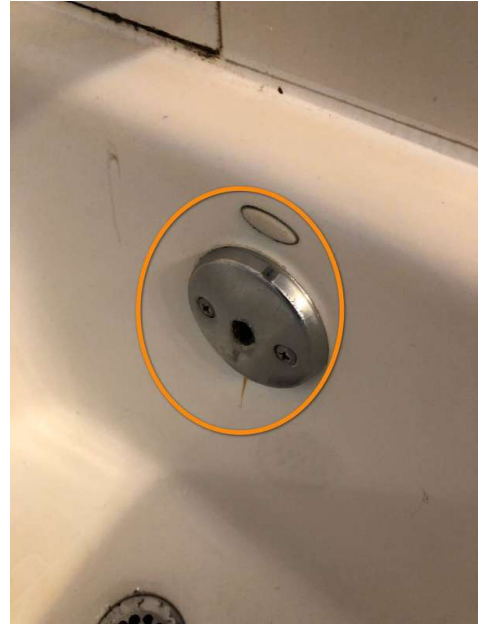
10.4.4 Fixtures, Toilets, Tubs & Showers

BATHTUB STOPPER - BROKEN

The bathtub stopper handle was broken/missing at the time of inspection.

Contact a qualified professional.

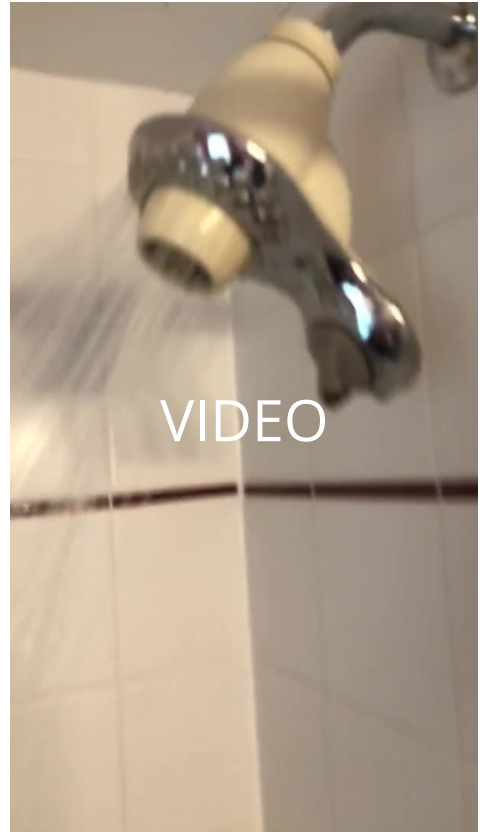
10.4.5 Fixtures, Toilets, Tubs & Showers

SHOWER - NOT FULL PRESSURE

2nd floor bathroom tub/shower did not have 100% of the water flow come out of the shower head when switched over from tub spout.

Contact a qualified plumbing contractor.

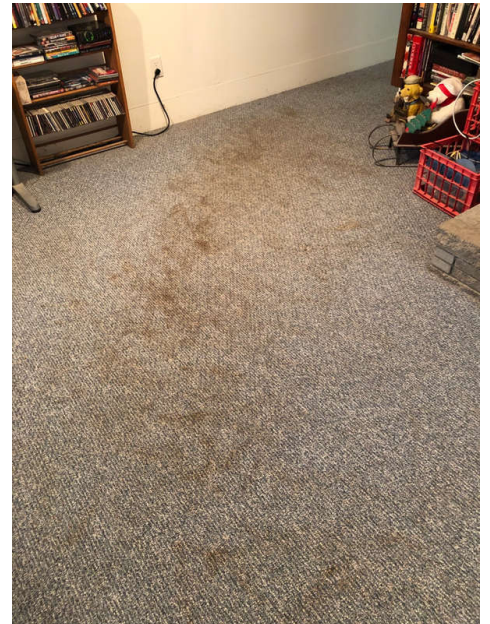
11.3.1 Interior Floors

CARPET STAINS

Carpet had areas of staining or discoloration. Recommend a thorough steam clean by a qualified carpet cleaning company

Contact a qualified cleaning service.

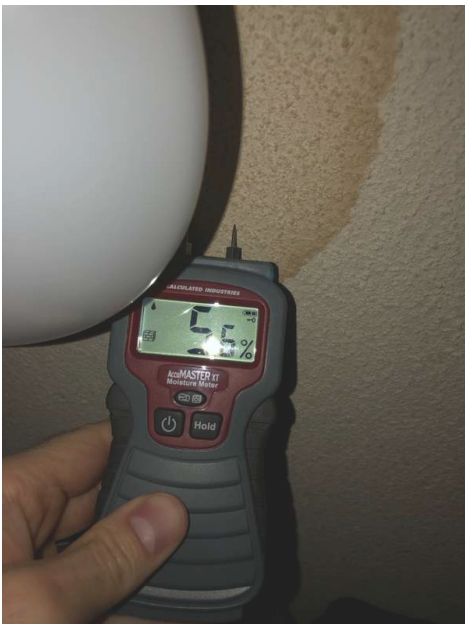
Front bedroom closet

11.5.1 Walls and Ceilings **MOISTURE DAMAGE**

Stains on the walls visible at the time of the inspection appeared to be the result of moisture intrusion. The source of moisture may have been corrected. Recommend further examination by a qualified contractor to provide confirmation.

Recommendation
Contact a qualified professional.

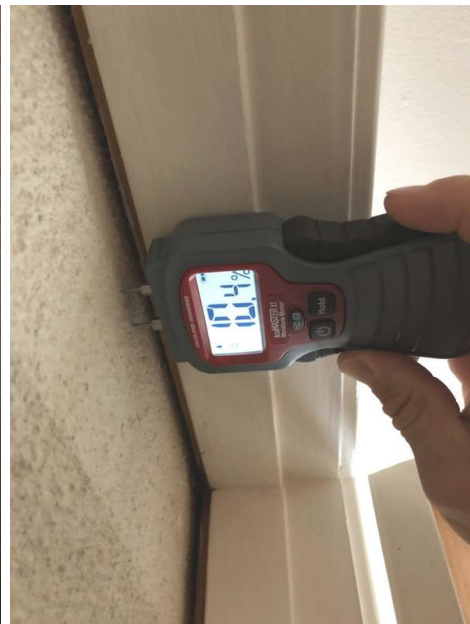
Front Bedroom Closet. 10.4% is consider low on the moisture meter scale. Low: 1.5% - 16% Med: 17% - 19% High: 20% - 33%

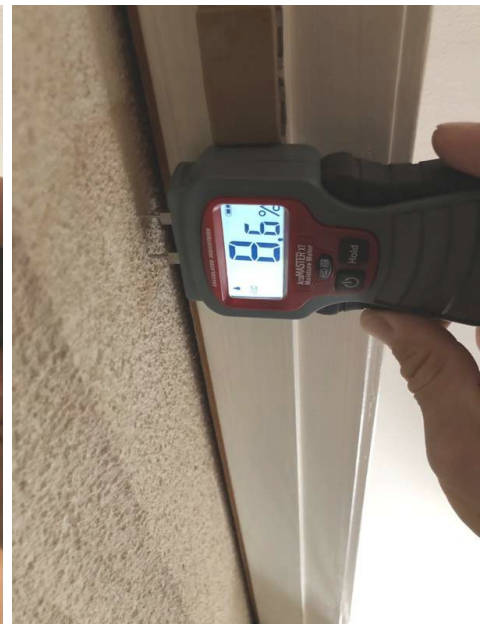
Front bedroom closet. 8.6% is considered present but low.

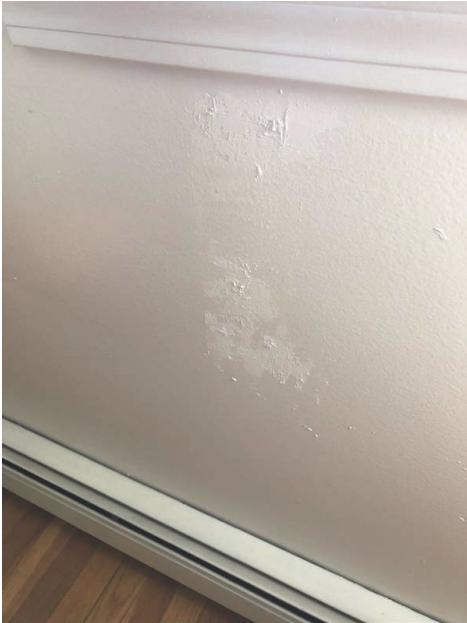
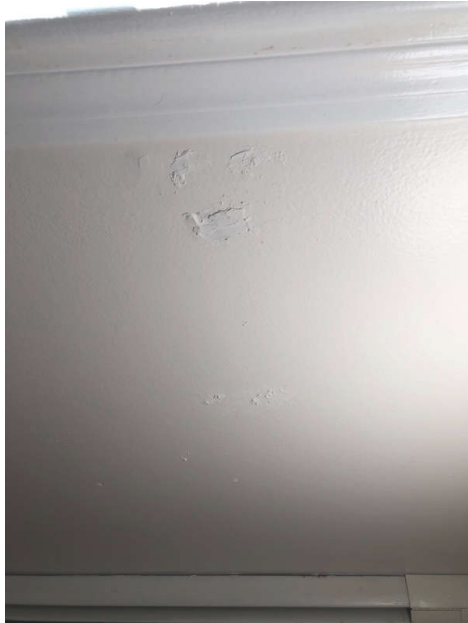
11.5.2 Walls and Ceilings

POOR PATCHING

Sub-standard drywall patching observed at time of inspection. Recommend re-patching.

Contact a qualified drywall contractor.

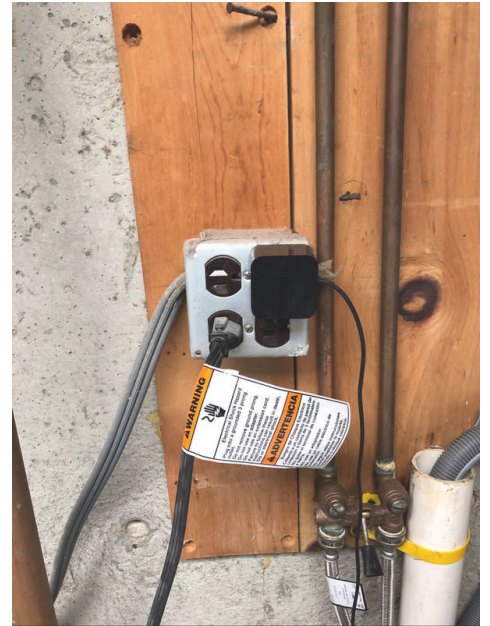
12.2.1 Electrical Components

MOSTLY OK - NO GFCI PRESENT

At the time of the inspection, the Inspector observed few deficiencies in the condition of electrical outlets in the laundry room. Notable exceptions will be listed in this report. Outlets had no Ground Fault Circuit Interrupter (GFCI) protection. For safety reasons, consider having GFCI protection installed for outlets within 6 feet of a plumbing fixture. This can be achieved by:

1. Replacing the current standard electrical receptacles with GFCI outlets;
2. Replacing the electrical receptacle nearest the overcurrent protection devices (breakers or fuses) protecting laundry room circuits with a GFCI receptacle; or
3. Replacing the breakers currently protecting the electrical circuits in the Laundry room with GFCI breakers.

Recommendation
Contact a qualified electrical contractor.

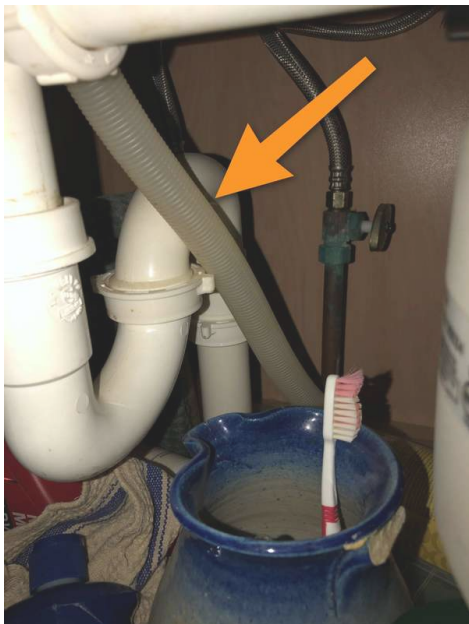
14.3.1 Dishwasher

HIGH LOOP NOT PRESENT

A high loop prevents the dirty water that is being drained from being inadvertently pulled back into the dishwasher or even siphoned back into the water system. Recommend high loop be installed by plumbing contractor.

Recommendation
Contact a qualified plumbing contractor.

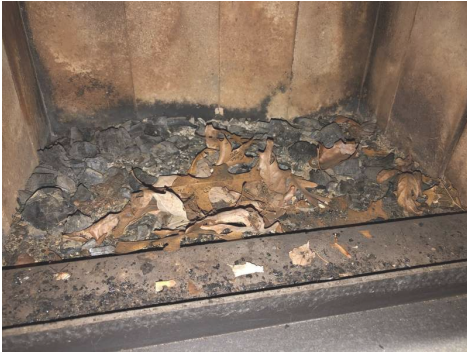
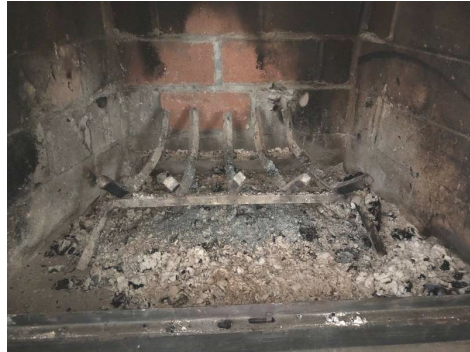
15.1.1 Fireplaces, Stoves & Inserts

FIRE BOX (DIRTY)

The firebox of the wood-burning fireplace(s) in the basement and living room needed cleaning at the time of the inspection.

Recommendation
Contact a qualified chimney sweep.

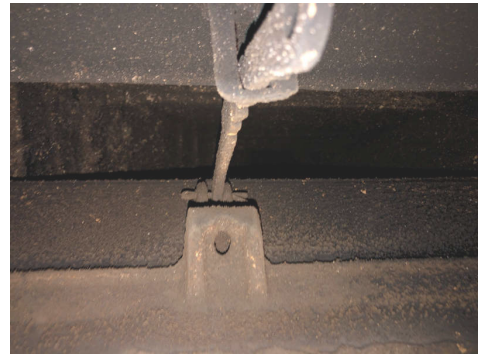
15.1.2 Fireplaces, Stoves & Inserts

VISIBLE FLUE (NEEDS CLEANING)

The exhaust flue of the wood-burning fireplace(s) and wood burning insert appeared to need cleaning. Dirty flues are potential fire hazards. The flue should be cleaned by a qualified contractor.

Recommendation
Contact a qualified chimney sweep.
