## SUMMARY

1234 Main St. Jenison Michigan 49428

Buyer Name  
02/08/2018 9:00AM

Michael Moores  
InterNACHI Certified Home Inspector  
Veteran Inspections & Services  
(616) 379-9388  
michael@veteraninspection.com

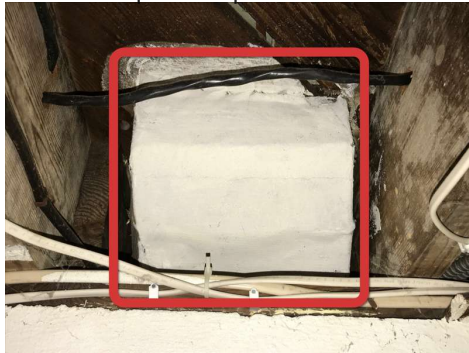
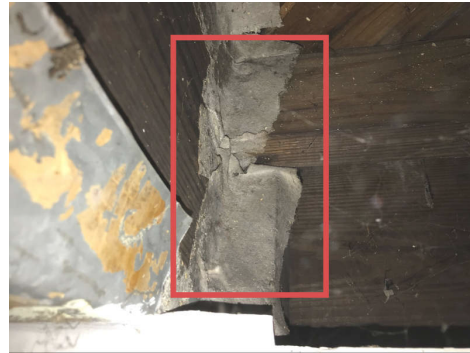
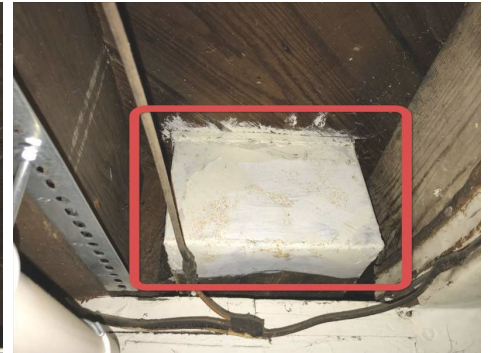
### POSSIBLE ASBESTOS TAPE/WRAP

Possible asbestos tape is present and should be taped over with metal foil tape or painted. To confirm the presence of asbestos a sample must be sent to a qualified lab for analysis.

Recommendation  
Contact a qualified professional.

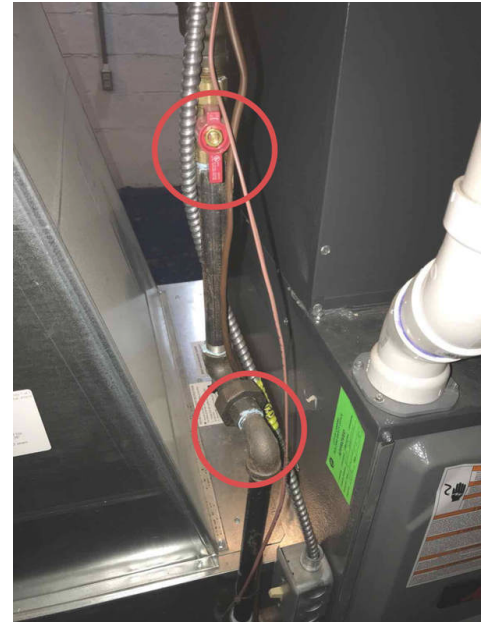
FURNACE

### GAS LEAK DETECTED

A gas leak as was detected which is a safety hazard. Further evaluation and repair by a licensed HVAC technician is strongly recommended.

Recommendation  
Contact a qualified HVAC professional.

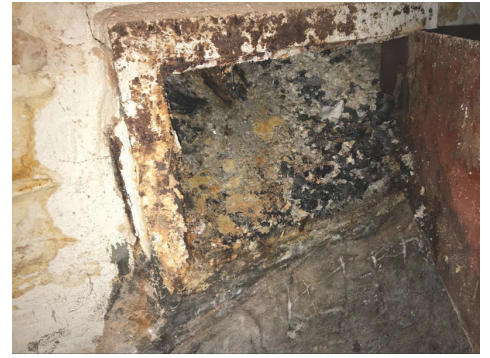
Fireplace Cleanout

### FIREPLACE CLEANOUT IN DISREPAIR

The chimney cleanout is in disrepair and should be further evaluated for safe use by a certified chimney sweep before operating the fireplace.

Recommendation  
Contact a qualified chimney sweep.

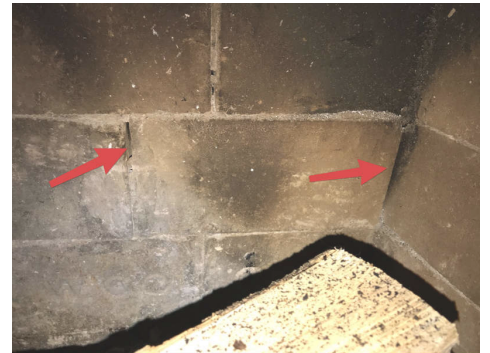
#### MISSING MORTAR IN FIREBOX

There is mortar missing between bricks/blocks of the chimney box. Over time, the bricks and the mortar may fail due to the expansion and contraction of the materials as they expand from room temperature to several hundred degrees Fahrenheit and back again. These gaps are dangerous because fire can potentially jump between the fire box and behind the fire bricks into the wood framed cavity wall by way of the mortar gaps. Repair by a certified chimney sweep is recommended.

Recommendation  
Contact a qualified chimney sweep.

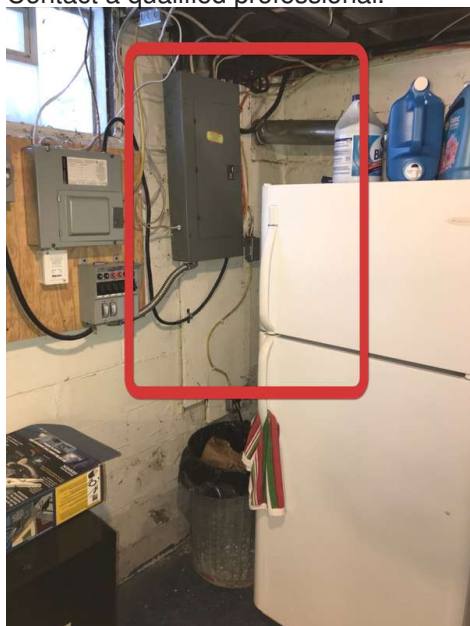
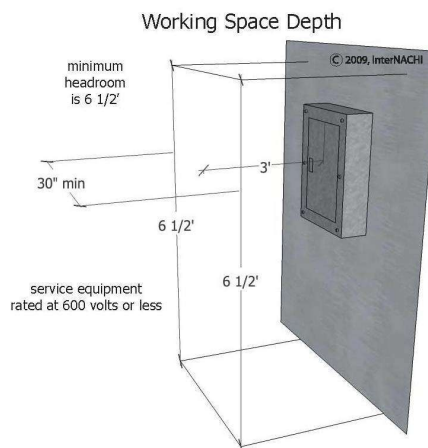
#### OBSTRUCTED SERVICE/SUB PANEL

Main electric and distribution panels require 3 square feet in front of the panel to ensure easy access to breakers in case of an emergency.

Recommendation  
Contact a qualified professional.

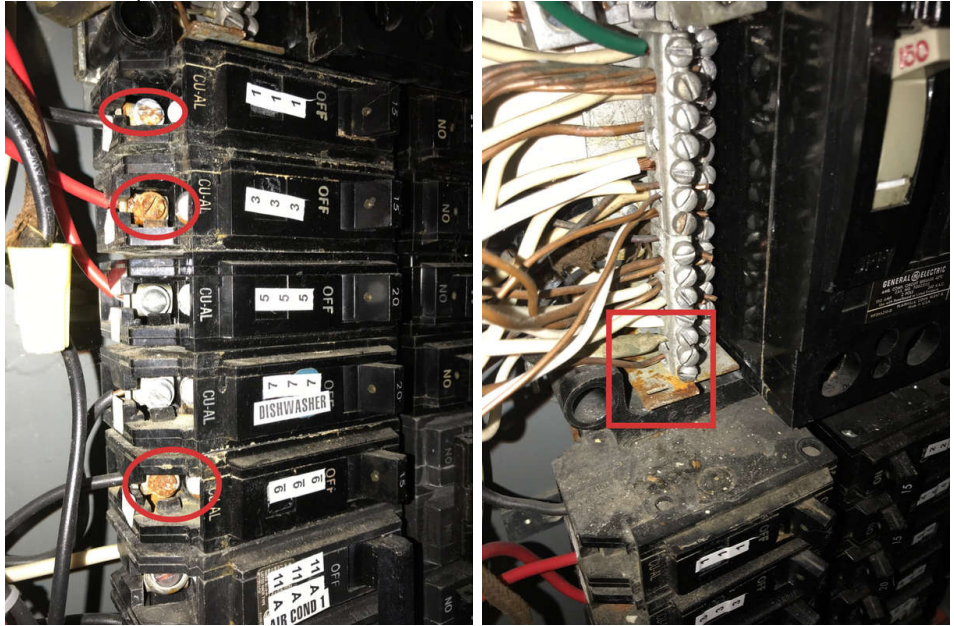
**RUST PRESENT**

Rust is present inside the electric panel indicating the presence of moisture. Moisture inside an electrical panel is a potential safety hazard and should be further evaluated by a licensed electrician.

Recommendation  
Contact a qualified electrical contractor.

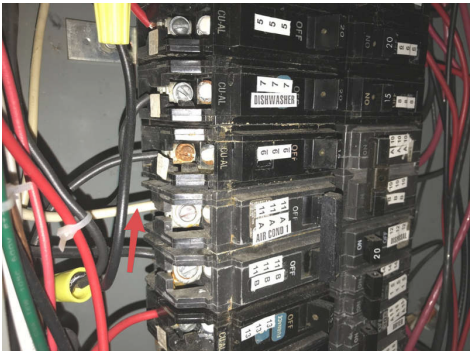
**IMPROPERLY MARKED WIRE(S)**

One or more neutral wires are being utilized as a "hot" wire and is connected to a breaker. This is improper and all wires being utilized as a hot wire must be marked. The standard solution is to wrap them with black electrician's tape. Due to the risk of accidentally touching the bus bar or other energized components, this should be performed by a licensed electrician.

Recommendation  
Contact a qualified electrical contractor.

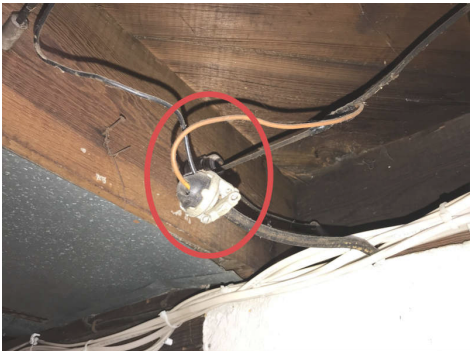
Mechanical Room

**IMPROPERLY SECURED WIRE(S)**

Improperly secured wiring was observed and should be secured as to prevent accidental bumping or snagging. Correction by a licensed electrician is recommended.

Recommendation  
Contact a qualified electrical contractor.

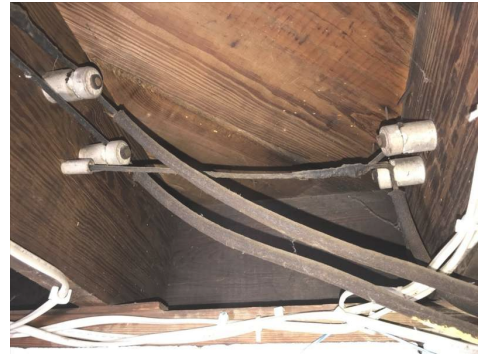
**KNOB & TUBE PRESENT**

This property has knob and tube wiring which was commonly installed prior to 1950. It is ungrounded, and considered unsafe by today's standards. Over time, the wires insulation becomes brittle and falls apart, resulting in exposed conductors and a risk of shock and/or fire. This wiring is also easily damaged by covering it with insulation (a common practice), and incorrectly tapping new wiring into it.

Some energized knob and tube wiring was found during the inspection. It is not within the scope of this inspection to determine what percentage of this property's wiring is of the knob and tube type or to determine what percentage of the knob and tube wiring is energized vs. abandoned. A qualified electrician should evaluate this wiring and make repairs or replace wiring as necessary.

Contact a qualified electrical contractor.

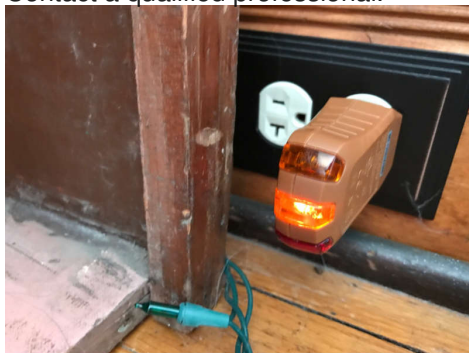
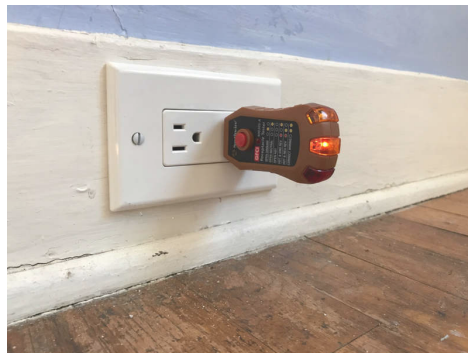
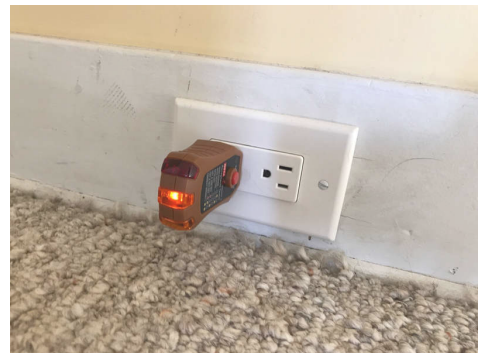
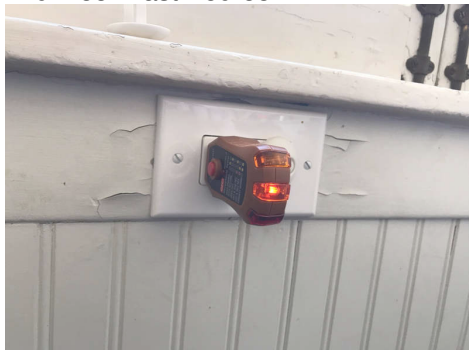
**UNGROUNDED 3-PRONG OUTLET(S)**

One or more outlets were determined to be ungrounded when tested. This is a generally simple fix that can be done by upgrading to grounded GFCI receptacle by a licensed electrician.

Contact a qualified professional.

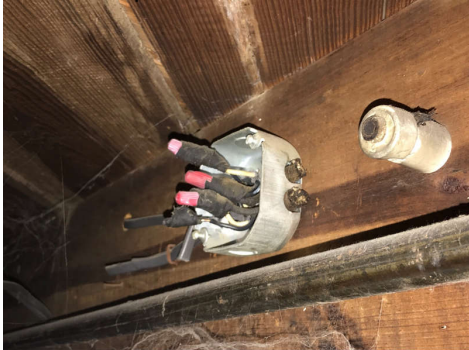
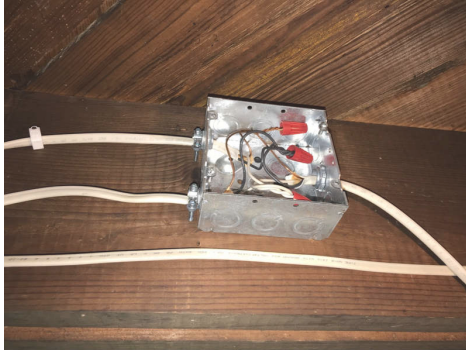
### MISSING BOX COVER

A junction box cover is missing which exposes wiring inside and is a safety hazard. Correction by a licensed electrician is recommended.

Contact a qualified electrical contractor.

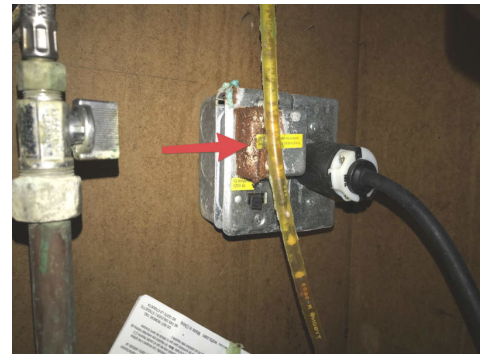
Kitchen Sink

### RUST ON RECEPTACLE(S)

Rust is present on one or more receptacles indicating the presence of moisture and is a potential safety concern. Further review and replacement is recommended.

In this particular instance the rust seems to have been caused by the nearby water tube and should be relocated away from the receptacle.

Contact a qualified electrical contractor.

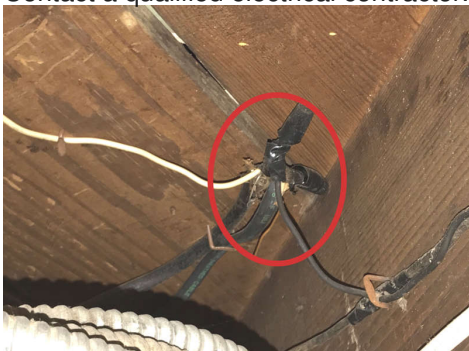
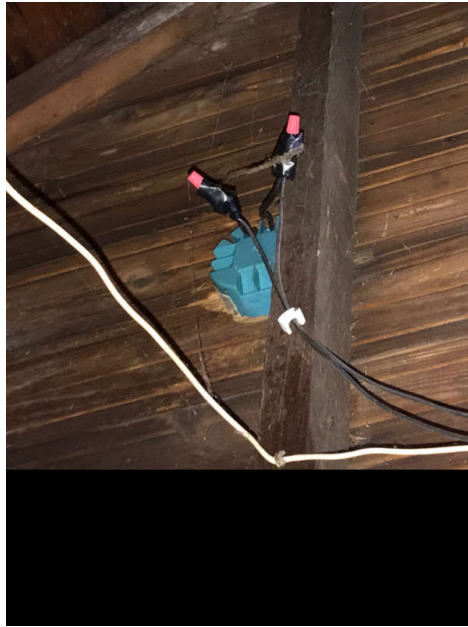
### EXPOSED SPLICE(S) - NEEDS JUNCTION BOX WITH COVER PLATE

All exposed splices must be secured in a proper box with cover plate to prevent electric shock. Correction by a licensed electrical contractor is recommended.

Contact a qualified electrical contractor.

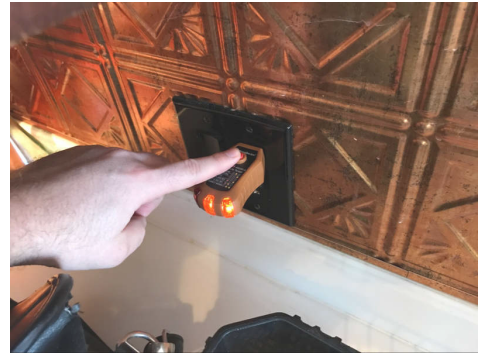
### **KITCHEN OUTLET(S) - NOT GFCI PROTECTED**

All outlets within 6' of a water or moisture source should be GFCI protected in accordance with today's standards. Updating by a licensed electrician is recommended.

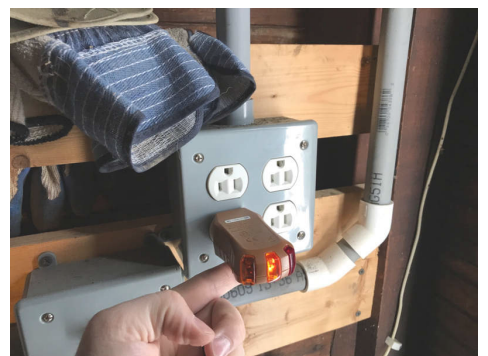
### **GARAGE OUTLET(S) - NOT GFCI PROTECTED**

The garage outlets are not GFCI protected and are not compliant to today's standards. Upgrading is recommended by a licensed electrician.

Recommendation  
Contact a qualified professional.

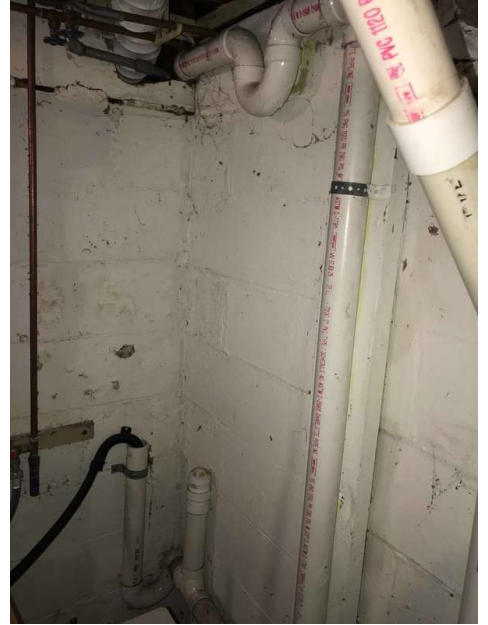
### **SEWER ODOR**

A sewer odor was detected when the washing machine was tested for functionality. Further review by a licensed plumber to confirm proper waste & drain pipe installation, and traps serving floor drains (if any) is recommended.

Recommendation  
Contact a qualified plumbing contractor.

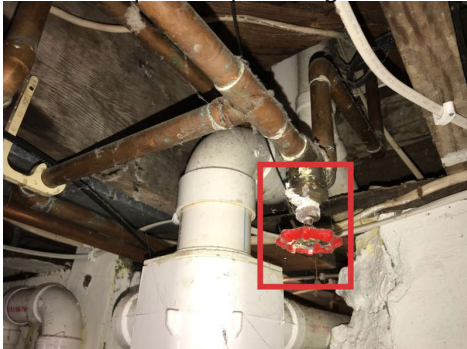
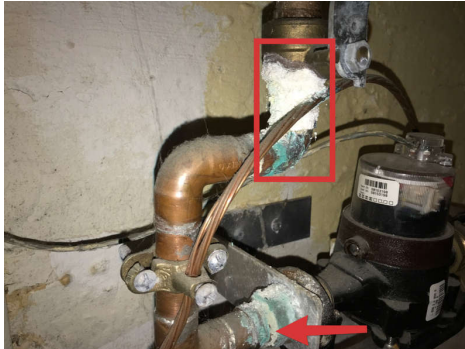
Water Meter

### **CORROSION ON SHUTOFF VALVE(S)**

Corrosion is present on one or more shut off valves. Replacement by a licensed plumber is recommended.

Contact a qualified plumbing contractor.

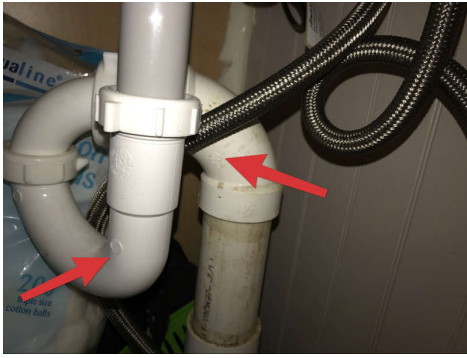
1st Floor Bathroom

### **IMPROPER S-TRAP INSTALLED- REPLACE WITH P-TRAP & VENT**

A common plumbing defect found in many older houses is an S trap. An S trap is named so because it looks like an S on its side it basically consists of a normal trap, and then another trap installed right up against it in an upside-down fashion. "P" traps have the potential to suck, or siphon, water out of the trap as the water flows down the drain which can allow unpleasant sewer odors and sewer gas to enter the living space. Correction by a licensed plumber is recommended.

Contact a qualified plumbing contractor.

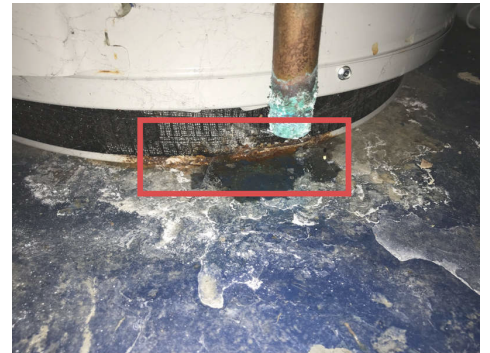
**WATER HEATER LEAK**

There is a leak observed at the bottom of the water heater. The cause of the leak could be from a faulty TPR valve or be originating from underneath the water heater. Further evaluation by a licensed plumber is recommended.

Recommendation  
Contact a qualified plumbing contractor.

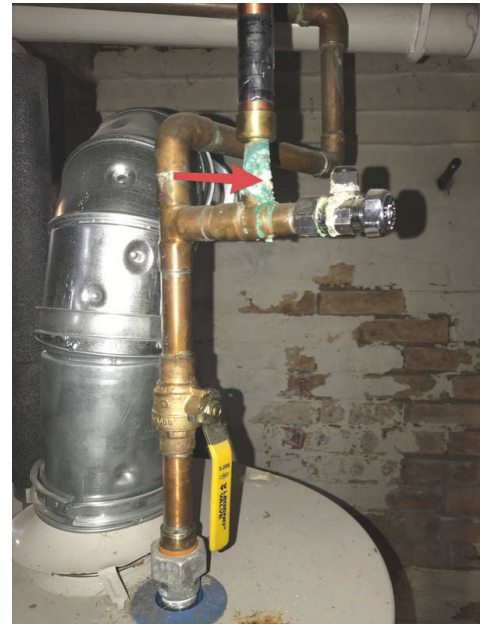
**CORROSION AT COLD WATER CONNECTION**

Corrosion is present at the cold water supply connection of the water heater. This is a possible result of a galvanic reaction between dissimilar metals touching, such as brass and galvanized metals, or excessive condensation causing the metal to rust. Replacement by a licensed plumber is recommended.

Recommendation  
Contact a qualified plumbing contractor.

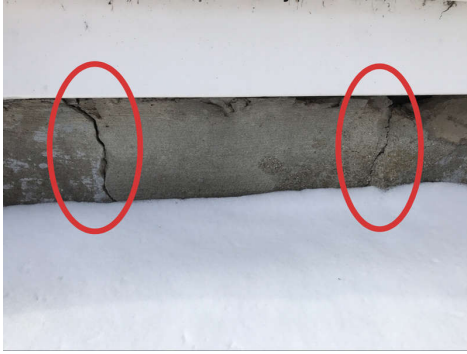
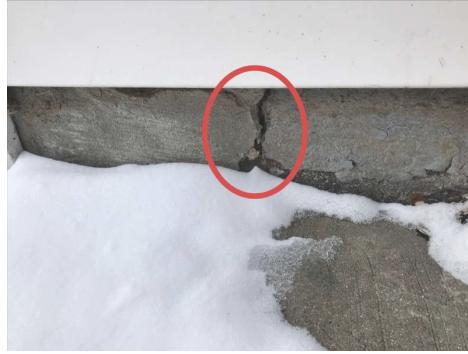
**EXTERIOR SETTLING CRACKS**

This/these cracks are representative of minor settling cracks observed on the exterior foundation wall of the home. Sealing and monitoring is recommended to prevent further cracking and water intrusion. If cracking worsens, further evaluation by a foundation specialist is advised.

Recommendation  
Recommended DIY Project

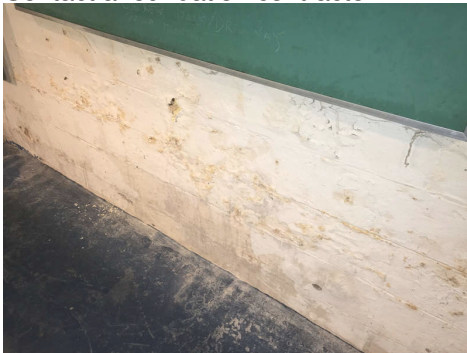
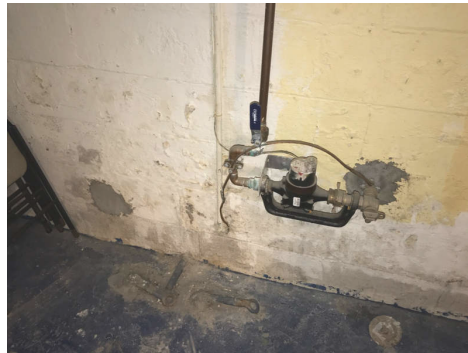
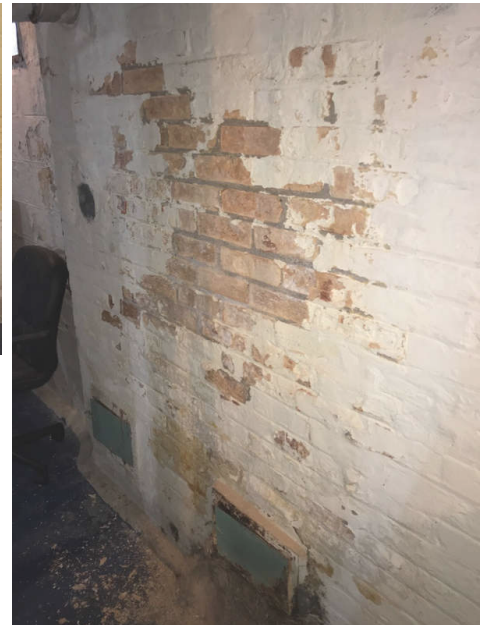
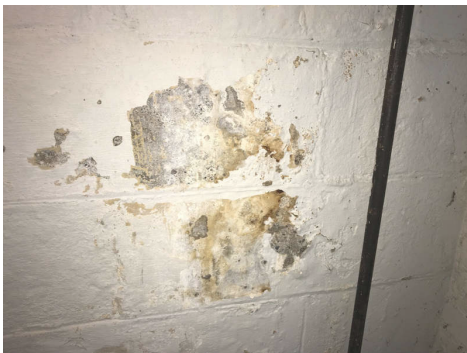
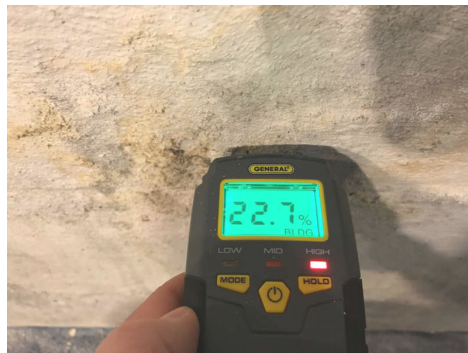
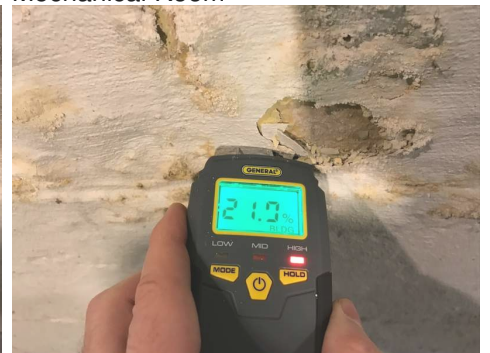
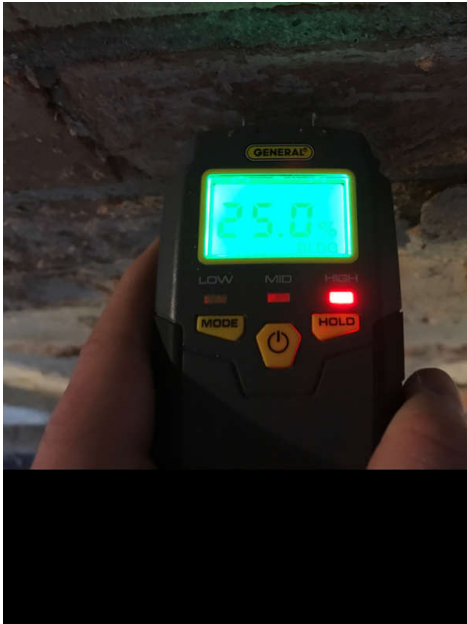
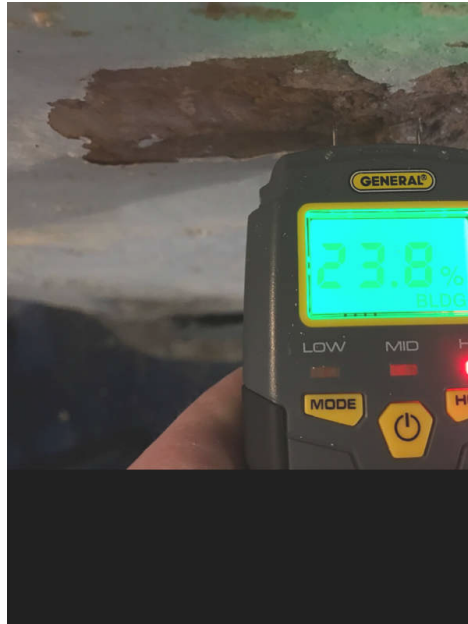
### EXCESSIVE FOUNDATION WALL CRUMBLING/SPALLING

Some foundation walls are crumbling/spalling due to moisture. Ensuring proper gutter drainage as well as ensuring landscaping near the home is sloped in such a way as to direct water away from the foundation will help prevent excessive water from penetrating into the bricks/blocks. Placement of a dehumidifier rated for the square footage of the room(s) effected is also recommended. There are many polymer modified cement based coatings contractors can use to easily restore the surface. Further evaluation and/or repair by a foundation specialist is recommended.

Recommendation  
Contact a foundation contractor.

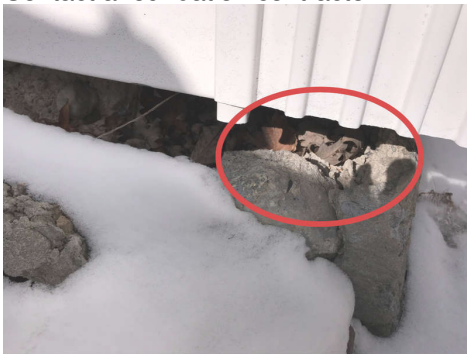
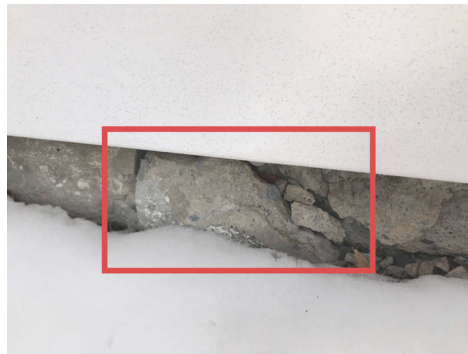
### EXTERIOR CRUMBLING/SPALLING

Some exterior foundation walls are crumbling/spalling due to moisture. Ensuring proper gutter drainage as well as ensuring landscaping near the home is sloped in such a way as to direct water away from the foundation will help prevent excessive water from penetrating into the bricks/blocks. There are many polymer modified cement based coatings contractors can use to easily restore the surface. Further evaluation and/or repair by a foundation specialist is recommended.

Recommendation  
Contact a foundation contractor.

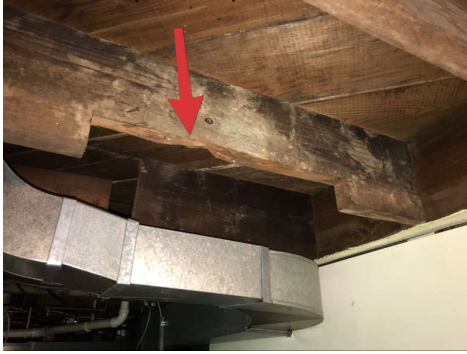
Rec Room

### IMPROPERLY NOTCHED JOIST(S)

One or more floor joists are improperly notched which reduces the load-bearing capacity to support the floor above and may be in need of additional support in these areas.

The maximum depth of a notch at the end of a joist (where it rests on a wall or beam) can't exceed one-quarter of the joist depth. The allowed maximum notch depth in the outer third of a joist is one-sixth of the joist depth. Notch length is limited to one-third of the joist depth. No notching is permitted in the middle third of a joist.

Further evaluation by a licensed contractor is recommended.

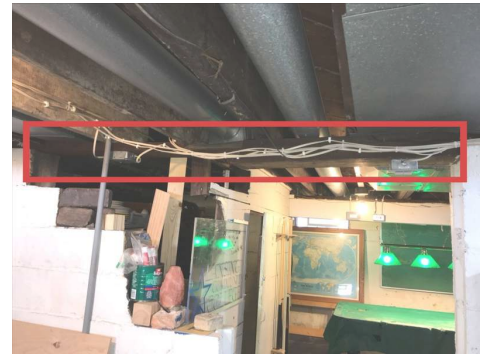
Basement

### IMPROPERLY SUPPORTED JOISTS

Improper/ineffective support in these areas may be causing the supported joists to be over-spanned. Further evaluation by a licensed contractor is recommended.

Recommendation  
Contact a qualified professional.

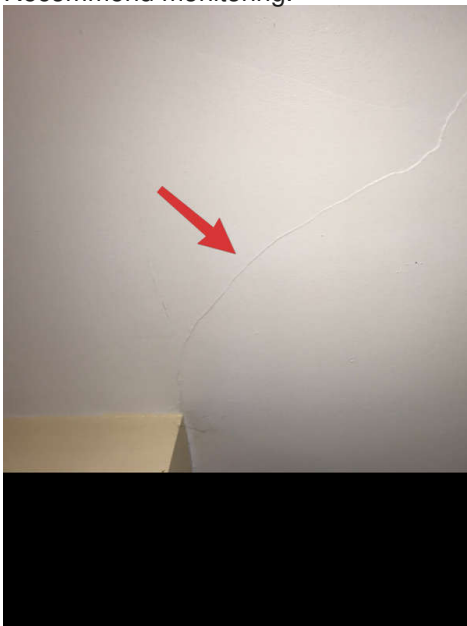
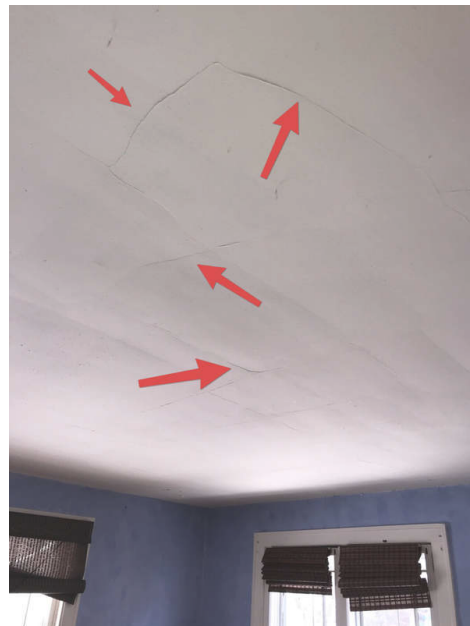
### COMMON SETTLING CRACKS

Common settling cracking is present on some walls of the home. These are common. Monitoring is recommended.

Recommendation  
Recommend monitoring.

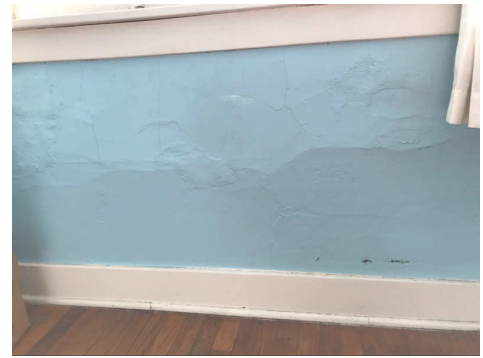
2nd Floor North Bedroom

**BOWED/BULGING**

Bowing/Bulging on one or more walls indicating possible moisture absorption in these locations. Removing wall coverings is and destructive testing is beyond the scope of a home inspection and should be further evaluated by a licensed contractor.

Recommendation  
Contact a qualified professional.

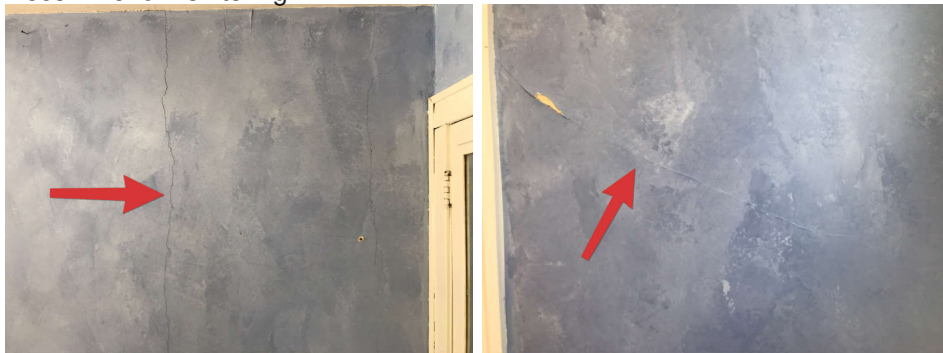
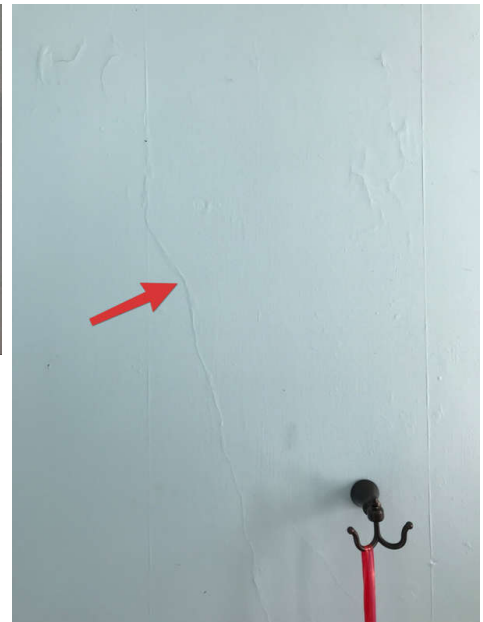
**COMMON SETTLING CRACKS**

One or more settling cracks are present and are caused by the natural settling of the home. In most cases these can be patched and painted. Monitoring these areas is recommended.

Recommendation  
Recommend monitoring.

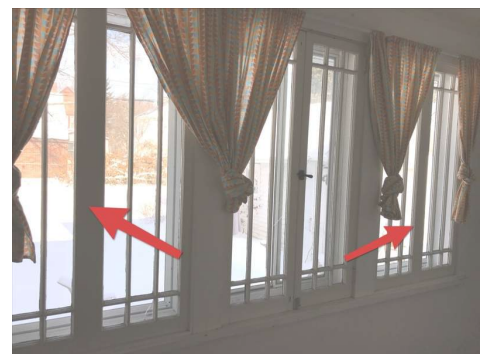
Mud Room

**STUCK OR PAINTED SHUT**

Some windows are stuck or painted shut and are unable to be opened/closed and work as intended.

Recommendation  
Contact a qualified professional.

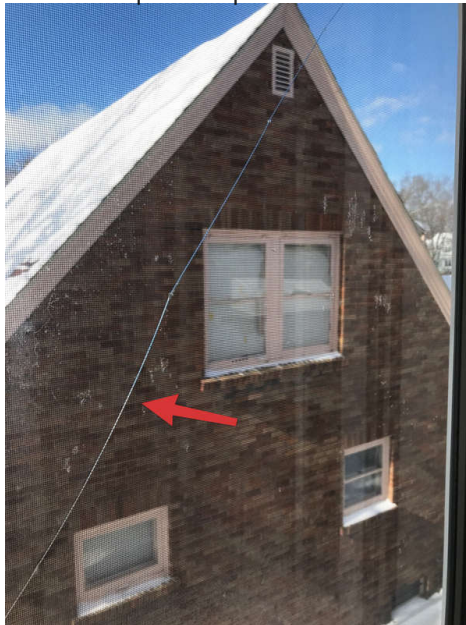
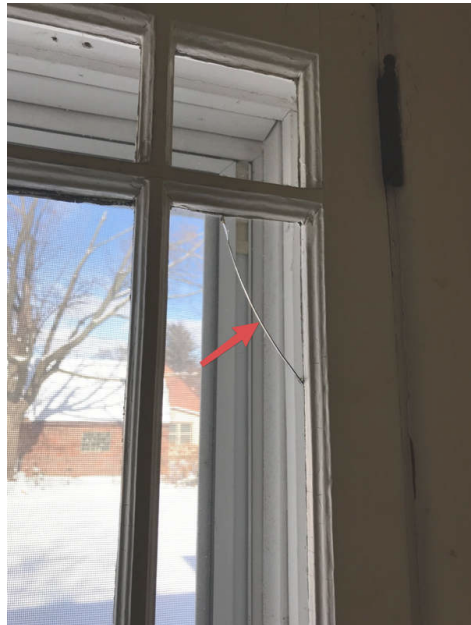
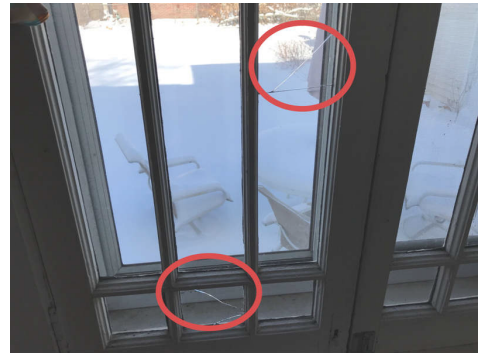
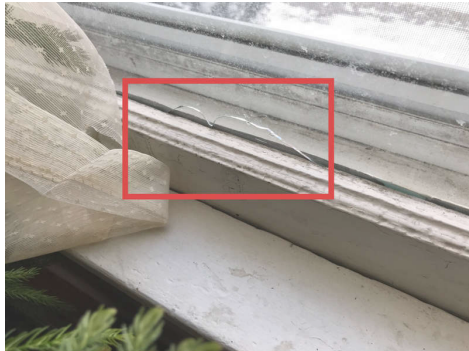
**CRACKED GLASS PANE(S)**

One or more glass panes is crack and in need of replacement by a licensed contractor.

Recommendation  
Contact a qualified professional.

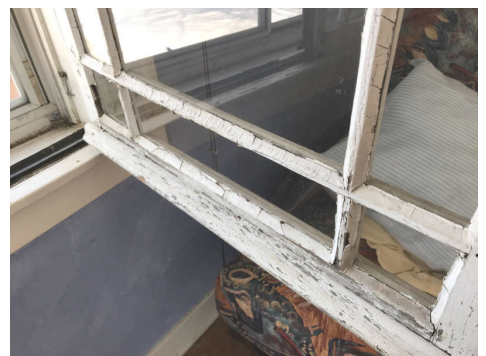
2nd Floor West Bedroom

**IN NEED OF PAINT**

One or more windows are in need of paint touch up to prevent rotting.

Recommendation  
Contact a qualified professional.

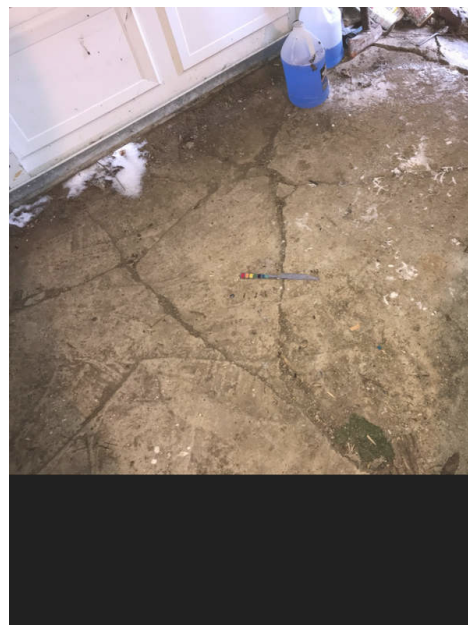
**FROST HEAVING PRESENT**

The concrete garage floor has experience heaving most likely due to "frost heaving". Frost heave occurs when freezing temperatures penetrate the ground, causing subsurface water to form ice structures that displace the soil along with anything that rests on or in that soil over time. If heaving continues repair will be needed. Monitoring this area is recommended.

Recommendation  
Recommend monitoring.

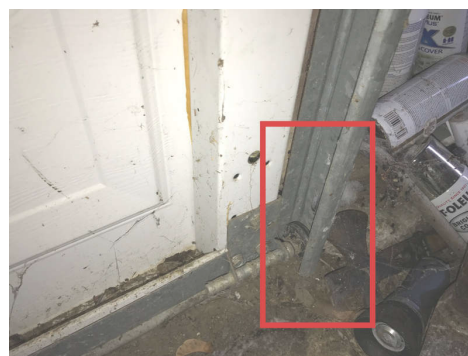
### **SENSORS NOT INSTALLED**

Photoelectric sensors are not installed and is a safety concern. Garage doors sensors is an important safety feature to prevent injury from the automatic garage door. Installation of photoelectric sensors to the manufacturer's instructions is recommended.

Recommendation  
Contact a qualified professional.

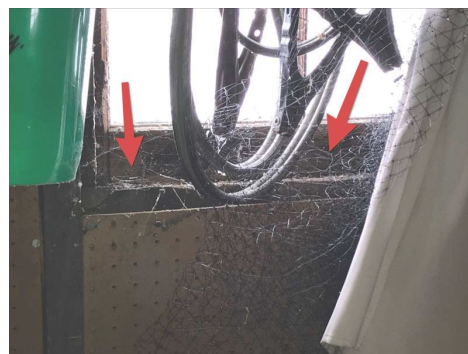
### **ROTTING FRAME/TRIM**

The window wood frame/trim appears to be rotting and is in need of repair/replacement by a qualified contractor.

Recommendation  
Contact a qualified window repair/installation contractor.

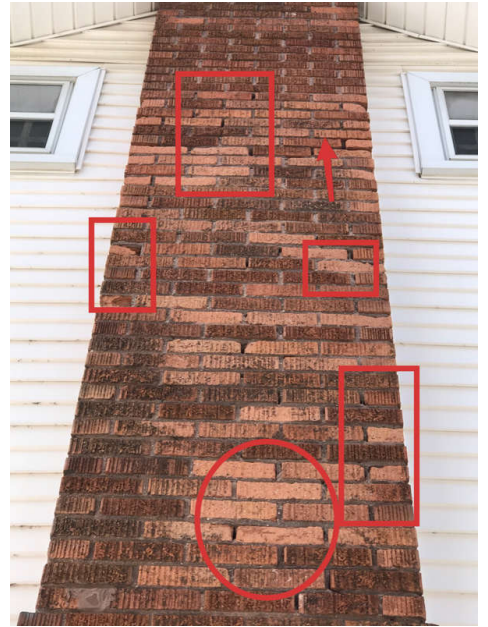
East Chimney

### **CHIMNEY - DETERIORATED MORTAR**

Chimney mortar has deteriorated in areas to prevent water intrusion which can cause future brick spalling and cracking. Repair is recommended by a licensed chimney contractor.

Recommendation  
Contact a qualified chimney contractor.

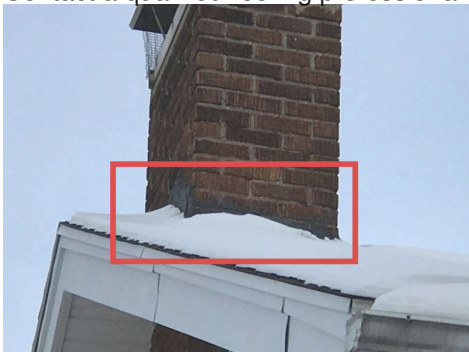
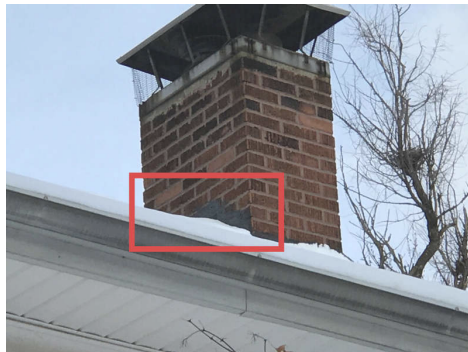
#### **HEAVY FLASHING AT CHIMNEY**

Heavy sealing is present at the chimney flashing. This may have been to correct a past water intrusion issue. Further review by a licensed roofer is recommended.

Contact a qualified roofing professional.

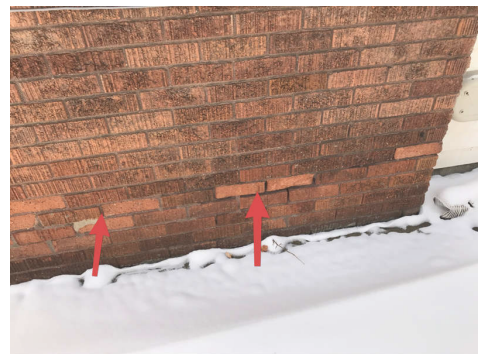
East Chimney

#### **SPALLING/DAMAGED BRICKS**

Chimney bricks are damaged/spalling due to moisture and are in need of repair by a licensed chimney repair contractor.

Contact a qualified chimney contractor.

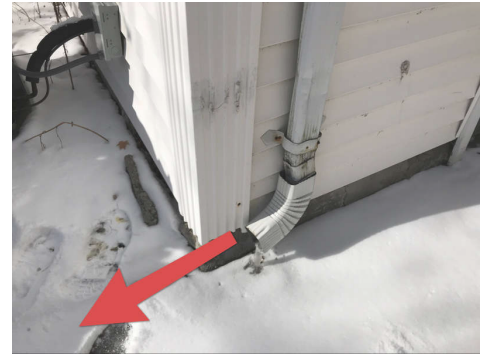
**GUTTER EXTENSION(S) NEEDED**

Gutter extension(s) are needed or redirected in a way to direct water away from the foundation to prevent erosion of soil and damage to the foundation structure.

Recommendation  
Recommended DIY Project

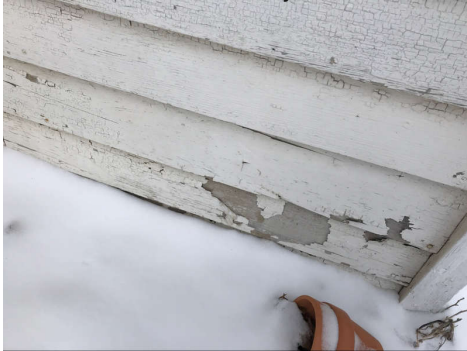
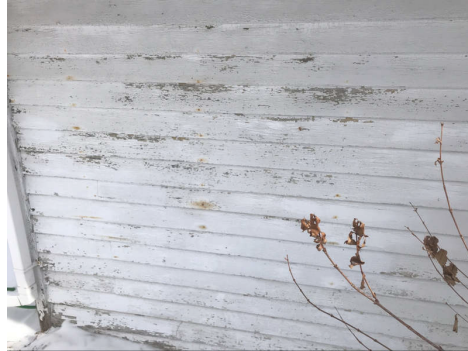
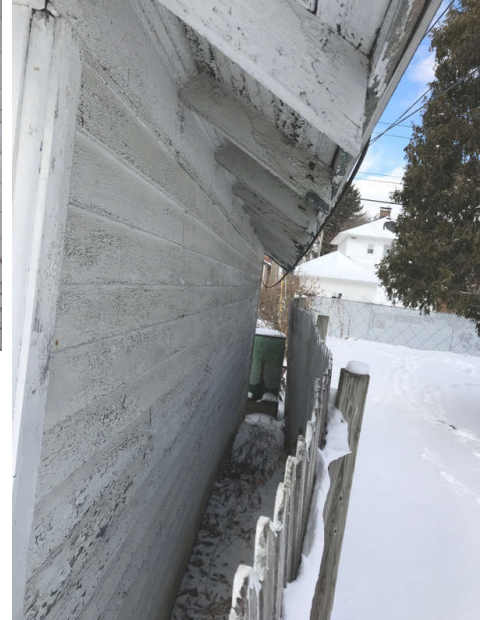
**PEELING PAINT**

Peeling paint is present at one or more areas and is in need of scraping, sanding, priming and re-painting. Homes built prior to 1978 may contain lead-based paint and should be tested and properly removed if present by a qualified lead abatement specialist.

Recommendation  
Recommended DIY Project
