**SUMMARY**  
 1234 Main St. Gulf Breeze FL 32563  
 Buyer Name  
 02/05/2019 9:00AM

Joshua Gregory  
 InterNACHI Certified Home Inspector  
 ProSite Property Inspections  
 740-331-9606

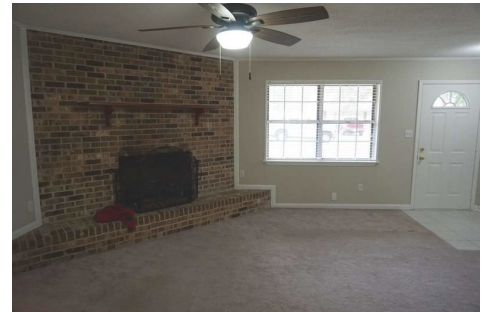
1.1.1 Structure Details

**NO CARBON MONOXIDE ALARMS**

This property has one or more fuel burning appliances, and no carbon monoxide alarms were visible. This is a safety hazard. Recommend installing one or more carbon monoxide alarms as necessary and as per the manufacturer's instructions.

Recommendation  
 Contact a qualified professional.

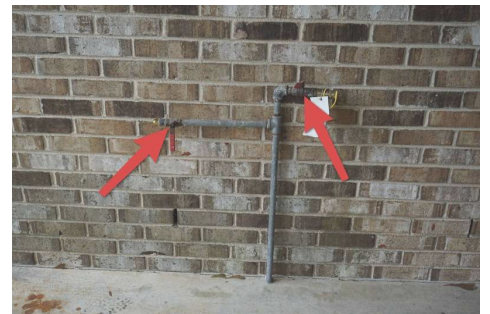
1.1.2 Structure Details

**GAS UTILITY LEAK**

Based on gas odors, gas appeared to be leaking at the one or more local shut-off valves or supply piping located at the back exterior. This is an explosion and fire hazard. A qualified contractor and/or the gas utility company should evaluate and repair immediately.

Recommendation  
 Contact a qualified plumbing contractor.

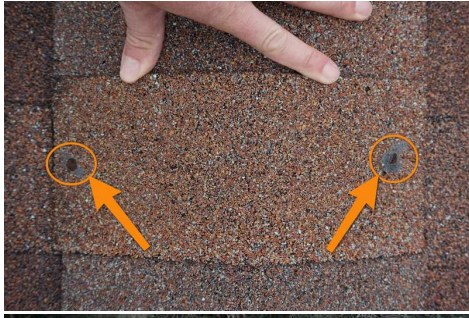
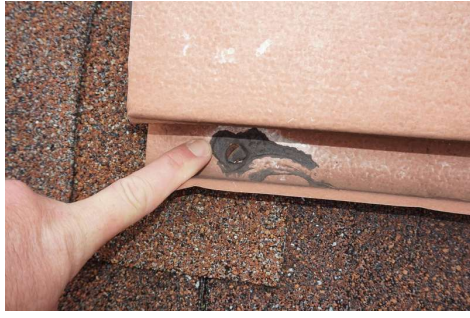
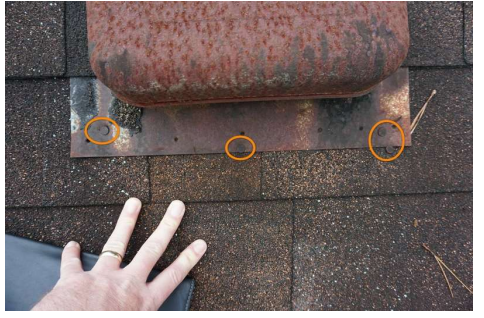
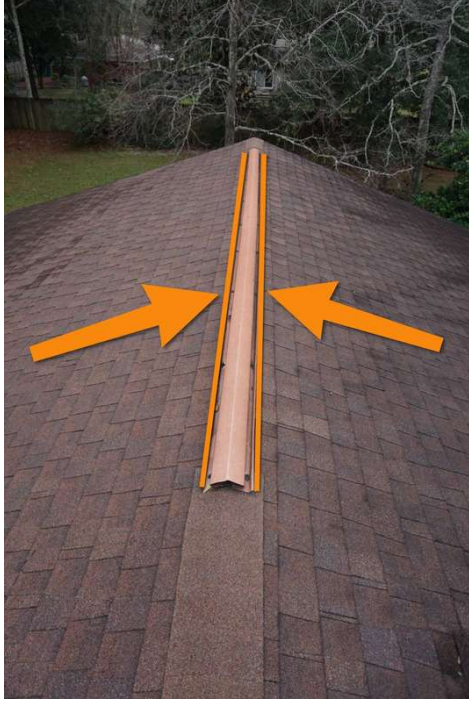
2.1.1 General

**EXPOSED NAIL HEADS**

Exposed nail heads observed. This a potential pathway for moisture intrusion. Although there was no evidence of a leak, we recommend sealing these areas and annually in the future by a licensed roofing contractor.

Recommendation  
 Contact a qualified roofing professional.

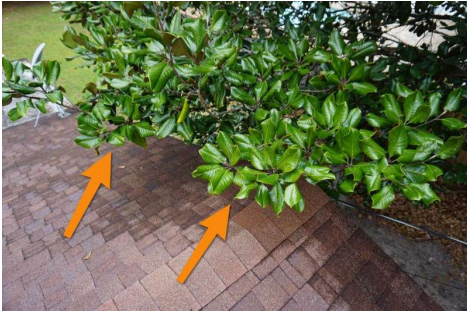
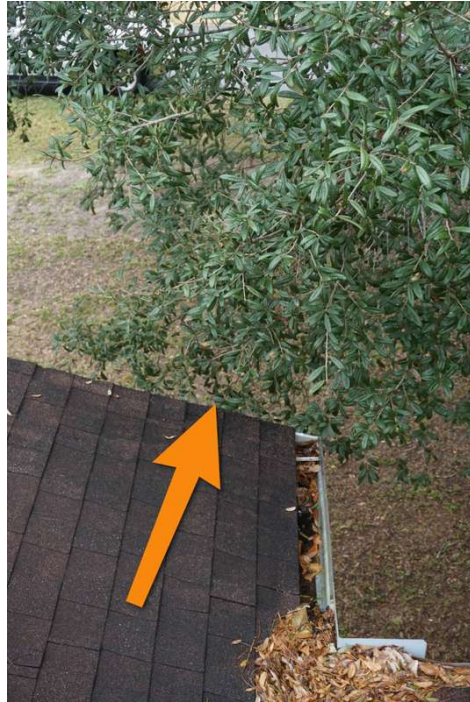
### 2.1.2 General

## VEGETATION IN CLOSE CONTACT OR OVERHANGS

Vegetation such as trees, shrubs, and/or vines overhung the roof surface or were in close contact with the roof edge. Organic debris such as leaves or needles are likely to accumulate in gutters and on the roof surface. Gutters can overflow and cause water to come in contact with the building exterior or water can accumulate around the foundation. This is a conducive condition for wood-destroying organisms. Vegetation in contact with the roof can damage the roof surface and/or the roof drainage system. Recommend pruning vegetation so as to not be in close contact with the roof and to not overhang the roof surface. If vegetation is too tall then it should be pruned at least 10 feet above the roof surface.

Contact a qualified tree service company.

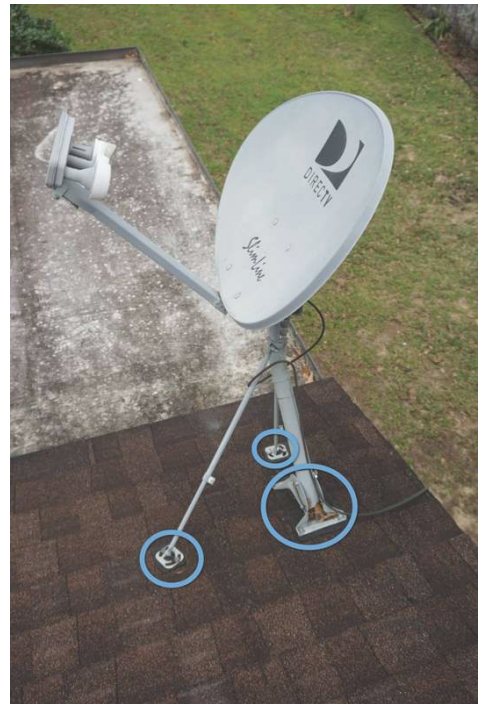
### 2.1.3 General

## SATELLITE DISH

Satellite dish was mounted on the roof should be inspected at the least annually, leaks can occur around mounting brackets and may need sealant applied to prevent leaks by a licensed roofing contractor.

Contact a qualified roofing professional.

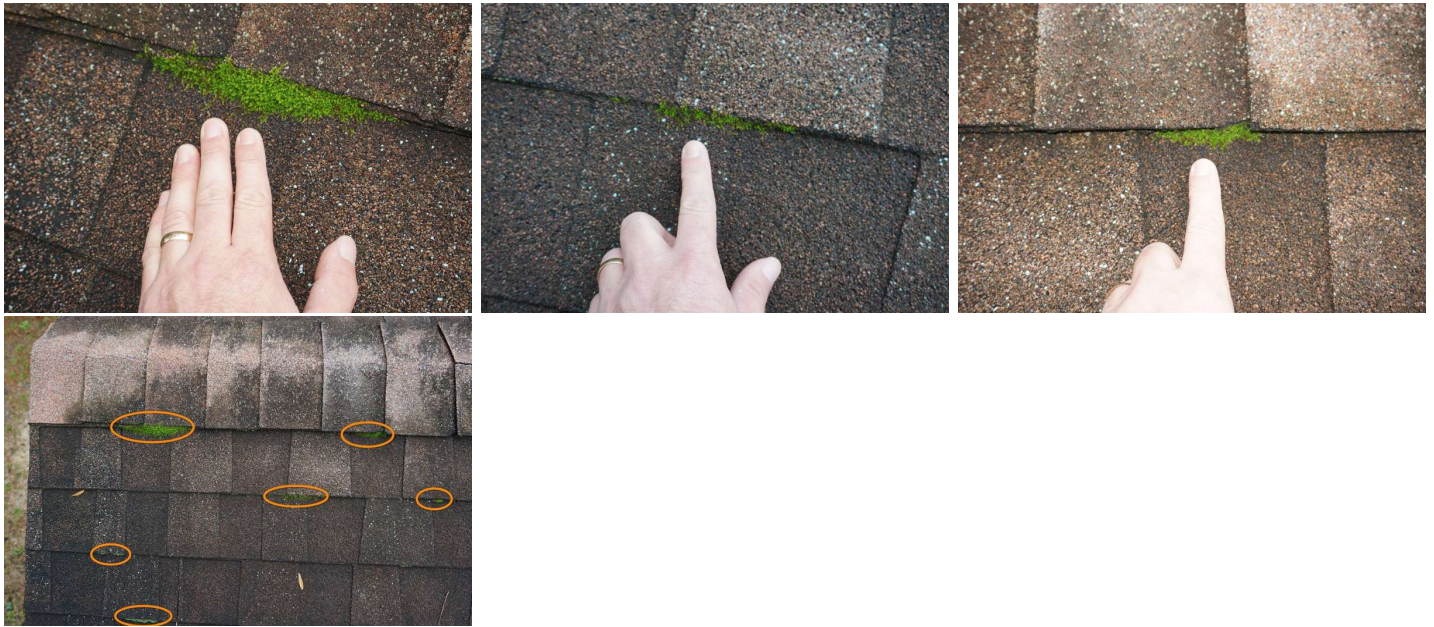
### 2.1.4 General

## MOSS GROWTH

Moss was growing on the roof. As a result, roofing material can lift or be damaged. Leaks can result and/or the roof surface can fail prematurely. Efforts should be made to kill the moss during its growing season (wet months). Typically, zinc or phosphate-based chemicals are used for this and must be applied periodically. Recommend further evaluation and removing moss by a licensed roofing contractor. Roof should also be evaluated by a licensed roofing contractor once moss is removed.

Contact a qualified roofing professional.

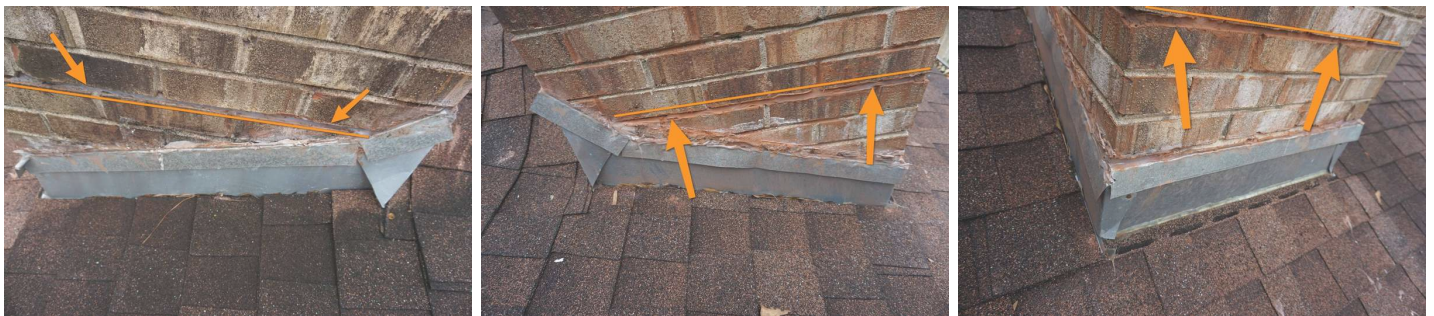
## 2.2.1 Chimney

### REPOINT MORTAR

Roofing sealant was observed at the chimney's mortar joint in one or more areas. This is not standard practice for repairing masonry mortar joints. The masonry chimney's mortar is may be deteriorated and should be further evaluated for deterioration. Recommend having a qualified chimney service contractor or masonry contractor evaluate and repair as necessary. This will likely require re-pointing the mortar.

Contact a qualified chimney contractor.

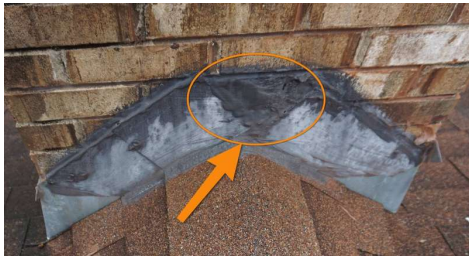
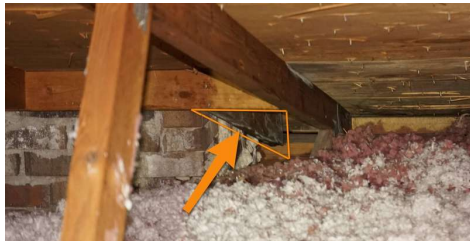
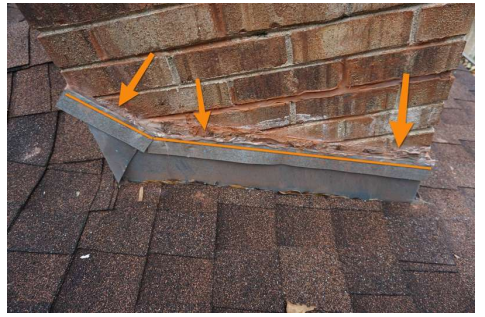
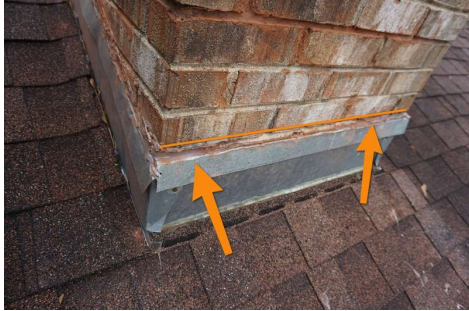
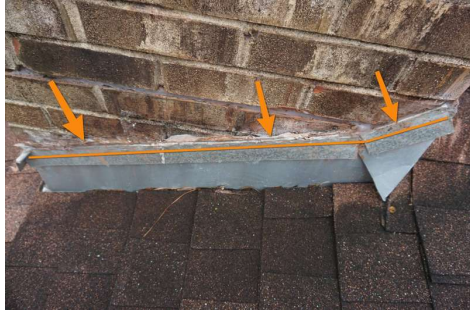
## 2.2.2 Chimney

### CHIMNEY FLASHING - SUBSTANDARD

Chimney flashing was not professionally installed. Leaks can occur as a result. This is conducive for wood destroying organisms. Moisture stains were evident at the roof structure around the chimney area in the attic space. The inspector was not able to traverse into this area to test for moisture due to low height. Excessive roofing sealant was observed at the chimney flashing which may also indicate problems with past moisture intrusion in this area. Roof decking and roof structure must be evaluated during repairs/replacement. Recommend evaluation and replacement of chimney flashing by a licensed roofing contractor.

Contact a qualified roofing professional.

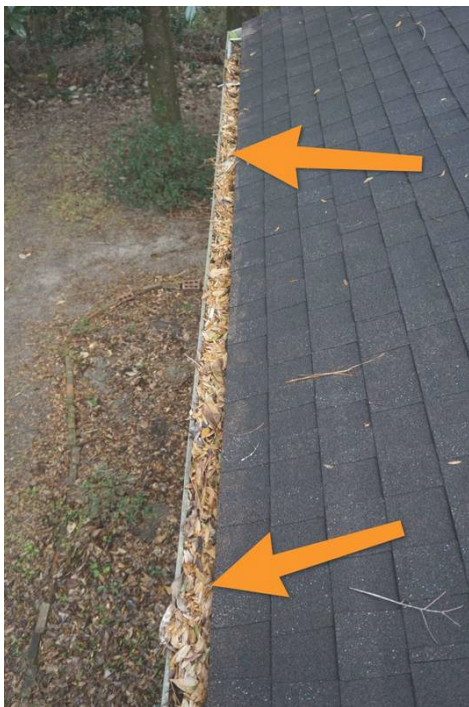
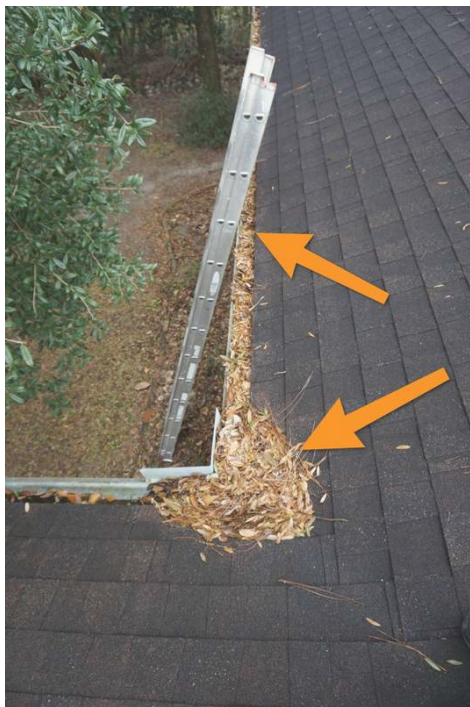
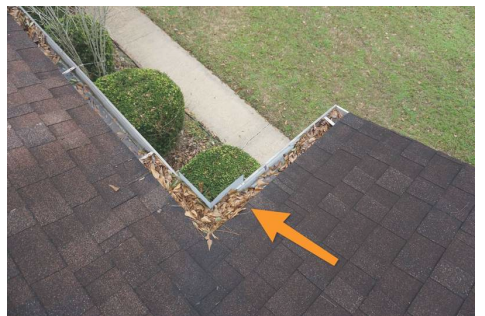
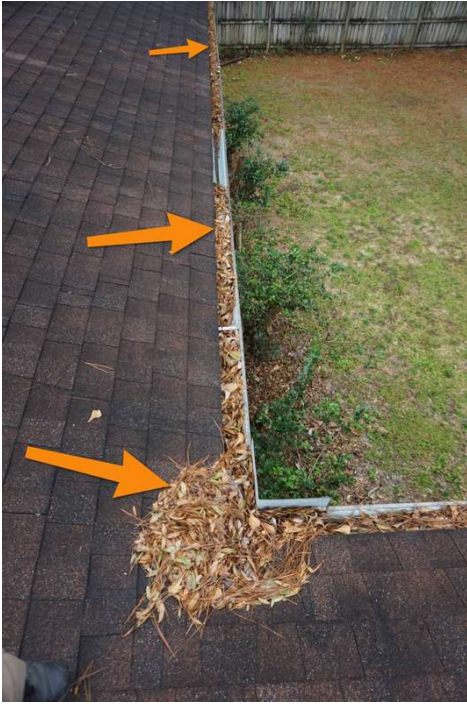
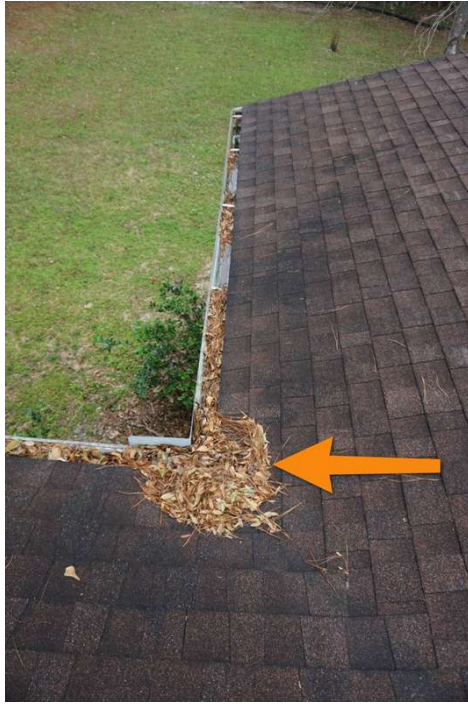
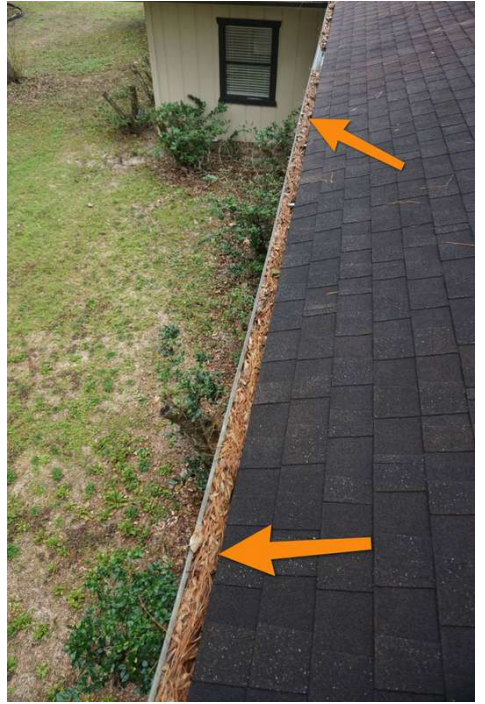
### 2.3.1 Gutters/drains

## CLOGGED GUTTERS/DOWNSPOUTS

Significant amounts of debris have accumulated in one or more gutters or downspouts. Gutters can overflow and cause water to come in contact with the building exterior, or water can accumulate around the foundation. This is a conducive condition for wood-destroying organisms. Recommend cleaning gutters and downspouts now and as necessary in the future.

Contact a handyman or DIY project

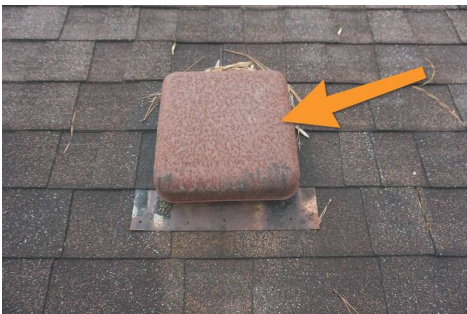
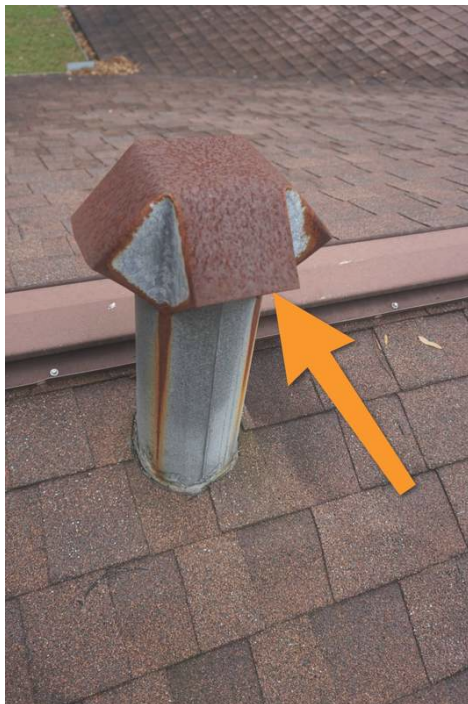
#### 2.4.1 Flashing/Vents

### RUSTY APPURTENANCES

Roof-top appurtenance such as vents were significantly corroded. Metal may deteriorate to the point of needing replacement. Leaks can occur around such items if flashing or sealant doesn't form a waterproof seal with the corroded metal. This can be a conducive condition for wood-destroying organisms. Recommend that a licensed roofing contractor repair as necessary. For example, by cleaning rust and repainting with a rust-inhibiting paint.

Contact a qualified roofing professional.

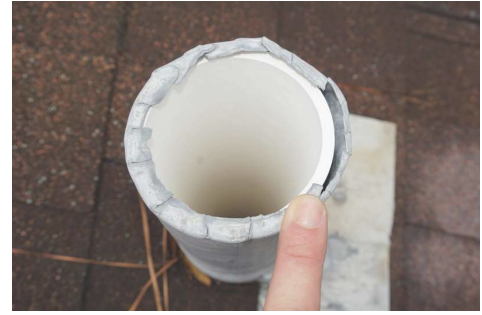
2.4.2 Flashing/Vents

**SUBSTANDARD LEAD FLASHING**

Lead flashing at one or more plumbing vent pipes was improperly installed. For example, shorter than the vent pipe or not bent over the edge of the vent pipe. Properly installed, the flashing should extend up and over the top edge of the pipe, and be bent down into the pipe. Otherwise, rain water can flow between the pipe and the flashing, resulting in leaks. This is a conducive condition for wood-destroying organisms. Recommend that a licensed roofing contractor repair per standard building practices.

Contact a qualified roofing professional.

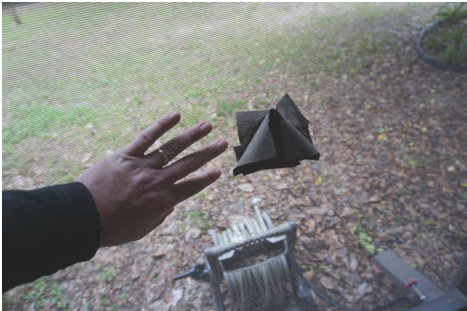
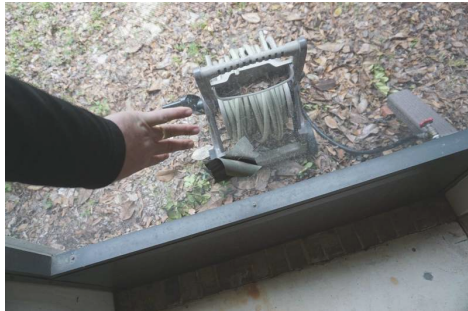
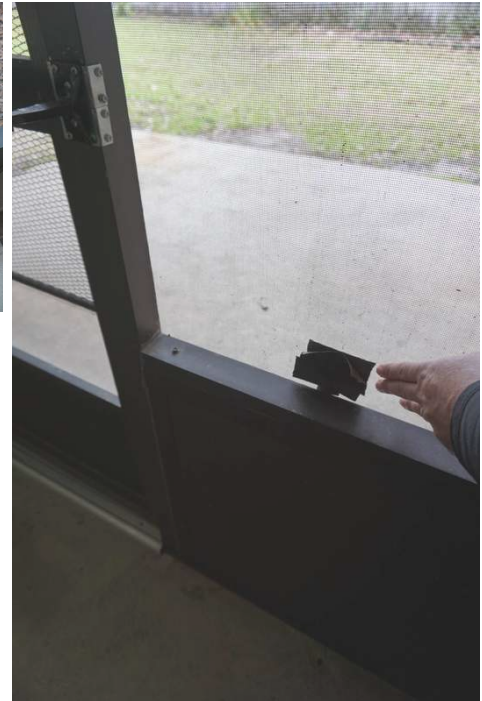
3.2.1 Driveway, Walkway, Patio

**SCREEN ENCLOSURE-SCREENS TORN**

One or more screens were damaged or torn or missing in the screen patio. A certified contractor should make the necessary repairs.

Contact a qualified handyman.

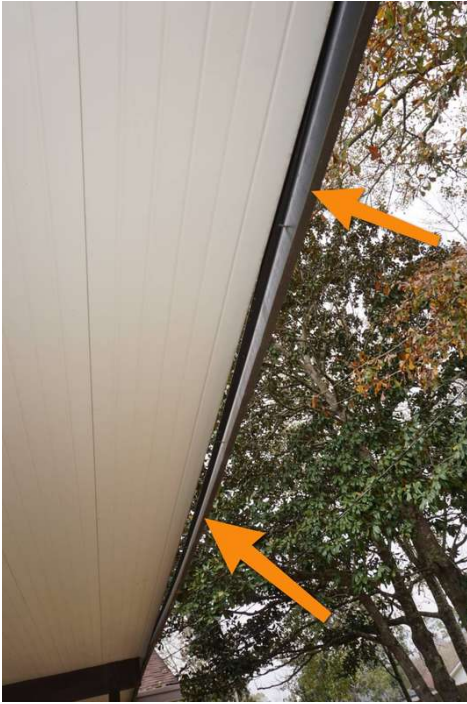
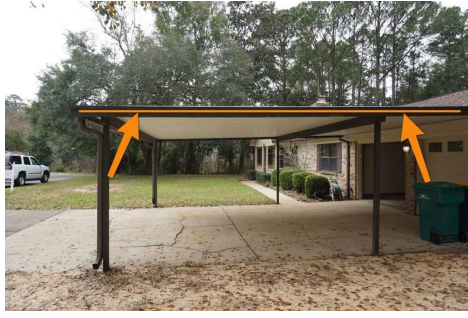
3.2.2 Driveway, Walkway, Patio

**CARPORT RAKE TRIM - LOOSE**

Carport rake trim located on the north side was loose. Recommend evaluation and repairs by a qualified professional.

Contact a qualified professional.

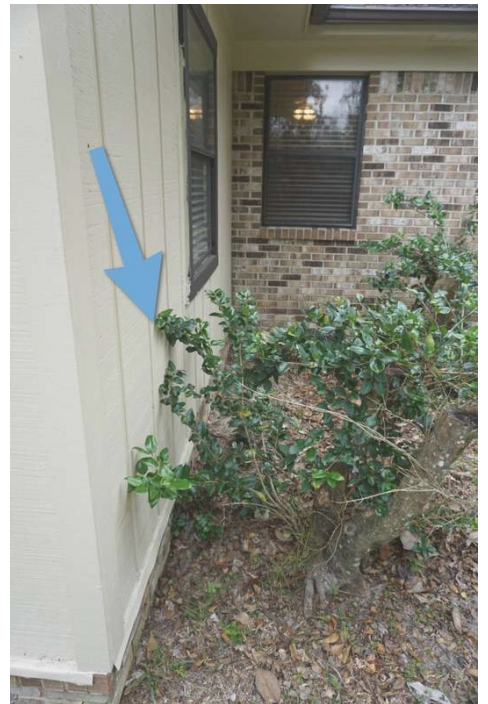
### 3.3.1 Exterior issues

## VEGETATION IN CONTACT WITH STRUCTURE

Vegetation observed within close contact of the house. This can create a pathway for insects and/or wood destroying organisms into the home interior. Recommend trimming vegetation by a qualified landscape professional.

Contact a qualified landscaping contractor

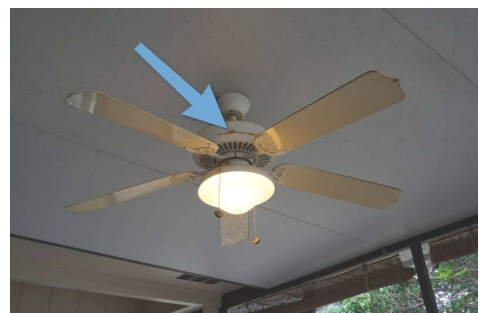
### 3.4.1 Electrical

## CEILING FAN INOPERABLE

Ceiling fan was inoperable. Recommend asking the property owner(s) about this, and if necessary, having a licensed electrical contractor evaluate and repair as necessary.

Contact a qualified electrical contractor.

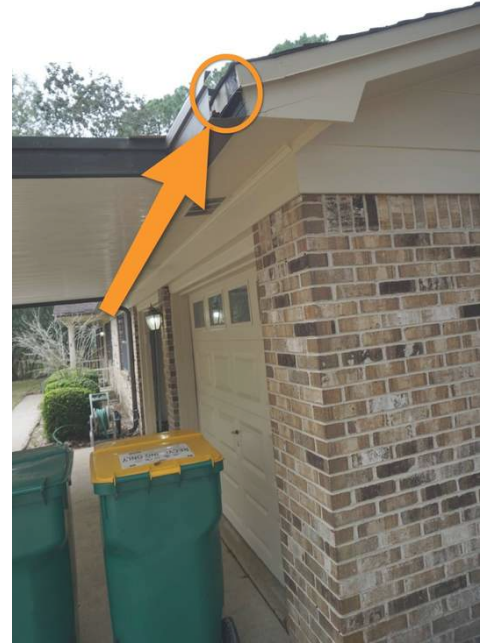
### 3.7.1 Gutters and Flashing

## GUTTER END CAP MISSING

Gutter end cap located at the front exterior north corner was missing. Rainwater may come in contact with the building exterior or accumulate around the foundation as a result. This can be a conducive condition for wood-destroying organisms. Recommend that a qualified person install or repair end caps where missing.

Contact a qualified professional.

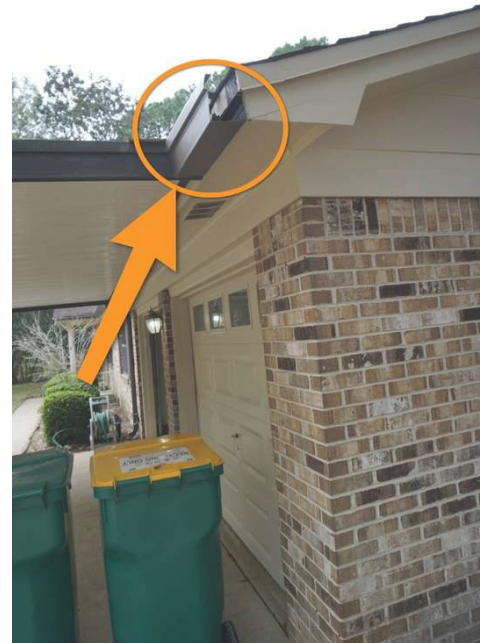
### 3.7.2 Gutters and Flashing

## NO DOWNSPOUT

There is no downspout installed at the front exterior north corner gutter system. This can cause water to accumulate around the homes foundation and cause soil a erosion. Also standing water could occur as well as low spots around the home. Downspouts should be installed as needed.

Contact a qualified professional.

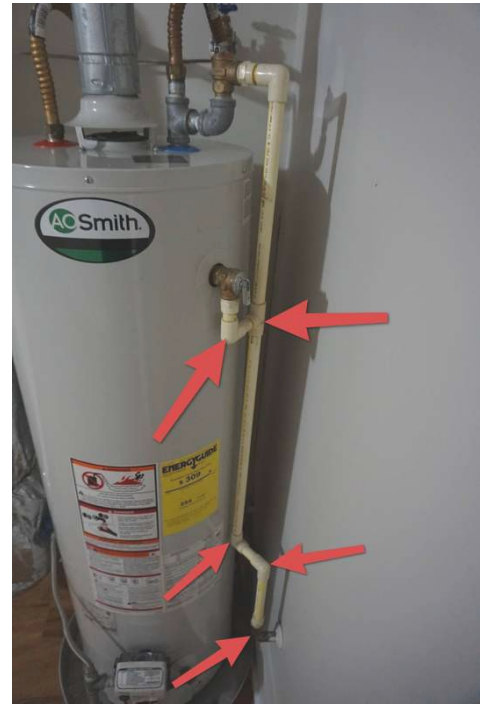
### 5.1.1 Water Heater

## TPR >4 ELBOWS

The temperature/pressure relief valve drain line has more than 4 elbows in it. This is a potential safety hazard due to the risk of explosion. Typically these valves are limited to 4 elbows or less in the drain line so venting is not restricted. A qualified plumber should evaluate and repair as necessary so the drain line complies with the temperature-pressure relief valve manufacturer's installation instructions.

Recommendation  
Contact a qualified plumbing contractor.

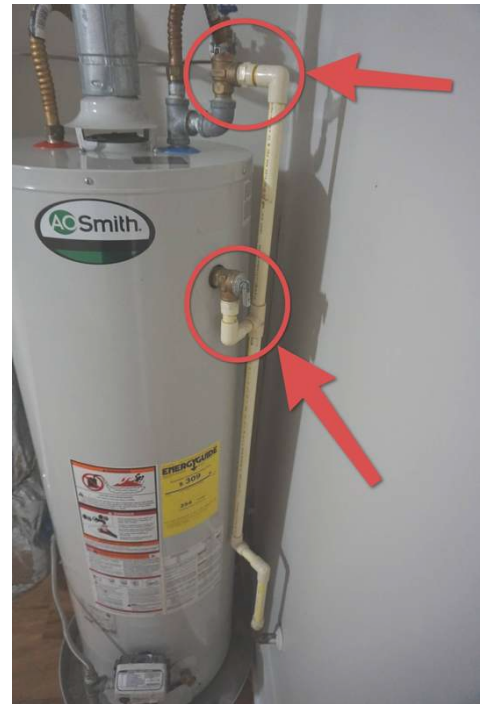
5.1.2 Water Heater  
**DISCHARGE LINE SERVES  
MULTIPLE VALVES**

This water heater discharge pipe served multiple temperature/pressure relief (TPR) valves. This condition is a potential safety hazard. Recommend further evaluation and repairs by a licensed plumbing contractor.

Recommendation  
Contact a qualified plumbing contractor.

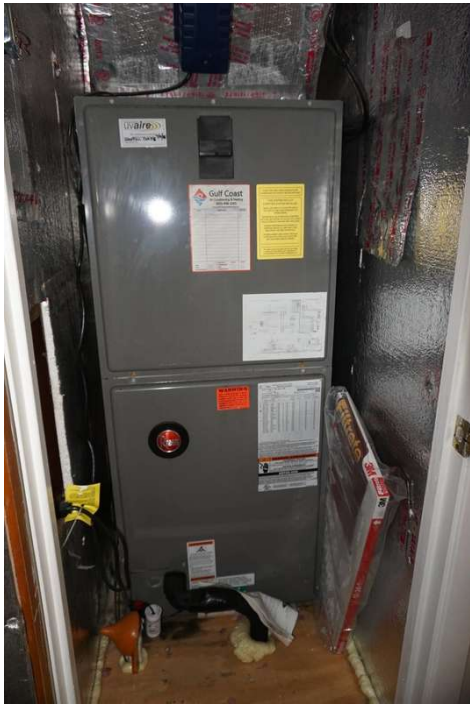
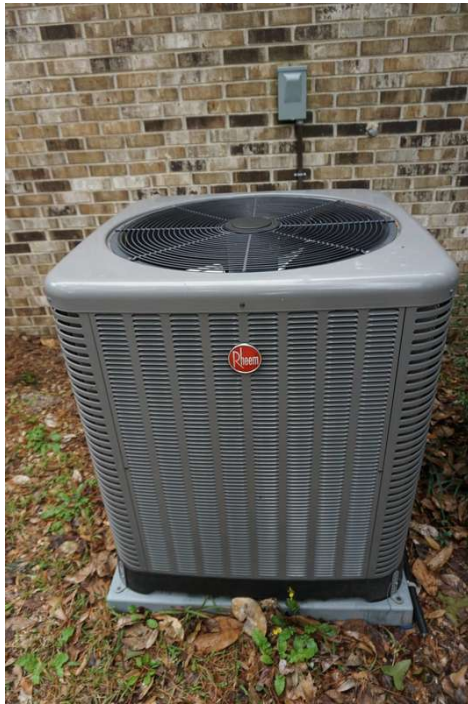
7.1.1 General  
**SERVICE A/C SYSTEM**

The last service date of this system appears to be more than one year ago, or the inspector was unable to determine the last service date. The client(s) should ask the property owner(s) when it was last serviced. If unable to determine the last service date, or if this system was serviced more than one year ago, a licensed heating and cooling contractor should inspect, clean, and service this system, and make repairs if necessary. This servicing should be performed annually in the future.

Recommendation  
Contact a qualified HVAC professional.

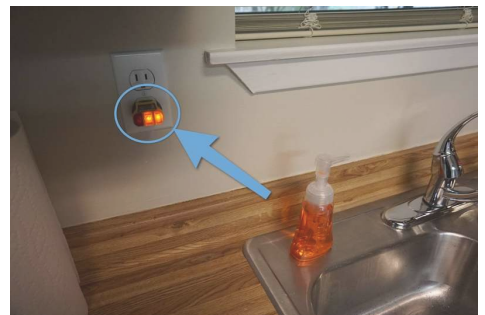
#### 8.4.1 Electrical

### **GFCI UPGRADE RECOMMENDED**

Ground Fault Circuit Interrupter (GFCI) protection of home electrical outlets were not present in the home at the time of inspection. Although GFCI protection may not have been required at the time the home was built, for safety reasons, consider upgrading the electrical system to include GFCI protection at the following locations:

1. Replacing the current standard outlets with GFCI outlets
2. Replacing the outlet in the garage circuit which is nearest the main electrical service panel with a GFCI outlet.
3. Replacing a non-GFCI breaker currently protecting an electrical circuit with a GFCI-type breaker.

Contact a qualified electrical contractor.

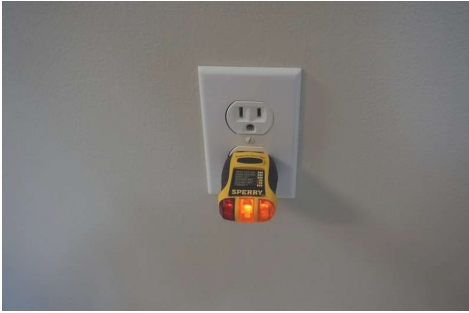
8.4.2 Electrical

**OPEN GROUND**

Modern 3-slot electric receptacle in the kitchen was found with an open ground. This is a shock hazard when appliances that require a ground are used with these receptacles. Examples of such appliances include computers and related hardware, refrigerators, freezers, portable air conditioners, clothes washers, aquarium pumps, and electrically operated gardening tools. Recommend that a licensed electrical contractor repair as necessary so all receptacles are grounded per standard building practices.

Contact a qualified electrical contractor.

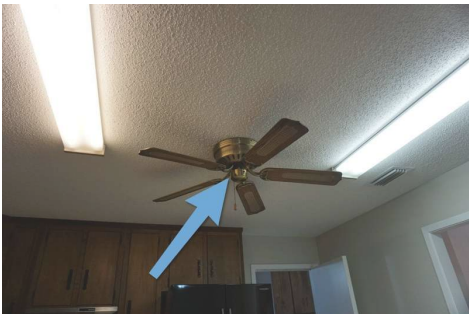
8.4.3 Electrical

**CEILING FAN INOPERABLE**

One or more ceiling fans appear to be inoperable. Recommend asking the property owner(s) about this, and if necessary, having a qualified electrician evaluate and repair as necessary.

Contact a qualified electrical contractor.

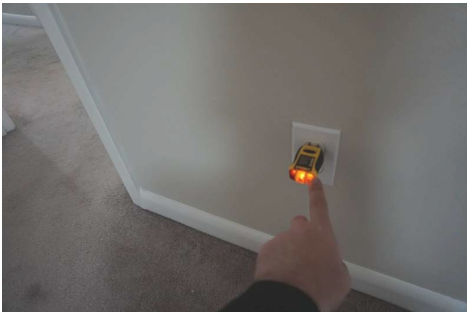
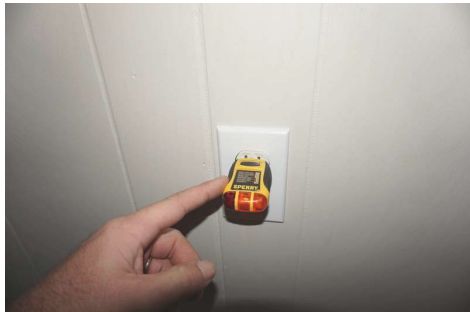
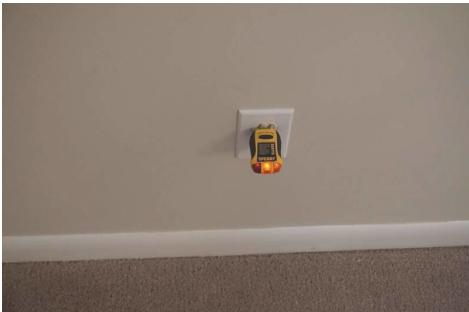
9.2.1 Electrical

**OPEN GROUND**

Modern, 3-slot electric receptacles were found with an open ground located in the living room, dining room and master bedroom. This is a shock hazard when appliances that require a ground are used with these receptacles. Examples of such appliances include computers and related hardware, refrigerators, freezers, portable air conditioners, clothes washers, aquarium pumps, and electrically operated gardening tools. Recommend that a licensed electrical contractor repair as necessary so all receptacles are grounded per standard building practices.

Contact a qualified electrical contractor.

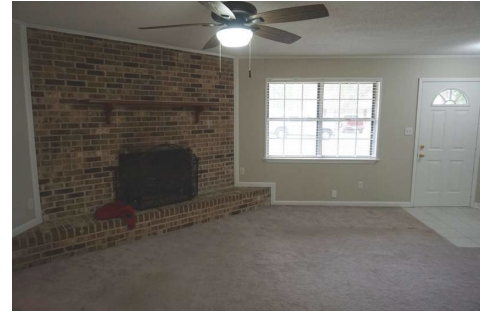
9.3.1 Smoke and CO alarms

**SMOKE ALARMS MISSING**

Smoke alarms were missing at all interior areas. This is a safety hazard. Smoke alarms should be installed as necessary so a functioning alarm exists in each hallway leading to bedrooms, in each bedroom, on each level and in any attached garage.

Contact a qualified electrical contractor.

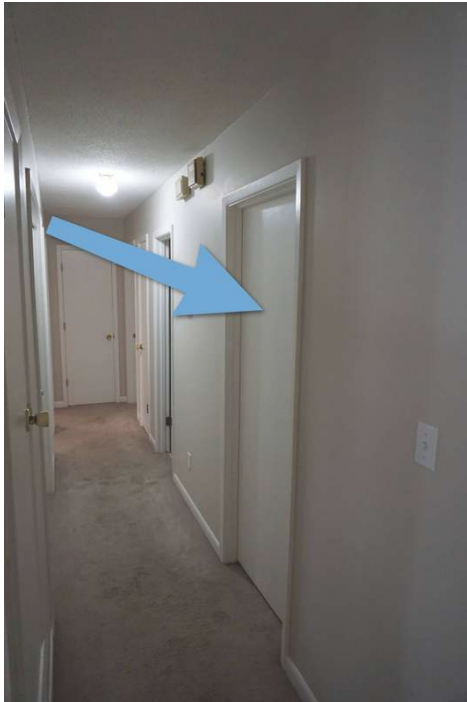
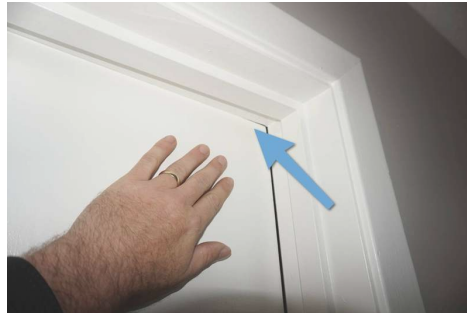
#### 9.4.1 Windows and Door

### DOOR-BINDS IN JAMB

Interior door binds in jamb and cannot be closed and latched, or are difficult to open and close. A qualified contractor should evaluate and repair as necessary. For example, adjusting jamba or trimming doors.

Contact a qualified door repair/installation contractor.

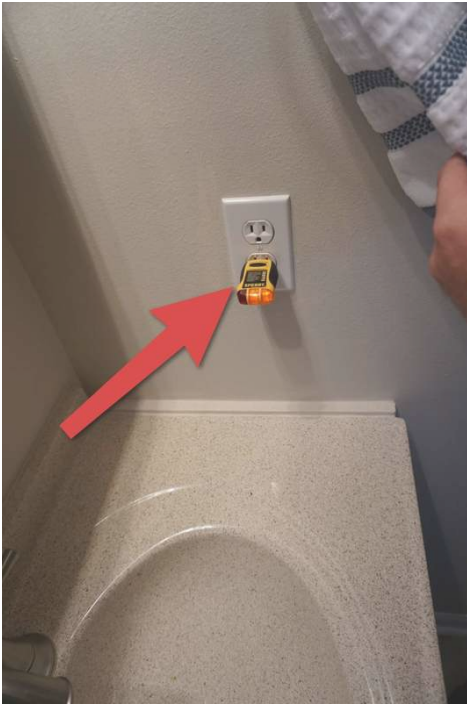
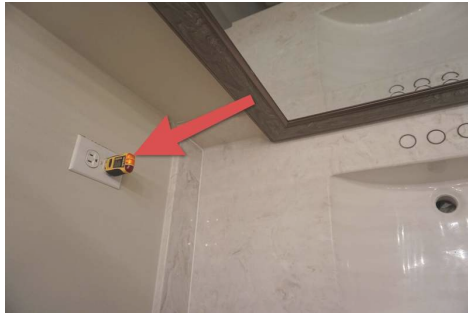
#### 10.4.1 Electrical

### GFCI MISSING

One or more electric receptacles at the bathroom(s) had no visible ground fault circuit interrupter (GFCI) protection, or the inspector was unable to determine if GFCI protection was present. If not GFCI-protected, receptacles in wet areas pose a shock hazard. Recommend that a licensed electrical contractor evaluate and install GFCI protection if necessary and per standard building practices. General guidelines for GFCI-protected receptacles include the following locations:

Contact a qualified electrical contractor.

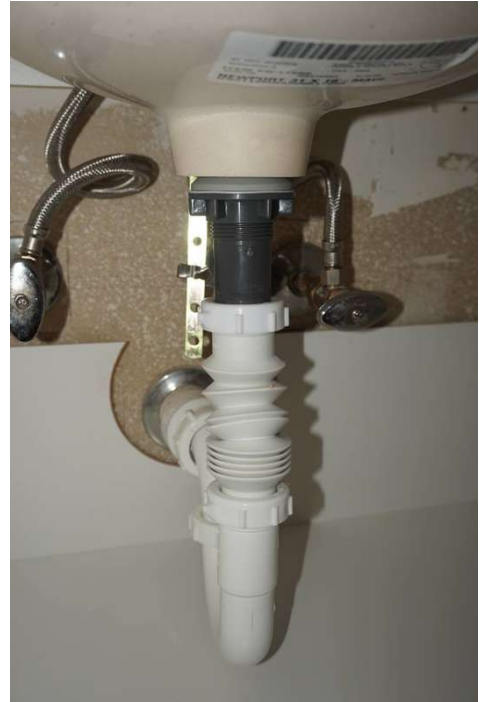
### 10.8.1 Sink/countertop

## **SINK DRAIN FLEX PIPE**

Sink drain for the master bathroom used flexible drain pipe. This type of drain pipe is more likely to clog than smooth wall pipe. Recommend having a licensed plumbing contractor replace this pipe with standard plumbing components (smooth wall pipe) to prevent clogged drains.

Contact a qualified plumbing contractor.

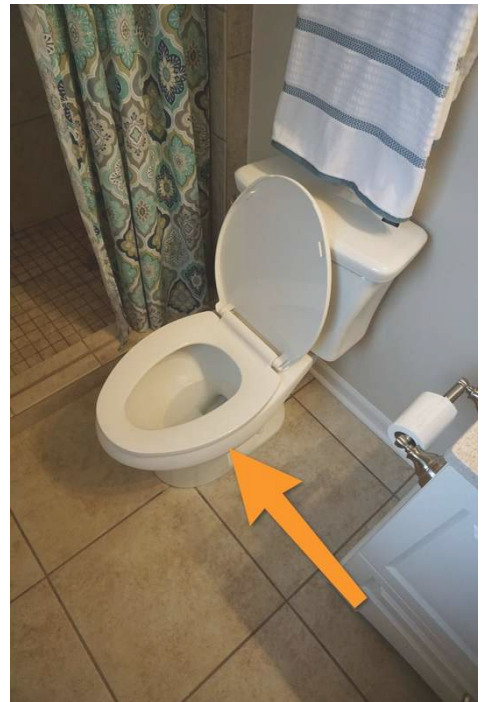
#### 10.9.1 Toilets

### TOILET - LOOSE

Toilets was loose. Plumbing leaks can occur as a result. A licensed plumbing contractor should remove the toilet(s) for further evaluation and repairs if necessary. A new wax ring should be installed and toilet(s) should be securely anchored to the floor to prevent movement and leaking.

Contact a qualified plumbing contractor.

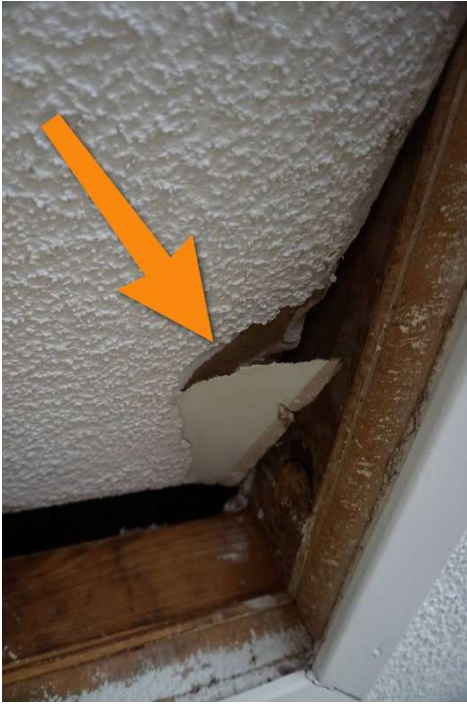
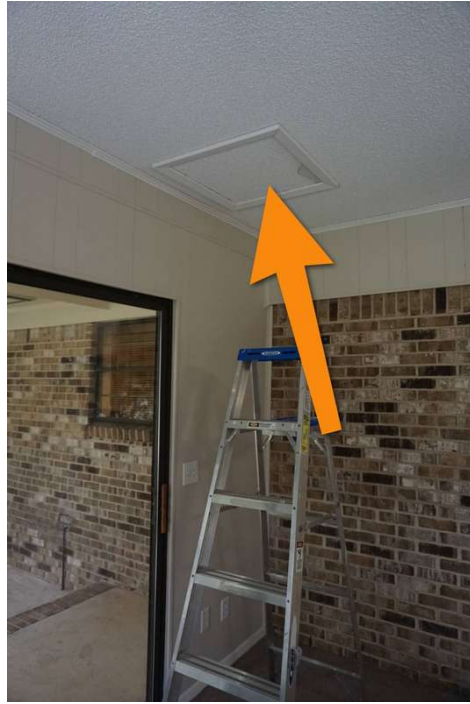
#### 12.2.1 Attic Hatch

### ACCESS COVER DAMAGE

The drywall access cover was damaged. The exit to cover should be replaced as a repair is not adequate. Recommend replacement by a qualified professional.

Contact a qualified professional.

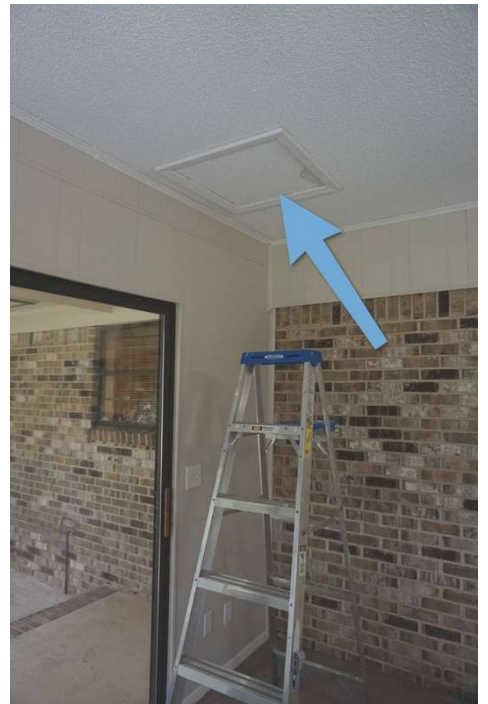
#### 12.2.2 Attic Hatch

### **NO INSULATION OVER SUNROOM**

No insulation was installed over the attic access hatch. Recommend installing insulation above hatch for better energy efficiency by a qualified professional.

Contact a qualified insulation contractor.

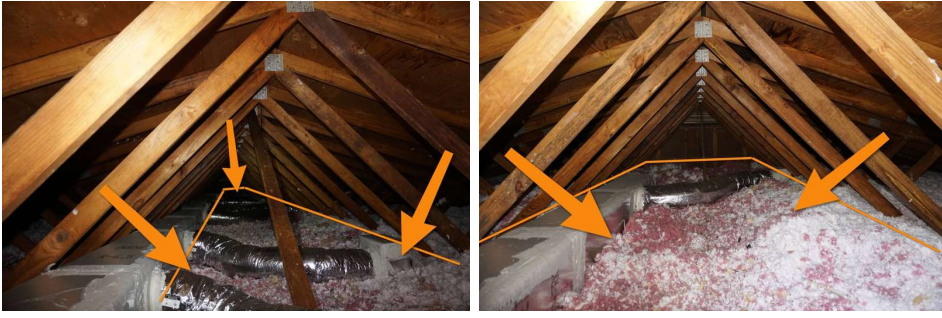
#### 12.4.1 Insulation

### **UNEVEN**

The ceiling insulation in one or more areas in the attic space was compacted or uneven. Heating and cooling costs may be higher due to reduced energy efficiency. Recommend that a qualified professional repair, replace or install insulation as necessary and per standard building practices (typically R-30).

Contact a qualified insulation contractor.

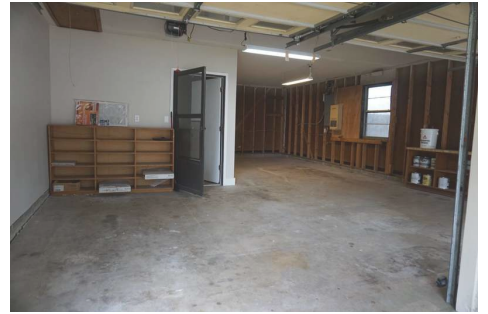
### 13.3.1 Electrical

## GFCI UPGRADE RECOMMENDED

Ground Fault Circuit Interrupter (GFCI) protection of home electrical outlets were not present in the home at the time of inspection. Although GFCI protection may not have been required at the time the home was built, for safety reasons, consider upgrading the electrical system to include GFCI protection at the following locations:

1. Replacing the current standard outlets with GFCI outlets
2. Replacing the outlet in the garage circuit which is nearest the main electrical service panel with a GFCI outlet.
3. Replacing a non-GFCI breaker currently protecting an electrical circuit with a GFCI-type breaker.

Contact a qualified electrical contractor.

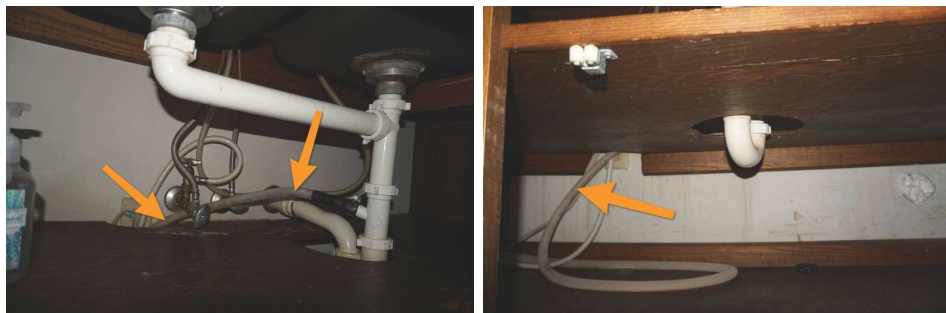
### 14.2.1 Dishwasher

## DISHWASHER NO HIGH LOOP

The dishwasher drain line is not configured with a "high loop" or "air gap". A high loop is created by routing the drain line up to the bottom surface of the counter top above, and securely fastening it to that surface. It is meant to prevent water from siphoning out of the dishwasher, and to prevent water from the sink drain or food disposal from entering the dishwasher. Some dishwashers have a built-in high loop where one is not required to be configured in the drain line. The clients should try to determine if a high loop is required for this brand and model of dishwasher (review installation instructions, etc.). If one is required, or it cannot be determined if one is not required, then a qualified contractor should install a high loop as per standard building practices.

Also, no "air gap" is installed. Air gaps are another device meant to prevent water from the sink drain or food disposal from entering the dishwasher. These are required in some municipalities for new construction and when remodeling. The client(s) should consult with a qualified contractor to determine if an air gap should be installed.

Contact a qualified appliance repair professional.
