SUMMARY

1234 Main St. Vancouver WA 98663

Buyer Name
03/31/2019 9:00AM

Northbank Home Inspection

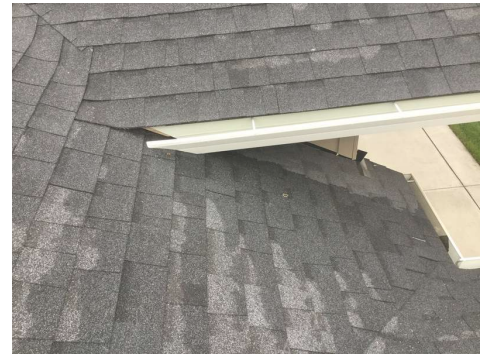
LOWER ROOF

2.2.1 Roof Drainage Systems

LOCALIZED WEAR

One or more gutters or downspouts discharge onto roof coverings. This can cause localized wear to occur and diminish the lifespan of roofing materials in those areas. Recommend a qualified contractor connect downspouts to gutter directly to help extend the life of the roof coverings.

Contact a qualified roofing professional.

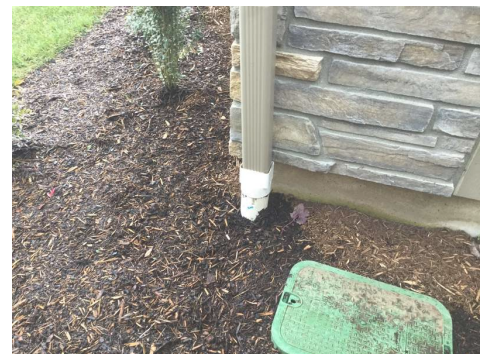
2.2.2 Roof Drainage Systems

UNDERGROUND STORM DRAINS

The roof drainage systems are connected to drains underground and I cannot verify if the discharge is an appropriate distance away from the foundation or if the drain lines are compromised. The minimum distance water should be diverted away from the foundation is 6 feet. Recommend monitoring.

Contact a qualified general contractor.

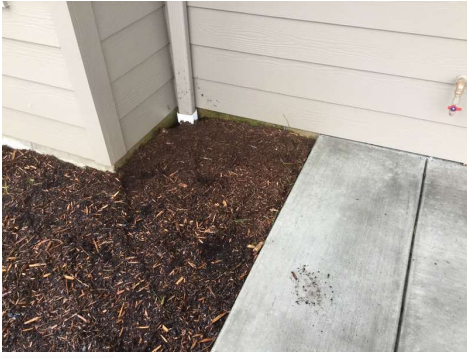
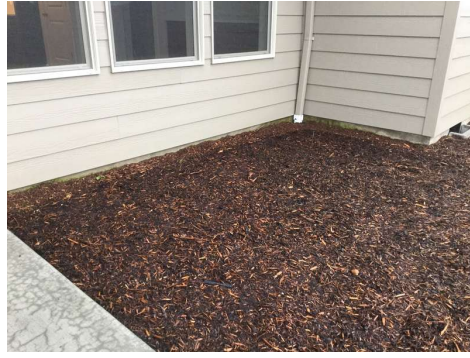
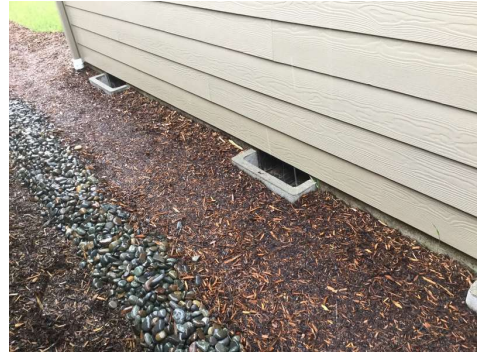
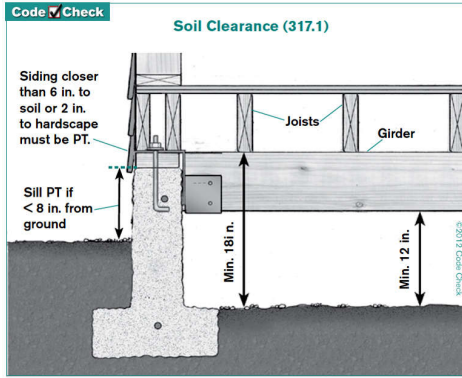
BACK, LEFT SIDE

3.1.1 Siding, Flashing & Trim

GROUND CLEARANCE

Inadequate clearance between siding and ground. Best practices recommend a minimum ground clearance between bottom of siding and the ground of 6"-8"; for hardscape (i.e. concrete), minimum clearance is 2". Siding close or in contact with the ground or soil can be a concern because it can provide direct access for wood destroying insects and moisture. Recommend a qualified siding contractor or landscaper repair. (re-grade soil near siding).

Contact a qualified siding specialist.

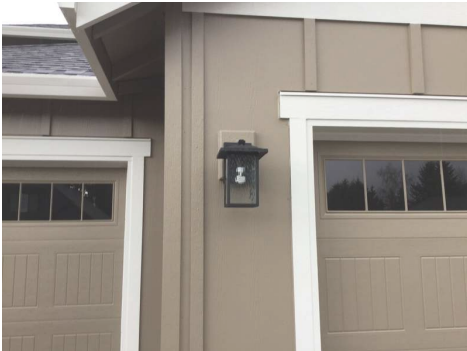
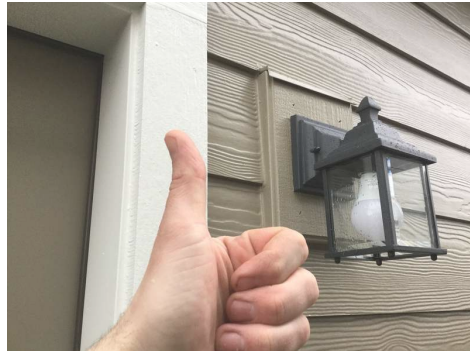
FIXTURES

3.1.2 Siding, Flashing & Trim

MISSING FLASHING

Flashing is not installed where its needed. This can allow water to damage the siding, windows, fixtures, or other components, and lead to multiple issues, including rot of wooden components. Appropriate flashings can help extend the life of building components. Recommend a qualified contractor install flashing where needed.

Recommendation
Contact a qualified siding specialist.

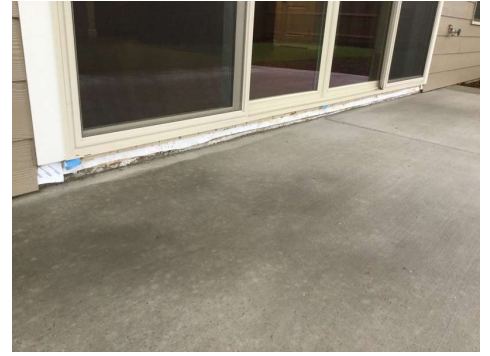
BACK SLIDING DOOR

3.1.3 Siding, Flashing & Trim

MISSING TRIM

Trim is missing in one or more areas of the home, exposing the sheathing. Recommend a qualified contractor install trim in appropriate areas.

Recommendation
Contact your builder.

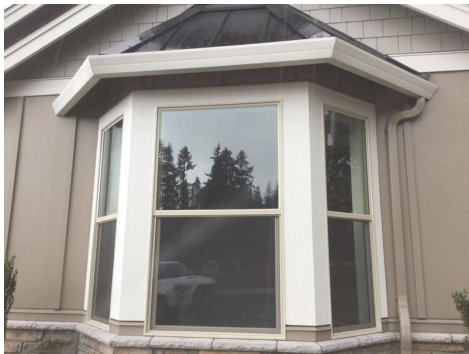
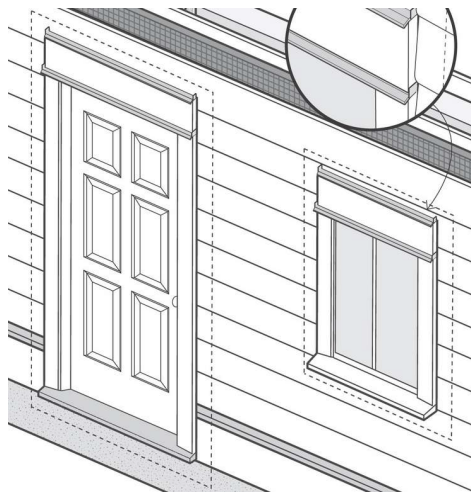
TRIMMED WINDOWS

3.1.4 Siding, Flashing & Trim

WINDOW FLASHING

Windows in one or more areas are missing flashing. This can lead to water intrusion and damage if exterior seals fail. Windows should have flashing installed above them to help shed water. This is a modern building standard. Recommend monitoring and maintaining sealant or installation of window flashing by a qualified contractor if needed.

Contact a qualified siding specialist.

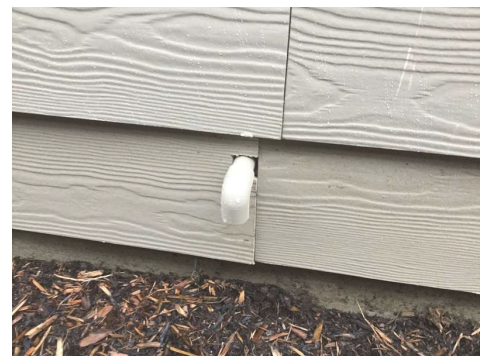
LEFT SIDE - WATER HEATER CONDENSATE DRAIN

3.1.5 Siding, Flashing & Trim

SIDING PENETRATION NOT SEALED

Penetrations in the siding are not sealed or flashed properly in one or more areas. This can lead to water intrusion, which can potentially cause damage, including rot, of siding and framing components. Recommend a qualified contractor repair with appropriate sealant and/or flashing.

Contact a qualified siding specialist.

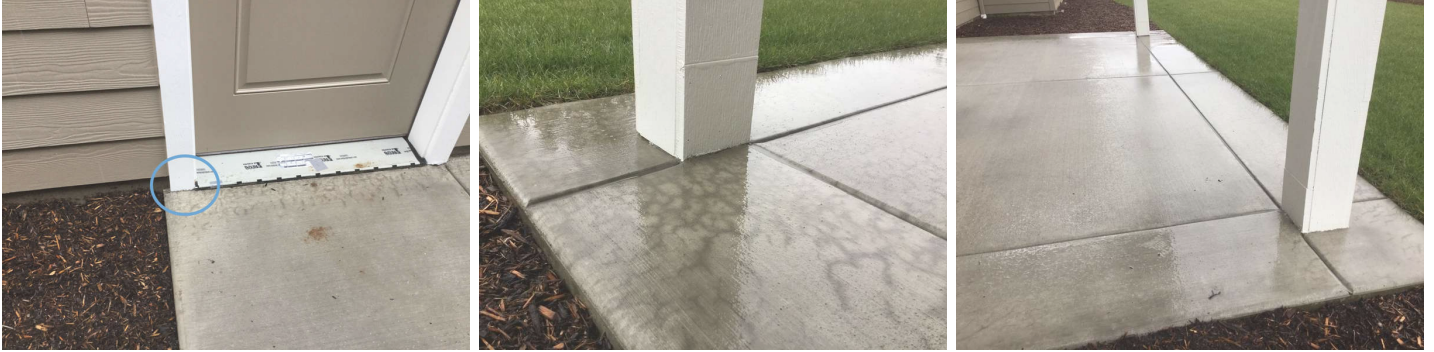
SIDE GARAGE DOOR, BACK PATIO

3.1.6 Siding, Flashing & Trim

TRIM GROUND CLEARANCE

Trim in one or more areas does not have enough clearance from the ground. Trim should be a minimum of 2 inches above hardscape, ie concrete, or 6-8 inches above soil to prevent water wicking up into the trim and causing damaged. Recommend a qualified contractor repair.

Recommendation
Contact a qualified handyman.

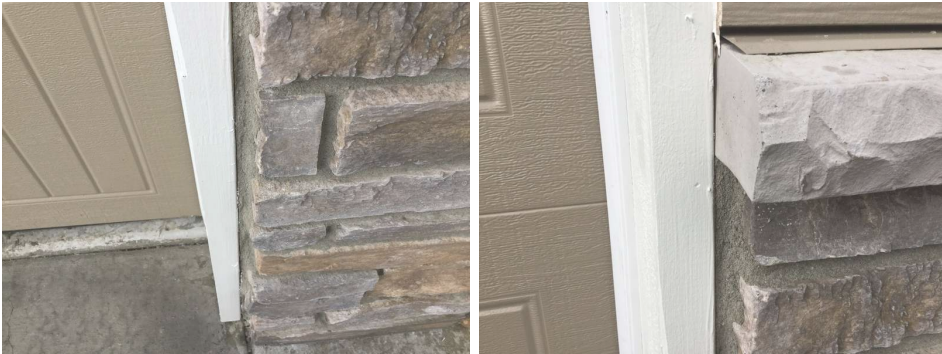
FRONT MASONRY

3.1.7 Siding, Flashing & Trim

MASONRY MISSING SEALANT

Masonry cladding is missing edge sealant. This can allow moisture intrusion behind the masonry, which can eventually lead to damage, including wood rot. Recommend a qualified contractor repair.

Recommendation
Contact a qualified masonry professional.

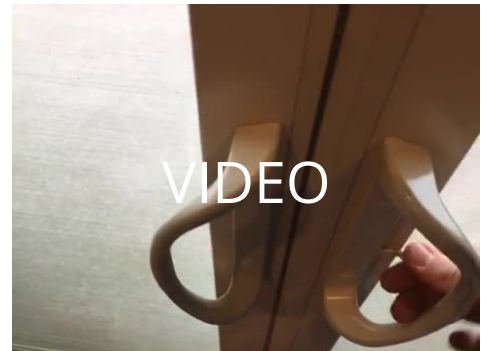
SLIDING DOOR

3.2.1 Exterior Doors

**SLIDING GLASS DOOR-
DIFFICULT LATCH**

The locking mechanism on the sliding screen door is difficult to latch. This can be a security issue. Recommend a qualified contractor repair.

Recommendation
Contact a qualified handyman.

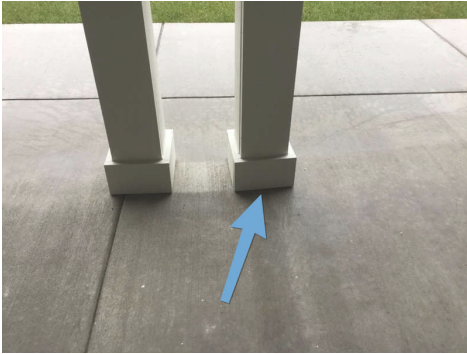
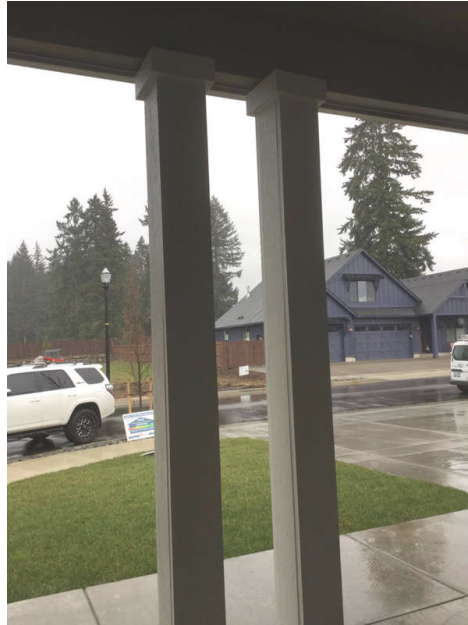
FRONT PORCH

3.4.1 Decks, Balconies, Porches & Steps

POST INSTALLATION

A post is installed in a substandard manner - the post is twisted and not square. This can sometimes indicate stress of the post from the load its bearing. Additionally, the double post design of the front patio is also atypical. Recommend asking builder about design and function of the posts, and to correct if necessary. It may be prudent to review original planned drawings to determine if deviations were made and for what purpose.

Contact your builder.

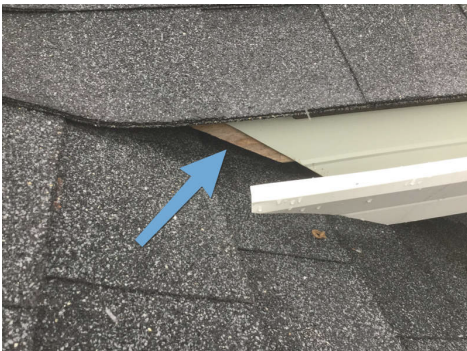
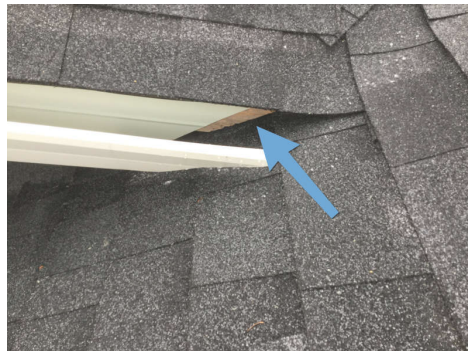
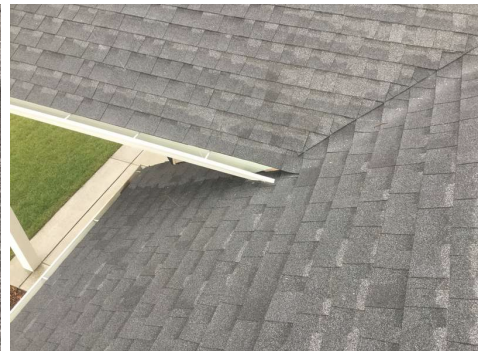
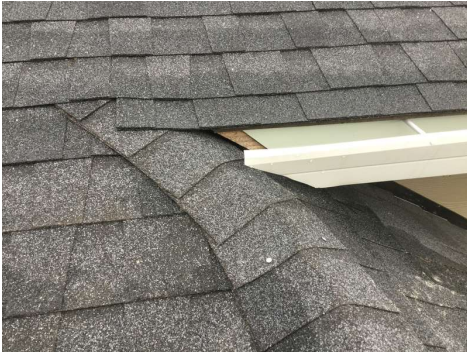
BACK ROOF

3.5.1 Eaves, Soffits & Fascia

FASCIA/RAFTER TAIL(S) NOT PAINTED

Portions of the fascia and/or rafter tails are not painted. Unpainted exterior wood should be painted to help protect it from moisture. Recommend a qualified contractor paint appropriate areas.

Contact a qualified painting contractor.

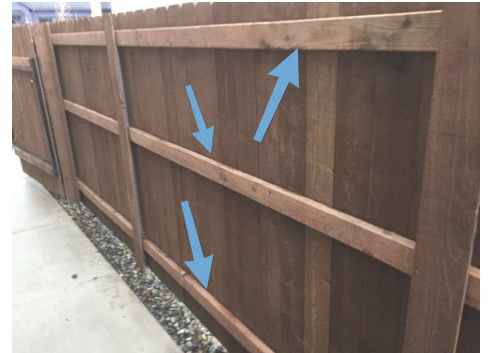
FENCE

3.7.1 Fence

NON-TREATED WOOD

The exterior fence is constructed with non-treated materials. Untreated components can deteriorate quickly in wet environments and lead to premature fence failure. Recommend maintaining stain of installed members regularly or replacing untreated members with treated wood.

Recommendation
Recommend monitoring.

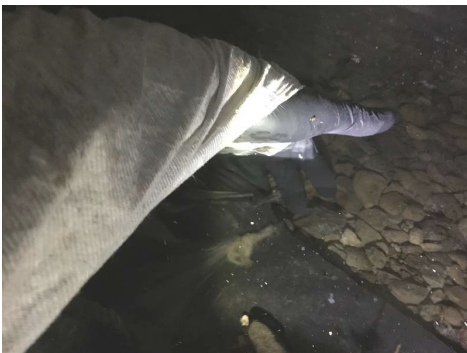
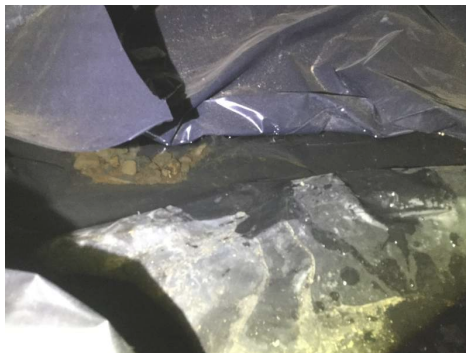
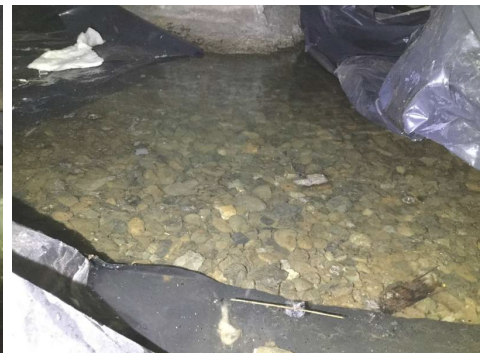
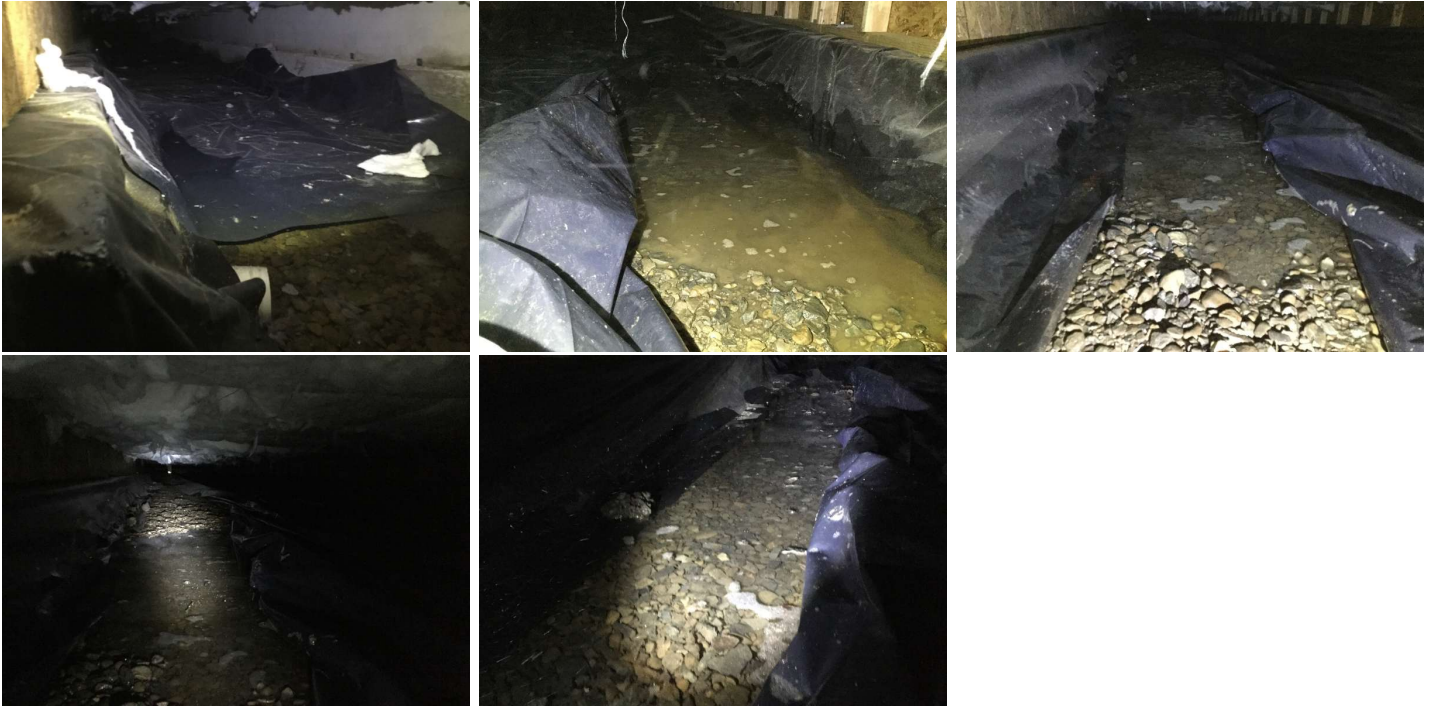
CRAWLSPACE MULTIPLE LOCATIONS

4.2.1 Basements & Crawlspaces

STANDING WATER

Standing water was observed in the crawlspace. The source of the moisture is not clear, but appears to be ground water. Moisture could be caused by issues including, but not limited to, a high water table, poor site drainage, damage to the irrigation system, or plumbing issues. If left as is, this can lead to a number of issues including mold growth and conducive conditions for wood-destroying organisms such as, carpenter ants and fungi. Recommend a qualified contractor evaluate to find source and install an effective water removal system, such as a sump pump or French drain system.

Recommendation
Contact a qualified general contractor.

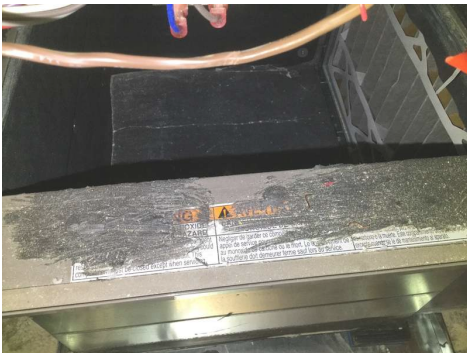
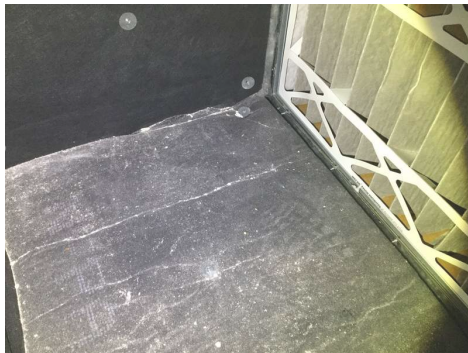
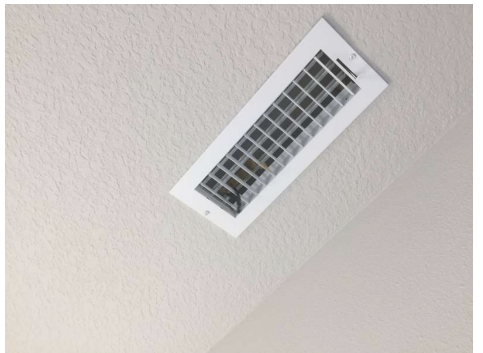
5.1.1 Heating Equipment

HVAC SYSTEM SERVICE (NEW CONSTRUCTION)

The furnace and duct system need servicing. During construction, if the HVAC system is not properly sealed off, construction debris can enter the duct system. This can impact energy efficiency and negatively impact air quality. Recommend builder service HVAC system.

Contact a qualified HVAC professional.

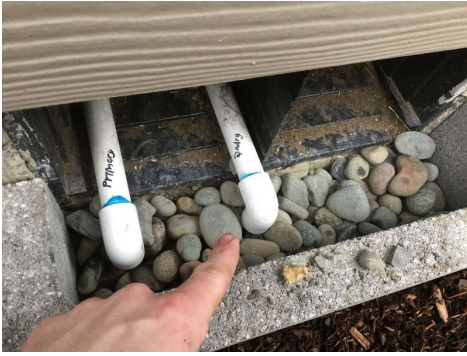
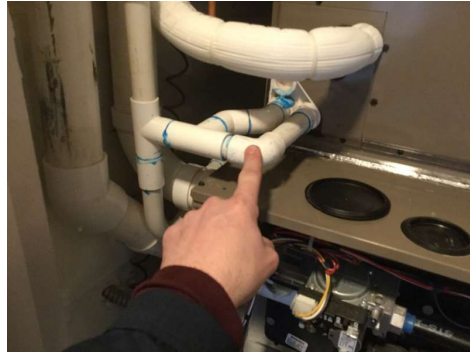
RIGHT SIDE EXTERIOR

5.1.2 Heating Equipment

IMPROPER INSTALL - SECONDARY CONDENSATE LINE

A secondary condensation drain is installed inappropriately - this drain discharges to the exterior next to the primary drain. This drain is a backup drain intended to catch condensation if the primary is clogged. The secondary drain should be routed to a conspicuous area where it can be easily noticed and accessed. If water is coming out of this drain the primary drain has failed and repairs to the system are likely needed. Recommend a qualified contractor properly install a secondary drain.

Contact a qualified HVAC professional.

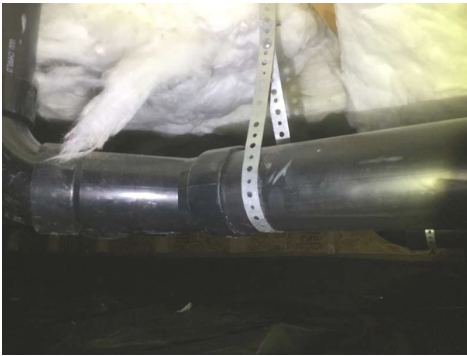
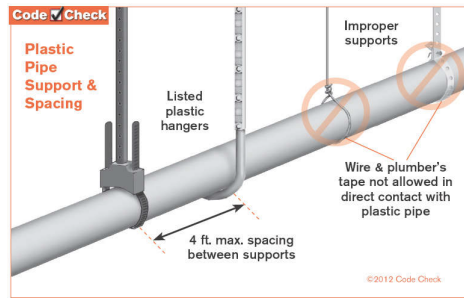
CRAWLSPACE

6.2.1 Drain, Waste, & Vent Systems

DRAINS HUNG W/ METAL STRAPPING

The ABS (plastic) drain lines are hung with metal straps. Metal straps can damage the ABS piping over long periods of time. Recommend a qualified maintenance person re-hang pipes with plastic material.

Recommendation
Contact a qualified handyman.

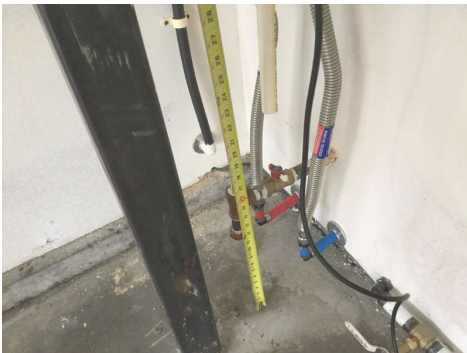
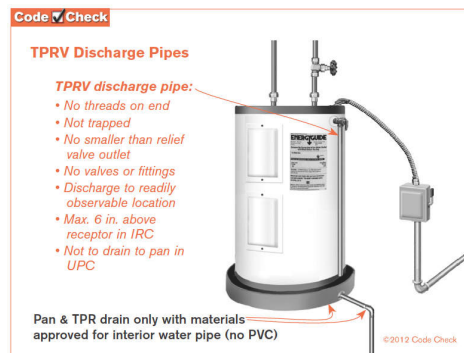
WATER HEATER

6.4.1 Hot Water Systems, Controls, Flues & Vents

TPR DISCHARGE INADEQUATE

The temperature pressure relief (TPR) valve pipe does not extend within 6 inches of the ground. If tripped due to high pressure, the steam released could scald someone nearby. Recommend a qualified professional extend the TPR valve pipe to prevent injury.

Recommendation
Contact a qualified plumbing contractor.

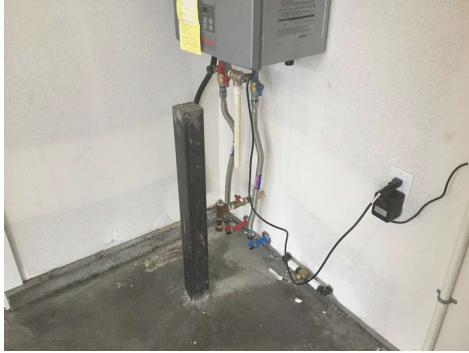
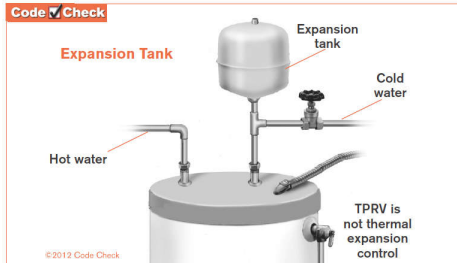
WATER HEATER

NO EXPANSION TANK

An expansion tank is not installed on the water heater. Expansion tanks allow for the thermal expansion of water in the plumbing system -- basically water expands when heated. Without an expansion tank, thermal expansion can put stress on plumbing connections and fixtures and eventually lead to premature failure. These tanks are standard in new installations. Recommend a qualified plumber evaluate and install.

Contact a qualified plumbing contractor.

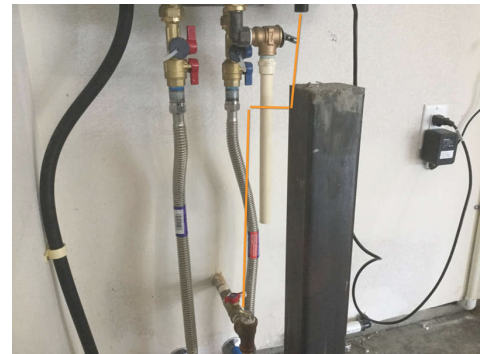
WATER HEATER GAS SUPPLY NOT CONNECTED

The gas water heater gas line is not connected. Gas is the energy source for this system; it will not function without it. Recommend a qualified plumbing contractor connect gas line to the water heater.

Contact a qualified plumbing contractor.

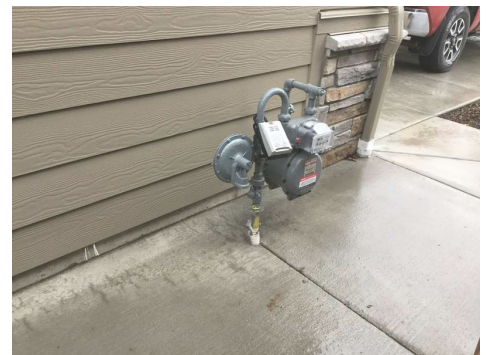
GAS METER

SHUT-OFF WRENCH

A gas valve shut-off wrench was not found in a reasonable range from the main gas shut-off. This is not required, but is helpful in the event of an emergency involving the natural gas systems of the home. Recommend installation of a gas valve shut-off wrench near the main gas valve.

Recommended DIY Project

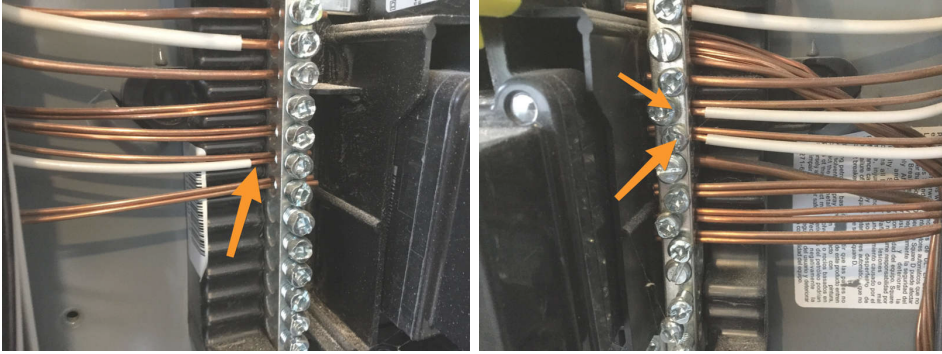
ELECTRICAL PANEL

BUS BAR - SHARED TERMINALS

One or more neutral conductors are sharing terminals with grounding conductors. This can be a safety hazard as it can negate grounding of those power sources. Recommend a qualified electrical contractor separate conductors appropriately.

Contact a qualified electrical contractor.

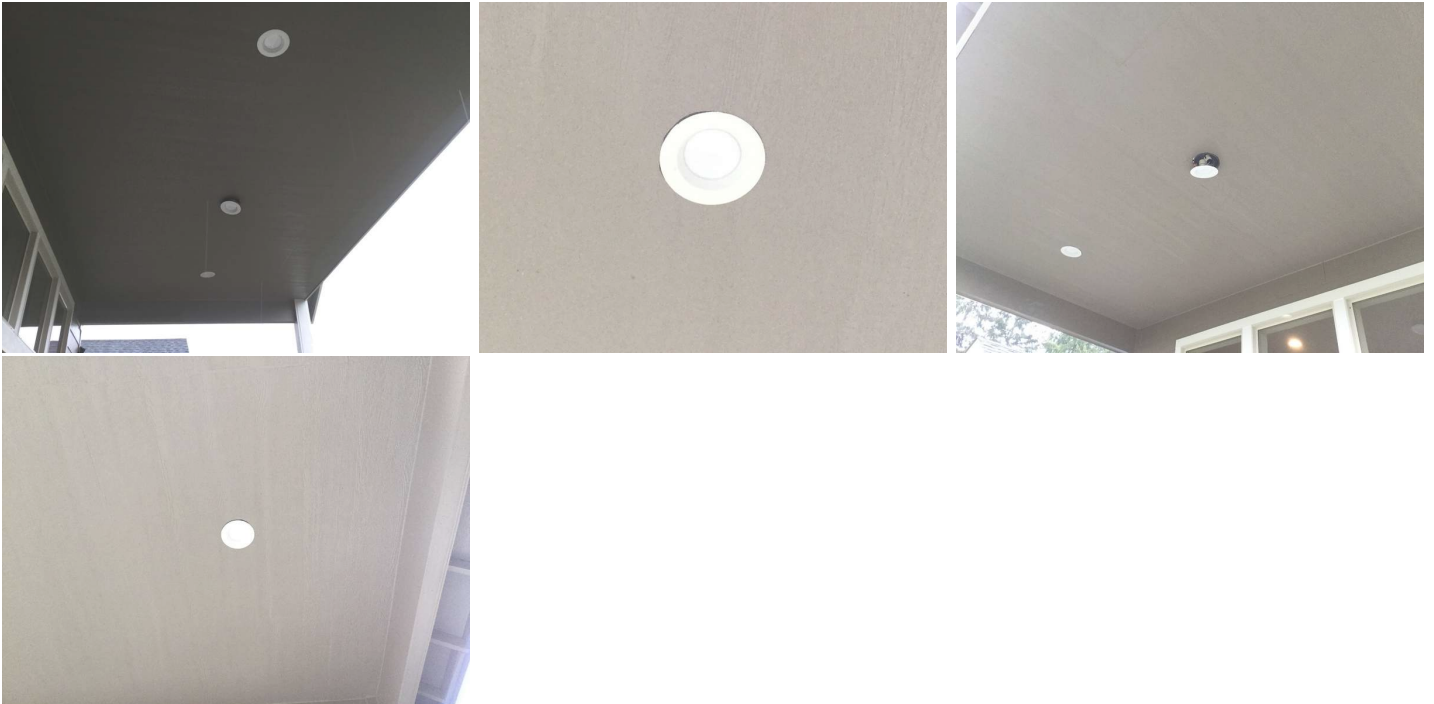
BACK PATIO

7.4.1 Lighting Fixtures, Switches & Receptacles

POOR INSTALLATION

Receptacles, fixtures, or switches are installed poorly in one or more areas. Recommend reinstallation by a qualified contractor.

Contact a qualified handyman.

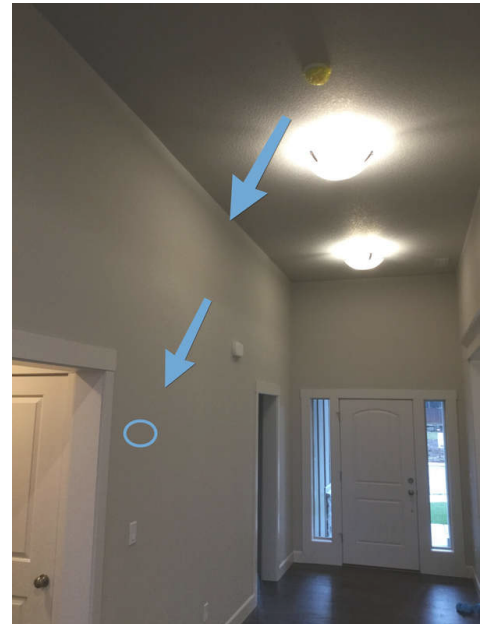
LIVING ROOM

7.7.1 Carbon Monoxide Detectors

INAPPROPRIATE LOCATION

Carbon monoxide detector effectiveness may be compromised due to location -- detector should be 5 feet from the ground -- where CO floats -- to properly function. CO detectors are required in common areas outside of each sleeping room on every floor and living space. If this unit is a dual smoke/CO detector, consider installing a stand-alone CO detector in an appropriate location. Recommend relocating according to manufacturer's instructions.

Recommendation
Recommended DIY Project

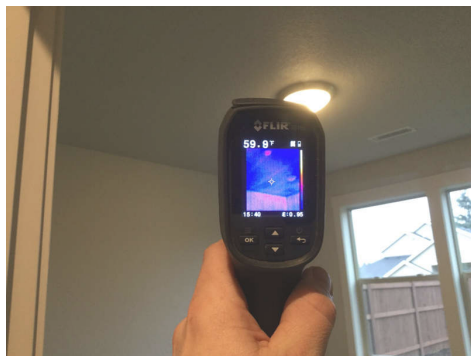
8.1.1 Attic Insulation

INSUFFICIENT INSULATION

Attic insulation is insufficient or missing in one or more areas. Dark blue areas of the thermal images indicate measured cold temperatures, which is typically where insulation is insufficient or missing. This can lead to energy loss and affect the comfort of the home. Recommend a qualified insulation contractor evaluate and remedy as needed.

Back left bedroom - Thermal image measured cold temperatures indicating ceiling insulation is missing or inadequate

Recommendation
Contact a qualified insulation contractor.

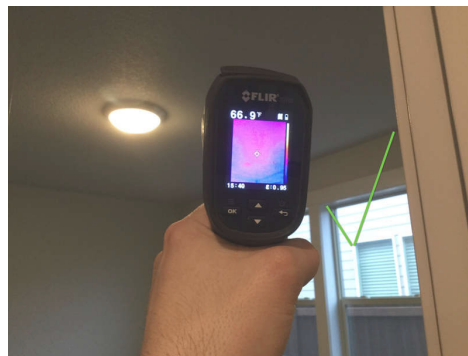
Thermal image of room with insulation

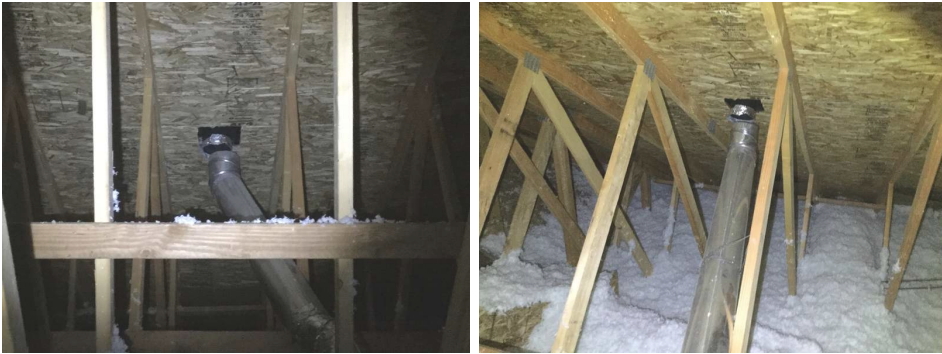
RANGE EXHAUST

8.3.1 Exhaust Systems

DUCTS LOOSE OR DISCONNECTED

Ductwork is loose or disconnected. This can promote moisture in the areas through which the ducting runs and create an environment conducive to mold, wood-destroying insects, and fungi. Recommend a qualified HVAC professional repair duct and terminate it to the exterior.

Contact a qualified HVAC professional.

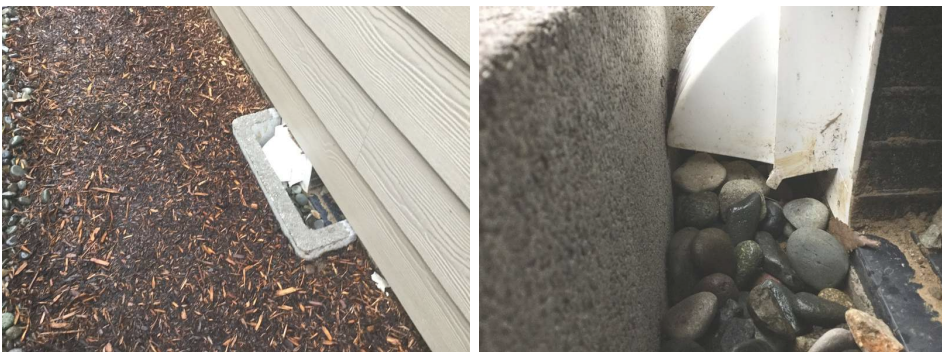
LEFT SIDE

8.3.2 Exhaust Systems

DRYER VENT HEIGHT

Dryer vent does not terminate to an appropriate height. This can be a safety issue because it could become blocked more easily by obstructions, such as tree debris, and become fire hazard. Recommend a qualified contractor evaluate and reinstall exhaust at an appropriate height, at least 12 inches above grade.

Contact a qualified HVAC professional.

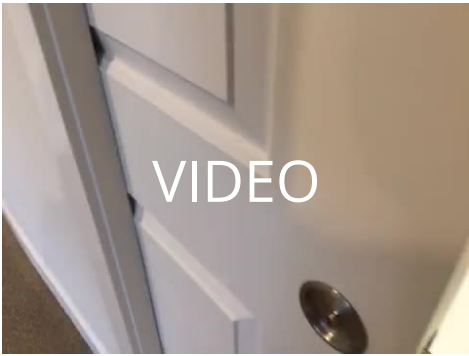
POCKET DOOR MASTER BATHROOM

9.1.1 Doors

DOOR STICKS

One or more doors stick and are difficult to use. Recommend a qualified contractor repair.

Contact a qualified handyman.

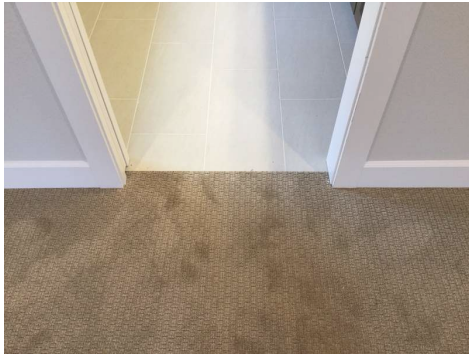
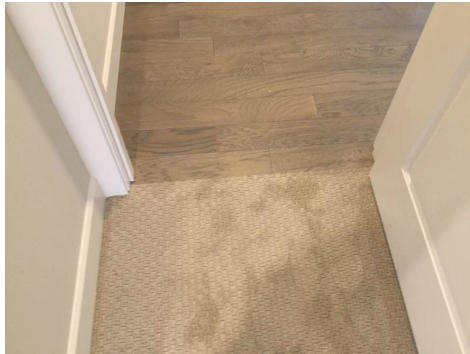
MULTIPLE LOCATIONS

9.3.1 Floors

MISSING TRANSITION

A flooring transition is missing in one or more areas. Transition pieces help protect flooring between different types of flooring. Recommend a qualified contractor install a transition piece.

Contact a qualified flooring contractor

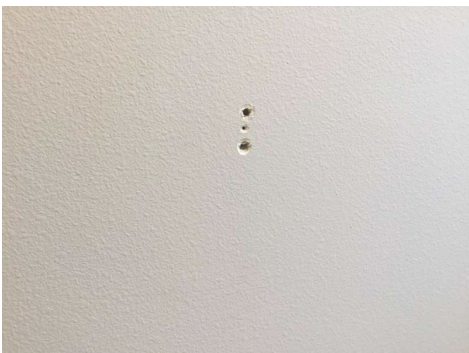
BATHROOM

9.4.1 Walls

MINOR DAMAGE

General damage and disrepair of the walls was observed in one or more areas. Recommend a drywall contractor repair as needed.

Contact a qualified drywall contractor.

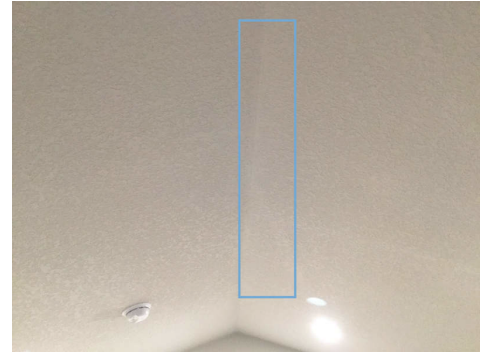
2ND FLOOR

9.5.1 Ceilings

DAMAGE - CRACKING

Ceiling cracking was observed. Some drywall cracking is part of normal settling. Moisture or other damage can also lead to cracking or ceiling blemishes. Recommend a qualified drywall contractor repair.

Recommendation
Contact a qualified drywall contractor.

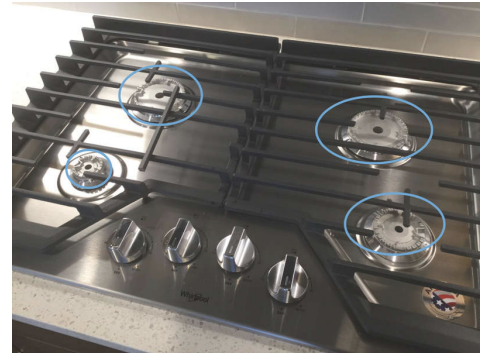
10.2.1 Range/Oven/Cooktop
MISSING BURNER PLATES
COOKTOP

The cooktop is missing burner plates that help to evenly distribute flame. This appliance did not appear to be fully installed at the time of inspection. Recommend ensuring appliance is properly installed and functional prior to closing.

Recommendation
Contact a qualified appliance repair professional.

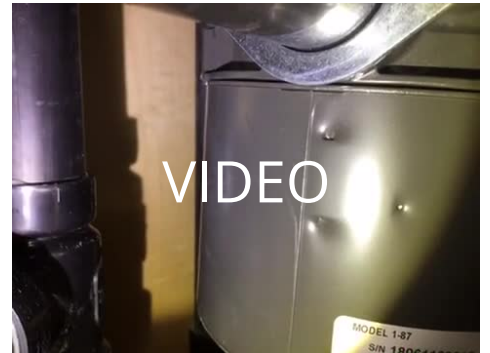
10.4.1 Garbage Disposal
DISPOSAL MALFUNCTION
KITCHEN

The garbage disposal malfunctioned during testing and began to smoke. This is a fire hazard. A qualified contractor should evaluate this installation and repair or replace unit.

Recommendation
Contact a qualified appliance repair professional.

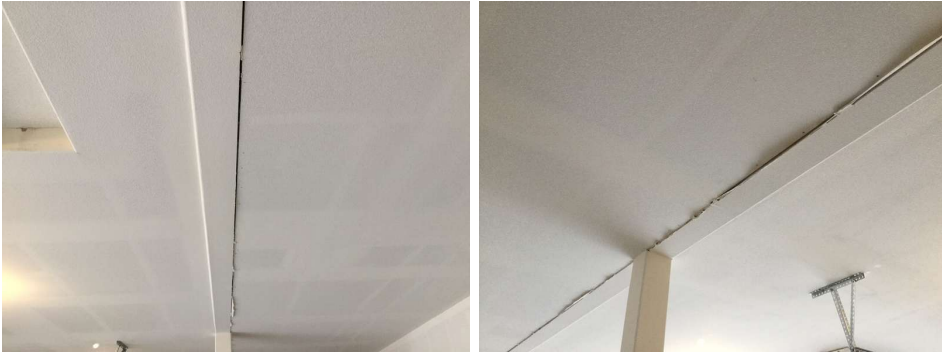
11.3.1 Walls & Firewalls
FIREWALL COMPROMISED
GARAGE

The firewall is compromised in one or more areas. This can allow a garage fire to spread more easily to the interior. Combustibles are more likely to be stored in the garage, and therefore, fires are more likely to start there. No gaps should exist and all firewall materials should be made of fire-resistant material. Gaps should be sealed with a fire-resistant sealant or other appropriate material. Recommend repair of compromised areas by a qualified contractor.

Recommendation
Contact a qualified professional.

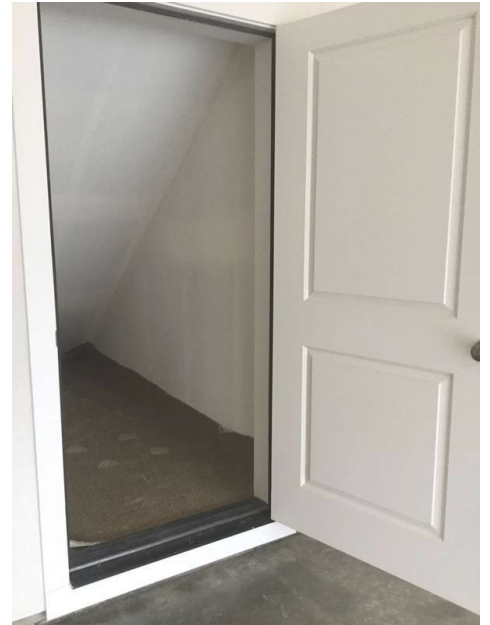
GARAGE - STORAGE BENEATH STAIRS

11.6.1 Occupant Door (From garage to inside of home)

NOT SELF-CLOSING

A door from the garage to the interior of the home has inadequate self-closing hinges or may need adjustment. Self-closing doors between the garage and home help to prevent the spread of a fire to the living space in the event of a garage fire. Combustible materials are more likely to be stored in the garage, and therefore, fires are more likely to begin there. Additionally, self-closing doors can help reduce the chance of vehicle- and gas appliance-created carbon monoxide from entering the home. Recommend a qualified contractor properly install or adjust self-closing hinges.

Contact a handyman or DIY project
