## SUMMARY

1234 Main St. Naches WA 98937

Buyer Name  
01/24/2018 9:00AM

Ryan Franke  
Lic. No. 809  
Integrity Inspection Services LLC  
509-823-1677  
ryan@inspectwithintegrity.com

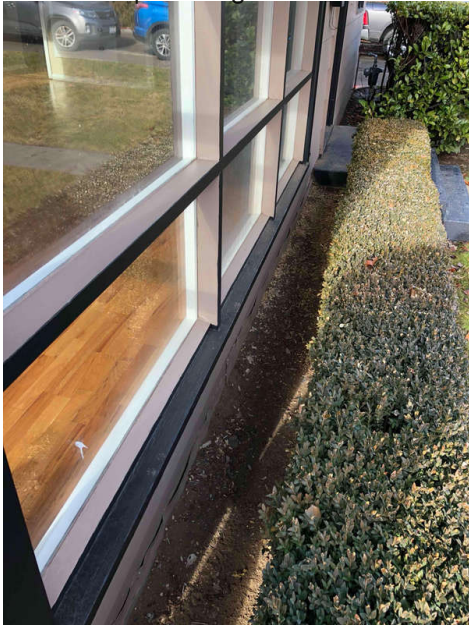
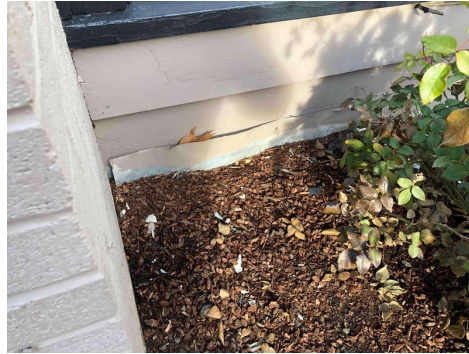
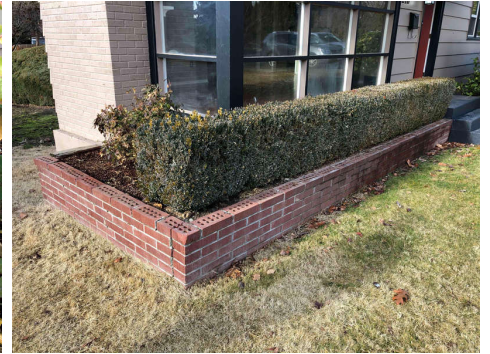
### 2.1.1 Vegetation, Grading & Drainage

Garden beds and planter boxes installed against exterior siding or foundation may pose a risk of moisture damage to structure and are generally not recommended. Recommend further evaluation and repair/remedy as needed.

Contact a qualified general contractor.

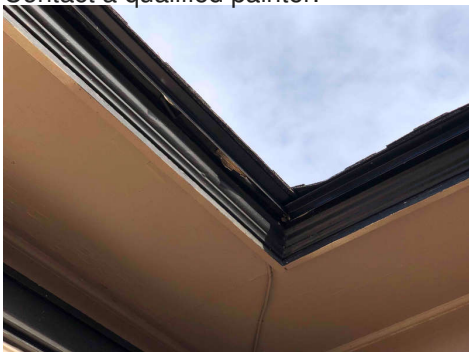
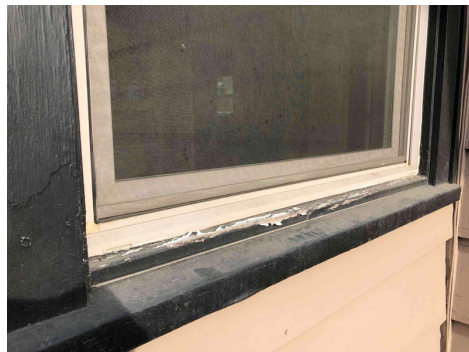
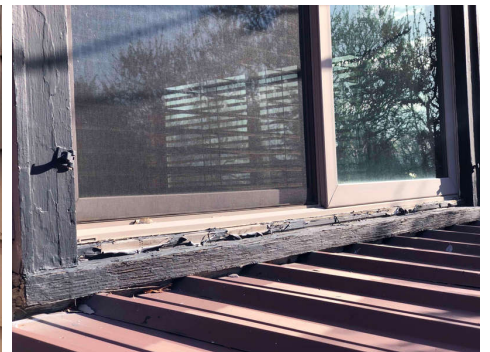
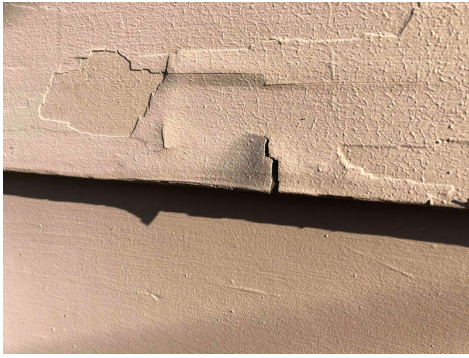
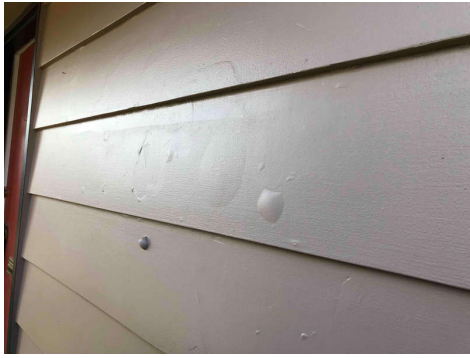
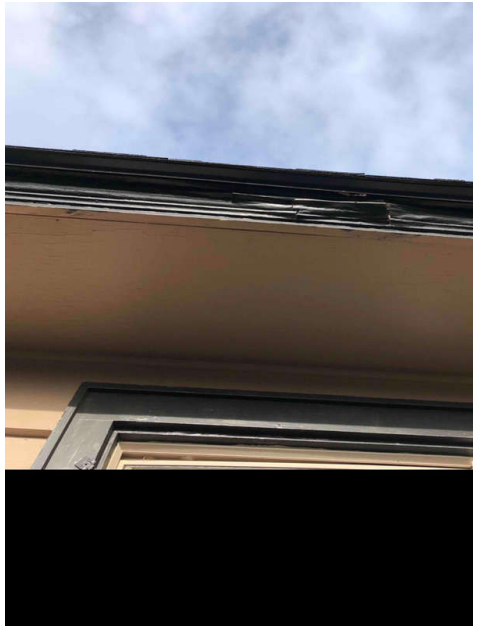
THROUGHOUT EXTERIOR

Peeling paint noted at exterior. Recommend maintaining paint/seal at all exterior wood siding, trim, posts, decks, etc. as needed to prevent possible compromise.

Contact a qualified painter.

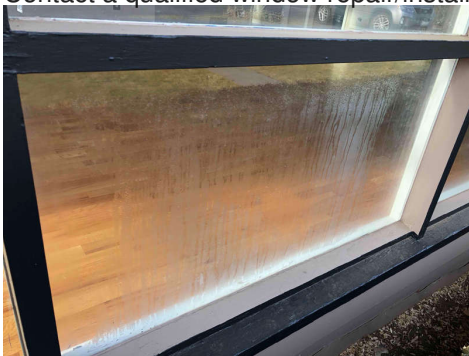
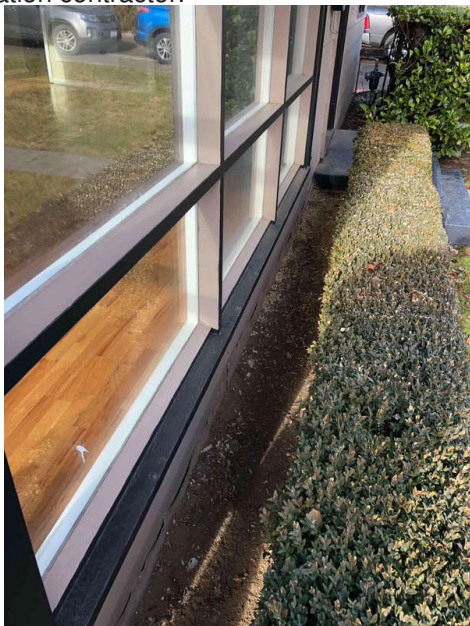
##### FRONT ENTRY

Condensation between window panes indicates a failed seal. Recommend qualified professional further evaluate and repair or replace as needed.

Contact a qualified window repair/installation contractor.

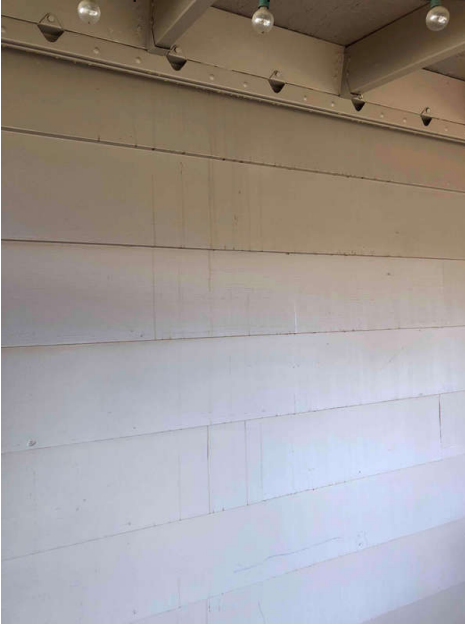
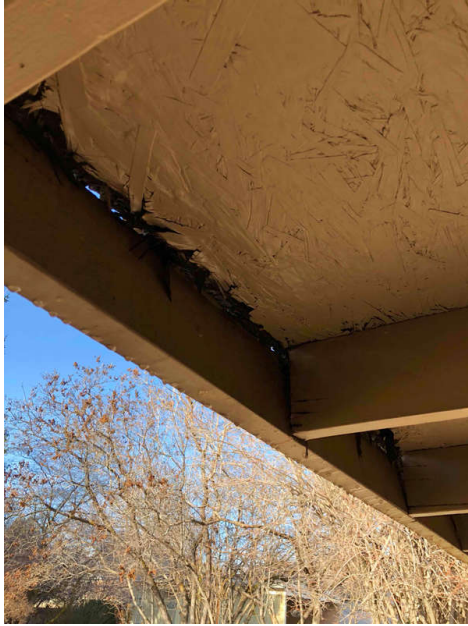
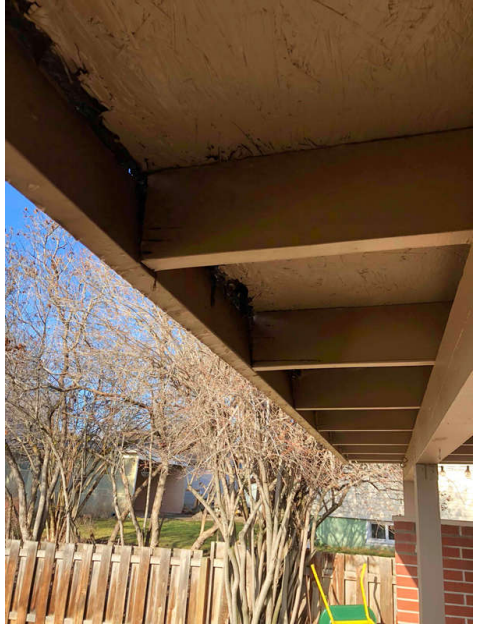
##### PATIO COVER

Moisture damage and deterioration noted at patio cover eaves and sheathing. Saturated trim and ledger boards may trap moisture against structural wood framing causing eventual rot/deterioration and potential structural compromise. Recommend further evaluation by a qualified professional and repair.

Contact a qualified carpenter.

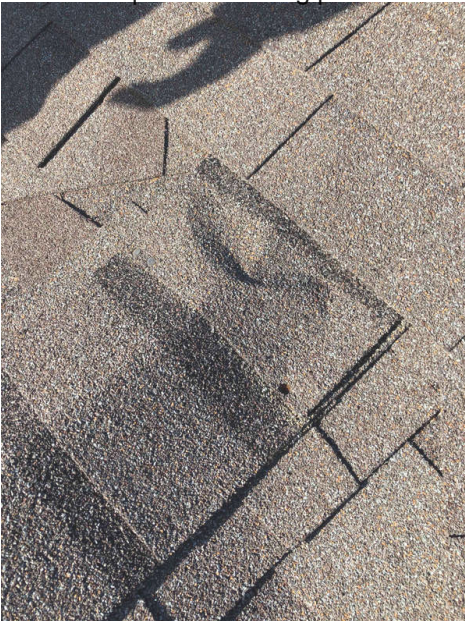
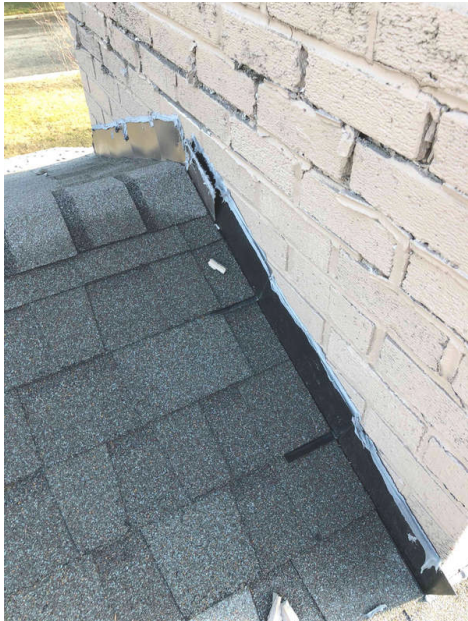
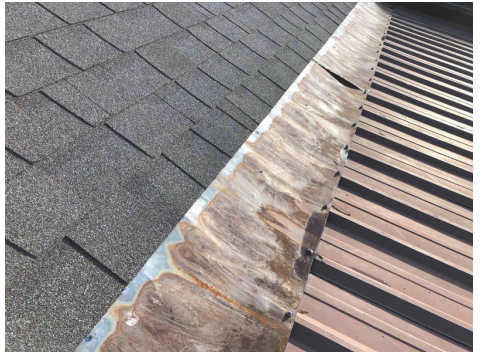
#### 4.1.1 Coverings

Some lifted shingles, loose flashing and exposed nail heads observed. Lifted shingles due to nail pops may be more susceptible to wind damage. Exposed nail heads and loose flashing should be sealed to prevent possible moisture intrusion.

Contact a qualified roofing professional.

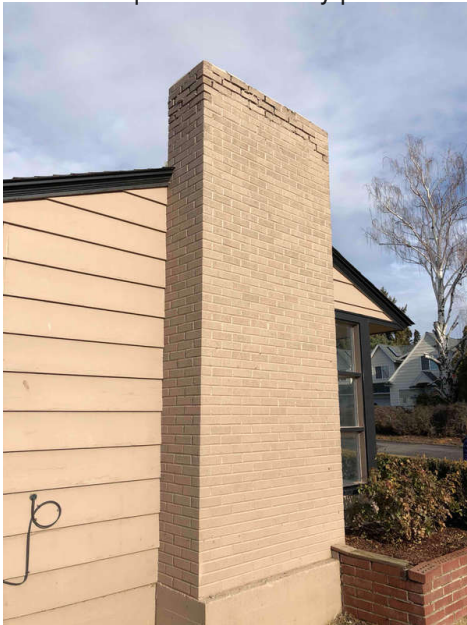
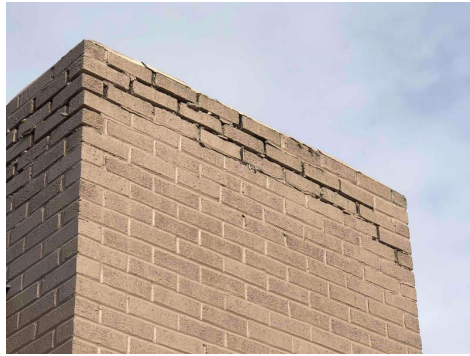
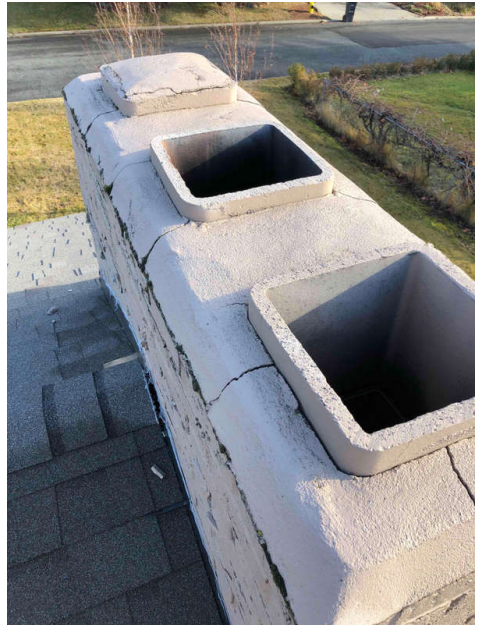
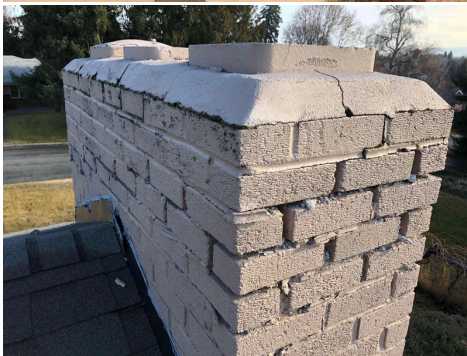
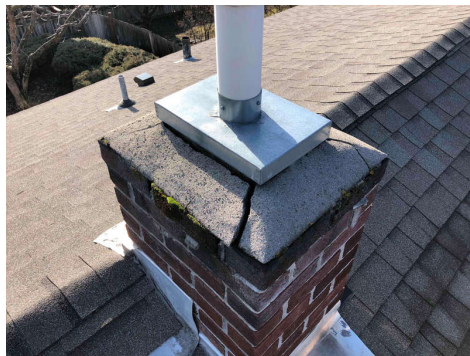
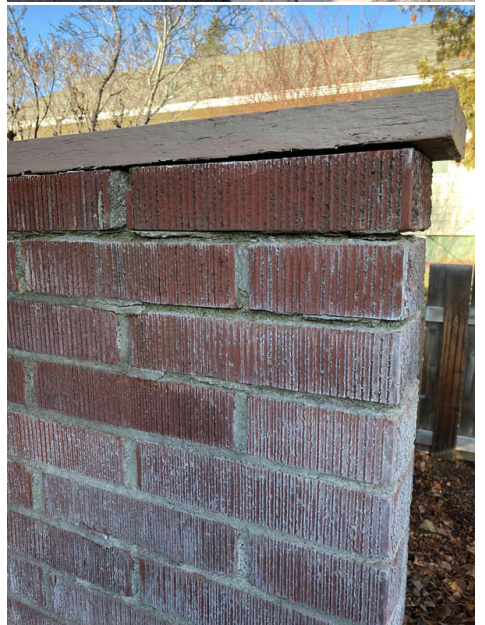
\*Chimney and Garage wall (minor)

Deterioration at mortar joints may allow for further moisture penetration risking eventual structural compromise and potential loose/falling bricks. Recommend repair.

Recommendation  
Contact a qualified masonry professional.

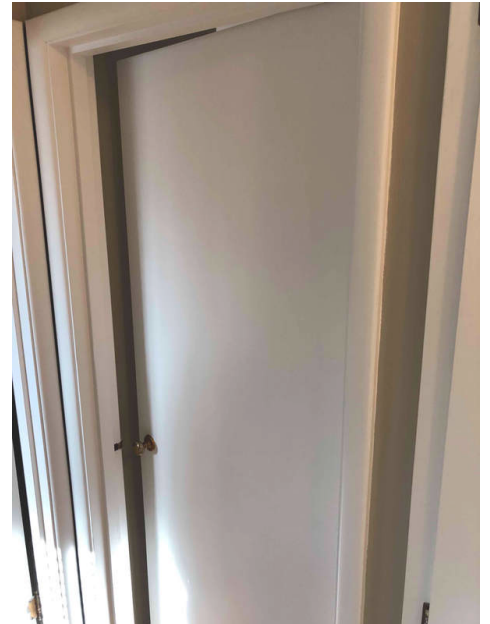
### BEDROOM

Some interior doors stick/rub or do not latch smoothly/properly and may be in need of adjustment or repair.

Contact a qualified door repair/installation contractor.

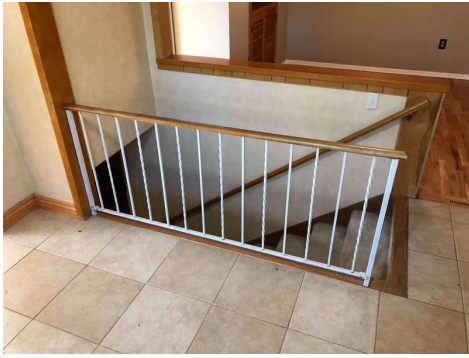
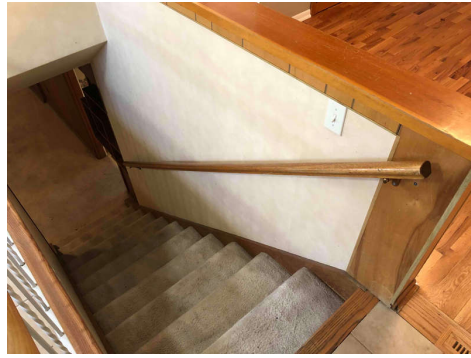
Interior stairs and landings must have a proper hand railing/guardrail system installed with a minimum height of 36" above walking surface. Vertical baluster spacing must not exceed 4" between balusters. Low or horizontal railings may present a safety hazard for children. Hand railing must be secure/stable and supported throughout. Recommend a qualified professional further evaluate and repair to local safety standards.

Contact a qualified carpenter.

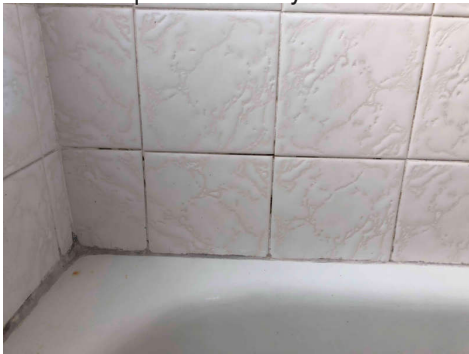
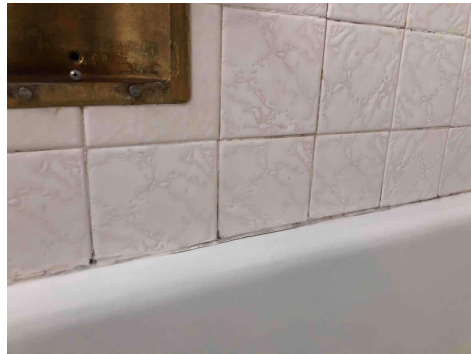
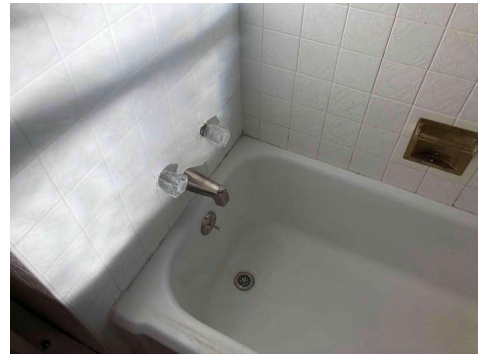
Recommend maintaining a proper seal at all tub-to-floor and tub-to-wall transitions. Tub/Shower penetrations (tub spout or shower head) must be caulked/sealed to prevent moisture intrusion and possible compromise.

Recommendation  
Contact a qualified handyman.

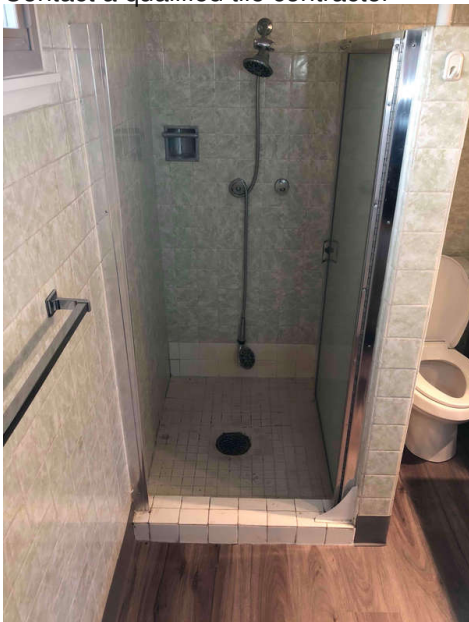
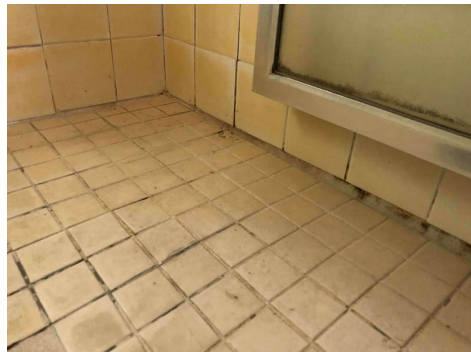
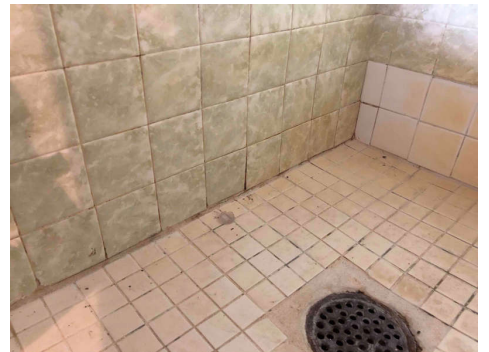
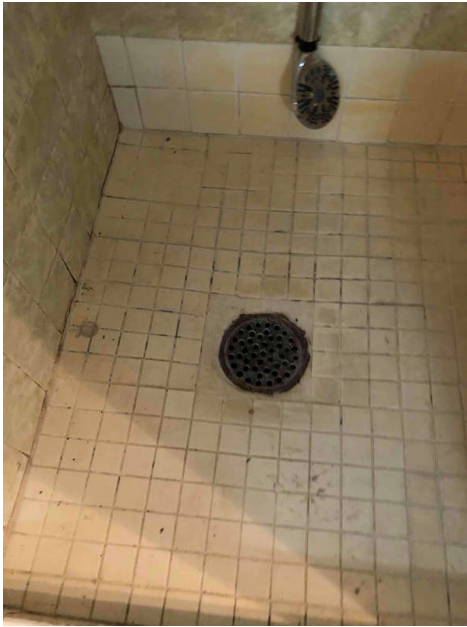
Recommend maintaining proper seal at tile shower walls, pan and all tub-to-wall, tub-to-floor transitions to prevent possible moisture intrusion and potential damage. Some cracking noted at tile grout lines.

Recommendation  
Contact a qualified tile contractor

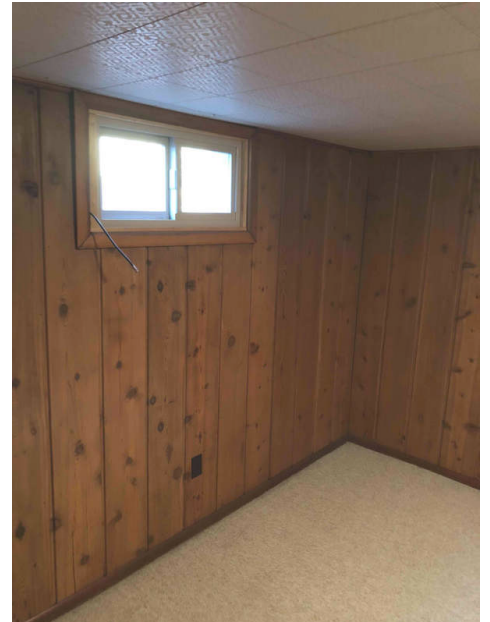
Some basement living space/s do not meet modern safety standards for fire/emergency egress (secondary means of exit). Although this home may predate such codes, it is an important consideration when using these rooms for living or sleeping quarters. Inspector recommends installing proper means of secondary egress at all bedroom/sleeping areas for optimal safety.

Contact a qualified general contractor.

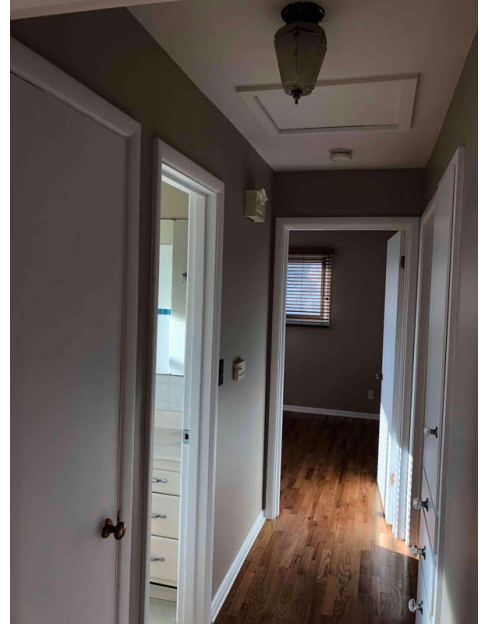
Carbon Monoxide Detectors are required to be installed on each floor and outside all bedroom/sleeping areas. Inspector was unable to confirm/identify Carbon Monoxide Detectors in all required locations at time of inspection. Recommend repair.

Recommended DIY Project

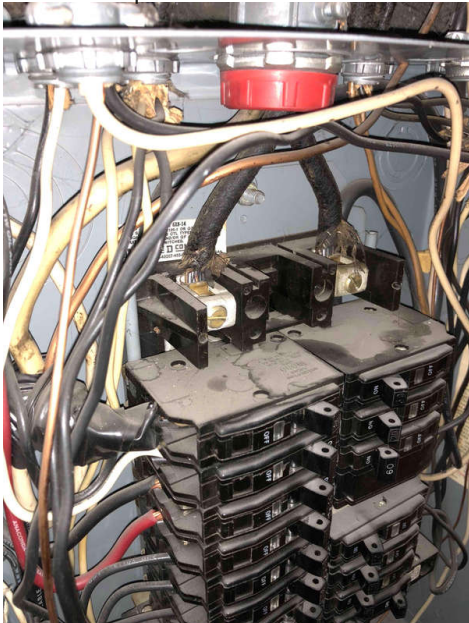
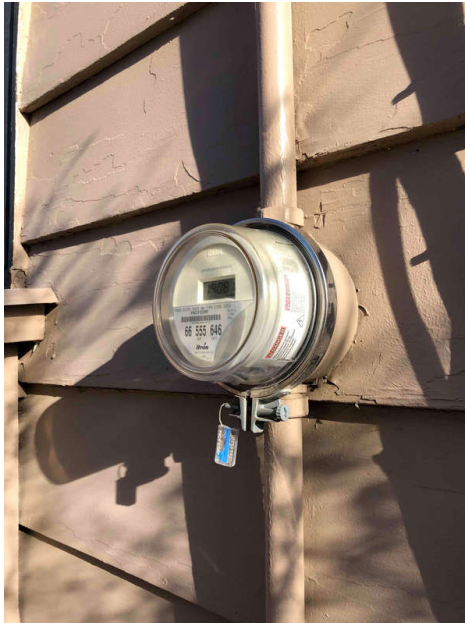
Round Meter Base and/or undersized Incoming Service Lines indicate a possible 60-125amp Service. Although this is not a defect in and of its self, Inspector recommends further evaluation by a qualified Electrician if any additions or alteration are considered. 60-125 amp Service may be considered under sized by todays standard electrical usage.

Contact a qualified electrical contractor.

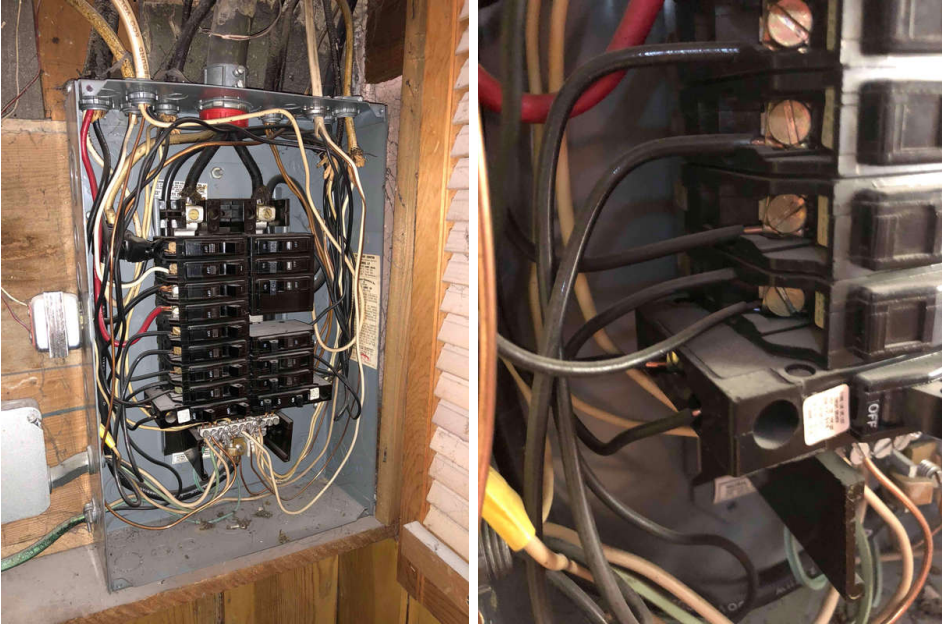
Double tapping of circuit breaker is generally not recommended or allowable and may be indication that panel has been tampered with or work performed by an unqualified person. Recommend further evaluation by a qualified professional and repair or replace as needed.

Contact a qualified electrical contractor.

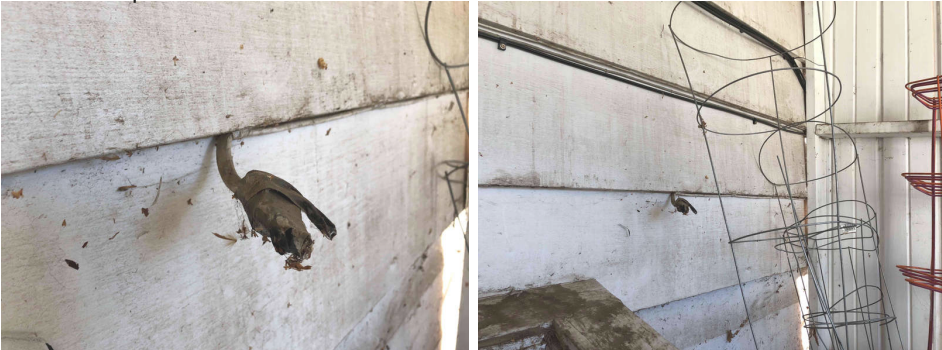
EXTERIOR BASEMENT STAIRWELL

Wire splices/connections and terminations must be secured/protected in an approved junction box (or removed completely if not in use). Potential safety hazard. Recommend a qualified professional repair as needed.

Contact a qualified electrical contractor.

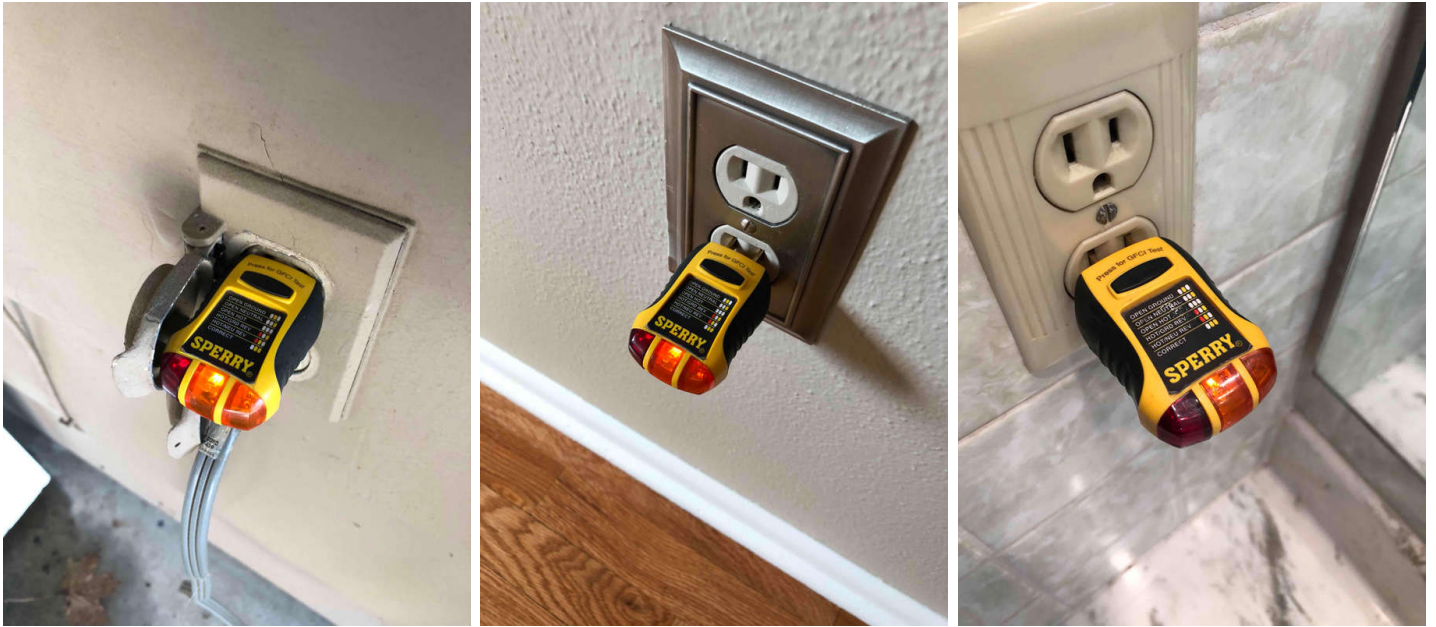
THROUGHOUT

Inspector noted ungrounded or "open ground" three-prong outlet/s at time of inspection. Recommend a qualified professional further evaluate and repair or replace as needed.

Contact a qualified electrical contractor.

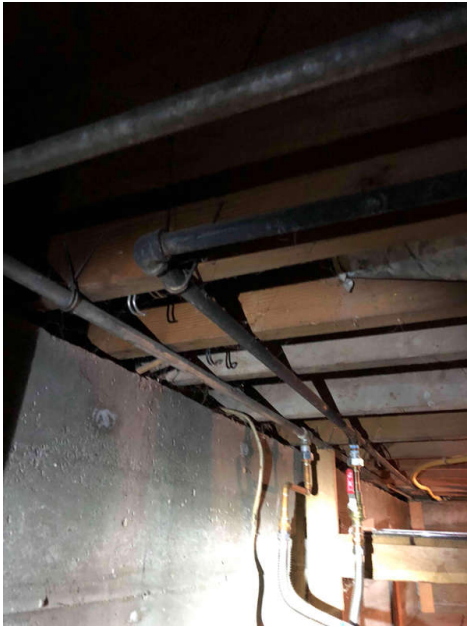
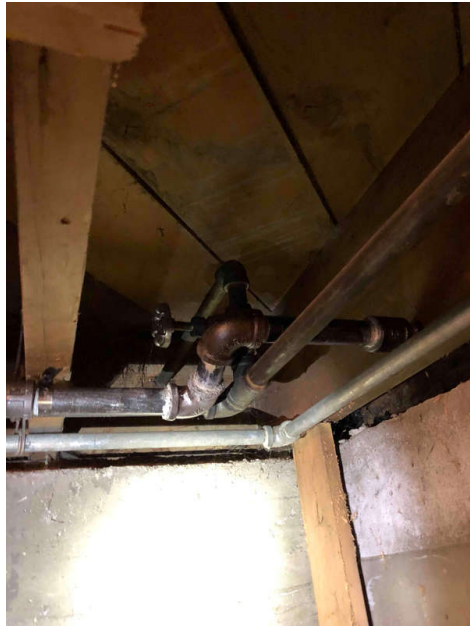
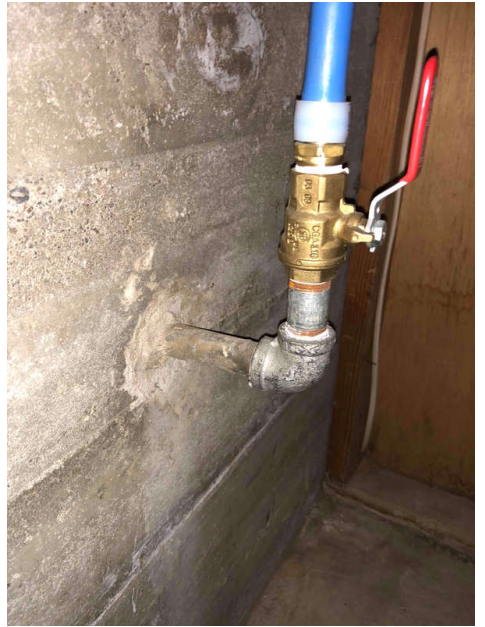
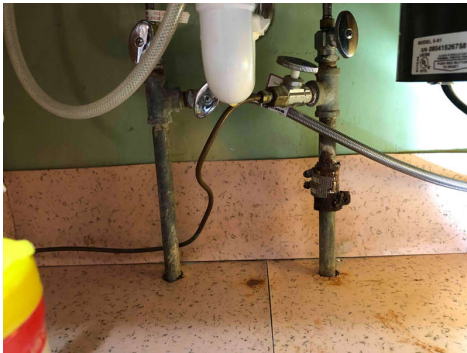
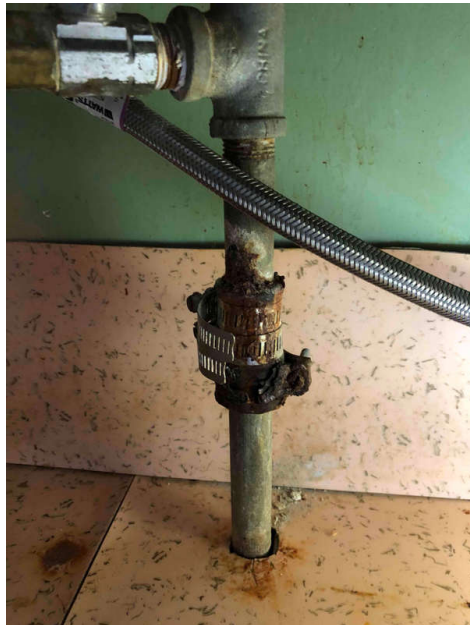
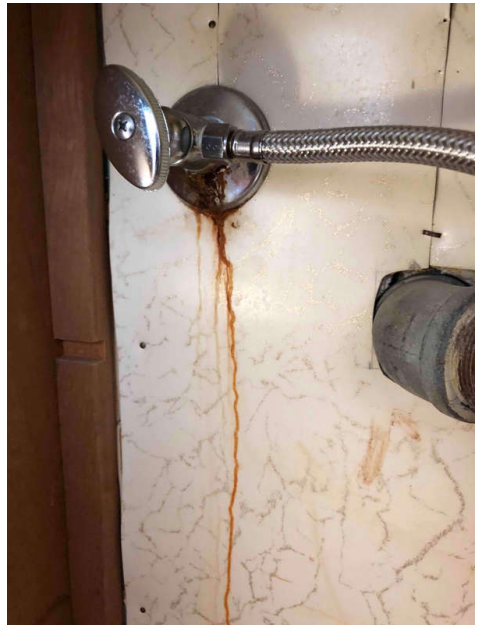
THROUGHOUT

Galvanized supply piping observed. Galvanized supply piping should be considered a Deferred Cost Item and may be at or nearing the end of its estimated useful life. Anticipate future maintenance and/or replacement. Recommend further evaluation by a qualified professional.

\*Some evidence of past leaks and past repairs noted.

Contact a qualified plumbing contractor.

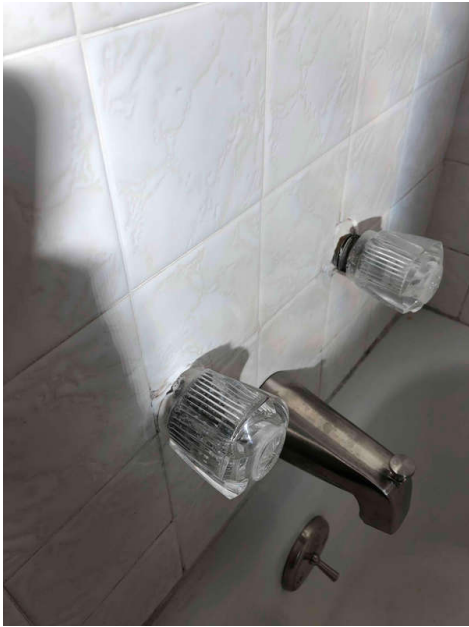
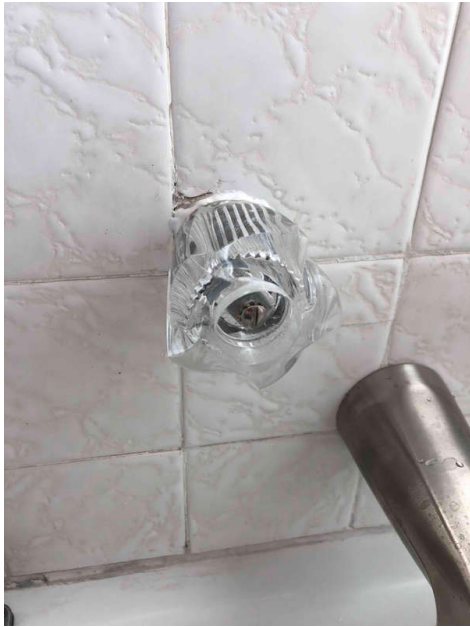
BATHROOM

Fixture damaged or not operating properly and may be in need of repair. Recommend further evaluation and repair or replace as needed.

Contact a qualified plumbing contractor.

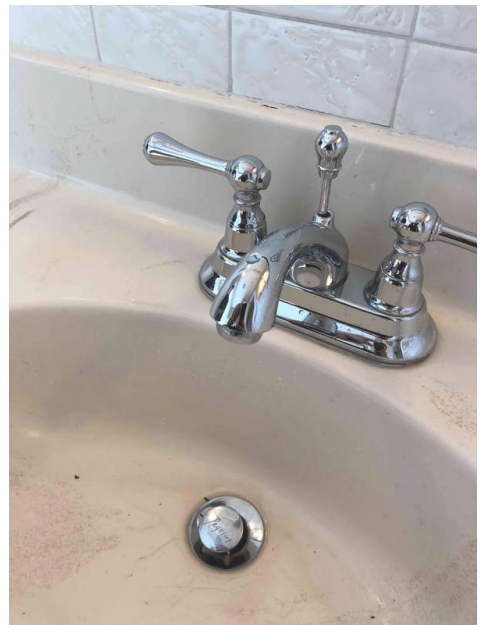
BATHROOM

Mechanical drain stop/plug not operating properly. Recommend repair.

Recommendation  
Contact a qualified professional.

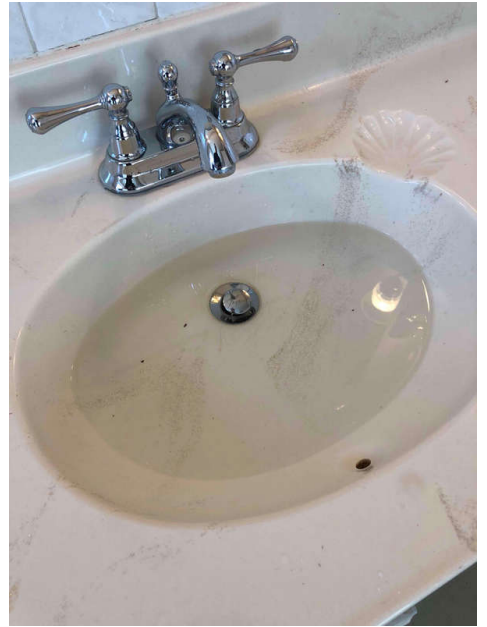
BATHROOM

Poor restricted drainage was observed at time of inspection.  
Recommend a qualified plumber evaluate and repair/remedy as needed.

Recommendation  
Contact a qualified plumbing contractor.

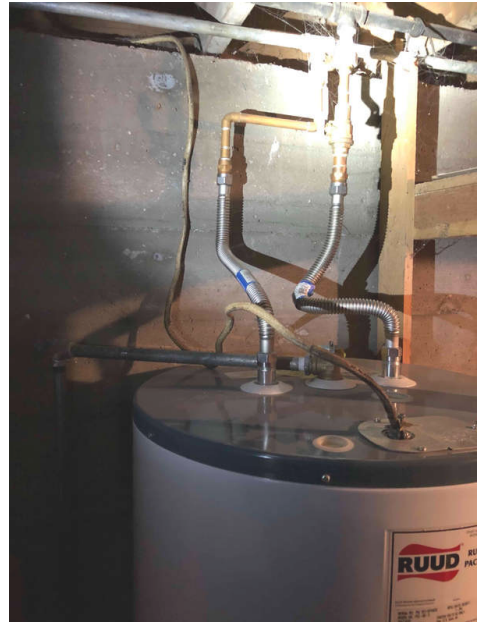
#### BEDROOM UTILITY ROOM

Wiring must be secured and protected from accidental damage. Recommend a qualified professional further evaluate and repair as needed.

Contact a qualified electrical contractor.

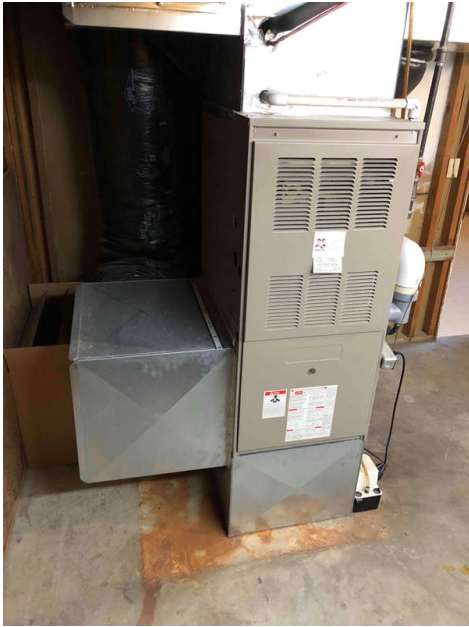
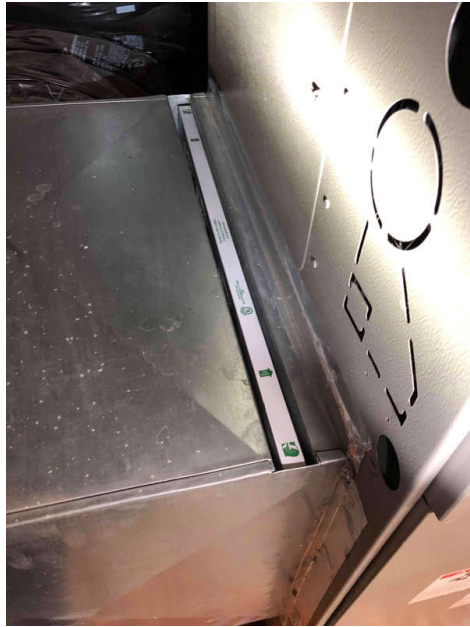
Furnace Filter cover improper or not installed. System air leaks will result in decreased system efficiency and unneeded maintenance due to dirty coils. Recommend repair or replace as needed.

Contact a qualified HVAC professional.

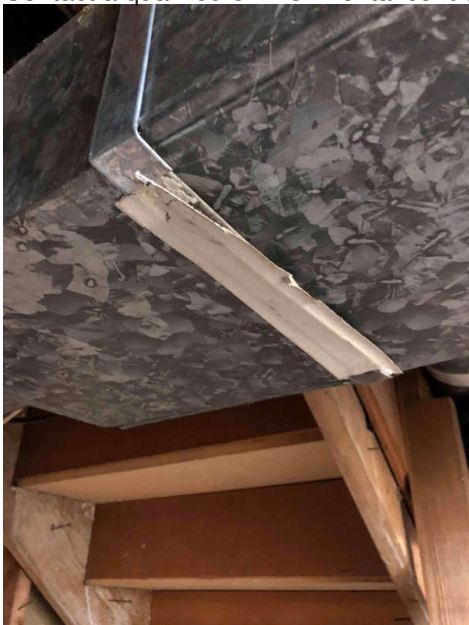
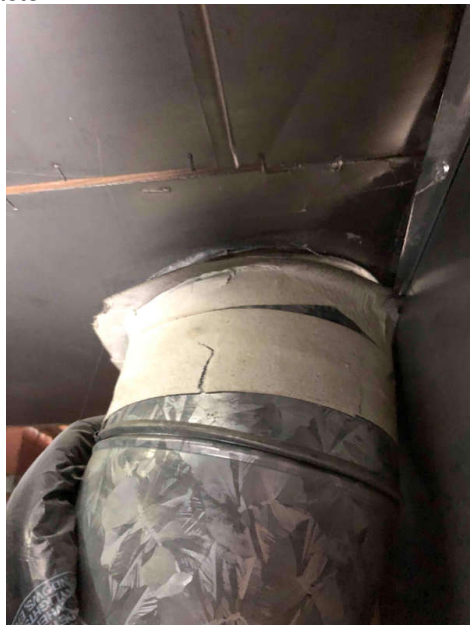
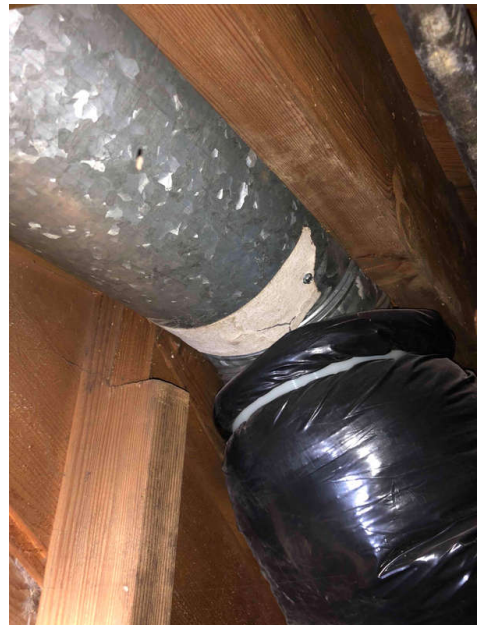
Some HVAC ducting was wrapped in cloth ducting tape. Cloth ducting tape is known to be a product that may contain Asbestos and should not be removed or disturbed without first consulting a qualified Environmental Contractor. Cloth ducting tape is generally not considered to be a health risk if it is left undisturbed on the outside of supply ducting. See a helpful article [here](#).

Contact a qualified environmental contractor

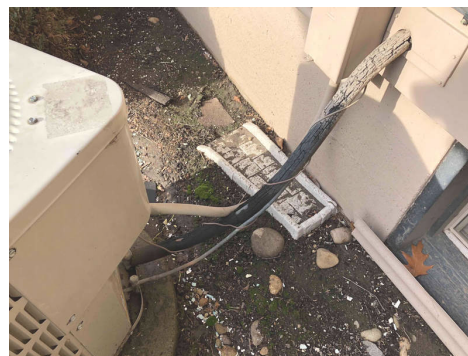
Missing or damaged insulation on refrigerant line can reduced system efficiency and produce condensation leading to possible moisture

damage in some installation situations. Recommend repair or replace as needed.

Contact a qualified HVAC professional.

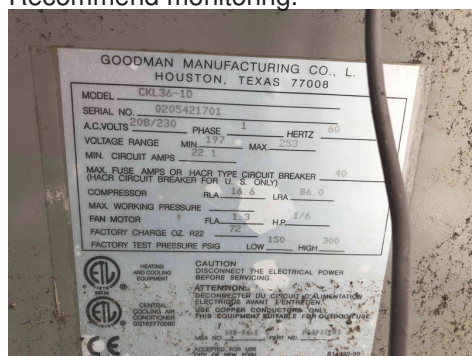
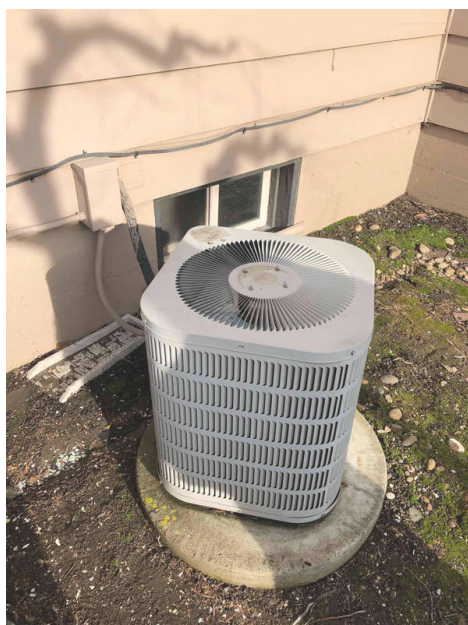
AC appears to be 15 years old or more and should be considered a Deferred Cost Item. This comment is based off of an estimated life expectancy of 15-20 years. Anticipate maintenance and/or future replacement. Recommend regular maintenance and inspection by a qualified HVAC professional.

Recommend monitoring.

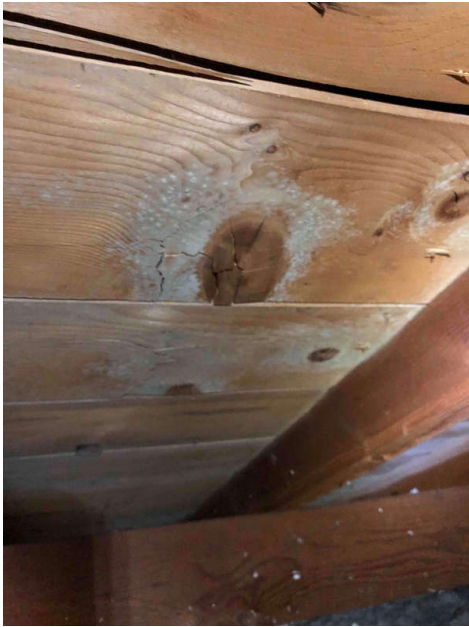
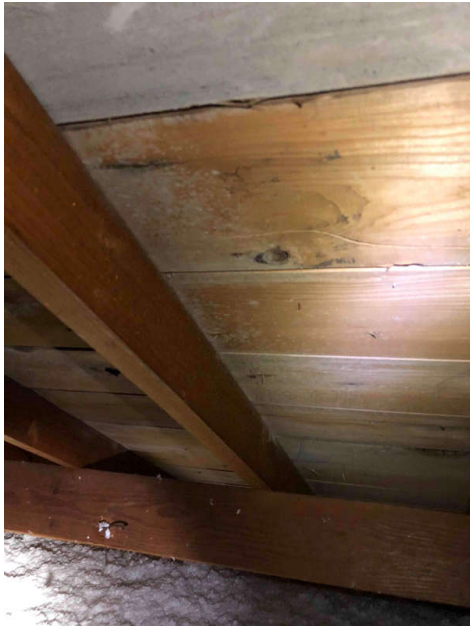
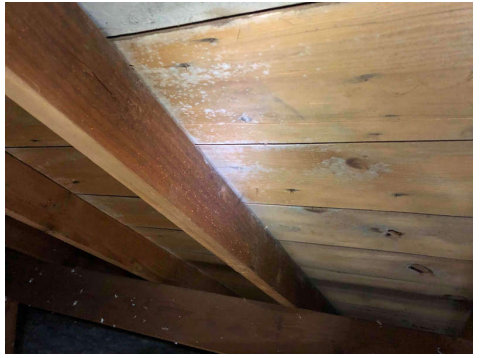
Attic venting is possibly insufficient or restricted for adequate attic ventilation/circulation. Modern standards recommend 1.5 square feet of venting area for every 300 square feet of attic floor space and a combination of high and low venting source. Recommend an attic entilarion contractor further evaluate and remedy. Black spotty staining and/or white biological growth noted at some attic sheathing and/or framing. Possible Mold, possible health risk. Recommend further evaluation and testing by a qualified Environmental Contractor and repair/remedy as needed.

Contact a qualified environmental contractor

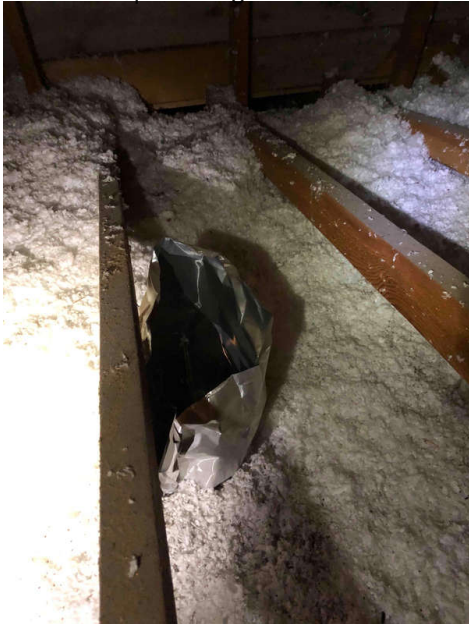
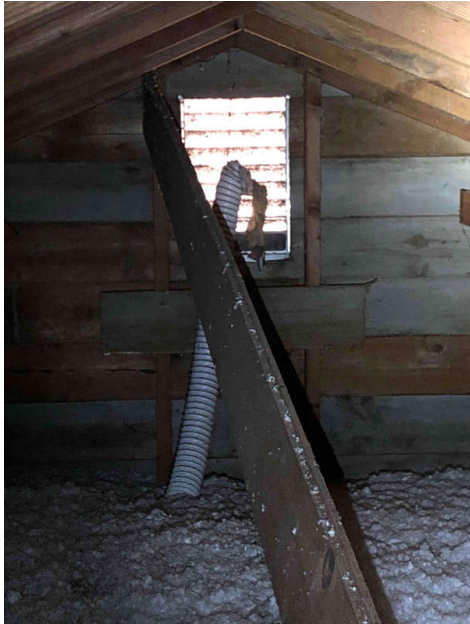
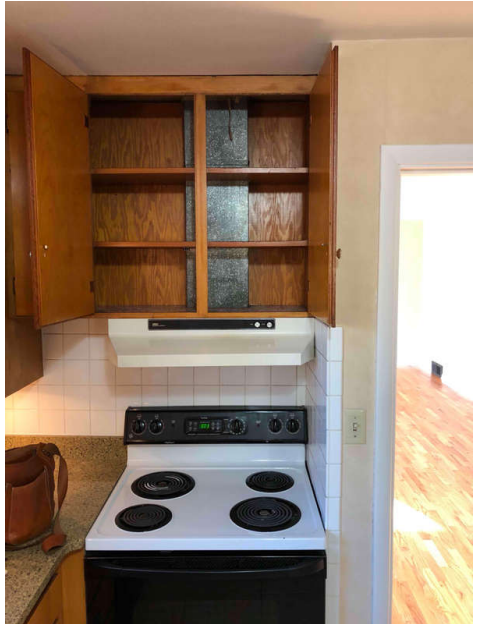
### ATTIC

Bathroom and Kitchen exhaust vent/s were not a secured/sealed termination to exterior. Condition conducive to excessive moisture in attic space. Recommend repair or replace as needed.

\*Some spotty staining or suspicious growth observed around Kitchen exhaust vent. See Ventilation comments.

Contact a qualified general contractor.

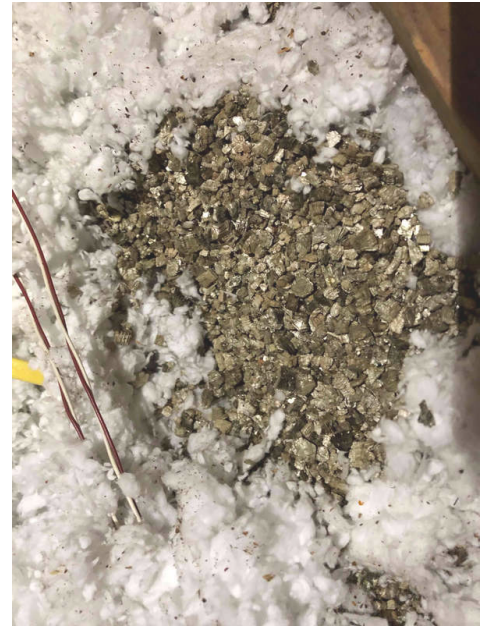
Vermiculite insulation noted in attic space. Vermiculite insulation is known to contain asbestos and may be considered a health risk. Recommend further evaluation and testing by a qualified environmental contractor and repair/remedy as needed.

Recommendation  
Contact a qualified environmental contractor

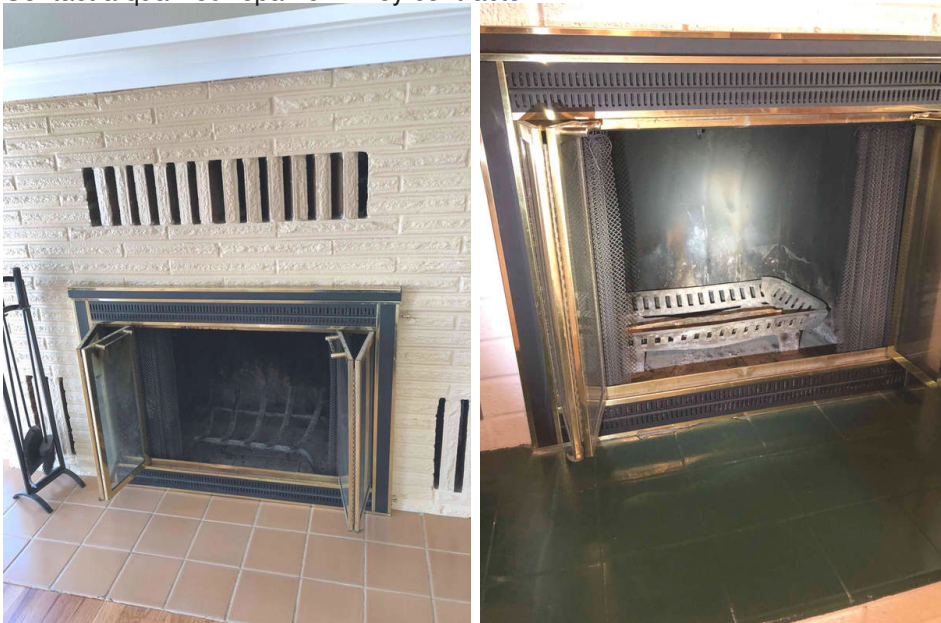
Regular maintenance and inspection is required with all fossil fuel burning appliance flues. Recommend having all fireplace and wood burning appliance flues serviced and inspected by a qualified chimney professional prior to use.

Recommendation  
Contact a qualified repair chimney contractor.

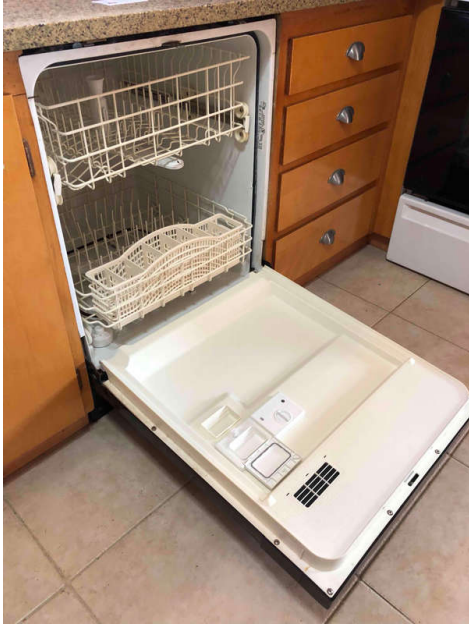
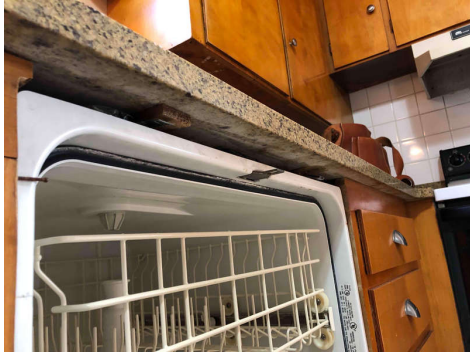
Dishwasher was not properly secured to cabinets/countertop and may be prone to tipping. Recommend repair.

\*Dishwasher door spring was damaged or not operating properly.

Recommendation  
Contact a qualified appliance repair professional.
