Here is a summary of the complete report. These are the recommended fixes and safety issues that were noted in the report.

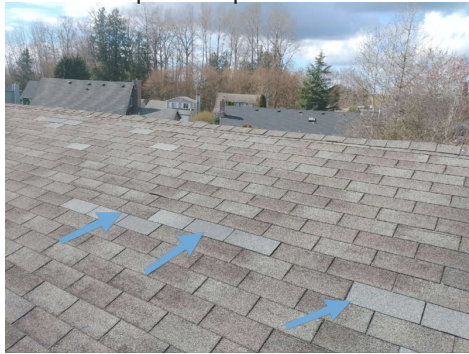
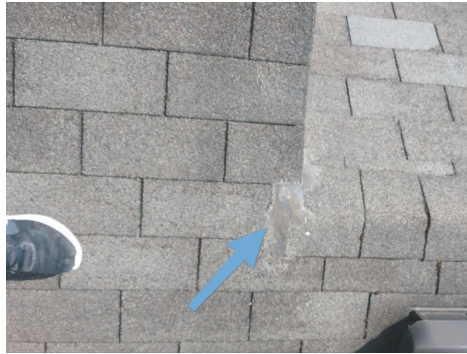
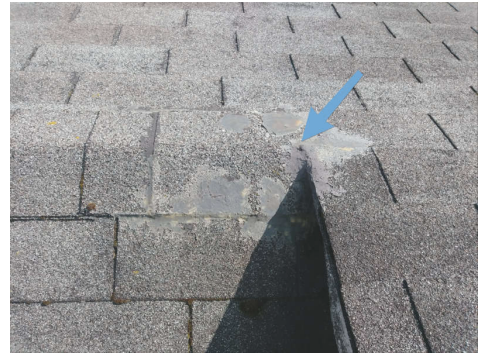
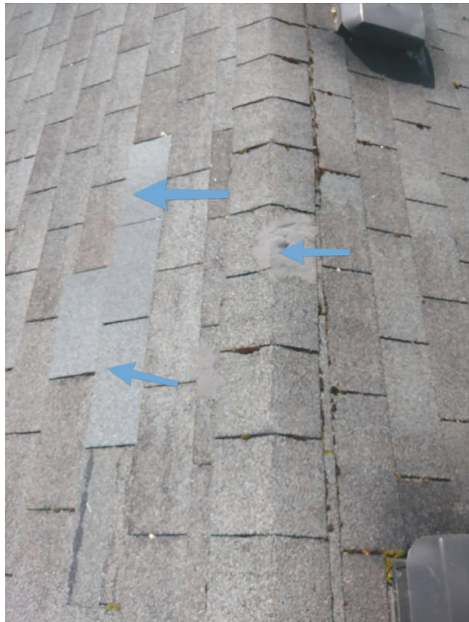
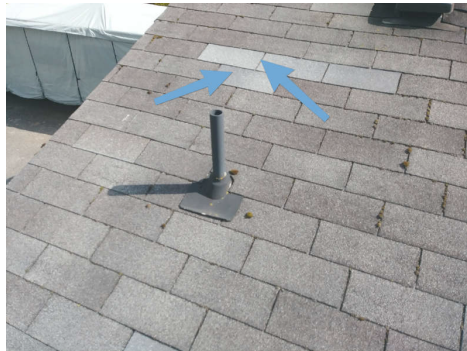
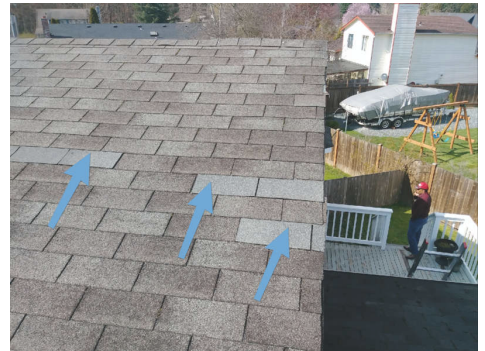
### 2.1.1 Coverings

#### **REPLACEMENT**

Roof is at or beyond expected life span. Shingles are cracked, warped, and delaminating. Multiple repairs have been made. Recommend replacement of the roof by a licensed/qualified roofer.

Contact a qualified professional.

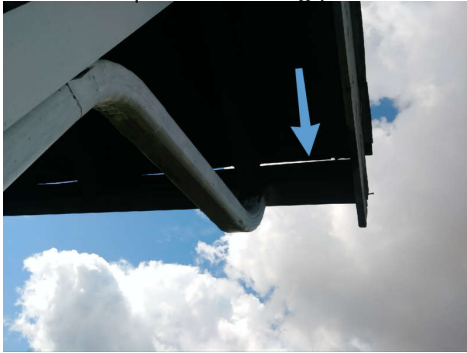
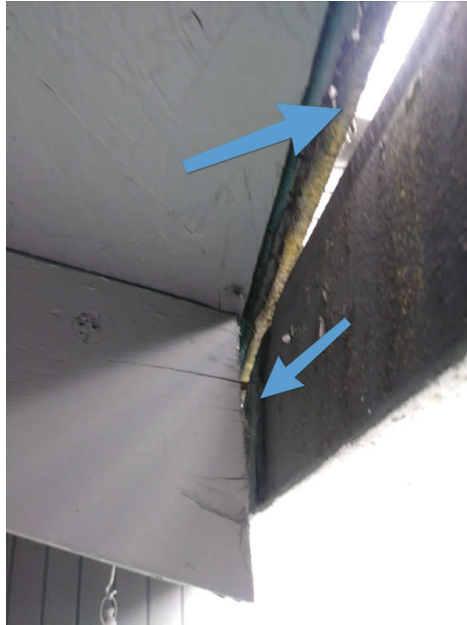
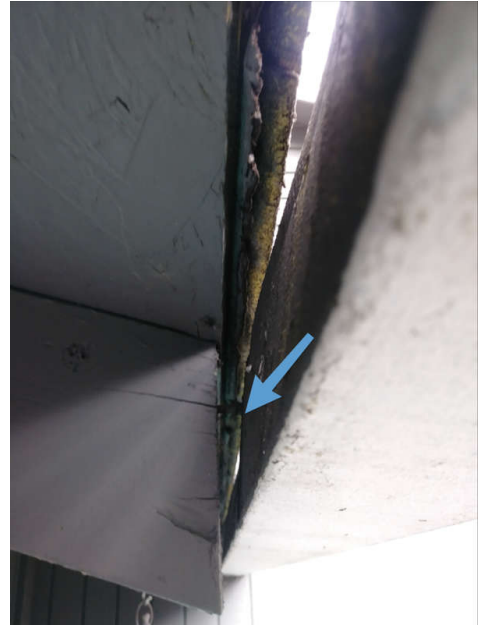
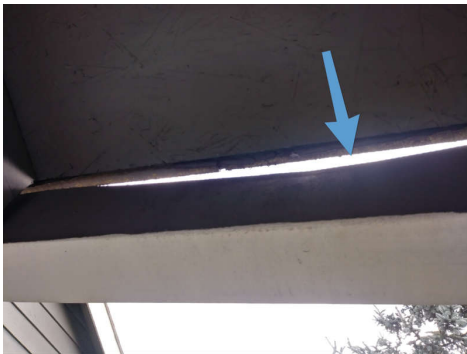
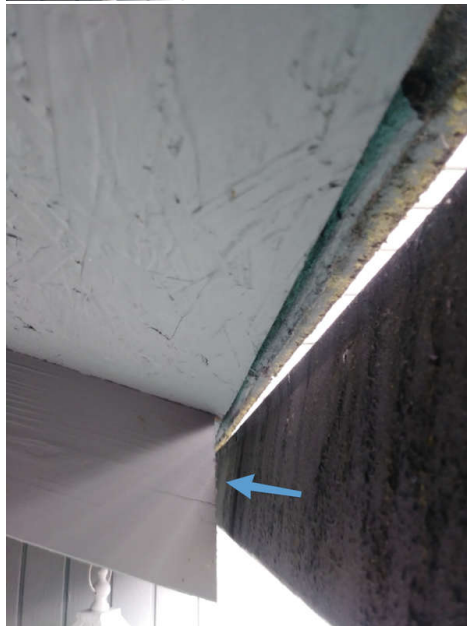
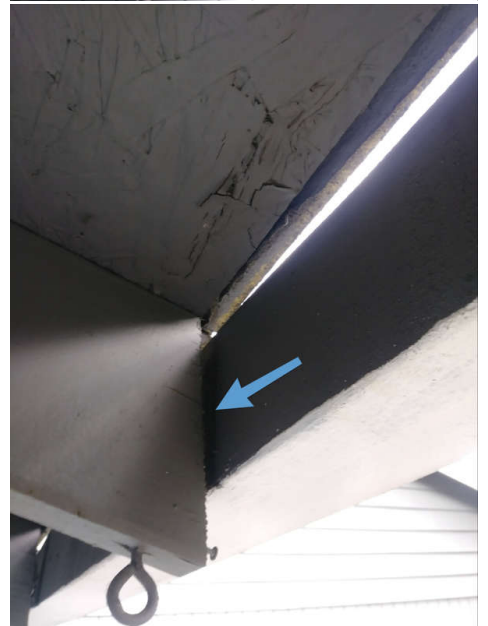
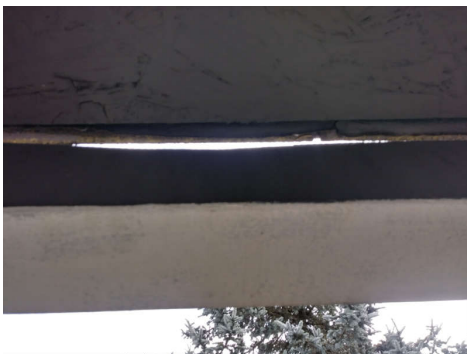
### 2.2.1 Roof Drainage Systems

#### **GUTTERS INSTALLATION IS LOOSE**

In one or more places the gutters were coming away from the house. I recommend having gutters re-installed and secured to the house.

When the new roof is installed, make sure there is proper overhang into the gutters.

Recommendation  
Contact a qualified roofing professional.

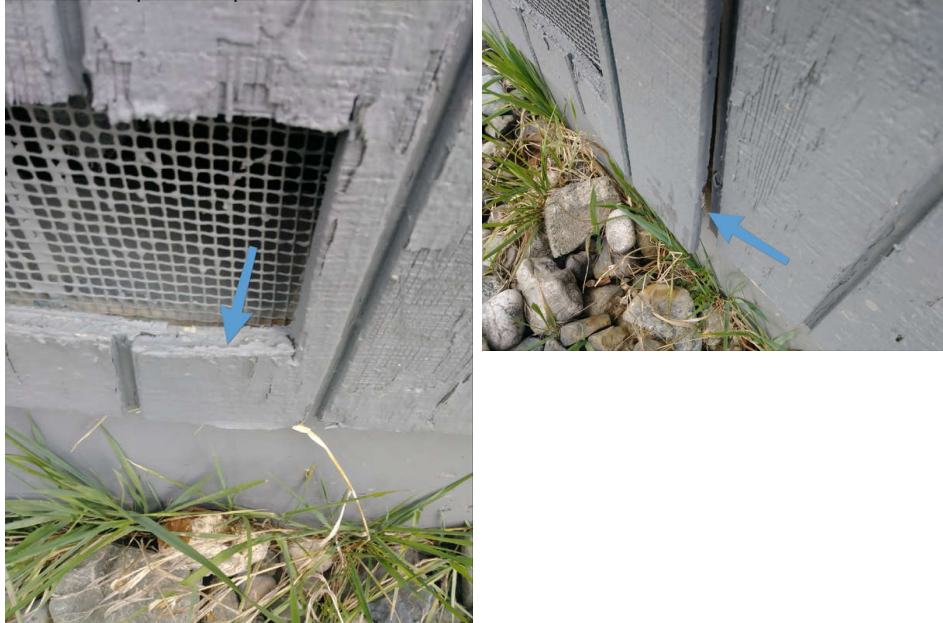
### 3.1.1 Siding, Flashing & Trim

#### **LOOSE BOARDS**

One or more siding boards were loose, which could result in moisture intrusion. Recommend a qualified siding contractor secure and fasten.

Contact a qualified professional.

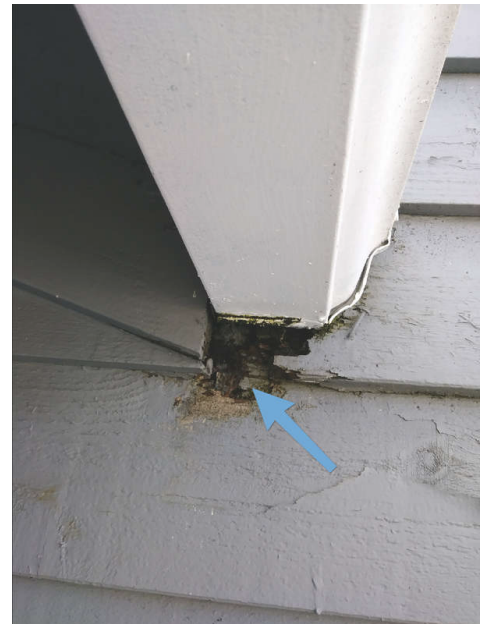
### 3.1.2 Siding, Flashing & Trim

#### **ROT - MINOR**

Signs of rot in the siding was noted in several locations around the house. Gutter end appears to be leaking, causing water damage and rot to the siding. Recommend further evaluation and repairs as needed to prevent further damage.

Contact a qualified professional.

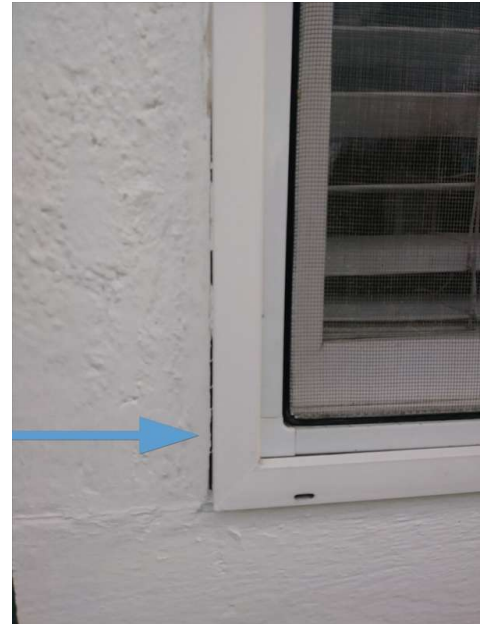
### 3.1.3 Siding, Flashing & Trim

#### **CAULKING CRACKING**

Caulking around one or more windows was cracking. I recommend cleaning out old caulking, and sealing with new caulking to prevent any potential moisture intrusion issues.

Recommended DIY Project

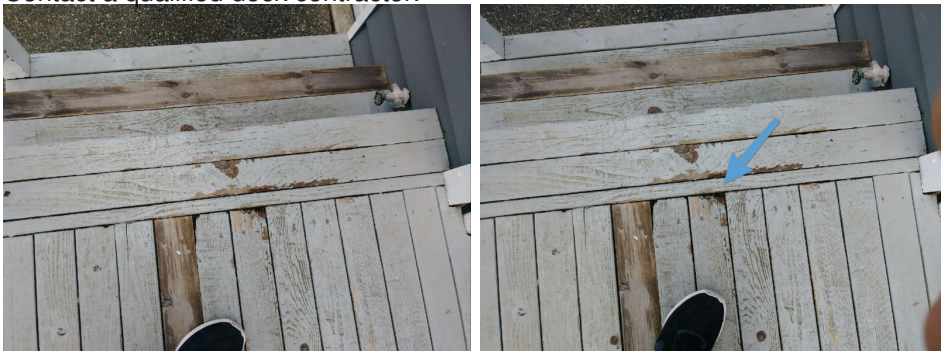
#### 3.4.1 Decks, Balconies, Porches & Steps

##### **DECK - ROTTED BOARDS**

One or more deck boards are showing signs of rot. Recommend a qualified deck contractor replace.

Contact a qualified deck contractor.

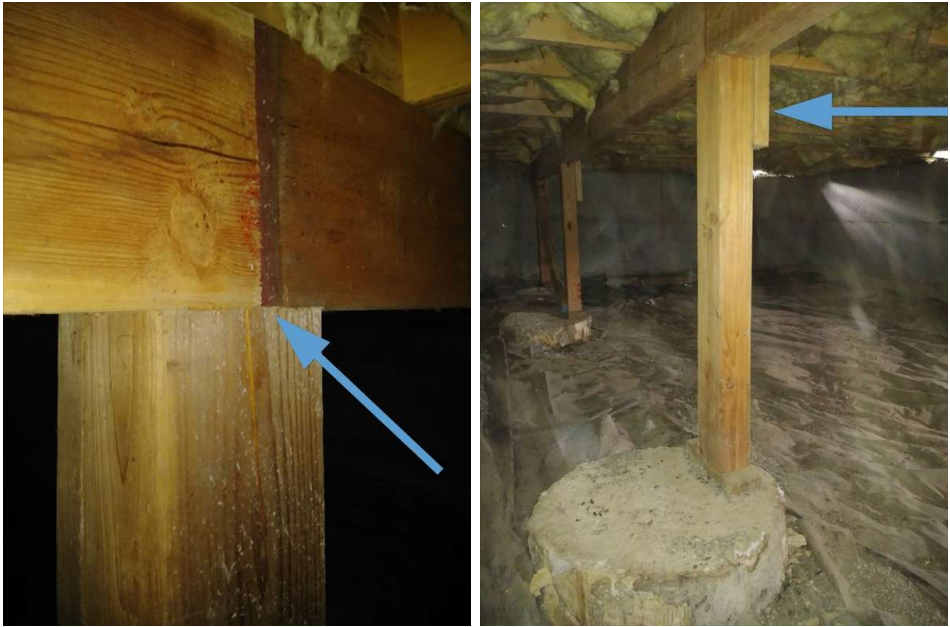
#### 4.2.1 Basements & Crawlspaces

##### **BEAM CONNECTIONS**

Under the house in the crawl space, the post and beam connections are only made on one side of each post/beam. I recommend installing positive connections on each side of every post/beam.

Contact a qualified general contractor.

I recommend duplicating this on the opposite side of each post.

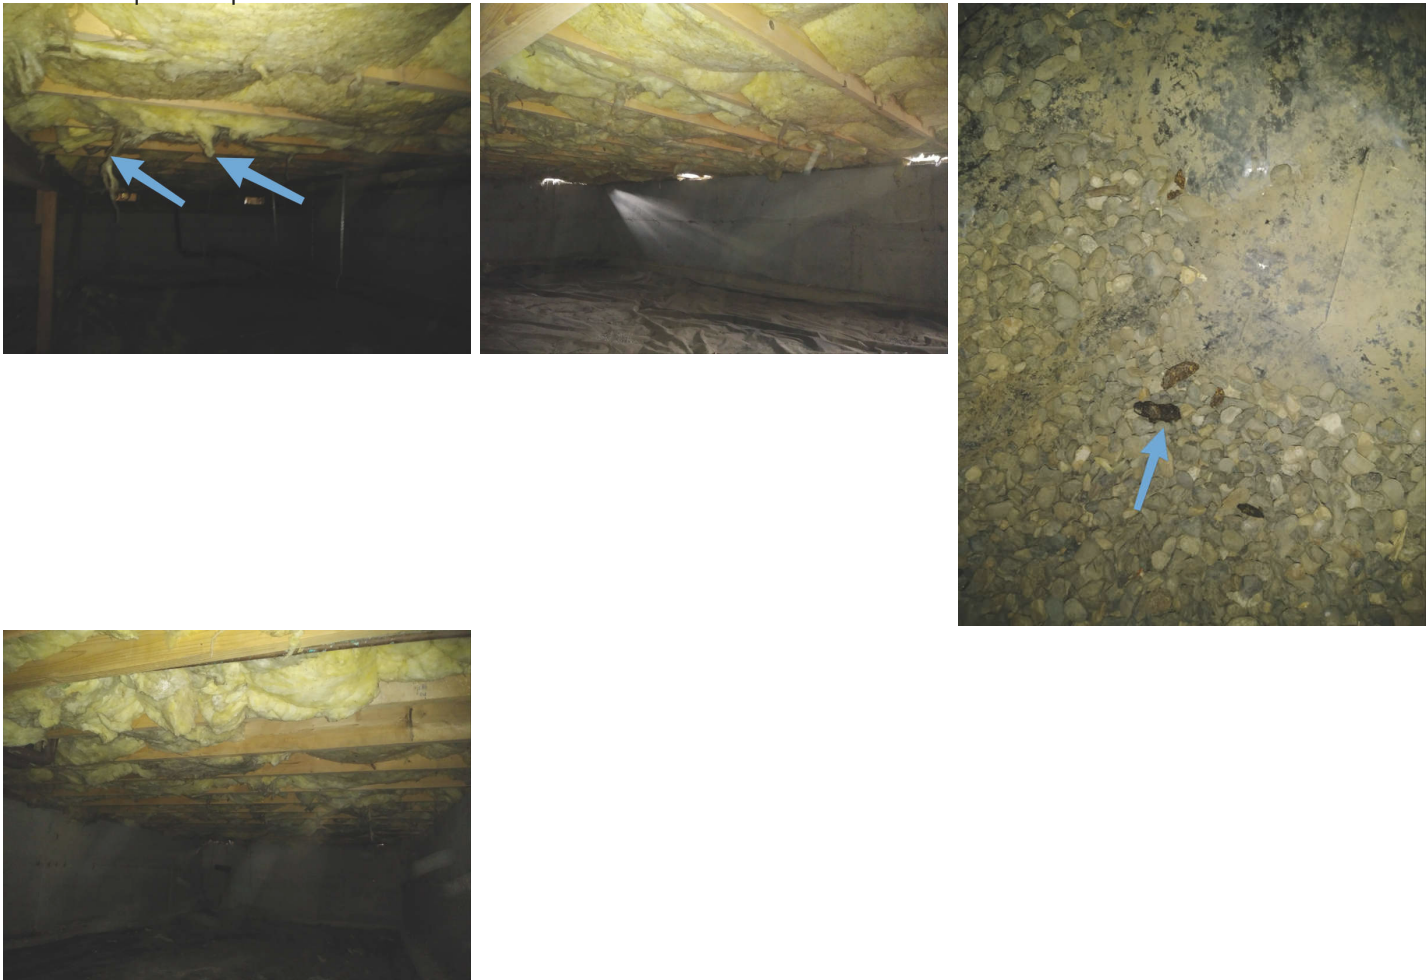
4.2.2 Basements & Crawlspace  
**RODENT**

Rodent evidence was present in the crawl space. Droppings on the vapor barrier and one dead carcass found. Reccommend monitoring and having pest control contractor evaluate if necessary.

Recommendation  
Contact a qualified professional.

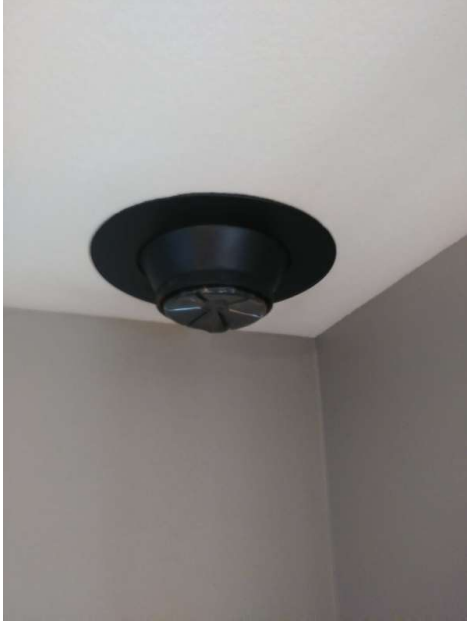
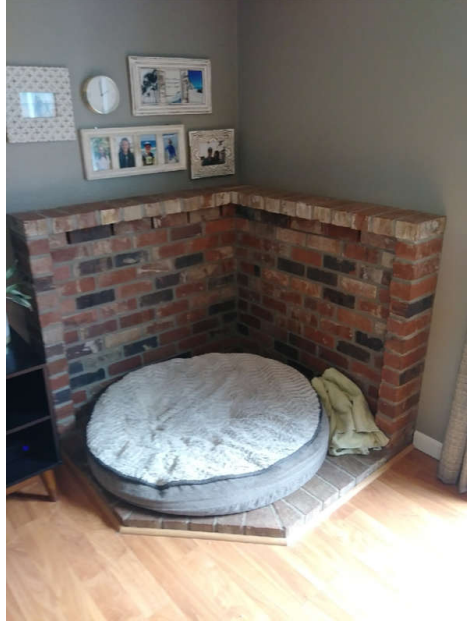
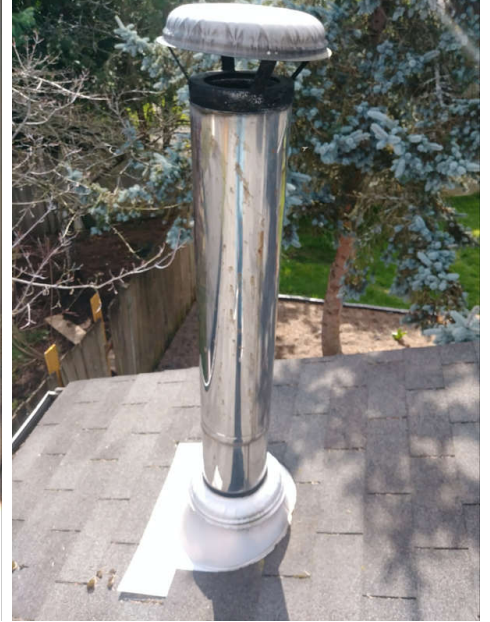
#### 5.3.1 Vents, Flues & Chimneys

### **FIREPLACED REMOVE**

It was observed that the fireplace was removed. The is just a observation. If there are no plans to re-install then the chimney can be removed from the roof.

Contact a qualified professional.

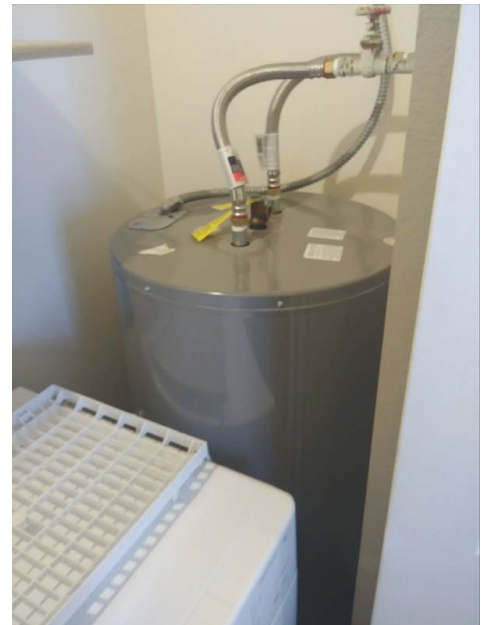
#### 6.4.1 Hot Water Systems, Controls, Flues & Vents

### **NO EXPANSION TANK**

No expansion tank was present. Expansion tanks allow for the thermal expansion of water in the pipes. These are required in certain areas for new installs. Recommend a qualified plumber evaluate and install.

Contact a qualified plumbing contractor.

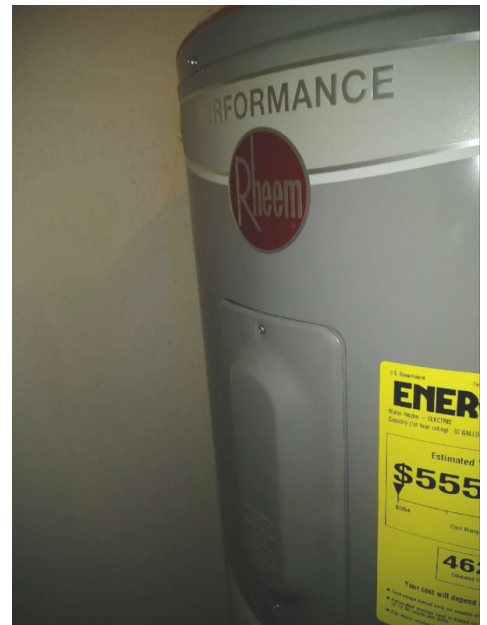
#### 6.4.2 Hot Water Systems, Controls, Flues & Vents

### **EARTHQUAKE STRAPS MISSING**

At the time of inspection no earthquake straps were installed. The home owner showed me the straps and said they plan on installing.

Recommend verifying installation of straps.

Recommendation  
Contact a qualified professional.

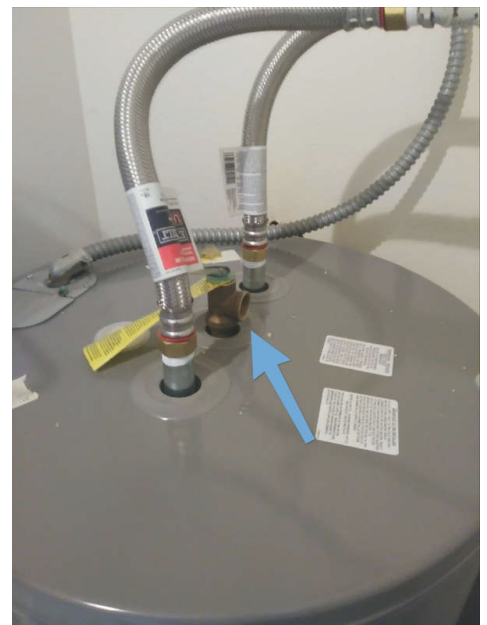
#### 6.4.3 Hot Water Systems, Controls, Flues & Vents

##### **TPR VALVE NOT CONNECTED**

TPR valve was not connected. It is important that these are connected properly. I recommend licensed plumber connects the TPR properly.

Recommendation  
Contact a qualified professional.

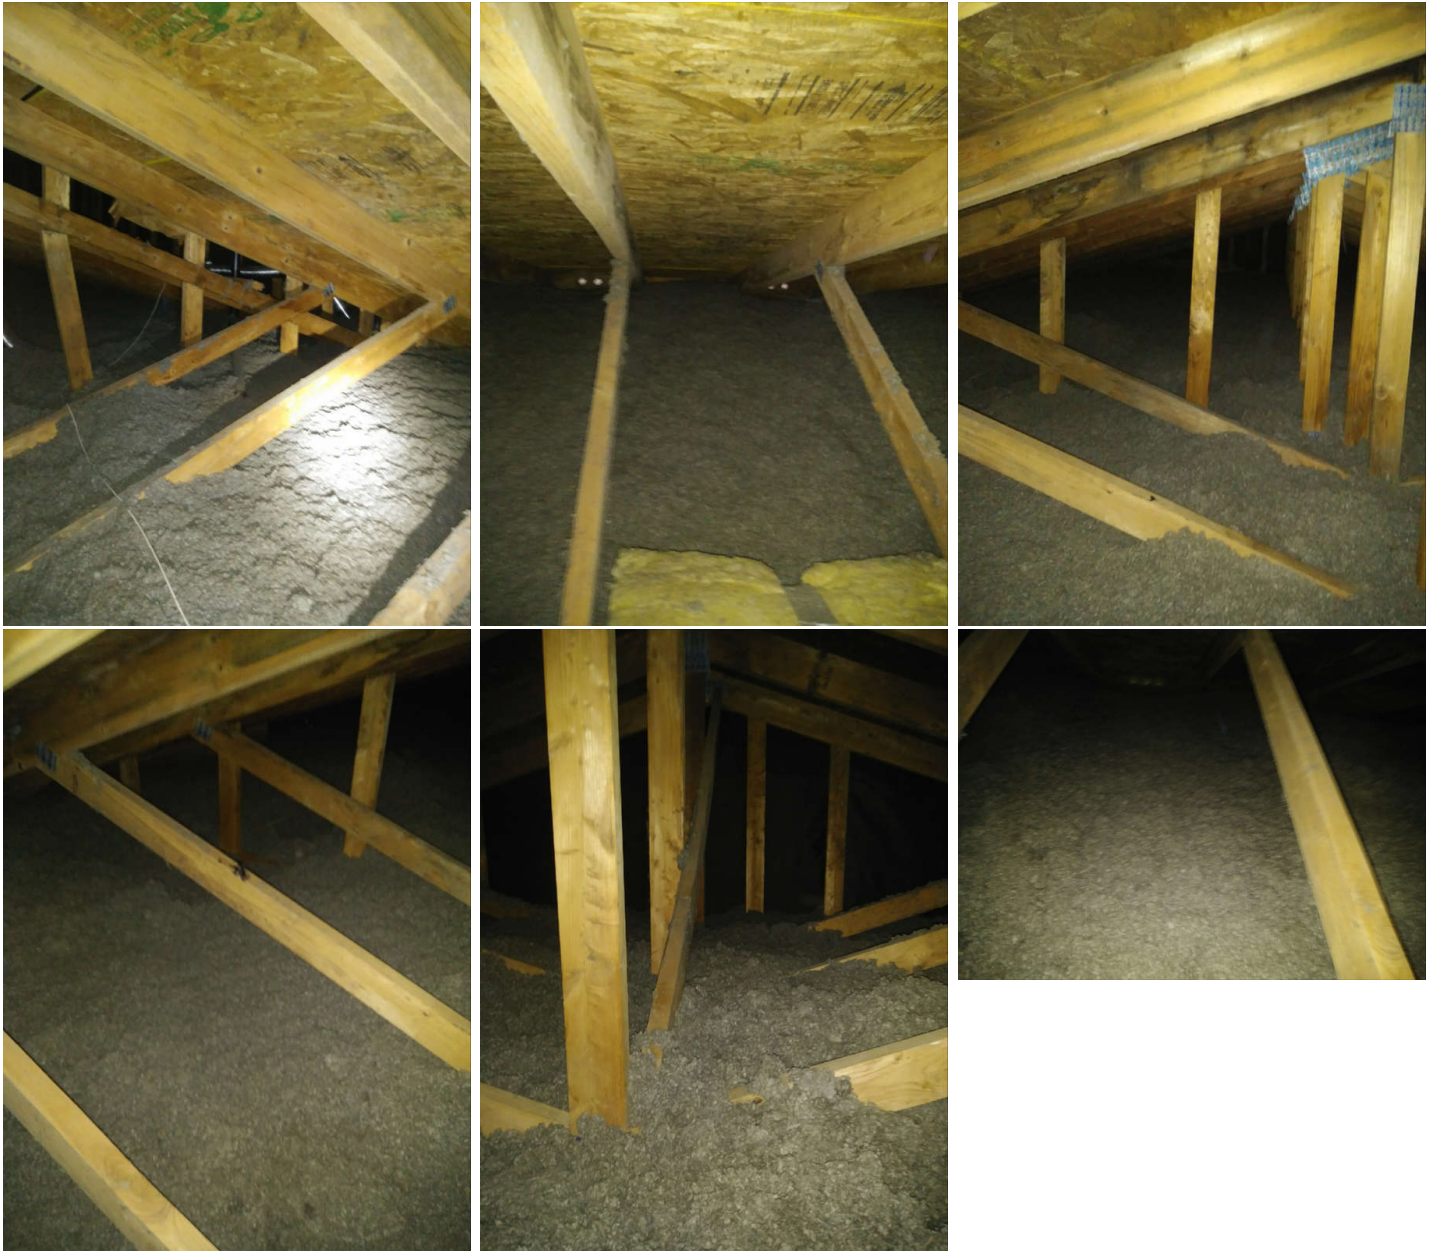
#### 8.1.1 Attic Insulation

##### **INSUFFICIENT INSULATION**

Insulation depth was inadequate. Recommend a qualified attic insulation contractor install additional insulation. Approximately 12" thick will achieve a R38 value in the attic.

Recommendation  
Contact a qualified insulation contractor.

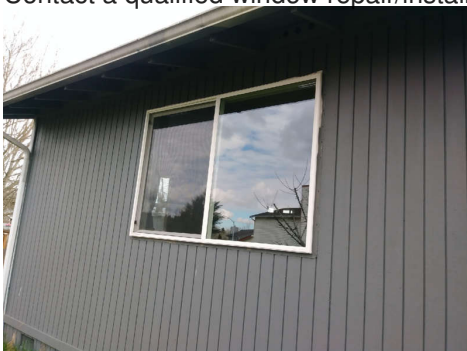
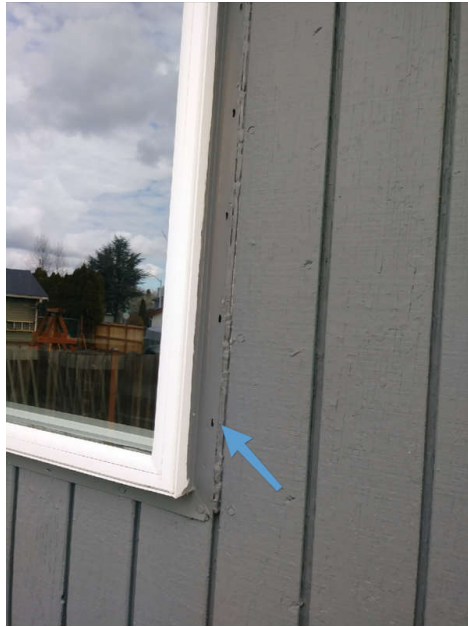
#### 9.2.1 Windows

### **IMPROPER INSTALLATION**

Windows was installed directly over the siding with no window trim installed. The flange is nailed and caulked to the siding. Exterior window trim should be installed, and sealed to prevent any potential water intrusion issues.

Contact a qualified window repair/installation contractor.

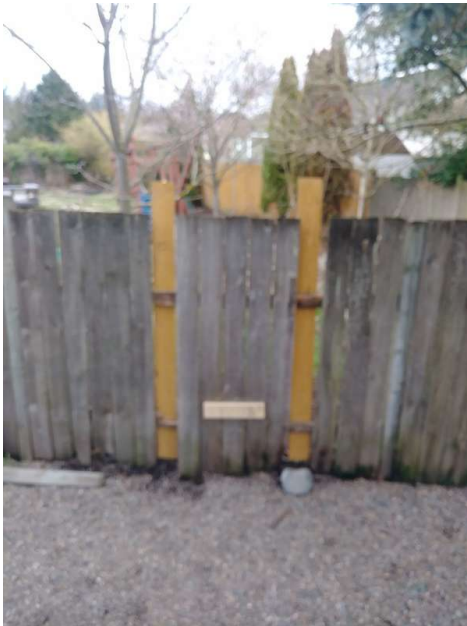
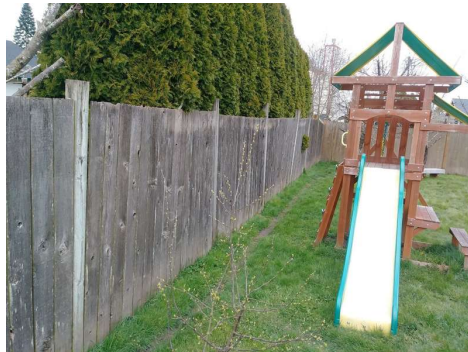
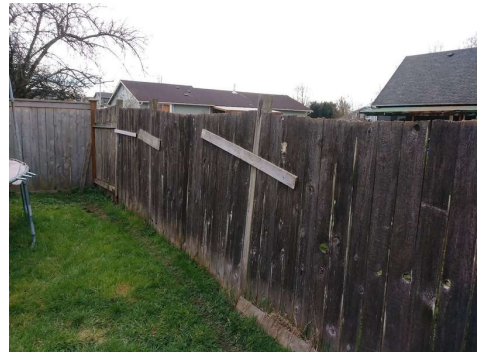
#### 11.1.1 Fence Condition

### **FENCE WORN OUT**

In one or more places the fence showed signs of wear and in need of repairs/replacement. I recommend a licensed contractor evaluates and repairs/replaces as needed.
