SUMMARY

1234 Main St. Yreka CA 96097

Michael Colombo
CMI, CPI, CCI

Shasta Premier Inspection Group
530-598-7856
mike@shastapremier.com

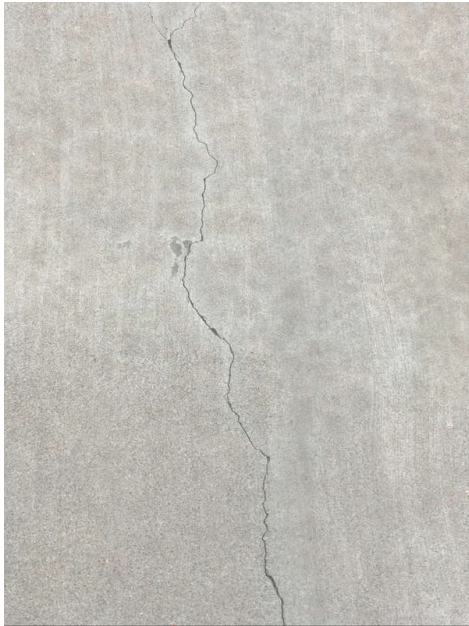
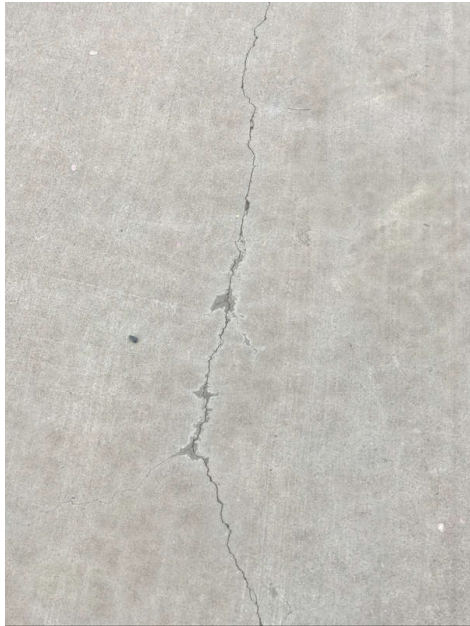
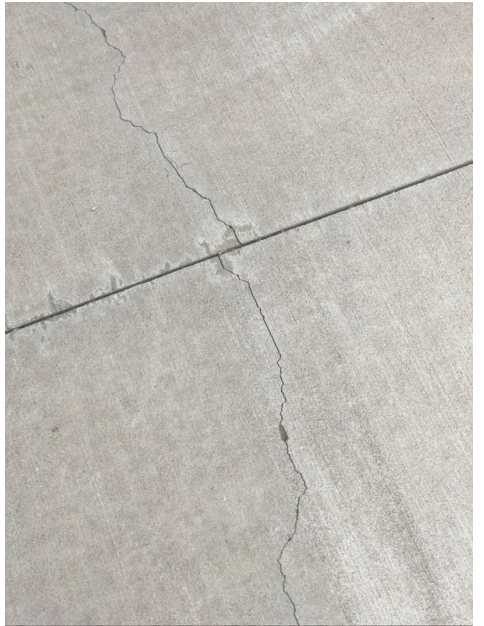
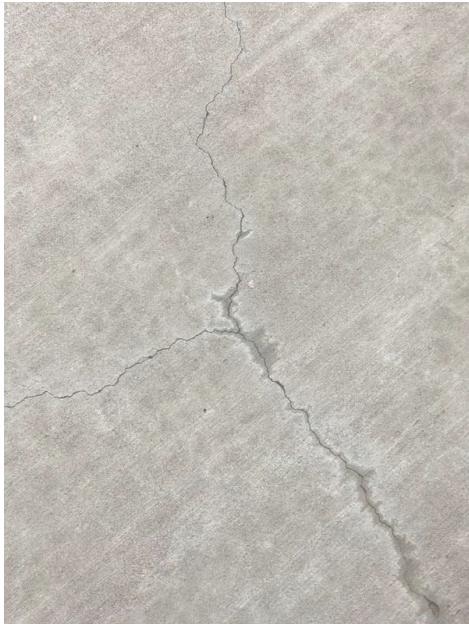
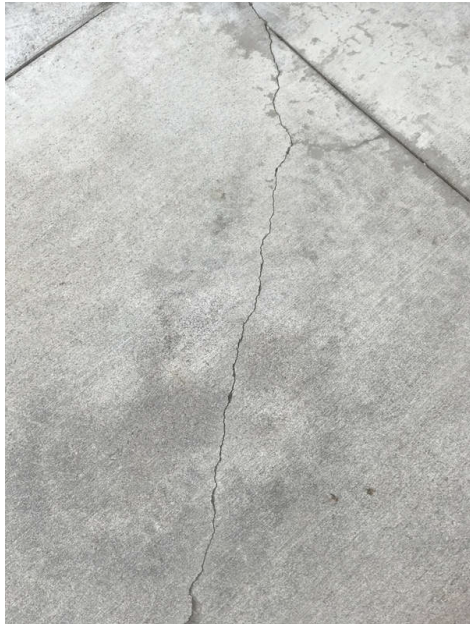
SETTLING CRACKS

Damage to cement was observed, that appeared to be caused by settling. This does not impact the house foundation and the slab appeared to be serviceable; however, the concrete was observed to have full width cracks with or without displacement. This could be caused by the method of preparation of the ground under the concrete, construction methods of the slab, the presence of moisture in the soil and the freeze/thaw cycle, tree roots, age, and other reasons. These cracks can be repaired and repair is recommended to extend service life and help arrest current damage.

Contact a handyman or DIY project

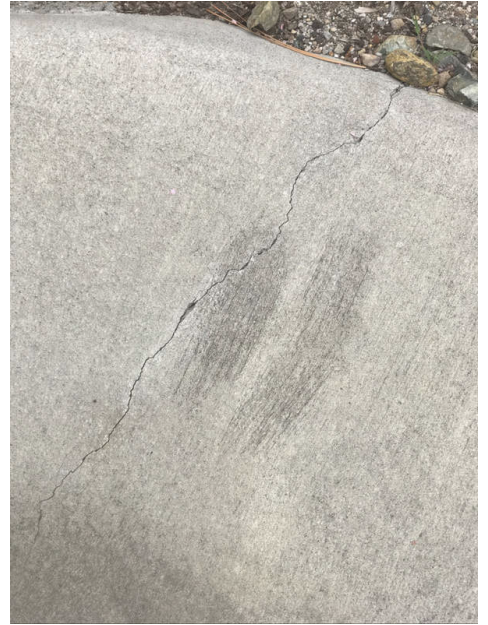
North

3.4.1 Walkways

SETTLING CRACKS

Damage to cement was observed, that appeared to be caused by settling. This does not impact the house foundation and the slab appeared to be serviceable; however, the concrete was observed to have full width cracks with or without displacement. This could be caused by the method of preparation of the ground under the concrete, construction methods of the slab, the presence of moisture in the soil and the freeze/thaw cycle, tree roots, age, and other reasons. These cracks can be repaired, and repair is recommended to extend service life and help arrest current damage.

Contact a handyman or DIY project

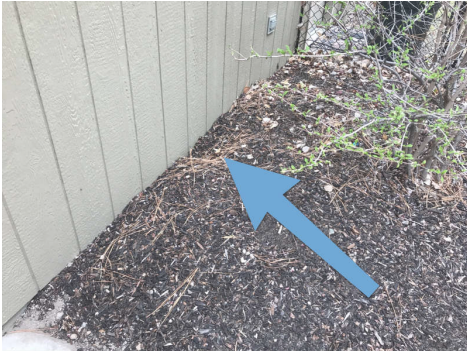
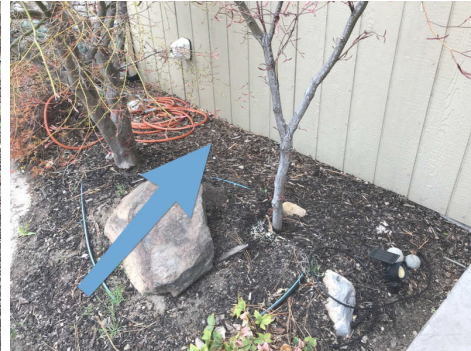
3.6.1 Siding

GROUND CLEARANCE

Siding was observed to be in contact with the ground. Wood that touches the ground/soil (including resting on cement) will wick moisture and start to deteriorate. This also sets up ideal conditions for dry rot to damage wood, and invites wood destroying pests. Recommend all soil be pulled away from siding for a minimum ground clearance of 6" to 8".

Contact a handyman or DIY project

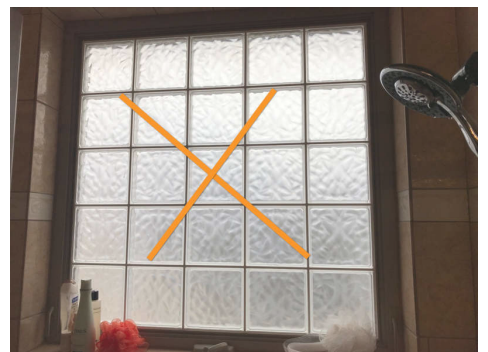
Master Bathroom

3.9.1 Windows

SCREENS

One or more screens were observed to be missing or damaged. Recommend repair or replacement.

Contact a handyman or DIY project

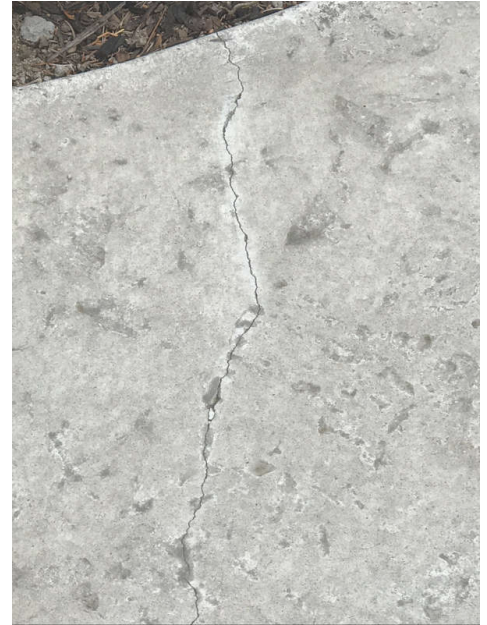
East

3.14.1 Patio

SETTLING CRACKS

Damage to cement was observed, that appeared to be caused by settling. This does not impact the house foundation and the slab appeared to be serviceable; however, the concrete was observed to have full width cracks with or without displacement. This could be caused by the method of preparation of the ground under the concrete, construction methods of the slab, the presence of moisture in the soil and the freeze/thaw cycle, tree roots, age, and other reasons. These cracks can be repaired and repair is recommended to extend service life and help arrest current damage.

Contact a handyman or DIY project

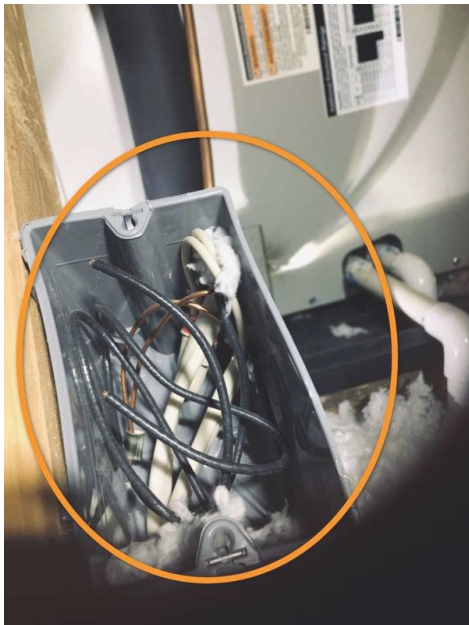
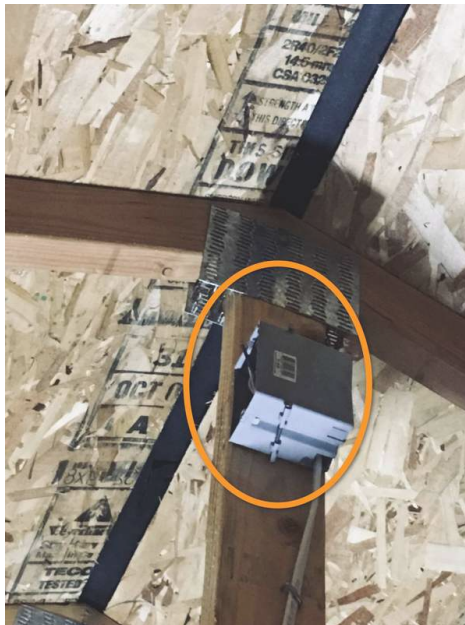
5.9.1 Switches & Receptacles

INCOMPLETE INSTALLATION

One or more electrical switches or outlets were observed to be partially installed. There are two attic locations that need to have installation complete; one should have a 110 receptacle and switch installed and one should have a light fixture installed. Also, the wiring has been left bare (uncapped and uncovered) and this is a safety hazard. Recommend repair to complete correct installation.

Contact a qualified electrical contractor.

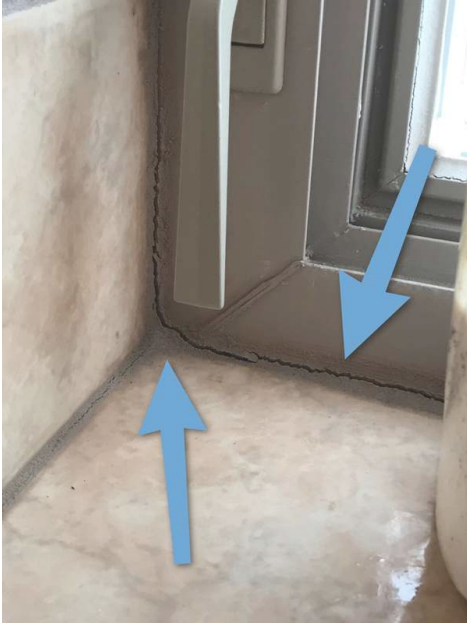
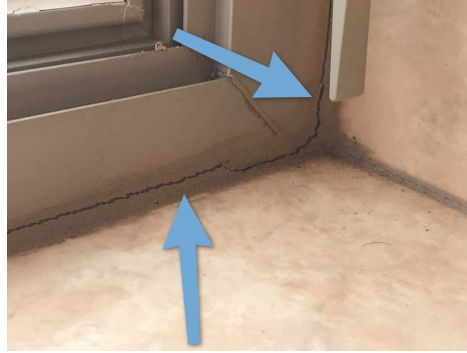
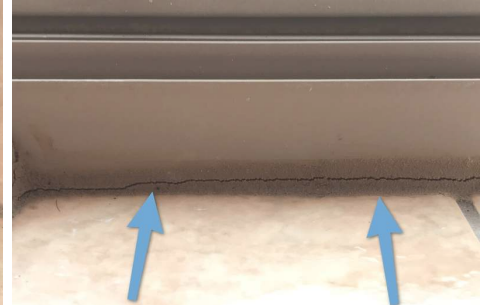
RE-SEAL

The grouting/seal around the window in the master bathroom was observed to be in need of resealing. As the location of this window is in the shower stall, the separation observed will allow water to penetrate behind the tile and into the window and wall framing. Seal with appropriate sealant to prevent water penetration.

Contact a handyman or DIY project

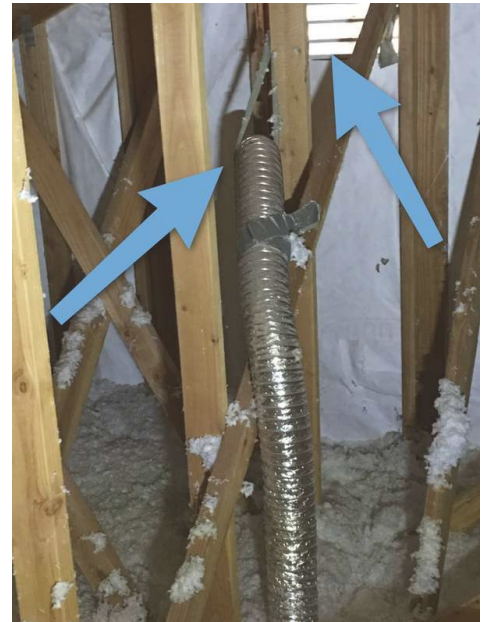
Attic

ATTIC TERMINATION

One or more bathroom, kitchen, and/or laundry room exhaust fans appeared to be venting into the attic, which can cause moisture problems and promote biological growth. The vent appeared to have disconnected at the gable vent and should be reconnected to allow exhaust air to vent to the outside.

ADDITIONAL INFORMATION: All exhaust vent ducts should terminate to the outside of the house with correct penetration and termination ductwork. Exhaust venting, especially for bathrooms, may cause moisture problems and encourage biological growth (e.g. mold, fungus, etc.) Recommend repair and/or modifications to ensure correct venting to exterior.

Contact a handyman or DIY project
