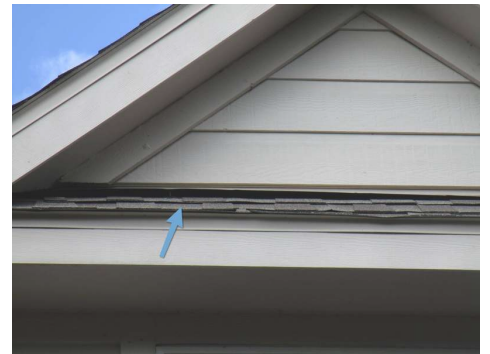
FRONT SLOPE

**FLASHING: LIFTED**

Flashing sections are lifted. Remedy as needed.

Contact a qualified roofing professional.

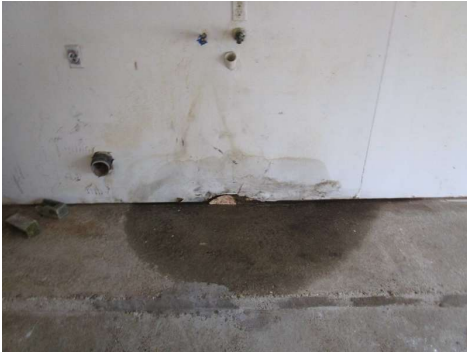
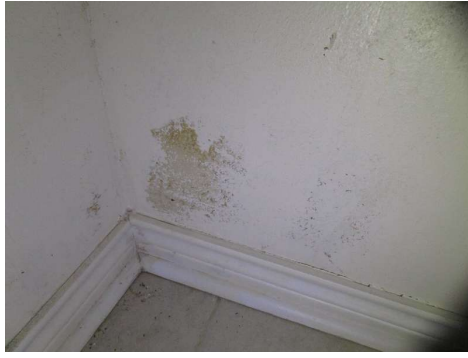
GARAGE AND FRONT ENTRY

**INTERIOR: ACTIVE WATER DAMAGE**

Active moisture was identified on the drywall at the time of inspection. The exact cause could not be determined.

Contact a qualified professional.

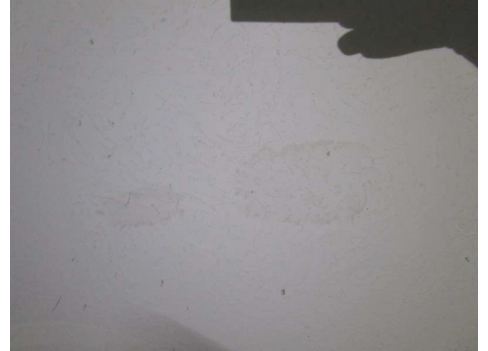
MASTER BEDROOM

### CEILING: EVIDENCE OF WATER INTRUSION

Discolored drywall ceiling indicates water contact. Active moisture was detected at the time of inspection using a surface moisture meter. The cause could not be determined.

Contact a qualified professional.

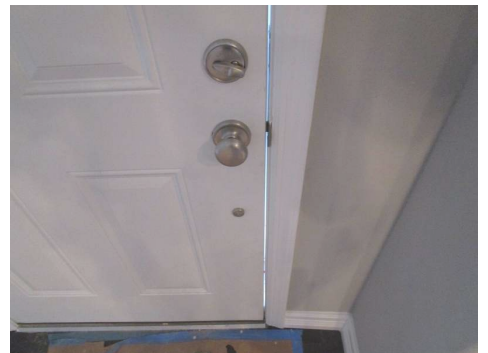
BACK DOOR

### WEATHERSTRIPPING INSUFFICIENT

Door is missing standard weatherstripping. This can result in significant energy loss and moisture intrusion. Recommend installation of standard weatherstripping.

Recommended DIY Project

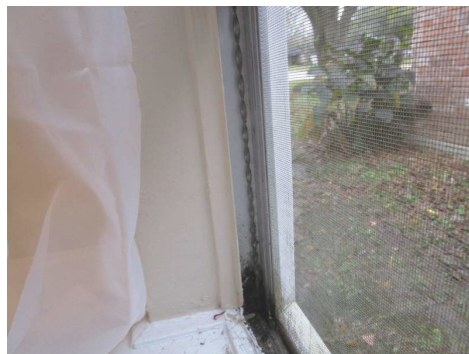
LIVING ROOM

### WINDOW BALLASTS/SPRINGS ARE BROKEN

Window ballasts (or guidesprings depending on the window style) were detached or damaged. These mechanisms serve to hold the window sash up, and if they are damaged the window may not stay open. Remedy as needed.

Contact a qualified window repair/installation contractor.

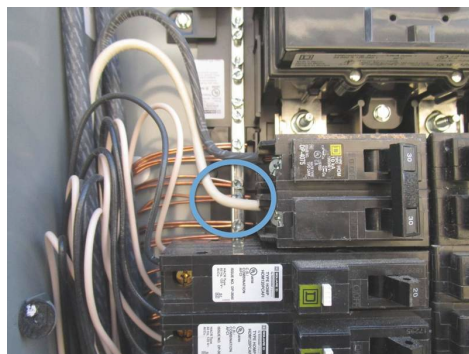
#### **WHITE WIRES NOT MARKED**

White wires connected to breakers are not marked with black or red electrical tape to indicate that they are "hot". Remedy as needed.

Contact a qualified professional.

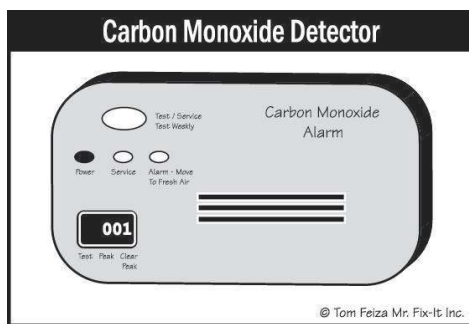
BEDROOMS

#### **CARBON MONOXIDE DETECTOR MISSING**

A carbon monoxide detector was not present. As gas appliance(s) were installed in the living portion of the home, installation of carbon monoxide detectors is recommended for safety. Remedy as needed.

Recommended DIY Project

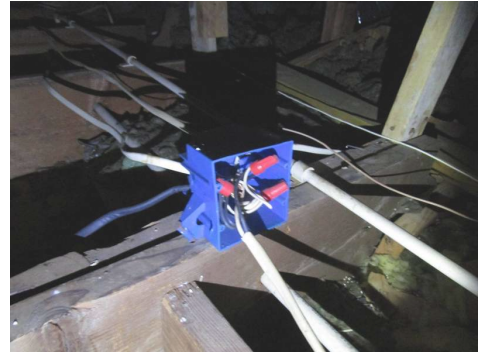
ATTIC

### OPEN JUNCTION BOX

An open junction box was present. Remedy as needed.

Recommendation  
Recommended DIY Project

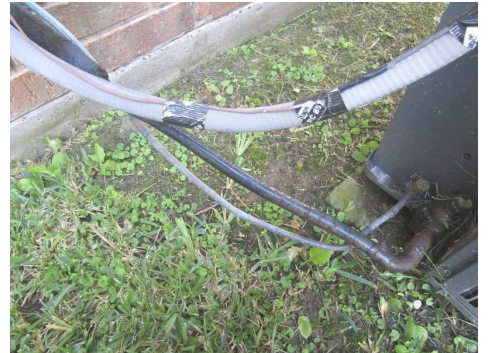
### REFRIGERANT LINES: INSULATION MISSING OR DAMAGED

Missing or damaged insulation on refrigerant line can cause energy loss and condensation. Remedy as needed.

Recommendation  
Contact a qualified HVAC professional.

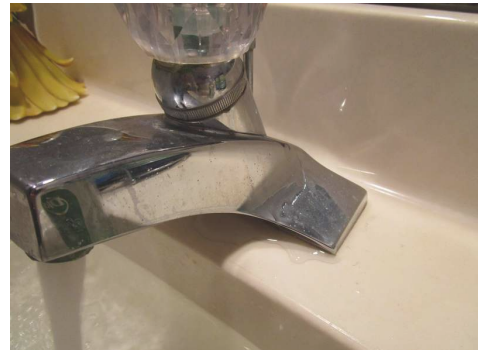
HALF BATHROOM

### FAUCET: STEM LEAKING

The faucet stem leaked when operated. Remedy as needed.

Recommendation  
Contact a qualified professional.

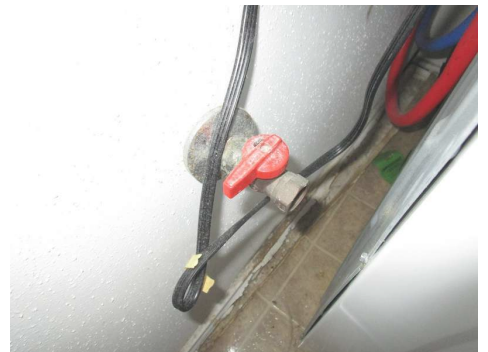
UTILITY ROOM

### GAS PIPING: UN-CAPPED GAS SUPPLY

An uncapped gas supply pipe was present. Gas supply pipes should be capped for safety when not in use. Remedy as needed

Recommendation  
Contact a qualified professional.

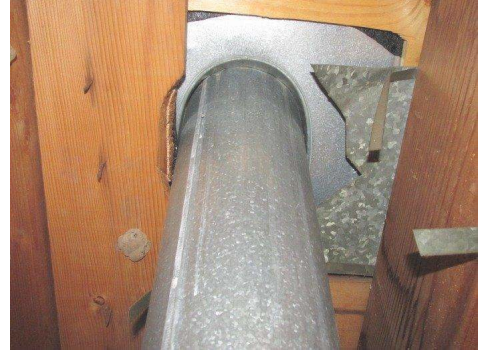
**VENTING SYSTEM: COMBUSTIBLE CLEARANCE**

Safety Hazard

The vent pipe (flue) is in direct contact with combustible materials. The required clearance should be 1" at minimum. This is a safety hazard, and should be further evaluated.

Recommendation  
Contact a qualified professional.
