# SUMMARY

1234 Main St. Chilhowie VA 24319

Joshua Lewis  
Licensed Home Inspector (VA & TN)  
Angle Square Inspections LLC  
(423) 797-8802  
support@anglesq.com

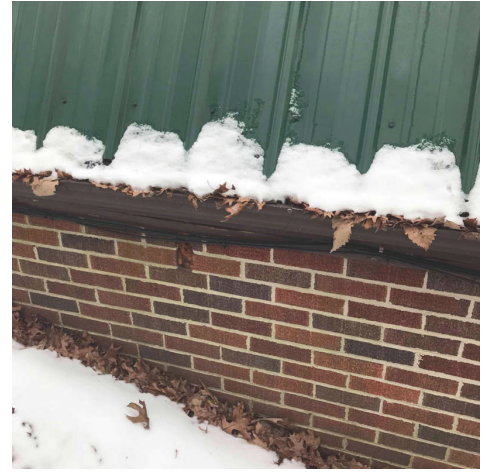
2.2.1 Gutters/drains

### CLOGGED GUTTERS/DOWNSPOUTS

EXTERIOR LEFT & RIGHT

Significant amounts of debris have accumulated in one or more gutters or downspouts. Gutters can overflow and cause water to come in contact with the building exterior, or water can accumulate around the foundation. This is a conducive condition for wood-destroying organisms. Recommend cleaning gutters and downspouts now and as necessary in the future.

Recommendation  
Recommended DIY Project

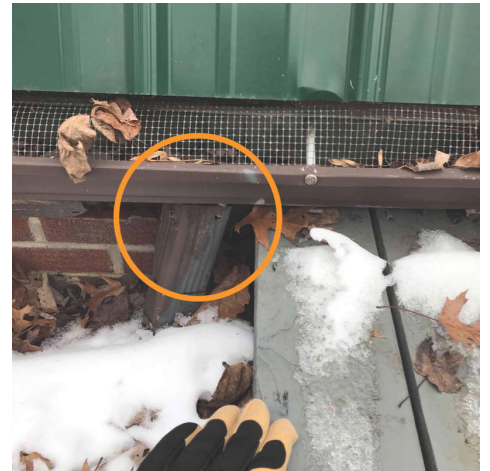
### 2.2.2 Gutters/drains

## DAMAGED/MISSING

EXTERIOR RIGHT

One or more gutters or downspouts were damaged or missing. Rainwater can come in contact with the building exterior or accumulate around the building foundation as a result. Recommend that a qualified person repair as necessary.

Recommendation  
Contact a qualified professional.

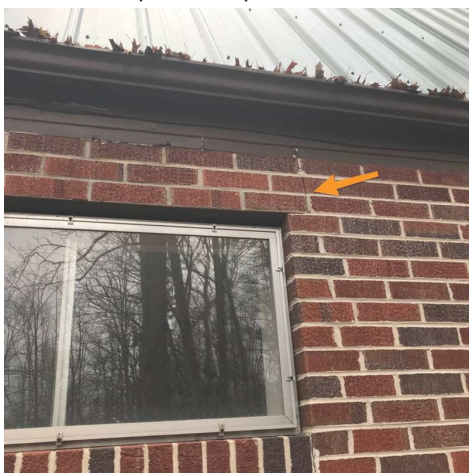
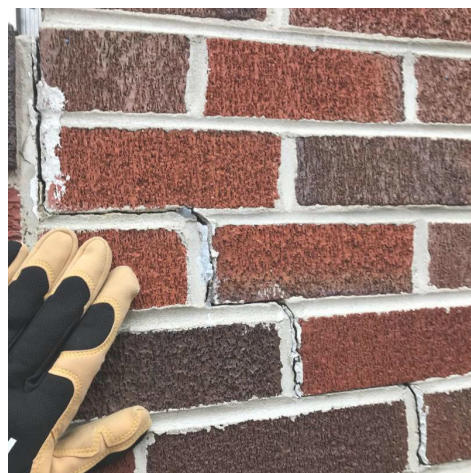
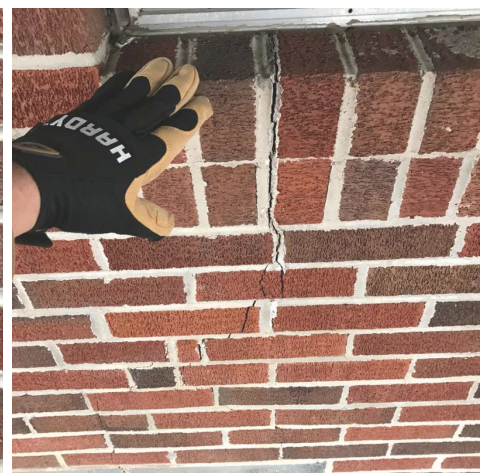
### 3.1.1 General

## EXPANSION CRACKS IN MASONRY WALL

EXTERIOR

Expansive cracks are often seen above and around window and door openings where the opening itself relieves the crack. This type of crack has a consistent width and it is this that distinguishes from other more serious cracks. An expansive crack is of no real structural significance, although it may allow water into the cavity in brick built houses, and subsequence cause deterioration of the wall ties. Therefore filling the crack with a mastic or sealastic compound is recommended.

Recommendation  
Contact a qualified professional.

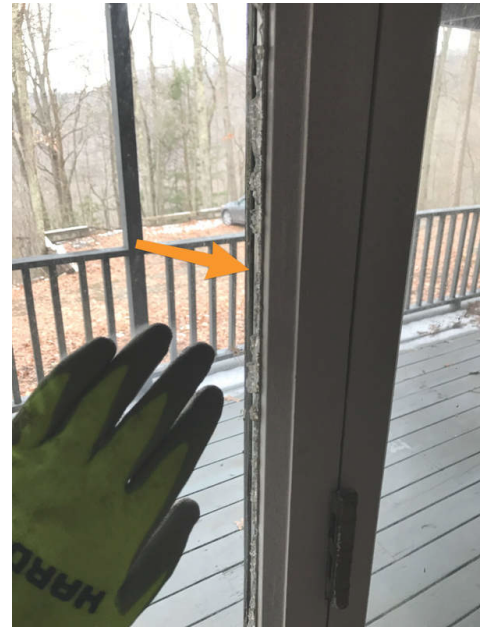
3.5.1 Windows and Door

**BROKEN WINDOW**

BASEMENT EXTERIOR DOOR

The interior window pane of the basement exterior door is broken. A licensed window repair contractor should replace the glass as needed.

Contact a qualified window repair/installation contractor.

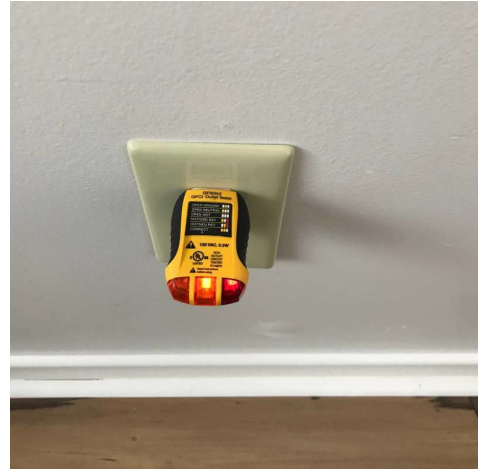
4.1.2 Electrical

**HOT-NEUTRAL REVERSE**

UPSTAIRS BEDROOM

One or more electric receptacles had reverse-polarity wiring, where the hot and neutral wires were reversed. This is a shock hazard.

Recommend that a qualified electrician repair as necessary.

Contact a qualified electrical contractor.

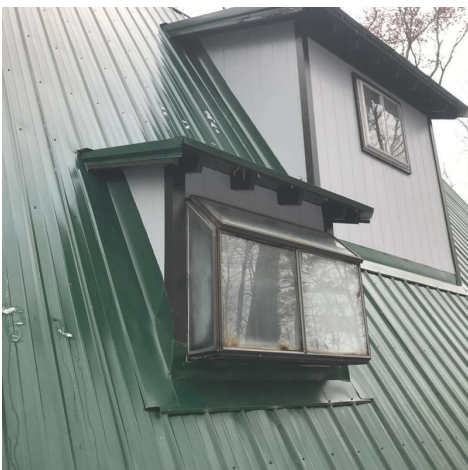
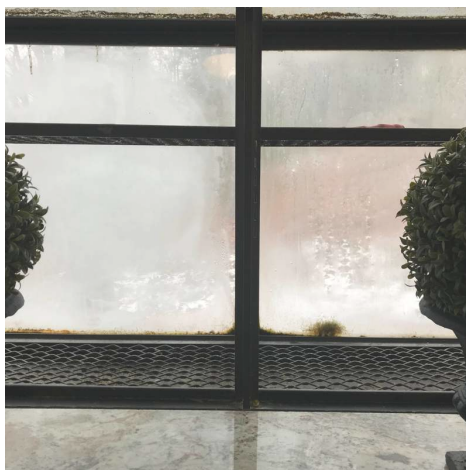
#### 4.4.1 Windows and Door

### **WINDOW-DOUBLE PANE SEAL**

#### KITCHEN

Seals between double-pane glass in one or more windows appear to have failed based on condensation or stains between the panes of glass. A qualified contractor should evaluate and replace glass where necessary.

Contact a qualified window repair/installation contractor.

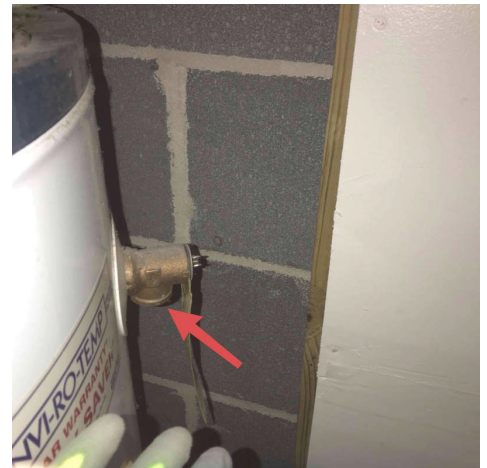
## 6.1.1 Water Heater

### TPR DRAIN MISSING

BASEMENT

No drain line is installed for the temperature-pressure relief valve. This is a potential safety hazard due to the risk of scalding if someone is standing next to the water heater when the valve opens. A qualified plumber should install a drain line as per standard building practices. For example, extending to 6 inches from the floor, or routed so as to drain outside.

Contact a qualified plumbing contractor.

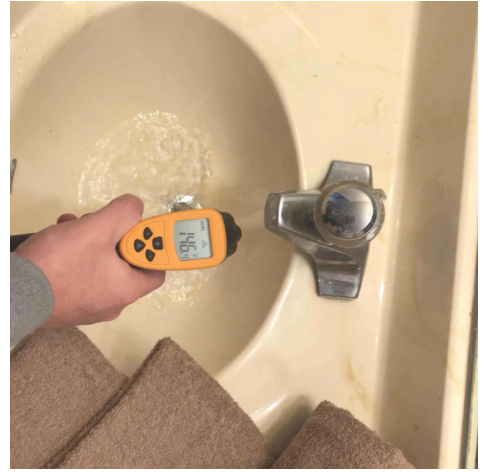
## 6.1.3 Water Heater

### TEMPERATURE >120

The hot water temperature is greater than 120 degrees Fahrenheit. This is a safety hazard due to the risk of scalding. The thermostat should be adjusted so the water temperature doesn't exceed 120 degrees.

Contact a qualified plumbing contractor.

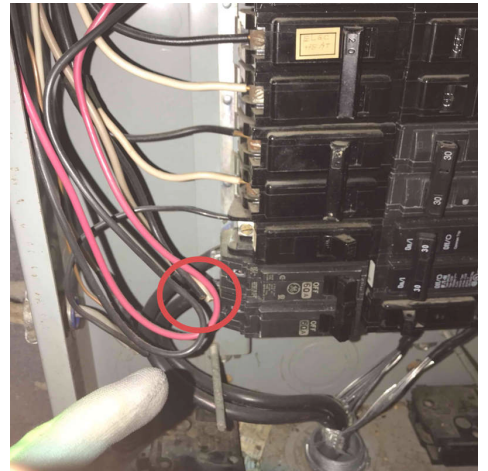
### 7.1.1 Electric Panel

#### **WIRE NOT TERMINATED**

BASEMENT

One or more wires inside panel were loose, and were not terminated. This poses a safety hazard for shock and/or fire. Recommend that a qualified electrician remove any abandoned wiring or repair as necessary. For example, by trimming wires to length and installing wire nuts.

Contact a qualified electrical contractor.

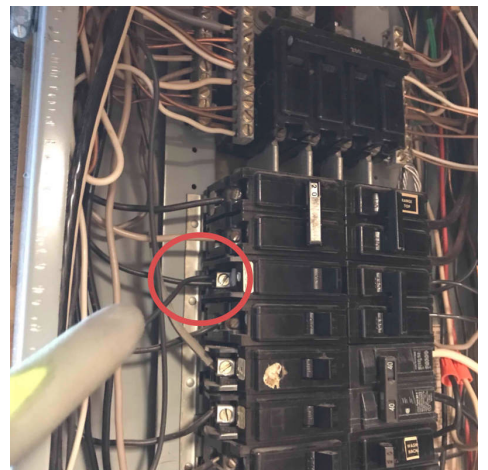
### 7.3.1 Circuit Breakers

#### **DOUBLE TAP**

BASEMENT

One or more circuit breakers in panel were "double tapped," where two or more wires were installed in the breaker's lug. Most breakers are designed for only one wire to be connected. This is a safety hazard since the lug bolt can tighten securely against one wire but leave other(s) loose. Arcing, sparks and fires can result. Recommend that a qualified electrician repair as necessary.

Contact a qualified electrical contractor.

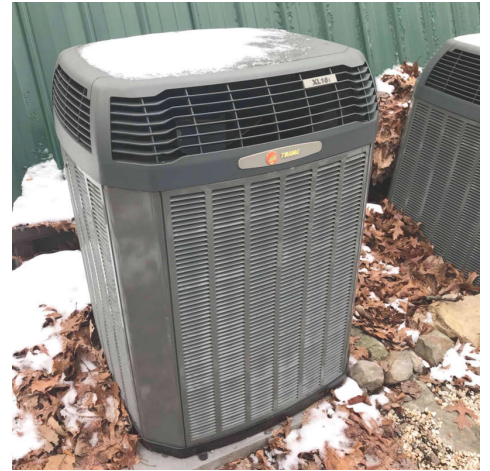
### 8.2.2 Condensing Unit (Left)

#### **NOT LEVEL**

EXTERIOR LEFT

The outside condensing unit is not level. Damage may occur if it is more than ten degrees off from level. A qualified contractor should evaluate and make repairs as necessary, such as replacing the pad that the condensing unit is installed on.

Recommendation  
Contact a qualified HVAC professional.

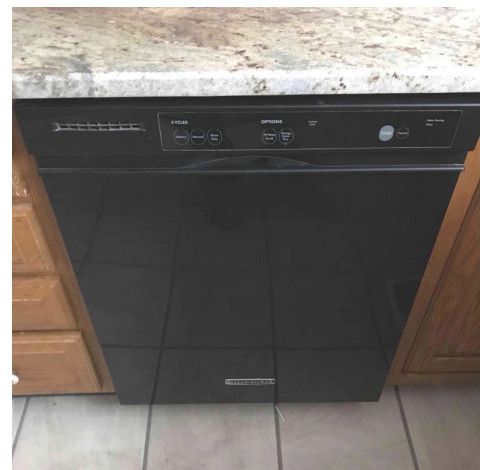
### 10.2.1 Dishwasher

#### **DISHWASHER CONTROLS**

KITCHEN

The controls for the dishwasher did not function as expected. The control panel for the dishwasher should be evaluated. The client(s) should ask the property owner(s) about this, and if necessary, the dishwasher should be replaced, or a qualified appliance technician should evaluate and repair.

Recommendation  
Contact a qualified appliance repair professional.

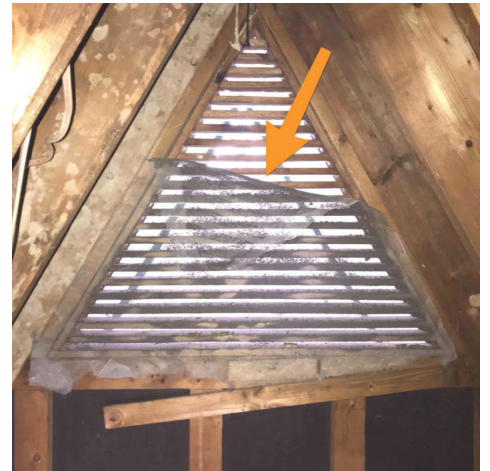
14.5.1 Ventilation

**DAMAGED SCREEN**

ATTIC

One or more attic or roof vent screens were missing, deteriorated or substandard. Recommend that a qualified person replace or repair screens as necessary to prevent birds or vermin from entering the attic.

Contact a qualified general contractor.

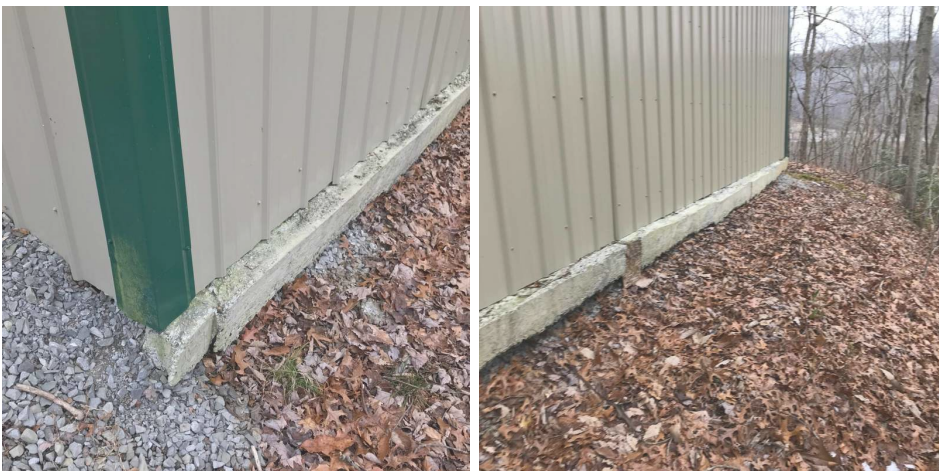
15.1.1 Carport-Detached Garage

**EROSION OBSERVED**

Erosion has created voids beneath the slab on the outer sections of the slab. No signs of structural issues were observed at the time of inspection. Further evaluation by a qualified contractor is recommended.

Contact a qualified professional.
