SUMMARY

1234 Main St. Beaverton OR 97006

Buyer Name
05/22/2019 9:00AM

Grant Waller
OCHI 1950, CCB 213007
PacWest Home Inspections
503-217-2000
grant@pw-hi.com

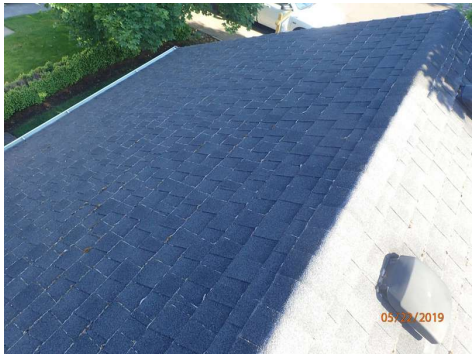
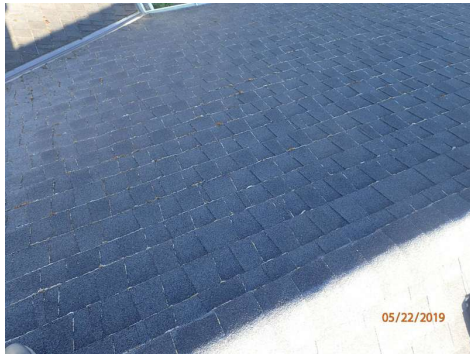
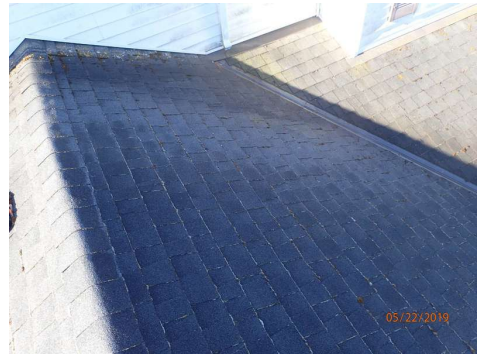
2.1.2 Coverings

MOSS

Recommend cleaning and removing any moss from the roof, after which a moss treatment plan can be established to limit future growth. Avoid power washing the moss off because that can drive moisture under the shingles, damaging the underlying roof components. If the roof is to high or steep, recommend contacting a licensed roofing contractor or moss removal specialist.

Moss growth is usually greatest on north-facing roofs, roof areas shaded by trees and other places that are not exposed to enough sun to dry out.

Once established, it acts like a sponge, soaking up and storing rainwater. Some of that water then wicks up under the shingles through capillary action and soaks into and through the roof underlayment, which is typically 15- or 30-pound felt. Eventually, it saturates the roof sheathing below.

Moss can shorten the life span of a shingled roof and result in costly repairs both structural and cosmetic that would not be necessary if the roof were maintained properly and kept clear of moss.

Contact a handyman or DIY project

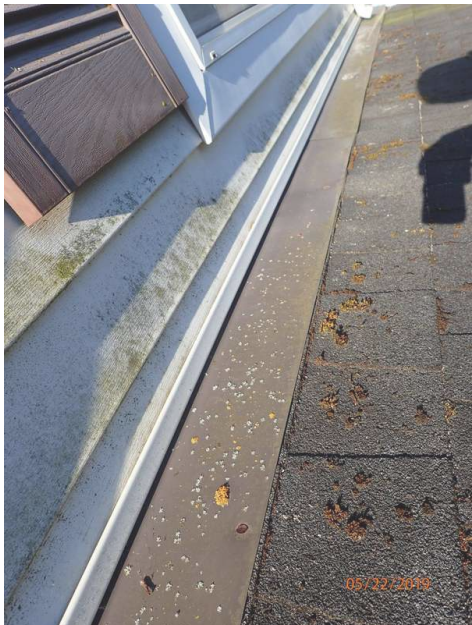
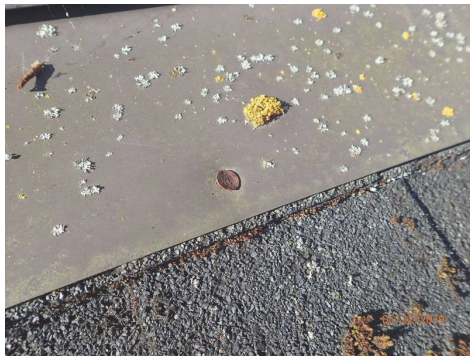
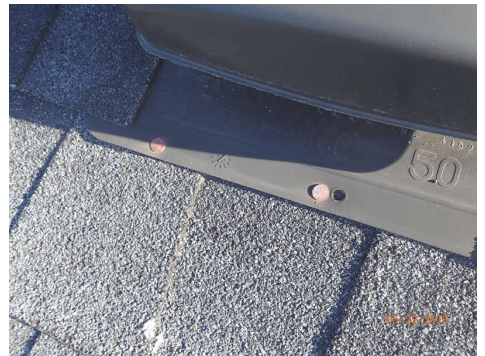
2.1.3 Coverings

FASTENERS - SEAL

During the inspection one or more nails/fasteners was observed to be lacking sealant or a rubber gasket to prevent a leak. Recommend a qualified roofing contractor evaluate and repair.

Contact a qualified roofing professional.

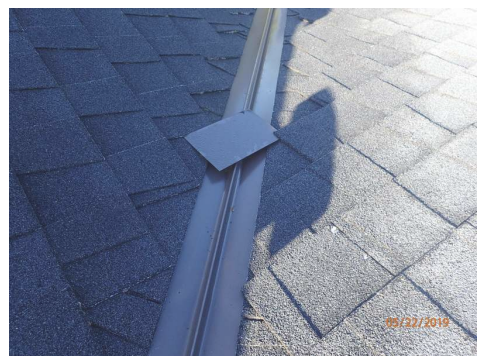
2.1.4 Coverings

DEBRIS - CONSTRUCTION

A piece of flashing was found lodged into the valley. This flashing was not able to be identified from anything necessary in the area and no leaks were noted in the attic. Recommend removing this and monitoring the roof closely as it ages.

Contact a qualified professional.

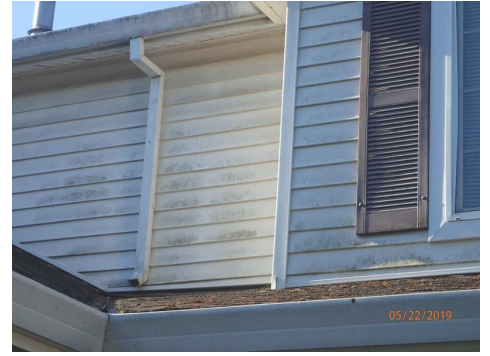
3.1.1 Siding

VINYL SIDING - DIRTY

Moss and dirt are heavy on several locations of the vinyl siding. Recommend cleaning to help Maximize life span.

Recommendation
Contact a qualified professional.

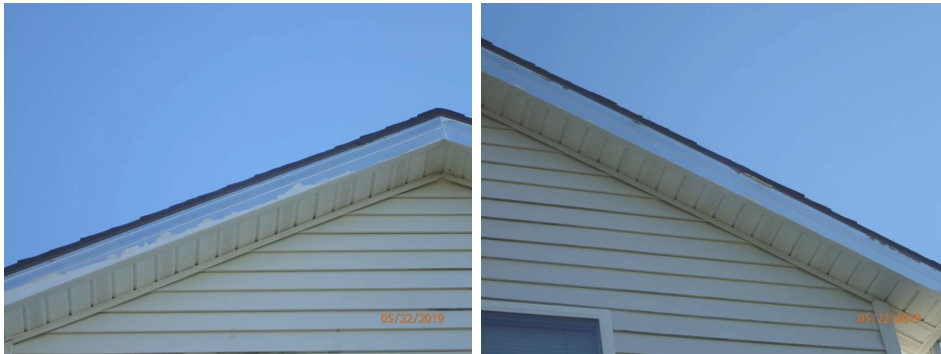
3.5.1 Eaves, Soffits & Fascia **PAINT/FINISH FAILING** SOUTH

Paint is peeling from the south fascia.

Recommendation
Contact a qualified painting contractor.

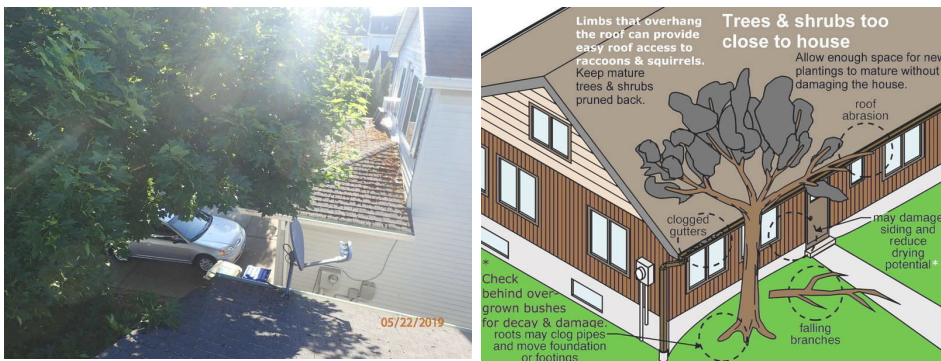
3.8.1 Vegetation, Grading, Drainage & Retaining Walls **TREE OVERHANG**

Trees observed overhanging the roof. This can cause damage to the roof and prevent proper drainage. Recommend a qualified tree service trim to allow for proper drainage.

Recommendation
Contact a qualified landscaping contractor

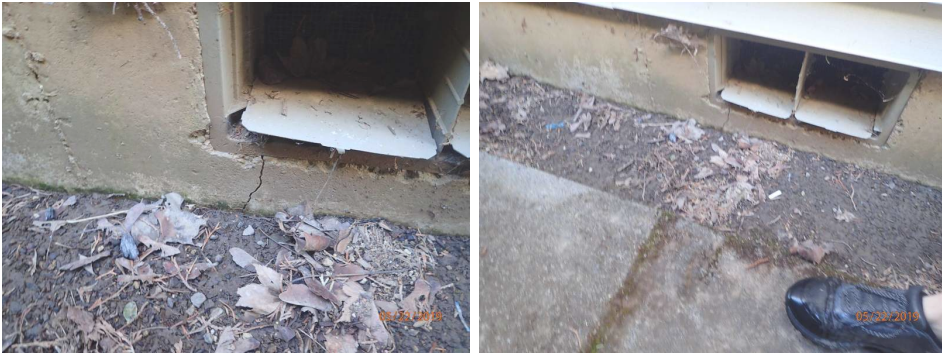
4.1.1 Foundation **SETTLING CRACKS** EAST SIDE

Settling cracks were noted at the foundation. This is common as concrete ages and shrinkage surface cracks are normal near breathing vents where the concrete is weakest. Recommend monitoring for more serious shifting/displacement.

Recommendation
Recommend monitoring.

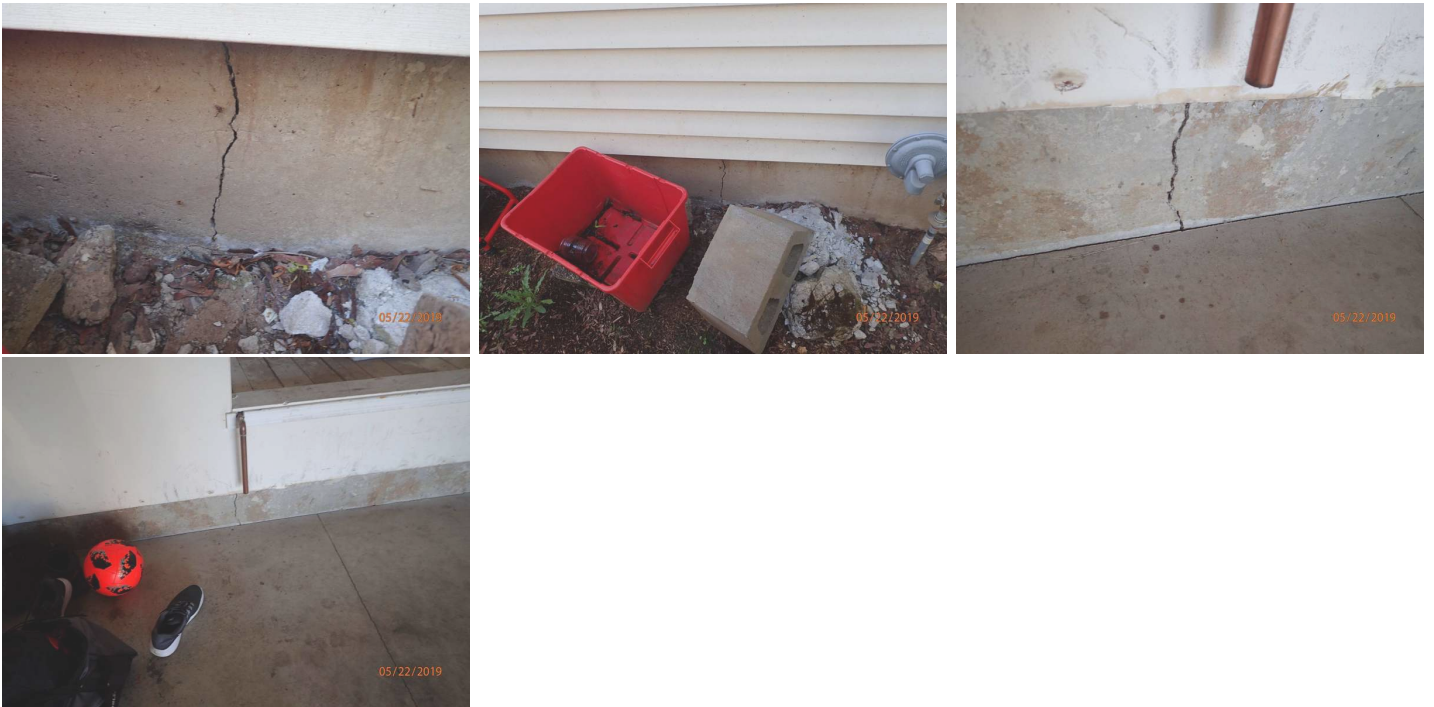
4.1.2 Foundation

FOUNDATION CRACKS-

EAST SIDE, GARAGE

Moderate cracking was noted at the foundation in one or more locations. This is common as concrete ages and shrinkage but cracks of this size are generally influenced by additional settling. Recommend monitoring for more serious shifting/displacement.

A foundation contractor should be consulted if the crack ever grows.

Recommendation
Recommend monitoring.

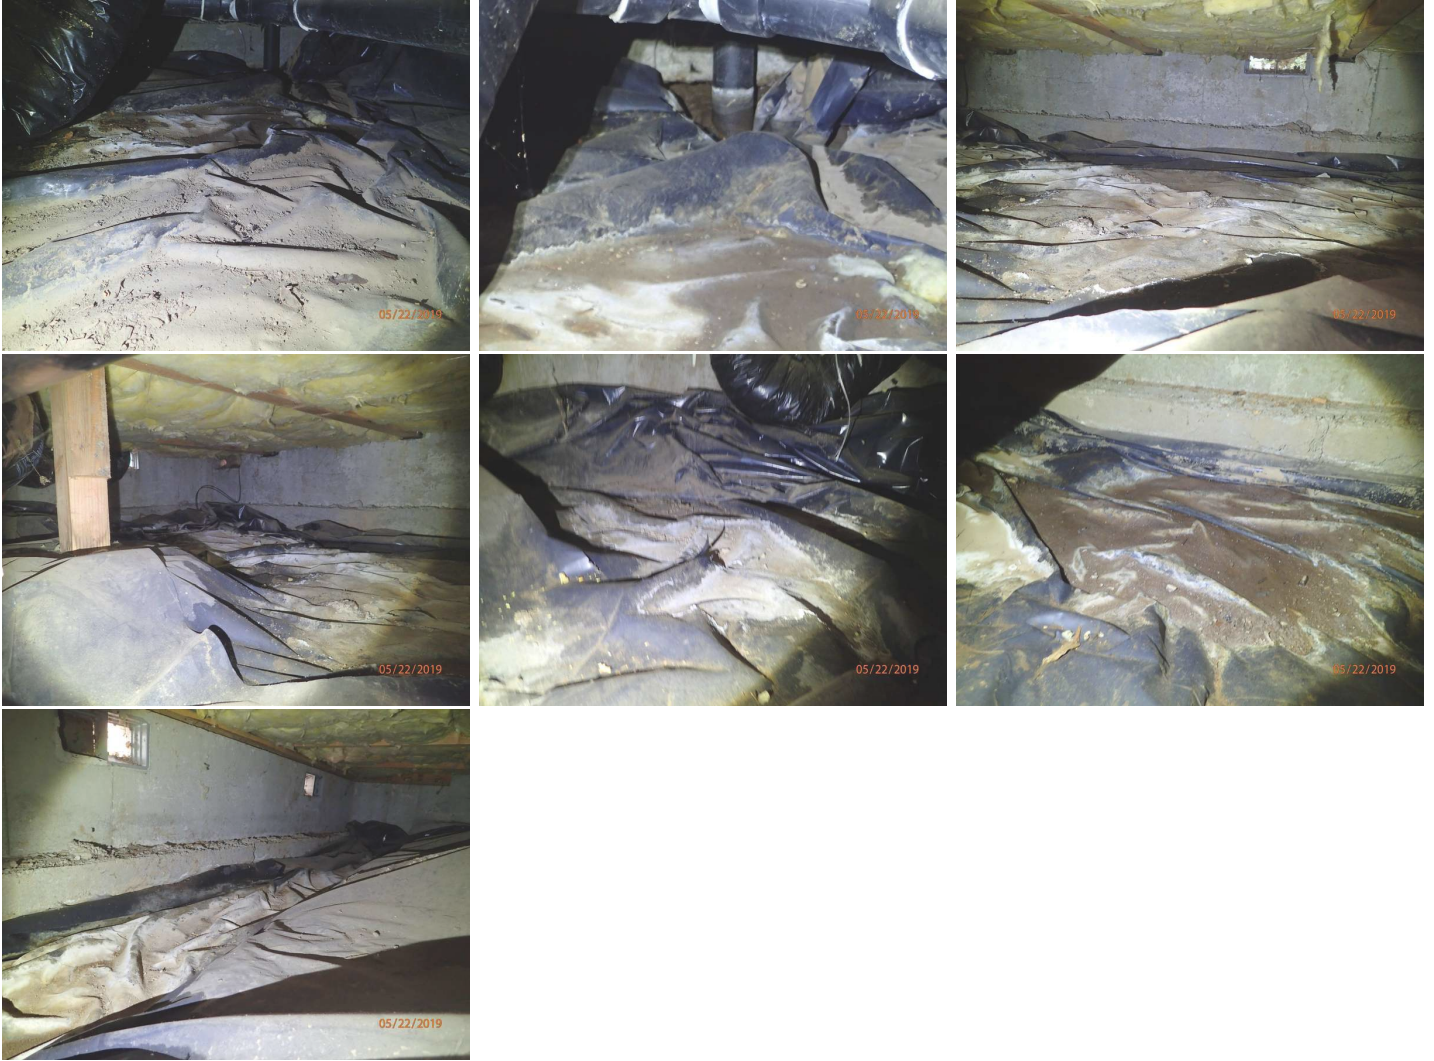
4.2.1 Basements & Crawlspaces

SILT STAINS/DIRT ON PLASTIC/FLOOR

Silt, water stains, and/or mud/dirt on the floor of a basement or the plastic of a crawl space generally indicate there was moisture there at one time. Recommend monitoring for future moisture intrusion.

Recommendation
Recommend monitoring.

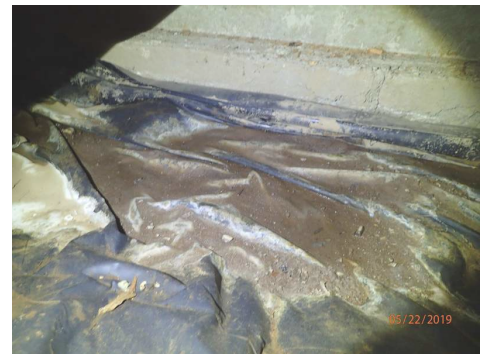
4.2.2 Basements & Crawlspaces

STANDING WATER

Standing water is present on basement / crawl space floor. Recommend a qualified contractor evaluate and locate potential source of moisture. A water mitigation system may be necessary for proper moisture management.

Recommendation
Contact a qualified environmental contractor

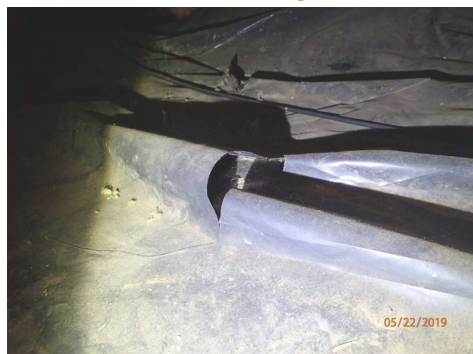
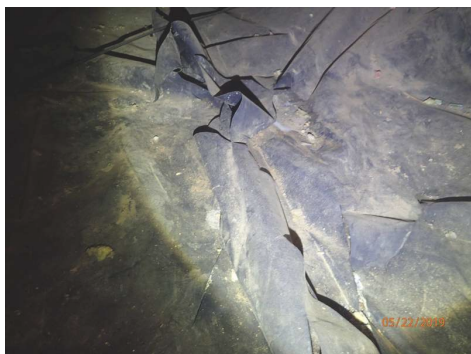
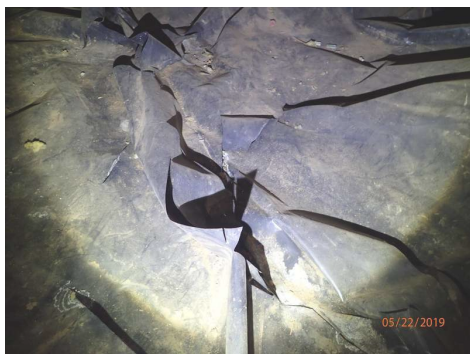
4.2.3 Basements & Crawlspaces

VAPOR BARRIER - CUT

The vapor barrier / visqueen was found cut during the inspection. This is generally an indication that there has been standing water at one point. As moisture gets on top of the plastic sheeting (whether from a leaking pipe or groundwater) it has a hard time draining and has to evaporate over time. This will typically leave silt stains that can show us how much moisture there might have been. The cuts in the plastic allow this moisture to drain and keep moisture levels low. The cuts in the plastic also defeat a small part of the purpose of having the vapor barrier (keeping the vapor/moisture under the plastic and away from the home). Recommend monitoring the crawl space during winter months for excess moisture and be prepared to install a water mitigation system if necessary. In the following years if there is no moisture, it would be advised to replace the cut vapor barrier.

Recommendation
Recommend monitoring.

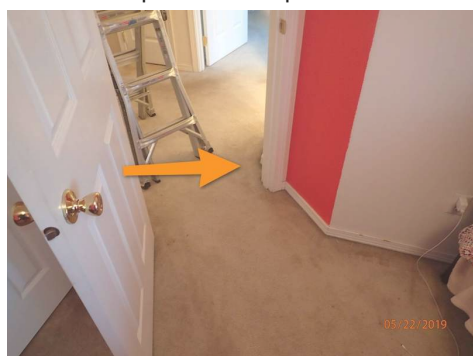
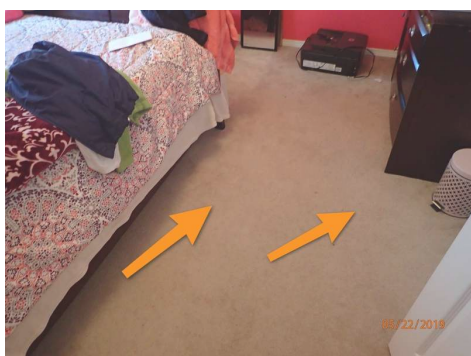
4.3.1 Floor Structure

SUBFLOOR - SQUEAKING

2ND FLOOR HALL, SW BEDROOM

The subfloor in one or more locations was creaking and squeaking more than typically found. Recommend a licensed carpenter to further evaluate and repair as desired.

Recommendation
Contact a qualified carpenter.

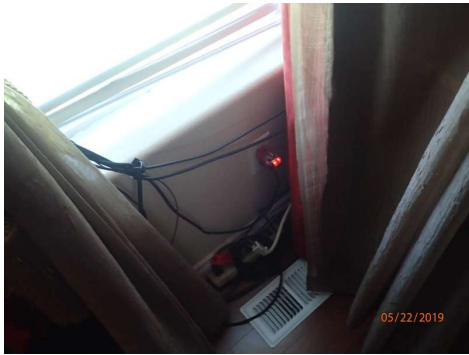
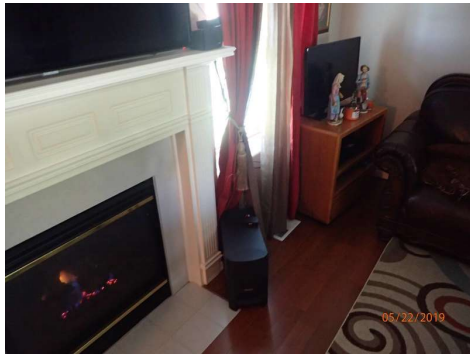
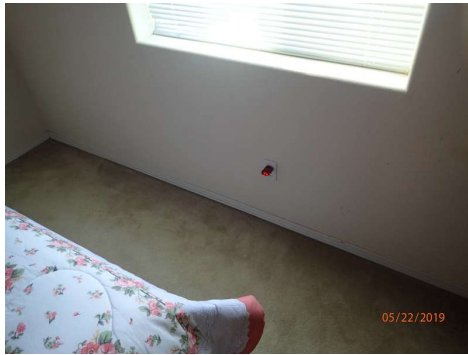
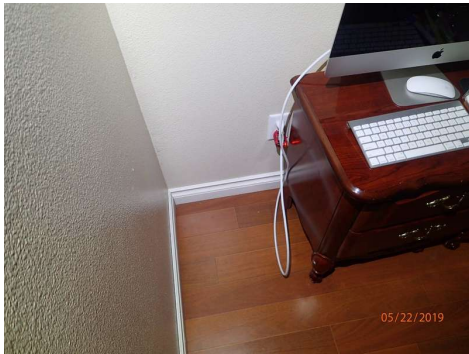
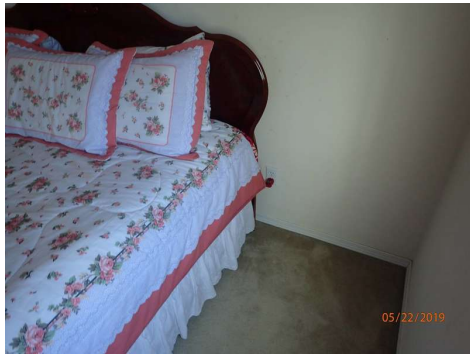
5.4.1 Outlets, Switches, Fixtures & Junction Boxes

OUTLET - LOOSE

LIVING ROOM, MASTER BEDROOM

One or more outlets is loose. Recommend tightening the receptacle and or the plate cover. Recommend hiring a licensed electrical contractor for safety if you are not comfortable with this repair.

Recommendation
Contact a qualified electrical contractor.

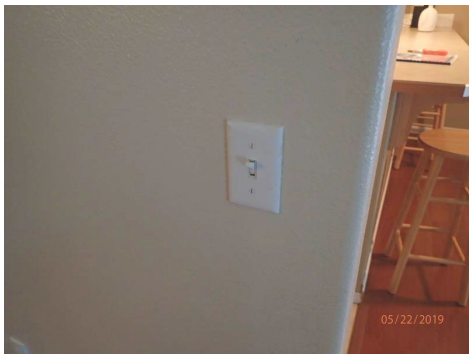
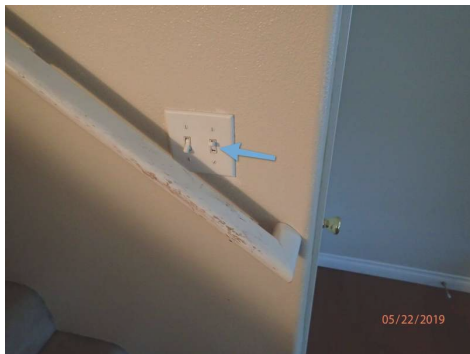
5.4.2 Outlets, Switches, Fixtures & Junction Boxes

SWITCH - UNIDENTIFIED USE

LIVING ROOM

During the inspection a use for this switch could not be verified, recommend asking the seller to clarify the purpose of this switch.

Contact a qualified professional.

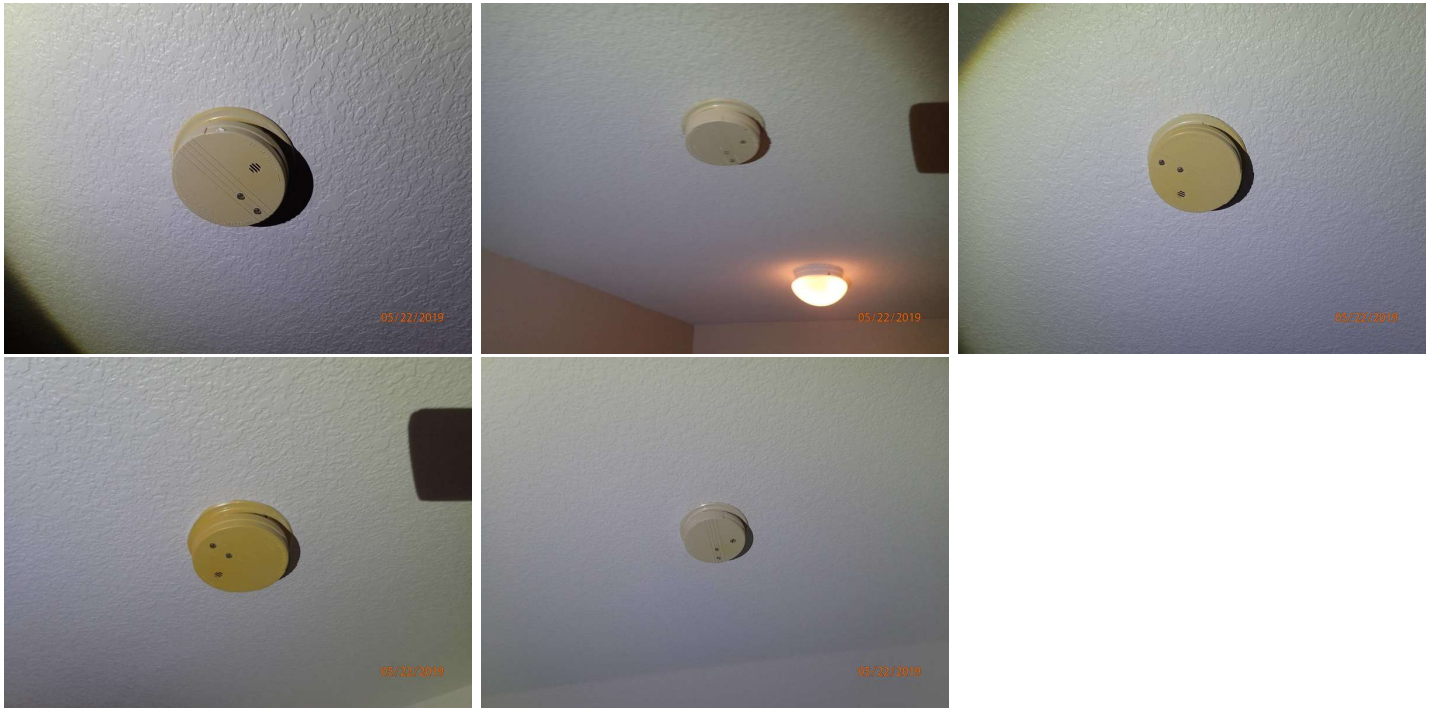
5.6.1 Smoke Detectors

OUT DATED

Some of the present smoke detectors are more than 10 years old. Nearly all smoke detectors and alarms are rated for 10 years or less. For safety it is recommend that any smoke detector or alarm older than 10 years be replaced and then tested. If the unit is wired, it must be replaced by another wired unit.

Contact a qualified professional.

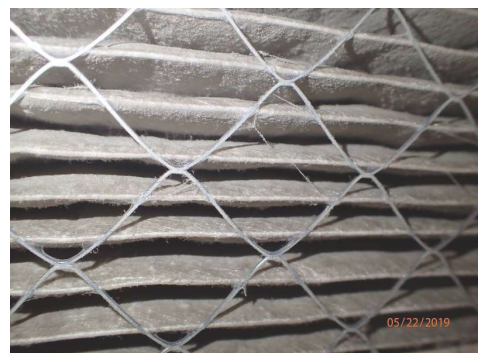
6.1.1 Equipment

FILTER - DIRTY

The furnace filter is dirty and needs to be replaced every 2-3 months for 1" thick filters and 4-6 months for 4" thick filters.

Contact a handyman or DIY project

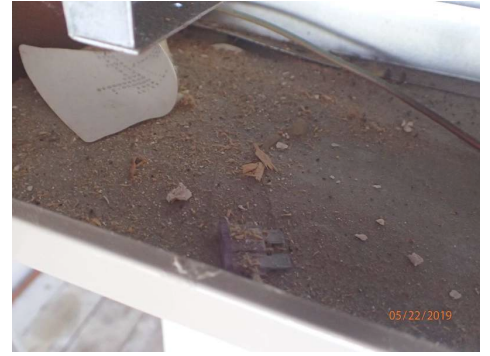
6.1.2 Equipment

FURNACE - SERVICING/CLEANING

Furnace should be cleaned and serviced annually. Recommend a qualified HVAC contractor clean, service and certify furnace.

Recommendation
Contact a qualified HVAC professional.

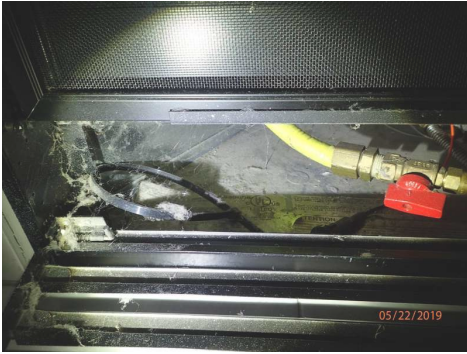
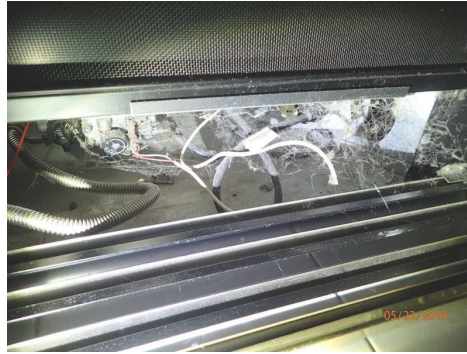
6.5.1 Gas/LP Firelogs & Fireplaces

DUST/DEBRIS

Recommend cleaning under and above the fireplace insert regularly for safety.

Recommendation
Contact a handyman or DIY project

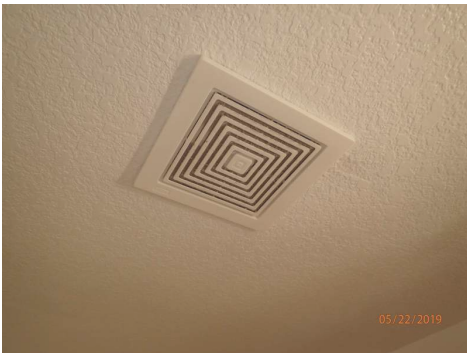
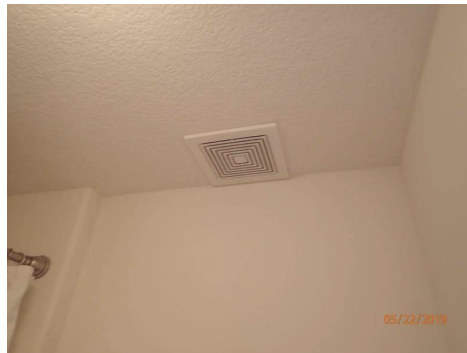
7.5.1 Exhaust Systems

EXHAUST FAN- DIRTY

2ND FLOOR HALL BATHROOM, MASTER BATHROOM

Over time the exhaust fan covers will begin to clog from lint and dust. This can greatly reduce the efficiency of the exhaust fan. Recommend cleaning on a regular basis to allow for efficient use.

Recommendation
Contact a handyman or DIY project

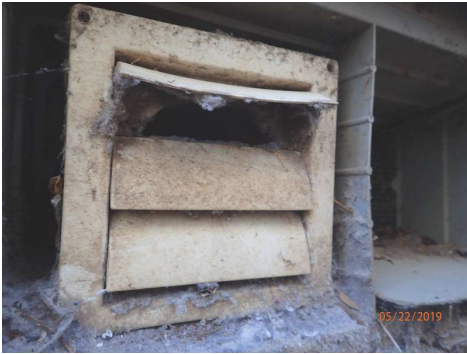
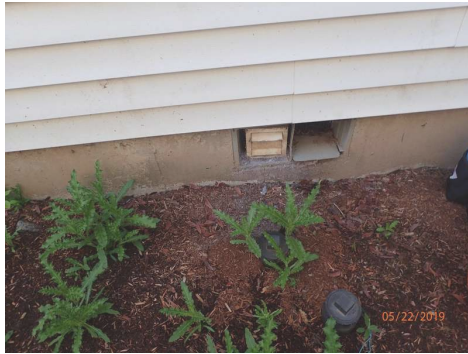
7.5.2 Exhaust Systems

EXHAUST VENT - EXTERIOR OBSTRUCTED

One or more of the exhaust vents to the exterior has noticeable lint or other debris clogging the pipe. This can reduce the effectiveness of the dryer or exhaust fan, increase the chance of a fire, and allow pests to enter the venting if the end cap is propped open from lint. Recommend cleaning on a regular basis.

Contact a handyman or DIY project

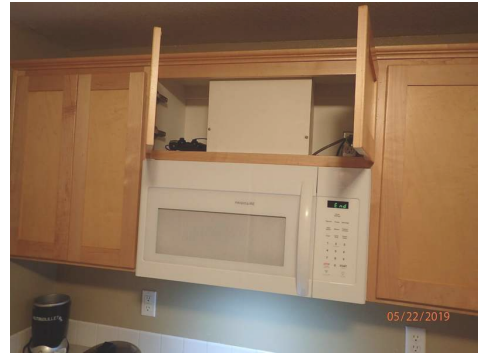
7.5.3 Exhaust Systems

RANGE HOOD - DISCHARGE

The range hood is not discharging to the exterior, recommend a qualified contractor to further evaluate and repair or install ducting.

The diverter plate needs to be removed or adjusted to allow for use of the exterior venting.

Contact a qualified professional.

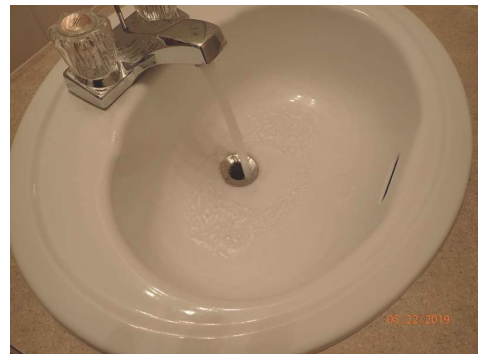
8.4.1 Sink, Basin, Laundry Tub

DRAIN STOP - MISSING

HALF BATH

During the inspection one or more of the sinks was found to be missing its drain stop, this will limit the inspection and not allow to test the overflow. Recommend installing a drain stop or plug.

Contact a qualified plumbing contractor.

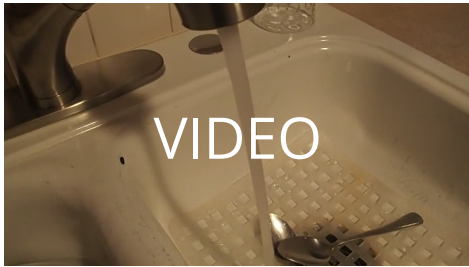
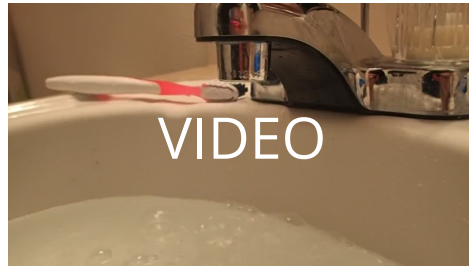
8.4.2 Sink, Basin, Laundry Tub

FIXTURE - SUPPLY INSUFFICIENT

KITCHEN, 2ND FLOOR HALL BATHROOM

Water supply was found insufficient. This could be in result of a kinked line, damaged or clogged valve, or clogged/deteriorating pipe. Recommend a licensed plumber to further evaluate and repair.

Contact a qualified plumbing contractor.

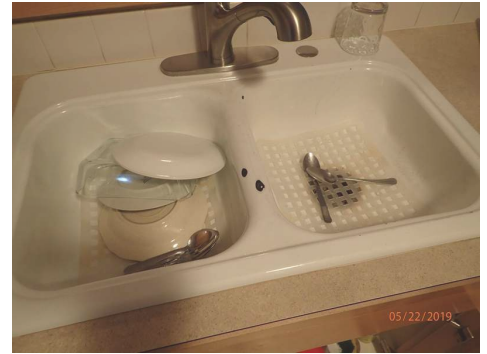
8.4.3 Sink, Basin, Laundry Tub

SINK - SURFACE DAMAGE

The sink has surface damage that is cosmetic but could also lead to a potential leak in the future. Recommend replacing the fixture at your own convenience.

Contact a qualified plumbing contractor.

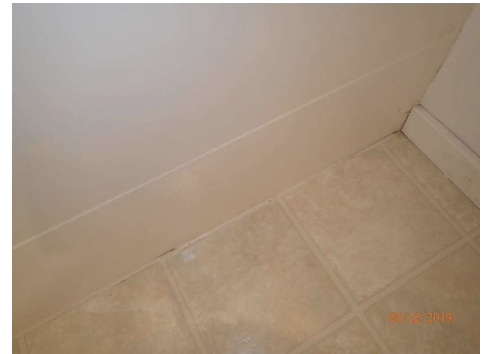
8.6.1 Tub / Shower

CAULKING/GROUT FAILING

2ND FLOOR HALL BATHROOM

Some of the caulking or grout in the bath and or shower area is failing. Caulking/grout is one of the most common items to fail in the bathroom. Because of its common failure rate it is also one of the largest contributors moisture damage in the bathroom. Recommend removing, cleaning, caulking/grouting, and inspecting on a regular basis to control the moisture in the bathroom.

Contact a handyman or DIY project

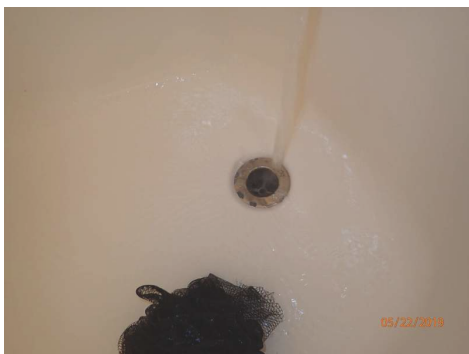
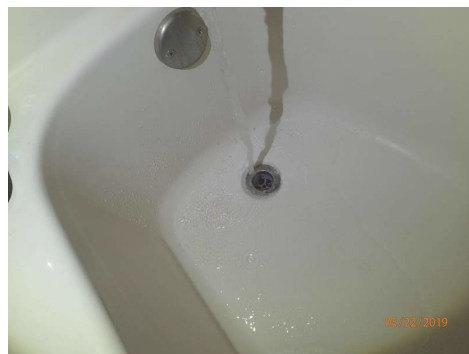
8.6.2 Tub / Shower

TUB/SHOWER - DRAIN STOP MISSING / INADEQUATE

2ND FLOOR HALL BATHROOM, MASTER BATHROOM

During the inspection there was no way to properly plug the drain and fill the tub. Recommend replacing with a new drain stop or plug.

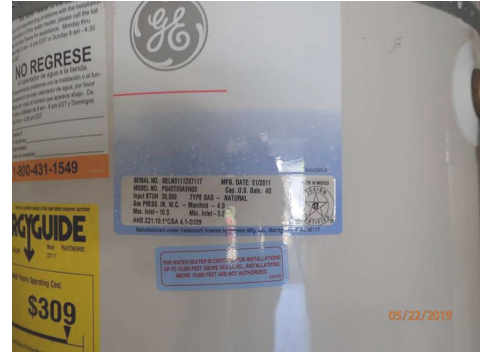
8.7.1 Water Heater
APPROACHING LIFE EXPECTANCY

8
 The estimated useful life for most water heaters is 8 to 12 years. This water heater appears to be approaching this age and may need replacing at any time. Recommend budgeting for a replacement in the near future.

Recommendation
 Contact a qualified plumbing contractor.

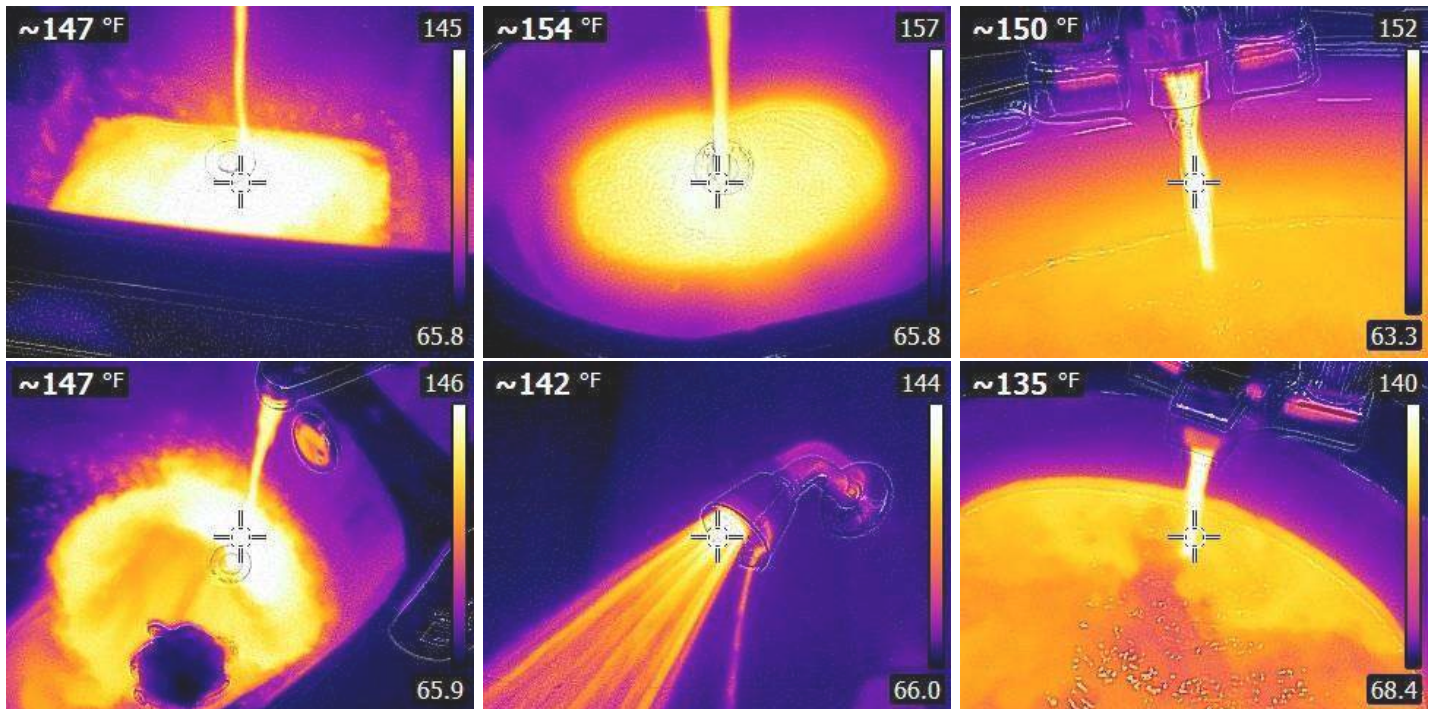
8.7.2 Water Heater
WATER TEMP UNSAFE

The water heater is turned up to produce water hotter than 120 degrees at the fixtures. This can generally be fixed by adjusting the thermostat at the water heater. Some styles such as electric water heaters may require the removal of panels which can leave you exposed to active electrical. Recommend contacting a licensed plumbing contractor if you are not comfortable in safely lowering the temperature.

Recommendation
 Contact a qualified professional.

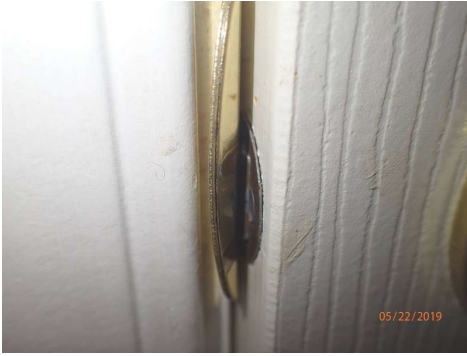
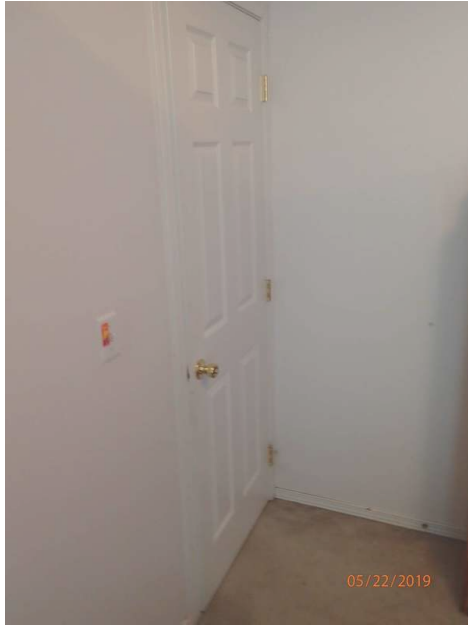
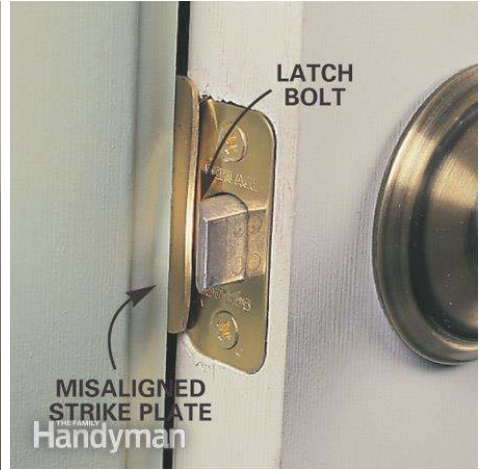
9.1.1 Doors
DOOR - LATCH ALIGNMENT
 2ND FLOOR NORTHWEST BEDROOM

Door latch and/or strike plate is out of alignment. Recommend a handyman repair.

Contact a handyman or DIY project

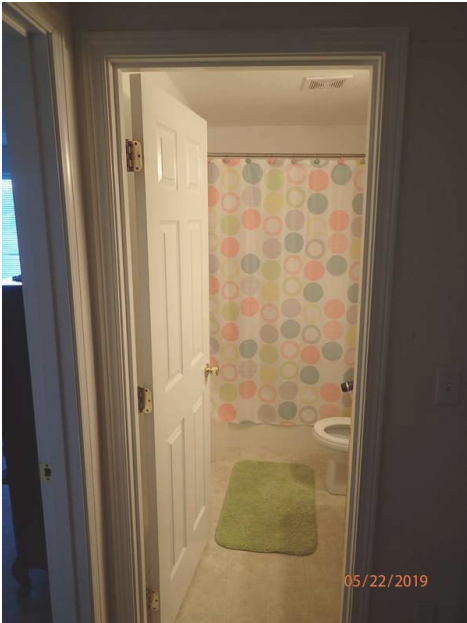
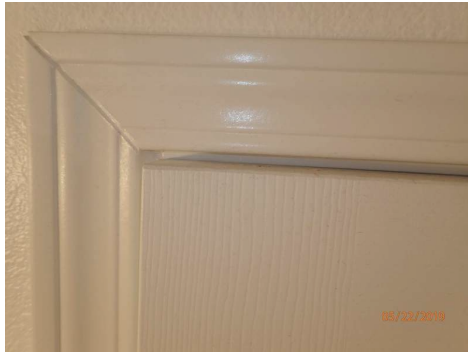
9.1.2 Doors

DOOR - POOR ALIGNMENT

2ND FLOOR HALL BATHROOM

The doors alignment will not allow it to open or close properly. Recommend adjusting to allow for proper use.

Contact a qualified door repair/installation contractor.

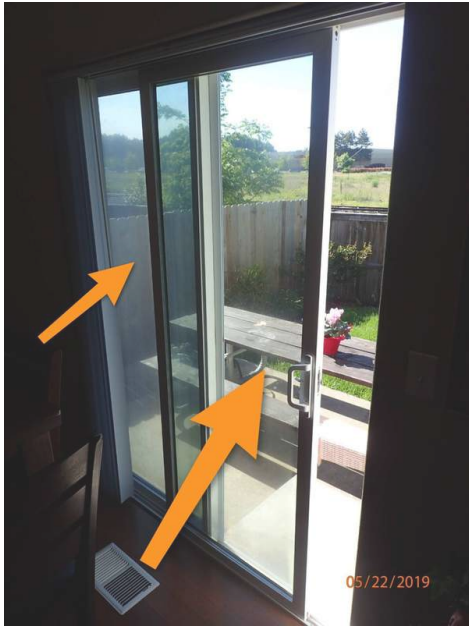
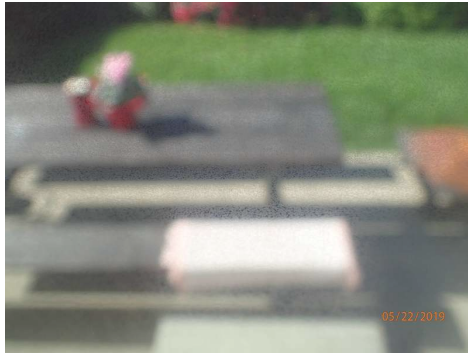
9.2.1 Windows

WINDOW - BROKEN SEAL

SLIDER

Observed condensation/debris between the window panes, which indicates a failed seal. Recommend a licensed and qualified window contractor to further evaluate & replace.

Contact a qualified window repair/installation contractor.

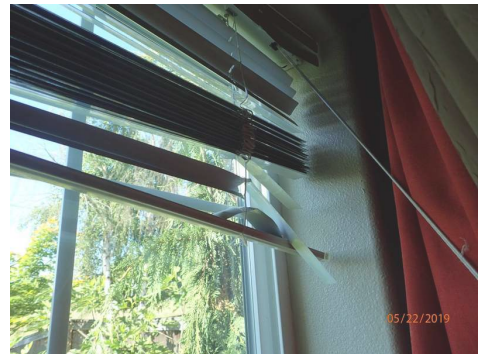
9.2.2 Windows

BLINDS - DAMAGED

LIVING ROOM

One or more blinds were found damaged or no operating properly during the time of inspection.

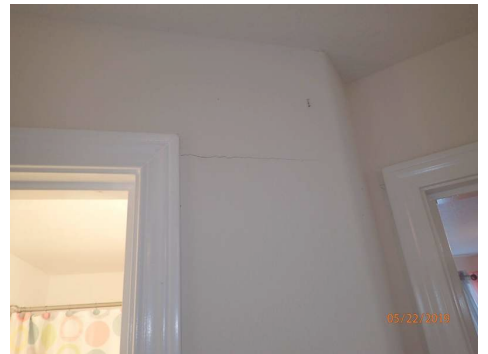
9.4.1 Walls

SETTLING CRACKS

2ND FLOOR HALL

Minor cracks on the walls in one or more locations. Appeared to be the result of long-term settling. Some settling is not unusual in a home of this age and these cracks appear not to be a structural concern.

Contact a qualified drywall contractor.

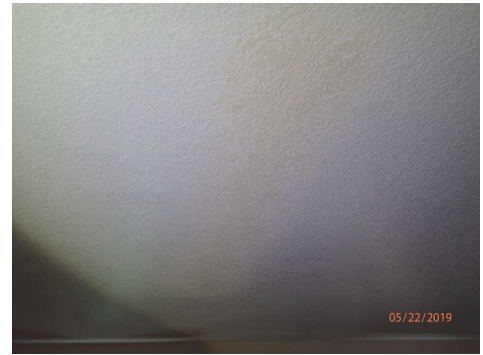
9.5.1 Ceilings

PATCHED

LIVING ROOM

One or more areas of the ceiling have been patched. This may have been from physical damaged or a leaking fixture/roof above. Recommend monitoring for future issues.

Recommend monitoring.

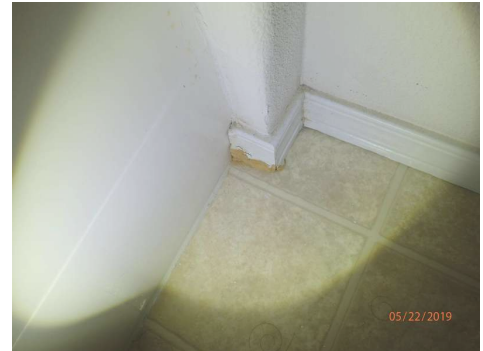
9.7.1 Trim

FLOOR TRIM - MOISTURE DAMAGE

MASTER BATHROOM

One or more areas of the flooring trim has signs of previous moisture damage. In areas such as a bathroom this could be caused from water splashing out of a bathtub/shower, a toilet or sink overflowing or leaking, or a leaking valve. In other areas the moisture source can be from wet debris, leaking pipes, or even a leak in the roof. Recommend monitoring and seeking further assistance if the problem persists.

Contact a qualified carpenter.

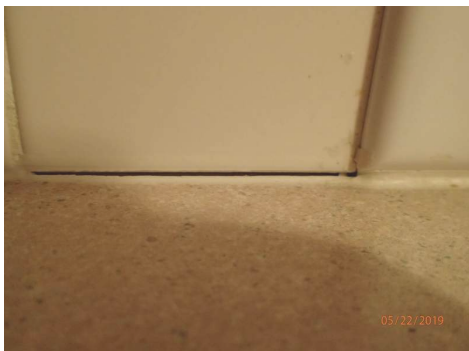
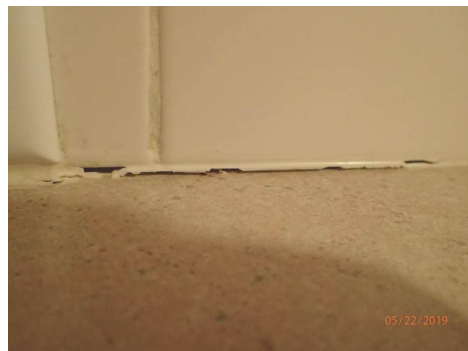
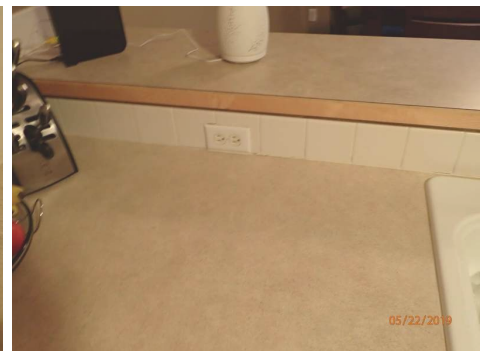
9.8.1 Countertops & Cabinets

COUNTERTOP - DETERIORATION CAULK/GROUT

Countertops have deteriorating grout and or insufficient caulk/sealant at the wall. This can lead to water damage. Recommend cleaning/removing existing sealant replacing at sides and corners where counters touch walls. Caulking tends to last longer in these areas due to its elasticity.

Contact a handyman or DIY project

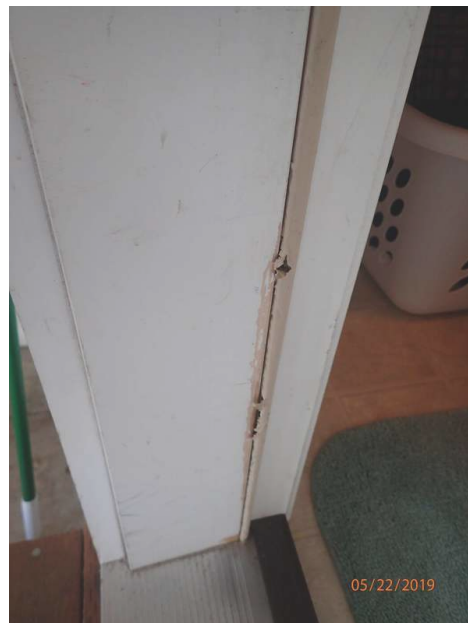
10.4.1 Occupant Door (From garage to inside of home)

SEAL - DETERIORATED

The man door into the garage is has a deteriorated weather seal. Recommend installing to properly and safely seal the garage from the inside of the house. The purpose of this seal is to assist in fire rating, prevent toxic fumes from entering the living space, and increase efficiency.

Contact a handyman or DIY project

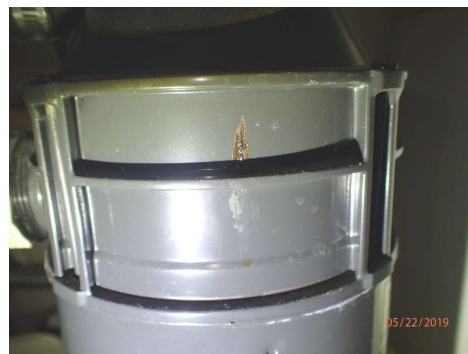
11.5.1 Garbage Disposal

DAMAGED - HOLE/CRACK

A hole/crack was found in the garbage disposal causing a leak. Often times parts can be found to repair this but it tends to be more economical to just replace the unit.
