PGR Home Inspections Page 1 of 20

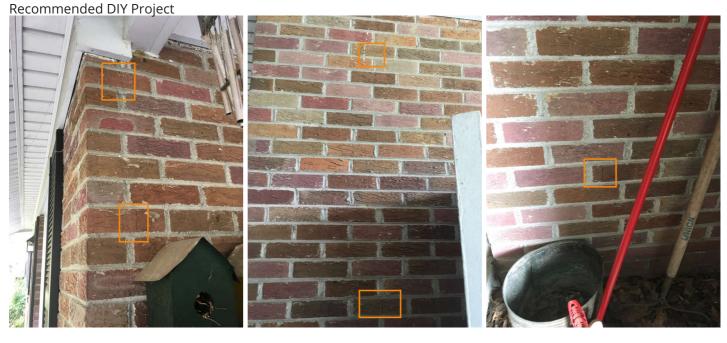
THROUGH BRICK CRACKS

Maintenance Item

Noticed several bricks that were cracked all the way through. This is a sign of settling. Recommend further evaluation from a foundation contractor to access the overall foundation.

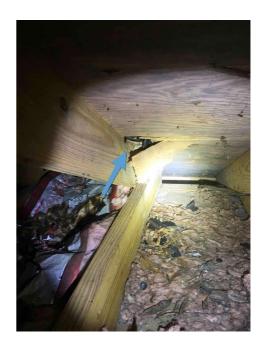
4.3.1 Attic Insulation

INSUFFICIENT INSULATION OR MISSING

Insulation depth was inadequate or missing completely. Some of the insulation was damaged to moisture making its R-value (resistance to heat transfer) extremely low. Recommend a qualified attic insulation contractor install additional insulation up to the appropriate R-value.

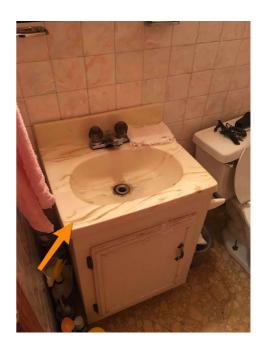
7.2.1 Sinks, Tubs/Showers, Toilets, Plumbing

CAULK/ GROUT NEEDED

Contact a handyman or DIY project

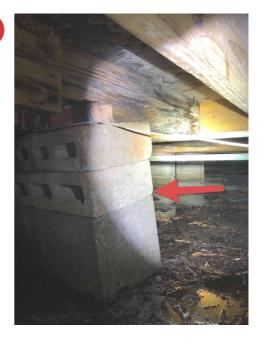
9.2.1 Basements & Crawlspaces

EFFLORESCENCE

Efflorescence noted on the crawlspace surface. This a white, powdery deposit that is consistent with moisture intrusion. This can compromise the soil's ability to support the home structure and/or lead to mold growth. Recommend a qualified contractor identify source or moisture and correct.
