SUMMARY

1234 Main St. Ringgold GA 30736

Mel Edwards
THI The Home Inspector LLC
423-902-4008
tihomeinspector@gmail.com

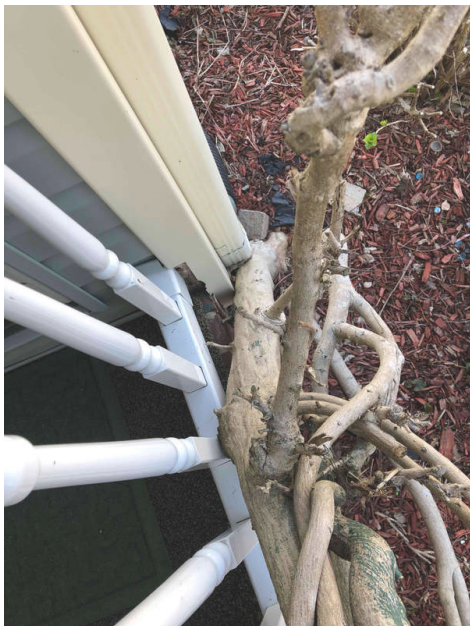
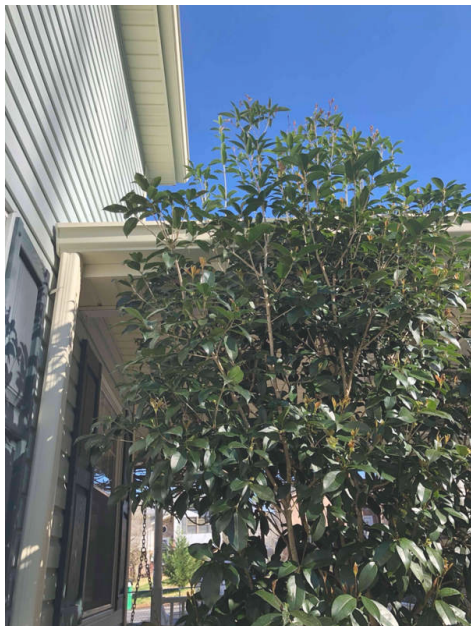
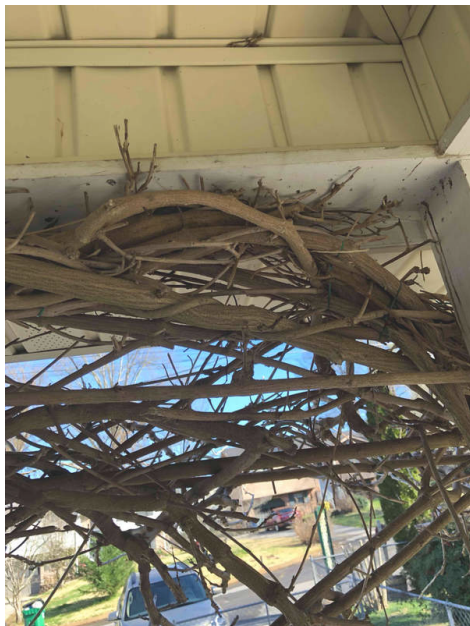
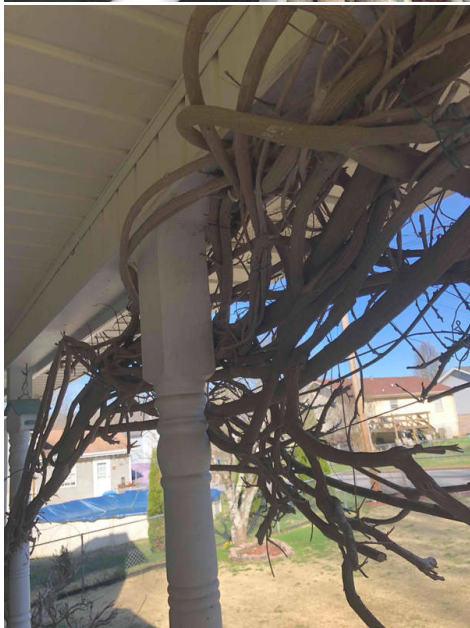
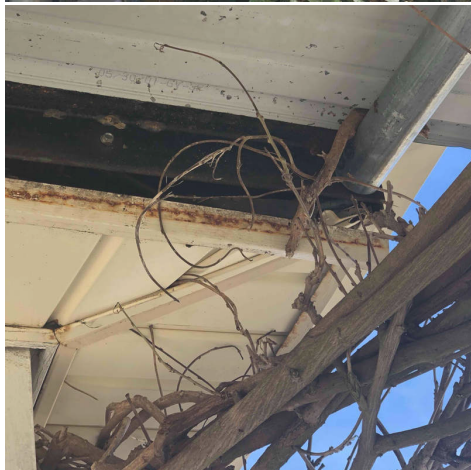
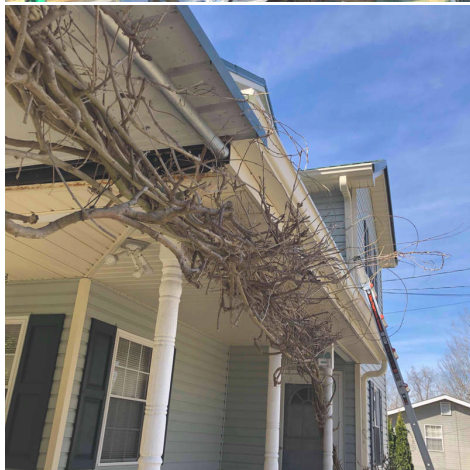
3.3.1 Vegetation Observations

VEGETATION IN CONTACT WITH HOME

Marginal Defect

There was vegetation in contact with the home in areas. Pruning or removal of any plants that are in contact with the home is recommended by a qualified person to eliminate pathways of wood destroying insects, and to allow moisture to adequately dry behind these areas after rainfall events.

Contact a qualified landscaping contractor

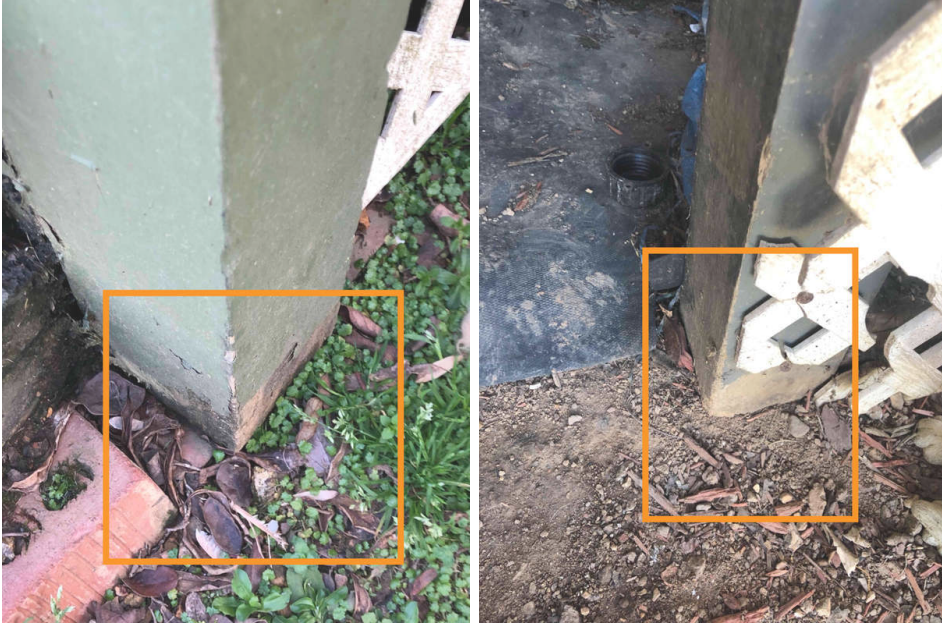
3.4.1 Decks

WOOD TO SOIL CONTACT PRESENT

Marginal Defect

Wood to soil contact was present on areas of the decks. This can encourage decay of the framing members and be susceptible to wood destroying insect activity. Modifications to remove soil to provide for adequate clearance is recommended by a qualified person.

Contact a qualified deck contractor.

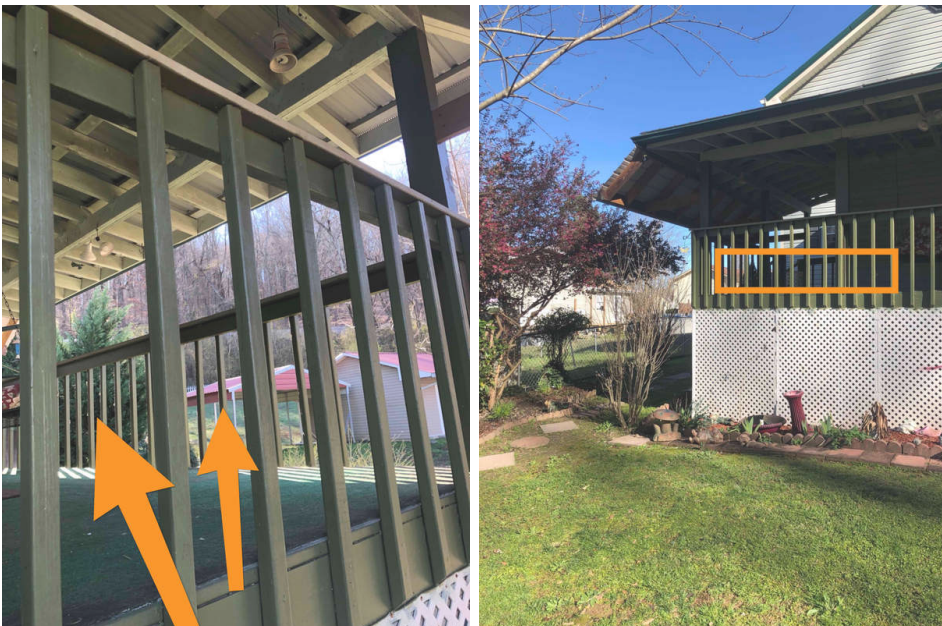
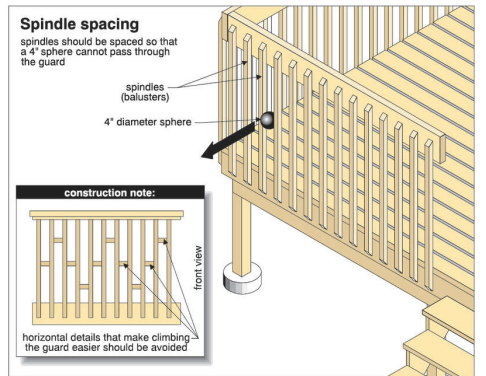
3.7.1 Guardrails, Handrails, Stair Railing, Etc.

GUARDRAIL SPACING EXCEEDED

Marginal Defect

There was spacing present between or under the guardrail balusters that was greater than 4 inches. Current safety standards require that guardrails be designed as to not allow the passage of a 4 inch sphere through them. Safety upgrades or modifications are recommended to be conducted here by a qualified person.

Contact a qualified deck contractor.

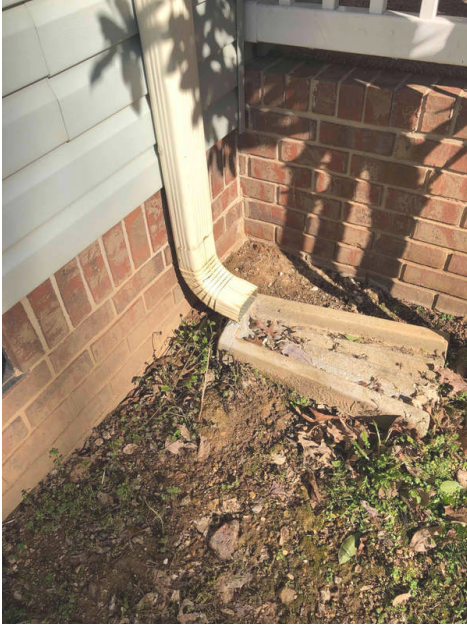
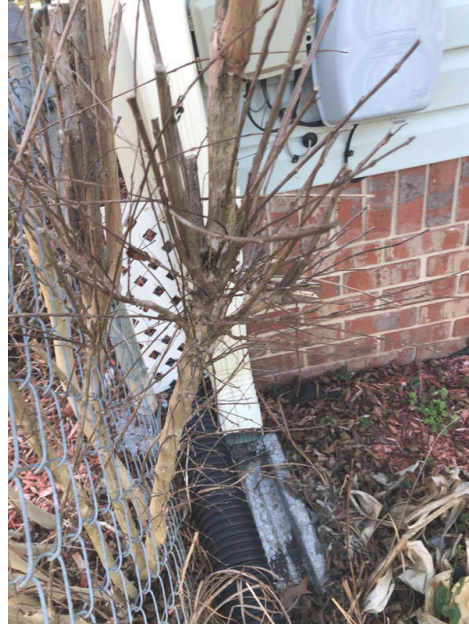
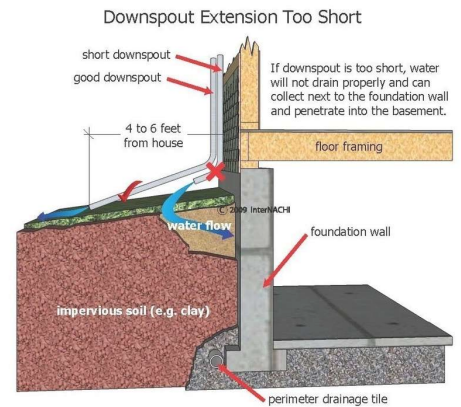
DOWNSPOUTS TERMINATING NEAR FOUNDATION

There were downspouts present that were discharging within five feet of the foundation of the home. Current standards require downspouts to be diverted at least five feet from the foundation of the home to prevent the grounds surrounding the foundation from becoming saturated. Saturated grounds can allow water / moisture to enter basement and crawl space areas, and in extreme cases can allow for settlement of the home. Properly extending all downspouts at least five feet away from the home is recommended by a gutter contractor.

Recommended DIY Project

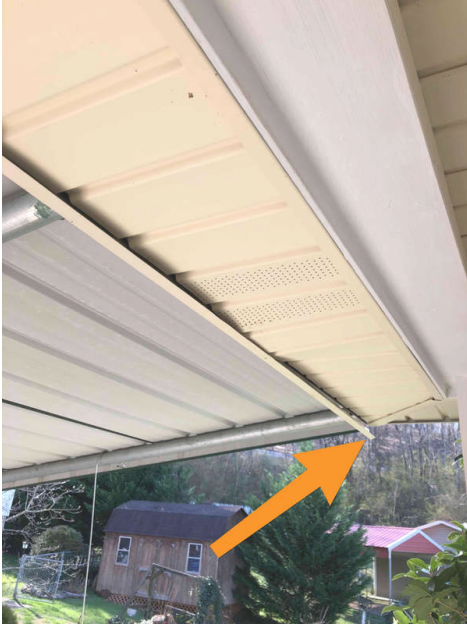
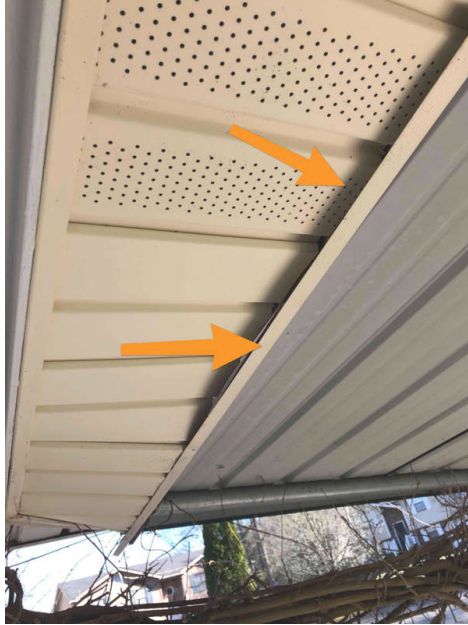
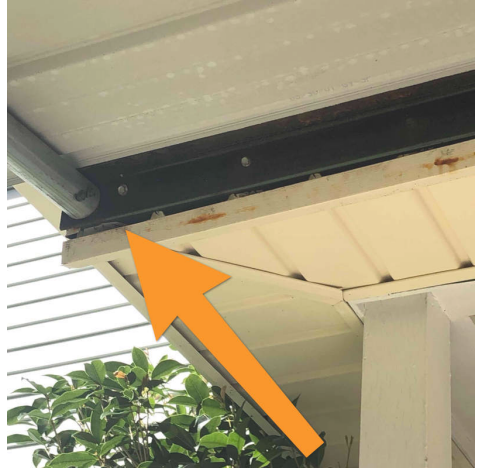
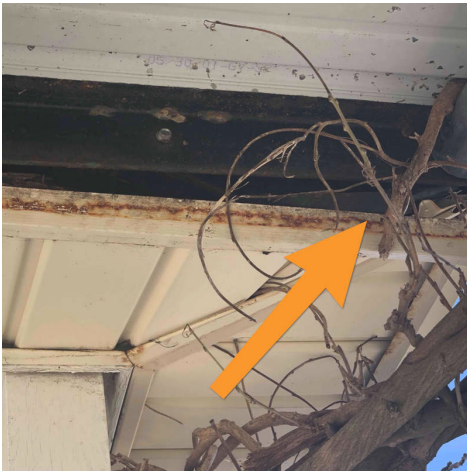
LEFT SIDE OF HOME FRONT

LOOSE TRIM

Trim was loose or damaged. Recommend repair.

Contact a qualified professional.

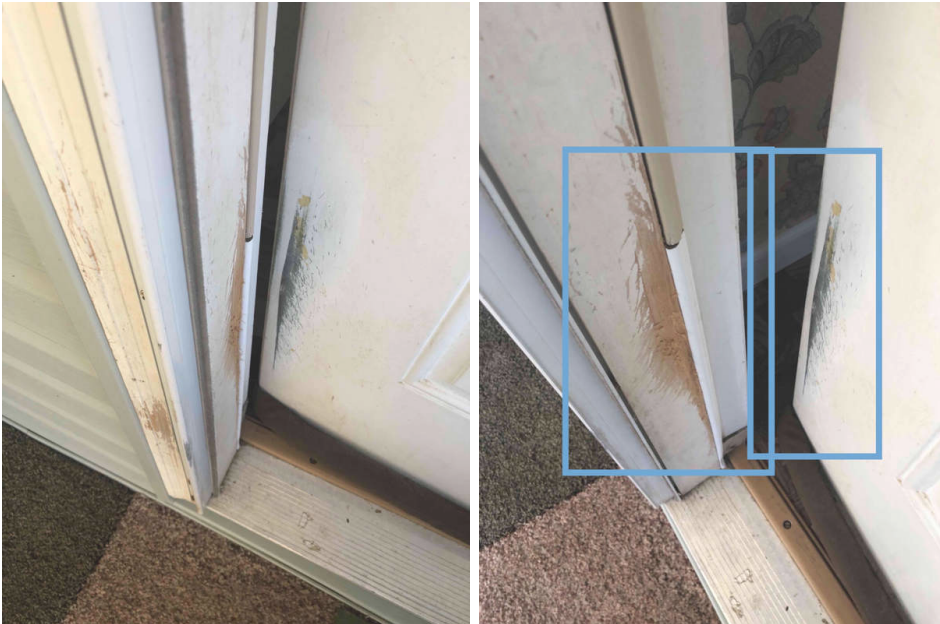
FRONT OF HOUSE

COSMETIC DAMAGE

Minor Defect, Maintenance Item, or FYI Item

Cosmetic damage was present to the door, this did not affect it's functionality. Repairs are recommended as needed for aesthetic purposes.

Contact a qualified professional.

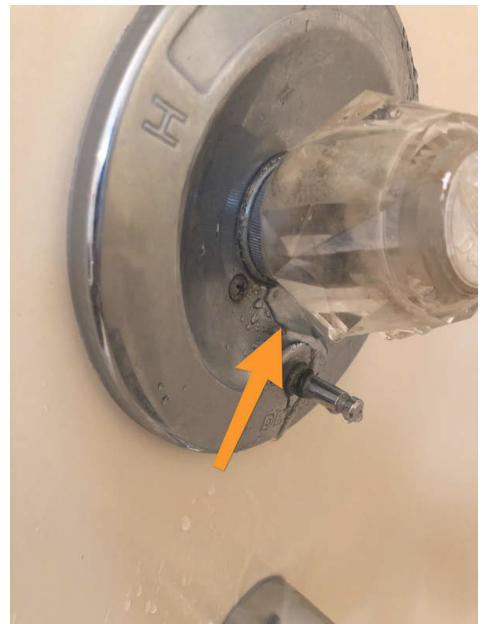
7.8.1 Bathtub(s)

LEAK FROM FAUCET VALVE

Marginal Defect

A leak was present from the faucet valve. Repairs are recommended as needed by a licensed plumber or other qualified person.

Contact a qualified plumbing contractor.

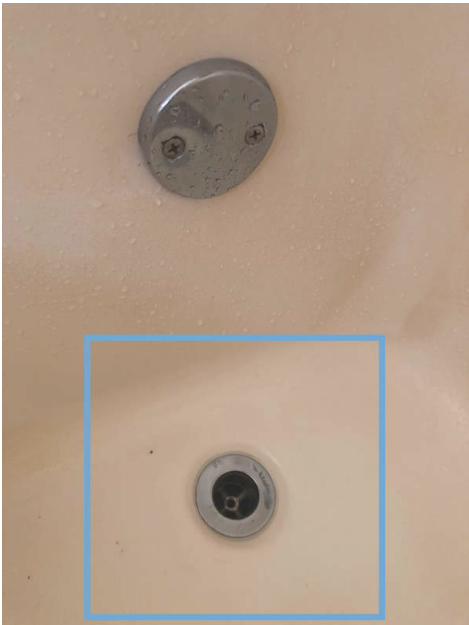
7.8.2 Bathtub(s)

**STOPPER
MISSING**

Minor Defect, Maintenance Item, or FYI Item

A stopper / pop-up was not present in the tub. The installation of a proper pop up is recommended by a qualified person.

Recommendation
Recommended DIY Project

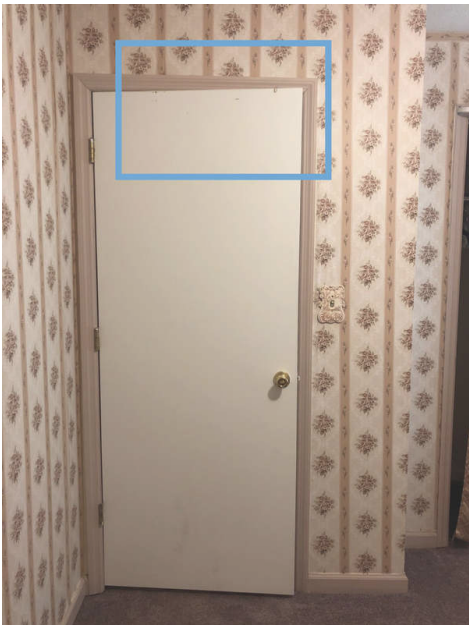
REAR OF HOME RIGHT

**BINDING
DOOR(S)
PRESENT**

Minor Defect, Maintenance Item, or FYI Item

There were door(s) that were binding / rubbing on an adjacent surface. Adjustments or modifications as needed for proper operation is recommended by a qualified person.

Recommendation
Contact a qualified handyman.

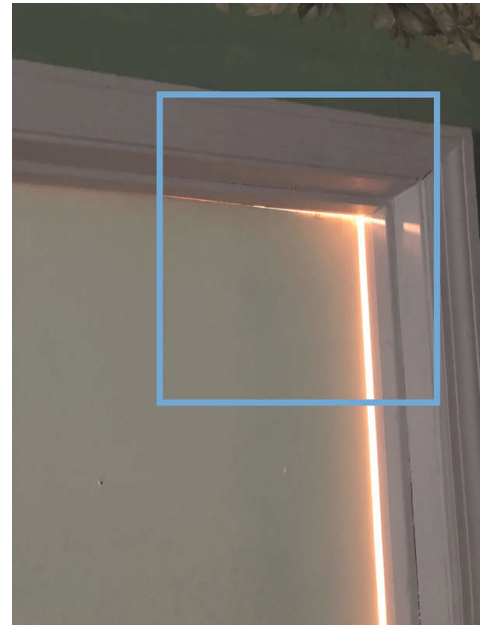
FRONT OF HOUSE BEDROOM LEFT

Minor Defect, Maintenance Item, or FYI Item

**BINDING
DOOR(S)
PRESENT**

There were door(s) that were binding / rubbing on an adjacent surface. Adjustments or modifications as needed for proper operation is recommended by a qualified person.

Recommendation
Contact a qualified handyman.

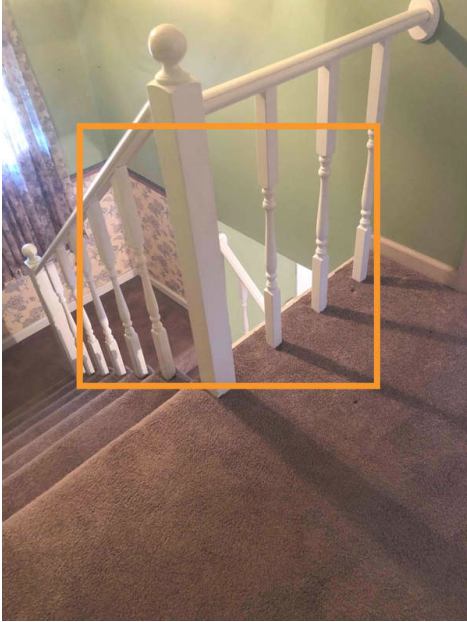
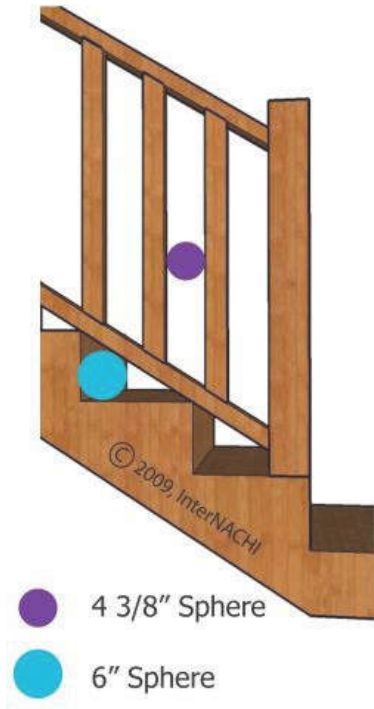
Stair Railing

BALUSTER SPACING

The stair railing had spacing that would allow the passage of a 4 3/8 inch sphere through the balusters, and/or the passage of a 6 inch sphere below them. Current safety standards require that spheres of the referenced sizes should not pass through the referenced areas. Safety upgrades should be considered here.

Recommendation
Contact a qualified professional.

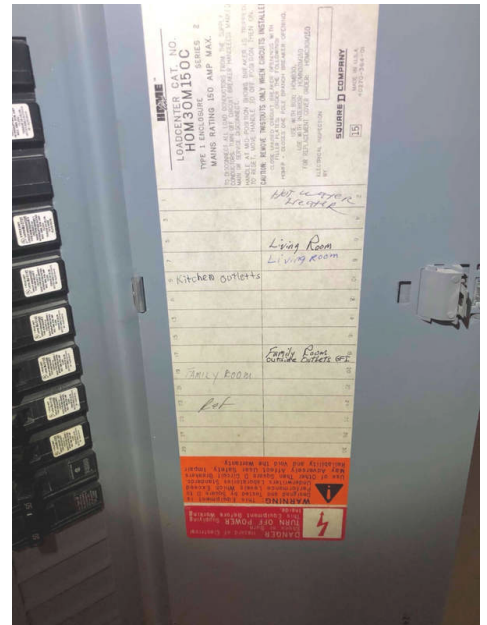
13.5.1 Electrical Panel / Service Equipment

Minor Defect, Maintenance Item, or FYI Item

INCOMPLETE OR MISSING LEGEND

The legend for the electrical panel was missing, incomplete, or incorrect. A legend is required so that breakers are properly labeled, ensuring correct circuits are shut off in case of the need of service, etc. I recommend consulting with the seller as to the labeling of the breakers, or have a licensed electrician to label the circuits.

Contact a qualified electrical contractor.

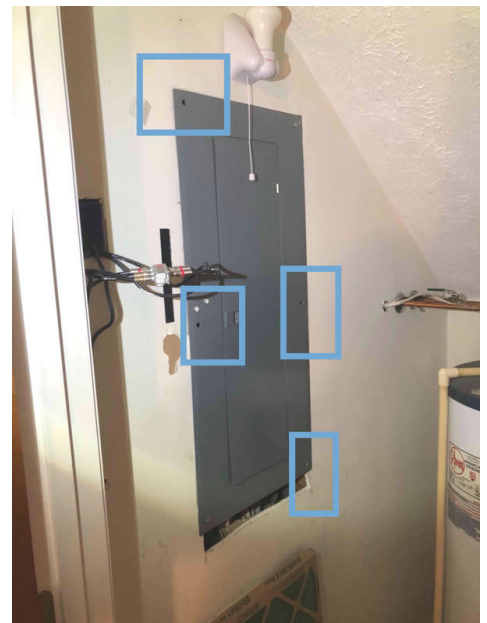
13.5.2 Electrical Panel / Service Equipment

Minor Defect, Maintenance Item, or FYI Item

PANEL COVER SCREWS MISSING

Some panel cover screw(s) were missing. All panel cover screw locations are required to be utilized to adequately secure the cover to the panel. Replacement of the screws is recommended.

Contact a handyman or DIY project

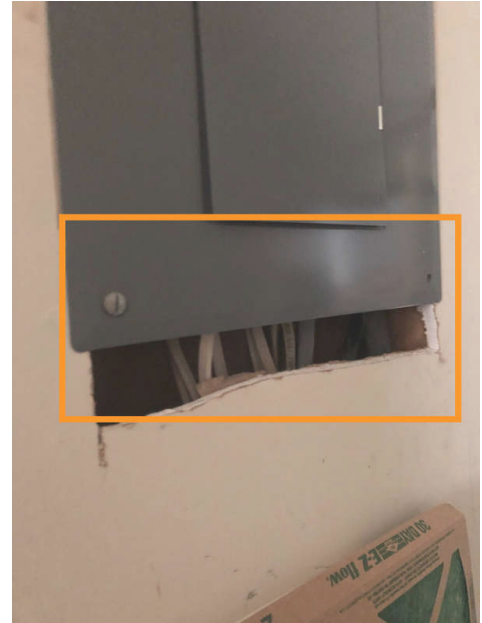
13.8.1 Branch Wiring

EXPOSED WIRING - INTERIOR

Marginal Defect

There was exposed wiring present. Recommend covering.

Contact a qualified electrical contractor.

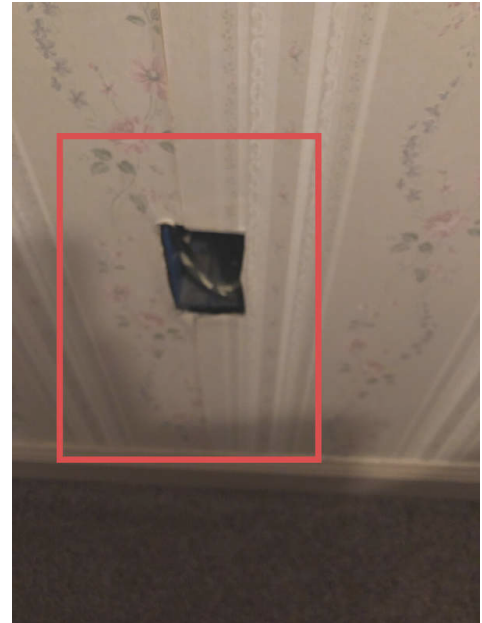
UPSTAIRS BEDROOM REAR LEFT

JUNCTION BOX - MISSING COVER

Significant Defect

There were junction boxes without a cover present. This is a potential electrocution hazard, and can be a fire hazard due to the possibility of arcing. The installation of a UL listed cover is recommended by a licensed electrician on any and all junction boxes in the home missing covers.

Contact a qualified electrical contractor.

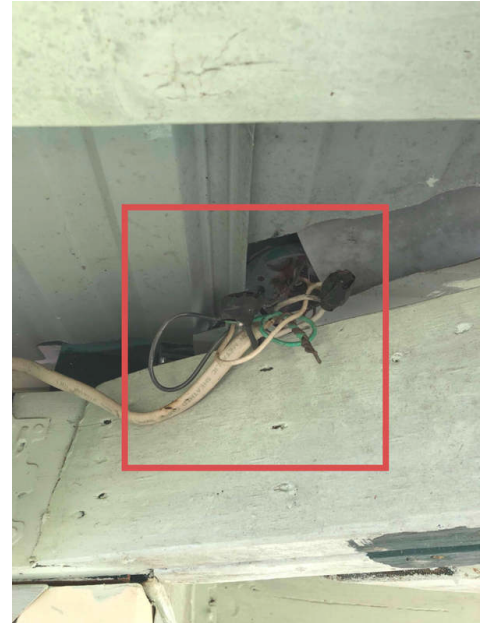
REAR OF HOME DECK

JUNCTION BOX - MISSING COVER

There were junction boxes without a cover present. This is a potential electrocution hazard, and can be a fire hazard due to the possibility of arcing. The installation of a UL listed cover is recommended by a licensed electrician on any and all junction boxes in the home missing covers.

Contact a qualified electrical contractor.

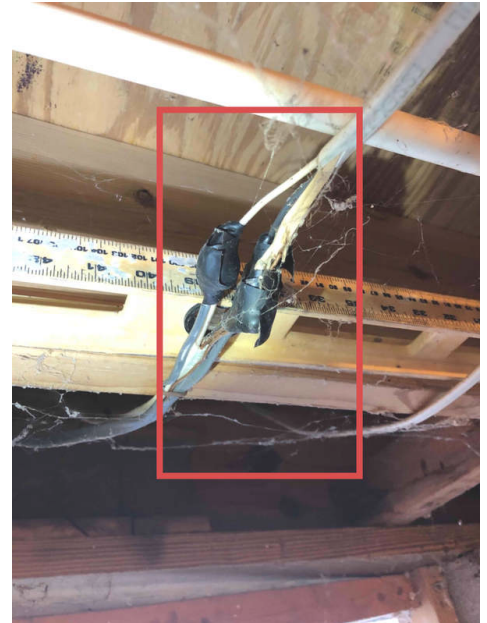
CRAWL SPACE

JUNCTION BOX - MISSING COVER

There were junction boxes without a cover present. This is a potential electrocution hazard, and can be a fire hazard due to the possibility of arcing. The installation of a UL listed cover is recommended by a licensed electrician on any and all junction boxes in the home missing covers.

Contact a qualified electrical contractor.

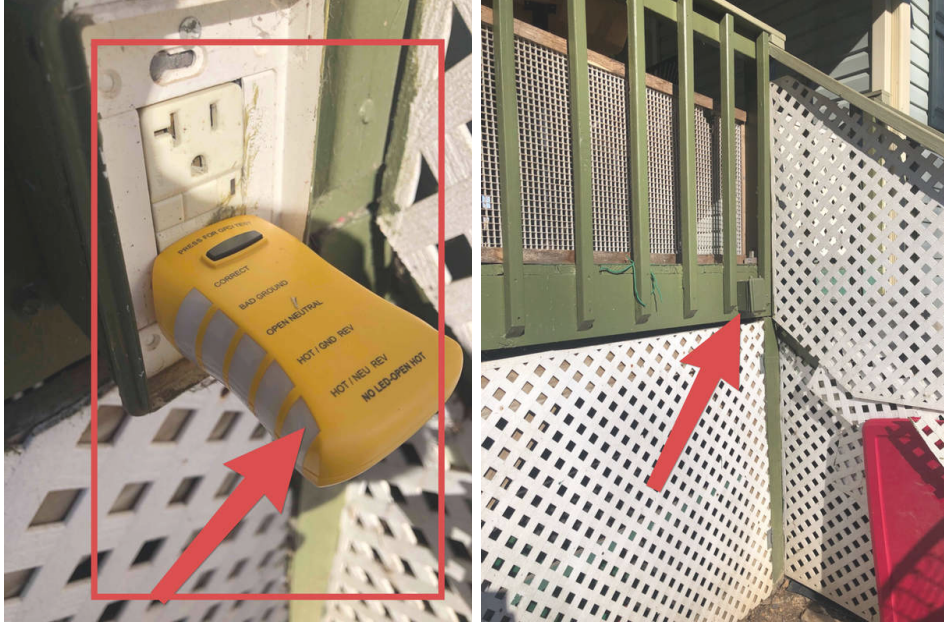
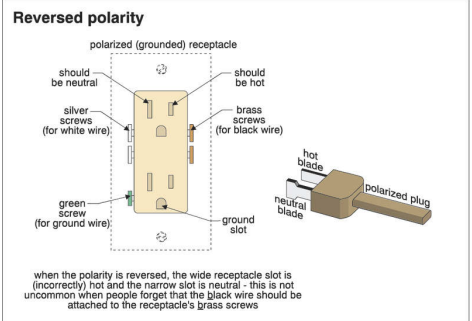
REAR OF HOME LEFT

REVERSED POLARITY

There were receptacle(s) present in the referenced areas that tested as being wired with reversed polarity (hot / neutral reversed). This is a potential shock hazard, as a wiring deficiency is present. Correction is recommended by a licensed electrician as needed.

Contact a qualified electrical contractor.

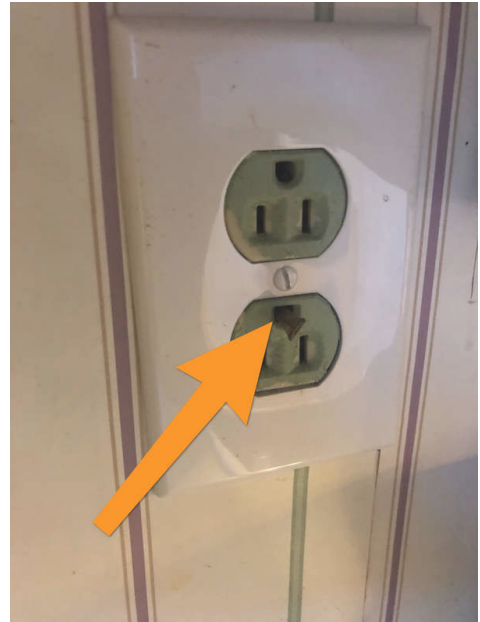
KITCHEN

FOREIGN OBJECT IN RECEPTACLE SLOT

A foreign object was present in a receptacle slot. Repairs are recommended as needed by a licensed electrician.

Contact a qualified electrical contractor.

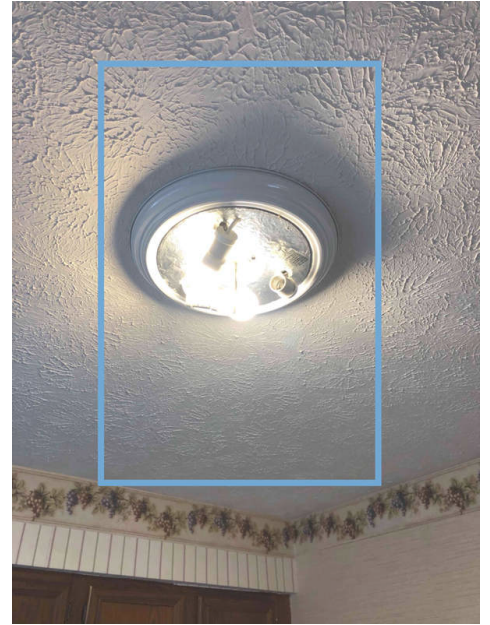
KITCHEN

MISSING LIGHT GLOBE - INTERIOR

There were bare bulbs present on some light fixtures. The installation of covers or globes on any fixtures in the home without globes is recommended by a qualified person to prevent accidental breakage, and possible electrocution.

Contact a handyman or DIY project

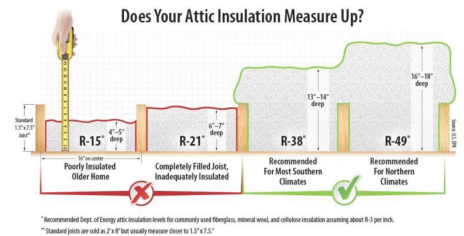
14.5.1 Insulation

TYPICAL FOR AGE - ADD MORE AS DESIRED

The insulation level was typical for when the home was constructed. Current standards require approximately 14 inches of insulation to achieve an R-38 rating. More insulation can be added as desired by an insulation contractor.

Contact a qualified insulation contractor.
