RESIDENTIAL INSPECTION

1234 Main Street
Denver CO 80210

02/15/2025 9:00AM

PROPERTY INSPECTION REPORT FORM

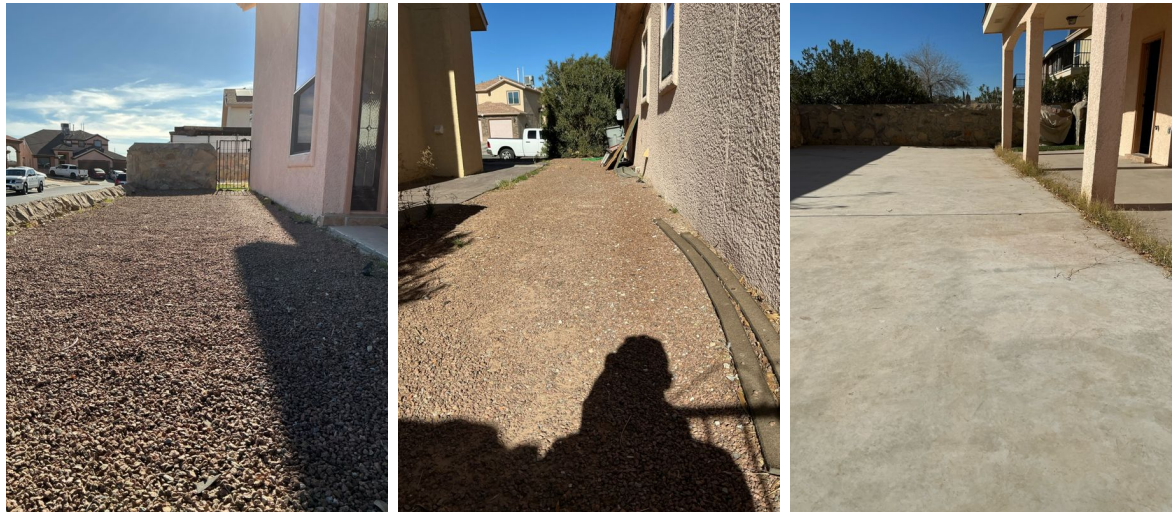
1: Marginal Grading

Marginal site drainage was observed. Proper drainage is needed to help prevent water from standing and/or ponding next to the foundation beam. Corrective measures may be needed if the water stands within 10-feet of the foundation perimeter beam for more than 24-hours.

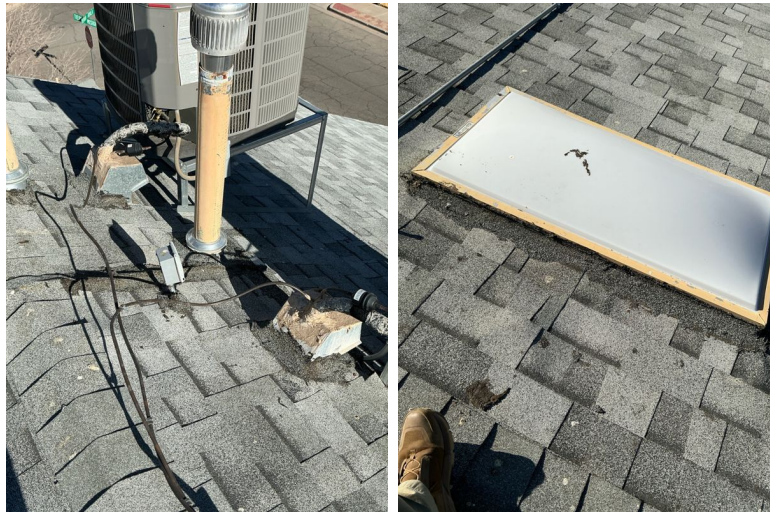
1: Sealant Utilized

Note: Sealant has been utilized around penetrations. We recommend regular monitoring and maintenance by a qualified roofer as the sealant will crack with time.

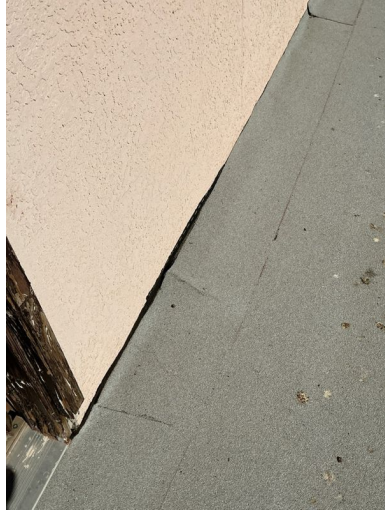
2: Flashing - Missing

Flashing is not present in this area. This condition could allow water intrusion at this location.

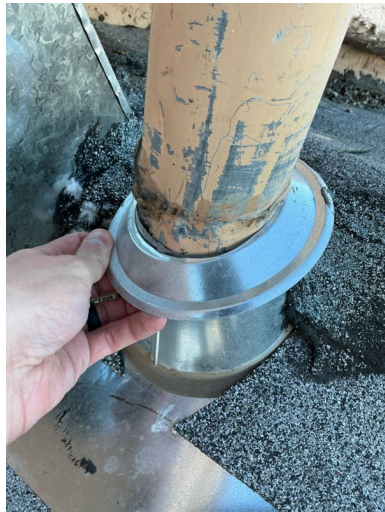
3: Flashing - Seal Storm Collar(s)

The storm collar(s) at the roof level gas equipment vent pipe(s) need to be properly sealed to help prevent water intrusion into the structure.

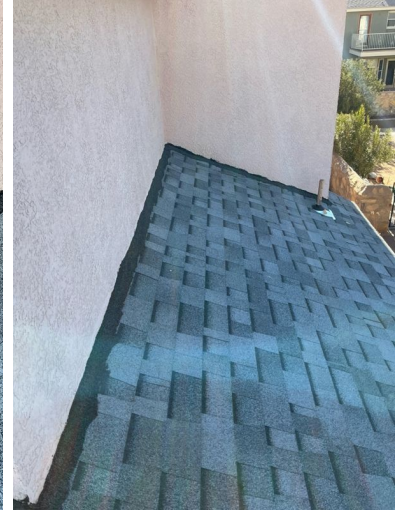
4: Flashing - No Flashing, Sealant Used

The sidewall and headwall area where the roof contacts the wall appears to be missing flashing and sealant was utilized in its place. This is a common local practice however does not meet industry standards. We recommend monitoring these areas and having a roofer regularly maintain the sealant as it will crack with time.

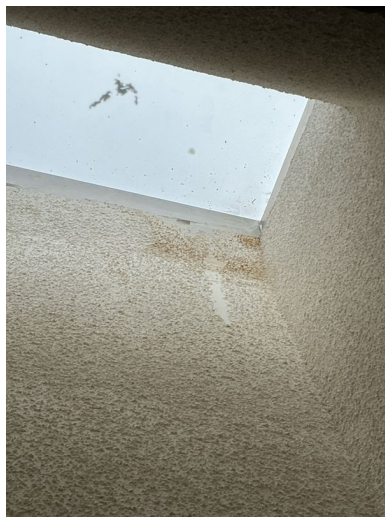
5: Skylight Leakage

The skylight shows signs of previous leakage. This should be closely monitored and corrected if necessary.

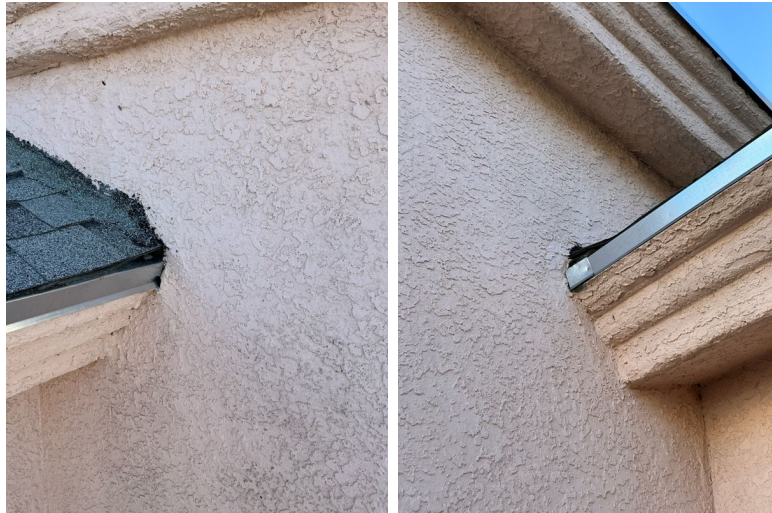
6: Flashing - Missing Kickout

There was no kickout flashing details observed at the lower bottom edge of the roof line interface and the sidewall that continues past the edge of the roof. The lack of this kickout flashing will allow water to penetrate at these points.

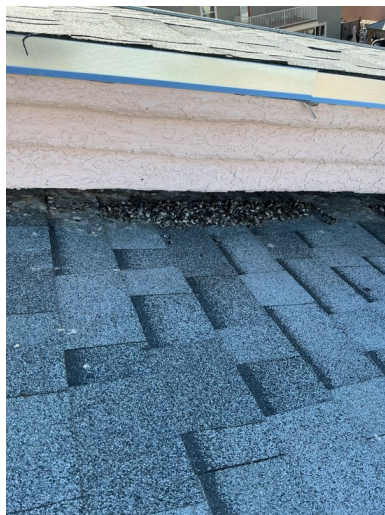
7: Evidence of bird activity

Evidence of bird activity. Recommend removing any nests or feces as this can damage the roof covering.

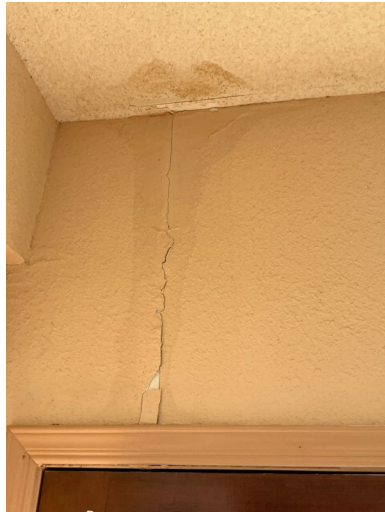
1: Interior - Joint Cracks

Interior wall joint cracks were observed. This is not indicative of major structural movement, however does appear to be from previous water damage. This condition should be further evaluated and corrected as necessary.

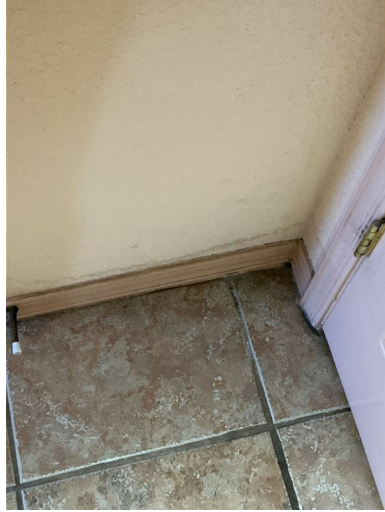
2: Water Stains

Half bath area

Water stains were observed on the walls. The cause and remedy should be further evaluated and corrected as necessary.

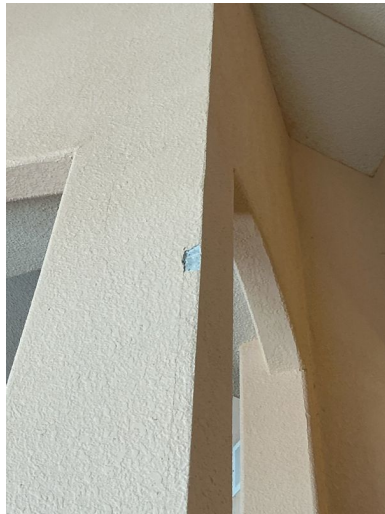
3: Interior Wall - Damaged

Wall surface damage was observed.

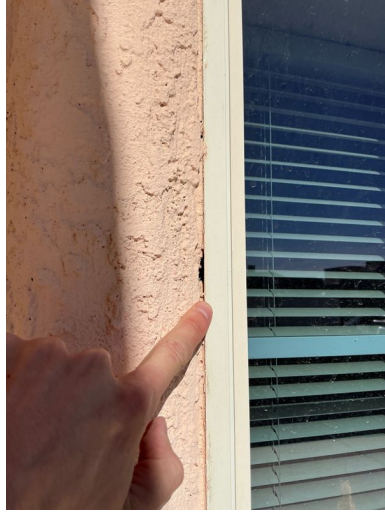
4: Caulking - Windows

Caulking improvements are recommended for the area between the exterior veneer and the window frames. It is recommended to use an elastomeric caulking.

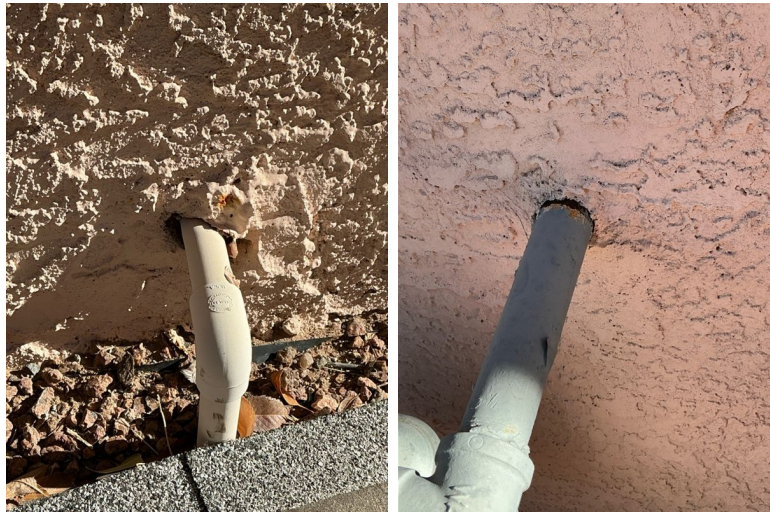
5: Sealant - Exterior Penetrations

The area between the exterior cladding / veneer and all of the wall penetrations / openings need to be properly sealed. Areas such as utility connections, downspouts, hose bibbs, lighting fixtures, receptacles etc. It is recommended to use an elastomeric caulking / sealant.

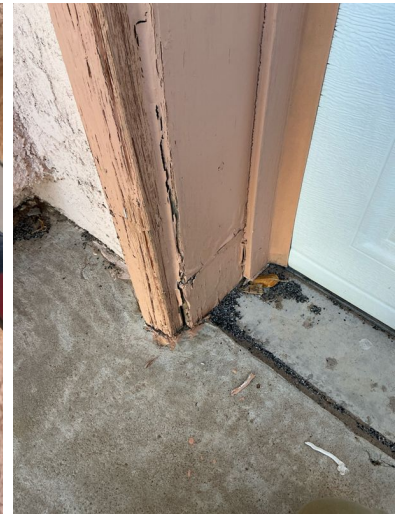
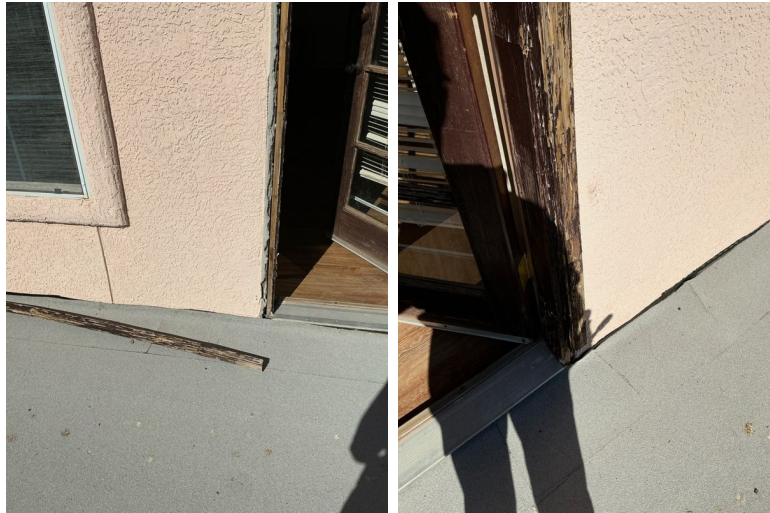
7: Wood Trim Damaged

The wood veneer trim has some deterioration or damage.

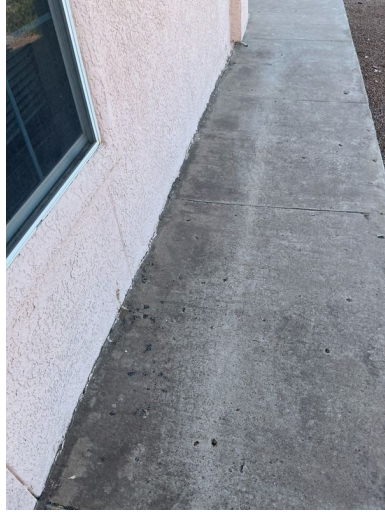
The exterior stucco type veneer/cladding has inadequate clearance from the concrete flatwork. Most manufacturers require a minimum of 2-inches of clearance from all concrete flatwork.

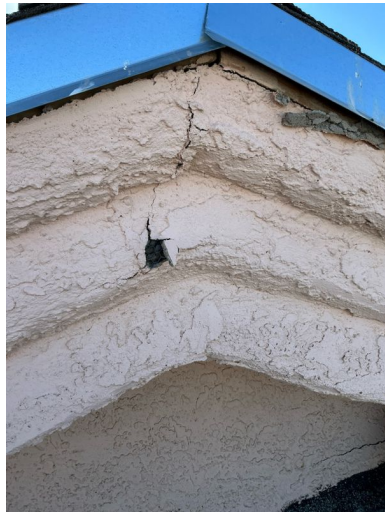
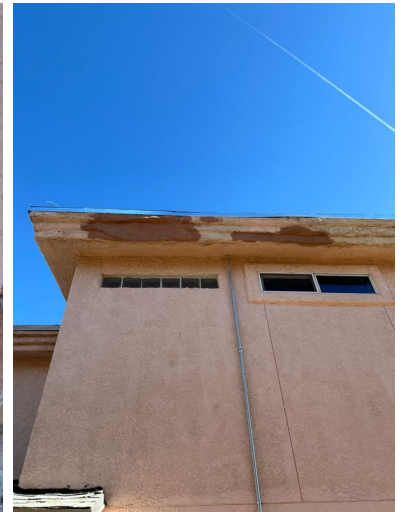
11: Stucco - Damaged

Some deterioration and/or damage to the stucco type veneer/cladding was observed.

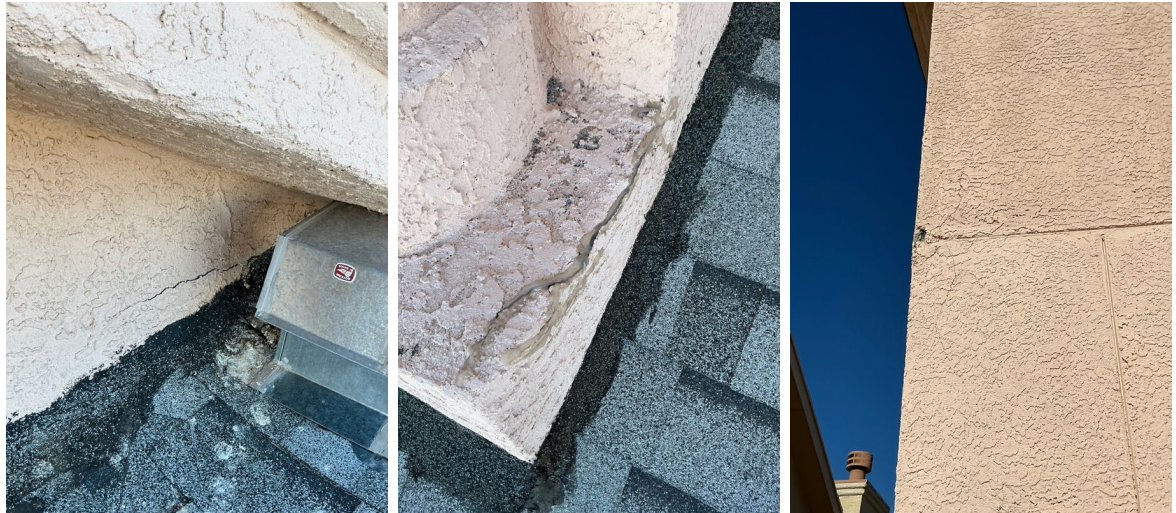
12: Stucco - Cracks

Cracking of the stucco type veneer/cladding was observed. This condition should be further evaluated and corrected as necessary.

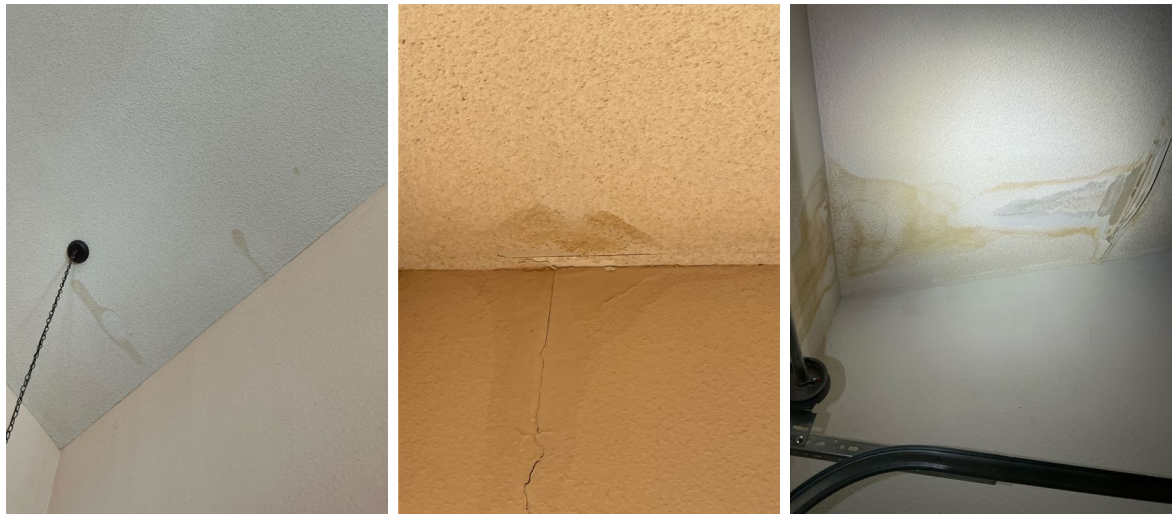
1: Ceiling - Water Stains

Water stains were observed on the ceiling finish. The cause and remedy should be further evaluated and corrected as necessary.

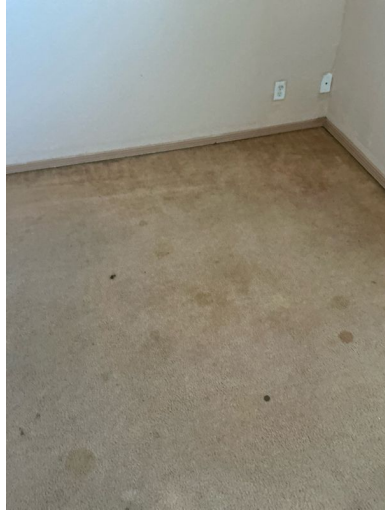
2: Floor - Worn/Damaged

The floor covering is worn and/or damaged in one or more locations of the home.

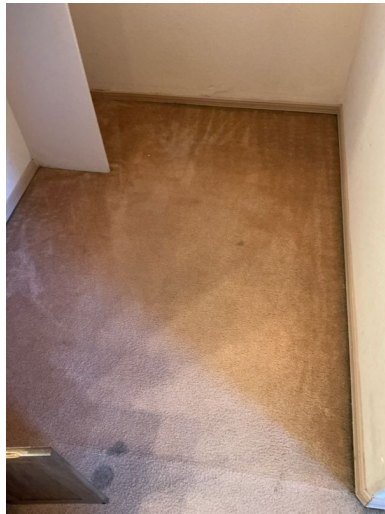
3: Floors - Upstairs Squeak

Note: The upstairs sub-floors (flooring) observed to squeak when walked over.

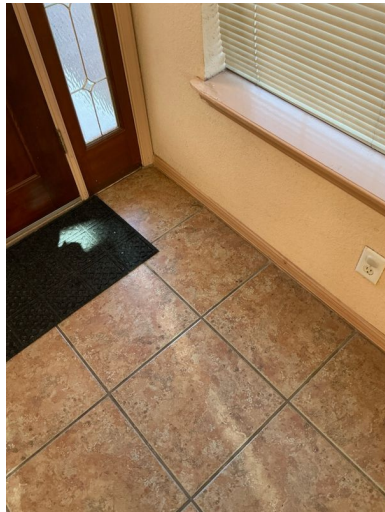
2: Door - Hardware Missing

Door stops missing in multiple locations.

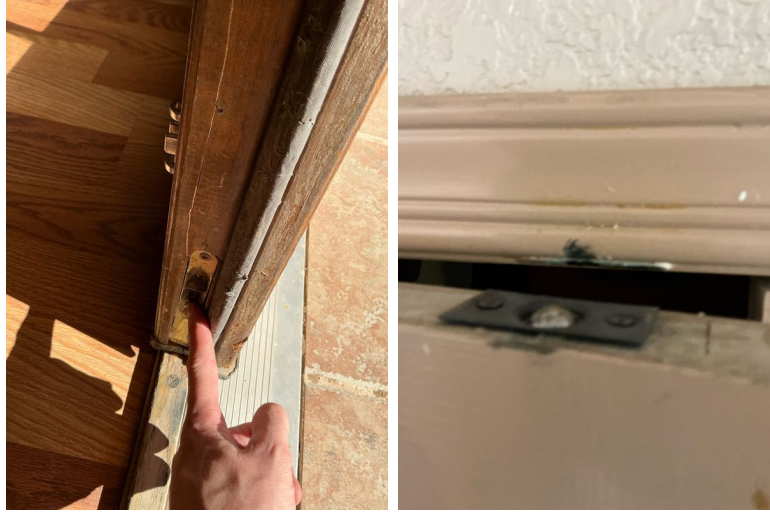
3: Door - Hardware not Functioning

Back door, pantry

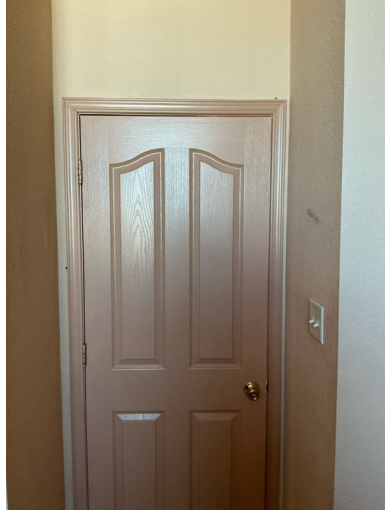
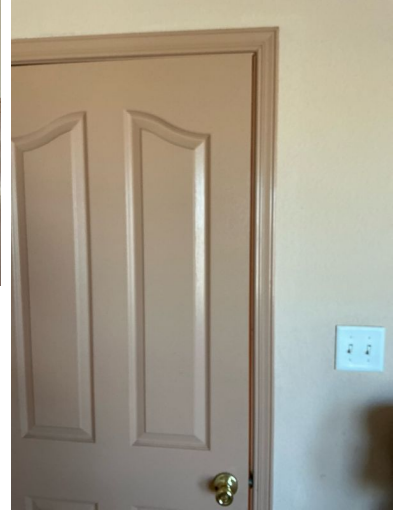
Some of the interior seconds story doors are not plumb and out of square upstairs and close on their own. Recommend evaluation and having adjustments be made. This could be due to un-level framing in these areas.

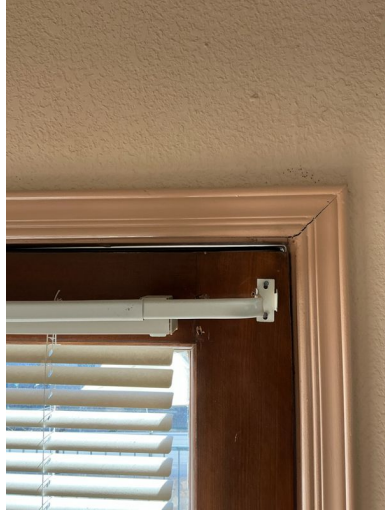
Weather-stripping improvements are recommended.

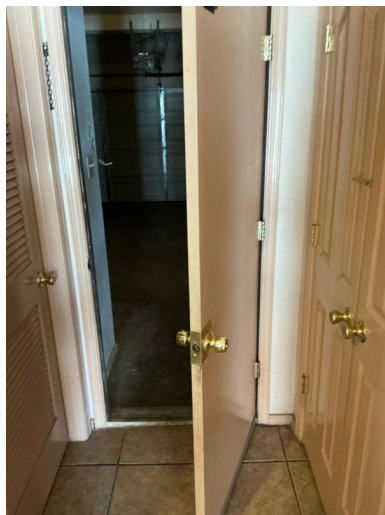
8: Garage Entry - Not Self Closing

The garage entry door is not equipped with a self-closing device.

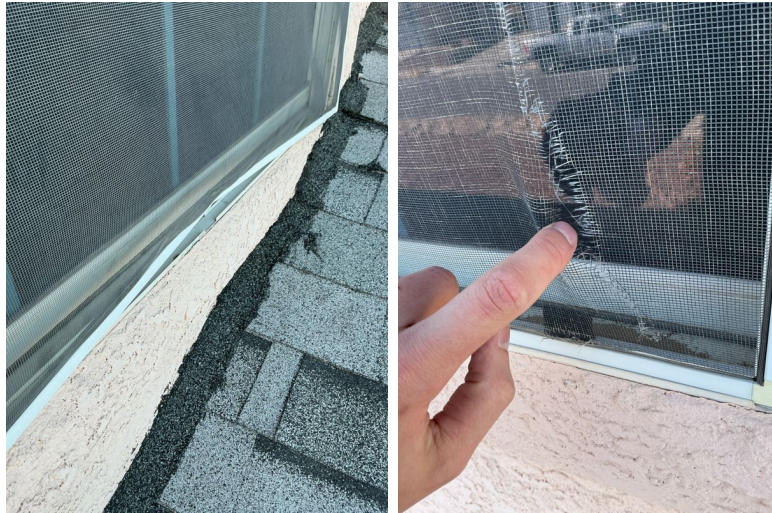
1: Screen - Damaged

One or more of the window screens were observed to be damaged.

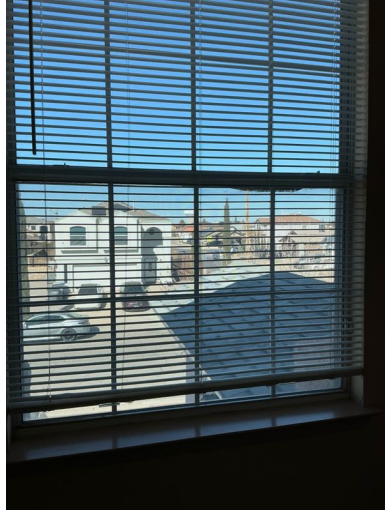
3: Damaged Guides

The window guide was observed to be damaged and the window will not stay in the open position.

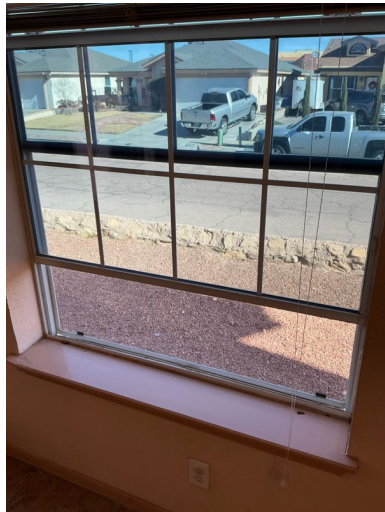
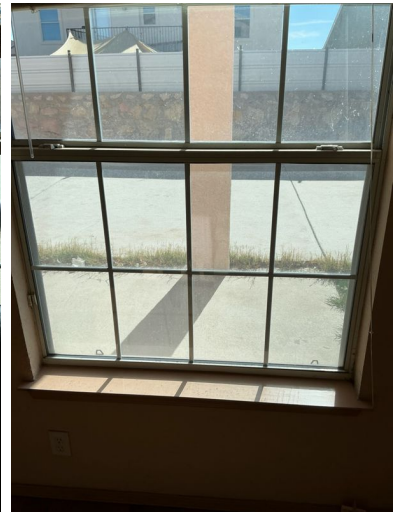
4: Difficult to Operate

One or more of the windows were observed to be stiff and hard to operate.

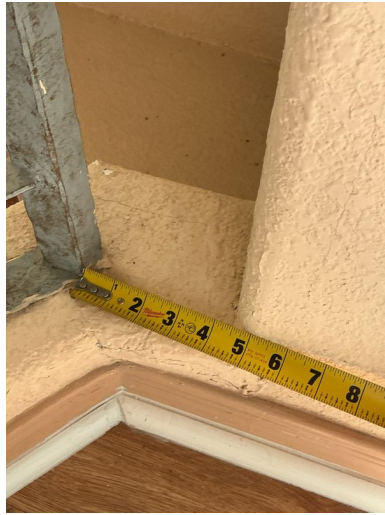
The stairway guard balusters and/or spindles are installed too far apart under current building standards. This may be an “as-built” condition but per TREC standards of practice we are required to report this condition as a deficiency. You may consider corrective measures for improved safety.

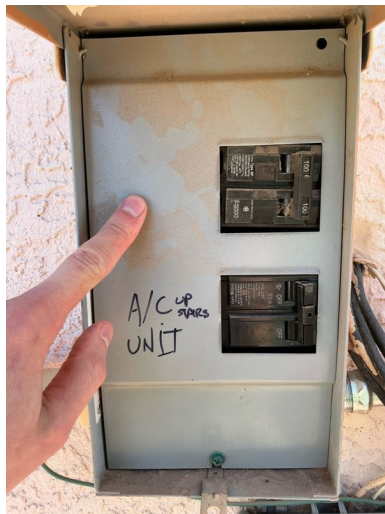
1: Breakers Improper Labeling

The breakers (overcurrent devices) in the electrical panel are not properly labeled.

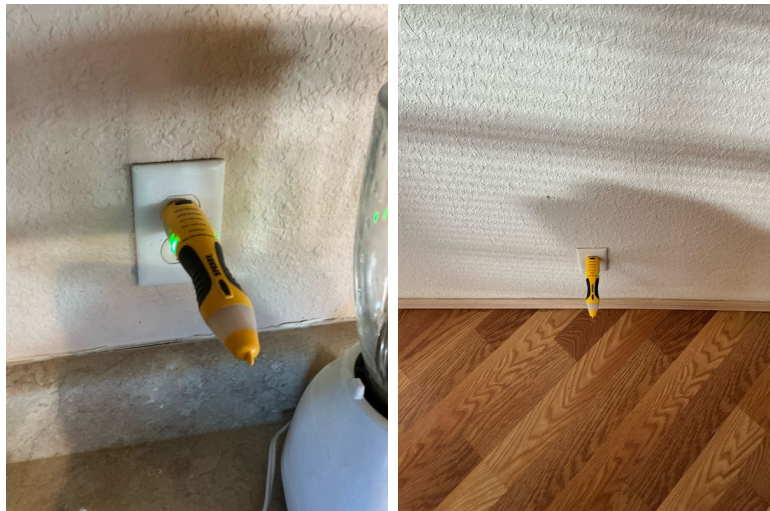
4: Loose Receptacles

One or more of the receptacles were observed to be loose at the wall mount.

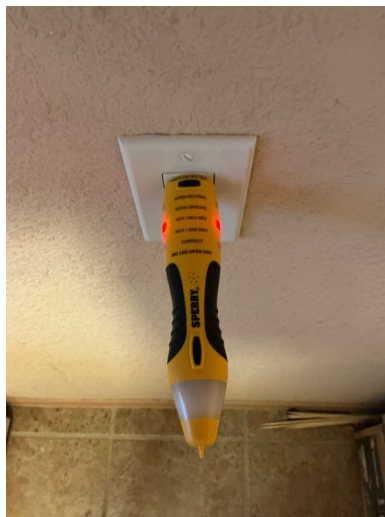
Laundry

One or more of the receptacles appear to have reversed polarity (i.e. it is wired backwards). This receptacle(s) and the circuit should be investigated and improved as necessary.

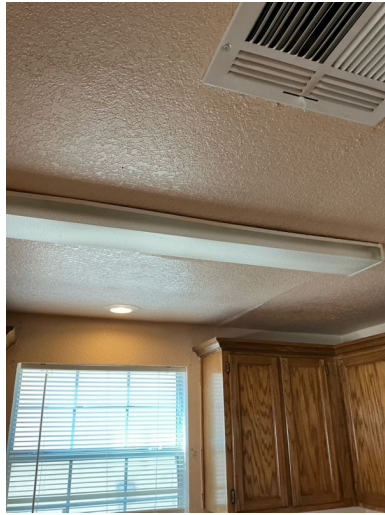
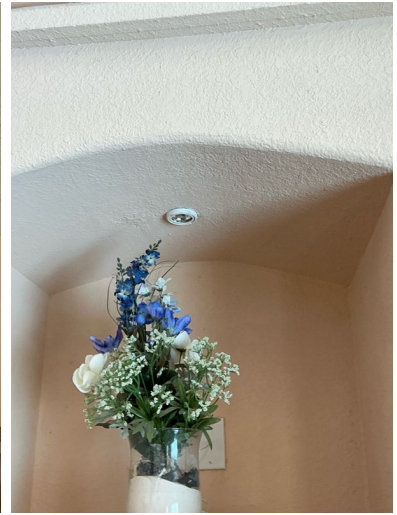
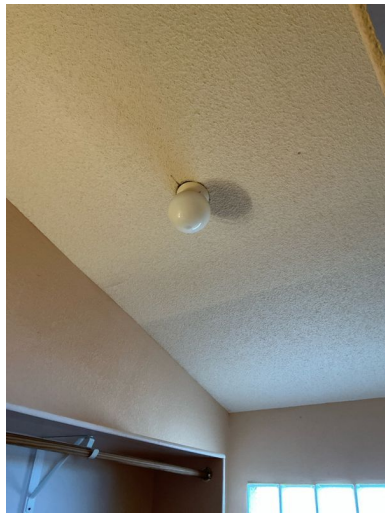
7: Light Fixture Inoperative

One or more of the light fixtures appear to be inoperative. This may be due to a bad bulb or some other unknown condition. This condition should be further evaluated and corrected as necessary.

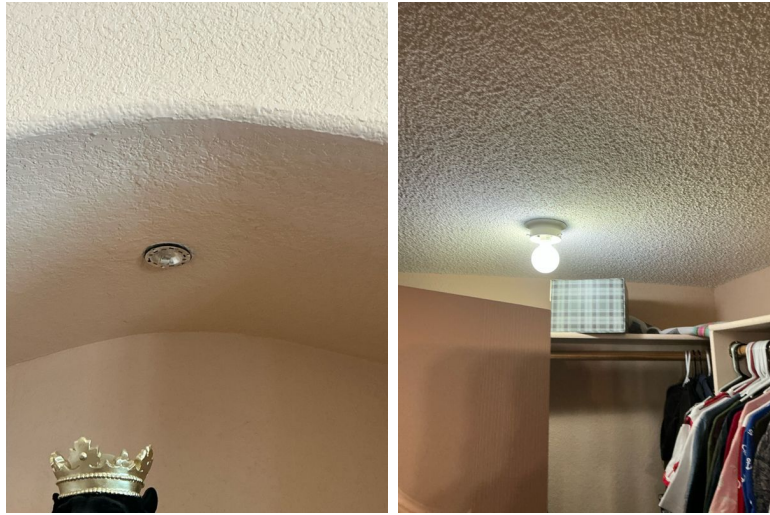
8: Missing Globe

One or more of the light fixture globes and/or covers are missing.

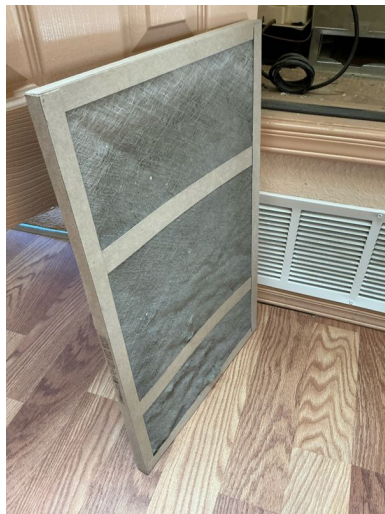
The dirty air filter should be replaced.

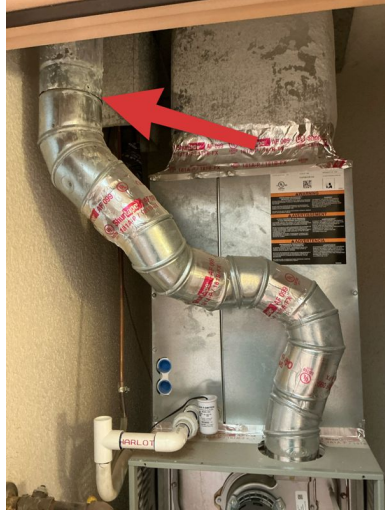
2: Vent Pipe Improper Installation

The vent pipe is not properly secured in an area. Recommend correction.

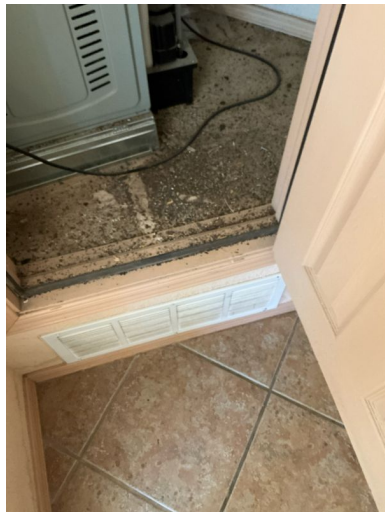
3: Debris in closet

Debris in furnace closet should be removed.

Recommendation: Contact a qualified professional.

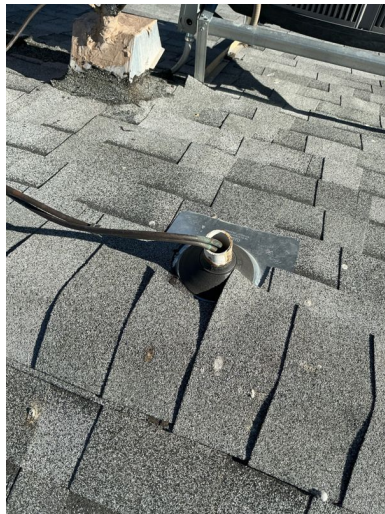
The primary condensate drain line is improperly terminating into a plumbing vent stack.

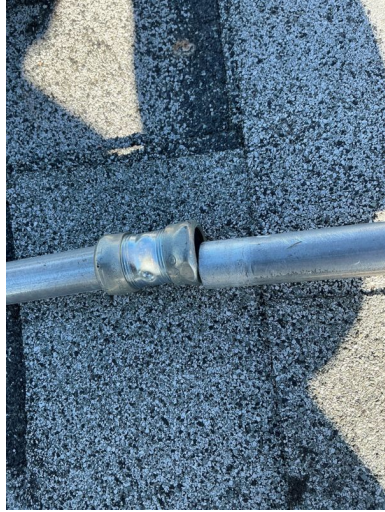
2: Conduit Loose

The electrical wire conduit has pulled loose at the outside condenser housing and/or service disconnect.

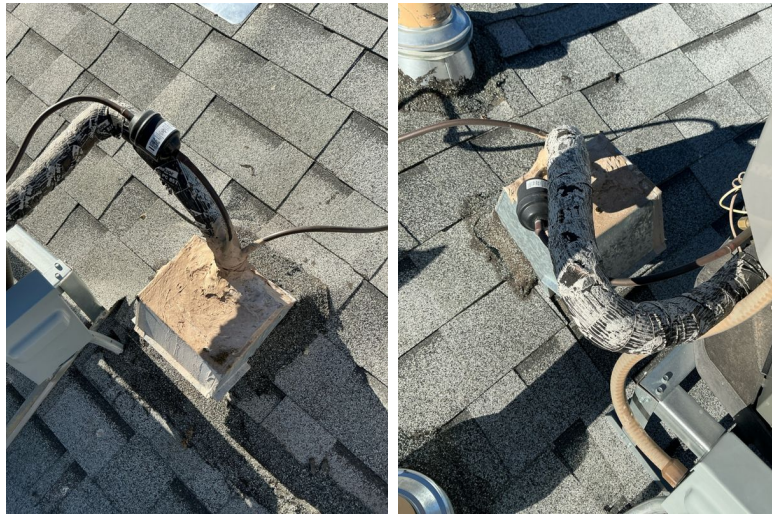
3: Line set installed through combustion air inlet

The line set for the condenser was ran through the combustion air vent. This is not a recommended practice.

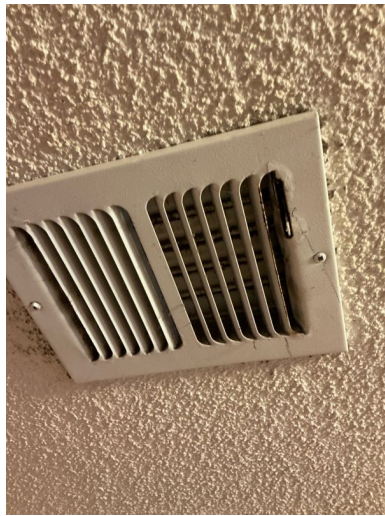
There is visible dust and/or mildew on the air registers. The cause and remedy should be further evaluated. It is recommended to have the air registers and duct system cleaned for air quality purposes. Laundry vent was difficult to operate and was closed.

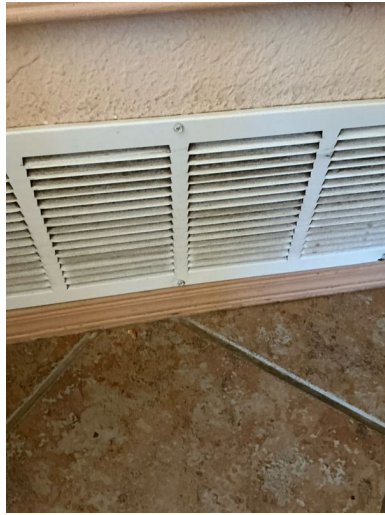
2: Dirty Return

The air-return chase for the HVAC system is dirty and should be cleaned to help maintain good air quality.

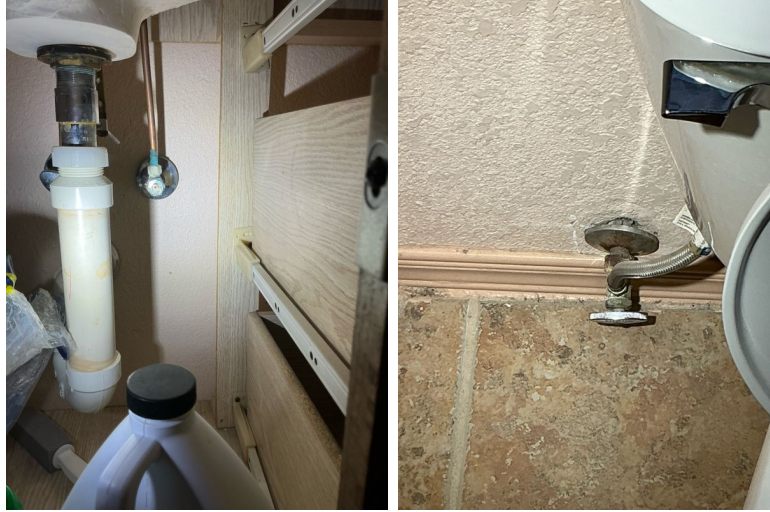
There is noticeable corrosion and blackening observed on the exterior surfaces of the copper water lines at the time of this inspection.

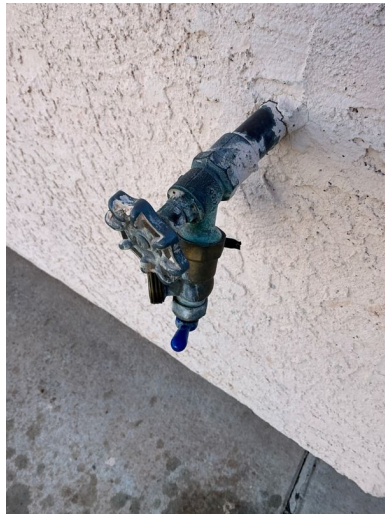
2: Exterior Bibb - Leaks when off

The exterior water hose bibb (faucet) leaks when turned off.

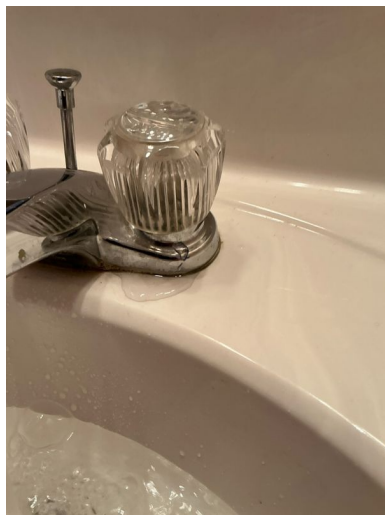
The faucet leaks at the handle when on.

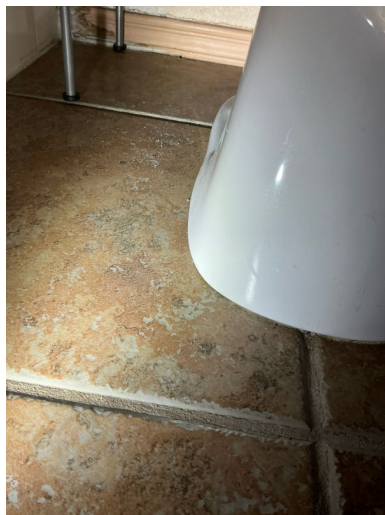
8: Toilet - Caulking Improvements

Cracked, deteriorated and/or missing toilet base caulking should be repaired or replaced as necessary.

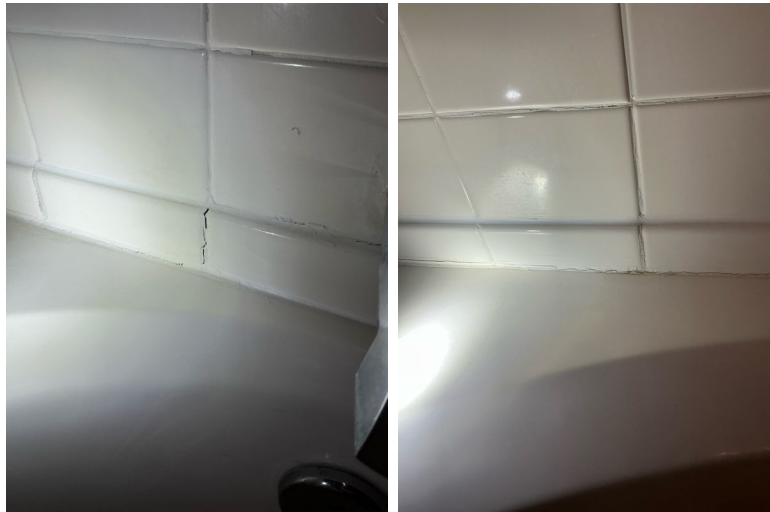
The tile bathtub enclosure requires repair. Any loose or damaged tile, grout and caulking should be repaired or replaced as necessary. Any damage to the wall behind the tile should also be repaired (if necessary).

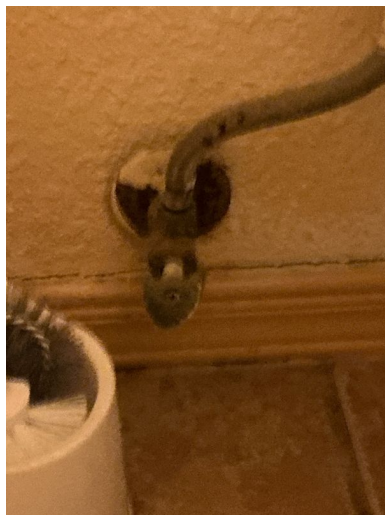
14: Toilet - Shutoff Valve Damaged/Missing

The commode shutoff valve handle is damaged and/or missing.

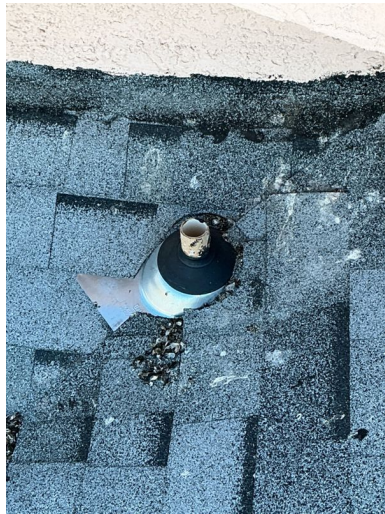
Some of the roof level plumbing stacks do not appear to extend to the proper height. The vent stacks that penetrate the roof should extend at least 6 inches above the roof structure.

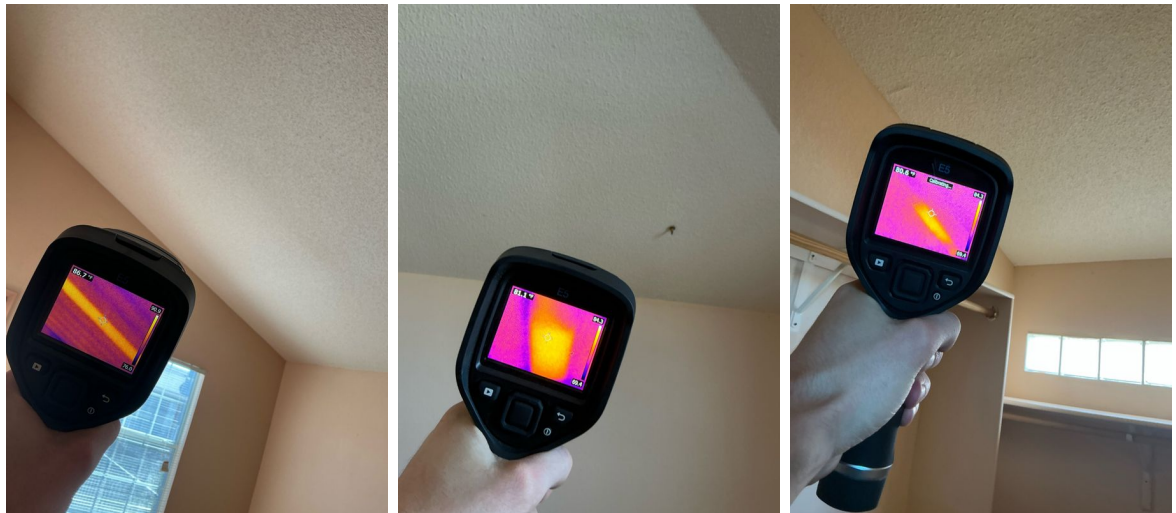
Several areas of suspected missing insulation was present. Upgrades can be made at your discretion for energy improvement.
