TIGER HOME AND BUILDING INSPECTIONS 970-468-0960

PROPERTY INSPECTION REPORT

1234 Main St. Eagle CO 81631

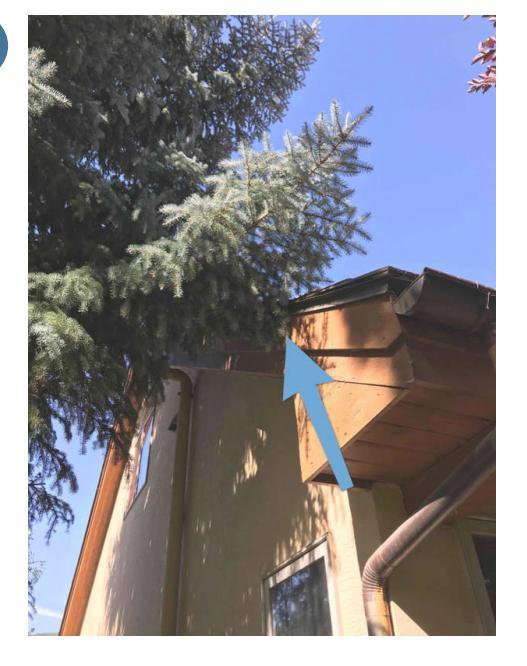
Cut back trees and branches that are in contact with the roof or siding. This can cause damage by rubbing and by trapping moisture.

Recommendation Contact a qualified landscaping contractor

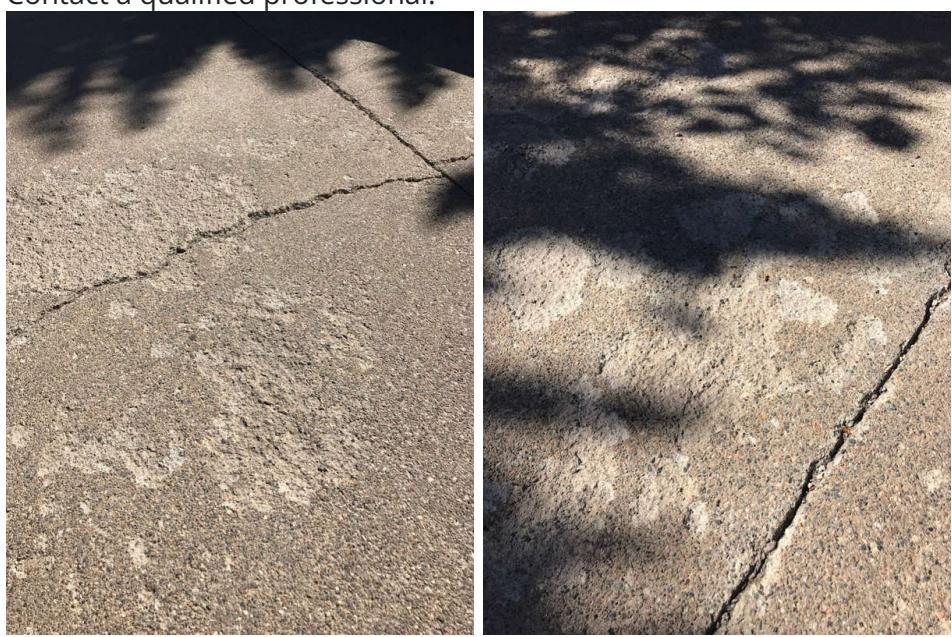
2.3.1 Driveway DRIVEWAYS - NEED REPAIR

Cracks, holes, settlement, heaving, spalling and/or deterioration were found in the driveway. Recommend that qualified contractor repair as necessary. Reseal cracks as needed.

Contact a qualified professional.

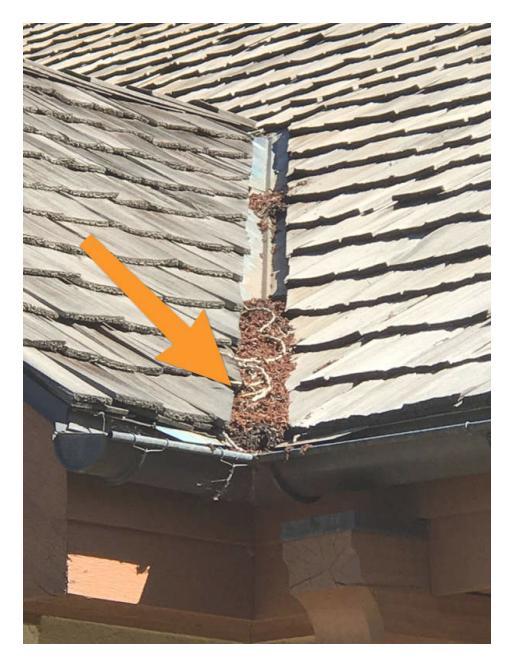
3.2.1 Roof surface condition **DEBRIS**

Significant amounts of debris such as leaves, needles, seeds, etc. have accumulated on the roof surface. Water may not flow easily off the roof, and can enter gaps in the roof surface. Leaks can occur as a result. Recommend cleaning debris from the roof surface now and as necessary in the future.

Contact a handyman or DIY project

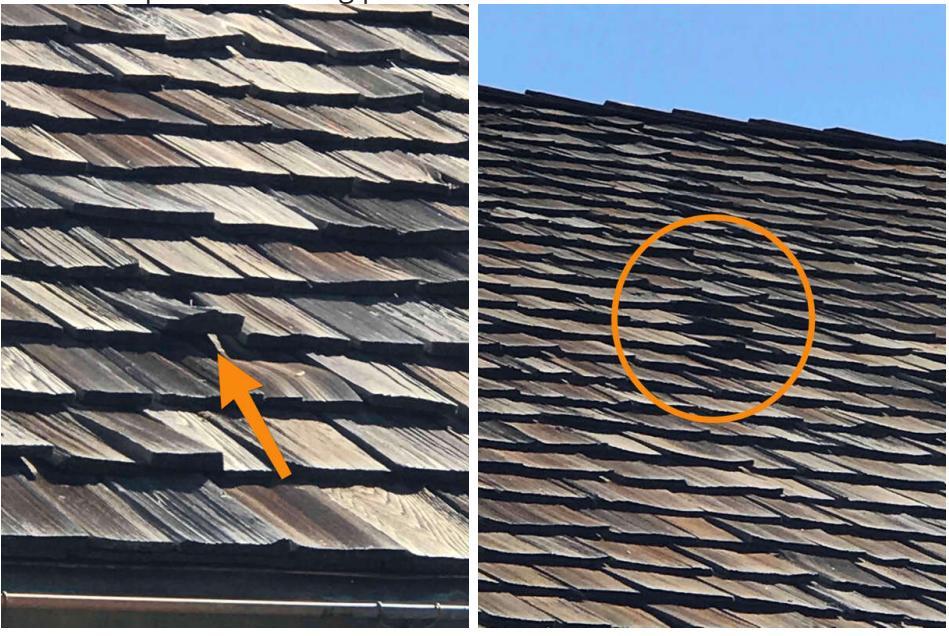
3.2.2 Roof surface condition

WOOD SHAKES - REPAIR

Some wood shakes or shingles were *worn / split / curling or deteriorated*. Leaks can occur as a result. Recommend that a qualified contractor repair as necessary. For example, by replacing or fastening shakes or shingles, or installing flashing.

Contact a qualified roofing professional.

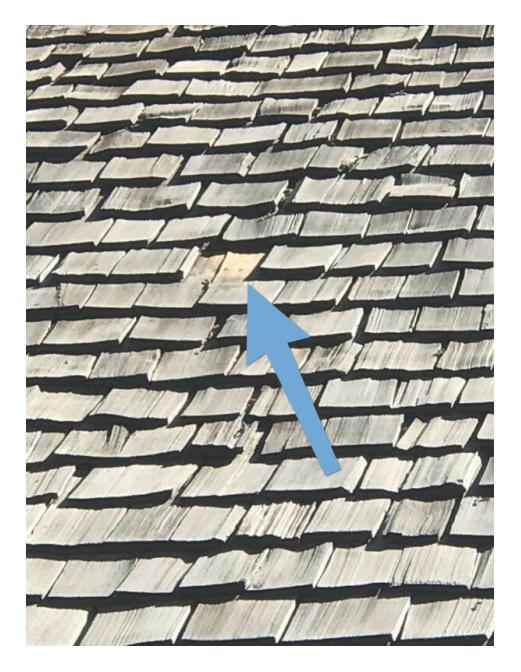
3.2.3 Roof surface condition **MISSING**

There is at least one missing shingle noted that needs to be replaced

Contact a qualified roofing professional.

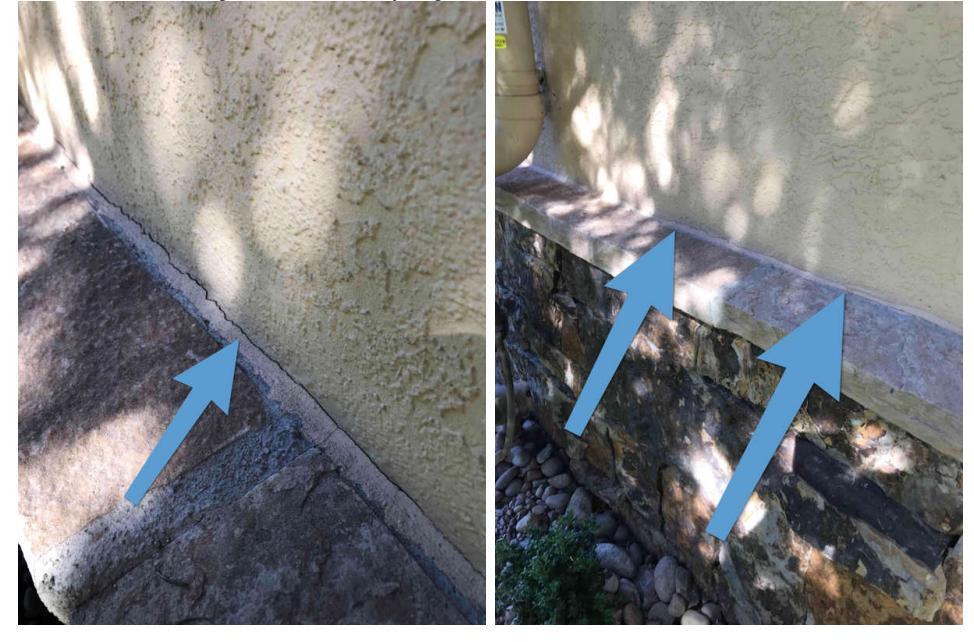
4.3.1 Siding / Trim BRICK, STONE VENEER - CRACKS, DETERIORATION

The masonry (brick or stone) veneer was deteriorated or damaged in some areas. Where cracks or openings are exposed, water can enter the wall structure causing mold, fungal growth and structural damage. Reseal where needed. Only noted in a few areas.

Contact a handyman or DIY project

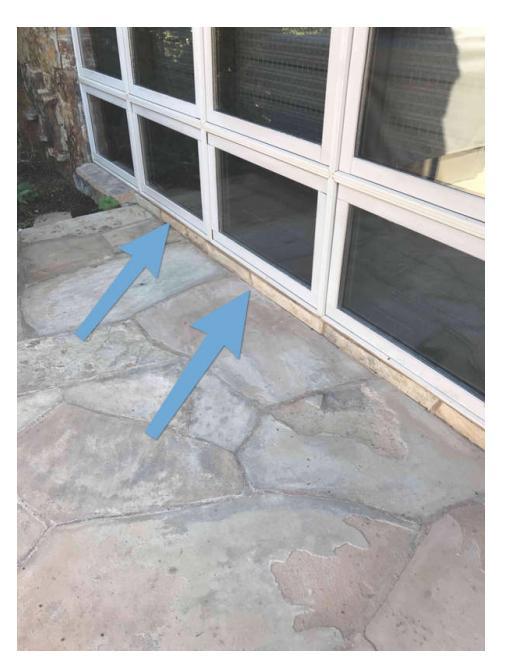
4.3.2 Siding / Trim LOOSE STONES OR BRICK

Loose stones or brick were noted. Recommend re-securing where needed.

Recommendation Contact a qualified professional.

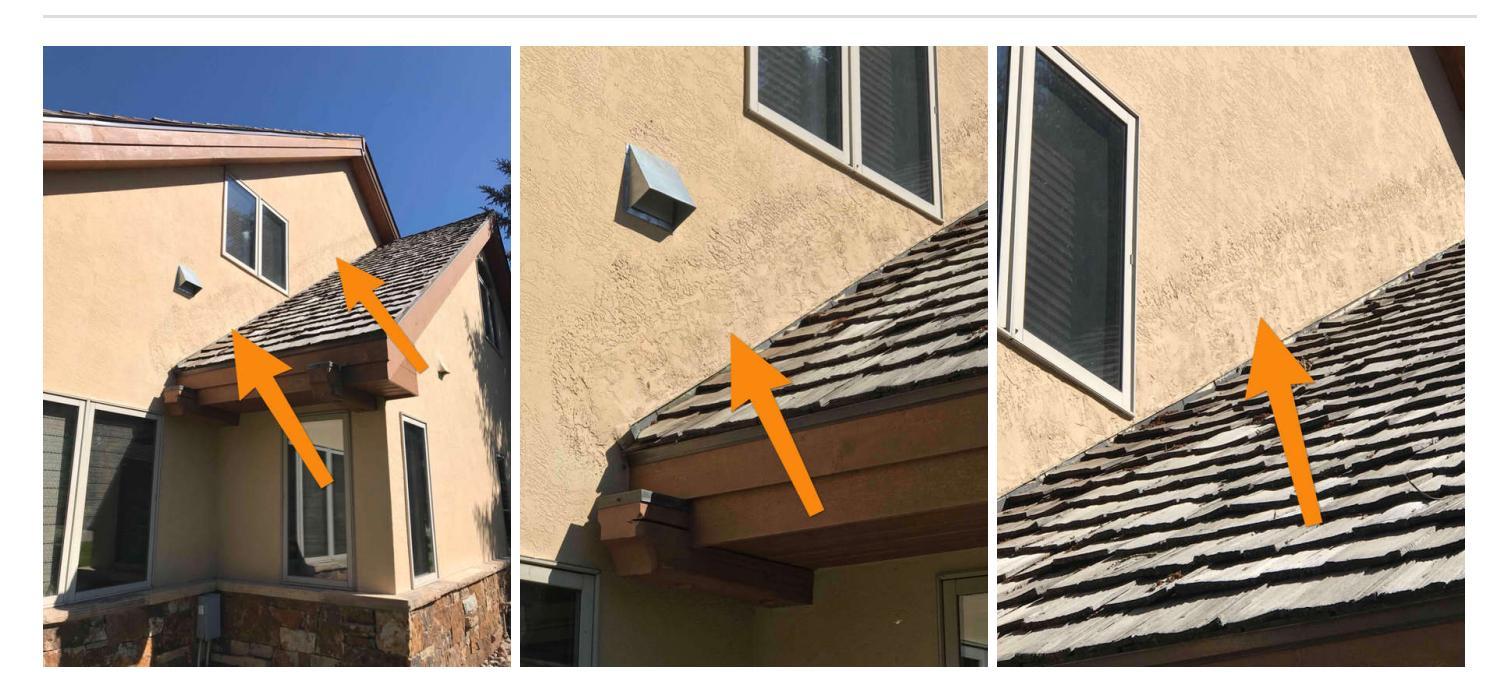
4.3.3 Siding / Trim

PREVIOUS REPAIR

There appears to be a previous repair done to the stucco on the left side. Consult seller about previous repairs.

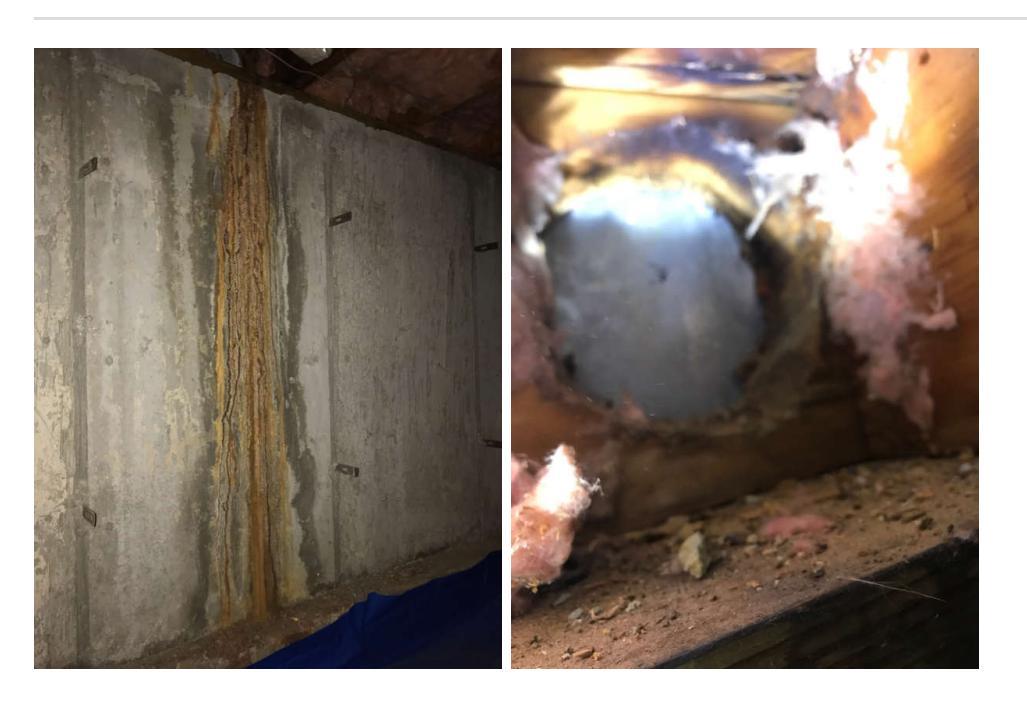
PAST, STAINS OR EFFLORESCENCE

Evidence of prior water intrusion or accumulation was found in one or more sections of the crawl space. For example, sediment stains on the vapor barrier or foundation, and/or efflorescence on the foundation. There is a hole in the sill area that has been blocked off by a piece of metal. Consult seller about this. Accumulated water is a conducive condition for mold growth and should not be present in the crawl space. Recommend that the client review any disclosure statements available and ask the property owner about past accumulation of water in the crawl space. The crawl space should be monitored in the future for accumulated water, especially after heavy and/or prolonged periods of rain. If water is found to accumulate, then recommend that a qualified contractor who specializes in drainage issues evaluate and repair as necessary.

Contact a qualified professional.

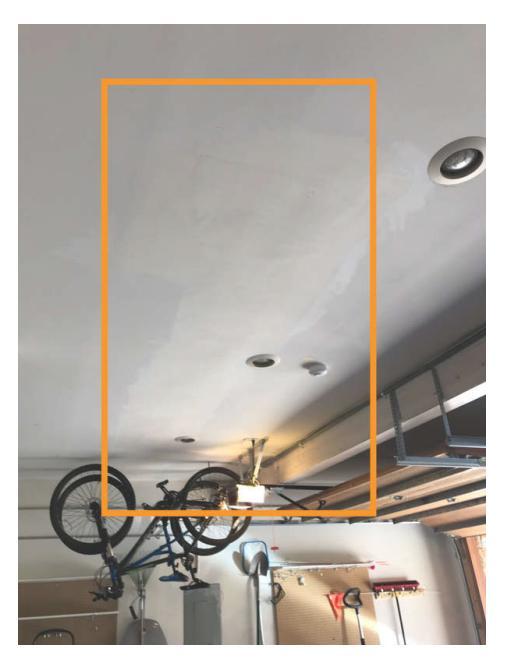
8.7.1 Interior/Walls/Ceilings

PAINTING OR EVIDENCE OF REPAIR PRESENT.

Consult seller about previous repair

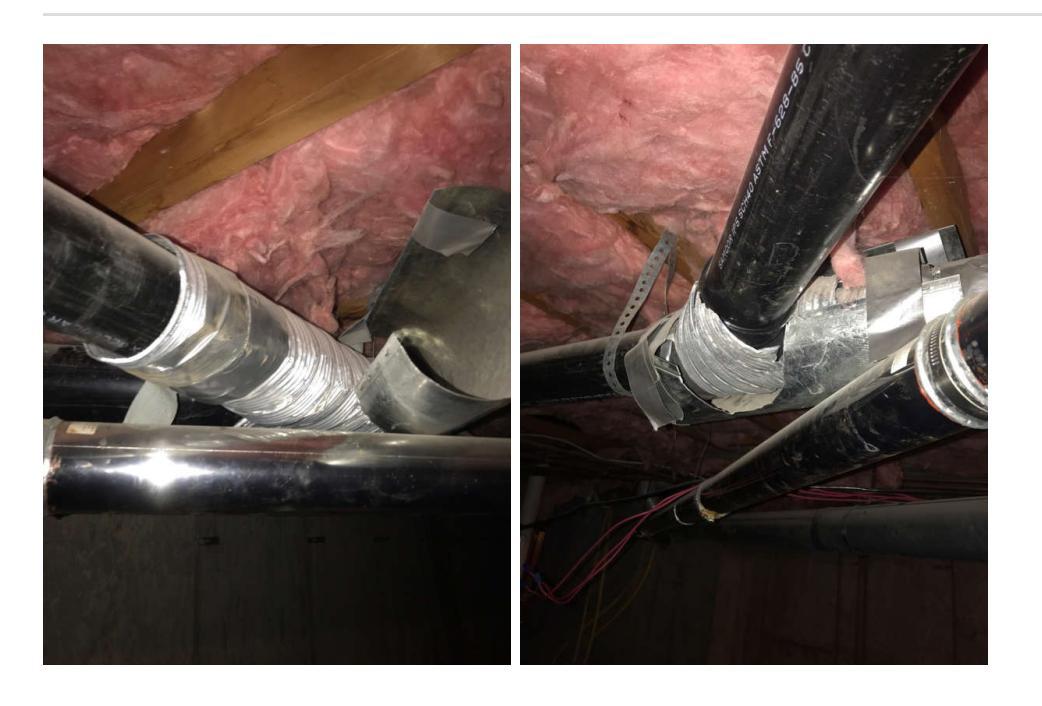
For some reason, there is some flex ducting material around one of the waste plumbing joints in the crawl space. No leaks were observed. Consult seller if they know why it's there or have it looked at and removed by a licensed plumber.

Contact a qualified plumbing contractor.

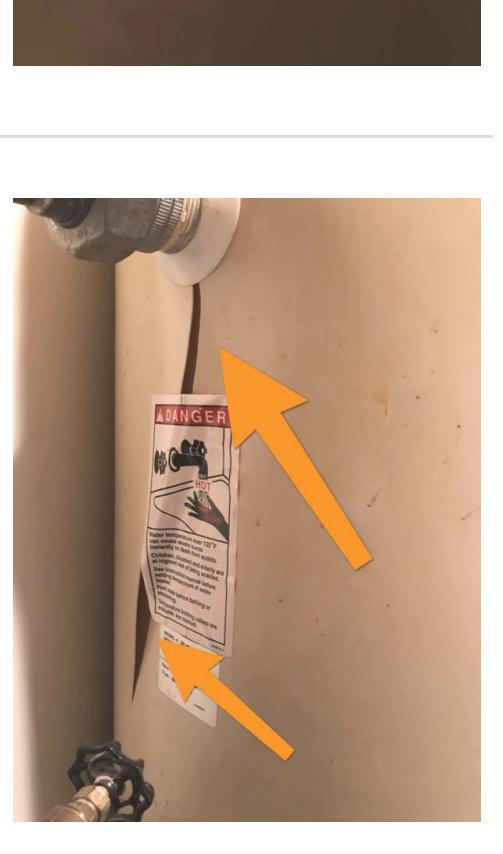
TANK DAMAGE

Tank damage was noted, but the tank is functional and not leaking at this time. The outer jacket is separated. Monitor

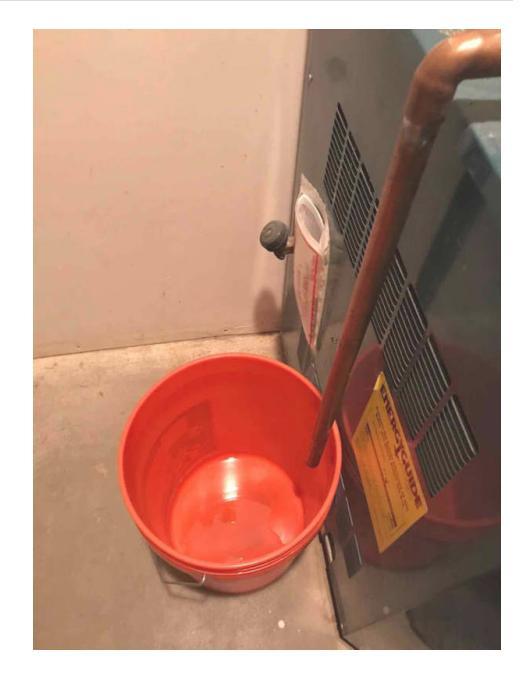
10.5.1 TPR Valve

LEAKING

The temperature-pressure relief valve was leaking. Recommend that a qualified plumber repair as necessary.

Contact a qualified plumbing contractor.

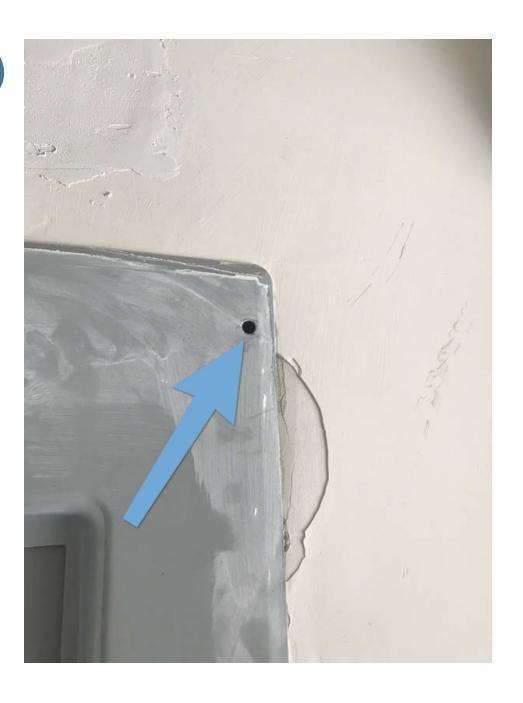
11.3.1 Main distribution panel **MISSING SCREWS** Install missing screw(s).

Recommendation Contact a qualified professional. 🔑 Maintenance Item

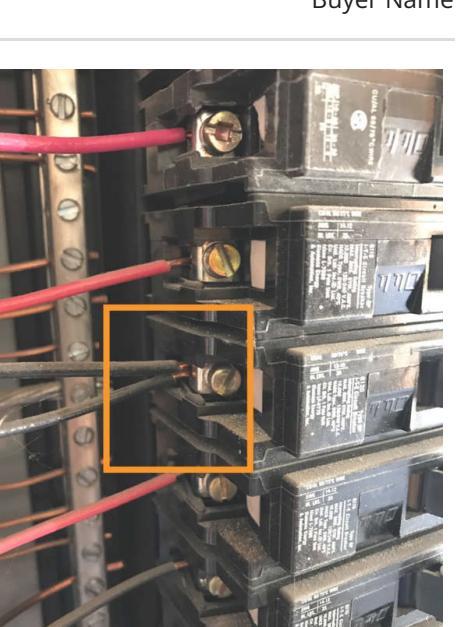
11.3.2 Main distribution panel

DOUBLE TAP

One circuit breakers in panel is "double tapped," where two or more wires were installed in the breaker's lug. Most breakers are designed for only one wire to be connected. This is a safety hazard since the lug bolt can tighten securely against one wire but leave other(s) loose. Arcing, sparks and fires can result. Recommend that a gualified electrician repair as necessary. For more information, visit:

Recommendation Contact a qualified electrical contractor.

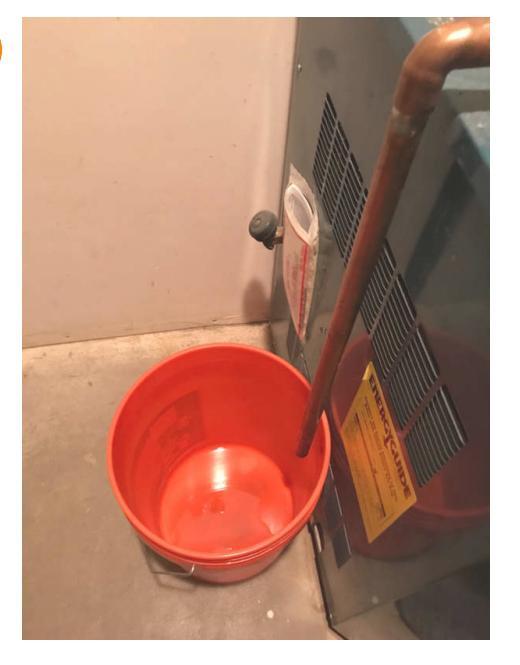
12.5.1 Hydronic TPR VALVE LEAKING

LEAKS

Contact a qualified heating and cooling contractor

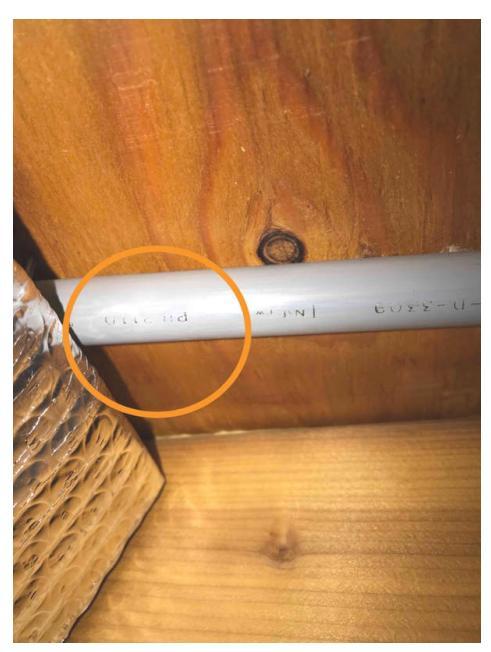
12.5.3 Hydronic

PΒ

Radiant heat pipes were made from polybutylene material. This material can be prone to fail without warning, causing damage to the home structure. Recommend a qualified plumber/heating contractor further evaluate and/or replace pipes and fittings with an approved material. You can read more about polybutylene piping here and here.

Recommendation Contact a qualified heating and cooling contractor

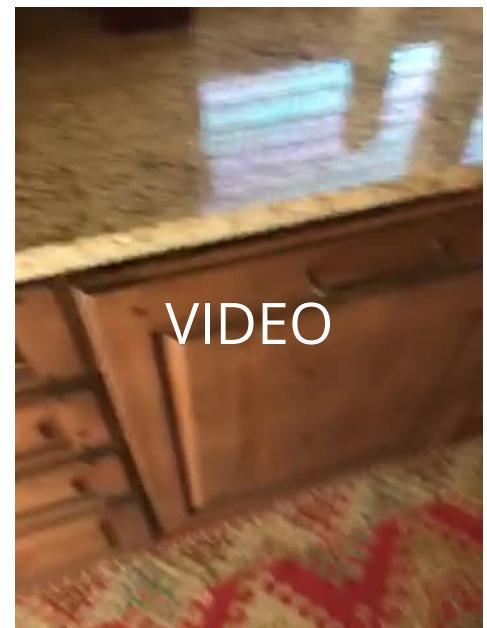
14.9.1 Dishwasher **NOT FASTENED TO THE CABINET.**

NOT LEVEL Recommendation Contact a qualified professional.

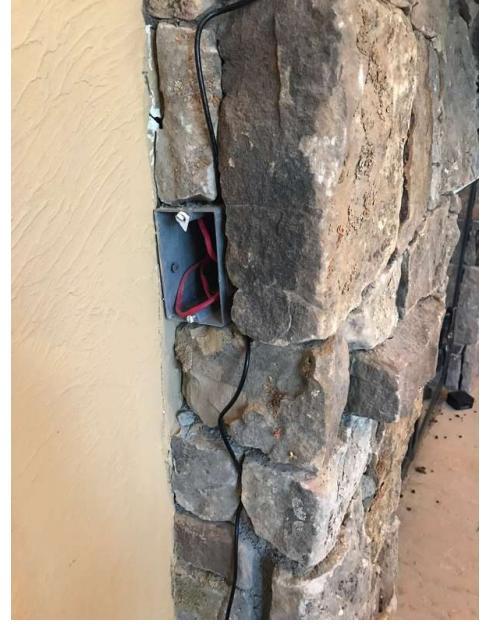
15.9.1 Accessible Electrical Outlets MISSING COVER PLATE Replace missing cover plate Recommendation Contact a handyman or DIY project

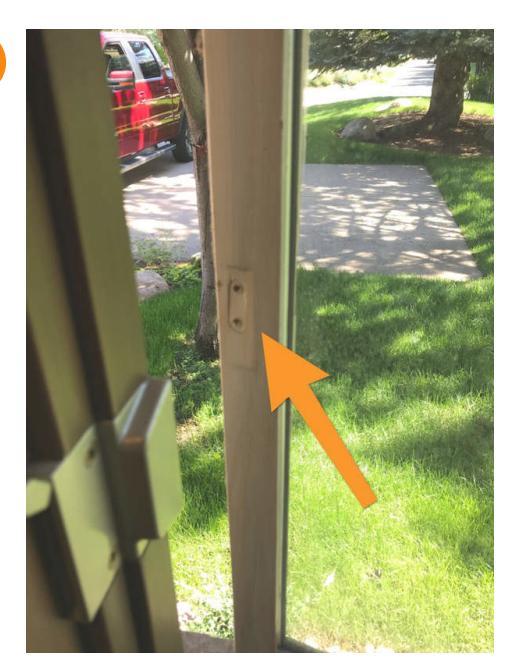
Lock mechanisms on one or more windows were *loose / missing / damaged / inoperable / difficult to operate*. This can pose a security risk. Recommend that a qualified person repair as necessary.

Recommendation Contact a qualified professional.
