907 HOME INSPECTIONS, LLC

RESIDENTIAL REPORT

1234 Main St.
Palmer AK 99645

Buyer Name
05/20/2019 9:00AM

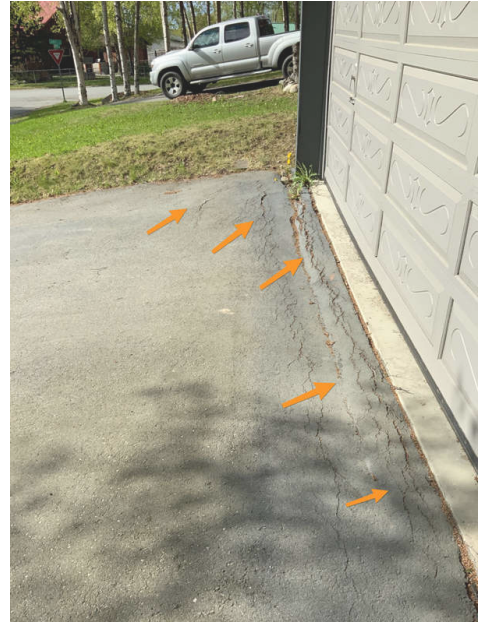
Recommendations**DRIVEWAY CRACKING - MAJOR**

Major cracks observed. Recommend driveway contractor evaluate and replace.

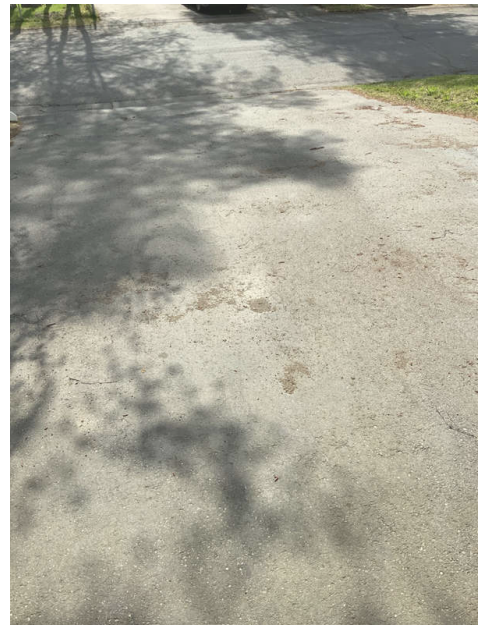
3.1.2 Walkways, Patios & Driveways

The asphalt driveway surface was worn and is prone to developing cracks from water penetration. Recommend that a qualified person reseal the driveway.

Contact a qualified professional.

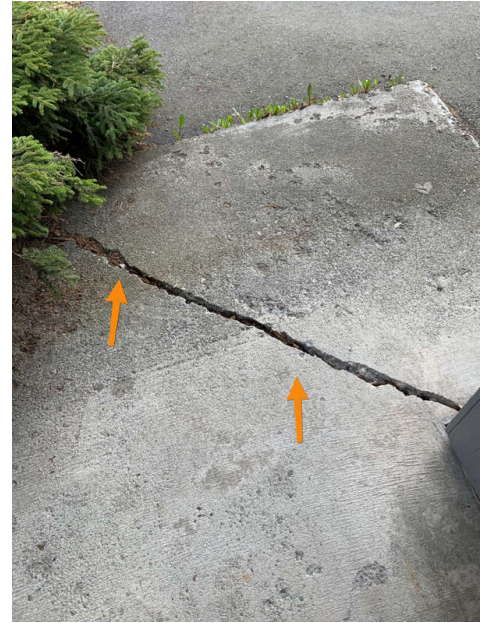
3.1.3 Walkways, Patios & Driveways

Recommendations**WALKWAY CRACKING - MAJOR**

Major cracks observed. Recommend concrete contractor evaluate and correct to prevent trip hazard & preserve appearance.

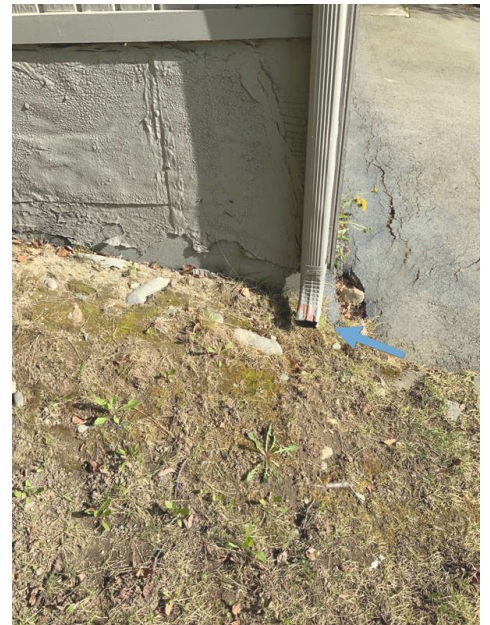
3.2.1 Vegetation, Grading, Drainage & Retaining Walls

Extensions such as splash blocks or drain pipes for one or more downspouts were *missing / poorly sloped / misaligned / clogged / substandard / damaged*. Water can accumulate around the building foundation or inside crawl spaces or basements as a result. Recommend that a qualified person install, replace or repair extensions as necessary so rainwater drains away from the structure.

Contact a qualified professional.

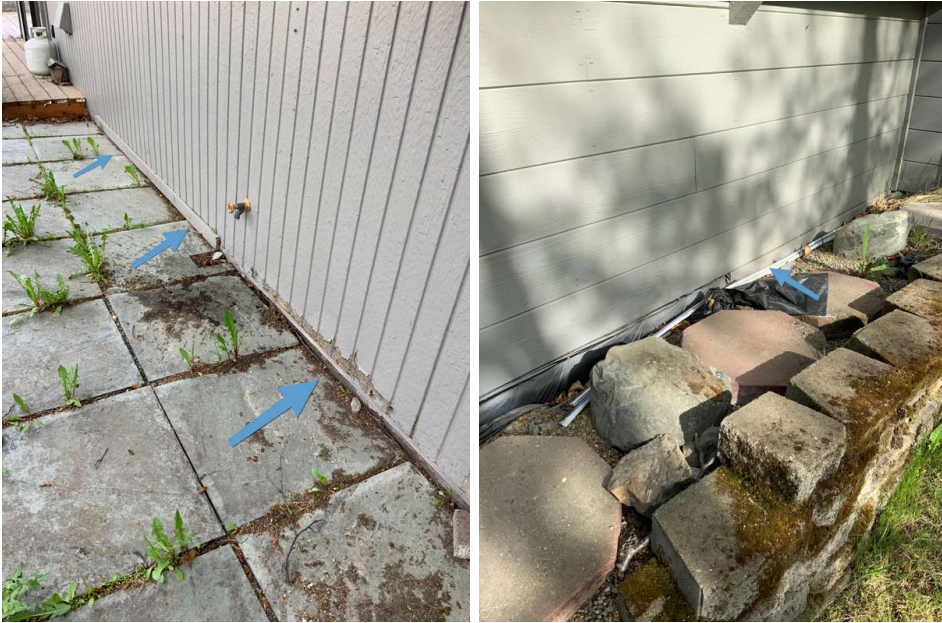
3.2.2 Vegetation, Grading, Drainage & Retaining Walls

Soil was in contact with or less than 6 inches from siding or trim. Regardless of what material is used for siding, it should not be in contact with the soil. If made of wood, siding or trim will eventually rot. For other materials, ground or surface water can infiltrate siding or trim and cause damage to the wall structure. Wood-destroying insects are likely to infest and damage the wall structure. This is a conducive condition for wood-destroying organisms. Recommend grading or removing soil as necessary to maintain a 6-inch clearance. Note that damage from fungal rot and/or insects may be found when soil is removed, and repairs may be necessary.

Recommended DIY Project

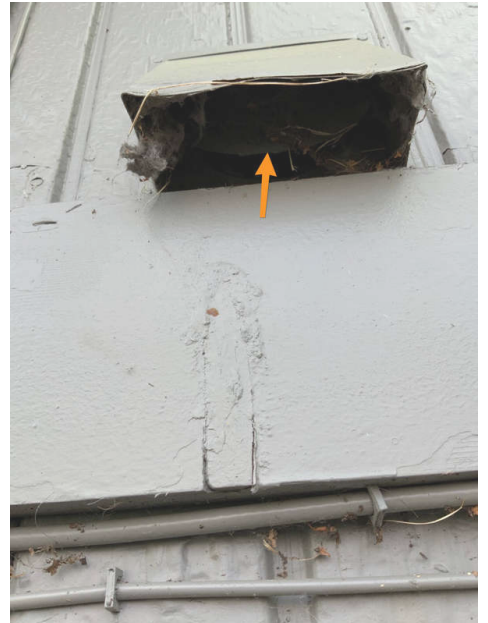
3.3.1 Exterior Issues

The dryer vent is clogged and needs to be cleaned. A clogged dryer vent can lead to dryer failure and extended dry times as well as being a fire hazard.

Recommend cleaning.

Replace screen after cleaning to prevent animal intrusion.

Contact a handyman or DIY project

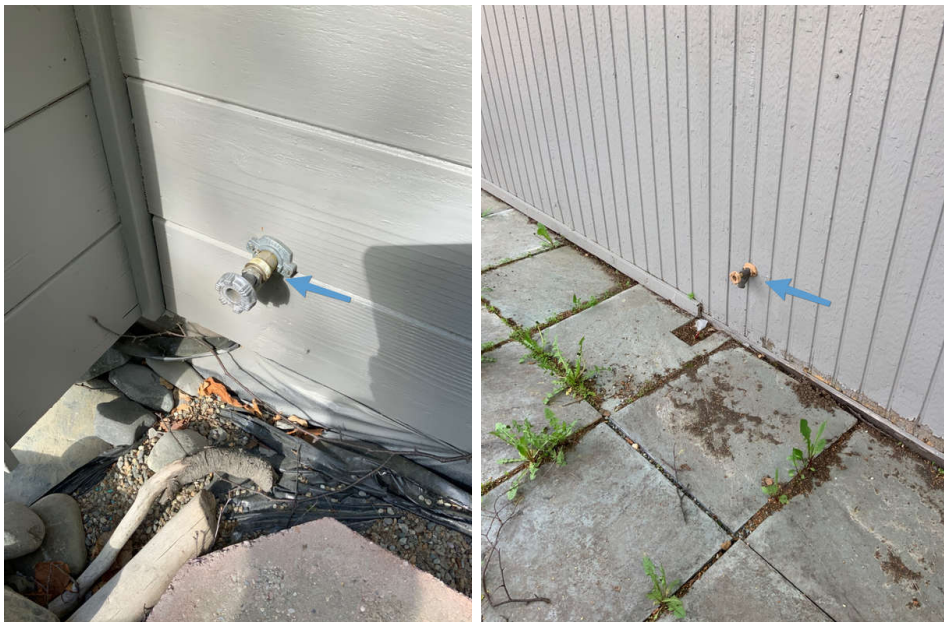
3.3.2 Exterior Issues

HOSE BIB MISSING BACKFLOW PREVENTER

One or more hose bibs were missing backflow prevention devices. These devices reduce the likelihood of gray water entering the potable water supply. Recommend installing backflow prevention devices on all hose bibs where missing. They are available at most home improvement stores and are easily installed.

Contact a handyman or DIY project

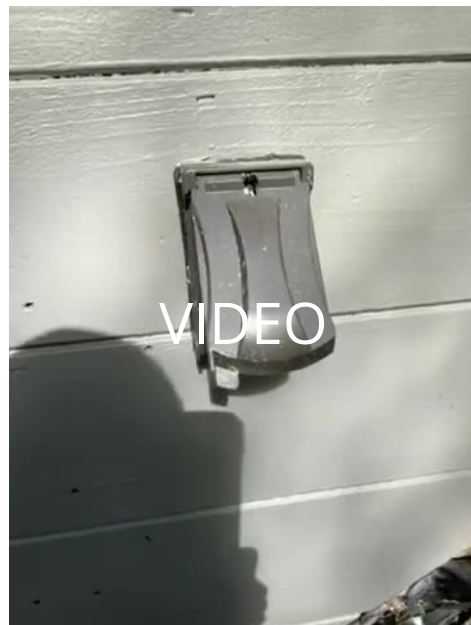
3.6.1 Exterior Electrical
NO GFCI PRESENT

One or more exterior outlets were not GFCI protected as required recommend consulting a licensed electrician to evaluate and remedy as needed.

Contact a qualified electrical contractor.

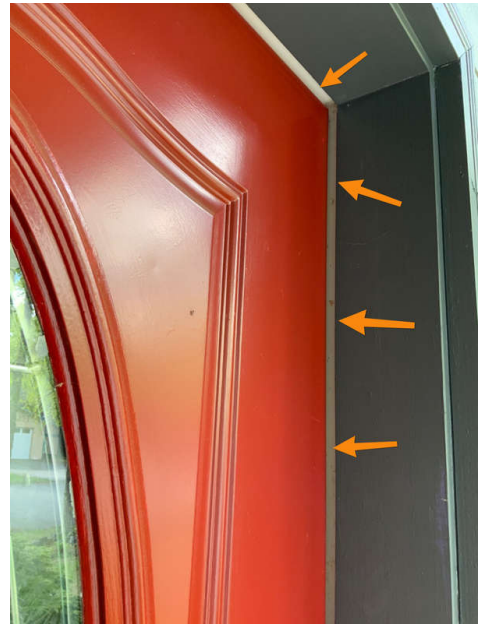
3.7.1 Exterior Doors

DOOR DOES NOT SEAL PROPERLY

Recommend a qualified contractor evaluate and repair as necessary to ensure the door seals as intended.

Contact a qualified professional.

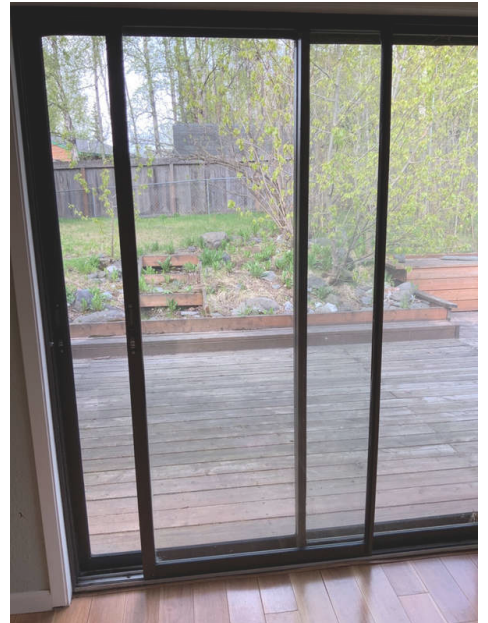
3.7.2 Exterior Doors

SLIDING GLASS DOOR DIFFICULT TO OPERATE

The sliding glass door was difficult to operate when tested. Recommend in cleaning and or lubricating the tracks to make the door operate as intended.

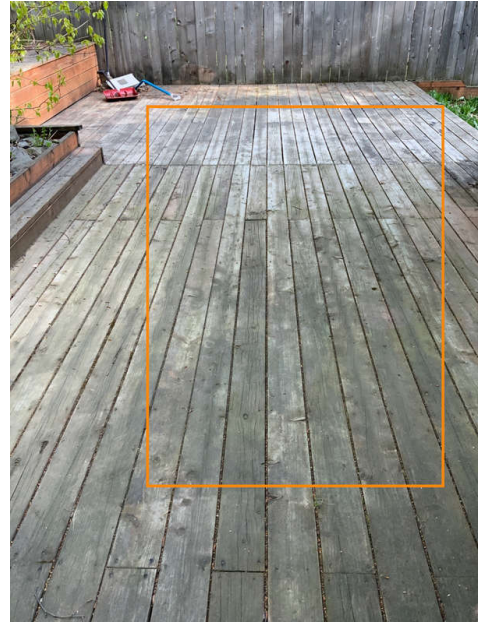
3.8.1 Decks, Balconies, Porches & Steps

DECK - WATER SEALANT REQUIRED

Deck is showing signs of weathering and/or water damage. Recommend water sealant/weatherproofing be applied.

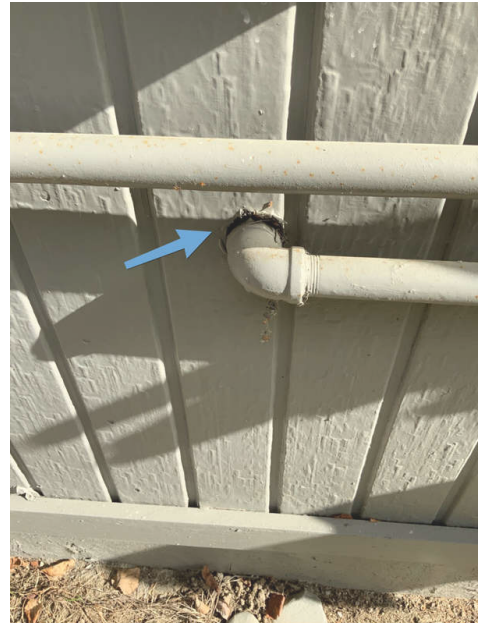
3.9.1 Siding, Flashing & Trim

CAULKING AT JOINTS

Caulk was *missing / deteriorated / substandard* in some areas. For example, *around windows / around doors / at siding butt joints / at siding-trim junctions / at wall penetrations*. Recommend that a qualified person renew or install caulk as necessary. Where gaps are wider than 1/4 inch, an appropriate material other than caulk should be used.

Contact a handyman or DIY project

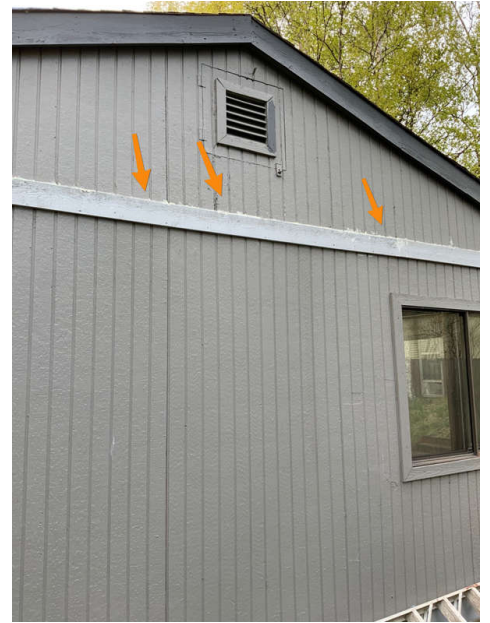
3.9.2 Siding, Flashing & Trim

EVIDENCE OF WATER INTRUSION

Siding showed signs of water intrusion. This could lead to further siding deterioration and/or mold. Recommend a qualified siding contractor evaluate and repair.

Contact a qualified siding specialist.

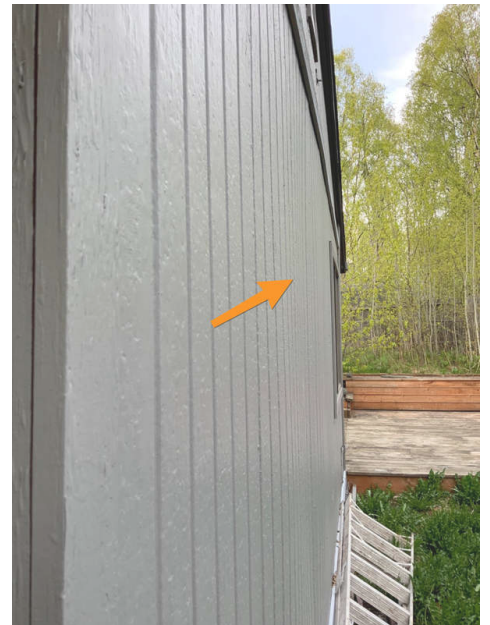
3.9.3 Siding, Flashing & Trim

IMPROPER CONSTRUCTION PRACTICES

Siding appears to be installed improperly and not up to standards. This could lead to moisture damage or deterioration of the home structure. Recommend a siding specialist evaluate and repair/replace.

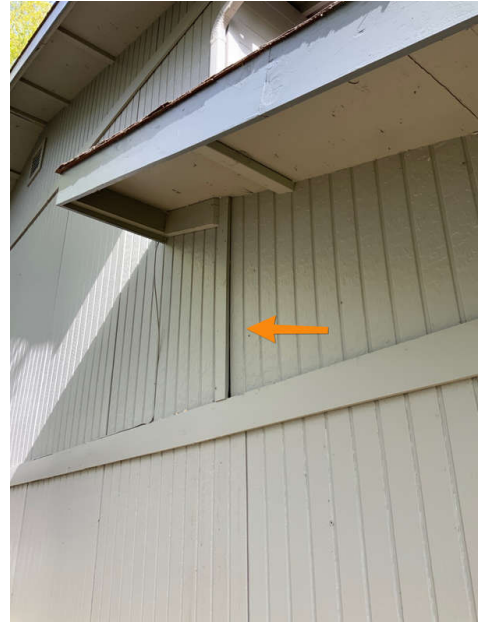
3.9.4 Siding, Flashing & Trim

SIDING/TRIM ISSUES

Sections of siding and/or trim were *deteriorated / loose / split / warped / missing / damaged / substandard / rotten*. Recommend that a qualified person repair, replace or install siding or trim as necessary.

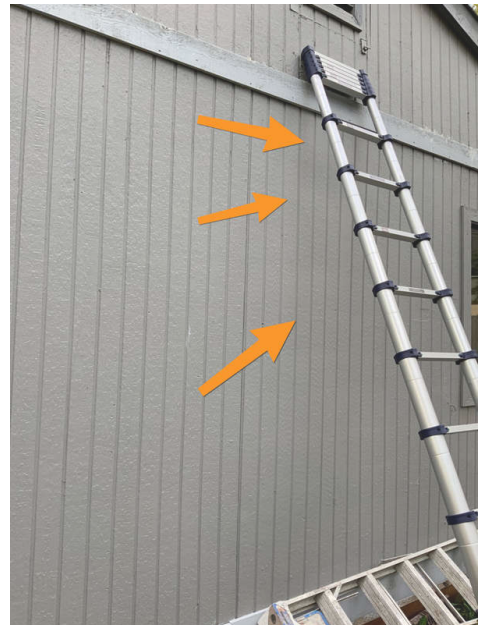
3.9.5 Siding, Flashing & Trim

SIDING BOWED OUT

Siding at the exterior of the house was bowed out in one or more locations. Recommend a qualified contractor evaluate and repair/remedy/replace as necessary.

Contact a qualified professional.

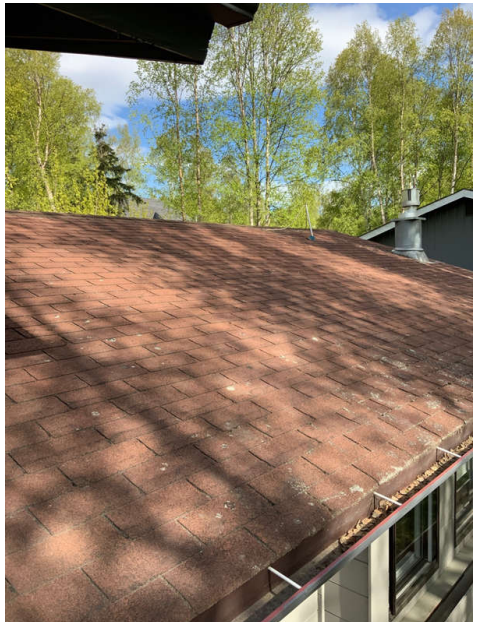
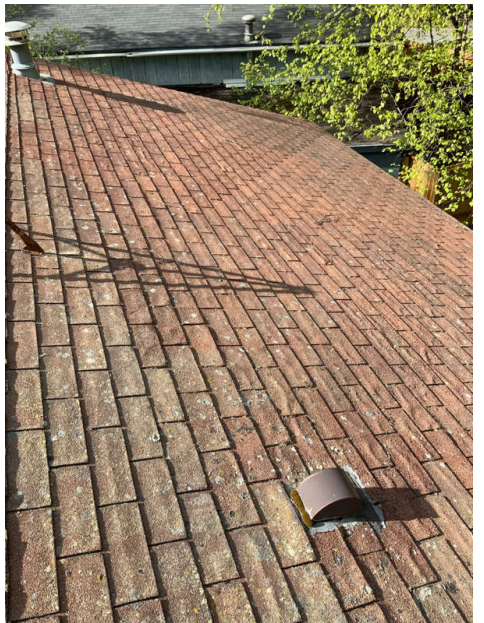
The roof surface was significantly deteriorated and appeared to be at or beyond its service life. It needs replacing now. This is a conducive condition for wood-destroying organisms and water penetration. Consult with a qualified contractor to determine replacement options. Note that some structural repairs are often needed after old roof surfaces are removed and the structure becomes fully visible. Related roofing components such as flashings and vents should be replaced or installed as needed and per standard building practices.

Contact a qualified roofing professional.

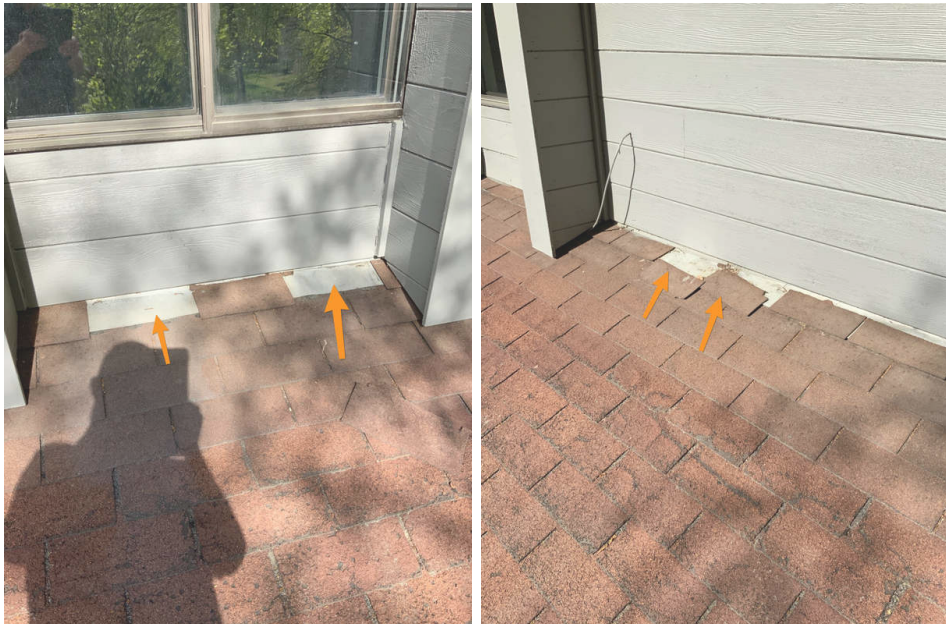
4.1.2 Coverings

SHINGLES MISSING

Observed areas that appeared to be missing sufficient coverings. Recommend qualified roofing contractor evaluate & repair.

Contact a qualified roofing professional.

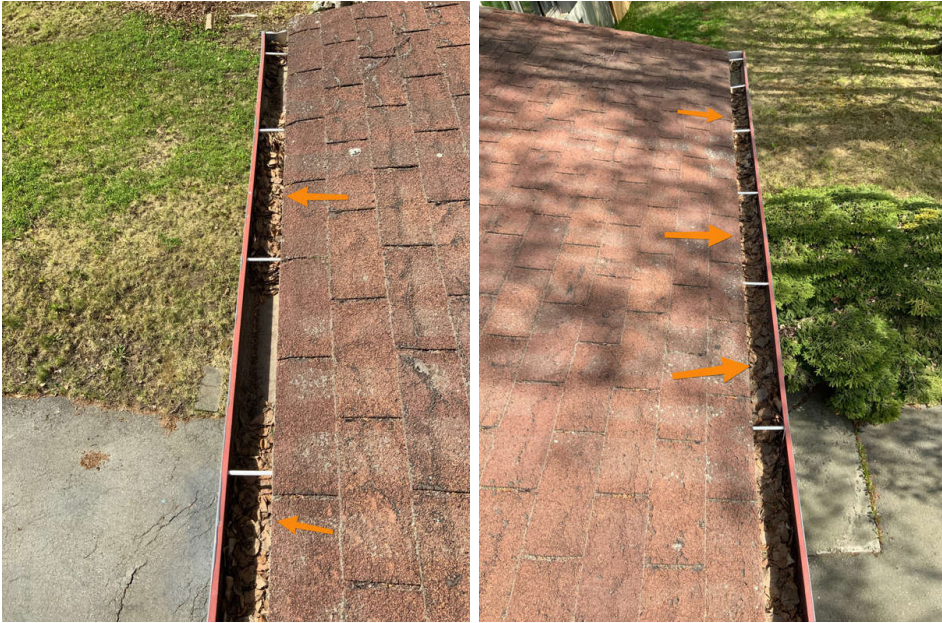
4.2.1 Roof Drainage Systems

Debris has accumulated in the gutters. Recommend cleaning to facilitate water flow.

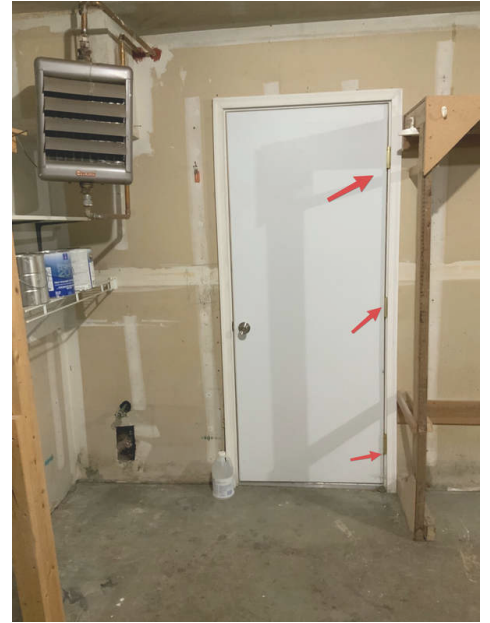
The garage-house door is equipped with an automatic closing device such as spring hinges that need to be adjusted or replaced.

Contact a qualified professional.

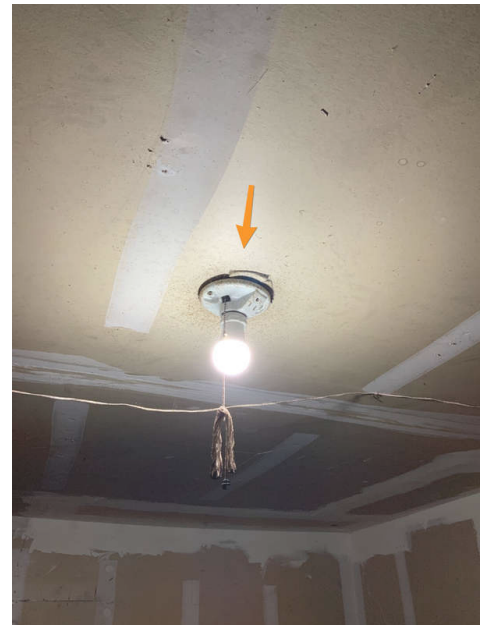
5.2.1 Electrical

DETERIORATED FIXTURES

One or more light fixtures are damaged and/or deteriorated. A qualified electrician should evaluate and repair or replace where necessary.

Contact a qualified electrical contractor.

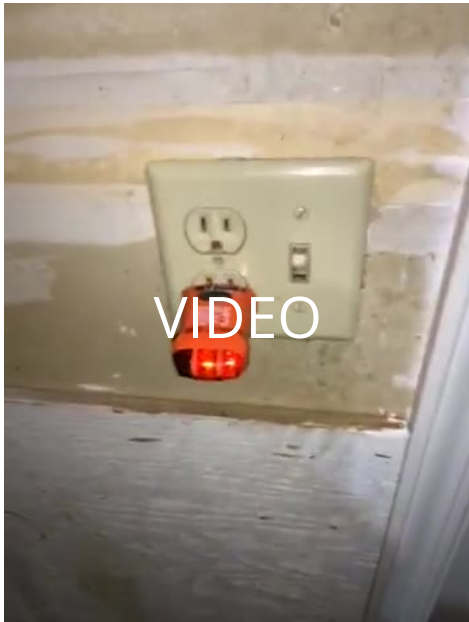
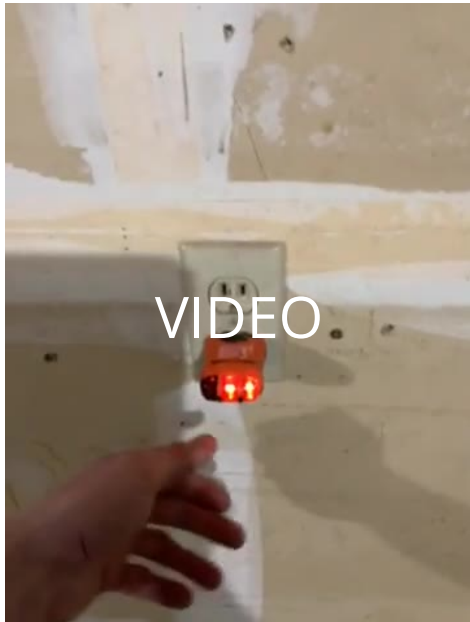
- ⚠️ 5.1.1 Garage - Interior-Exterior doors-Windows: Adjust Self-Closing Hinges
- ⊖ 5.2.1 Garage - Electrical: Deteriorated Fixtures
- ⚠️ 5.2.2 Garage - Electrical: No GFCI

Contact a qualified electrical contractor.

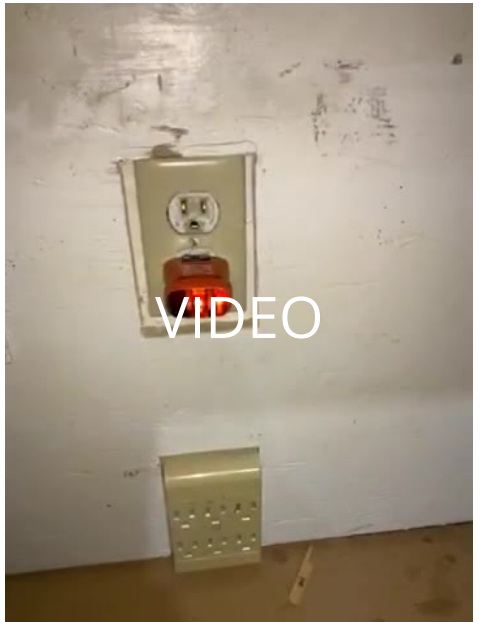
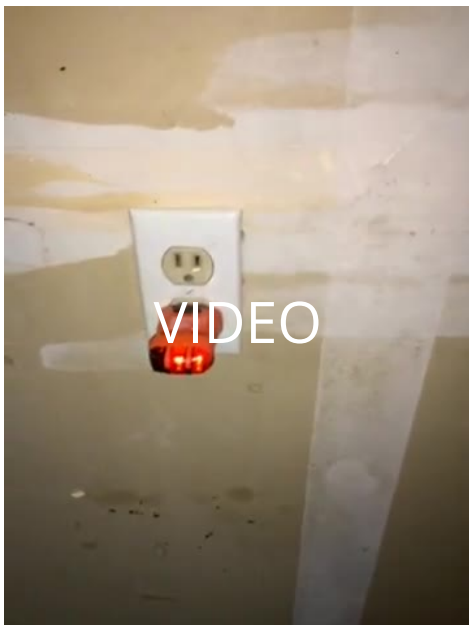
5.2.2 Electrical

One or more garage electric receptacles appear to have no ground fault circuit interrupter (GFCI) protection. This is a safety hazard due to the risk of shock. A qualified electrician should evaluate to determine if GFCI protection exists, and if not, repairs should be made so that all garage receptacles, except for one for use with a refrigerator or freezer, have GFCI protection. For example, install GFCI receptacles or circuit breaker(s) as needed.

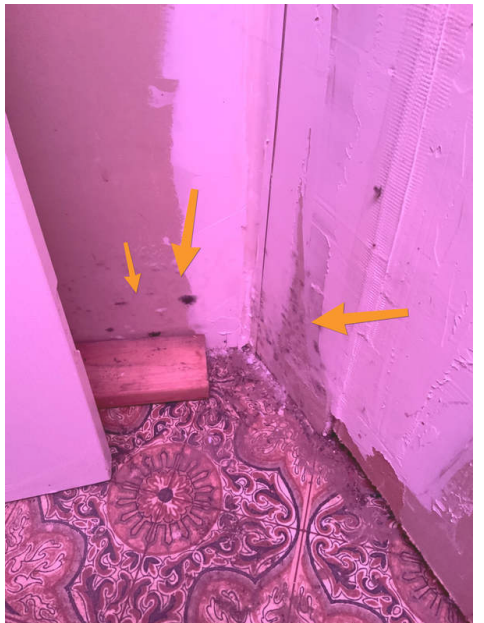
5.3.1 Floors, walls, Ceiling

MICROBIAL GROWTH

Surface Microbial growth was found on one or more walls/ceilings of the garage. This appears to be due to items previously stored and should be cleaned

Contact a qualified professional.

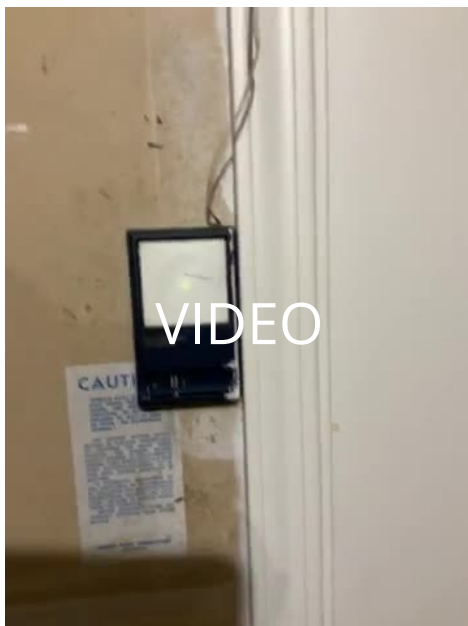
One or more garage vehicle door openers are inoperable. A qualified contractor should evaluate and make repairs as necessary.

Contact a qualified garage door contractor.

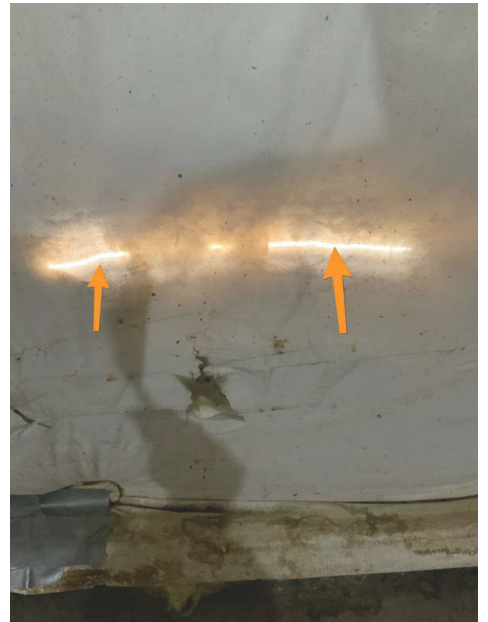
5.4.2 Vehicle door

PANEL DAMAGE

Garage door panel is damaged and may need repair/replacement. Recommend a qualified garage door contractor evaluate.

Contact a qualified garage door contractor.

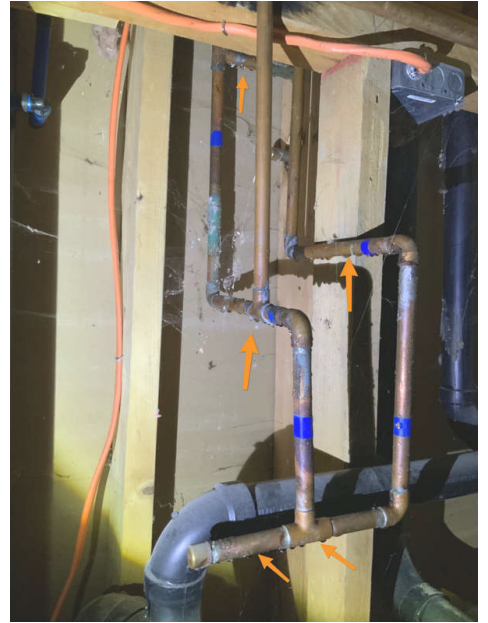
Recommendations
POSSIBLE LEAK

Evidence of condensation or pipes potentially leaking in the crawlspace recommend consulting a licensed plumber for evaluation.

Contact a qualified plumbing contractor.

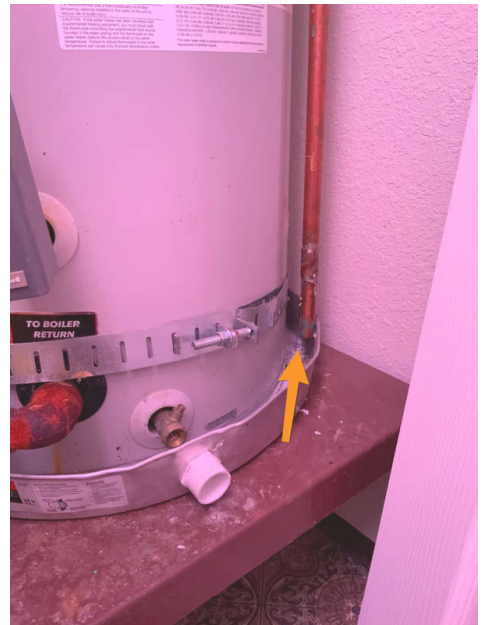
6.4.1 Water Heater

Recommendations
TPR TOO SHORT

The TPR (temperature-pressure relief) valve drain line was too short. This is a potential safety hazard due to the risk of scalding if someone is standing next to the water heater when the valve opens. Recommend that a qualified plumber repair per standard building practices. For example, by extending the drain line to within 6 inches of the floor for indoor hot water heaters, or within 24 inches of exterior grade for outdoor water heaters.

Contact a qualified plumbing contractor.

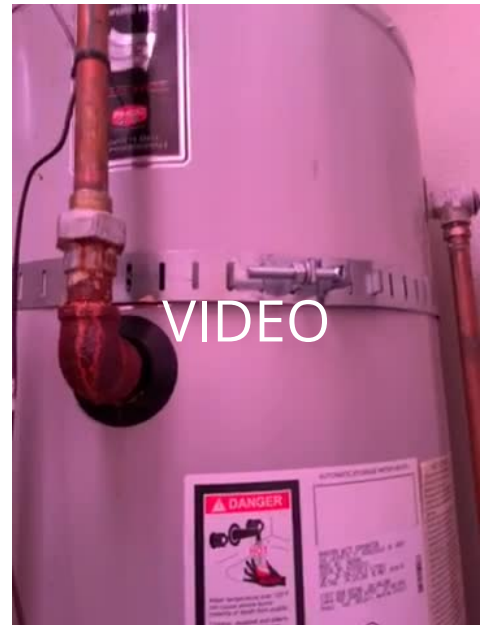
6.4.3 Water Heater

Earthquake straps were not installed as per standard building practices recommend adjusting the earthquake straps.

Contact a handyman or DIY project

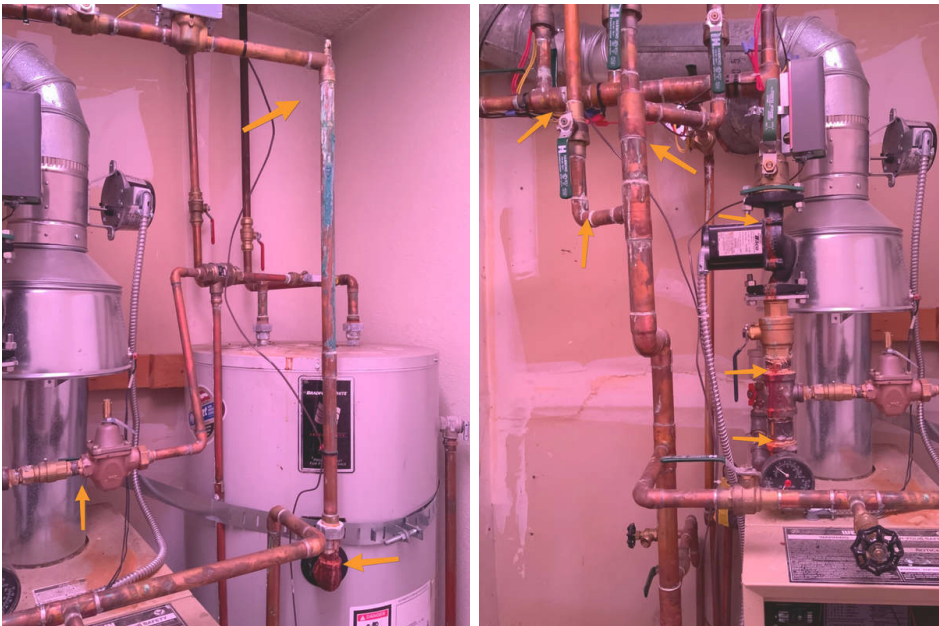
8.1.4 Heating Equipment

CORROSION PRESENT

Contact a qualified professional.

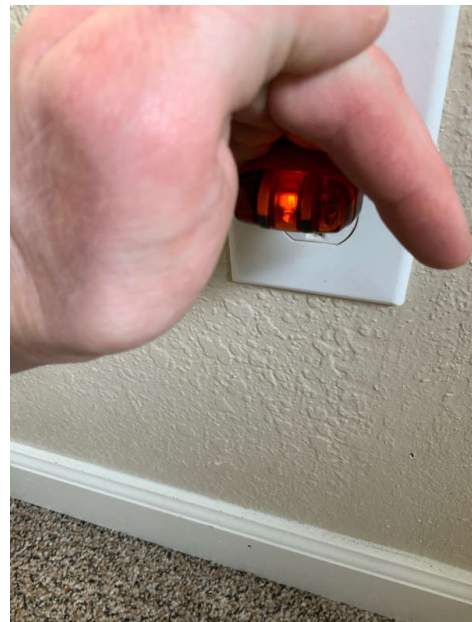
9.5.1 Electrical

OUTLET(S) NOT GROUNDED

One or more outlets are not grounded. Recommend a qualified electrician replace non-grounded outlets with grounded ones.

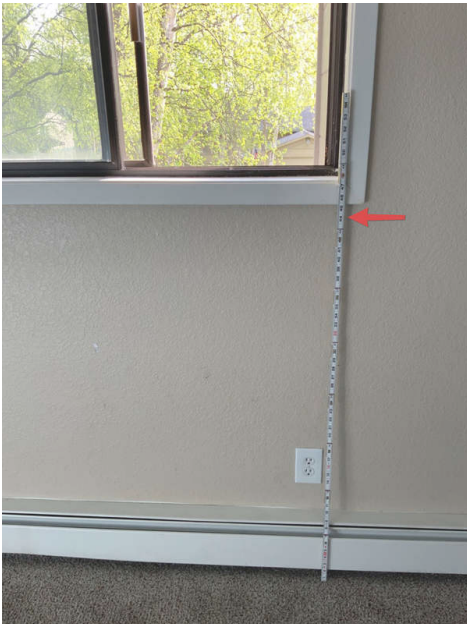
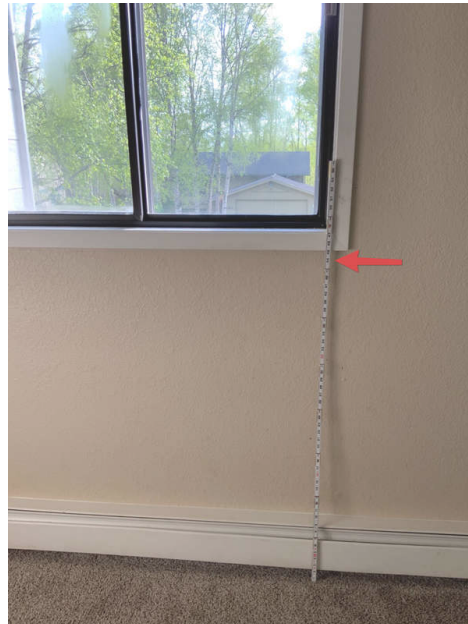
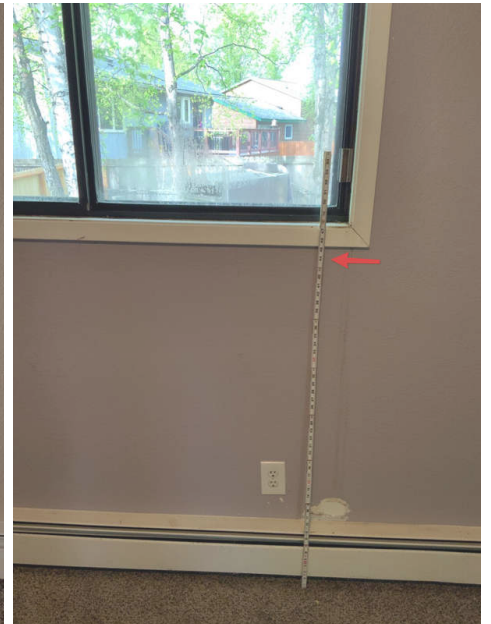
9.7.2 Windows and Door

IMPROPER SILL HEIGHT

Contact a qualified professional.

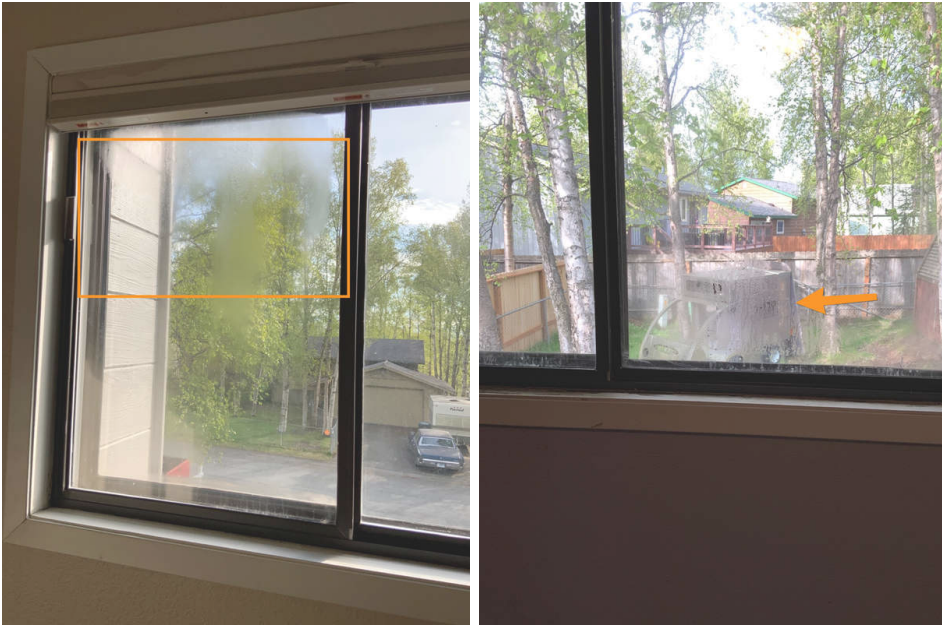
Seals between double-pane glass in one or more windows appear to have failed based on condensation or stains between the panes of glass. A qualified contractor should evaluate and replace glass where necessary.

The client(s) should be aware that evidence of broken seals may be more or less visible from one day to the next depending on the temperature, humidity, sunlight, etc. Windows or glass doors other than those that the inspector identified may also have failed seals and need glass replaced too.

Contact a qualified window repair/installation contractor.

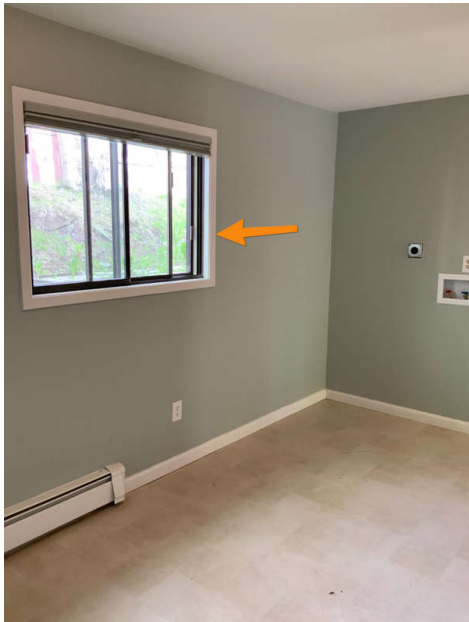
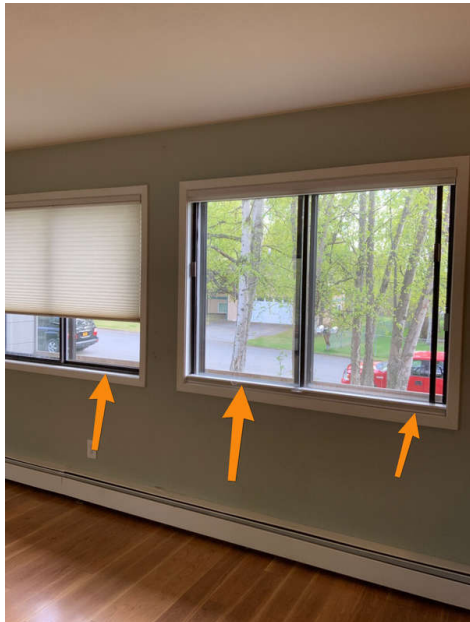
9.7.4 Windows and Door

WINDOW HARD TO OPEN

One or more windows are difficult to open and close. The windows should be adjusted so that they will open and close freely all necessary repairs should be made.

Contact a qualified professional.

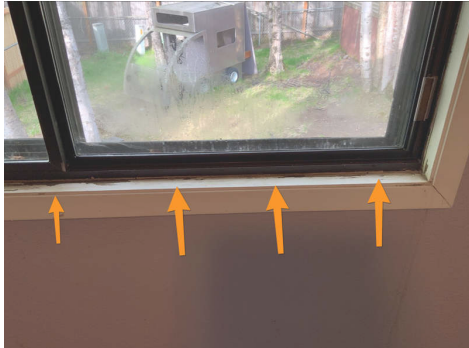
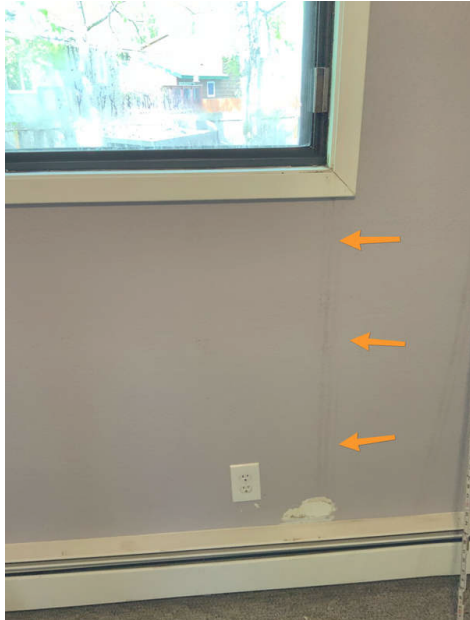
9.7.5 Windows and Door

EVIDENCE OF PAST LEAK

Evidence of a past leak was observed at one or more bedroom windows. Recommend consulting a qualified window professional to ensure that the leak is remediated.

Contact a qualified professional.

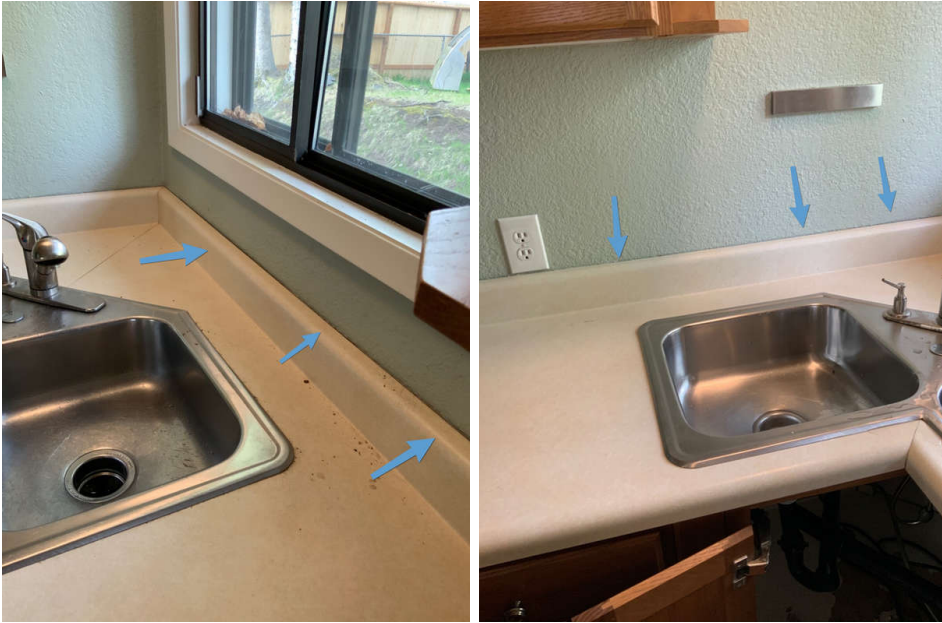
One or more areas of the kitchen counter top(s) are recommended to be re-sealed (caulked) to keep any moisture and or water out and prevent future damage.

Recommended DIY Project

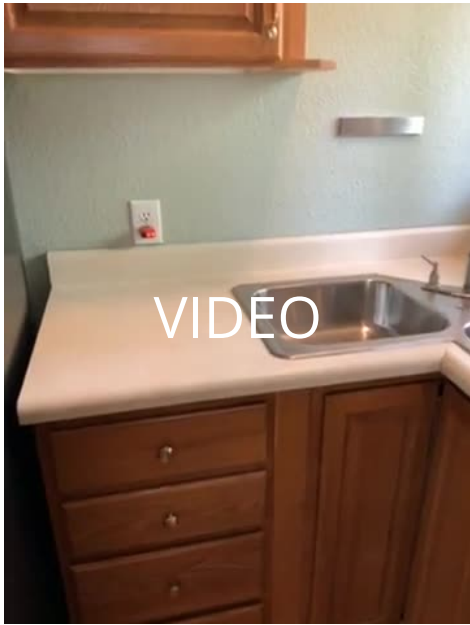
10.3.1 Electrical

GFCI MISSING

One or more electric receptacles at the kitchen had no visible ground fault circuit interrupter (GFCI) protection, or the inspector was unable to determine if GFCI protection was present. If not GFCI-protected, receptacles in wet areas pose a shock hazard. Recommend that a qualified electrician evaluate and install GFCI protection if necessary and per standard building practices. General guidelines for GFCI-protected receptacles include the following locations:

Contact a qualified electrical contractor.

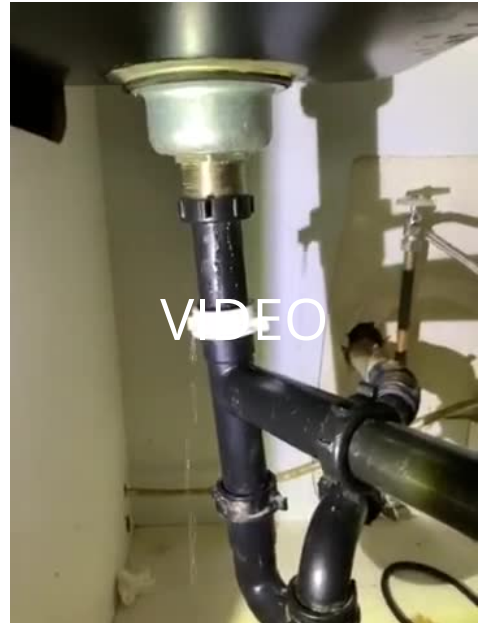
10.5.1 Sink

DRAIN LEAK

One or more sink drains have an active leak. For example, at pipe fittings and/or junctions between pipe and sink. A qualified plumber should evaluate and repair as necessary.

Contact a qualified plumbing contractor.

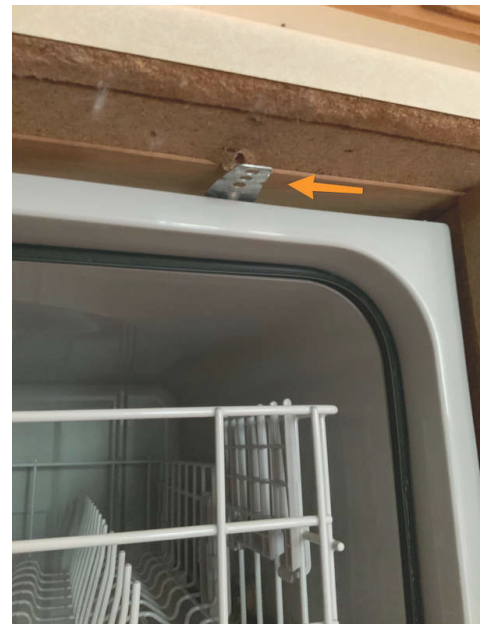
The bracket that attaches the dishwasher to the underside of the countertop is loose, missing or installed in a substandard way. Repairs should be made as necessary, such as installing or reinstalling the bracket, and by a qualified contractor if necessary.

Contact a qualified appliance repair professional.

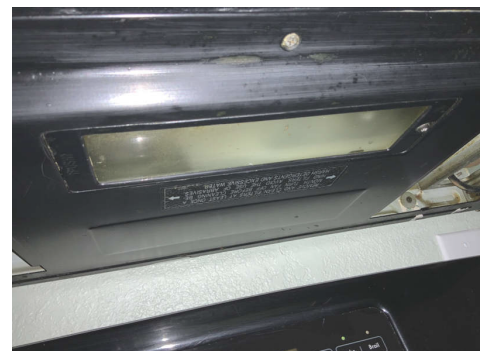
11.5.1 Hood/Vent

LIGHT INOPERABLE

The light in range hood is inoperable. Recommend replacing light bulb(s) or having repairs made by a qualified contractor as necessary.

Recommended DIY Project

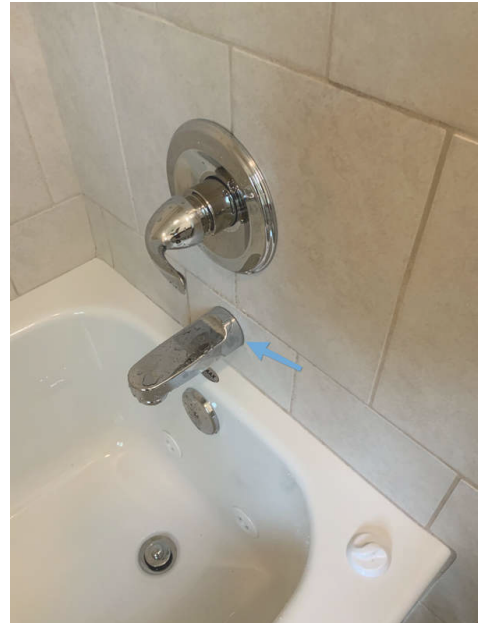
Caulk is missing or deteriorated around the base of the bathtub spout. It should be replaced where deteriorated and/or applied where missing to prevent water intrusion and damage to wall structures.

Recommended DIY Project

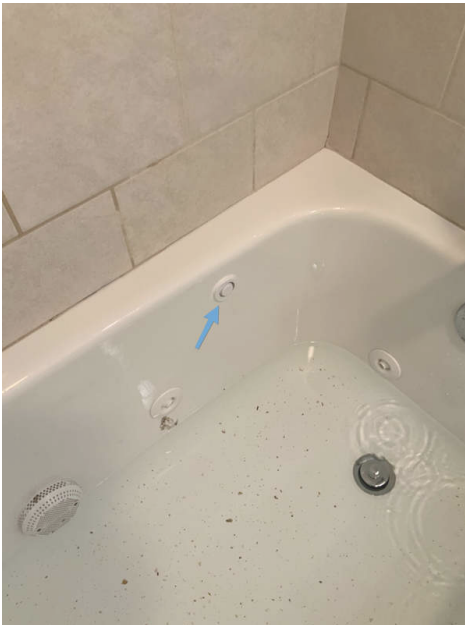
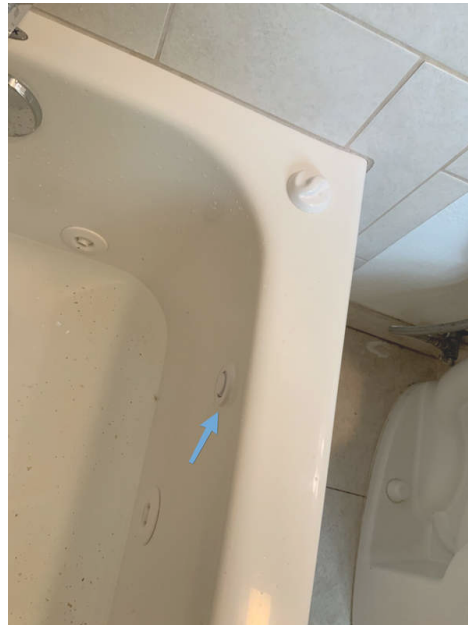
12.2.4 Bathub

CONTROLS DETACHED

The controls for the jetted tub controls have been detached recommend re-fixing the controls as intended.

Contact a qualified professional.

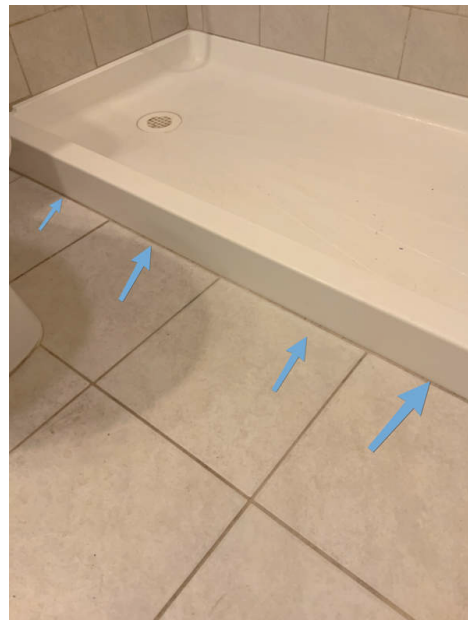
12.3.1 Shower

Caulk is missing or deteriorated along the base of the shower, where flooring meets the shower. It should be replaced where deteriorated and/or applied where missing to prevent water intrusion and damage to the floor structure.

Recommendation
Recommended DIY Project

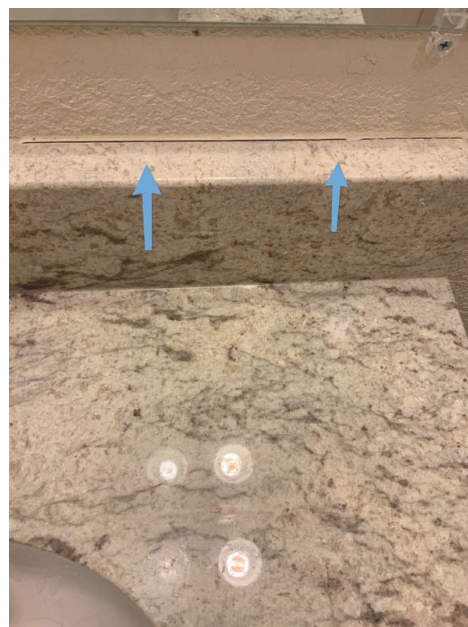
12.4.1 Sink/Countertop

Caulk is missing and/or deteriorated where counter tops meet back splashes in wet areas, such as around sinks. Caulk should be replaced where deteriorated and/or applied where missing to prevent water damage.

Recommendation
Recommended DIY Project

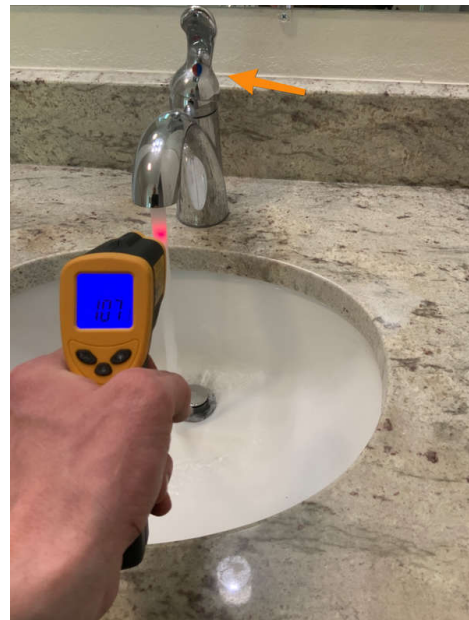
12.4.2 Sink/Countertop

One or more bathroom faucets appear to be reversed plumbed. The cold water comes on in the hot water position and the hot water comes on in the cold position. A certified plumbing contractor should evaluate the fixture and make the necessary repairs.

Recommendation
Contact a qualified plumbing contractor.

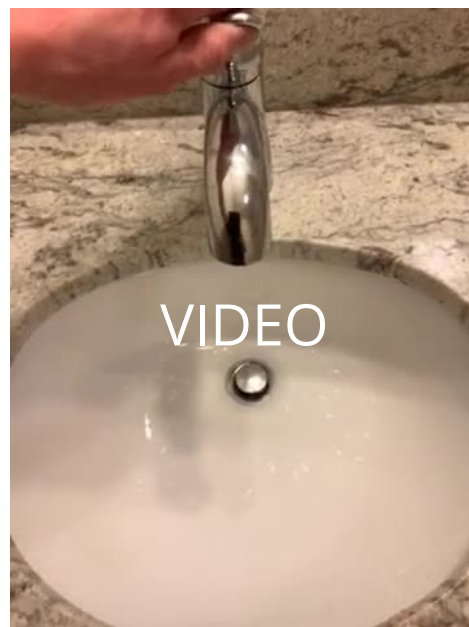
12.4.3 Sink/Countertop

AERATOR MISSING

The aerator for the bathroom sink is missing and recommend replacing to prevent splattering.

Recommended DIY Project

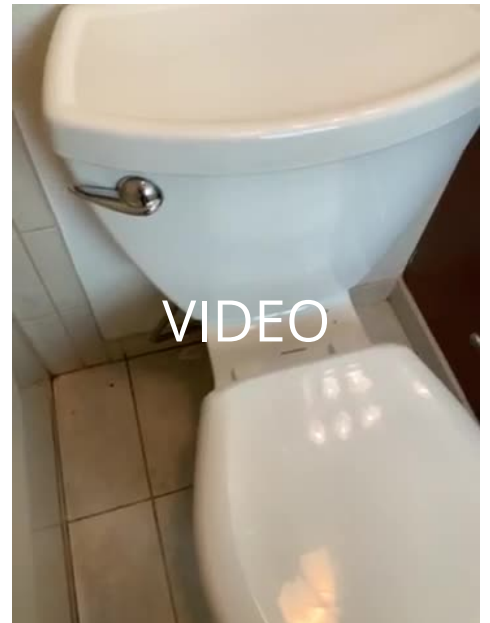
The toilet "run" after being flushed, where water leaks from the tank into the bowl. Significant amounts of water can be lost through such leaks. A qualified plumber should evaluate and repair or replace components as necessary.

Contact a qualified plumbing contractor.

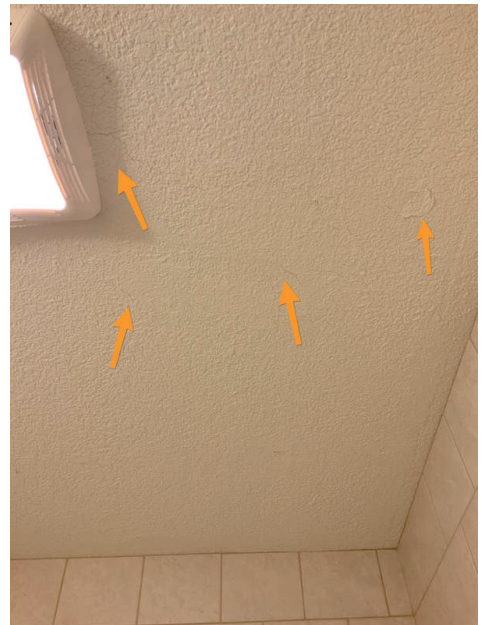
MINOR CRACKING OBSERVED

Cracking in the paint above the shower has deteriorated recommend repainting need to prevent moisture intrusion.

Contact a qualified professional.

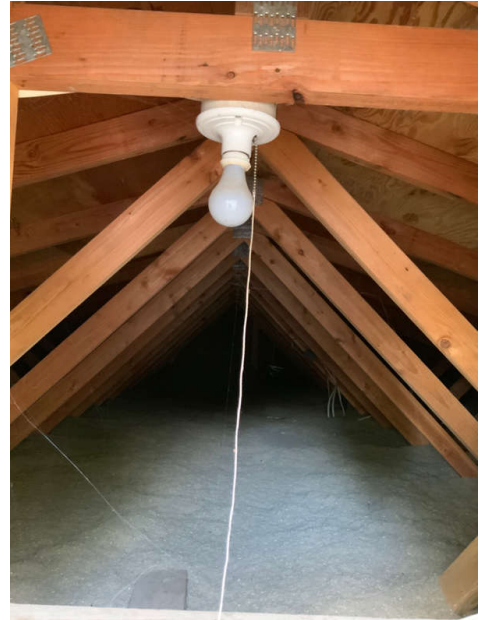
14.4.3 Electrical

FIXTURE INOPERABLE

Recommend replacing the bulb(s).

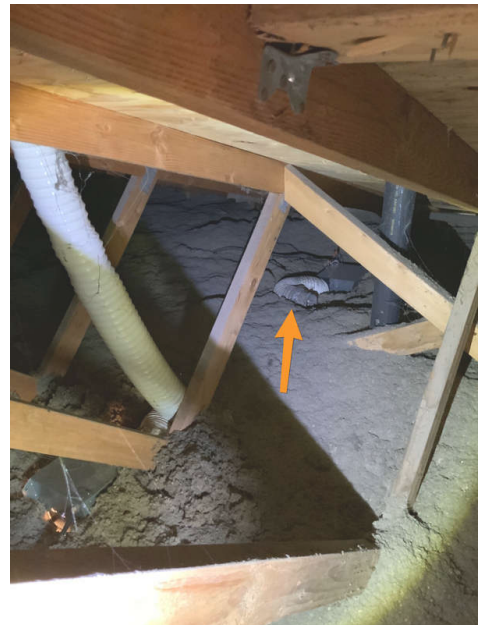
14.6.1 Ventilation

Recommendations**EXHAUST TERMINATE IN ATTIC**

One or more exhaust fan ducts terminate in attic do to a roof or side vent has never been installed through the roof or exterior wall surfaces. This is a conducive condition for wood destroying insects and organisms due to increased moisture levels in the attic from the exhaust air. A qualified contractor should evaluate and install vent caps where missing and as per standard building practices, so all exhaust air is vented outside.

Contact a qualified HVAC professional.
