907 HOME INSPECTIONS, LLC

RESIDENTIAL REPORT

1234 Main St.
Palmer AK 99645

Buyer Name
05/20/2019 9:00AM

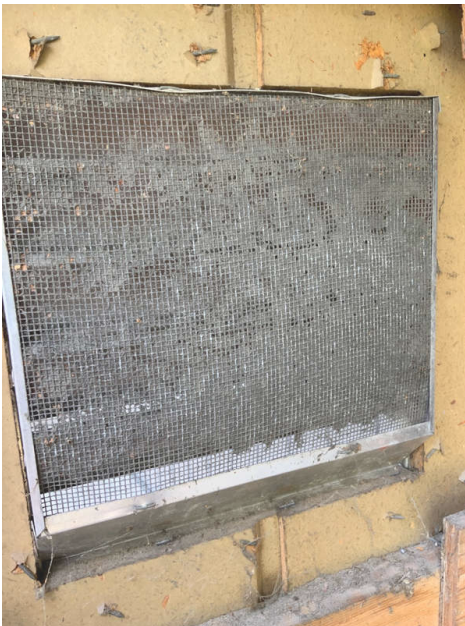
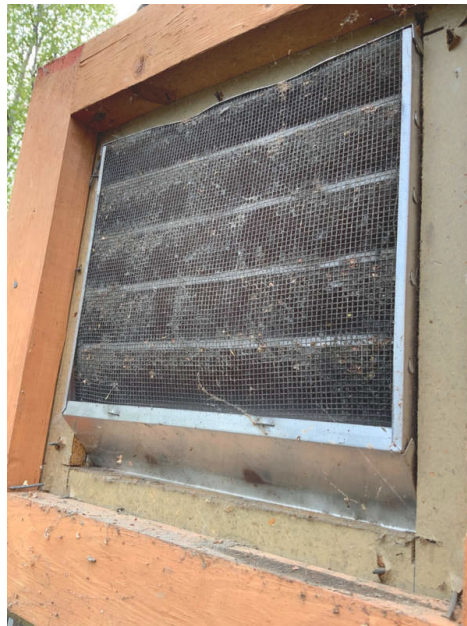
One or more gable/ridge/soffit vents in the attic were clogged with insulation material. Recommend cleaning or adjusting to allow adequate air flow and ventilation through the attic.

Contact a qualified professional.

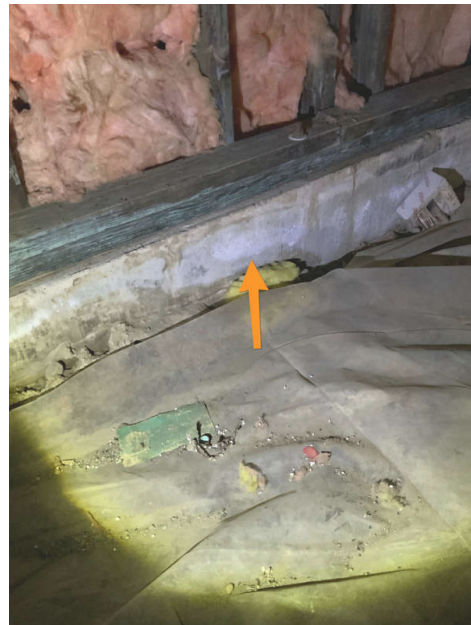
15.2.1 Foundation, Basement & Crawlspaces

**EFFLORESCENCE**

Efflorescence noted on the crawlspace surface. This a white, powdery deposit that is consistent with moisture intrusion. This can compromise the soil's ability to support the home structure and/or lead to mold growth. Recommend a qualified contractor identify source or moisture and correct.

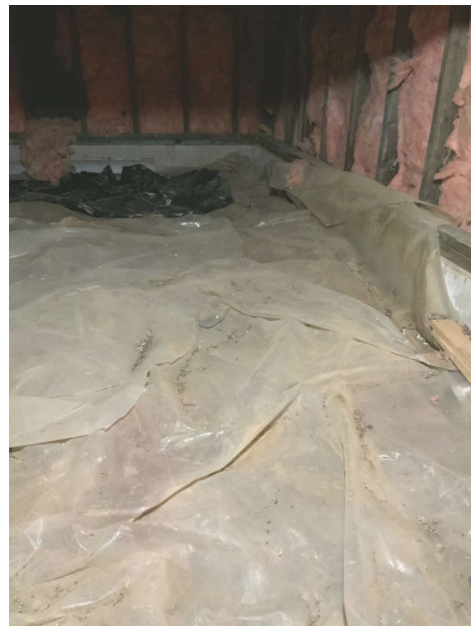
15.4.1 Vapor Retarder (Barrier)

**IMPROPER INSTALLATION**

Vapor barrier is improperly installed. This can result in unwanted moisture. Recommend insulation contractor evaluate and repair/replace as needed.

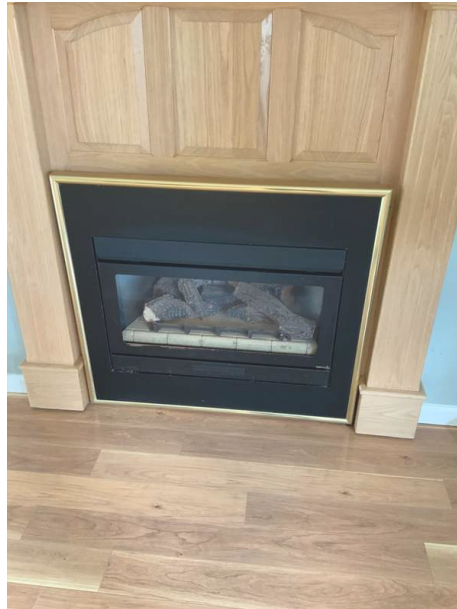
Fireplaces, Stoves & Inserts:
Fireplace type
 Metal insert

Chimney & Vent Systems:
Chimney type
 Metal

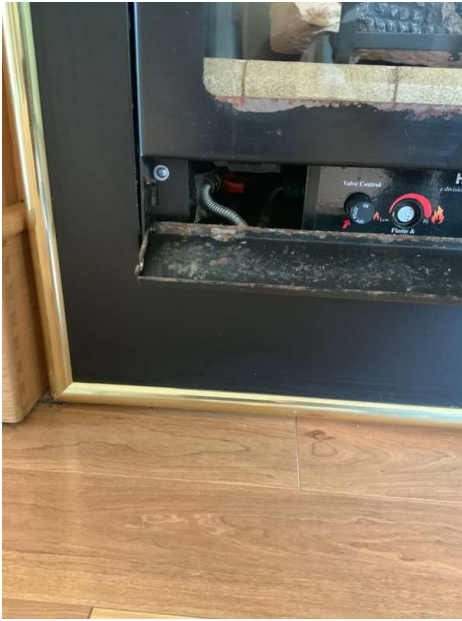
Fireplaces, Stoves & Inserts: Fireplace Turned Off

Fireplace controls are in the off position therefore the gas fireplace was not tested and is outside of the scope of this inspection. Recommend consulting with the owner to ensure that the fireplace operates as intended.
