FULL HOME INSPECTION

1234 Main St.
Miami Florida 33183

01/30/2019 9:00AM

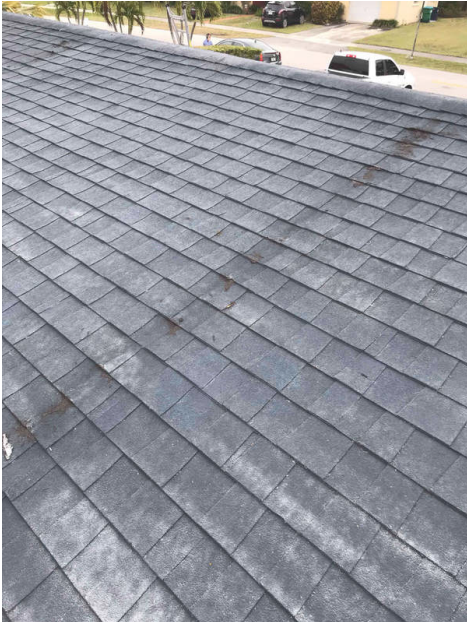
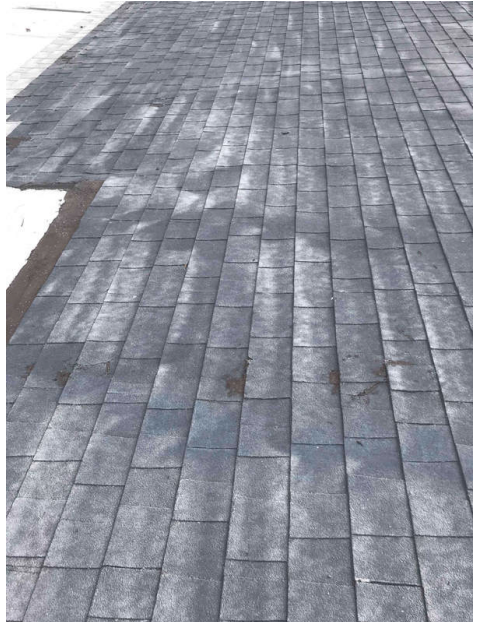
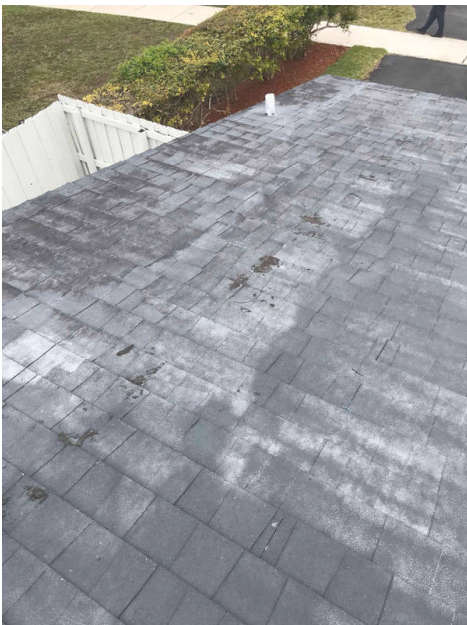
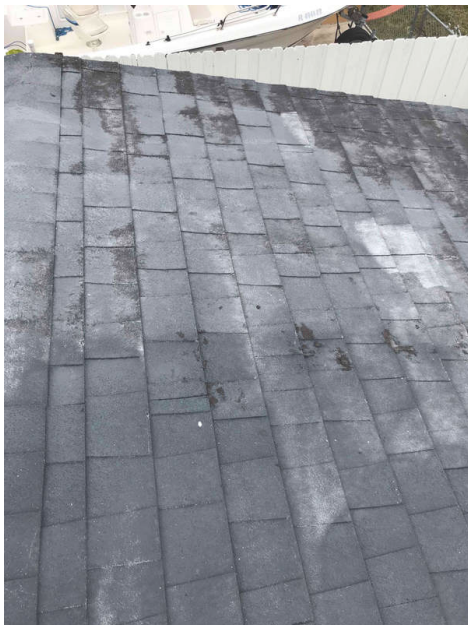
2.1.1 Coverings

REPLACEMENT RECOMMENDED

Roof is damaged and deteriorated; replacement recommended. Roof is 24 years old, shingles are deteriorating, leaks observed, improper patching, and flat roof seems to have been replaced without a permit.

Contact a qualified roofing professional.

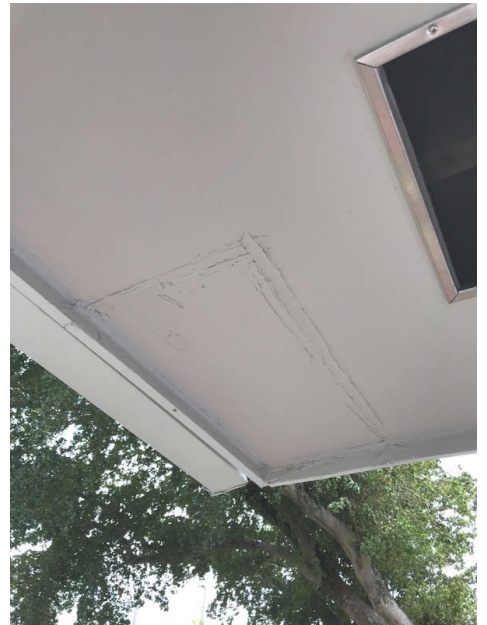
2.5.1 Eaves, Soffits & Fascia

EAVES - DAMAGED

One or more sections of the eaves are damaged. Recommend qualified roofer evaluate & repair.

Contact a qualified general contractor.

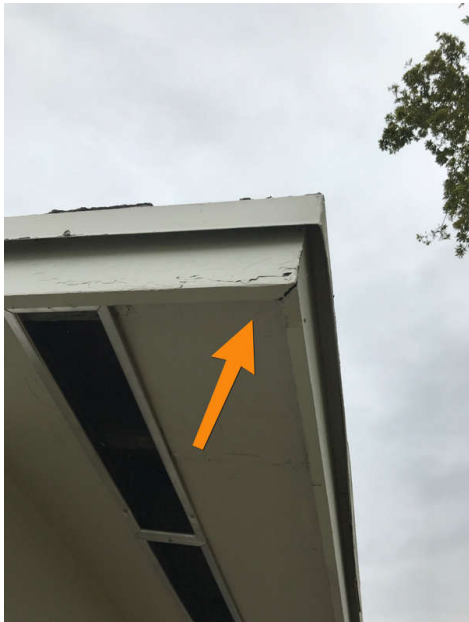
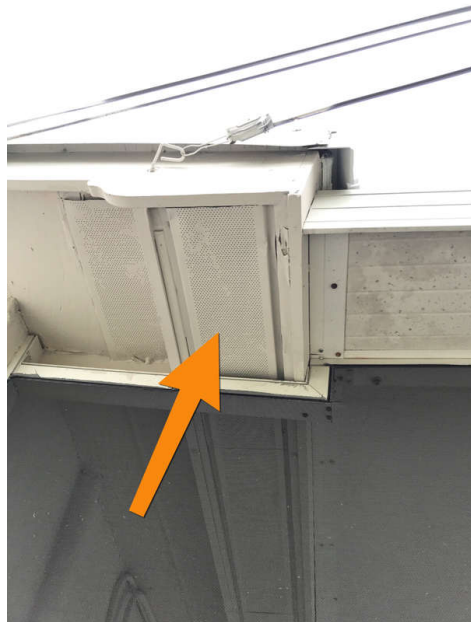
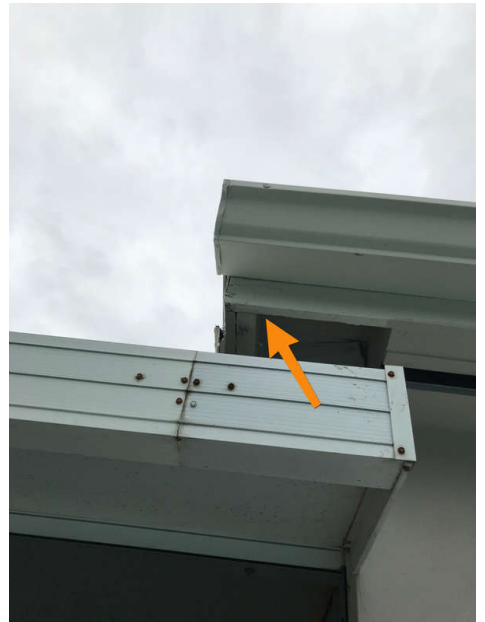
2.5.2 Eaves, Soffits & Fascia

FASCIA - DAMAGED

One or more sections of the fascia are damaged. Recommend qualified roofer evaluate & repair.

Contact a qualified general contractor.

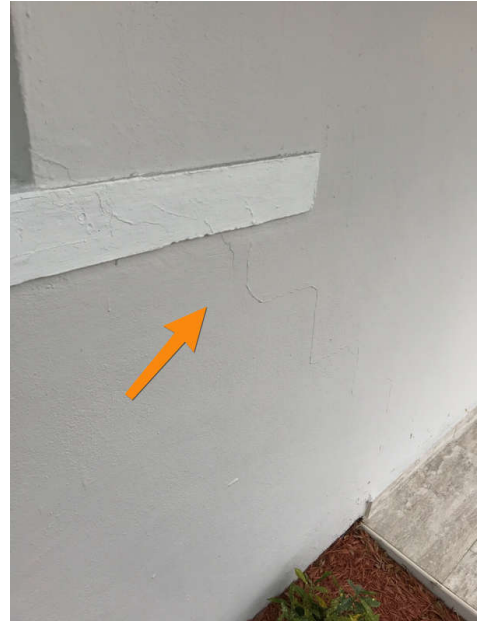
3.2.1 Siding, Flashing & Trim

CRACKING - MINOR

Siding showed cracking in one or more places. This is a result of temperature changes, and typical as homes with stucco age. Recommend monitoring.

Contact a qualified general contractor.

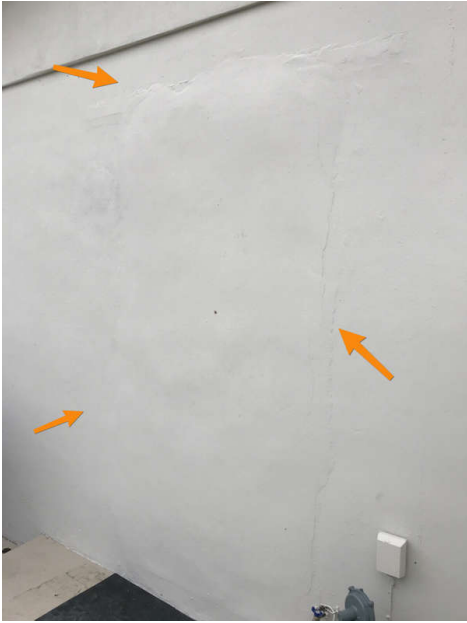
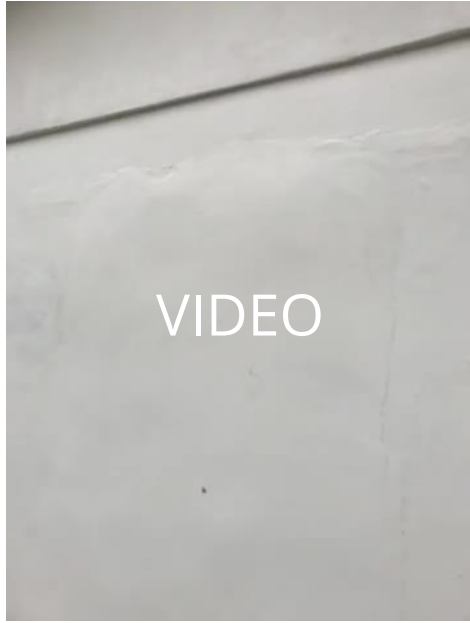
4.4.1 Wall Structure

IMPROPER CONSTRUCTION

Exterior door on right elevation was closed using wood frame and not concrete. Also, patchwork observed was sub-par.

Contact a qualified general contractor.

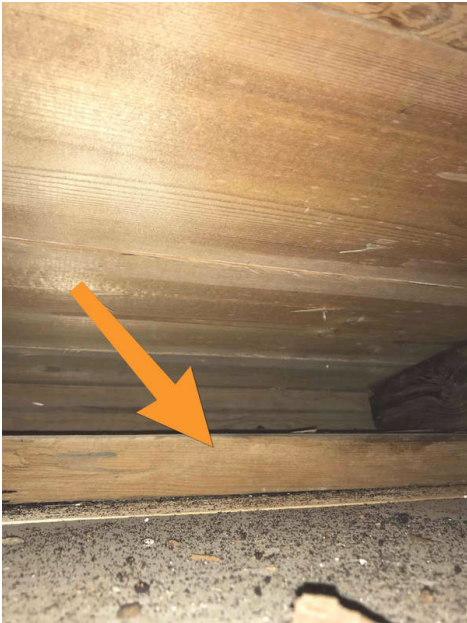
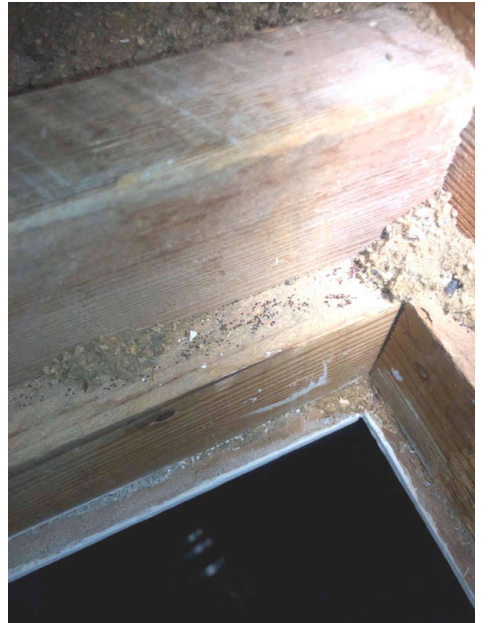
4.5.1 Wood Destroying Organisms

VISIBLE EVIDENCE

Wood destroying organisms evidence observed at the property. Treatment is recommended.

Contact a qualified pest control specialist.

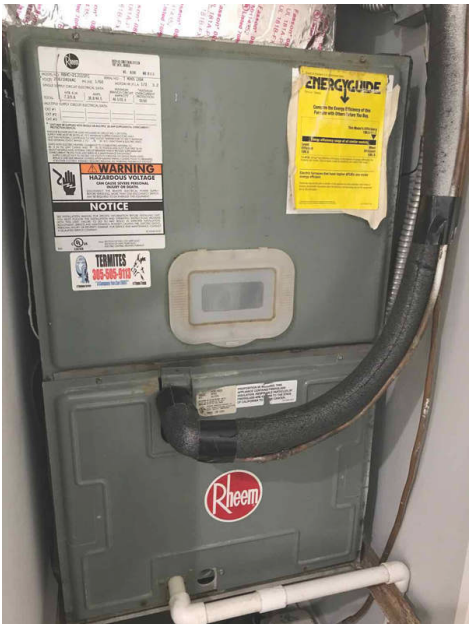
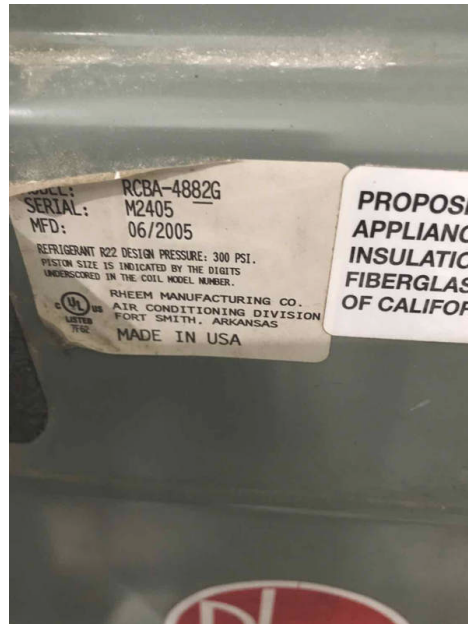
6.1.2 Cooling Equipment

UNIT PAST LIFE EXPECTANCY; REPLACEMENT ANTICIPATED

Unit has exceeded it's life expectancy and replacement should be anticipated.

Contact a qualified heating and cooling contractor

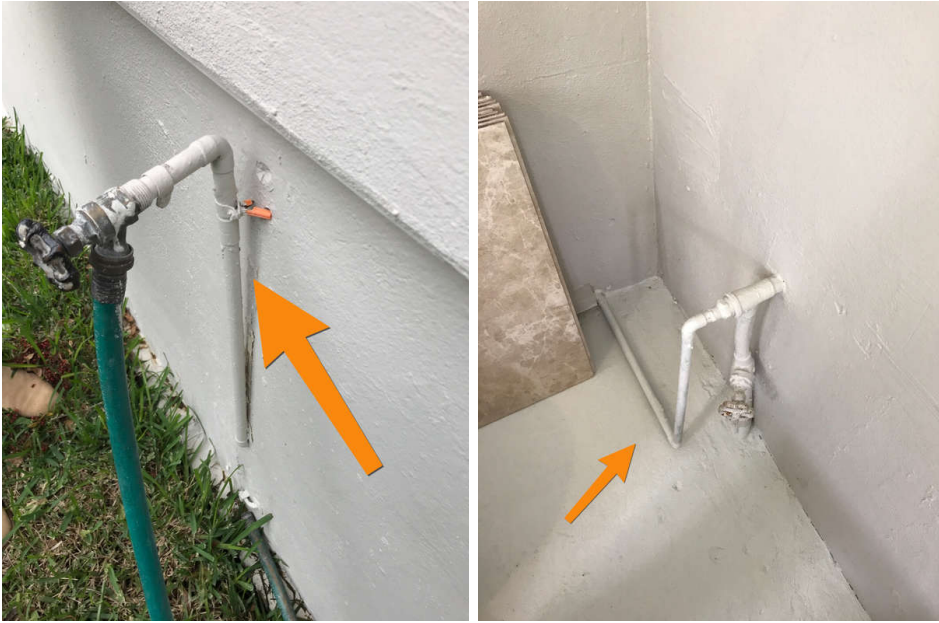
7.3.1 Water Supply, Distribution Systems & Fixtures

IMPROPER INSTALLATION

Distribution pipes were installed in a sub-standard way. Recommend a qualified plumber evaluate and properly fit and install pipes.

Contact a qualified plumbing contractor.

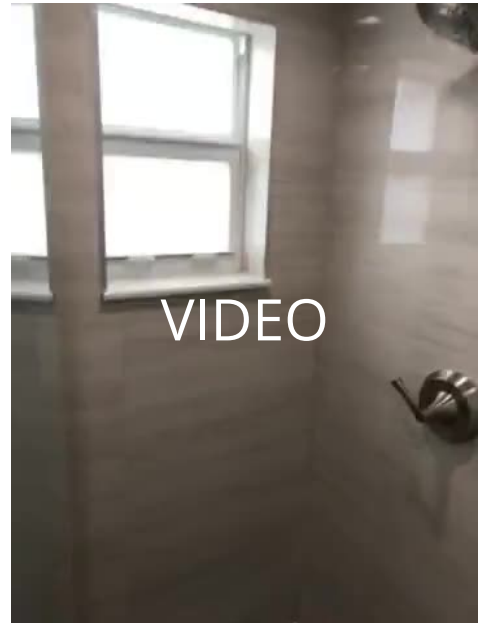
7.3.2 Water Supply, Distribution Systems & Fixtures

POOR WATER PRESSURE

Property has poor water pressure. A licensed plumber is recommended for further evaluation.

Contact a qualified plumbing contractor.

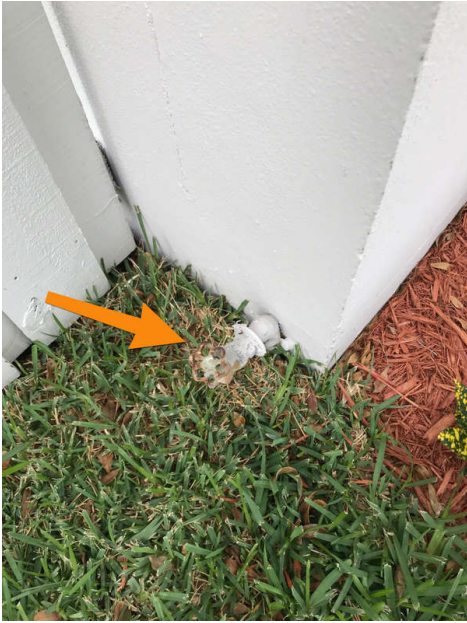
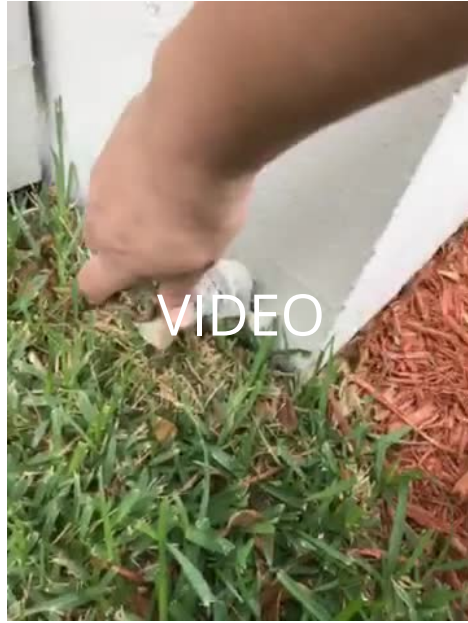
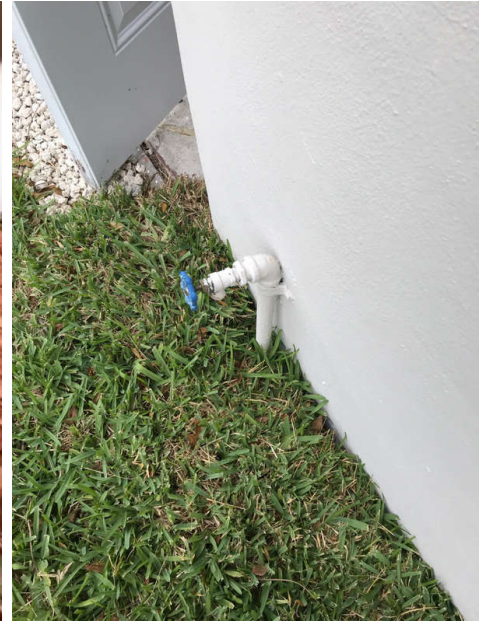
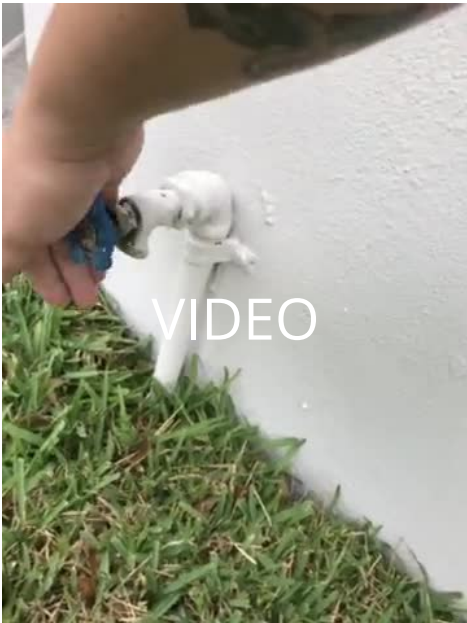
7.3.3 Water Supply, Distribution Systems & Fixtures

NO WATER PRESSURE

Faucet located on front elevation has no water pressure.

Contact a qualified plumbing contractor.

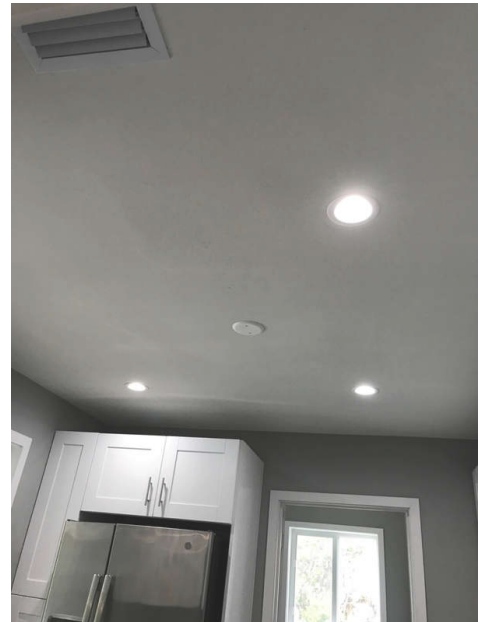
8.6.1 Smoke Detectors

NOT PRESENT

Smoke detectors are not present.

Contact a qualified fire suppression contractor.

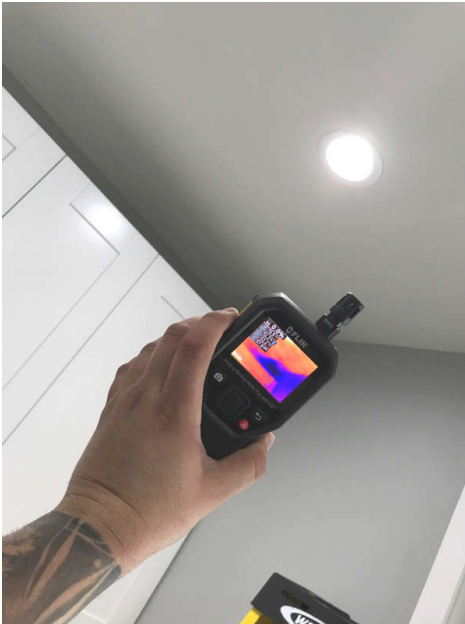
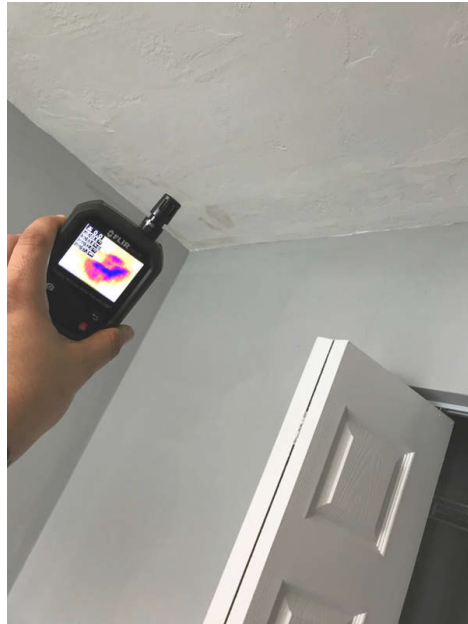
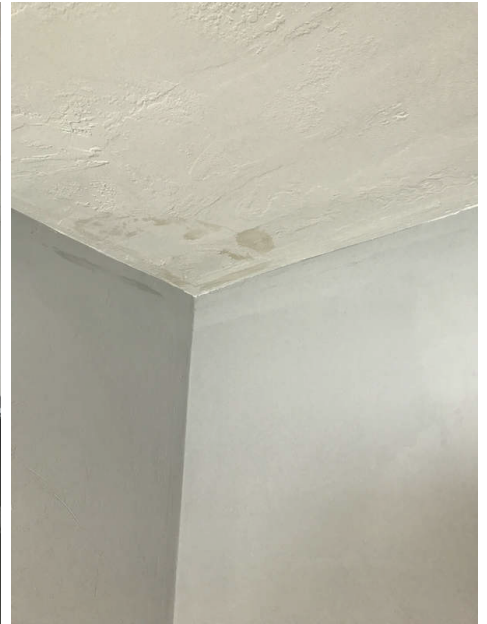
RECENT ROOF LEAK DAMAGE

Stains on the ceiling appear to be the result of roof leaks. The source of leakage should be identified and corrected, and the ceiling re-painted.

Contact a qualified roofing professional.

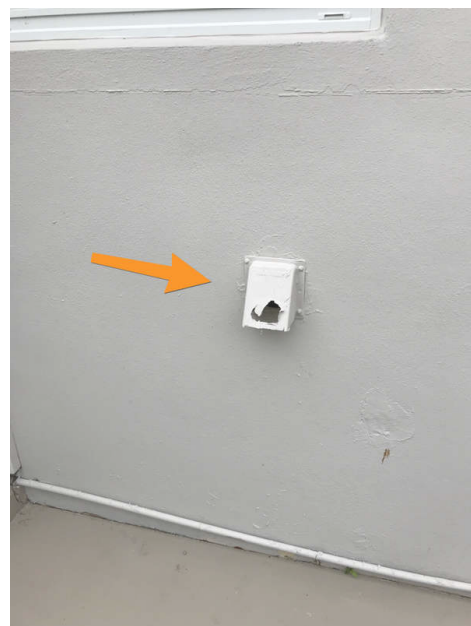
VENT IS DAMAGED

Observed damaged dryer vent. Dryer must properly vent in order to avoid a fire.

Contact a qualified appliance repair professional.

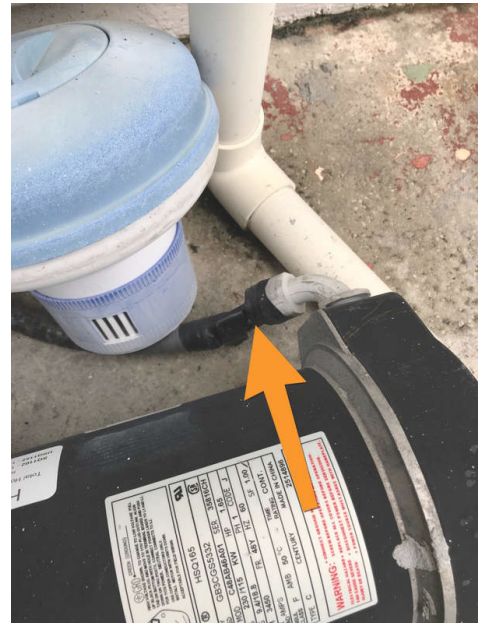
IMPROPER ELECTRICAL CONNECTIONS

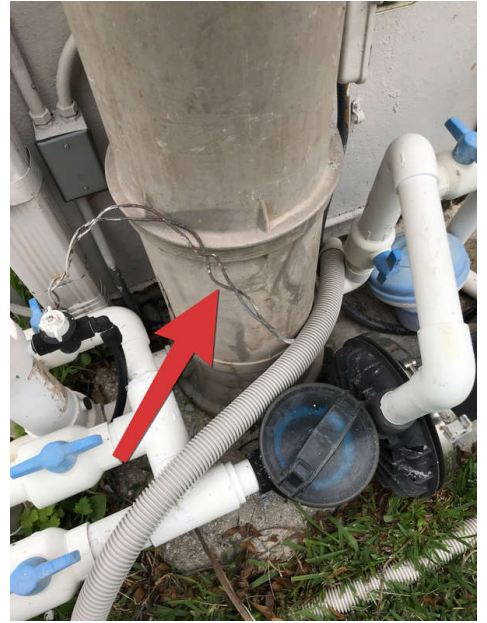
16.1.2 Installed Equipment

NOT BONDED

Contact a qualified Swimming Pool Contractor

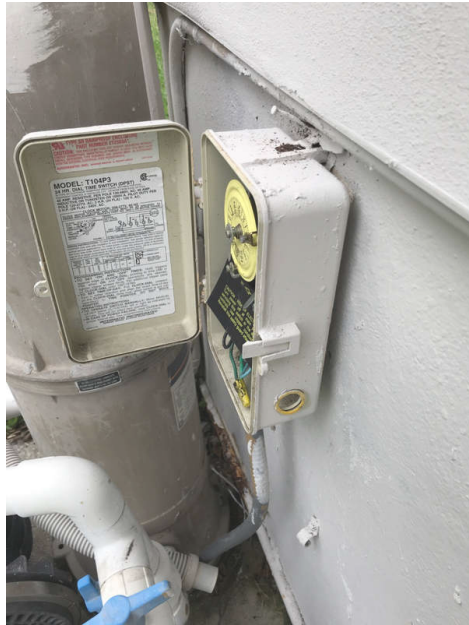
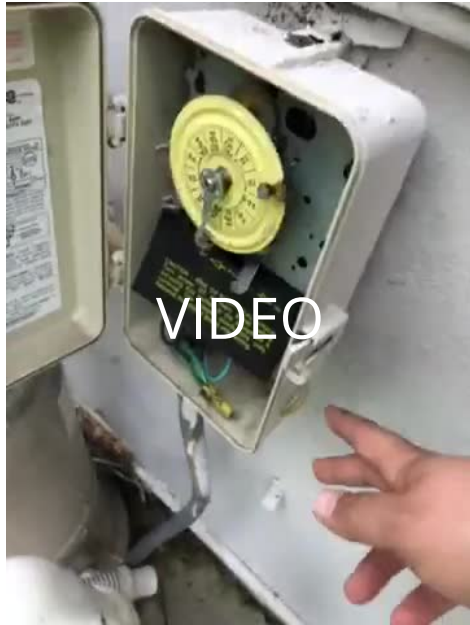
16.1.3 Installed Equipment

DAMAGED TIMER

Pool equipment timer box is damaged and replacement is recommended.
