DB HOME INSPECTION SERVICE

4 PARK PLACE

1234 Main St.
San Rafael California 94903

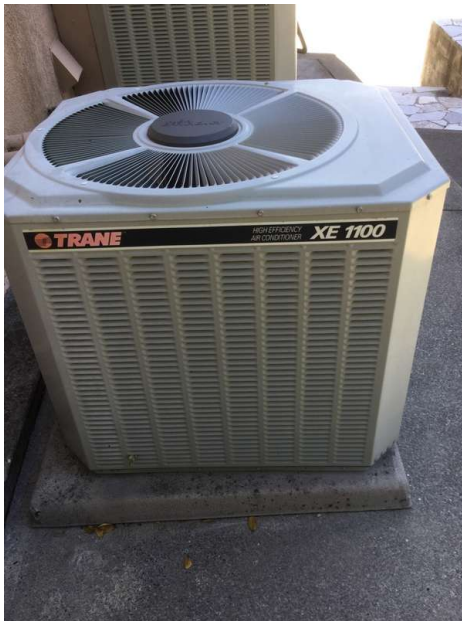
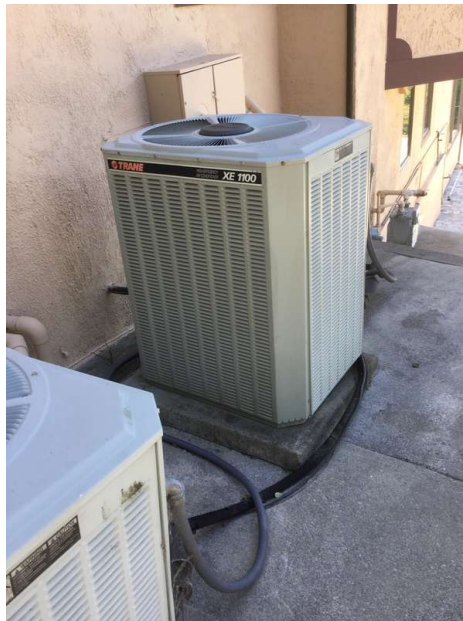
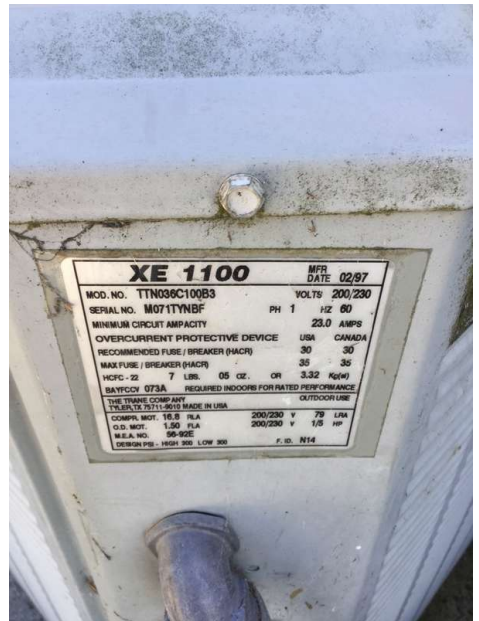
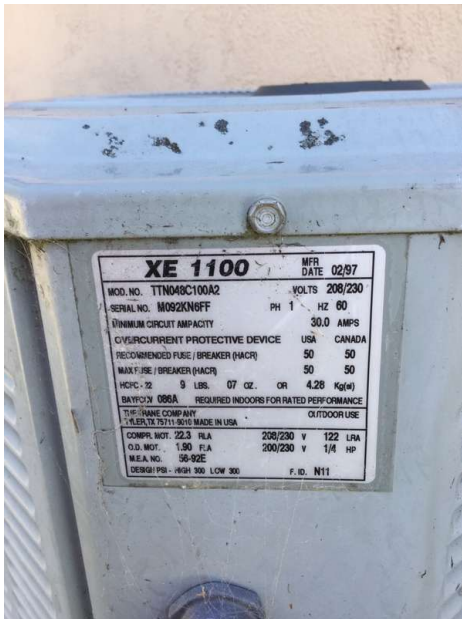
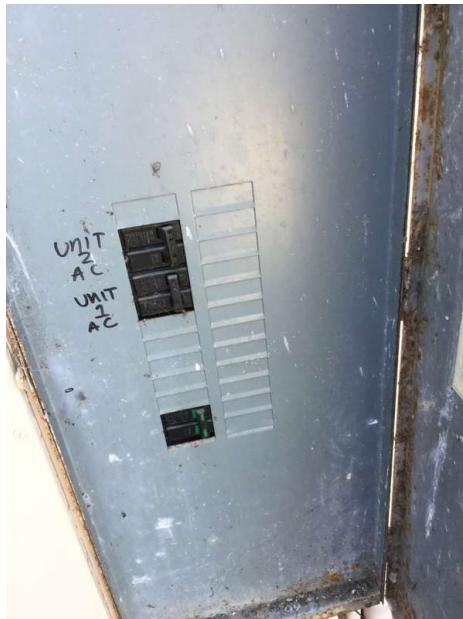
The A/C units were likely installed when the house was built, and are heading towards the end of their working lives. When an inspection is performed on the furnaces it would be worth having the HVAC person assess the A/C units as well. They appear to be not suffering too badly from exposure to the elements, but their efficiency may be limited at this point.

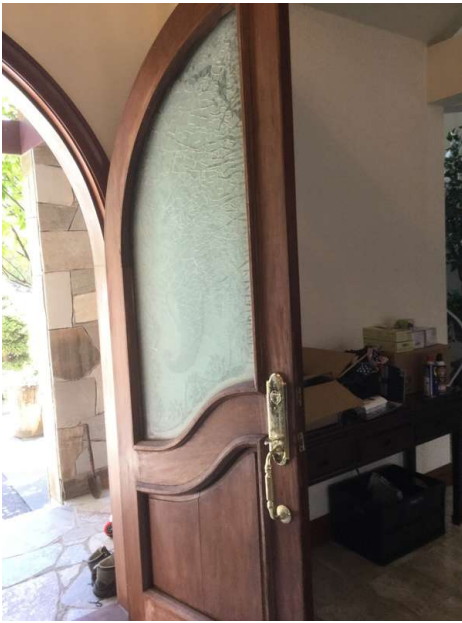
Main Entry door appears to show some signs of wear and tear, and the hardware is not functioning properly.

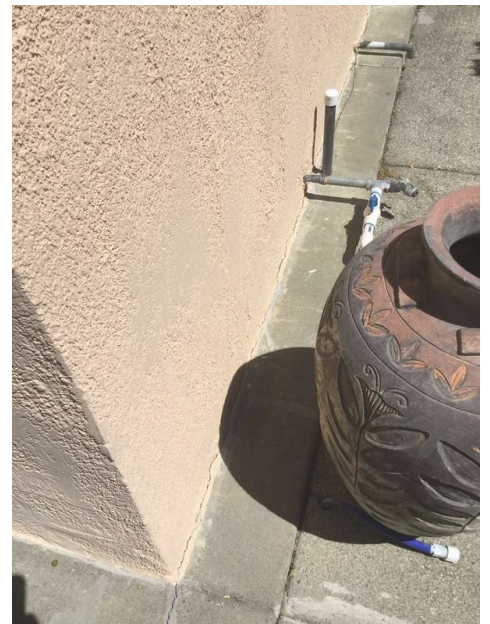
3.2.1 Foundation

FOUNDATION CRACKS - MINOR

Minor cracking was noted at the foundation meeting the stucco

This is common as concrete ages and shrinkage surface cracks are normal. Recommend monitoring for more serious shifting/displacement.

Recommend monitoring.

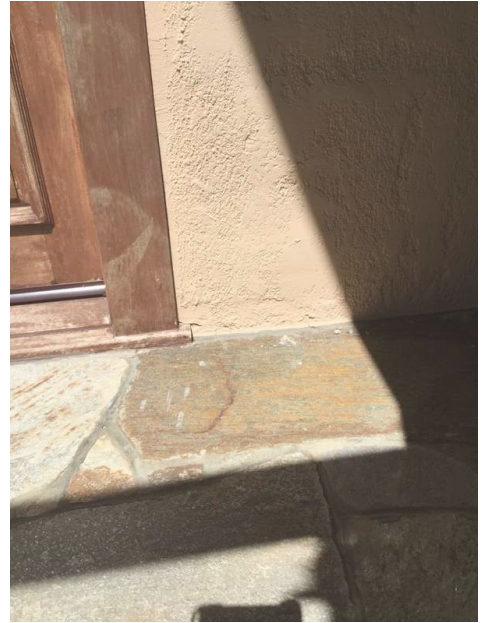
3.3.1 Siding, Flashing & Trim

CRACKING - MINOR

Siding showed cracking in one or more places. This is a result of temperature changes, and typical as homes with stucco age. Recommend monitoring.

Recommended DIY Project

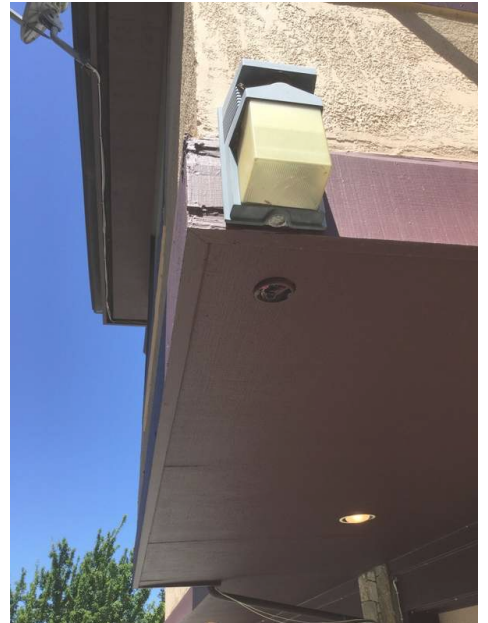
3.3.2 Siding, Flashing & Trim

DAMAGE TO TRIM BEHIND FIXTURE

The trim behind the exterior light fixture appeared to have some previous damage that was painted over, it is not possible to know the cause of that damage due to the paint coverage. check with owner or replace with new piece of wood

Contact a qualified professional.

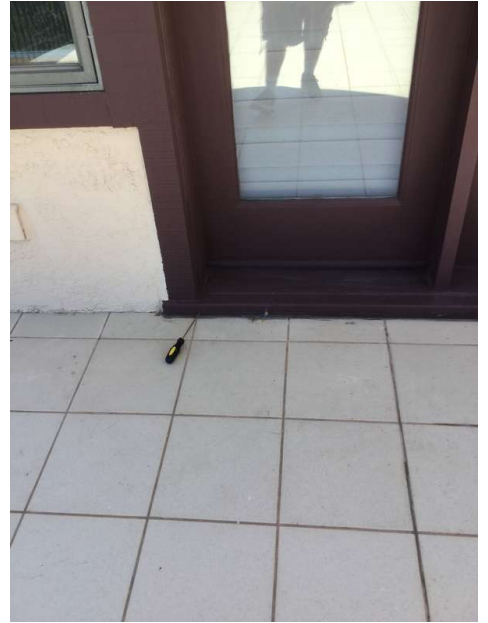
3.4.1 Exterior Doors

DOOR SILL/TRIM

Door sill and/or trim is loose, deteriorated or worn and repair or replacement should be considered.

Contact a qualified door repair/installation contractor.

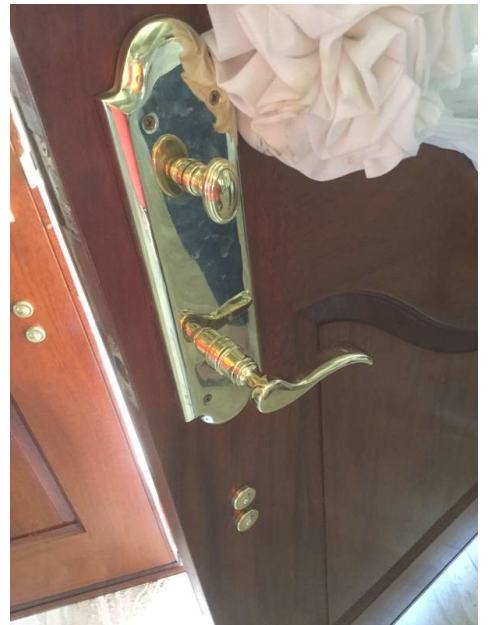
3.4.2 Exterior Doors

HARDWARE DAMAGED

One or more pieces of door hardware are damaged. Recommend repair or replace.

Recommended DIY Project

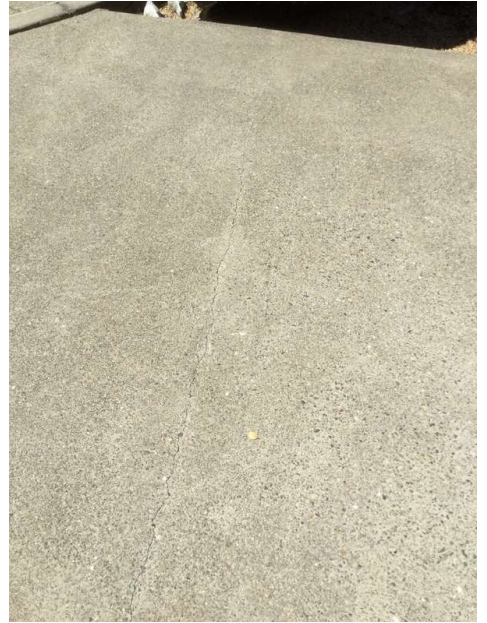
3.5.1 Walkways, Patios & Driveways

DRIVEWAY CRACKING - MINOR

Minor cosmetic cracks observed, which may indicate movement in the soil. Recommend monitor and/or have concrete contractor patch/seal.

Contact a qualified concrete contractor.

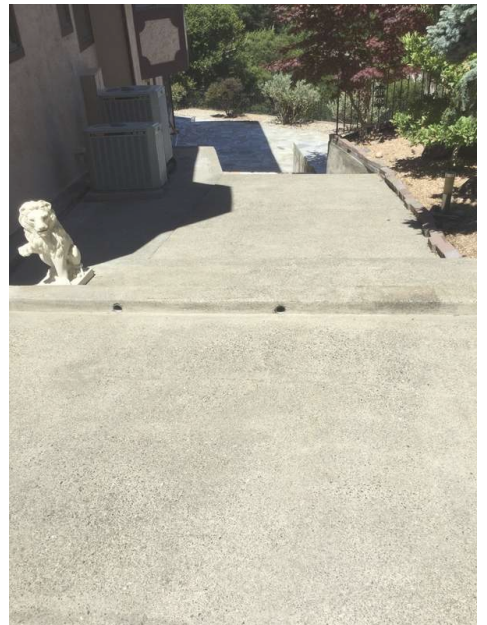
3.5.2 Walkways, Patios & Driveways

DRIVEWAY TRIP HAZARD

Trip hazards observed. This ridge is important in the role of drainage but may need to be marked in some way to prevent tripping

Recommended DIY Project

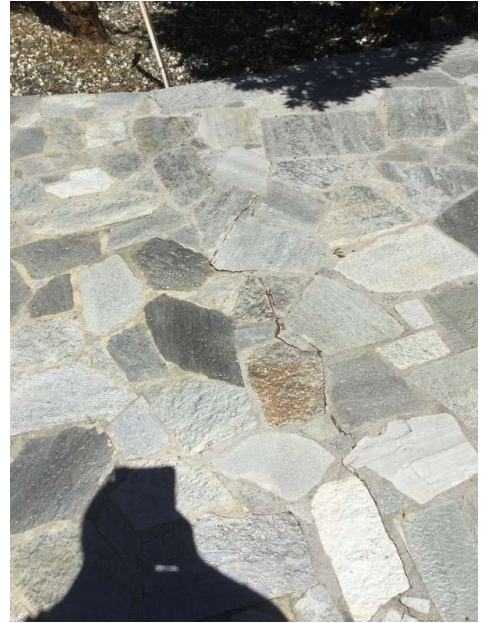
3.5.3 Walkways, Patios & Driveways

PATIO CRACKING - MINOR

Normal settling & cracking observed. Recommend monitor and/or patch/seal.

Recommended DIY Project

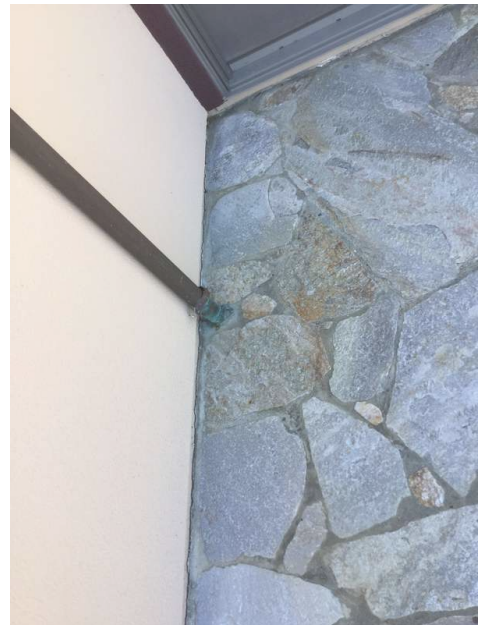
3.5.4 Walkways, Patios & Driveways

WALKWAY CRACKING - MINOR

Minor cosmetic cracks observed. Recommend monitor and/or patch/seal.

Recommended DIY Project

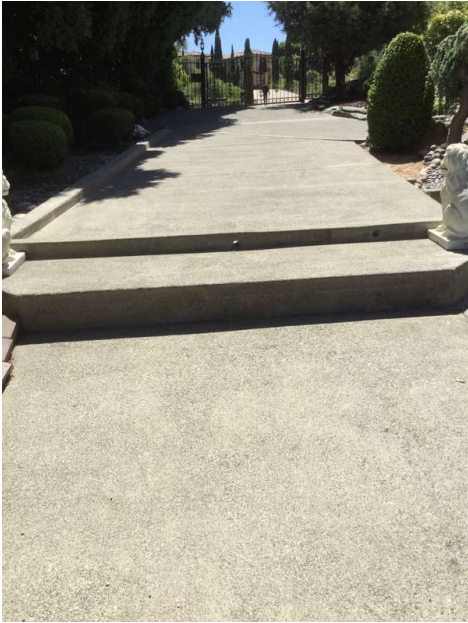
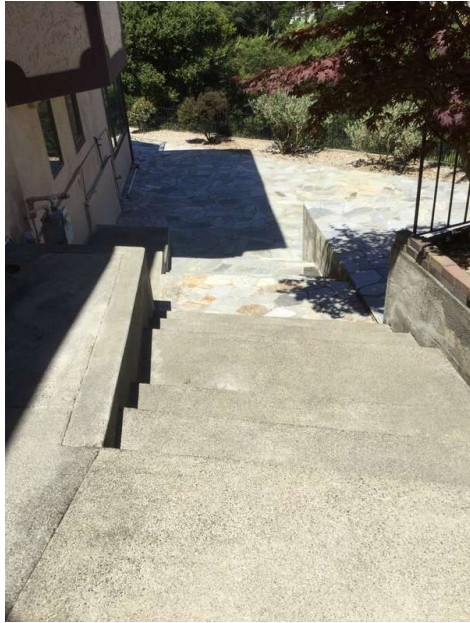
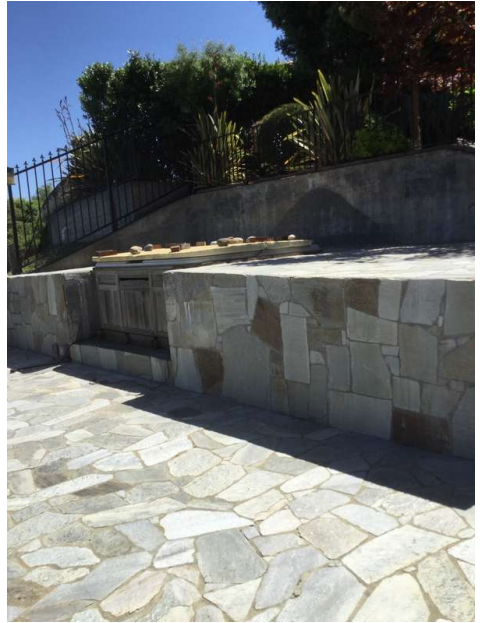
3.5.5 Walkways, Patios & Driveways

RAILINGS

Recommend installing handrails in places where needed for safety

Contact a qualified professional.

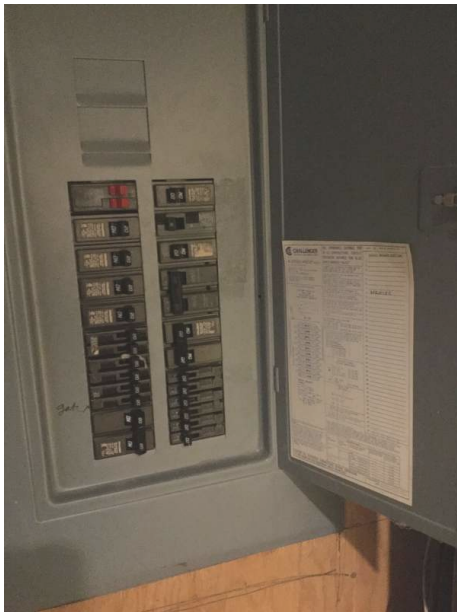
Branch Wiring Circuits, Breakers & Fuses: Branch Wire 15 and 20 AMP
Copper

Branch Wiring Circuits, Breakers & Fuses: Wiring Method
Conduit, Romex

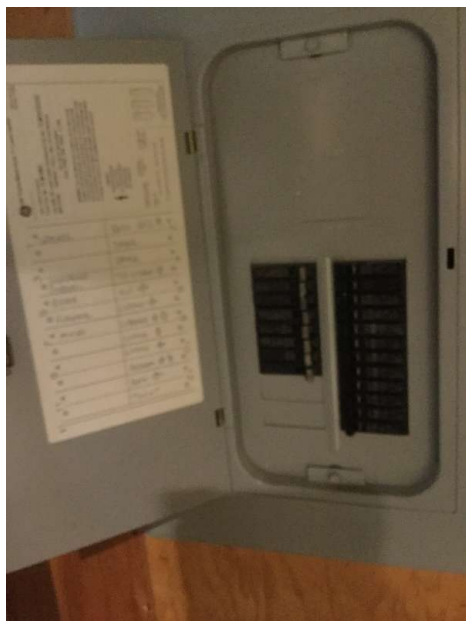
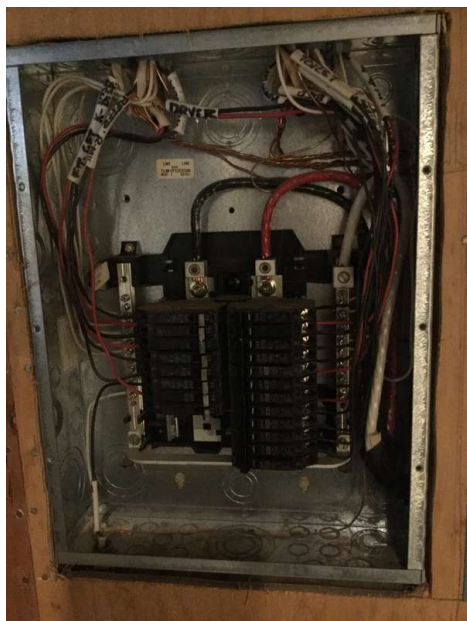
The electrical panels inside the utility room are both in good shape and are of adequate size for the property, The main service as it comes into the house is 220amp, and the spa is already taken care of on that panel before it gets to the main house panel. There is 125 at the main panel and an additional sub panel. The exterior box with power in to the house should be monitored for corrosion and animal intrusion as a matter of course, and all the penetrations into the house should be checked to ensure that they are filled and tight.

Main & Subpanels, Service & Grounding, Main Overcurrent Device: Sub Panel Location
Utility Room

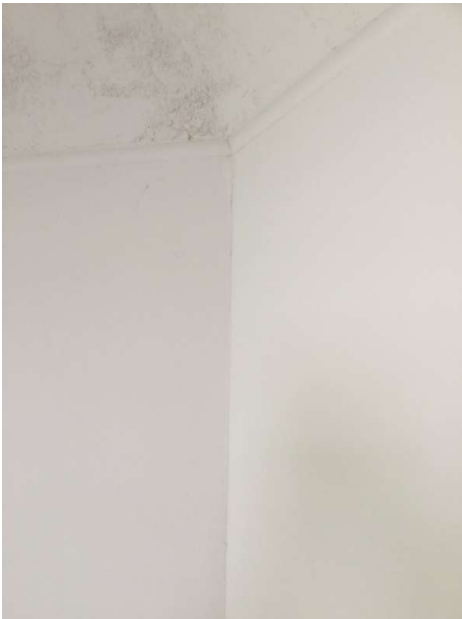
Cracking in corner : Minor patch and monitor

There are some minor cracks in the ceiling of the stairway , they should be monitored to make sure there is no movement or evidence of water intrusion in rainy weather.

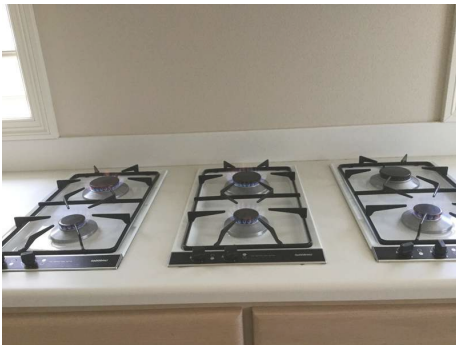
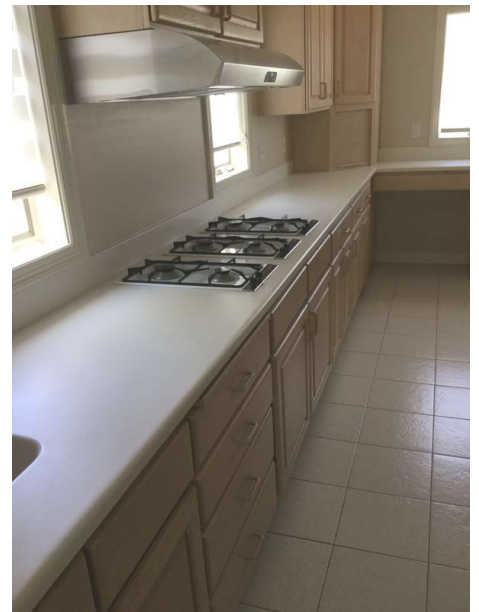
The range top was temperamental to light but all lit eventually

Bulbs need replacing on lights
Difficult to turn off fan

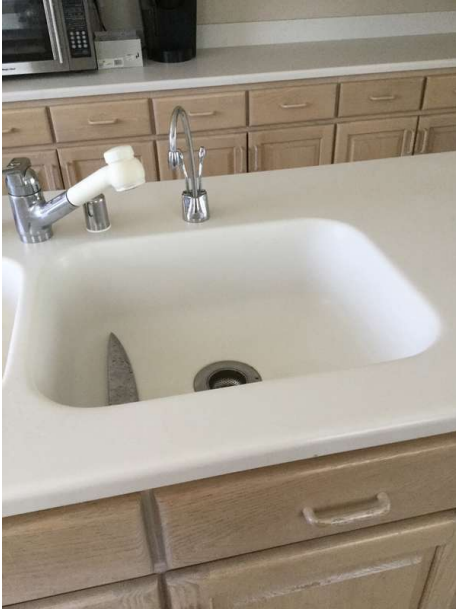
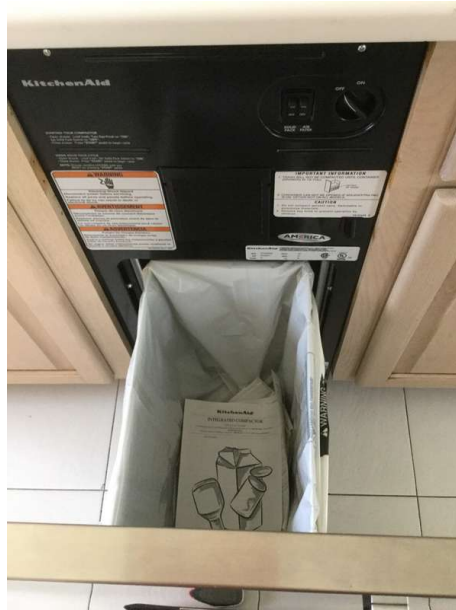
Sink : Sinks intergal to counters Trash compactor: New / never used

The kitchen is well maintained but is aging. One has begun to see wear and tear on the cabinets and the cook top. The counters are generally in good shape and as the sinks are intergal to the counters they are also in generally good condition but not new.

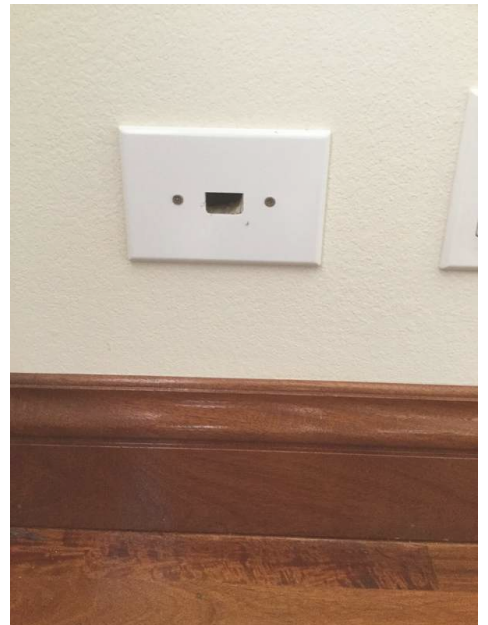
9.7.1 Lighting Fixtures, Switches & Receptacles

COVER PLATES DAMAGED

One or more receptacles have a damaged cover plate. Recommend replacement.

Contact a qualified electrical contractor.

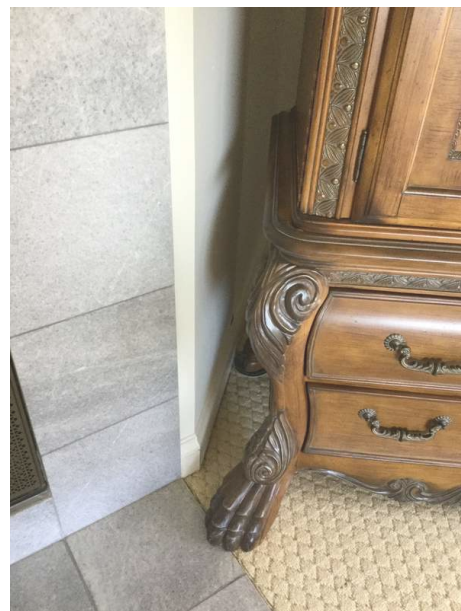
Fireplace: Not operable due to furniture placement

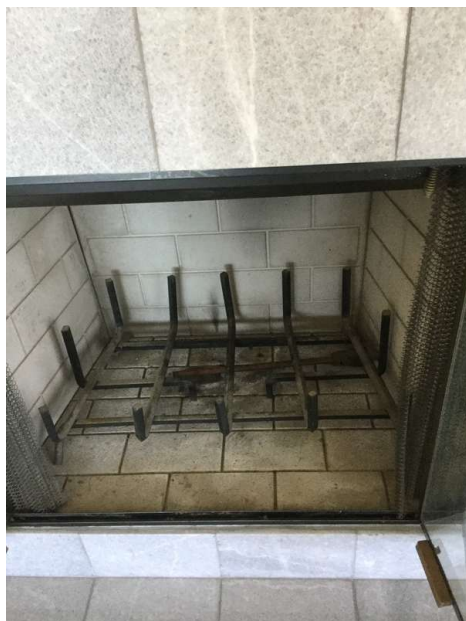
Fireplace: Damper wedge

Fireplace: Clean

the fireplace looks to be in good condition and clean

Recommend chimney inspection before use by next owners

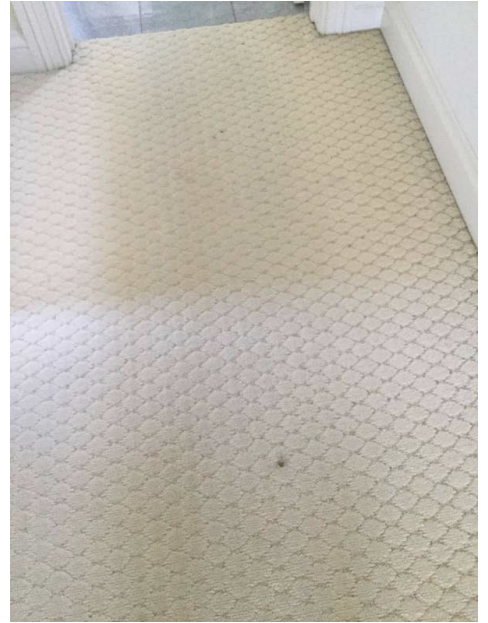
11.4.1 Floors

CARPET STAINS

Carpet had areas of staining or discoloration. Recommend a thorough steam clean by a qualified carpet cleaning company

Contact a qualified cleaning service.

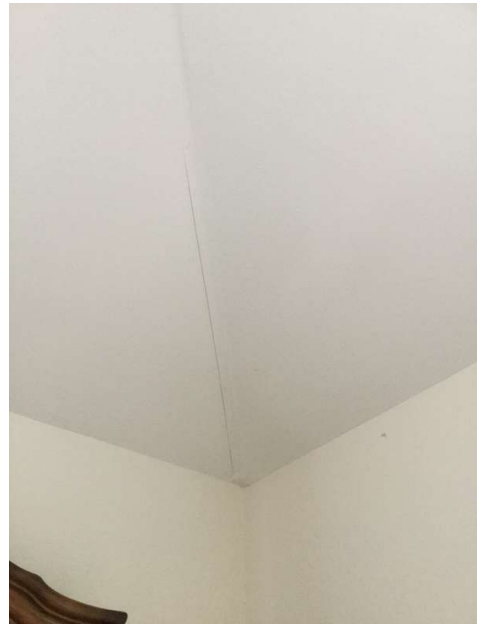
11.6.1 Ceilings

MINOR DAMAGE

Minor damage or deterioration to the ceiling was visible at the time of the inspection.

Monitor in case it is caused by water intrusion

Contact a qualified professional.

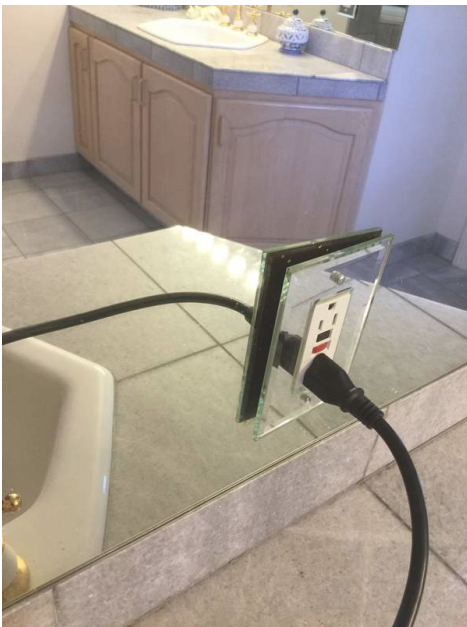
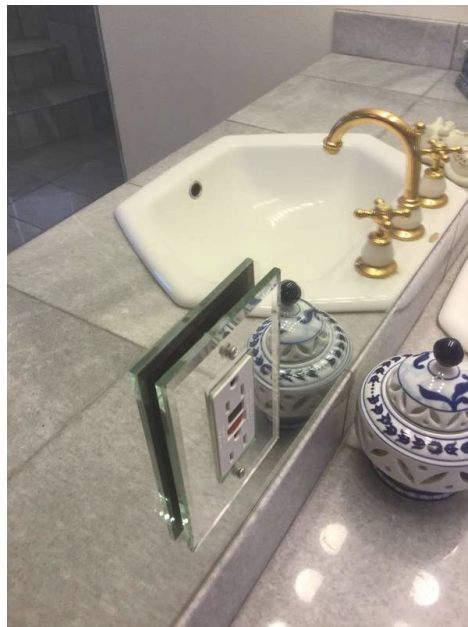
12.5.1 Lighting Fixtures, Switches & Receptacles

COVER PLATES DAMAGED

The glass cover plates are not flush to the mirror
this creates a safety hazard and needs to be fixed

Contact a qualified electrical contractor.

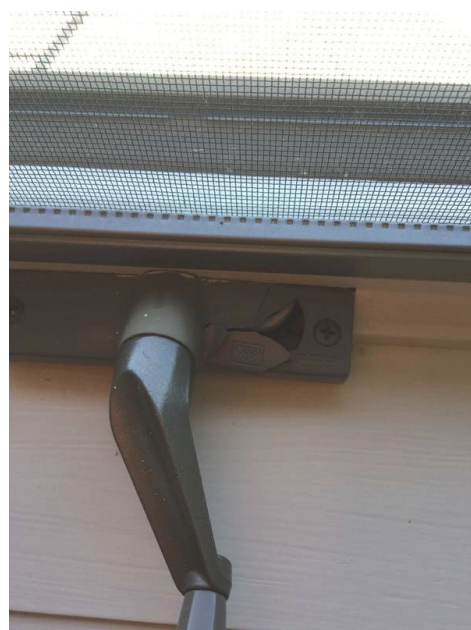
13.3.1 Windows

DAMAGED

One or more windows appears to have general damage, but are operational. Recommend a window professional clean, lubricate & adjust as necessary.

Contact a qualified window repair/installation contractor.

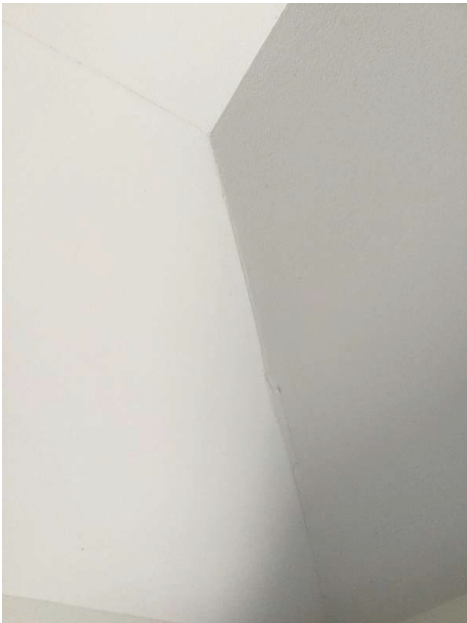
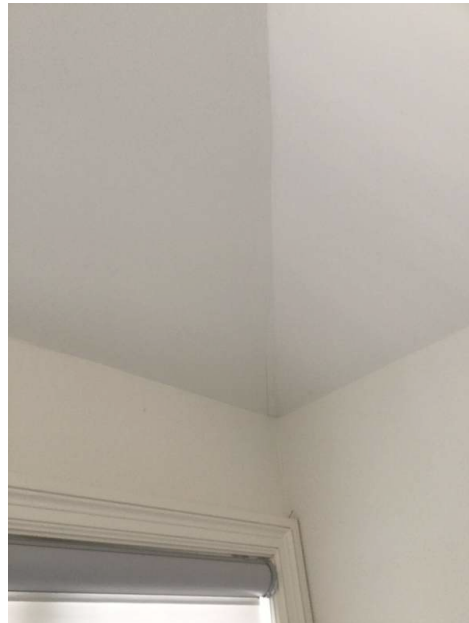
13.6.1 Ceilings

MINOR DAMAGE

Minor damage or deterioration to the ceiling was visible at the time of the inspection.

This should be monitored for change or deterioration

Contact a qualified professional.

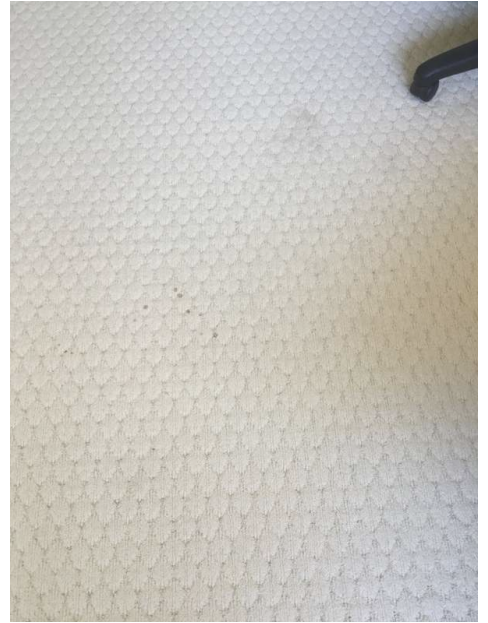
15.4.1 Floors

CARPET STAINS

Carpet had areas of staining or discoloration. Recommend a thorough steam clean by a qualified carpet cleaning company

Contact a qualified cleaning service.

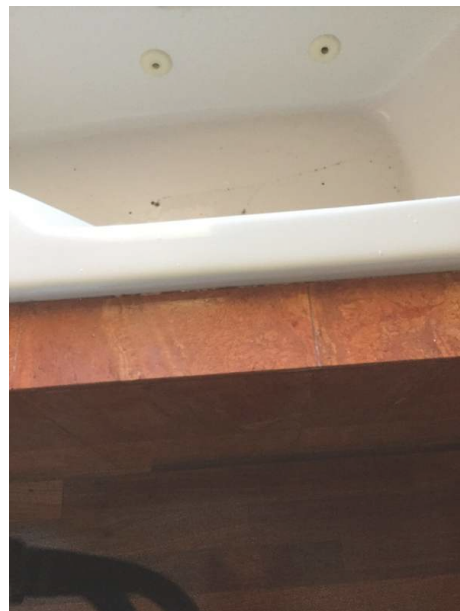
Tub: Needs recaulking

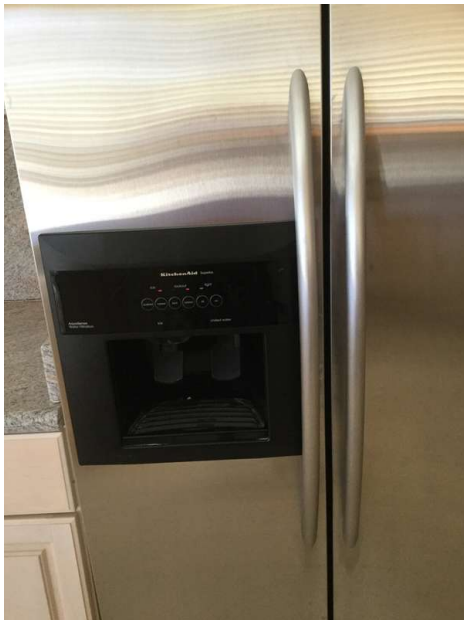
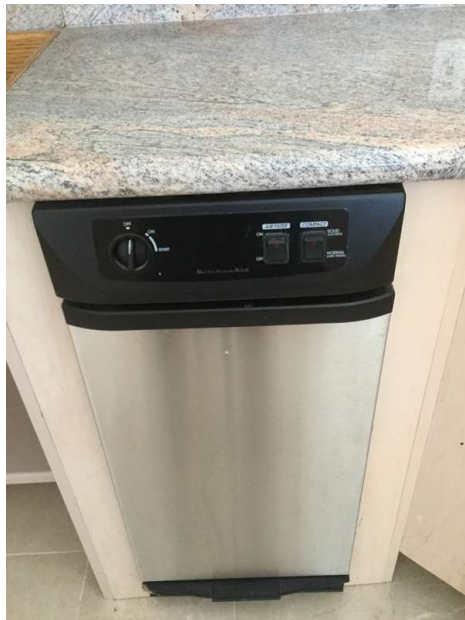
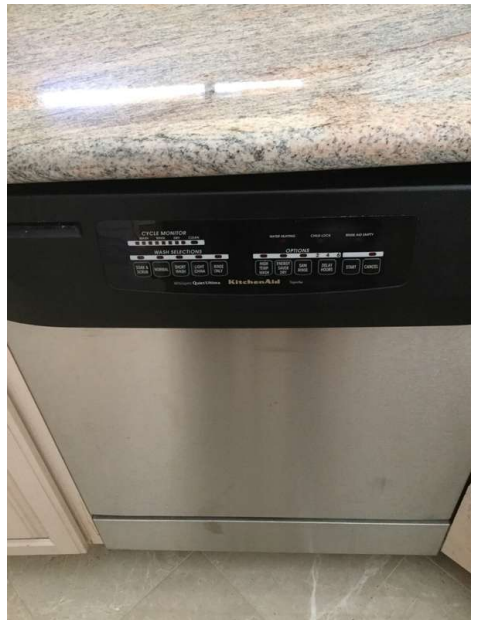
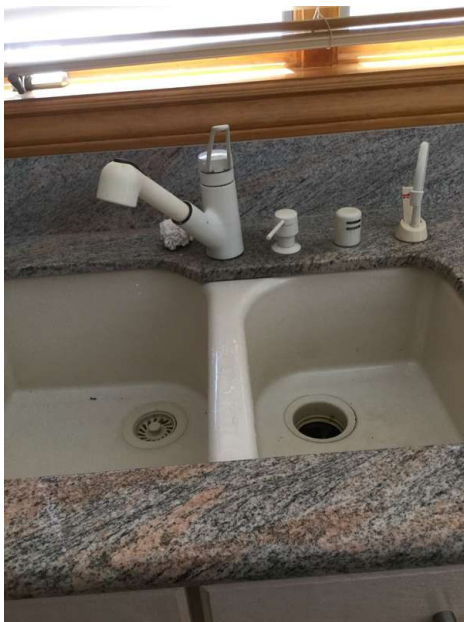
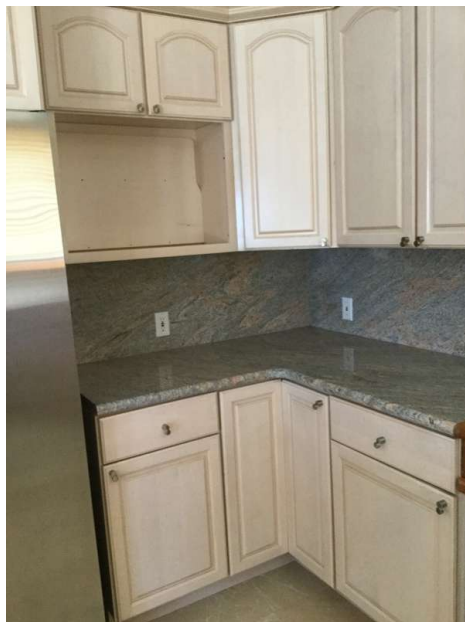
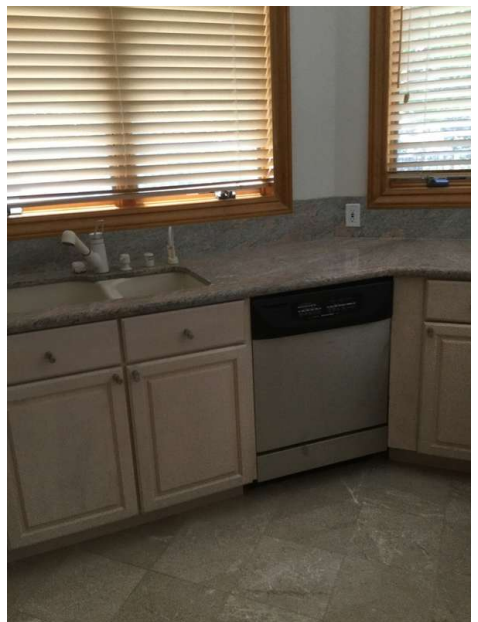
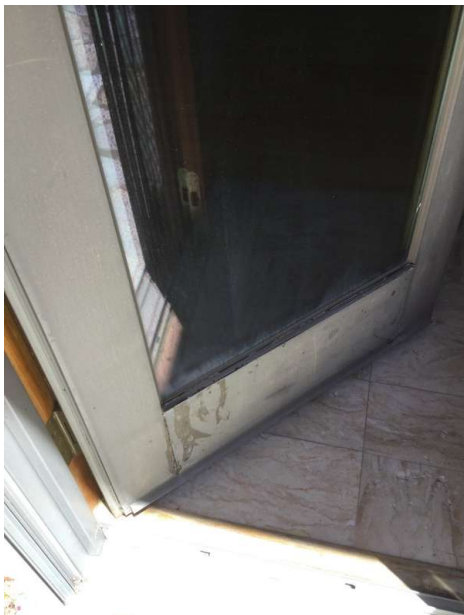
Lower Kitchen

The second kitchen that accompanies the game room did not appear to be in use therefore the appliances could not be tested.

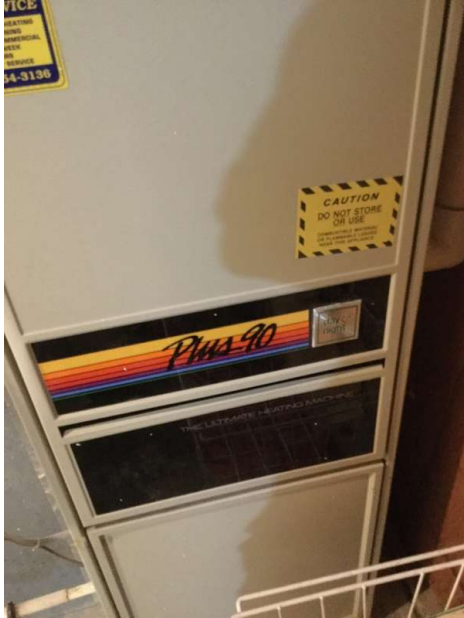
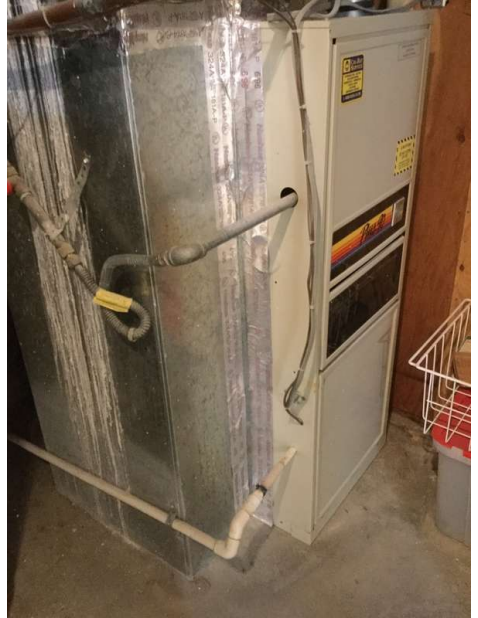
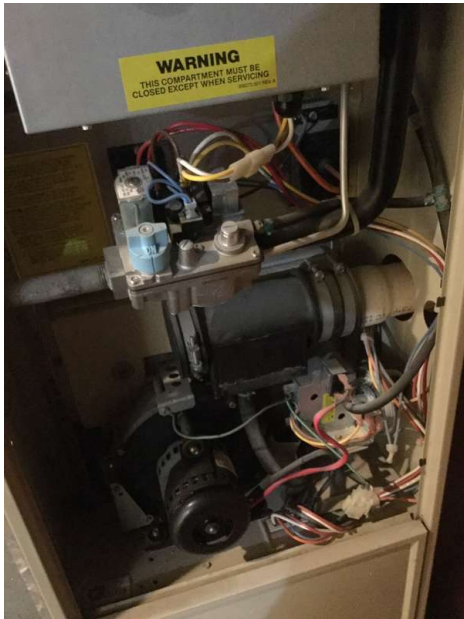
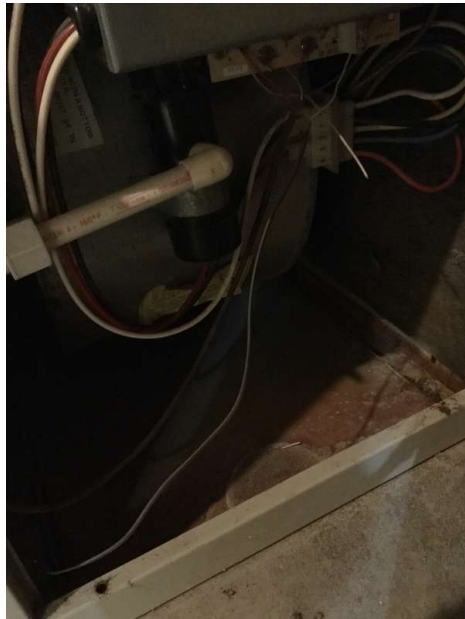
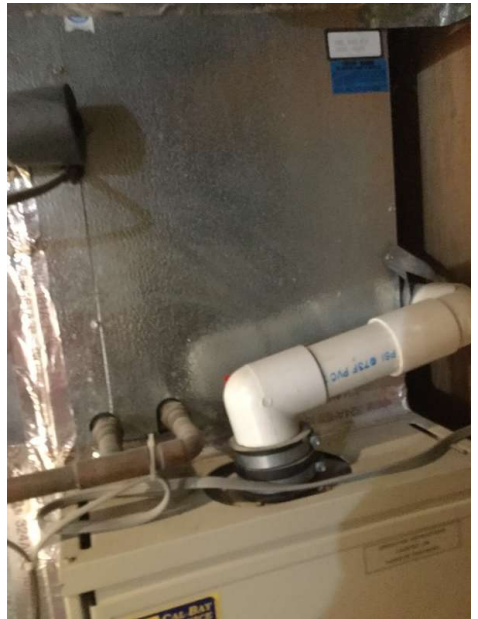
It would be my assumption that the furnace is original to the house, it has substantial corrosion on the outside of the unit and some on the inside indicating that water has intruded into the unit.

It appears to be in much better shape on the outside of the unit with less corrosion. however it does appear to

It is my recommendation that there should be a furnace inspection for this furnace too. They are both possibly original to the house and could be heading towards the end of their working lives. More efficient furnaces are available and it is possible that a combined heating and cooling unit could be appropriate.

I would highly recommend a full furnace inspection.

At the very minimum they should be assessed and serviced

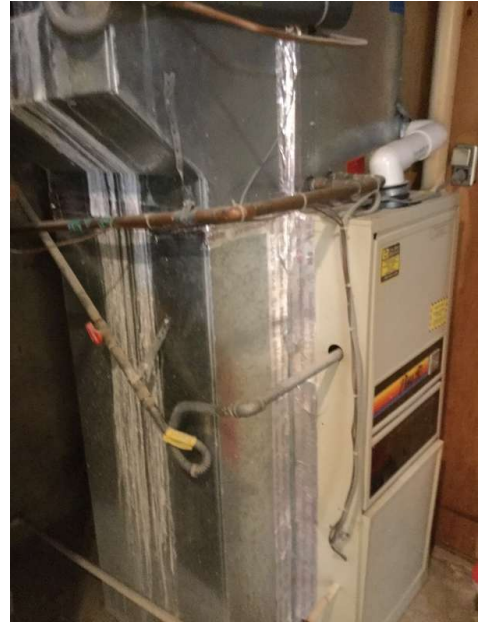
26.1.1 Heating Equipment

CORROSION

Furnace was corroded in one or more areas. This could be the result of improper venting, which the source would need to be identified. Recommend a HVAC contractor evaluate and repair.

Recommendation

Contact a qualified HVAC professional.
