PLATINUM HOME INSPECTIONS

RESIDENTIAL HOME INSPECTION REPORT

1234 Main St.
Merrimack NH 03054

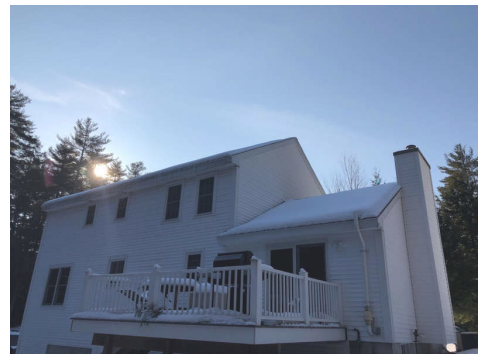
NOT WALKED ON - FROST/SNOW COVERED

At time of inspection the roof area was covered with snow. Full visibility of these areas is not possible at this time. Recommend further evaluation as weather permits.

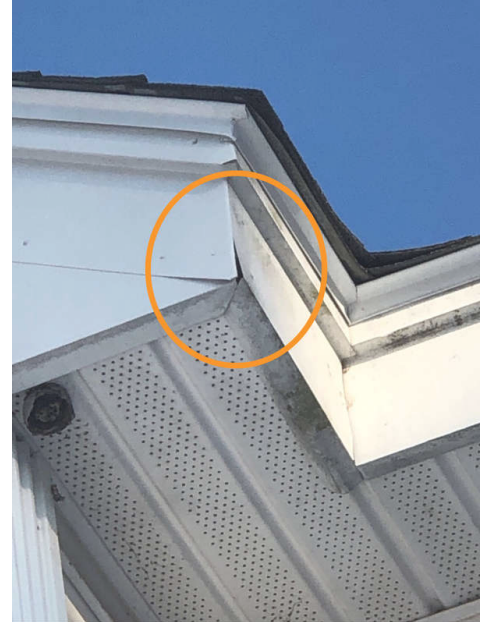
Recommendation / Improvement**GAP**

There is opening, gap or hole in fascia / soffit which should be repaired. This can allow water intrusion and rodent infestation as well as deterioration of the surrounding material.

Contact a qualified roofing professional.

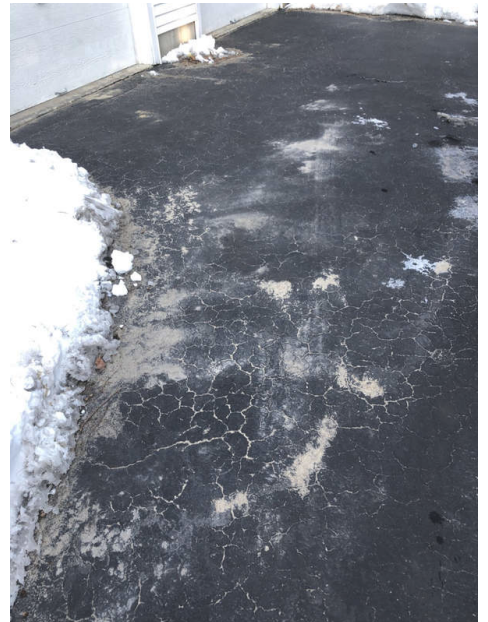
ASPHALT DRIVEWAY - TYPICAL CRACKING

Asphalt driveway... this material has typical cracking which is normal for its age recommend seal coating as needed to prolong life expectancy.

Contact a qualified professional.

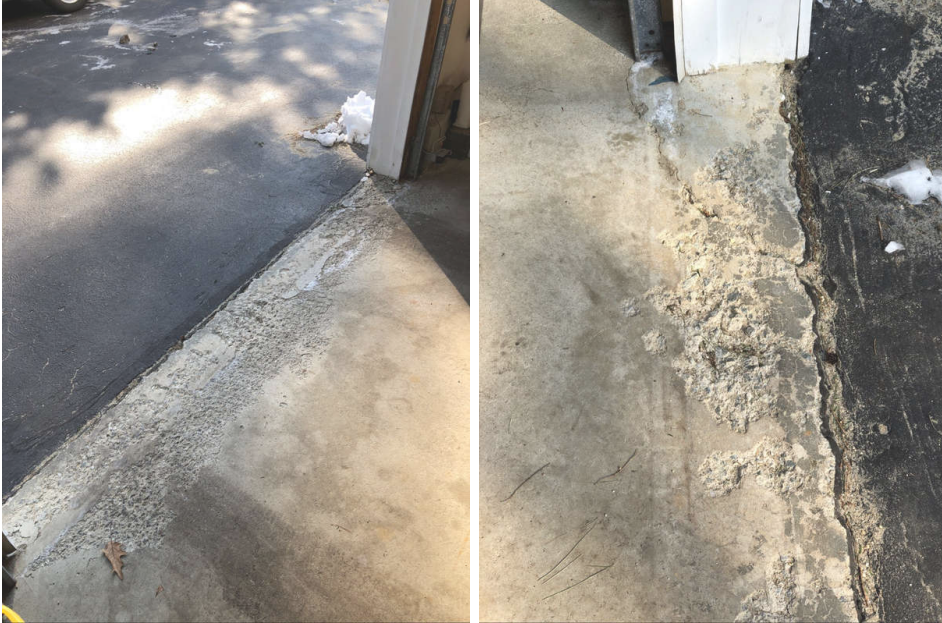
CRACKING / SPALLING

Typical cracking/settlement observed in concrete. If trip hazards become present, recommend licensed contractor to repair to prevent injuries.

Contact a qualified concrete contractor.

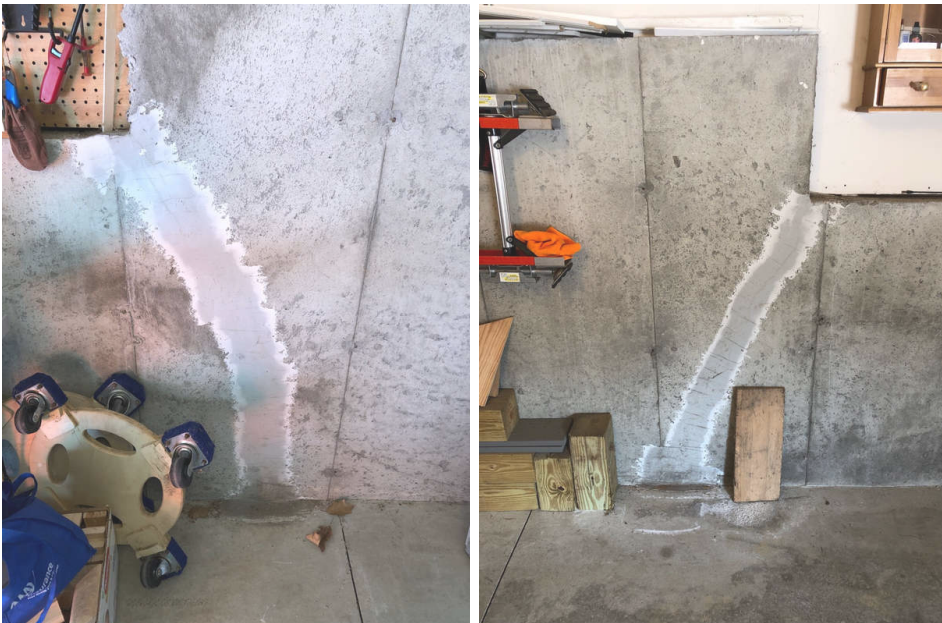
REPAIRED STRUCTURE

Garage shows history of movement, which has recently been repaired. Recommend monitoring for future movement and possible moisture intrusion.

Recommend monitoring.

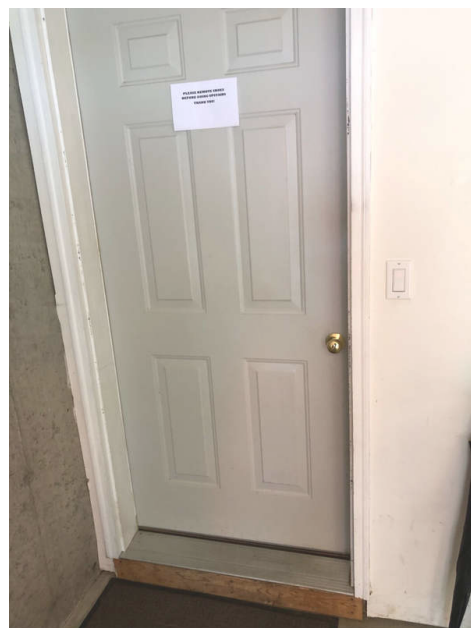
Door from garage to home should have self-closing hinges to help prevent spread of a fire to living space. Recommend a qualified contractor install self-closing hinges.

Contact a qualified door repair/installation contractor.

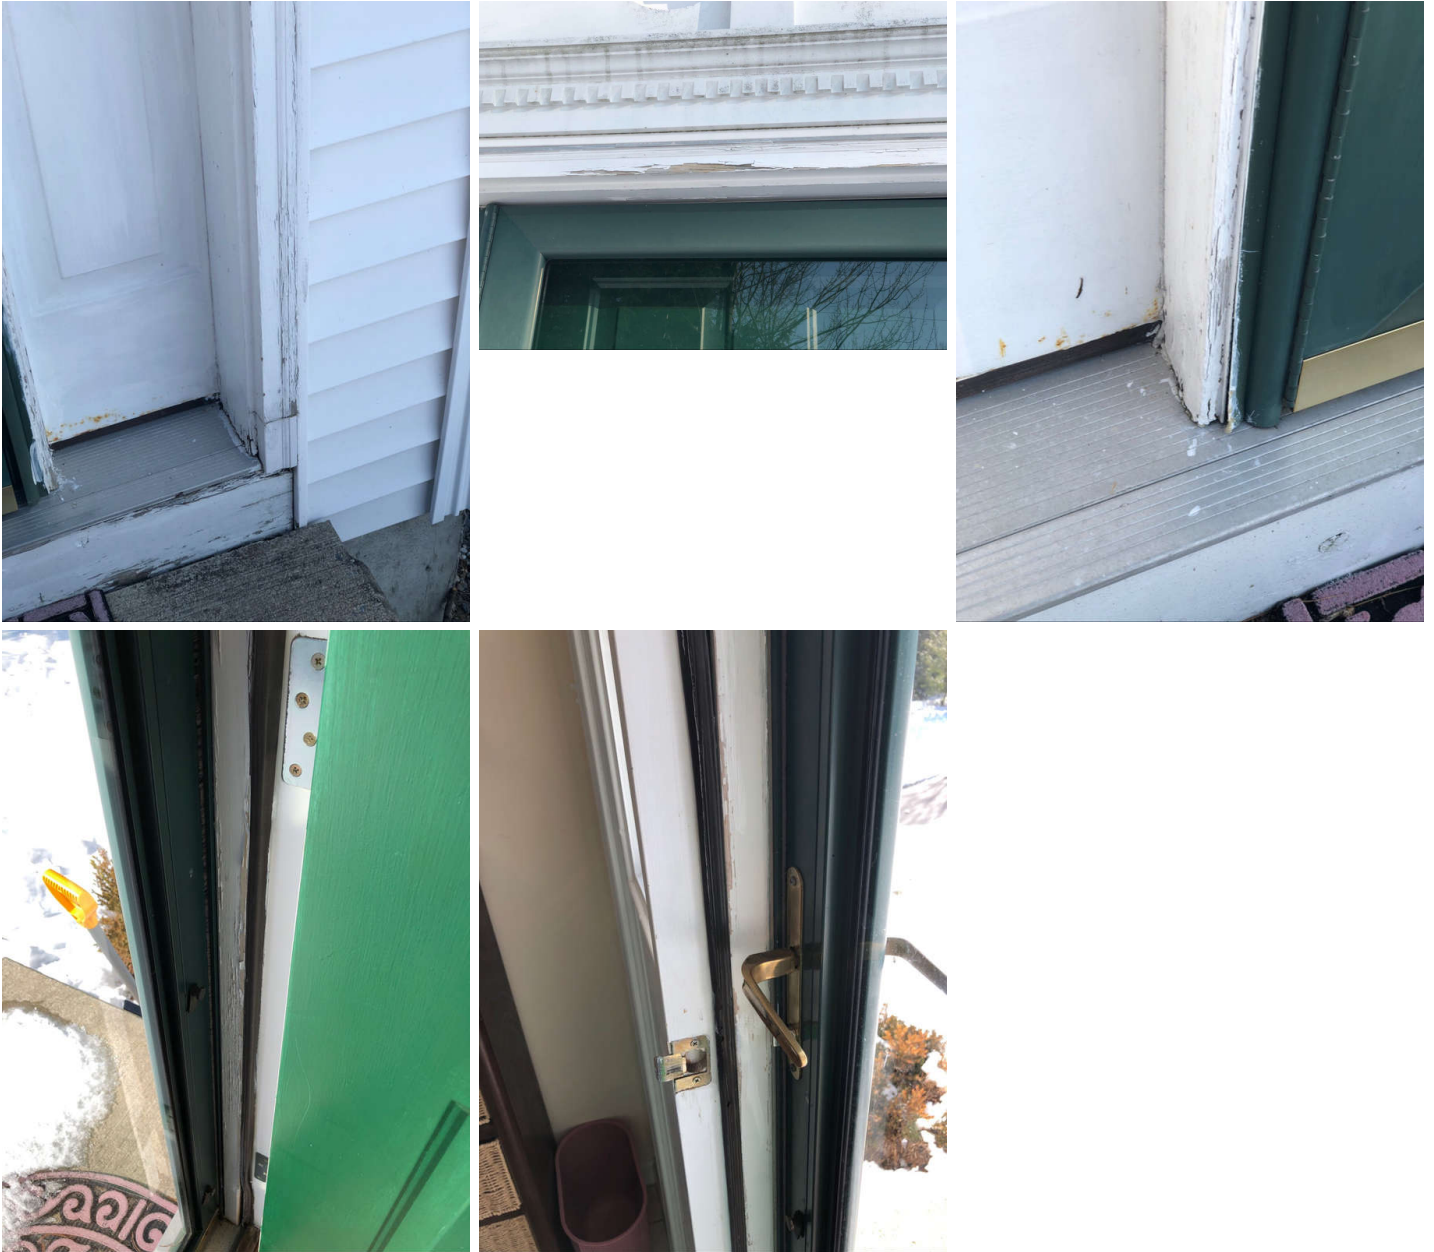
Door finish is worn. Recommend refinish and/or paint to maximize service life.

Contact a qualified door repair/installation contractor.

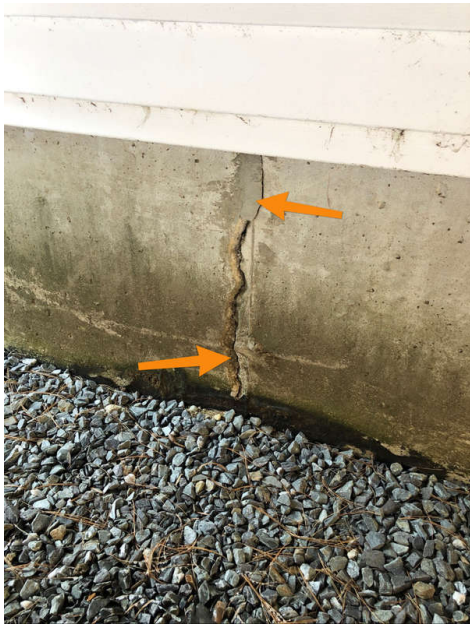
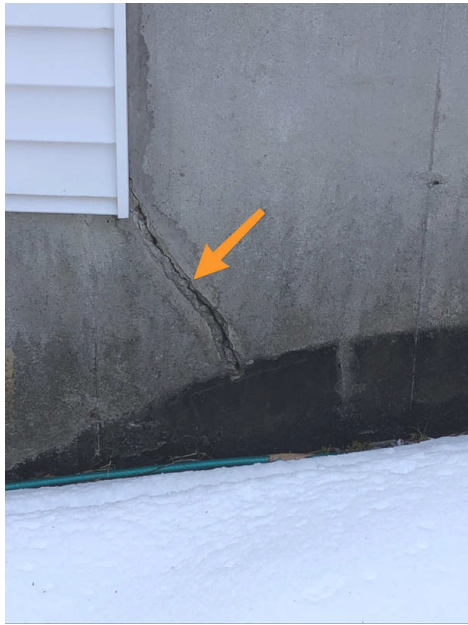
TYPICAL CRACKING

Exterior foundation contains typical cracks due to shrinkage and normal freeze thaw cycle. Recommend patching as needed to prevent moisture intrusion.

Under Deck

Garage Exterior

Contact a foundation contractor.

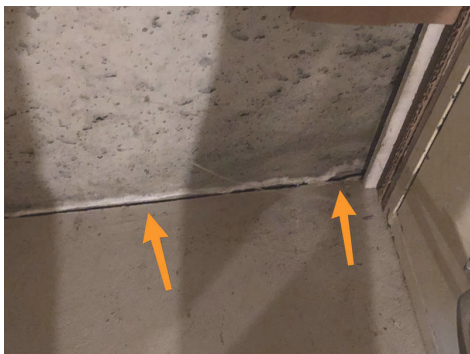
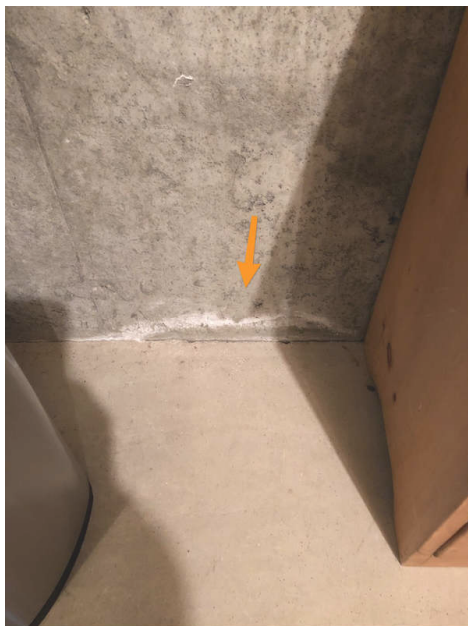
Evidence of efflorescence was observed on foundation walls/floor. This is an indication of moisture intrusion. Recommend maintaining proper grading, clean (or add) gutters to prevent moisture intrusion. Seal or repair as needed.

Contact a foundation contractor.

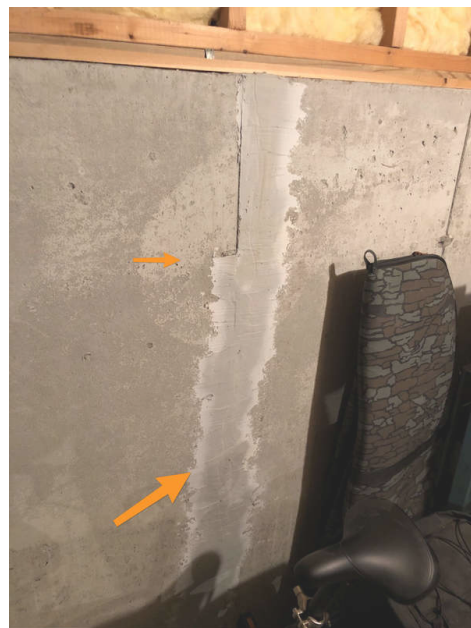
FOUNDATION REPAIR

Foundation shows evidence of a previous repair. This may have been a repair of typical shrinkage cracks. No structural damage was observed.

Recommend monitoring.

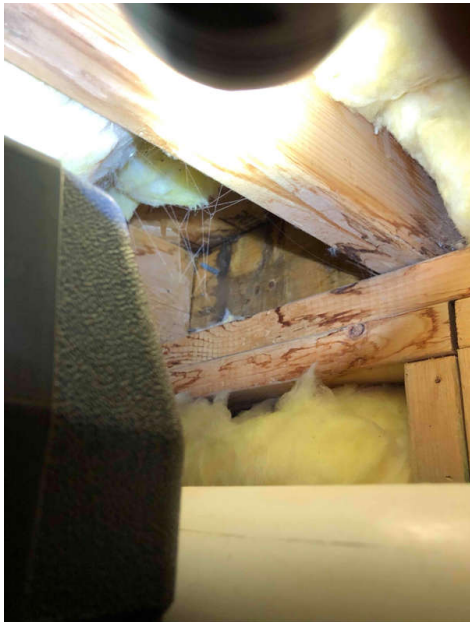
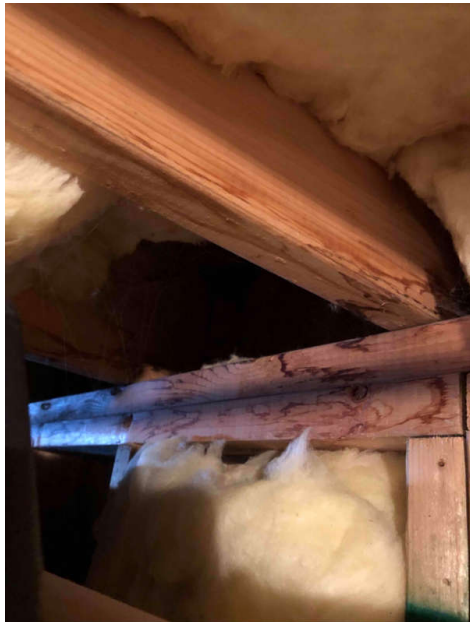
EVIDENCE OF PRIOR WATER / MOISTURE

There were signs of past water intrusion in the underlying floor structure. This area was dry at the time of inspection. Recommend monitoring and identifying source of moisture and repairing if continues.

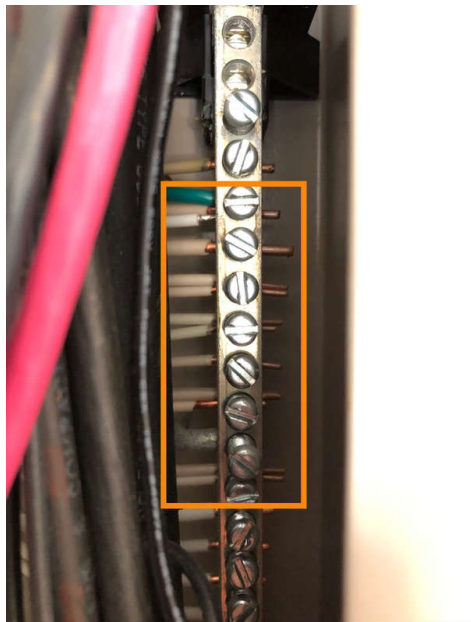
Double tapped neutrals at the electrical panel should be repaired by a licensed electrician.

Double-Tapped Breakers

Contact a qualified professional.

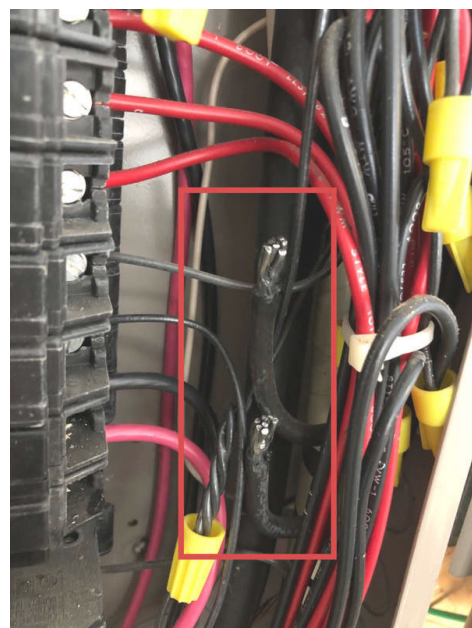
UNSAFE ELECTRICAL WIRING OBSERVED

Evidence of a live disconnected electrical conductor was observed this is a safety hazard recommend licensed electrician to repair to prevent possible injury

Contact a qualified electrical contractor.

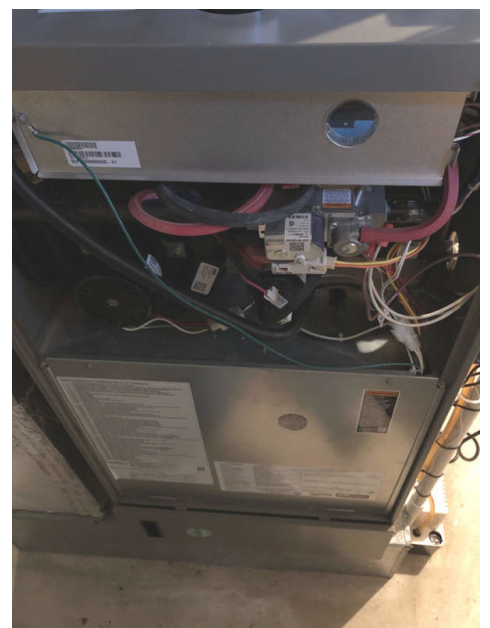
The furnace was a high-efficiency system and had a sealed combustion chamber which would require invasive measures which lie beyond the scope of the General Home Inspection to inspect. The Inspector recommends that an evaluation be performed by a qualified heating, ventilation and air-conditioning (HVAC) contractor.

Contact a qualified HVAC professional.

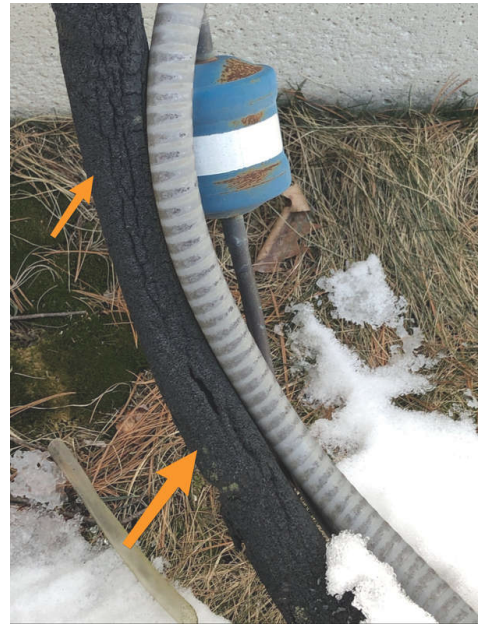
**INSULATION MISSING
OR DAMAGED**

Missing or damaged insulation on refrigerant line can cause energy loss and condensation.

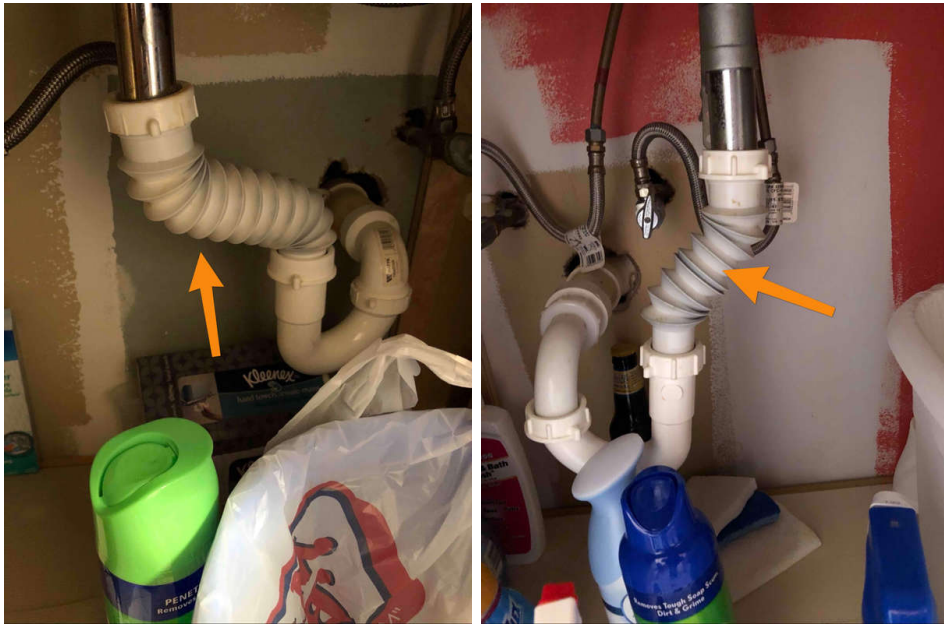
Bathroom drains have accordion style drain pipe present. This style of pipe is not recommend as the zig zag style of pipe can trap hair and gunk as well as slow down the flow of water.

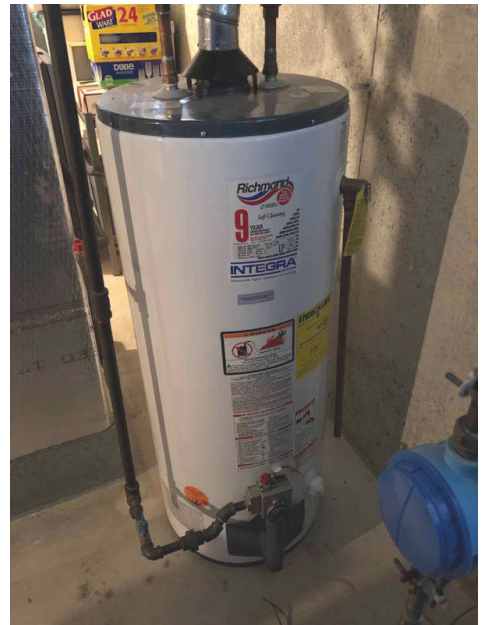
Water heaters have an average life span of 10 years. While operating as it should at the time of inspection, this water heater is approaching normal life expectancy. Recommend budgeting for replacement.

Contact a qualified plumbing contractor.

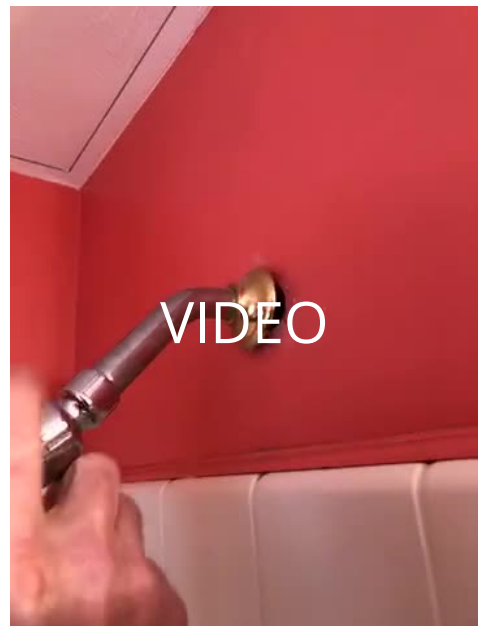
SHOWER HEAD LOOSE

Master Bathroom shower piping is loose. Recommend filling the back with spray foam which will insulate and keep the shower head pipe in place.

Contact a qualified professional.

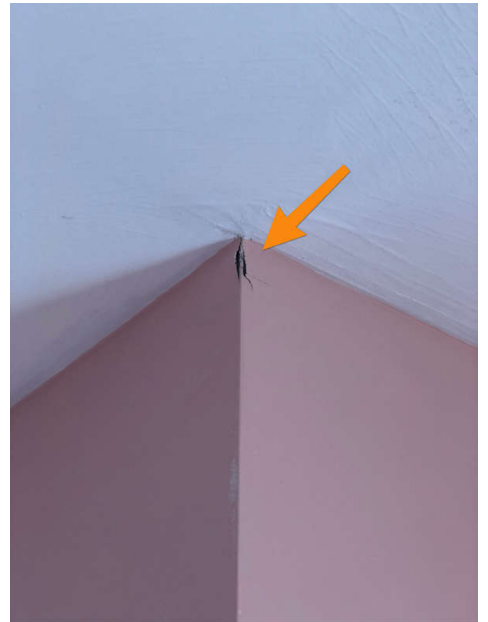
MINOR CORNER CRACKS

Minor cracks in walls Appeared to be the result of long-term settling. Some settling is not unusual in a home of this age and these cracks are not a structural concern.

Contact a qualified professional.

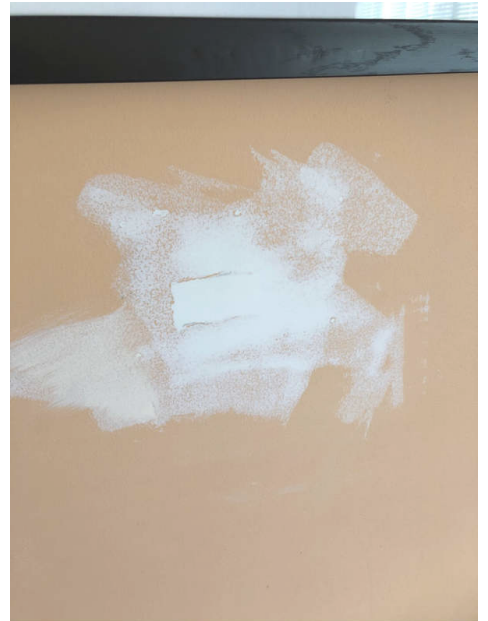
Observed section of drywall in the family room to have been patched but has not been sanded and painted.

Contact a handyman or DIY project

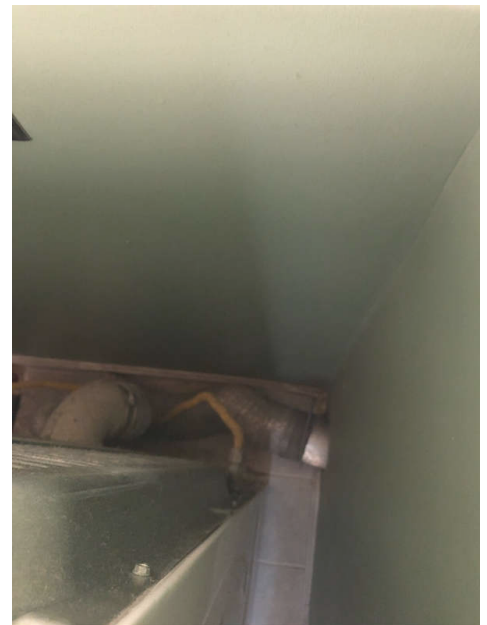
The dryer was vented using a flexible, ribbed, foil-like vent that is not approved by the Underwriter's Laboratory (UL). This type of dryer exhaust vent is more likely to accumulate lint than a smooth metal vent, creating a potential fire hazard. Excessive lint accumulation can also increase drying time and shorten the dryer's lifespan. The Inspector recommends replacing this plastic vent with a properly-installed, UL-approved dryer vent. All work should be performed by a qualified contractor.

Contact a handyman or DIY project

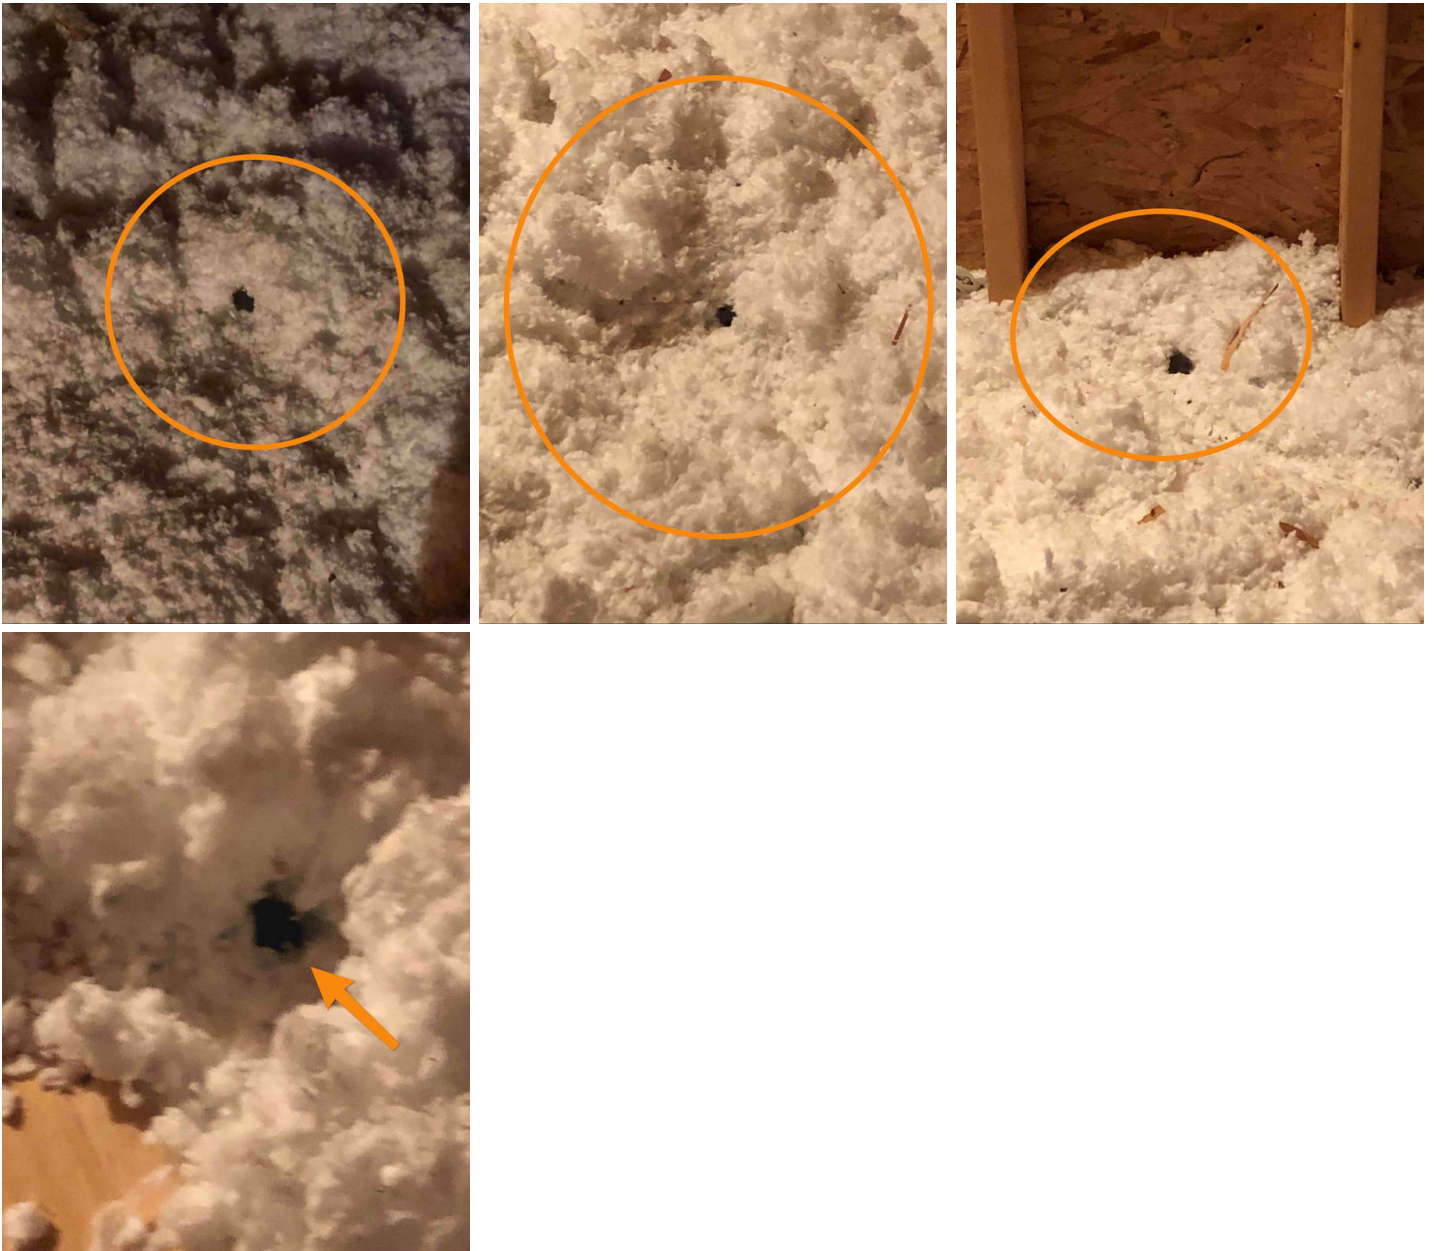
Evidence of pest and or rodent nesting was observed in attic area, recommend licensed pest control contractor to evaluate and repair as needed.

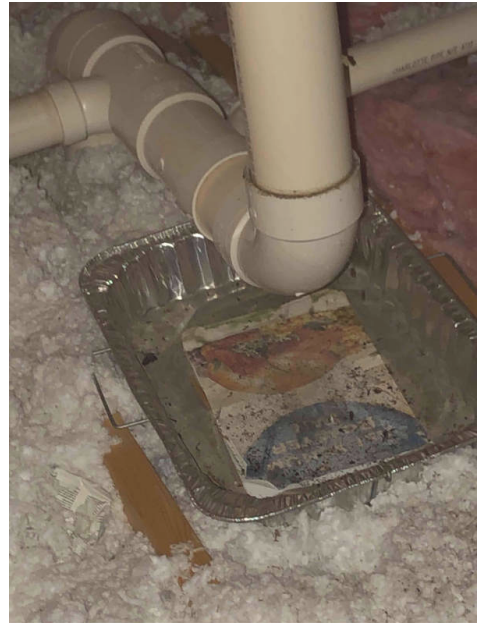
PAN PRESENT UNDER EXHAUST

Observed a foil pan present underneath the exhaust for the kitchen sink. The pan is dry and no moisture is present. Recommend asking the home owner what this may have been for??
