RESIDENTIAL REPORT

1234 Main St.
Oreana IL 62554

Buyer Name
06/28/2018 9:00AM

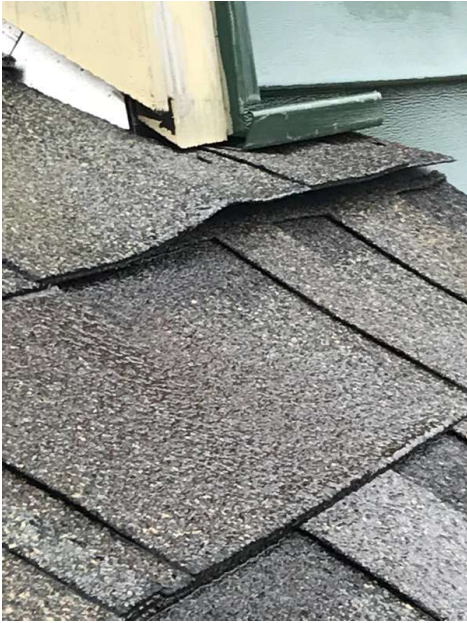
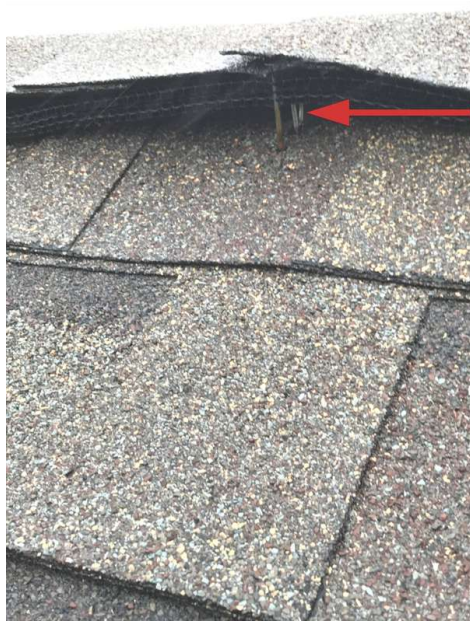
IMPROPER/INCOMPLETE NAILING

Roof coverings showed signs of improper installation and fastening. Recommend a qualified roofing contractor evaluate and repair.

Contact a qualified roofing professional.

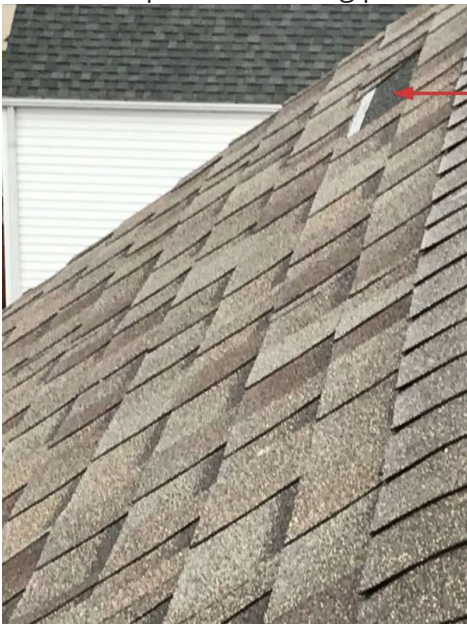
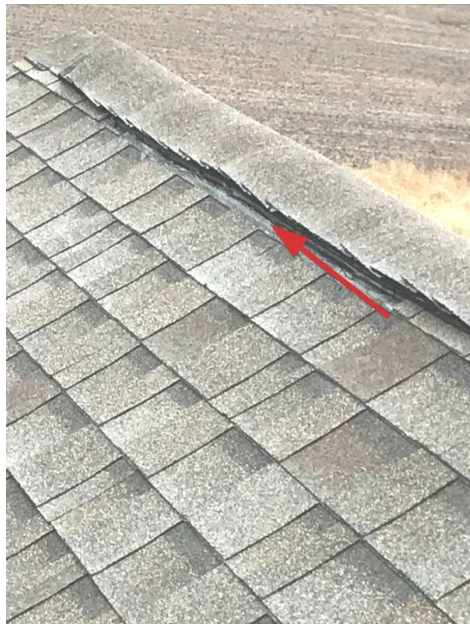
2.1.2 Coverings

SHINGLES MISSING

Observed areas that appeared to be missing sufficient coverings. Recommend qualified roofing contractor evaluate & repair.

Contact a qualified roofing professional.

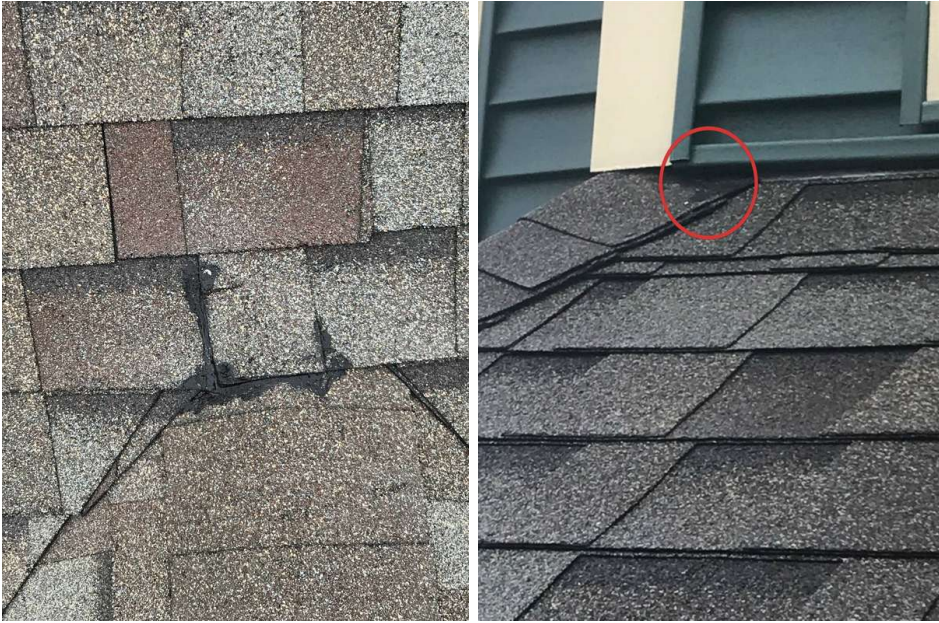
2.1.3 Coverings

EVIDENCE OF PATCHING

During the inspection, I observed areas of patching. This could indicate preventative patching or could indicate corrective repairs to prior leaking. Recommend further evaluation or monitoring.

Contact a qualified roofing professional.

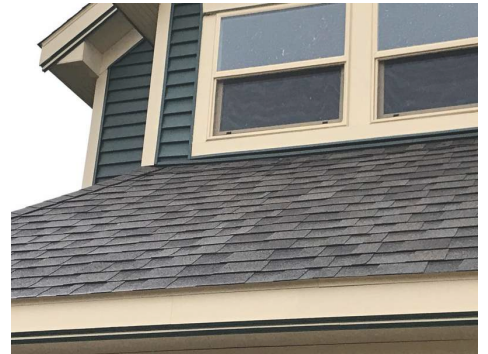
2.2.1 Roof Drainage Systems

DOWNSPOUTS MISSING

Home was missing downspouts in one or more areas. This can result in excessive moisture in the soil at the foundation, which can lead to foundation/structural movement. Recommend a qualified contractor install downspout extensions that drain at least 6 feet from the foundation.

Contact a qualified roofing professional.

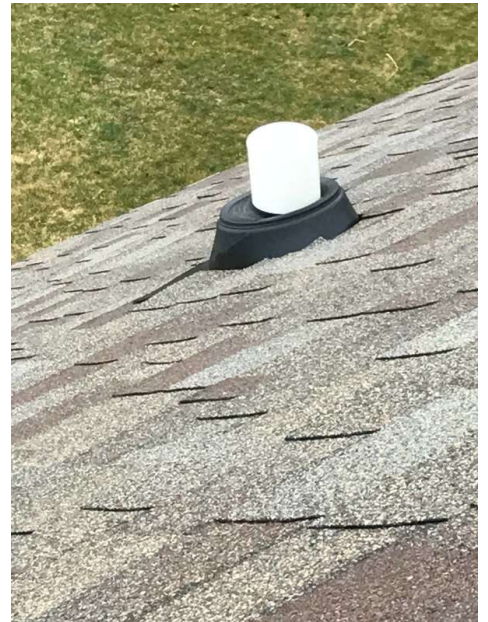
PIPE BOOT

The rubber pipe boot appears to be inverted at the collar. This can lead to leaking and premature failure due to ponding water and or snow/ice.

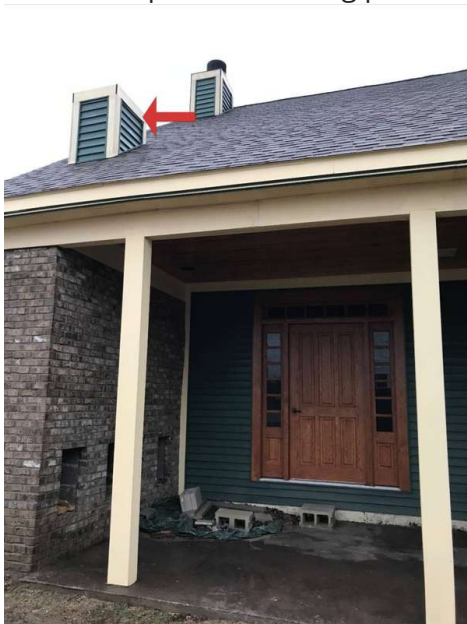
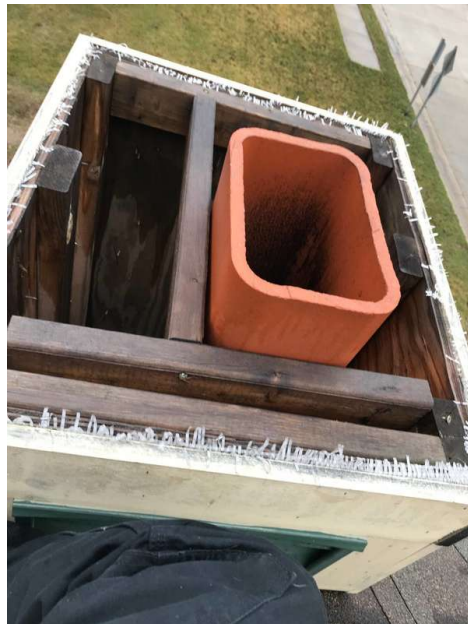
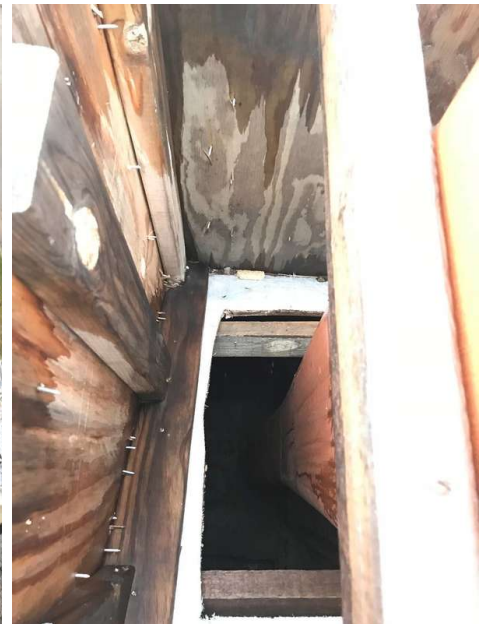
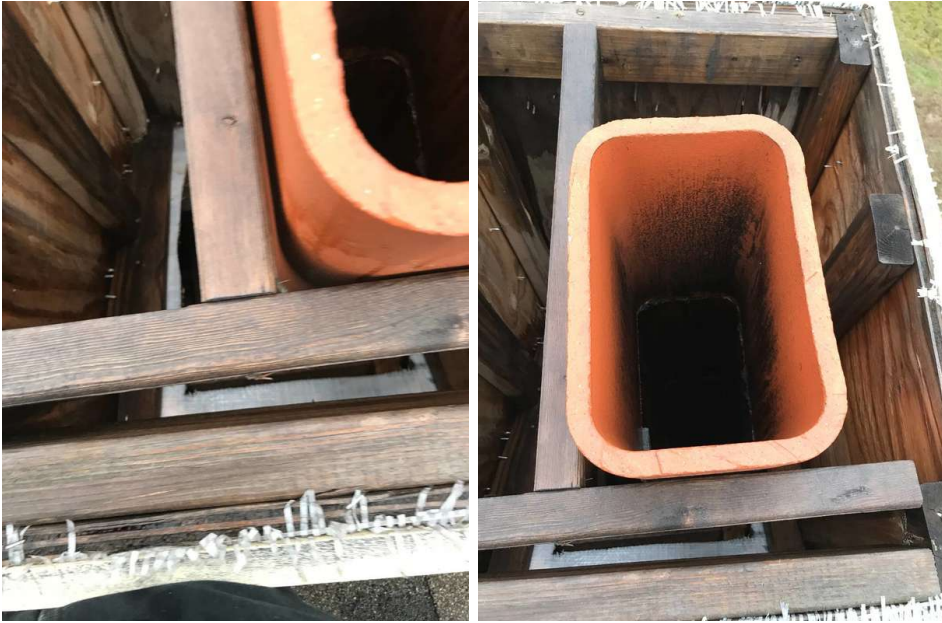
2.4.1 Skylights, Chimneys & Other Roof Penetrations

CHIMNEY CAP MISSING

No chimney cap was observed. This is important to protect from moisture intrusion, weathering and wildlife nesting. Recommend a qualified roofer or chimney expert install.

Contact a qualified roofing professional.

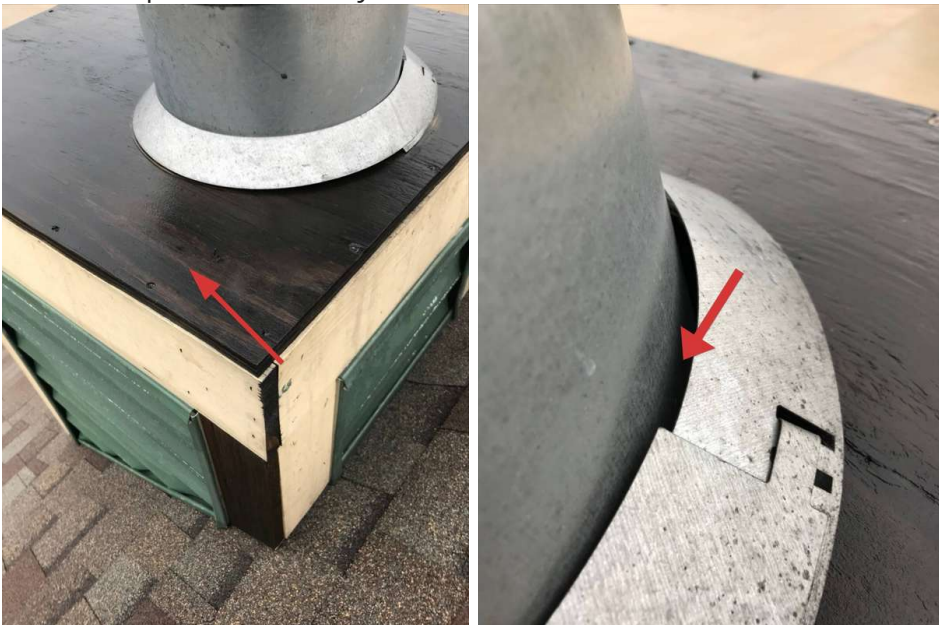
2.4.2 Skylights, Chimneys & Other Roof Penetrations

CHIMNEY CAP IMPROPERLY INSTALLED

CHIMNEY TO INDOOR WOOD BURNING FIREPLACE

Chimney cap was installed using flat plywood rather than recommended materials. This will potentially result in wood rot and water intrusion. Recommend chimney repair contractor install proper cap.

Contact a qualified chimney contractor.

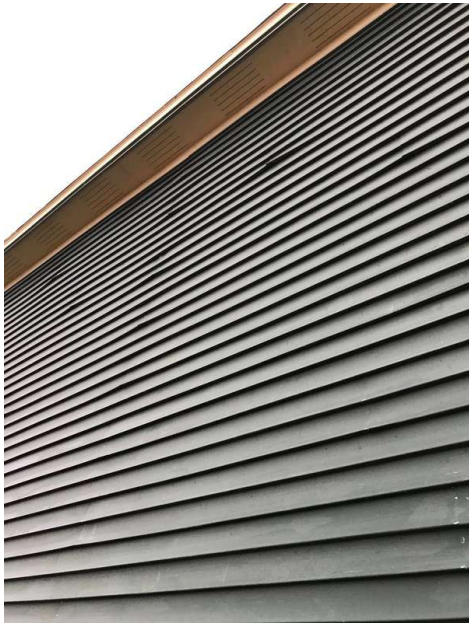
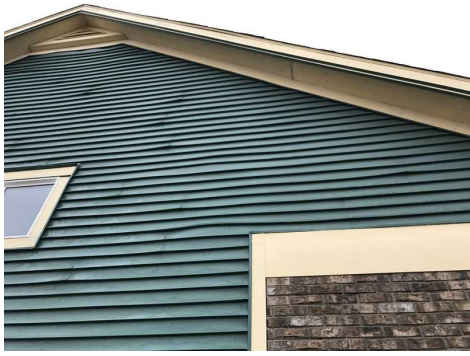
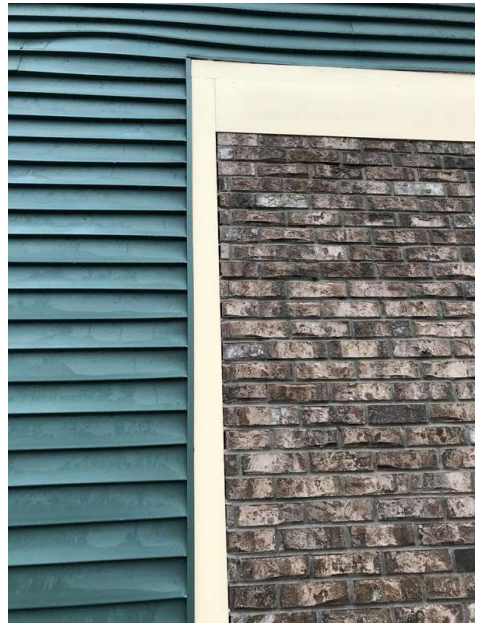
Vinyl siding was warping or buckling in areas. This is often as a result of nailing siding boards too tight to the home, preventing expansion/contraction. Recommend a qualified siding contractor evaluate and repair.

Contact a qualified siding specialist.

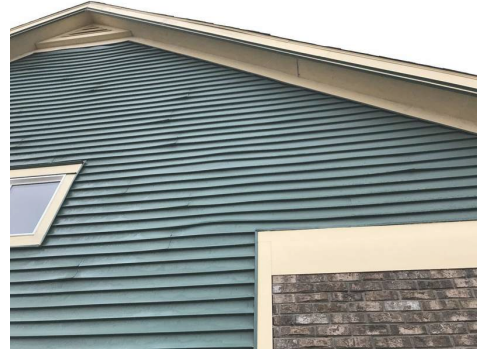
3.1.2 Siding, Flashing & Trim

TRIM IMPROPERLY SEALED

Trim is improperly sealed which could cause moisture intrusion. Recommend proper sealing.

Contact a handyman or DIY project

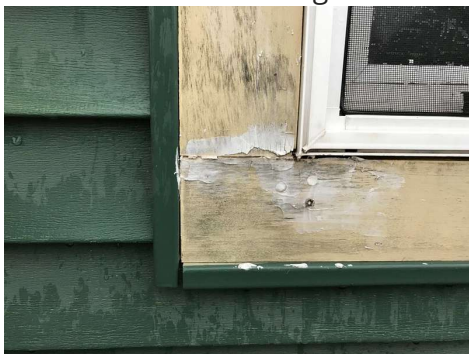
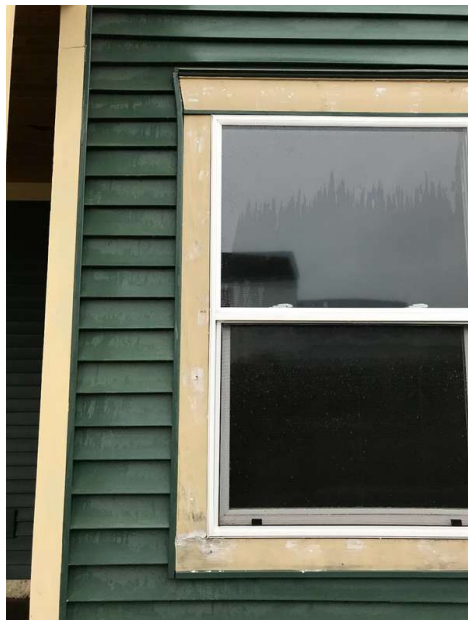
3.1.3 Siding, Flashing & Trim

WOOD TRIM EXPOSED TO ELEMENTS

Trim around exterior windows is wood material. Does not seem to be treated or painted and is exposed to the elements. Recommend treating and monitoring to prevent future wood rot and water intrusion.

Recommend monitoring.

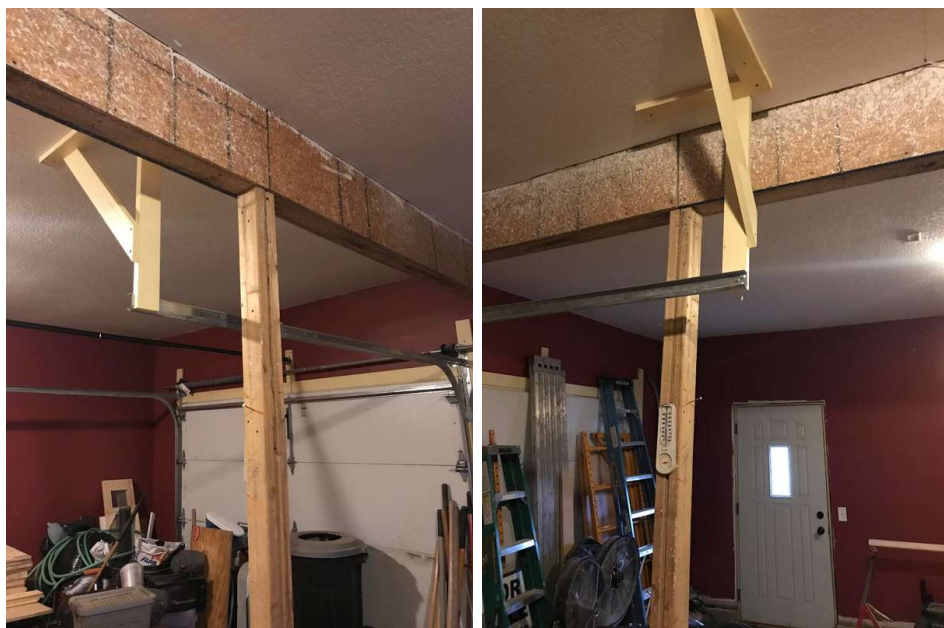
3.2.1 Exterior Doors

GARAGE DOORS

I was unable to test garage overhead doors due to ongoing construction and homeowners belongings.

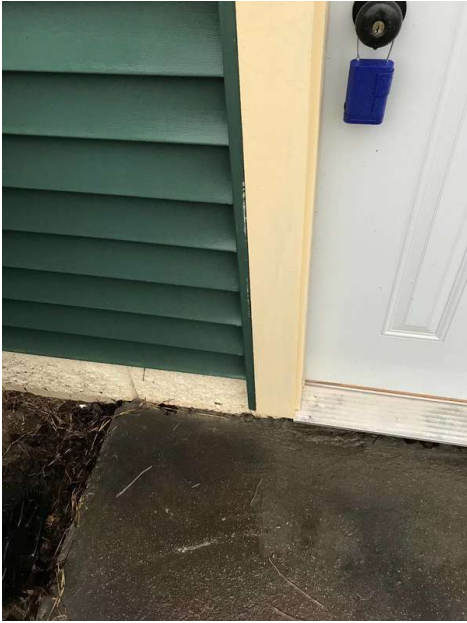
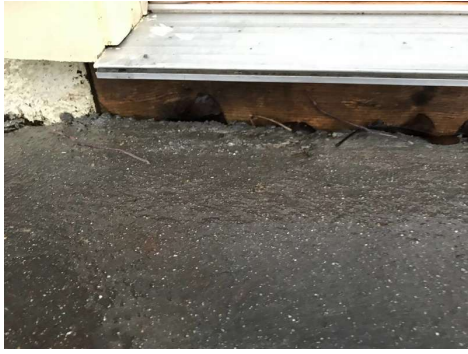
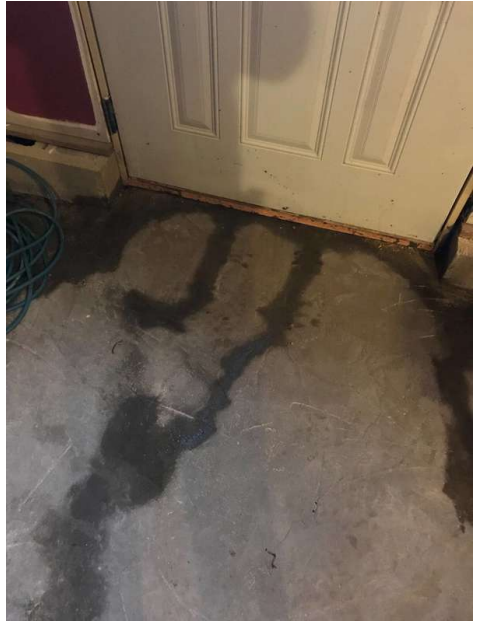
3.2.2 Exterior Doors

LEAKING

Water intrusion most likely due to improper installation or missing trim. Recommend DIY or Qualified Professional to correct.

Contact a qualified professional.

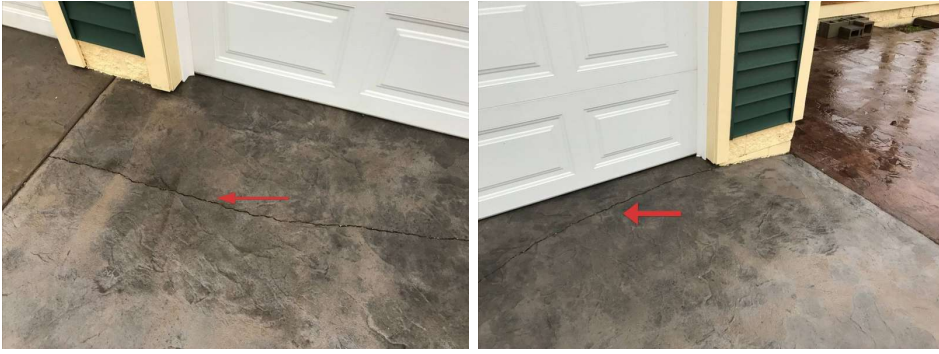
3.3.1 Walkways, Patios & Driveways

DRIVEWAY CRACKING - MINOR

Minor cosmetic cracks observed, which may indicate movement in the soil. Recommend monitor and/or have concrete contractor patch/seal.

Contact a qualified concrete contractor.

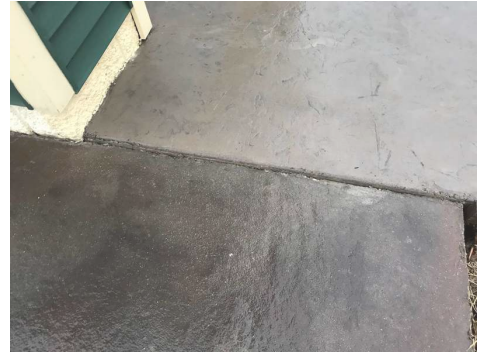
3.3.2 Walkways, Patios & Driveways

DRIVEWAY TRIP HAZARD

Trip hazards observed. Patch or repair recommended.

Recommended DIY Project

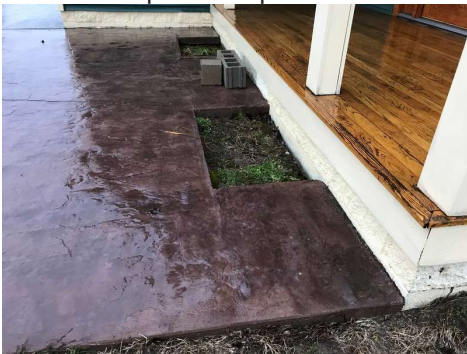
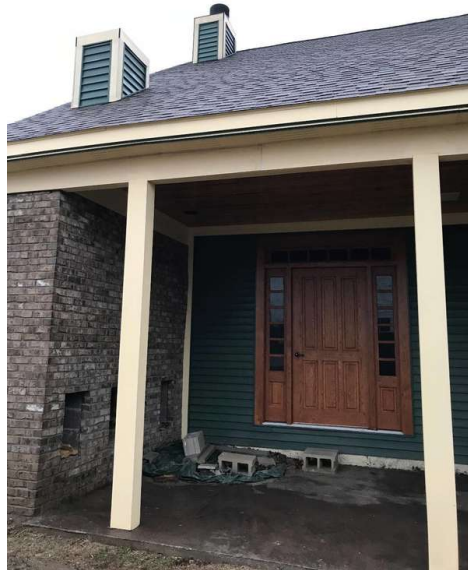
3.4.1 Decks, Balconies, Porches & Steps

MISSING STAIRS

Construction is ongoing so there are no steps leading to the front porch. There are cutouts that may be foundation supports for future steps. The rear patio has no steps leading up to the door for entry to the home. Recommend stairs in both locations.

Contact a qualified professional.

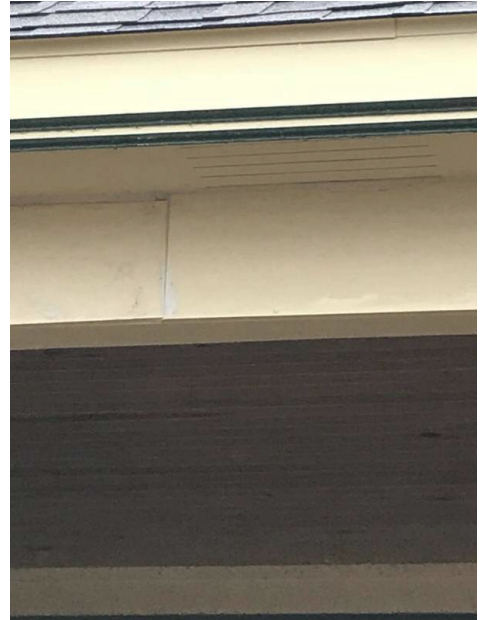
3.5.1 Eaves, Soffits & Fascia

WOOD FINISH

Eaves, Soffits & Fascia are all wood material. Recommend monitoring and maintenance as needed to prevent wood rot and water intrusion.

Contact a qualified professional.

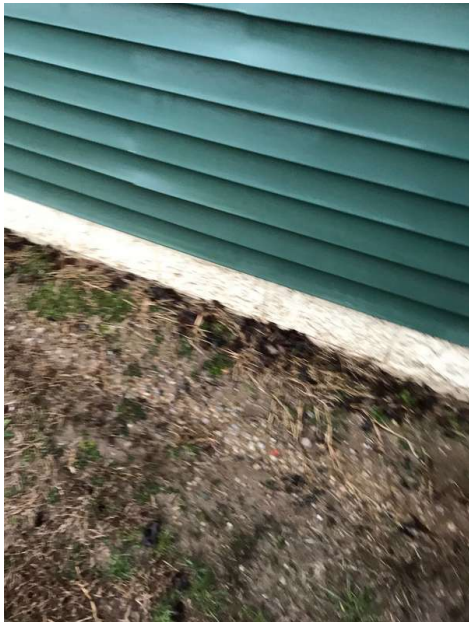
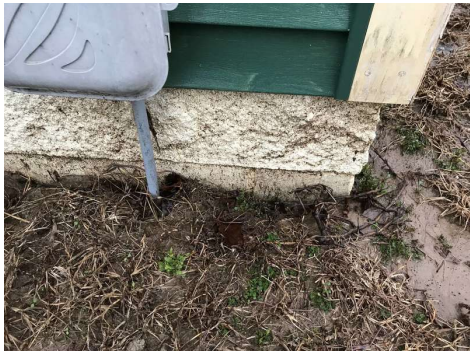
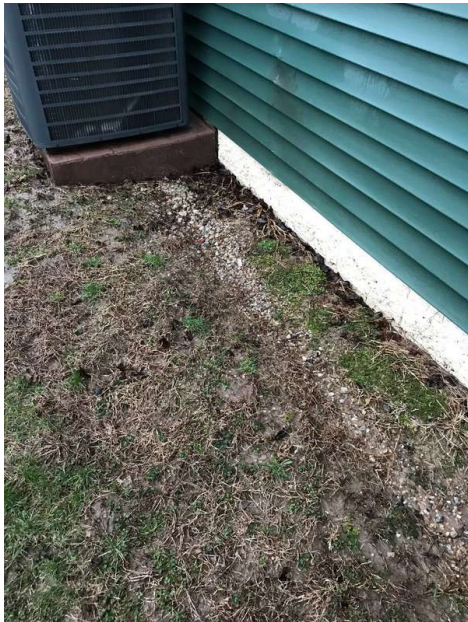
Construction still in progress, gutters have not been installed causing improper drainage. This is creating a trench that is pushing water towards the foundation. Recommend gutter installation and proper grading to prevent future water intrusion.

Contact a qualified grading contractor.

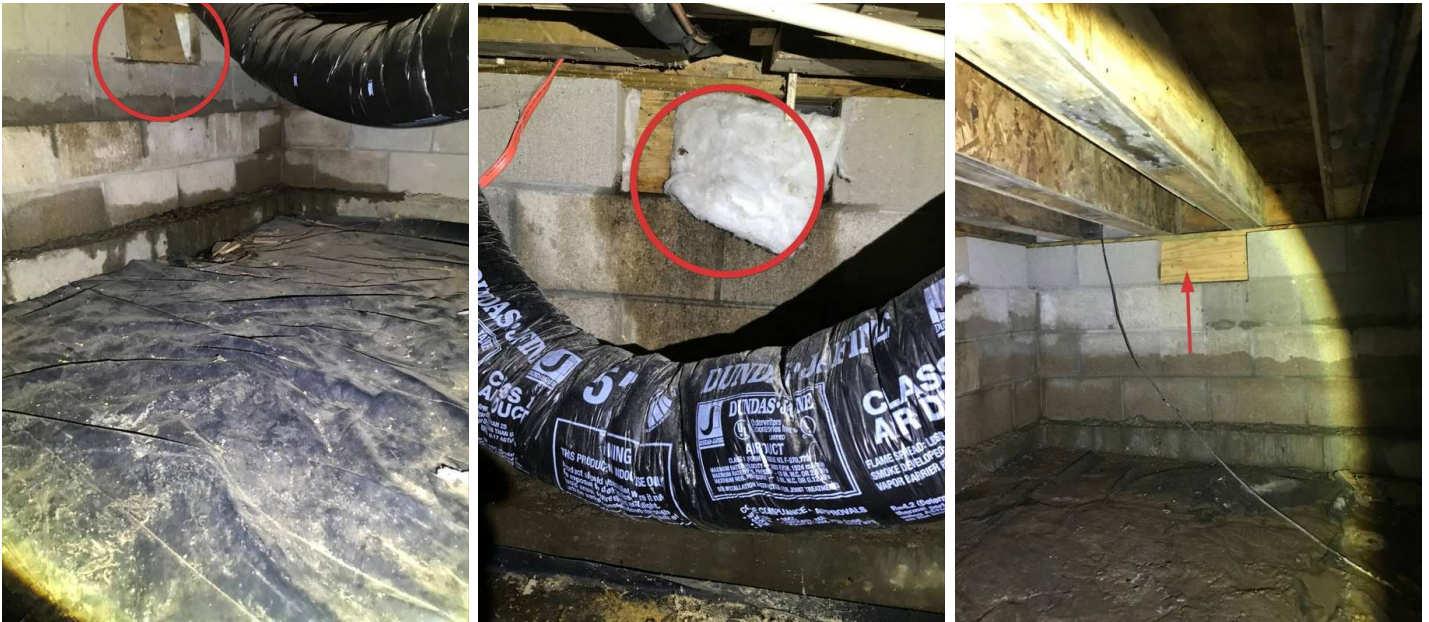
4.1.1 Foundation

POOR VENTILATION OF FOUNDATION AREA

The foundation is poorly ventilated. Increased ventilation (introduction and movement of fresh air) is recommended. This can be accomplished by partially opening basement windows, doors and/or vents on opposite sides of the foundation on a regular basis (when weather is suitable). And by installing a dehumidifier to decrease moisture.

Contact a qualified professional.

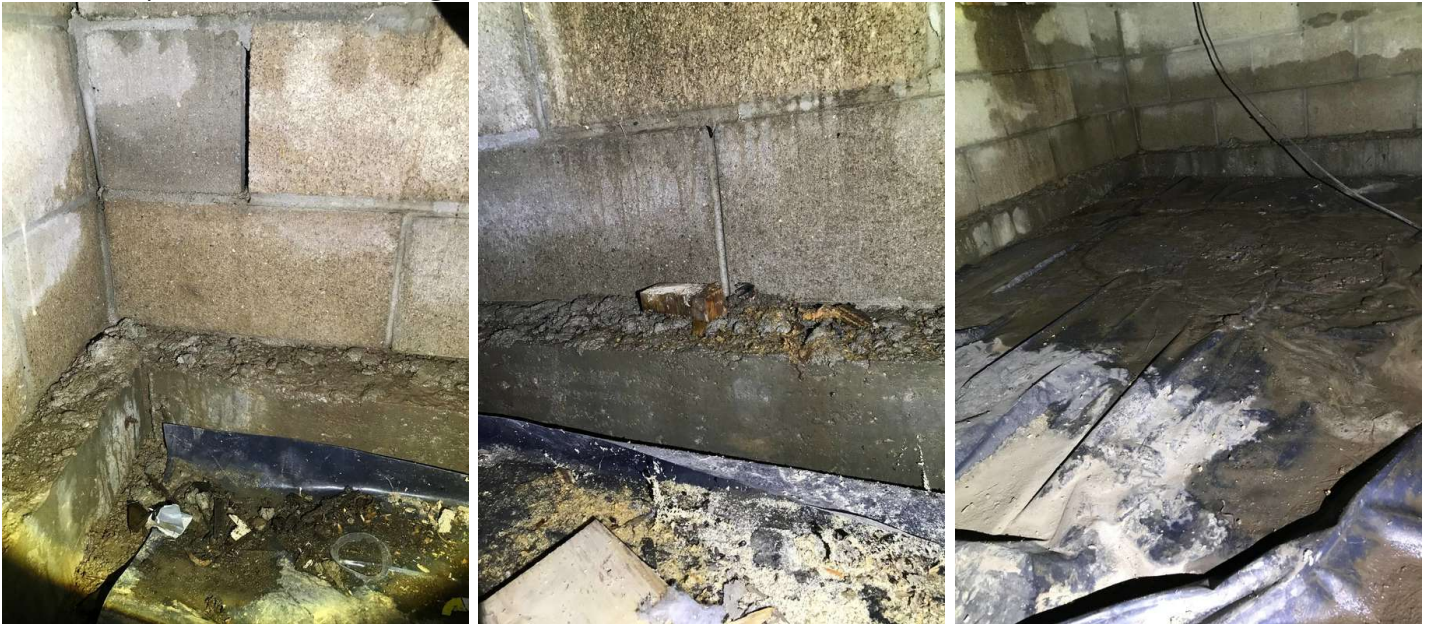
4.1.2 Foundation

WATER INTRUSION

Water intrusion was evident on the surface of the floor slab or in the basement/crawlspace. This can compromise the soil's ability to stabilize the structure and could cause damage. Recommend a qualified contractor identify the source of moisture and remedy.

Contact a qualified structural engineer.

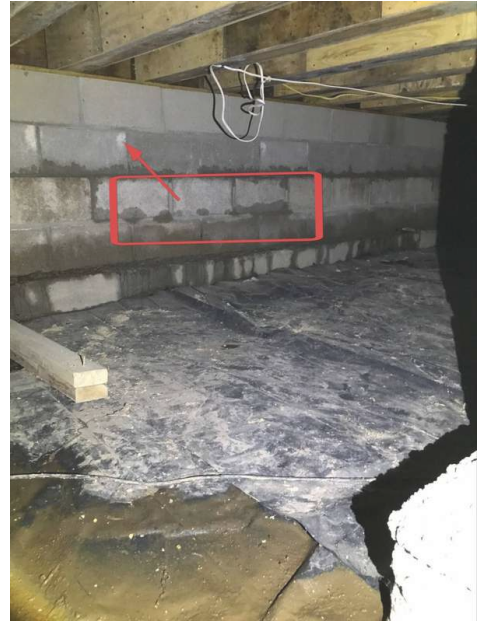
4.2.1 Basements & Crawlspaces

EFFLORESCENCE

Efflorescence noted on the crawlspace surface. This a white, powdery deposit that is consistent with moisture intrusion. This can compromise the soil's ability to support the home structure and/or lead to mold growth. Recommend a qualified contractor identify source or moisture and correct.

Contact a qualified professional.

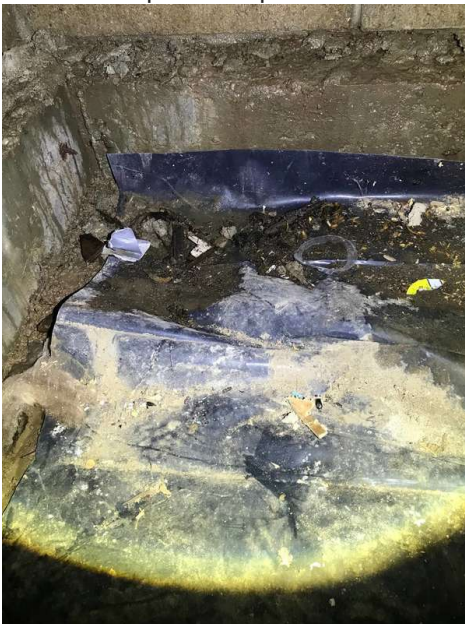
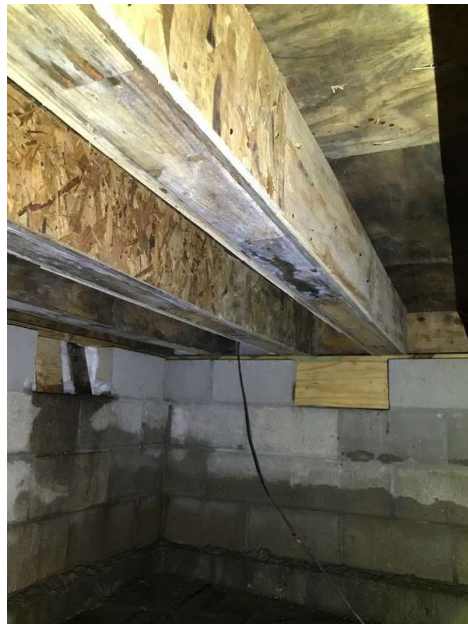
4.2.2 Basements & Crawlspaces

HIGH MOISTURE LEVELS

High levels of moisture were noted in areas of the basement. Recommend monitoring and finding source of moisture intrusion to prevent damage to structure.

Contact a qualified professional.

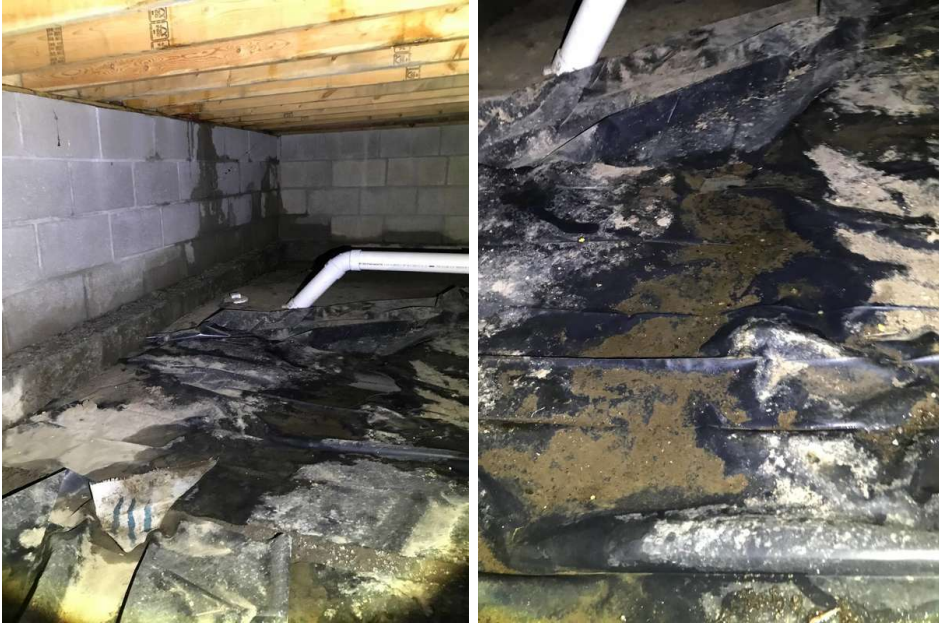
4.2.3 Basements & Crawlspaces

STANDING WATER

Observed signs that standing water may have been present on basement floor. Recommend a qualified contractor evaluate and find potential source of moisture.

Contact a qualified professional.

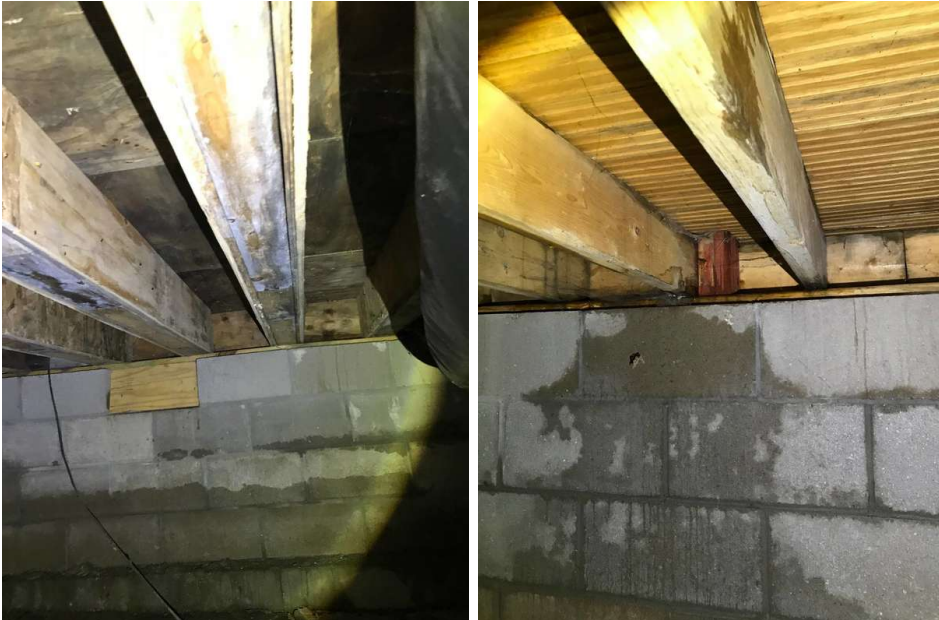
4.3.1 Floor Structure

EVIDENCE OF WATER INTRUSION

There were signs of water intrusion in the underlying floor structure. Recommend identifying source of moisture and repairing.

Contact a qualified structural engineer.

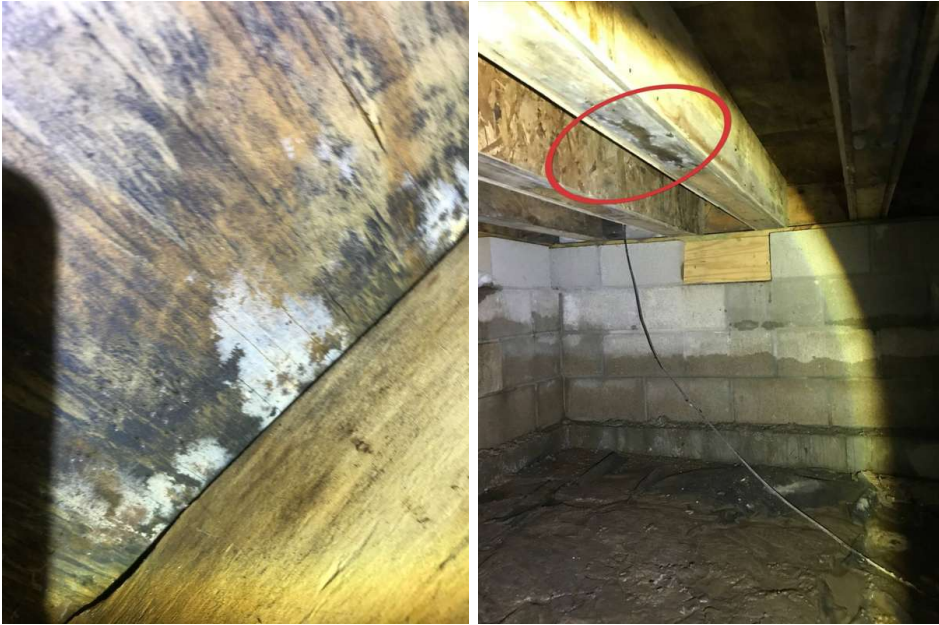
4.3.2 Floor Structure

MOLD

Observed signs of mold in one or more areas in the flooring structure. Recommend identifying source or moisture intrusion and sending samples to a lab for testing.

Contact a qualified mold inspection professional.

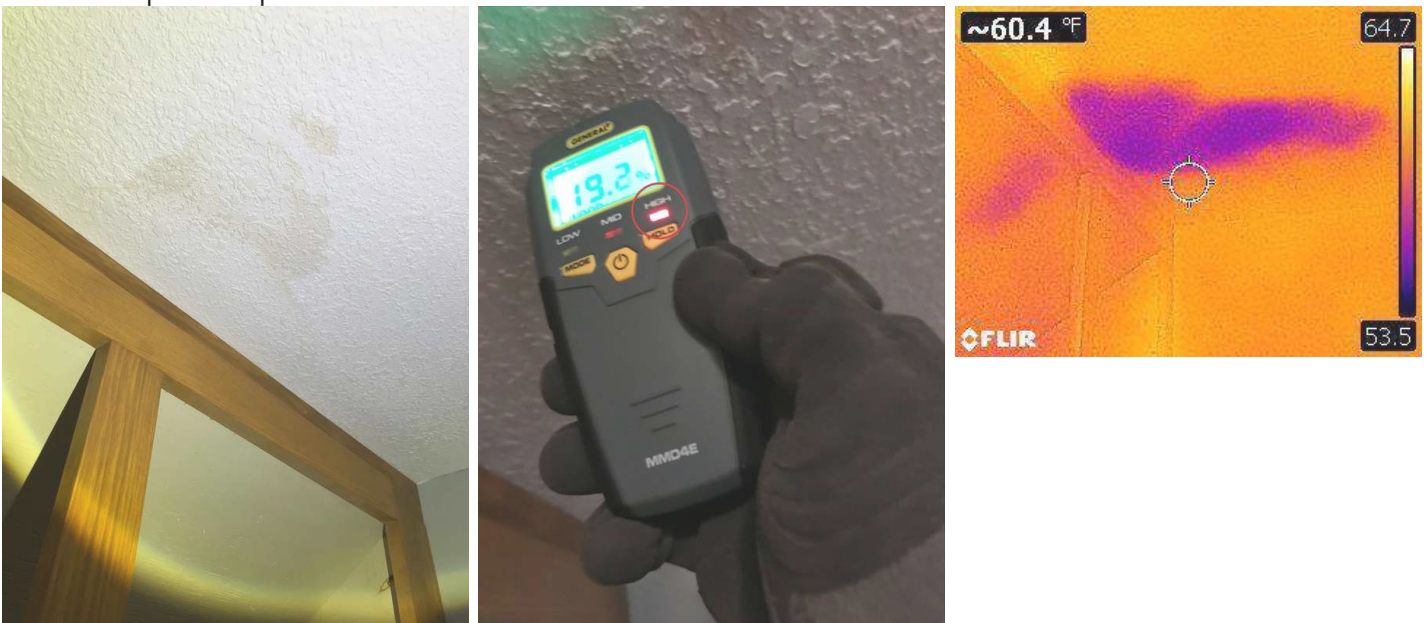
4.5.1 Ceiling Structure

EVIDENCE OF WATER INTRUSION

Ceiling structure showed signs of water intrusion, which could lead to more serious structural damage. Recommend a qualified contractor identify source or moisture and remedy.

Contact a qualified professional.

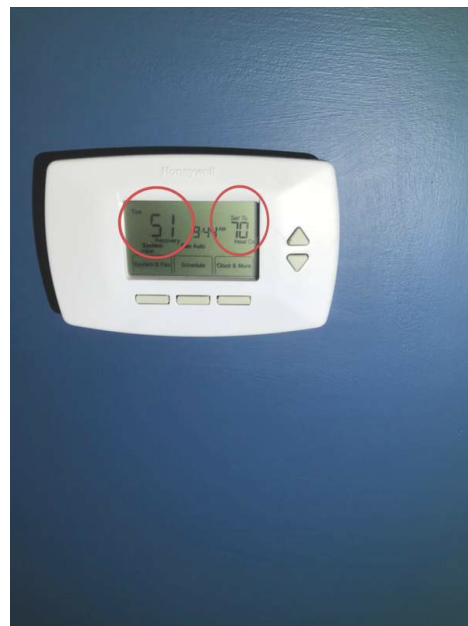
Heating element was inoperable at time of inspection. Recommend qualified HVAC professional evaluate & ensure functionality.

Contact a qualified HVAC professional.

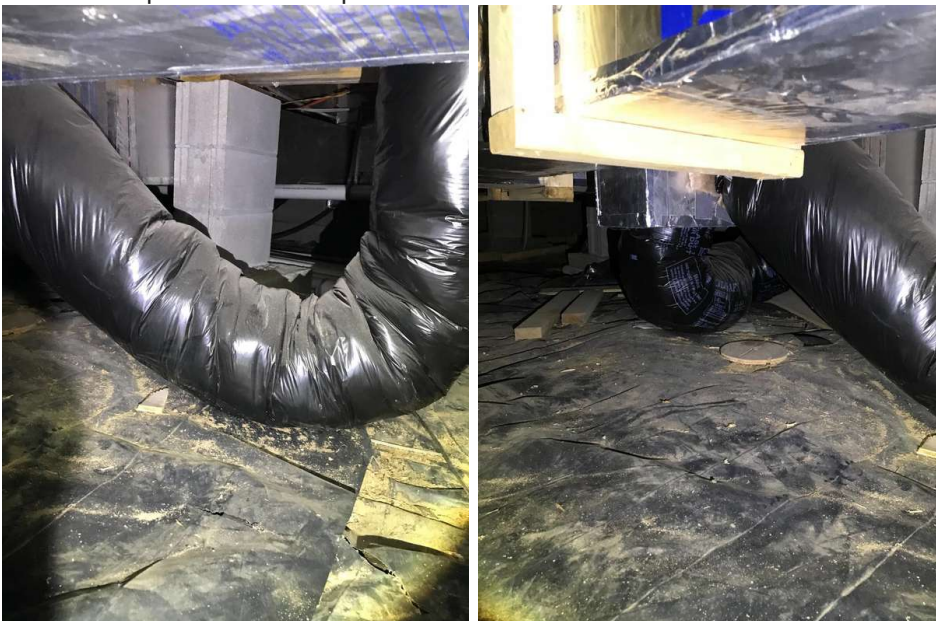
DUCT IMPROPERLY SECURED

Ducts were not properly secured causing them to hang in areas. This can make it more difficult for heat system to push air through. Recommend HVAC technician evaluate and repair.

Contact a qualified HVAC professional.

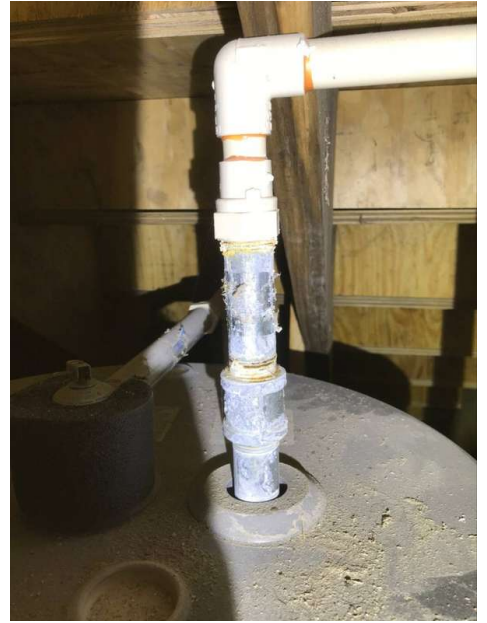
7.4.1 Hot Water Systems, Controls, Flues & Vents

CORROSION

Corrosion was noted at the burn chamber or pipe fittings. Recommend a qualified plumber evaluate for repair/replacement.

Contact a qualified plumbing contractor.

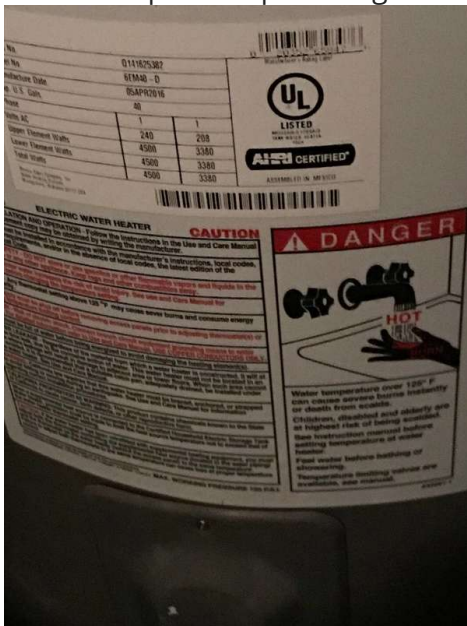
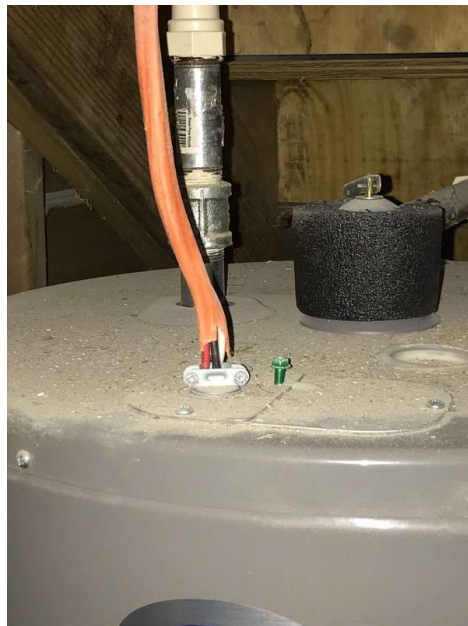
7.4.2 Hot Water Systems, Controls, Flues & Vents

NO DRIP PAN

No drip pan was present. Recommend installation by a qualified plumber.

Contact a qualified plumbing contractor.

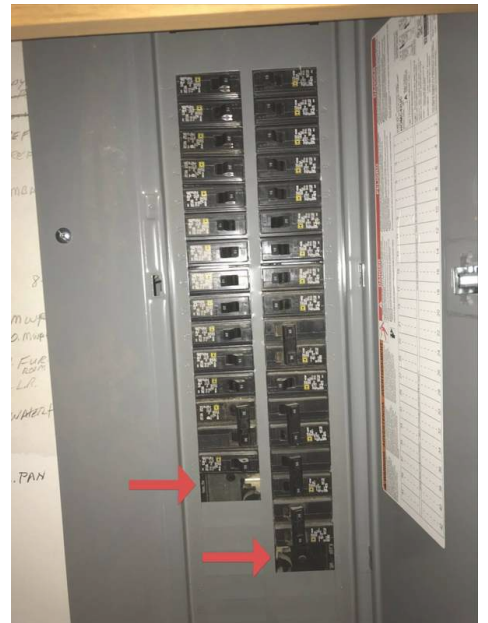
8.2.1 Main & Subpanels, Service & Grounding, Main Overcurrent Device

KNOCKOUTS MISSING

"Knockouts" are missing on the electric panel. This poses a safety hazard and it is recommended that the opening in the panel caused by the missing knockout(s) be properly sealed by a licensed electrician.

Contact a qualified electrical contractor.

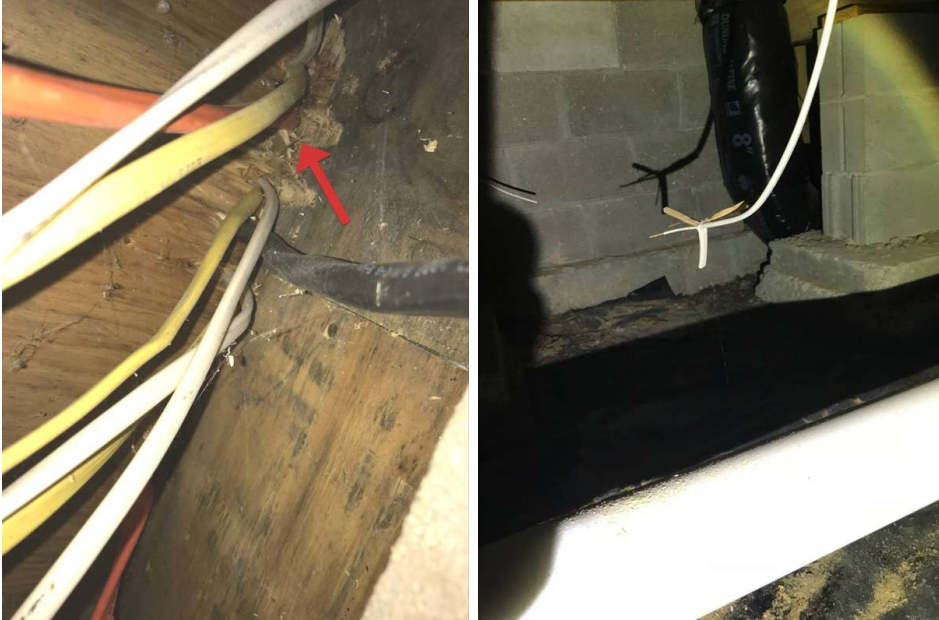
IMPROPER WIRING

Wiring is run through flooring into the crawlspace. The hole is jagged which may cause future fraying of the wire. Recommend a qualified electrician further evaluate the wiring and electrical system.

Unknown exposed wire

Contact a qualified electrical contractor.

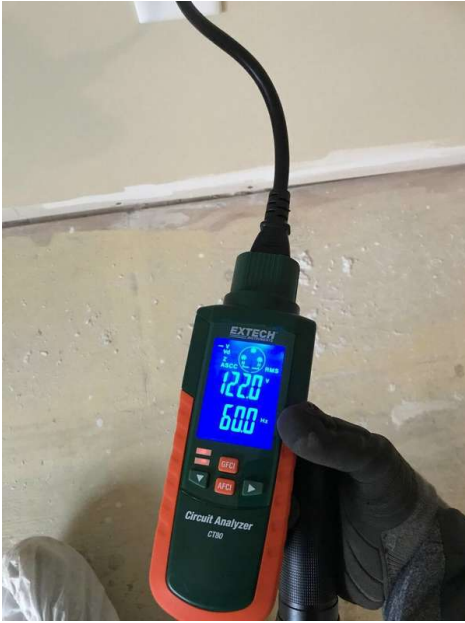
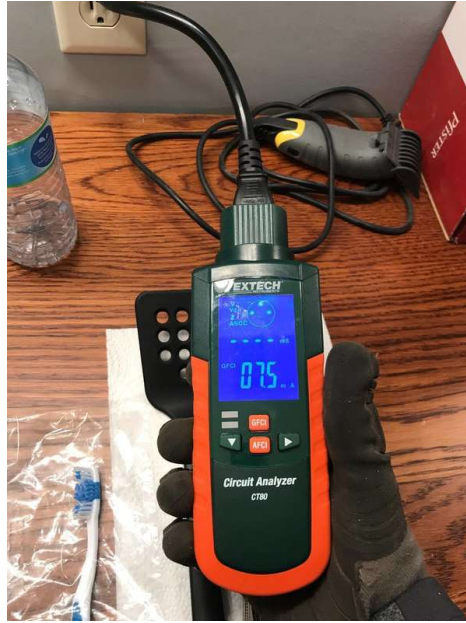
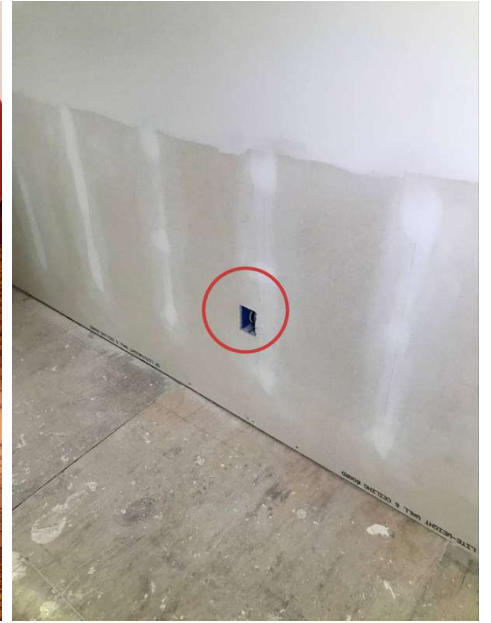
Due to ongoing construction, several plate covers were missing. There were outlets yet to be installed. All receptacles did not have power or light fixtures were missing. I did test a representative number of outlets and switches. The ones that were tested seemed to be in working order.

Contact a qualified electrical contractor.

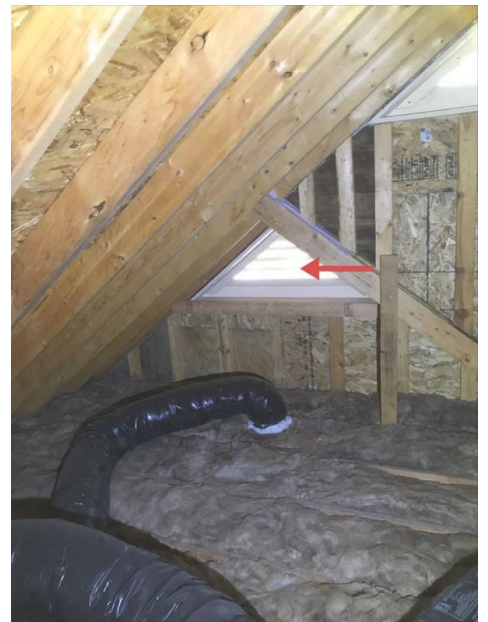
MISSING VENTILATION

I was not able to observe all ventilation systems at the time of this inspection. It is a possibility that the soffit vents were covered by insulation. Recommend evaluate further. Also observed no screen on the attic vent. Recommend screen to prevent vermin from entering residence.

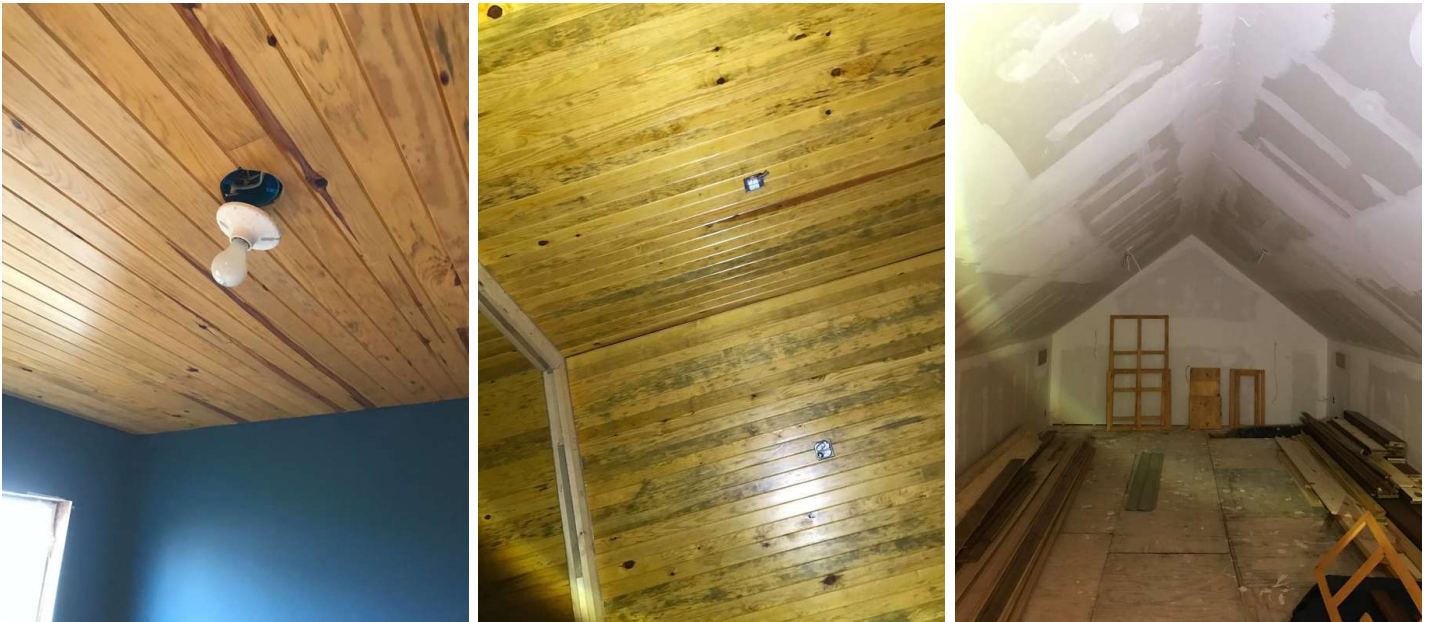
UNFINISHED

Due to ongoing construction, ceilings were unfinished in some areas

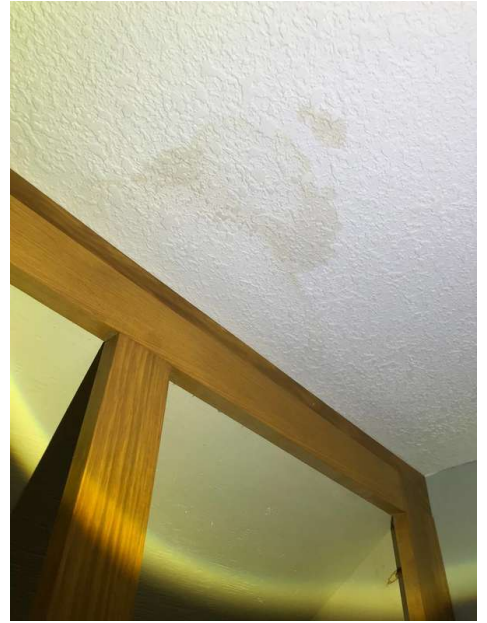
10.5.1 Ceilings

STAIN(S) ON CEILING

There is a stain on ceiling/wall that requires repair and paint. Source of staining should be determined.

Contact a qualified professional.

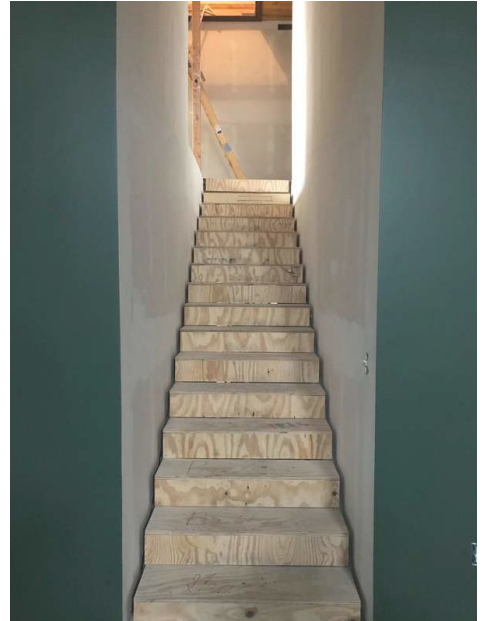
10.6.1 Steps, Stairways & Railings

NO HANDRAIL

Staircase had no handrails. This is a safety hazard. Recommend a qualified handyman install a handrail.

Contact a qualified handyman.

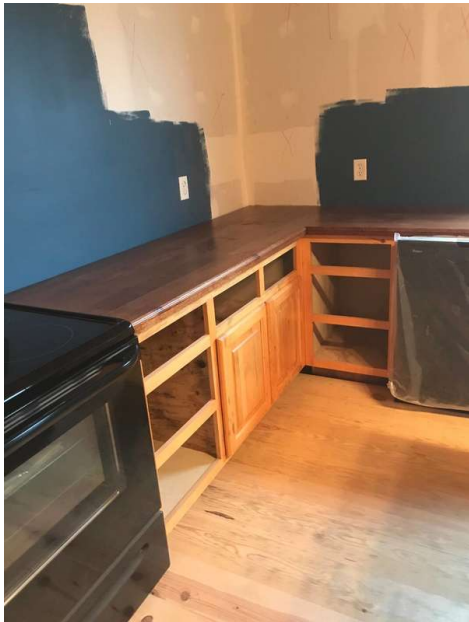
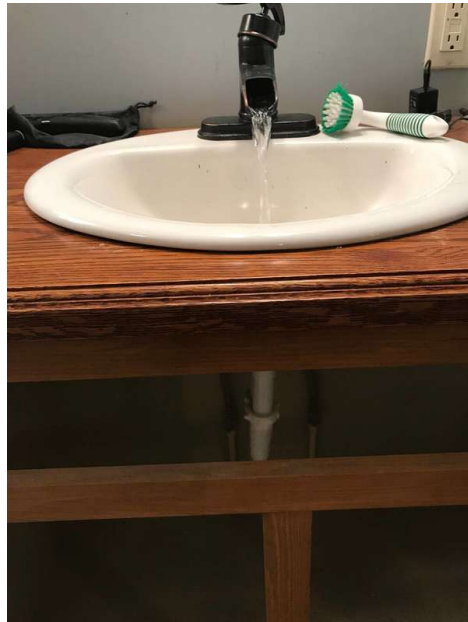
10.7.1 Countertops & Cabinets

CABINET DOOR MISSING

One or more cabinet doors were missing.

Contact a qualified cabinet contractor.
