ROOM-BY-ROOM RESIDENTIAL

1234 Main St.
Ewa Beach Hawaii 96706

02/01/2019 9:00AM

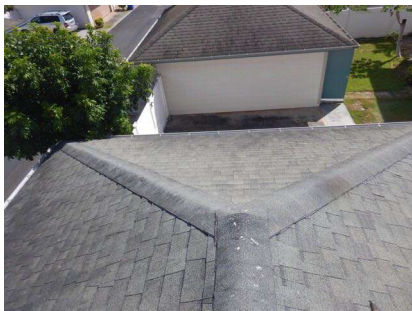
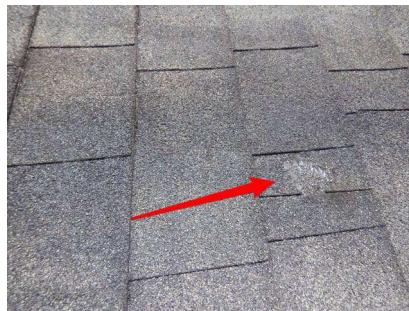
2.1.1 Coverings

DAMAGED (GENERAL)

GARAGE ROOF

Roof coverings showed moderate damage.

Recommend a qualified roofing professional evaluate and repair.

Recommendation
Contact a qualified roofing professional.

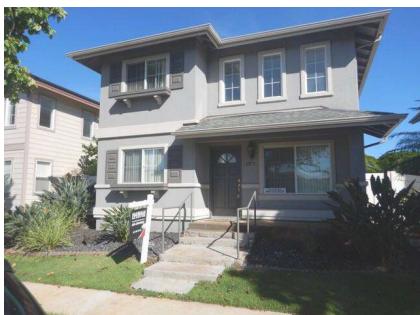
2.3.1 Flashings

LOOSE/SEPARATED

Flashings observed to be loose or separated, which can lead to water intrusion and/or mold. Recommend a qualified roofing contractor repair.

Flashing is loose. Needs nailed down and caulked. Recommend further evaluation from a licensed Roofer.

Recommendation

Contact a qualified roofing professional.

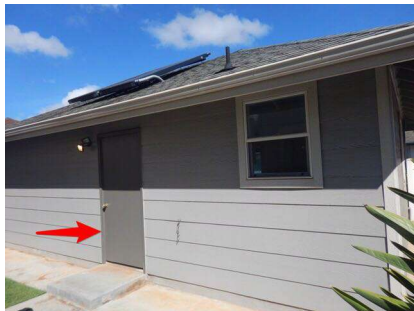
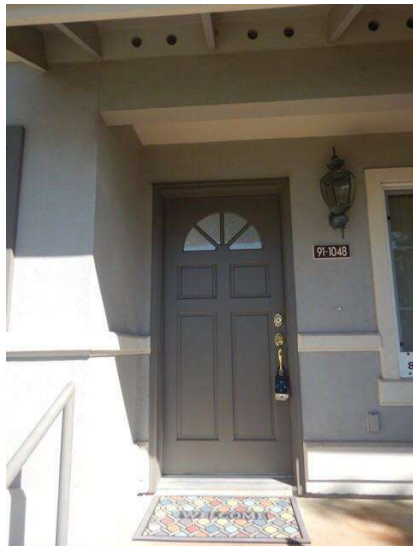
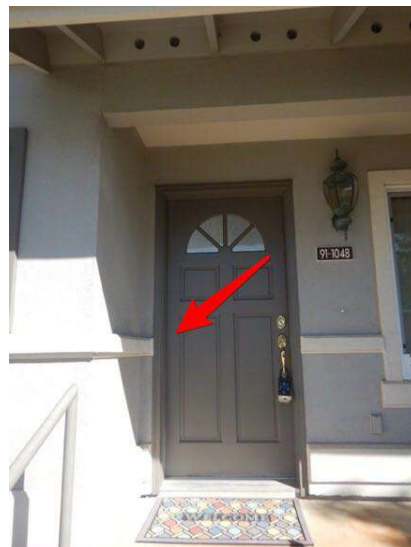
3.1.1 Exterior Doors

PAINT/REFINISH NEEDED

FRONT DOOR AND GARAGE DOOR

1. Door finish is worn. Recommend refinish and/or paint to maximize service life.

Front Door and Garage Door entry ways need repainted

Recommendation
Contact a qualified painter.

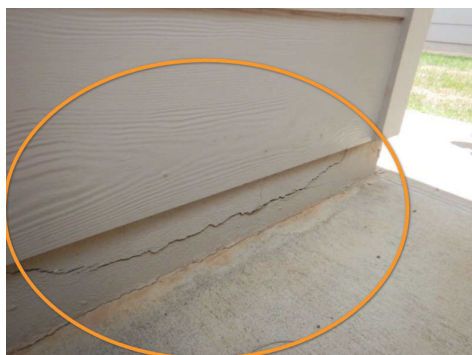
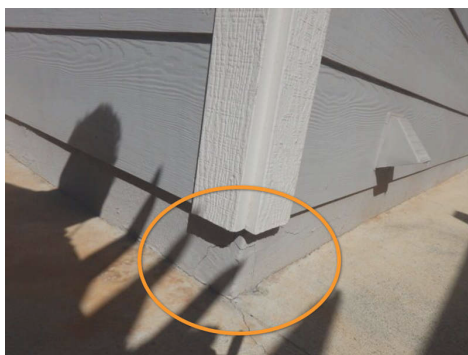
3.2.1 Foundation

FOUNDATION CRACKS - MINOR

GARAGE FOUNDATION

Minor cracking was noted at the foundation. This is common as concrete ages and shrinkage surface cracks are normal. Recommend monitoring for more serious shifting/displacement.

Recommendation
Contact a qualified concrete contractor.

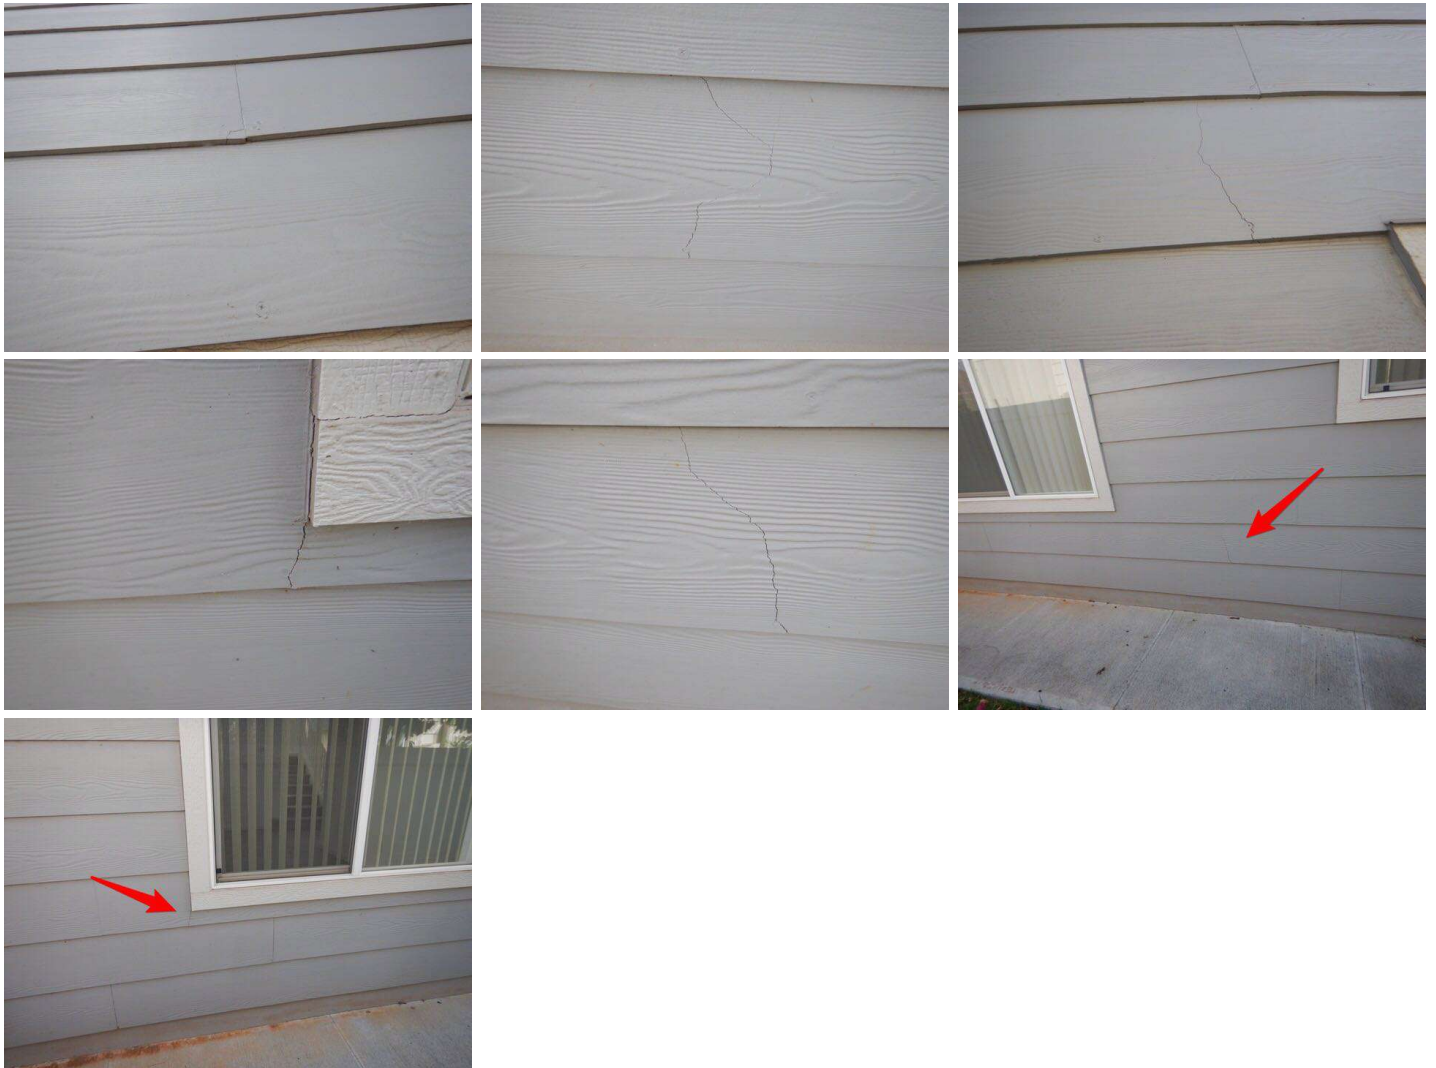
3.3.1 Siding, Flashing & Trim

CRACKING - MINOR

Siding showed cracking in one or more places. This is a result of temperature changes, and typical as homes with stucco age. Recommend monitoring.

Recommendation
Contact a qualified siding specialist.

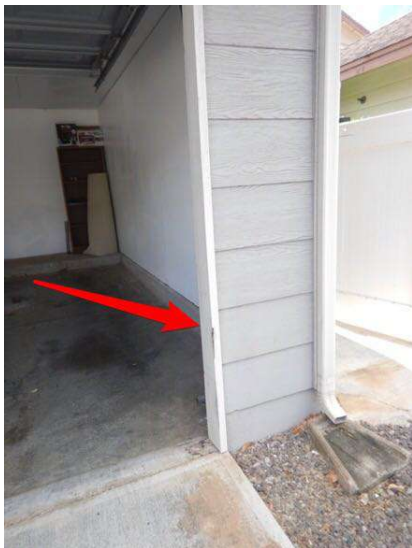
3.3.2 Siding, Flashing & Trim

GARAGE DOOD TRIM

Trim around overhead Garage Door, seems to have been damaged. Recommend repair by a carpenter.

Recommendation
Contact a qualified carpenter.

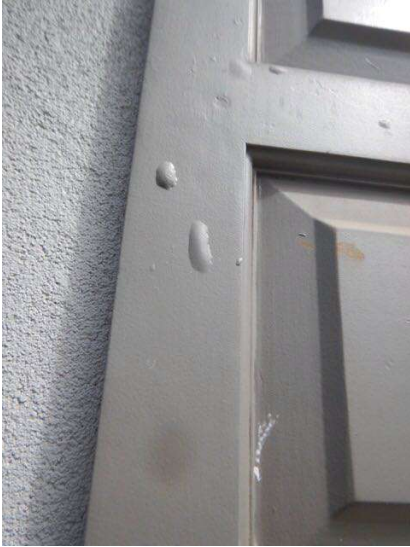
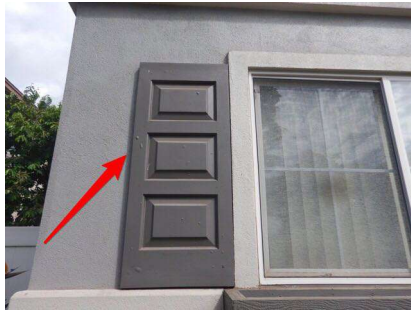
3.3.3 Siding, Flashing & Trim

WINDOW PANELS

Window Panels on front of the house have bubbled paint. Needs repainted and surveyed by a qualified painter.

Recommendation
Contact a qualified painter.

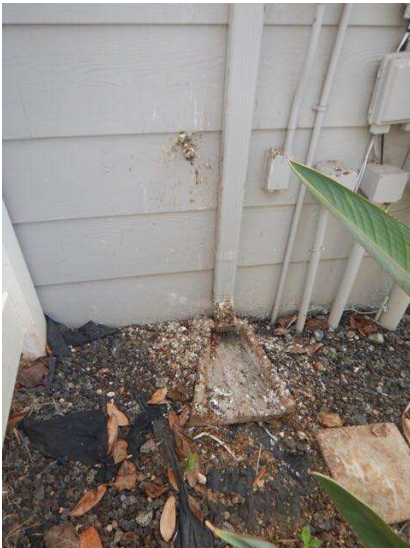
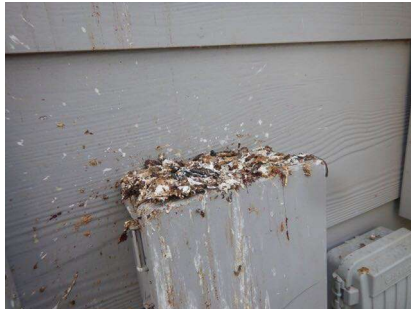
3.3.4 Siding, Flashing & Trim

EXCESSIVE BIRD DROPPINGS ON SIDE OF THE HOUSE

Recommend having a handyman power washing bird droppings and debris.

Recommendation
Contact a qualified professional.

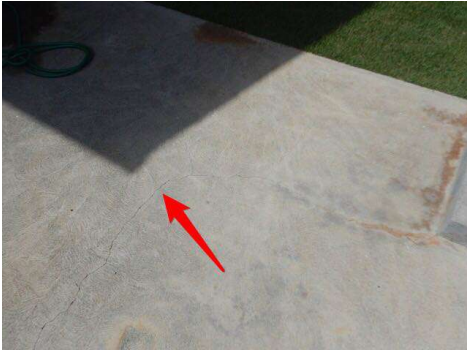
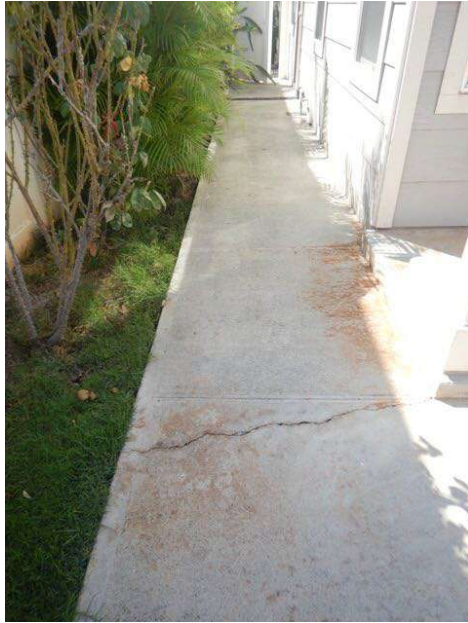
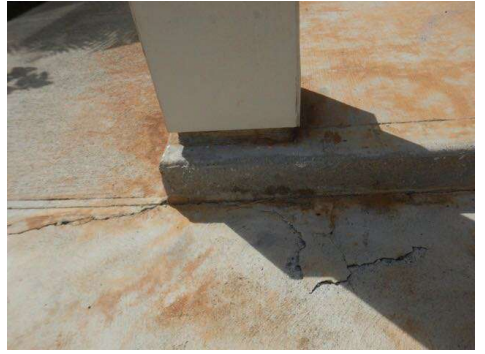
3.4.1 Walkways, Patios & Driveways

PATIO CRACKING - MINOR

Normal settling & cracking observed. Recommend monitor and/or patch/seal.

Contact a qualified concrete contractor.

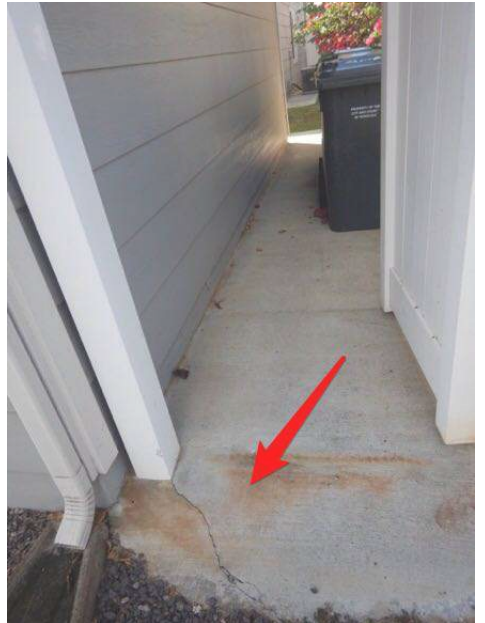
3.4.2 Walkways, Patios & Driveways

WALKWAY CRACKING - MINOR

Minor cosmetic cracks observed. Recommend monitor and/or patch/seal.

Contact a qualified concrete contractor.

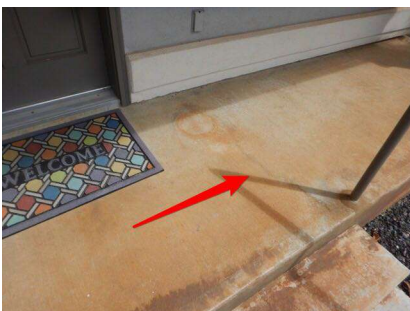
3.5.1 Decks, Balconies, Porches & Steps

FRONT PORCH AND STAIRS

FRONT PORCH

Minor Cracks on front porch and stairs.

Contact a qualified concrete contractor.

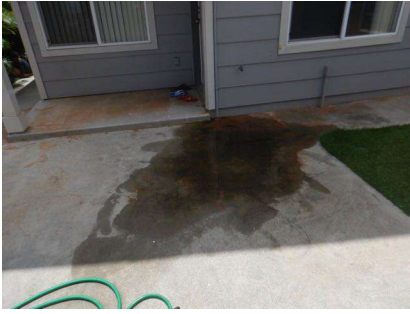
3.7.1 Vegetation, Grading, Drainage & Retaining Walls

STANDING WATER

BACK PATIO

Standing water observed, which could indicate poor drainage and/or grading. Recommend monitor and have looked at by a concrete specialist.

Contact a qualified concrete contractor.

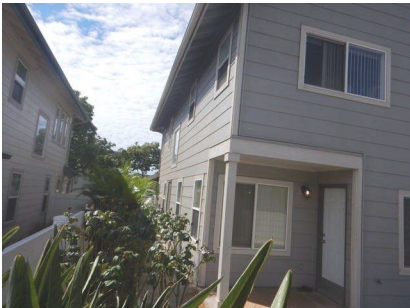
3.7.3 Vegetation, Grading, Drainage & Retaining Walls

VEGETATION ENCROACHING/GROWING CLOSE TO SIDE OF HOUSE.

Recommend to trim vegetation even with walkway. Vegetation can bring moisture and mold onto siding, creating further problems down the road. Recommend further evaluation by a qualified landscaper.

Contact a qualified professional.

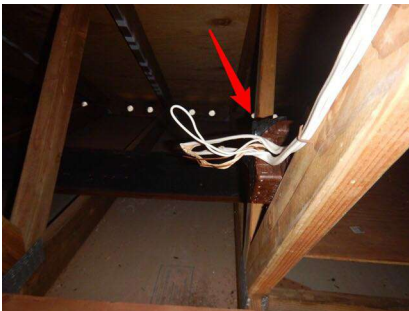
4.3.1 Branch Wiring Circuits, Breakers & Fuses

IMPROPER WIRING

GARAGE

The electrical wires for the garage attic ceiling light switch are showing a sub standard installation. Excessive wires exist which are not sealed properly at the switch box. Repair is needed.

Contact a qualified electrical contractor.

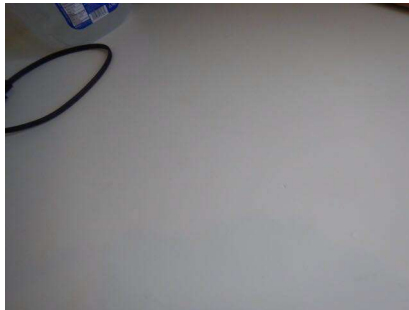
The solid surface countertop has a small chipped area on it.

Contact a qualified countertop contractor.

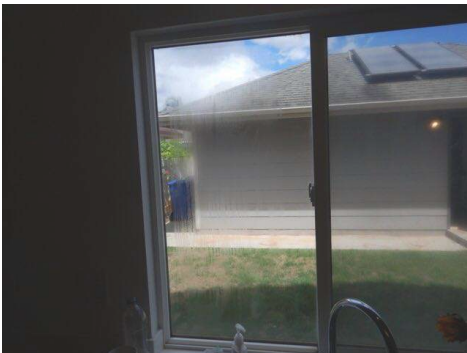
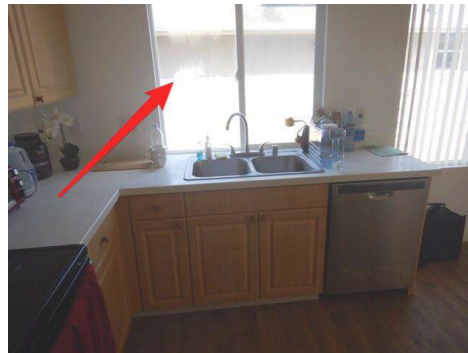
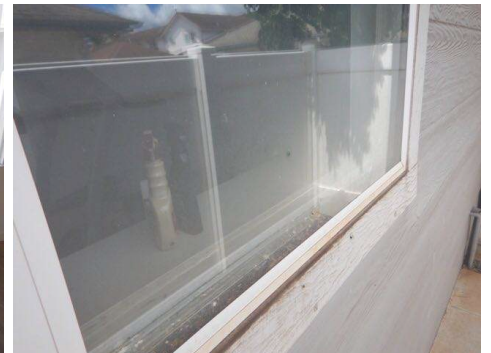
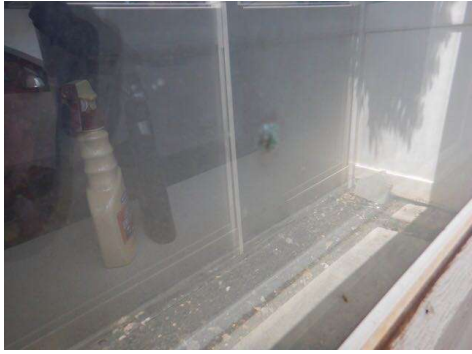
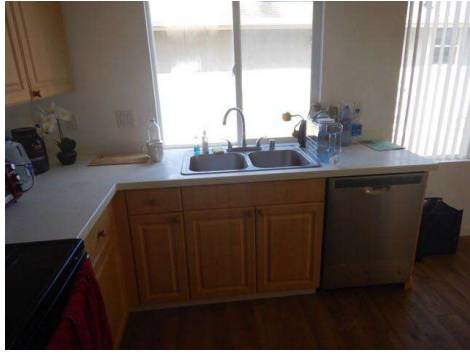
There is condensation between the panes of glass of one double pane window. This indicates a failed seal. We recommend the lens assembly be replaced, which is the only method for correcting this deficiency.

Contact a qualified window repair/installation contractor.

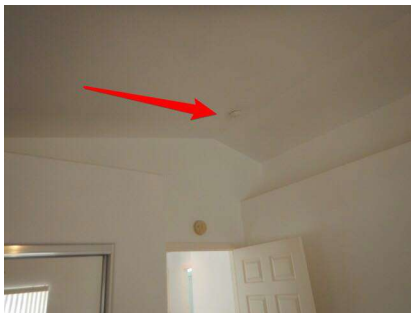
DEFECTIVE

MASTER BEDROOM

Smoke detector is connected, but not functioning properly. Recommend replacement.

Recommendation
Recommended DIY Project

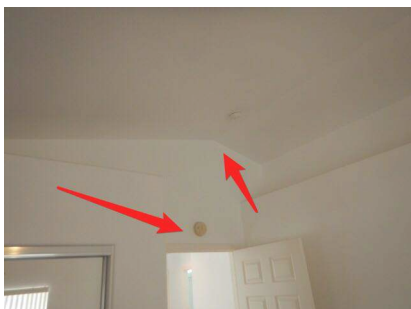
9.3.2 Smoke Detectors

INAPPROPRIATE LOCATION

Smoke detector effectiveness may be compromised due to location. Recommend relocating according to manufacturers instructions.

Recommendation
Recommended DIY Project

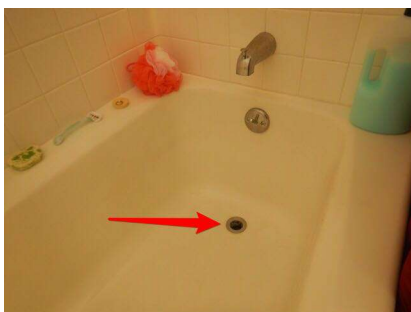
10.1.1 Shower/Bathtub

BATHTUB

The tub's drain stop is missing. We recommend it be replaced.

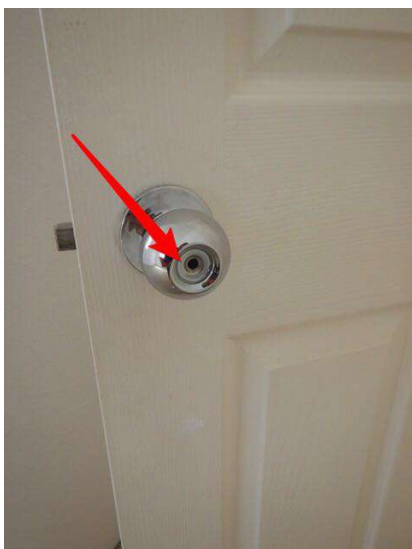
The bedroom door knob lock is missing.

Replacement is needed.

Contact a qualified professional.

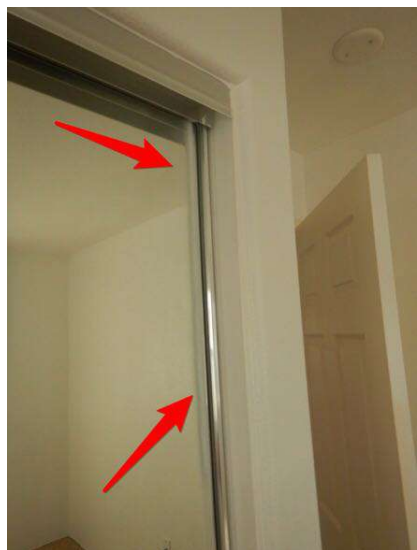
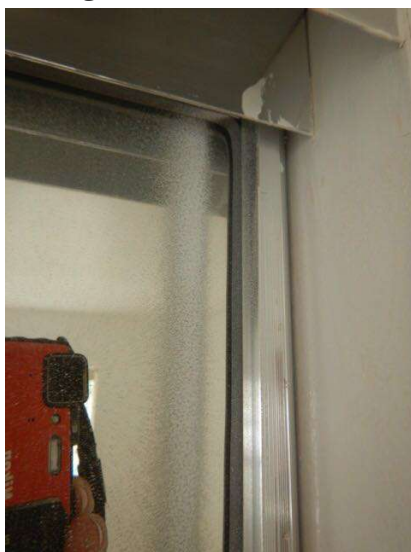
12.2.2 Door

CLOSET DOORS

The right side mirror closet door has paint over-spray at one side. Repair is needed.

Contact a qualified professional.

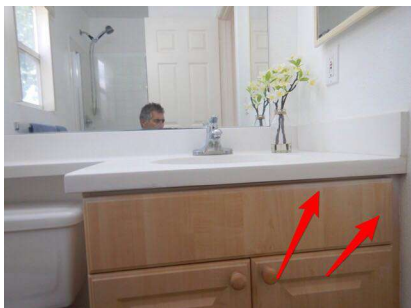
PAINT OVERSPRAY

GROUND FLOOR BATHROOM

Some paint over-spray exist on the front right side of the sink cabinet.

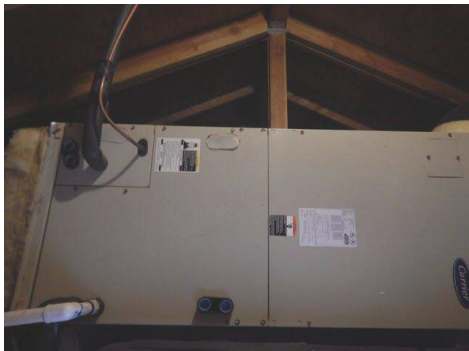
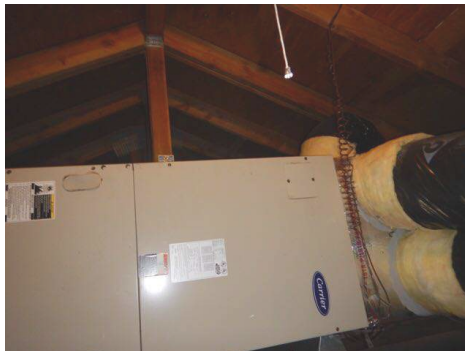
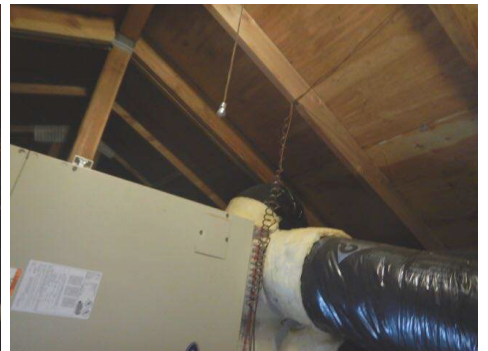
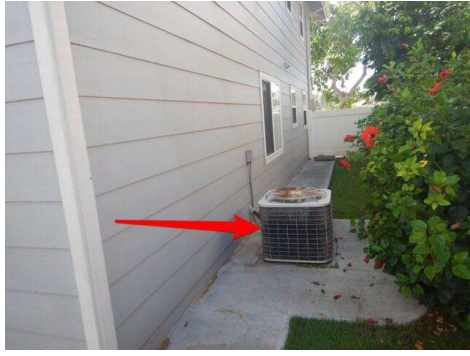
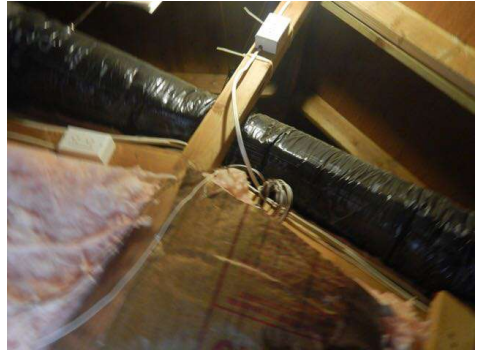
AC HAS SIGNS OF WEAR

HVAC system is moderately worn

Contact a qualified HVAC professional.

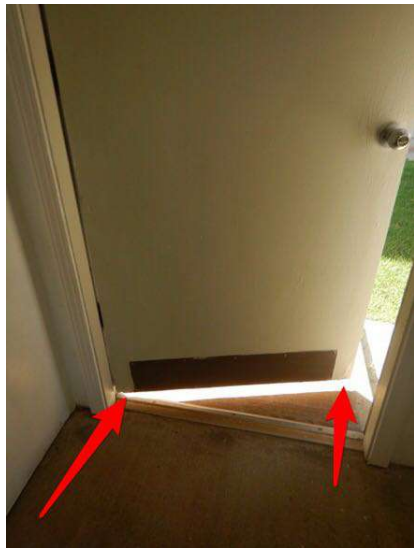
18.3.1 Walls & Firewalls

DOOR HAS WEAR

Recommendation
Contact a qualified professional.

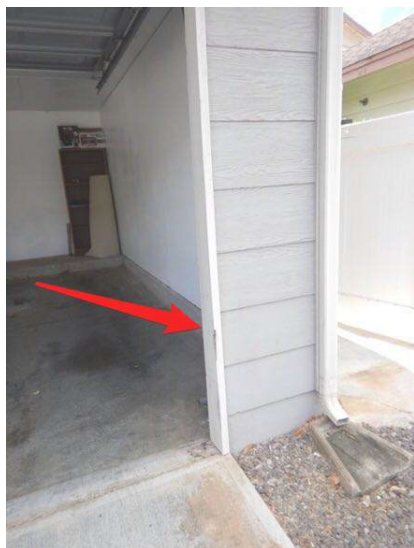
18.3.2 Walls & Firewalls

OUTSIDE TRIM DAMAGED

Recommendation
Contact a qualified professional.
