L&L Home Inspections, LLC

HOME INSPECTION REPORT

1234 Main St.
Lansdale Pennsylvania 19446

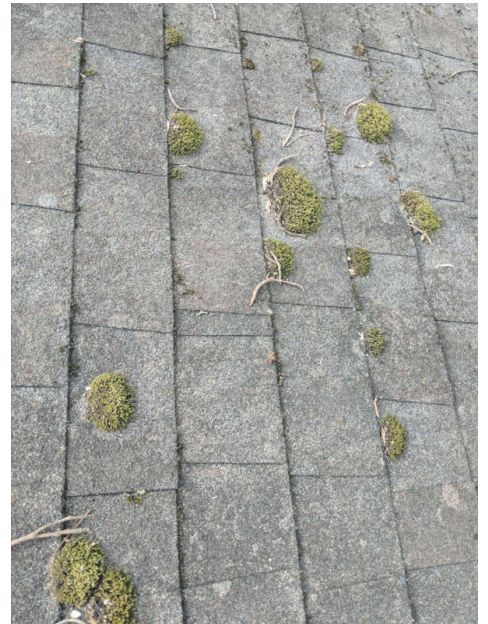
Moss was growing on the roof. As a result, shingles can lift or be damaged. Leaks can result and/or the roof surface can fail prematurely. Efforts should be made to kill the moss during its growing season (wet months). Typically, zinc or phosphate-based chemicals are used for this and must be applied periodically.

Contact a qualified professional.

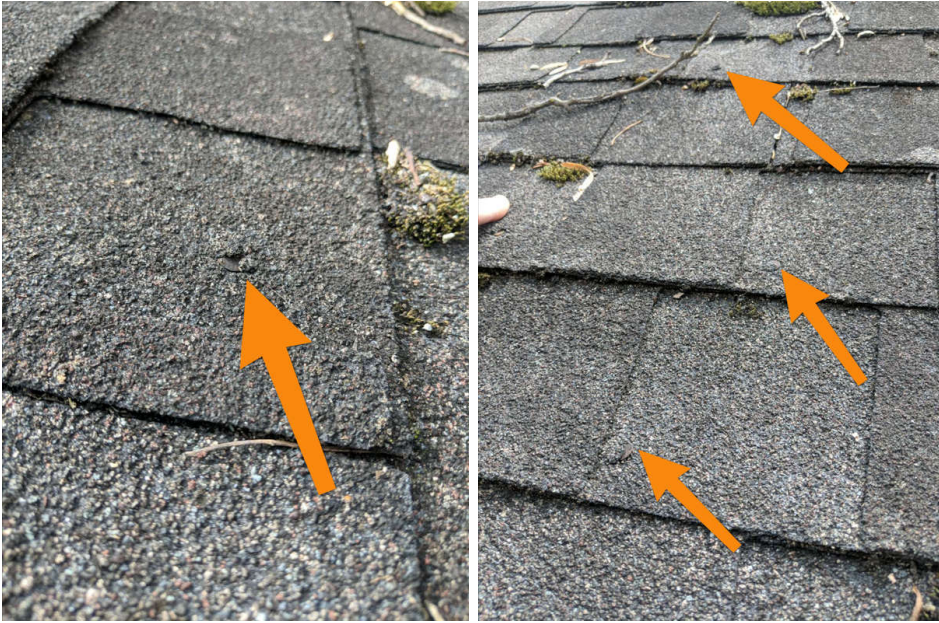
2.3.2 Shingles

**Deficiencies****NAIL POPS**

One or more roofing nails weren't fully seated and shingles were lifting or nail heads were protruding through shingle surfaces. The nails may have loosened, or were not pounded in fully when installed. Shingles are likely to be wind damaged, and leaks can occur as a result. Recommend that a qualified contractor repair as necessary. For example, by replacing shingles.

Contact a qualified roofing professional.

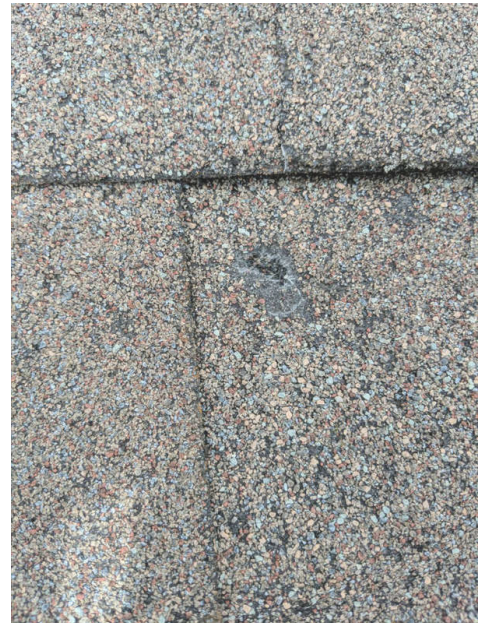
2.3.3 Shingles

SHINGLE CRACKING

Several shingles are cracking. Cracking can occur from shingle age and/or ventilation issues. Roof leaks may occur. A certified roofing contractor should evaluate as the shingles may be at the end of life expectancy.

Contact a qualified roofing professional.

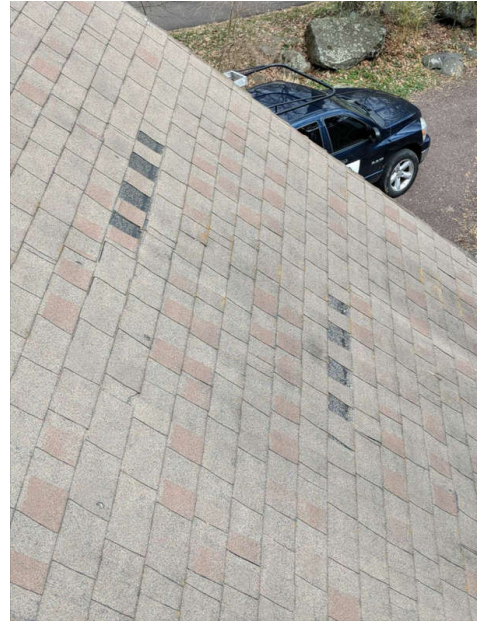
2.3.4 Shingles

SHINGLES MISSING

Roofing shingles were missing. This can cause deterioration and moisture intrusion. Leaks can occur as a result. This is a conducive condition for wood-destroying organisms, e.g. wood fungi. Recommend that a qualified contractor repair as necessary. For example, by replacing shingles.

Contact a qualified roofing professional.

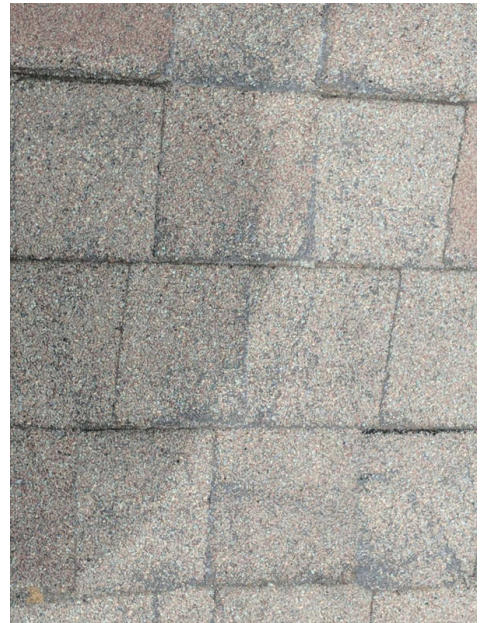
2.3.5 Shingles

GRANULE LOSS

There is granule loss on the shingles. Based on the age of this roof the granule loss is considered normal. It is recommended to have the roof evaluated by a certified roofing contractor.

Contact a qualified roofing professional.

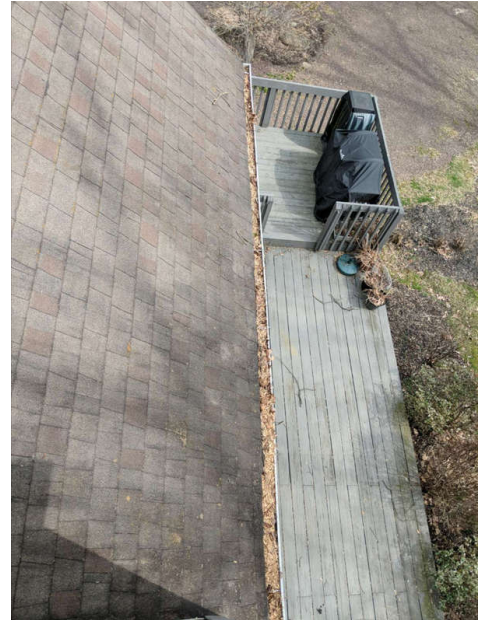
2.5.1 Gutters/drains

CLOGGED GUTTERS/DOWNSPOUTS

Significant amounts of debris have accumulated in one or more gutters or downspouts. Gutters can overflow and cause water to come in contact with the building exterior, or water can accumulate around the foundation. This is a conducive condition for wood-destroying organisms. Recommend cleaning gutters and downspouts now and as necessary in the future.

Recommended DIY Project

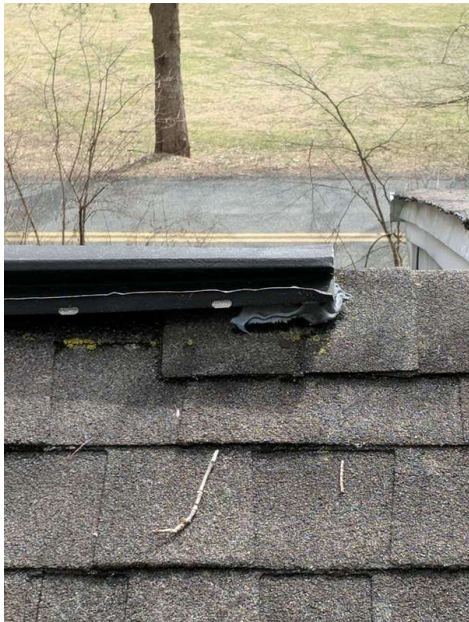
The ridge vents we're lifted or loose. A licensed roofer should repair the ridge vents

Contact a qualified roofing professional.

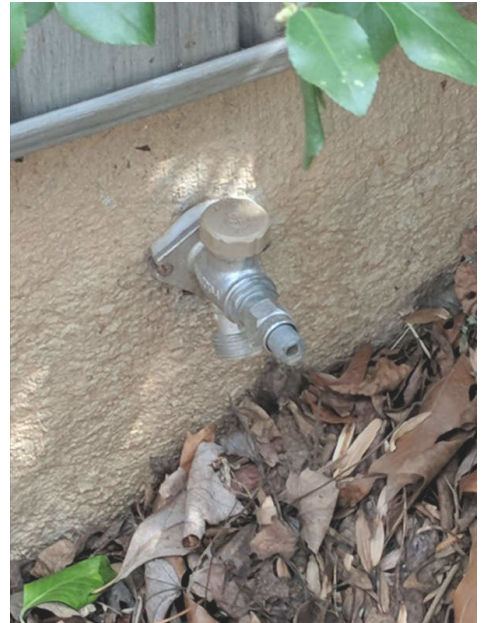
One or more hose faucet handles were *missing / loose / broken*. Recommend that a qualified person replace handles or make repairs as necessary.

Contact a qualified professional.

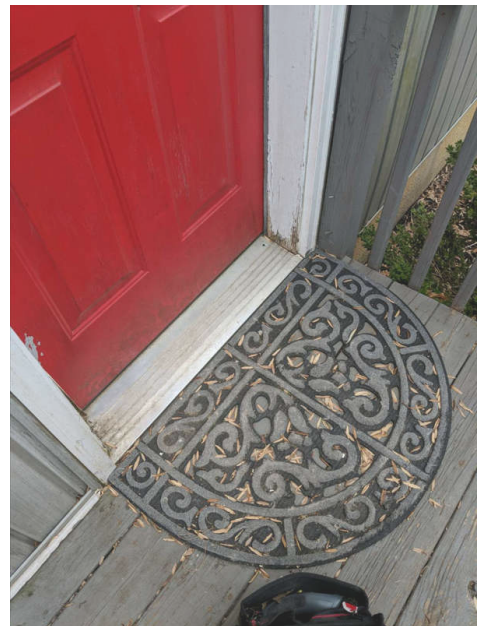
3.3.2 Exterior issues

PAINT FAILING

The paint or stain finish in some areas was failing (e.g. peeling, faded, worn, thinning). Siding and trim with a failing finish can be damaged by moisture. Recommend that a qualified contractor prep (e.g. clean, scrape, sand, prime, caulk) and repaint or restain the building exterior where necessary and per standard building practices.

Contact a qualified painting contractor.

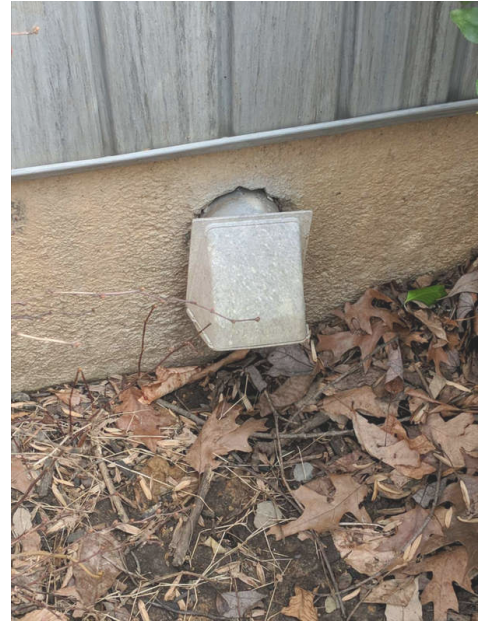
3.3.3 Exterior issues

SEALANT DETERIORATED AROUND EXTERIOR FIXTURES

Sealant is deteriorated around exterior fixtures where they exit the wall (I.e. Hose faucets, conduit, lights, wires). These areas should be properly sealed to help prevent moisture intrusion.

Contact a handyman or DIY project

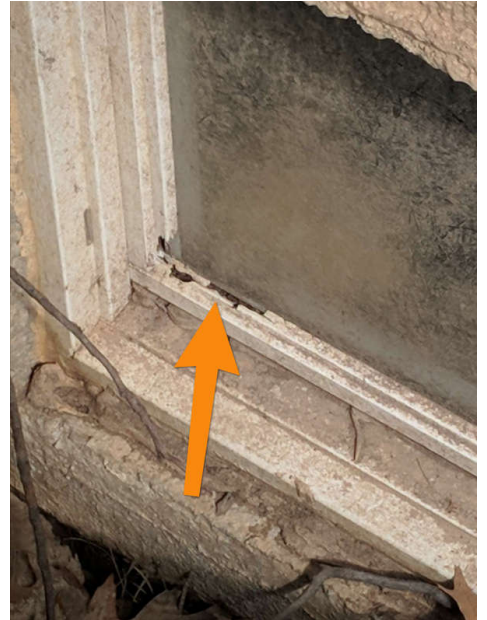
3.5.2 Windows and Door

WINDOW TRIM DAMAGED

The window trim is damaged. We recommend it be repaired or replaced

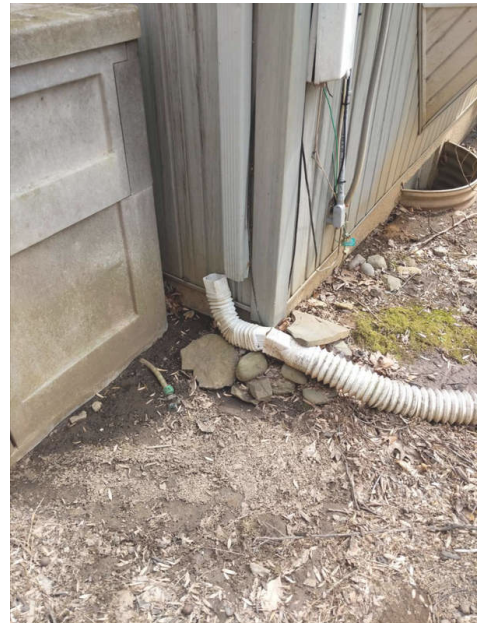
3.7.1 Gutters and Flashing

One or more of the downspouts terminate next to the house. We recommend extending the downspout discharge away from the home to prevent water pooling at the foundation.

Contact a qualified professional.

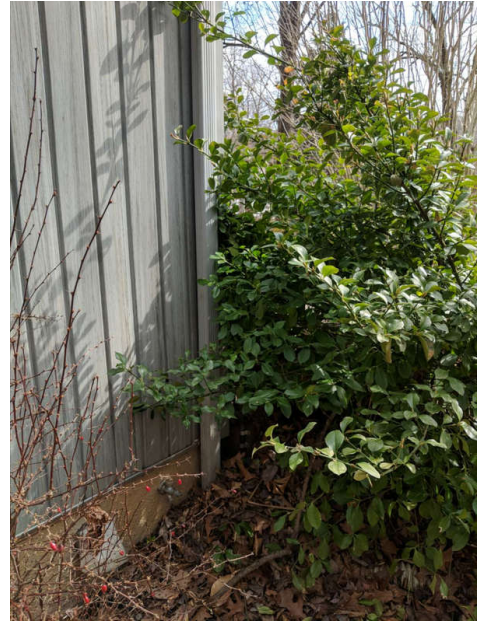
3.8.1 Vegetation and Grading

Vegetation such as trees, shrubs and/or vines was in contact with or close to the building exterior. Vegetation can serve as a pathway for wood-destroying insects and can retain moisture against the exterior after it rains. This is a conducive condition for wood-destroying organisms. Recommend pruning, moving or removing vegetation as necessary to maintain at least 6 inches of space between it and the building exterior. A 1-foot clearance is better.

Contact a qualified landscaping contractor

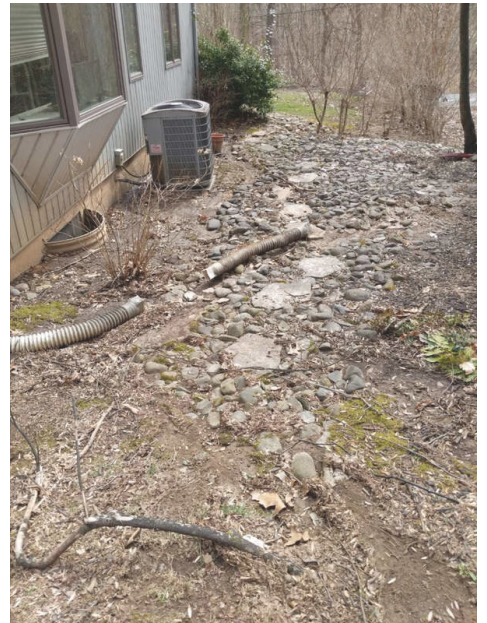
3.8.2 Vegetation and Grading

Significant erosion was found in one or more areas. Recommend having a qualified person evaluate and make repairs as necessary to repair erosion, and to prevent erosion in the future.

Contact a qualified landscaping contractor

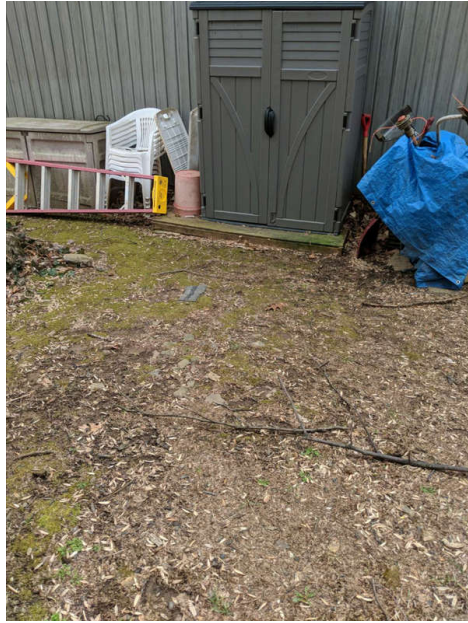
3.8.3 Vegetation and Grading

Surfaces sloped down towards building perimeters in one or more areas. This may result in water accumulating around building foundations or underneath buildings. Monitor these areas in the future, especially during and after periods of rain. If significant amounts of water are found to accumulate, then recommend that a qualified contractor evaluate and repair as necessary. For example, by installing drain(s) or removing old pavement and installing new.

Contact a qualified professional.

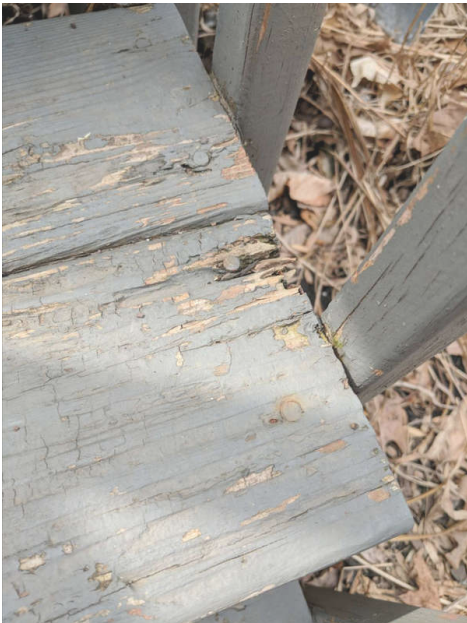
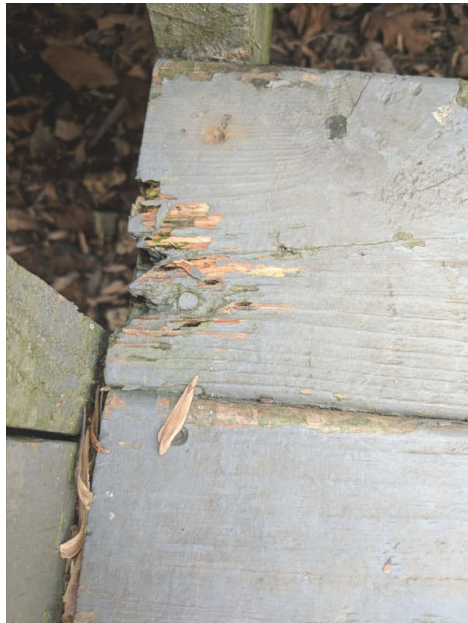
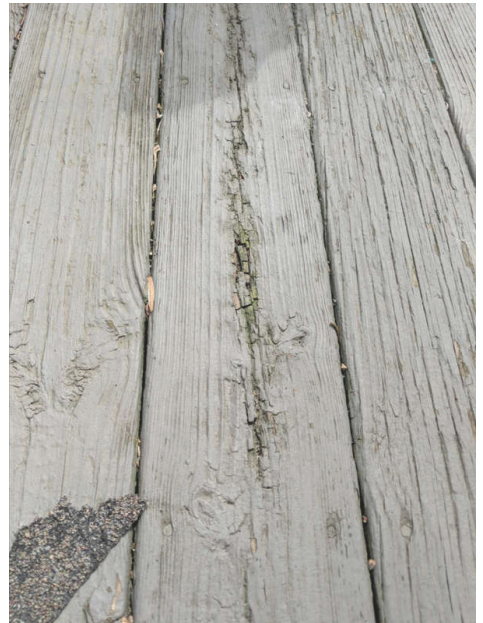
3.10.1 Deck

DECK BOARD ROT

Fungal rot was found in decking boards at one or more decks or porches. The boards were generally in serviceable condition during the inspection, but it's likely that the fungal rot will spread and require all boards to be replaced. Boards with significant rot should be replaced now and in the future until the deck or porch is rebuilt. Recommend budgeting for replacement decking in the near future. Note that when decking boards are replaced, other structural repairs may be needed.

Contact a qualified professional.

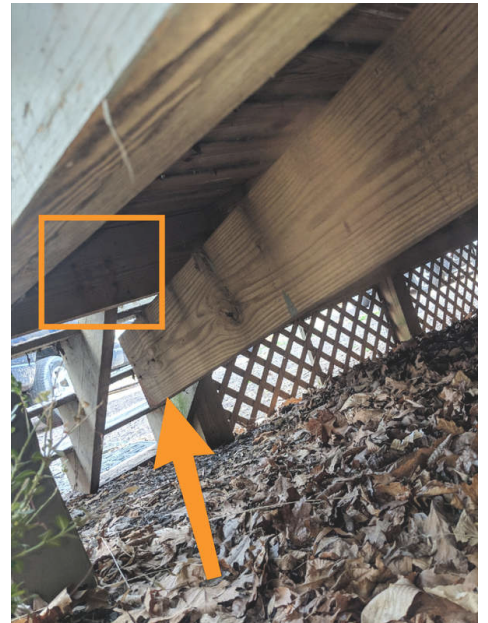
3.10.2 Deck

Fasteners for the deck, porch or balcony *joist hangers / support post brackets / tie plates* were *missing / substandard*. Approved fasteners such as Teco nails should be installed in every nail hole in such hardware. Recommend that a qualified person install approved fasteners where necessary.

Contact a qualified professional.

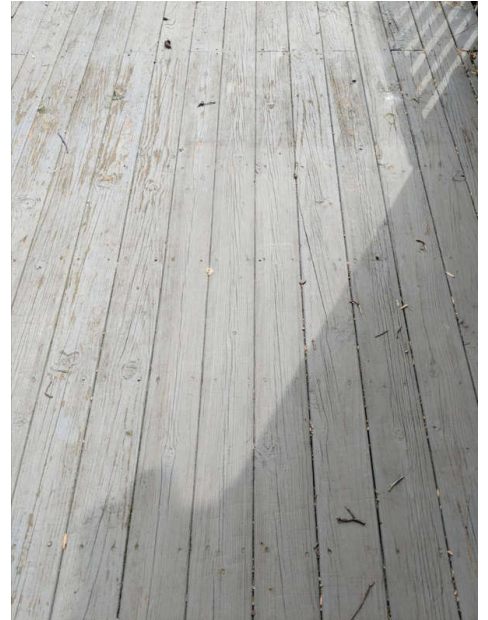
3.10.3 Deck

Decking boards were installed with little or no gap between them. Organic debris such as leaves or evergreen needles may accumulate in between the boards will likely cause rot or deterioration. This is a conducive condition for wood-destroying organisms. At a minimum, keep decking boards clean in the future. Ideally boards should be reinstalled with a 3/8 inch gap between them.

Contact a qualified professional.

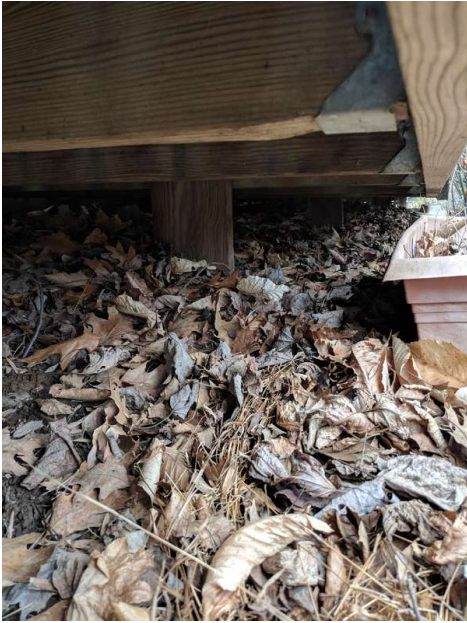
SUPPORTS INADEQUATE

The deck supports are not standard. There is a slight bow in the deck due to over spanning of the joist and inadequate supports. We recommend additional supports be installed

Contact a qualified deck contractor.

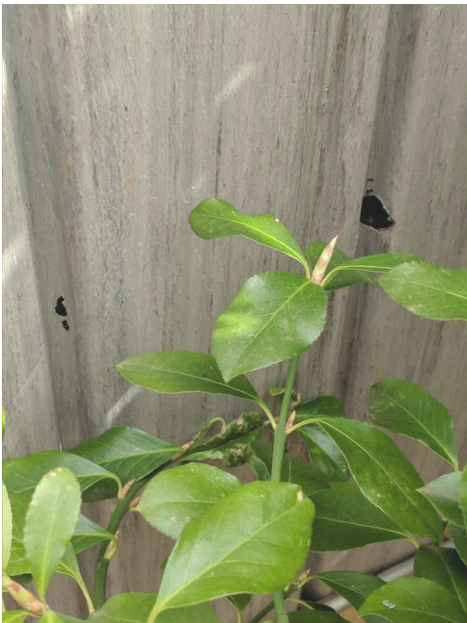
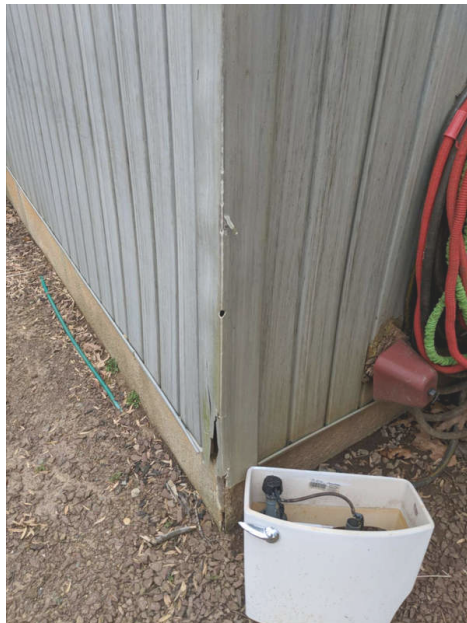
3.12.1 Siding

PUNCTURES

There were several puncture marks in the exterior siding. Repair is recommended

Contact a qualified professional.

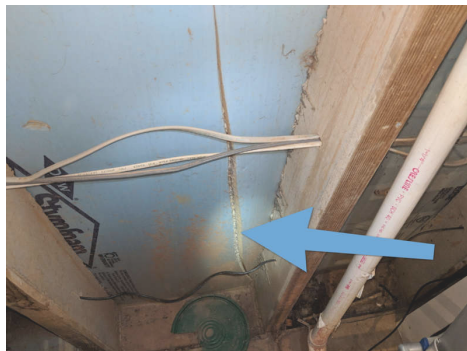
4.2.1 Foundation

Recommendation

Recommend monitoring.

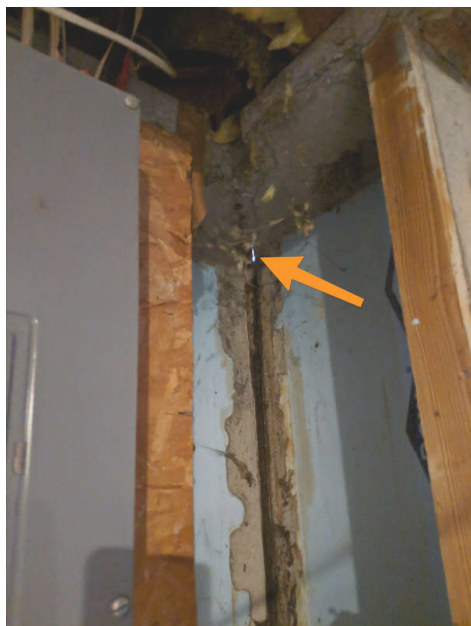
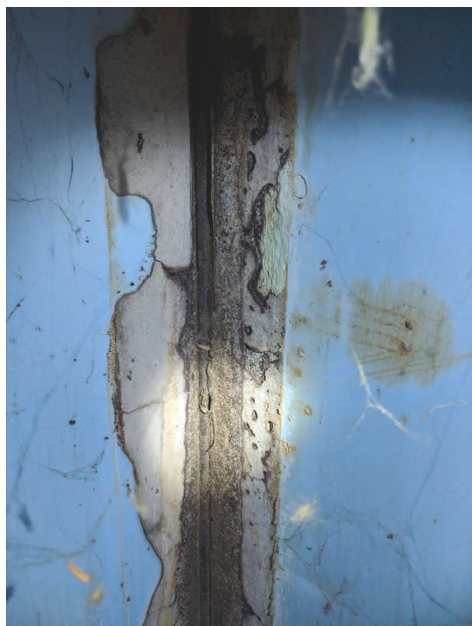
4.2.2 Foundation

Daylight was seen at the sill. Water stains and organic growth were seen at the corner by the electrical panel. This area should be sealed up from the exterior to prevent water entry. Organic growth should be treated and or removed

Contact a qualified professional.

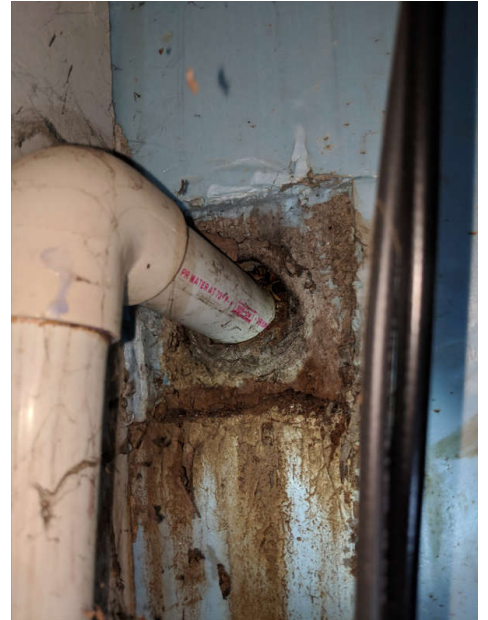
4.2.3 Foundation

Water stains seen at foundation wall penetrations. We recommend sealing wall penetrations to prevent water entry

Contact a qualified professional.

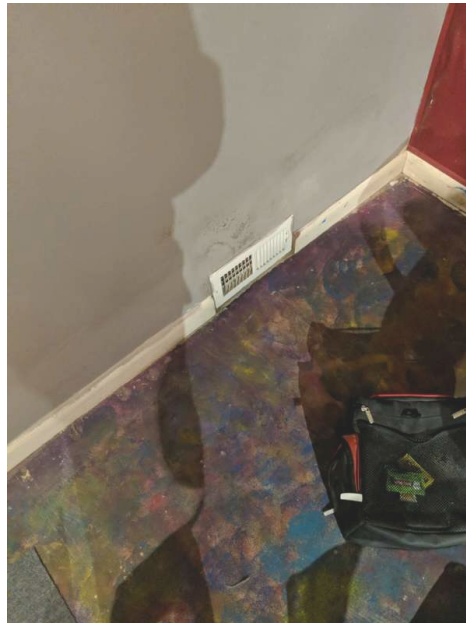
4.7.1 Basement

MOLD/MILDEW

Mold or mildew was noted in the basement. Mold testing is not part of a home inspection. Samples would need to be collected and sent to the lab for testing.

Contact a qualified mold inspection professional.

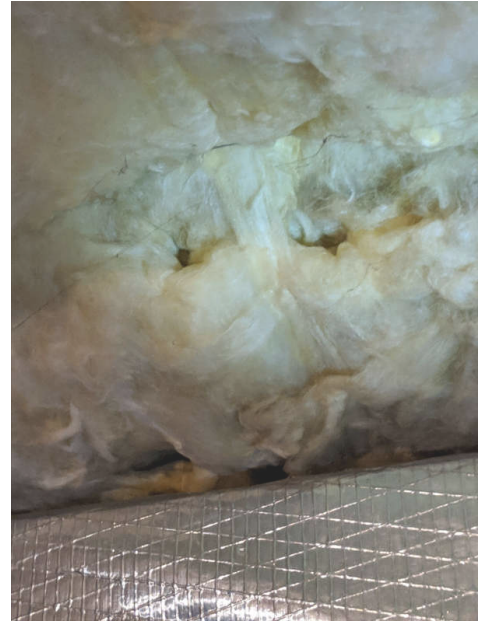
4.7.2 Basement

PEST EVIDENCE

Pest evidence such as burrows were observed in the insulation in the basement. Rodents have been active in the past and can possibly still be present. We recommend traps be set

Contact a qualified professional.

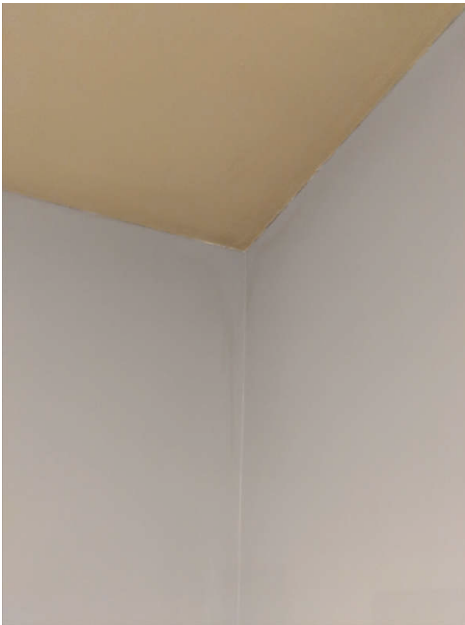
4.7.3 Basement

DRY STAINS

Stains were found in one or more ceiling areas. However, no elevated levels of moisture were found. If elevated moisture is found in the future, a qualified contractor should evaluate and repair as necessary.

Recommend monitoring.

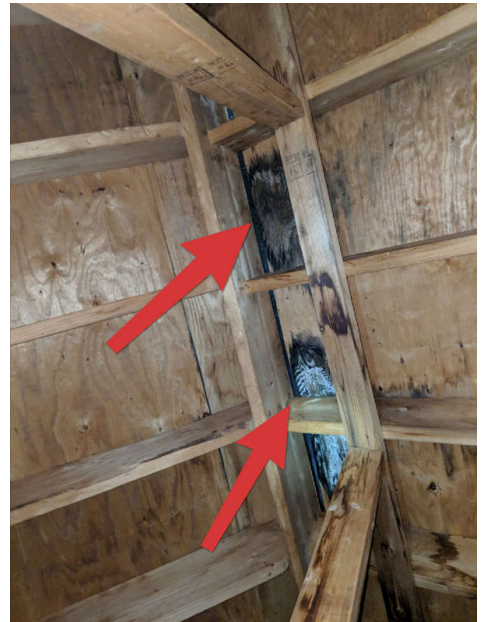
ACTIVE LEAK

One or more active roof leaks were found. Recommend further evaluate and repair any roof leaks. Recommend obtaining estimate(s) prior to closing.

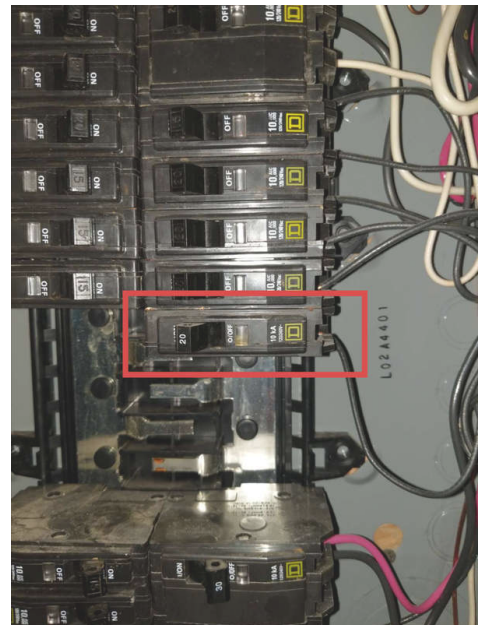
We found over-fusing in the main service panel, meaning the fuse or breaker is not rated for the connected wire. This is a potential fire hazard. We recommend the circuit be equipped with a properly rated overcurrent protection device.

Contact a qualified electrical contractor.

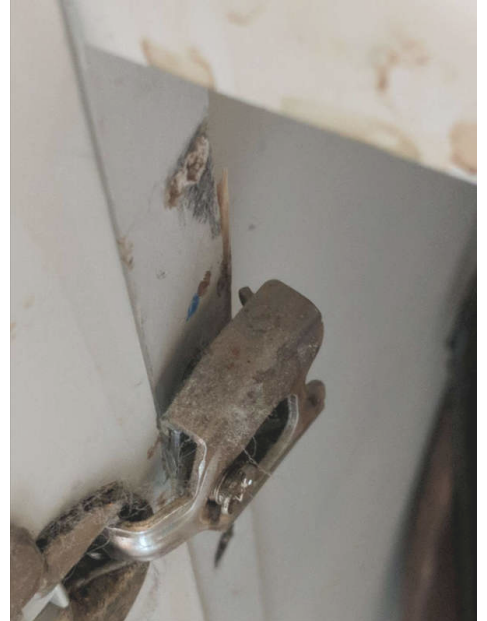
LOOSE HARDWARE

Hardware such as hinges, latches or pulls are loose and/or missing on one or more cabinets. Repairs should be made and/or hardware should be replaced as necessary, and by a qualified contractor if necessary.

Contact a qualified cabinet contractor.

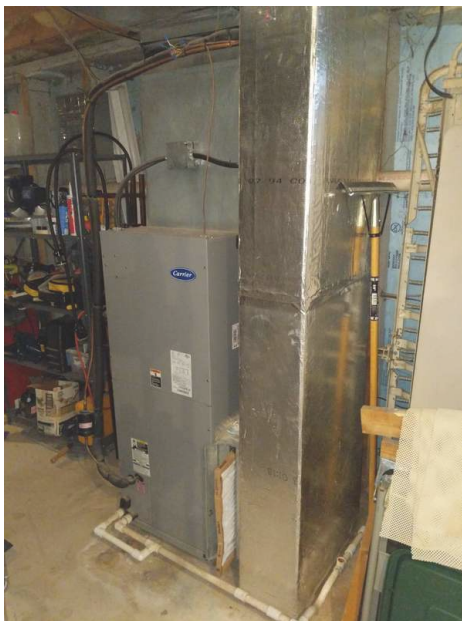
Heating / Forced Air: Equipment Photos

Heating / Forced Air: Appears Functional

Heat system appears to be in working order. A forced air heating system has a typical lifespan of 15-20 years.

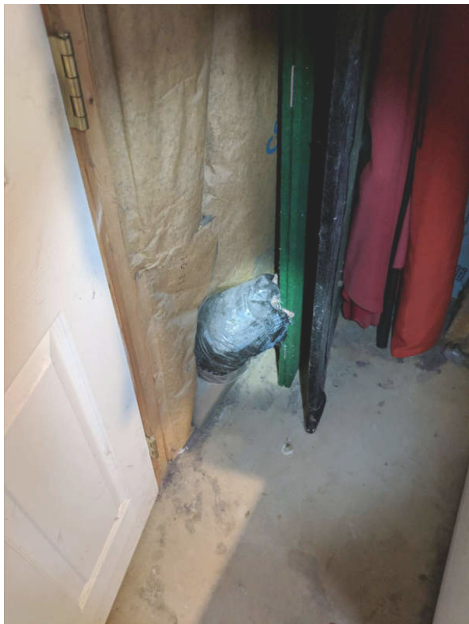
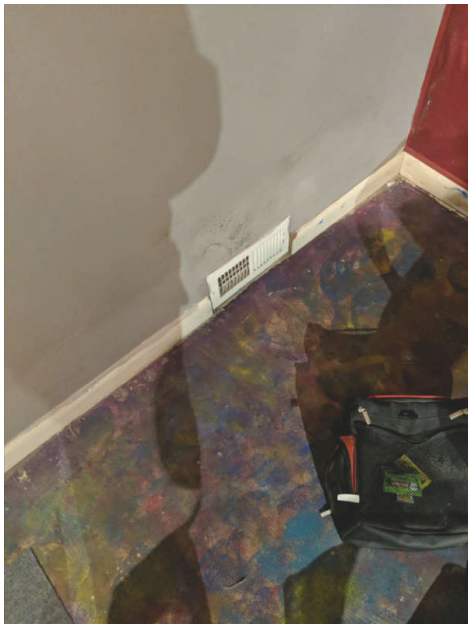
The ducting to the registers has been removed. We recommend following up with the home owner as to why it was removed and installing new duct work as needed

Recommendation
Contact a qualified HVAC professional.

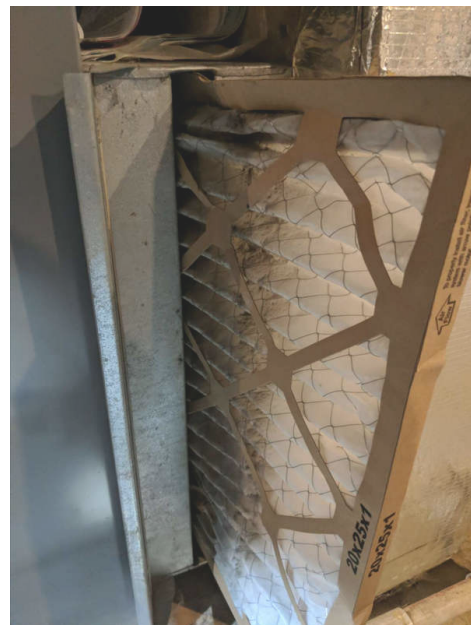
8.6.1 Filter & Thermostat

Air filters for the heating and/or cooling system were dirty at one or more locations. Indoor air quality will be reduced as a result. Recommend installing good quality filters at intended locations (e.g. in or at the air handler, behind return air grills). Filters should be sized correctly to minimize air gaps. Many types of filters are available. Recommend installing pleated filters or better rather than the cheapest disposable kind.

Recommendation
Recommended DIY Project

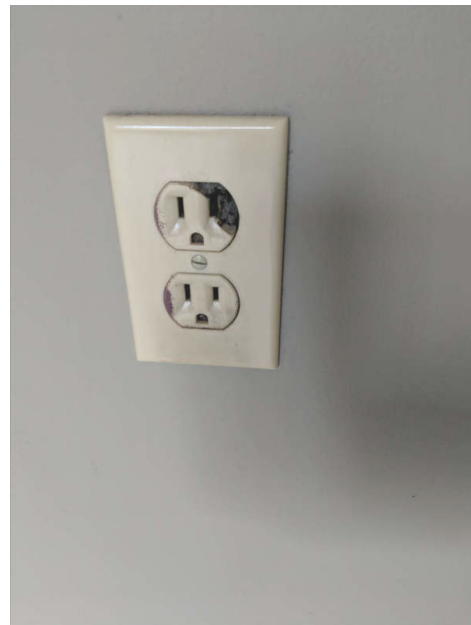
2nd Floor Bedroom

10.1.4 Electrical

Deficiencies

Recommendation

Contact a qualified electrical contractor.

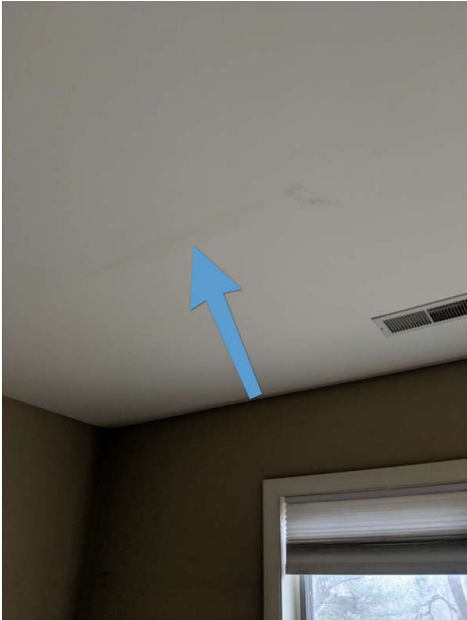
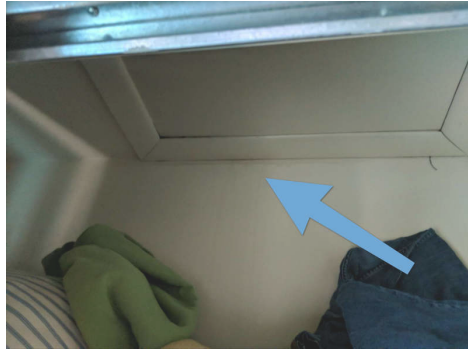
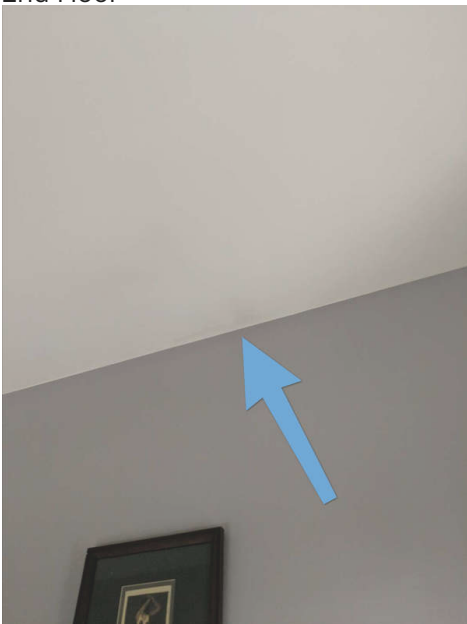
2nd Floor

10.2.1 Floors, Walls, Ceilings

Recommendation

Recommend monitoring.

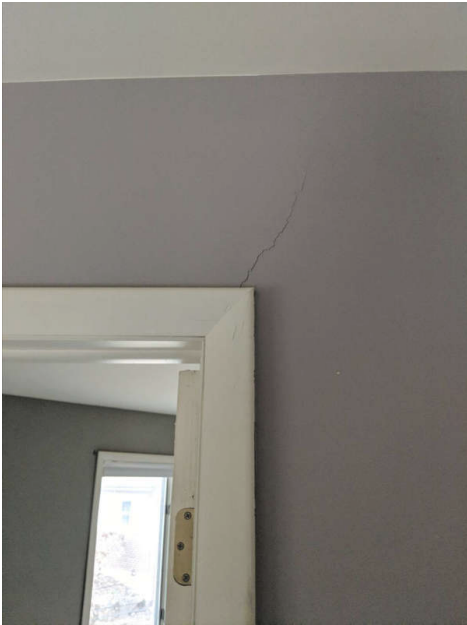
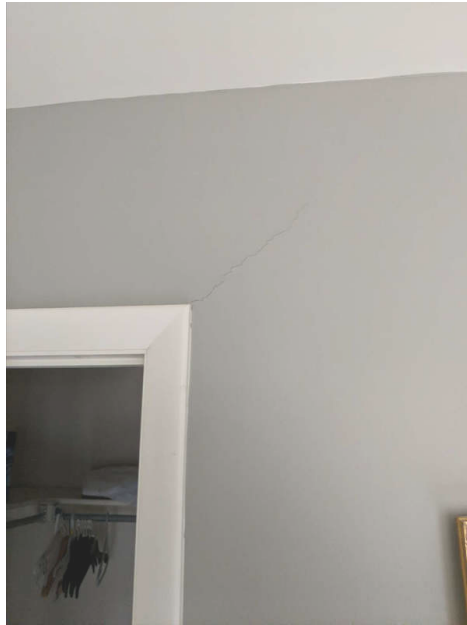
10.2.2 Floors, Walls, Ceilings

Recommendation

Contact a qualified drywall contractor.

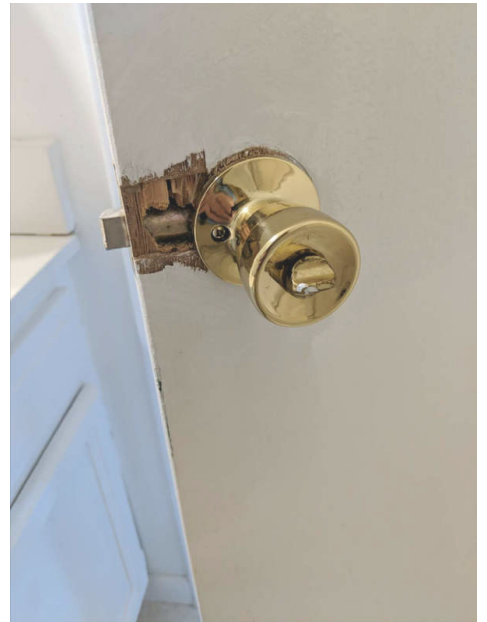
DOOR INTERIOR-DETERIORATED

One or more interior doors are damaged and/or deteriorated and should be repaired or replaced by a qualified contractor.

Contact a qualified door repair/installation contractor.

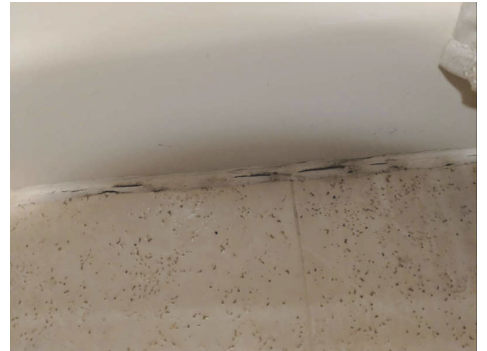
Caulk is missing or deteriorated along the base of one or more bathtubs, where flooring meets the tub. It should be replaced where deteriorated and/or applied where missing to prevent water intrusion and damage to the floor structure.

Recommended DIY Project

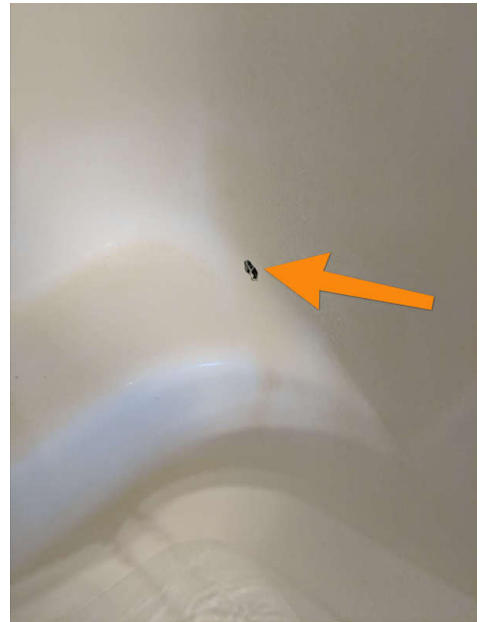
CRACK INSERT

There is a crack in the fiberglass insert for the shower pan. This may allow water to intrude below the shower Pan causing moisture issues. Recommend to have the shower Pan repaired to help prevent moisture intrusion in unseen areas.

Contact a qualified professional.

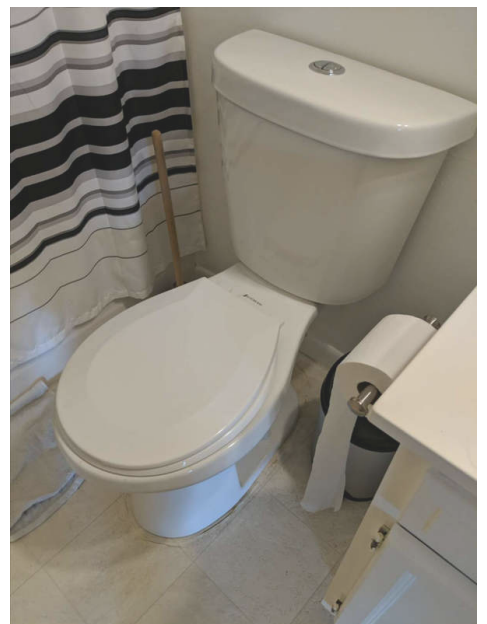
LOOSE

One or more toilets are loose. A qualified contractor should remove the toilet(s) for further evaluation and repairs if necessary. A new wax ring should be installed and toilet(s) should be securely anchored to the floor to prevent movement and leaking.

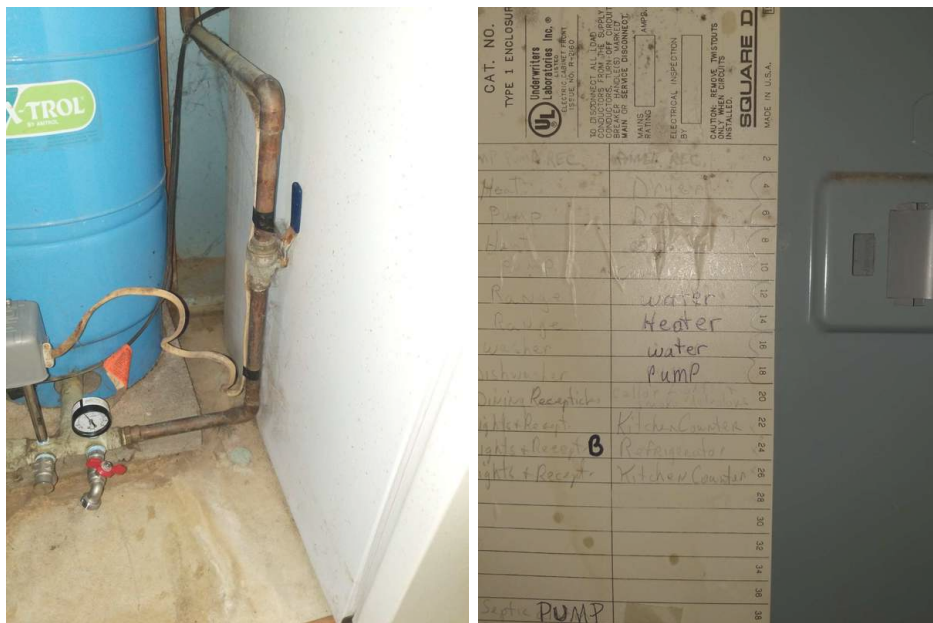
General: Location of Main Shut off

Basement
