BLESS THIS NEST INSPECTIONS, LLC

PROPERTY INSPECTION REPORT

1234 Main St.
Margate Florida 33063

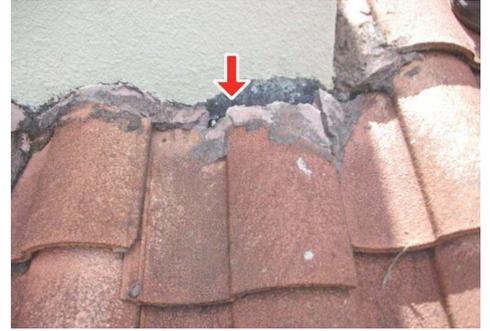
CRACKED/BROKEN TILES

There are broken/cracked Roofing tiles. This is usually cosmetic, but can lead to issues in not addressed timely. If underlayment is exposed to UV rays deterioration may occur. This can lead to leaks if the proper repairs are not made. A licensed roofing contractor should repair or replace any broken tiles.

Contact a qualified roofing professional.

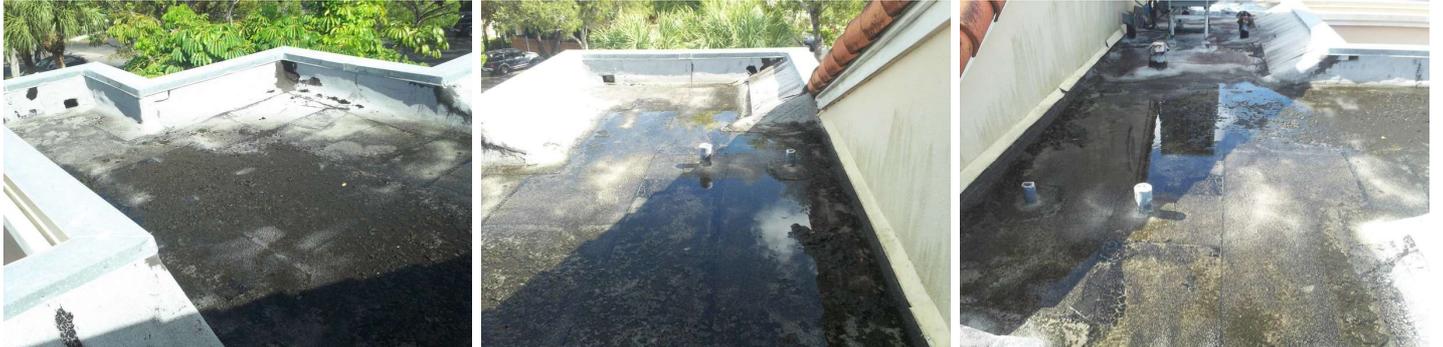
Ponding (pools of standing water) was found at one or more locations on the flat or low-slope roof surface. Even on a flat roof, water should be removed by a drainage system so that any remaining water evaporates within 48 hours after it rains. According to the roof report, the ponding has led to active roof leaks and needs to be replaced.

Contact a qualified roofing professional.

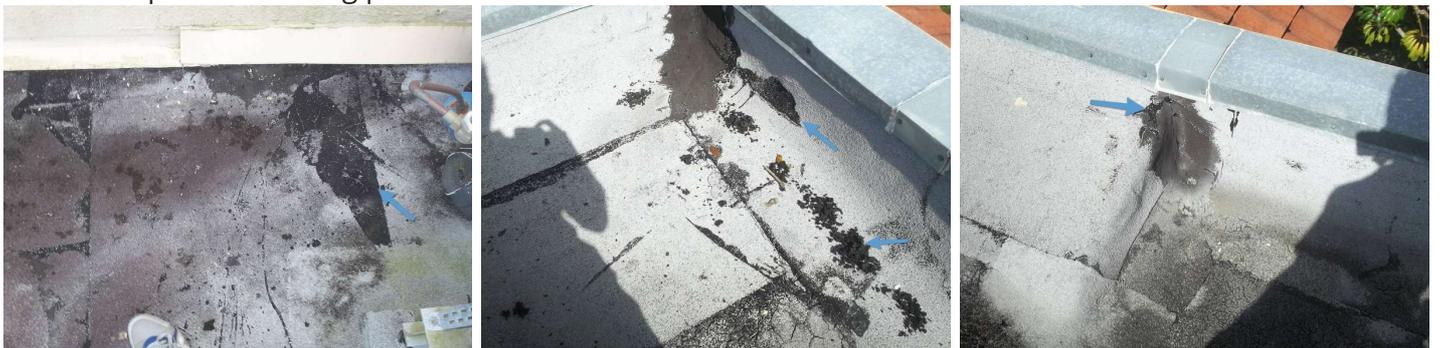
2.3.2 Flat

DAMAGE

According to the roof report, there is damage to one or more areas of the flat roof. This can lead to moisture intrusion and leaks at interior living spaces. Any damaged roofing should be repaired or replaced as necessary.

Contact a qualified roofing professional.

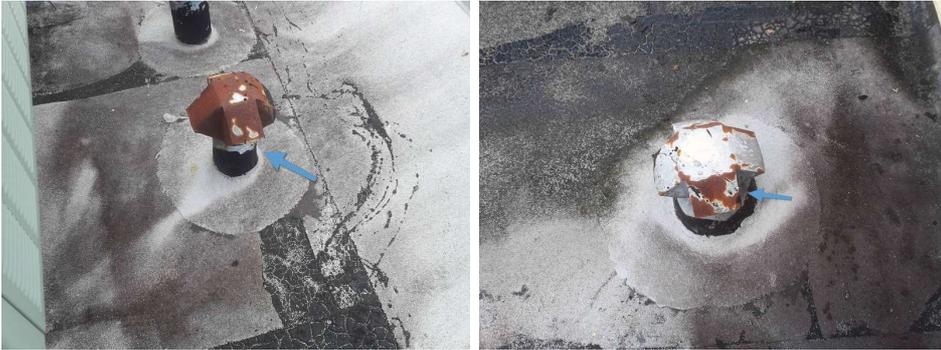
2.5.1 Flashing/Vents

VENT SEALING

As noted in the roofing report, the area around one or more of the sewer vents should be properly sealed; as not to allow sunlight or weathering to enter into the underlayment area which will cause a deterioration and possible leakage in the future. These areas should be sealed.

Contact a qualified roofing professional.

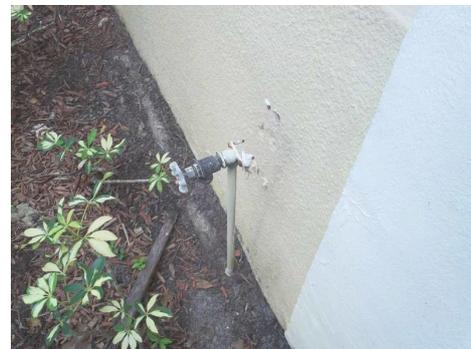
LOOSE FAUCET

The outside water faucet is loose by the front door and need to be secured to the wall at the front of home. Repairs are needed. A qualified licensed plumber should repair or correct as needed.

Contact a qualified plumbing contractor.

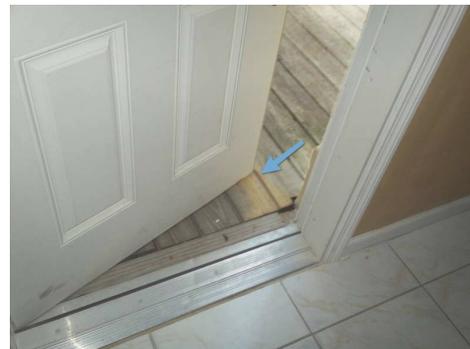
3.5.1 Windows and Door

DOOR - RUBS AT BOTTOM

The main entry door rubs at bottom when closing. This can cause some heat loss in winter and loss of cool air in summer if not corrected. This is considered unsafe and needs correcting. A qualified person should repair or replace as needed.

Contact a qualified professional.

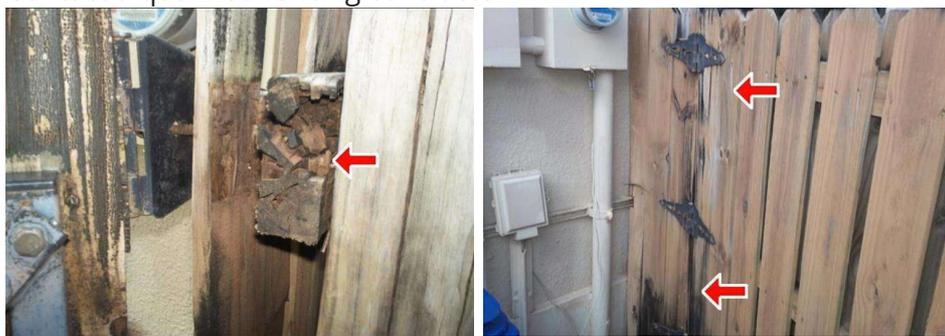
DAMAGED FENCE

Areas of the fencing are deteriorated and damaged. Fencing should be repaired as needed or replaced.

Contact a qualified fencing contractor

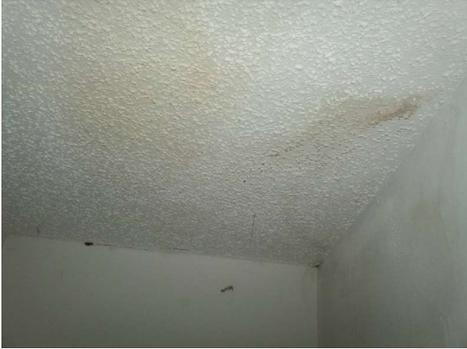
CEILING-DRY STAINS

Stains were found in one or more ceiling areas. However, no elevated levels of moisture were found. The stain(s) may be due to past roof and/or plumbing leaks. Recommend asking the property owner(s) about this, and monitoring the stained area(s) in the future, especially after heavy or prolonged rain. If elevated moisture is found in the future, a qualified contractor should evaluate and repair as necessary.

Recommend monitoring.

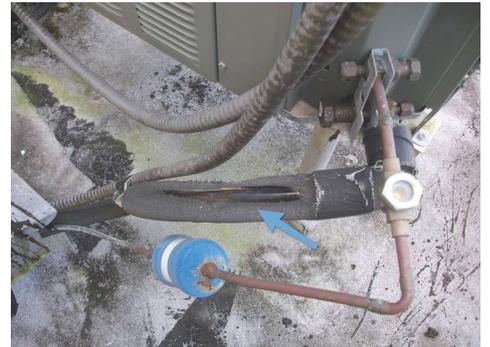
Insulation for the outside condensing unit's refrigerant lines is damaged, deteriorated and/or missing in one or more areas. This may result in reduced efficiency and increased energy costs. A qualified heating and cooling contractor should replace insulation as necessary.

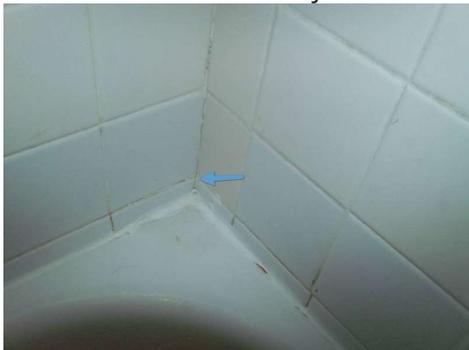
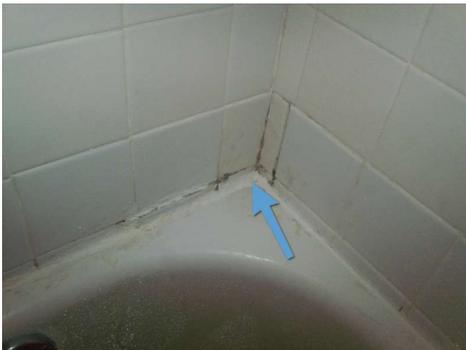
9.1.1 Bathub

Caulk is missing or deteriorated above one or more bathtubs, where the tub surround meets the tub. It should be replaced where deteriorated and/or applied where missing to prevent water intrusion and damage to the wall structure.

Recommended DIY Project

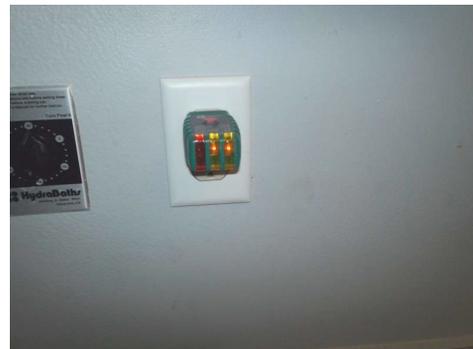
GFCI MISSING

One or more electric receptacles at the bathroom(s) had no visible ground fault circuit interrupter (GFCI) protection, or the inspector was unable to determine if GFCI protection was present. If not GFCI-protected, receptacles in wet areas pose a shock hazard. Recommend that a qualified electrician evaluate and install GFCI protection if necessary and per standard building practices. General guidelines for GFCI-protected receptacles include the following locations:

Contact a qualified electrical contractor.

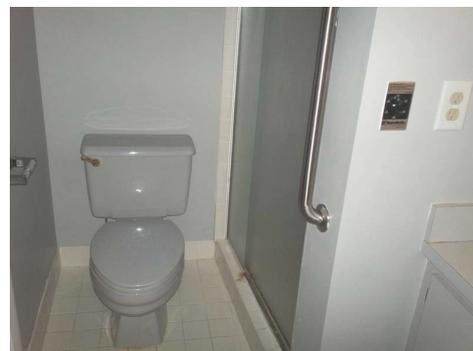
SHOWER DOOR OBSTRUCTED

Shower door was improperly installed and is obstructed by the toilet causing it to not fully open. This is considered unsafe and needs correcting. A qualified contractor should repair or replace as needed.

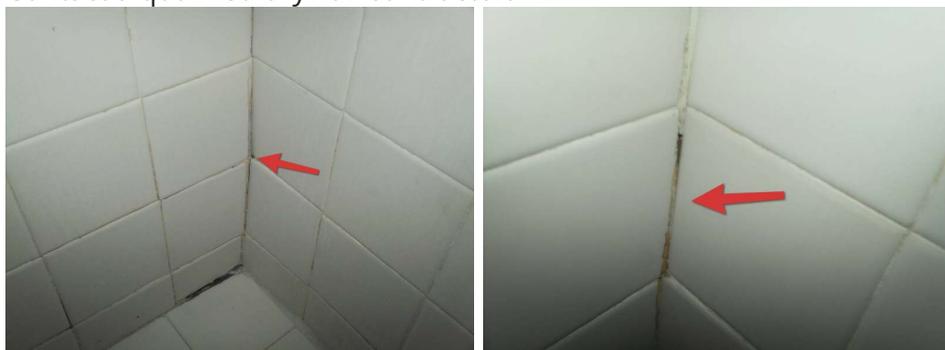
WATER DAMAGE WALL

The floor / wall by the shower was water-damaged. Framing in wall may need repair as well (not visible). Recommend that a qualified person repair/replace as necessary.

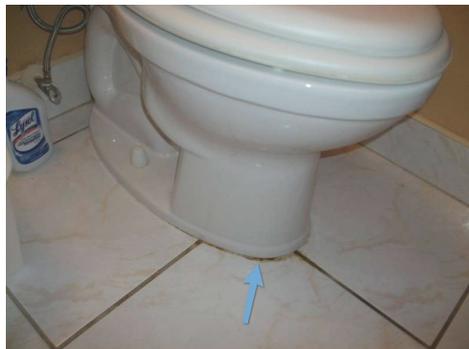
LOOSE

One or more toilets are loose. A qualified contractor should remove the toilet(s) for further evaluation and repairs if necessary. A new wax ring should be installed and toilet(s) should be securely anchored to the floor to prevent movement and leaking.

Contact a qualified plumbing contractor.

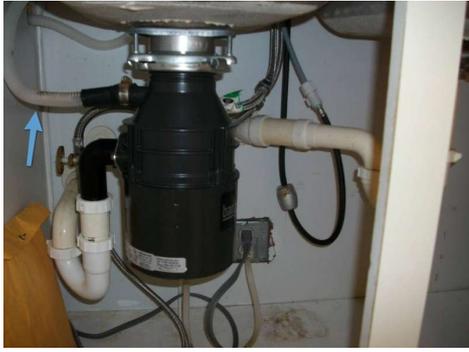
The dishwasher drain line is not configured with a second "high loop" to create a trap under the sink. It is meant to prevent water from siphoning out of the dishwasher, and to prevent water from the sink drain or food disposal from entering the dishwasher. Licensed plumber should correct improper installation.

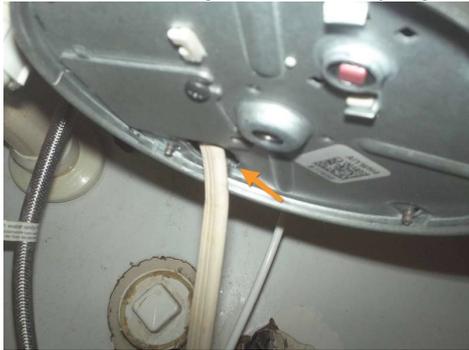
11.3.1 Garbage Disposal

The garbage disposal wiring is missing a romex connector (anti-strain device). Recommend repair as needed.

Contact a handyman or DIY project

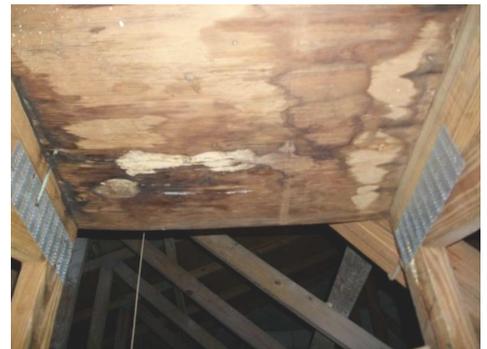
Repair/Evaluation**DRY STAIN**

Stains were visible on the roof structure in one or more areas. These areas were dry at the time of the inspection. The stains may be caused by a past leak. Recommend asking the property owner(s) about past leaks. The client(s) should monitor these areas in the future, especially after heavy rains, to determine if active leaks exist. If leaks are found, a qualified roofing contractor should evaluate and repair as necessary.

Contact a qualified roofing professional.

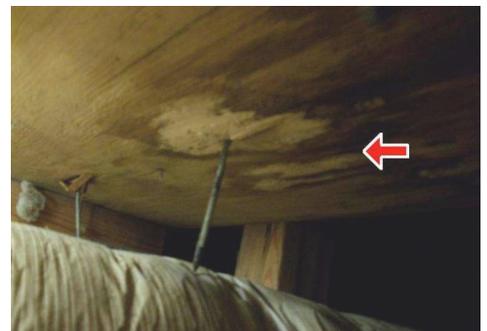
Repair/Evaluation**WET STAIN**

One or more areas of the roof structure were wet or had elevated levels of moisture at the time of the inspection. There appears to be an active leak in the roof or structure exterior. A qualified contractor should evaluate and repair as necessary.

Contact a qualified roofing professional.
