REDBUD PROPERTY INSPECTIONS, LLC

## RESIDENTIAL INSPECTION

1234 Main St.  
Edmond OK 73012

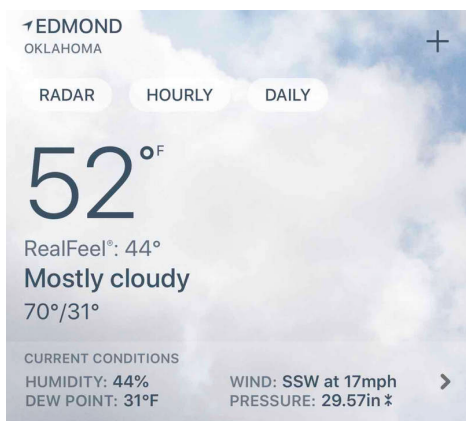
**General: Relative Humidity- Interior**

34 %

Except in specialized facilities, the relative humidity in your building should be between 30% and 50%. Condensation on windows, wet stains on walls and ceilings, and musty smells are signs that relative humidity may be high.

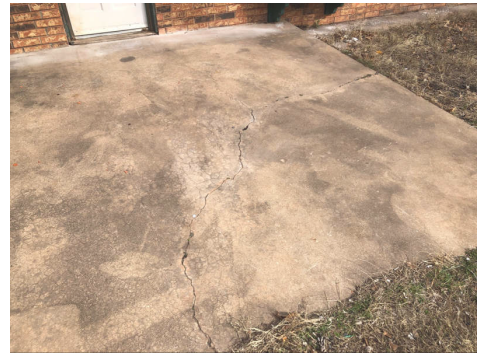
### 3.1.1 Patios

#### PATIO CRACKING (MODERATE)

The patio surface had moderate cracking visible at the time of the inspection. Cracks wider than 1/8" should be filled with an appropriate material to help prevent continued deterioration.

Moderate/Repair Item

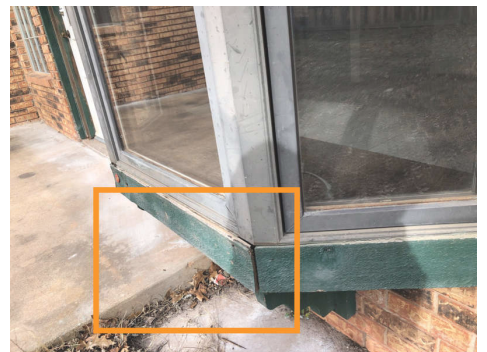
### 3.3.1 Siding, Flashing & Trim

#### LOOSE BOARDS

One or more siding boards were loose, which could result in moisture intrusion. Recommend a qualified siding contractor secure and fasten.

Moderate/Repair Item

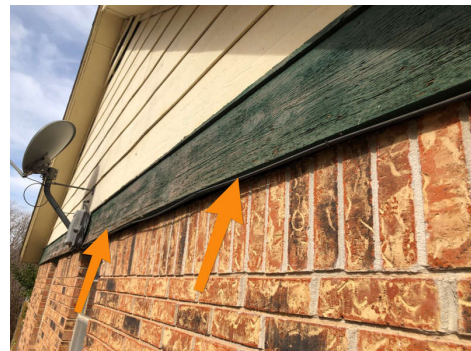
### 3.3.2 Siding, Flashing & Trim

#### WARPING/BUCKLING

Wood siding was warping or buckling in areas, potentially allowing for moisture intrusion. Recommend a qualified siding contractor evaluate and repair/replace.

Large gap

Moderate/Repair Item

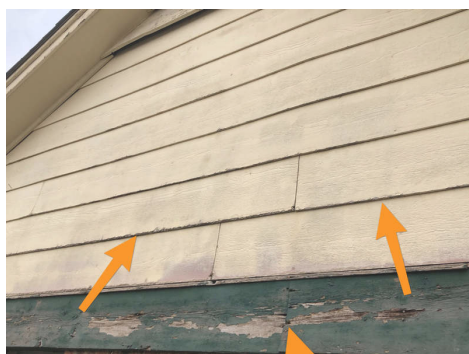
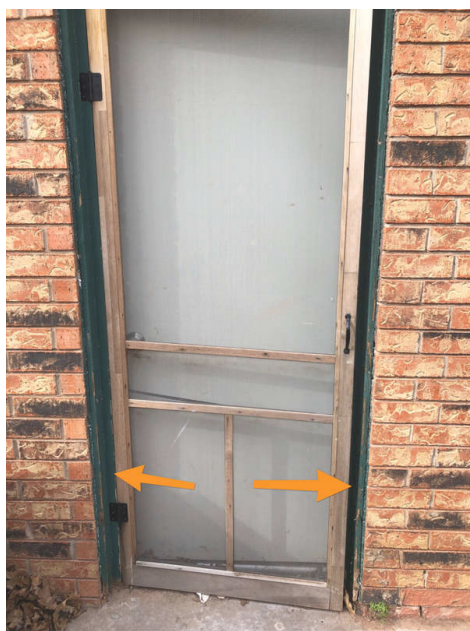
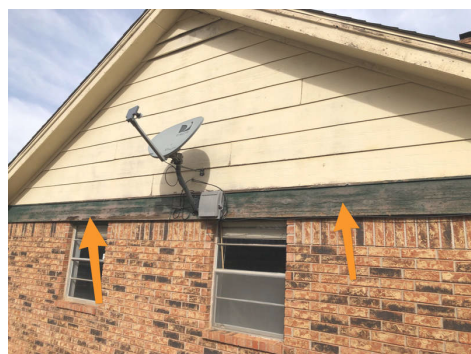
3.3.3 Siding, Flashing & Trim

**PAINT/FINISH FAILING**

The paint or finish is failing. This can lead to deterioration and rot of the material. Recommend that the areas be properly prepared and painted / finished.

Contact a qualified painting contractor.

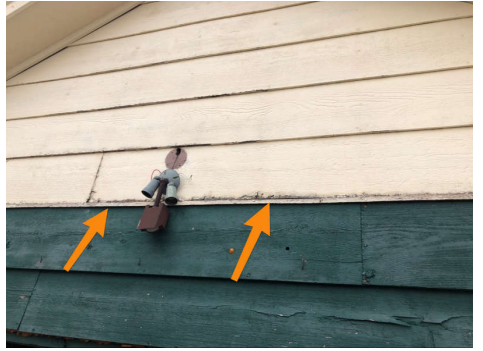
3.3.4 Siding, Flashing & Trim

**ROT-TYPE DAMAGE**

An area of exterior siding/trim showed signs of wood rot. These areas should be repaired/replaced as necessary by a qualified siding contractor to prevent further deterioration.

Contact a qualified siding specialist.

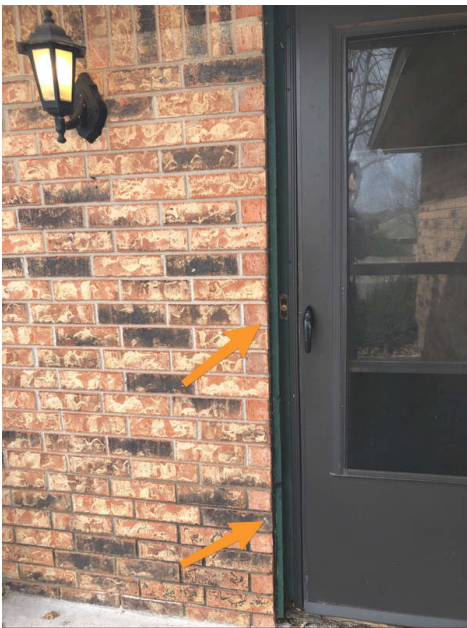
3.3.5 Siding, Flashing & Trim

**CAULKING/SEALANT RECOMMENDED**

Caulking/Sealant is recommended in one or more areas of the exterior to prevent moisture and/or pest intrusion.

Contact a handyman or DIY project

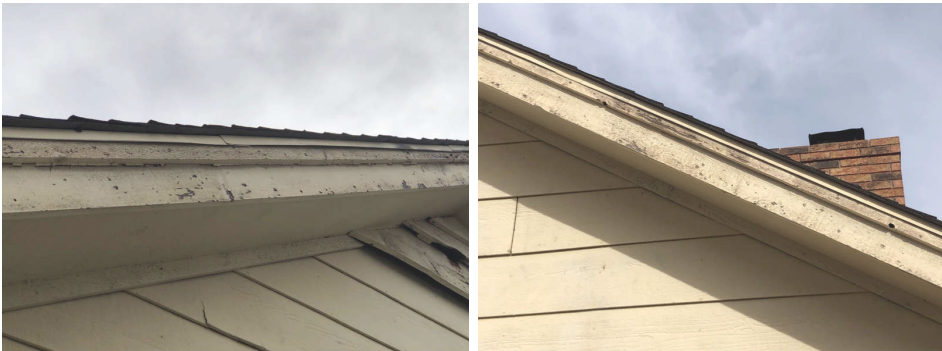
3.4.2 Eaves, Soffits & Fascia  
**PAINT/FINISH FAILING**

The paint or finish is failing. This can lead to deterioration and rot of the material. Recommend that the areas be properly prepared and painted / finished.

Contact a qualified painting contractor.

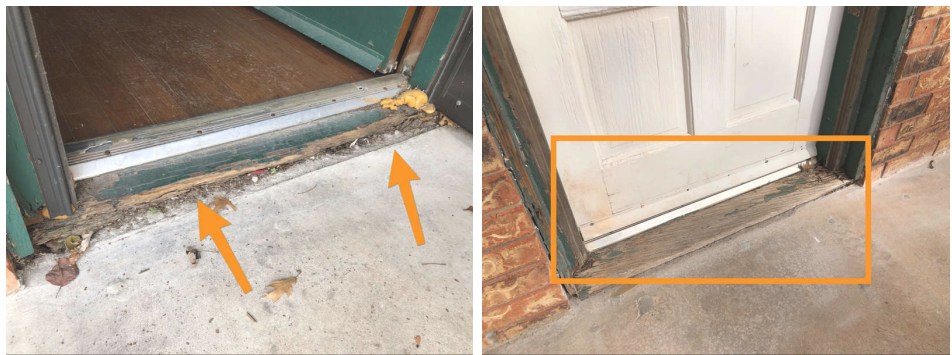
3.5.1 Exterior Doors

**DOOR SILL/TRIM**

Door sill and/or trim is loose, deteriorated or worn and repair or replacement should be considered.

Contact a qualified door repair/installation contractor.

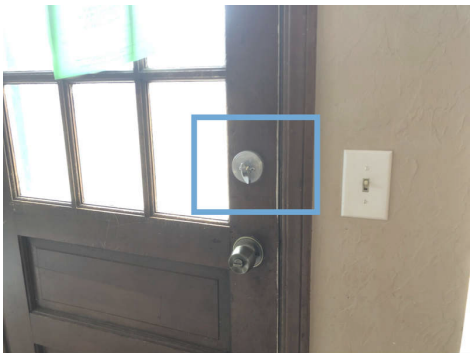
3.5.2 Exterior Doors

**DEADBOLT STRIKEPLATE NEEDS ADJUSTMENT**

The strike plate for the deadbolt requires the doorknob to be pulled tightly in order to latch. Recommend adjusting the strike plate to allow for easier operation and less wear on the deadbolt mechanism.

Contact a handyman or DIY project

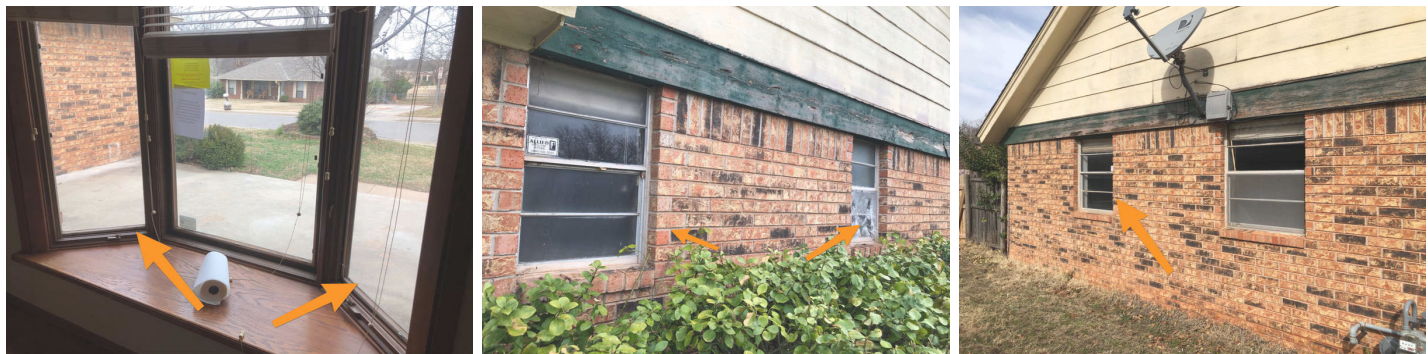
3.6.1 Window Exteriors

**SCREEN DAMAGED/MISSING**

A window screen was damaged or missing altogether. Recommend repair/replacement by Handyman.

Contact a qualified professional.

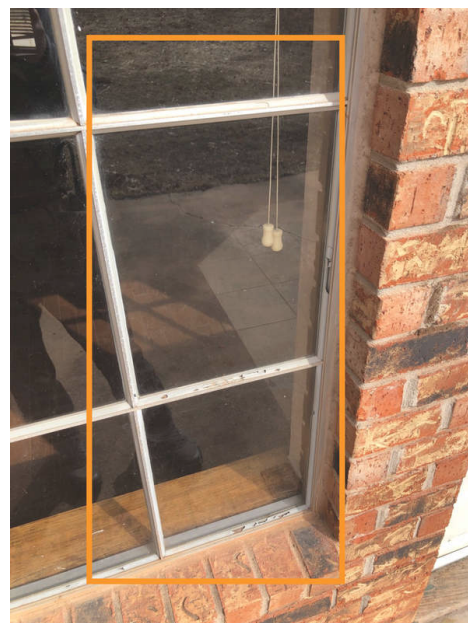
## 3.6.2 Window Exteriors

**GLAZING STRIP DAMAGE**

The plastic glazing strip around a window pane was damaged. This can lessen the integrity of the window and should be repaired/replaced as necessary.

Contact a handyman or DIY project

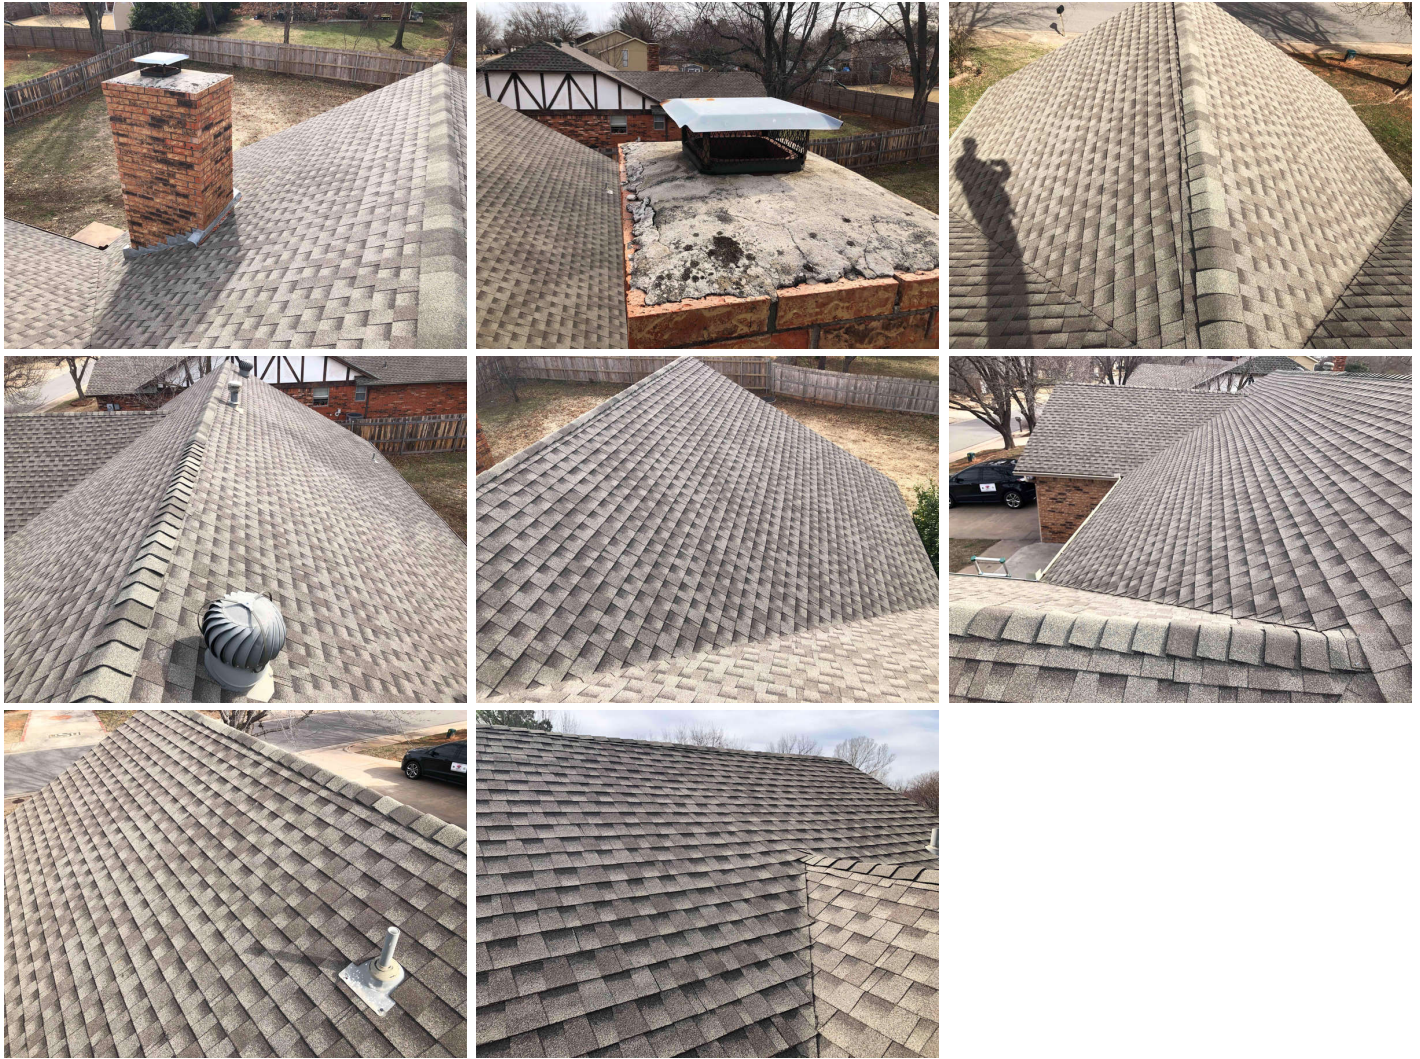
### Notable Roof Photos

The Inspector observed no deficiencies in the condition of the exterior roof structure.

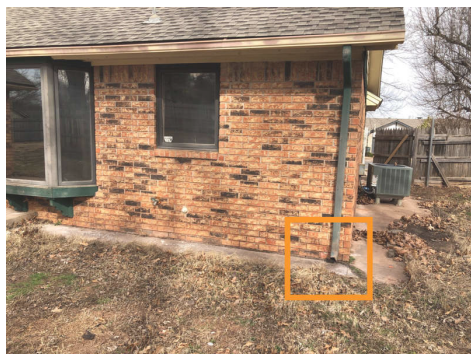
4.4.1 Roof Drainage Systems

One or more downspouts drain too close to the home's foundation. This can result in excessive moisture in the soil at the foundation, which can lead to foundation/structural movement. Recommend adjusting downspout extensions to drain at least 4-6 feet from the foundation.

Contact a handyman or DIY project

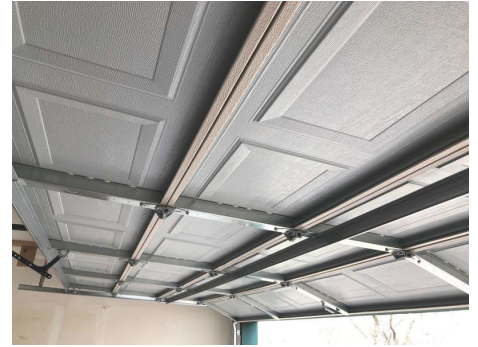
### Garage Overhead Door: Material

Metal, Non-insulated

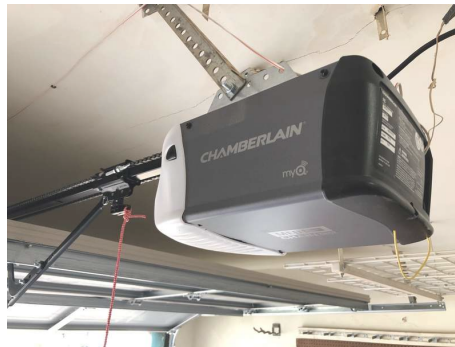
Chamberlain

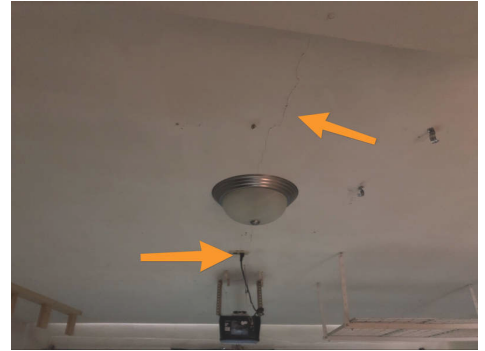
### 5.2.1 Ceiling

#### DRYWALL (OPENER CRACKS)

Moderate/Repair Item

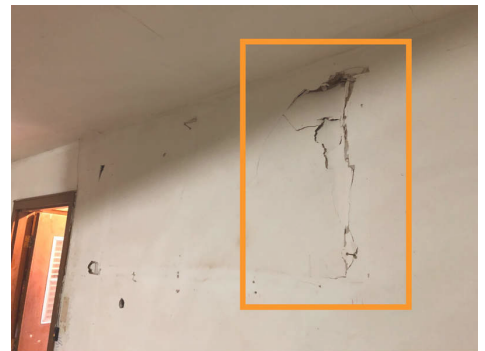
### 5.4.1 Walls/Firewalls

#### FIREWALL (VIOLATIONS)

Moderate/Repair Item

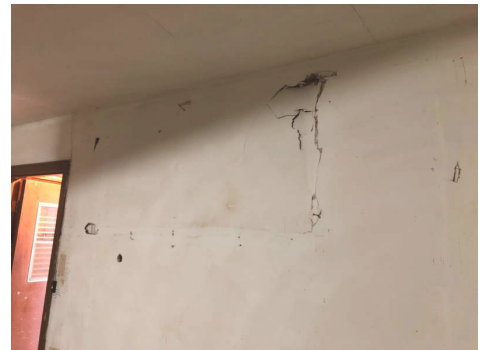
### 5.4.2 Walls/Firewalls

#### WALLS (MODERATE DAMAGE)

Moderate/Repair Item

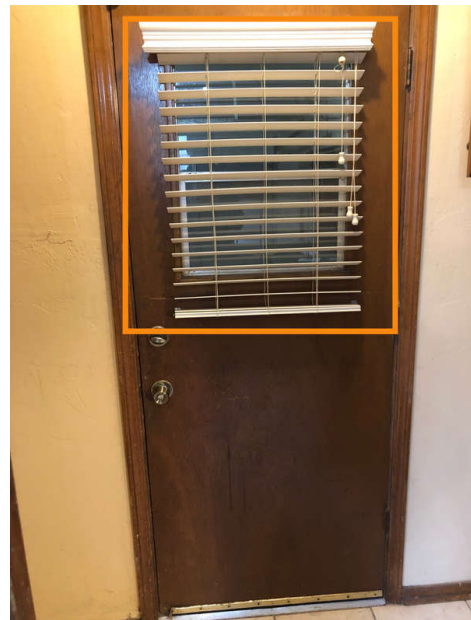
### 5.7.1 Occupant Door (From garage to inside of home)

#### DOOR TO LIVING SPACE (NON-COMPLIANT)

Moderate/Repair Item

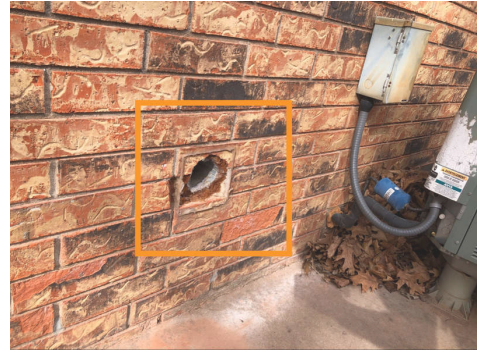
7.4.2 Exhaust Systems

**DRYER VENT LOUVER MISSING**

Moderate/Repair Item

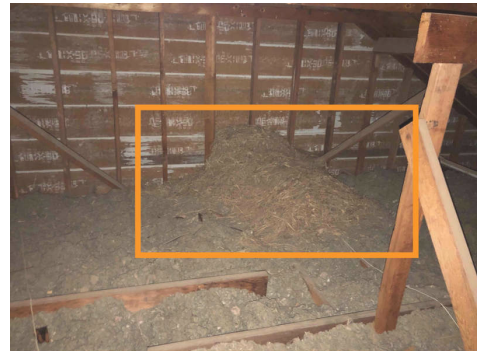
7.5.1 Attic (Structure)

**EVIDENCE OF WILDLIFE INTRUSION**

Moderate/Repair Item

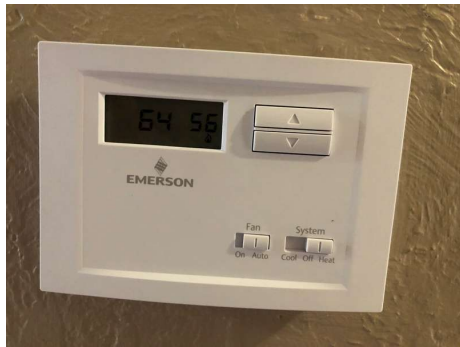
### Normal Operating Controls: Thermostat Type/Location

West Hallway  
Digital

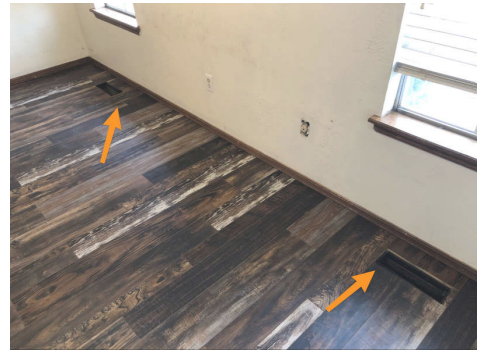
8.2.2 Distribution System

**FLOOR REGISTER MISSING**

Moderate/Repair Item

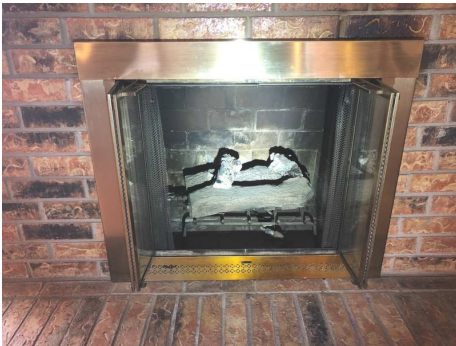
**Solid Fuel Heating Device (Fireplace, Woodstove): Solid Fuel Fireplace System Photos**

Masonry, Gas Burner, Wood Burning

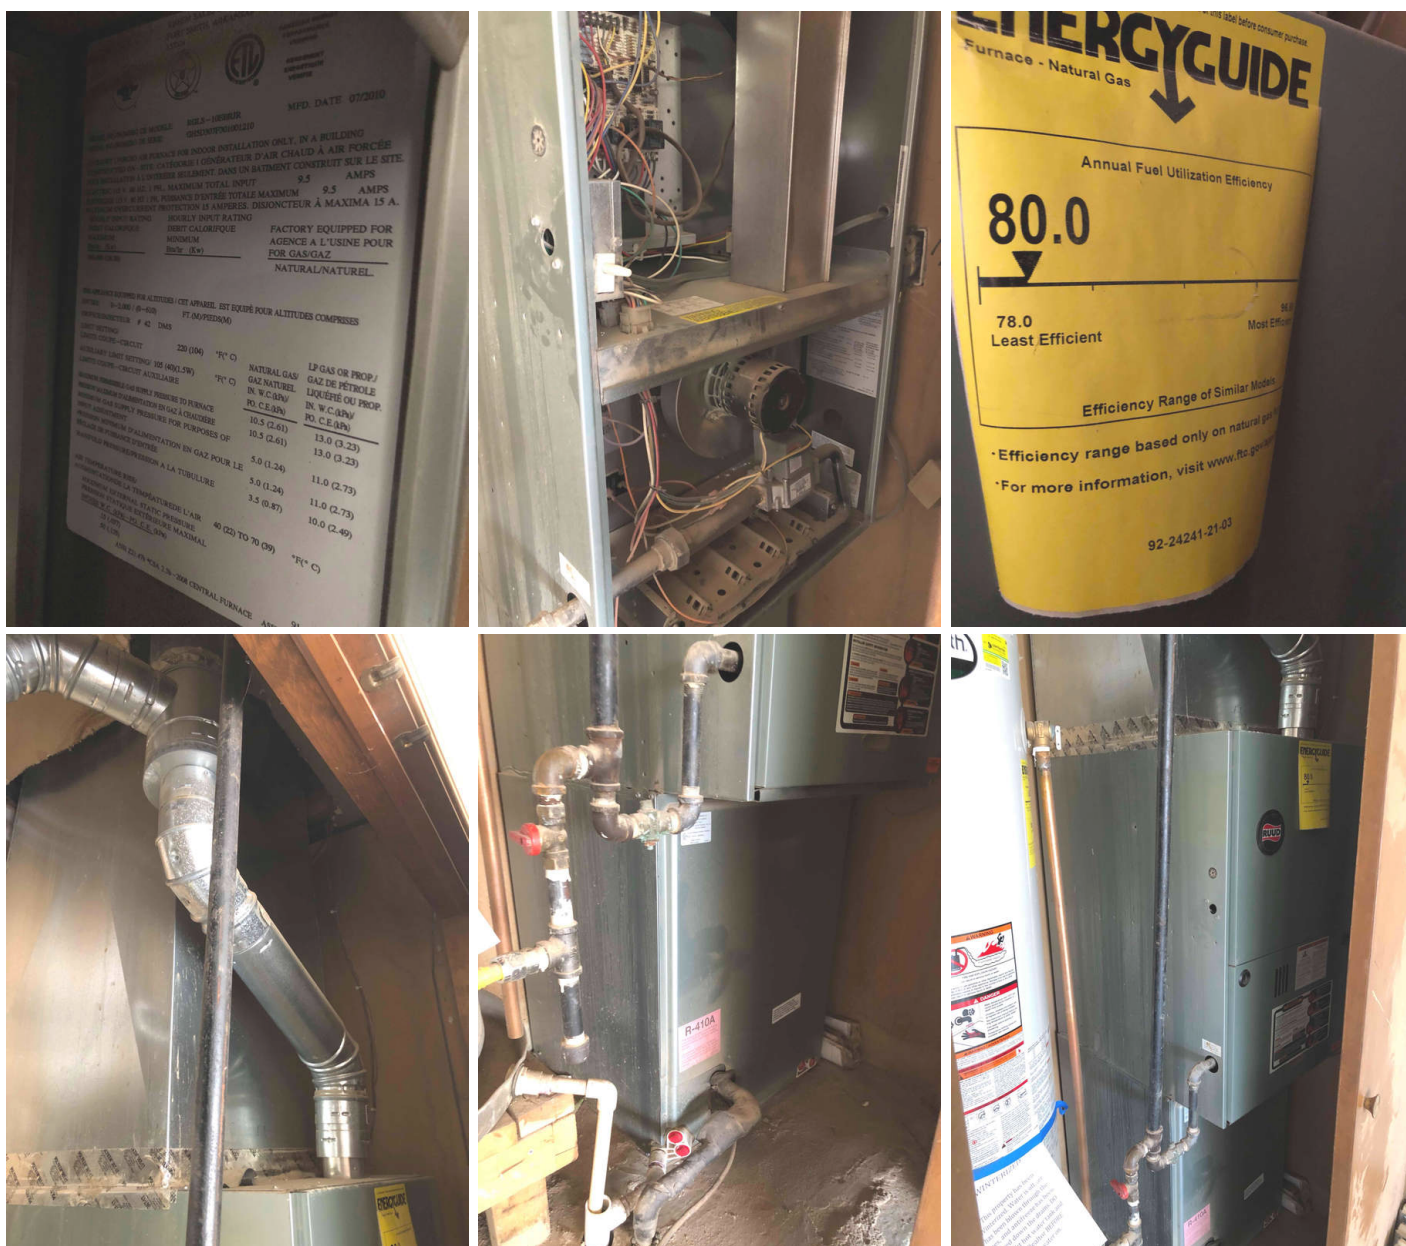
**Equipment: Equipment Photos**

At the time of the inspection, the Inspector observed no deficiencies in the condition of this furnace. Inspection of the furnace typically includes examination/operation of the following:- cabinet exterior- fuel supply and shut-off (not tested);- electrical shut-off;- adequate combustion air;- proper ignition;- burn chamber conditions (when visible);- exhaust venting;- air filter and blower;- plenum and ducts;- response to the thermostat;- return air system; and- condensate drain components (where applicable).

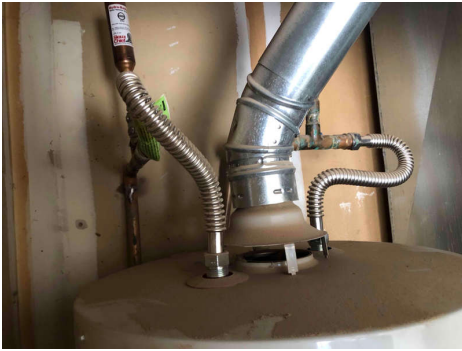
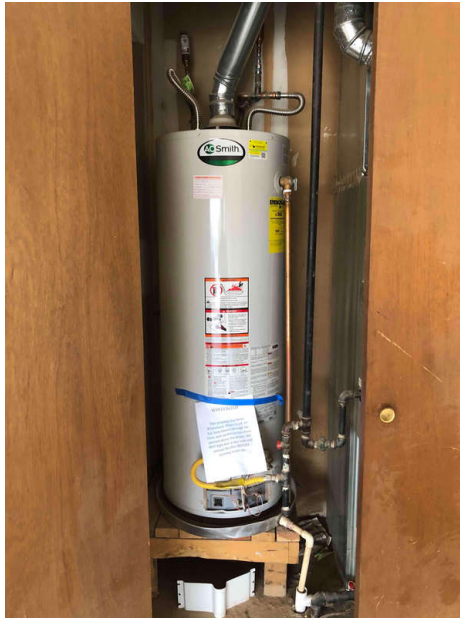
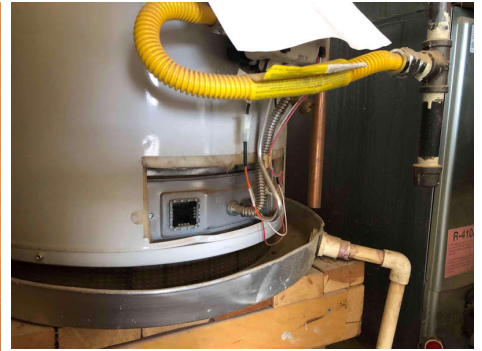
## Hot Water Systems, Controls, Flues & Vents: Water Heater Photos

This water heater was gas-fired. Gas water heaters heat water using a gas burner located in a chamber beneath the water tank. The gas control mechanism contains safety features designed to prevent gas from leaking into the living space if the burner should fail for some reason. Gas-fired water heaters must be properly installed so that the gas fuel is safely delivered to the water heater and so that the water heater safely exhausts the products of combustion to the home exterior. Gas-fired water heaters can be expected to last the length of the stated warranty and after its expiration may fail at any time.

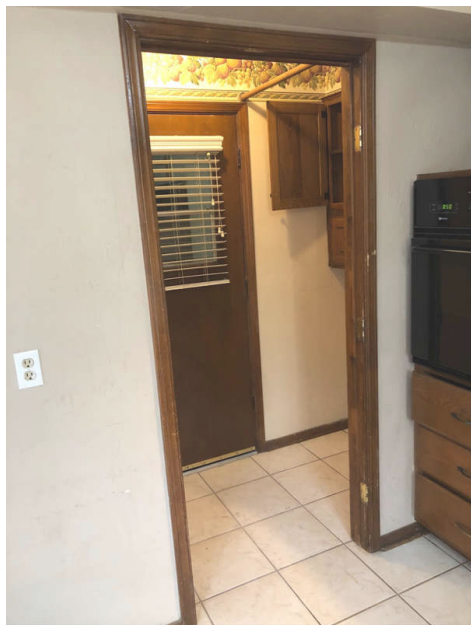
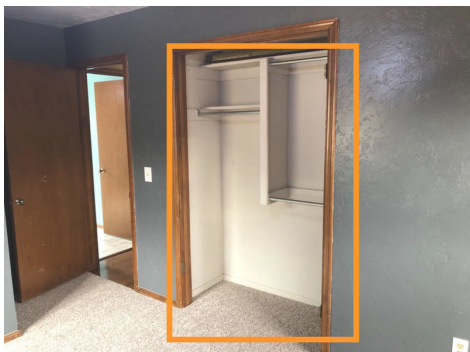
12.3.2 Doors

KITCHEN TO LAUNDRY, SOUTH BEDROOM CLOSET

One or more doors were not installed and were not located on the premises. It may be that the door was never installed or was removed out of convenience. Nonetheless, the door was missing.

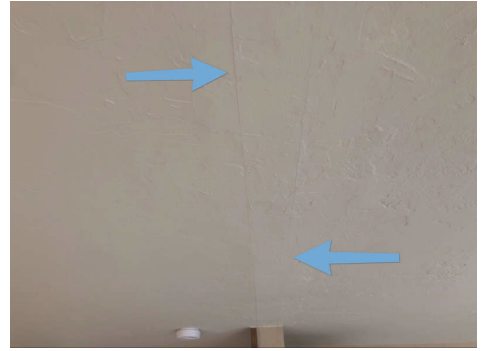
12.7.1 Ceilings

**DRYWALL SEAM CRACKS- MINOR**

Contact a qualified drywall contractor.

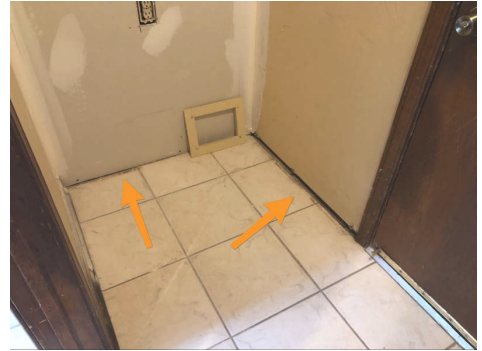
12.8.1 Trim

**INTERIOR TRIM PIECE MISSING**

Contact a qualified carpenter.

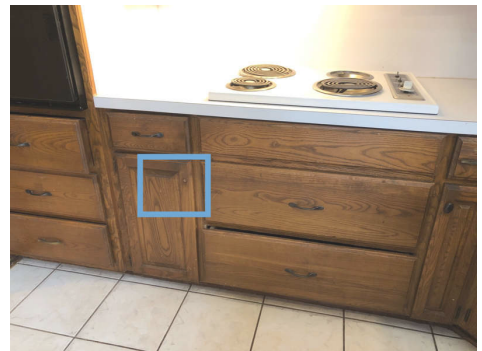
12.9.1 Countertops & Cabinetry

**CABINET/DRAWER PULL/HANDLE MISSING**

Contact a qualified cabinet contractor.

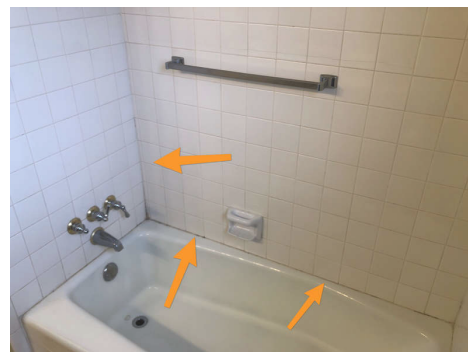
12.10.2 Tiled Areas- Kitchen, Bath & Laundry

**GROUT DETERIORATING**

Contact a qualified countertop contractor.

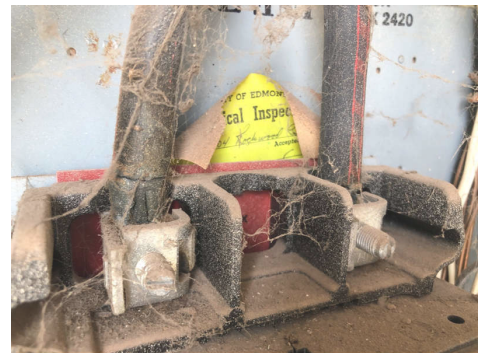
### 13.2.1 Main & Subpanels, Service & Grounding, Main Overcurrent Device

#### **MISSING LABELS ON PANEL**

Moderate/Repair Item

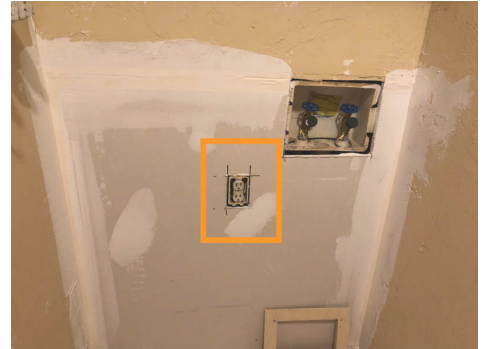
**COVER PLATES MISSING**

At the time of the inspection, an electrical receptacle cover plate was missing. This condition left energized electrical components exposed to touch, a shock/electrocution hazard. The Inspector recommends a cover plate be installed by Handyman/DIY.

Contact a qualified electrical contractor.

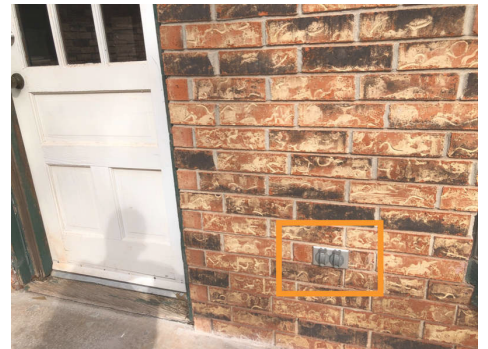
13.4.3 Lighting Fixtures, Switches & Receptacles

An electrical receptacle was inoperable at the time of the inspection. The Inspector recommends service by a qualified electrical contractor.

Contact a qualified electrical contractor.

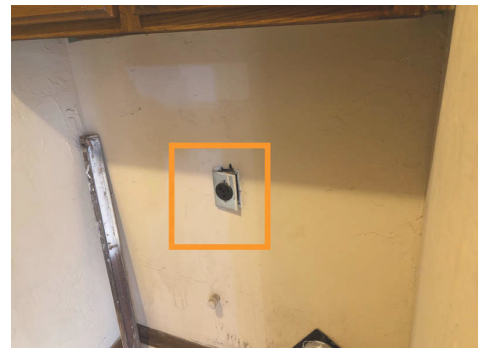
13.4.4 Lighting Fixtures, Switches & Receptacles

**LOOSE RECEPTACLE**

An electrical receptacle was improperly secured. Receptacles should be securely installed to prevent fire, shock and/or electrocution hazard. The Inspector recommends correction by a qualified electrical contractor.

Contact a handyman or DIY project

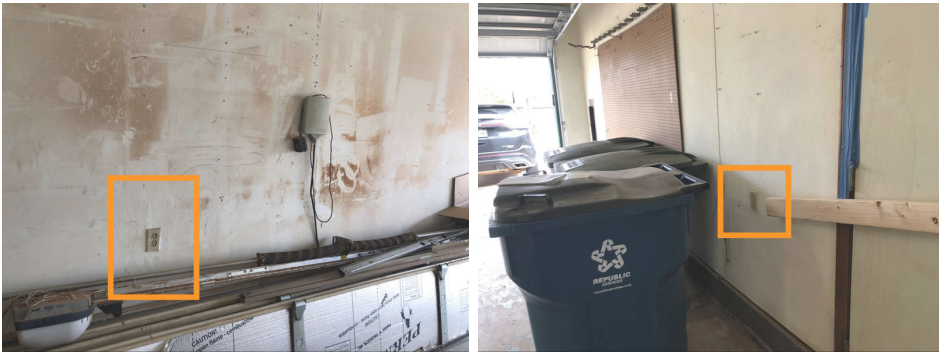
## 13.4.5 Lighting Fixtures, Switches &amp; Receptacles

Moderate/Repair Item
**UNGROUNDED RECEPTACLE, 3-PRONG**

Although the 3-prong electrical receptacles installed in this home typically indicate a home with grounded branch wiring, this home had no grounding system installed to protect devices such as switches, light fixtures and electrical receptacles. This condition is especially dangerous because it leads those using the electrical system to believe they are protected by a grounding system when they are not. Ungrounded electrical receptacles should be labeled as such. Although ungrounded electrical systems may have been commonly considered safe or acceptable at the time the home was originally constructed, as general knowledge of safe building practices has improved with the passage of time, building standards have changed to reflect current understanding. For safety reasons, the Inspector recommends that receptacles located in basements, crawlspaces, garages, the home exterior, and interior receptacles located within 6 feet of a plumbing fixture be provided with ground fault circuit interrupter (GFCI) protection in good working order to avoid potential electric shock or electrocution hazards. This can be achieved relatively inexpensively by: 1. Replacing an individual standard receptacle with a GFCI receptacle. 2. Replacing the electrical circuit receptacle located closest to the overcurrent protection device (usually a breaker) with a GFCI receptacle. 3. Replacing the breaker currently protecting the electrical circuit that contains the receptacles of concern with a GFCI breaker. Adding equipment grounding and a service grounding system will also increase home safety.

Contact a qualified electrical contractor.

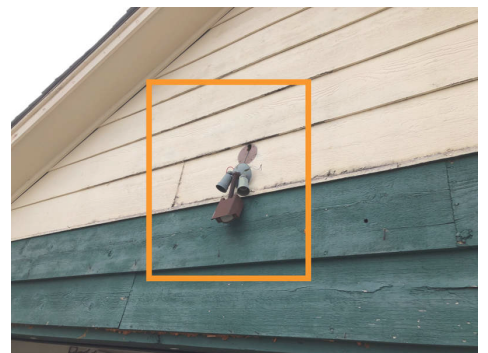
## 13.4.6 Lighting Fixtures, Switches &amp; Receptacles

Moderate/Repair Item
**DAMAGED LIGHT FIXTURE**

A light fixture showed visible damage. Recommend repair/replacement by qualified electrical contractor.

Contact a qualified electrical contractor.

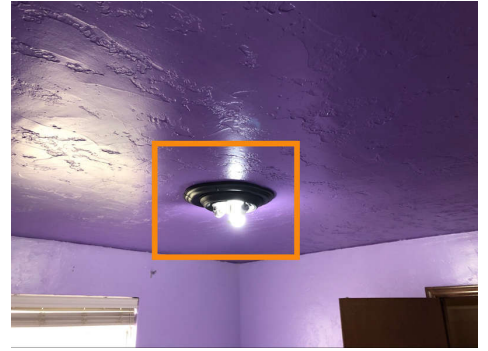
## 13.4.7 Lighting Fixtures, Switches &amp; Receptacles

Moderate/Repair Item
**LIGHT MISSING GLOBE/COVER**

A light fixture was missing its cover. Replacement is recommended.

Contact a handyman or DIY project

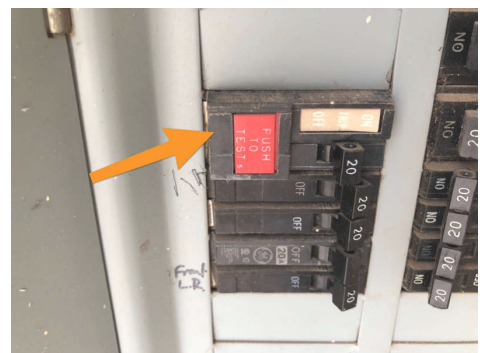
## 13.5.1 GFCI &amp; AFCI

**GFCI PROTECTION NOT INSTALLED**

Moderate/Repair Item

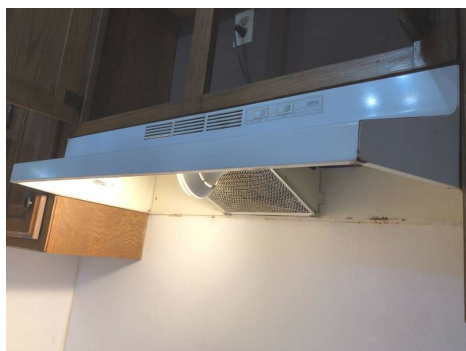
### Cooktop/Exhaust Fan: Exhaust Fan OK

At the time of the inspection, the Inspector observed no deficiencies in the condition and operation of the exhaust fan.

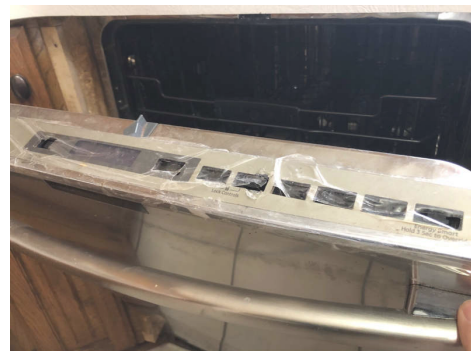
**CONTROL PANEL DAMAGED**

The dishwasher control panel was damaged. Operation could not be verified.

Contact a qualified appliance repair professional.

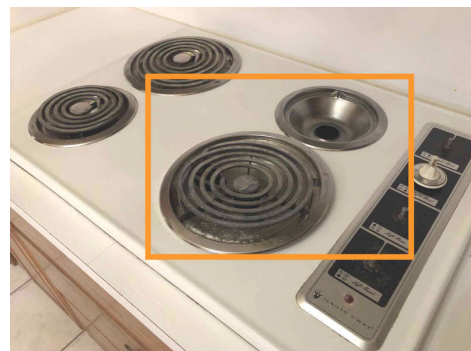
14.2.1 Cooktop/Exhaust Fan

**COOKTOP BURNER INOPERABLE**

Moderate/Repair Item

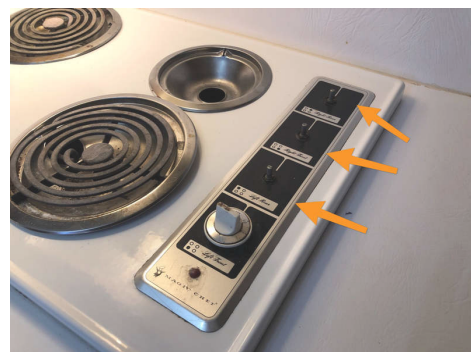
14.2.2 Cooktop/Exhaust Fan

**COOKTOP MISSING CONTROL KNOBS**

Moderate/Repair Item
