## CAL-SPEC RESIDENTIAL

1234 Main St.  
Rancho Mirage CA 92270

Buyer Name  
03/10/2019 9:00AM

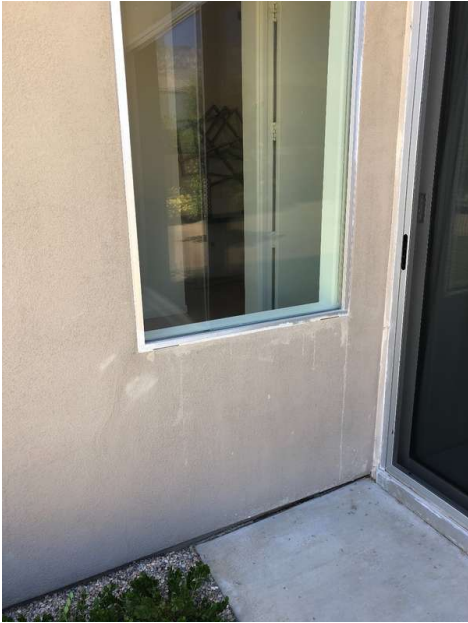
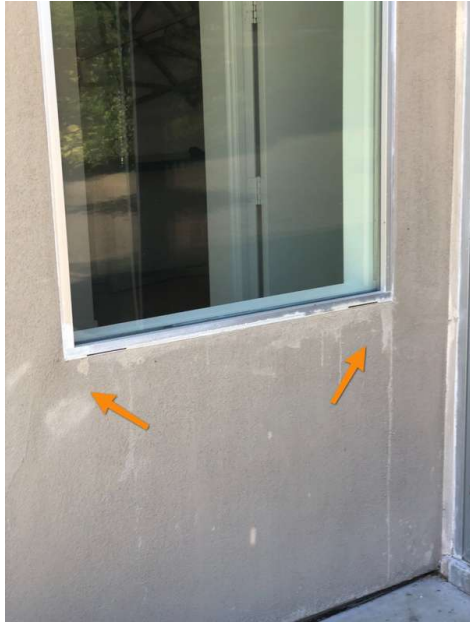
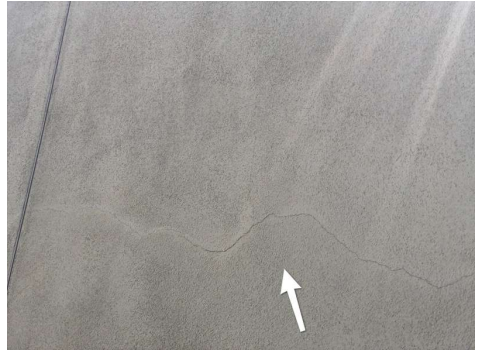
2.2.1 Siding, Flashing & Trim

**CRACKING - MINOR**

Siding showed cracking in one or more places. This is a result of temperature changes, and typical as homes with stucco age. Recommend monitoring.

Recommendation

Contact a stucco repair contractor

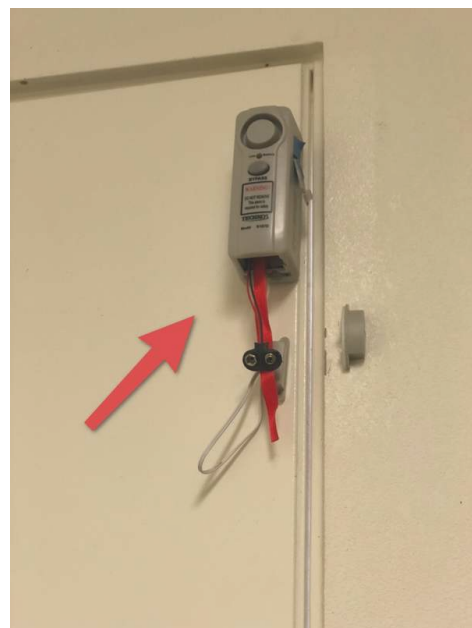
##### 3.1.1 Access Door

#### ACCESS DOOR

The access door to the garage is equipped with a swimming pool alarm.

This alarm has been disconnected and must be operational for safety protocols.

Recommendation

Contact a qualified professional.

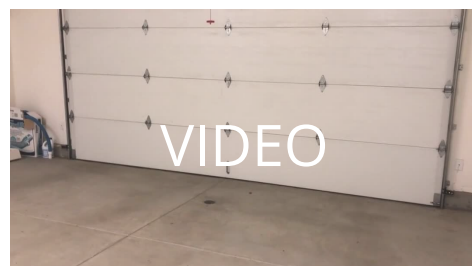
##### 3.8.1 Garage Door Opener

#### GARAGE DOR OPERATOR

The operator is under strain and starts ver rough upon opening. Please see video and contact professional for further evaluation.

Recommendation

Contact a qualified garage door contractor.

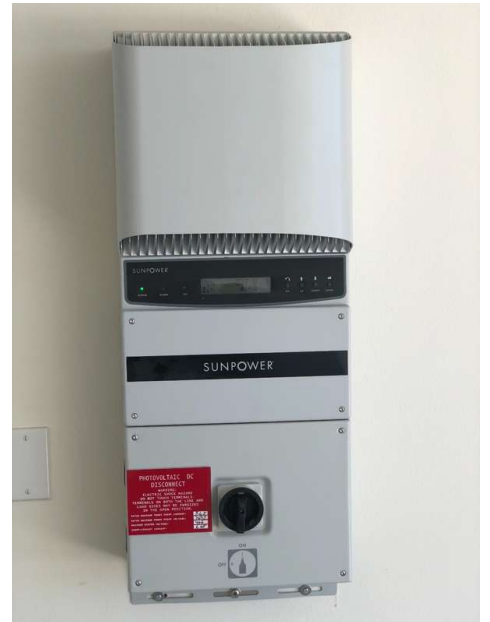
Cal-Spec Inc. does not inspect Photovoltaic systems as to the intricate electrical componants.

If this system is of concern to you, we recommend that you contact a specialist for further evaluation.

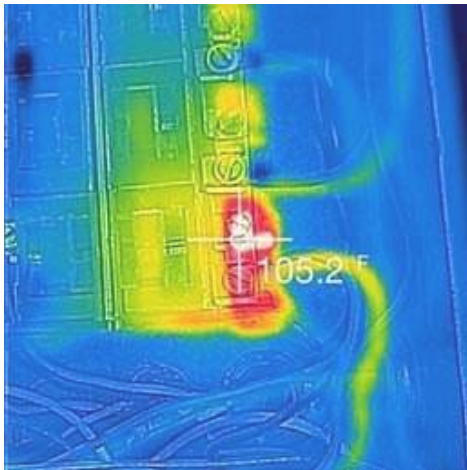
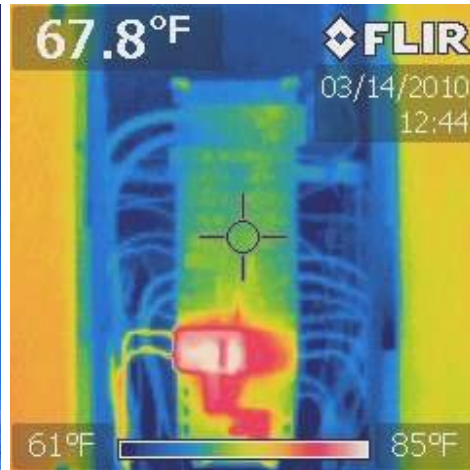
5.2.1 Main & Subpanels, Service & Grounding, Main Overcurrent Device

### **BREAKER INCORRECTLY WIRED**

Circuit breaker was incorrectly wired / installed. This indicates that work was probably not performed by a licensed electrician and poses a safety hazard. Recommend that a licensed electrician check the entire panel and repair and replace as need.

Please noted the over headed circuits in the infrared photos.

Recommendation

Contact a qualified electrical contractor.

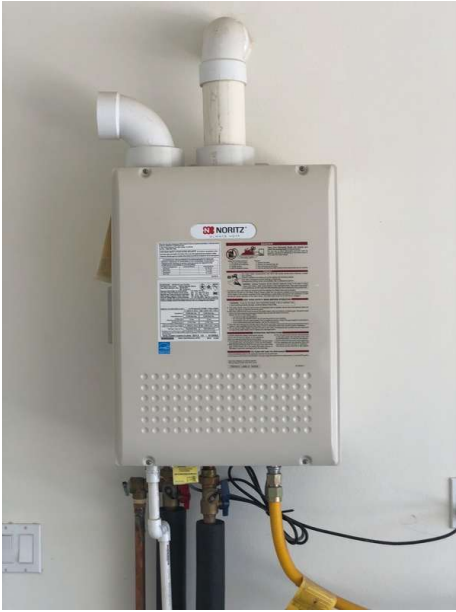
**Hot Water Heater(S): Servicable**

Tankless unit is functional at the time of inspection.

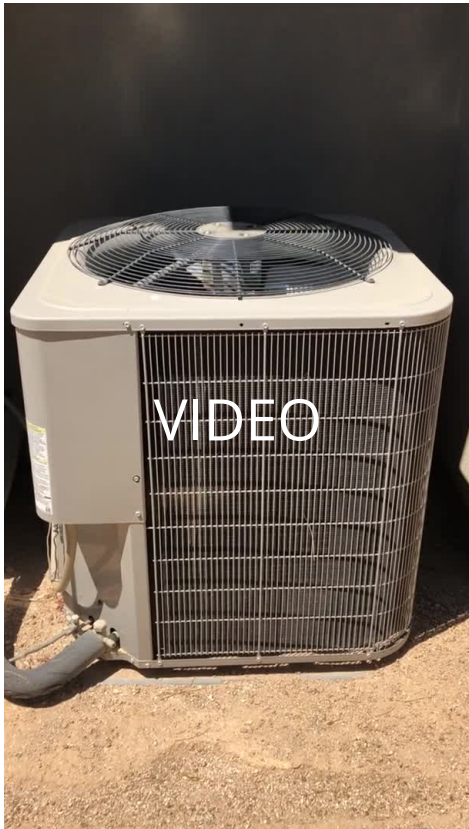
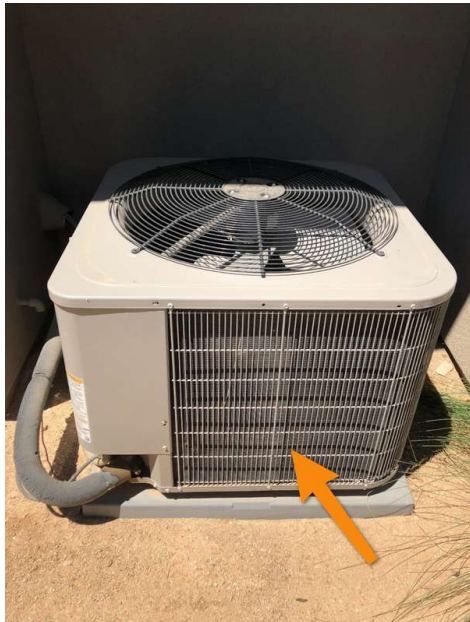
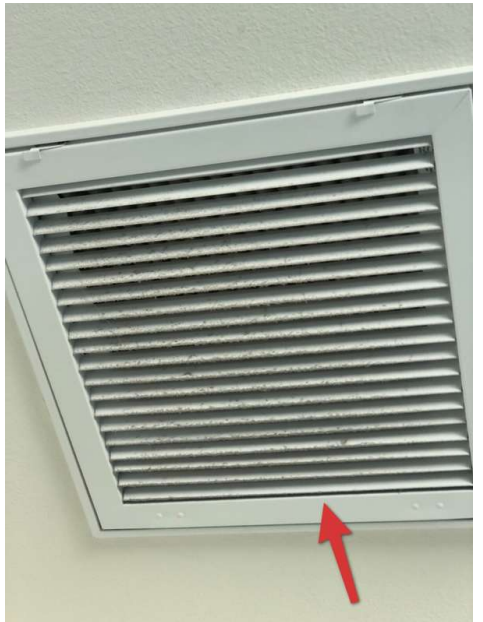
7.1.1 Central Air Conditioning System(s)

**SERVICE NEEDED**

\*HVAC units are operational at time of inspection. However, due to age, variable conditions & use of these units, we recommend service and verification by an HVAC specialist

Recommendation

Contact a qualified HVAC professional.

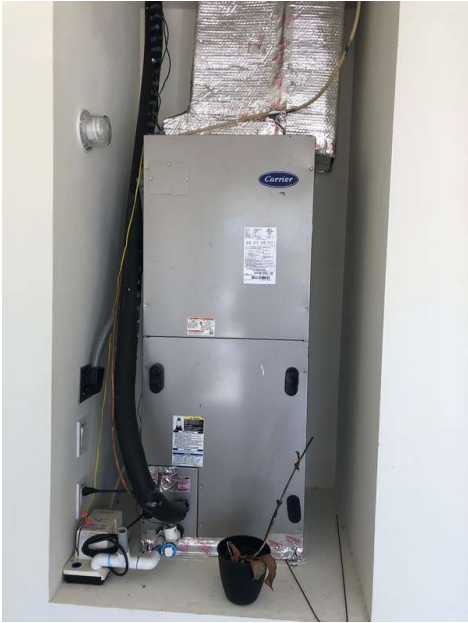
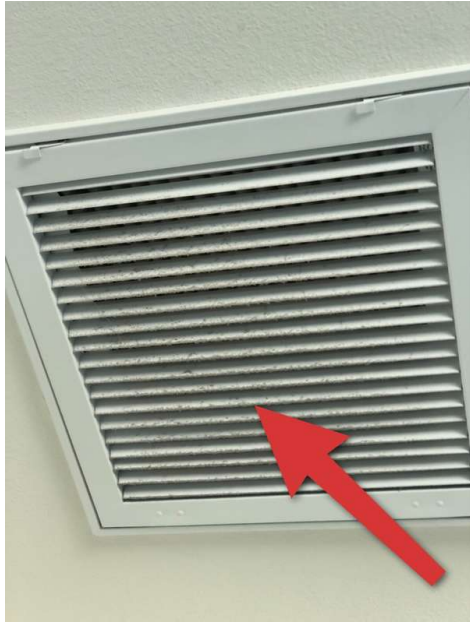
7.2.1 Forced Air Heating Equipment  
**NEEDS SERVICING/CLEANING**

Furnace should be cleaned and serviced annually. Recommend a qualified HVAC contractor clean, service and certify furnace.

Recommendation

Contact a qualified HVAC professional.

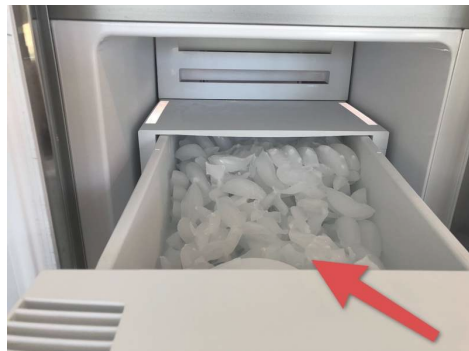
8.13.1 Refrigerator

### ICE MAKER

Ice Maker had not been used for a long period and the ice was frozen so much that the unit was under strain.

Because of the length of time it would take to make ice, we recommend verification before closing.

Recommendation

Contact a qualified appliance repair professional.

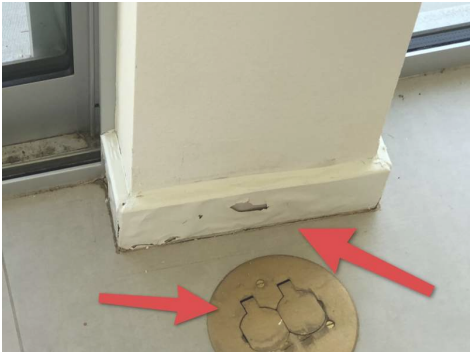
10.4.1 Walls

### WATER DAMAGE

We observed water damage to the center posterior wall.

Since there is no plumbing in this wall, more than likely the source was from the exterior i.e broken sprinkler head.

This water intrusion was also very close to a floor receptacle, and we recommend verification that no corrosion has affected this circuit.

Recommendation

Contact a qualified professional.

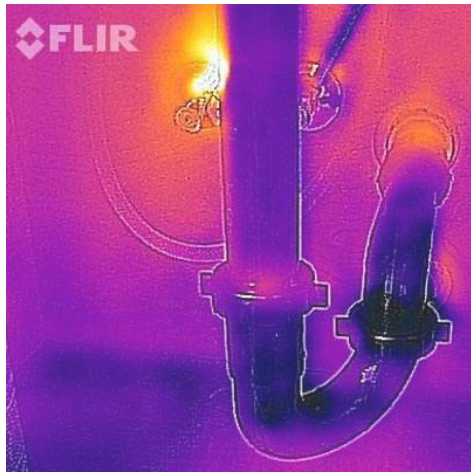
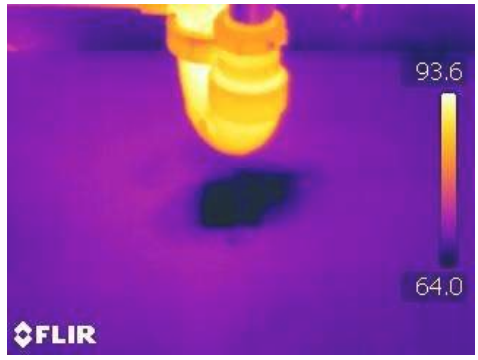
13.13.1 Counter/Cabinets

### LEAK UNDER MAIN VANITY

Moisture present under main vanity sink. Please note infrared photos.

Recommendation

Contact a qualified professional.

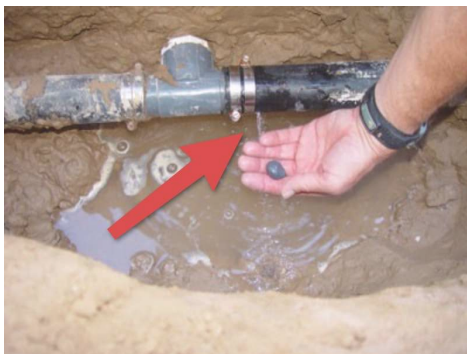
WE detected underground plumbing leaks that when the system is activated could flood the equipment area and cause electrical safety hazards.

We strongly recommend a licensed professional do these repairs!

Recommendation

Contact a qualified Swimming Pool Contractor
