PEACE OF MIND HOME INSPECTIONS

1234 Main St.
Hilmar CA 95324

Buyer Name
02/28/2019 9:00AM

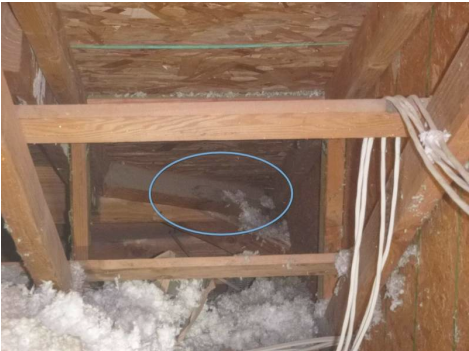
ROOF WATER STAINS

Water stains were observed on the roof structure or insulation in the attic. Periodic inspection are recommended.

Recommend monitoring.

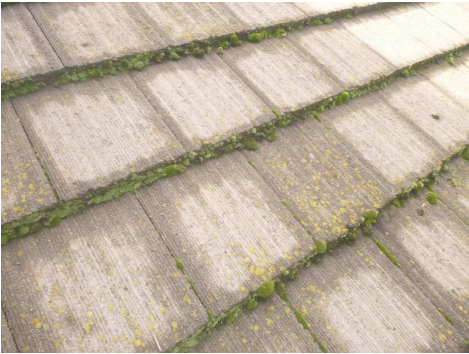
3.1.2 Sloped Roof Covering

MOSS/ORGANIC BUILD UP

Recommendation
Contact a qualified roofing professional.

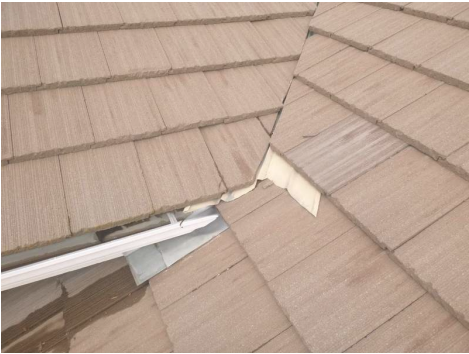
3.1.3 Sloped Roof Covering

PRIOR REPAIRS EVIDENT

Prior repairs to the roofing were evident. The client should ask the seller as to the history of these repairs.

Recommendation
Recommend monitoring.

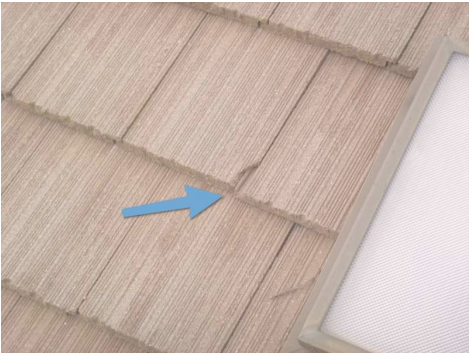
3.1.4 Sloped Roof Covering

TILE CHIPPED

Upon inspecting the roof, the corners of the roofing tile(s) was/were observed to be chipped or cracked. Chipped tiles with crack less than 3" from the bottom typically do not represent a leaking situation and repairing them typically is done for more aesthetic purposes.

Recommendation
Contact a qualified roofing professional.

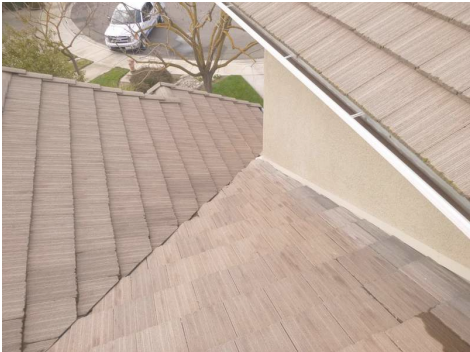
3.1.6 Sloped Roof Covering

VULNERABLE AREAS/DESIGN

The design of the roof is vulnerable to leaks. Annual inspections, repairs and ongoing maintenance (cleaning of debris and vegetation) will be critical.

Recommendation
Recommend monitoring.

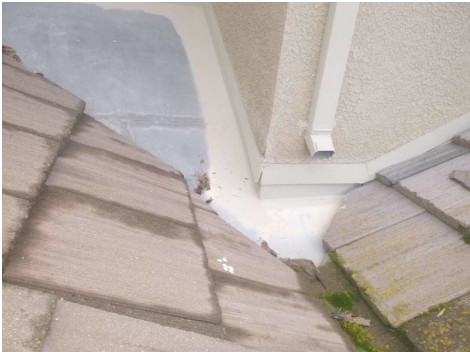
3.2.1 Flashings

HOLES/GAPS/OPENING

The roof flashing was observed to have holes, gaps or openings.

Recommendation
Contact a qualified roofing professional.

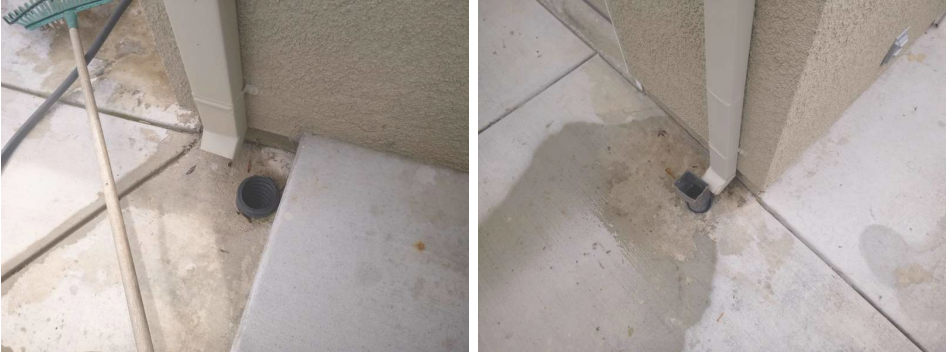
3.3.1 Roof Drainage Systems

DOWNSPOUT UNDERGROUND DRAINAGE

Recommendation
Contact a handyman or DIY project

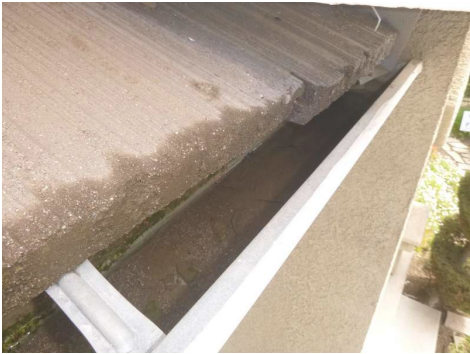
3.3.2 Roof Drainage Systems

GUTTER CLEANING

Recommendation
Contact a handyman or DIY project

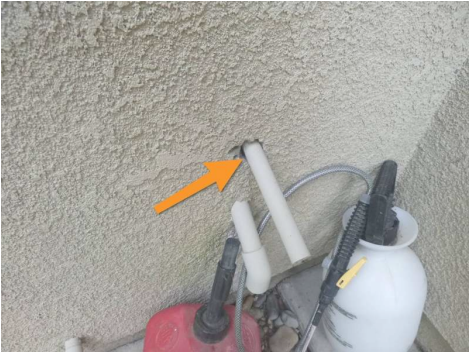
4.1.2 Siding & Trim

SIDING GAP/OPENING/HOLES
WEST

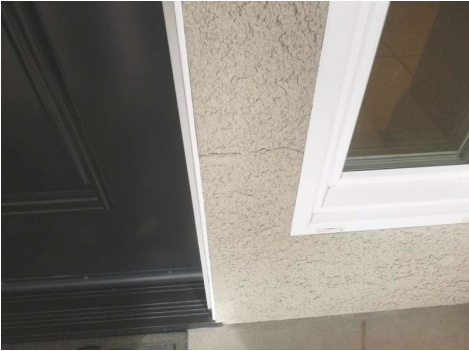
4.1.3 Siding & Trim

STUCCO CRACK

Stucco crack(s) were observed on the exterior walls of the house.

Recommend monitoring.

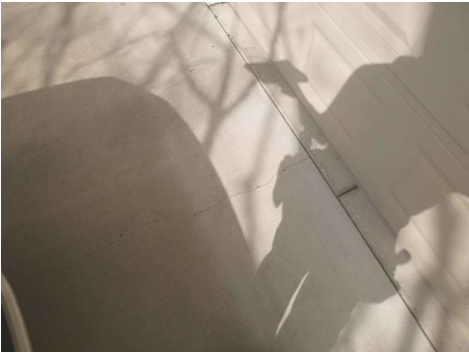
4.4.1 Walkways & Driveways

DRIVEWAY CRACKS

Cracks were observed on the driveway.

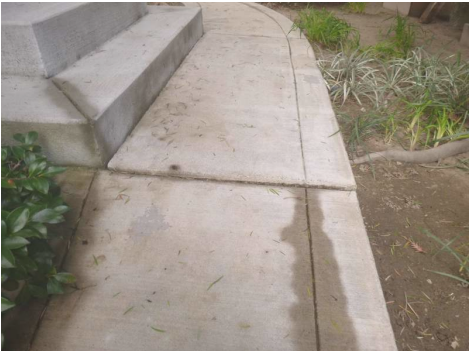
4.4.2 Walkways & Driveways

WALKWAY TRIP HAZARD

The walkway presents a trip hazard. A tripping hazard is considered to be an uneven surface or sudden or unexpected lip.

Contact a handyman or DIY project

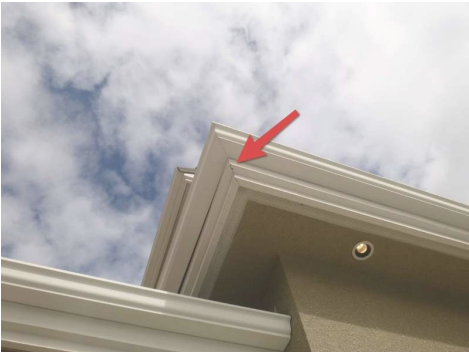
4.5.1 Eaves, Soffits & Fascia

EAVES - WATER DAMAGE TERMITE REPORT

The eaves, (fascia, sheathing and/or rafters) shows evidence of water damage/wood deterioration. The client should refer to the wood destroying pest and organism report (termite report) for all locations of wood deteriorations. The client should also contact a licensed roofing contractor further evaluate.

Contact a qualified pest control specialist.

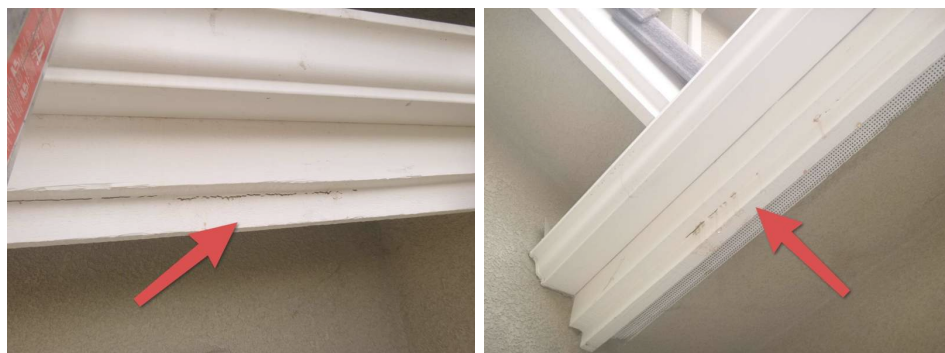
4.5.2 Eaves, Soffits & Fascia

EAVES - WATER STAIN ROOFER RECOMMENDED

Water staining was observed on the eave(s). This suggests that the roof may be leaking, the client should contact a licensed roofing contractor for further evaluation of the roofing material and repairs should be made as found needed.

Contact a qualified roofing professional.

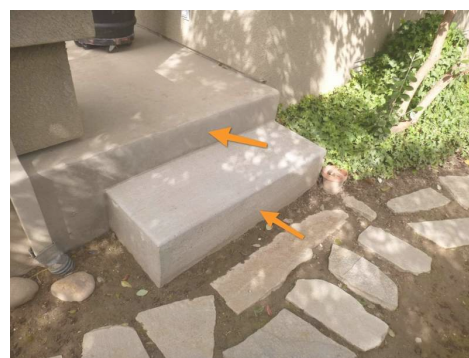
4.8.1 Porch, Stairways & Railings

STAIRS/STEPS - NOT THE SAME SIZE

The stairs/steps height or depth are not the same sizes which may pose a tripping hazard.

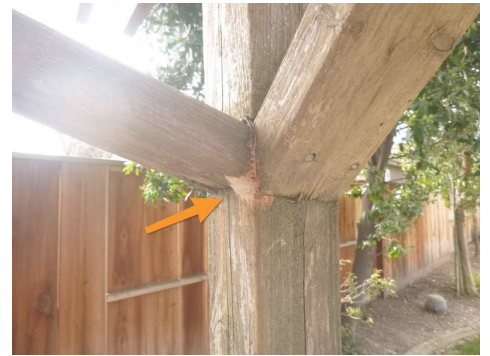
4.10.2 Covers

COVER - WATER DAMAGE

The cover shows evidence of water damage or wood deterioration.

Contact a qualified pest control specialist.

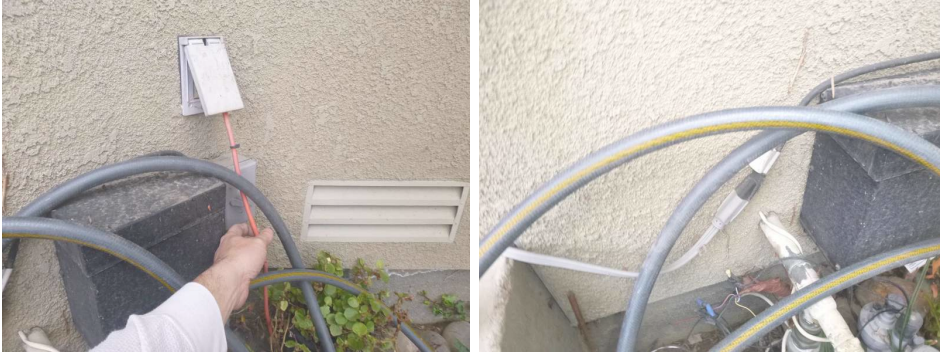
6.4.2 Branch Wiring Circuits

WIRE EXTENSION CORDS

Contact a qualified electrical contractor.

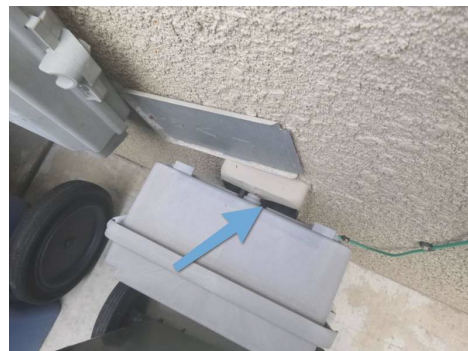
6.7.1 TV, Telephone, Door Bell

**TV/TELEPHONE COVER
MISSING/DAMAGED/LOOSE**

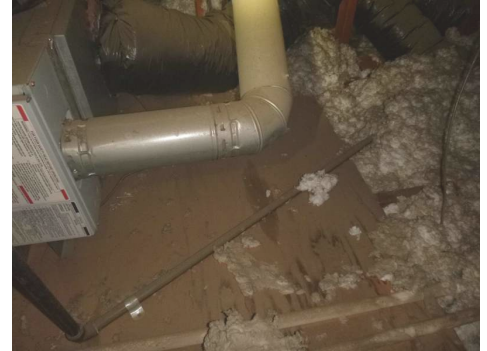
7.1.2 Heating Equipment 1st Floor

GAS NO DRIP LEG

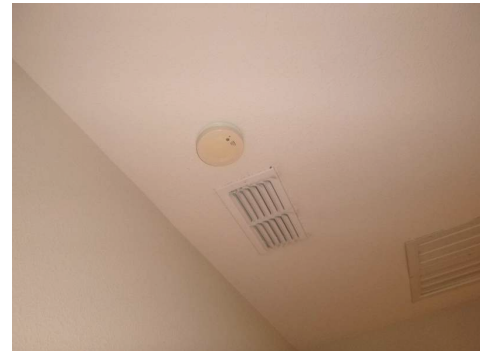
7.6.1 Distribution Systems

REGISTER NO HVAC SUPPLY

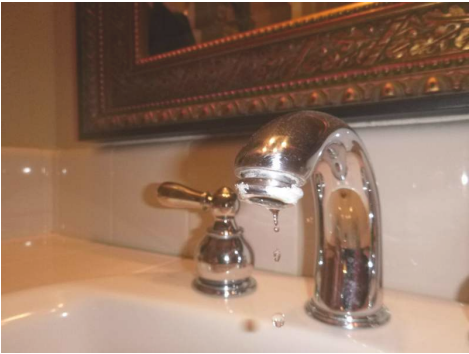
8.6.1 Sinks

SINK DRAIN LEAK
