INSPEX HOME INSPECTIONS  
Office: 725-605-5888 | Mobile: 725-222-1001  
inspex@cox.net  
<https://www.inspexgroup.com>

## PROPERTY INSPECTION REPORT

1234 Main St.  
Denver CO 80210

Buyer Name  
06/24/2019 9:00AM

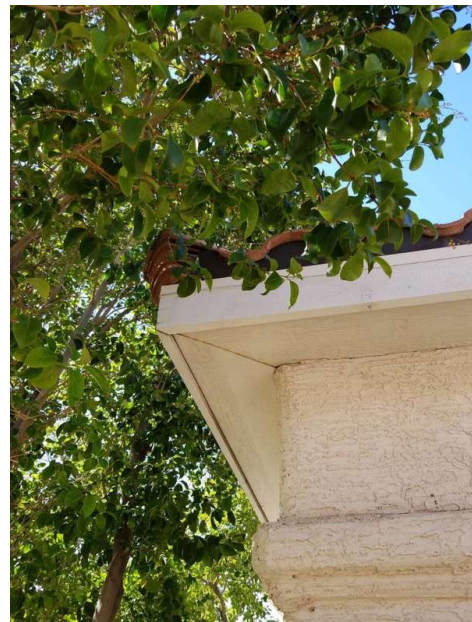
Tree branches were in contact with the roof or were close/or touching the structure at one or more locations. Damage to the building or the roof can occur, especially during high winds, or may have already occurred (see other comments in this report if applicable). Recommend that a qualified tree service contractor or certified arborist prune back the trees as necessary to prevent damage to the roof and to the building exterior.

Contact a qualified tree service company.

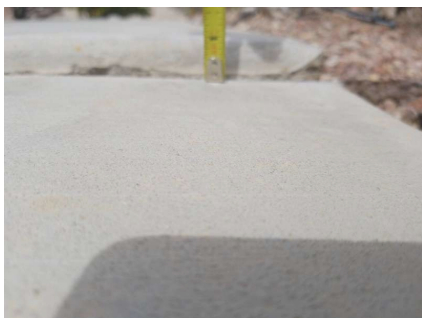
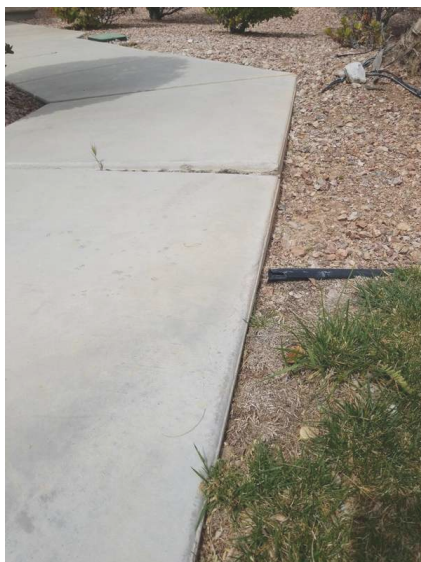
1.3.1 Driveway / Patio / Sidewalks

**SIDEWALKS / PATIOS - TRIP HAZARD**

Cracks, holes, settlement, heaving and/or deterioration resulting in trip hazards were found in the sidewalks or patios. For safety reasons, recommend that a qualified contractor repair as necessary to eliminate trip hazards.

Contact a qualified concrete contractor.

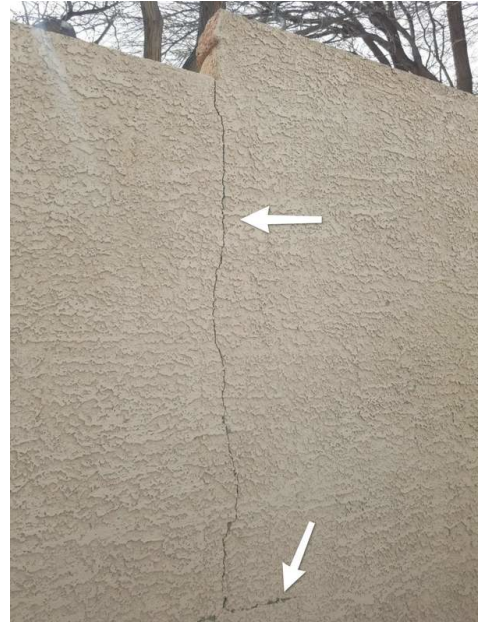
1.5.1 Fences / Gates

**PERIMETER WALL CRACKS / DETERIORATION - MONITOR**

Minor cracks, deterioration, leaning or bowing were found in one or more perimeter walls. The perimeter walls appeared to be serviceable, but recommend monitoring them in the future. Further deterioration may occur and retaining walls may need significant repairs or replacement at some point. Note that such repairs are often expensive.

Recommend monitoring.

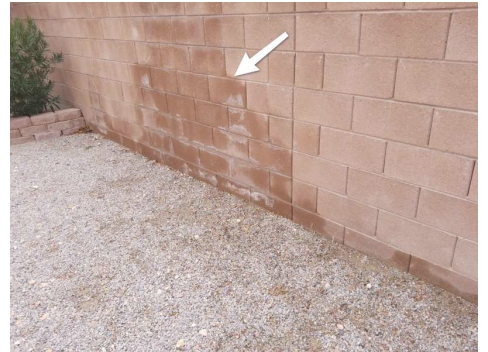
### 1.5.2 Fences / Gates

#### PERIMETER WALL - EFFLORESCENCE

Evidence of water intrusion or accumulation was found in one or more sections of the perimeter wall. Recommend that a qualified contractor evaluate and repair as necessary.

Contact a qualified professional.

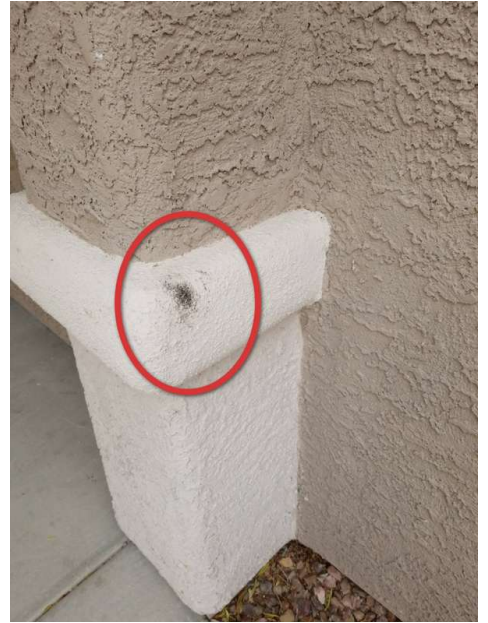
One or more holes or gaps were found in siding or trim. Vermin, insects or water may enter the structure. Recommend that a qualified person repair as necessary.

Contact a qualified handyman.

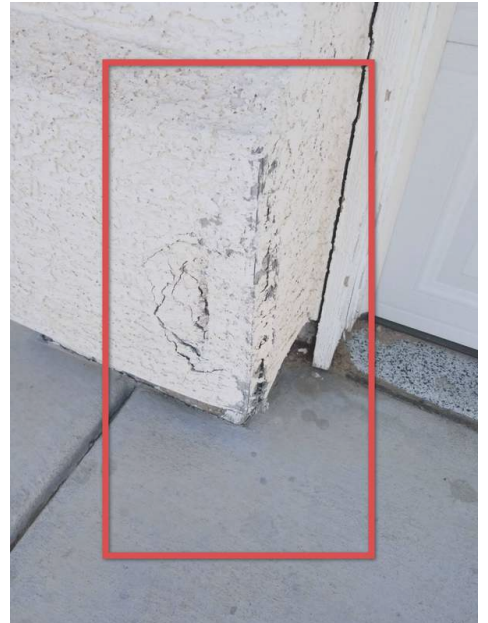
### 3.3.2 Exterior Walls / Trim

#### **STUCCO CRACK(S) / DAMAGE NEEDS REPAIR**

Cracks, deterioration and/or damage were found in one or more areas of the exterior stucco finish. In damp climates, moisture can enter cracks or damaged areas and further deteriorate the stucco. Also the wall behind the stucco can become damaged from moisture. Note that areas behind the stucco are inaccessible and excluded from this inspection. Recommend that a qualified contractor repair or replace stucco as necessary.

Contact a stucco repair contractor

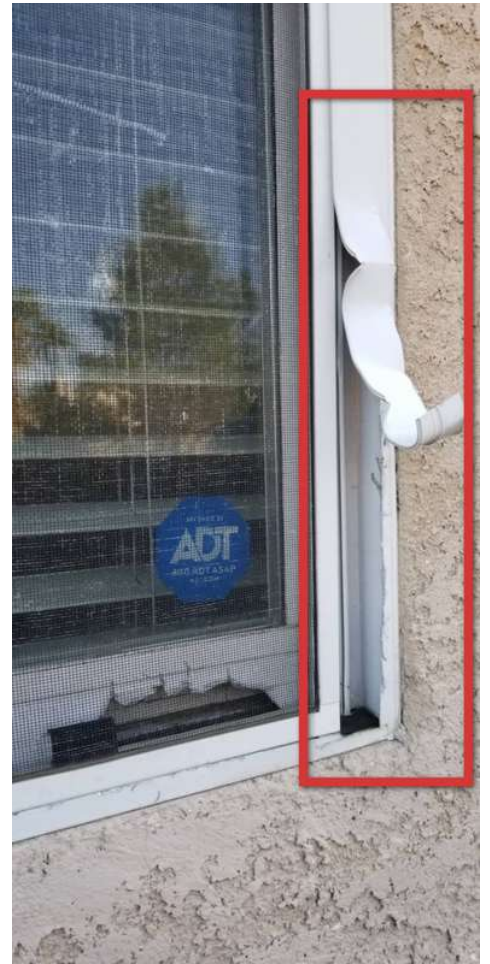
### 3.4.1 Exterior Windows

#### **WINDOW FRAME LOOSE / DAMAGED**

Window frame was damaged at one or more windows. Recommend repairs be made by a qualified contractor.

Contact a qualified window repair/installation contractor.

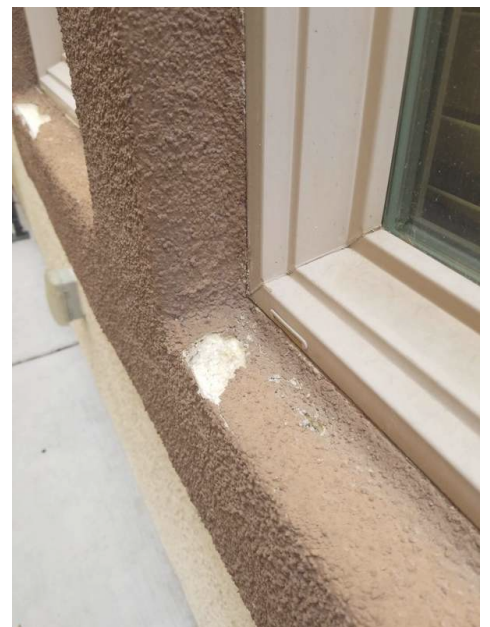
3.4.2 Exterior Windows

**WINDOW TRIM DAMAGED**

Window sill appeared to be damaged and in need of repair.  
Recommend repairs be made by a qualified licensed contractor.

Contact a qualified professional.

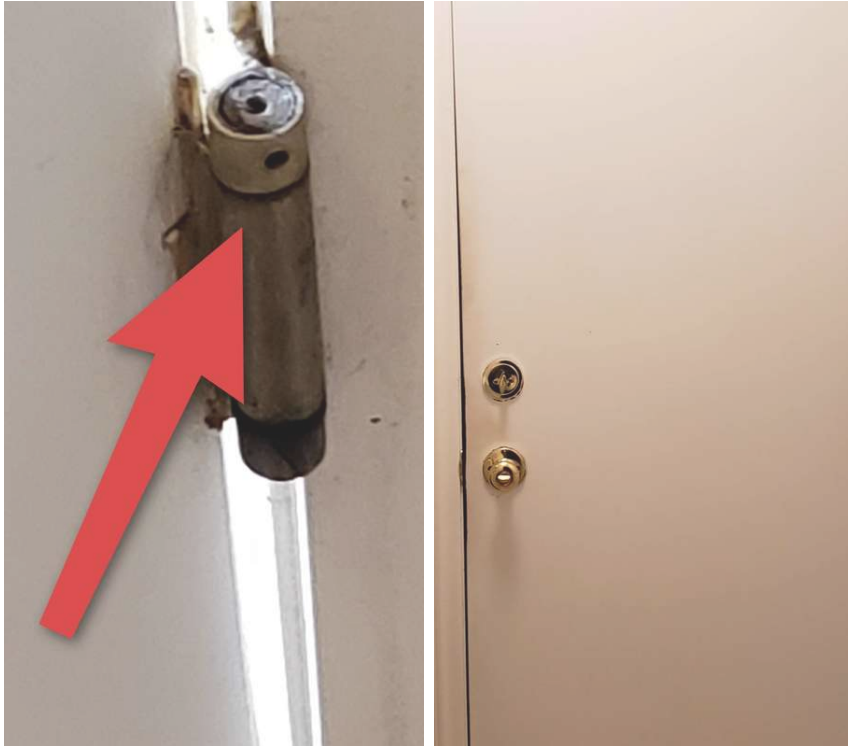
4.2.1 House Door

**SELF-CLOSING DEVICE NEEDS REPAIR OR REPLACEMENT**

The self-closing device on the door between the garage and the house didn't close and latch the door. These devices are installed to keep the door closed to prevent possible fire and fumes from the garage from spreading to the house. Recommend that a qualified person repair as necessary.

Contact a qualified professional.

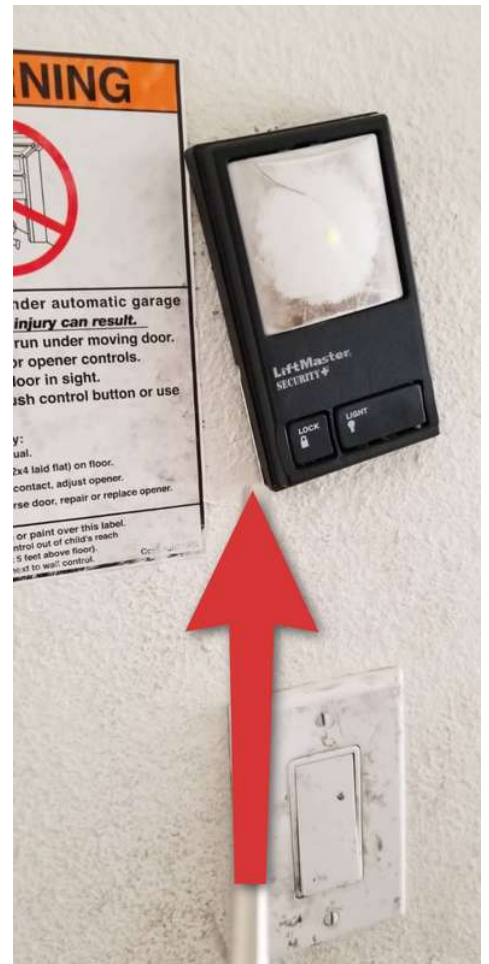
#### 4.4.1 Automatic Opener

### CONTROL LOOSE

The control button or panel for operating one or more automatic garage vehicle door openers was loose. A qualified person should repair as necessary so buttons or control panels are securely attached to wall surfaces.

Recommended DIY Project

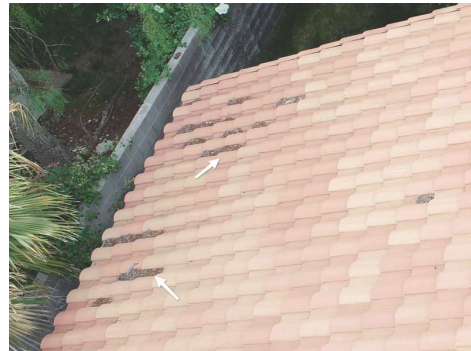
Debris such as leaves, needles, seeds, etc. have accumulated on the roof surface. Water may not flow easily off the roof, and can enter gaps in the roof surface. Leaks can occur as a result. This is a conducive condition for wood-destroying organisms. Recommend cleaning debris from the roof surface now and as necessary in the future.

Contact a qualified roofing professional.

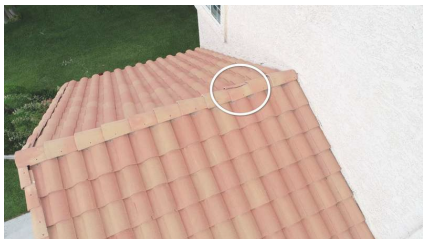
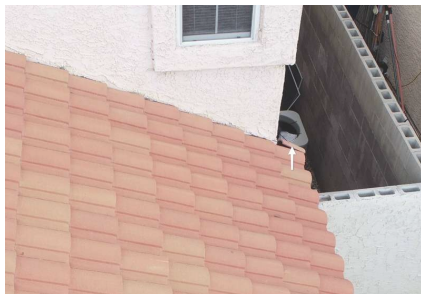
5.2.2 Roof Coverings

**ROOF TILES CRACKED, BROKEN OR LOOSE**

Roof tiles were cracked, broken or loose. Leaks may occur as a result. This is a conducive condition for wood-destroying organisms. Recommend that a qualified person replace tiles or make repairs as necessary.

Contact a qualified roofing professional.

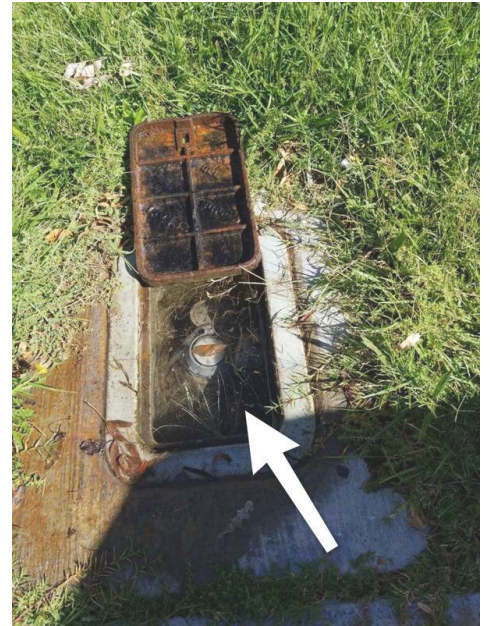
#### WATER METER LEAKING

The water was leaking at the water meter. Recommend that a qualified plumber repair or replace the valve as necessary.

Contact a qualified plumbing contractor.

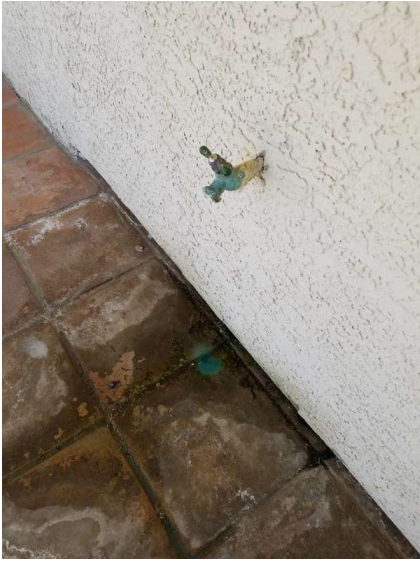
### 6.3.1 Supply Lines

#### HOSE BIB MISSING BACKFLOW PREVENTER

One or more hose bibs were missing backflow prevention devices. These devices reduce the likelihood of gray water entering the potable water supply. Recommend installing backflow prevention devices on all hose bibs where missing. They are available at most home improvement stores and are easily installed.

Contact a handyman or DIY project

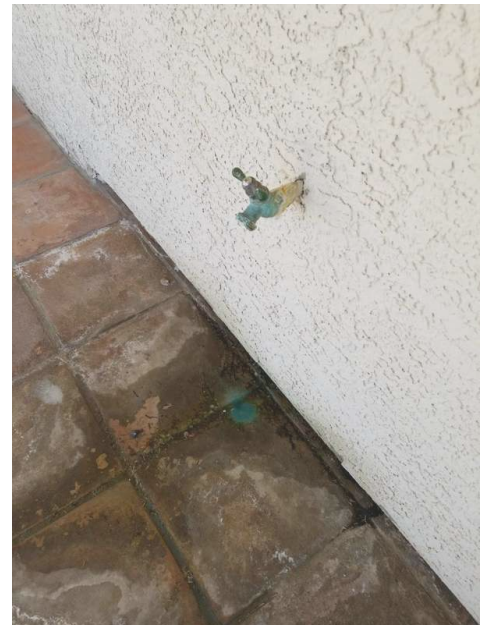
### 6.3.2 Supply Lines

#### HOSE BIB LEAKED WHILE OFF

One or more hose bibs (outside faucets) leaked while off. When hose bibs leak while turned off, it's often caused by a worn valve seat or a loose bonnet. Recommend that a qualified plumber repair as necessary.

Contact a qualified plumbing contractor.

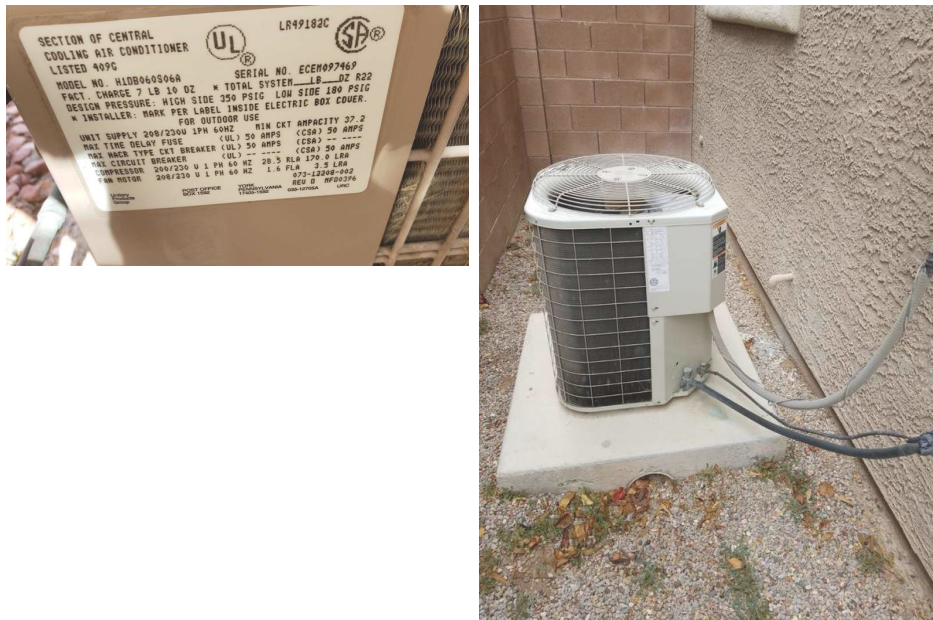
**Air Conditioner: Equipment Photos**

The temperature split differential between the return air and supply registers was within the 14-22 degree (F) range at time of inspection.

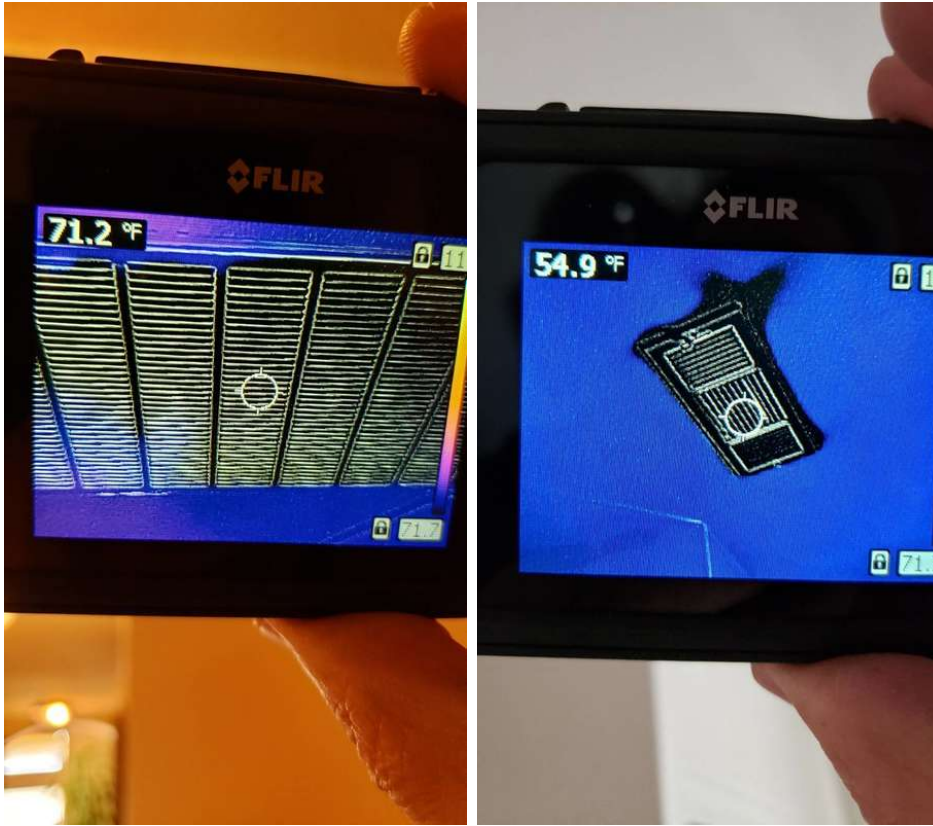
The photo(s) below is/are a thermal image of the air temperature at supply and return air register(s) at the time of this inspection.

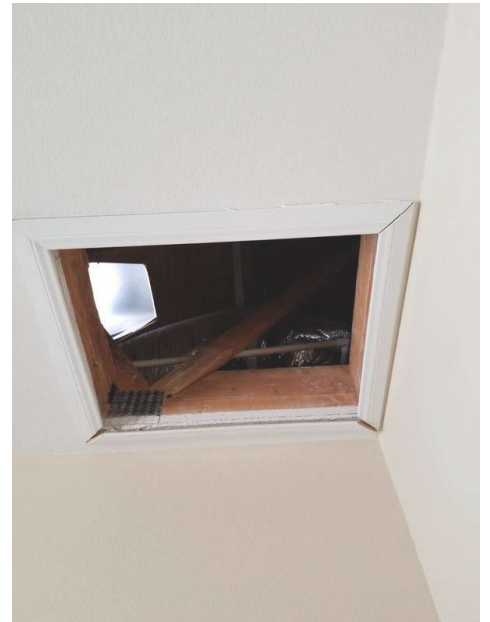
## 9.1.1 Attic Access

## Recommendation

Contact a handyman or DIY project

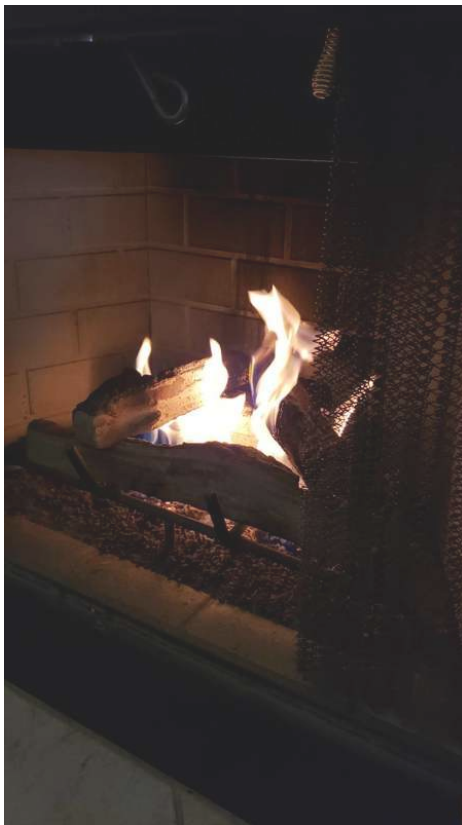
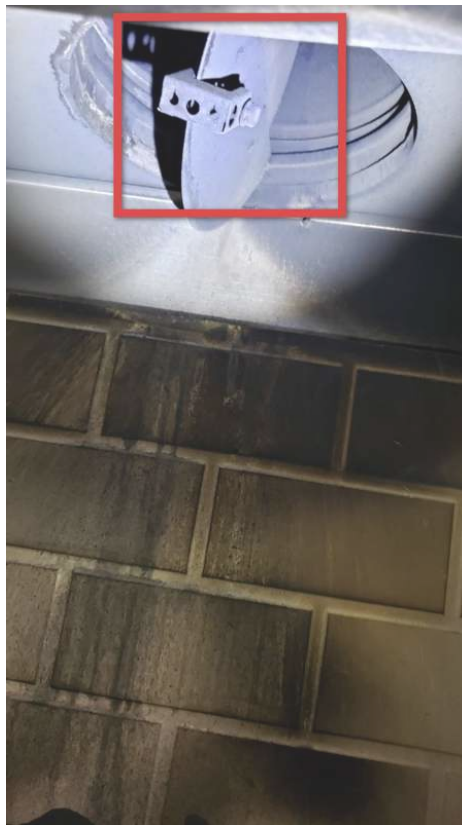
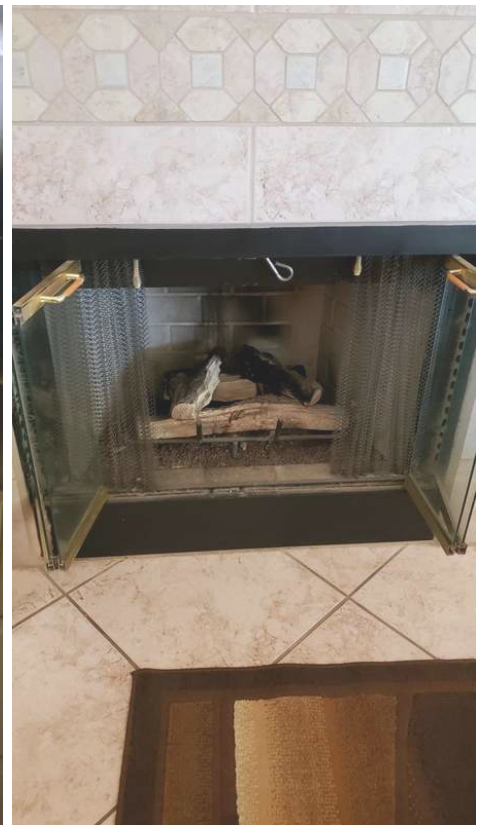
### Fireplaces, Stoves & Inserts: View of Gas Fireplace and/or Pellet Stove During Operation

A damper clamp was present. Damper clamp function is to prevent the damper from ever closing.

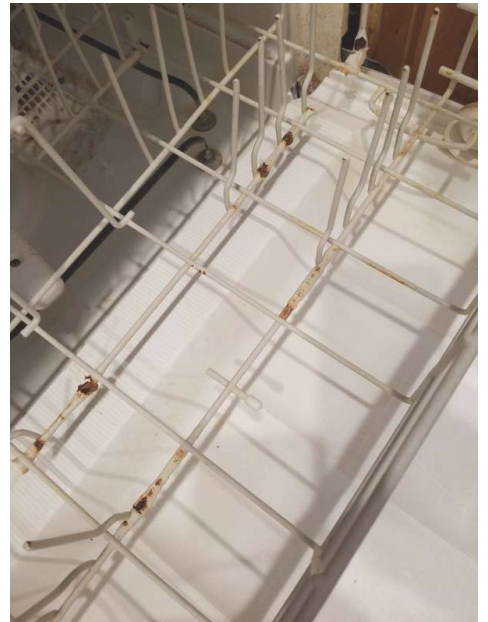
14.5.1 Dishwasher

**INTERIOR PARTS MISSING / DAMAGED**

Contact a qualified professional.

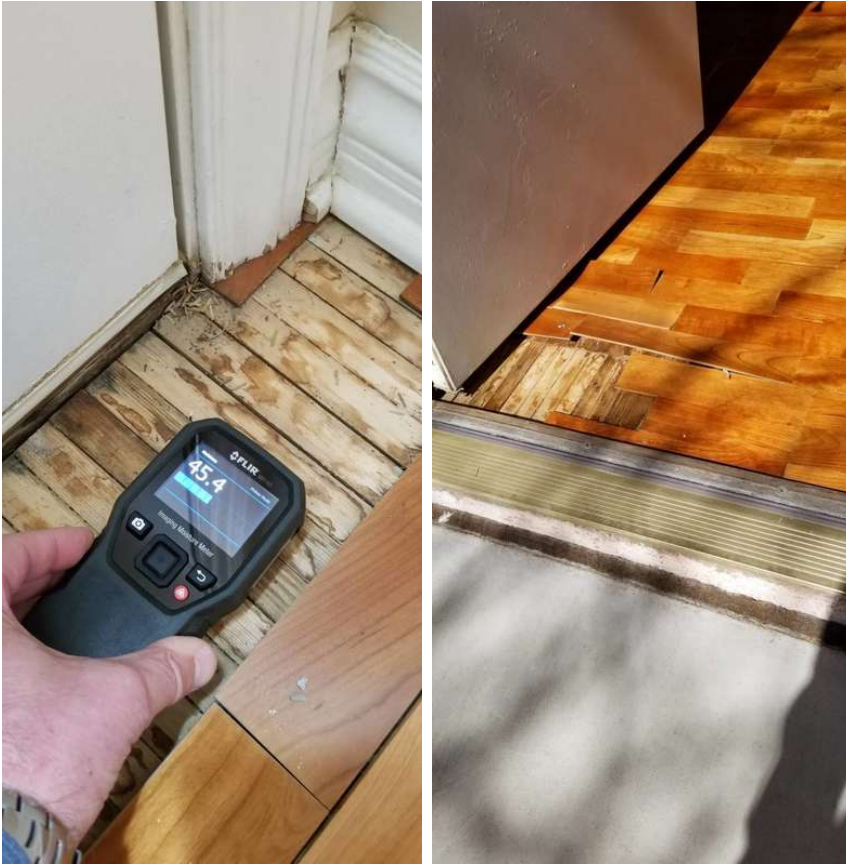
15.2.2 Floors

**WOOD FLOOR DAMAGED**

Contact a qualified flooring contractor

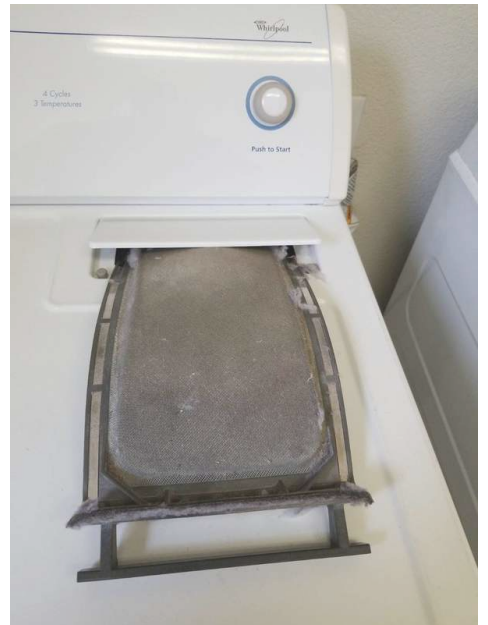
16.1.2 General

**LINT SCREEN NEEDS CLEANING**

Contact a qualified professional.
