RESIDENTIAL INSPECTION REPORT - MAIN HOUSE

1234 Main St.
Yreka CA 96097

Buyer Name
03/21/2019 9:00AM

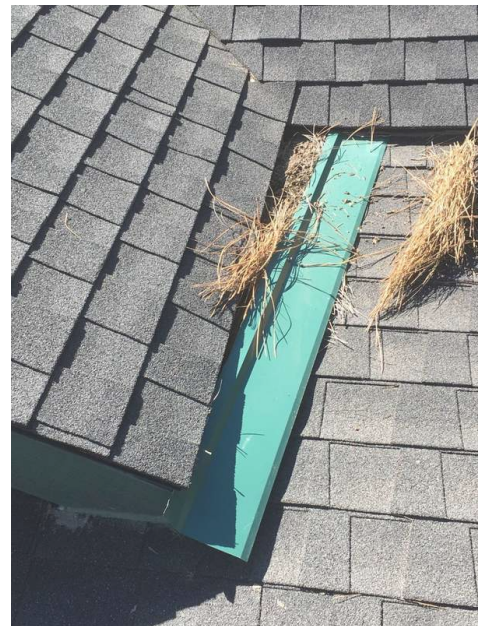
LOOSE/SEPARATED

Flashings observed to be loose or separated, which can lead to water penetration. Recommend repair.

Contact a qualified roofing professional.

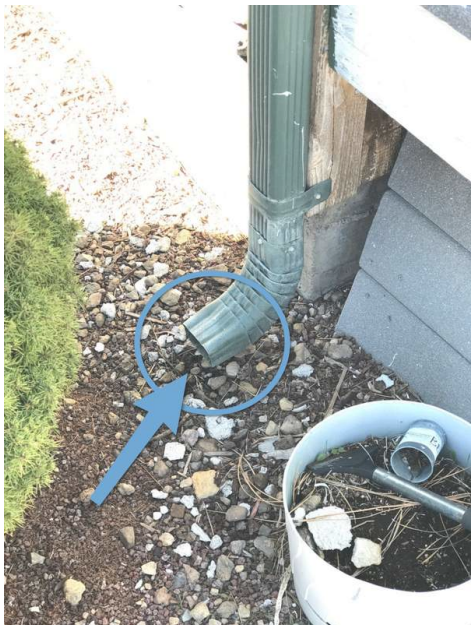
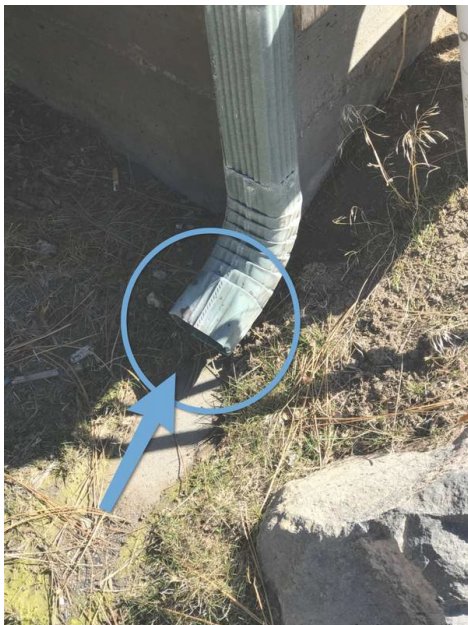
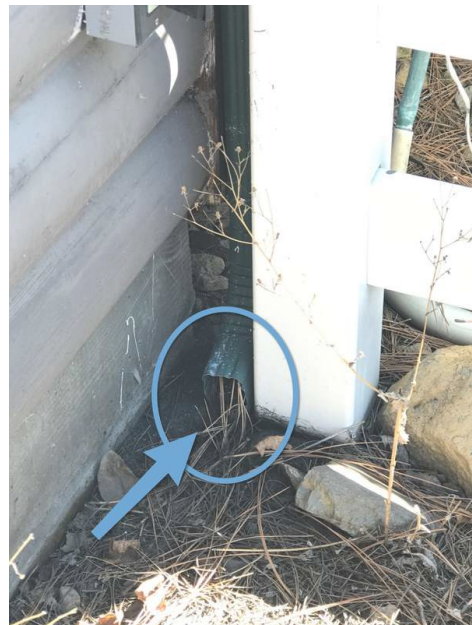
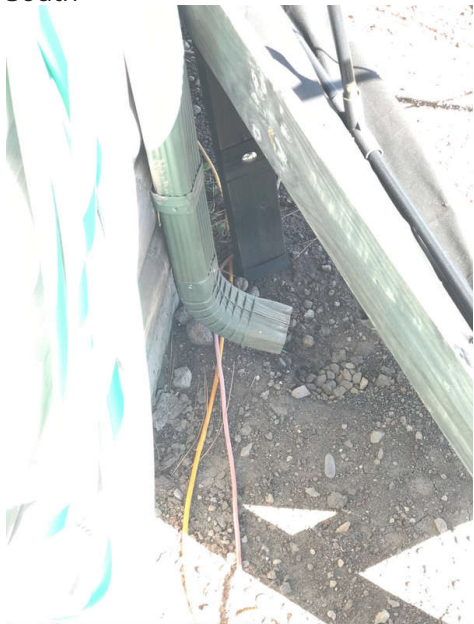
2.6.1 Roof Drainage System

One or more downspouts were observed to terminate (discharge or drain) too close to the foundation. This can result in excessive saturation of the soil around the foundation, which can lead to foundation deterioration, damage and structural movement. Recommend installing downspout extensions to direct water at least four feet from the foundation.

Contact a handyman or DIY project

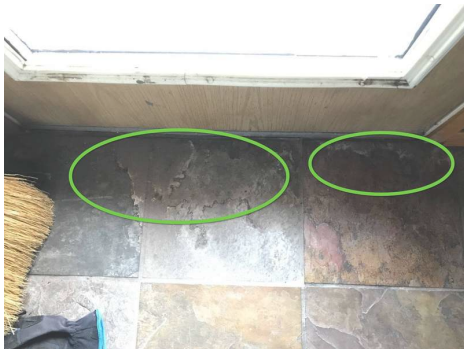
Exterior South Utility/Laundry Room

Doors: Possible Water Penetration

Evidence of possible water penetration at South facing exterior door in laundry room. This does not appear to be due to a construction or door deficiency, and is due to ordinary storm activity. There is not much that can be done to correct this beyond constructing a cover over the door to protect it from storm activity.

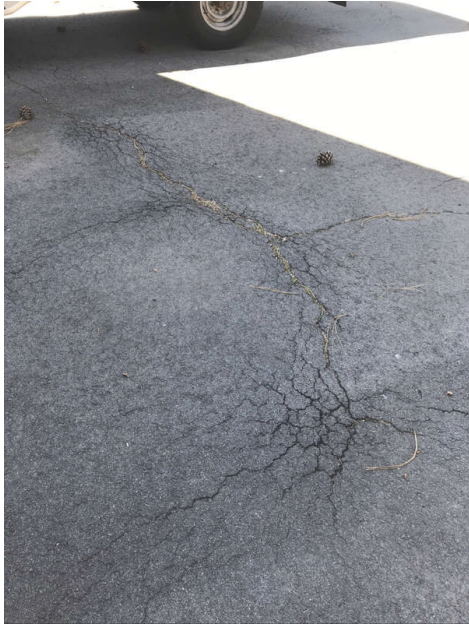
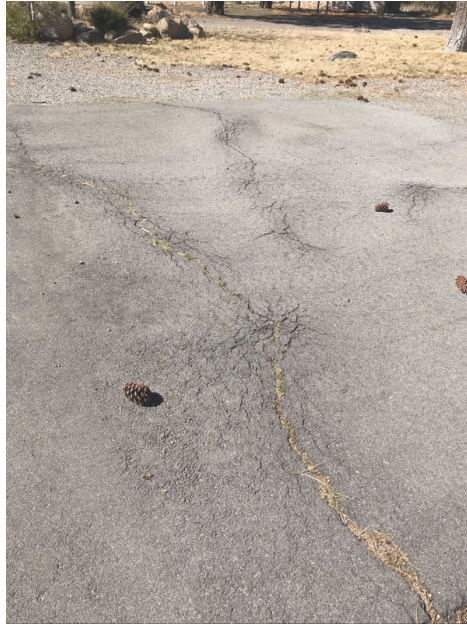
North

ASPHALT DAMAGE

Cracks were observed in asphalt driveway apron that appeared to be caused by tree roots. Repair will entail removing the tree and repaving driveway apron.

Contact a qualified professional.

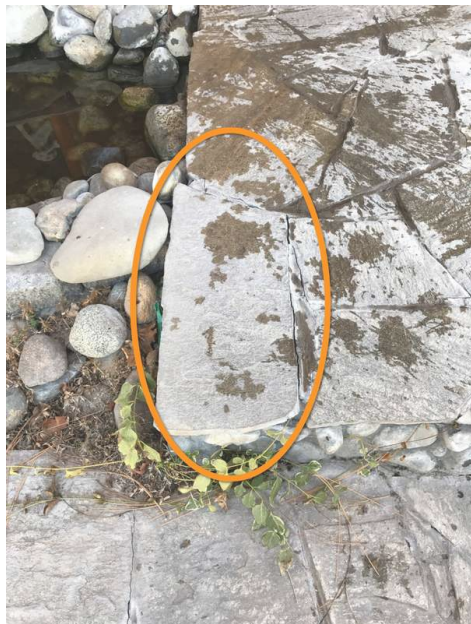
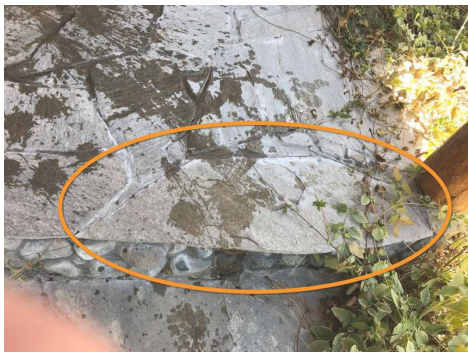
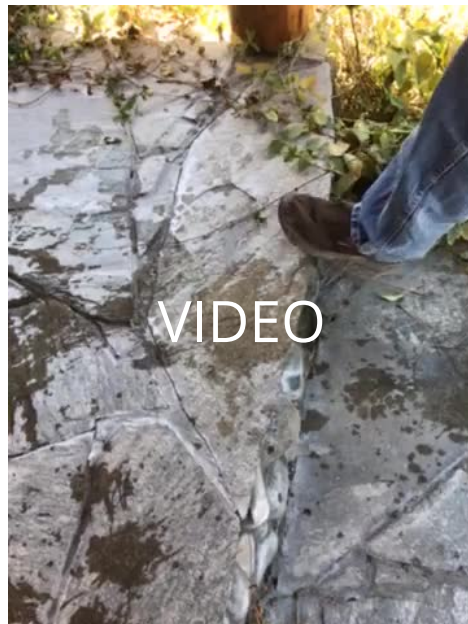
North

DAMAGED

Damaged areas of the walkway were observed. These areas may be a tripping/injury hazard and should be repaired.

Contact a qualified professional.

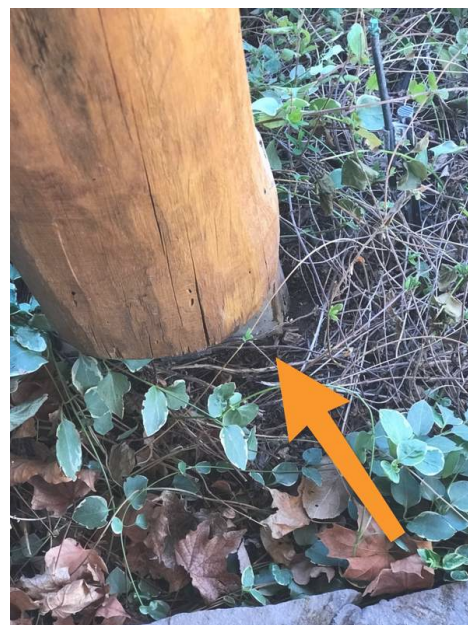
North

DETERIORATED - WOOD ROT

The structural post was observed to have a small area of moisture damage with wood rot (dry rot.) Recommend repair.

Dry Rot: Wood rot/dry rot is caused by biological fungal organisms that require a certain amount of moisture to thrive. The fungus digests the parts of the wood that give the wood strength and stiffness. Scraping or painting only, will not stop dry rot from continuing to infiltrate the wood and compromise its integrity.

Treating and preventing dry rot is a three-step process. Step 1 is to locate and stop the source of the moisture. Step 2 is to remove and replace any damaged wood that has become structurally weakened. Step 3 is to treat new and existing wood with borate wood preservative to prevent growth of the dry rot fungus and kill any fungus already in the wood.

Contact a handyman or DIY project

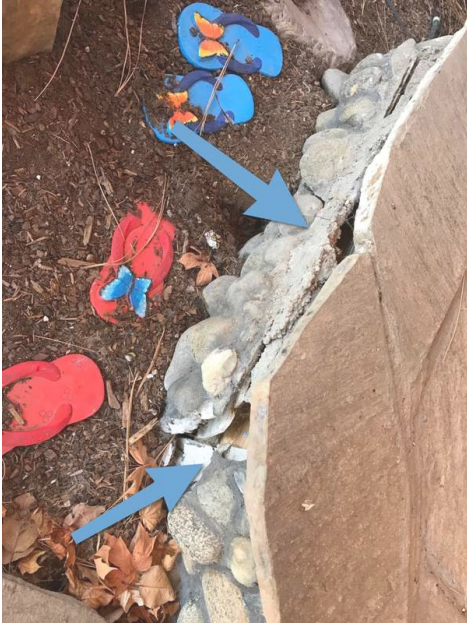
North

DETERIORATION OR DAMAGE

One or more areas of damage or deterioration was observed in the veneer treatment. Recommend repair.

Contact a qualified professional.

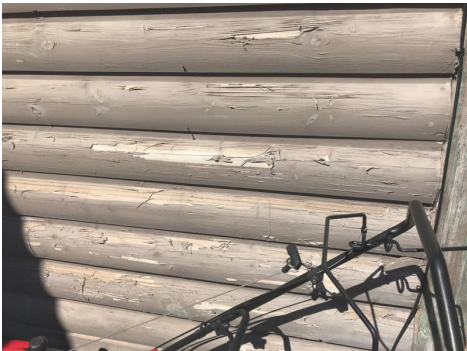
South

The wood log veneer siding was observed to be have one or more areas of deteriorated, missing, peeling paint, or seal. This will allow moisture penetration that will further deteriorate siding. Additionally, all areas where cracking (or checking) is present should be sealed before painting. Recommend re-painting or sealing house siding.

Contact a qualified painting contractor.

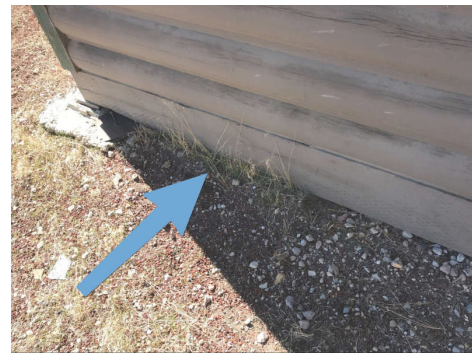
East

GROUND CONTACT

Inadequate clearance between siding and/or trim and ground was observed, with deterioration and/or damage present. Recommend a minimum ground clearance between bottom of siding and ground of 6" to 8". Siding was observed to be in contact with ground, with evidence of wood rot (dry rot). Wood that touches the ground/soil will wick moisture and start to deteriorate. This also sets up ideal conditions for dry rot to damage wood, and invites wood destroying pests. Recommend soil be pulled away from all trim for a minimum ground clearance between bottom of trim and ground of 6" to 8" and replace and treat areas of dry rot, as necessary.

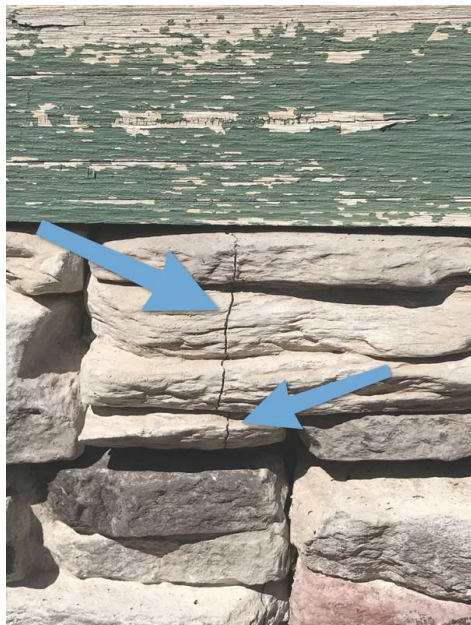
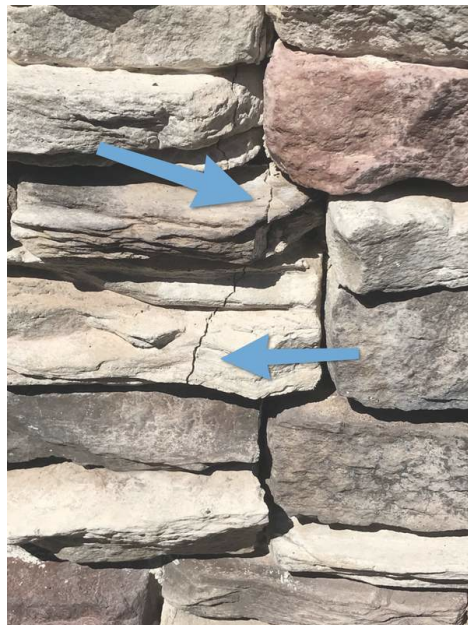
South (Stress Crack)

MINOR CRACKS

Small stress cracks were observed in masonry siding. This type of crack can occur due to stress, age, damage, settling over time and other causes. These were not, at the time of inspection, observed to be compromising the integrity of the siding; however, due to water penetration, which will contribute to and hasten deterioration, it is recommended that these cracks be sealed.

Contact a qualified professional.

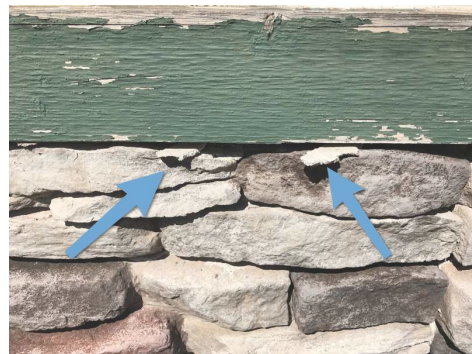
South (Mortar Deterioration)

Additionally, the mortar in some areas was observed to be deteriorating and falling away. This can happen with normal shrinkage and the quality of the mortar. Recommend these areas be repaired, as necessary.

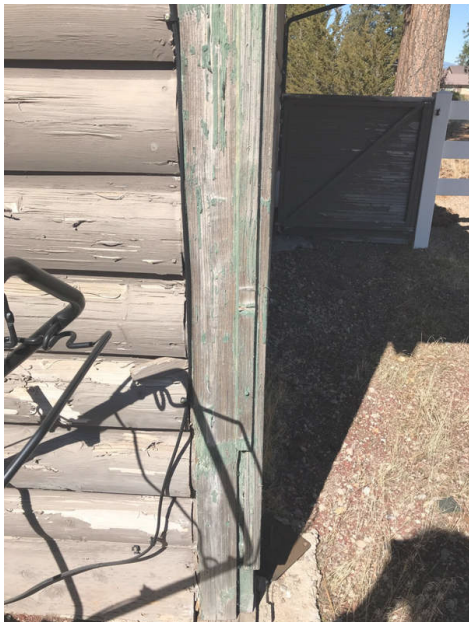
Southeast

Trim was observed to have deteriorated, peeling, missing paint, or seal. Trim that is unsealed and open to weathering will deteriorate and be vulnerable to wood rot (dry rot) conditions. Trim functions as more than an aesthetic accoutrement to the house structure. Trim is an important part of protecting the house structure from water and pest infiltration. Recommend painting or sealing all trim.

Contact a handyman or DIY project

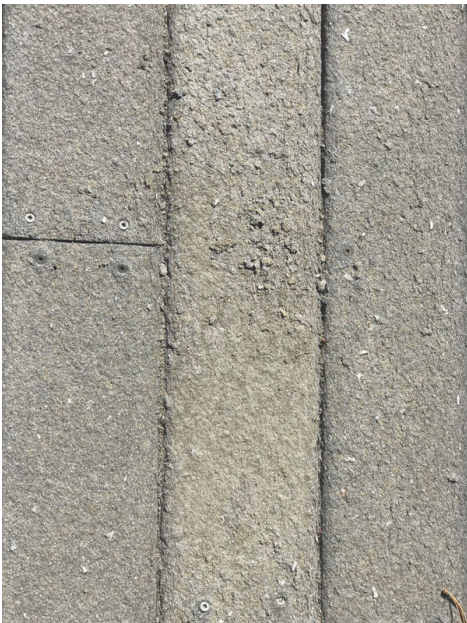
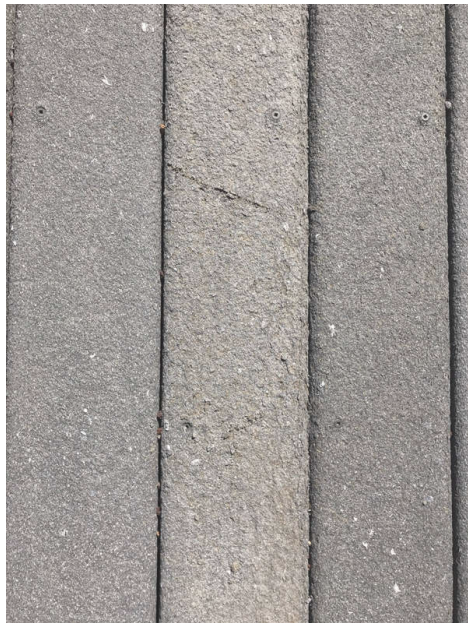
South

Trex Company Re-announces to Consumers the Replacement Program for Defective Decking Manufactured between 2002 and 2007 for Sale in the Western United States

Trex is issuing this re-announcement notice because boards exhibiting the surface flaking defect may continue to deteriorate over time and ultimately break, posing a safety hazard. Trex has received reports of step-through incidents that have occurred as a result of boards that have not been replaced. These incidents have not involved significant injury, however, the potential for serious injury exists if deteriorating boards are not replaced on a timely basis.

Trex strongly encourages homeowners in the western United States to closely examine their decks, particularly in high traffic areas, for any signs of cracking or peeling. If a homeowner notices evidence of flaking or board deterioration, they should contact Trex immediately and participate in the established replacement program.

Contact a qualified professional.

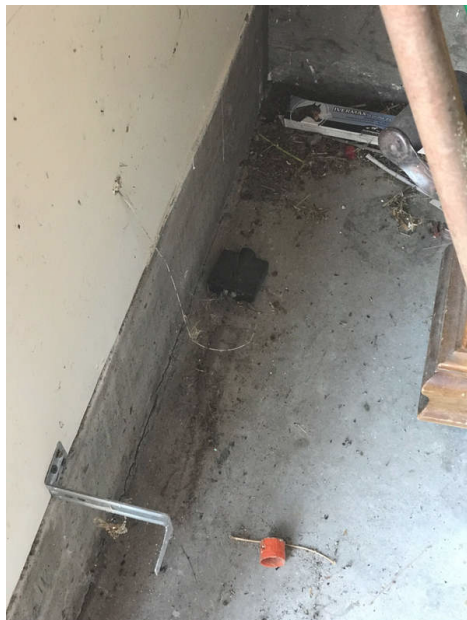
Garage

Deficiency Observed**AUTO REVERSE**

The auto reverse was missing or the sensor was not responding at time of inspection. This is a safety concern for children and pets. Recommend checking alignment of sensors and repair/replace, if necessary.
