BEE SURE HOME INSPECTION SVCS.

BEE SURE HOME INSPECTION - INTERNACHI RESIDENTIAL TEMPLATE  
COPY

1234 Main St.  
Grayslake Illinois 60030

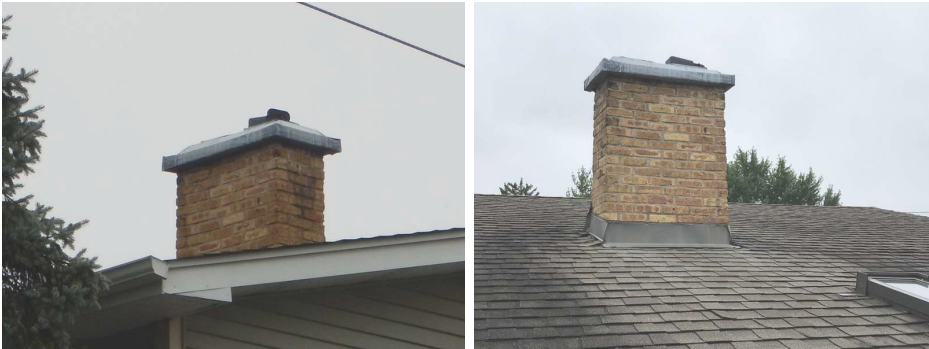
Chimney cap or crown appears to have been wrapped in either sheet metal or an EPDM type membrane. Unable to identify the specific cap material or condition from the eave area.

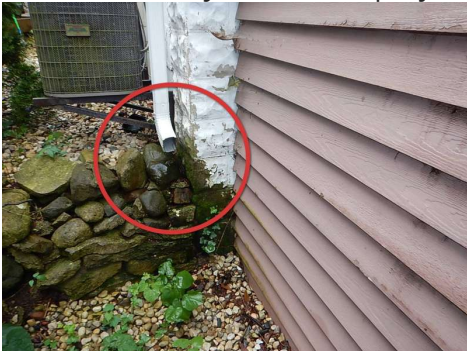
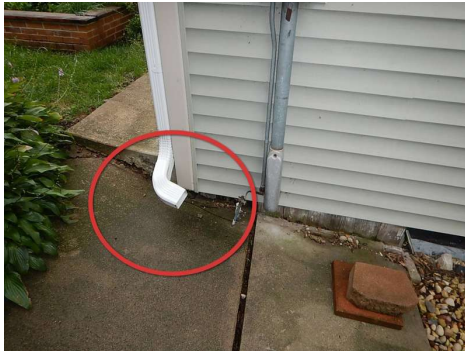
gutters and downspouts

Downspout Extension Too Short

Contact a handyman or DIY project

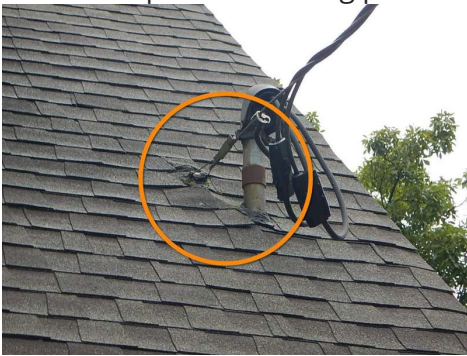
### 3.4.2 Flashings

## NO FLASHING, SEALANT ONLY

sealant / tar applied around roof penetrations, may be vulnerable to future leakage

Recommendation

Contact a qualified roofing professional.

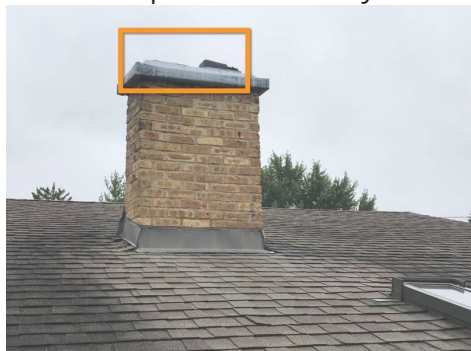
Fireplace flue appears to have no spark arrestor

Contact a qualified chimney contractor.

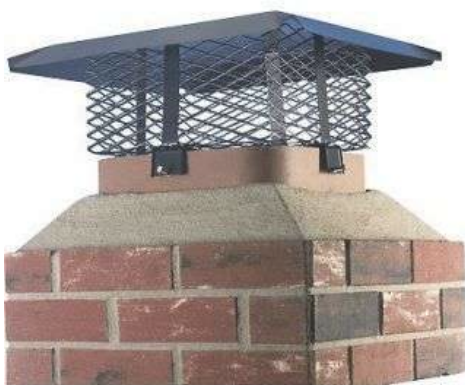
cap and spark arrestor

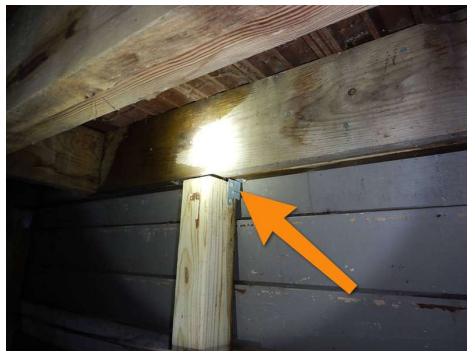
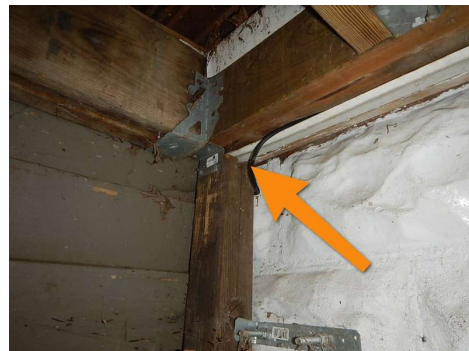
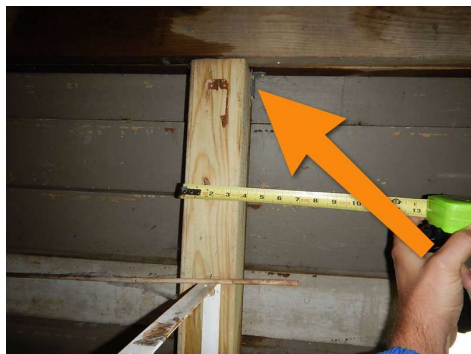
Post to Beam Attachment

Contact a qualified deck contractor.

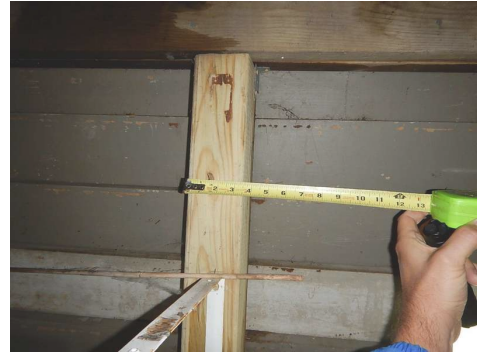
It appears that the elevated deck structure is being supported by posts or columns which may be undersized according to modern accepted deck construction standards. It is recommended that the support posts be upgraded to a larger dimensional lumber size for added safety and support of the deck structure. Though these sized columns or posts may have been widely accepted during the era of construction for this deck, current modern accepted building and safety standards call for larger dimensional lumber (minimum 6"x6") to be used in this application. Consult with a qualified deck repair professional for further evaluation / repair / or replacement.

#### Recommendation

Contact a qualified deck contractor.

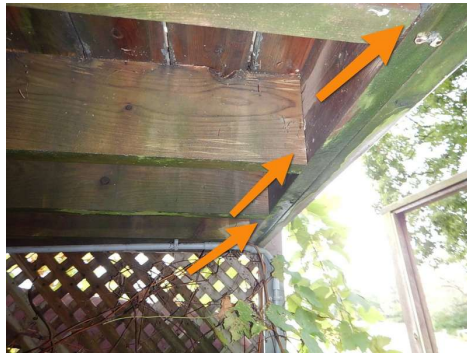
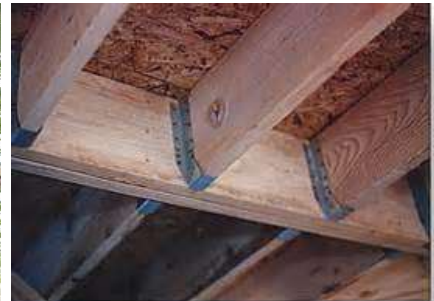
Joist Hangers

Contact a qualified deck contractor.

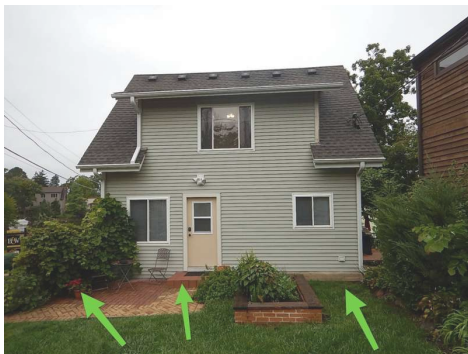
negative grading @ East side of home

Recommendation

Contact a foundation contractor.

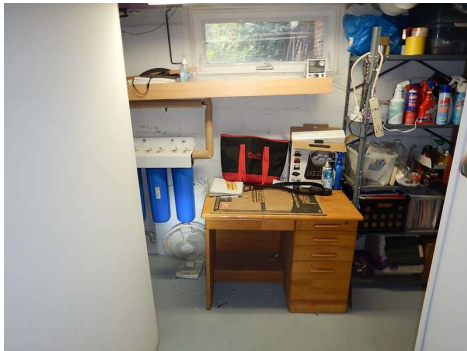
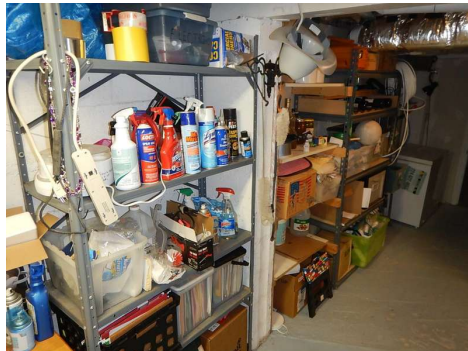
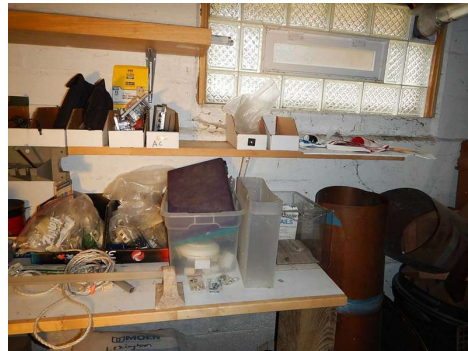
Stored items in the unfinished area of the basement or crawl space prevented full view of the foundation walls. It is recommended prior to your closing, and after the owner has removed their belongings, that you observe the exposed foundation walls for any signs of cracks, leakage, discoloration, or staining.

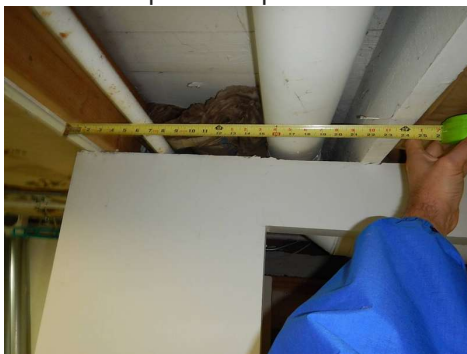
Visible sagging of floor joists in the basement appeared to be the result of inadequate engineering design (overspanning or undersizing of the joists). You may wish to consult a qualified contractor / framing professional to determine the cost of any needed corrections. This condition is not uncommon in older / historic homes as building practices were not on par with modern construction and engineering designs. As a result of the overspanned or undersized joists, some floor areas in the home may show signs of minor sloping or unevenness, or minor cracking may be observed in some wall or ceiling surfaces.

joists span 24" O.C. - modern dimensional lumber floor framing typically will span 16" O.C., by today's standards, 24" O.C. spacing is considered "overspanned"

Contact a qualified professional.

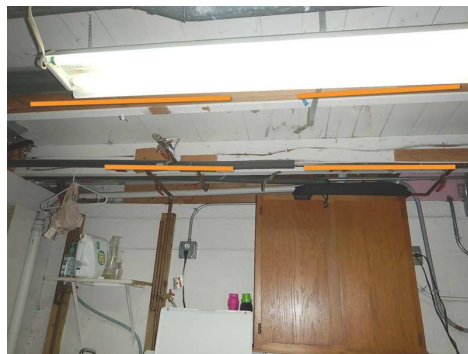
one area where minor sagging was observed at North end of basement

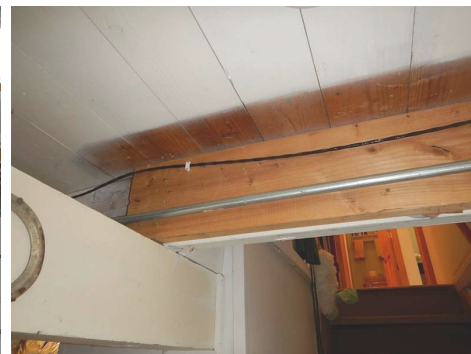
a "sistered" joist repair to solidify the floor structure

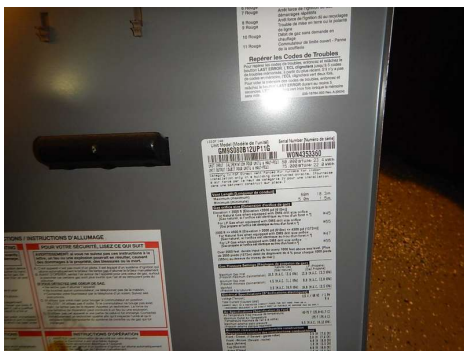
According to the manufacturers data plate, this furnace was manufactured in 2004 and has a 80K BTU capacity. A well maintained gas forced air furnace unit can expect on average 15-20 years of service life.

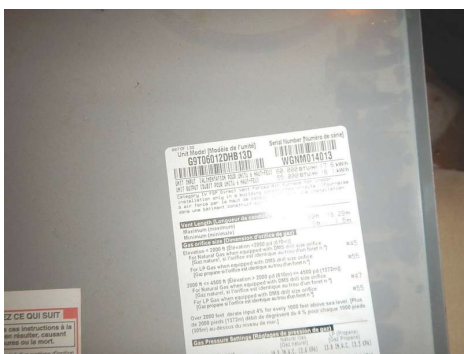
Attic

According to the manufacturers data plate, this furnace was manufactured in 2004 and has a 60K BTU capacity. A well maintained gas forced air furnace unit can expect on average 15-20 years of service life.

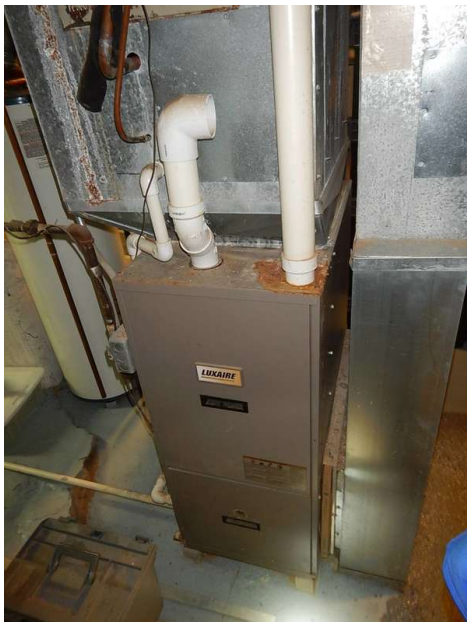
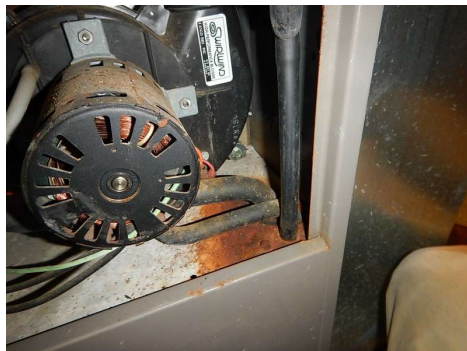
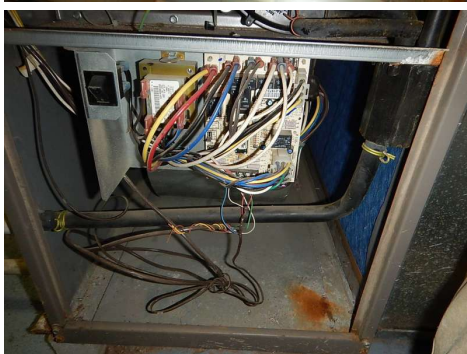
There was rusting and corrosion visible inside the furnace cabinet which suggests leakage may be occurring or has occurred in the past from condensate drainage systems.

Contact a qualified HVAC professional.

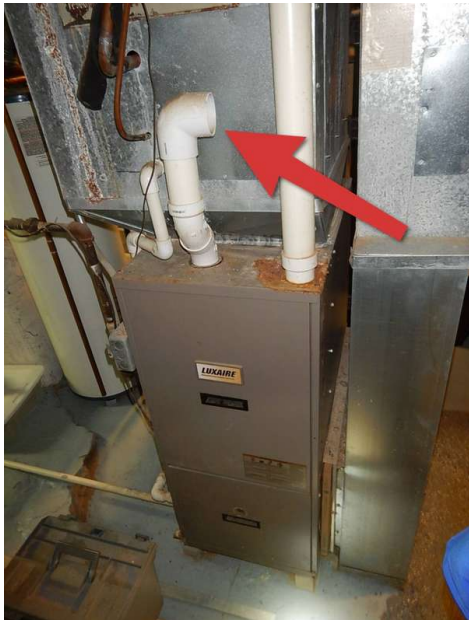
### 6.1.2 Equipment 1- Basement

## HIGH EFFICIENCY FURNACE - OBTAINING COMBUSTION AIR FROM INDOORS

Significant and/or Safety Concern

melted and scorched plastic bushing near water heater draft hood, indicative of back drafting condition

combustion air inlet for high efficiency furnace - recommend obtaining all combustion air from the exterior of the home

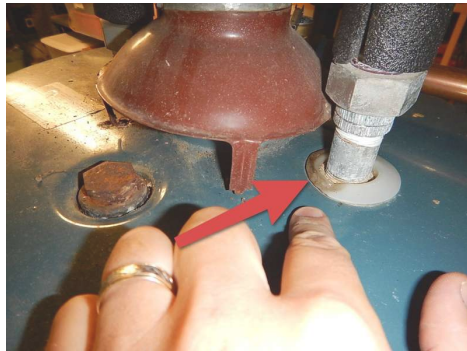
Obtaining combustion air from indoors may be causing some negligible negative pressure inside the home, and may be a contributing factor to the water heater showing signs of back drafting. It is recommended that you consider installing proper piping to obtain combustion air from the exterior of the home to aid in proper venting of flue gases from the water heater.

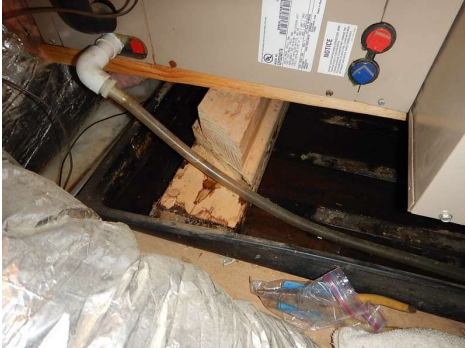
The installed condensate drain line on the HVAC unit is improperly installed. The line must be provided with a trap and a clean out. Recommend correction to the drain line from qualified HVAC professional.

Contact a qualified HVAC professional.

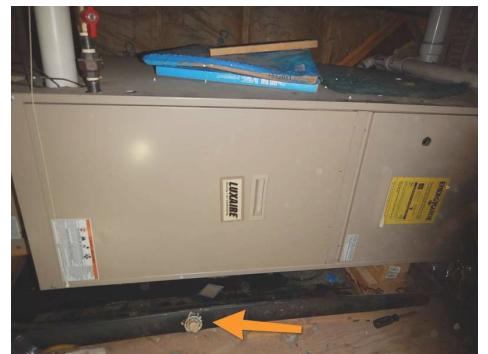
The catch pan installed beneath this furnace does not appear to have been plumbed to the household drain system. This leaves the home at risk for possible water damage due to a leaking furnace or air conditioning system. Recommend correction from a qualified HVAC professional.

drain for the catch pan has not been plumbed into the household drain systems

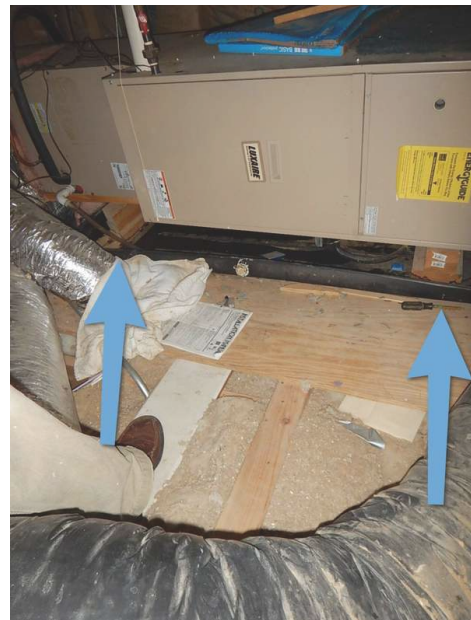
furnace rests on ceiling framing

Recommendation

Contact a qualified HVAC professional.

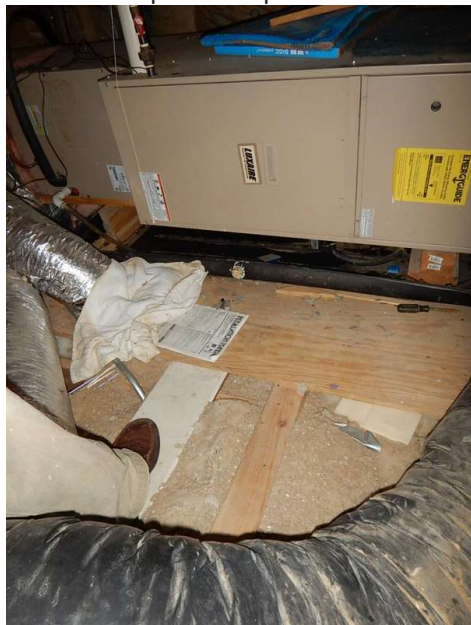
6.2.5 Equipment 2 - Attic

installed pathway and service platform are inadequate and pose a hazard

Recommendation

Contact a qualified professional.

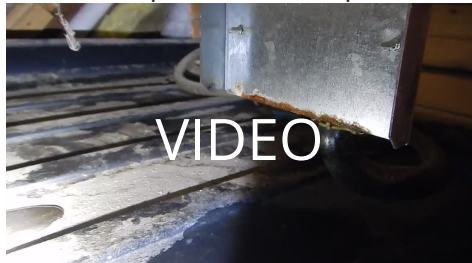
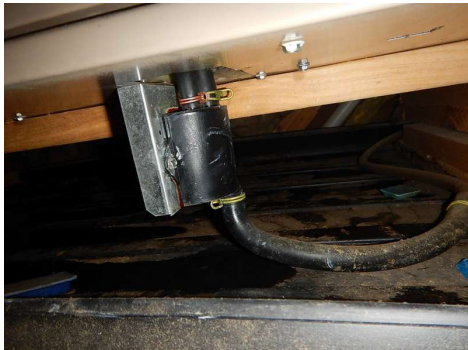
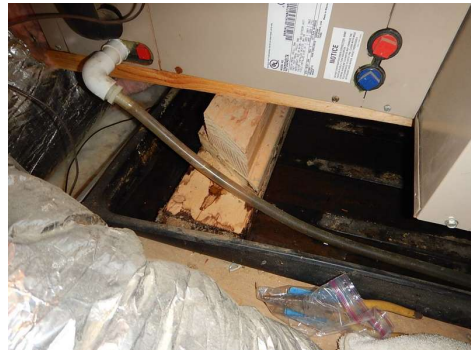
The furnace unit was observed to have an active leak from the condensate drainage systems and is in need of repair from a qualified HVAC professional.

Contact a qualified HVAC professional.

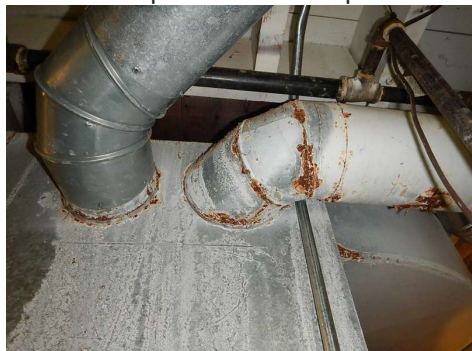
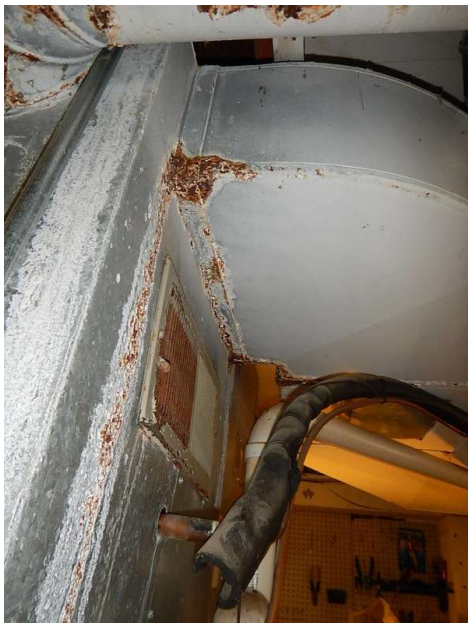
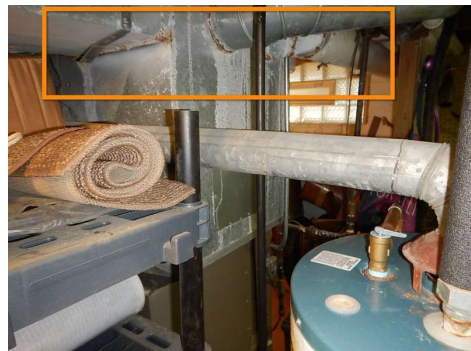
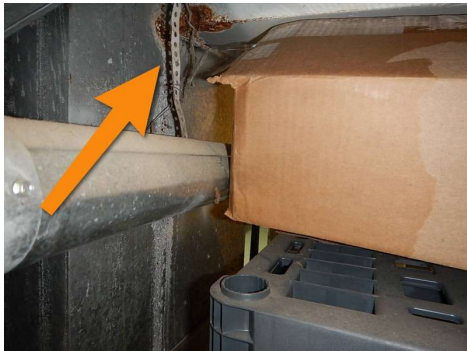
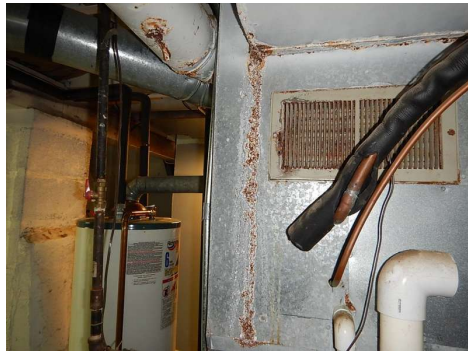
Some of the duct work for the HVAC system was observed to have moderate corrosion and rust present. This may indicate that the duct work is at or nearing the end of its useful lifespan. It is recommended that you have the duct work evaluated by a qualified HVAC professional to determine the extent of any damage or needed repairs / replacements at this time.

Contact a qualified HVAC professional.

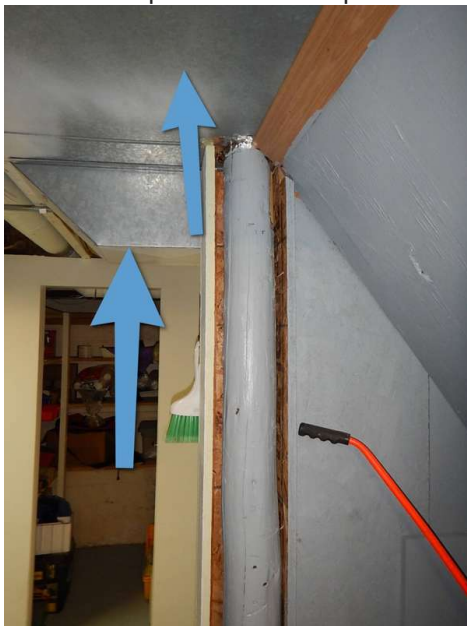
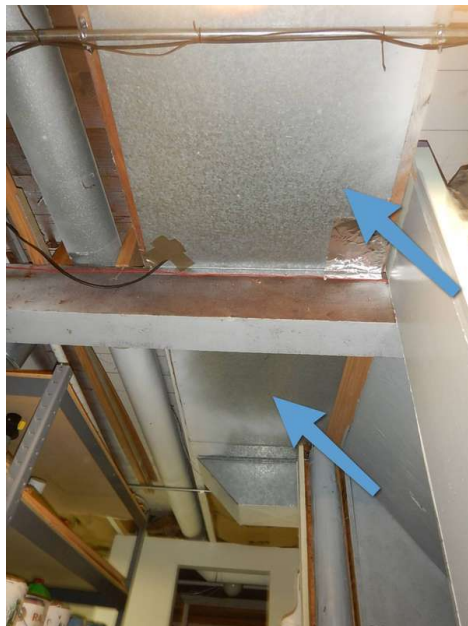
6.4.2 Distribution Systems

using building cavities as return plenums results in significant duct leakage - difficult to seal and clean

Recommendation

Contact a qualified HVAC professional.

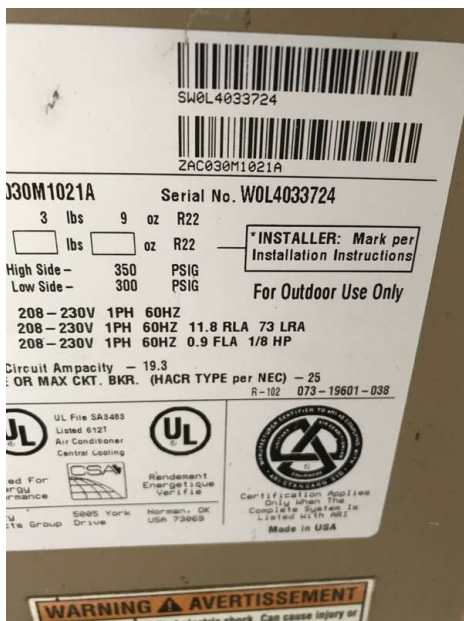
According to the manufacturers data plate, this air conditioning unit was manufactured in October 2004, and has a 2.5 ton cooling capacity. The average lifespan today for most air conditioning units is roughly 12-15 years.

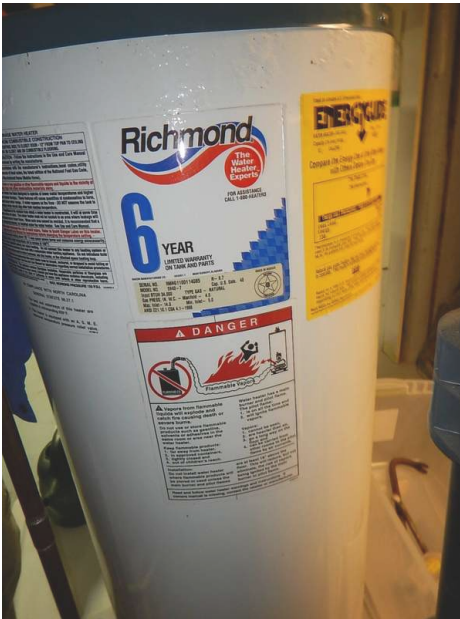
According to the manufacturers data plate, the water heater was manufactured in November of 2000 and has a 40 gallon capacity. The average lifespan for this type of water heater is roughly 8-12 years. Most water heater warranties last between 6-10 years. Units which exceed 12 years of life may be at increased risks for developing possible leaks or even tank failures due to hidden corrosion which may be present inside the tank.

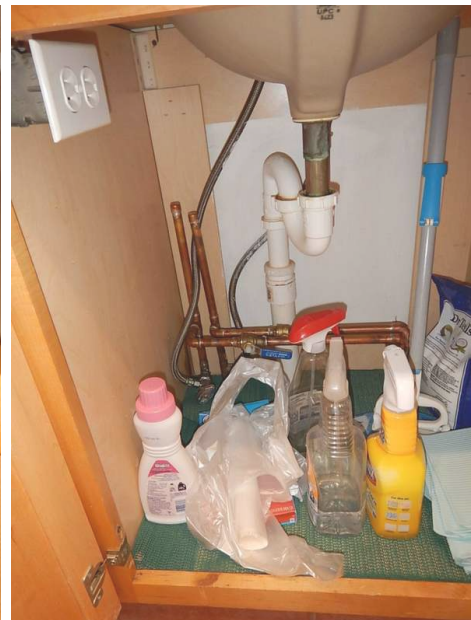
2nd Floor Bathroom

S-Trap vs. P-Trap

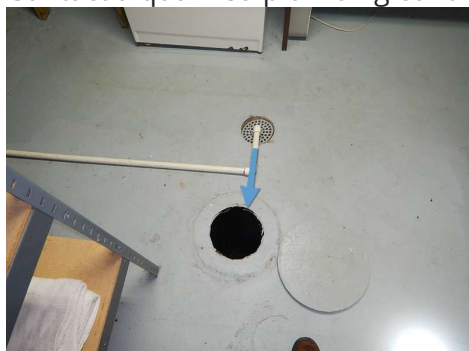
catch basin in use, floor drain is actively discharging to basin

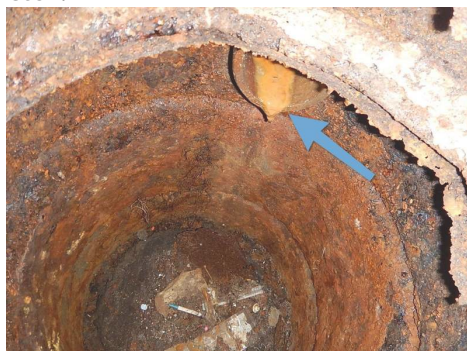
floor drain is actively discharging into a catch basin

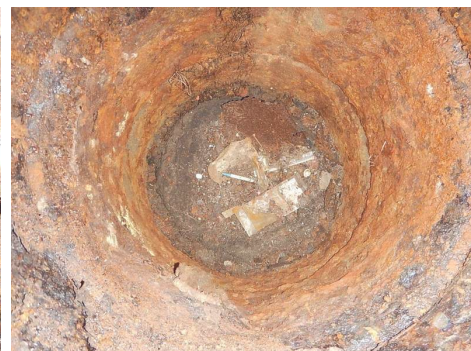
basin is heavily corroded, full of debris, and inspector unable to verify if there is a drain at bottom of basin, or where it may be plumbed to - further evaluation is recommended

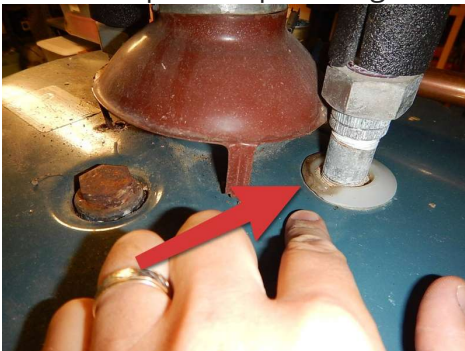
scorching / melting of plastic bushing adjacent to draft collar

Contact a qualified plumbing contractor.

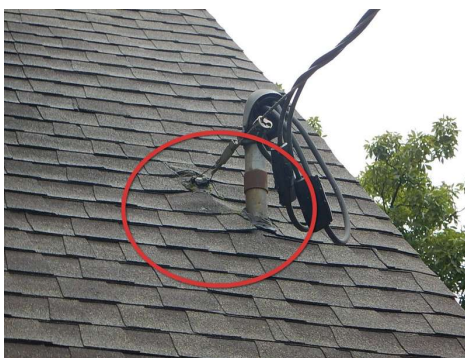
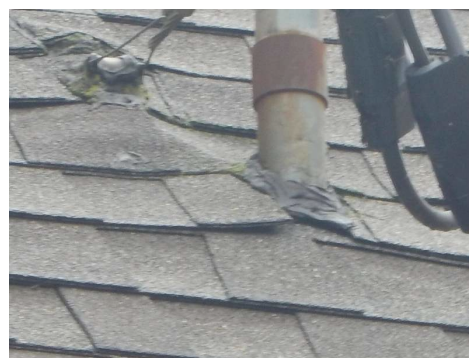
It appears the shingles may be lifting around the electrical attachment. Further evaluation is recommended. This may just be how the shingles were installed, or could be an underlying problem with the connection coming loose.

Contact a qualified professional.

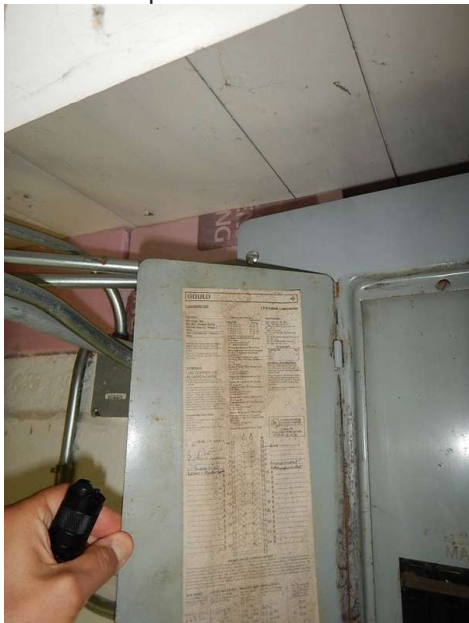
Panel manufactured by Gould

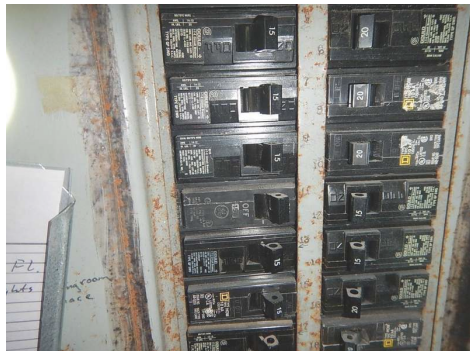
Electrical panel manufacturers stipulate that only their brand of service equipment should be utilized in the electrical panel. For example, General Electric service panels call for use of General Electric brand circuit breakers. The use of other manufacturers equipment in the electrical panel is poor practice, may result in poor connections and fire risks, and will void most panel manufacturers warranties. There were circuit breakers observed to be in use inside the electrical panel(s) which may not be conforming to the panel manufacturer specifications, and further evaluation / replacement is recommended from a qualified electrical professional.

circuit breakers are present which are not manufactured by Gould such as G.E., Square D, and Siemens - evaluate and correct as necessary to conform with panel manufacturer specifications

Contact a qualified electrical contractor.

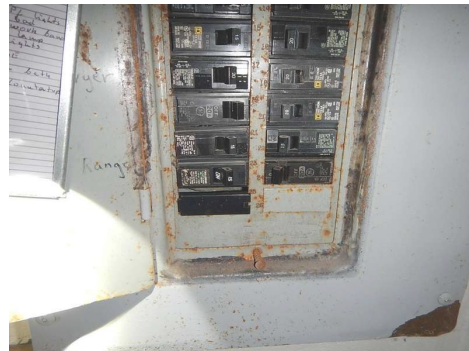
circuit breakers are present which are not manufactured by Gould such as G.E., Square D, and Siemens - evaluate and correct as necessary to conform with panel manufacturer specifications

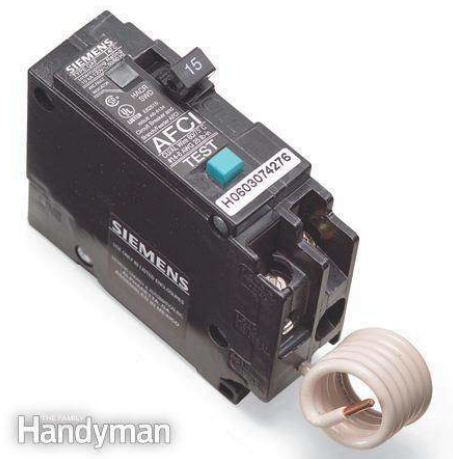
No arc-fault circuit interrupter (AFCI) protection was installed to protect electrical circuits in bedrooms. Safety standards with which new homes must comply require the installation of AFCI protection of all bedroom electrical receptacles. This type of protection is designed to detect electrical arcing, which is a potential fire hazard.

Although AFCI protection was not required at the time the home was originally constructed, as general knowledge of safe building practices has improved with the passage of time, building standards have changed to reflect current understanding. The Inspector recommends updating the existing bedroom receptacles to provide AFCI protection. Arc-fault protection can be provided using either of two methods: 1. Arc Fault Circuit Interrupters (AFCI's) electrical receptacles that have this capability built in.

2. AFCI circuit breakers installed at the main electrical panel that provide this protection to all non-AFCI outlets on the circuit controlled by that AFCI breaker. All work should be performed by a qualified contractor.

Contact a qualified electrical contractor.

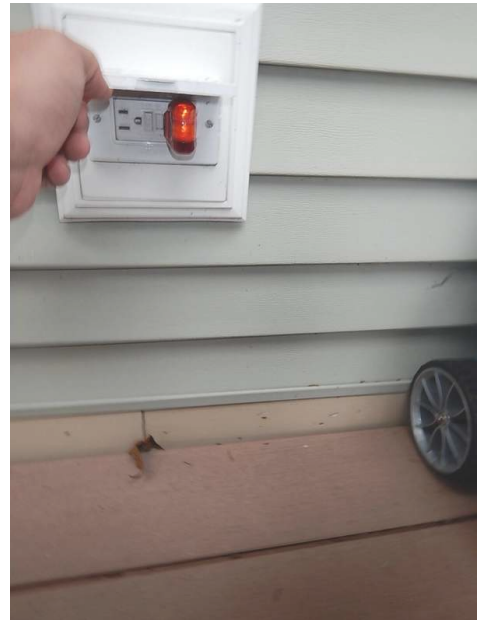
One or more of the exterior GFCI protected electrical receptacles failed to pass a trip test with our instrument. It is recommended that the receptacle(s) be evaluated for repair or replacement by a qualified electrical professional for your safety. Condition is common on older model GFCI receptacle units as a result of age, or on receptacles which have been improperly installed or miswired.

Contact a qualified electrical contractor.

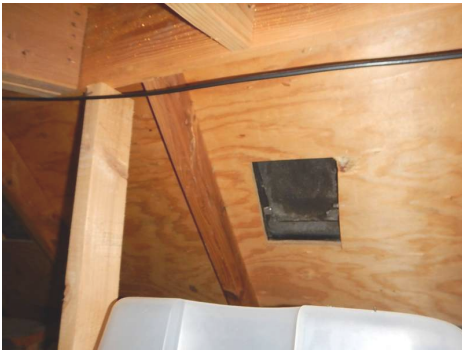
turtle vents

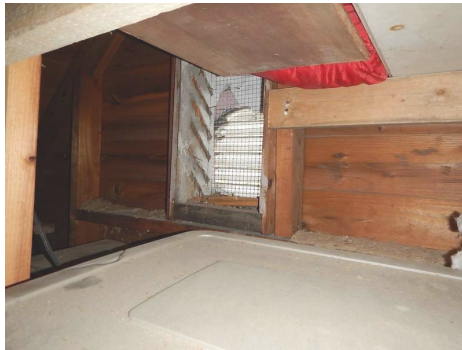
gable vent

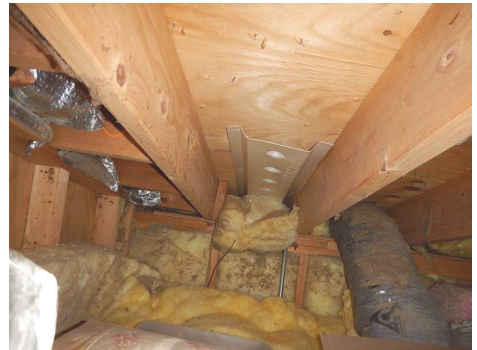
soffit vents with installed chutes

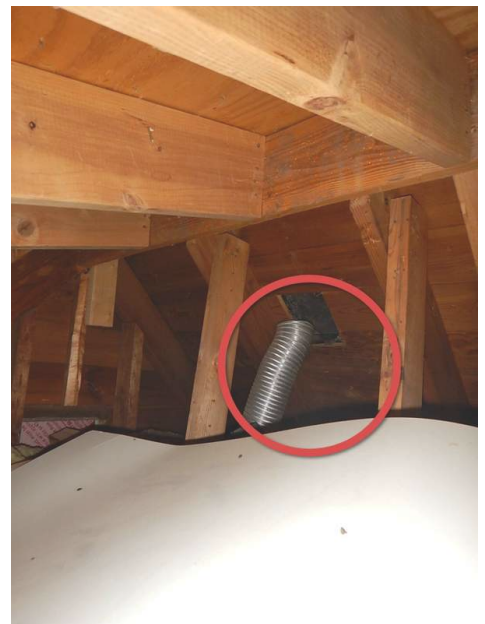
Bathroom fan(s) were observed to be terminated near an installed roof top turtle vent. Directional winds can prevent the bath exhaust products from exiting the attic area, which can potentially cause problems with, moisture and mold. Recommend a qualified attic ventilation contractor or roofing professional properly install exhaust fans to terminate to the exterior, via a baffled jack vent.

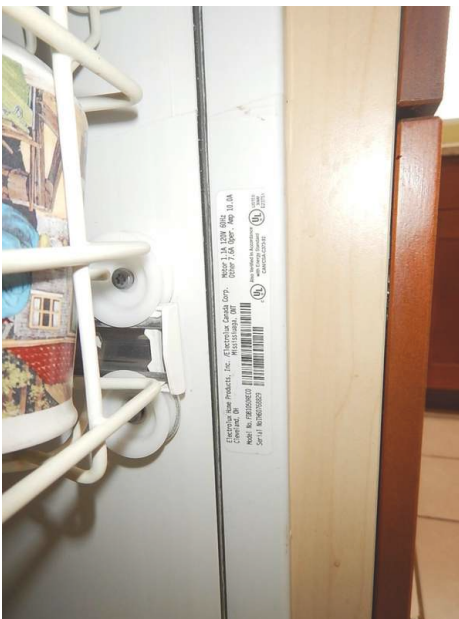
According to the manufacturers date plate, this dishwasher was likely manufactured in February of 2006 or 2016. A call to the manufacturer may be needed to accurately date this appliance.

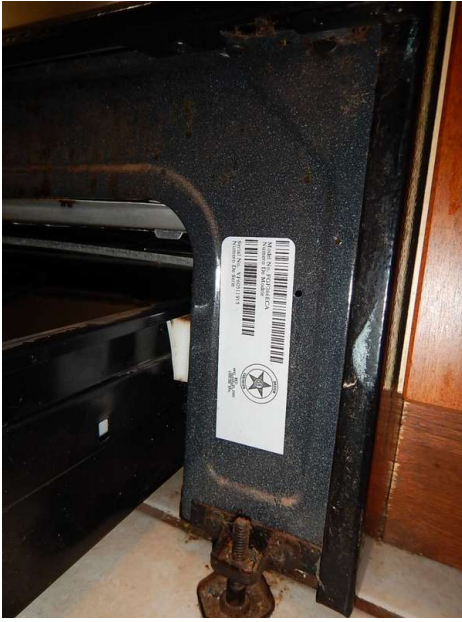
According to the manufacturers data plate, this cook top unit was most likely manufactured in January of 2006. A call to the manufacturer may be necessary to accurately date this appliance.

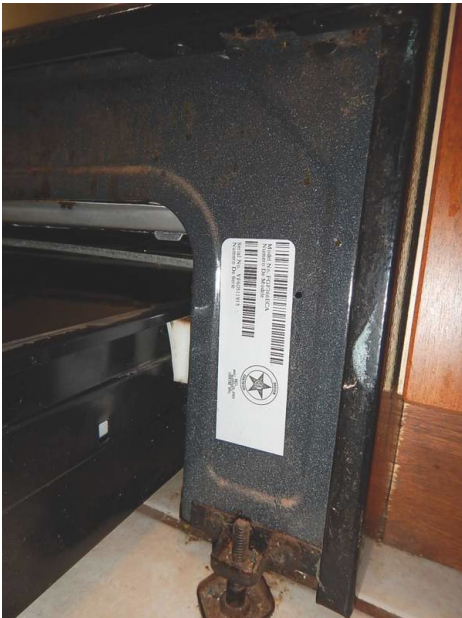
According to the manufacturers data plate, this oven unit appears to have been manufactured in January of 2006.

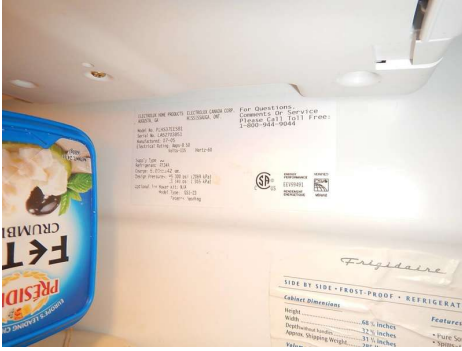
According to the manufacturers data plate, the refrigerator appears to have been manufactured in July of 2005.

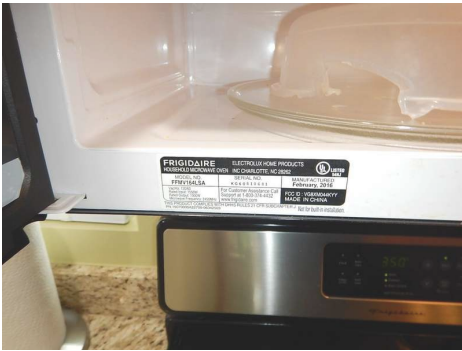
According to the manufacturers data plate, this microwave unit appears to have been manufactured in February of 2016.

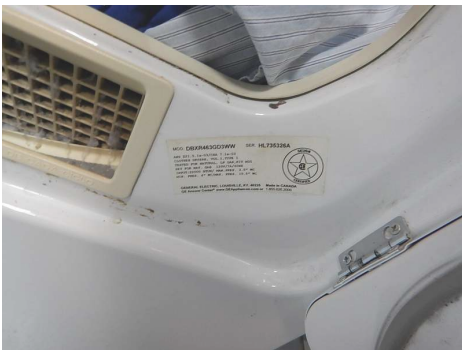
According to the manufacturers data plate, this clothes dryer appears to have been manufactured in May of 2006

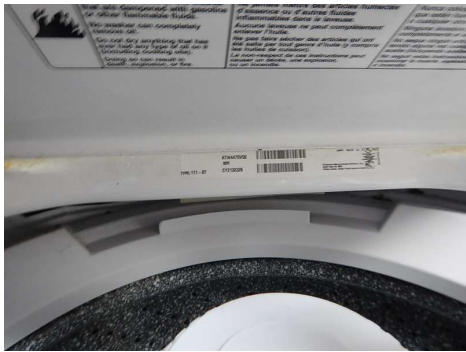
According to the manufacturers data plate, the clothes washer appears to have been manufactured in May of 2009

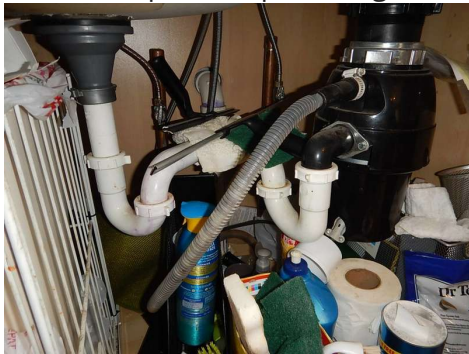
High Loop installation - IL prohibits connections to disposers

Contact a qualified plumbing contractor.

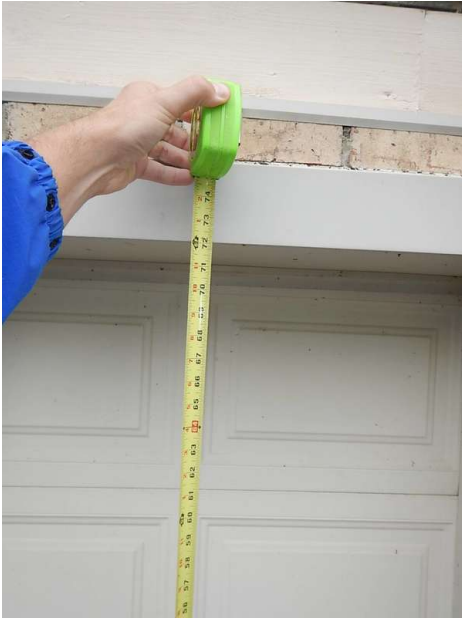
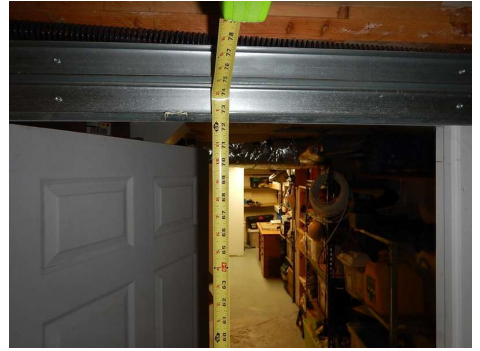
This garage was observed to have low clearances overhead, and may create head hazards as well as prevent some vehicles from being able to enter or utilize the garage space.

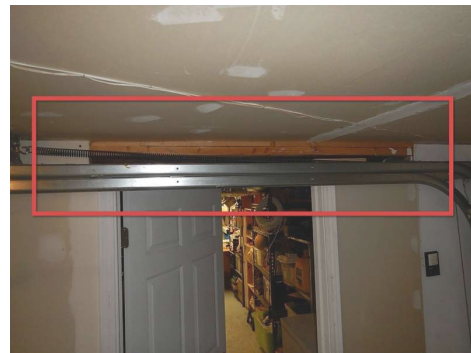
Firewall separating the home and garage is not compliant with modern building standards. Firewalls should be built with materials to prevent the spreading of a fire into the home living space. Though these requirements may have not been in place at the time of construction, it is recommended for safety that you consider repairing these systems and bringing into compliance with modern standards to reduce risks of fire / spreading.

Recommend a qualified contractor evaluate and bring firewall up to standards.

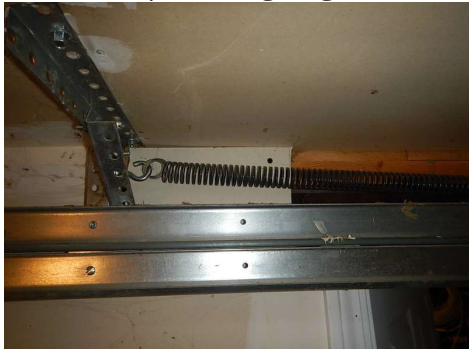
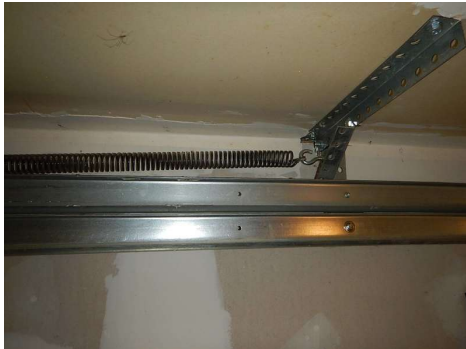
The installed springs for the automatic garage door are lacking required safety cables. A cable should be routed inside the spring to contain the spring in the event of breakage. Springs are under tremendous tension and lack of safety cables could result in springs causing serious injury to occupants if nearby when springs break or fail.

Recommendation

Contact a qualified garage door contractor.

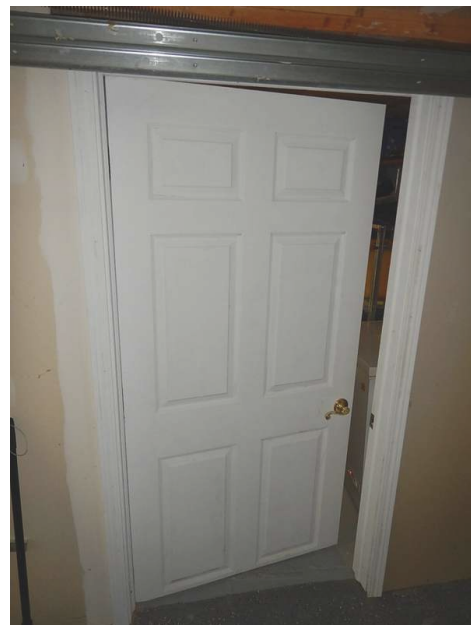
13.6.1 Occupant Door (From garage to inside of home)

**Significant and/or Safety Concern**

Recommendation

Contact a qualified door repair/installation contractor.
