1234 Main St.
STANWOOD Washington 98292

Buyer Name
06/18/2018 9:00AM

Table of Contents

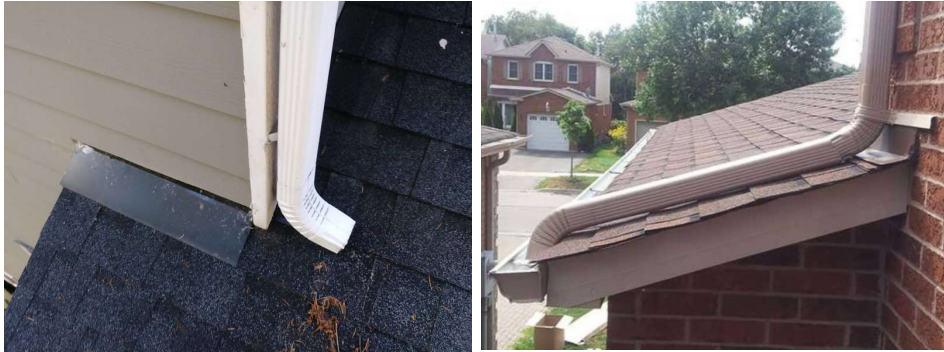
2.2.1 Gutters/drains

**GUTTER DRAINS ON ROOF**

One or more downspouts terminated above a roof surface, and concentrated rainwater from the downspouts washes over the roof surface below. This is a common configuration, but in some cases large quantities of rainwater can damage shingles by removing granules and reduce the life of the roof surface. I recommend installing extensions to route the rainwater directly to the closest gutter below to prevent such damage to the roofing material.

Preferred Installation Method

Contact a qualified professional.

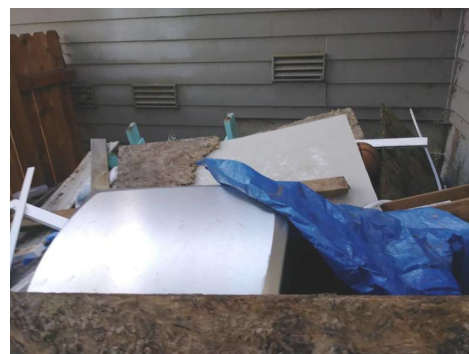
Exterior issues

EXTERIOR WALLS OBSCURED

Exterior wall sections were obscured by *vegetation / stored items / debris* and couldn't be fully evaluated. They are excluded from this inspection. On the left side of the house.

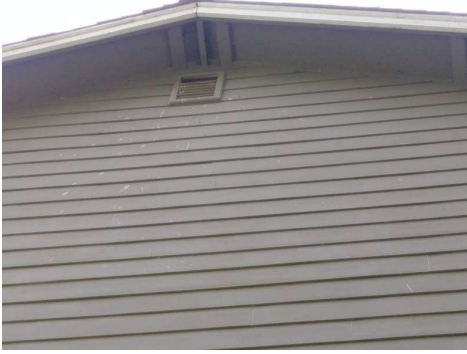
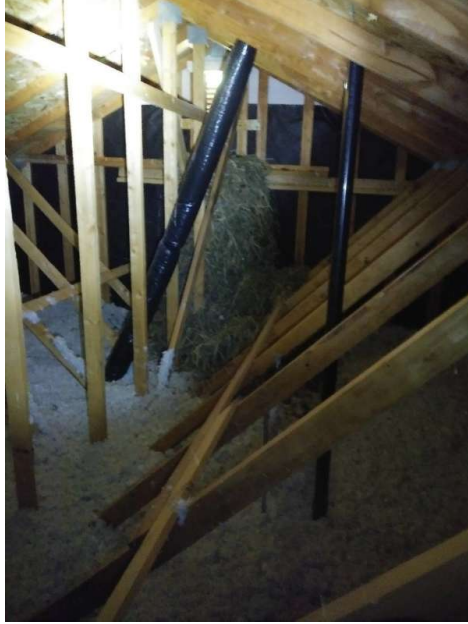
3.3.1 Exterior issues

GABLE VENT DAMAGE

One gable vent on the left of the house was damaged. Their purpose is to allow air into the attic, and keep out birds, rodents and bugs. The screen on one of the gable vent appears to be damaged and birds have built a nest in the attic space. I recommend the nest is removed/cleaned from the attic, and new screen is installed over the gable vent.

Contact a qualified professional.

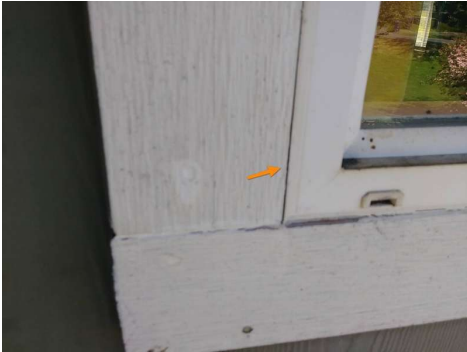
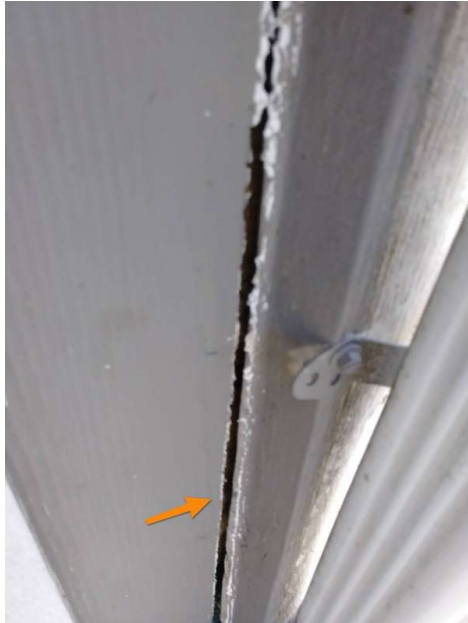
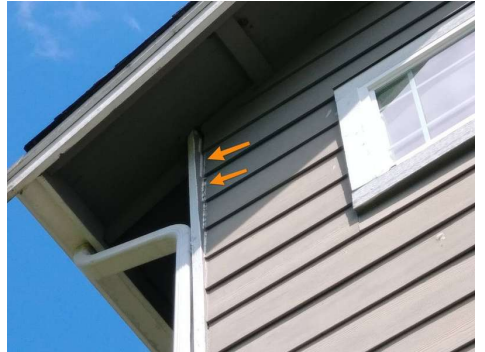
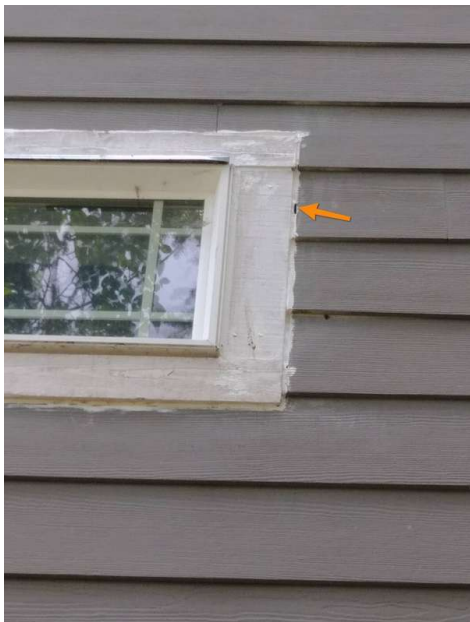
3.3.2 Exterior issues

SEALANT MAINTENANCE

Some of the caulking in various places around the exterior need to be sealed. Around windows, doors, siding seams, siding meets trim, etc...I recommend that these areas are re-sealed to prevent any potential moisture intrusion issues.

Contact a qualified professional.

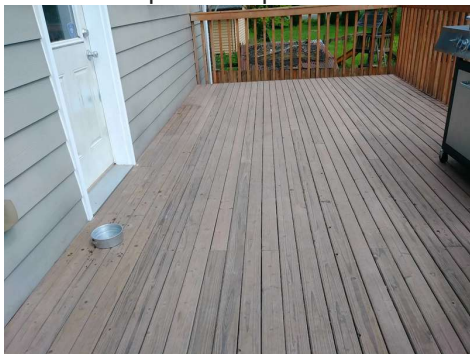
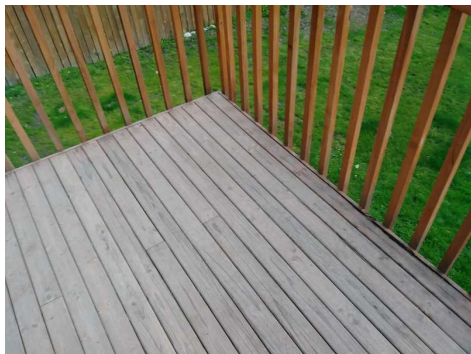
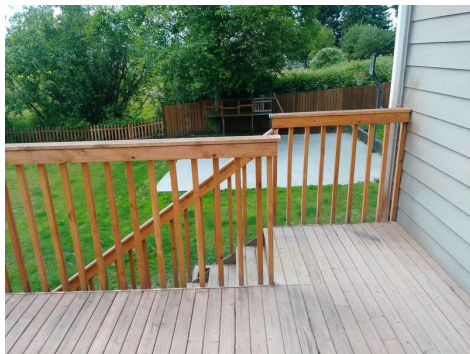
3.3.3 Exterior issues

DECK SEALANT

The deck is staining/water sealing is faded. It is important to keep the deck stained/water sealed to prevent decking from decay. Decking wears out not only from rain, but also from UV rays. A good quality stain will help extend the life of the deck and protect it from the weather. I recommend the deck is stained/water sealed.

Contact a qualified professional.

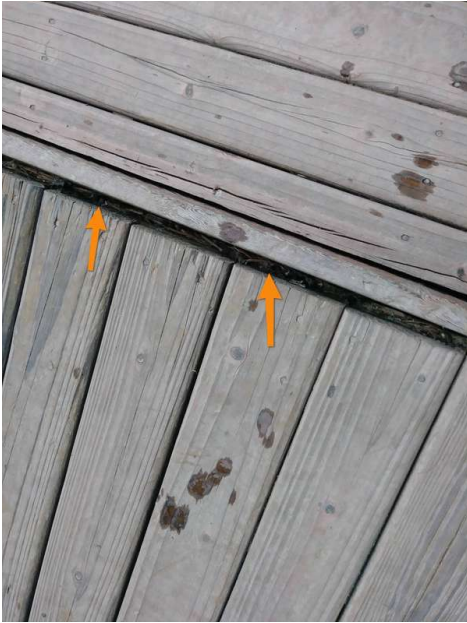
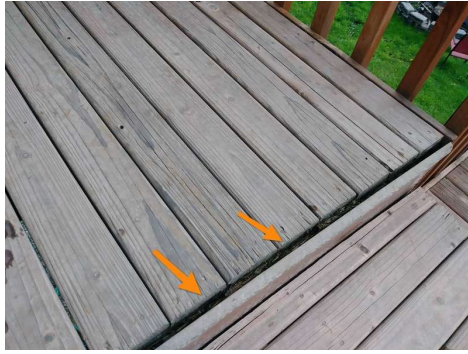
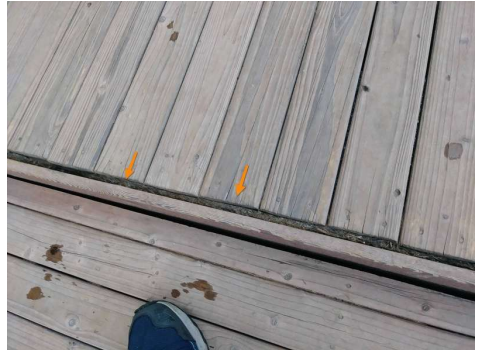
3.3.4 Exterior issues

DECK BOARD DAMAGE

Several deck boards were starting to show some signs of wear/decay. It is recommended these are repaired and replaced before staining or water sealing the deck

Contact a qualified professional.

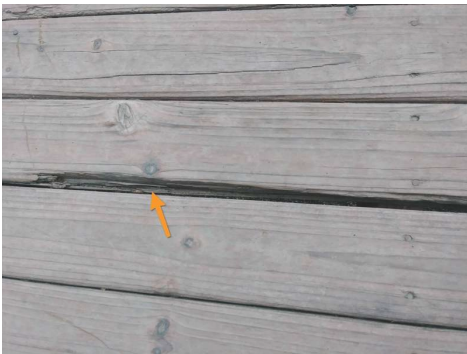
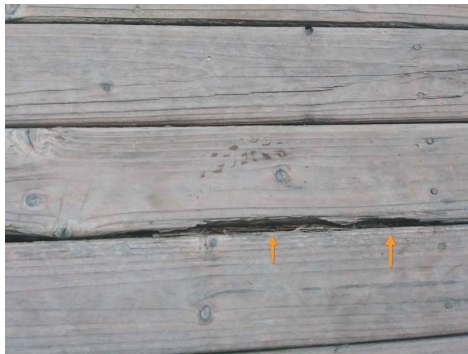
Debris is filled in-between the deck and fascia board.

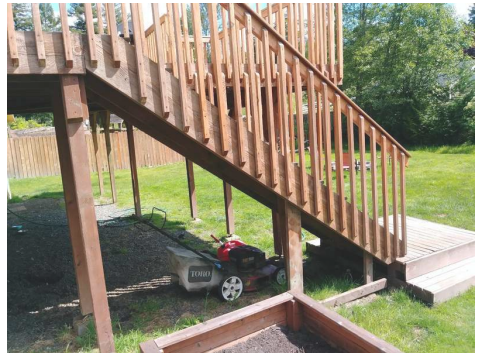
3.3.5 Exterior issues

DECK PICKETS

A couple of the deck pickets as you come down the stairs have come loose. I recommend these are re-secured for child safety.

Contact a qualified professional.

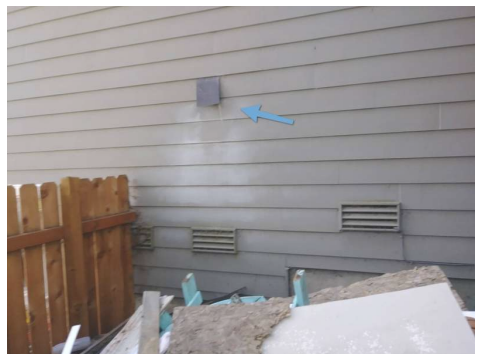
3.3.6 Exterior issues

DRYER VENT CLEANING

I recommend the dryer vent is cleaned on an annual basis. This is good maintenance for the house and the dryer. A clogged dryer vent can lead to dryer failure an extended dry times.

Contact a qualified professional.

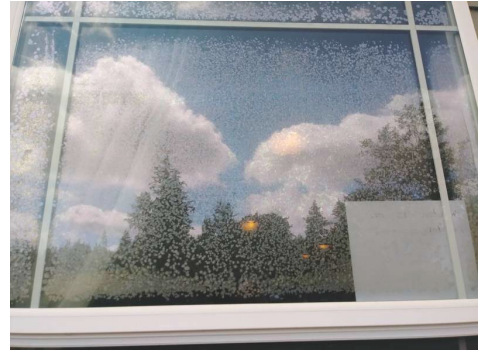
3.5.1 Windows and Door

Recommendations**FAILED SEAL**

One window overlooking the back deck had a failed seal. I was informed during the inspection that the window was on order and is being replaced. This is an informational comment. Verify the window pane replacement is completed.

Contact a qualified professional.

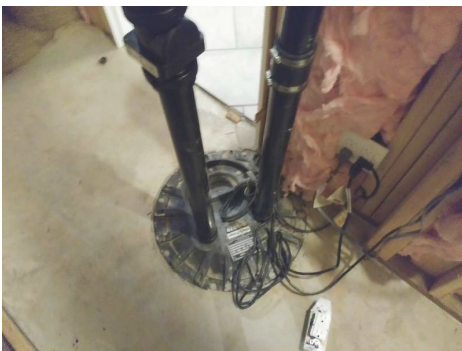
Drain and Waste: Pump station

There is a pump station located in the basement of the home. Upon inspection everything seemed to be in working order. A buzzer alarm has been installed. In the event the alarm goes off, shut down the pump and contact the septic company for repairs.

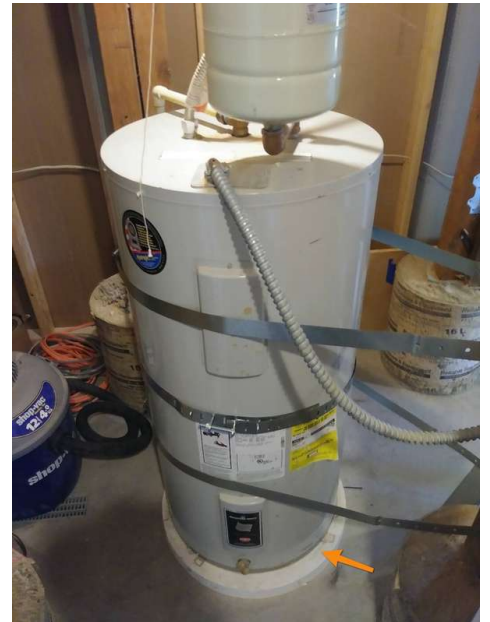
5.1.1 Water Heater

PAN MISSING SAME ELEVATION

A water heater is installed at the same elevation as the finished living spaces and has no catch pan and drain installed. Recommend having a qualified contractor install a catch pan and drain to prevent water damage to finished interior spaces if/when the water heater develops a leak or is drained.

Contact a qualified plumbing contractor.

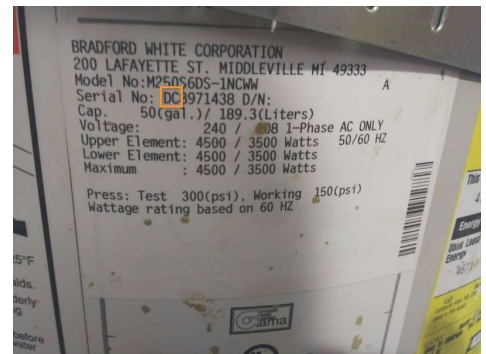
5.1.2 Water Heater

NEAR LIFE EXPECTANCY

The estimated useful life for most water heaters is 8 to 12 years. This water heater appears to be approaching this age and may need replacing in the near future. Recommend budgeting for a replacement in the near future. Everything was functional at the time of inspection and in good working order. The hot water tank was manufactured in 2007 making it about 11 years old.

Here is a link to showing the age. On these tanks it is done by the first 2 letters of the serial number. DC on this tank.

Contact a qualified plumbing contractor.

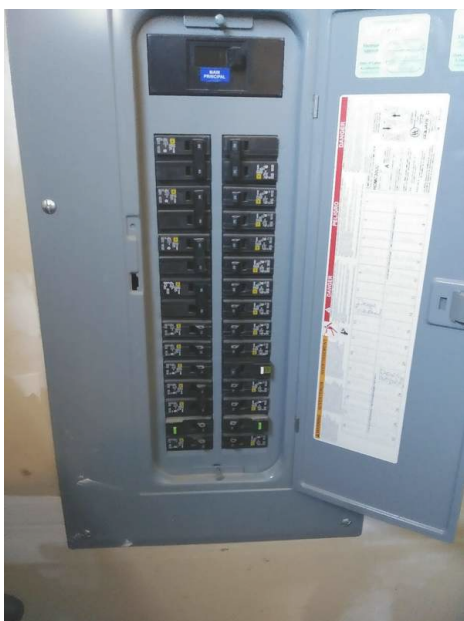
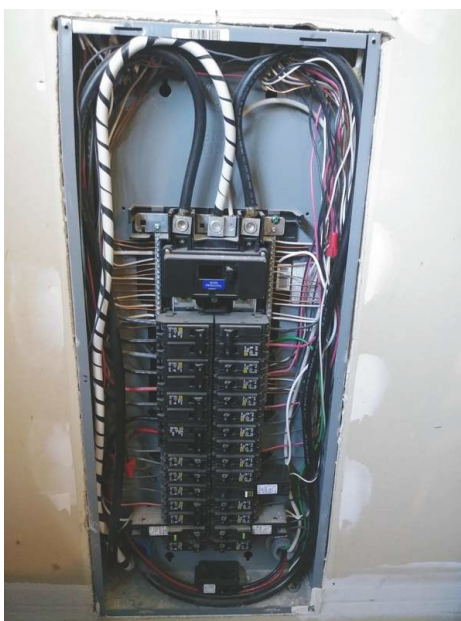
Electric Panel: Panel pictures

The size of the electrical service is sufficient for the typical single family needs. The electrical panel is well arranged and all fuses/breakers are properly sized. All outlets and light fixtures that were tested operated satisfactorily. All 3-prong outlets that were tested were appropriately grounded. Ground fault circuit interrupter (GFCI) devices have been provided in some areas of the home. These devices are extremely valuable, as they offer an extra level of shock protection. All GFCI's that were tested responded properly. Dedicated 220 volt circuits have been provided for all 220 volt appliances within the home. All visible wiring within the home is copper. This is a good quality electrical conductor.

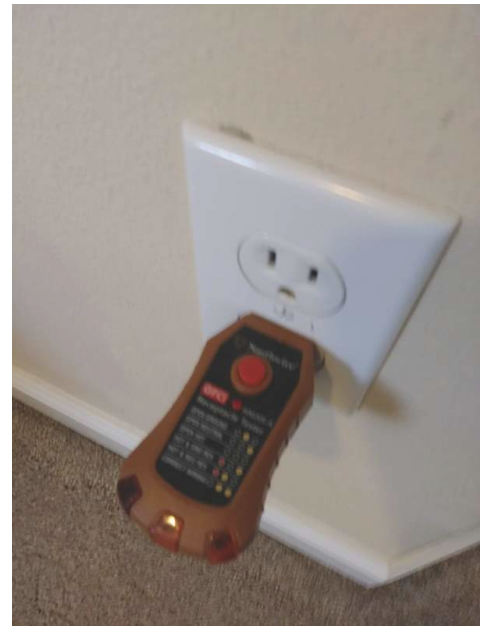
6.3.1 Outlets, Switches, Lights

BEDROOM OUTLET

One bedroom outlet was not working on my tester. The bedroom to the left at the top of the stairs. The outlet is to the left as you walk in the door. I recommend this outlet is diagnosed and repaired/replaced by a electrical contractor.

Contact a qualified professional.

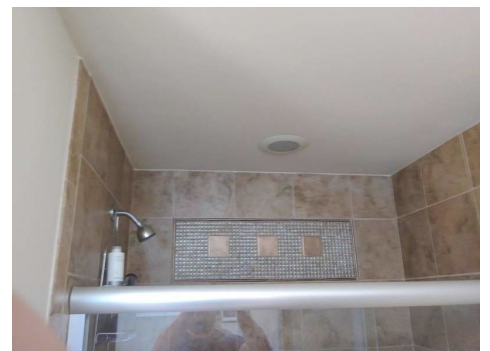
6.3.2 Outlets, Switches, Lights

LIGHT ABOVE SHOWER NOT WORKING

Light above the shower I could not get to turn on with any switches. It may just need to have a bulb/LED replaced. I recommend replacing the bulb and verify the light fixture is working.

Contact a qualified professional.

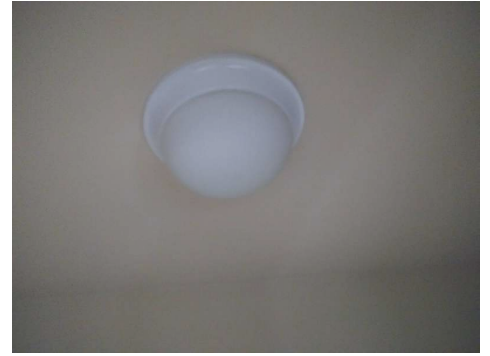
6.3.3 Outlets, Switches, Lights

CLOSET LIGHT OUT

Light in one of the closets was not working. More than likely just needs a new bulb. I recommend replacing the bulb and verifying the light fixture is working.

Contact a qualified professional.

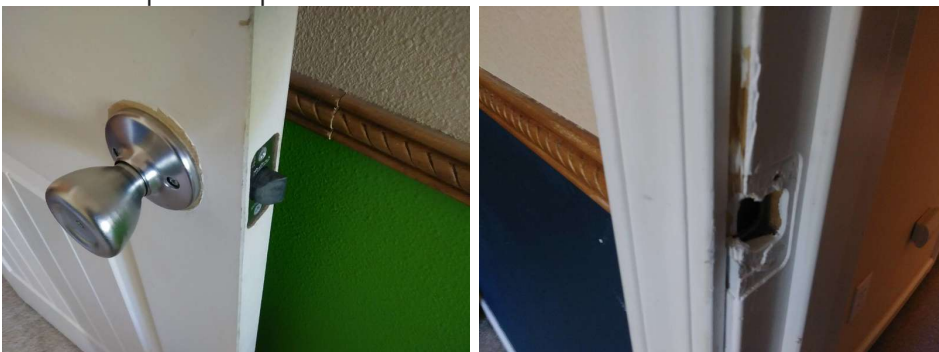
9.4.2 Windows and Door

DOOR LATCH DAMAGED

One of the bedroom door latches was damaged and prevent the door from closing/latching. I recommend repairs are made so the door can latch properly when closed.

Contact a qualified professional.

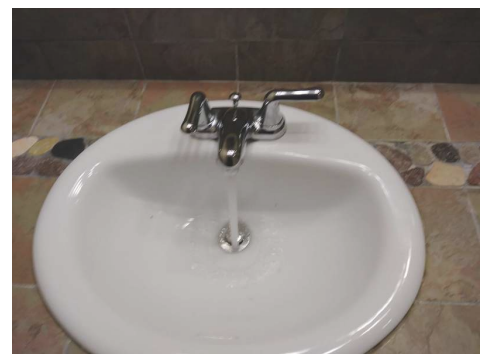
10.7.1 Sink/countertop

SINK DRAINS SLOW

The master bathroom sink was clogged and draining very slowly. Drain(s) should be cleared as necessary, and by a qualified plumber if necessary.

Contact a qualified plumbing contractor.

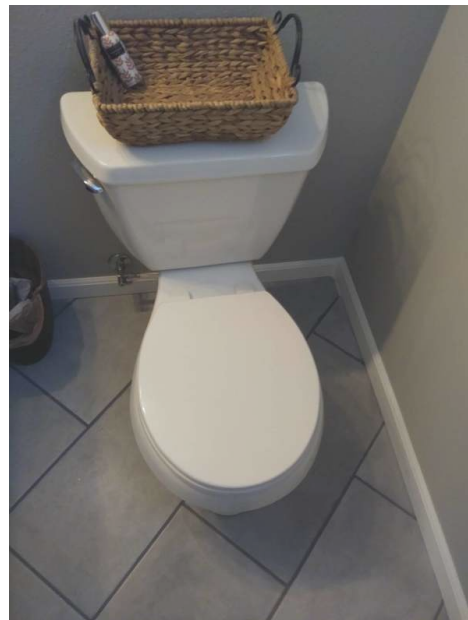
10.8.1 Toilets

Recommendations**LOOSE**

One toilet was loose during inspection. A qualified contractor should remove the toilet(s) for further evaluation and repairs if necessary. A new wax ring should be installed and toilet(s) should be securely anchored to the floor to prevent movement and leaking.

Contact a qualified plumbing contractor.

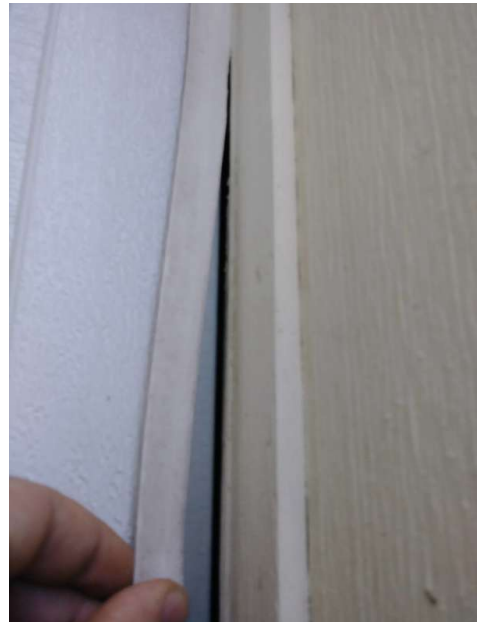
WEATHER STRIP DETERIORATED

Weatherstrip at the sides vehicle door is damaged and/or deteriorated. It should be replaced where necessary to prevent intrusion of the exterior elements.

Contact a qualified garage door contractor.
