RESIDENTIAL REPORT COPY

1234 Main St.
Liberty MO 64068

05/23/2018 9:00AM

1: INSPECTION DETAILS

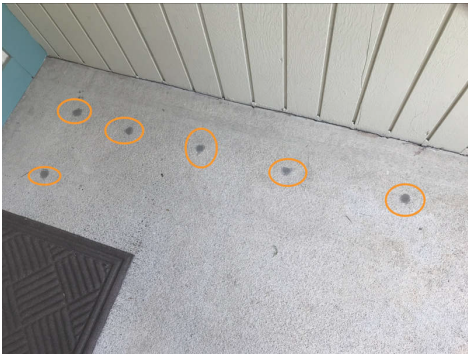
3.3.1 Walkways, Patios & Driveways

POSSIBLE TERMITE TREATMENT

FRONT PORCH

Contact a qualified professional.

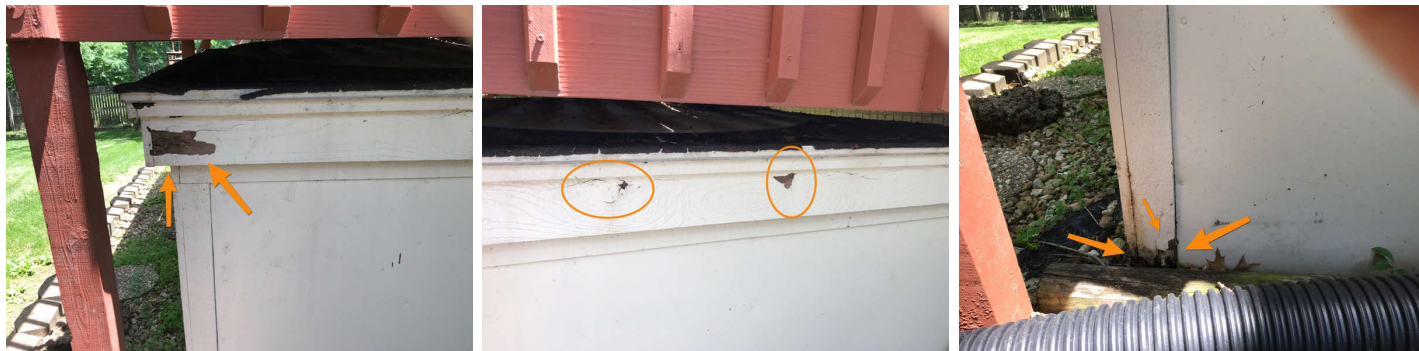
3.4.1 Decks, Balconies, Porches & Steps

SHED SIDING ROTTEN AND PEELING PAINT

SHED UNDER DECK

Contact a qualified professional.

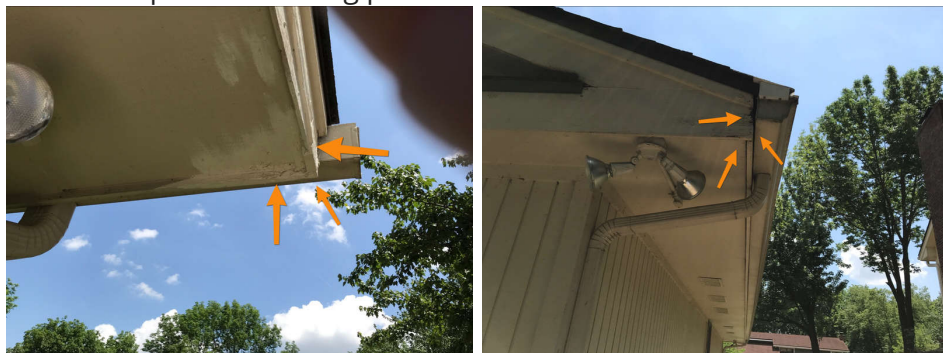
3.5.1 Eaves, Soffits & Fascia

FASCIA - ROTTED

SOUTHEAST AND NORTHWEST SIDE OF HOUSE

One or more sections of the fascia are rotted. Recommend qualified roofer evaluate & repair.

Contact a qualified roofing professional.

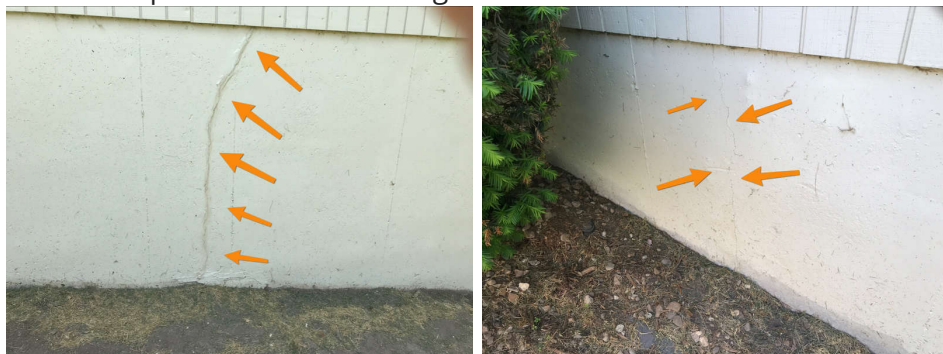
4.1.1 Foundation

FOUNDATION CRACKS - MINOR

EAST SIDE OF HOUSE

Minor cracking was noted at the foundation. This is common as concrete ages and shrinkage surface cracks are normal. Recommend monitoring for more serious shifting/displacement.

Contact a qualified structural engineer.

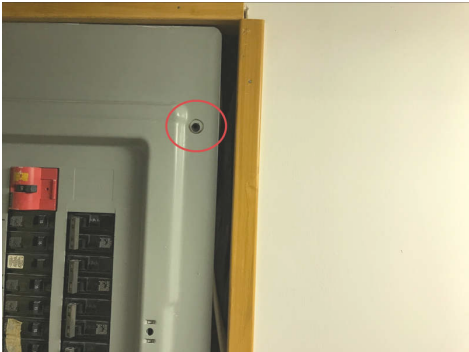
7.2.1 Main & Subpanels, Service & Grounding,
Main Overcurrent Device

MAIN PANEL COVER MISSING SCREW

BASEMENT
Recommendation
Recommended DIY Project

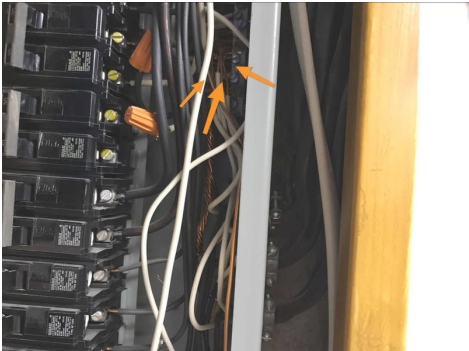
7.2.2 Main & Subpanels, Service & Grounding, Main Overcurrent
Device

DOUBLE TAPPED NEUTRAL WIRES

Recommendation
Contact a qualified electrical contractor.

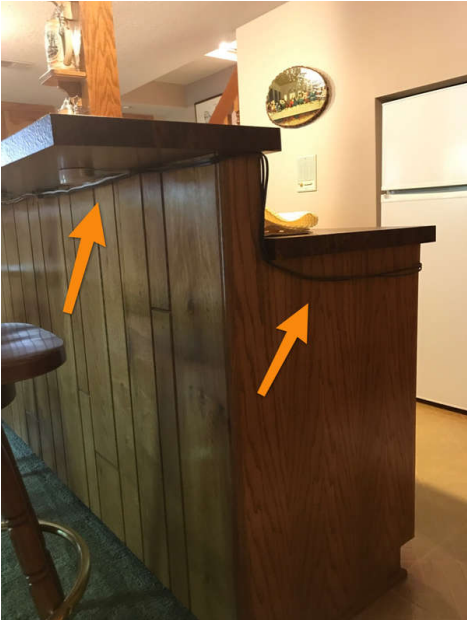
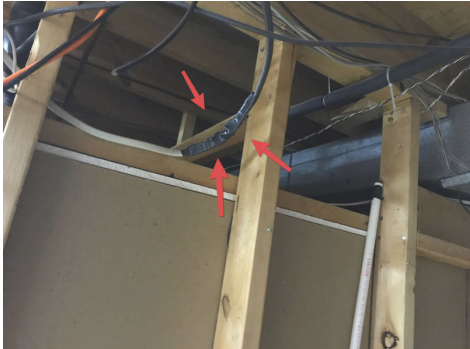
7.3.1 Branch Wiring Circuits, Breakers & Fuses

IMPROPER WIRING

BASEMENT UTILITY ROOM AND BASEMENT BAR
Improper wiring needs attention.
Recommendation
Contact a qualified electrical contractor.

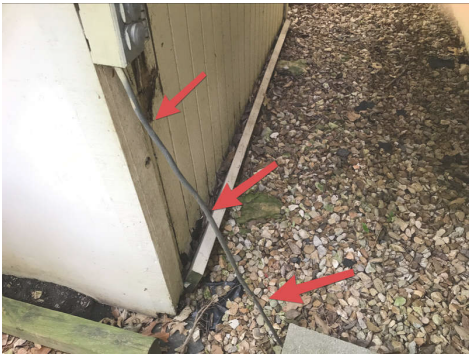
7.3.2 Branch Wiring Circuits, Breakers & Fuses

IMPROPER ELECTRICAL RECEPTACLE INSTALLATION

ON SHED UNDER DECK

Contact a qualified professional.

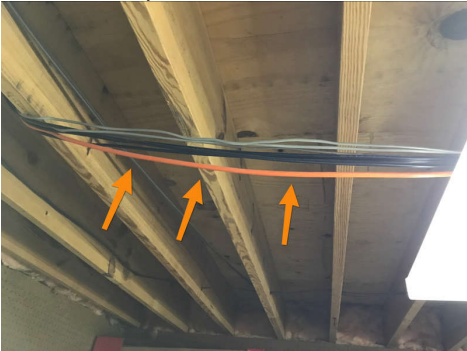
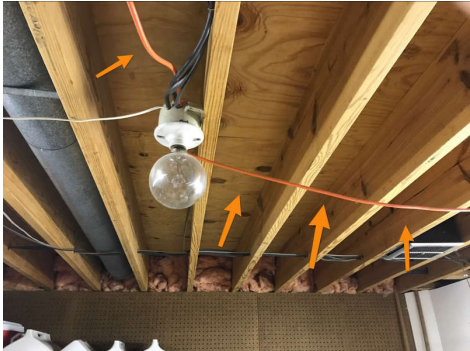
7.3.3 Branch Wiring Circuits, Breakers & Fuses

IMPROPER ELECTRICAL WIRING

BASEMENT UTILITY ROOM

Contact a qualified electrical contractor.

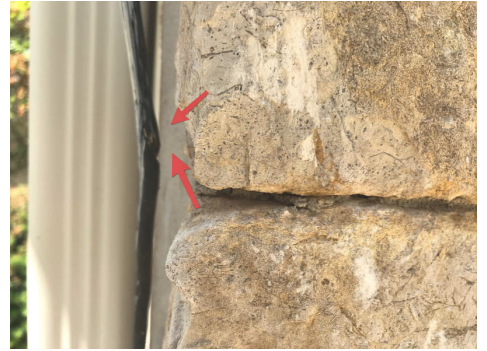
7.3.4 Branch Wiring Circuits, Breakers & Fuses

SPLIT ELECTRICAL WIRE

WEST CORNER OF GARAGE UNDER LIGHT FIXTURE

Contact a qualified professional.

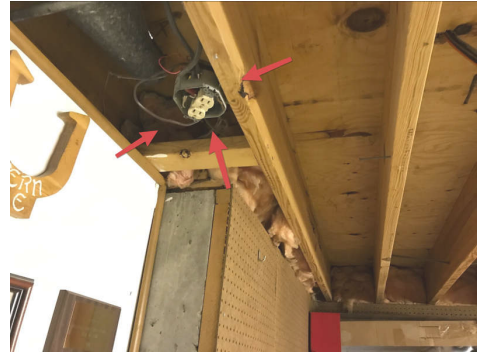
7.4.1 Lighting Fixtures, Switches & Receptacles

COVER PLATES MISSING

UTILITY ROOM IN BASEMENT

One or more receptacles are missing a cover plate. This causes short and shock risk. Recommend installation of plates.

Contact a qualified electrical contractor.

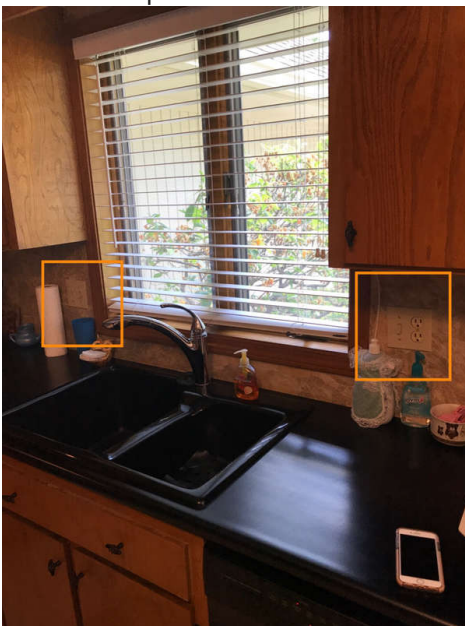
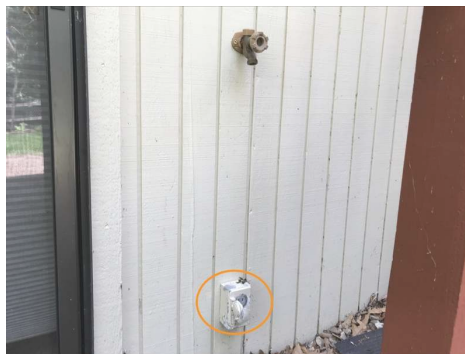
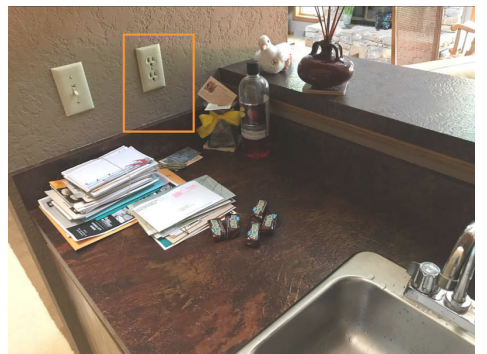
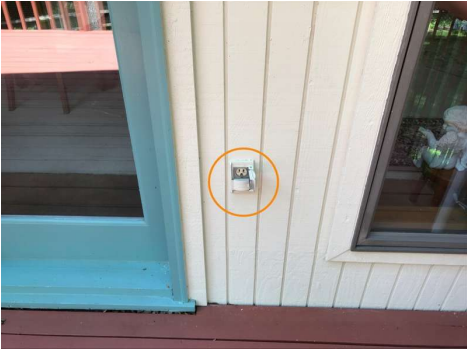
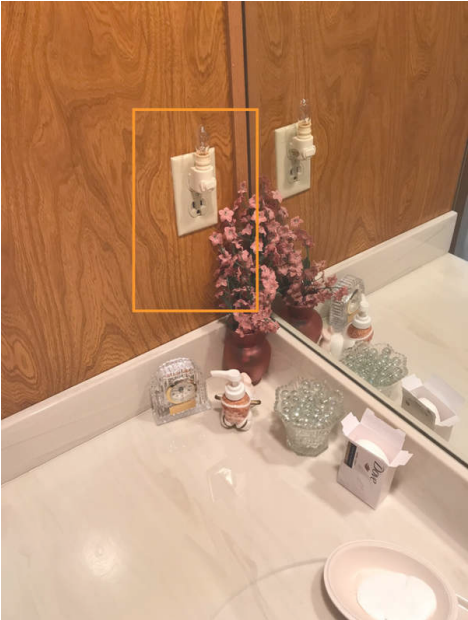
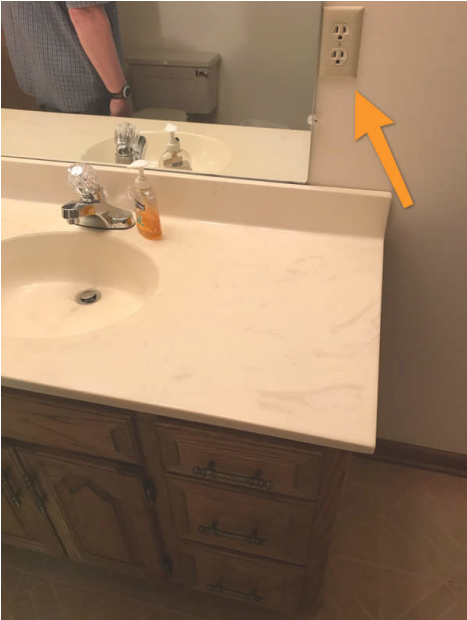
7.5.1 GFCI & AFCI

NO GFCI PROTECTION INSTALLED

No GFCI protection present in all locations. Recommend licensed electrician upgrade by installing ground fault receptacles in all locations.

Contact a qualified electrical contractor.

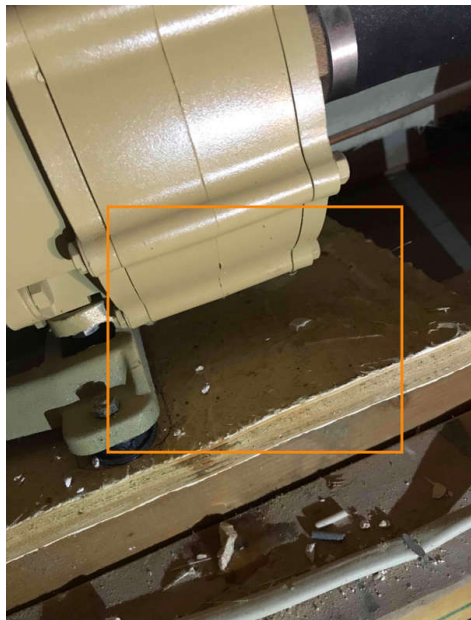
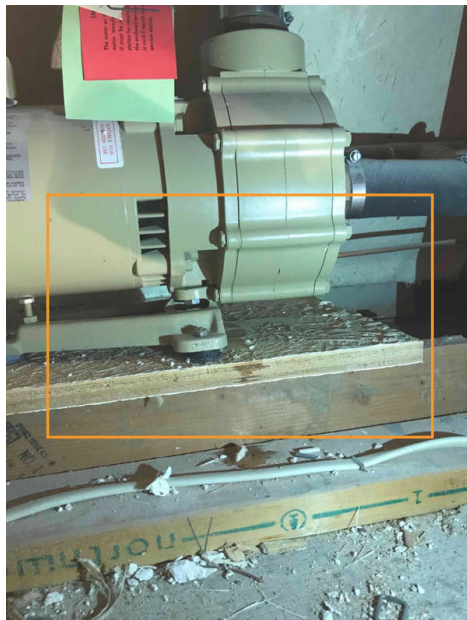
8.3.1 Water Supply, Distribution Systems & Fixtures

JETTED TUB PUMP LEAKING

Water dripping observed while jetted tub operating. Recommend inspection and repair by a plumbing professional.

Recommendation
Contact a qualified professional.

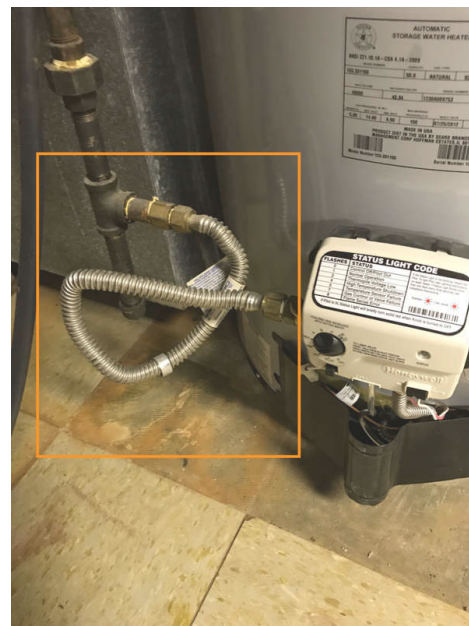
8.4.1 Hot Water Systems, Controls, Flues & Vents

CORRUGATED STAINLESS STEEL SUPPLY LINE

Recommend replacement with iron; susceptible to lightening strike.

Contact a qualified plumbing contractor.

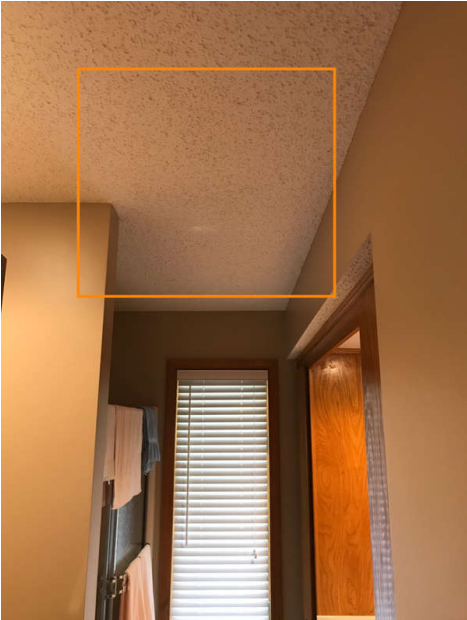
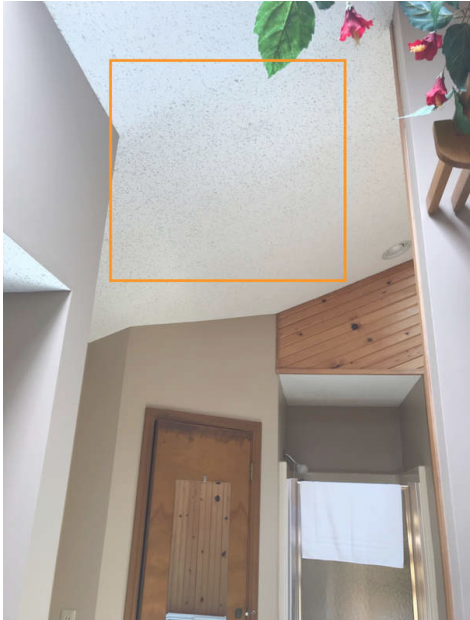
BATHROOM VENT MISSING

Contact a qualified handyman.

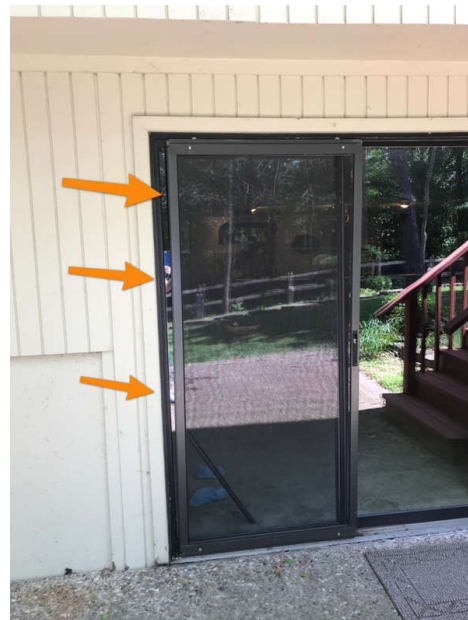
Basement Exterior Door

Door latch and/or strike plate is out of alignment. Recommend a handyman repair.

Contact a qualified door repair/installation contractor.

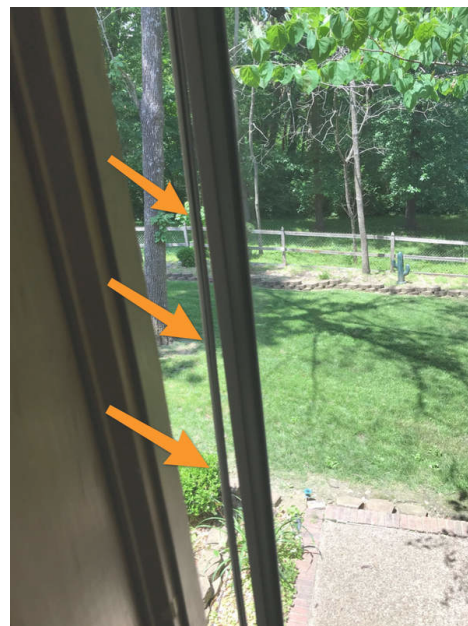
10.2.1 Windows

FAILED SEAL

Seal separated from window frame; not allowing casement window to properly close. Recommend securing to allow window to completely close.

Contact a qualified window repair/installation contractor.

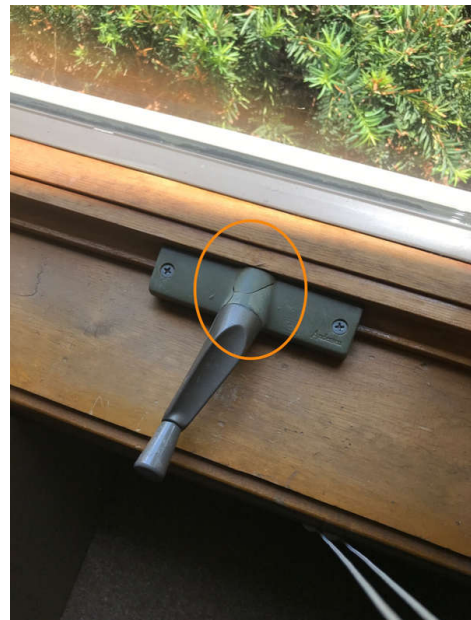
10.2.2 Windows

MINOR CRANK DAMAGE

Minor cosmetic damage to crank. Window still opens properly.

Recommended DIY Project

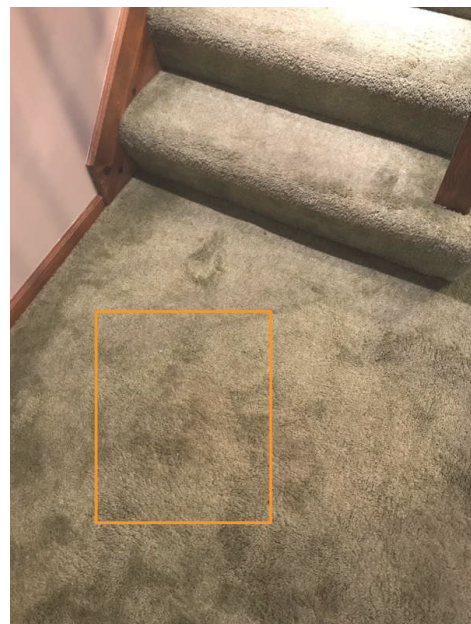
10.3.1 Floors

CARPET STAINS

Carpet had areas of staining or discoloration. Recommend a thorough steam clean by a qualified carpet cleaning company

Contact a qualified cleaning service.

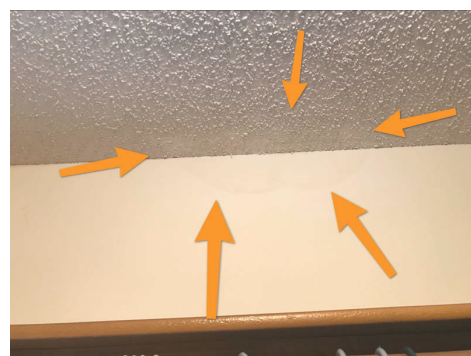
10.5.1 Ceilings

STAIN(S) ON CEILING

There is a stain on ceiling/wall that requires repair and paint. Source of staining should be determined.

Contact a qualified professional.

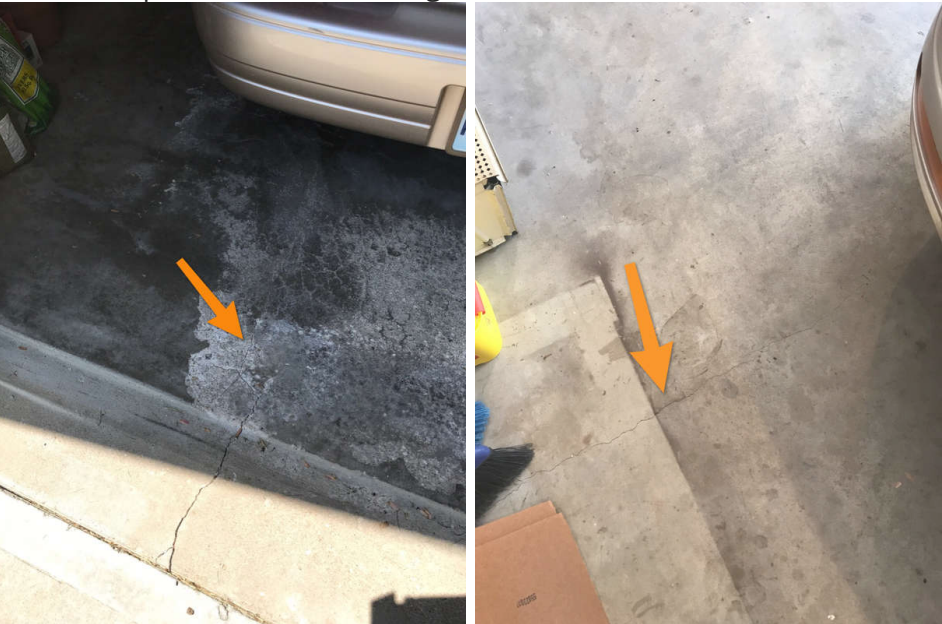
CRACKING

Cracking visible in the garage floor. I recommend a structural engineer evaluate.

Recommendation
Contact a qualified structural engineer.
