NY RESIDENTIAL HOME INSPECTION

1234 Main St.
Greenwich CT 06831

12/06/2018 9:00AM

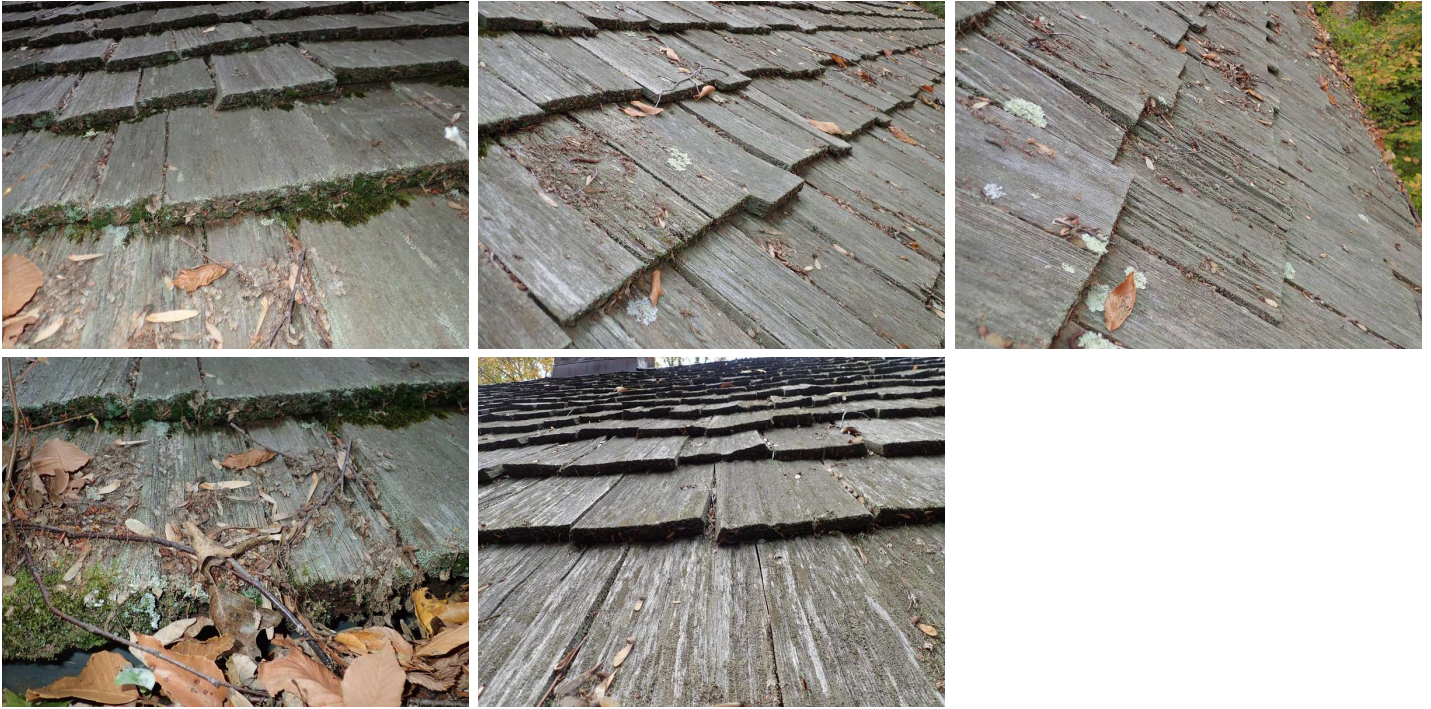
The wood shake roof covering appeared to be at the end of its long term service life and was in need of replacement. The wood shakes exhibited widespread splitting, decay and rot with interlayment exposed in several areas. A general rule of thumb is complete replacement is warranted when the percentage of cracked, damaged or missing shingles exceeds approximately 30 percent of the roof-covering material. I recommend you consult with a qualified roofing contractor to discuss options and costs for roof replacement.

Contact a qualified roofing professional.

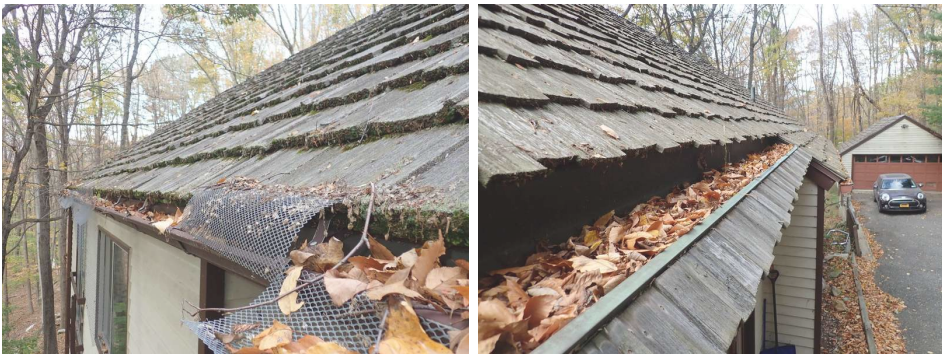
2.4.1 Roof Drainage System

The roof gutters and downspouts were completely filled with leaf debris and no performing their intended functions. Recommend having gutters replaced when roof is replaced, installing larger gutters to better capture the rain water at the roof thereby diverting water away from the foundation and sidewalls

Contact a qualified professional.

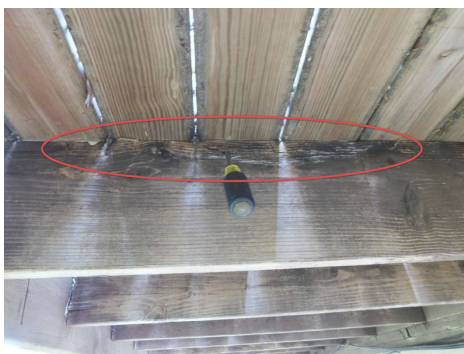
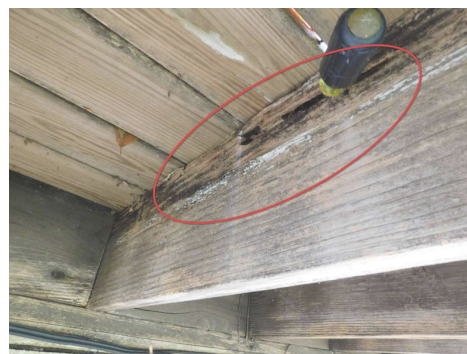
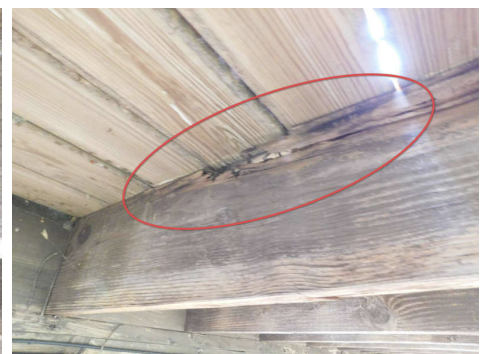
ROT AT DECK JOISTS

The cantilevered wood supports for the deck at the rear of the home were showing signs of heavy wood rot. A cantilevered deck relies on the integrity of the wood supports as the decks only means of support. When wood rot is found in the supports the deck is no longer safe for use. Recommend having a qualified person remove and rebuild the deck as a conventional deck with an attached ledger board and support posts at the outer end of the deck

Contact a qualified professional.

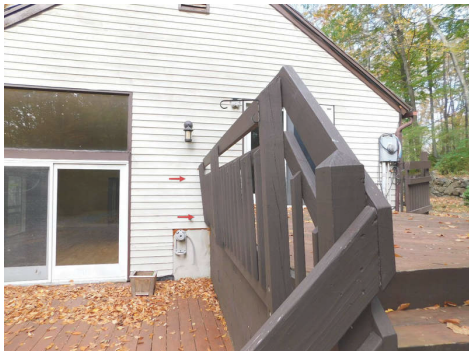
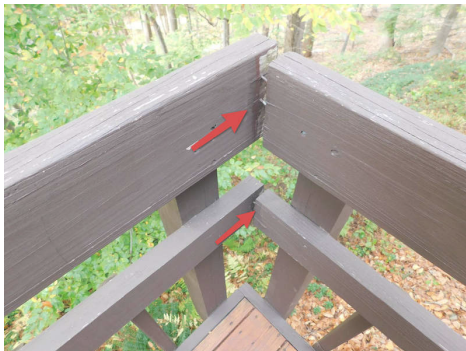
3.2.2 Deck, Porch & Patio

LOOSE RAILINGS

The railings at the deck are not safely attached to the deck and can easily be pushed off of the deck. Recommend having the railings replaced with new railings that conform to current building and safety standards. This is a fall hazard that needs to be corrected.

Railings Separated

Contact a qualified professional.

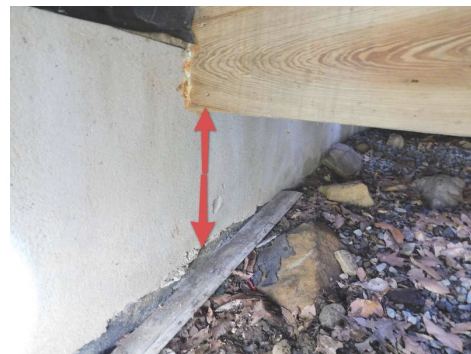
3.2.3 Deck, Porch & Patio

MISSING POSTS

The deck main beams at the new section of the deck are missing support posts where they meet the house. Recommend having posts installed under the beams as needed for proper support.

Missing Post Under Support Beam on Deck

Contact a qualified professional.

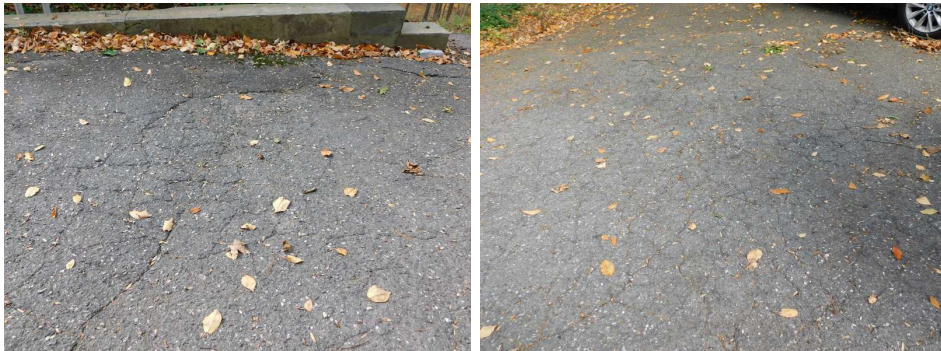
3.3.1 Driveway & Walkways

DRIVEWAY WELL WORN

The asphalt driveway was well worn with several large cracks and depressions. As driveways age they become brittle and develop more cracks and holes until the driveway is repaved or replaced.

Contact a qualified professional.

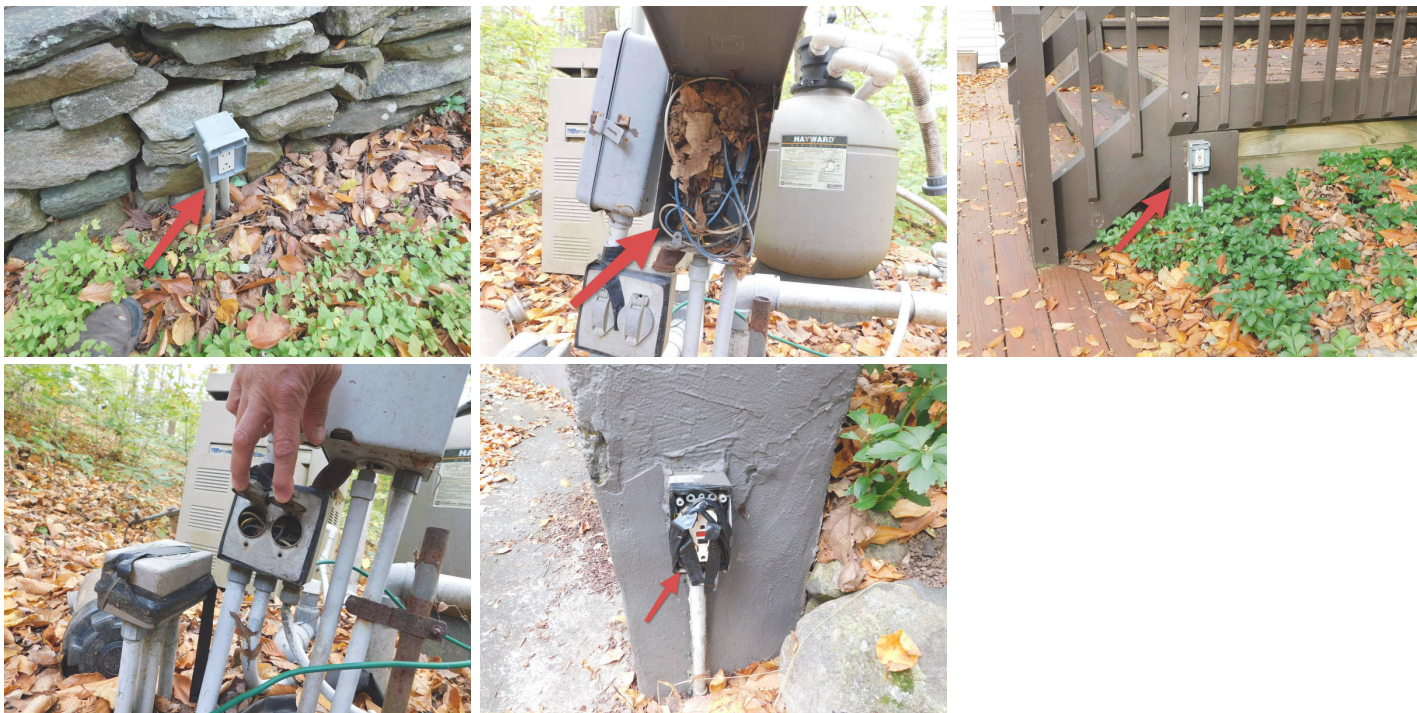
3.6.1 Exterior Electrical

DAMAGED OUTLETS

There were damaged outlet boxes, open/uncovered boxes and open pull boxes around the exterior of the home.

Recommend having all repaired with new waterproof covers as needed for safety

Contact a qualified electrical contractor.

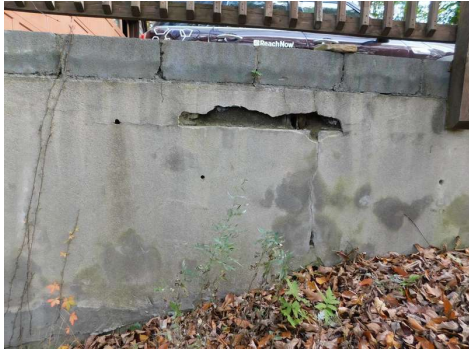
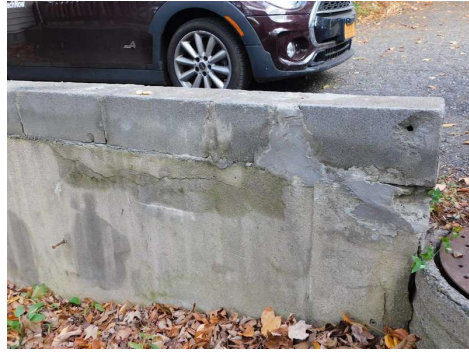
3.9.1 Retaining walls (with respect to their effect on the condition of the building)

RETAINING WALL DAMAGE

The retaining wall at the bottom of the driveway was deteriorated and in need of repair or replacement. Recommend having further evaluated by a qualified person to identify if patching is possible or if replacement is needed.

Contact a qualified professional.

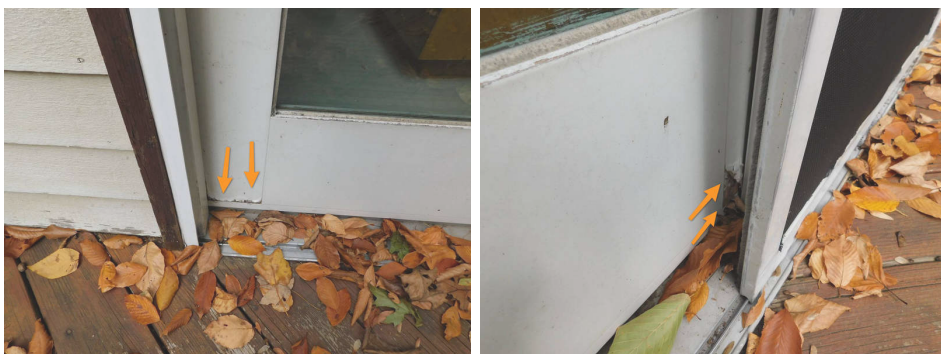
The kitchen sliding doors were showing signs of wood rot along their bottom edges. Recommend having repaired as needed.

Contact a qualified carpenter.

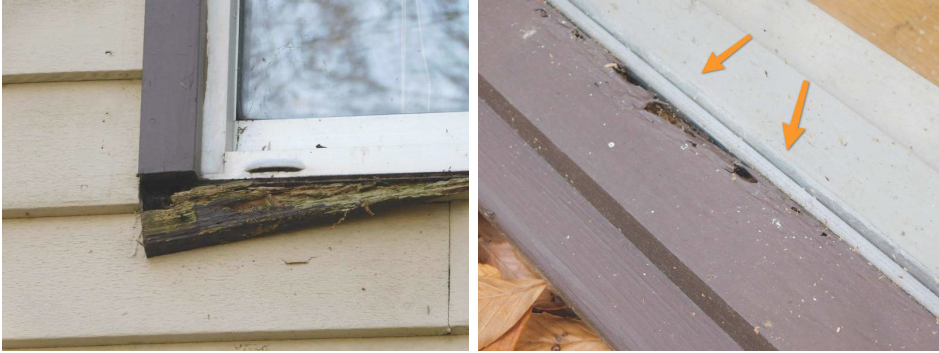
4.1.2 Door & Window Exteriors

WINDOW DAMAGED

Rot was found on a window along the right side of the home and along the deck doors. Repair as needed

Contact a qualified professional.

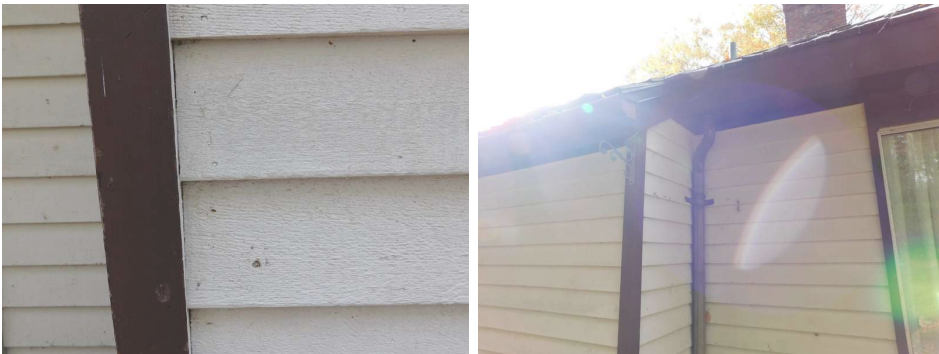
4.5.1 Exterior Trim

FAILING PAINT

The paint or stain finish in some areas was failing (e.g. peeling, faded, worn, thinning) Exterior Trim with a failing finish can be damaged by moisture. Recommend that a qualified contractor prep (e.g. clean, scrape, sand, prime, caulk) and repaint or restain the building exterior where necessary and per standard building practices. Any repairs needed to the trim should be made prior to this.

Contact a qualified painter.

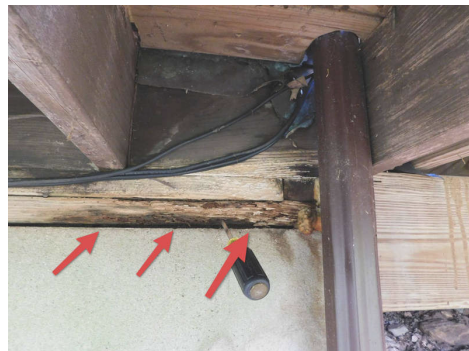
SILL PLATE ROT

Sill plates along the rear of the building have some rot at different location. Recommend having the damaged wood framing members replaced as needed

Contact a qualified professional.

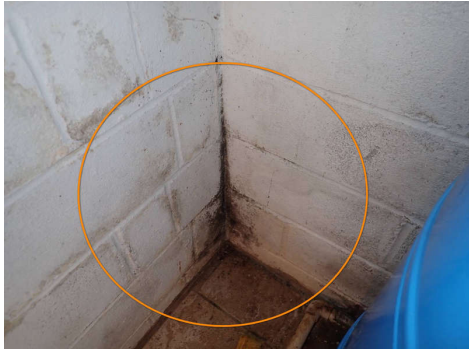
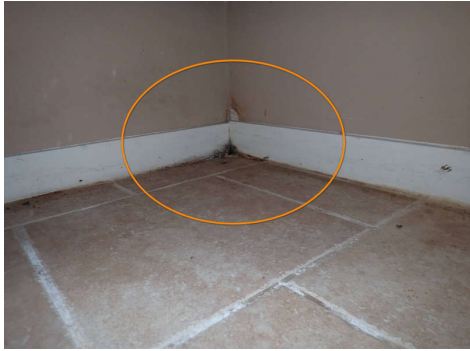
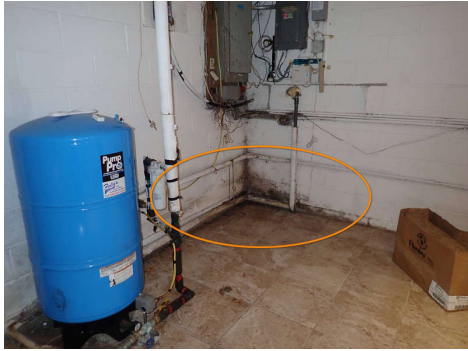
6.7.1 Report Any Signs of Water Intrusion or Unusually Damp Areas

DAMP WALLS

There were signs of moisture along the foundation walls at the front of the building. Recommend having a qualified person repair the problem as needed.

Contact a qualified professional.

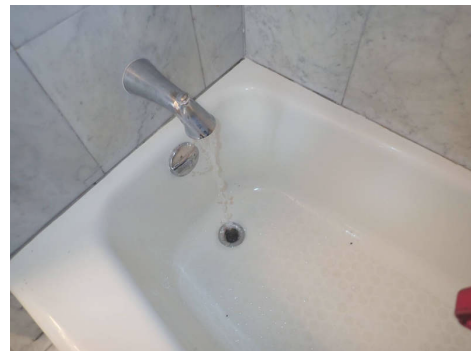
The water pressure in the home was not good. Water only ran from a faucet for a few seconds before the pressure disappeared. I recommend having a qualified well company further evaluate to determine the cause of low/ no pressure and the costs to fix or repair.

Very Low Flow at Fixtures

Contact a qualified well service contractor.

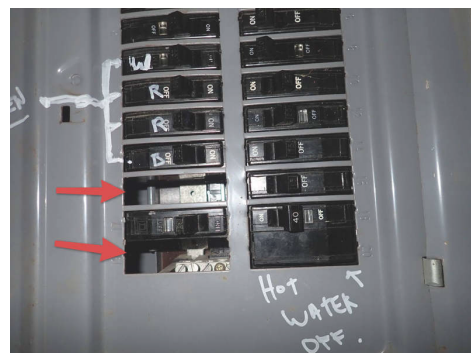
BASEMENT

PANEL SLOST MISSING

One or more slots where circuit breakers are normally installed were open in the front of the electrical panel. Energized equipment was exposed and is a shock hazard. Recommend that a licensed electrician install closure covers where missing.

Contact a qualified electrical contractor.

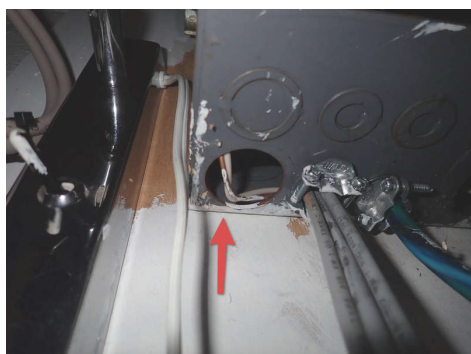
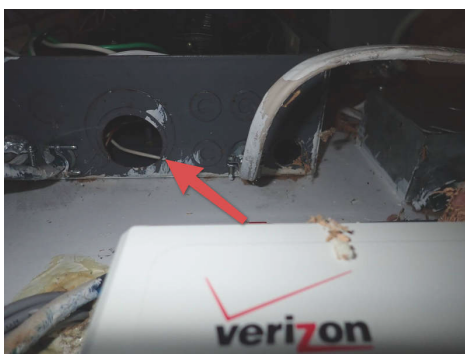
MISSING KNOCKOUTS

One or more knockouts were missing from the electrical panel. Holes in the panel enclosures are a potential fire hazard if a malfunction ever occurs inside the panel. Recommend that a licensed electrician install knockout covers where missing as per standard building practices.

Contact a qualified electrical contractor.

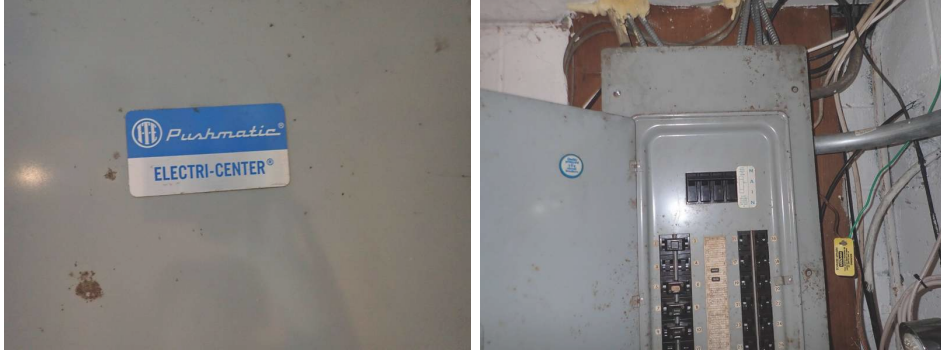
8.2.4 Main & Distribution Panels

PUSHMATIC

Suggested Improvement - The main electrical panel was a "Pushmatic" brand panel. These panels are found in older electrical systems. Their circuit breakers are known to become very stiff and difficult to operate or reset over time. Breakers may remain on after attempts to trip or turn them off have been made. They also have an indicator flag that falsely indicated the on/off tripped state. The breakers rely on thermal tripping only, whereas modern breakers have both thermal and magnetic trip mechanism. These conditions pose shock and fire hazards. Recommend that a qualified electrician replace pushmatic brand panels with more modern panels that offer more flexibility for new, safer protective technologies like GFCIs (ground fault circuit interrupts) and AFCIs (arc fault circuit interrupts).

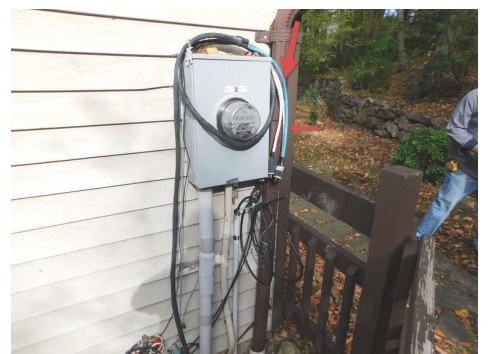
8.4.2 Connected Devices, Fixtures & Outlets

GENERATOR

The generator wiring was done improperly and is unsafe to use. This was not done by an electrician and was not inspected by the electrical inspector. Recommend immediate removal by a qualified person.

Contact a qualified electrical contractor.

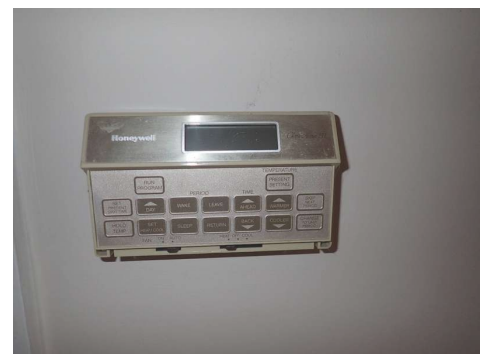
The basement thermostat was not operating. Recommend having replaced as needed. The basement level heat was not tested as a result.

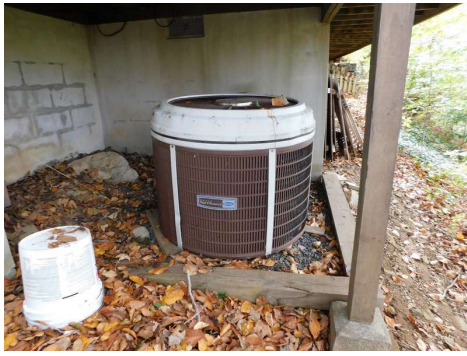
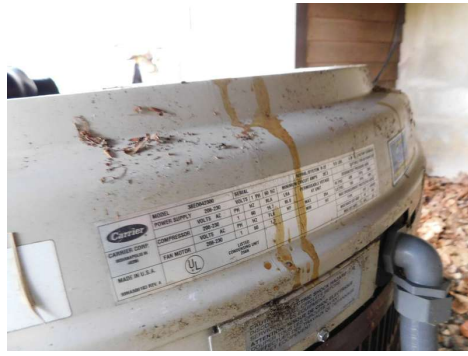
10.1.1 Central Air Conditioner

The estimated useful life for most air conditioning equipment is 15-20 years. This equipment appeared to be near, at, or beyond this age and/or its useful lifespan and may need replacing or significant repairs at any time. Recommend budgeting for a replacement in the near future.

Contact a qualified heating and cooling contractor

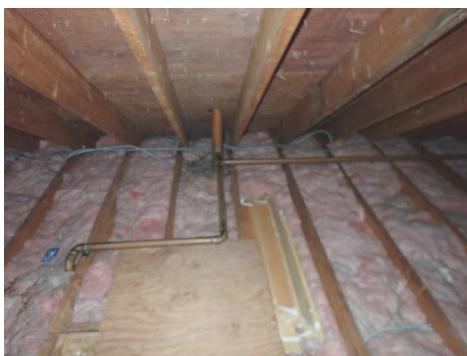
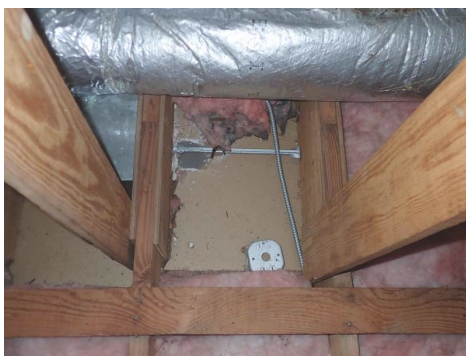
CEILING INSULATION

Suggested Improvement - Ceiling insulation installed in the attic was less than the amount recommended by today's building standards. Recommend that a qualified contractor install insulation for better energy efficiency and per current standard building practices (typically 12" with an R rating of R-38).

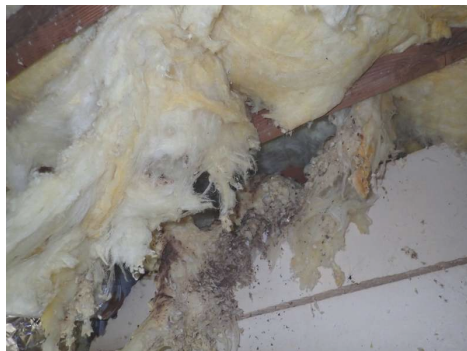
11.2.1 Insulation Under Floor System

The insulation in the crawlspace was fouled by heavy rodent activity. I recommend having the insulation removed and replaced by a qualified person.

Contact a qualified professional.

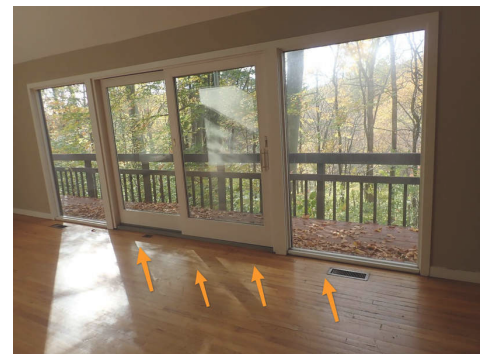
The floor along the rear wall of the building in the living room was spongy and slightly sunken. The framing under the floor may be damaged by wood rot and termite activity that could not be seen from below due to insulation and ductwork. Recommend further evaluation when insulation is removed from crawlspace.

Contact a qualified professional.

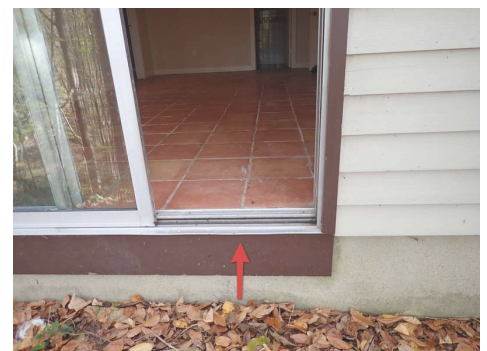
12.2.1 Doors (representative number)

The basement sliding door was dangerous. The step to the exterior was far in excess of a typical seven inch step. Anyone unfamiliar with the door could fall and become injured. Recommend correcting as needed by adding steps or sealing up the door.

Contact a qualified professional.

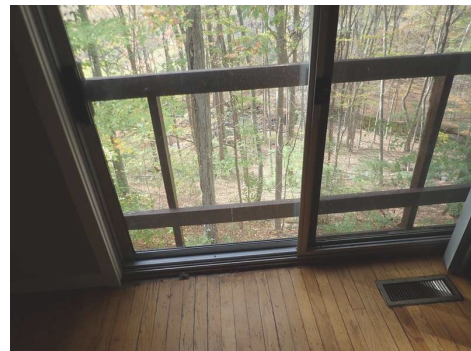
12.2.2 Doors (representative number)

NEED FALL PROTECTION

The 2nd floor doors in the master bedroom do not have adequate fall protection and what is installed has been damaged by wood rot. Recommend installing railing as per current building standards for safety

Contact a qualified carpenter.

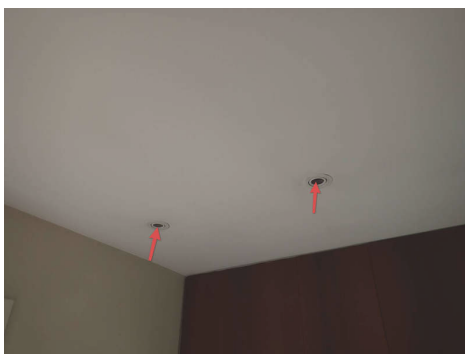
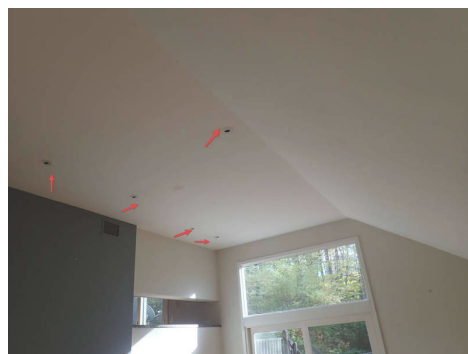
The lighting in the kitchen and the lighting in the living room did not work. Recommend having repaired as needed by a qualified person.

Kitchen

Living Room

Contact a qualified electrical contractor.

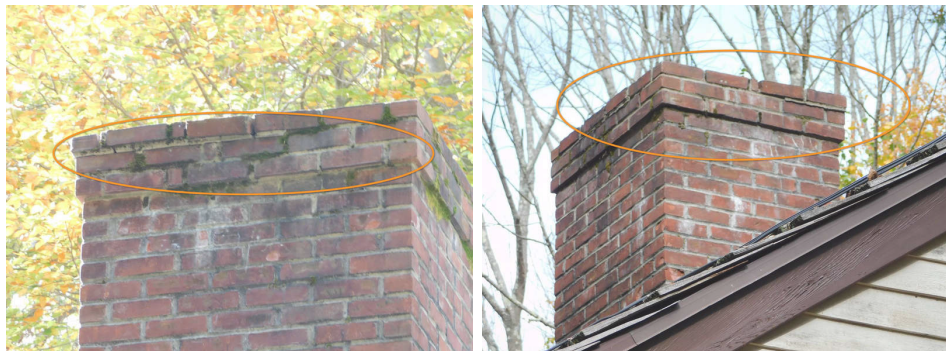
16.6.1 Chimney Structure/Exterior

CHIMNEY REPOINTING

Mortar at the top or sides of the brick chimney was deteriorated (e.g. loose, missing, cracked). As a result, water is likely to infiltrate the chimney structure and cause further damage. Recommend that a qualified contractor evaluate and repair as necessary. For example, by repointing the mortar or replacing damaged bricks.

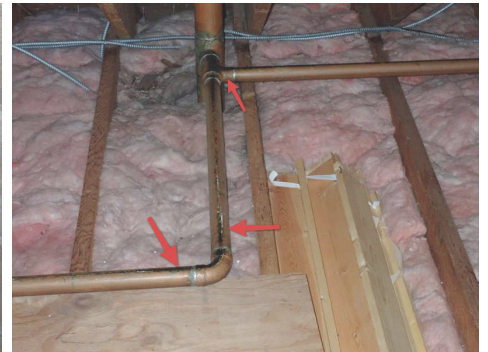
Mouse Trails Attic

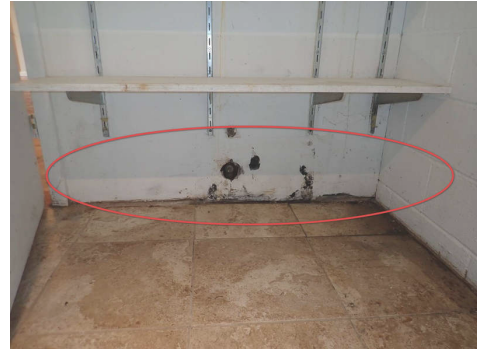
17.2.1 Possible Microbial Growth

MOLD

Possible microbial growths were found at one or more locations. It is beyond the scope of this inspection to identify what organism or substance this staining is. However, such staining is normally caused by excessively moist conditions, which in turn can be caused by plumbing or building envelope leaks and/or substandard ventilation. These conducive conditions should be corrected before making any attempts to remove or correct the staining. Normally, affected material such as drywall are removed, enclosed spaces are allowed to dry thoroughly, a mildewcide may be applied, and only then is drywall reinstalled. For evaluation and possible mitigation, consult with a qualified or NYS Licensed industrial hygienist or mold/moisture assessment specialist. For more information, visit: <http://www.sterlinghomeinspections.com/index/#/mold/>

Contact a qualified environmental contractor

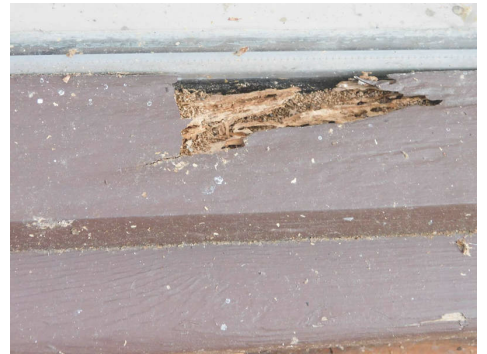
Rear of Home along Deck at Windows

Contact a qualified pest control specialist.
