IZON INSPECTION SERVICES

## RESIDENTIAL REPORT

1234 Main St.  
Oklahoma City OK 73134

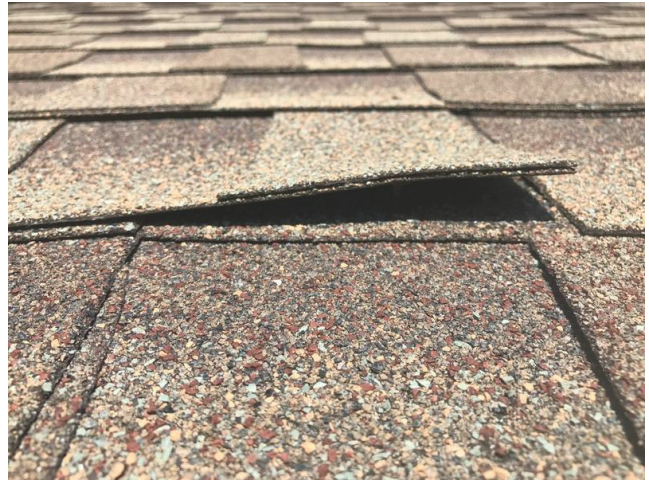
Observed one or more under-driven nails/fasteners (nail pops). Recommend a qualified roofing contractor evaluate and repair.

Contact a qualified roofing professional.

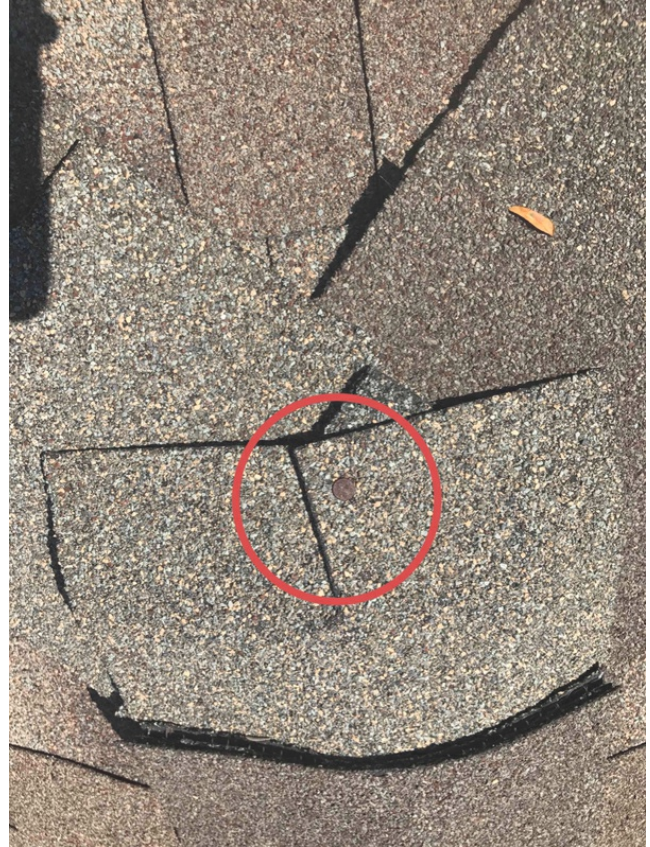
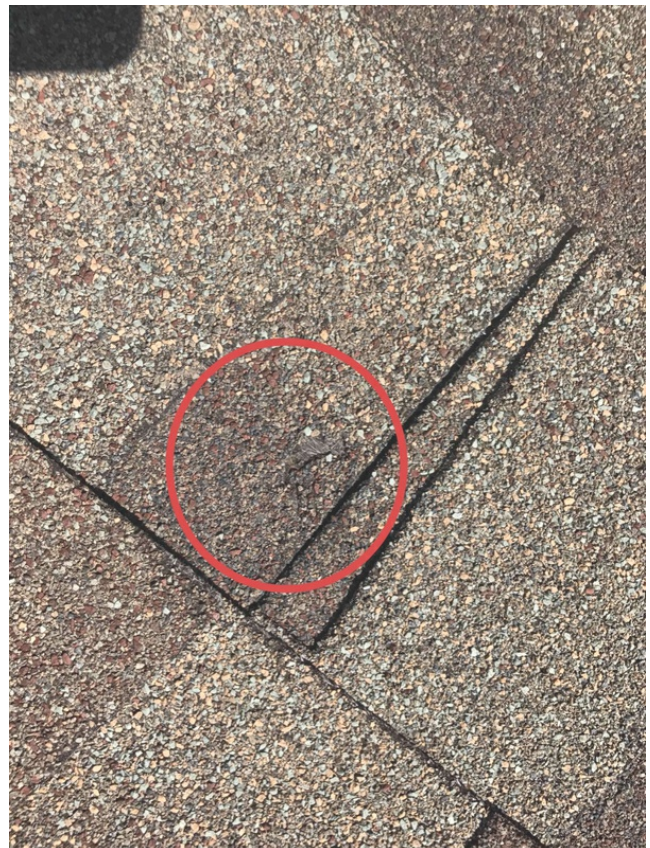
2.1.2 Coverings

# EXPOSED NAILS/FASTENERS

One or more exposed nails/fasteners were observed. This condition increases the chances of leaks and damage to underlayment in this area. Recommend sealing nails to prevent moisture intrusion.

Contact a qualified roofing professional.

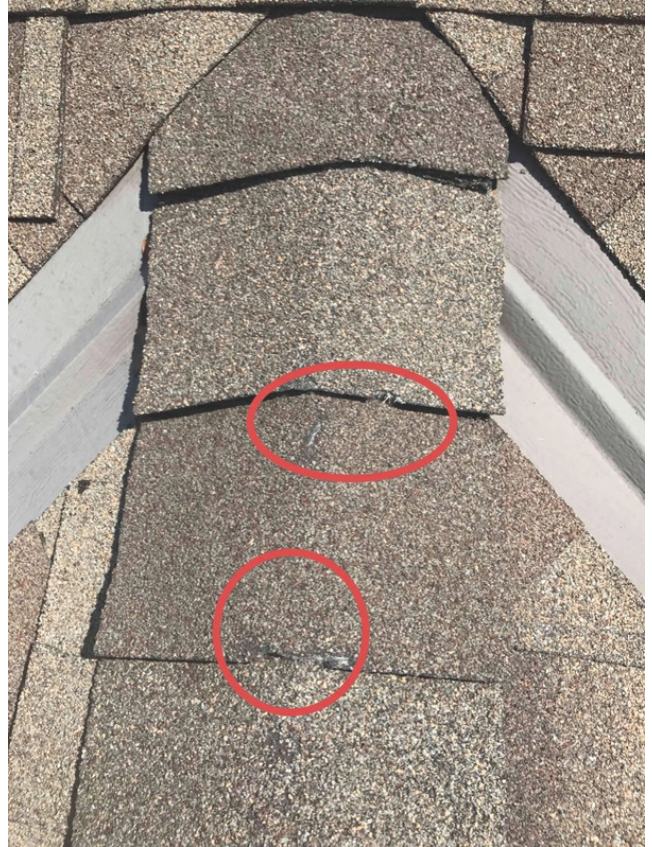
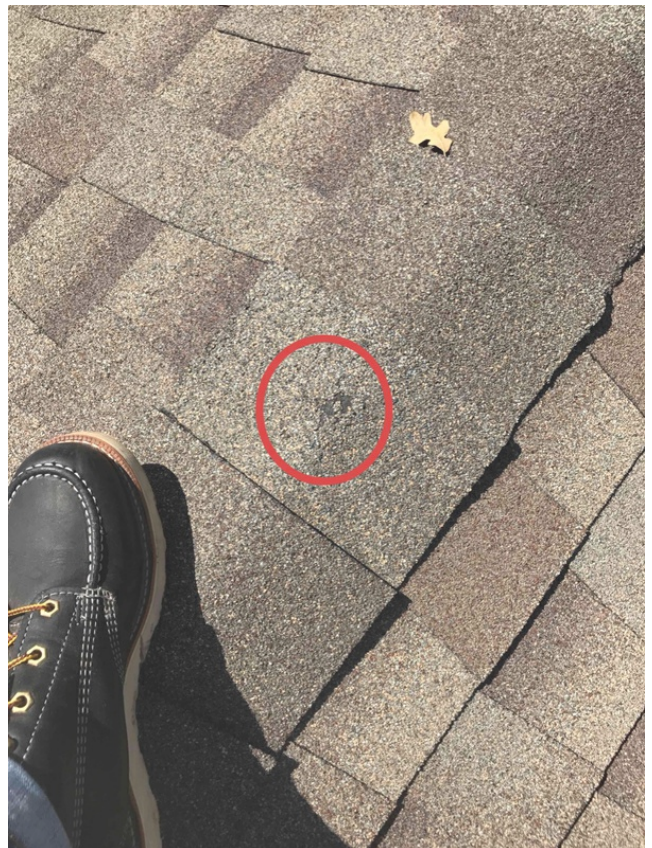
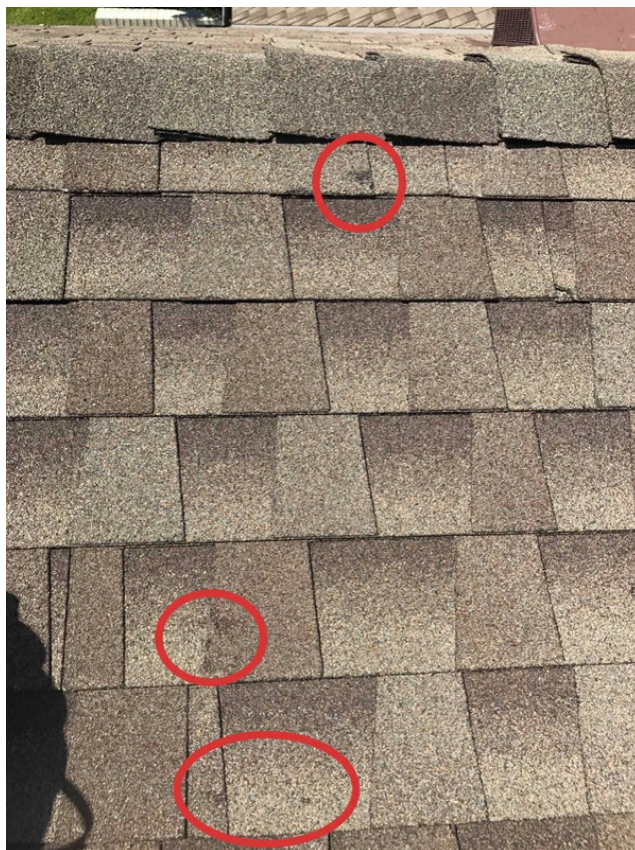
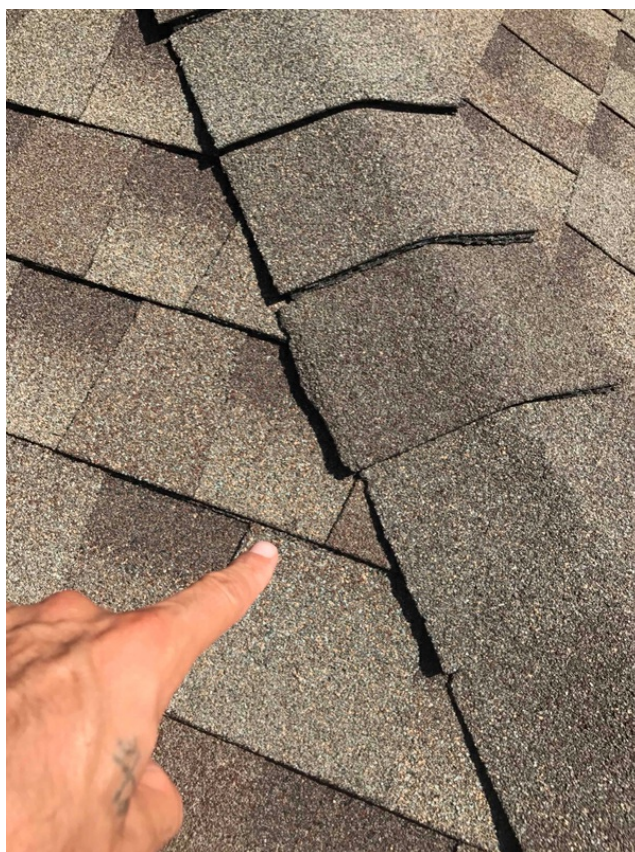
2.1.3 Coverings

# DAMAGED (MODERATE)

Roof coverings showed moderate damage. Recommend a qualified roofing

professional evaluate and repair.  
Contacting your insurance company to  
verify insurability is always recommended  
as well.

Contact a qualified roofing professional.

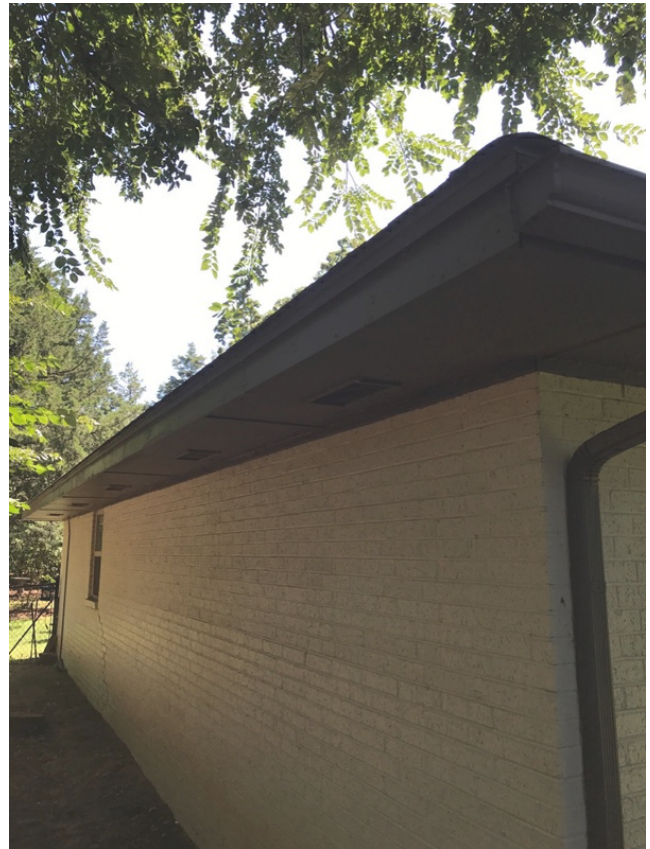
2.2.1 Gutters & Downspouts

## GUTTERS MISSING

There are not gutters present all the way around the home. Gutters are recommended because they collect rain water from the roof and direct it away from the building.

Contact a qualified professional.

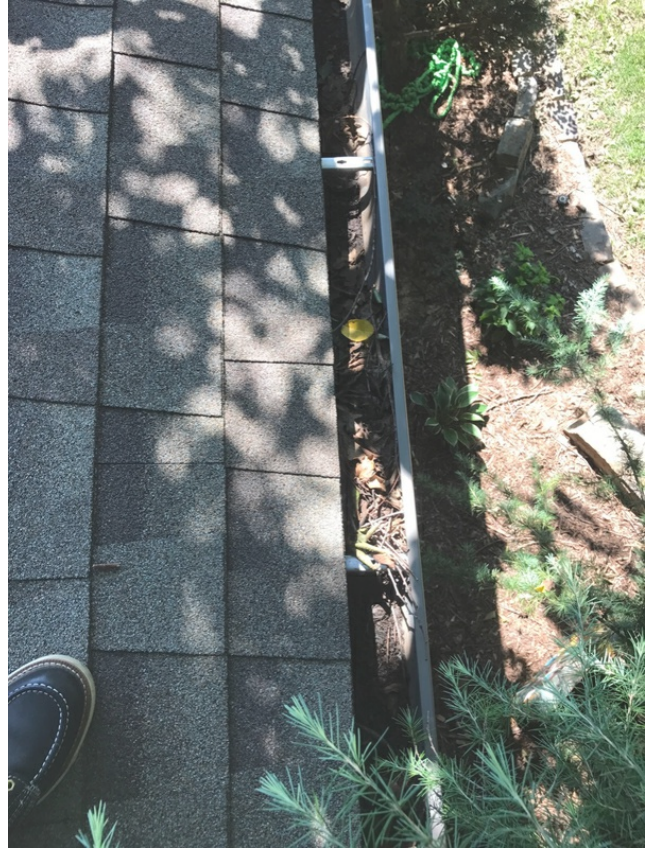
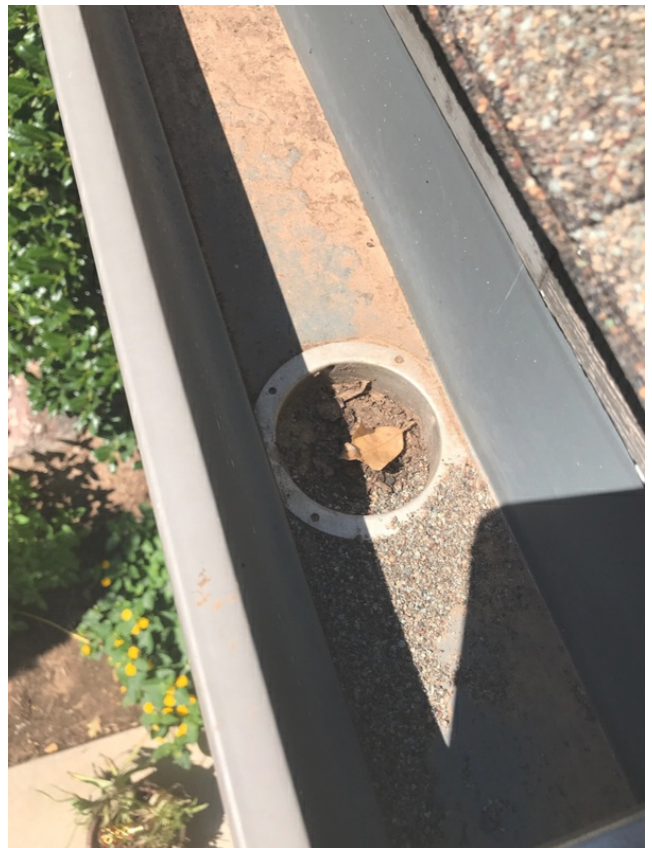
2.2.2 Gutters & Downspouts

## DEBRIS BUILD-UP

Debris has accumulated in the gutters. Recommend cleaning to facilitate water flow.

Contact a qualified roofing professional.

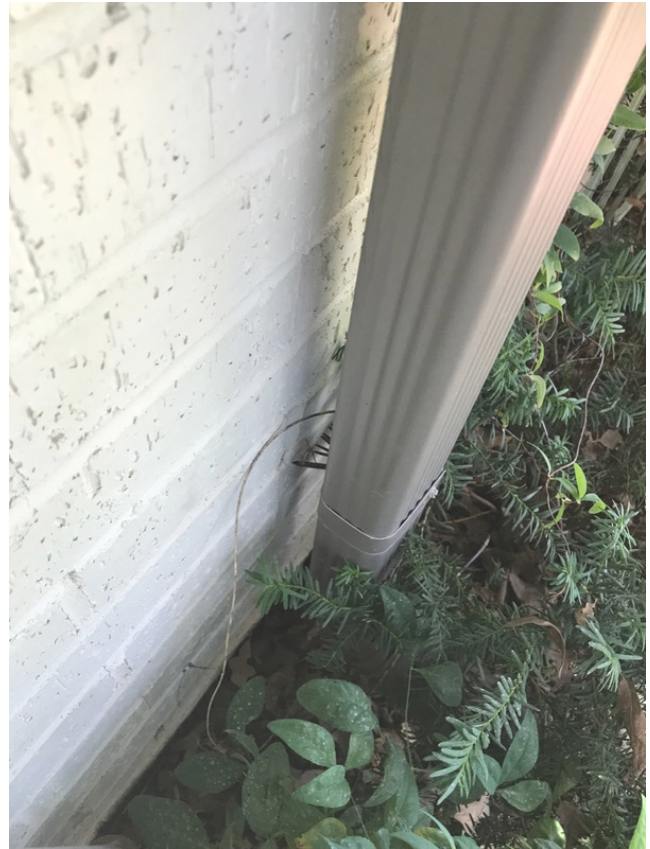
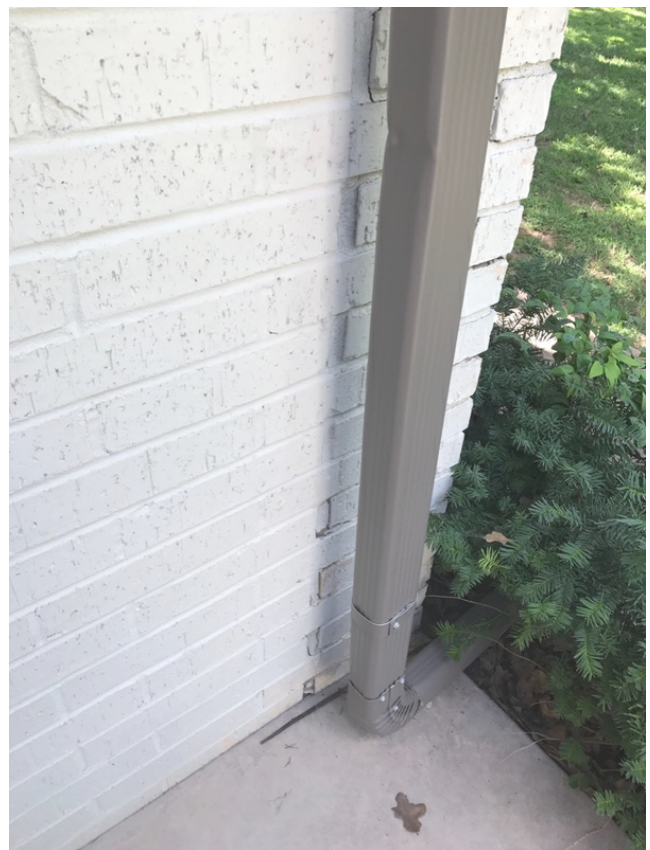
2.2.3 Gutters & Downspouts

## DETACHED GUTTER

The gutter(s) is loose and needs to be re-fastened. Recommend correction by qualified professional.

Contact a qualified professional.

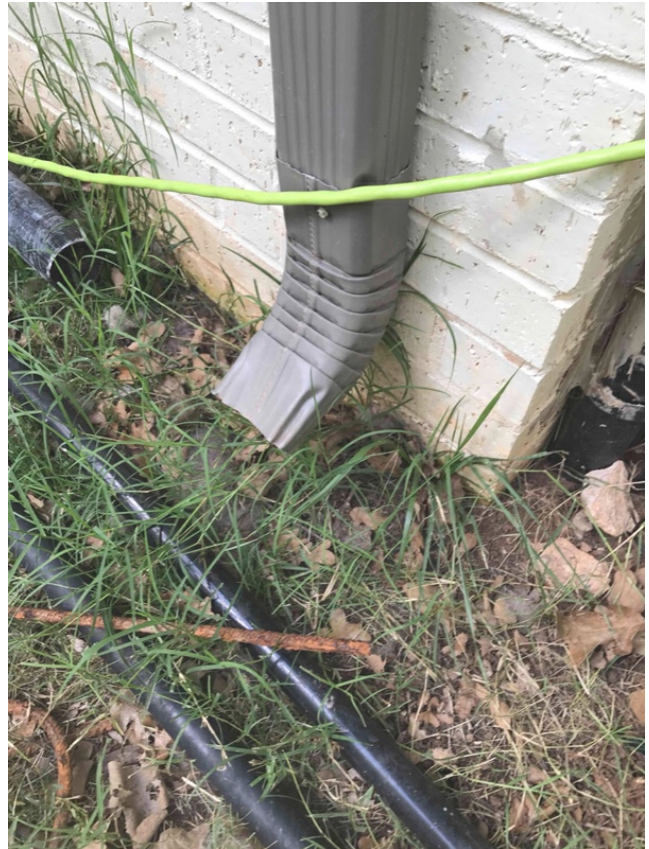
2.2.4 Gutters & Downspouts

## DOWNSPOUTS DRAIN NEAR HOUSE

One or more downspouts drain too close to the home's foundation. This can result in excessive moisture in the soil at the foundation, which can lead to foundation/structural movement. Recommend a qualified professional adjust or add downspout extensions to drain at least 6 feet from the foundation.

Contact a qualified roofing professional.

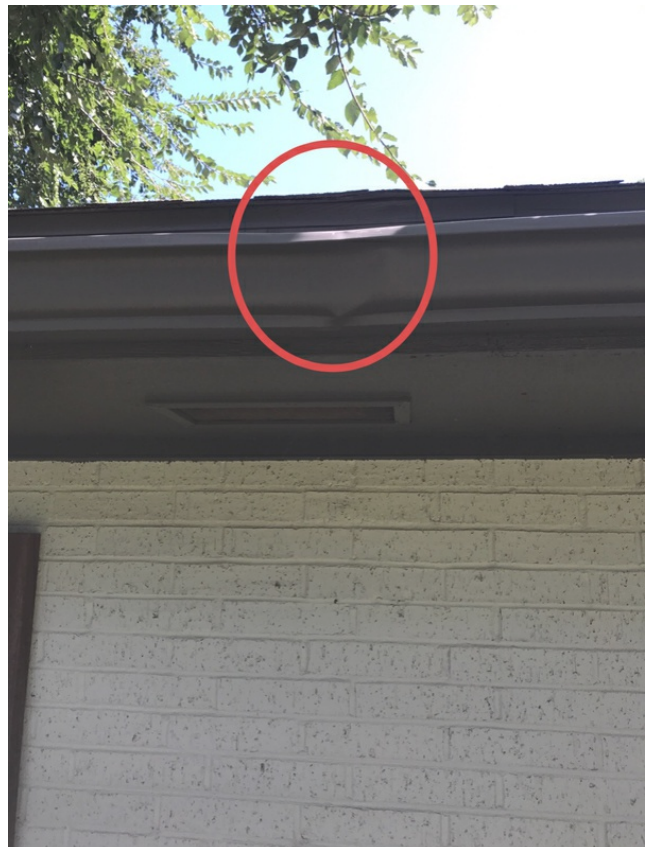
2.2.5 Gutters & Downspouts

## GUTTER DAMAGED

Gutters were damaged. This can result in excessive moisture in the soil at the foundation, which can lead to foundation/structural movement. Recommend a qualified contractor evaluate and repair.

Contact a qualified roofing professional.

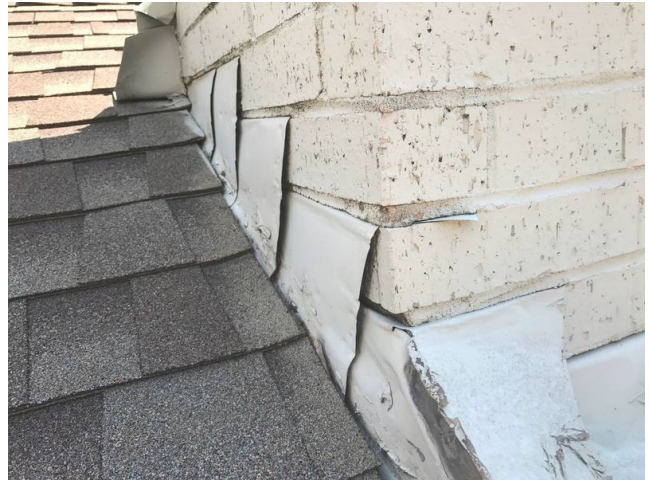
2.3.1 Flashings

## LOOSE/SEPARATED

Flashings observed to be loose or separated, which can lead to water intrusion and/or mold. Recommend a qualified roofing contractor repair.

Contact a qualified roofing professional.

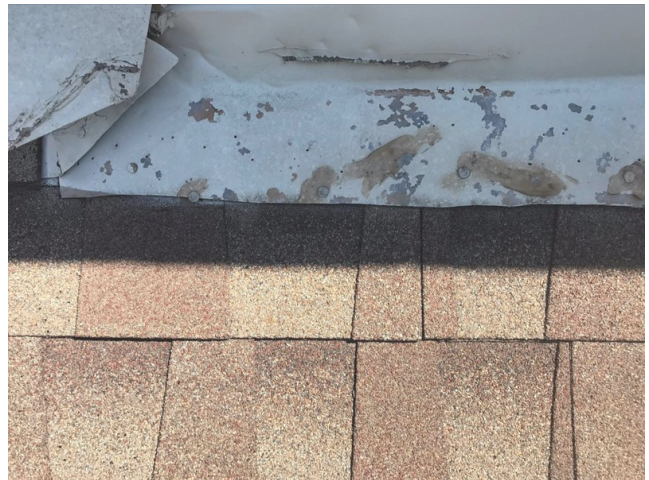
2.3.2 Flashings

## EXPOSED NAILS AT FLASHING

Nails were exposed at flashing(s) and should be properly sealed to prevent moisture intrusion. Recommend correction by a qualified professional.

Contact a qualified professional.

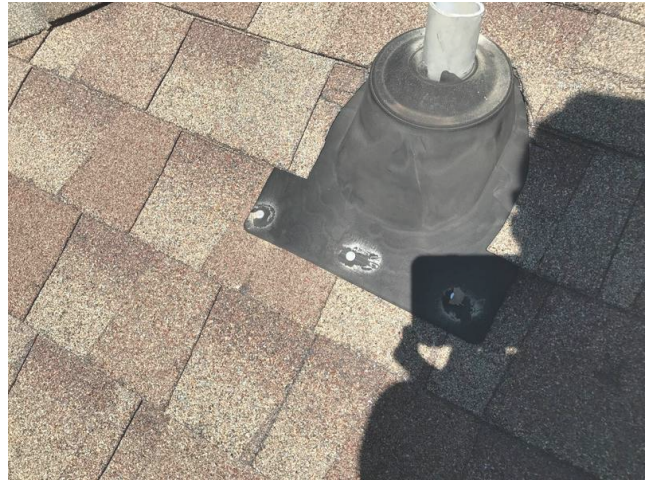
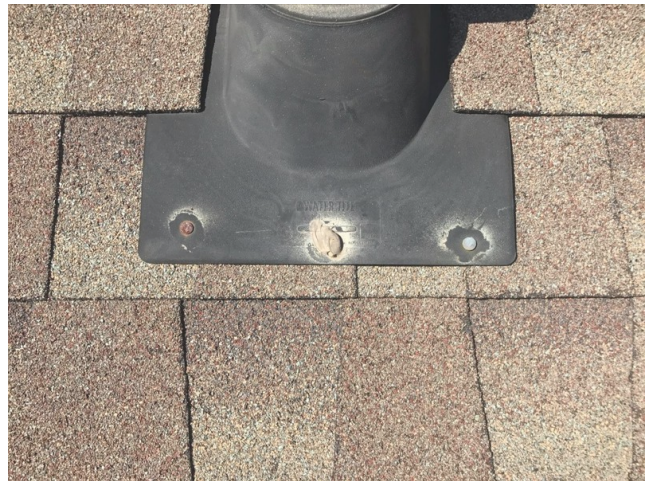
One or more exposed nails at the boots. This condition increases the chances of moisture intrusion. Recommend correction by a qualified professional.

Contact a qualified professional.

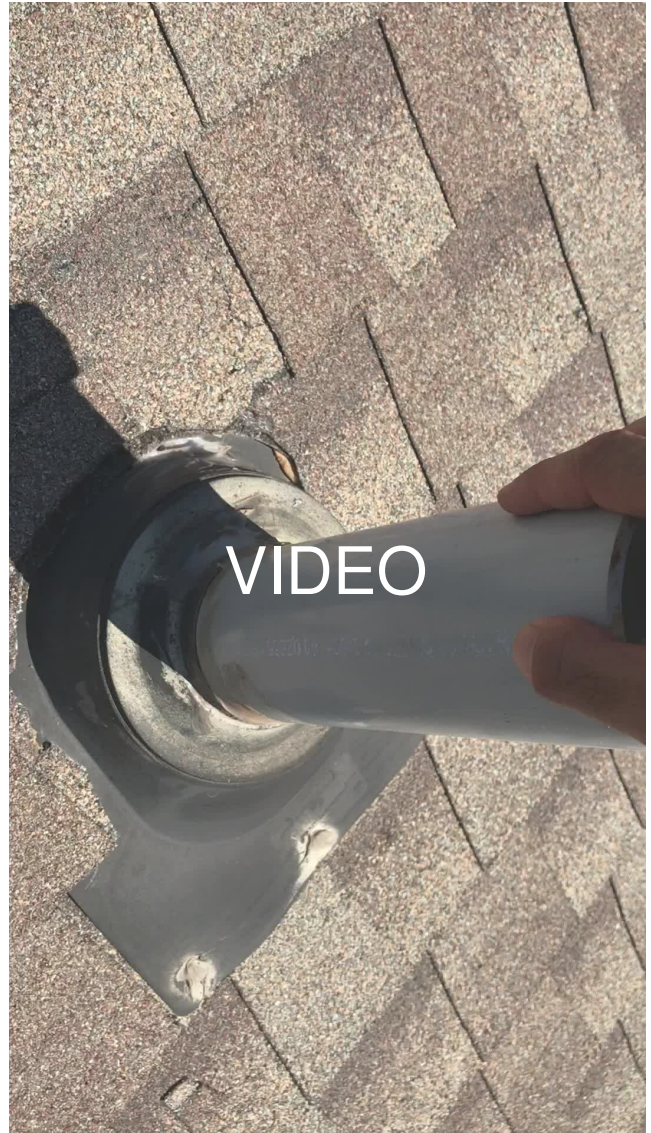
2.4.2 Roof Penetrations

## LOOSE BOOT / POOR INSTALLATION

One or more roof jacks or plumbing boots were loose. This could lead to water intrusion if not properly installed. Recommend correction by a qualified professional.

Contact a qualified professional.

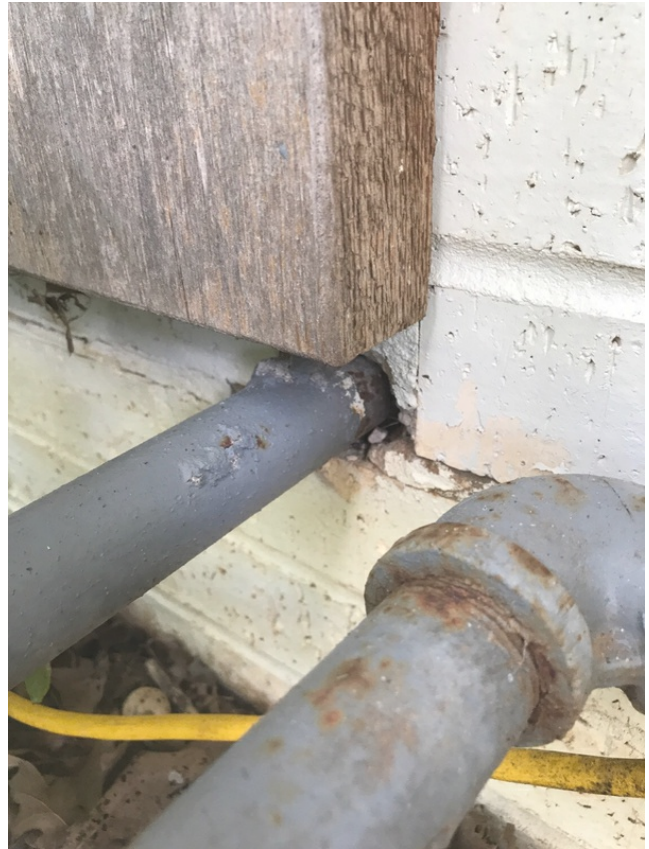
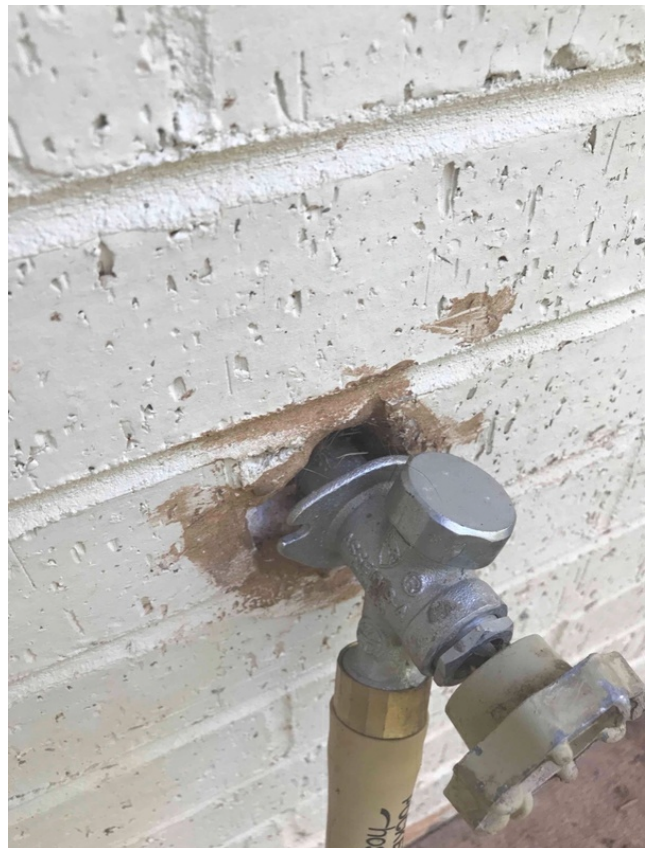
Exterior wall penetrations or pipes had gaps that should to be sealed with an appropriate sealant to prevent moisture and insect entry. All work should be performed by a qualified contractor.

Contact a qualified professional.

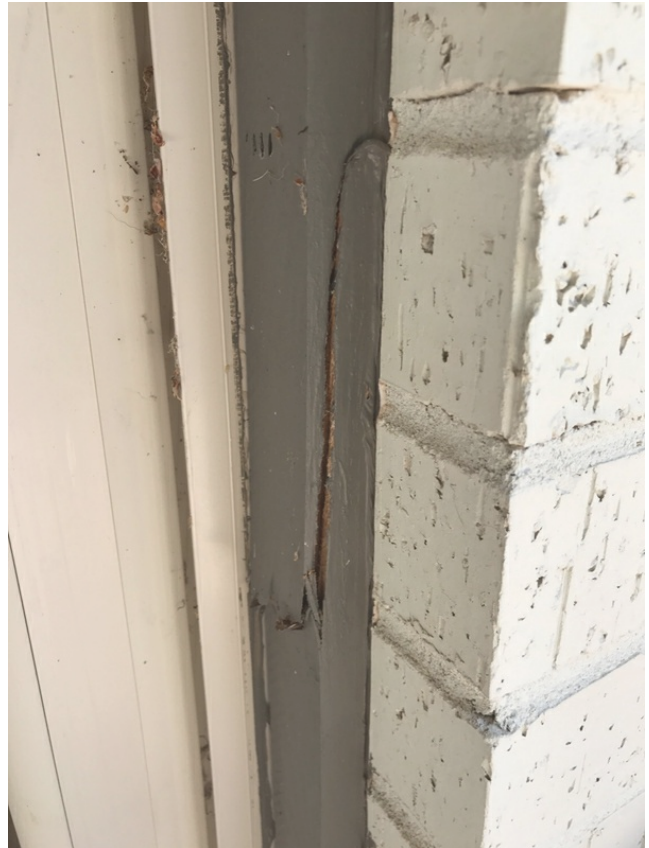
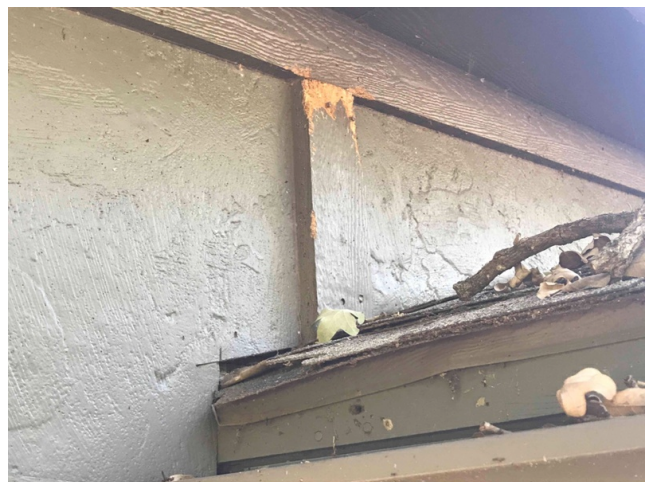
## TRIM - DAMAGED/CRACKED

One or more sections of the trim are damaged. Recommend correction by a qualified professional.

Contact a qualified professional.

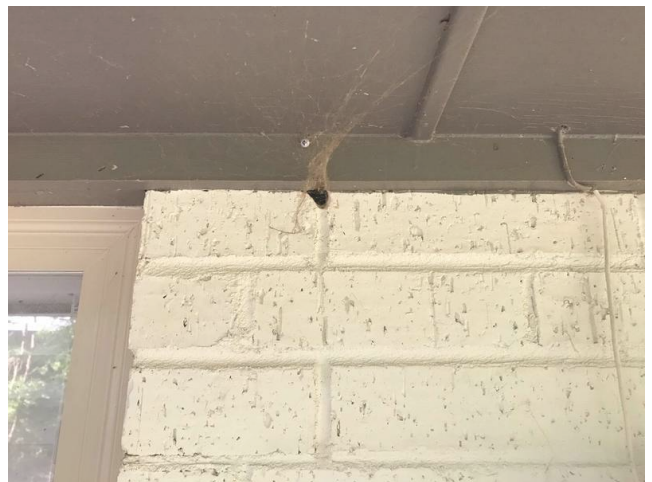
3.2.3 Trim

Exposed hole in the trim. Inspector recommends to seal hole to prevent moisture and pest intrusion. All work should be performed by a qualified professional.

Contact a qualified professional.

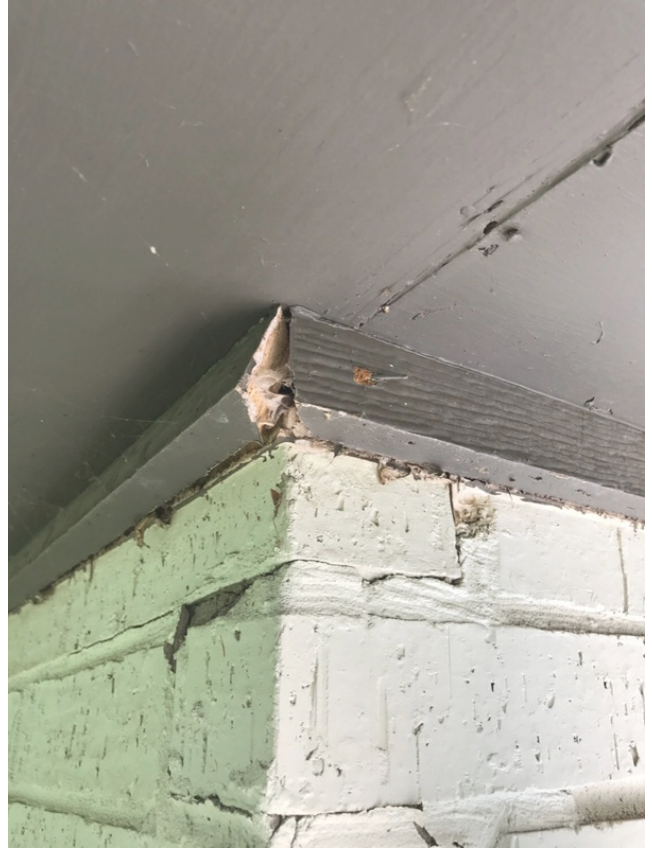
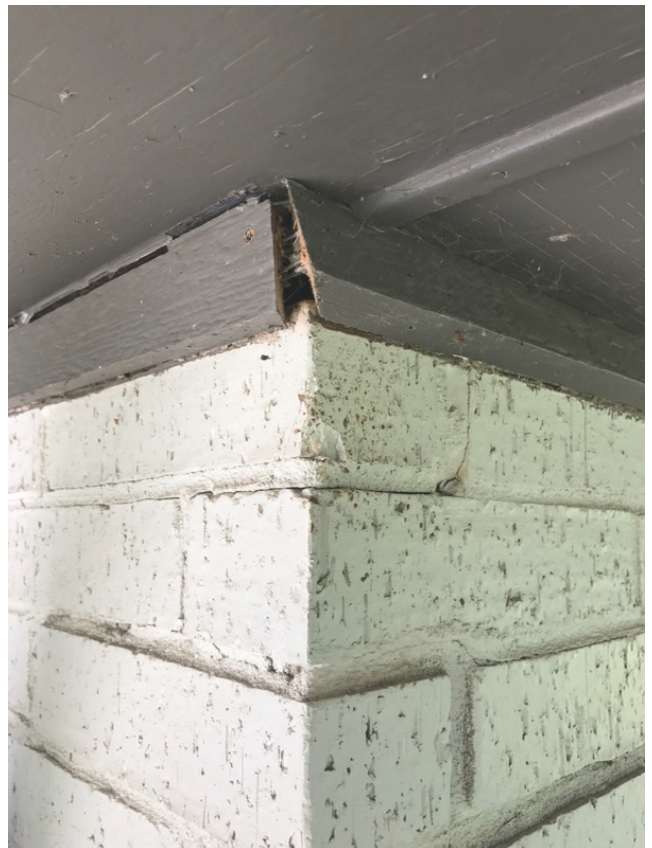
3.2.4 Trim

## SEPARATED TRIM

Gaps were observed at one or more locations of trim junctions. Recommend correction by a qualified professional to prevent moisture or insect intrusion.

Contact a qualified professional.

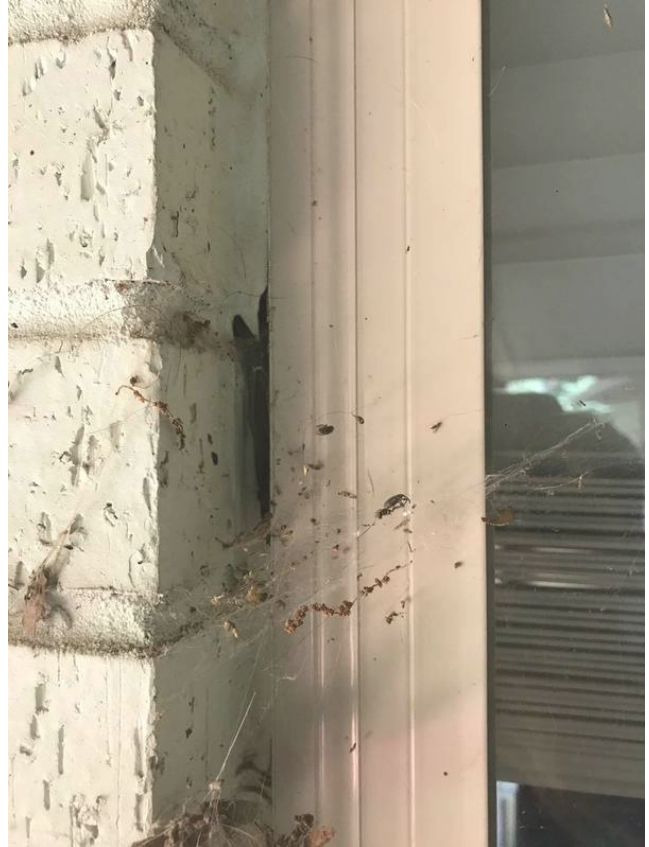
One or more gaps were observed at the window trim. Recommend to seal gaps with an approved sealant to prevent not only moisture and pest intrusion but energy loss.

Contact a qualified professional.

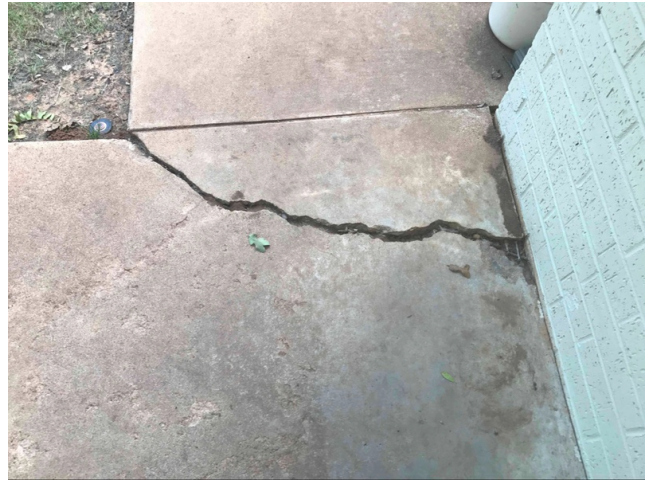
## WALKWAY CRACKING - MINOR

Minor cosmetic cracks observed.  
Recommend monitor and/or patch/seal.

Recommended DIY Project

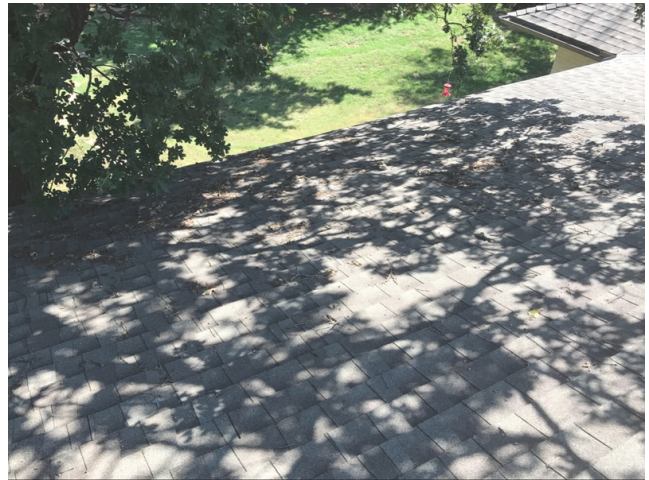
3.6.1 Grounds

## TREE DEBRIS ON ROOF

Tree debris observed on roof. This can cause improper drainage to gutters and downspouts. Recommend clearing debris.

Contact a quality handyman.

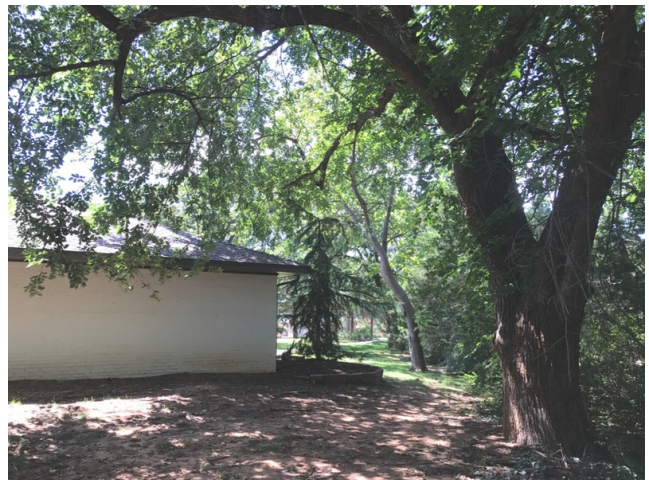
3.6.2 Grounds

## TREE OVERHANG

Large trees near the house have limbs that overhang the home. Falling limbs due to conditions such as wood decay, high winds or heavy snow loads may cause injury, death or damage. Consider having these trees evaluated by a qualified professional. Evaluating trees lies beyond the scope of the general Home Inspection.

Contact a qualified tree service company.

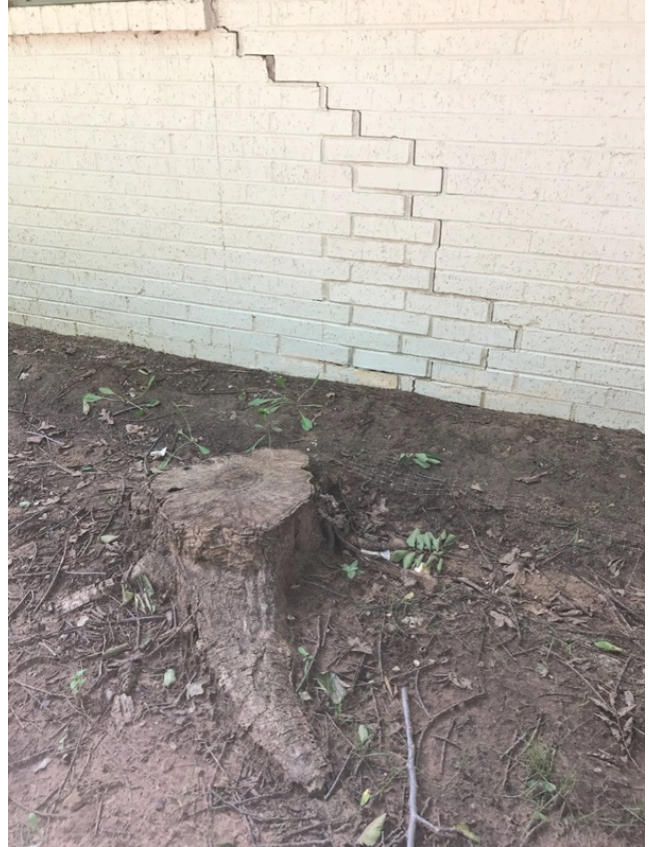
Roots from a tree located near the foundation may cause foundation damage as the tree grows and the root system expands. Monitor this area of the foundation during the growing season (usually May through September) for signs of damage. If signs of damage appear (such as cracks) the tree may need to be removed. The potential for damage from tree roots varies with tree species. Consider evaluation by a qualified arborist.

Contact a qualified professional.

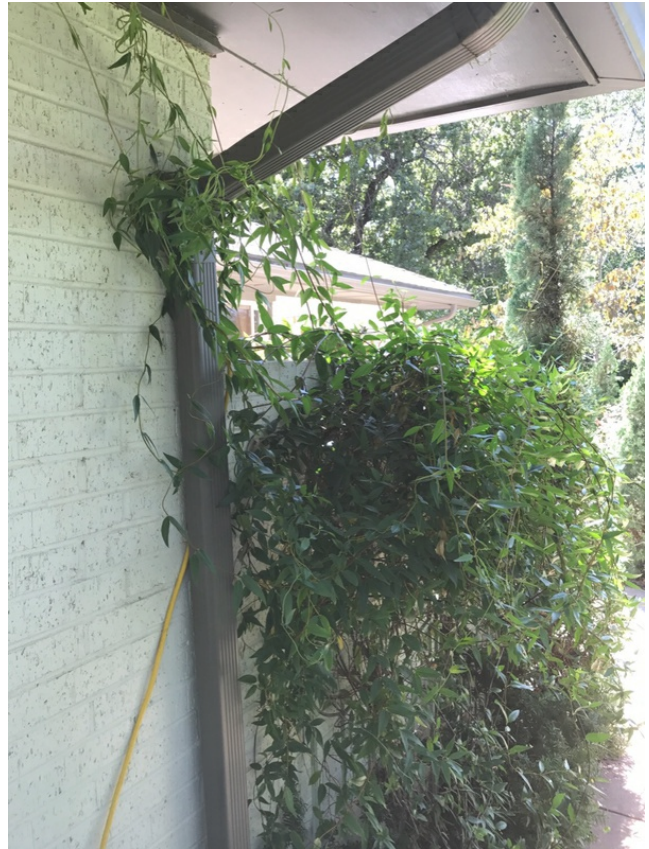
Vines growing on the exterior walls may introduce insects, pests and/or accelerate deterioration of the exterior wall covering by retaining moisture. Over time, vine tendrils may damage wall covering materials.

Watering this vegetation will introduce moisture to the soil which may eventually reach the foundation. Moisture in soil supporting the foundation can affect the ability of the foundation to support the weight of the structure above and can cause damage from soil heaving or settling, depending on soil composition and other conditions. The Inspector recommends removal of the vegetation from exterior walls.

Contact a qualified professional.

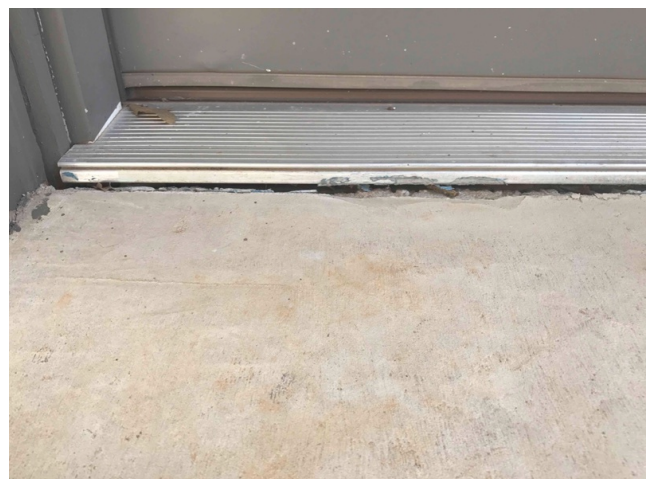
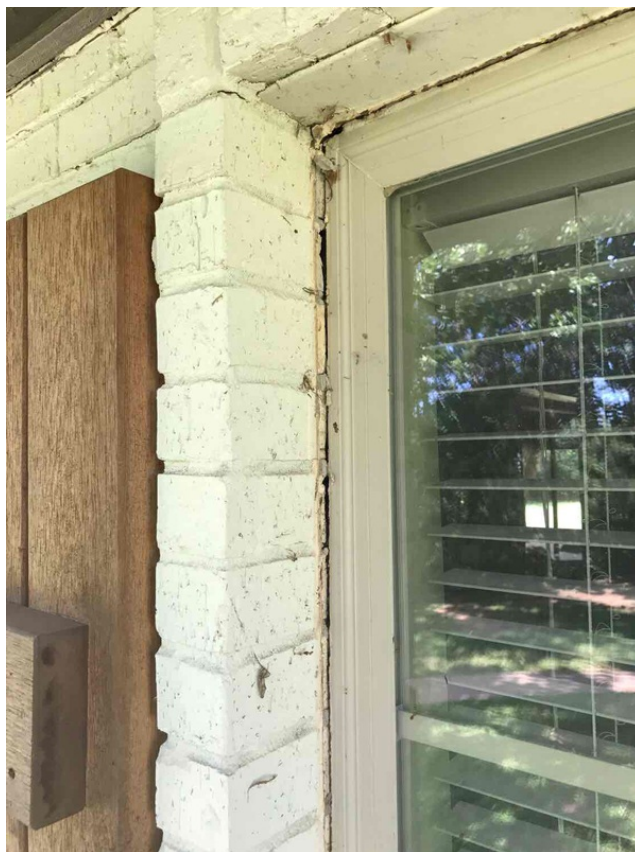
4.1.1 Foundation

### EVIDENCE OF STRUCTURAL DAMAGE

Evidence of structural damage was found in the wall structure. Recommend a structural engineer evaluate and advise on how to repair.

Contact a qualified structural engineer.

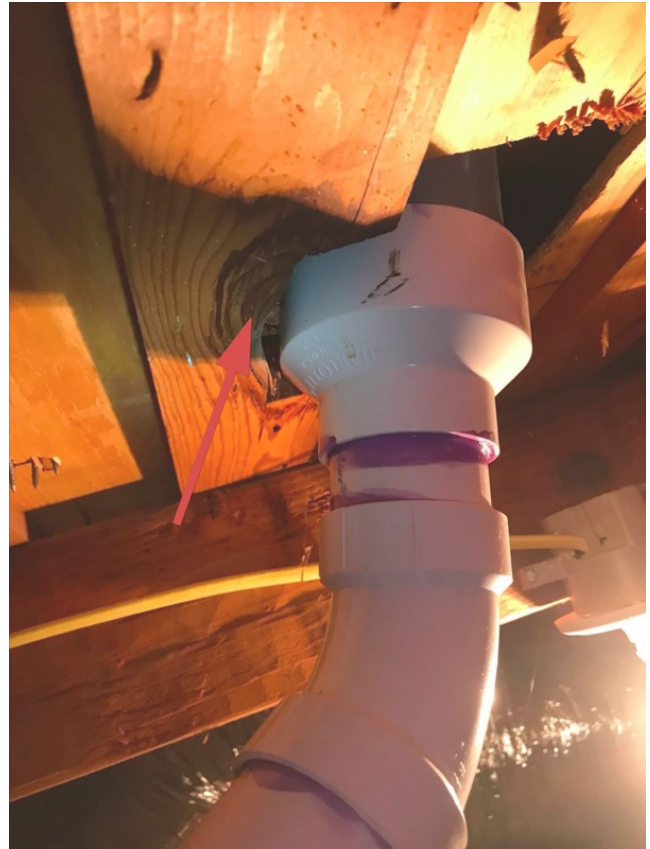
## EVIDENCE OF MOISTURE INTRUSION

Area around plumbing vent stack showed signs of water/moisture intrusion. Recommend correction by a qualified professional.

Contact a qualified professional.

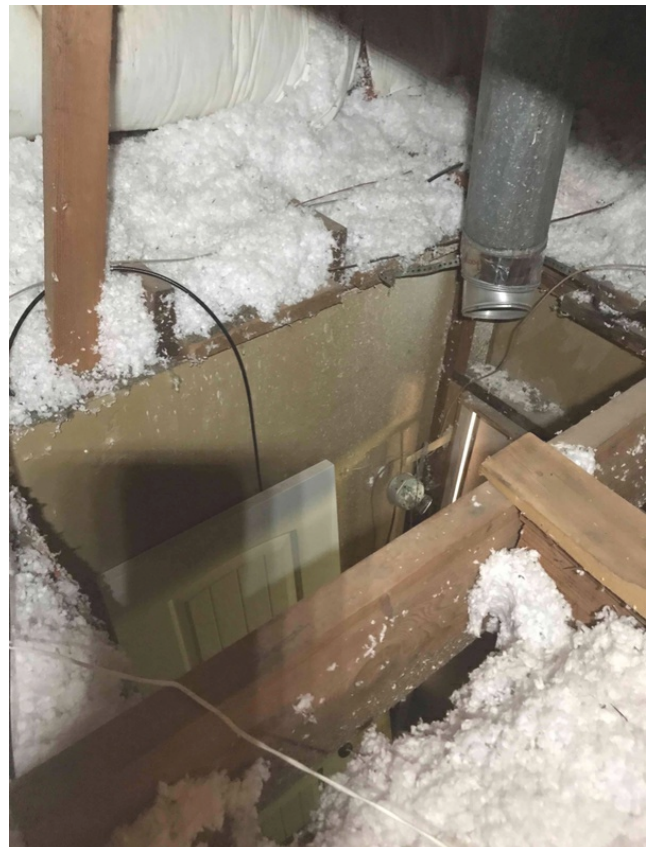
5.1.2 Structure

## NO FIRESTOP

Water heater was moved but the chase has not been sealed off. Recommend sealing off abandoned closet for safety to prevent the spread of fire, should one occur. All work should be done by a qualified professional.

Contact a qualified professional.

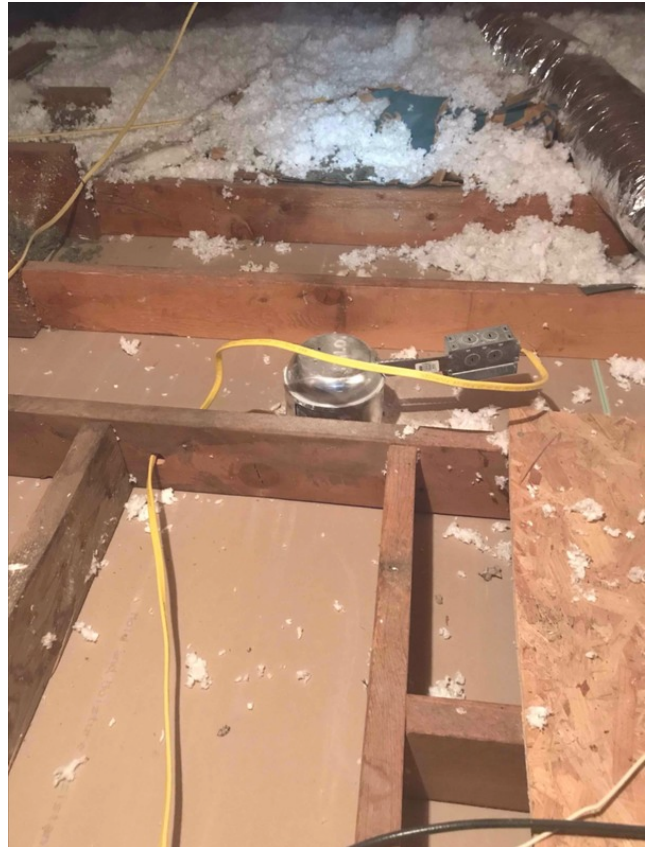
5.3.1 Insulation

## MISSING INSULATION

The Inspector observed areas of the attic  
iZON Inspection Services

that were missing insulation. Recommend have a qualified professional add insulation to cover appropriately.

This photo was taken above the bathroom next to the garage.

Contact a qualified professional.

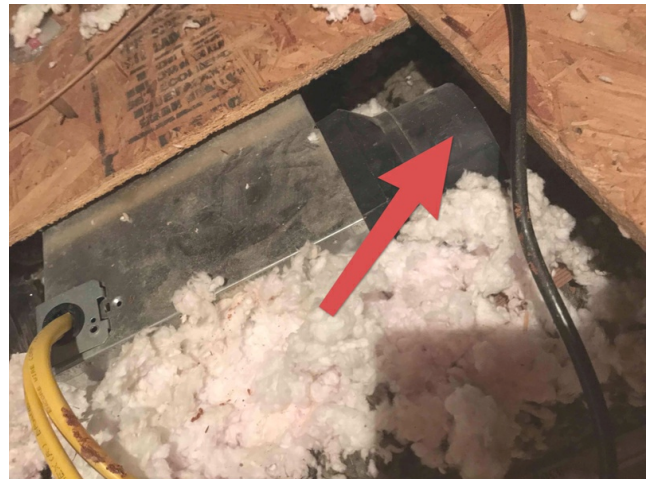
Bathroom fan vents into the attic, which can cause moisture and mold. Recommend a qualified attic contractor properly install exhaust fan to terminate to the exterior.

Contact a qualified HVAC professional.

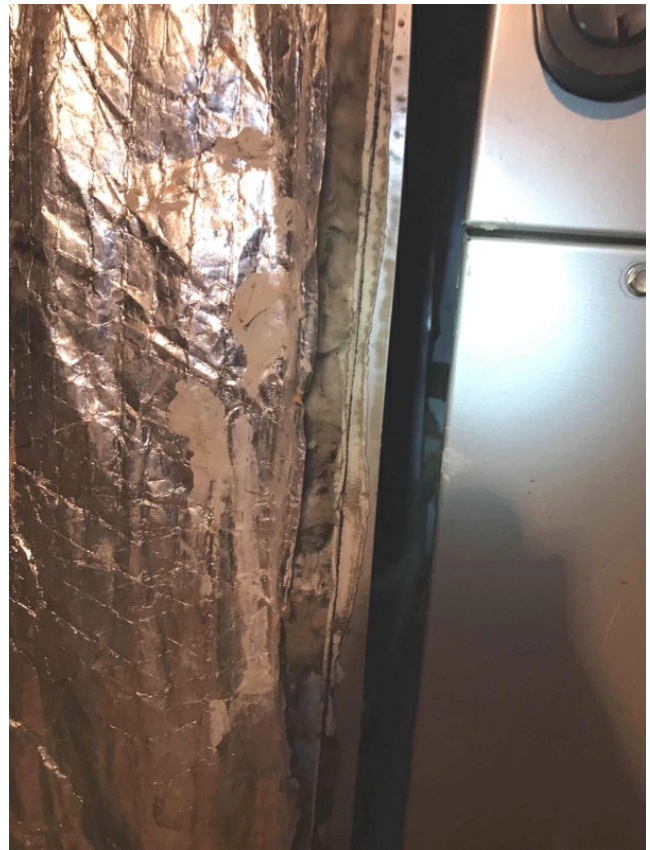
### FILTER MISSING

The furnace filter was missing.  
Recommend replacement.

Contact a qualified HVAC professional.

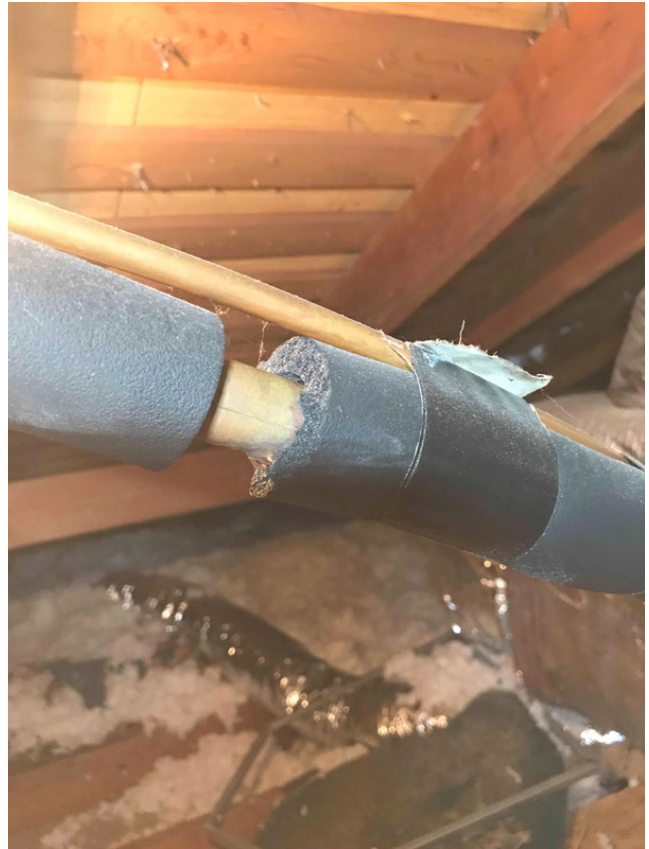
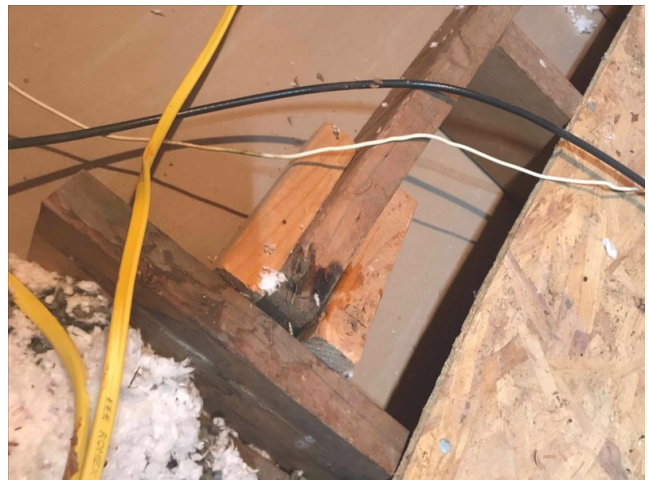
Insulation on the air-conditioning suction (large, insulated) line was damaged or missing at areas and should be replaced by a qualified HVAC professional.

Condensation dripping on framing members.

Contact a qualified professional.

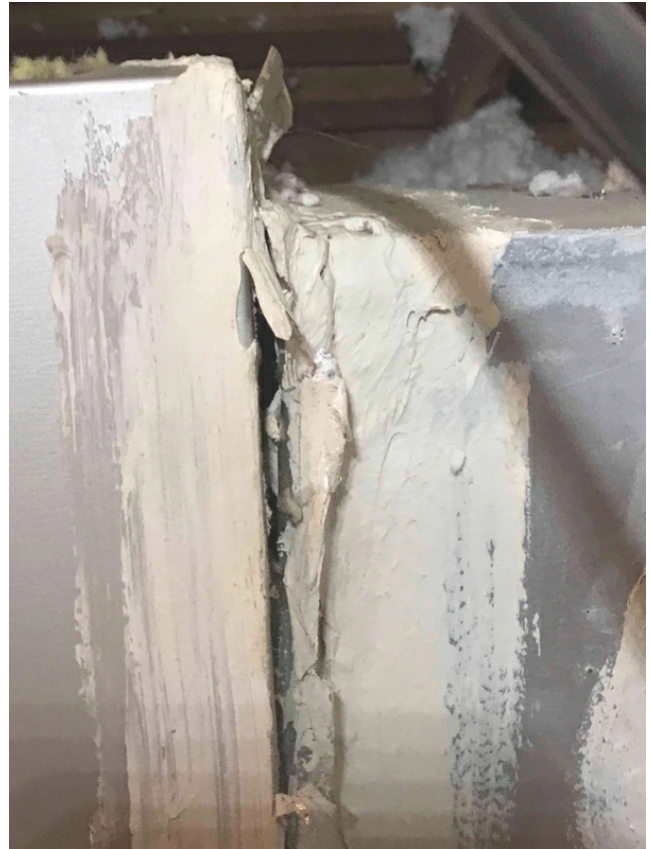
6.2.3 Cooling Equipment

# AIR LEAK

The Inspector observed an air leak at the plenum and ductwork connection in the attic. Recommend correction by a qualified professional.

Contact a qualified professional.

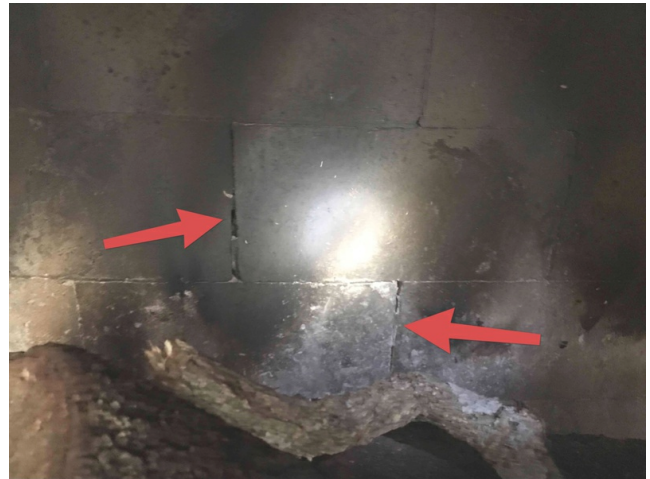
## FIREBRICK - MINOR CRACKS

One or more minor cracks were observed in the fire brick mortar. Recommend monitor over time and repair as necessary.

Contact a qualified professional.
