WISCO RESIDENTIAL REPORT

1234 Main St.
Cambridge Wisconsin 53523

10/16/2018 9:00AM

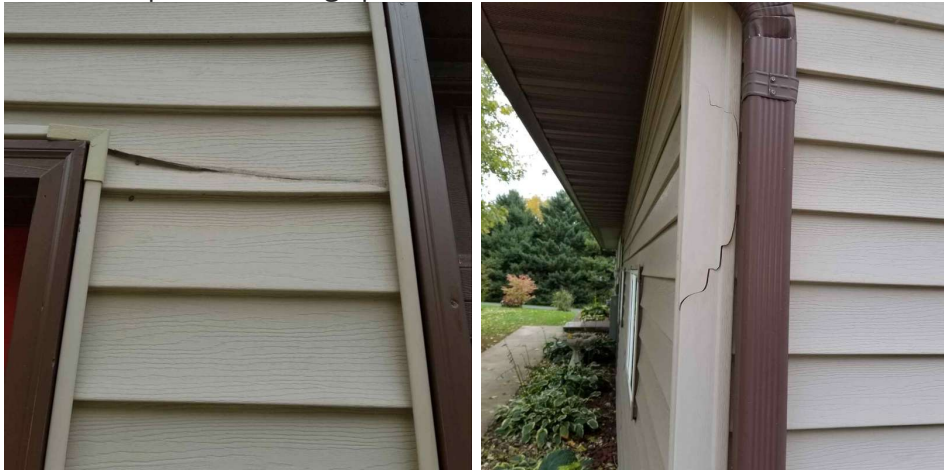
2.8.1 Siding, Flashing & Trim

VINYL DAMAGE

One or more areas of vinyl siding was damaged. Recommend repairing to prevent water intrusion.

Contact a qualified siding specialist.

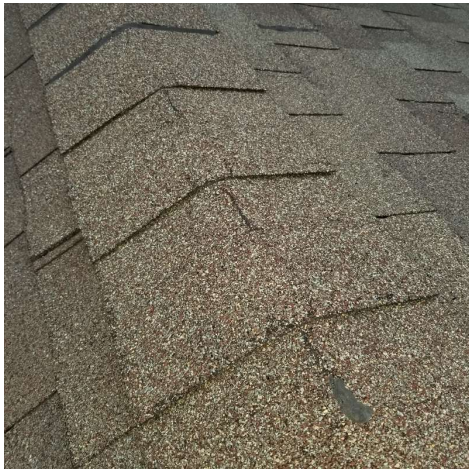
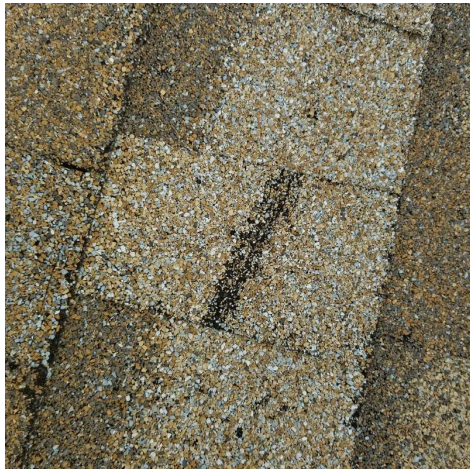
4.1.1 Coverings

SPLITTING

The asphalt composition shingle roof had torn or split shingles which could lead to moisture intrusion. Recommend a qualified roofing contractor repair. You should also inquire to the seller regarding shingle manufacturer information to see if roof qualifies for a warranty claim.

Contact a qualified roofing professional.

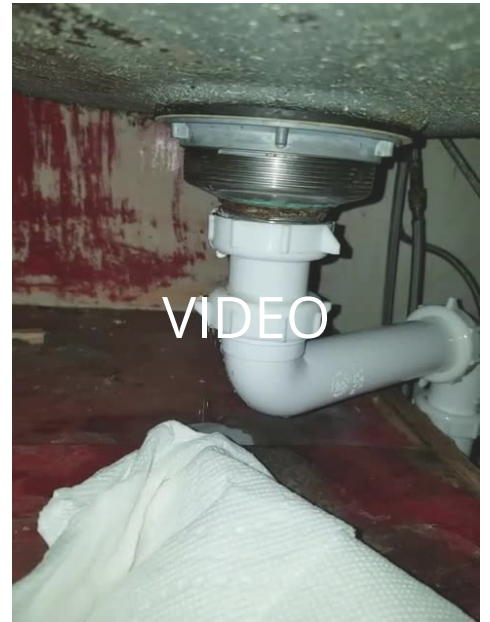
5.2.1 Plumbing

DRAIN LINES LEAKING

Drain lines are leaking. Recommend plumber evaluate and make repairs

Contact a qualified plumbing contractor.

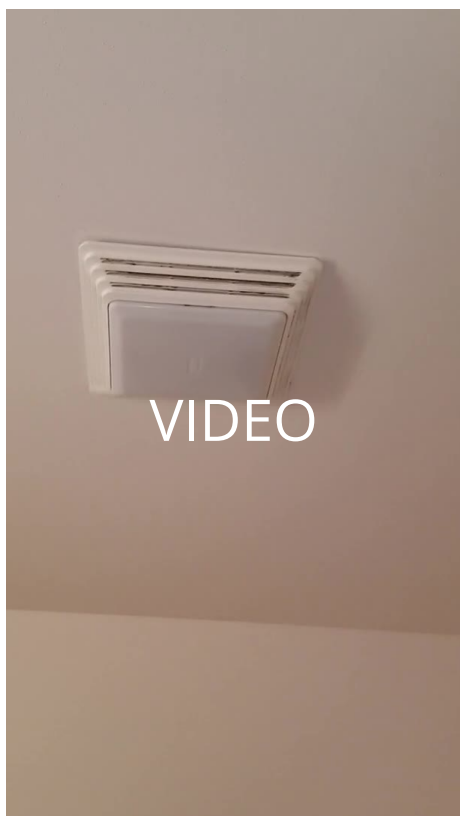
Tub / Shower Area: Exhaust Fans

Fan With Light
