RESIDENTIAL REPORT

1234 Main St.
Edmonton AB T5T3E9

Buyer Name
06/19/2018 9:00AM

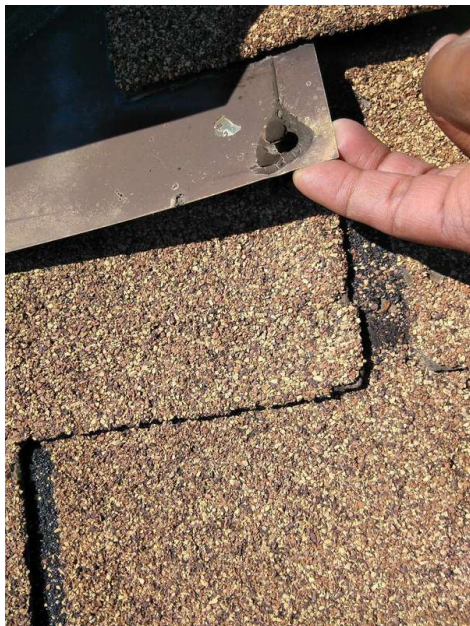
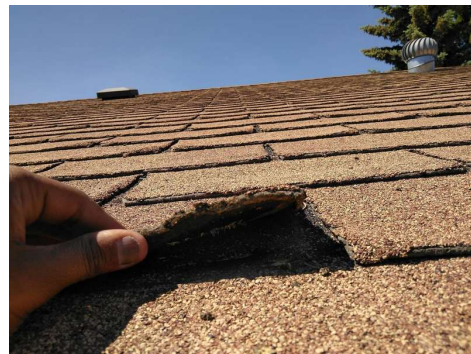
2.1.1 Coverings

SIGNS OF CURLING/POPPING

Observed signs of curling on roof shingles, appeared functional though near the end of its service life and will likely need replacing within 3 to 5 years. Recommend further evaluation and Repair/replace by qualified professional.

Contact a qualified roofing professional.

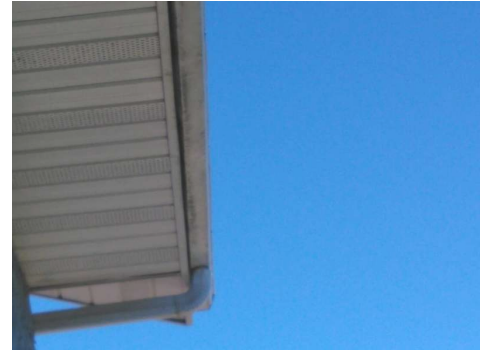
2.2.4 Roof Drainage Systems

OVERFLOW STAIN

Stains were found at the front of the gutters and indicate that the gutters have overflowed. If they have overflowed, it's usually due to debris clogging gutters or downspouts. The inspector was unable to verify that the gutters and downspouts drained adequately due to lack of recent, significant rainfall. Monitor the roof drainage system in the future while it's raining to determine if problems exist. Then if necessary, recommend that a qualified person clean, repair or replace gutters, downspouts and/or extensions.

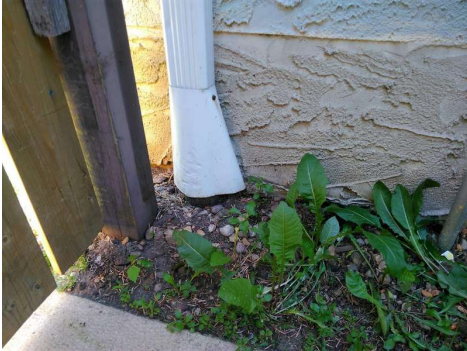
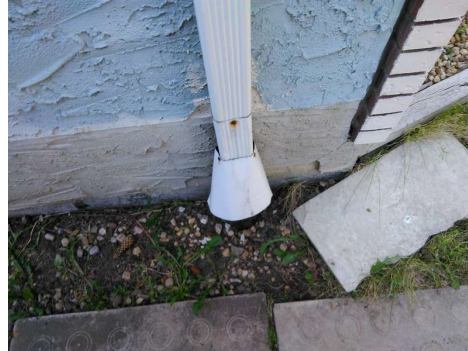
2.2.5 Roof Drainage Systems

UNDERGROUND ROOF DRAINAGE

Underground roof drainage observed- recommend discharging rain water 6ft away from the foundation as underground drainage tend to damage or clogged overtime & undetermined of its effectiveness/operation. This can result in excessive moisture in the soil at the foundation, which can lead to foundation/structural movement.

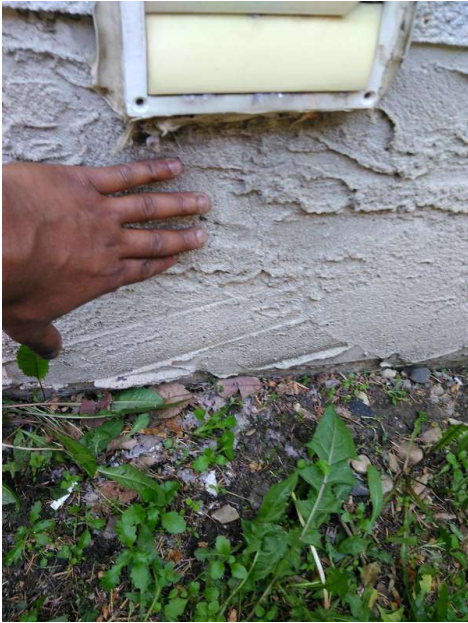
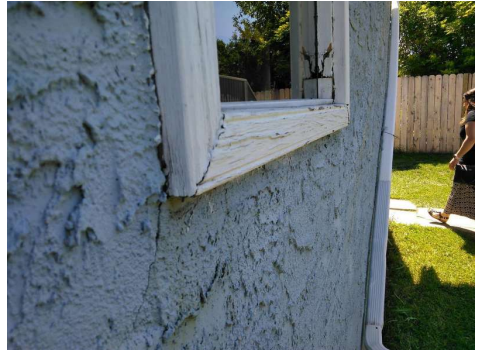
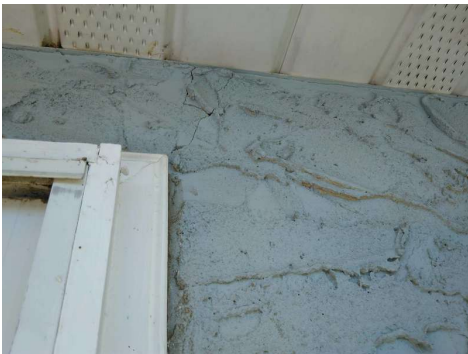
3.1.1 Siding, Flashing & Trim

CRACKING - MINOR

Siding showed minor cracking in one or more places. This is a result of temperature changes, and typical as homes with age. Recommend Repair and monitoring.

Recommended DIY Project

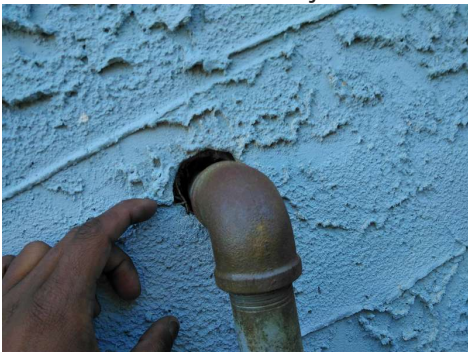
3.1.2 Siding, Flashing & Trim

EXTERIOR PENETRATION

Observed missing exterior sealant , recommend sealing all opening to void moisture intrusion.

Recommended DIY Project

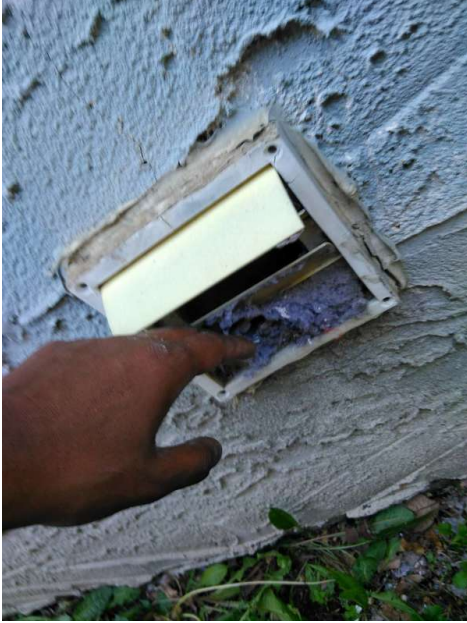
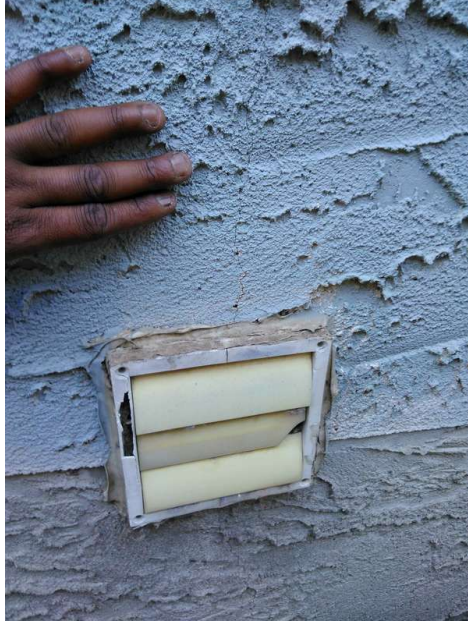
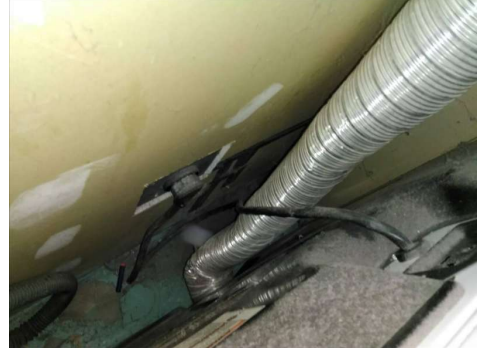
3.1.3 Siding, Flashing & Trim

VENT CAP

Observed Dryer Vent cap is damage & Clogged, recommend replacing and cleaning to avoid moisture and fire hazards.

Damage replace recommended

Contact a qualified professional.

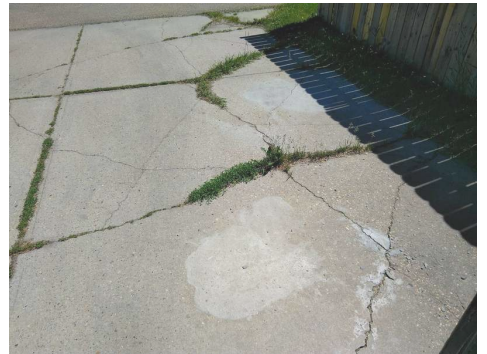
3.3.1 Walkways, Patios & Driveways

DRIVEWAY CRACK - MODERATE

Moderate cracks observed. Recommend concrete contractor evaluate and repair.

Contact a qualified concrete contractor.

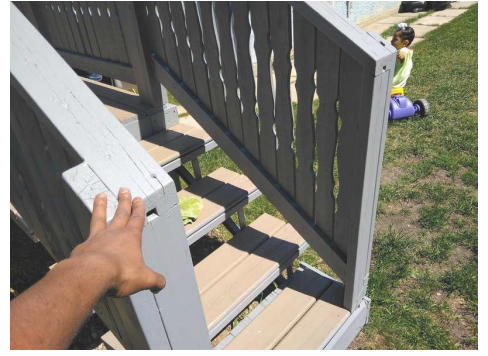
3.4.1 Decks, Balconies, Porches & Steps

HANDRAIL/GUARDRAIL

Observed loose, recommend monitoring if worsen seek repair to avoid fall hazards.

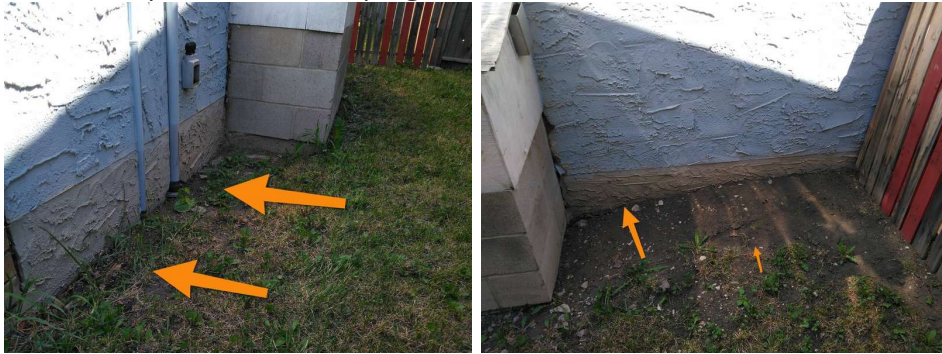
3.6.1 Vegetation, Grading, Drainage & Retaining Walls

NEGATIVE GRADING

Grading is sloping towards the home in some areas. This could lead to water intrusion and foundation issues. Recommend qualified landscaper or foundation contractor regrade so water flows away from home.

Contact a qualified landscaping contractor

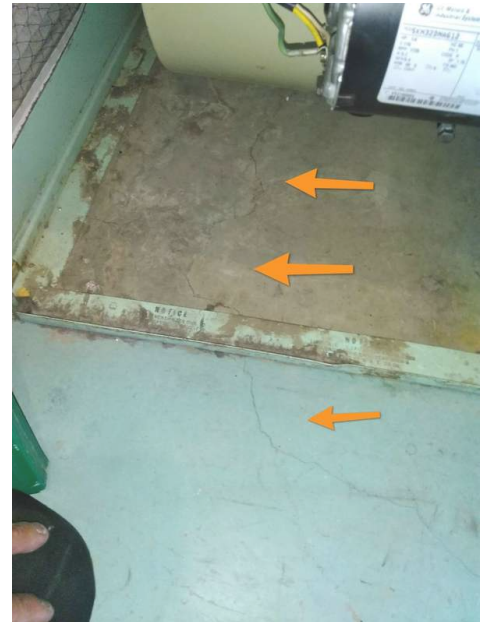
4.3.1 Floor Structure

MINOR CRACK

Minor crack observed in the basement concrete floor near sum pump, these cracks are common when the pumps are install near edge of the slab, recommend monitoring.

Recommend monitoring.

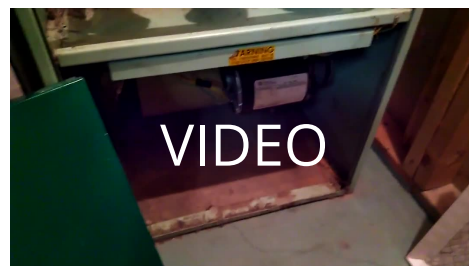
5.1.1 Equipment

BLOWER - EXCESSIVE NOISE

Furnace blower was excessively noisy during operation. Recommend a qualified HVAC technician evaluate and repair.

Contact a qualified HVAC professional.

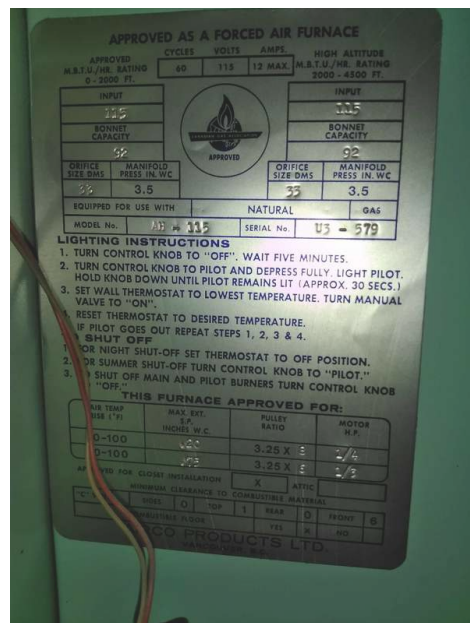
5.1.2 Equipment

NEAR/BEYOND END OF FURNACE LIFE

Observed 39 years old Airco furnace functional at the of inspection. Recommend upgrading in near future for better efficiency and Air quality.

Contact a qualified HVAC professional.

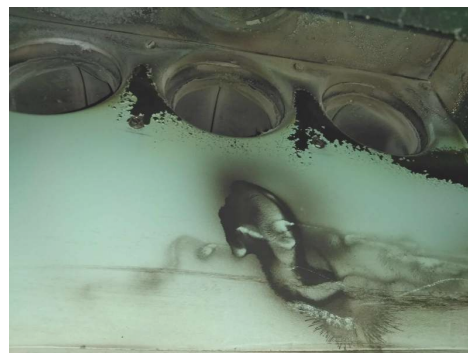
5.1.4 Equipment

NEEDS SERVICING/CLEANING

No cleaning label found- Recommend a qualified HVAC contractor clean, service and certify furnace.

Contact a qualified HVAC professional.

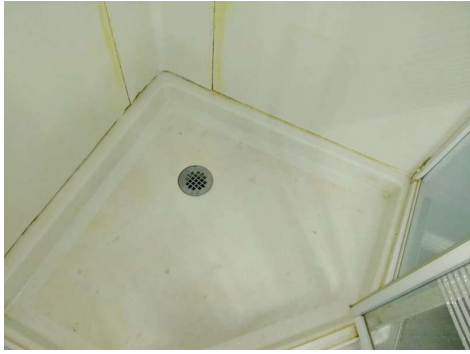
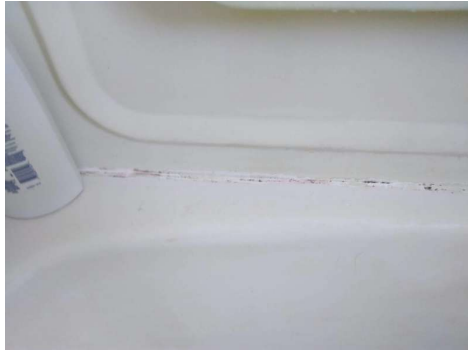
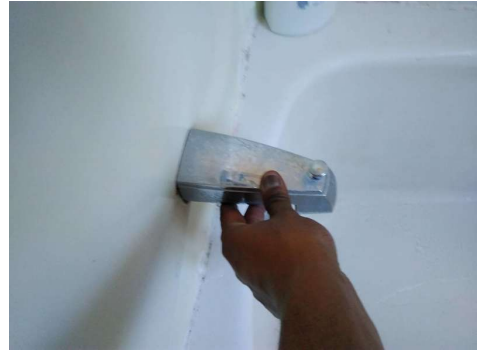
6.2.1 Drain, Waste, & Vent Systems

BATH TUB

Bath tub and shower had some poor caulking/sealant, Bath Faucet in main floor were loose. this can lead to water damage, recommend replacing or repair.

Contact a qualified professional.

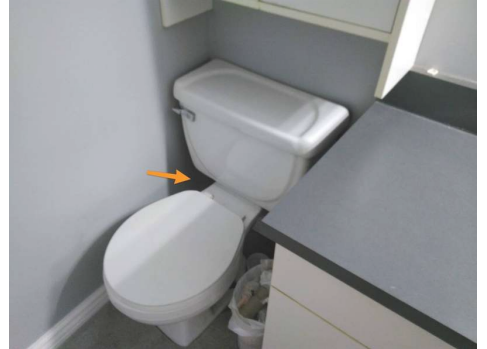
6.2.2 Drain, Waste, & Vent Systems

SHUT OFF VALVE

Observed no shut off valve near toilet, recommend upgrading.

Contact a qualified plumbing contractor.

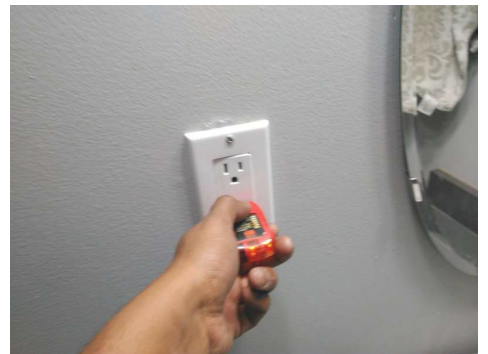
7.5.1 GFCI & AFCI

NO GFCI PROTECTION INSTALLED

No GFCI protection present. Recommend licensed electrician upgrade by installing ground fault receptacles in all locations, except 2nd floor washroom.

Contact a qualified electrical contractor.

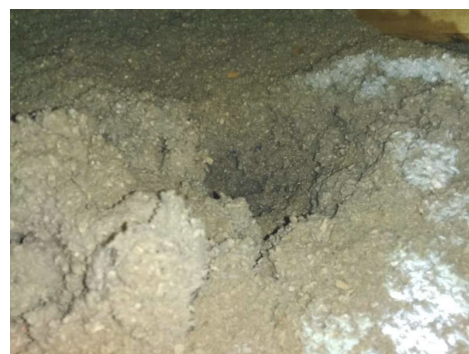
8.1.1 Attic Insulation

INSUFFICIENT INSULATION

Insulation depth was inadequate. Recommend a qualified attic insulation contractor install additional or replacing the insulation.

Contact a qualified insulation contractor.

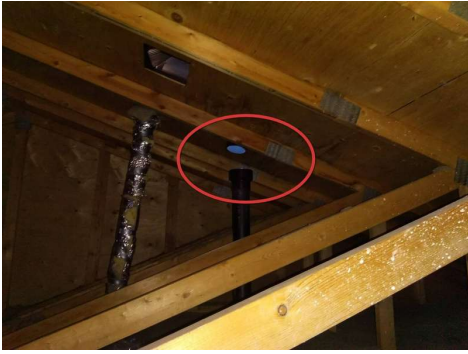
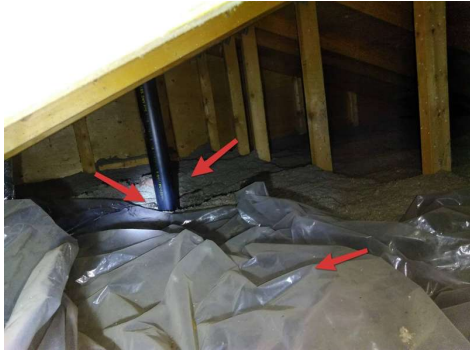
8.3.1 Ventilation

PLUMBING VENTS LOOSE

observed damage/loose Plumbing Vent into attic and signs of previous moisture intrusion near the vent. recommend correction to avoid moisture intrusion or possibly mold.

Contact a qualified professional.

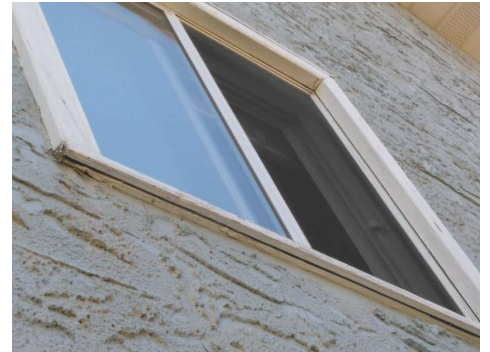
9.2.1 Windows

Observed signs of deterioration but functional, recommend maintenance like repair and/or upgrading in future .

Contact a qualified window repair/installation contractor.

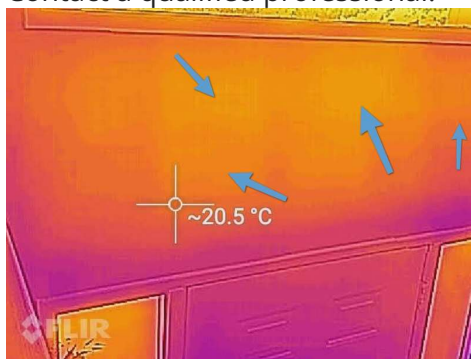
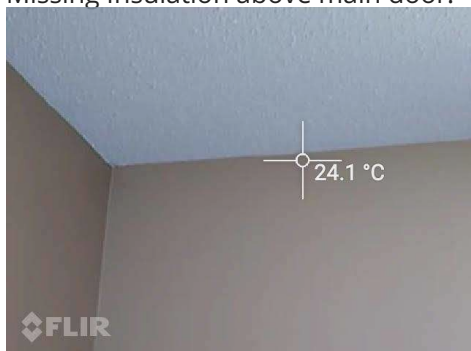
9.4.1 Walls

Observed Cold spot one or more area, no active leak or moisture detected at the time of inspection. could be missing insulation.

Missing Insulation above main door.

Main floor Bedroom

Contact a qualified professional.

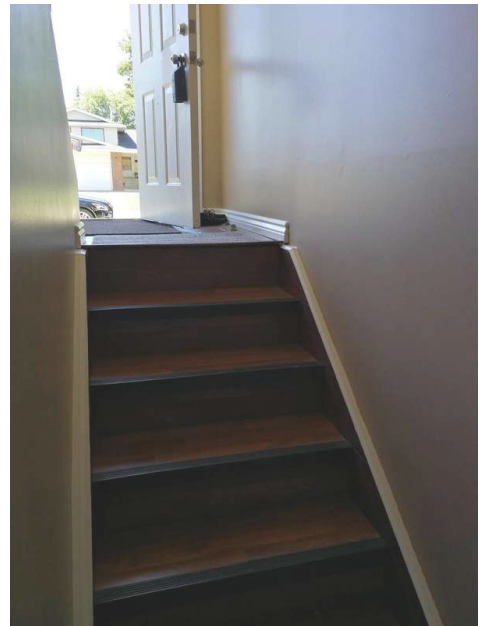
9.6.1 Steps, Stairways & Railings

Staircase had no handrails. This is a safety hazard. Recommend a qualified handyman install a handrail.

Contact a qualified handyman.

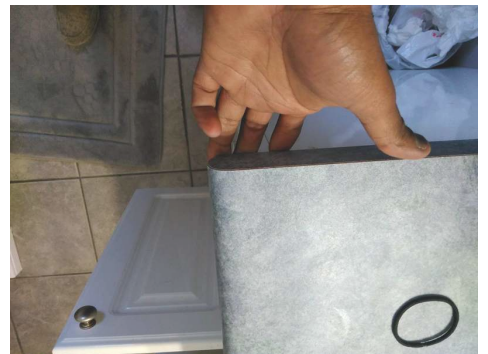
9.7.1 Countertops & Cabinets

Main Floor Full Bathroom countertop appeared insecure/loose. Recommend qualified countertop contractor evaluate and secure countertop properly.

Contact a qualified countertop contractor.

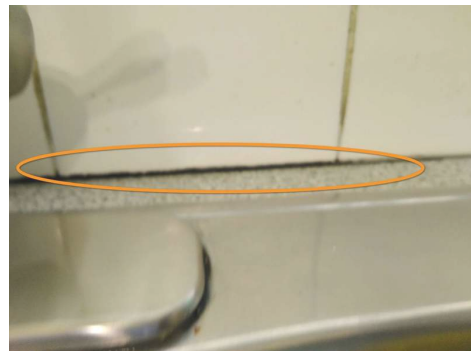
9.7.2 Countertops & Cabinets

Maintenance Item**GROUT DETERIORATING**

Grout lines were cracked or severely deteriorated. Recommend a qualified contractor repair or replace grout.

Contact a qualified countertop contractor.

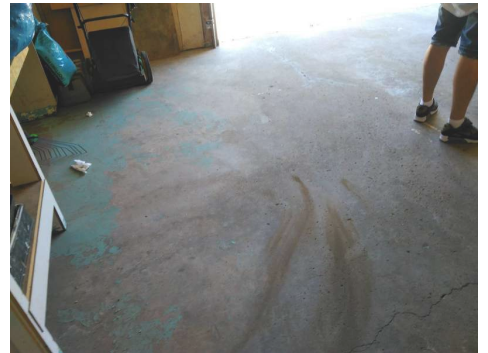
MINOR CRACK/DAMAGE

Observed minor crack and some damage, recommend repair and monitoring.

Recommended DIY Project

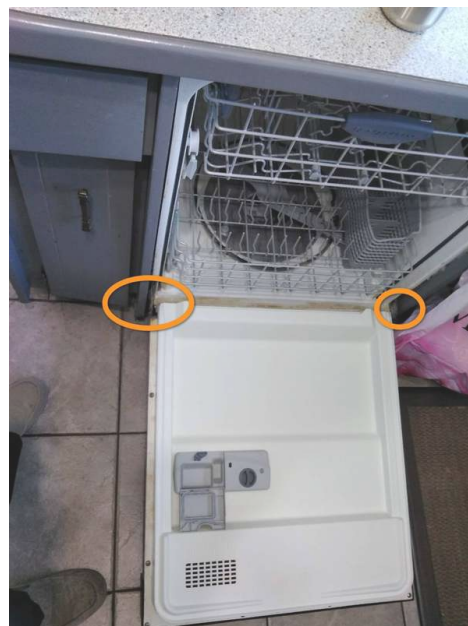
DISHWASHER DOOR

Observed the latch is damage, recommend correction.
