PROPERTY INSPECTION REPORT

1234 Main St.
Santa Ana CA 92701

06/13/2018 9:00AM

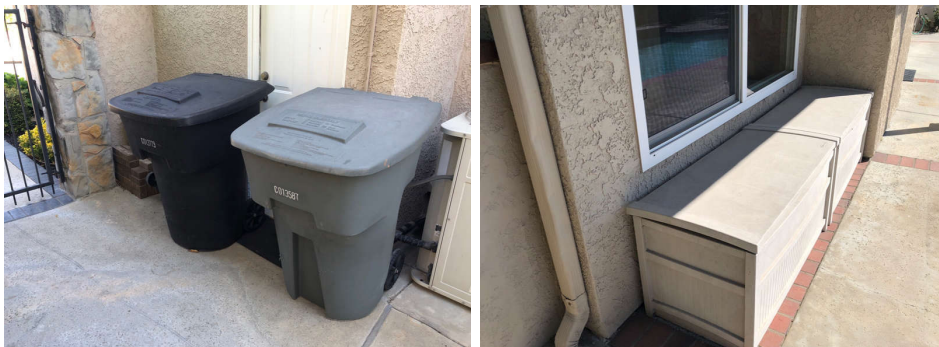
Right Side

FOUNDATION AND/OR WALLS

One or more sections of foundation and/or exterior walls are excluded from this inspection due to lack of access from vegetation, debris and/or stored items.

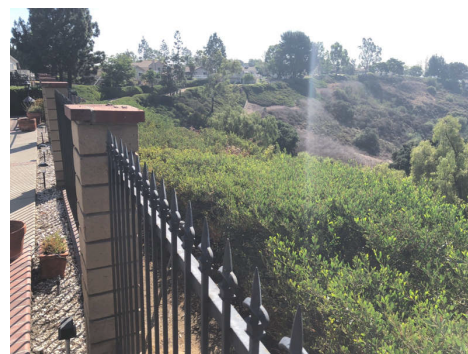
STEEP SLOPE

Home inspectors are not soil engineers and generally advised against making comment and recommendations regarding slopes noted on property. If client is concerned about possible lot and or/soil movement it is recommended that the client contact and hire a licensed and reputable soil engineer for further evaluation.

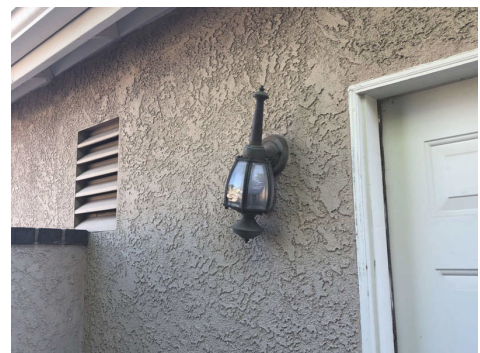
Right Side

LIGHT FIXTURES - LOOSE OR SUBSTANDARD

One or more light fixtures are loose or installed in a substandard way. A qualified contractor or electrician should evaluate and make repairs as necessary so light fixtures are securely mounted and installed in accordance with the manufacturer's installation instructions.

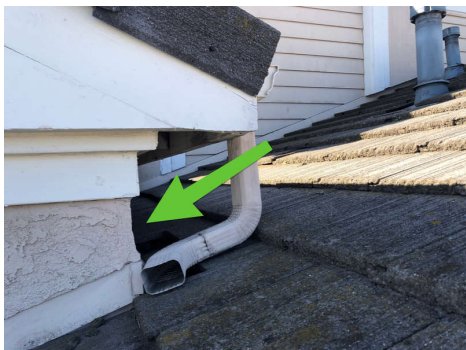
Outside Front

Roof Design: Slope - Wall

One or more roof surface sections slope down towards exterior walls. Debris such as leaves or needles are more likely to accumulate in this area than rest of the roof. Leaks may occur as a result. Recommend monitoring such areas for accumulated debris in the future and cleaning as necessary.

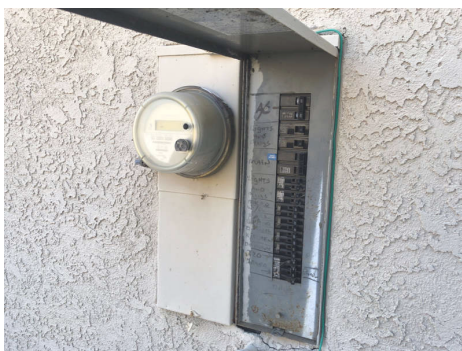
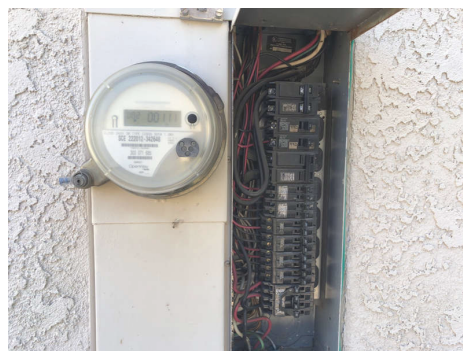
Outside Right Side

Location of Main Service Switch

Outside

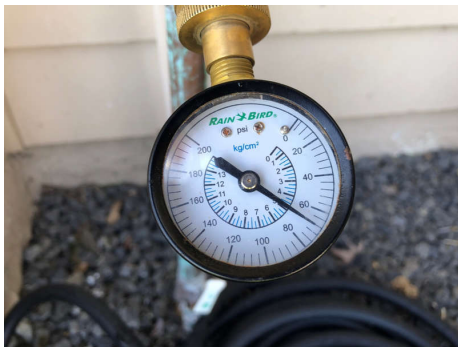
Water Pressure
60 to 70 psi

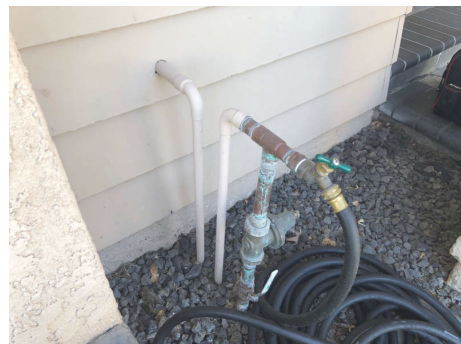
Outside Front

Location of Main Water Shut-Off
Outside

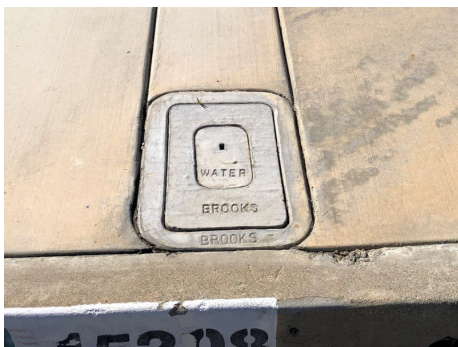
Outside Front

Location of Main Water Meter
Outside

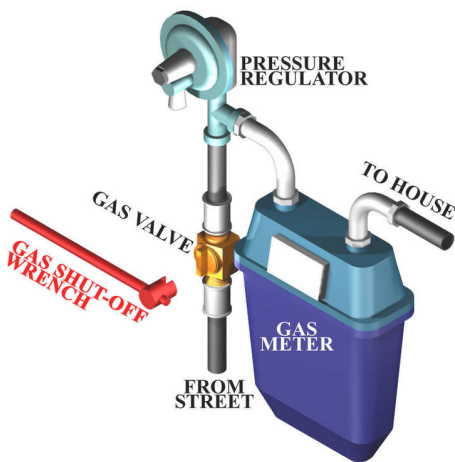
A meter wrench should be located in the vicinity of the gas meter as recommended in areas subject to seismic activity. A proper wrench should be chained to the meter to provide a convenient means for shutoff in an emergency. The valve can be turned 90 degrees in either direction to shut the gas supply off.

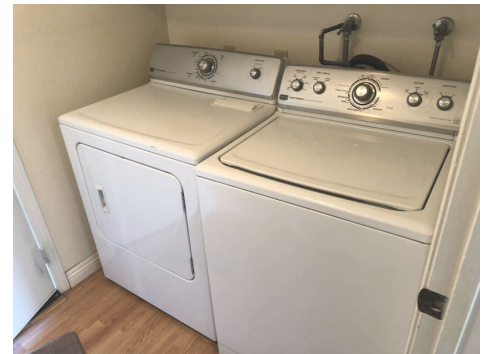
Laundry

LAUNDRY APPLIANCES

Neither the clothes washer nor dryer were operated or evaluated if present. These units are not built in, are typically personal property and are excluded from this inspection.

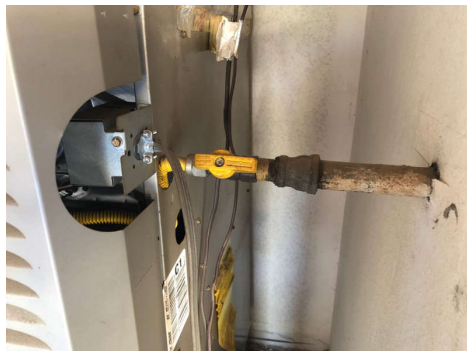
8.3.2 Gas Heat

One or more flexible gas supply connectors are routed through a metal cabinet. Standard building practices require that solid iron pipe be used where gas supply lines are routed through holes in metal cabinets. Continued vibration from this equipment may cause the edge of the metal cabinet to wear through the flexible connector, resulting in gas leaks. This is a safety hazard. A qualified heating and cooling contractor should evaluate and make repairs and/or modifications as necessary.

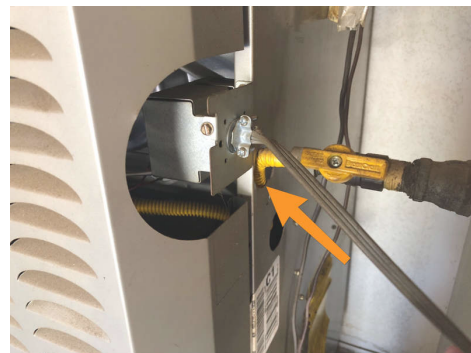
FLEX CONNECTOR - THROUGH CABINET

Recommendation

Contact a qualified HVAC professional.

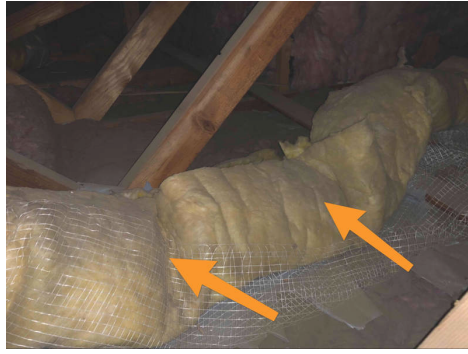
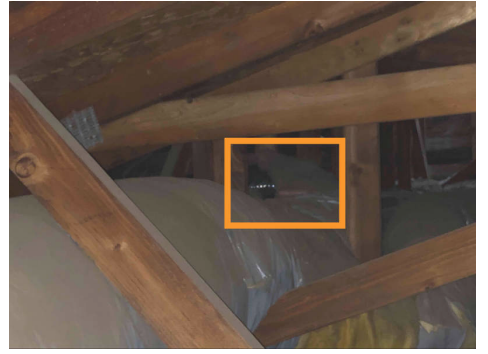
Attic

**DUCT INSULATION - DETERIORATED**

Insulation on one or more heating/cooling ducts in unconditioned spaces is damaged, delaminating and/or deteriorated. A qualified contractor should evaluate and replace insulation and/or ducts as necessary and as per standard building practices.

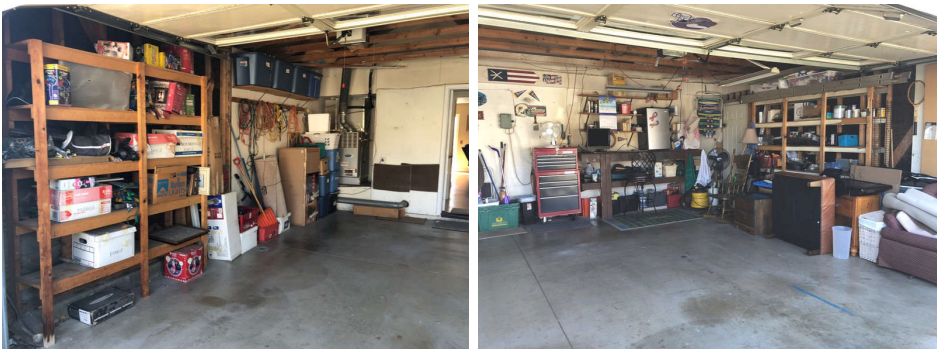
Garage

PERIMETER

The interior perimeter of the garage is excluded from this inspection due to lack of access from stored items.

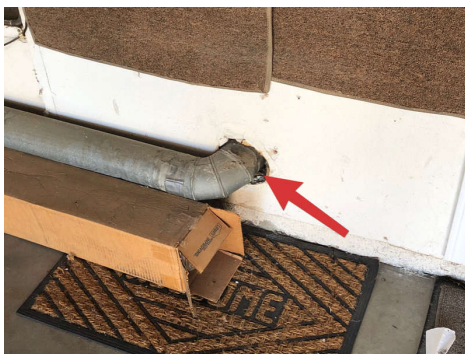
Garage

One or more wall and/or ceiling surfaces between the attached garage and interior living spaces have gaps, holes, or missing or inadequate surface materials. These surfaces are intended to prevent vehicle fumes from entering living spaces, and to slow the spread of fire from the garage to living spaces. A qualified contractor should evaluate and make repairs as necessary so the attached garage wall and ceiling surfaces that adjoin living spaces are tightly sealed and fire rated as per standard building practices. Typically these surfaces require a one-hour fire rating.

Contact a qualified drywall contractor.

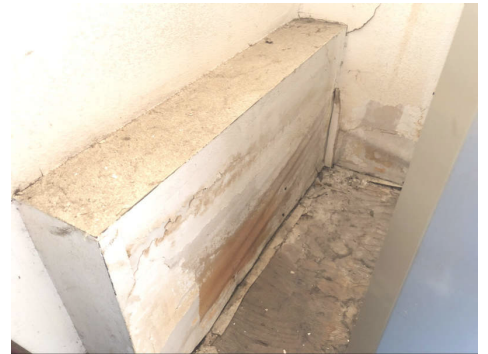
Garage

GARAGE WALL DAMAGE

Minor damage were found in walls in one or more areas. They do not appear to be a major concern, but the client(s) may wish to repair these for aesthetic reasons.

Contact a qualified drywall contractor.

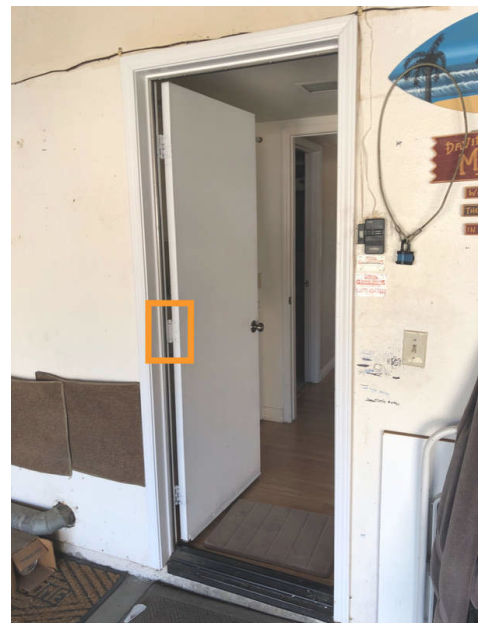
Garage

REPAIR/REPLACE AUTO-CLOSE

The automatic door closing device (sprung hinges, etc.) on the garage-house door needs adjustment, repair or replacing. The door doesn't close and latch easily and/or completely via the force of the automatic closing device. This door is intended to prevent vehicle fumes from entering living spaces and to slow the spread of fire from the garage to living spaces. A qualified contractor should evaluate and make repairs as necessary.

Contact a qualified door repair/installation contractor.

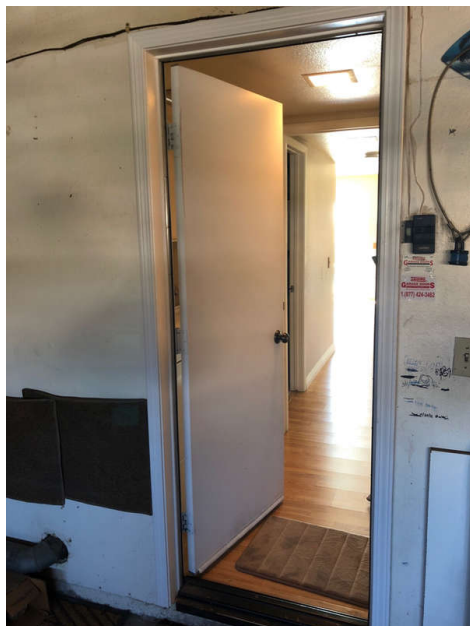
Garage

The garage-house door poses a fire risk because it's not fire-rated (metal or solid-core construction or **no rating tag visible**). A qualified contractor should replace this door with a fire-rated door.

Contact a qualified door repair/installation contractor.

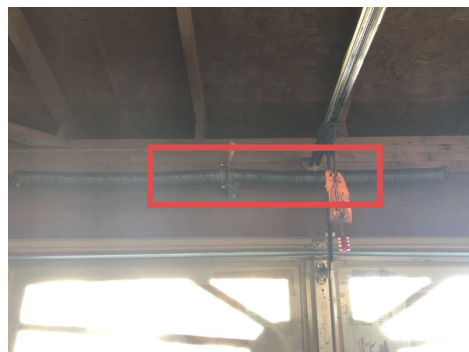
Garage Right Side

The vehicle door isn't balanced. The door won't stay in place when it's partially opened and falls to the ground instead. This is a safety hazard since the door may fall when open. A qualified contractor should evaluate and make repairs as necessary.

Contact a qualified garage door contractor.

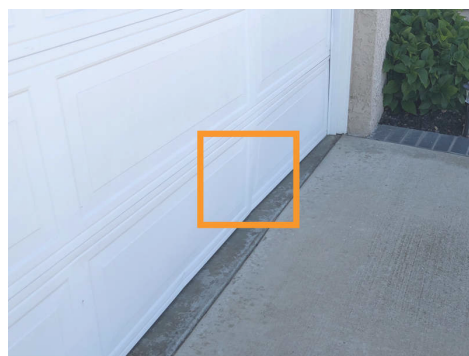
Garage Right Side

The garage vehicle door is damaged or deteriorated. A qualified contractor should evaluate and repair or replace the door as necessary.

Contact a qualified garage door contractor.

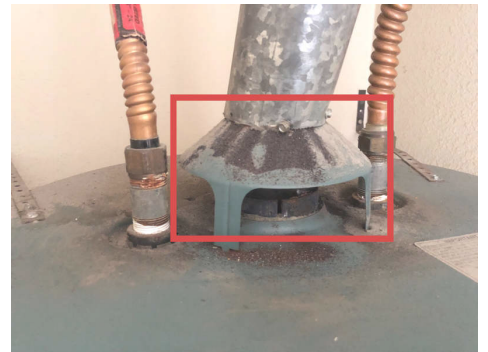
10.2.3 Gas Water Heater

< 1 INCH

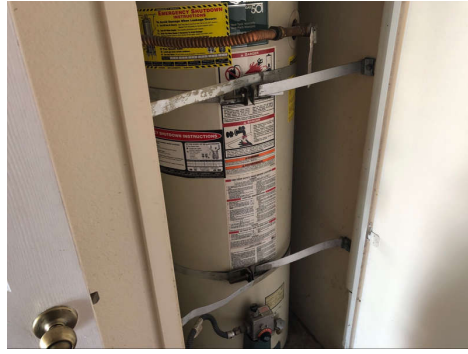
10.9.1 Drain Line

DRAIN LINE ROUTED UP

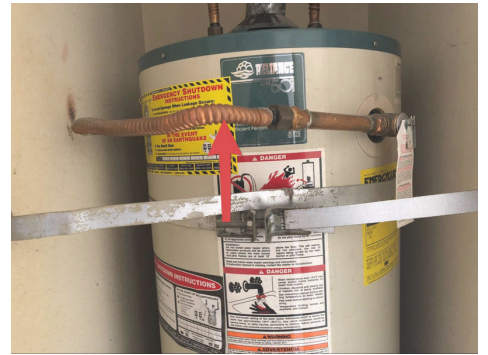
10.9.2 Drain Line

IMPROPER MATERIAL

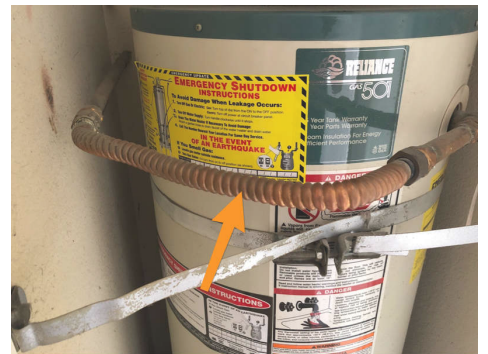
10.10.1 Expansion Tank

MISSING EXPANSION TANK

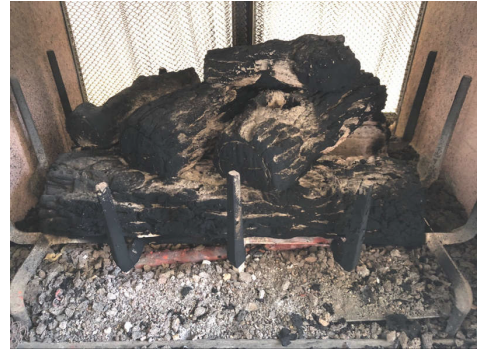
Living Room

FIREPLACE FIREBOX OBSCURED BY ASHES OR DEBRIS

Significant amounts of ashes, wood and/or debris are in the fireplace. The inspector was unable to fully evaluate it.

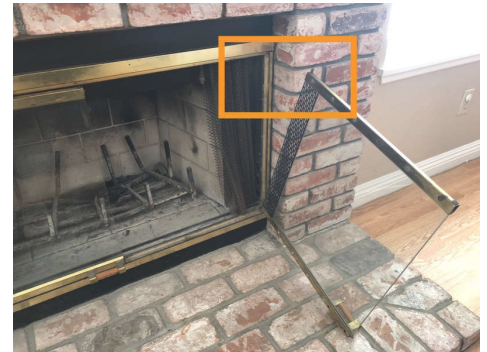
Family Room

The doors/screens of the fireplace were difficult to operate. A qualified fireplace contractor should make repairs accordingly.

Contact a qualified fireplace contractor.

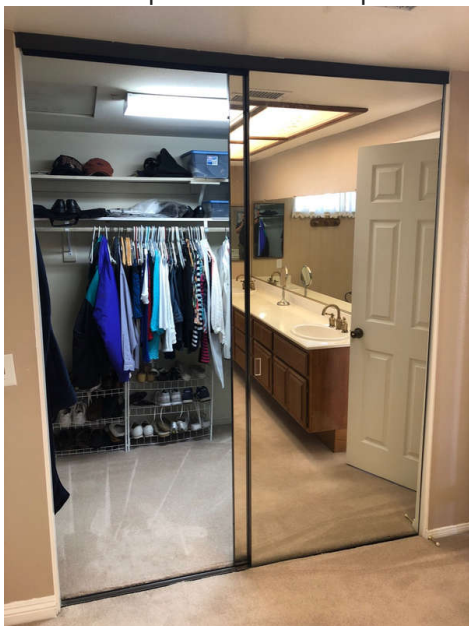
Master Bedroom Closet

One or more doors bind in their jamb and cannot be closed and latched, or are difficult to open and close. A qualified contractor should evaluate and repair as necessary. For example, adjusting jambs or trimming doors.

Contact a qualified door repair/installation contractor.

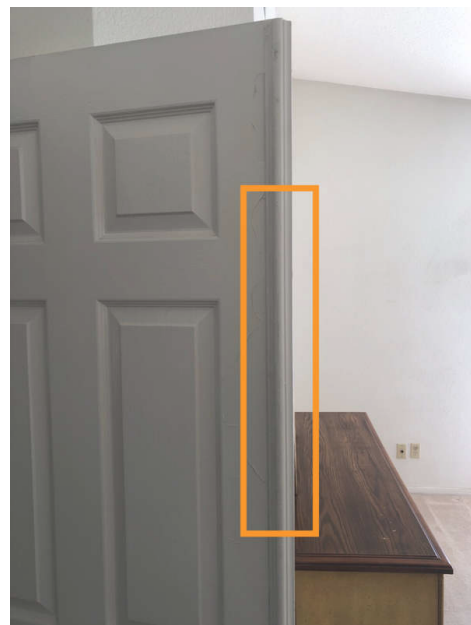
Master Bedroom

One or more interior doors are deteriorated and or damaged and should be repaired or replaced by a qualified contractor.

Contact a qualified door repair/installation contractor.

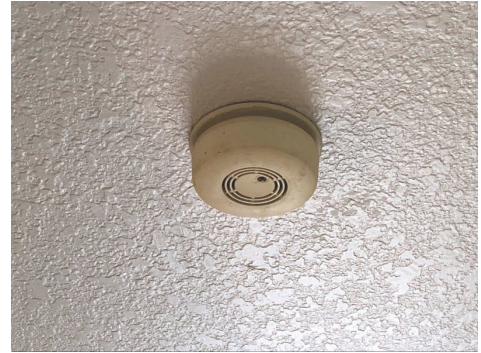
SMOKE ALARMS - > 10 YEARS OLD

Based on the age of this structure and the appearance of existing smoke alarms, the alarms may be older than 10 years old. According to [National Fire Protection Association](#), aging smoke alarms don't operate as efficiently and often are the source for nuisance alarms. Older smoke alarms are estimated to have a 30% probability of failure within the first 10 years. Newer smoke alarms do better, but should be replaced after 10 years. Unless you know that the smoke alarms are new, replacing them when moving into a new residence is also recommended by NFPA.

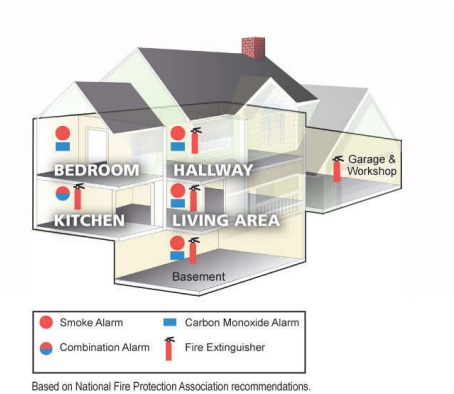
SMOKE ALARMS - REPLACE BATTERIES

Batteries in all the smoke alarms should be replaced after taking occupancy, and annually in the future. "Chirping" noises emitted from smoke alarms typically indicate that batteries need replacing.

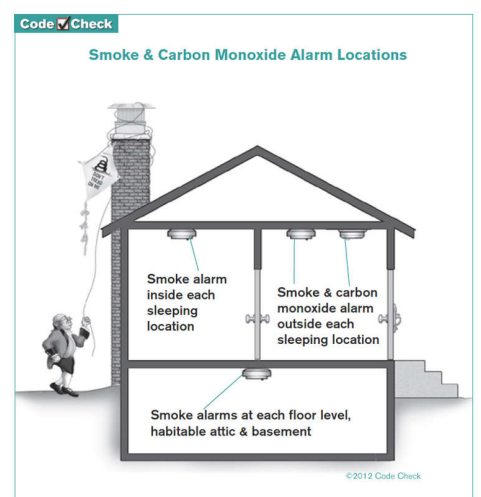
SMOKE ALARMS - TOO FEW

An insufficient number of smoke alarms are installed. Additional smoke alarms should be installed as necessary so a functioning one exists in each hallway leading to bedrooms, and in each bedroom.

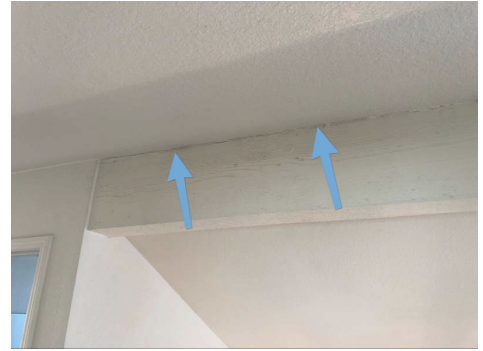
2nd Floor Hallway

Cracks and or damage were found in ceilings in one or more areas. They do not appear to be a major structural concern, but the client(s) may wish to repair these for aesthetic reasons or have them further evaluated if client has additional concerns.

Contact a qualified drywall contractor.

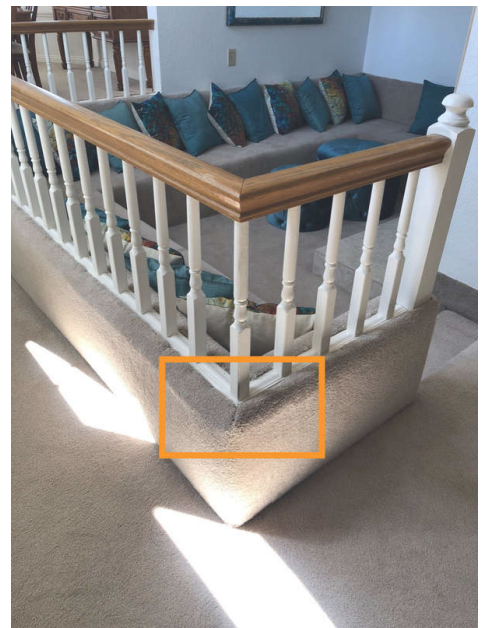
Living Room

Carpeting in one or more rooms is damaged and/or significantly deteriorated. Recommend replacing carpeting where necessary.

Contact a qualified professional.

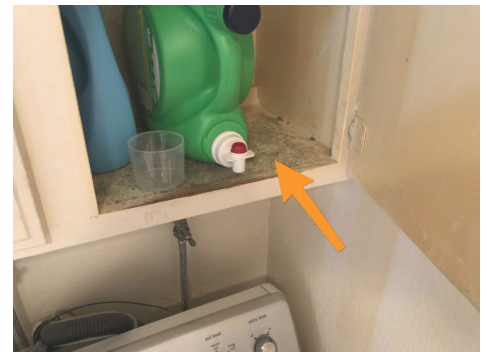
Laundry

Microbial growths were found at one or more locations. It is beyond the scope of this inspection to identify what substance or organism this staining is. However such staining is normally caused by excessively moist conditions, which in turn can be caused by plumbing or building envelope leaks and/or substandard ventilation. These conducive conditions should be corrected before making any attempts to remove or correct the staining. Normally affected materials such as drywall are removed, enclosed affected spaces are allowed to dry thoroughly, a mildewcide may be applied, and only then is drywall reinstalled. For evaluation and possible mitigation, consult with a qualified industrial hygienist or mold/moisture mitigation specialist.

Contact a qualified mold inspection professional.

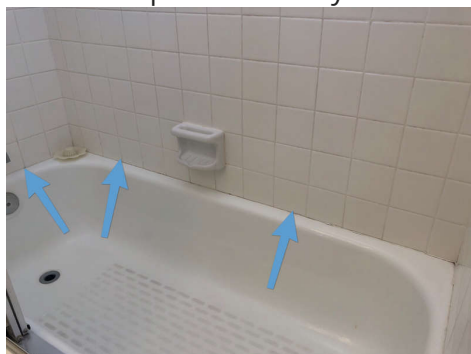
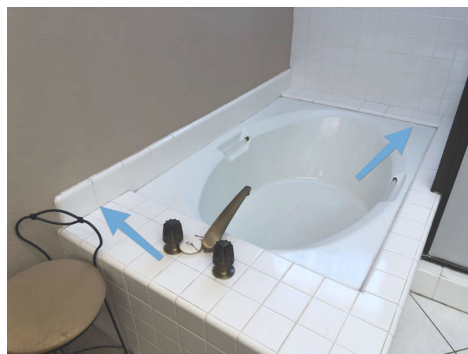
Caulk is missing or deteriorated above one or more bathtubs, where the tub surround meets the tub. It should be replaced where deteriorated and/or applied where missing to prevent water intrusion and damage to the wall structure.

Contact a qualified handyman.

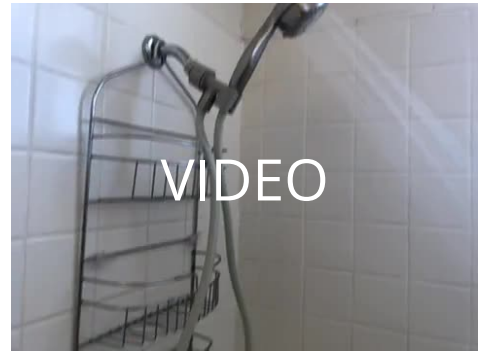
The shower diverter valve for one or more bathtub faucets is defective. A significant amount of water comes out of the bathtub spout when the shower is turned on. Water will be wasted as a result. A qualified plumber should evaluate and replace components or make repairs as necessary.

Contact a qualified plumbing contractor.

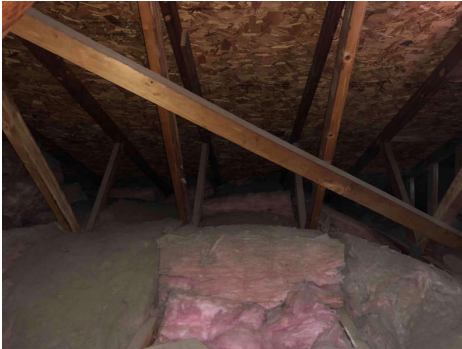
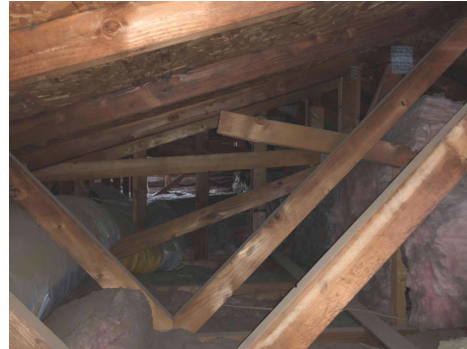
Although home mechanical system (HVAC or water heater) equipment was installed in the attic, no lights or walkway were installed to provide service access to this equipment. This condition is potentially hazardous to those who must service this equipment. The inspector recommends that lights and a walkway that comply with current safety standards be installed by a qualified contractor.

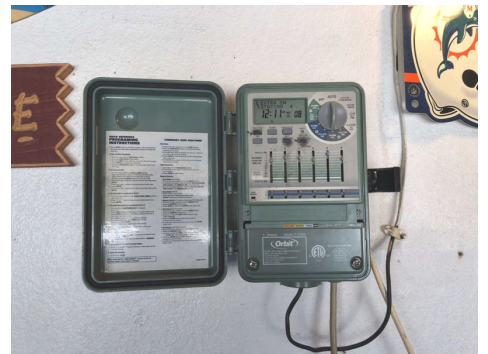
BOX LOOSE/DAMAGED

The landscape irrigation timer box is loose and or damaged. Recommend repair and or replacement by a qualified and reputable professional.

Contact a qualified lawn care professional.

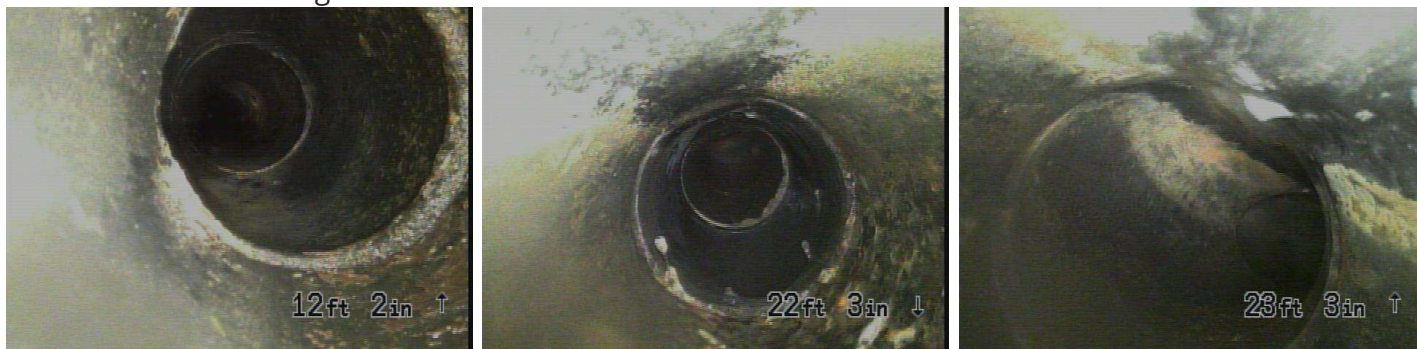
Offset pipes joints were visible during the sewer camera inspection. It is not necessary to be repaired at this time but possibly in the future when it gets worse where debris could get blocked and clog the pipe.

Recommend monitoring.
