KENCO HOME INSPECTION

RESIDENTIAL REPORT

1234 Main St.
Palm Beach Gardens Florida 33410

07/29/2018 9:00AM

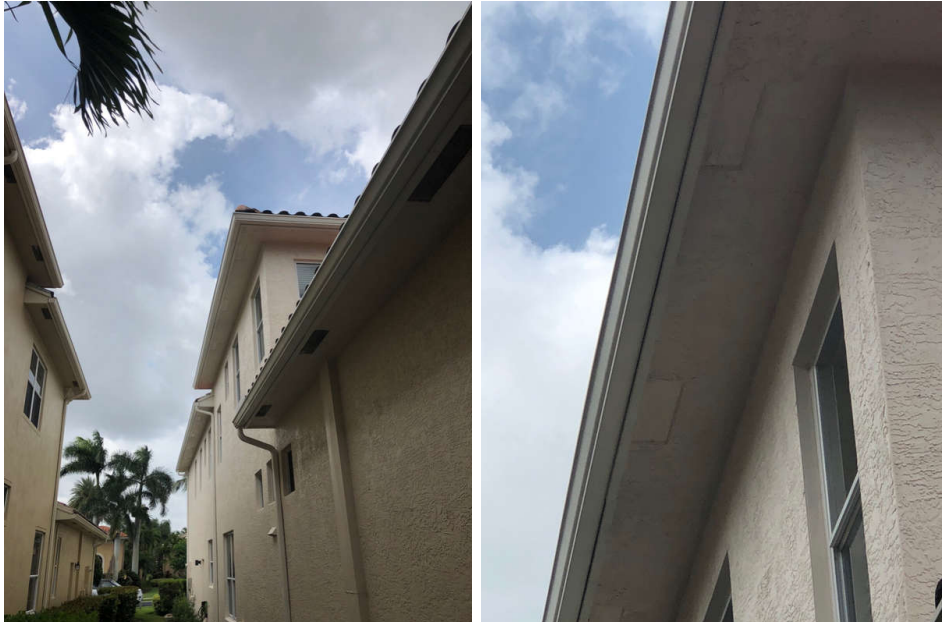
There are areas of the soffit vents that have been painted/taped over restricting the air flow to the attic as designed. recommend repair/replace the vents to provide appropriate air flow.

Contact a qualified general contractor.

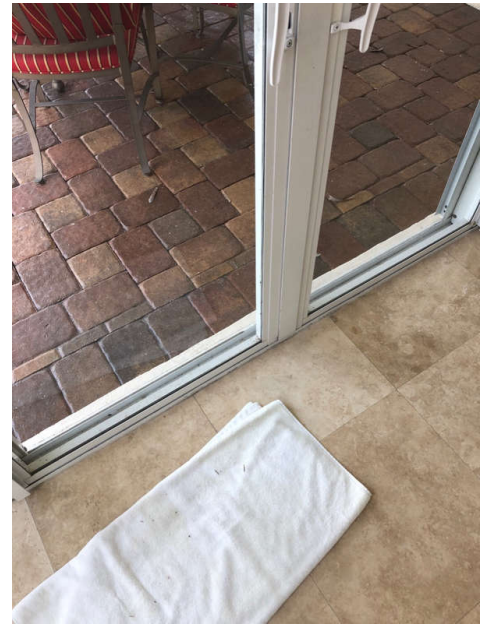
2.5.1 DOORS (Sliders and Screens)

Recommend a maintenance cleaning and lubrication of the sliding glass door tracks rollers and latches using a wax based lubricant such as LC wax Alumaslick or similar product.

Contact a qualified door repair/installation contractor.

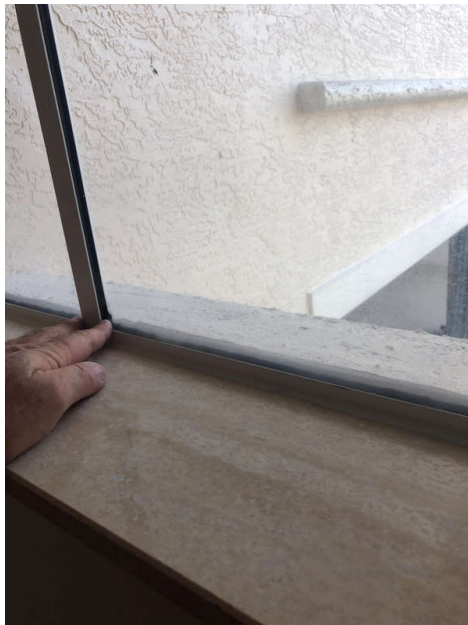
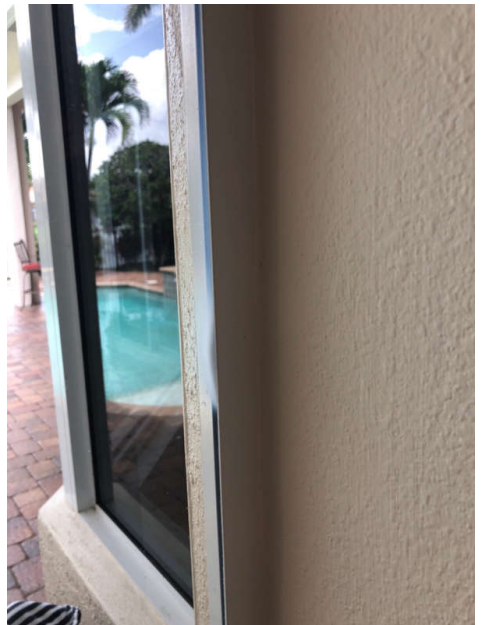
2.6.1 WINDOWS AND SCREENS

EXTERIOR WINDOWS (DELAMINATION)

There are windows that show delamination between the panes of glass and will require replacement

Contact a qualified professional.

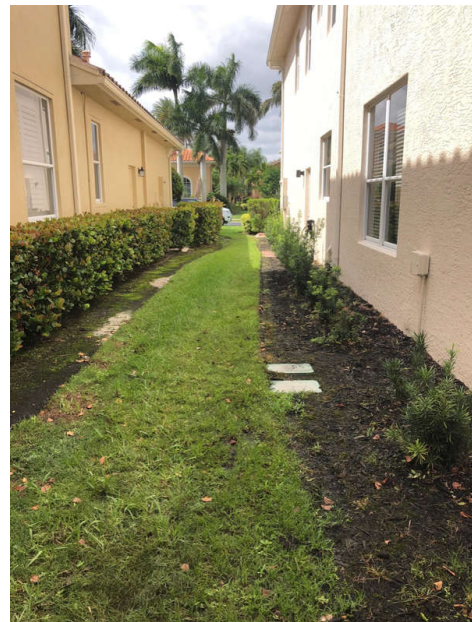
2.10.1 VEGETATION, GRADING AND DRAINAGE

There is noted standing water and saturation of the ground in several areas of the exterior grounds. These areas should be evaluated or modified to allow the water to properly drain away to the appropriate locations

Contact a qualified grading contractor.

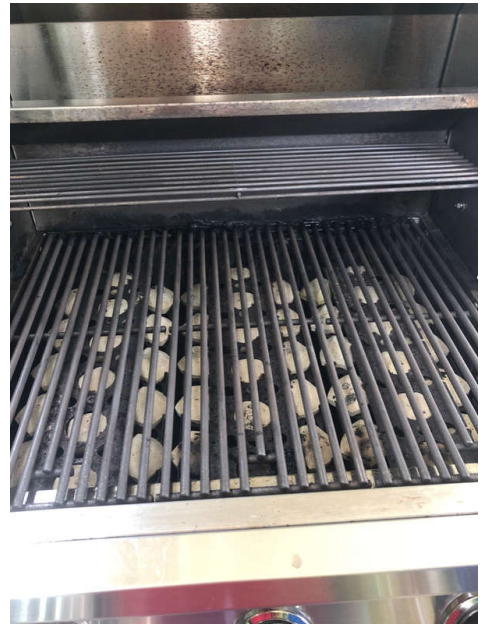
2.14.1 OTHER

OUTDOOR KITCHEN

The exterior gas grill will need a full maintenance service, there is visible rust and buildup in the unit. The system was operational

Contact a qualified professional.

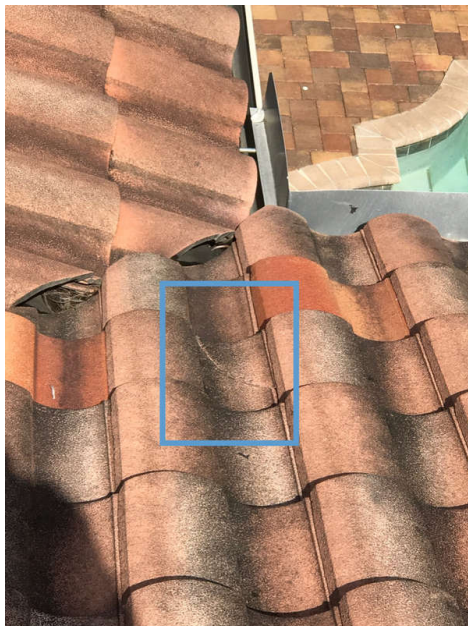
3.1.3 ROOF COVERINGS

TILE ROOF (CRACKED)

There are cracked roof tiles in various areas of the surface, these are typically considered cosmetic in nature with no signs of visible leaks as a result

Contact a qualified roofing professional.

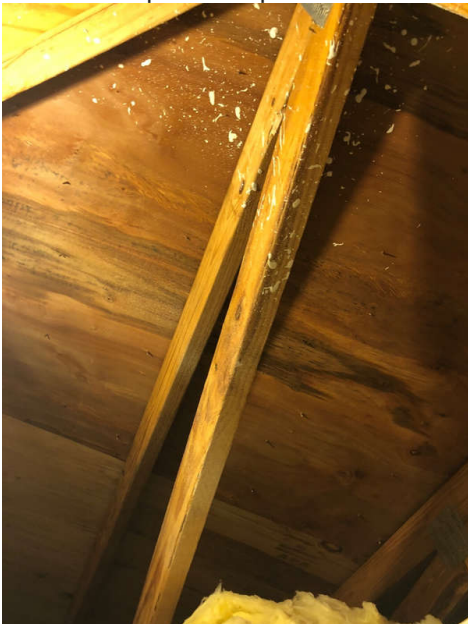
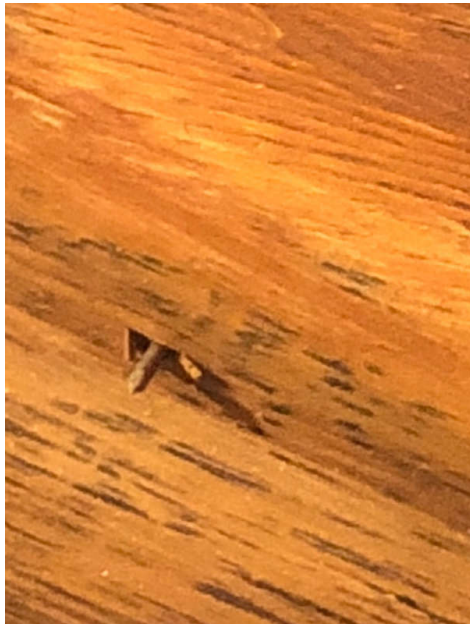
3.3.1 Evidence of Leaks (past or present)

EVIDENCE OF PREVIOUS LEAKS

There is visible evidence that there have been previous leaks. While no active moisture was detected in these areas at the time of inspection and all areas were not fully visible. This is typically an indication that repairs have either been performed or may need performance in the future

Contact a qualified professional.

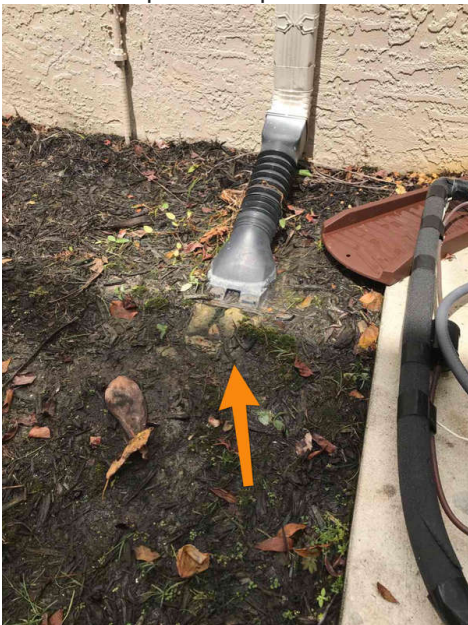
4.1.2 Gutters, Leaders and Downspouts

RESTRICTED LEADER

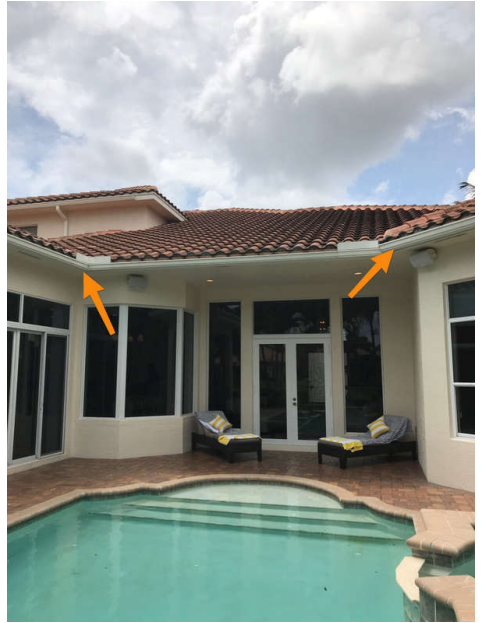
4.1.3 Gutters, Leaders and Downspouts

GUTTERS (SEAM LEAKS)

There are multiple areas of the gutter seams that are leaking and require maintenance re-sealing

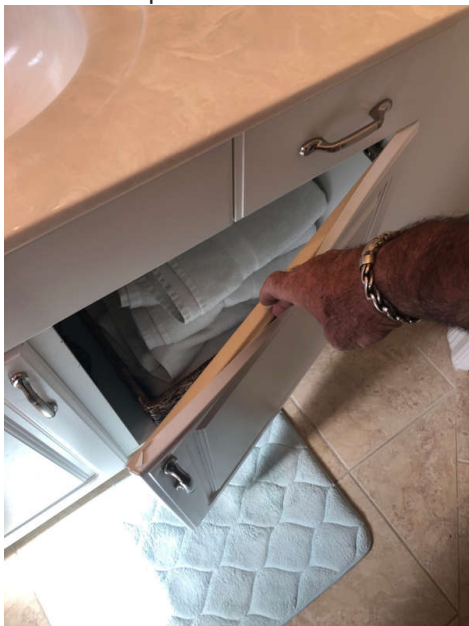
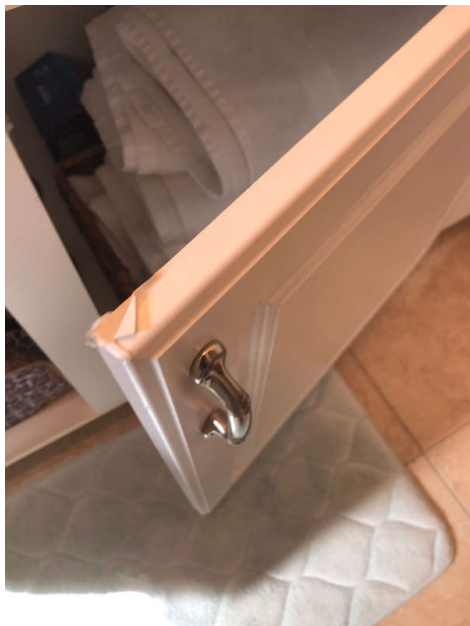
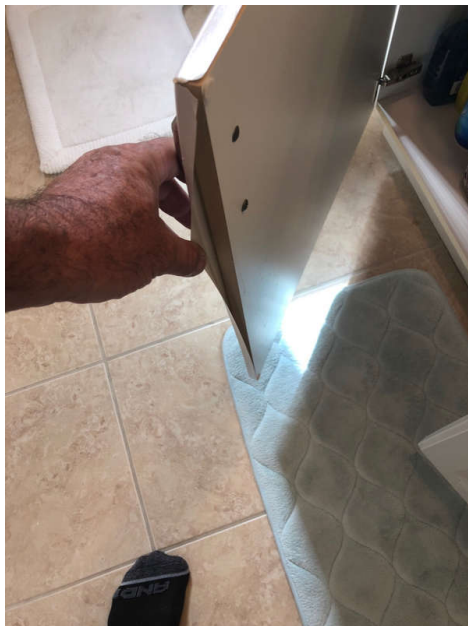
There are areas of the thermofoil cabinets that have major areas of delamination that will likely require replacement

Contact a qualified cabinet contractor.

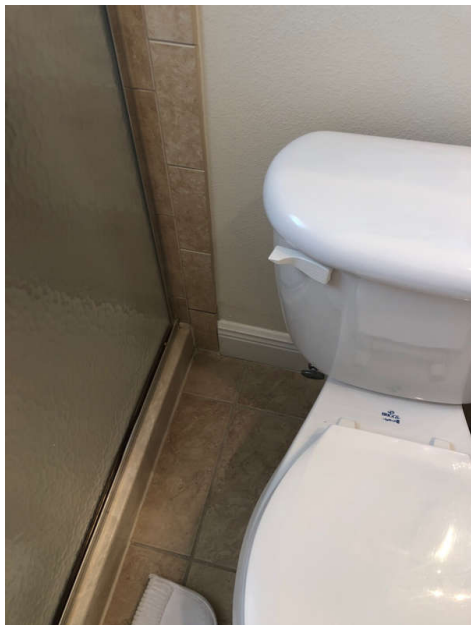
6.3.1 SHOWERS AND BATHS

SHOWER WALL (LOOSE TILE)

Multiple areas of the bathroom shower have loose tiles, this indicates the tiles have lost the bond to the substrate likely due to water intrusion, possible hidden damage behind the tiles is likely.

Contact a qualified tile contractor

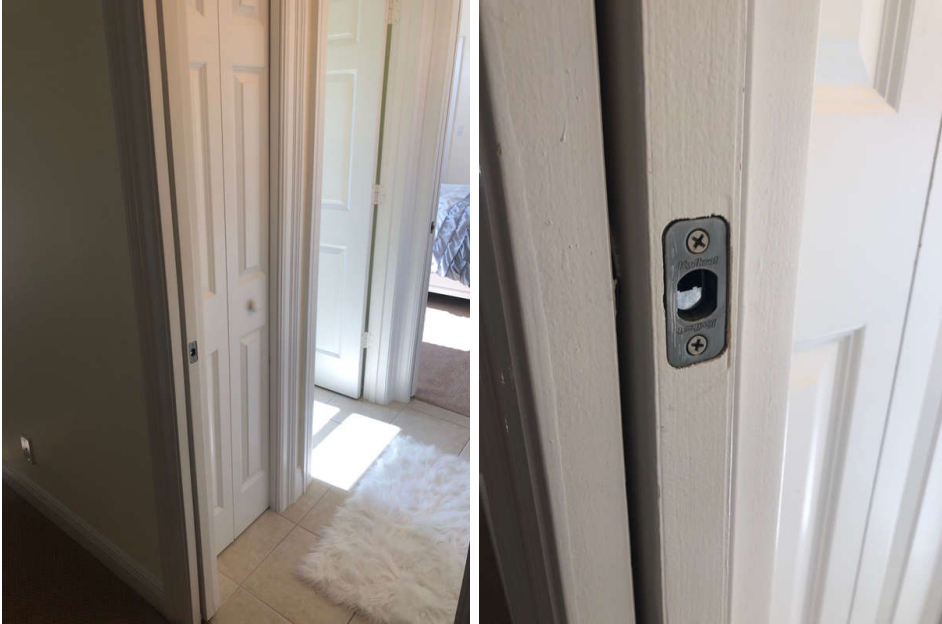
6.4.1 DOORS and HARDWARE

POCKET DOOR (BROKEN LATCH)

The pocket door latch is physically damaged and does not operate

Contact a qualified professional.

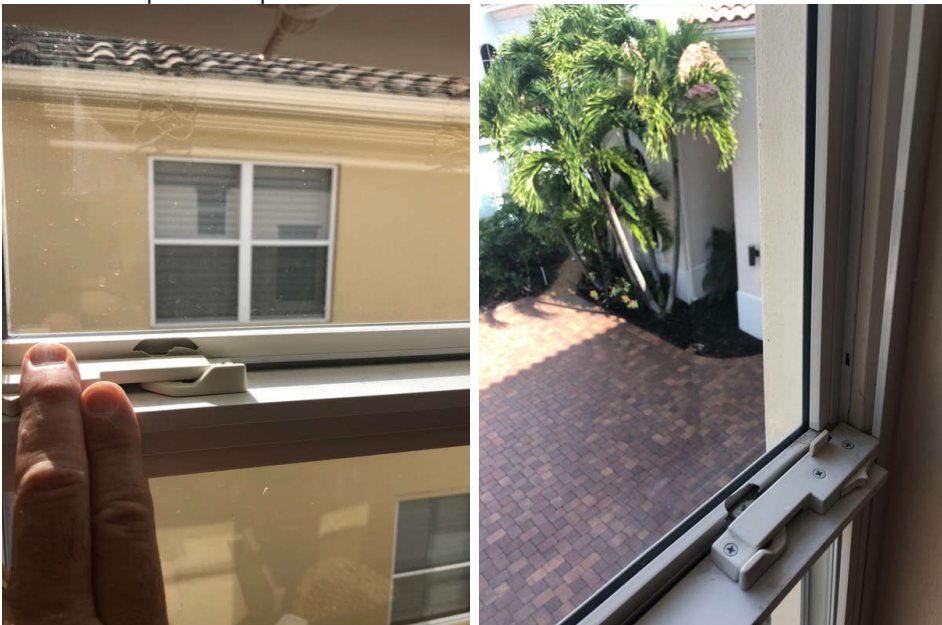
6.5.1 WINDOWS

The plastic trim on the interior windows is deteriorating in several areas. While this may not effect performance it is a cosmetic failure

Contact a qualified professional.

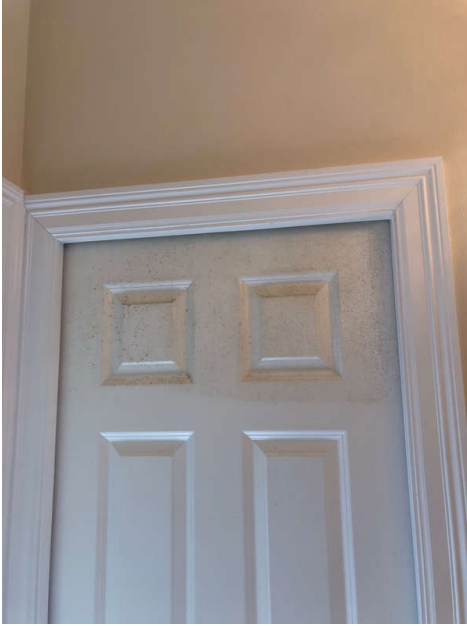
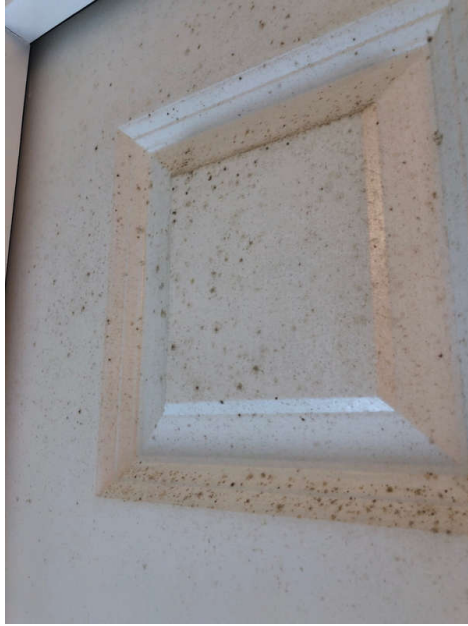
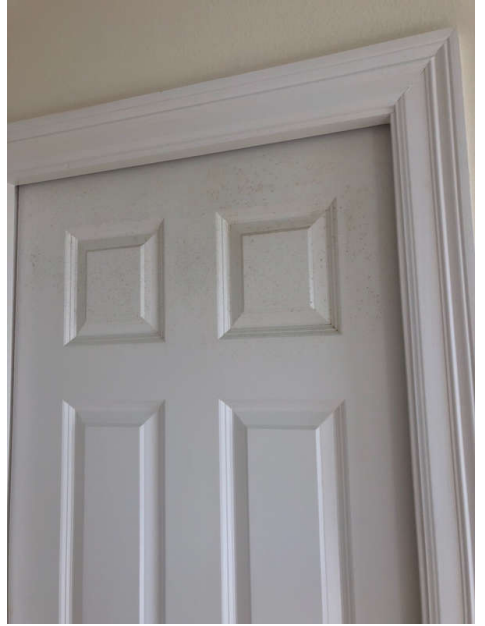
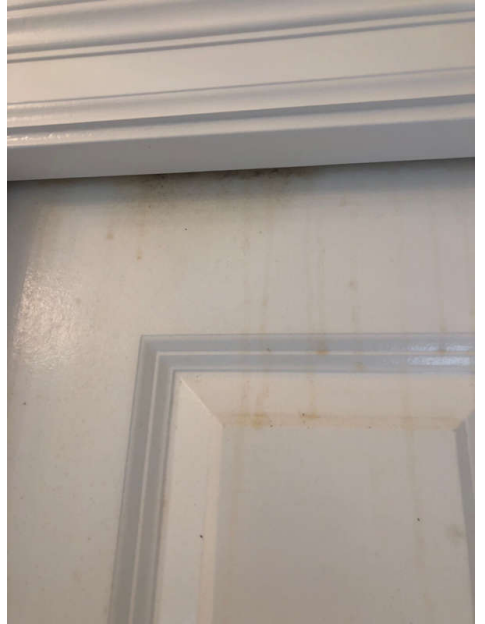
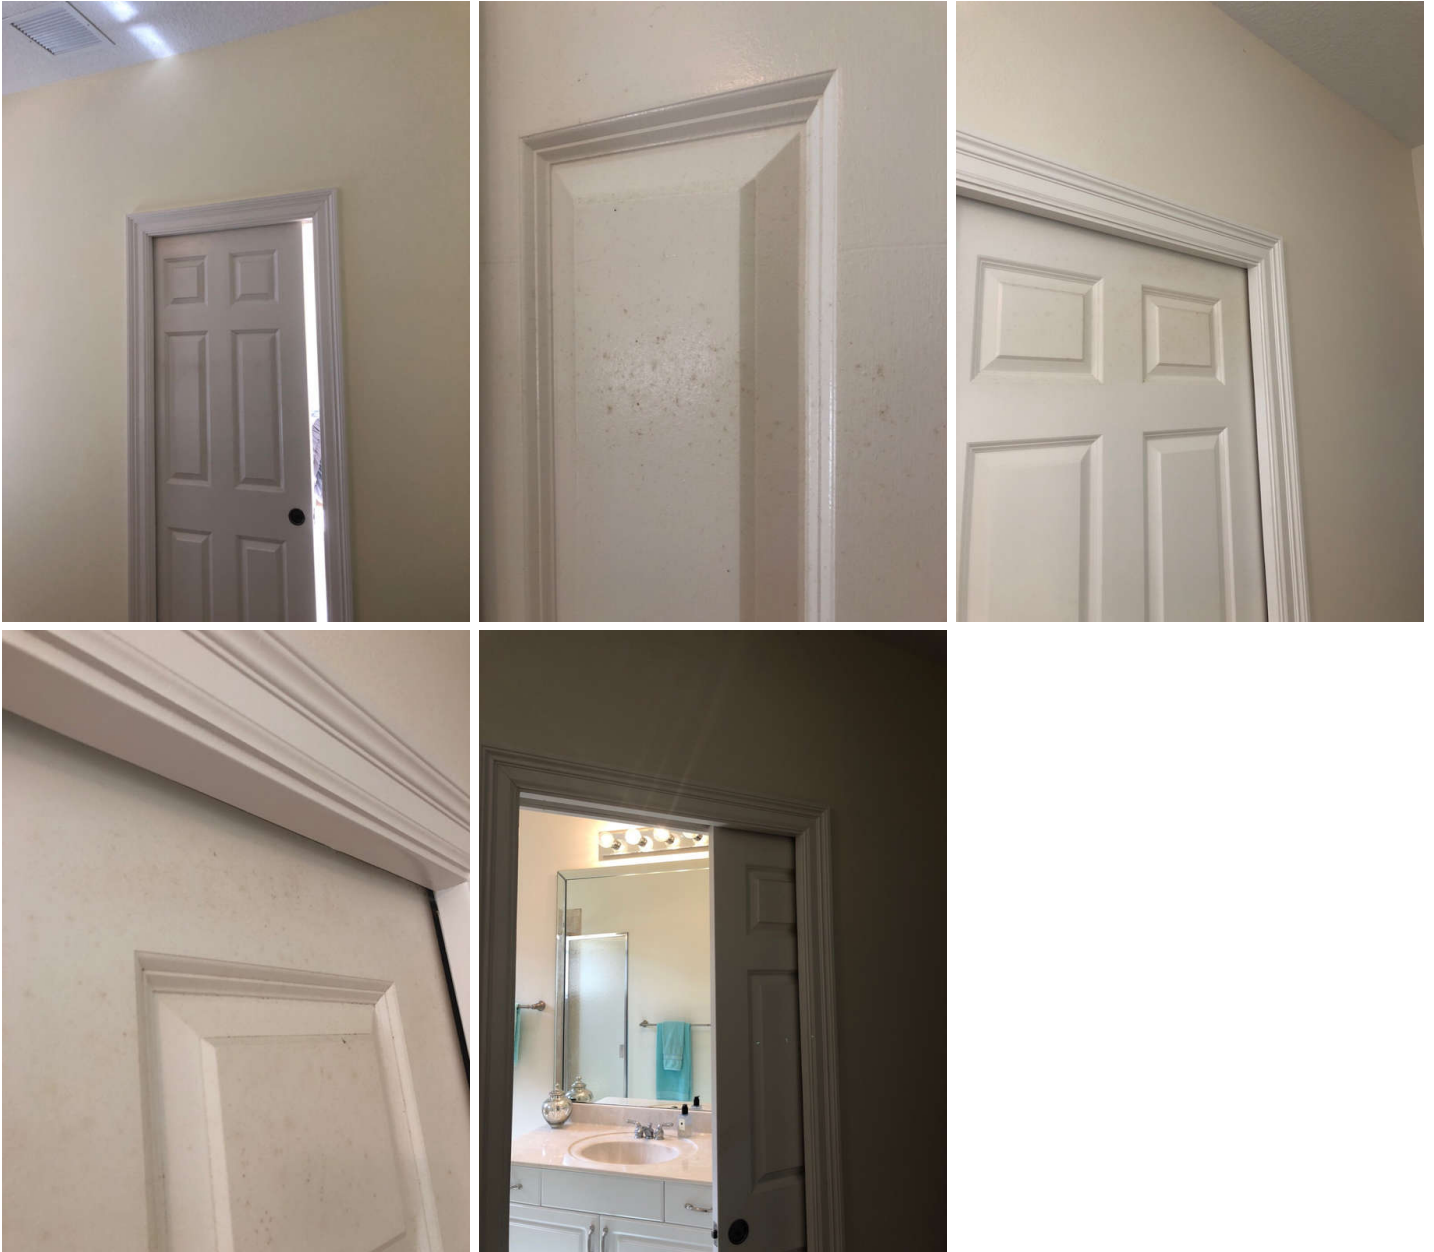
6.6.1 EVIDENCE OF MOISTURE OR MOLD

VISIBLE MOLD (NO ACTIVE MOISTURE)

There is visible mold or indications of mold on the interior of the home. There is no active moisture in the area at the time of inspection. However this does indicate either a previous moisture event, or excessive humidity in the area has occurred. It is highly recommended that a fall mold assessment be performed, to determine the extent of damage in the proper course of repair

Contact a qualified professional.

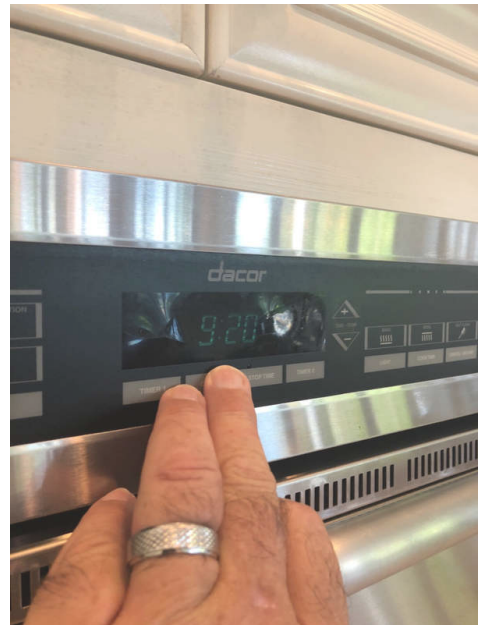
7.2.1 RANGES/OVENS/COOKTOPS/RANGE HOOD

DISPLAY DAMAGE

The display is damaged and does not operate properly. This will require repair or replacement

Contact a qualified appliance repair professional.

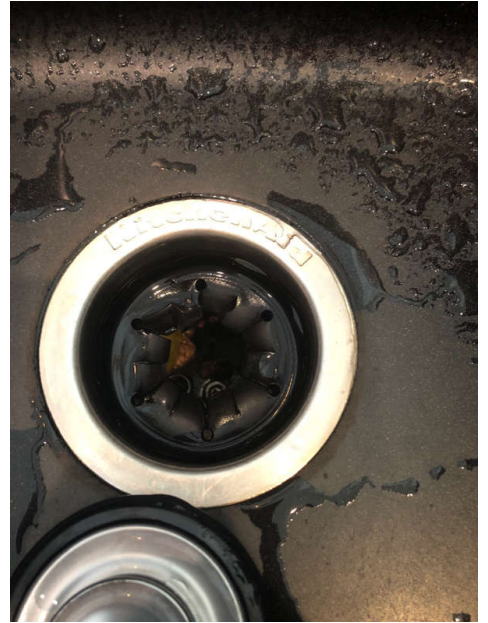
7.3.1 FOOD WASTE DISPOSER

The garbage disposal splash guard is missing/damaged and will require replacment.

Contact a qualified appliance repair professional.

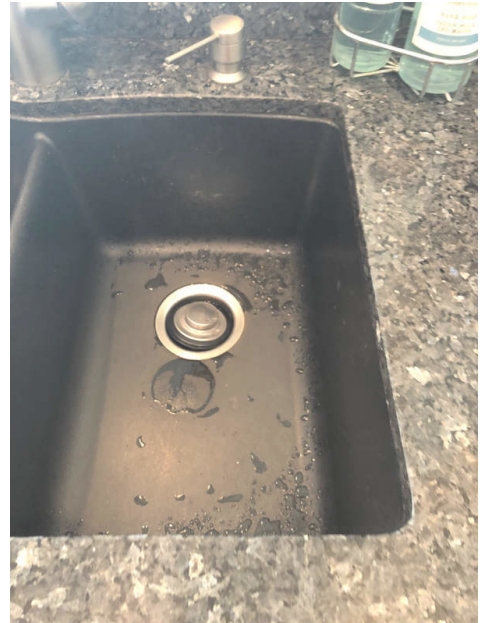
7.3.2 FOOD WASTE DISPOSER

DISPOSAL (NOISY OPERATION)

The disposal is noisy during operation and will require service/repair or replacement

Contact a qualified appliance repair professional.

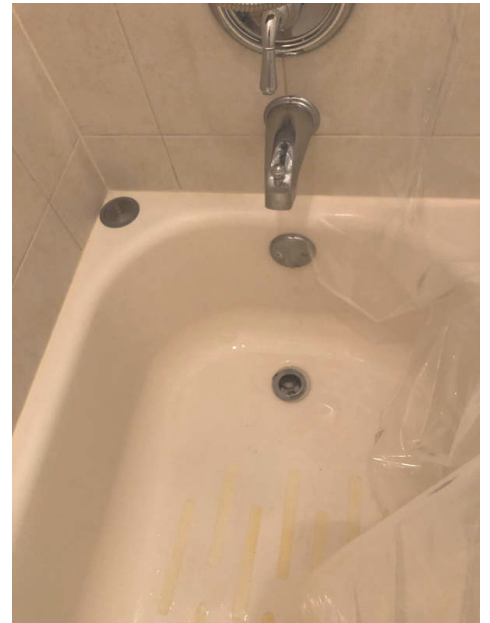
Tub Drain Stops are damaged or missing components

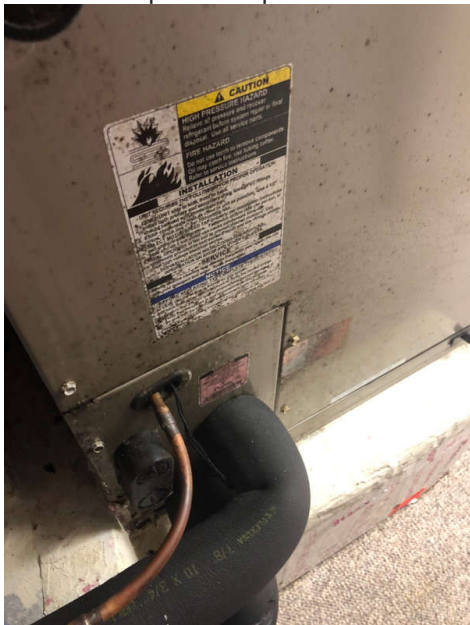
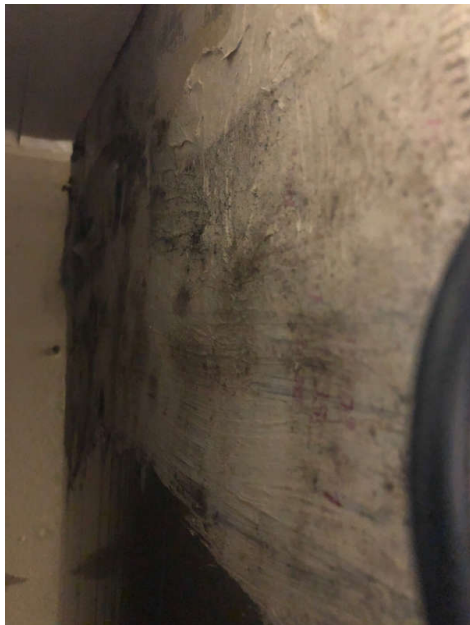
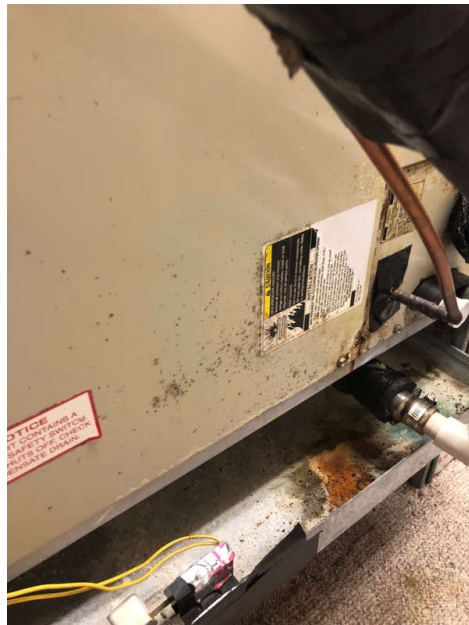
There is visible mold around the plenum and the air handler in the garage. Recommend for maintenance service, cleaning and evaluation

Contact a qualified professional.

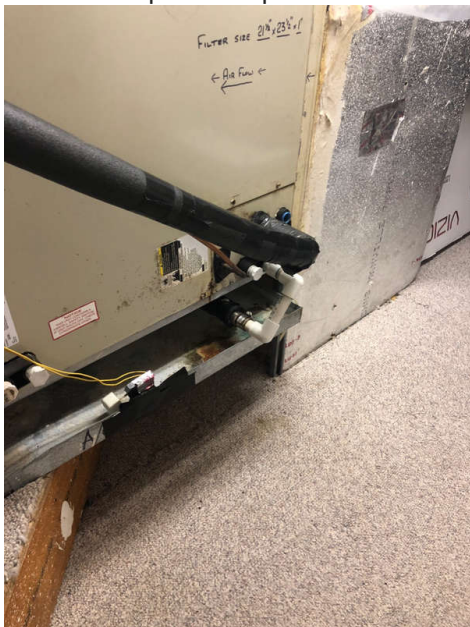
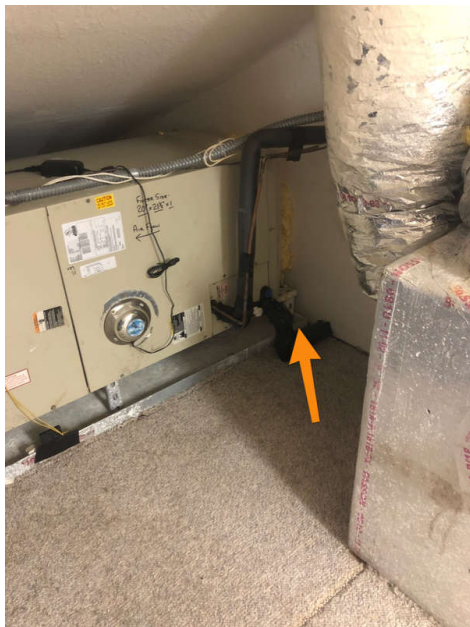
10.5.1 AUTOMATIC SAFETY CONTROLS

Recommend installation of an inline condensate overflow switch. This is a safety device that helps to prevent damage due to an overflow of the condensate drain pan.

Contact a qualified professional.

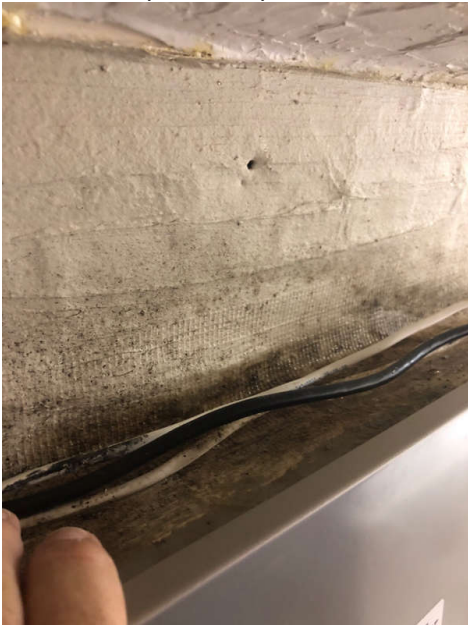
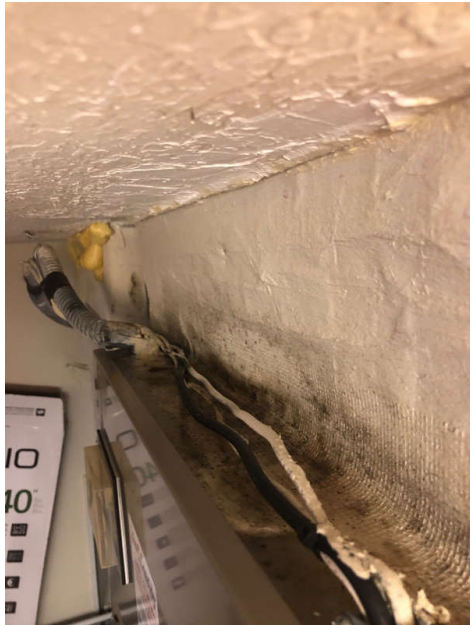
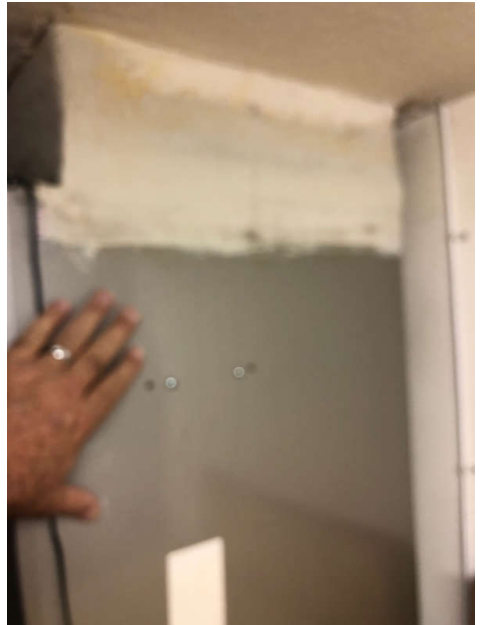
10.7.1 DISTRIBUTION SYSTEMS

AC PLENUM/AIR HANDLER (CONDENSATION BUILDUP)

There is notable condensation buildup on the AC Plenum and air handler. This may indicate improper Insulation, These areas have notable visible organic growth and active moisture. The system will require maintenance service, cleaning, and periodic maintenance. The notable air leaks should be resolved and the Plenum properly insulated to prevent further damage

Contact a qualified professional.

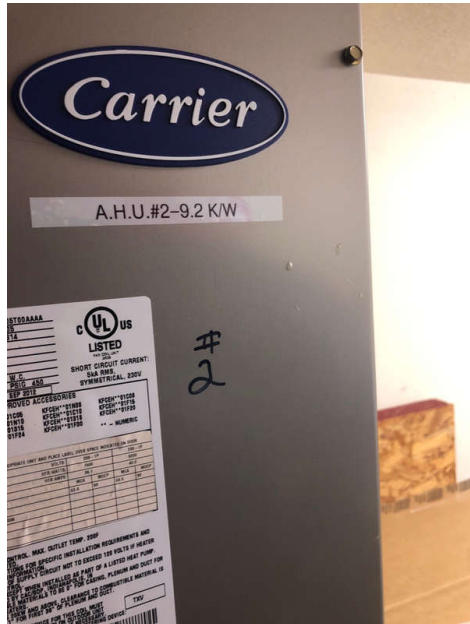
10.9.1 OPTIONAL COMPONENTS

The UV light system is apparently inoperative And will require repair/replacement for further diagnosis

Contact a qualified professional.

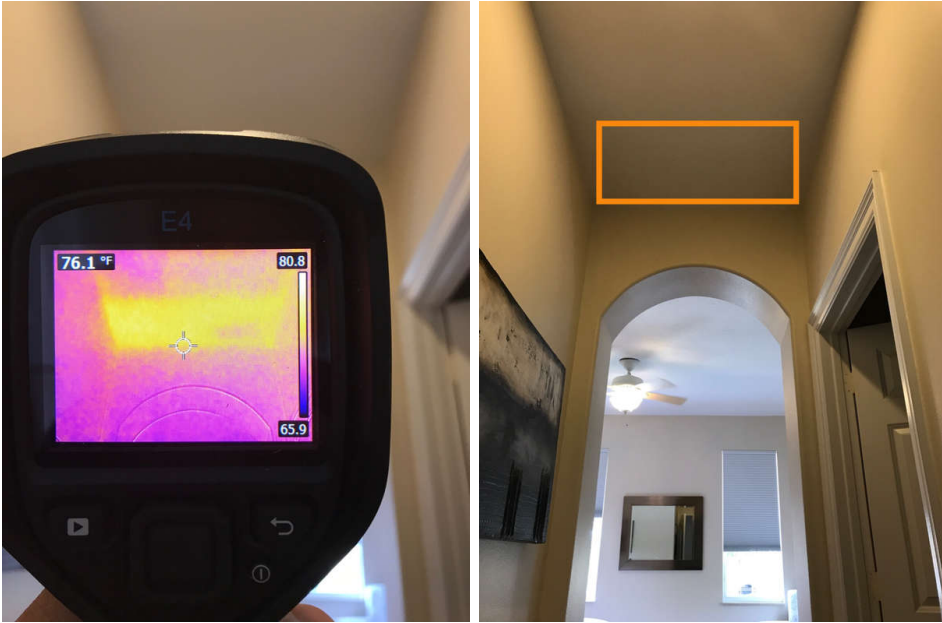
MISSING

The majority of the attic insulation is missing, is damaged or improperly installed. Recommend full evaluation to properly insulate the attic.

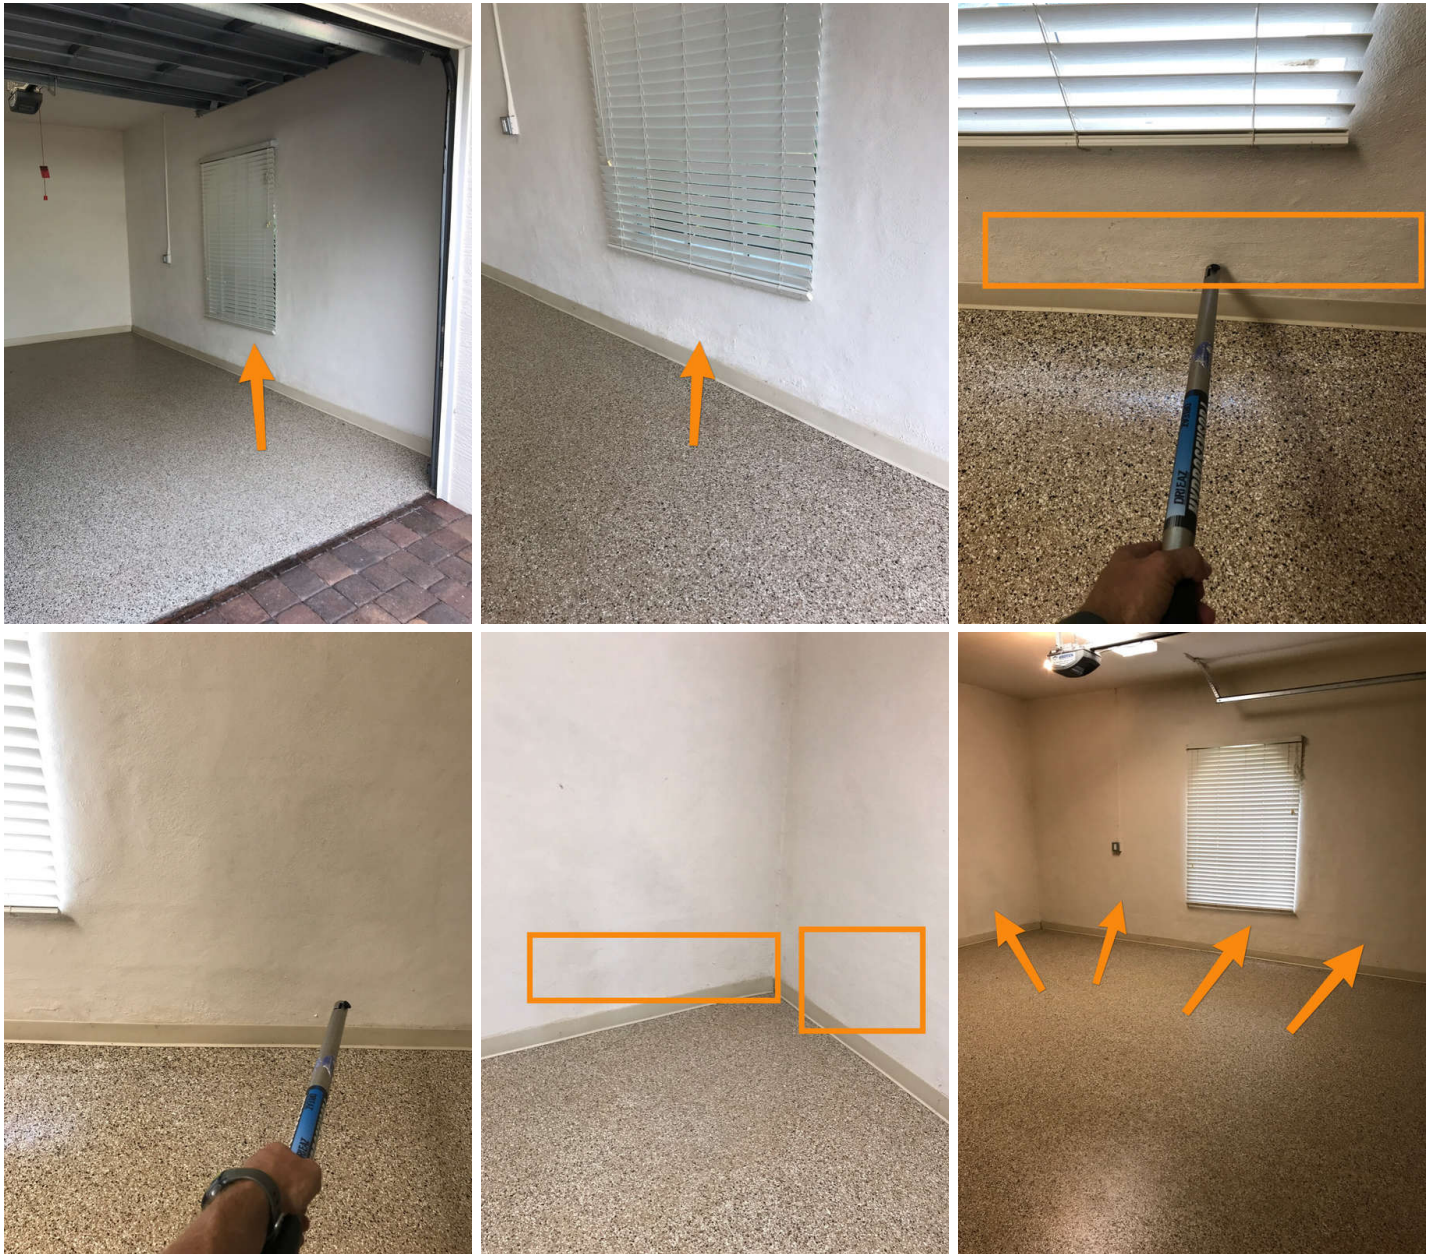
MOISTURE DAMAGE

There is visible moisture damage at the right hand side front of the garage wall. The source of the moisture cannot be determined. There is visible areas of peeling or bubbling paint.

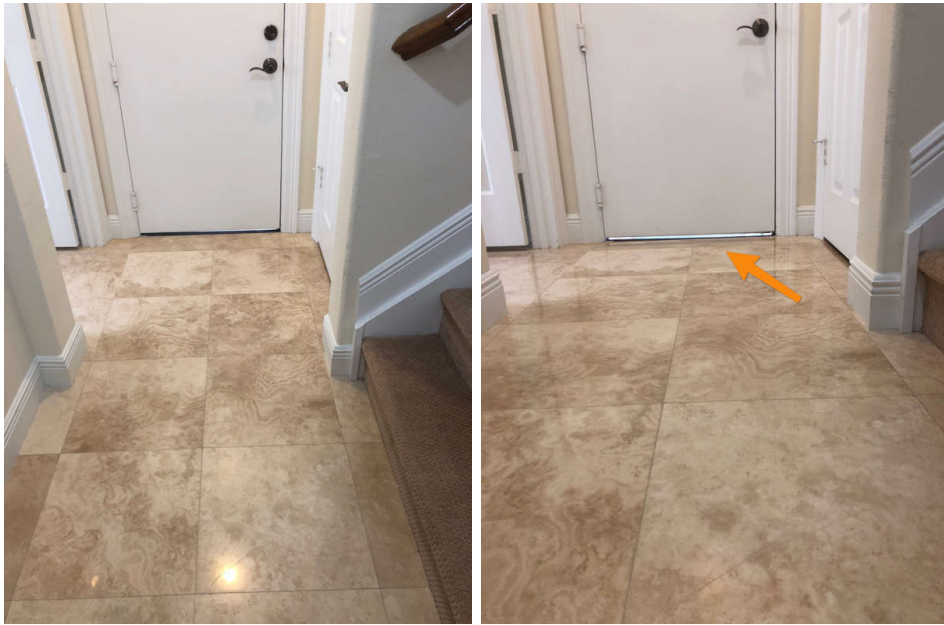
13.5.1 OCCUPANT DOOR FROM GARAGE TO INSIDE HOME

WEATHERSTRIP MISSING

The weatherstrip at the threshold for the garage pedestrian entry door is missing in the door does not properly seal

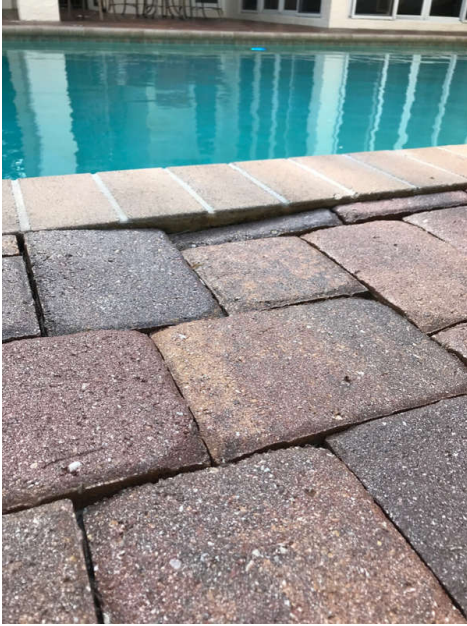
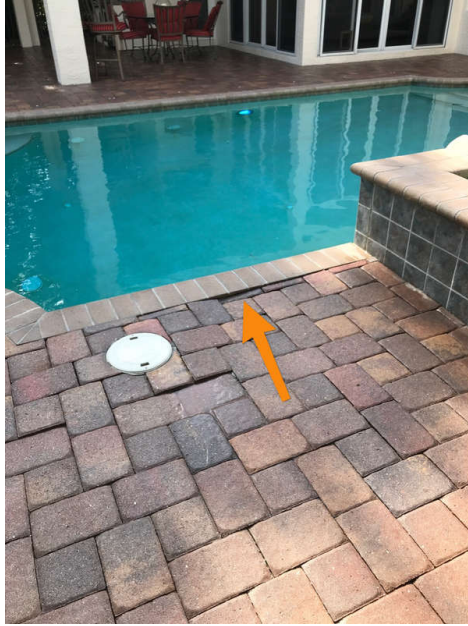
15.4.1 POOL DECK AND COPING

BRICK PAVER SETTLEMENT

There are multiple areas of uneven surfaces on the brick pavers around the pool. Specifically around the skimmer, the paver is loose and creates a potential trip hazard. Recommend removal of the pavers identifying the cause and repair

Contact a qualified professional.

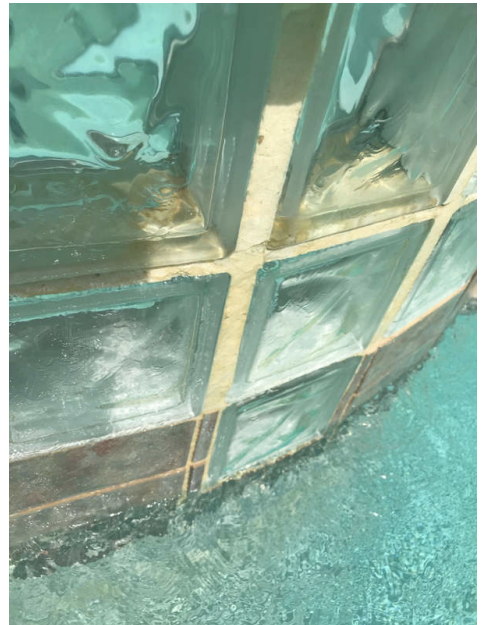
15.4.2 POOL DECK AND COPING

GLASS BLOCK (MORTAR)

Moisture penetration and deterioration of grout glass block of waterfall. Recommend replair of grout to prevent further deterioration.

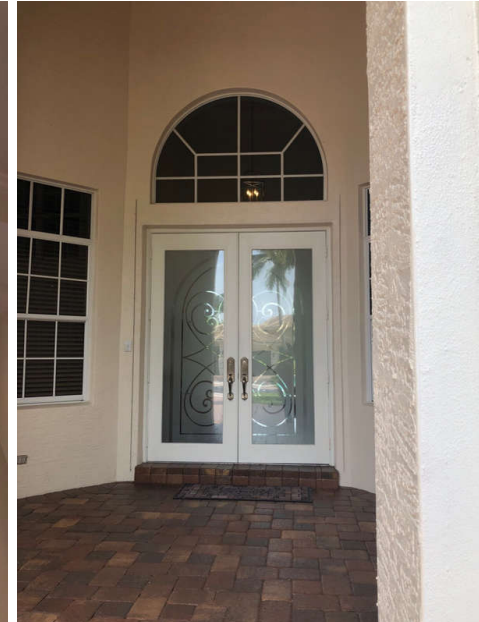
There are multiple areas of the impact rating information/stickers that have either been partially removed, or are missing. The stickers are required to verify compliance with large missile impact rating for insurance purposes

Contact a qualified professional.
