#### **HOME INSPECTOR**

#### TAYLORED INSPECTION (801) 440-5502 inspector@tayloredinspection.com https://www.tayloredinspection.com

### RESIDENTIAL REPORT

1234 Main St. West Jordan UT 84081

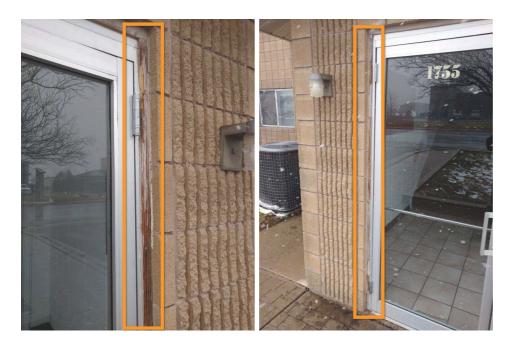
Door sill and/or trim is loose, deteriorated or worn and repair or replacement should be considered.

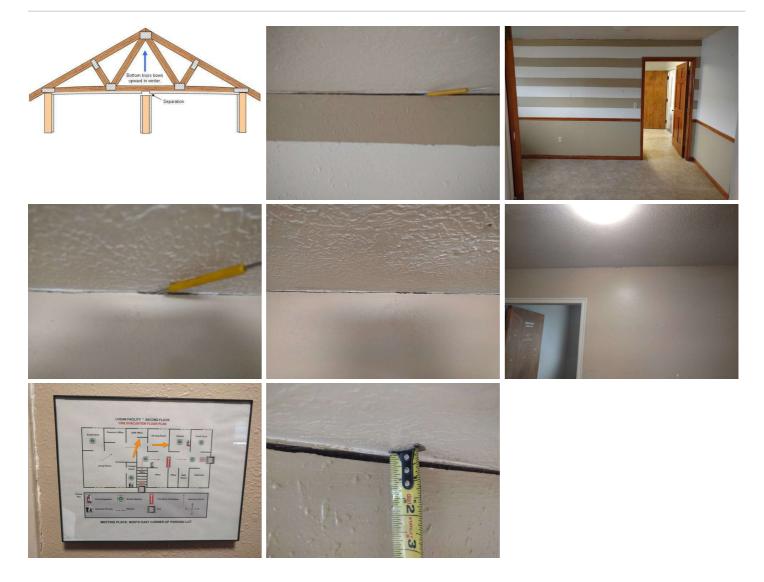
4.5.1 Ceiling Structure

### TRUSS UPLIFT

Due to temperature and humidity changes in the winter, trusses expand and contract which can cause the bottom of the truss (ceiling) to bow up in the middle and lift off of the top of the interior walls. This is not a structural issue, just a cosmetic issue.

Recommendation

Contact a qualified professional.

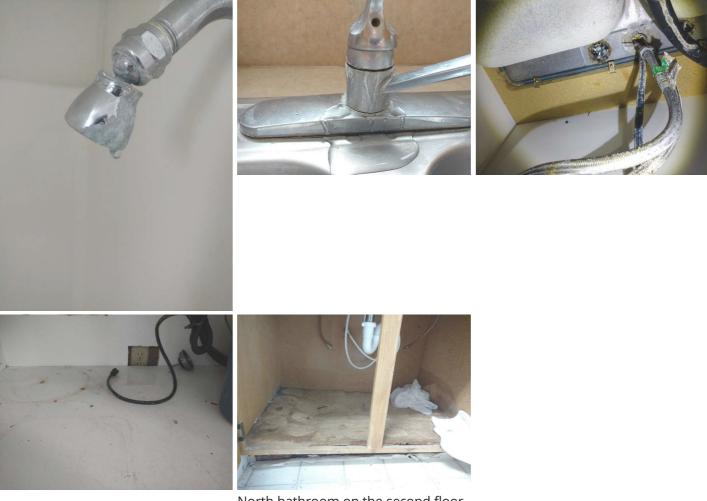
Leaking fixtures were observed. The shower in the north bathroom on the first floor is leaking and is missing the handle to turn on the water. The first floor kitchen faucet leaks when turned on and drips in the cabinet underneath the sink.

North bathroom on the second floor shows signs of water damage. No leaks were observed during the inspection.

Contact a qualified professional.

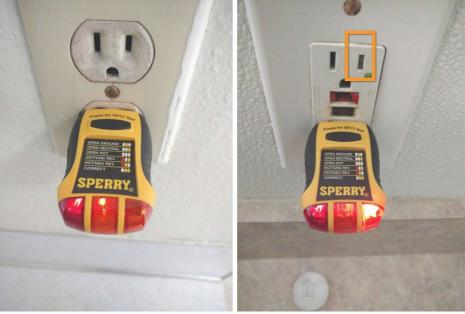
First Floor North and South Bathroom

### **REVERSE POLARITY**

One or more receptacles have been wired with reverse polarity. This can create a shock hazard. Recommend licensed electrician evaluate & repair.

First Floor North Bathroom

First Floor South Bathroom Top right outlet slot is blocked by a piece of an outlet protector that broke off inside. GFCI Test/Reset button broken.

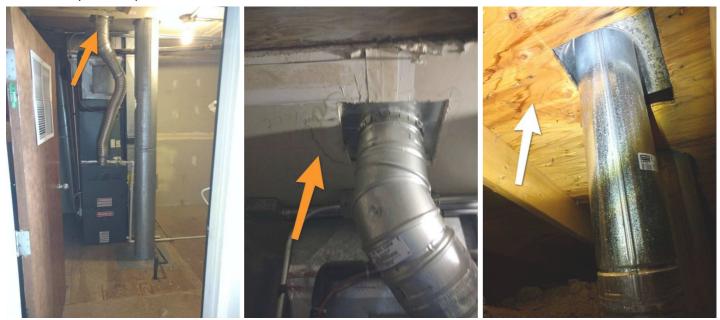
#### SIGNS OF WATER ON FURNACE EXHAUST VENT

Signs of moisture intrusion were observed on the furnace exhaust vent. Snow was falling and melting on the roof at the time of inspection and not moisture was detected.

Daylight coming in from around vent pipe.

Contact a qualified professional.

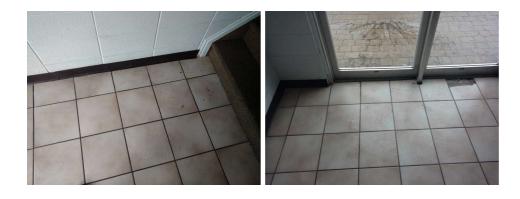
11.3.3 Floors TILES MISSING One or more floor tiles were missing or cracked. Recommend installing/replacing missing tiles in main entryway.
