RESIDENTIAL REPORT

1234 Main St.
Cadiz KY 42211

Buyer Name
09/15/2018 9:00AM

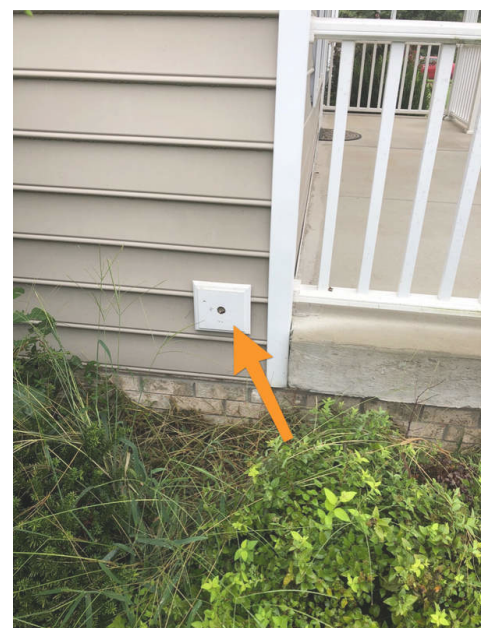
2.1.1 Exterior Cladding

FLASHING/TRIM IMPROPERLY INSTALLED

Trim piece was installed for a wall penetration that is no long there. The unsealed hole could result in moisture intrusion and damaging leaks. Recommend a qualified siding contractor evaluate and repair.

Southeast

Contact a qualified siding specialist.

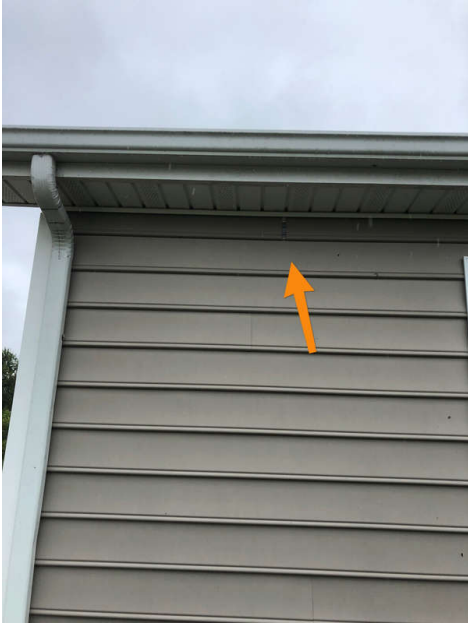
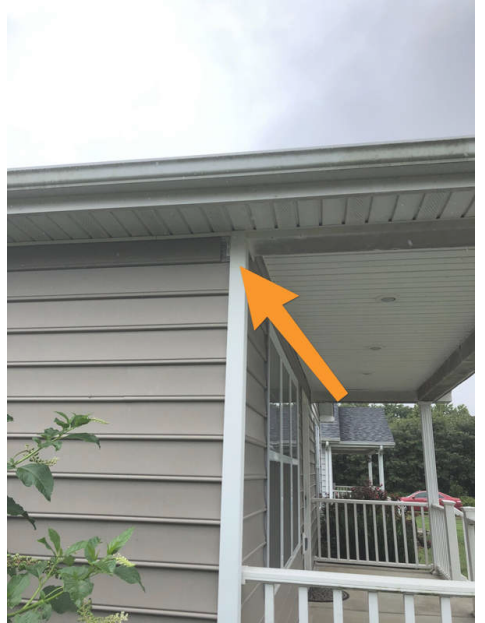
2.1.2 Exterior Cladding

IMPROPER INSTALLATION

One or more areas of the siding appear to be installed incorrectly. Recommend further evaluation by a siding contractor.

Southeast

Contact a qualified siding specialist.

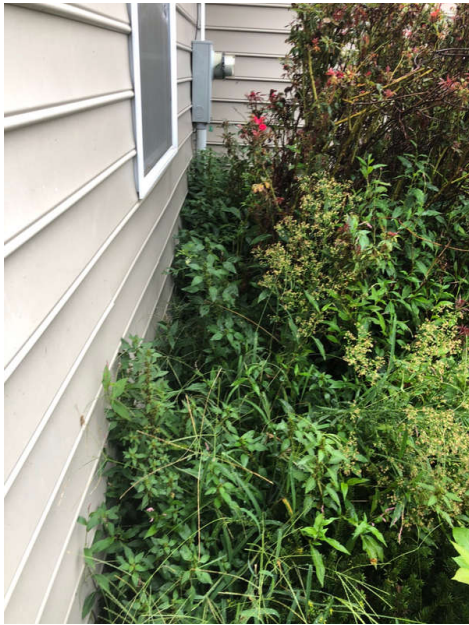
2.2.1 Vegetation, Grading, Drainage & Retaining Walls

VEGETATION TOO CLOSE TO HOUSE

Vegetation too close to house. Recommend trimming bushes too late to leave at least 10 to 12 inches of clearance around house to prevent staining and water intrusion into house.

Southeast

Contact a handyman or DIY project

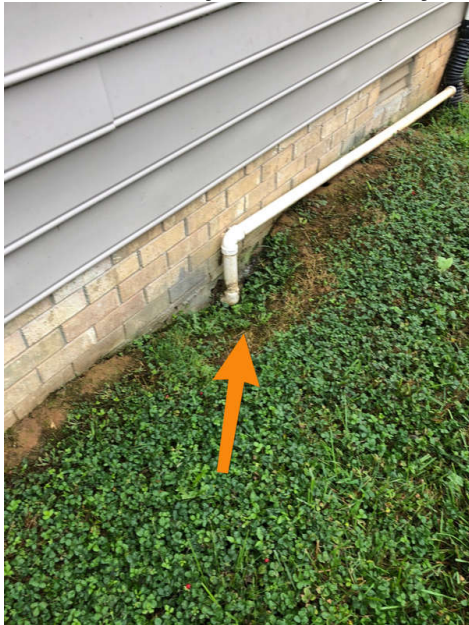
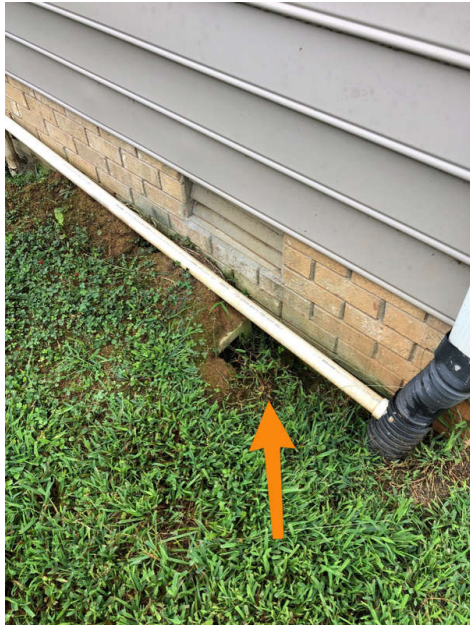
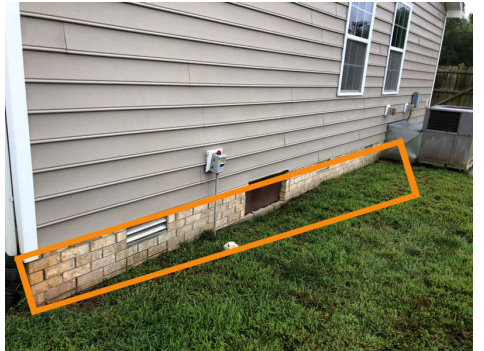
2.2.2 Vegetation, Grading, Drainage & Retaining Walls

LOW AREAS

Low areas next to foundation, possible for water to pool and enter into the crawlspace. Recommend adding some dirt to create a slope away from house

Contact a handyman or DIY project

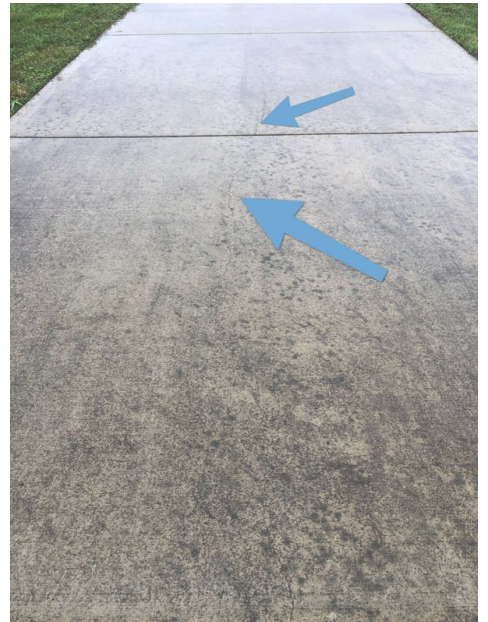
2.3.1 Driveways & Walkways

DRIVEWAY CRACKING - MINOR

Minor cosmetic cracks observed, consist with age. Recommend monitor for further damage and patch or seal current cracks.

Contact a handyman or DIY project

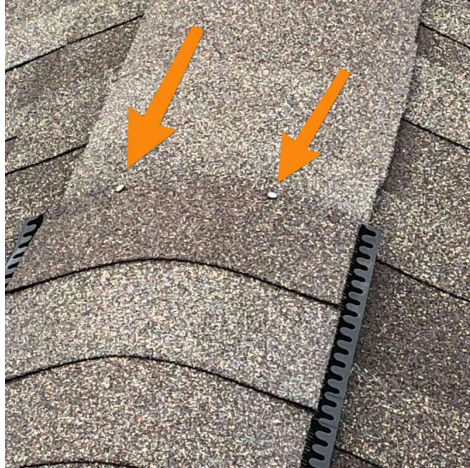
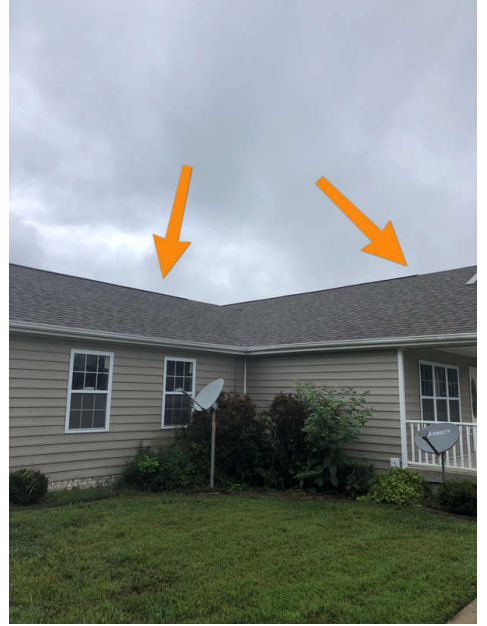
3.1.1 Coverings

EXPOSED NAIL

RIDGE VENT ROOF GARAGE, RIDGE VENT HOUSE

There are exposed nails on the roof. Recommend ceiling the nails to prevent water intrusion.

Contact a handyman or DIY project

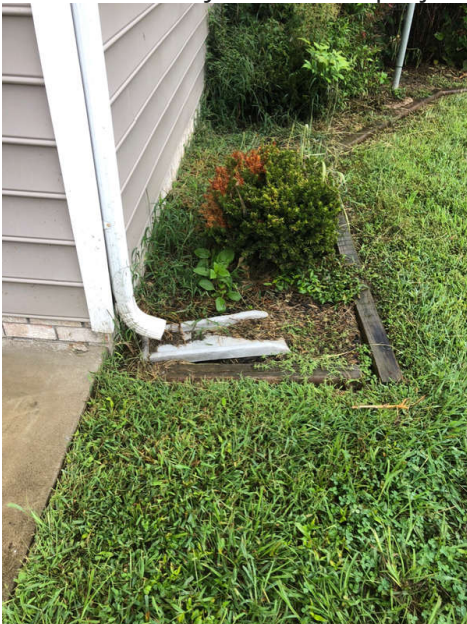
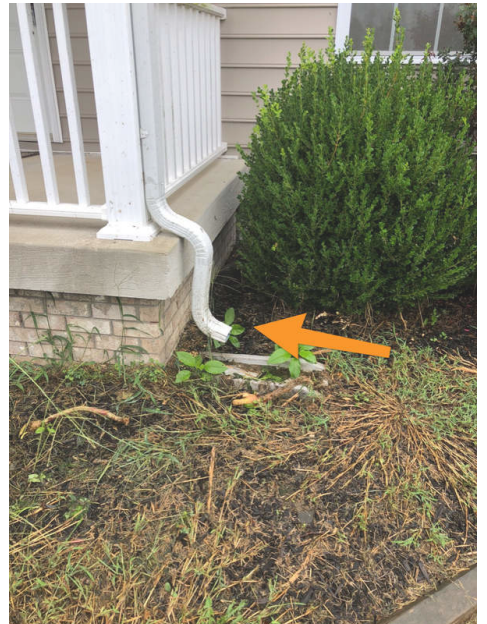
3.2.1 Roof Drainage Systems

DOWNSPOUTS DRAIN NEAR HOUSE

One or more downspouts drain too close to the home's foundation. This can result in excessive moisture in the soil at the foundation. Recommend improving downspout extensions to drain 4- 6 feet from the foundation.

Southeast Corner

South Side Porch

North Side Porch

Contact a handyman or DIY project

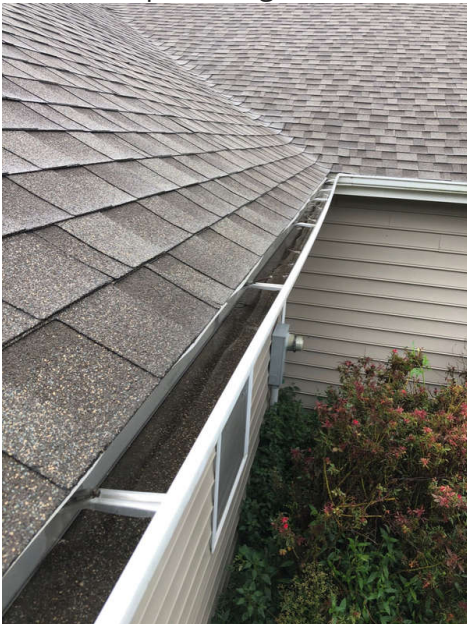
3.2.2 Roof Drainage Systems

GUTTER IMPROPERLY SLOPED

Gutter are improperly sloped in areas, which could result in runoff drainage around the foundation and possible structural shifting. Recommend qualified roofing or gutters contractor repair.

Standing water Southeast

Contact a qualified general contractor.

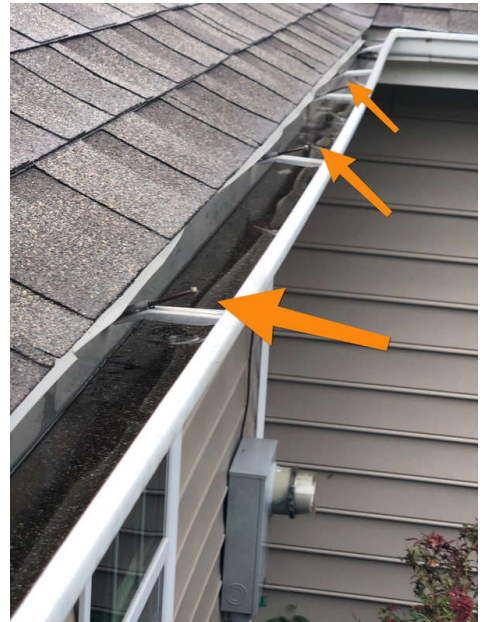
3.2.3 Roof Drainage Systems

GUTTER LOOSE

The gutter(s) is loose and needs to be re-fastened to fascia and pitched properly.

Three screws not completely installed Southeast

Contact a handyman or DIY project

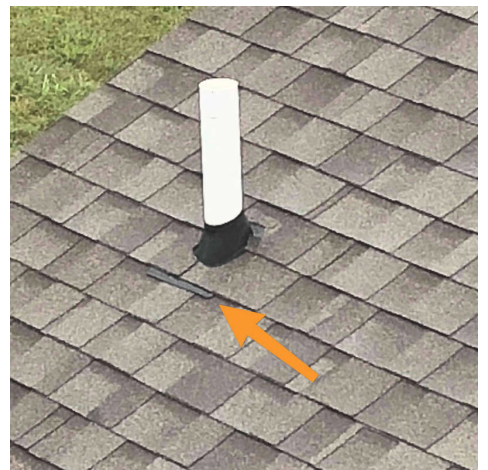
3.3.1 Flashings

IMPROPER FLASHING

Flashing is incrotty installed. Recommend repair or replace by a qualified roofer.

Contact a qualified roofing professional.

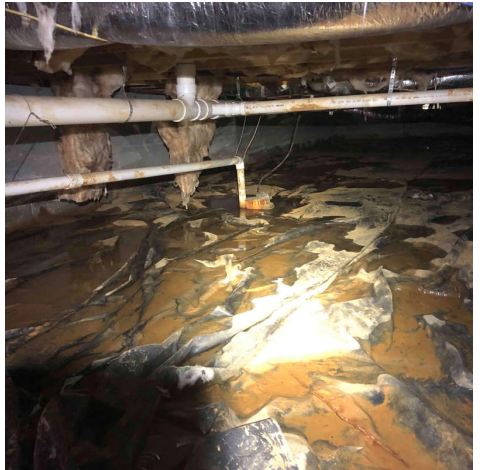
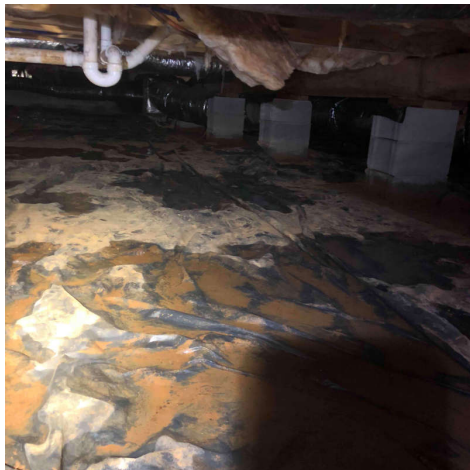
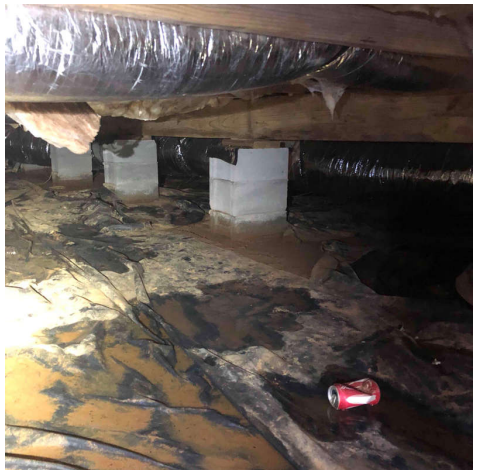
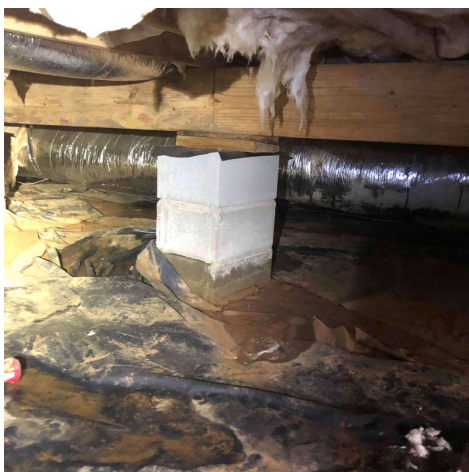
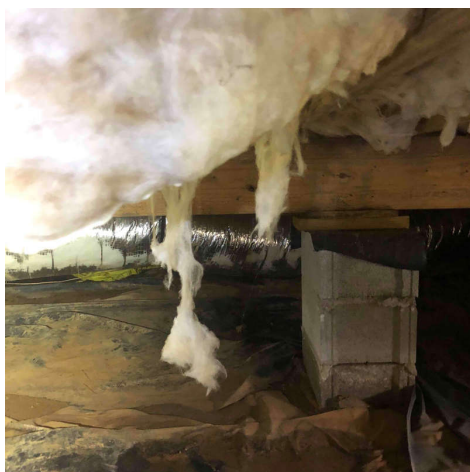
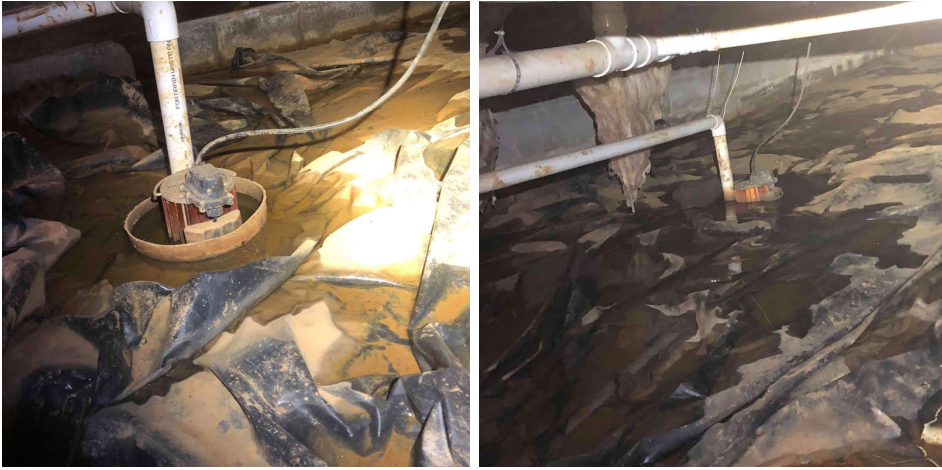
4.1.1 Basements & Crawlspaces

STANDING WATER CRAWLSPACE

Observed standing water on crawlspace floor. Recommend a qualified contractor specializing in wet basement/crawlspace evaluate and advise on corrective action.

Contact a qualified professional.

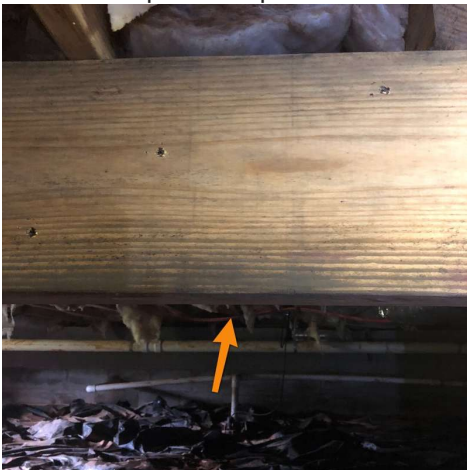
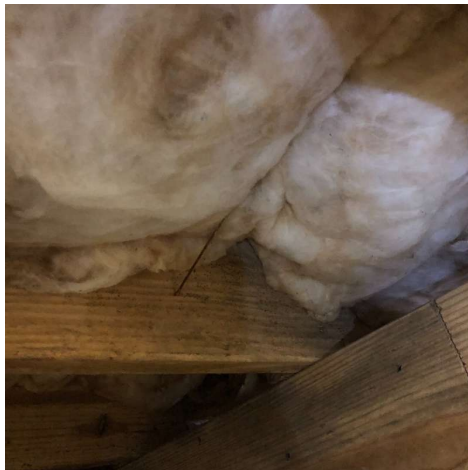
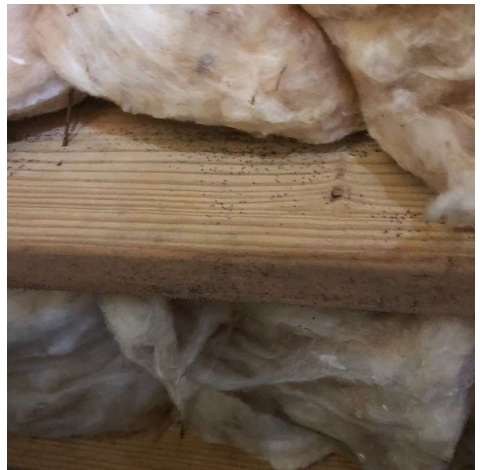
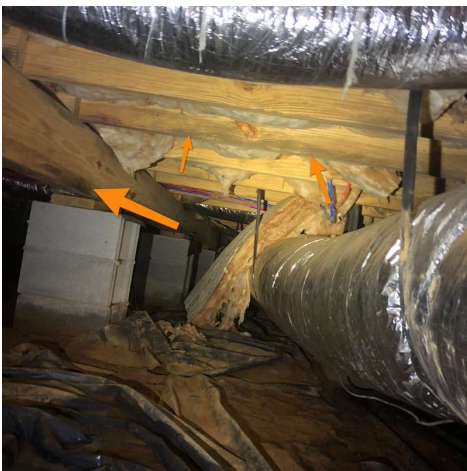
4.1.2 Basements & Crawlspace

ORGANIC GROWTH

A substance similar in appearance to mold is present, this is a sign of poor ventilation. Recommend further evaluation from a wet crawlspace/basement specialist.

Contact a qualified professional.

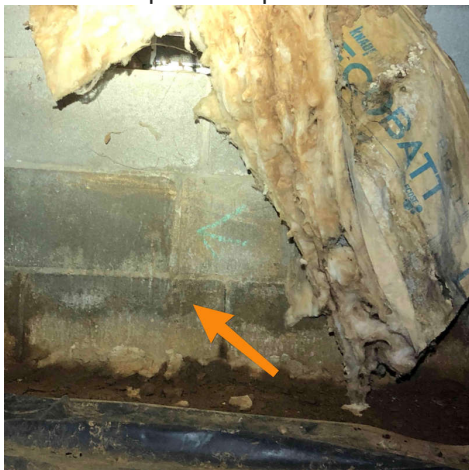
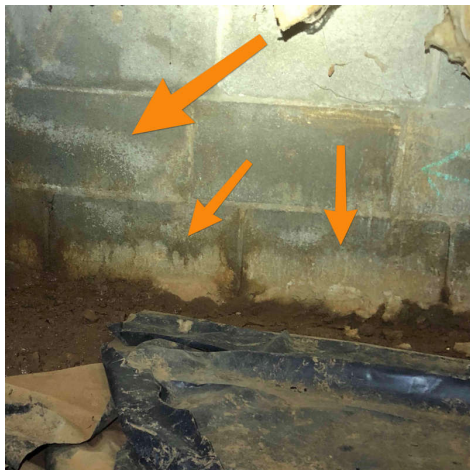
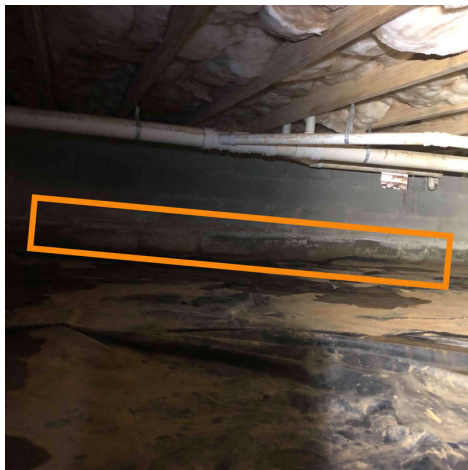
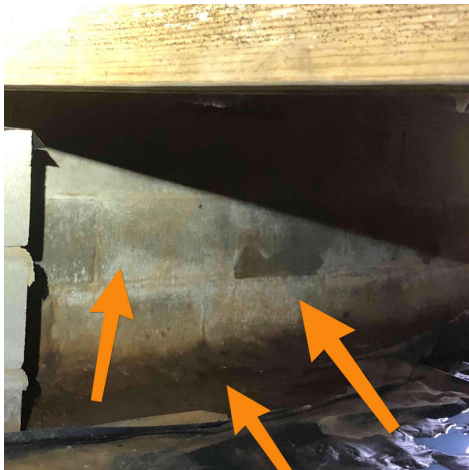
4.2.1 Foundation

EFFLORESCENCE

Efflorescence noted on the crawlspace surface. This a white, powdery deposit that is consistent with moisture intrusion. This can compromise the soil's ability to support the home structure and/or lead to mold growth. Recommend a qualified contractor identify source of moisture and advise on corrective action.

Contact a qualified professional.

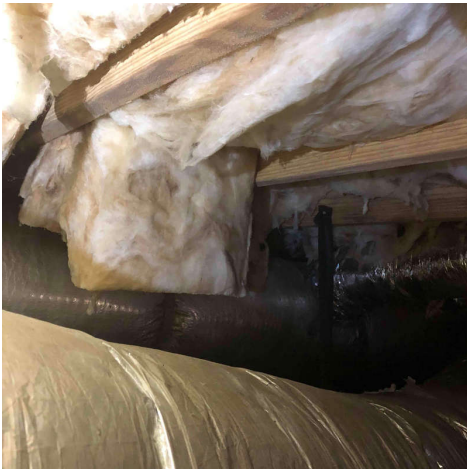
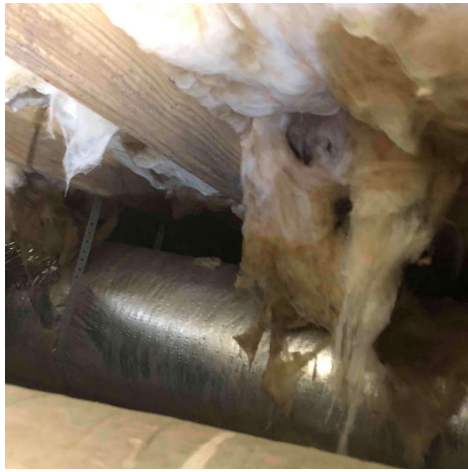
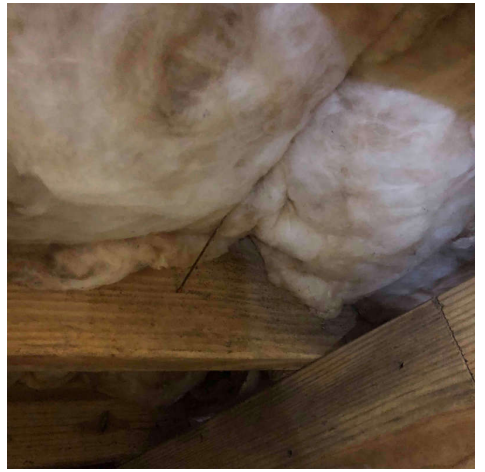
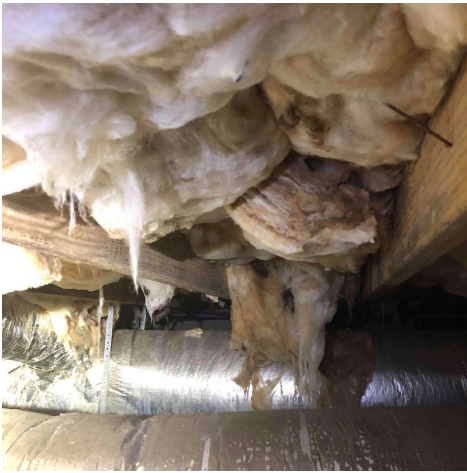
4.3.1 Insulation

WATER DAMAGE

Insulation in the crawlspace has been damaged by prolonged exposure to moisture. Recommend a insulation contractor evaluate for repair or replacement.

Contact a qualified insulation contractor.

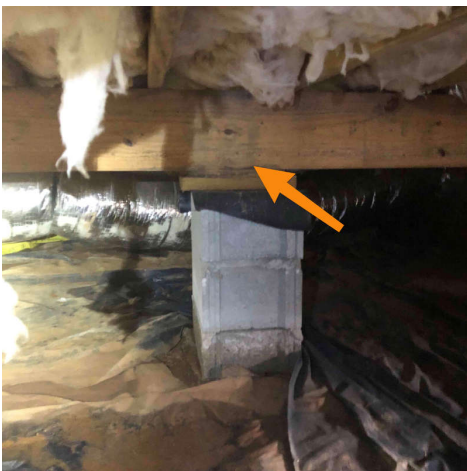
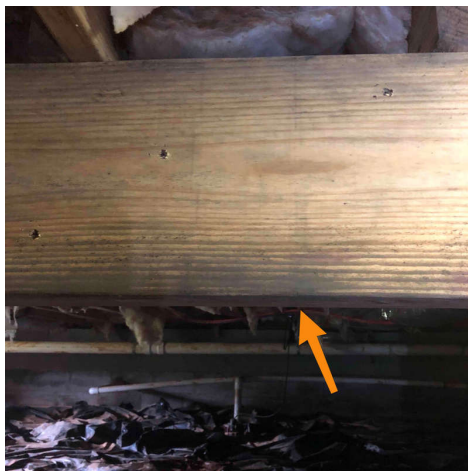
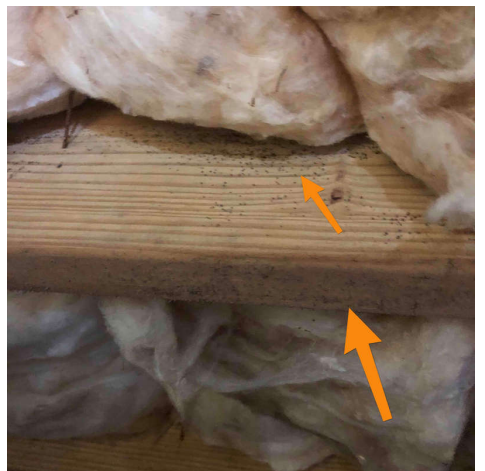
4.4.1 Floor Structure

MILDEW

Observed signs of possible mildew/mold in one or more areas in the flooring structure. Recommend wet basement/crawlspace specialist identifying source of moisture, advise on corrective action and test for possible mold

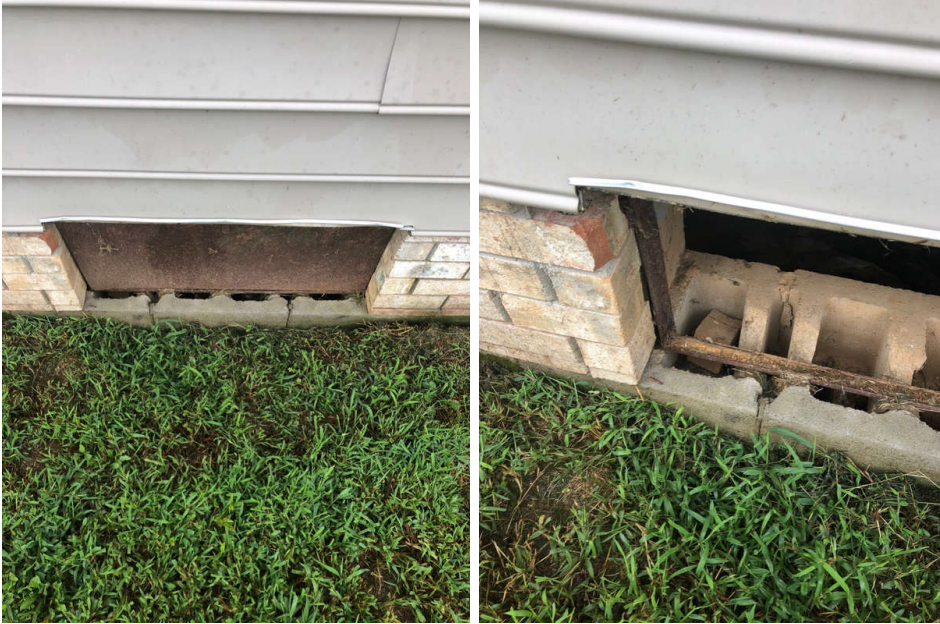
4.6.1 Access

IMPROPERLY INSTALLED

The access hatch for the crawlspace is improperly installed, the bottom course of masonry block should not be open, they need to be sealed to prevent water intrusion. The frame for the metal access hatch is not secure to the masonry block. Recommend repair or replace by a mason.

Contact a qualified masonry professional.

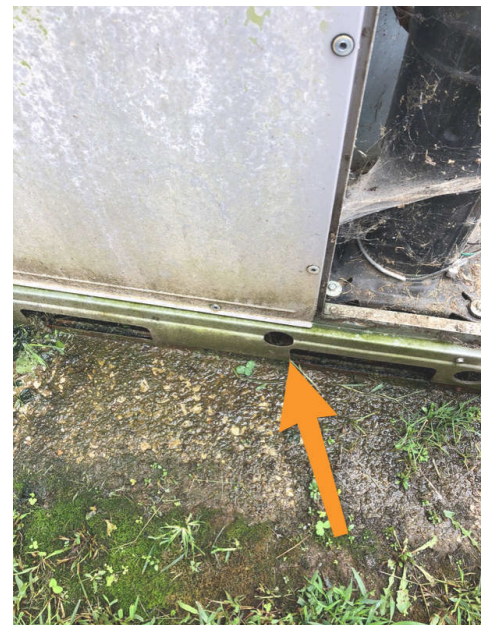
5.1.1 Heat Pump

NO CONDENSATE DRAIN

Condensate tube was not present which limits safe discharge of condensation produced by evaporator coils. Recommend a qualified HVAC technician repair.

Contact a qualified HVAC professional.

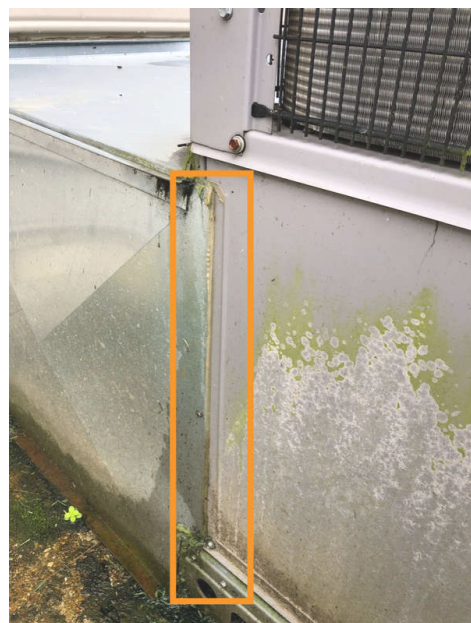
5.1.2 Heat Pump

UNABLE TO ACCESS

Was unable to access parts of the HVAC unit. Recommend a full evaluation by a licensed HVAC contractor.

Sealed

Contact a qualified heating and cooling contractor

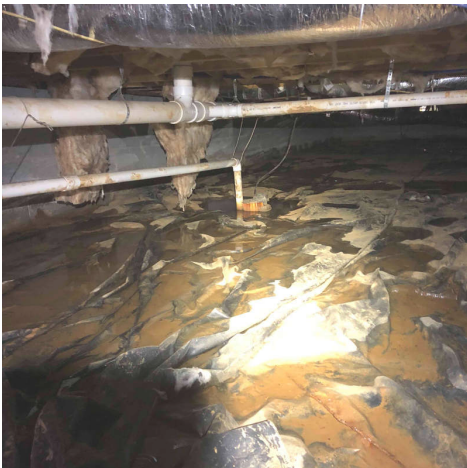
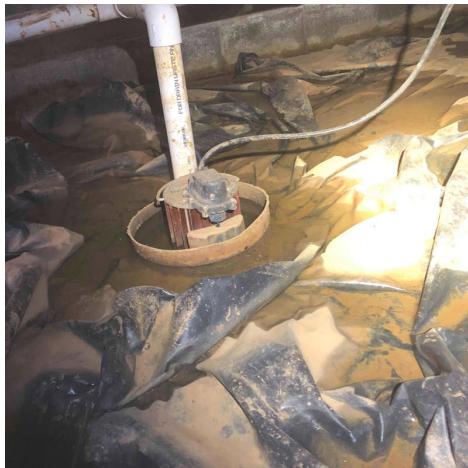
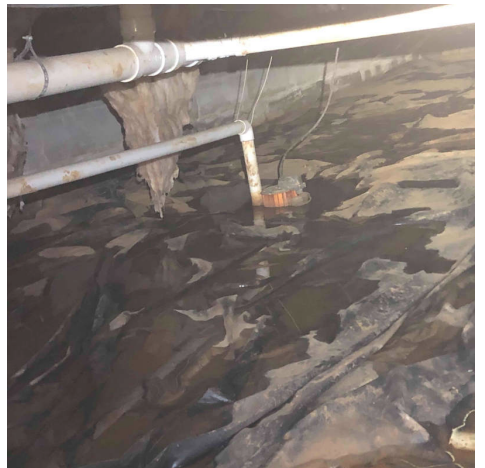
Sump pump was not operating at the time of inspection, despite high water levels. Recommend qualified plumber evaluate and repair.

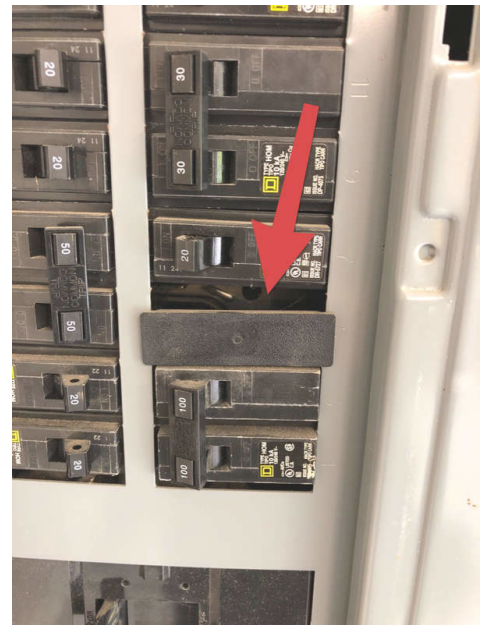
KNOCKOUTS MISSING

"Knockouts" are missing on the electric panel. This poses a safety hazard and it is recommended that the opening in the panel caused by the missing knockout(s) be properly sealed by a licensed electrician.

Contact a qualified electrical contractor.

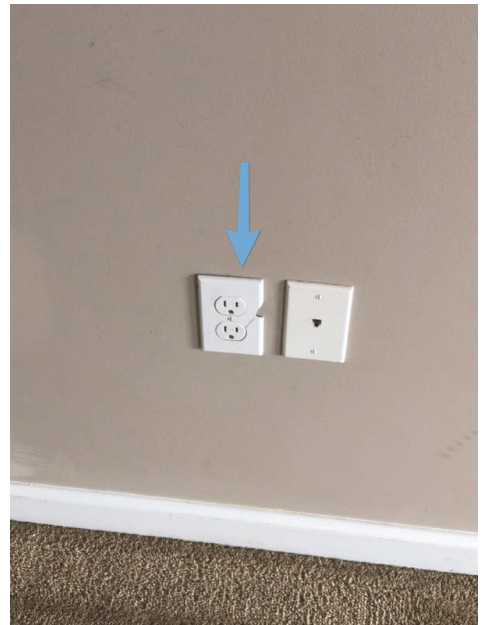
8.4.1 Lighting Fixtures, Switches & Receptacles

COVER PLATES DAMAGED

One or more receptacles have a damaged cover plate. Recommend replacement.

Contact a handyman or DIY project

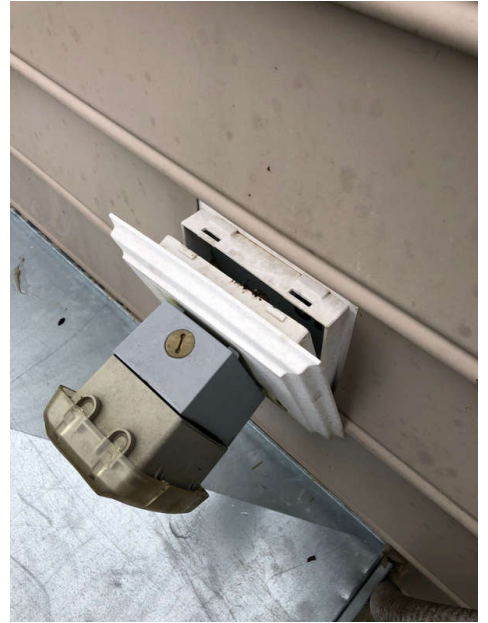
8.4.2 Lighting Fixtures, Switches & Receptacles

DAMAGED RECEPTACLE

Damaged receptacle. Recommend repair or replace by qualified electrician

Exterior East

Contact a qualified professional.

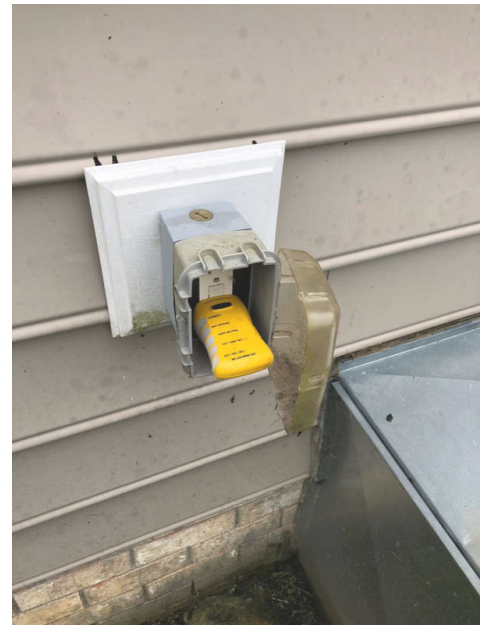
8.5.1 GFCI

Nonworking GFCI. Recommend repair or replace by a qualified electrical contractor.

Exterior East

Contact a qualified electrical contractor.

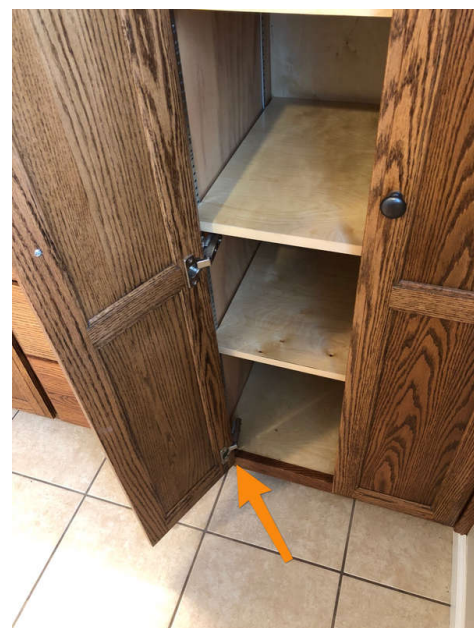
CABINET HINGE LOOSE

One or more cabinet hinges were loose. Recommend a qualified handyman or cabinet contractor repair.

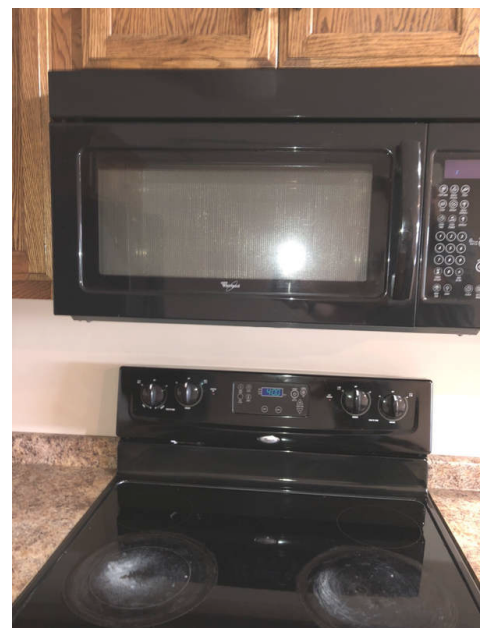
The light underneath the microwave is not working. Most likely cause is burned out lightbulb. Recommend changing lightbulb. If that does not correct the problem, recommend further evaluation by an appliance specialist.

Contact a qualified appliance repair professional.

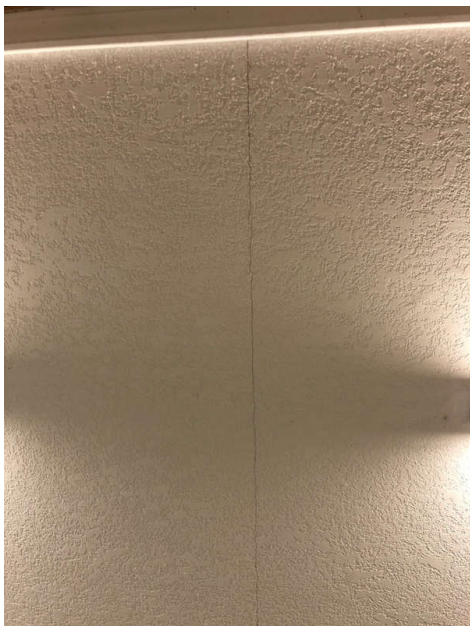
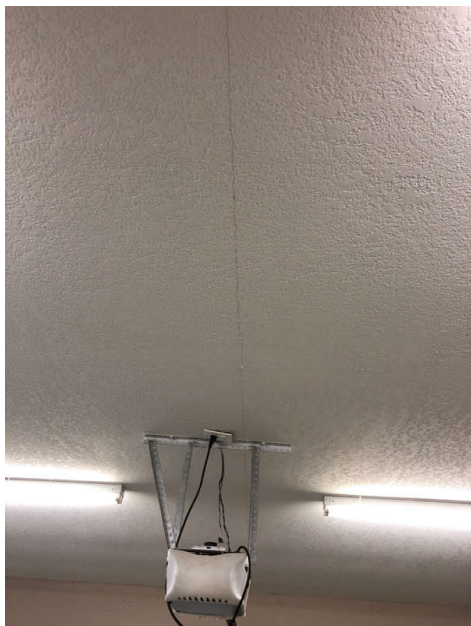
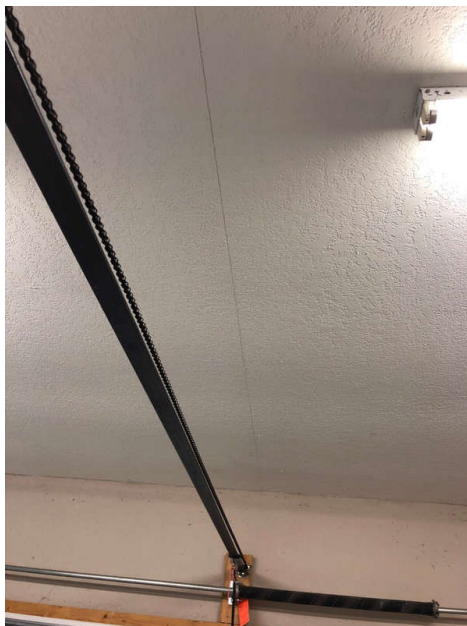
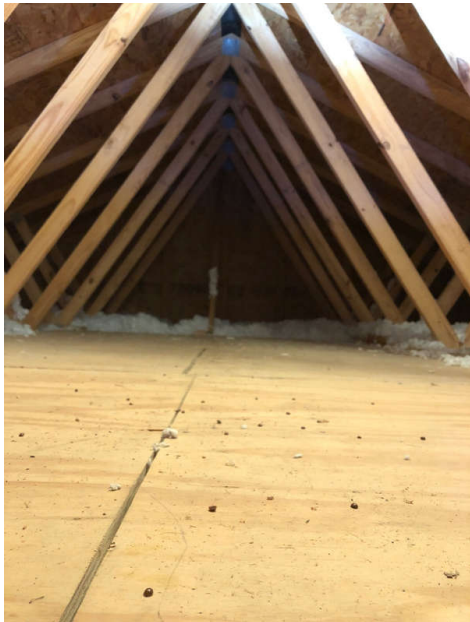
DAMAGED

Garage ceiling was damaged. The location of the crack indicate a possible deflection of the ceiling structure due to items being stored. Recommend qualified contractor evaluate and advise.
