A PRECISE HOME INSPECTION, INC.

HOME INSPECTION REPORT

1234 Main St.
Colorado Springs CO 80920

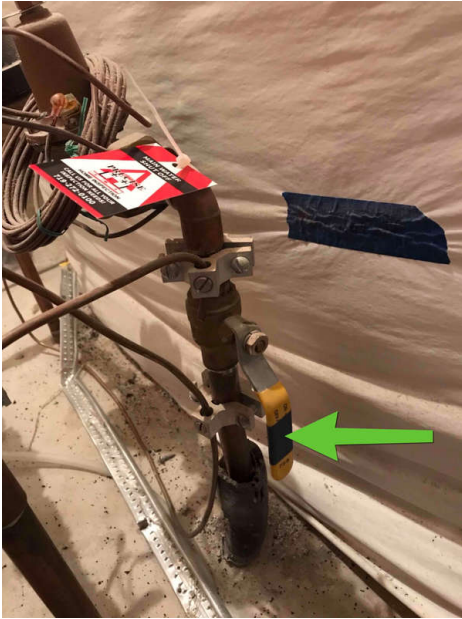
Water - Main Shut Off Valve: Location

Utility Room, Next to the Water Heater

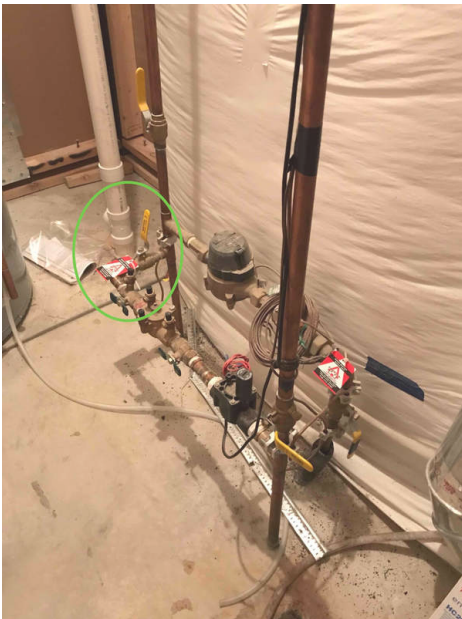
Sprinkler System - Main Shut Off Valve: Location

Next to the Water Heater, Utility Room

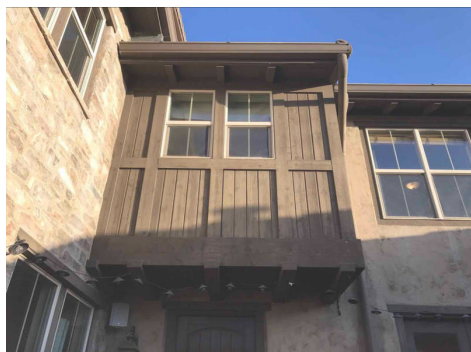
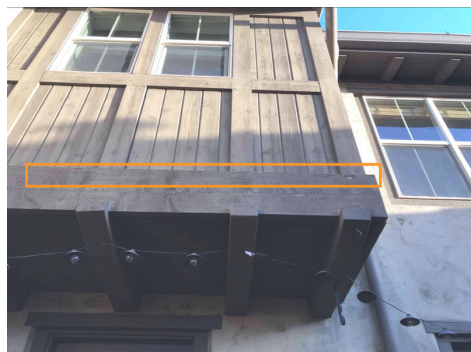
Areas of the exterior paint and caulking are in need of maintenance/repairs. In order to prevent moisture intrusion and to extend the life of the siding and trim, I recommend having the caulking and exterior paint evaluated and repaired as necessary by a qualified painting contractor prior to closing.

Contact a qualified painter.

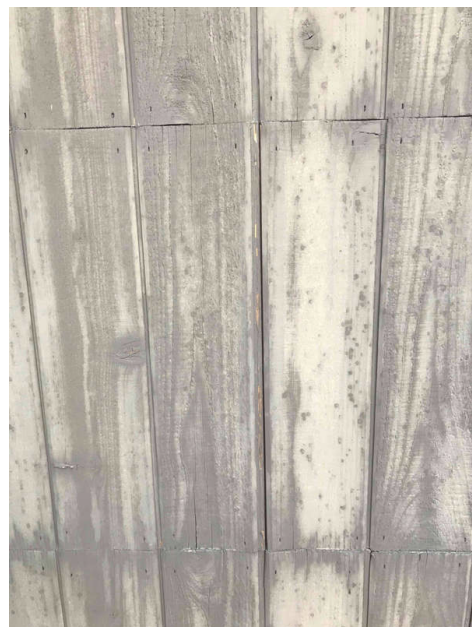
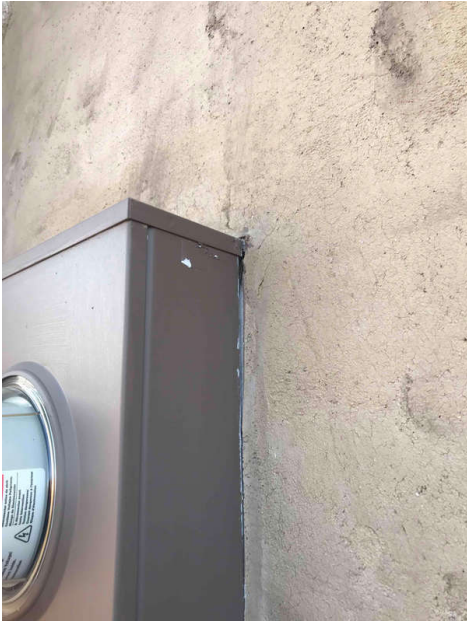
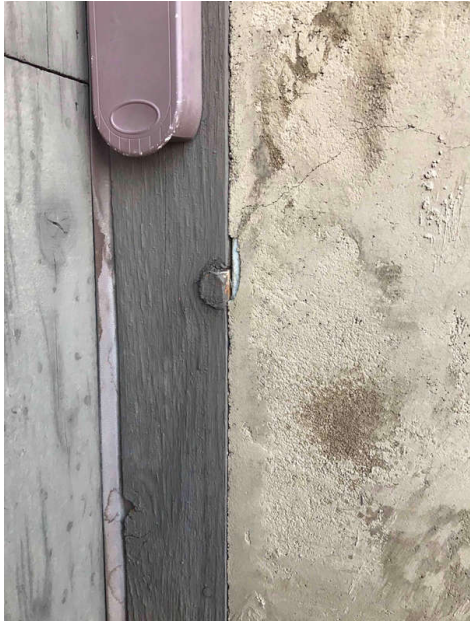
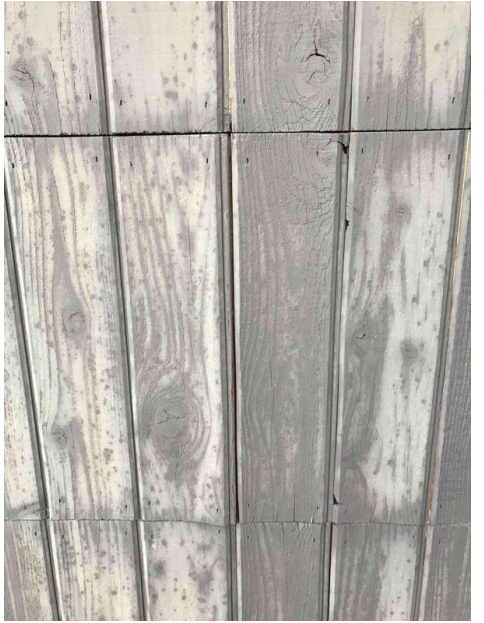
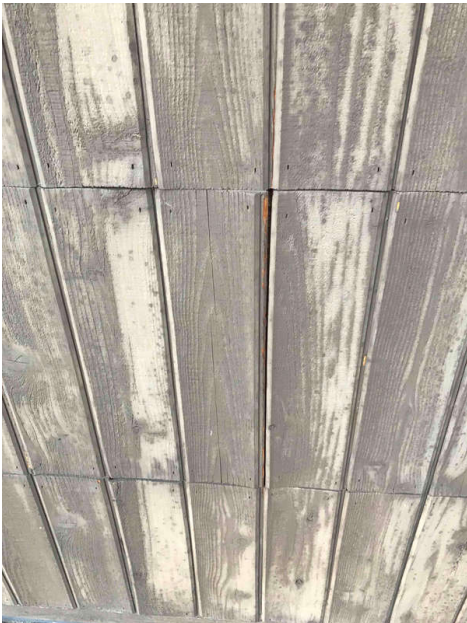
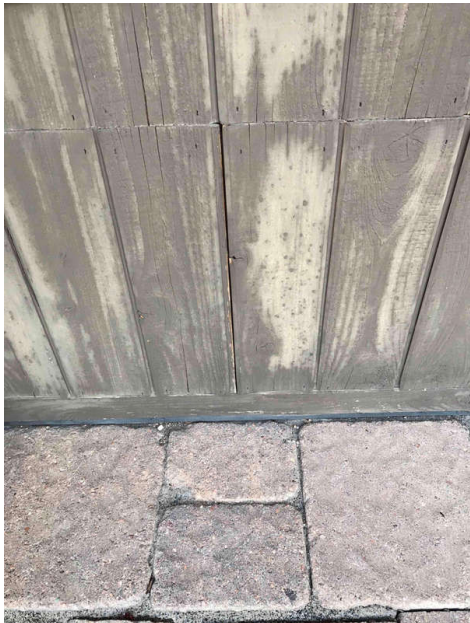
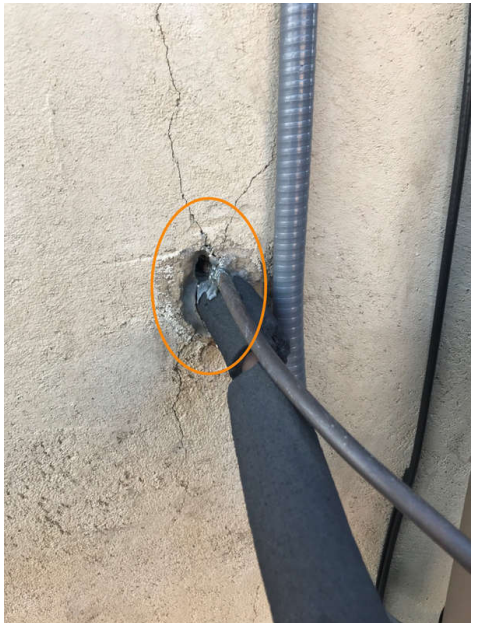
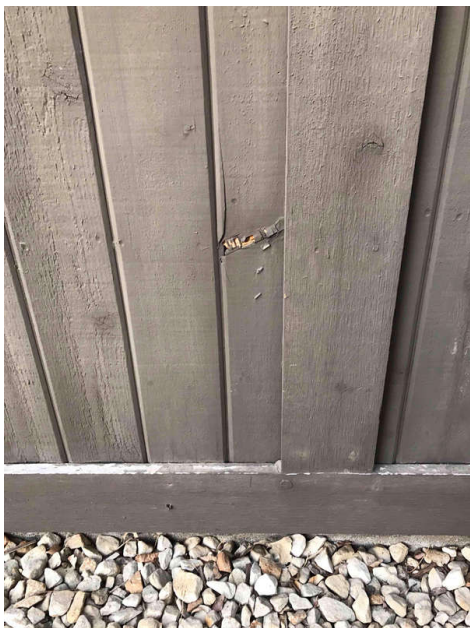
3.1.1 Siding, Flashing & Trim

SIDING/TRIM - MAINTAIN PAINT/CAULKING

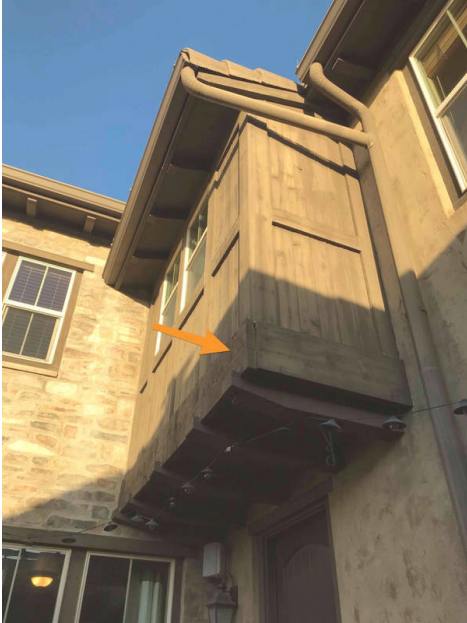
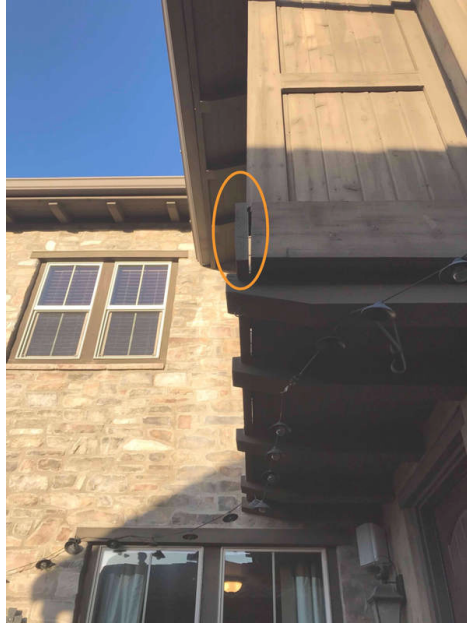
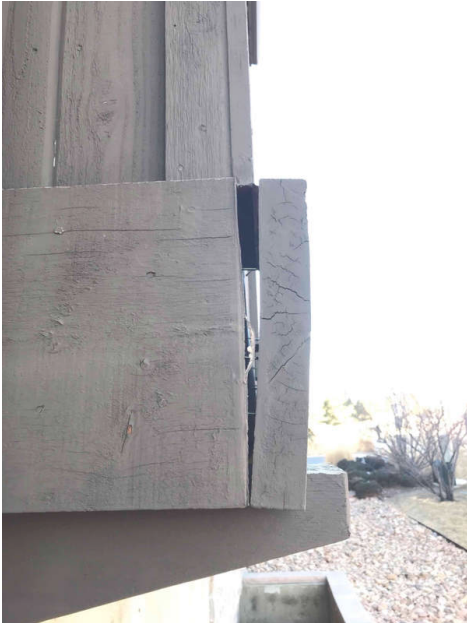
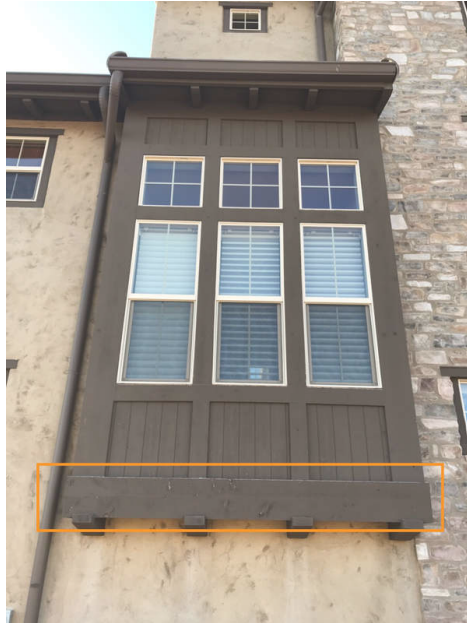
3.1.2 Siding, Flashing & Trim

SIDING/TRIM - LOOSE

SOUTH SIDE OF EXTERIOR

Siding/trim appeared to be loose in areas. I recommend having these areas evaluated and resecured/repared by a licensed siding contractor prior to closing.

Contact a qualified siding specialist.

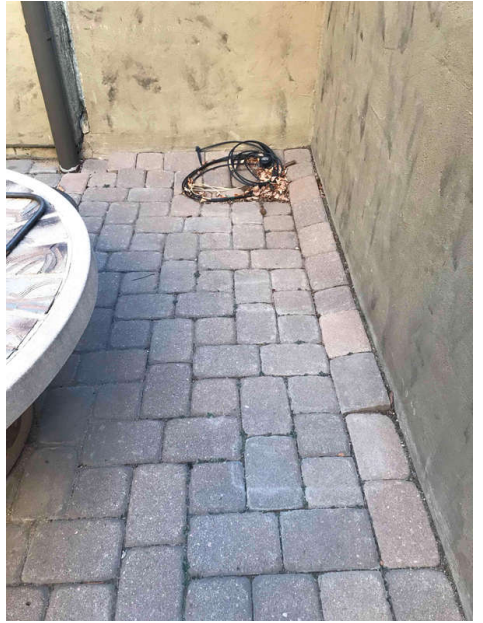
3.3.1 Sidewalks, Patios, Porches, & Driveways

PAVER PATIO - HEAVING/SETTLEMENT

Areas of the pavers appear to be heaving or settling. I recommend having this evaluated and repaired/addressed as necessary by a qualified landscaping contractor prior to closing.

Contact a qualified landscaping contractor

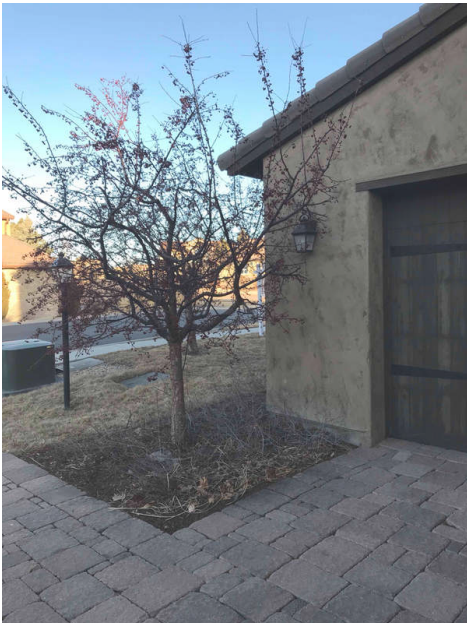
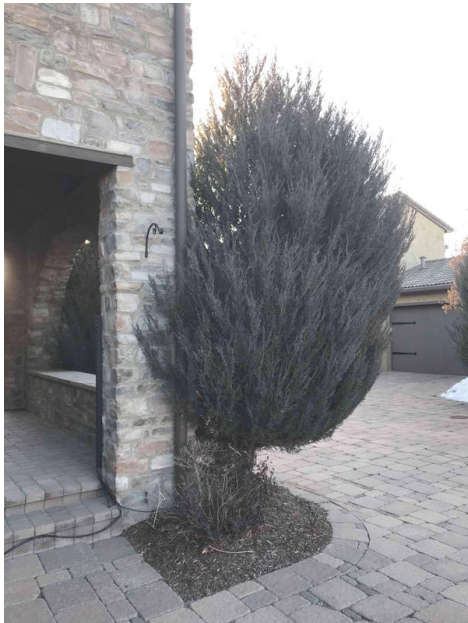
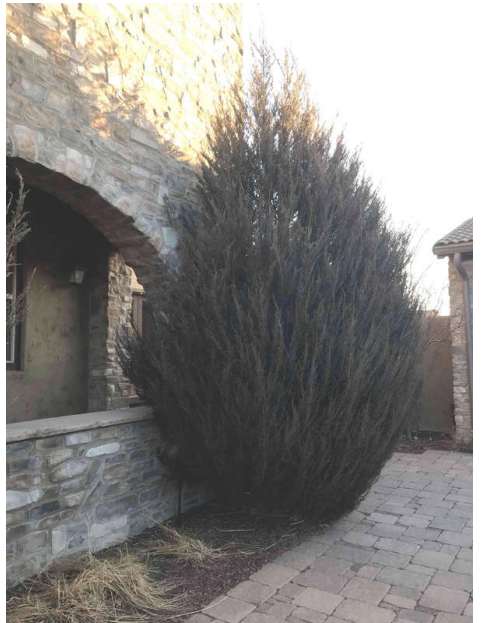
3.6.1 Vegetation, Grading, Drainage & Retaining Walls

VEGETATION - IN CLOSE CONTACT WITH HOUSE

Areas of vegetation are in close contact with the home. In order to prevent branches from chafing the siding or roof, leaves from clogging gutters, and roots from damaging the foundation, critters from having a way to get onto the roof, etc., I recommend having the vegetation evaluated and addressed as necessary.

Contact a qualified landscaping contractor

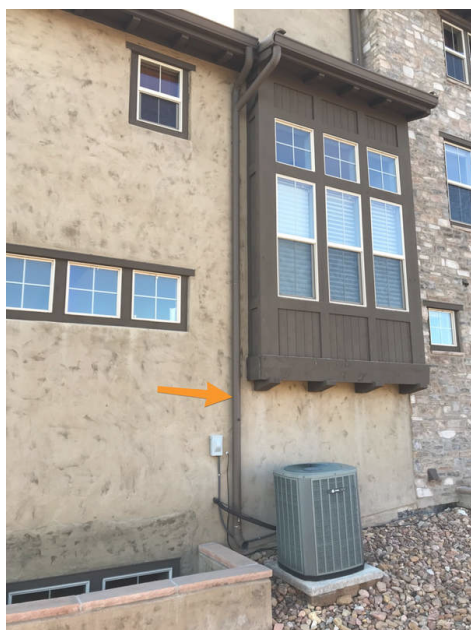
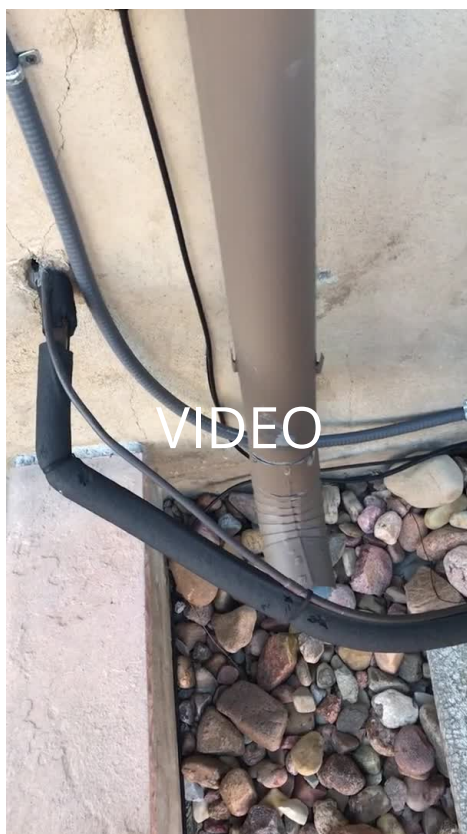
4.4.1 Gutters

GUTTER - LOOSE DOWNSPOUT

NORTH SIDE OF EXTERIOR

One or more downspouts appeared to be improperly secured. I recommend having the downspouts evaluated and properly secured.

Contact a qualified handyman.

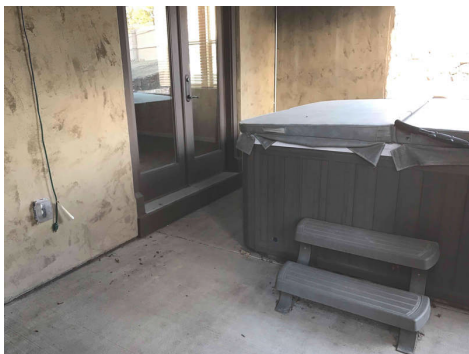
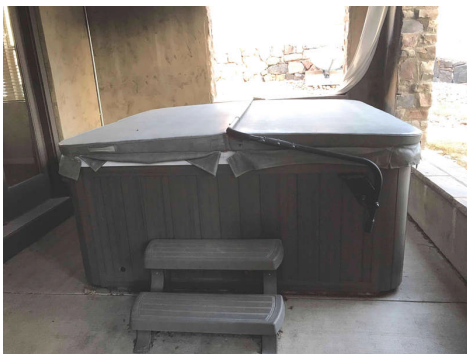
7.4.1 Branch Wiring Circuits, Breakers & Fuses

The electrical circuit for the hot tub does not appear to have been installed when the home was built, therefore a permit should have been pulled with the local Building Department. This would show that the work was done by a licensed Electrician and passed all necessary code/safety inspections by the Building Department. It is possible that the permits were pulled and just weren't available on their website, so I recommend consulting with them to confirm. In order to ensure that the work was done safely and properly, I recommend having it evaluated and that all repairs are made by a licensed electrician prior to closing, as well as having it permitted with the Building Department.

Contact a qualified professional.

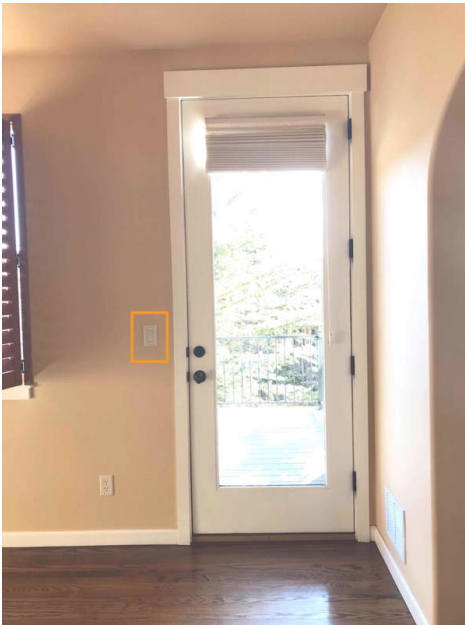
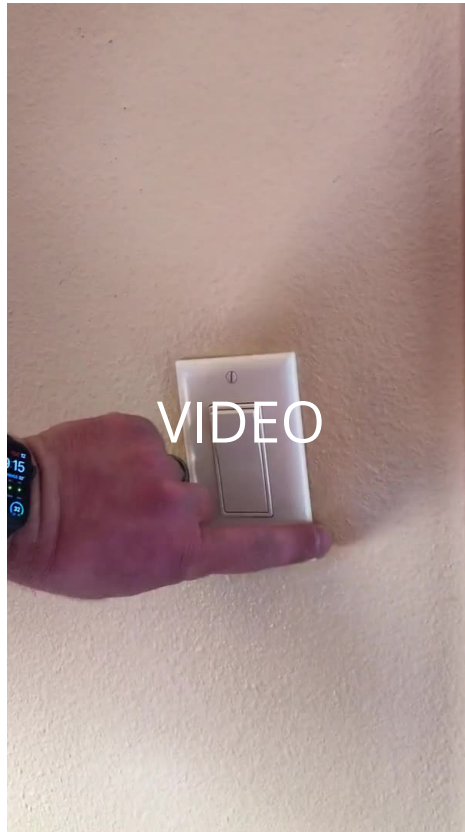
ELECTRICAL BOX - LOOSE OR IMPROPERLY INSTALLED BOX

One or more boxes that holds receptacles or light switches were loose or appeared to be improperly installed. I recommend having this evaluated and properly secured by a licensed electrician prior to closing.

Contact a qualified electrical contractor.

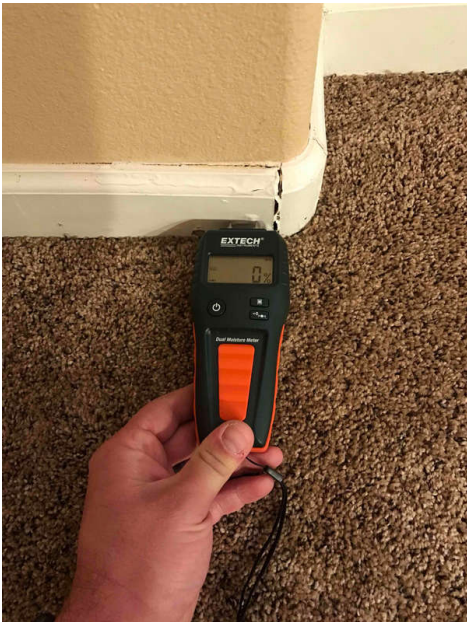
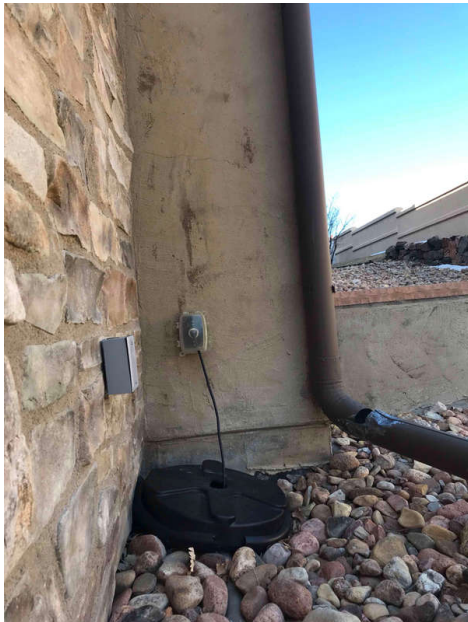
EVIDENCE OF MOISTURE INTRUSION

One or more areas of the interior walls have evidence of moisture intrusion. The area was tested with a moisture meter and did not show high levels of moisture at that time. I recommend having the area repaired and monitored, then addressed as necessary.

Contact a qualified professional.

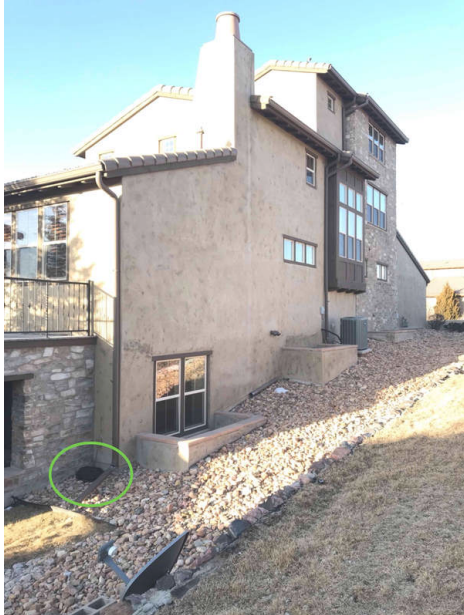
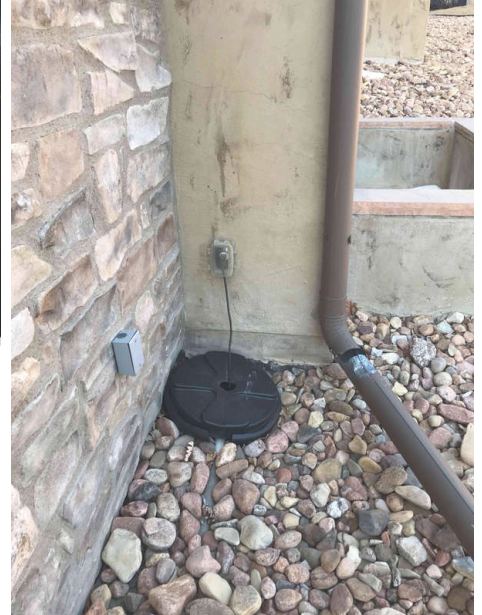
Northeast Corner of Exterior

The sump pump installation was inspected and the pump was tested to ensure function (unless limitation are listed). The discharge pipe outside the home was inspected to ensure that water is getting properly discharged away from the home. Any defects are noted below.

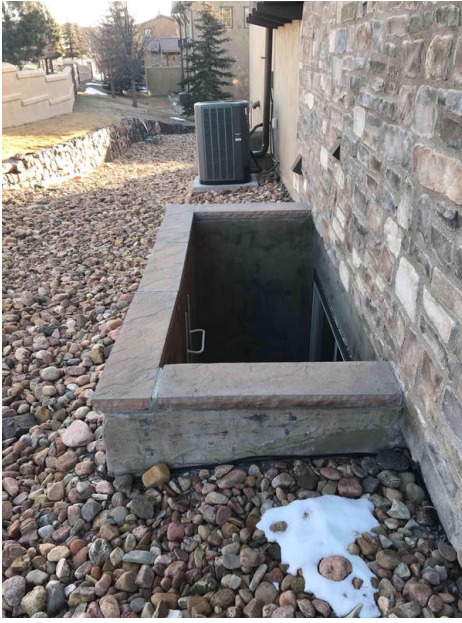
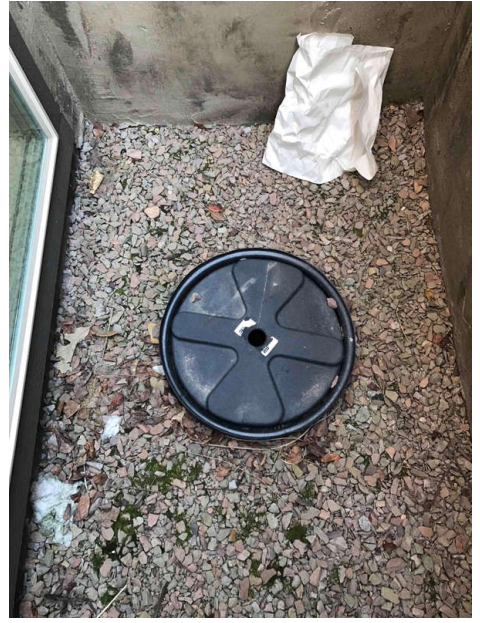
A sump pit was present but did not have a pump installed. I recommend checking the sump pit after rains. If water is ever present inside the pit, I recommend having a sump pump installed by a licensed contractor. Any defects are noted below.

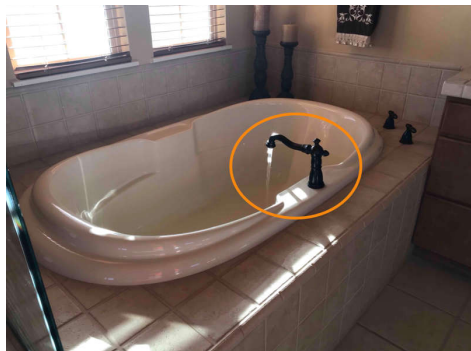
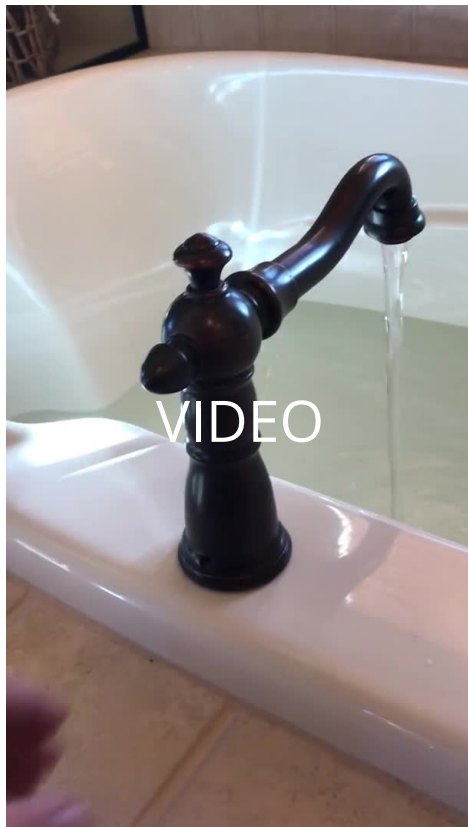
FAUCET - LOOSE

One or more faucets were not tightly secured to the counter top/sink. I recommend having the fixture properly secured by a qualified contractor prior to closing.

Contact a qualified professional.

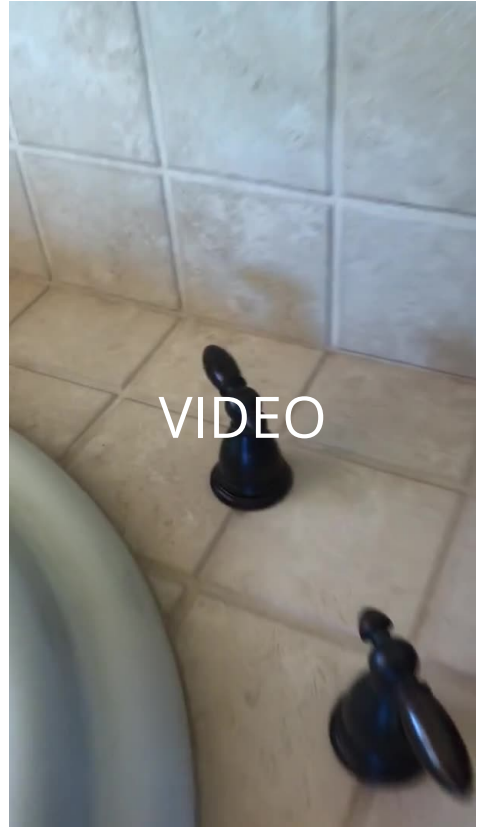
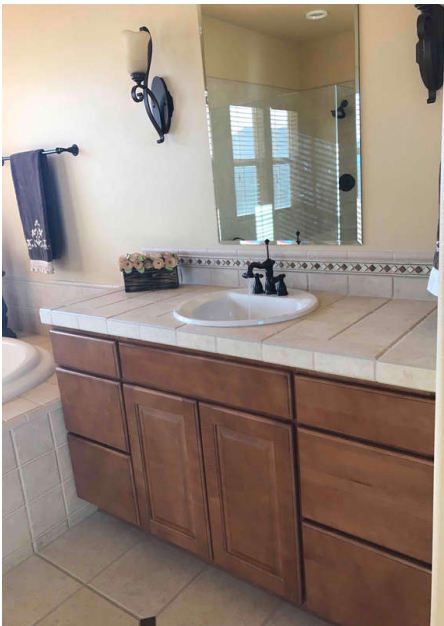
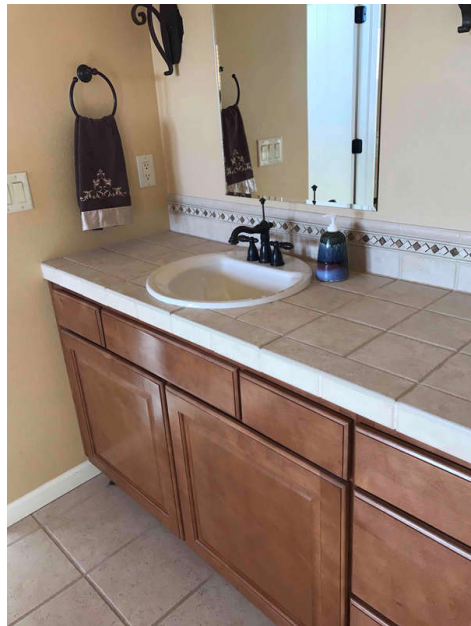
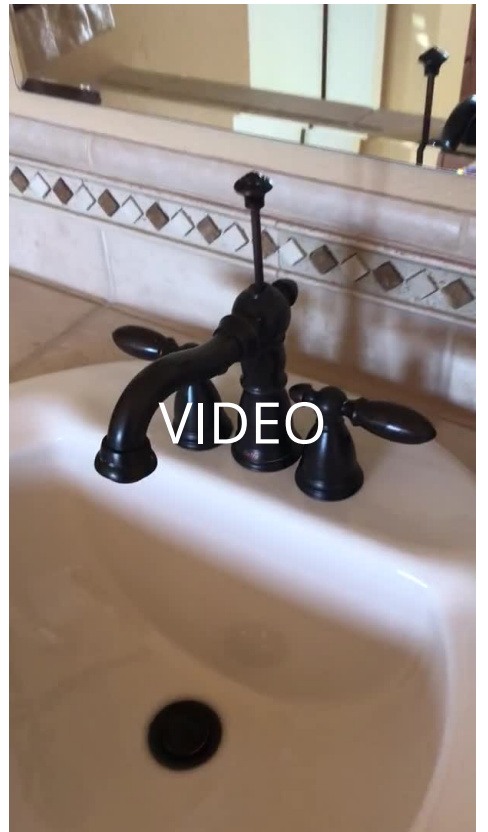
One or more faucets appeared to be in need of repair. The handles were not properly secured to the valve stems. I recommend having these evaluated and secured by a qualified contractor prior to closing.

Contact a qualified plumbing contractor.

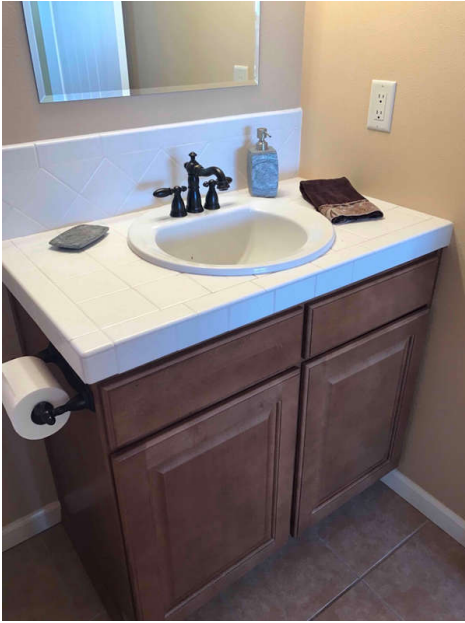
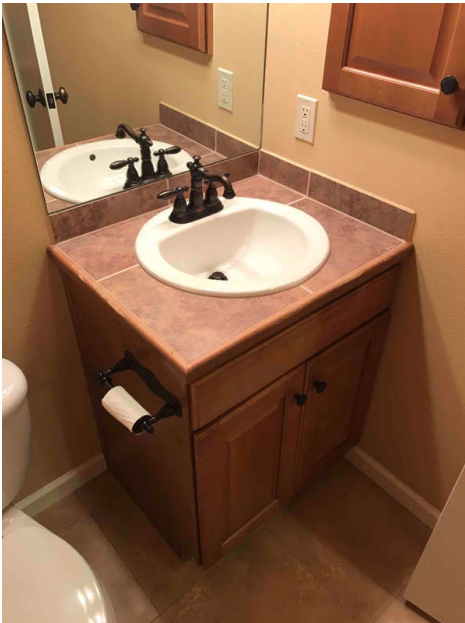
9.5.2 Fixtures

FAUCET - HANDLES NOT SECURED

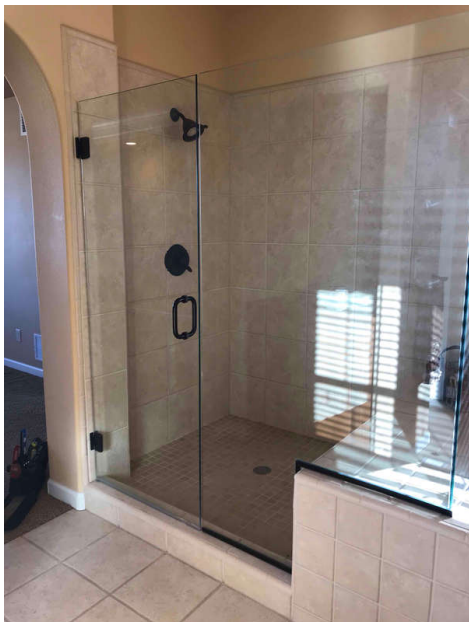
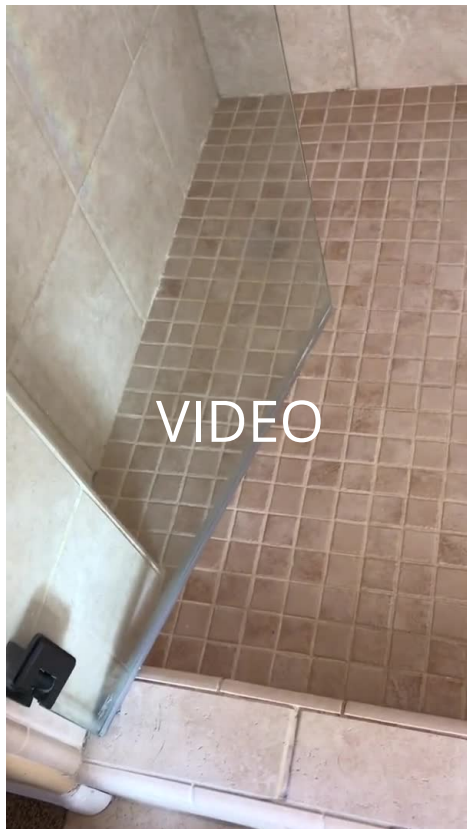
9.5.3 Fixtures

SHOWER DOOR - DOESN'T OPEN/CLOSE PROPERLY

The tub/shower door does not open/close properly. It comes into contact with the curb. I recommend having it evaluated and adjusted/repared as necessary by a licensed contractor prior to closing.

Contact a qualified professional.

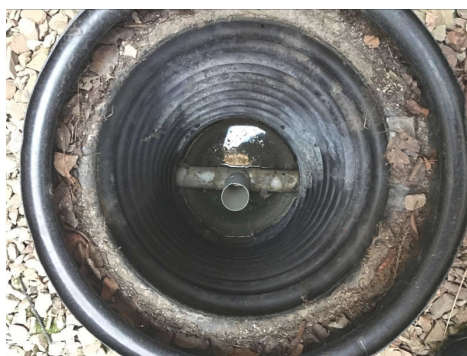
9.6.1 Sump Pump

NO SUMP PUMP - WATER PRESENT

Water was observed in the sump pump pit but a pump was not installed. I recommend having this evaluated and a pump installed as necessary by a licensed and qualified plumber prior to closing.

Contact a qualified plumbing contractor.

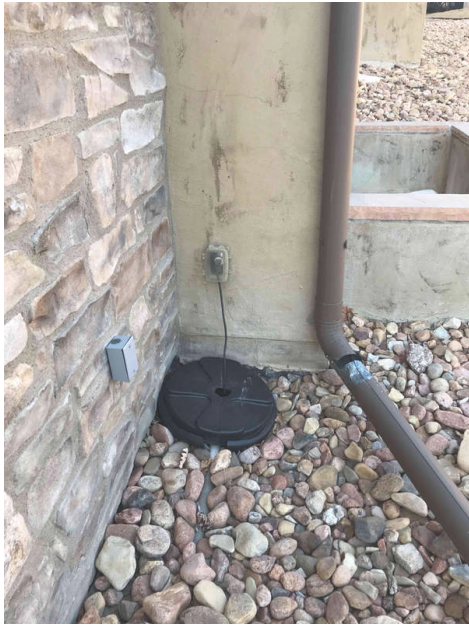
Water was present in the sump pit. The water level appeared to be high enough that the pump should have turned on, removing the water from the pit. This may be an indication that the pump is not operational. I recommend having this evaluated and repaired/replaced as necessary by a licensed plumber prior to closing.

Contact a qualified plumbing contractor.

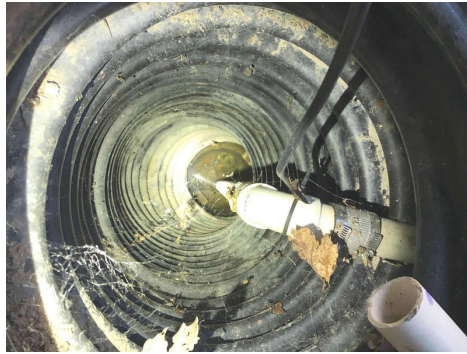
9.6.2 Sump Pump

SUMP PUMP - WATER PRESENT

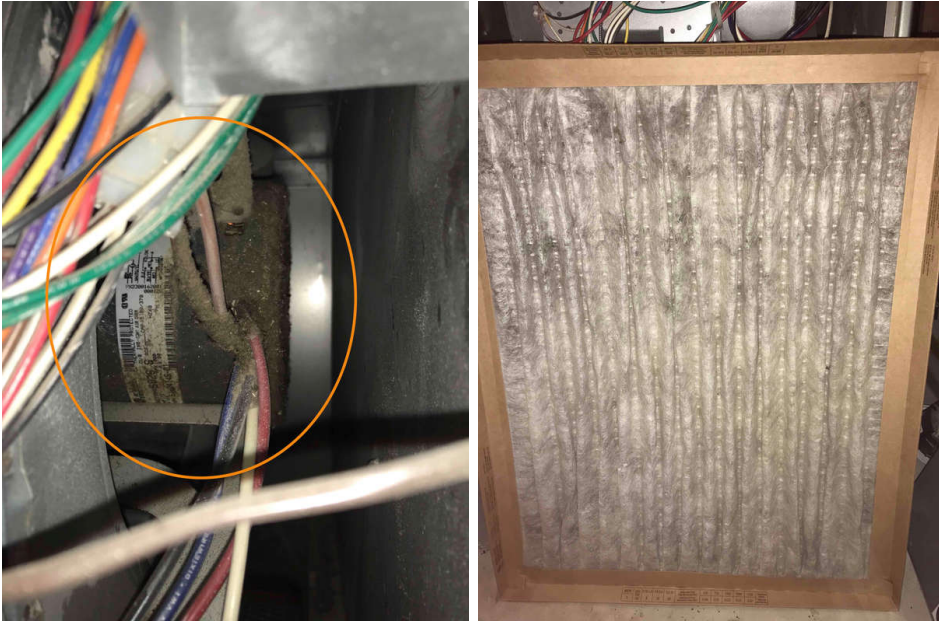
The furnace appeared to be in good overall condition, however I recommend having it cleaned and serviced prior to closing, followed by annually.

Contact a qualified HVAC professional.

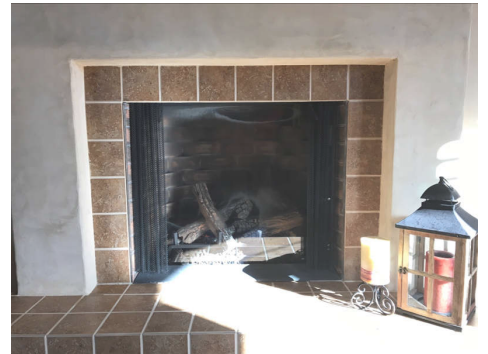
The gas fireplace appeared to be dirty. I recommend having it cleaned and serviced by a qualified fireplace contractor prior to closing, followed by annually.

Contact a qualified fireplace contractor.

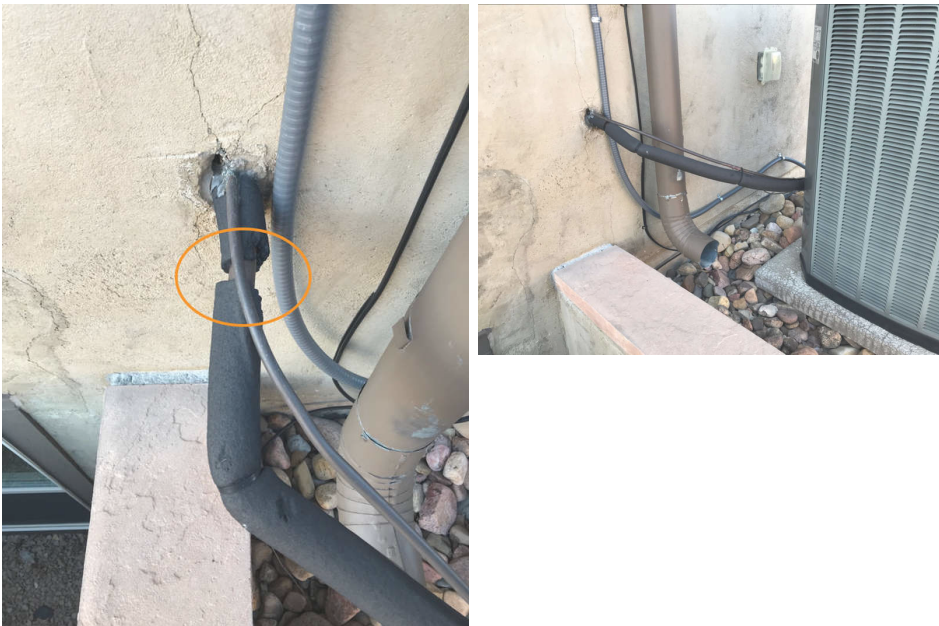
13.1.1 Air Conditioning

**AIR CONDITIONING - LINESET INSULATION DAMAGED**

The insulation on the suction line for the air conditioning appeared to be in need of repair. Insulating the suction line (larger pipe) is done for two reasons. First, it prevents condensation forming on the pipe. Condensation could drip from the pipe and cause moisture damage to the home. Also, the suction and liquid lines should not touch or come in contact with one another. The warm liquid line would transfer heat to the cooler suction line. The warmer the refrigerant is, the harder the compressor and condenser have to work. Minimizing the temperature of the refrigerant in the suction line, helps the condensing unit work more effectively. I recommend having this evaluated and repaired/replaced as necessary by a licensed and qualified HVAC technician prior to closing.

Contact a qualified HVAC professional.

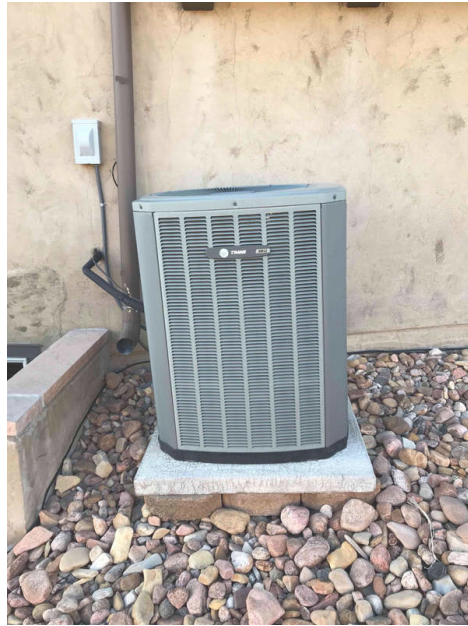
13.1.3 Air Conditioning

The concrete pad that supports the condenser does not appear to be level. This can cause the unit to need additional servicing or repairs. I recommend having an HVAC technician level the pad in order to ensure proper function of the unit.

Contact a qualified HVAC professional.
