## RESIDENTIAL HOME INSPECTION REPORT

1234 Main St.  
Merrimack NH 03054

11/13/2018 9:00AM

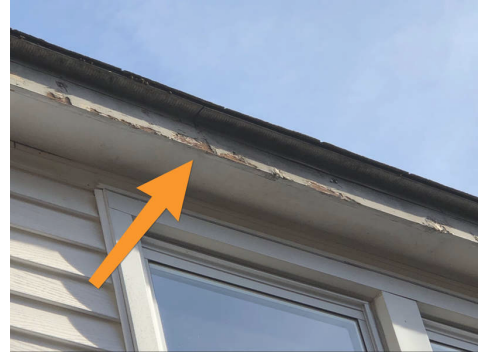
Rear

Recommendation / Improvement**FASCIA - DAMAGED**

One or more sections of the fascia are damaged. Recommend qualified roofer evaluate & repair.

Contact a qualified roofing professional.

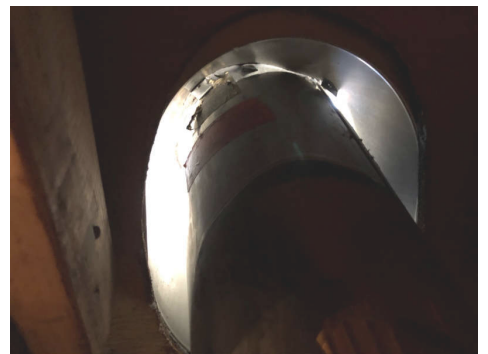
Recommendation / Improvement**VENT FLASHING (IMPROPER)**

One or more vent penetrations were incorrectly flashing at the time of the inspection. This condition increases the chance of roof leakage at these areas. The Inspector recommends correction by a qualified contractor.

Furnace vent needs exterior flashing

Contact a qualified roofing professional.

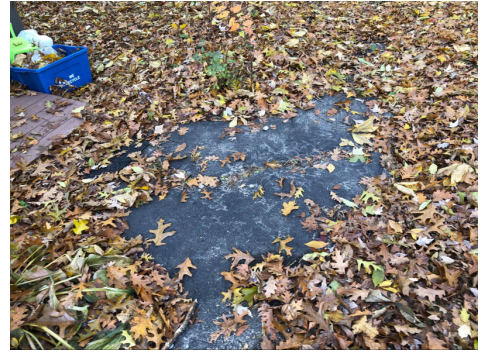
#### **WALKWAY CRACKING - MINOR**

Minor cosmetic cracks observed. Recommend monitor and/or patch/seal.

Recommended DIY Project

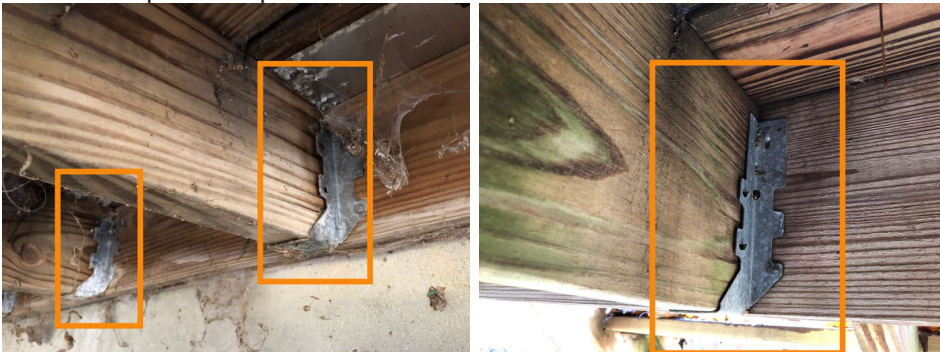
#### CONNECTORS (UNFILLED HOLES)

Most of the metal connectors used in deck framing had unfilled holes. To perform as designed, metal connectors should have all holes filled with the fasteners specified by the hardware manufacturer. The Inspector recommends correction by a qualified contractor.

Contact a qualified professional.

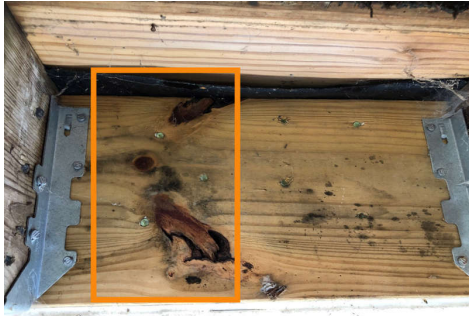
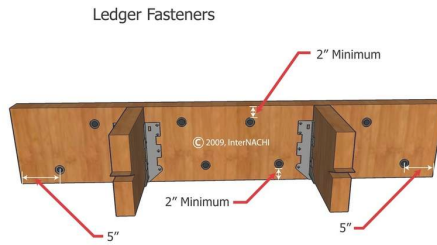
#### LEDGER BOARD - NAILED ON, NO SCREWS OR BOLTS

Ledger boards for one or more decks, balconies or porches appeared to be attached with nails only. This method of attachment is substandard and may result in such structures separating from the main building. This is a potential safety hazard. Modern standards call for ledger boards to be installed with 1/2 inch lag screws or bolts into solid backing, and brackets such as [Simpson Strong Tie DTT2 brackets and threaded rod](#), connecting interior and exterior joists. Recommend that a qualified contractor repair per standard building practices. For more information, visit:

Would prefer to see thru bolts or lag screws

Contact a qualified deck contractor.

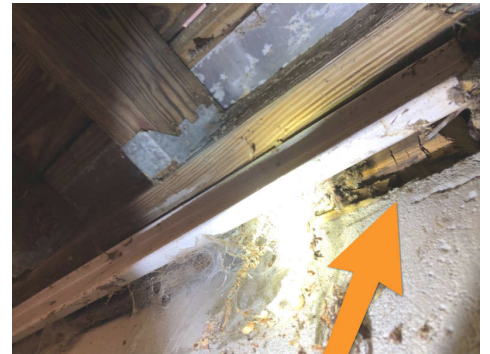
Observed sections of the ledger board under the deck (back corner of house) to be rotting. Recommend qualified contractor repair/replace.

Contact a qualified professional.

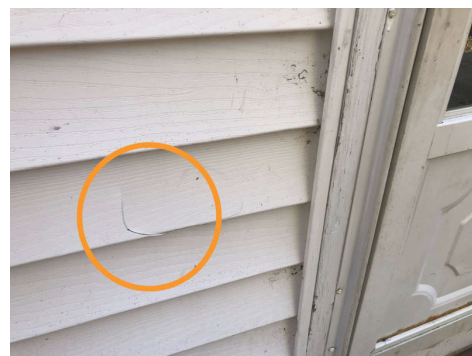
#### **MINOR DAMAGE**

Siding has some typical minor damage. Recommend repair/replace as needed.

Crack

Contact a qualified siding specialist.

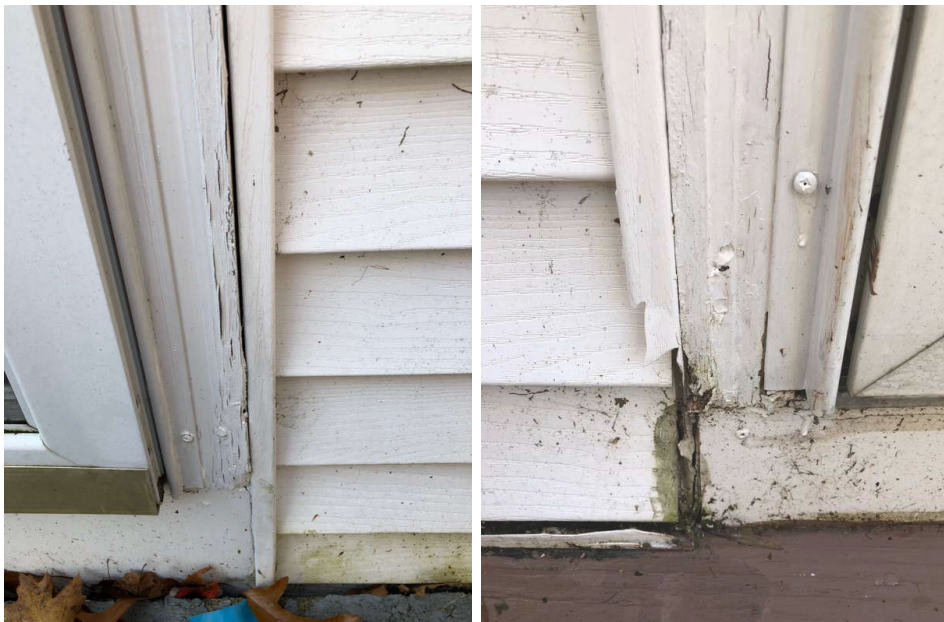
Front Door

Door sill and/or trim is loose, deteriorated or worn and repair or replacement should be considered.

Contact a qualified door repair/installation contractor.

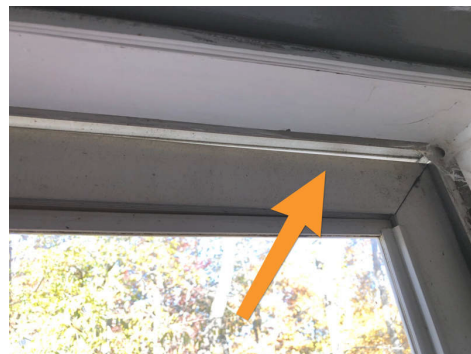
Door is missing standard weatherstripping. This can result in significant energy loss and moisture intrusion. Recommend installation of standard weatherstripping.

Contact a qualified door repair/installation contractor.

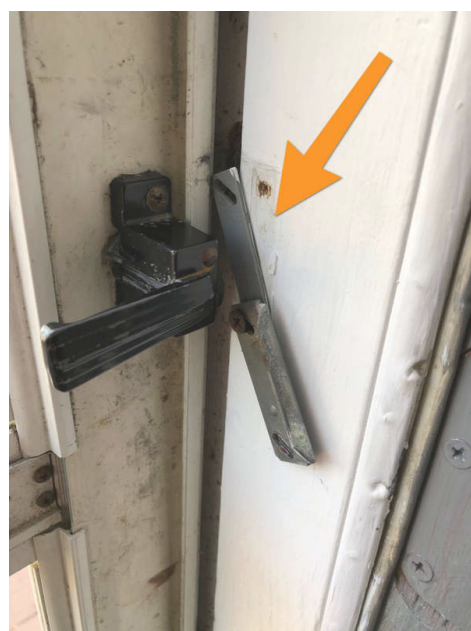
**SCREEN DOOR DAMAGE**

Screen door was observed to have damage which was partially repaired. Recommend repair or replacement as needed

Contact a qualified door repair/installation contractor.

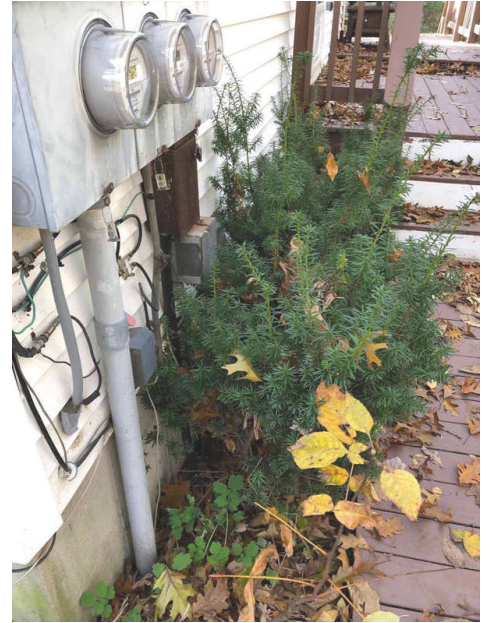
Electrical meter and main electrical disconnect or obstructed by vegetation recommend removal of vegetation for proper access to electrical equipment.

Contact a qualified landscaping contractor

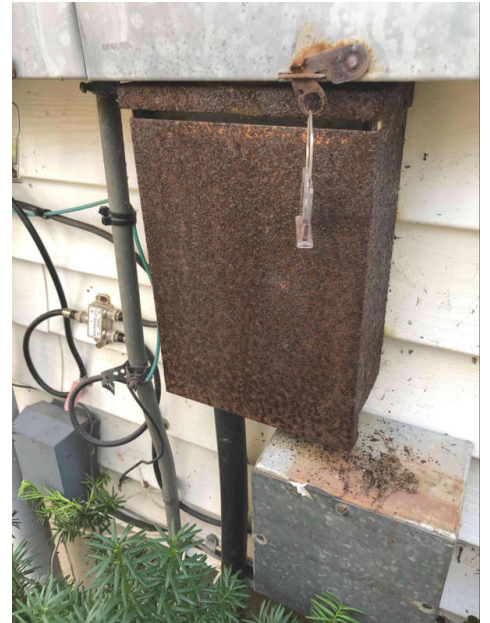
### RUSTED ENCLOSURE

Observed exterior electrical box to be rusted inside and out. There where no clear signs as to why this is at the time of inspection. Recommend licensed electrician evaluate further

Contact a qualified professional.

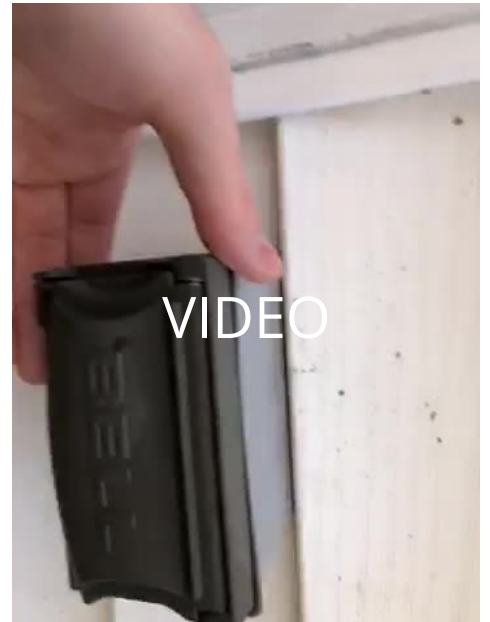
### WEATHERPROOF COVER LOOSE

One or more exterior receptacles are missing a weatherproof cover. This causes short and shock risk. Recommend installation of proper covers.

Contact a qualified electrical contractor.

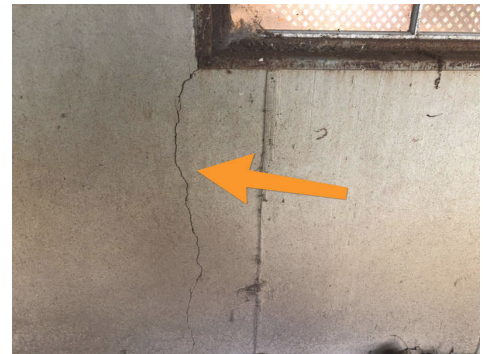
**TYPICAL CRACKING**

Exterior foundation contains typical cracks due to shrinkage and normal freeze thaw cycle. Recommend patching as needed to prevent moisture intrusion.

Contact a foundation contractor.

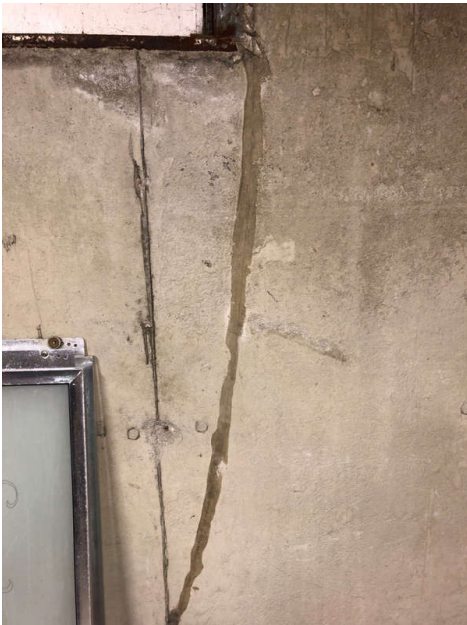
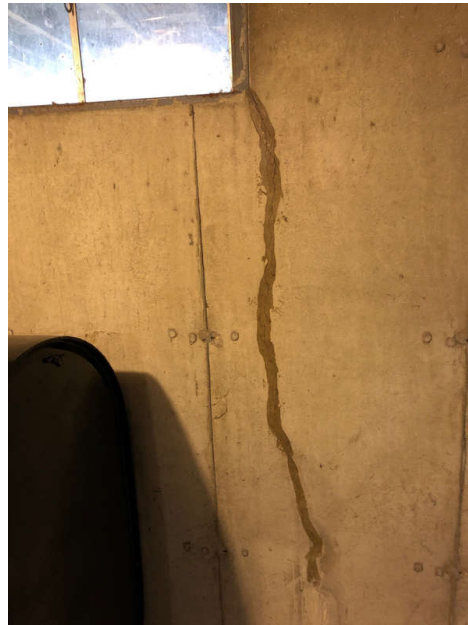
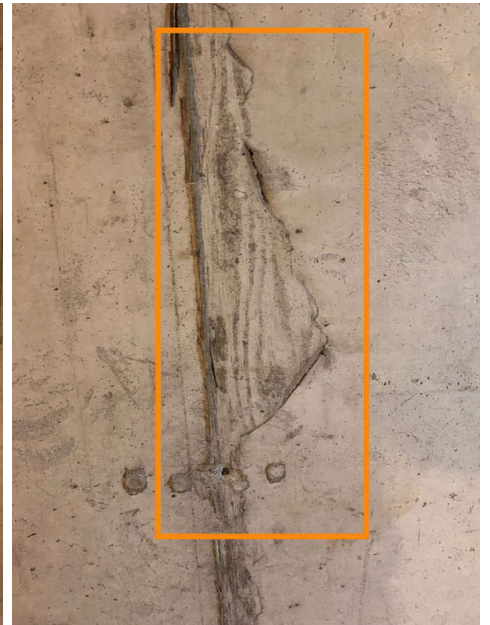
**FOUNDATION CRACKS - MINOR**

Minor cracking was noted at the foundation. This is common as concrete ages and shrinkage surface cracks are normal. Recommend monitoring for more serious shifting/displacement.

Contact a foundation contractor.

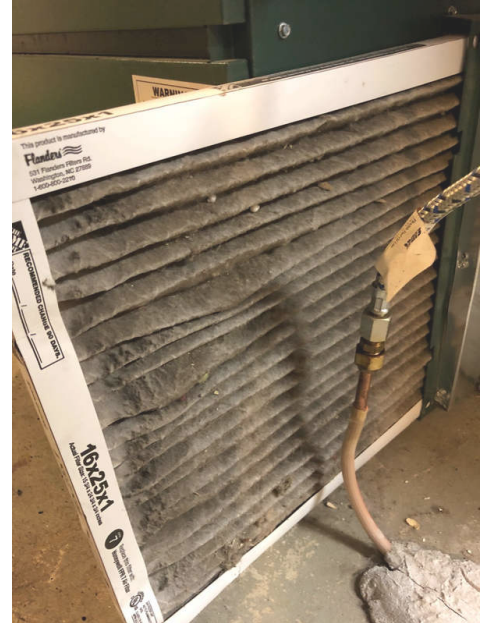
The furnace filter is dirty and should to be replaced every 3-6 months.

Contact a qualified HVAC professional.

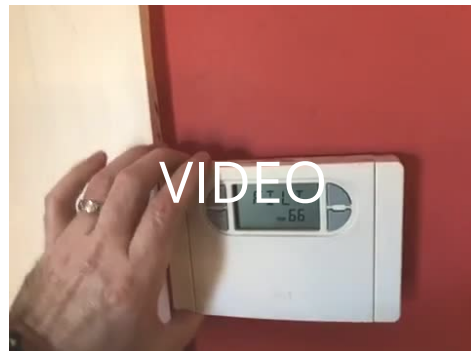
#### **LOOSE THERMOSTAT**

Thermostat was loose on the wall. Recommend repair or replacement.

Contact a qualified HVAC professional.

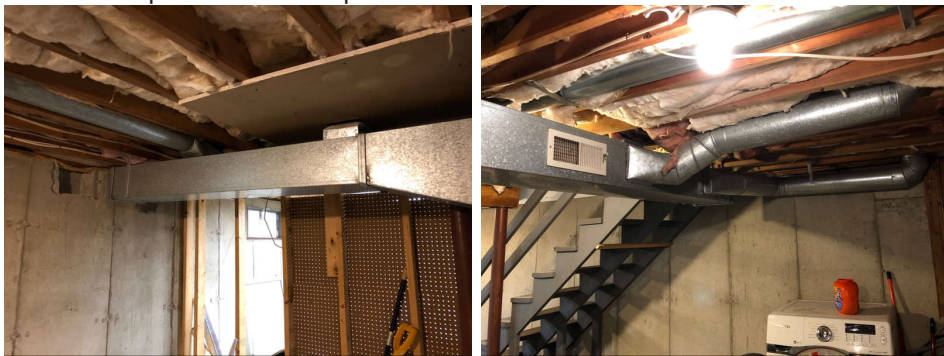
**DUCT INSULATION MISSING**

One or more heating and/or cooling ducts in an unconditioned space (e.g. crawl space, attic or basement) were not insulated. This can result in reduced energy efficiency, moisture inside heating ducts, and/or "sweating" on cooling ducts. Recommend that a qualified person evaluate per standard building practices. For example, by wrapping ducts in insulation with an R-value of R-8.

Contact a qualified HVAC professional.

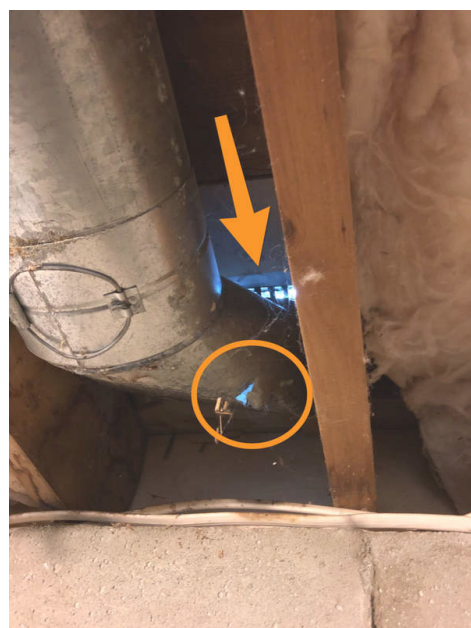
**DUCT DAMAGED**

Air supply duct was damaged and not properly attached to the register above. This is causing the heat to enter the basement and not the room above. Recommend a qualified HVAC contractor repair.

This is for the dining room near slider

Contact a qualified HVAC professional.

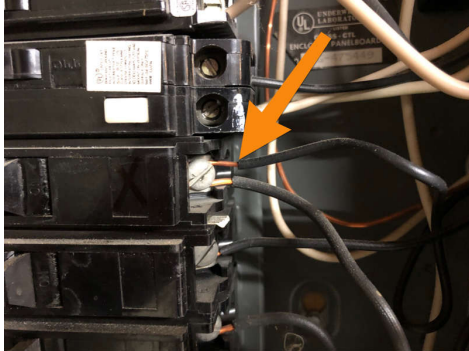
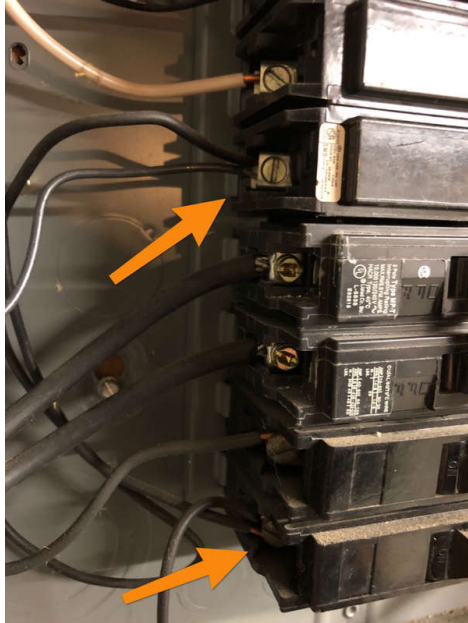
Double taps at the electrical panel should be repaired by a licensed electrician.

Contact a qualified professional.

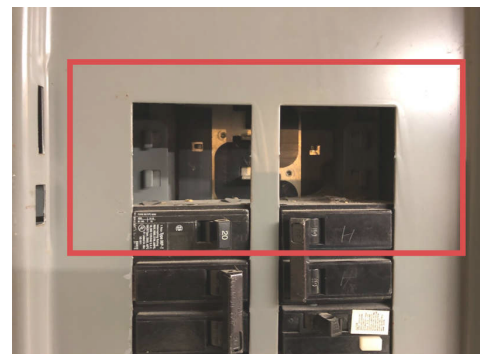
#### KNOCKOUTS MISSING

"Knockouts" are missing on the electric panel. This poses a safety hazard and it is recommended that the opening in the panel caused by the missing knockout(s) be properly sealed by a licensed electrician.

Contact a qualified electrical contractor.

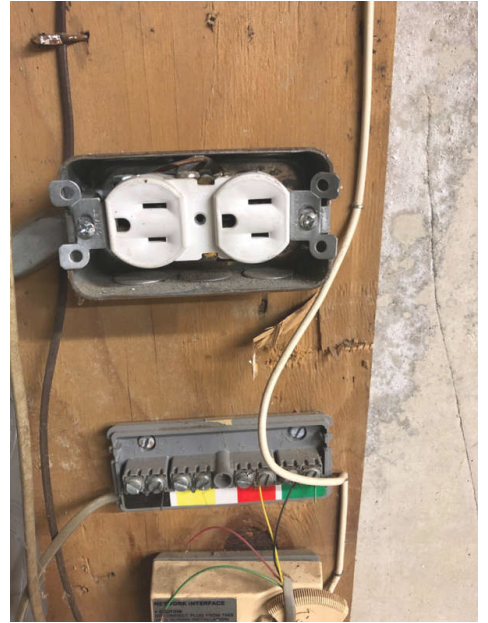
#### COVER PLATES MISSING

One or more receptacles are missing a cover plate. This causes short and shock risk. Recommend installation of plates.

Contact a qualified electrical contractor.

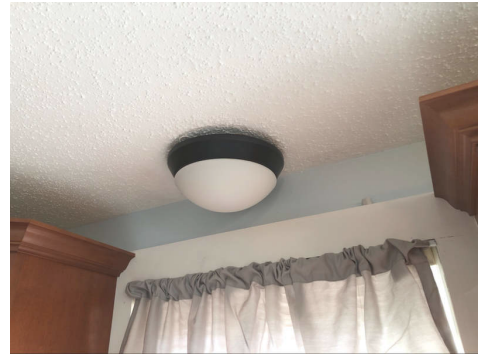
Kitchen sink light (also loose)

Contact a qualified electrical contractor.

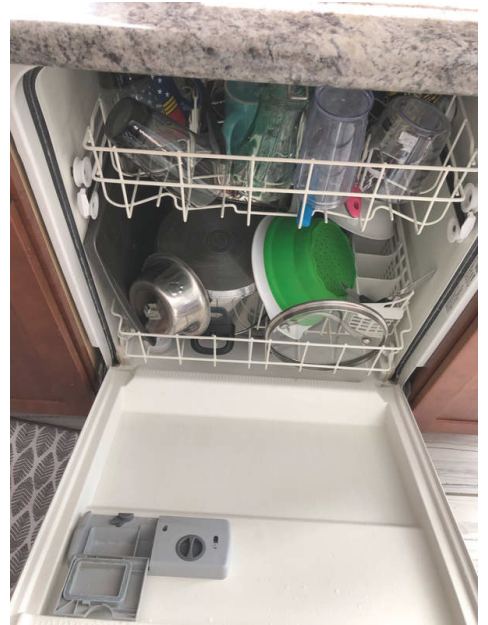
DW not attached to cabinets
