L&L Home Inspections, LLC

HOME INSPECTION REPORT

1234 Main St.
Lansdale Pennsylvania 19446

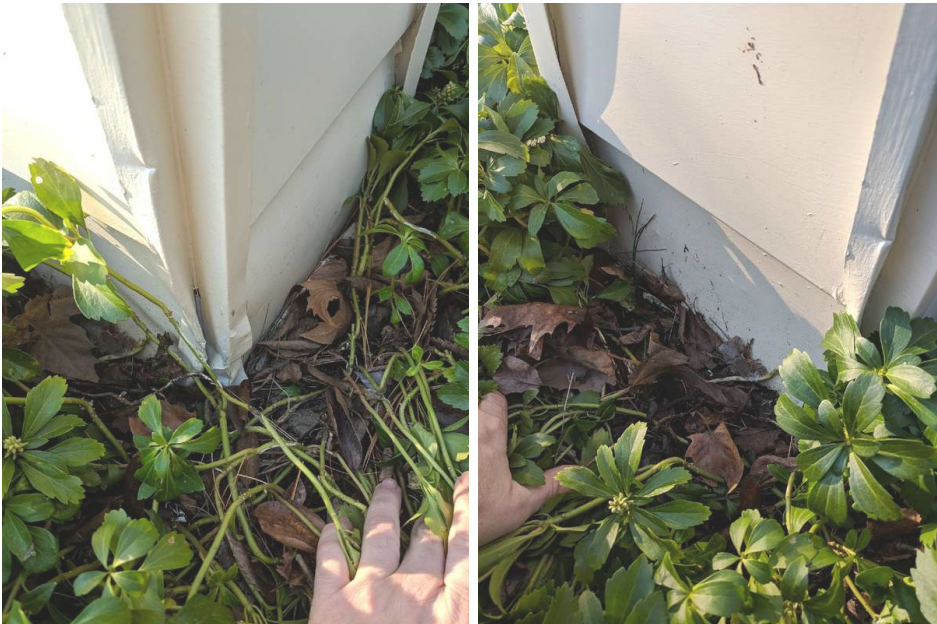
SIDING TO GRADE CLEARANCE

The siding is installed at or below grade. This allows a condition conducive to wood destroying organisms. We generally recommend a gap of 2" to prevent moisture from wicking up behind the siding into the framing.

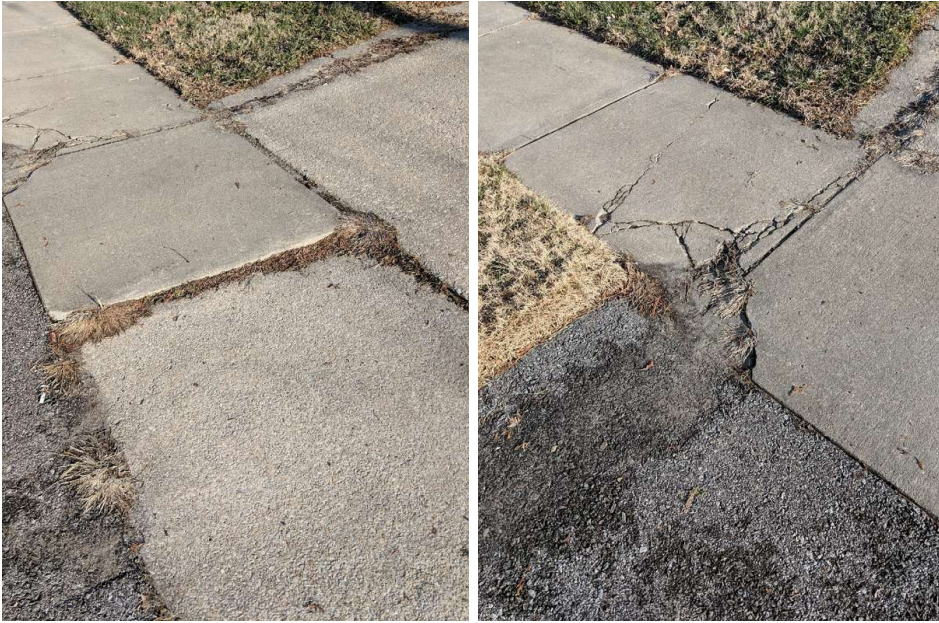
2.2.1 Driveway, Walkway, Patio

TRIP HAZARD-SIDEWALK

Cracks, holes, settlement, heaving and/or deterioration resulting in trip hazards were found in the sidewalks or patios. For safety reasons, recommend that a qualified contractor repair as necessary to eliminate trip hazards.

Contact a qualified professional.

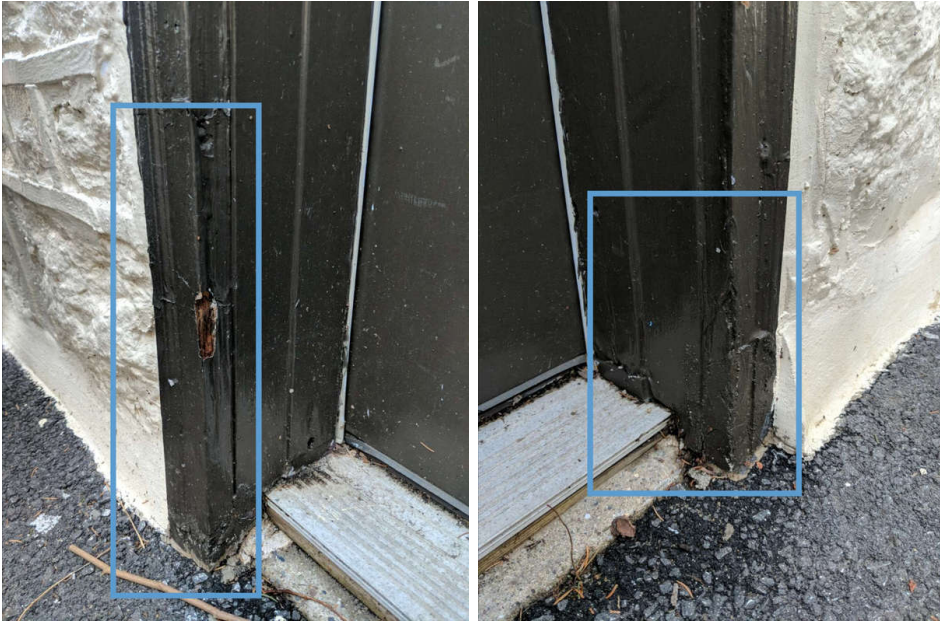
TRIM ROTTED/DAMAGED

The trim at the base of the door frames damaged. This is a typical area of concern. This area should be sealed on all sides to prevent water wicking and further deterioration. The damaged wood should be repaired or replaced

Contact a qualified professional.

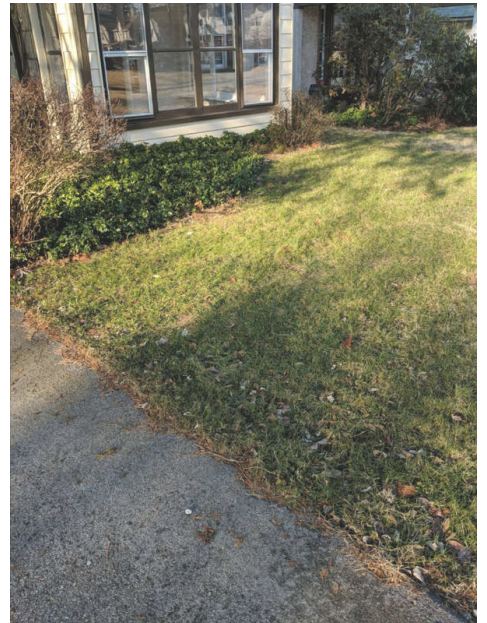
2.8.1 Vegetation and Grading

Surfaces sloped down towards building perimeters in one or more areas. This may result in water accumulating around building foundations or underneath buildings. Monitor these areas in the future, especially during and after periods of rain. If significant amounts of water are found to accumulate, then recommend that a qualified contractor evaluate and repair as necessary. For example, by installing drain(s) or removing old pavement and installing new.

Contact a qualified professional.

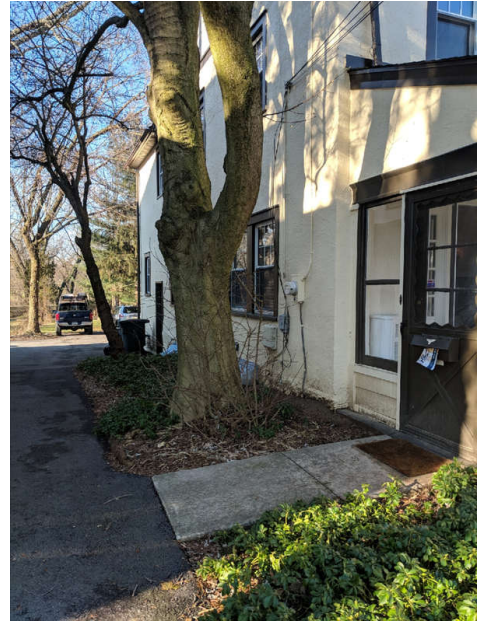
2.8.2 Vegetation and Grading

TREE NEAR FOUNDATION

One or more large trees were very close to the foundation. Tree roots can cause significant structural damage to foundations. Recommend that a qualified tree service contractor or certified arborist remove trees as necessary to prevent damage to foundations.

Contact a qualified tree service company.

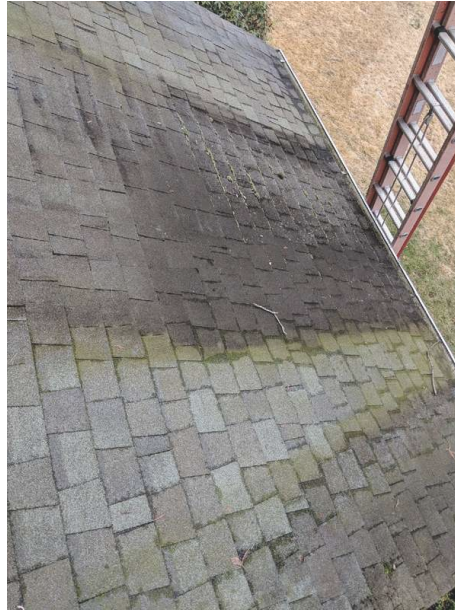
Shingles: Age of shingles

10-15 years

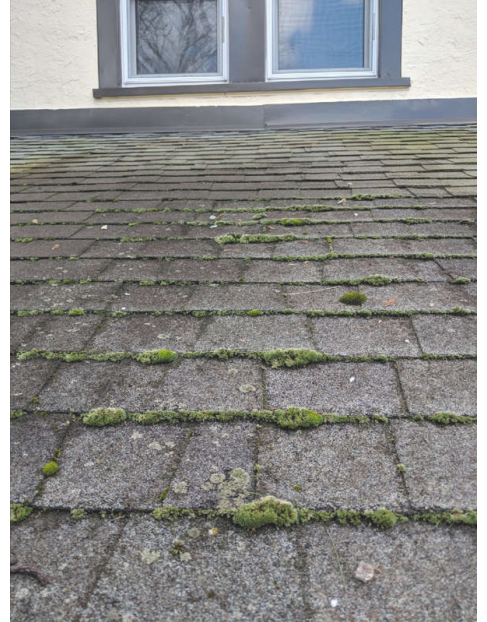
Moss was growing on the roof. As a result, shingles can lift or be damaged. Leaks can result and/or the roof surface can fail prematurely. Efforts should be made to kill the moss during its growing season (wet months). Typically, zinc or phosphate-based chemicals are used for this and must be applied periodically.

Contact a qualified professional.

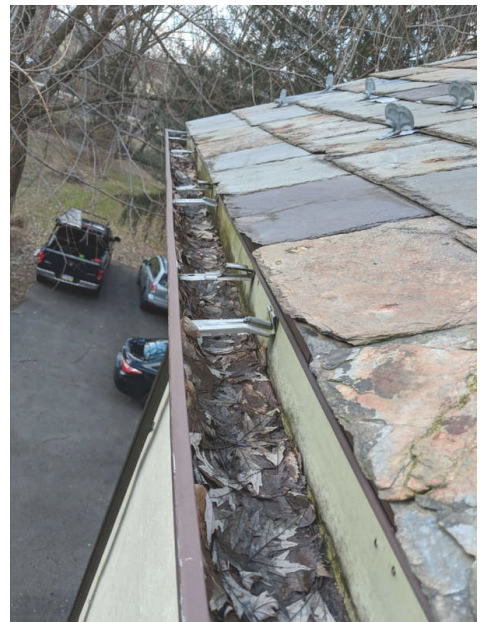
3.5.1 Gutters/drains

Significant amounts of debris have accumulated in one or more gutters or downspouts. Gutters can overflow and cause water to come in contact with the building exterior, or water can accumulate around the foundation. This is a conducive condition for wood-destroying organisms. Recommend cleaning gutters and downspouts now and as necessary in the future.

Recommended DIY Project

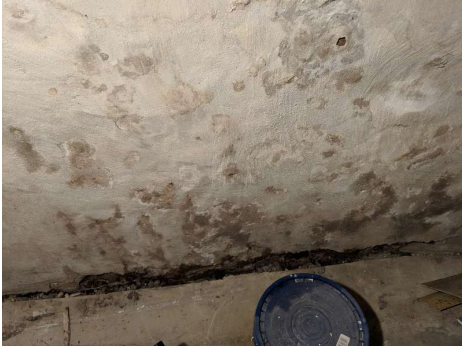
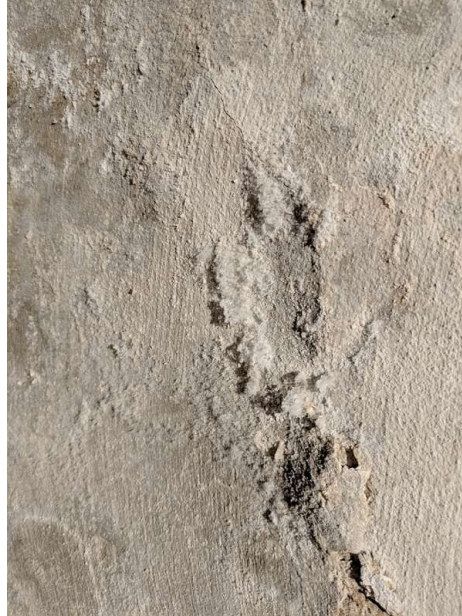
Foundation: Efflorescence

The white powder on the basement walls is known as 'efflorescence' and is a result of moisture passing through and evaporating on the surface of the concrete. This causes no harm but indicates excessive moisture on the soil side of the walls.

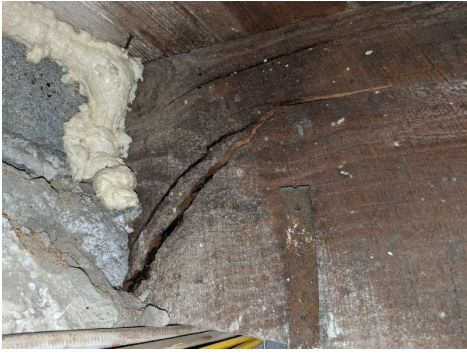
One or more floor joists were damaged or improperly installed. This can cause damage to the structural integrity of the home. Recommend a qualified structural engineer evaluate and advise on how to correct.

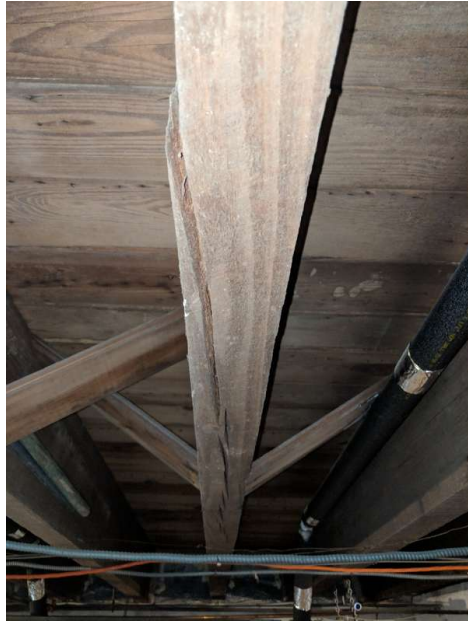
JOISTS NEED REPAIR

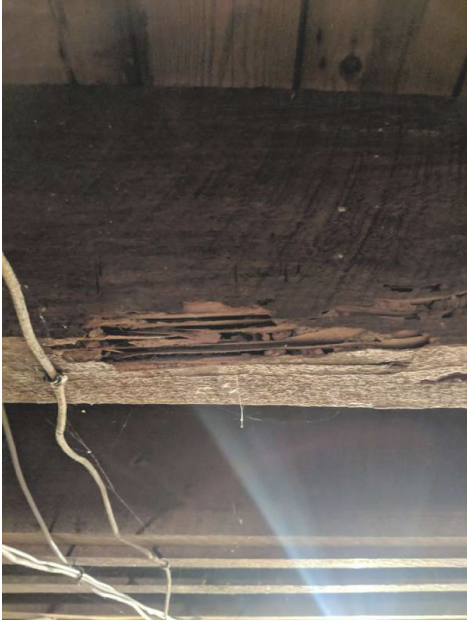
5.3.2 Floor Structure

WDI DAMAGE

Wood destroying insects damage was noted. We recommend an invasive Inspection to determine the extent of damage. A qualified contractor should further evaluate and make necessary repairs

Contact a qualified professional.

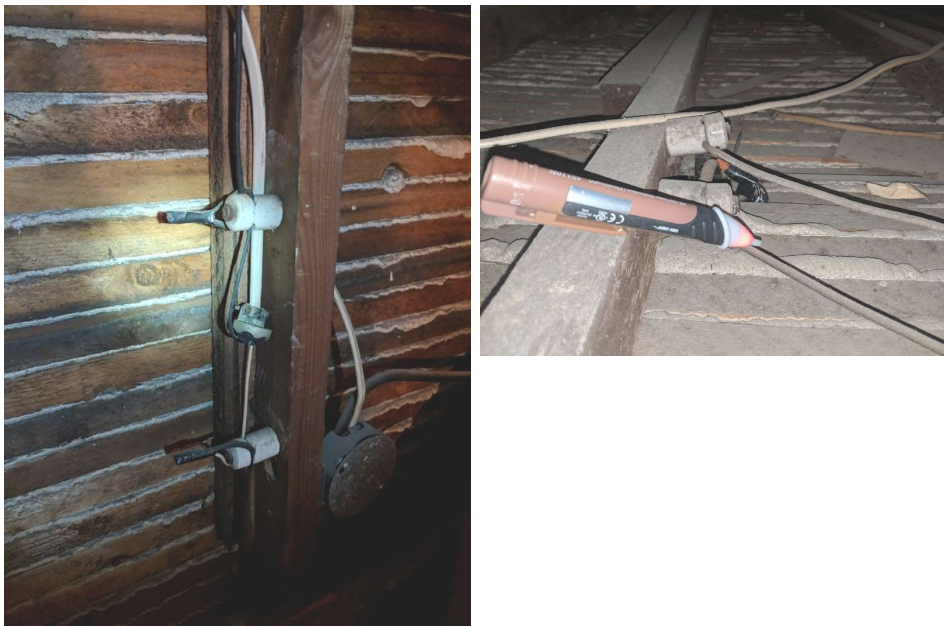
6.2.1 Branch Wiring

This property has "knob and tube" wiring, which was commonly installed prior to 1950. It is ungrounded, and considered unsafe by today's standards. Over time, the wire's insulation may become brittle and fall apart or wear thin, resulting in exposed conductors and a risk of shock and/or fire. This wiring is also easily damaged by covering it with insulation (a common practice), and incorrectly tapping new wiring into it.

Some energized knob and tube wiring was found during the inspection. It is not within the scope of this inspection to determine what percentage of this property's wiring is of the knob and tube type, or to determine what percentage of the knob and tube wiring is energized vs. abandoned. A qualified electrician should evaluate this wiring and make repairs or replace wiring as necessary.

Contact a qualified electrical contractor.

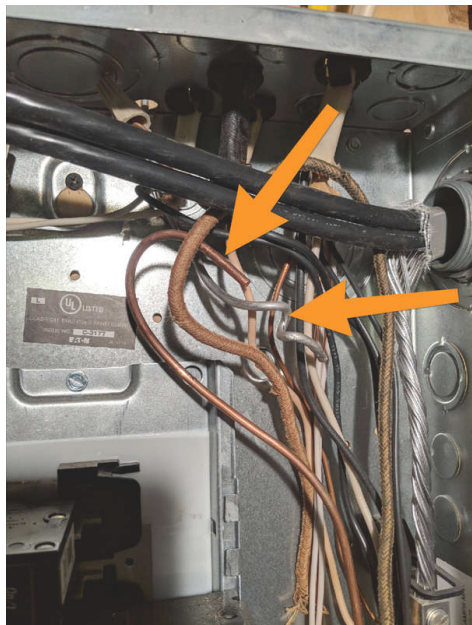
6.3.1 Circuit Breakers

The system ground has been disconnected inside the electrical panel. We recommend repair by a licensed electrician

Contact a qualified electrical contractor.

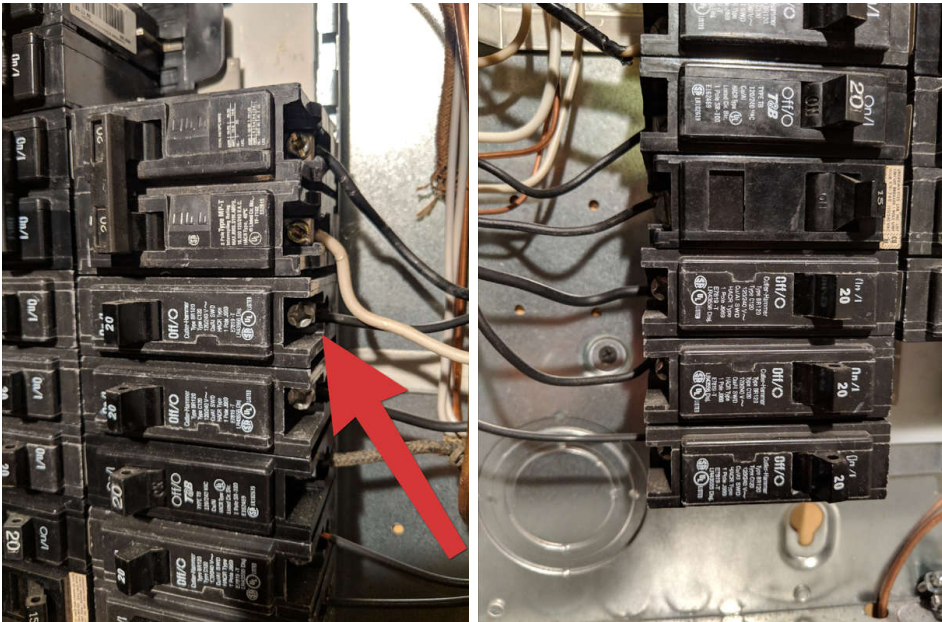
6.3.2 Circuit Breakers

We found over-fusing in the main service panel, meaning the fuse or breaker is not rated for the connected wire. This is a potential fire hazard. We recommend the circuit be equipped with an properly rated overcurrent protection device.

Contact a qualified professional.

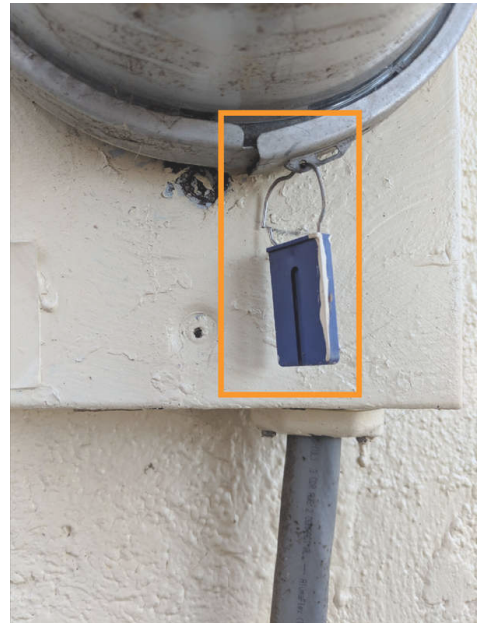
6.4.1 Meter

SEAL MISSING/BROKEN

The seal for the metal ring securing the electric meter to its base is missing or broken. The utility company installs these seals. Recommend consulting with the property owner(s) about this and/or contacting the utility company to have one reinstalled.

Contact your local utility company

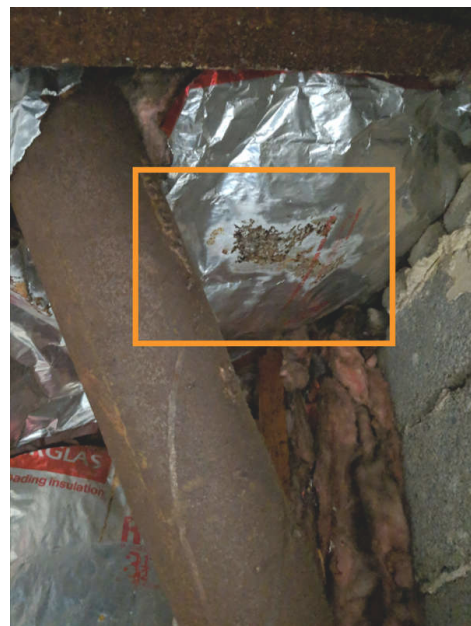
WATER STAINS

The area around the plumbing vent had water stains. We indicated no active leaking. It is possible this leak has been addressed. We recommend monitoring during heavy rainfall.

Contact a qualified professional.

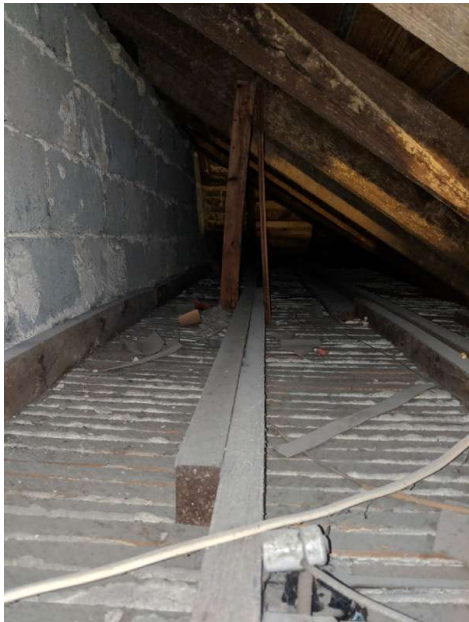
7.4.1 Insulation

MISSING

Ceiling insulation is missing in some areas. Recommend installing insulation where missing for better energy efficiency.

Contact a qualified insulation contractor.

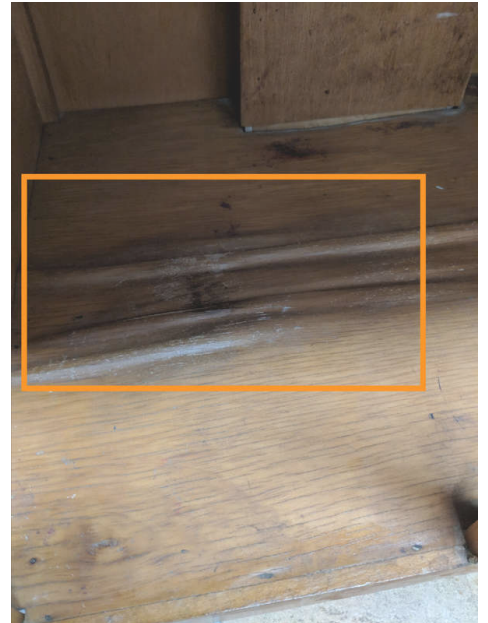
WATER DAMAGE MINOR

Water stains and/or minor water damage was found in the shelving or cabinet components below the sink. The client(s) should evaluate and consider having repairs made.

Contact a qualified cabinet contractor.

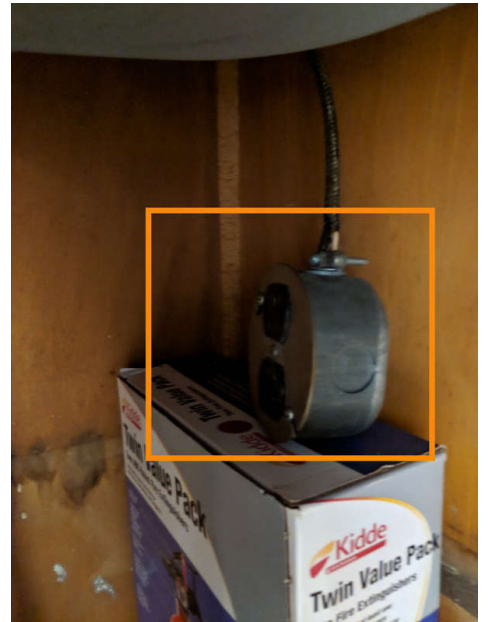
RECEPTACLE LOOSE

One or more electric receptacles and/or the boxes they are installed in are loose and/or not securely anchored. Wire conductors may be damaged due to repeated movement and/or tension on wires, or insulation may be damaged. This is a safety hazard due to the risk of shock and fire. A qualified electrician should evaluate and repair as necessary.

Contact a qualified electrical contractor.

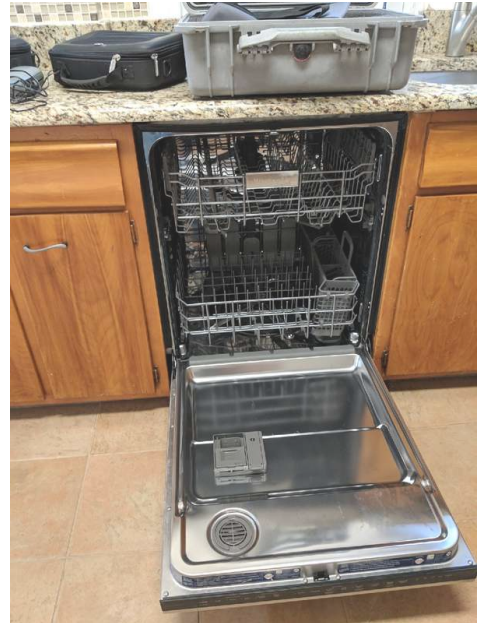
The bracket that attaches the dishwasher to the underside of the countertop is loose, missing or installed in a substandard way. Repairs should be made as necessary, such as installing or reinstalling the bracket, and by a qualified contractor if necessary.

Contact a qualified appliance repair professional.

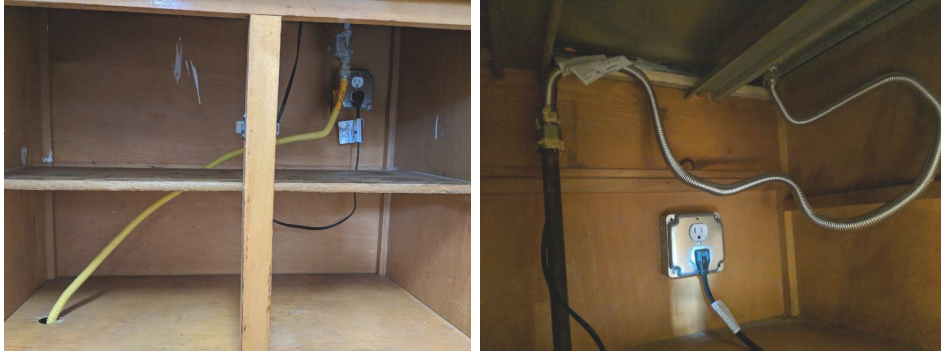
9.6.1 Range-Cooktop-Oven

NO SHUT OFF

There was no shut off present for the gas operated stove/oven/range cooktops. This may have been standard practice when the home was built. We recommend consideration be given to install shut off valve in accordance with current building standards

Contact a qualified professional.

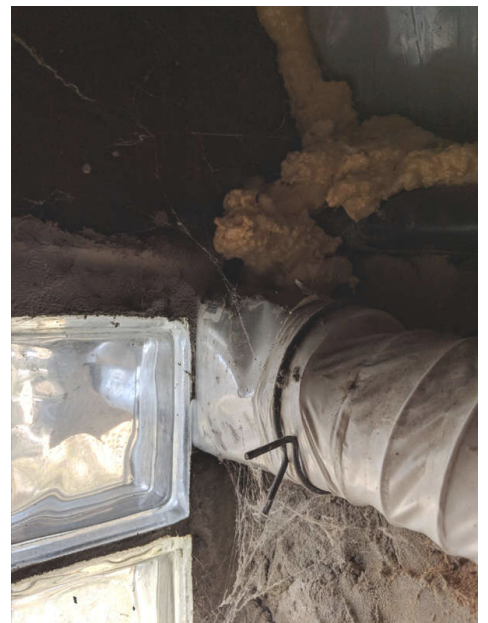
The clothes dryer exhaust duct is kinked, crushed and/or damaged. Air flow is restricted as a result. This is a safety hazard due to the risk of fire. The exhaust duct should be replaced or repaired, and by a qualified contractor if necessary.

Contact a qualified appliance repair professional.

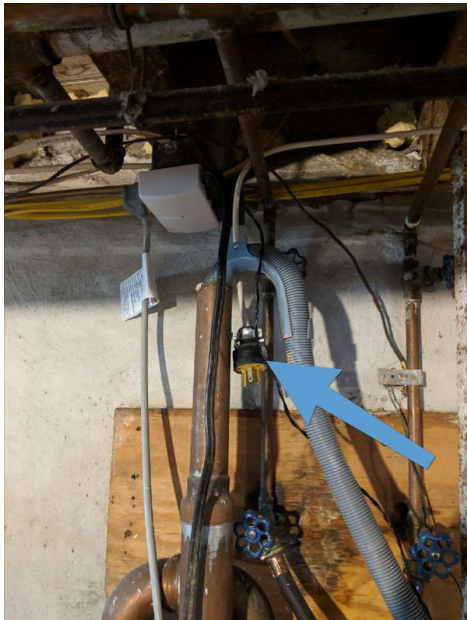
Extension cords were being used as permanent wiring at one or more locations. They should only be used for portable equipment on a temporary basis. Using extension cords as permanent wiring is a potential fire and shock hazard, and indicates that wiring is inadequate and needs updating. Extension cords may be undersized. Connections may not be secure resulting in power fluctuations, damage to equipment, overheating and sparks that could start a fire. Recommend that a qualified electrician repair per standard building practices and eliminate extension cords for permanently installed equipment.

Contact a qualified electrical contractor.

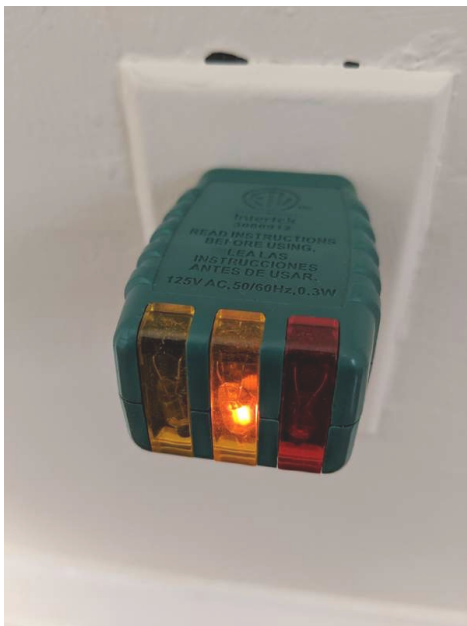
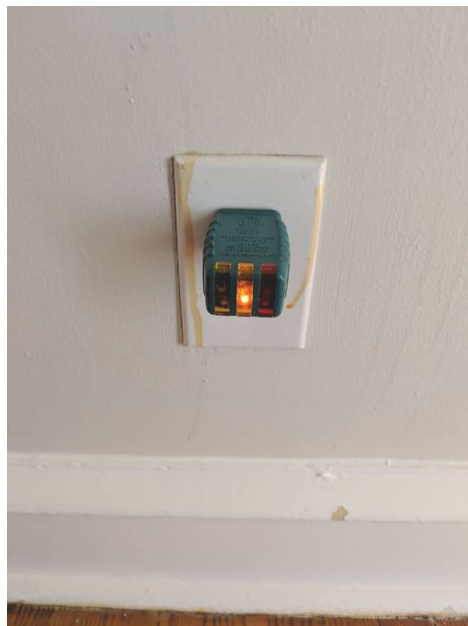
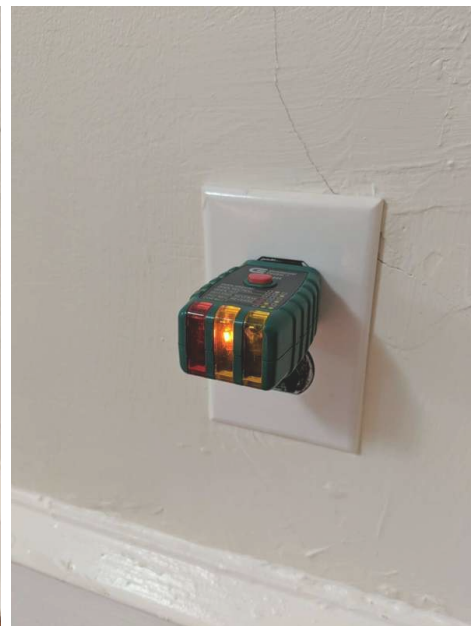
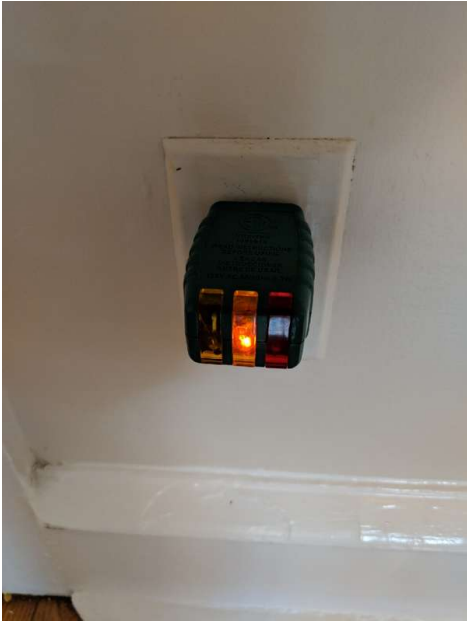
One or more modern, 3-slot electric receptacles were found with an open ground. This is a shock hazard when appliances that require a ground are used with these receptacles. Examples of such appliances include computers and related hardware, refrigerators, freezers, portable air conditioners, clothes washers, aquarium pumps, and electrically operated gardening tools. Recommend that a qualified electrician repair as necessary so all receptacles are grounded per standard building practices.

Contact a qualified electrical contractor.

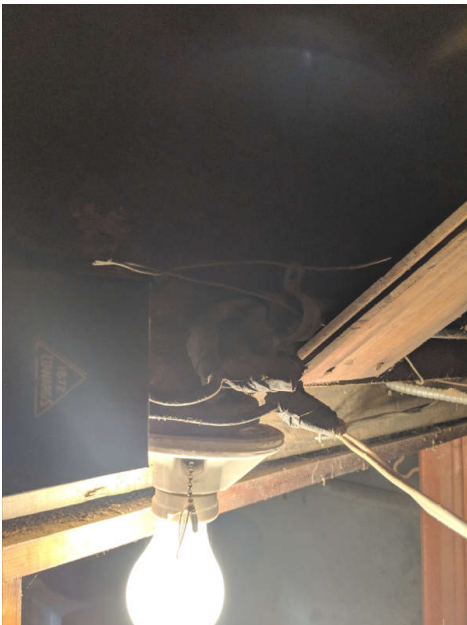
11.1.4 Electrical

Wire splices were exposed and were not contained in a covered junction box. This is a potential shock or fire hazard. Recommend that a qualified electrician repair per standard building practices. For example, by installing permanently mounted junction boxes with cover plates where needed to contain wiring splices.

Contact a qualified electrical contractor.

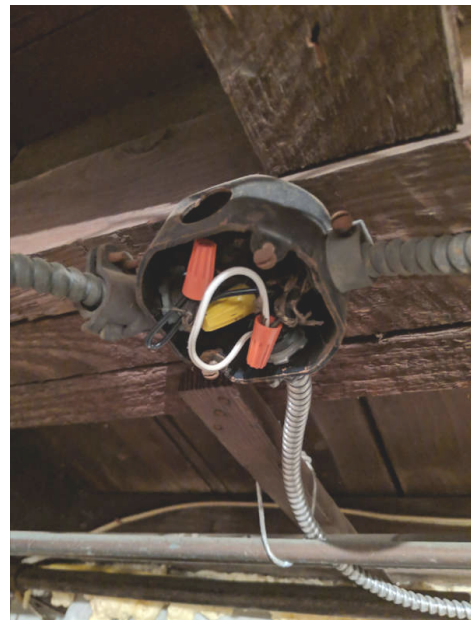
COVER PLATE MISSING

Cover plate(s) are missing from one or more electric boxes, such as for receptacles, switches and/or junction boxes. They are intended to contain fire and prevent electric shock from exposed wires. This is a safety hazard due to the risk of fire and shock. Cover plates should be installed where missing.

Contact a qualified electrical contractor.

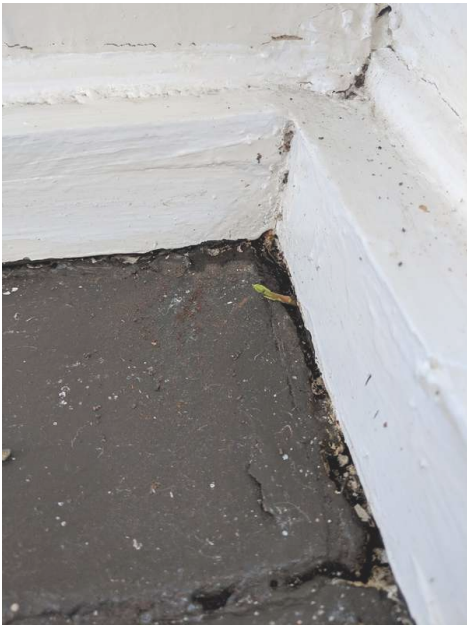
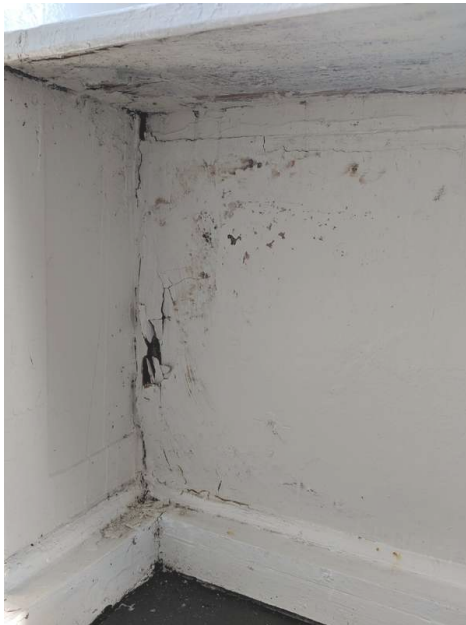
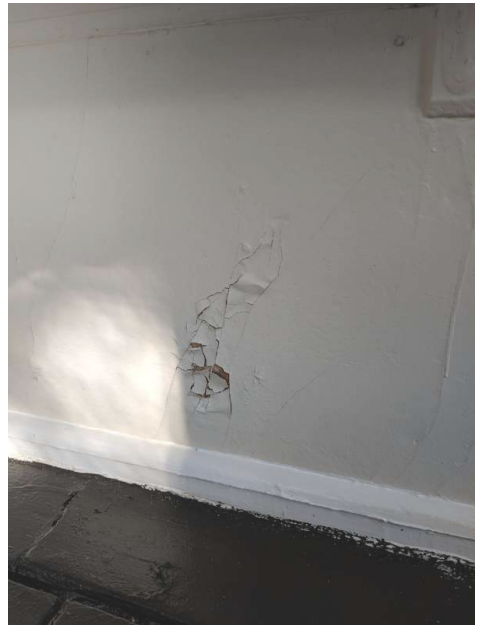
11.2.2 Floors, Walls, Ceilings

Deficiencies

Recommendation

Contact a qualified professional.

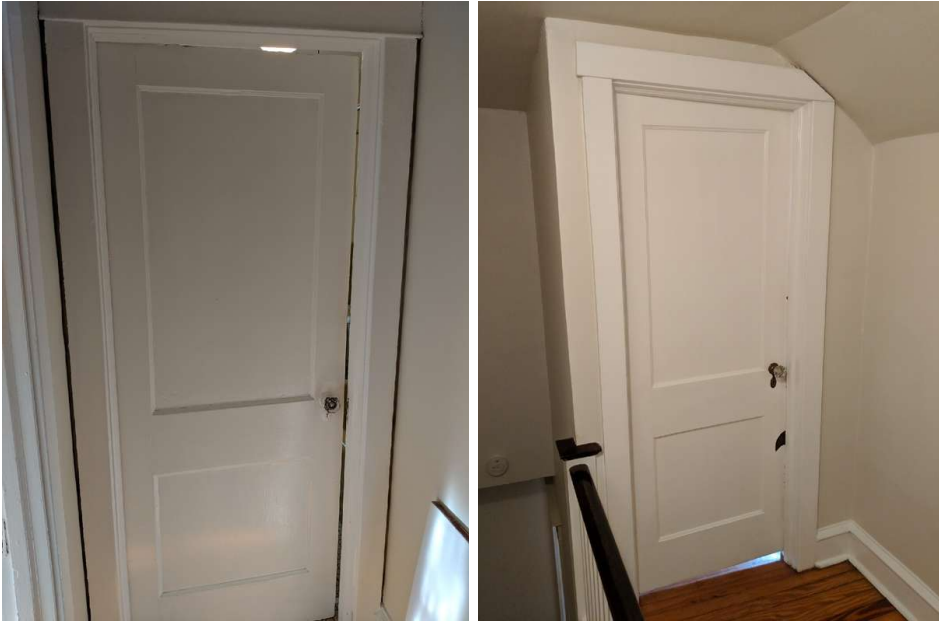
DOOR RUBS

Recommendation

Contact a qualified door repair/installation contractor.

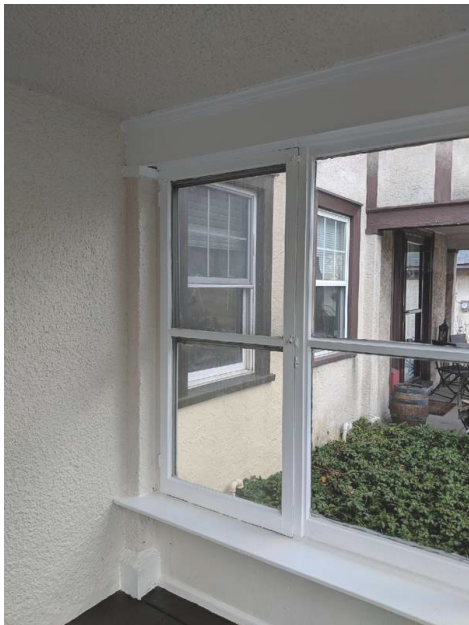
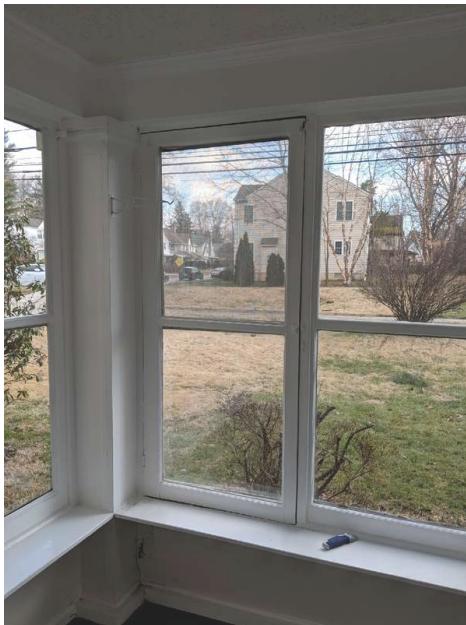
11.5.6 Windows and Door

Deficiencies

Recommendation

Contact a qualified window repair/installation contractor.

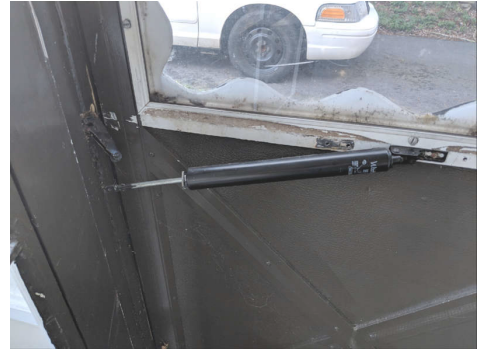
11.5.7 Windows and Door

Deficiencies

Recommendation

Contact a qualified professional.

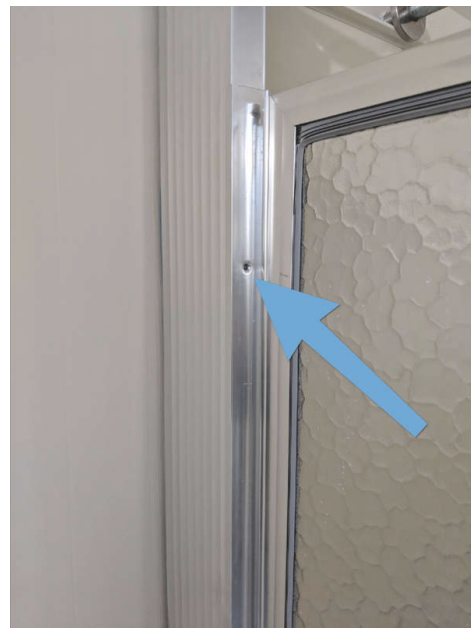
HARDWARE MISSING

The shower door is very loose and the hardware is missing. This is causing a rough operation. We recommend d the door be repaired

Contact a qualified professional.

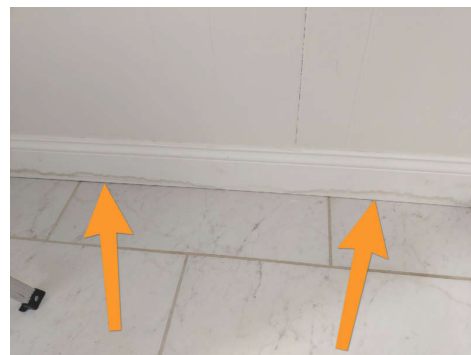
12.6.3 Shower

PAST WATER DAMAGE

Evidence of past water damage was noted on the floor around the shower. We recommend monitoring and repairing if needed

Contact a qualified professional.

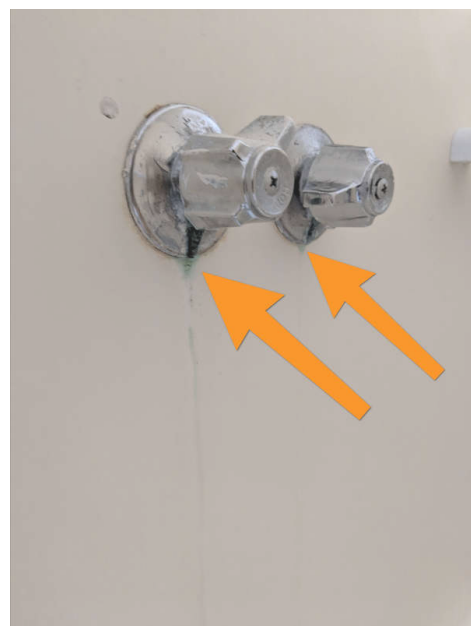
12.7.1 Sink/countertop

FAUCET LEAKS ON

One or more faucets leak by handle(s) or at their base when turned on. A qualified plumber should evaluate and repair as necessary.

Contact a qualified plumbing contractor.

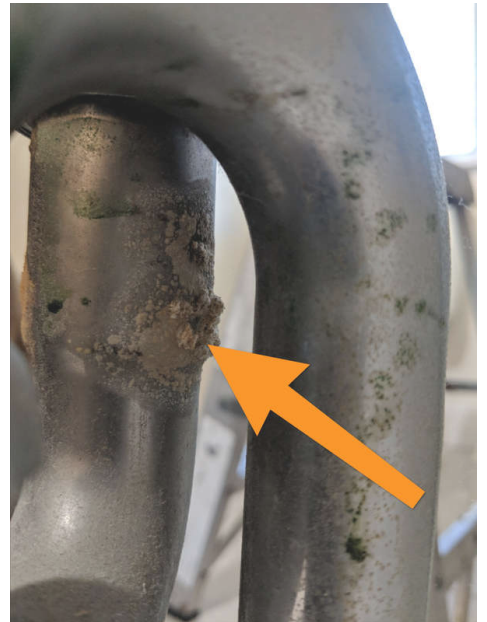
12.7.2 Sink/countertop

Deficiencies**SINK DRAIN LEAK**

One or more sink drains have an active leak. For example, at pipe fittings and/or junctions between pipe and sink. A qualified plumber should evaluate and repair as necessary.

Contact a qualified plumbing contractor.

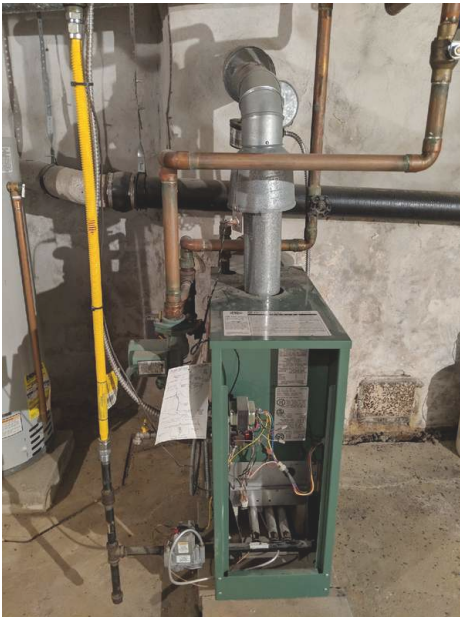
Boiler: Unit photos

The heating system has not been serviced in over a year. We recommend a qualified contractor be retained to service, clean, and tune the system.

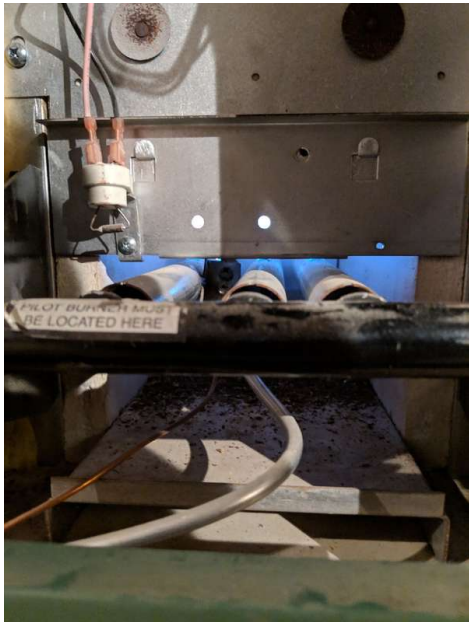
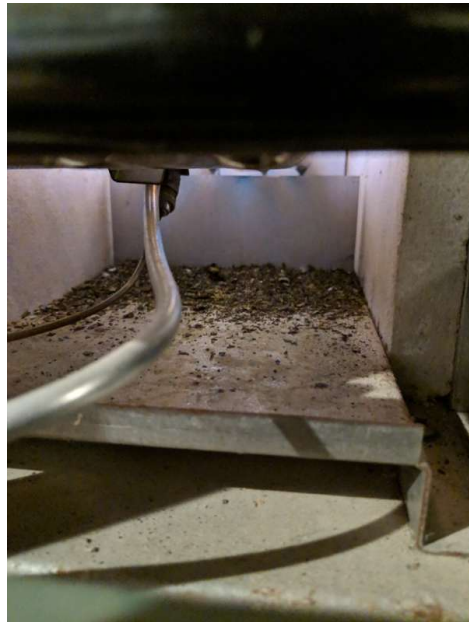
SERVICE HEATING UNIT

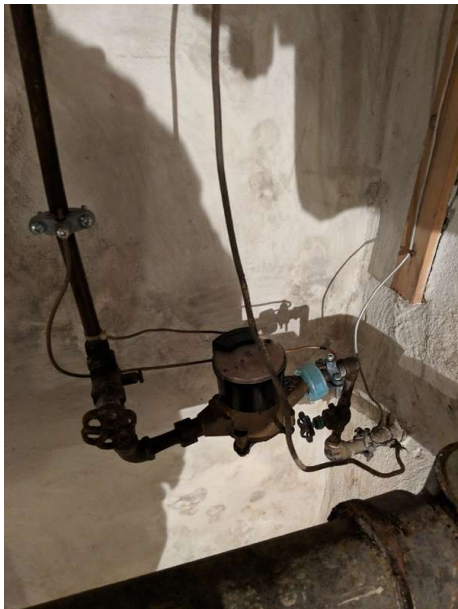
General: Location of Main Shut off

Basement

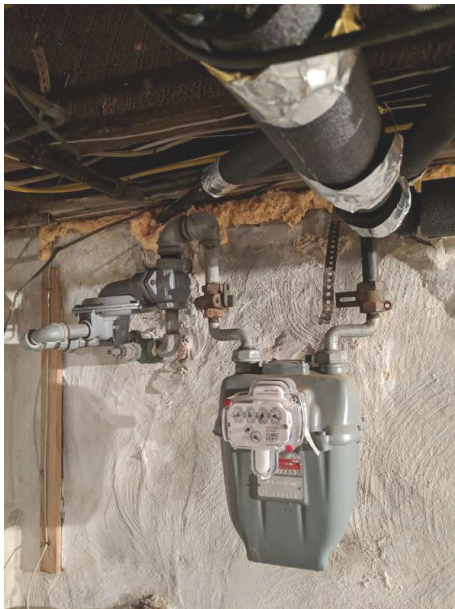
General: Location of main fuel shut off

Basement

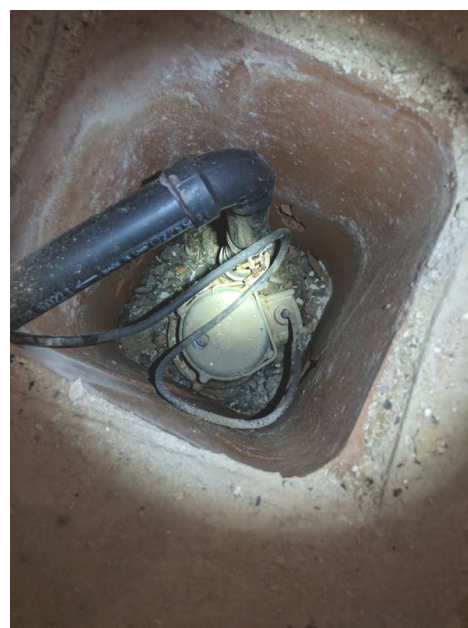
NO WATER- NOT TESTED

The sump well was dry and the pump could not be safely operated. The pump should be tested when there is a sufficient amount of water to allow its operation without the possibility of causing damage.

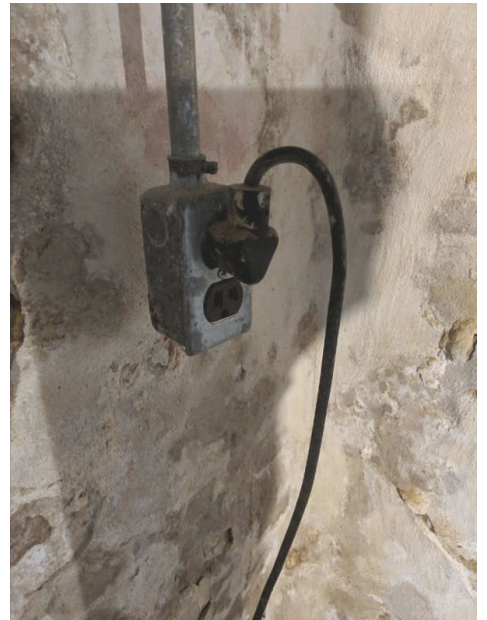
Deficiencies**GFCI MISSING**

The sump pump electrical connection is not ground fault protected, as would be required today. GFI protection for the sump pump would provide a higher margin of safety and is recommended as an optional upgrade.

The outlet is not properly fastened to the wall. We recommend it be anchored to the wall to prevent damage to the wiring.

Contact a qualified professional.

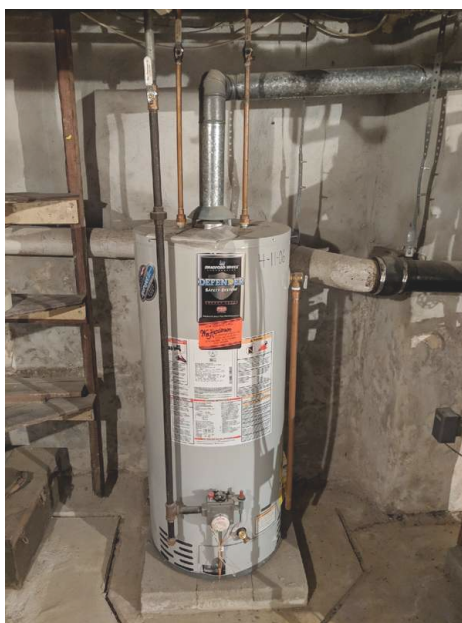
Water Heater: Pictures of Unit

The estimated useful life for most water heaters is 8 to 12 years. This water heater appears to be at this age or older and may need replacing at any time. Recommend budgeting for a replacement in the near future.

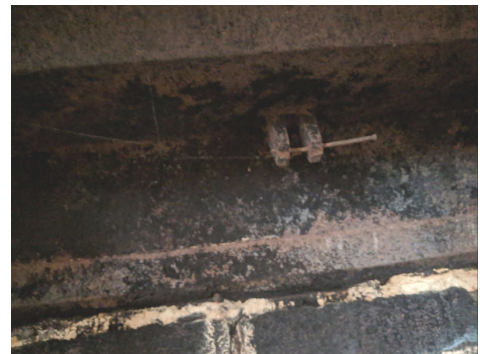
The damper in one or more fireplaces is stuck and cannot be opened or closed. A qualified chimney service contractor should evaluate and make repairs as necessary.

Contact a qualified chimney contractor.

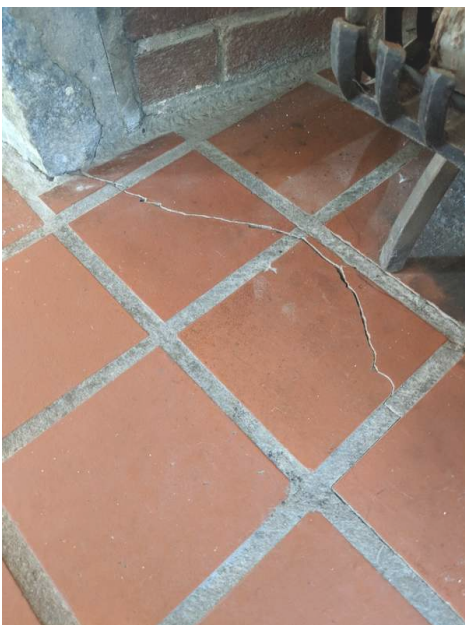
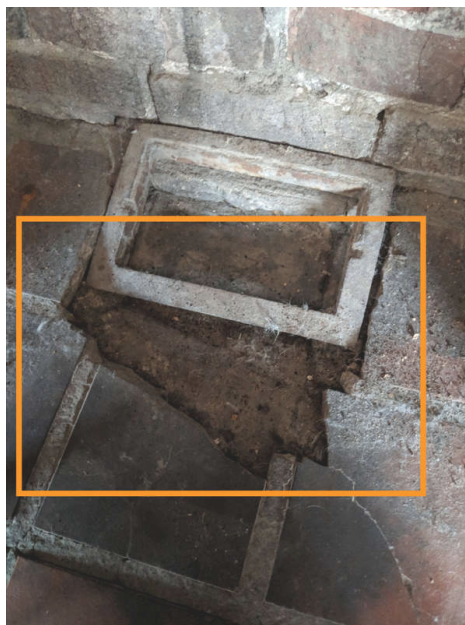
16.3.1 Hearth

**DETERIORATED**

One or more fireplace and/or woodstove hearths are damaged and/or deteriorated. For example, loose or broken tiles and/or bricks. A qualified contractor should evaluate and make repairs as necessary.

Contact a qualified fireplace contractor.

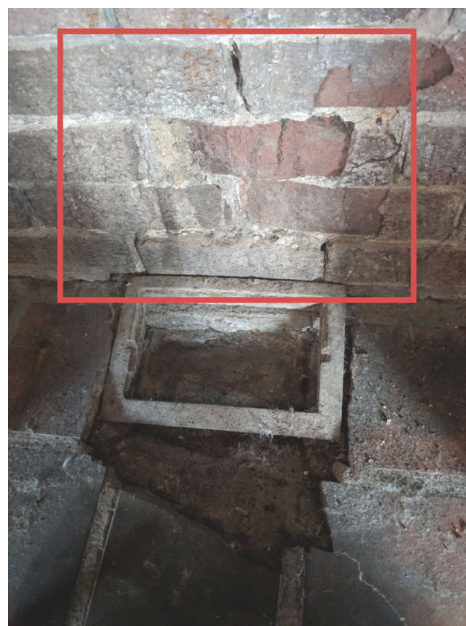
16.4.1 Liner, Firebricks, Panels

REPAIR, REPLACE BRICKS

Fire bricks in one or more fireplace fireboxes are loose and/or significantly deteriorated or pitted. This is a fire hazard. A qualified chimney service contractor should evaluate and repair as necessary.
