**AGI: PROPERTY INSPECTIONS**

## RESIDENTIAL REPORT

1234 Main St.  
Lake Charles LA 70611

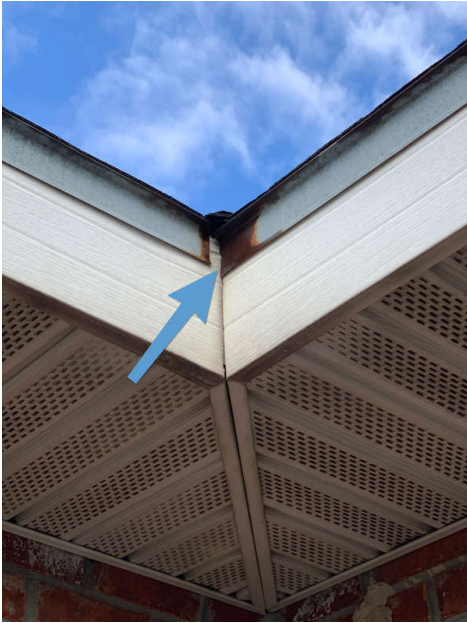
Front of House

#### **CORRODED - MINOR**

Roof flashing showed signs of corrosion, but are still in working condition. Flashing should be monitored to prevent severe corrosion leading to moisture intrusion.

Contact a qualified roofing professional.

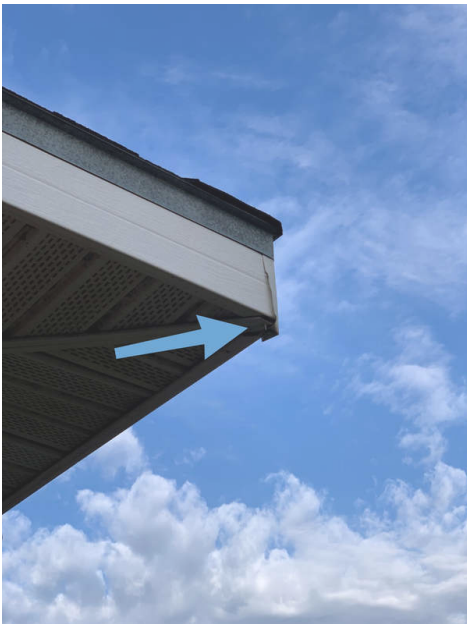
Right Side- facing the house

**LOOSE/SEPARATED**

Flashings observed to be loose or separated in one or more areas, which can lead to water intrusion and/or mold.

Contact a qualified roofing professional.

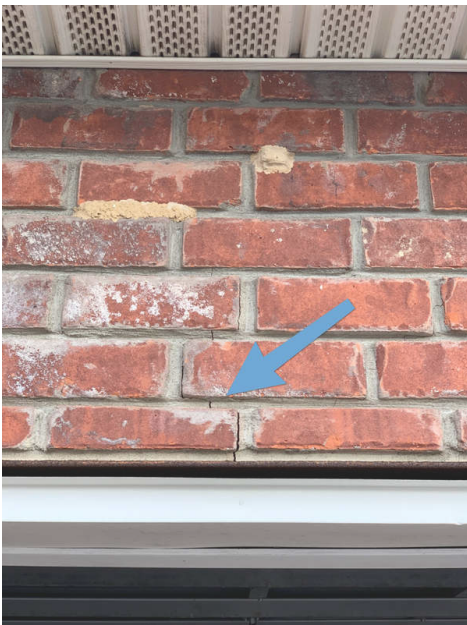
Front of House

#### **CRACKING - MINOR**

Siding showed some cracking in one or more places.

Contact a qualified masonry professional.

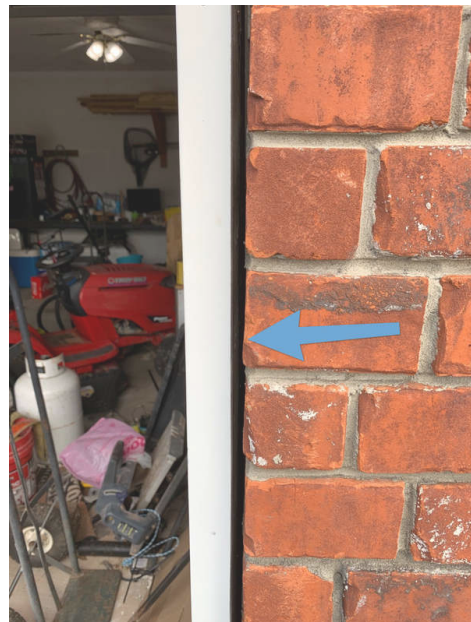
Garage

One or more areas of siding had a gap between seams with exposed structure. This should be repeated to prevent damage to the structural components of the home.

Contact a qualified siding specialist.

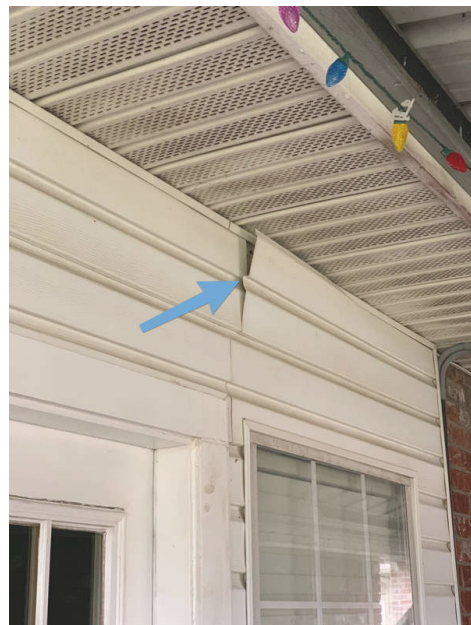
Rear of House

**LOOSE SIDING**

One or more pieces of siding were loose, which could result in moisture intrusion.

Contact a qualified siding specialist.

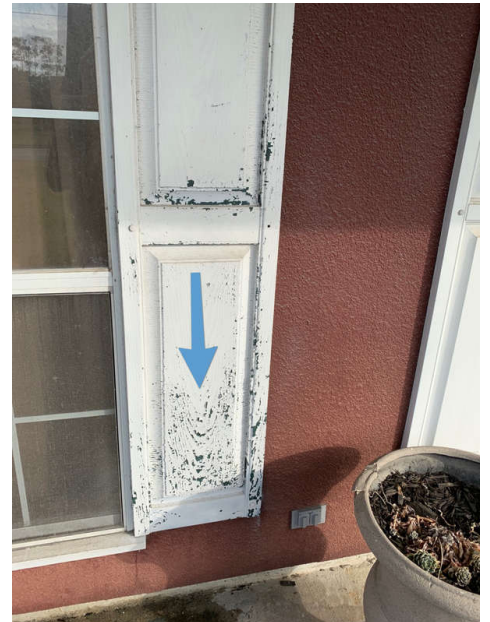
Front of House

Paint was peeling in one or more areas and should be refinished to prevent premature damage to structural components.

Contact a qualified painter.

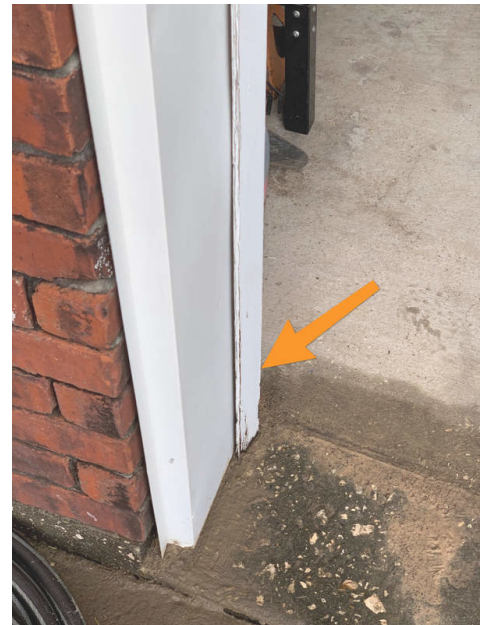
Garage

**TRIM- DAMAGED**

One or more areas of exterior trim was damaged at the time of inspection.

Contact a qualified siding specialist.

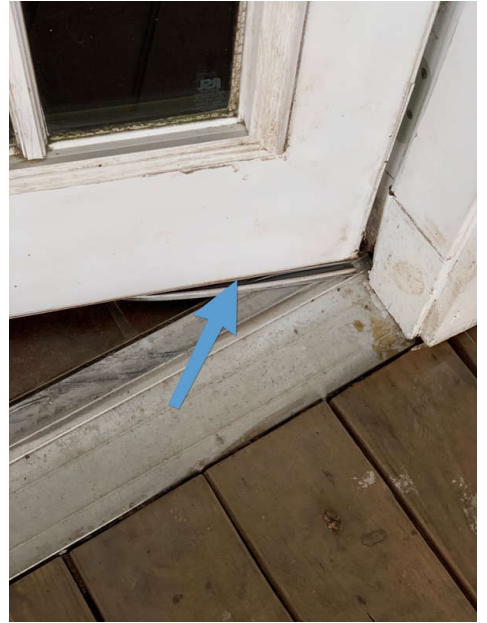
Rear of House

**SWEEP- DAMAGED**

Sweeps at exterior doors in the home were damaged or deteriorated.

Contact a qualified door repair/installation contractor.

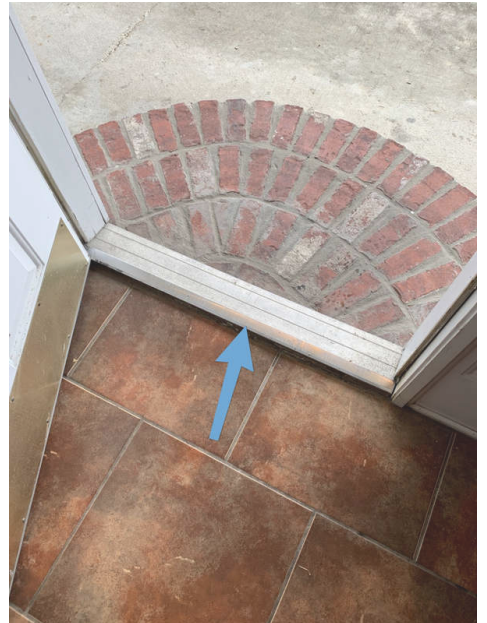
Front of House

**THRESHOLD- DAMAGED**

Threshold for exterior door was damaged and should be replaced. This can cause energy loss and allow access for exterior conditions to come inside; weather, moisture, pests.

Contact a handyman or DIY project

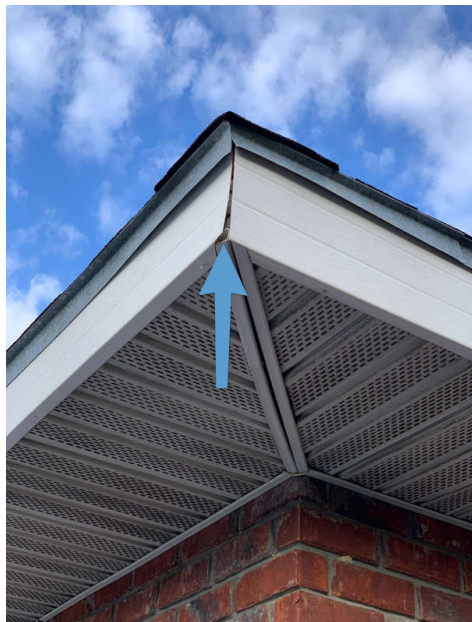
Right Side- facing the house

**FASCIA - LOOSE**

One or more sections of the fascia are loose and should be repaired to prevent moisture intrusion to the structure.

Contact a qualified roofing professional.

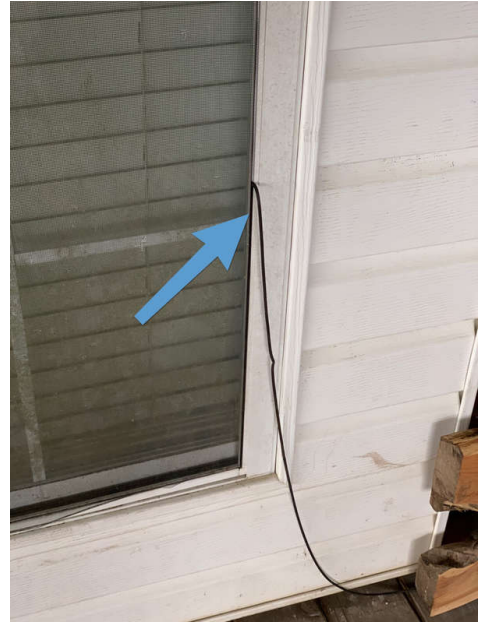
Rear of House

**DAMAGED SCREEN**

One or more screens were damaged. Inspector recommends replacement

Contact a qualified professional.

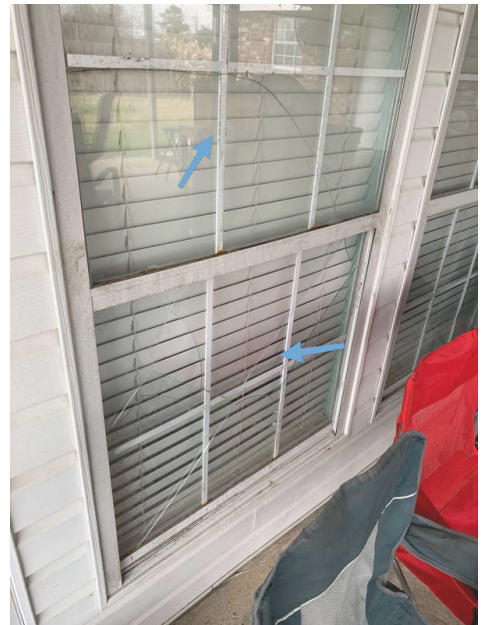
Rear of House

**GLAZING-  
CRACKED/DAMAGED**

One or more glazing (glass panes) were damaged at the time of inspection.

Contact a qualified window repair/installation contractor.

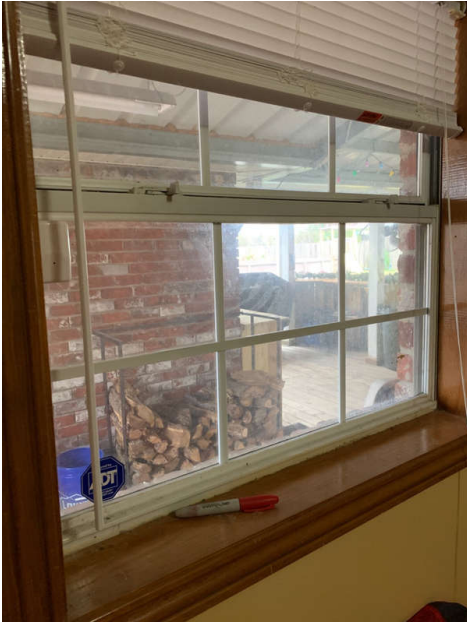
Bedroom 3

**MISSING/DAMAGED SCREEN**

Window had damaged or missing screen.

Recommendation

Contact a qualified window repair/installation contractor.

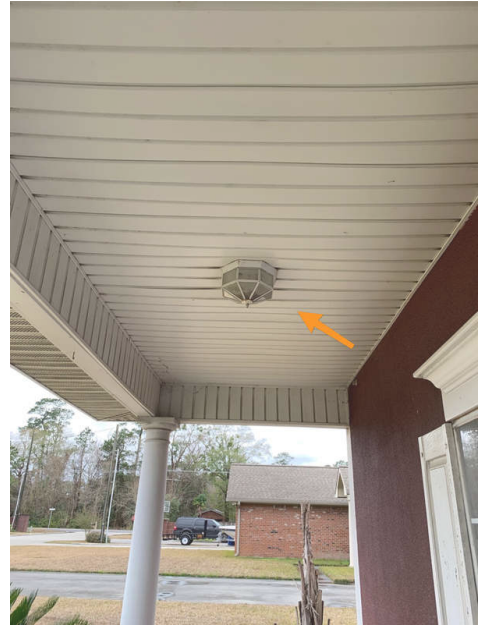
Front of House Garage

One or more lights were inoperable at the time of the inspection. The bulb may need to be replaced or there may be a problem with the switch, wiring or light fixture.

Contact a qualified electrical contractor.

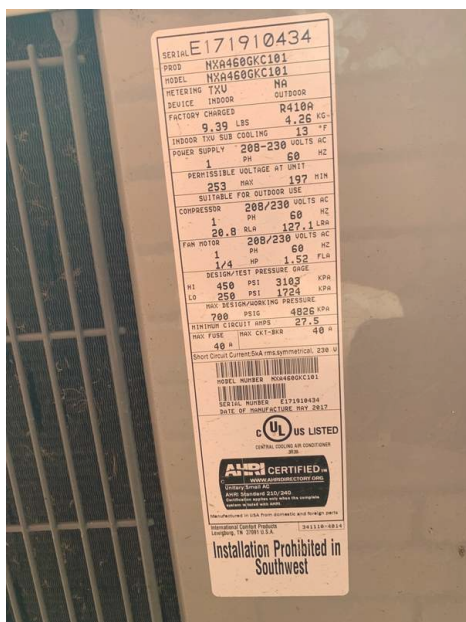
### Equipment: System Data Plate

Information from the air-conditioner label/data plate is shown in the photo.

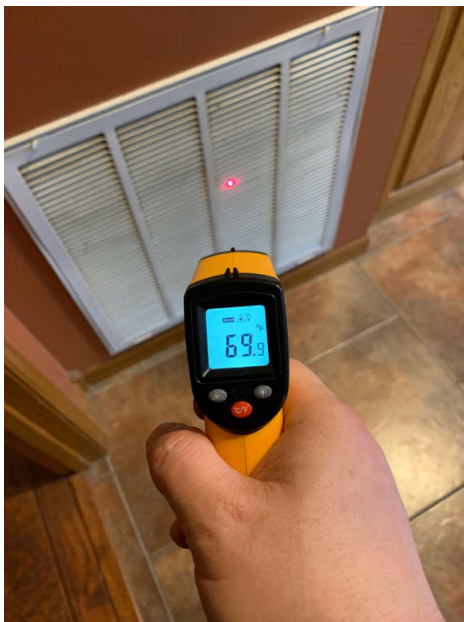
Return air temp

The differences in air temperature measured at supply and return registers fell within the acceptable range.

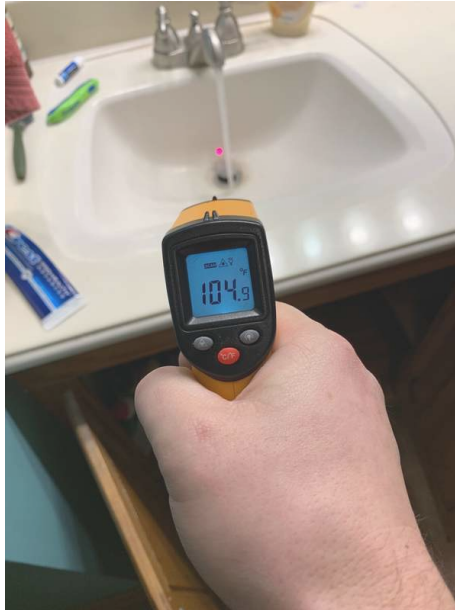
Hot water operation temp

This is the thermal reading of the hot water, at the time of inspection.

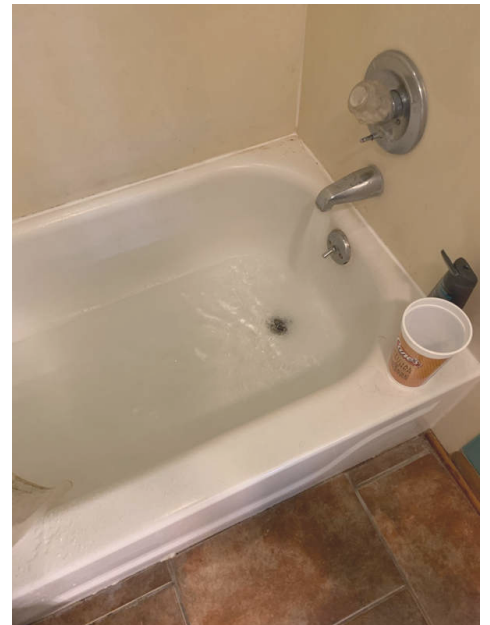
Bathroom

**TUB - POOR DRAINAGE**

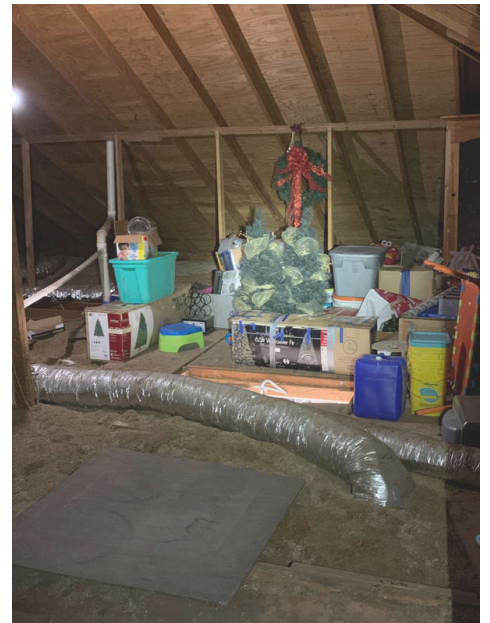
Attic

#### LIMITED ACCESS- OCCUPANTS BELONGINGS

The occupant's belongings were stored in the attic at the time of the inspection and blocked access to and view of portions of the attic. You may wish to have these portions of the attic re-inspected after access is provided by removal of the items which limited the attic inspection.

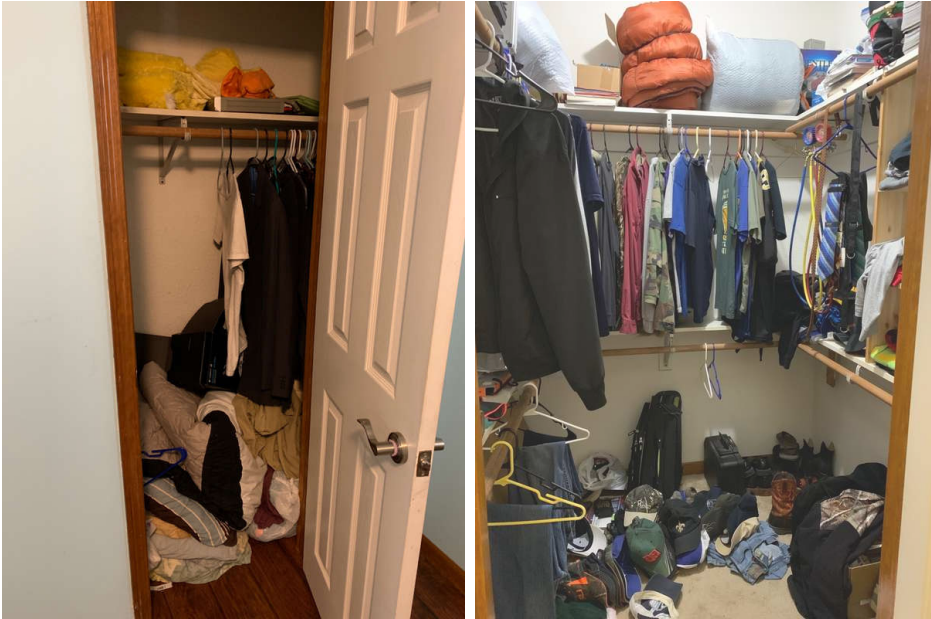
Bedroom 2 Closet

There were one or more closets where the occupant belongings obstructed the view. As a result, the Inspector was unable to verify that there were not defects in all areas of the floor, walls, windows or electrical receptacles in the home. Therefore the Inspector disclaims any possible damage in the areas that were unable to be inspected as a result.

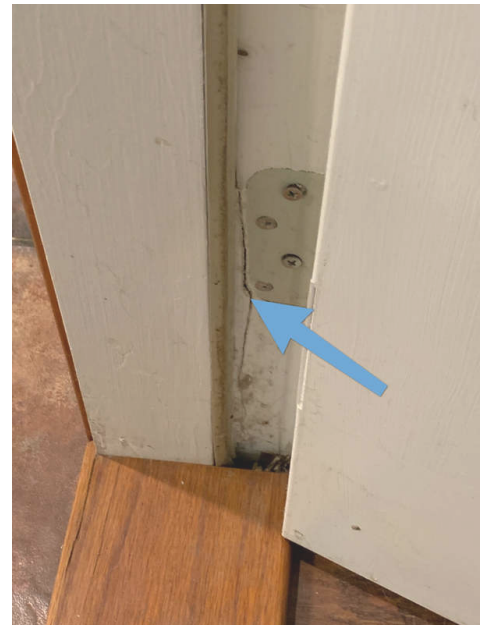
Master

#### **DAMAGE- MINOR**

One or more interior door(s) exhibited minor damage or deterioration at the time of the inspection.

##### Recommendation

Contact a qualified door repair/installation contractor.

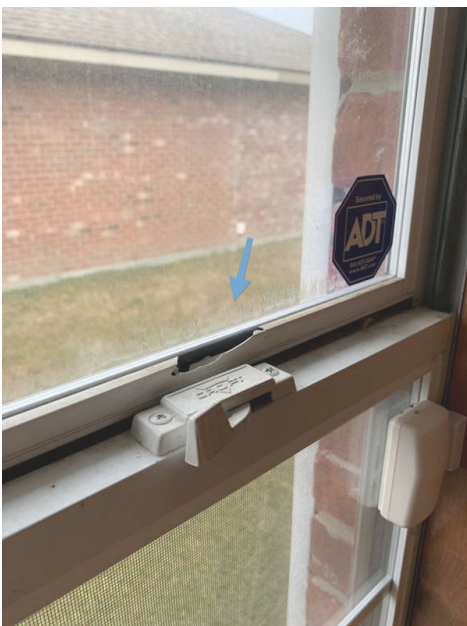
Bedroom 2

**SASH DAMAGE**

One or more window sash exhibited minor damage.

Recommendation

Contact a qualified window repair/installation contractor.

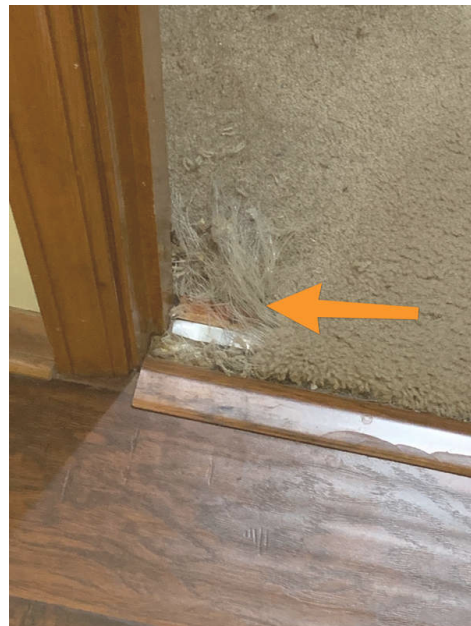
Master Closet

**DAMAGED**

One or more areas of the floor were damaged at the time of the inspection.

Recommendation

Contact a qualified flooring contractor

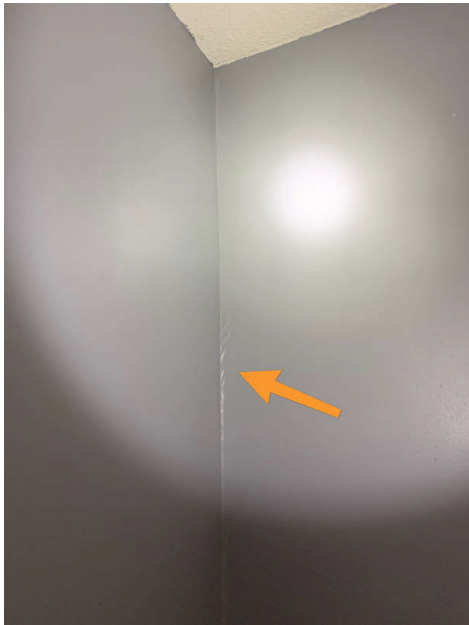
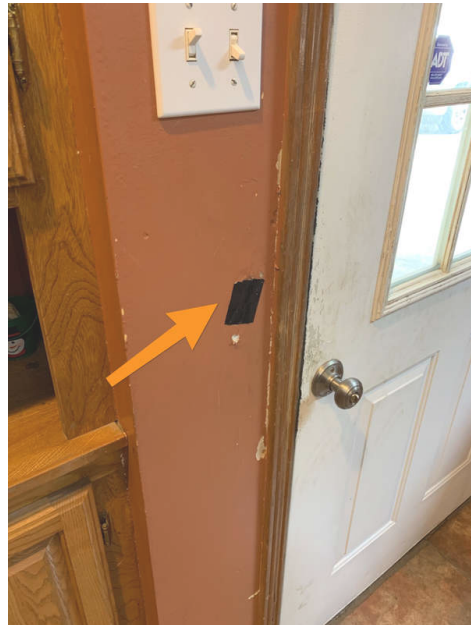
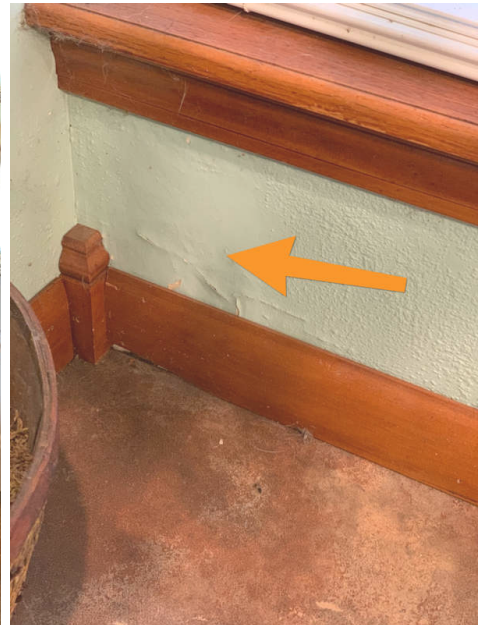
**DAMAGED**

One or more areas of wall were damaged as the time of inspection.

Recommendation

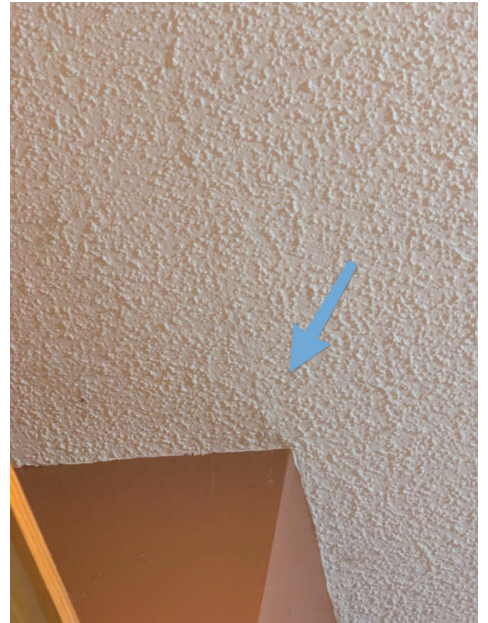
Kitchen

#### **DAMAGE**

Minor damage or deterioration to the ceiling was visible at the time of the inspection.

Recommendation

Contact a qualified drywall contractor.

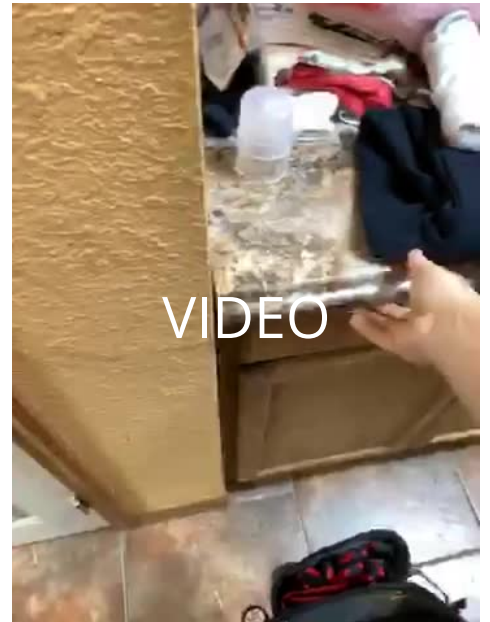
Kitchen countertop appeared to be improperly secured to base.

Recommendation

Contact a handyman or DIY project

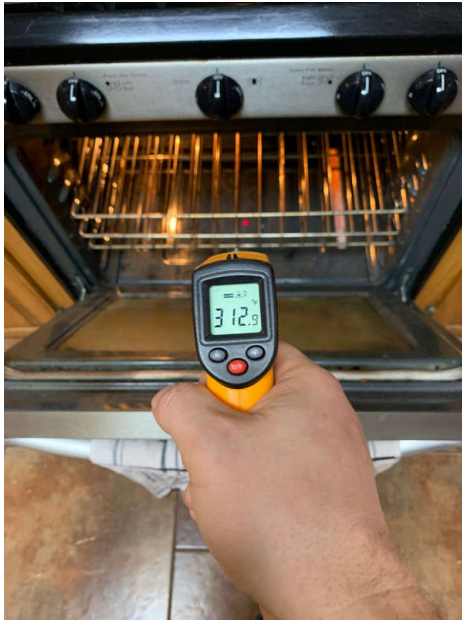
Oven operation temp

**Range/Oven/Cooktop: Oven**
