45TH PARALLEL HOME INSPECTION

RESIDENTIAL HOME INSPECTION COPY

1234 Main St.
Vancouver WA 98683

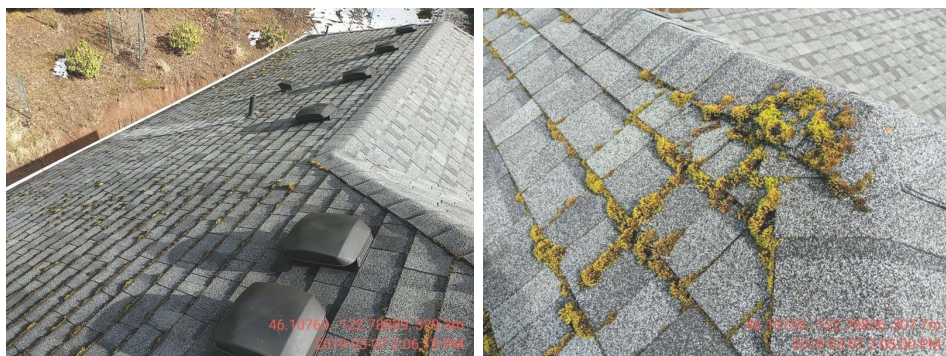
There is moderate to heavy moss on the roof covering. Moss can damage the roof covering and potentially promote leaking. I recommend having the moss cleaned off of the roof covering as soon as possible. Never pressure wash shingles as this can damage them and shorten roof cover life.

Contact a qualified professional.

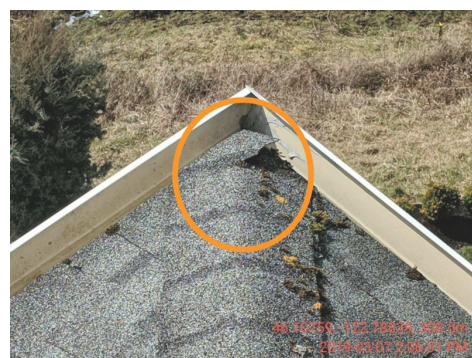
2.1.2 Roof Coverings

DAMAGED SHINGLES

There are damaged shingles on the roof which need replacing as necessary by a roofer to prevent potential moisture intrusion and damage to the home's structure. Have a roofer further inspect the roof covering for all necessary repairs.

Contact a qualified roofing professional.

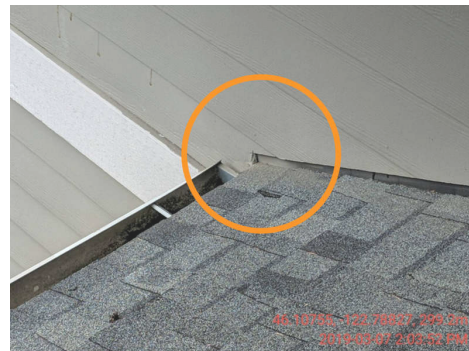
2.2.1 Roof Flashing

Kickout flashing directs water away from the wall cladding and into the gutter at roof eave / sidewall intersections to prevent water running down and potentially behind the wall cladding causing damage to the structure. While not required on older homes when built, it is a VERY good item to have installed for preventative maintenance if not currently installed and can help prevent leaks and costly repairs. I recommend having a roofer add kickout flashing to areas not having one.

Contact a qualified roofing professional.

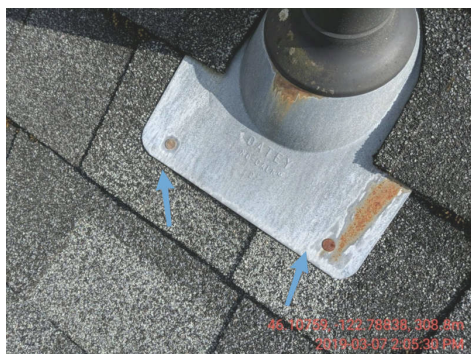
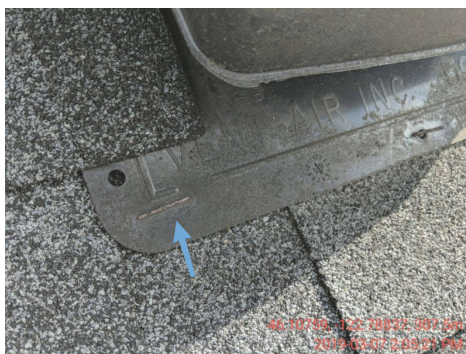
2.3.1 Skylights, Chimneys and Roof Penetrations

Where fasteners have been driven through the roof covering leaving the fastener head exposed, it is recommended to seal the penetration with roofing cement / sealant to prevent possible leakage around that point. I recommend sealing exposed penetrations / fastener heads. Note that a representative number of areas are inspected and photos do not typically include all locations recommended for repair.

Contact a qualified professional.

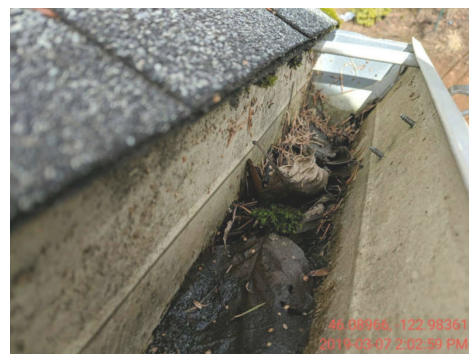
2.4.1 Roof Drainage Systems

MINOR GUTTER DEBRIS

There is a minor amount of debris in the gutters. There is not enough debris to prevent water flow currently, however, it is important to keep gutters clean to properly manage water around the home. Overflowing gutters can deposit larger amounts of water next to the home and cause damage to the structure. Check gutters at least twice yearly Spring and Fall and clean as necessary.

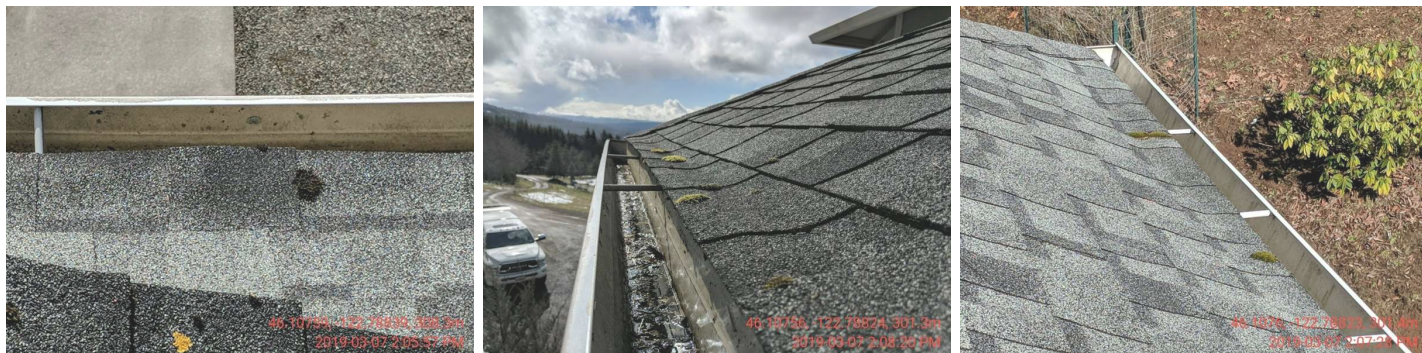
2.4.2 Roof Drainage Systems

In some areas, the gutter is too high and the shingles are pitched up at the roofline creating a spot where water does not drain properly. I recommend adjusting the gutter to avoid pooling water on the shingles as this can lead to moisture damage to the roof structure below.

Contact a qualified gutter contractor

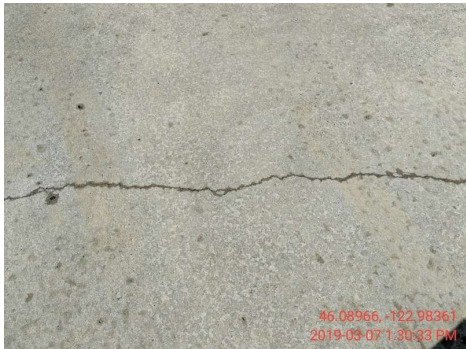
Vegetation, Grading, Drainage, Driveways, Patios, Walkways and Retaining Walls: Typical cracking

There are typical cracks in the driveway / walkways. The driveway and walkways are still serviceable.

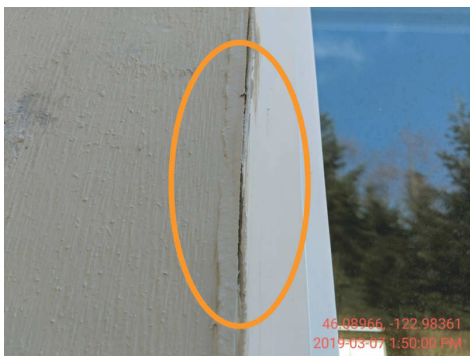
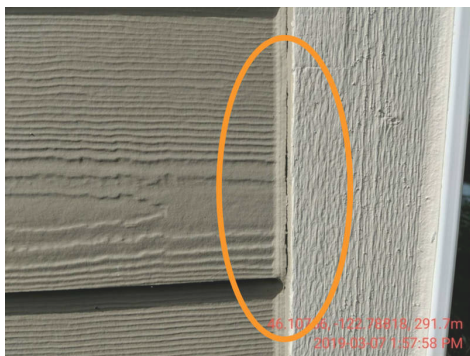
CAULK GAPPING / CRACKING

The caulking is cracking or gapping in some areas. Caulking needs to be well maintained at siding / trim, siding / window, and butt joints if the joint is not flashed. This is a maintenance item and should be periodically inspected and repaired as necessary. I recommend re-caulking in these areas to prevent water intrusion and damage to the structure.

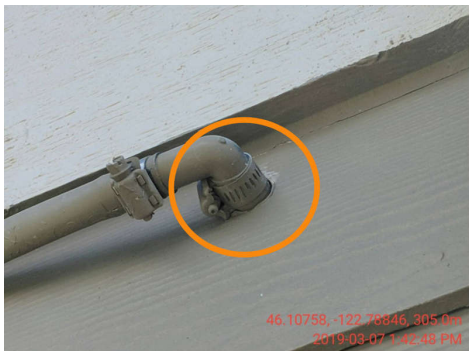
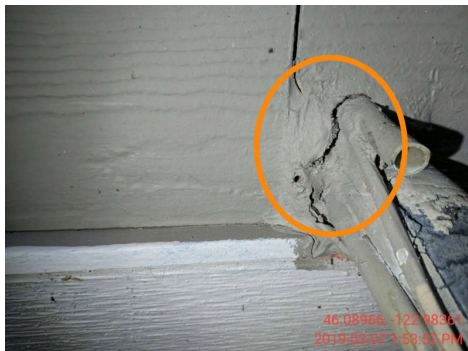
3.1.2 Wall Cladding, Flashing, and Trim

NORTH, SOUTH

There are penetrations in the siding where the hole or gap should be caulked or sealed to prevent water and pest intrusion. Even small holes can allow significant amounts of water into a wall cavity over time and cause damage. Repair as soon as possible.

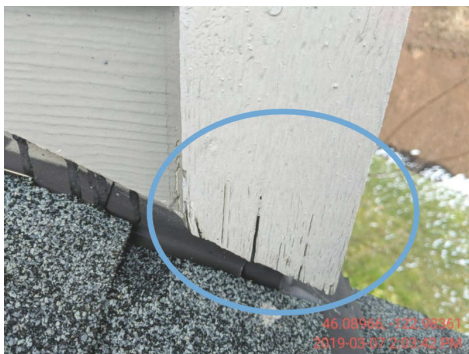
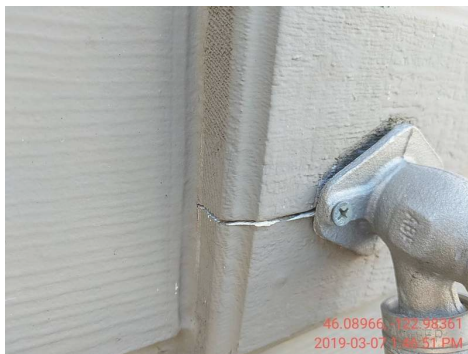
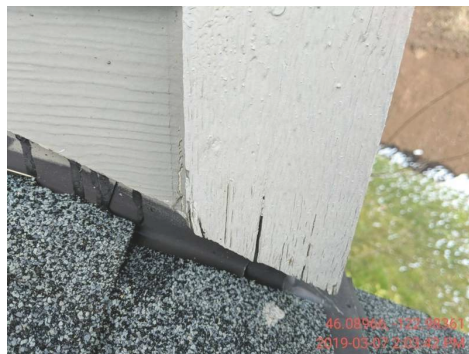
3.1.3 Wall Cladding, Flashing, and Trim

SIDING MAINTENANCE NEEDED

The siding needs general maintenance. Repairing any over driven nail holes by caulking / sealing, and repairing any paint by removing loose paint and re-painting is recommended. Repair seal any gaps, splits, in the siding or joints. Drive or replace any nails which are coming loose. Pro-active inspection and siding maintenance will keep it in better shape longer.

Contact a handyman or DIY project

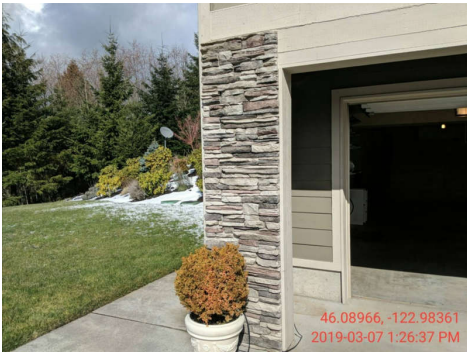
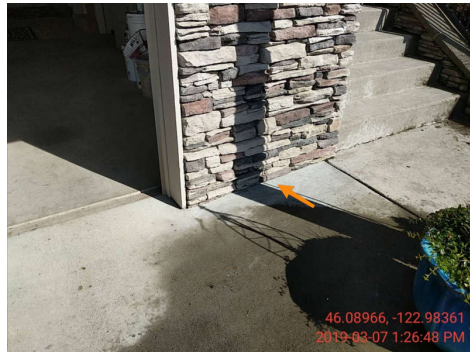
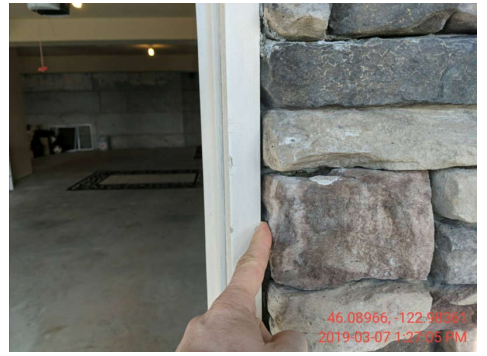
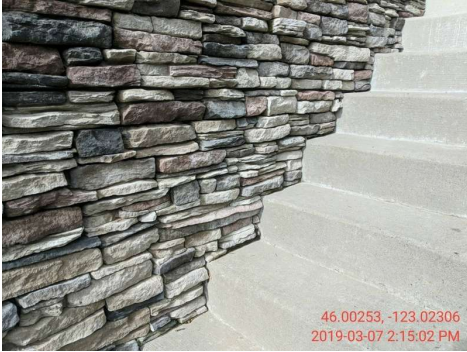
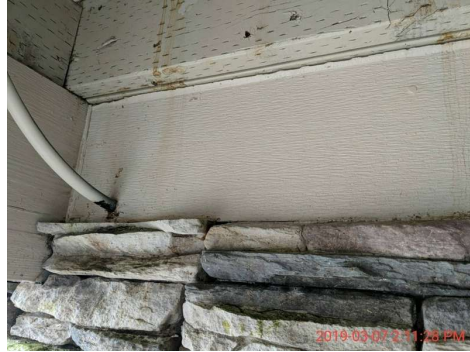
The AMSV (Adhered Manufactured Stone Veneer) or cultured stone as many people call it is not properly installed according to published industry guidelines. The MVMA (Masonry Veneer Manufacturers Association) publishes guidelines for proper installation of manufactured stone veneer. These guidelines help to prevent moisture related issues with the veneer. Not all best practices may be required by a jurisdiction. While I do not see any current moisture issues as a result of the installation, however, it has a higher risk of moisture related issues due to the lack of following best practices. Have it further inspected by a manufactured stone veneer inspector if you would like more information on whether repairs are recommended for this particular installation. Please keep in mind, if this is an older installation, it may have been installed prior to some of the current requirements, however, the best practices still apply to older installations, and they may benefit from being repaired to minimize risk of moisture related issues.

Recommendation

Contact a qualified professional.

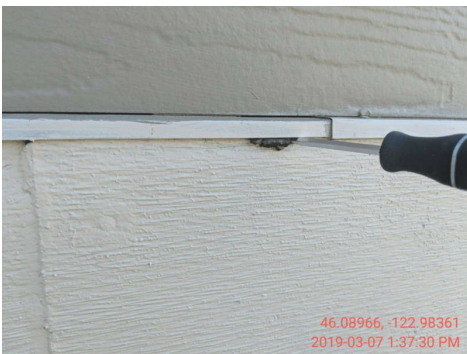
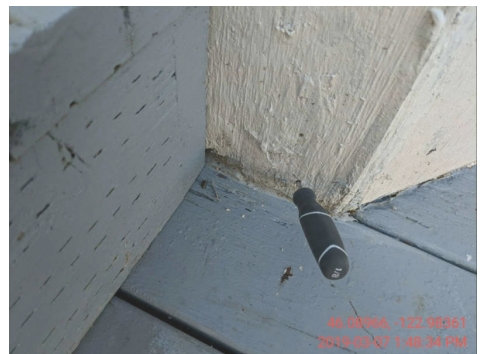
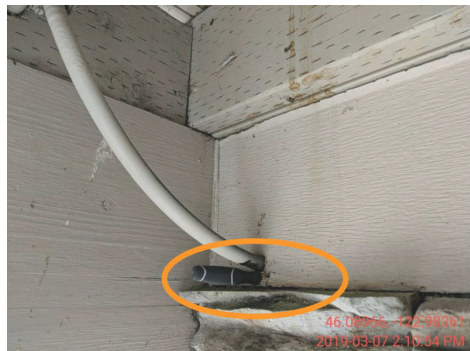
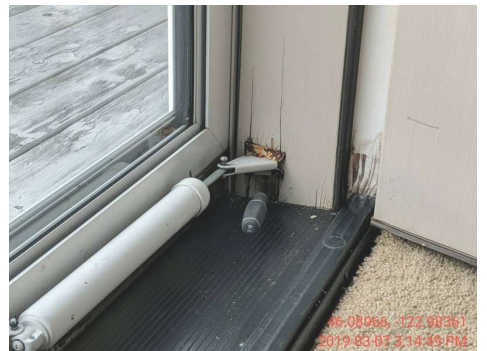
WOOD ROT

There is some trim / siding around the home that has some wood decay. Decayed wood can potentially attract pests such as insects. I recommend replacement of any decayed wood. Have a siding contractor further review the siding to find and repair all areas.

Contact a qualified siding specialist.

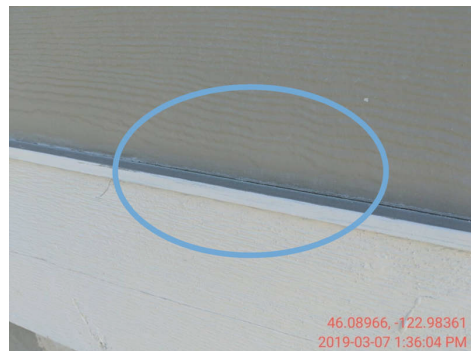
3.1.6 Wall Cladding, Flashing, and Trim

GAP OVER FLASHING CAULKED

The gap over flashings is caulked. This is improper installation. There should be an approximate 1/4 inch gap over head flashings which is not caulked for proper water drainage from behind the siding. This could potentially increase the likelihood of water damage to the structure. If the siding is replaced in the future, ensure the installer does not caulk the gap over flashings.

Contact a qualified professional.

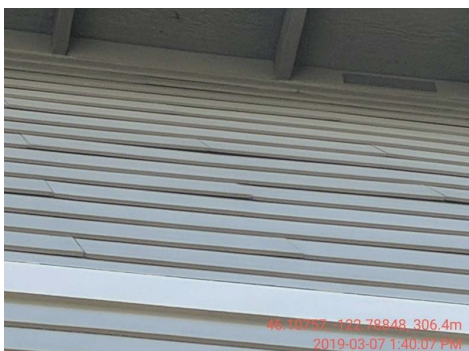
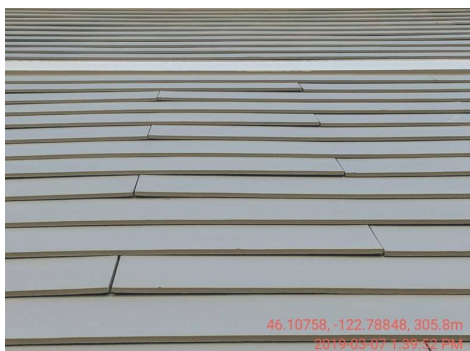
LOOSE BUTT JOINTS

Some siding course butt joints have edges curling up away from the home and needs to be pinned back to prevent moisture intrusion behind the siding. Be sure and follow manufacturer directives for placement and fastener specifics. It is usually indicated to use stainless or galvanized finish nails only.

Contact a qualified siding specialist.

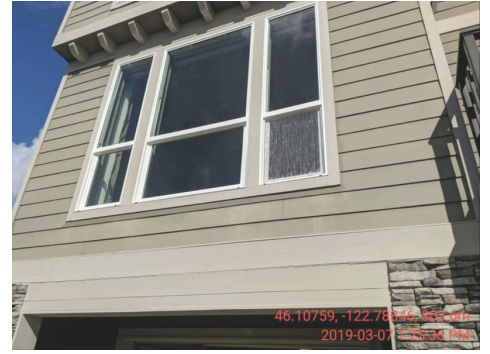
3.1.8 Wall Cladding, Flashing, and Trim

The house is due for paint. Some areas appear thin and there are many areas of peeling is missing paint. I recommend having the entire house painted to help protect the structure.

Contact a qualified painting contractor.

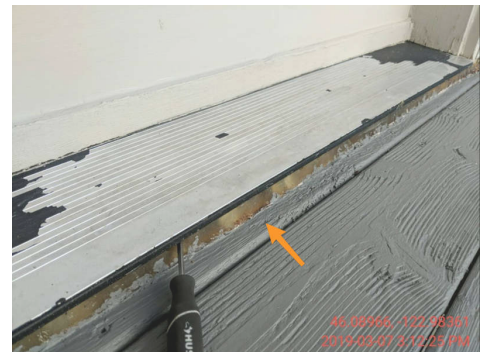
3.2.1 Doors (Exterior)

Exterior doors should be wrapped at the bottom sill and properly flashed to prevent water intrusion. This door does not appear to be properly flashed to prevent water intrusion. There is a lot of sealant at the bottom of the door in the attempt to seal this area. There are gaps in the sealant. I recommend having a contractor with knowledge of proper door flashing review this door to make appropriate repairs and prevent potential water damage.

Contact a qualified door repair/installation contractor.

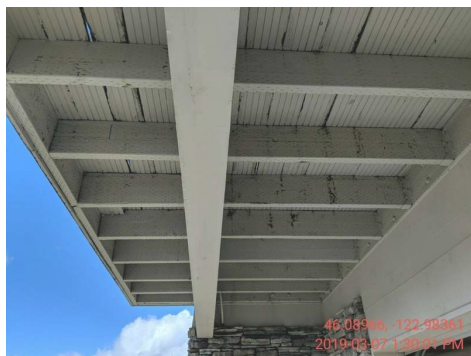
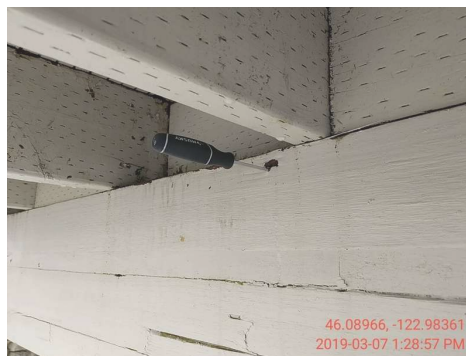
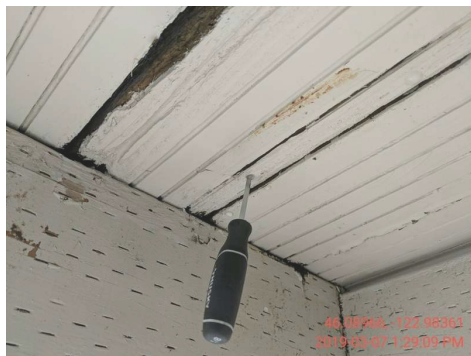
Wood decay in structure, No metal hold downs from rim joist to floor joists, Cantilevered more than 1/4 supported span

Over the years, deck construction standards have changed significantly. A deck built to standards at the time of construction may not meet current standards today. Decks, like other systems, have a lifespan, typically 10-15 years on average. The current deck building standards are outlined in the DCA 6 - Prescriptive Residential Wood Deck Construction Guide. I note multiple issues with the deck and recommend a deck contractor familiar with current standards review and correct the deck as necessary including any additional deficiencies discovered.

Contact a qualified deck contractor.

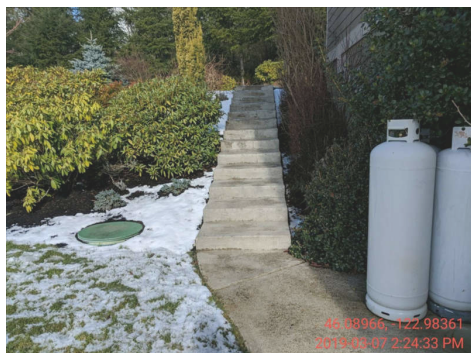
3.4.2 Decks, Balconies, Stoops, Steps, Areaways, Porches, Covers and Railings

There is no railing installed in an area in which current safety standards require a railing or guard. I recommend installation of a railing / guard in this area for safety. Stairways with 4 or more risers should have an approved graspable profile railing and balusters spaced no more than 4 inches apart if the side of the stairs is exposed to falls. Walking surfaces greater than 30 inches above the ground within 3 feet of the walking surface should have a railing installed for safety. Areas noted:

Contact a qualified deck contractor.

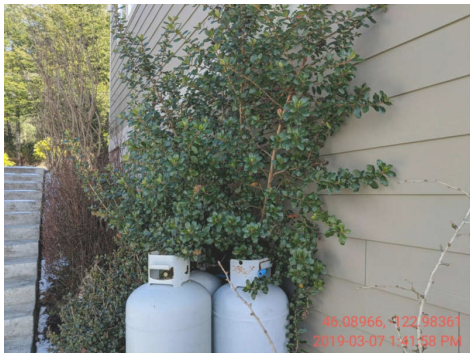
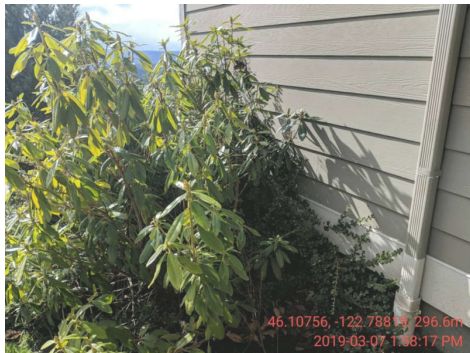
3.5.1 Vegetation, Grading, Drainage, Driveways, Patios, Walkways and Retaining Walls

TRIM VEGETATION

In some areas, there is vegetation in contact with or close to the siding. Vegetation against the siding can trap moisture against the home and facilitate pest intrusion. I recommend trimming all vegetation away from the home by at least 1-2 feet and 5 feet away from the roof to prevent damage and pest intrusion.

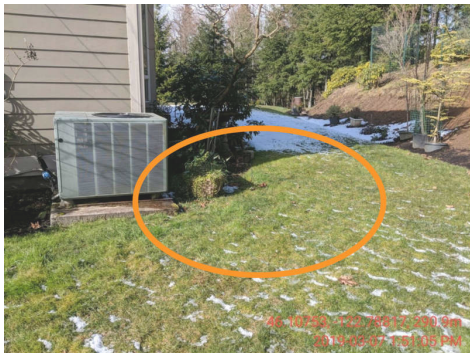
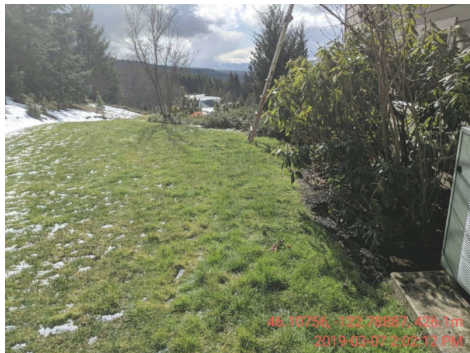
3.5.2 Vegetation, Grading, Drainage, Driveways, Patios, Walkways and Retaining Walls

SOUTHEAST, SOUTH

There is a negative slope or drainage towards the home in one or more areas. This area does not drain water away from home and needs landscaping and / or drainage corrected. Recommend any areas that slope toward the home be corrected to maintain positive drainage of water away from the home. Proper slope away from the home is 5% or 6 inches for the first ten feet of ground cover, and 1/4 inch per foot on other surfaces such as patios. If proper drainage cannot be met by landscaping, additional drainage may be necessary, and a drainage contractor should review the premises for further advice.

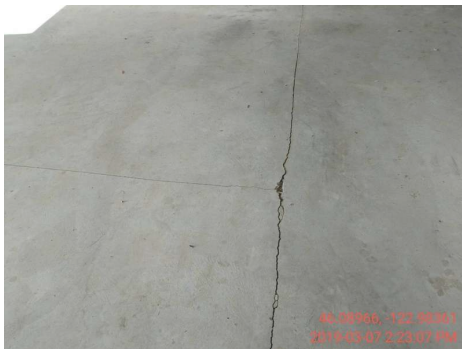
Garage Floor: Typical floor cracks

There are typical concrete shrinkage cracks in the garage floor. All concrete cracks and these look typical of garage slab shrinkage cracking. No action is necessary.

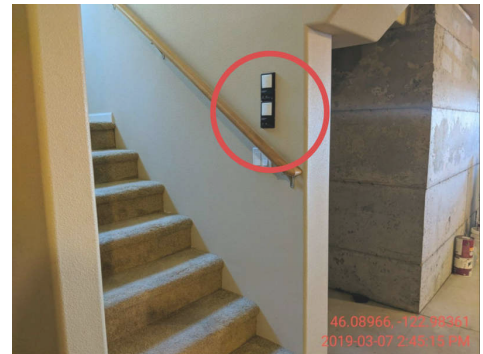
The garage door opener control is installed less than 5 feet tall above the walking surface. Manufacturers recommend installation at least 5 feet above the walking surface to avoid small children from operating the door. Have the controller raised to be at least 5 feet above walking surface.

Contact a qualified garage door contractor.

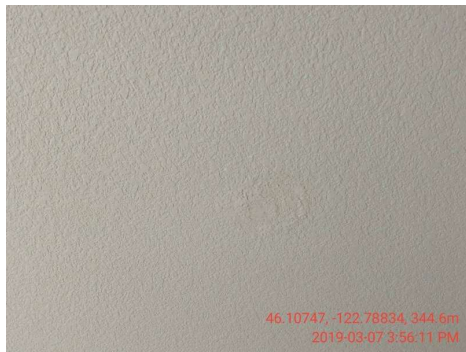
Ceilings: Repairs noted

Southeast Bedroom

Repairs are noted to the ceiling in one or more places in the home. This is for your information.

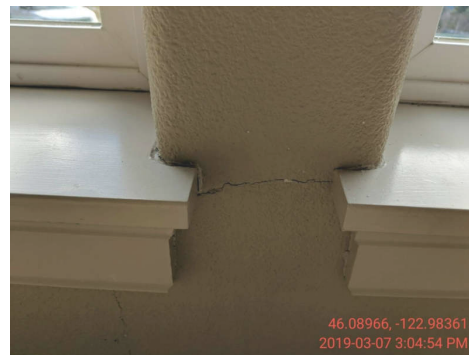
**SHEETROCK CRACKS
NORMAL**

There are some cracks in the sheetrock in the ceiling around the home. This appears to be cosmetic in nature. Recommend monitor and repair as necessary.

Contact a qualified professional.

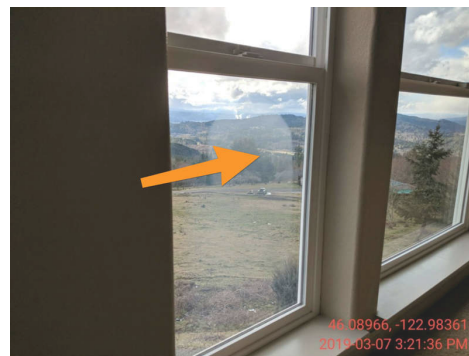
5.4.1 Windows (representative number)

Some windows around the home have a broken seal and there is some haziness between the panes. These windows still function fine as insulated windows, however, aesthetically they are not appealing and do not provide a clear view. Have them repaired or replaced by a glass contractor.

Contact a qualified window repair/installation contractor.

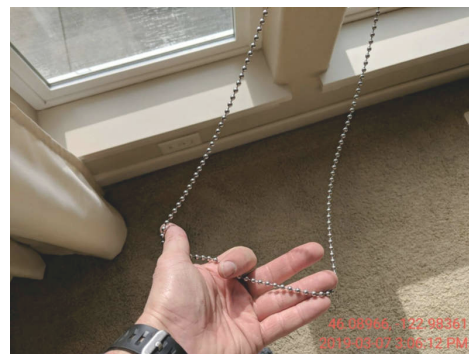
5.4.2 Windows (representative number)

BLIND CORDS CONTAIN LOOP

Some window blind cords contain loops. This is a potential strangle hazard for small children. I recommend cords that do not contain loops.

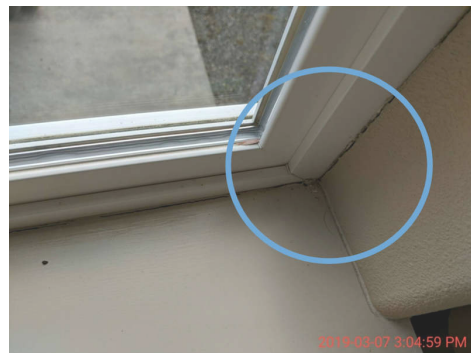
5.4.4 Windows (representative number)

One or more windows around the home where the sill has some gapping or missing sealant. Air movement can be prevented around windows with proper sealing I recommend repair / caulking.

Contact a handyman or DIY project

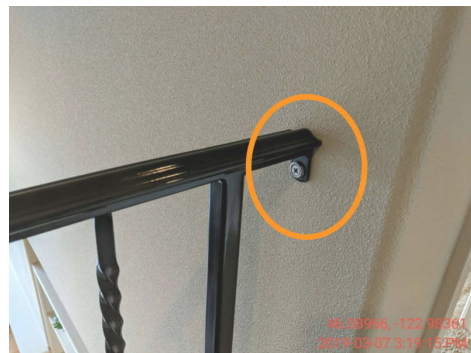
5.6.1 Steps, Stairways, Balconies and Railings

RAILING LOOSE

2ND FLOOR

The railing is loose in one or more areas. I recommend repair as necessary.

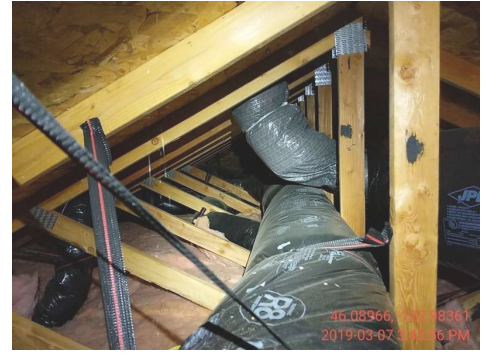
SOME ATTIC AREAS INACCESSIBLE

Not all areas of attic visible or accessible. All readily accessible areas were traversed, inspected and observations in the report include these areas. The inaccessible areas were not inspected and no observations have been reported for these areas.

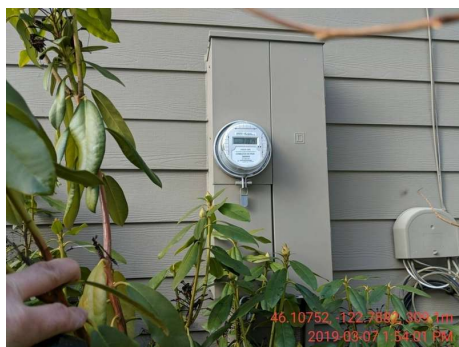
Service entrance location

Exterior of home, South

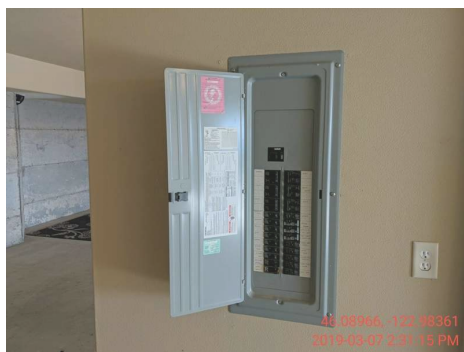
Main panel location

garage

Maintain proper clearance around electrical panels which is 30 inches wide measured either from the centerline (15 inches each way) or from one edge of the panel, 3 feet to the front of the panel, and all the way from 6 feet 6 inches high to the floor. It is important to keep this area clear for working access and for quick access in the event of an emergency.

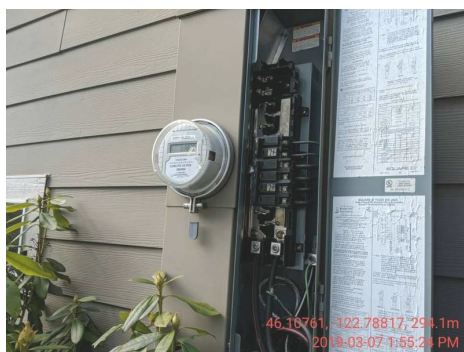
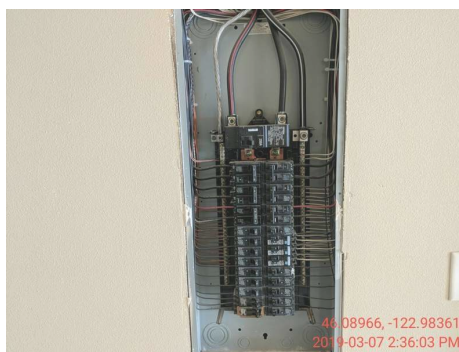
Service and Grounding Equipment, Main Overcurrent Device, Main and Distribution Panels: Inspected

The main electrical panel was inspected.

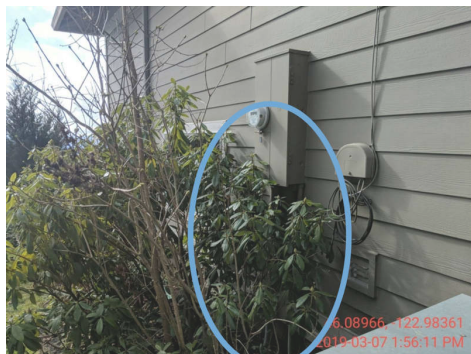
INADEQUATE PANEL CLEARANCE

Electrical panel clearance is required to be 30 inches minimum width, 3 feet to the front and extending from 6 feet 6 inches tall all the way to the floor to allow adequate working space around the electrical panel. There is inadequate clearance around the electrical panel per requirements. I recommend repair to provide proper working clearance.

Working distance around electrical panels

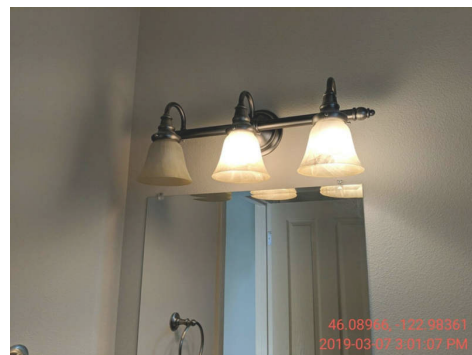
7.4.1 Connected Devices and Fixtures (Observed from a representative number on the building interior and exterior)

BATHROOM

There are one or more burned out or missing bulbs at light fixtures around the home. Try changing the bulb, and that does not work, have an electrician repair the wiring.

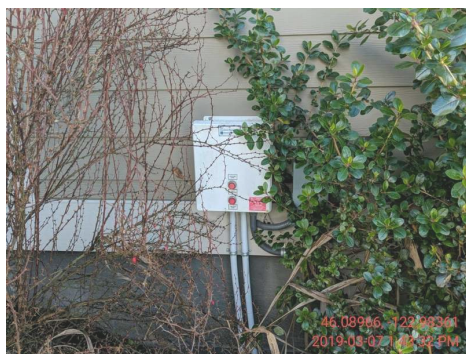
Plumbing Drain, Waste and Vent Systems: Septic alarm

There is a septic alarm for the septic system. If the system is in alarm status, you should call a septic contractor.

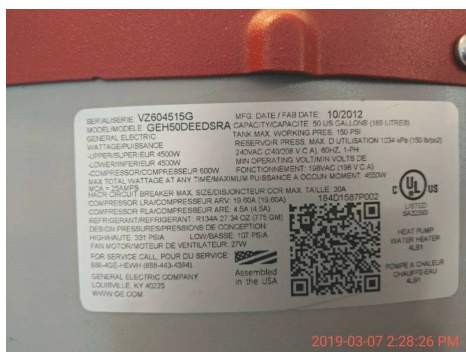
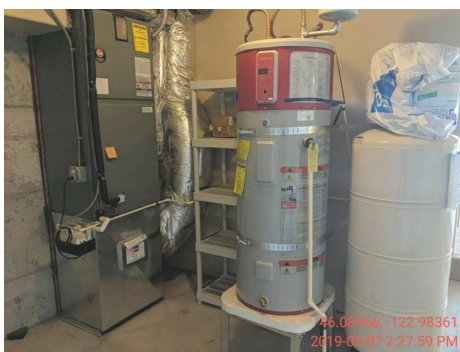
Hot Water Systems, Controls, Chimneys, Flues and Vents: Electric water heater

7 years old
There is an electric water heater installed. The typical life expectancy of water heaters is 10-12 years. You can potentially extend the life with yearly maintenance including servicing by a plumber, changing the anode rod(s), and draining the tank to help eliminate sediment.

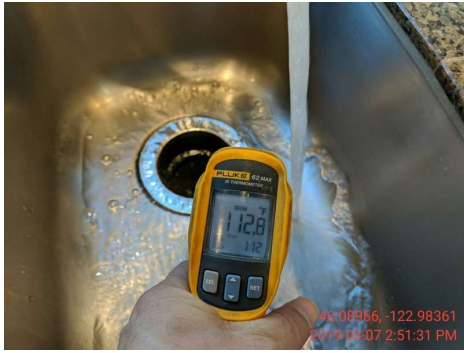
Hot Water Systems, Controls, Chimneys, Flues and Vents: Normal hot water temp

You have normal hot water temperature in the expected range of 100 - 120 Fahrenheit (F). Please note that water temperature in excess of 120 degrees F is a scalding hazard and should be avoided.

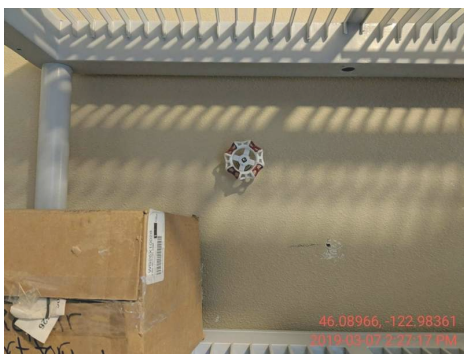
Main Water Shut-off Device (Describe location): Water shutoff location

garage

Note your main water shutoff location in case you need to quickly turn off the water in case of emergency.

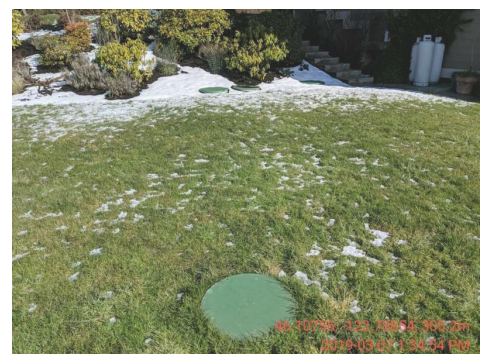
SEPTIC SYSTEM NOT INSPECTED

To note, this home appears to have a septic system. The septic system was not inspected and is outside the scope of the home inspection. I recommend you have the septic system inspected by a qualified septic contractor and serviced as recommended. I also recommend you know where the septic lid / covers are located and ensure that they always remain securely fastened or buried to avoid the possibility of children or animals falling into the septic tank. Septic tanks are particularly dangerous to children.

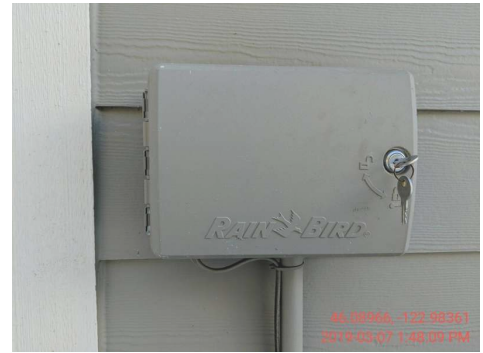
IRRIGATION SYSTEM NOT INSPECTED

The home is equipped with an irrigation system. This system is mostly underground and not visible, is beyond the scope of the home inspection, and was not inspected. I recommend an irrigation company test your irrigation system to verify it is working properly and does not have any leaks. You may also need yearly testing of the backflow prevention device by a certified tester. The [Clark County irrigation safety document](#) is a good document for your reference.

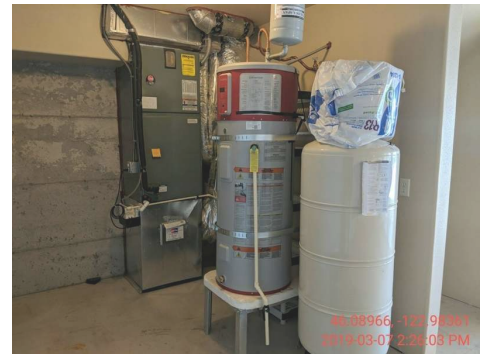
WATER WELL FURTHER INSPECTION

This house is on a well water system. The well was not inspected, and is outside of the scope of the home inspection. I recommend you have the water quality tested and flow tested, and the well inspected by a qualified contractor and serviced as recommended. I recommend asking current owner or qualified contractor to instruct you in the operation and maintenance of the well water system.

Pressure tank located in the garage.

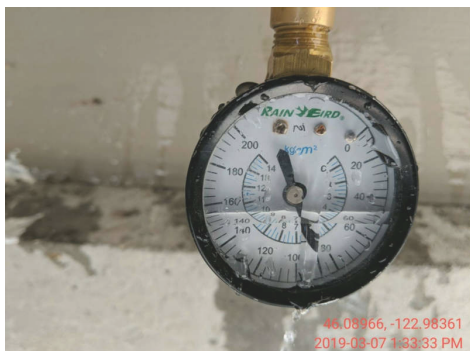
8.2.3 Plumbing Water Supply, Distribution System and Fixtures

90 PSI P

The water pressure to the home exceeds 80 psi. Recommended maximum pressure is 80 psi to prevent potential damage to internal plumbing and appliances. Recommend a qualified plumber add a pressure regulator for you to maintain water pressure at or below 80 psi. Current pressure approximately:

Contact a qualified plumbing contractor.

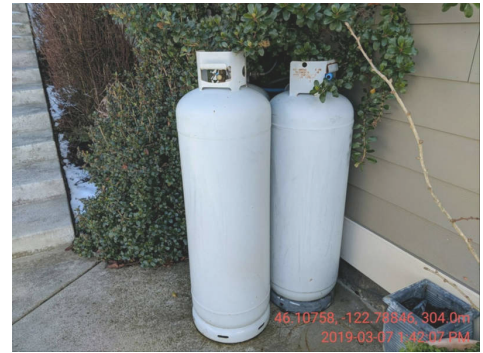
8.5.2 Fuel Storage and Distribution Systems (Interior fuel storage, piping, venting, supports, leaks)

It is only allowed to store up to 120 gallons of propane next to the home. Do not exceed this amount 4 recommended safety guidelines.

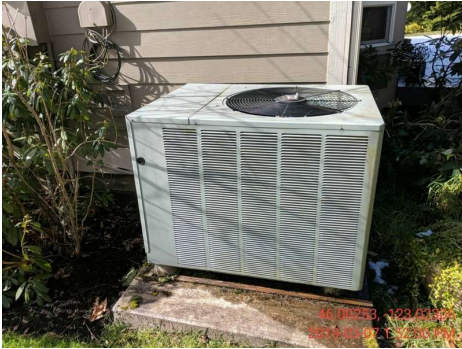
Heating Equipment: Heat pump

This house has a heat pump for the main source of heating. Life expectancy of heat pumps is statistically about 15 years. The temperatures were checked at the house registers in heat pump heating mode and found to be within normal operating range. I recommend servicing by an HVAC technician yearly. According to the serial number, your unit is approximately: 13 years

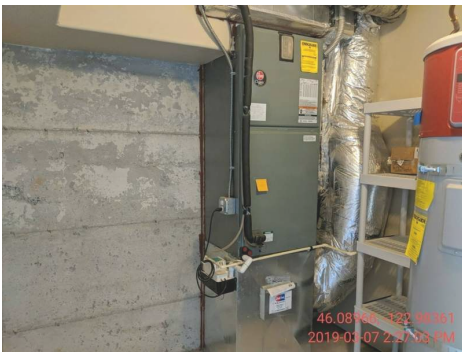
Heating Equipment: Electric furnace

This furnace unit is an electric forced air furnace. Typical life span furnaces is 15 - 20 years. You can identify potential problems and extend the life of your furnace with regular servicing from an HVAC technician. The age of your furnace according to the manufacturer data plate or serial number is:

The furnace operated using thermostat controls

The output temperature at the register was within normal expected temperature rise for an electric furnace.

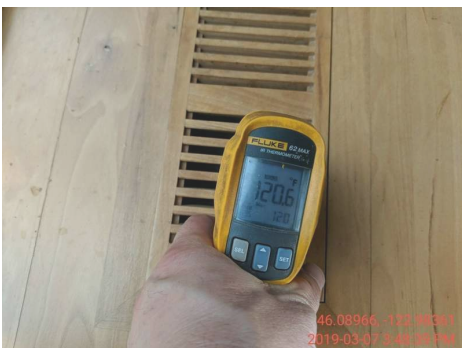
Heating Equipment: Heat pump normal temp

The heat pump was operated using thermostat controls and the output temperature at the register was within normally expected temperature ranges for a heat pump.

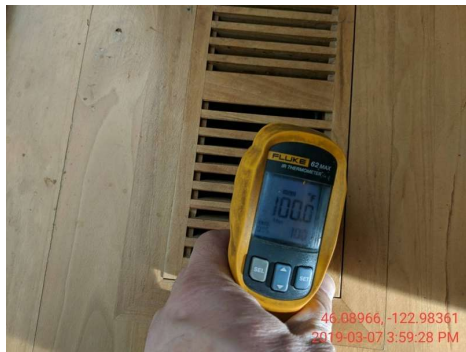
Heating Equipment: Backup emergency heat normal temp

The heat pump system was operated in backup emergency electric furnace heat mode, responded normally to thermostat input and temperatures at the register were in the normal expected range.

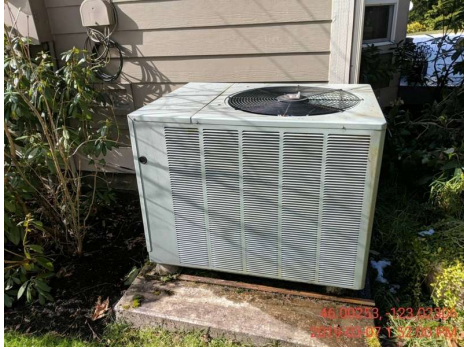
The home has an air conditioner installed. Typical life expectancy of a compressor is 12-15 years. This appliance, according to manufacturer serial numbers or data plate information is approximately: 13 years

I recommend yearly servicing by an HVAC technician.

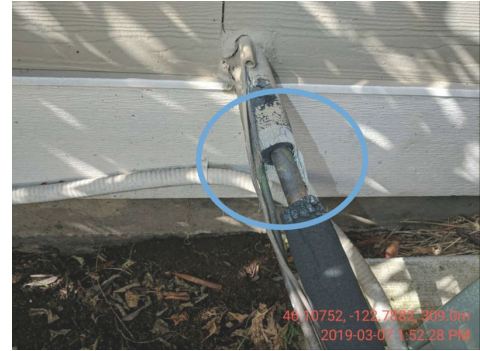
MISSING DAMAGED FOAM

SOUTH AT HEAT PUMP

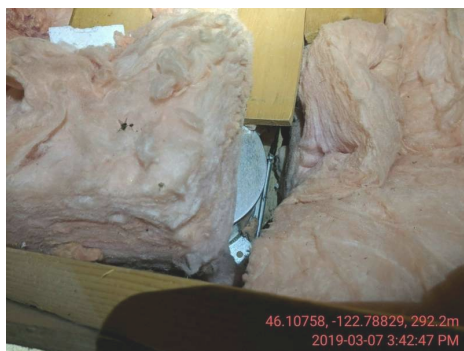
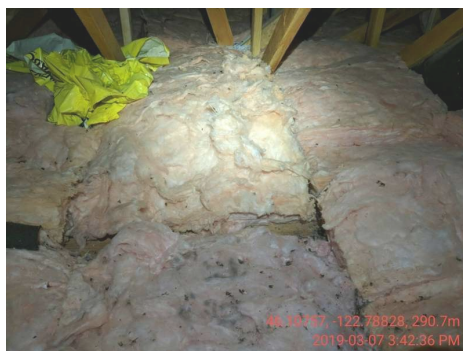
Insulation in Attic: Fiberglass batt insulation has gaps

The fiberglass batt insulation in the attic has some gaps and areas where the fiberglass does not cover the ceiling well. It would be a bump in efficiency to have some blown fiberglass insulation installed to help eliminate the gaps and voids which is very difficult to avoid with fiberglass batts

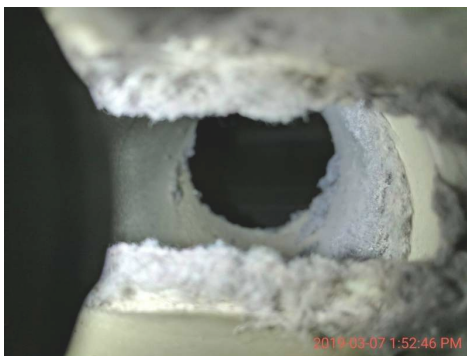
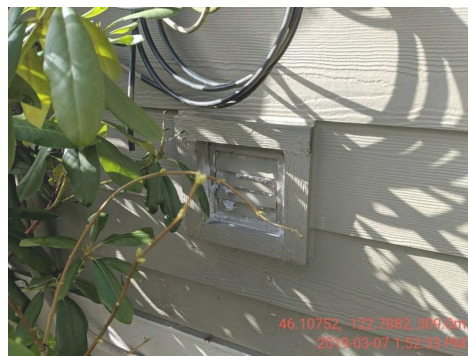
There is lint buildup in the dryer exhaust duct work. I recommend having the dryer duct cleaned. Too much lint buildup is a fire hazard.

Recommendation

Contact a qualified professional.

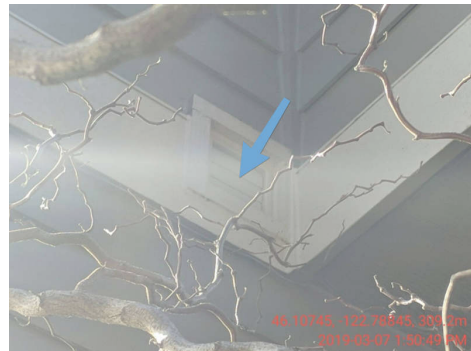
SOUTHEAST

The exhaust vent louvers are painted or stuck shut I need to be freed to operate normally and allow adequate air flow from the exhaust fans.

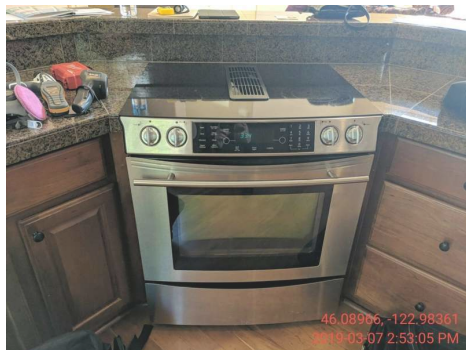
Ranges/Ovens/Cooktops: Aged range

The range/stove is an aged appliance, and due to it's age, and I recommend budgeting for a new unit.
